## JOURNEY RISK MANAGEMENT (JRM) STUDY

### Salem Terminal TO SRI MURUGAN AGENCIES UNIT II

**Route Safety Analysis from Sangagiri to Vennamalaipatty  
Railway Bridge, Karur**

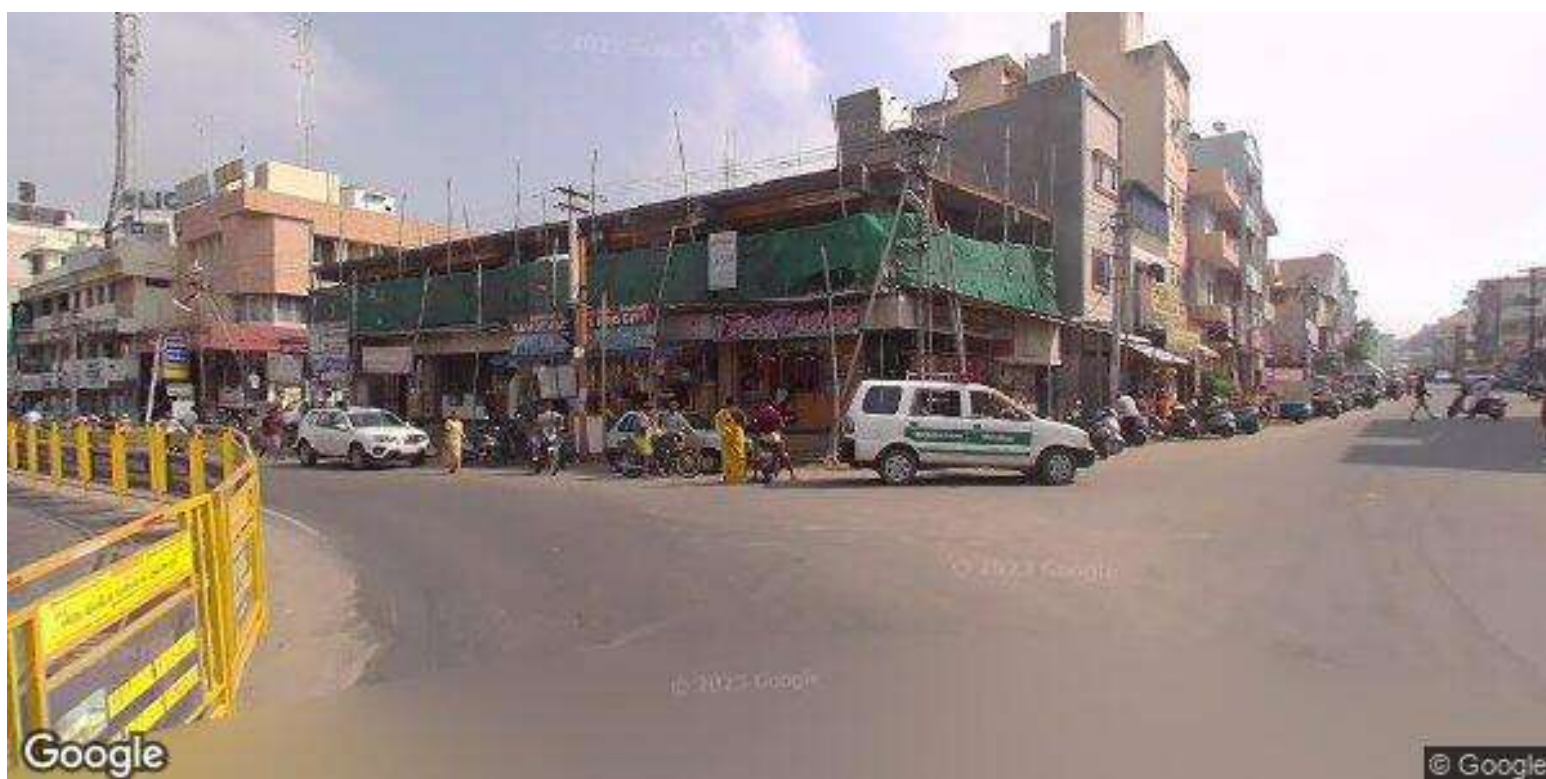
**Coordinates:** 11.37868, 77.89498

**Risk Type:** Turn

**Risk Level:** High

**Speed Limit:** 15 KM/Hr

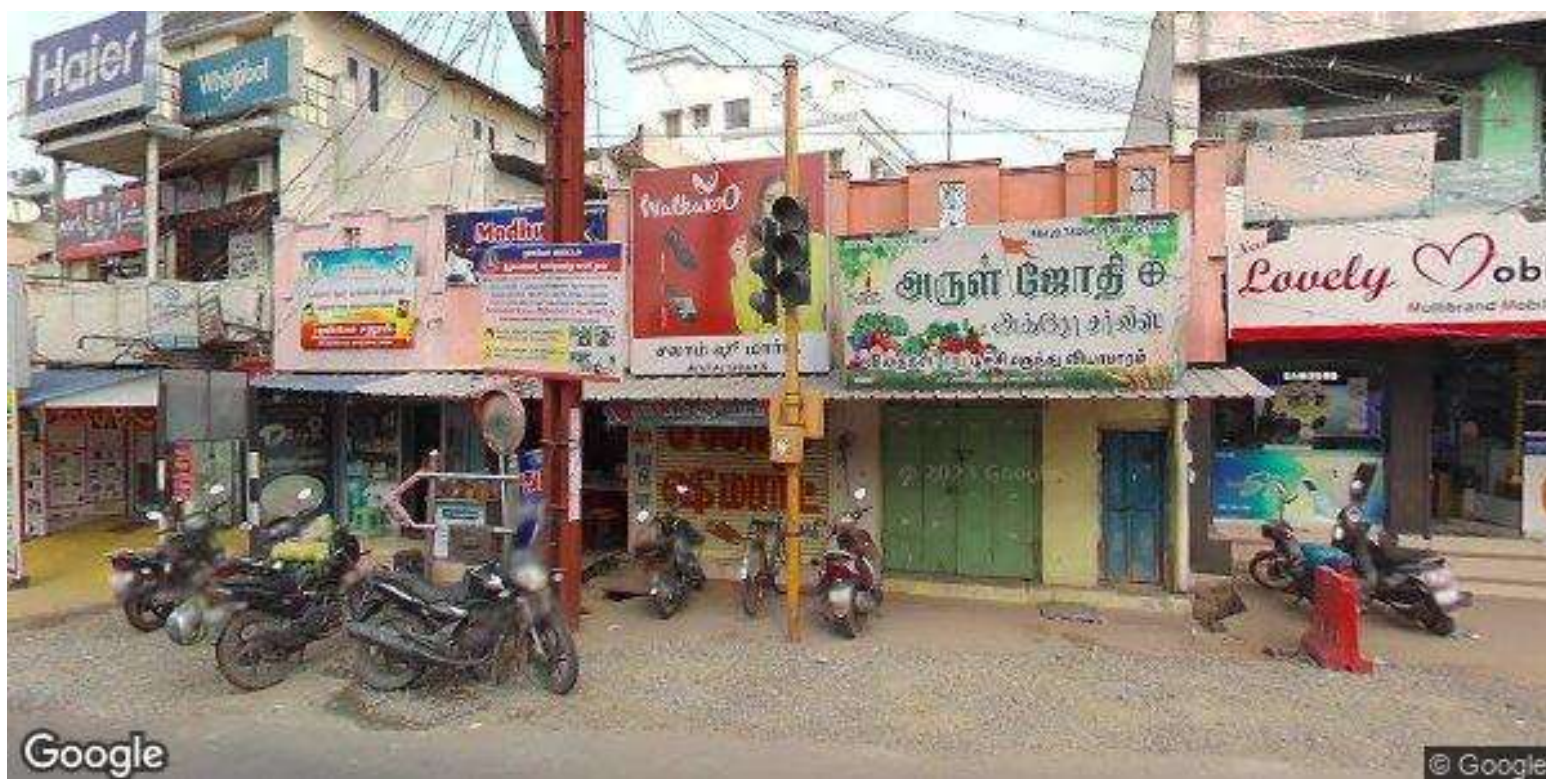
**Risk Type:** Turn  
**Risk Level:** High  
**Speed Limit:** 15 KM/Hr  
**Coordinates:** 11.37850, 77.89453

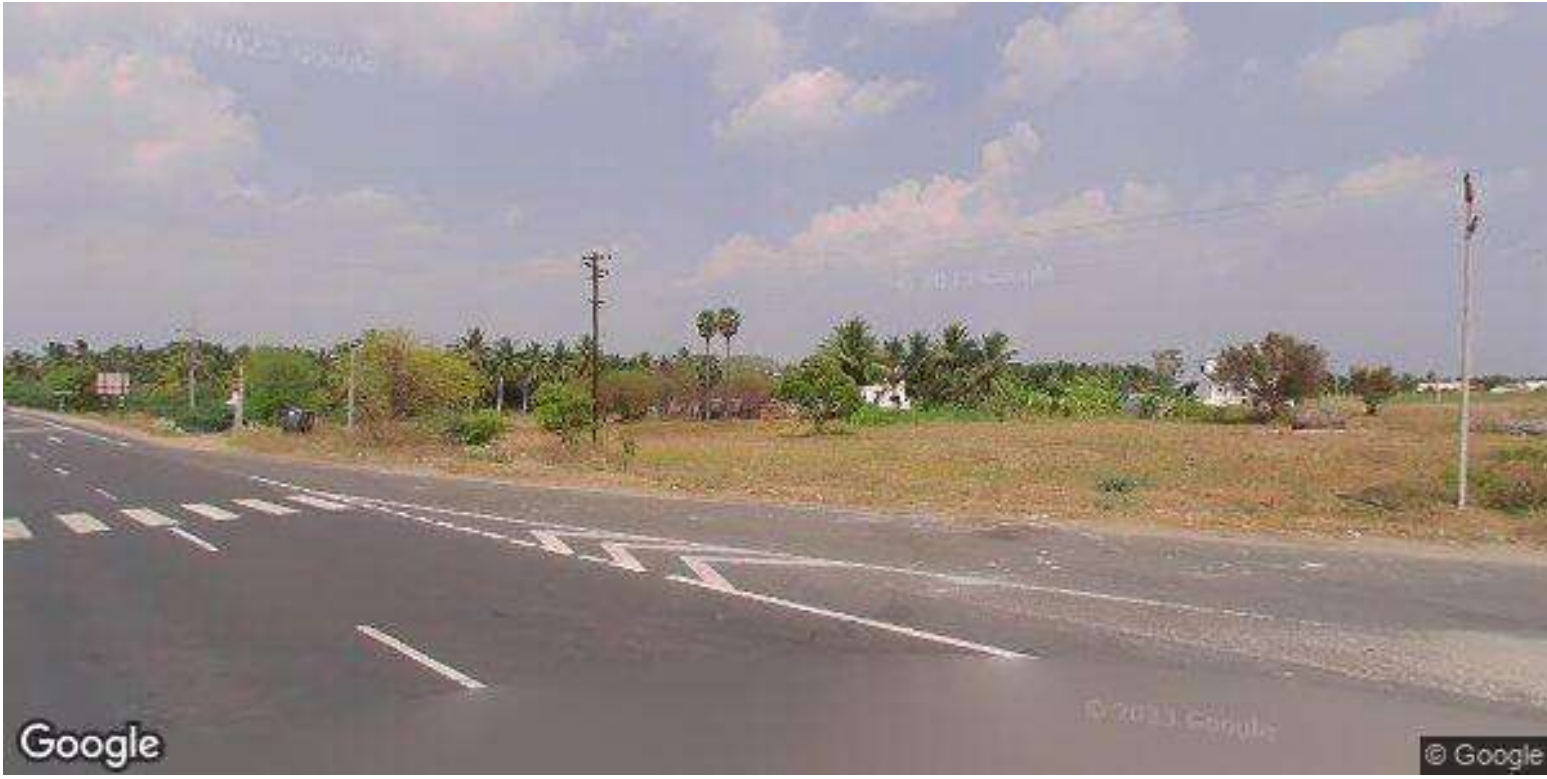
**Risk Type:** Turn  
**Risk Level:** High  
**Speed Limit:** 15 KM/Hr  
**Coordinates:** 11.14480, 78.02291
