# IndianOil

## JOURNEY RISK MANAGEMENT (JRM) STUDY

### Salem Terminal to SREE VARI FUELS

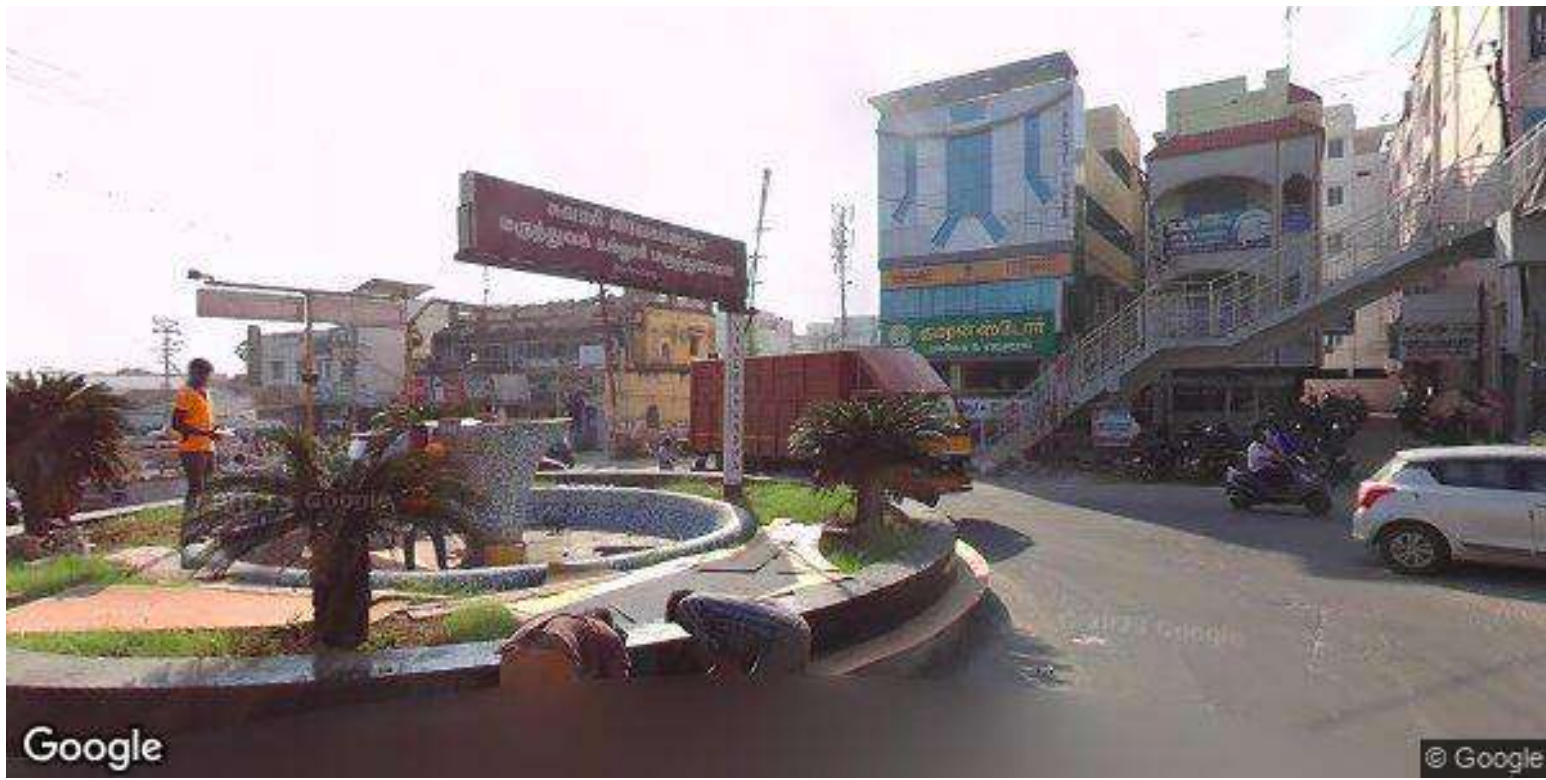
**Coordinates:** 11.38395, 77.89480

| | Risk Type | Risk Level | Coordinates | Speed Limit |
|---|---|---|---|---|
| 0 | Roundabout | High | 11.38395, 77.89480 | 15 KM/Hr |

**Risk Type:** Roundabout

**Risk Level:** High

**Speed Limit:** 15 KM/Hr

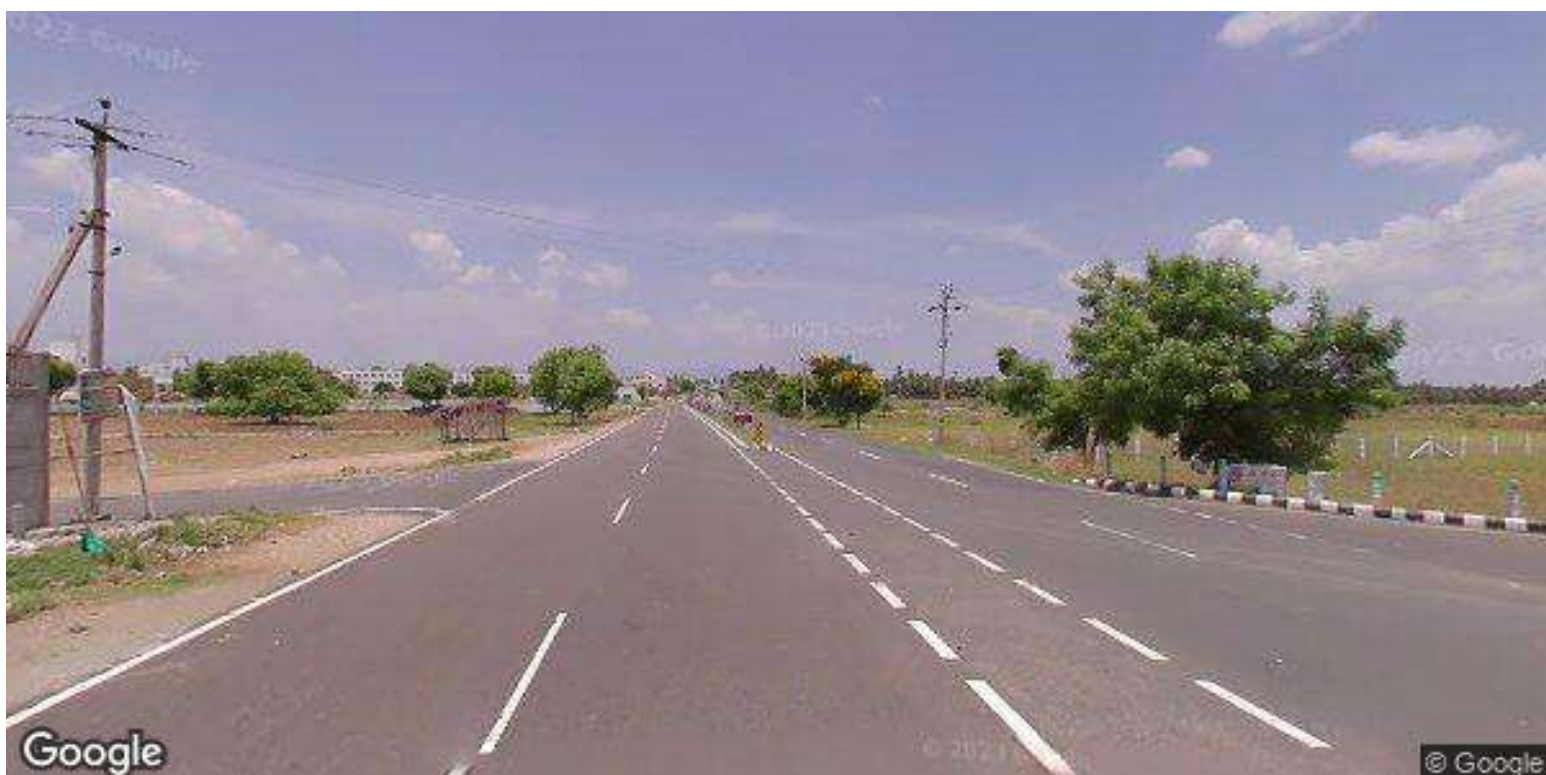
| | Risk Type | Risk Level | Coordinates | Speed Limit |
|---|---|---|---|---|
| 6 | Blind Spot | Blind Spot | 11.29183, 78.05599 | 10 KM/Hr |

**Risk Type:** Blind Spot  
**Risk Level:** Blind Spot  
**Speed Limit:** 10 KM/Hr  
**Coordinates:** 11.29183, 78.05599

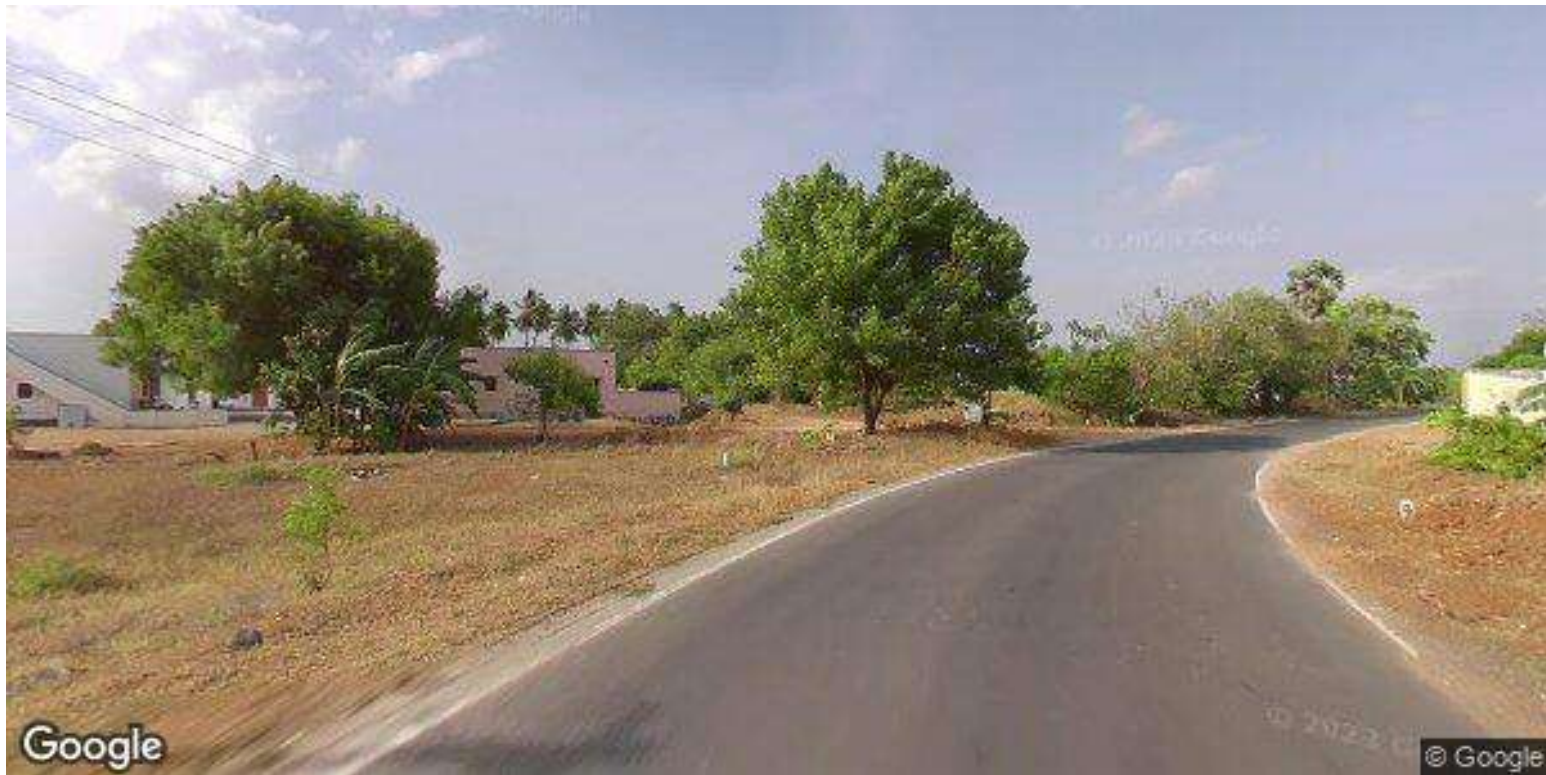
| | Risk Type | Risk Level | Coordinates | Speed Limit |
|---|---|---|---|---|
| 7 | Turn | Medium | 11.28990, 78.05311 | 30 KM/Hr |

**Risk Type:** Turn  
**Risk Level:** Medium  
**Speed Limit:** 30 KM/Hr  
**Coordinates:** 11.28990, 78.05311

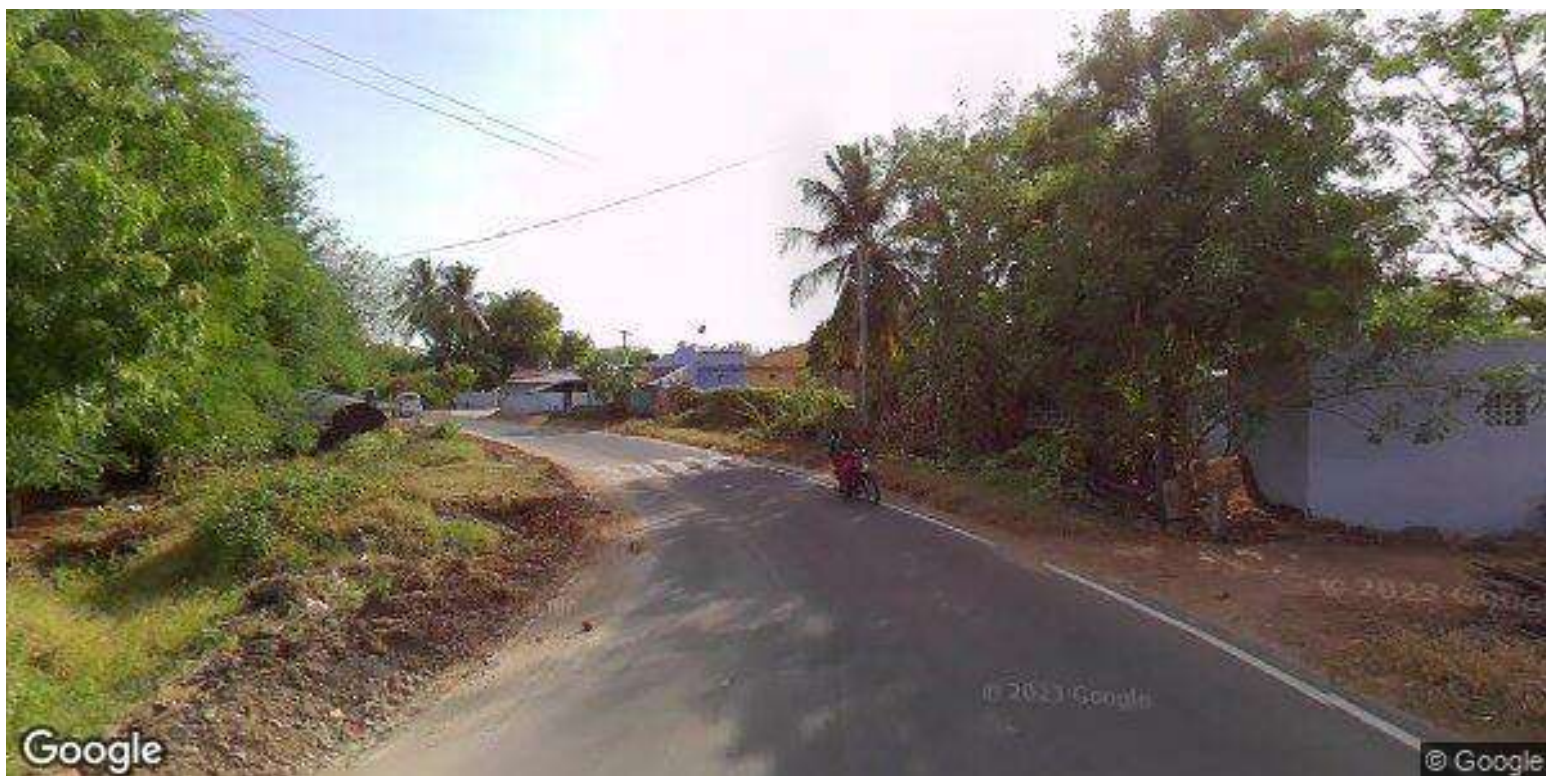
| | Risk Type | Risk Level | Coordinates | Speed Limit |
|---|---|---|---|---|
| 8 | Turn | Medium | 11.29044, 78.04863 | 30 KM/Hr |

**Risk Type:** Turn  
**Risk Level:** Medium  
**Speed Limit:** 30 KM/Hr  
**Coordinates:** 11.29044, 78.04863

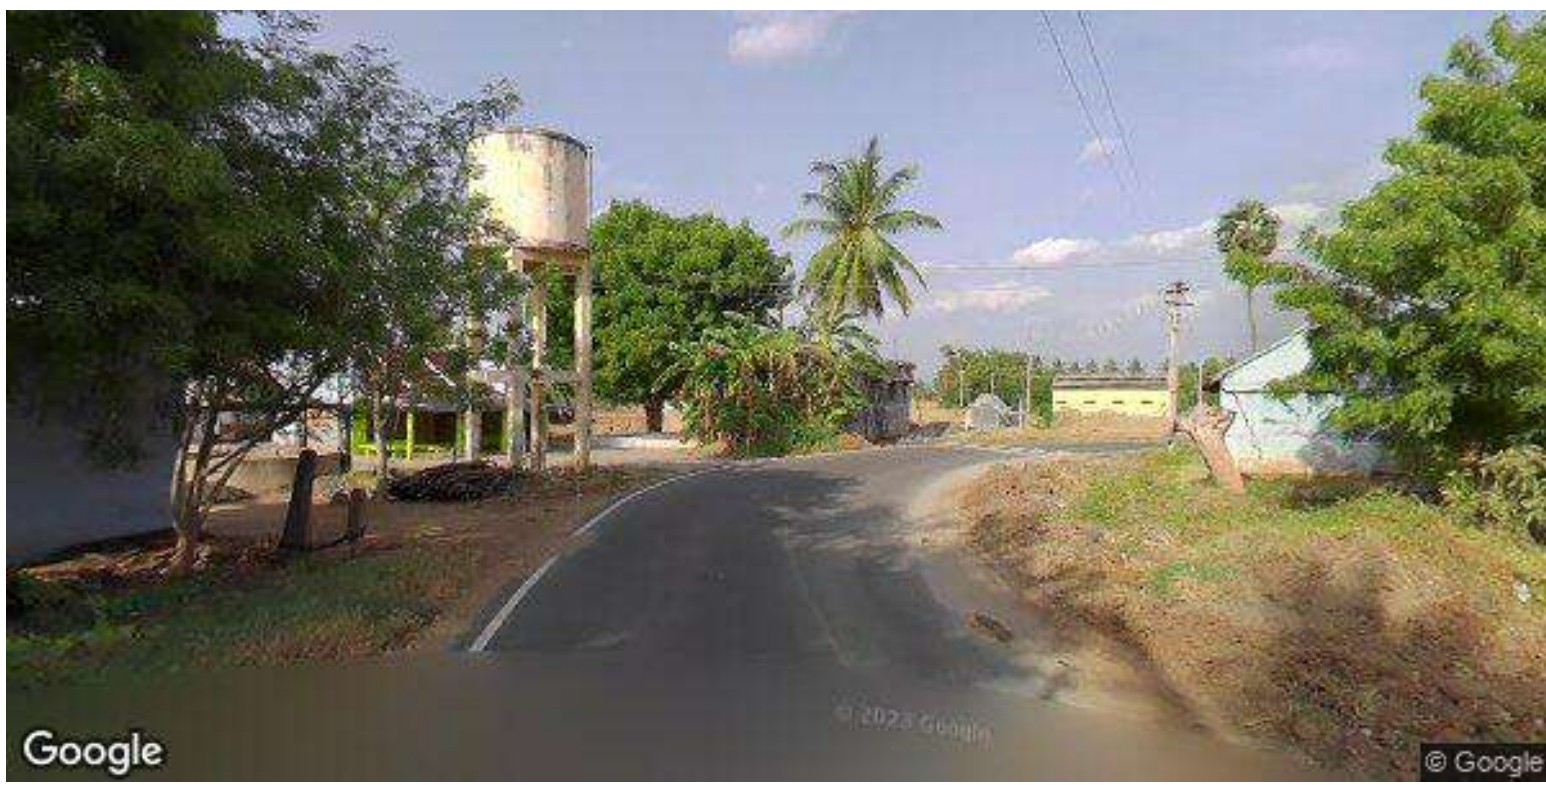
**Coordinates:** 11.29043, 78.04848

| | Risk Type | Risk Level | Coordinates | Speed Limit |
|---|---|---|---|---|
| 9 | Turn | Medium | 11.29043, 78.04848 | 30 KM/Hr |

**Risk Type:** Turn

**Risk Level:** Medium

**Speed Limit:** 30 KM/Hr
