# IndianOil

## JOURNEY RISK MANAGEMENT (JRM) STUDY

### Salem Terminal to ANNAMAR AGENCIES

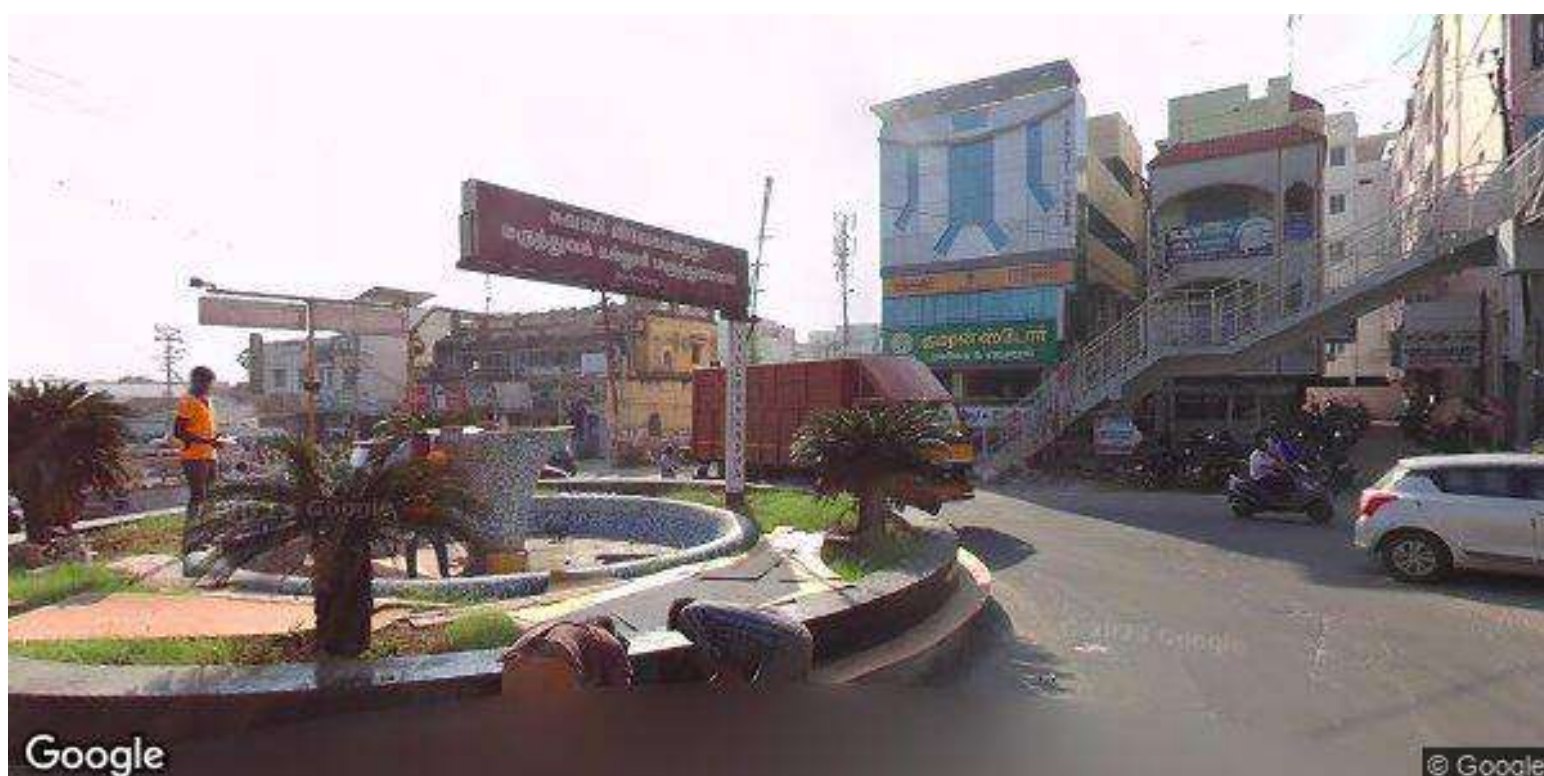
**Coordinates: 11.38395, 77.89480**

**Risk Type: Roundabout**

**Risk Level: High**

**Speed Limit: 15 KM/Hr**

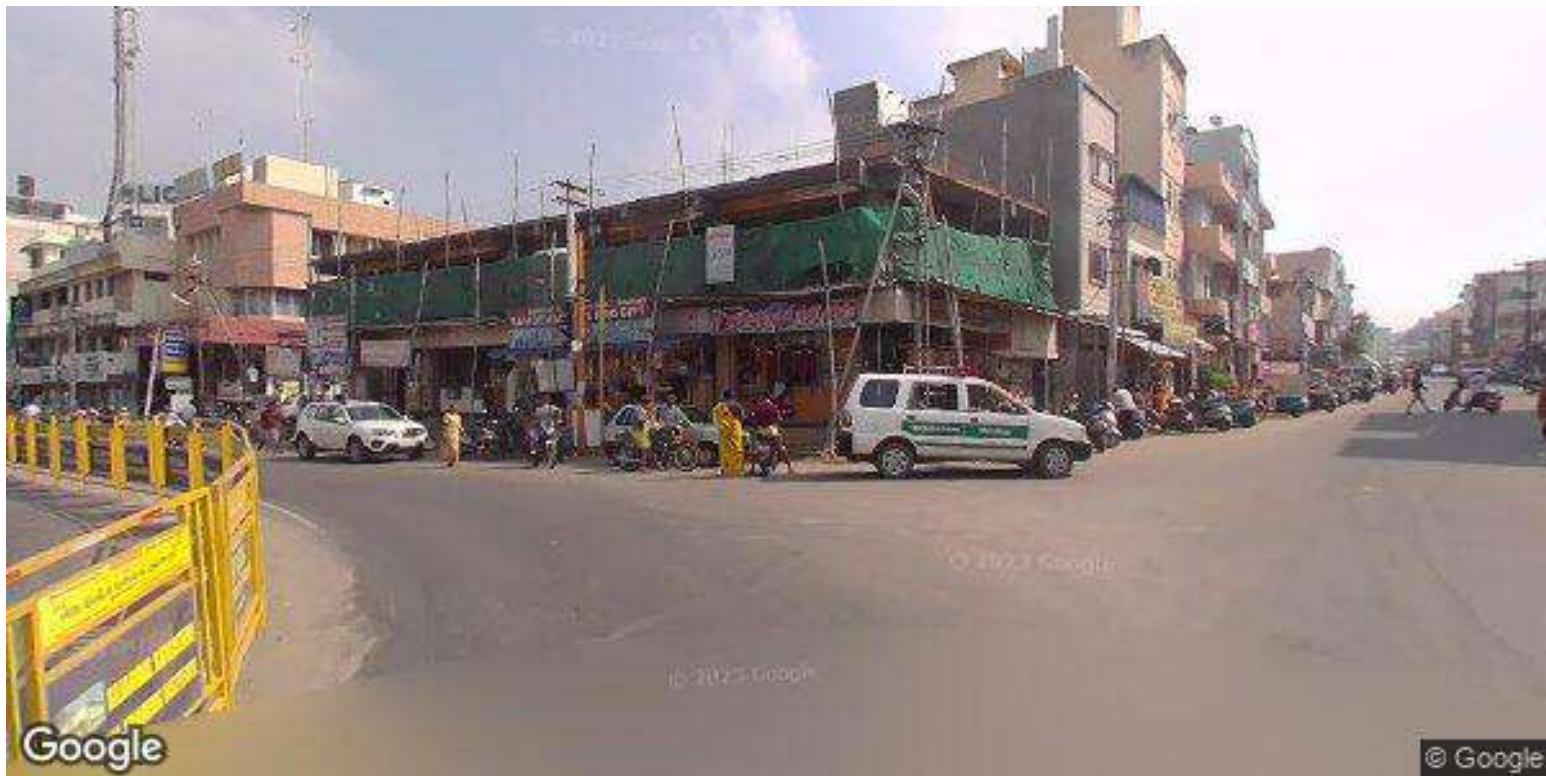
**Coordinates: 11.37868, 77.89498**

**Risk Type: Turn**

**Risk Level: High**

**Speed Limit: 15 KM/Hr**

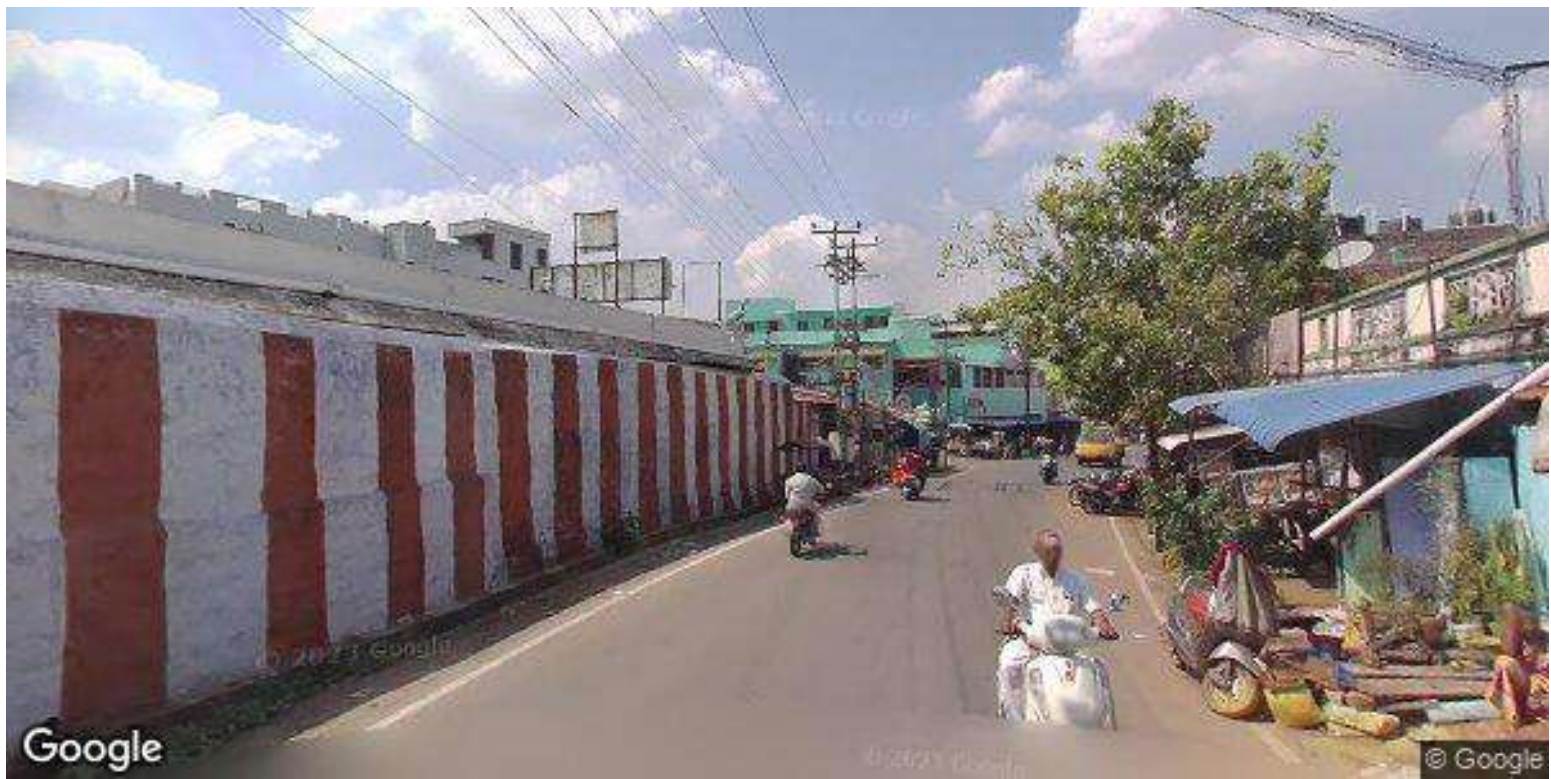
**Coordinates:** 11.37809, 77.89834

**Risk Type:** Turn

**Risk Level:** Medium

**Speed Limit:** 30 KM/Hr

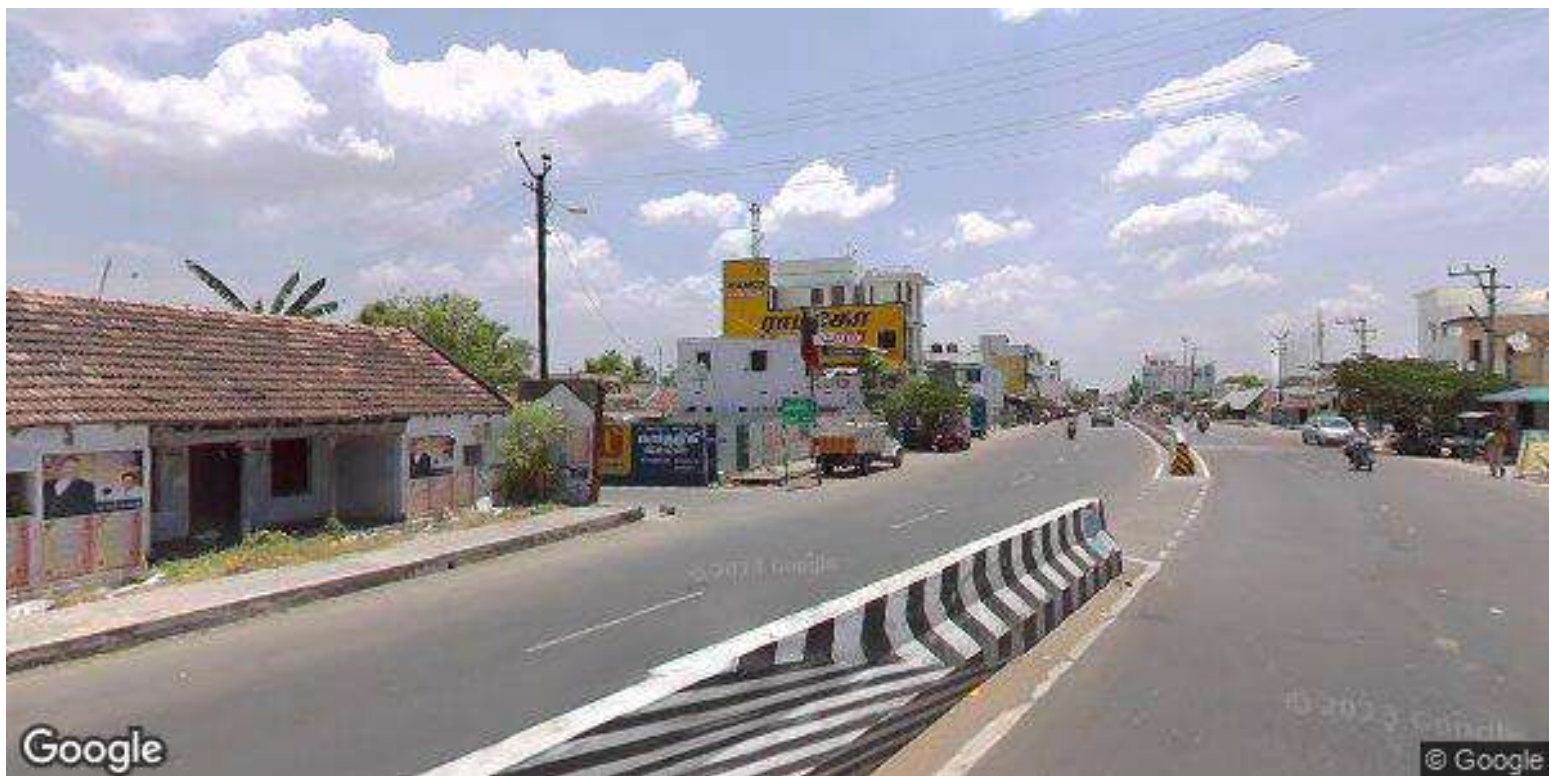
**Coordinates:** 11.23746, 78.15041

**Risk Type:** Turn

**Risk Level:** Medium

**Speed Limit:** 30 KM/Hr

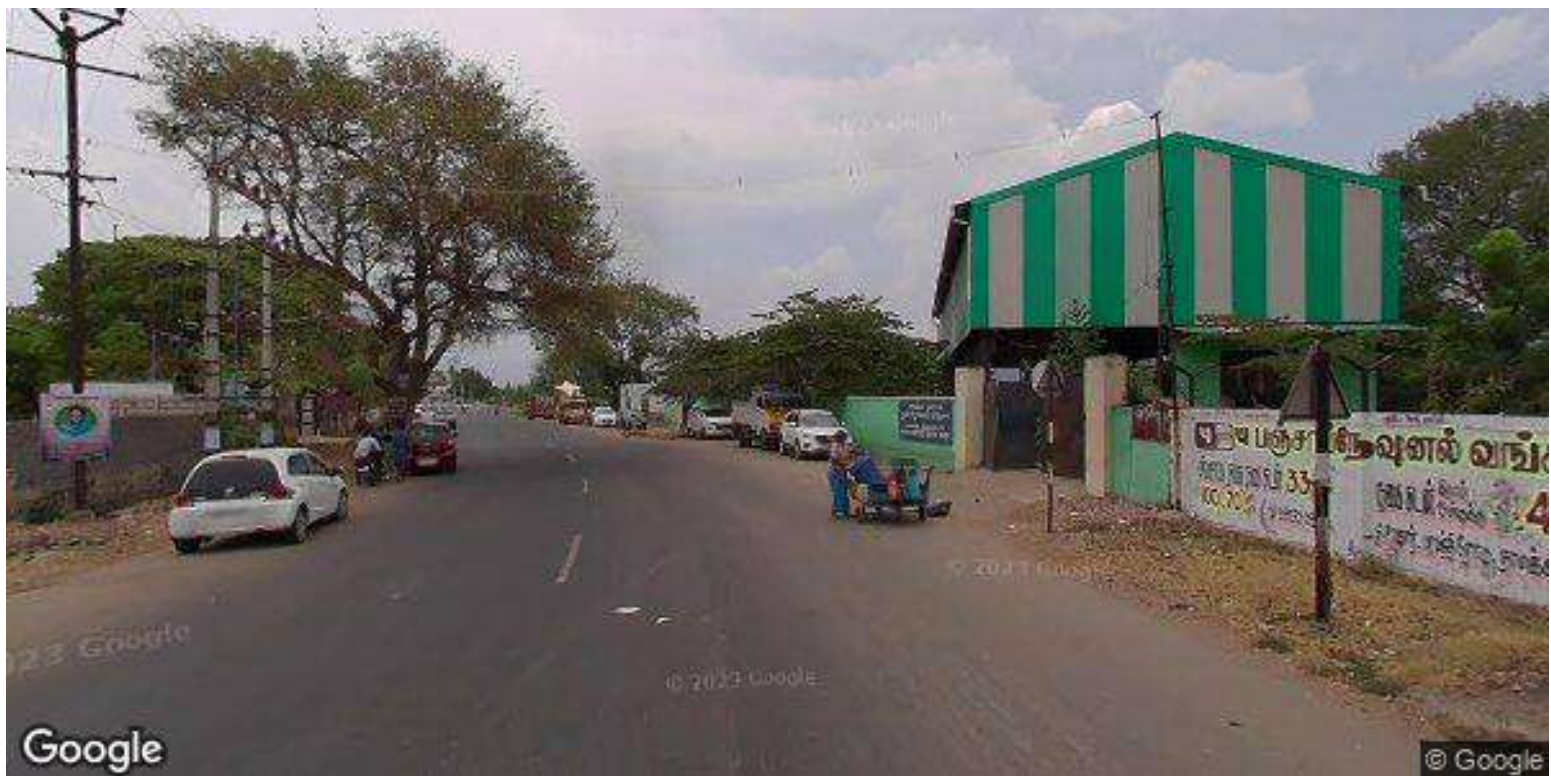
**Risk Type:** Turn  
**Risk Level:** Medium  
**Speed Limit:** 30 KM/Hr  
**Coordinates:** 11.22410, 78.17210

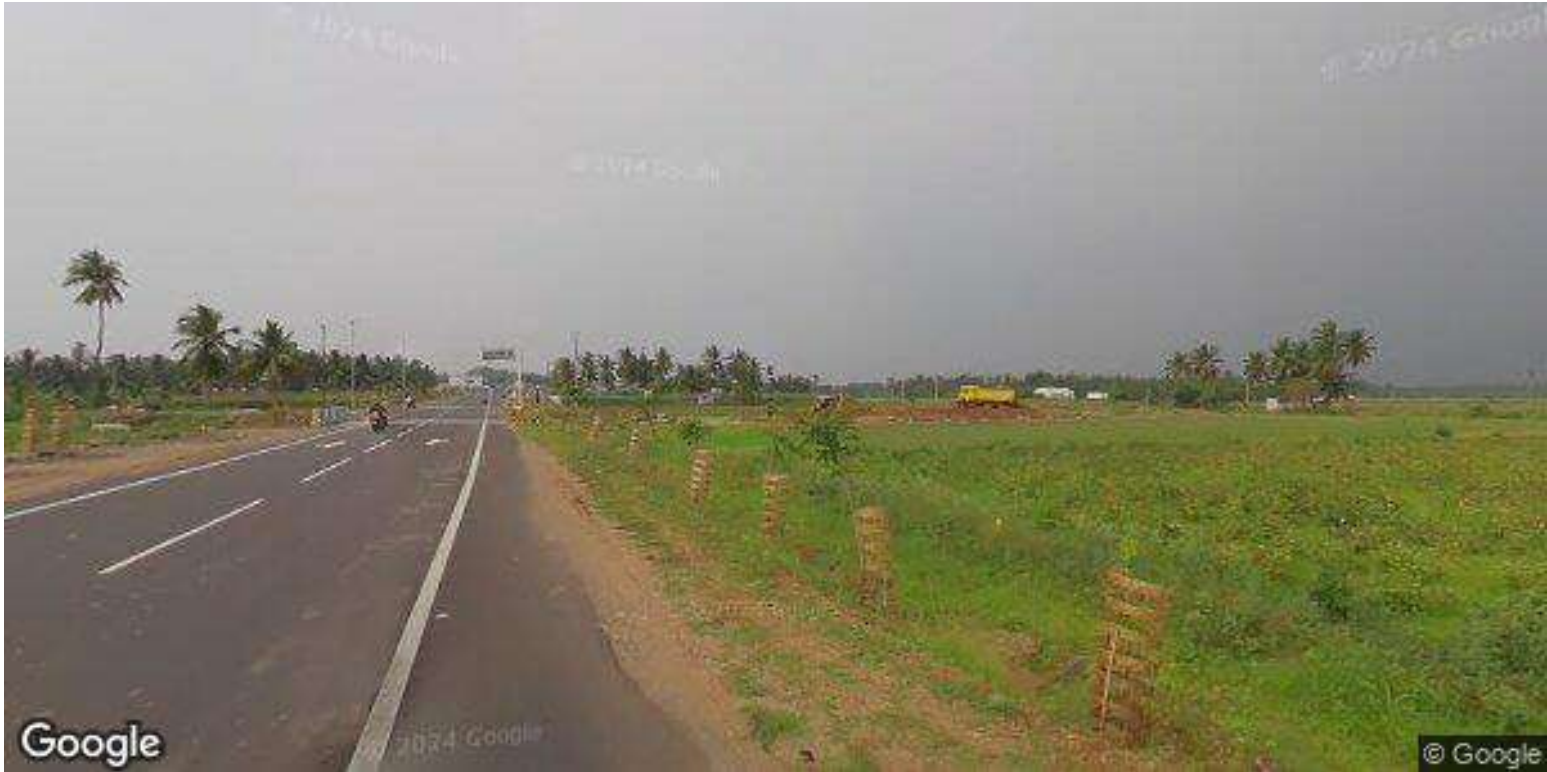
**Risk Type:** Blind Spot  
**Risk Level:** Blind Spot  
**Speed Limit:** 10 KM/Hr  
**Coordinates:** 11.24309, 78.23751

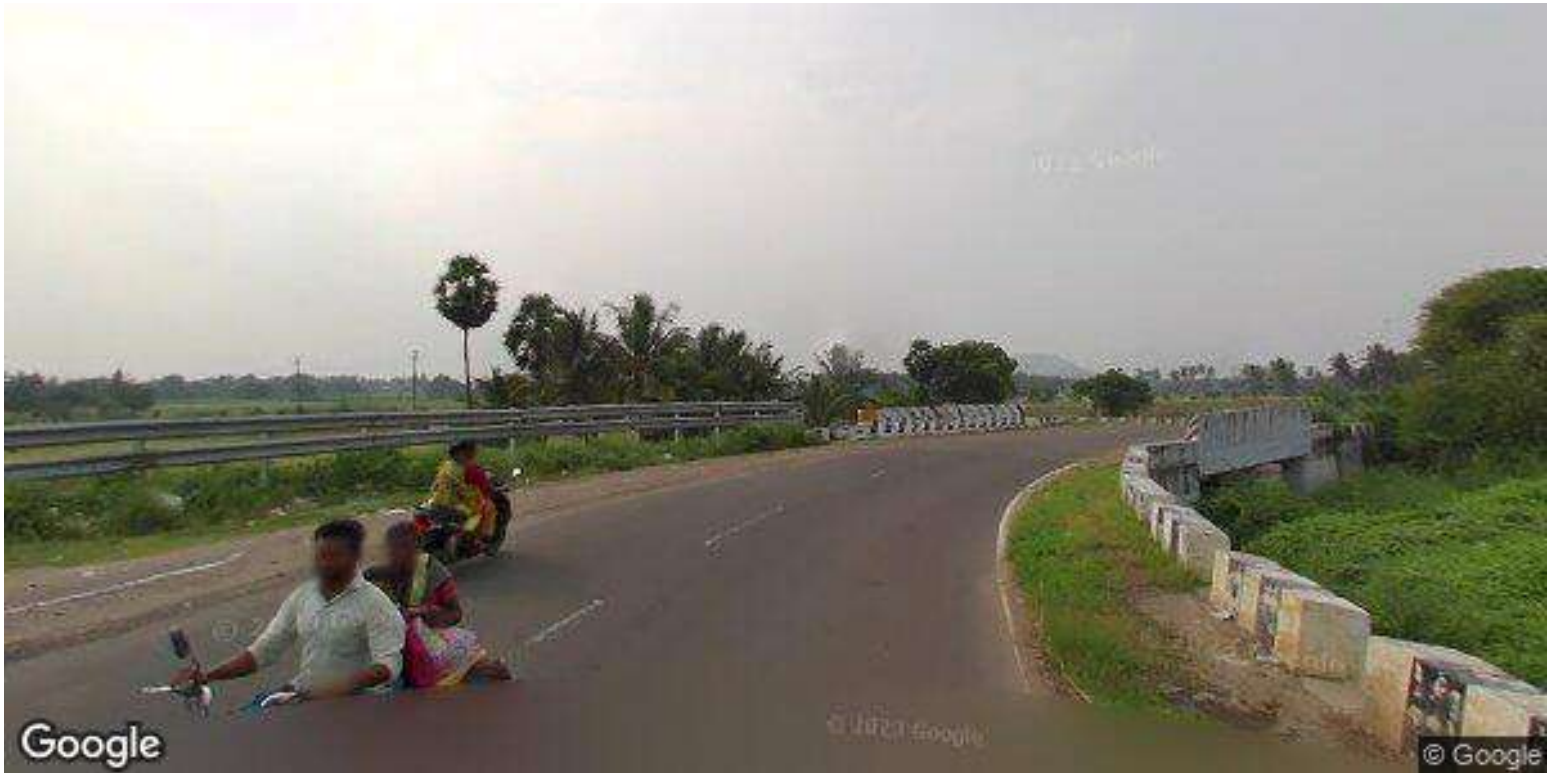
**Risk Type:** Turn  
**Risk Level:** High  
**Speed Limit:** 15 KM/Hr  
**Coordinates:** 11.23967, 78.23801

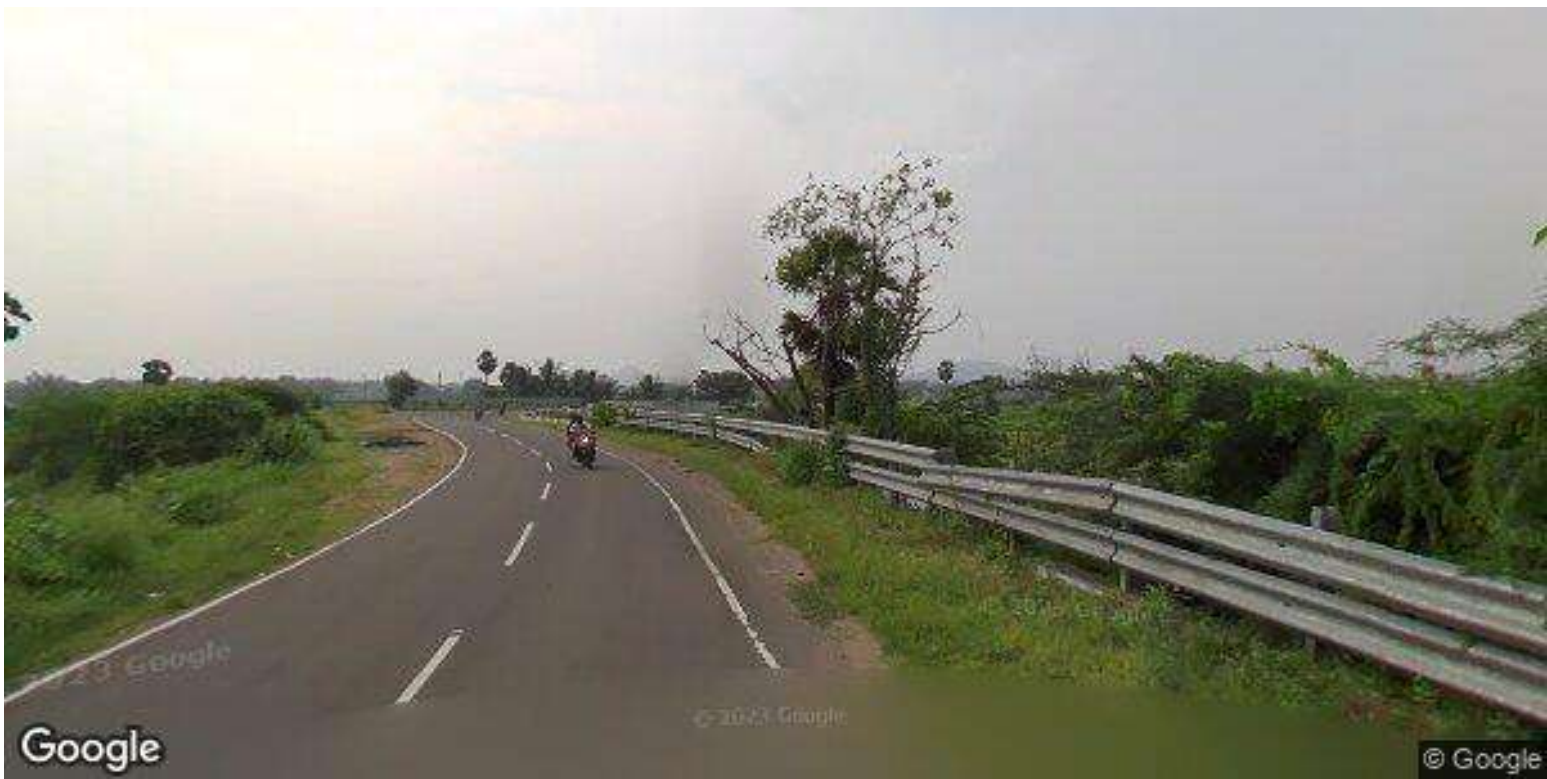
**Coordinates:** 11.23939, 78.23885

**Risk Type:** Turn

**Risk Level:** Medium

**Speed Limit:** 30 KM/Hr

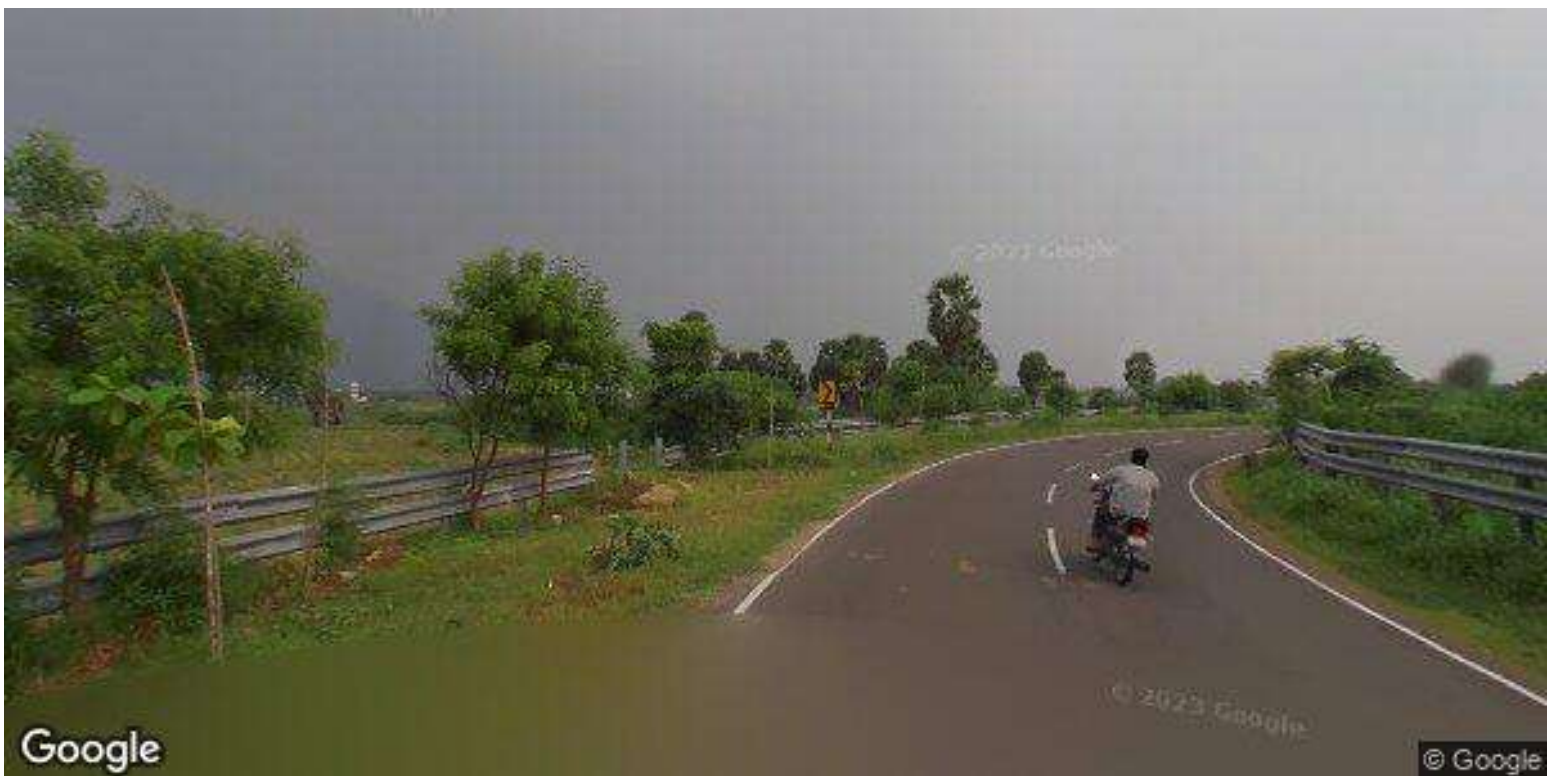
**Coordinates:** 11.23898, 78.23928

**Risk Type:** Turn

**Risk Level:** Medium

**Speed Limit:** 30 KM/Hr

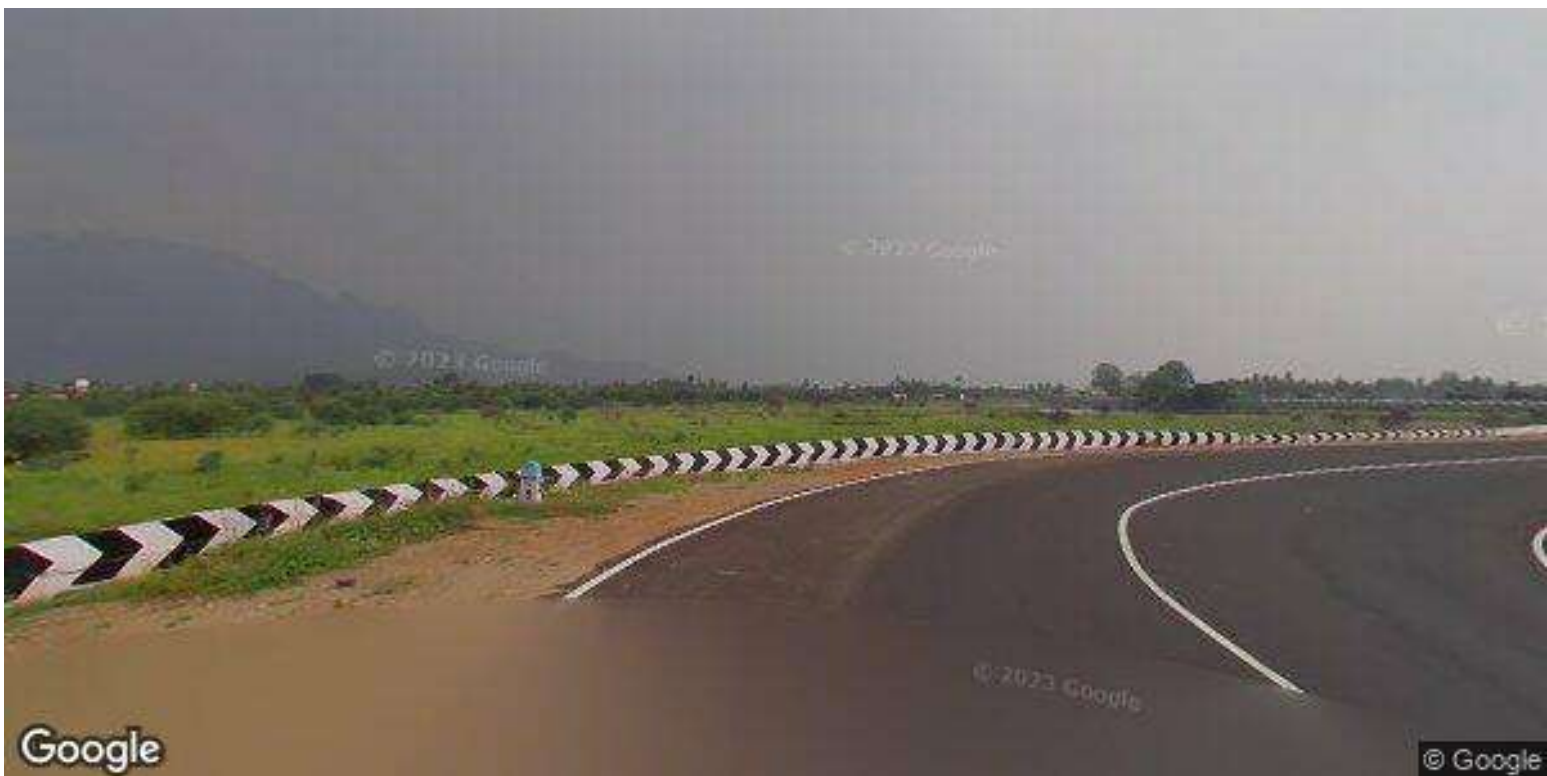
**Coordinates: 11.23506, 78.24036**

**Risk Type: Turn**

**Risk Level: High**

**Speed Limit: 15 KM/Hr**

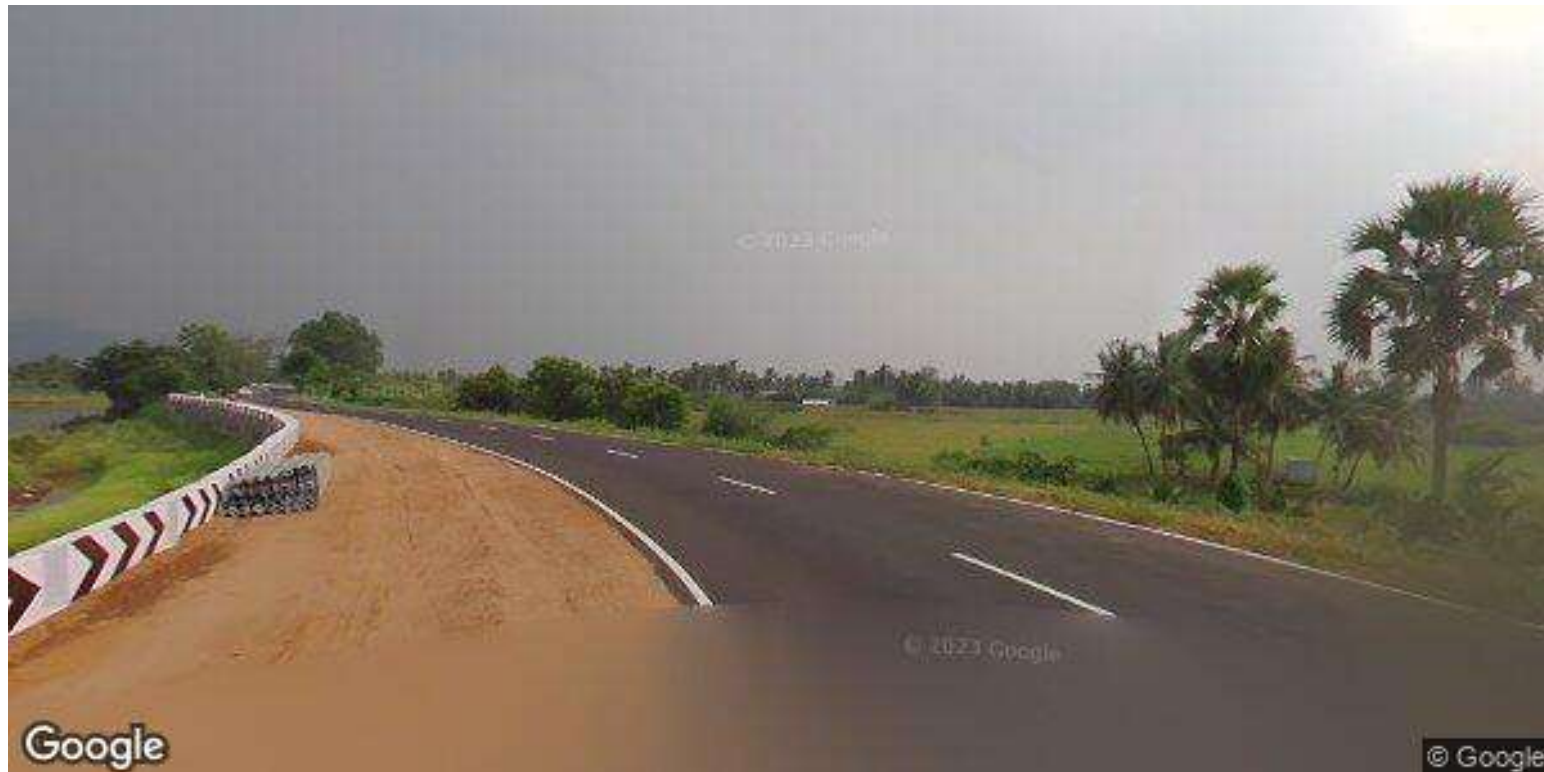
**Coordinates: 11.23265, 78.23980**

**Risk Type: Turn**

**Risk Level: Medium**

**Speed Limit: 30 KM/Hr**

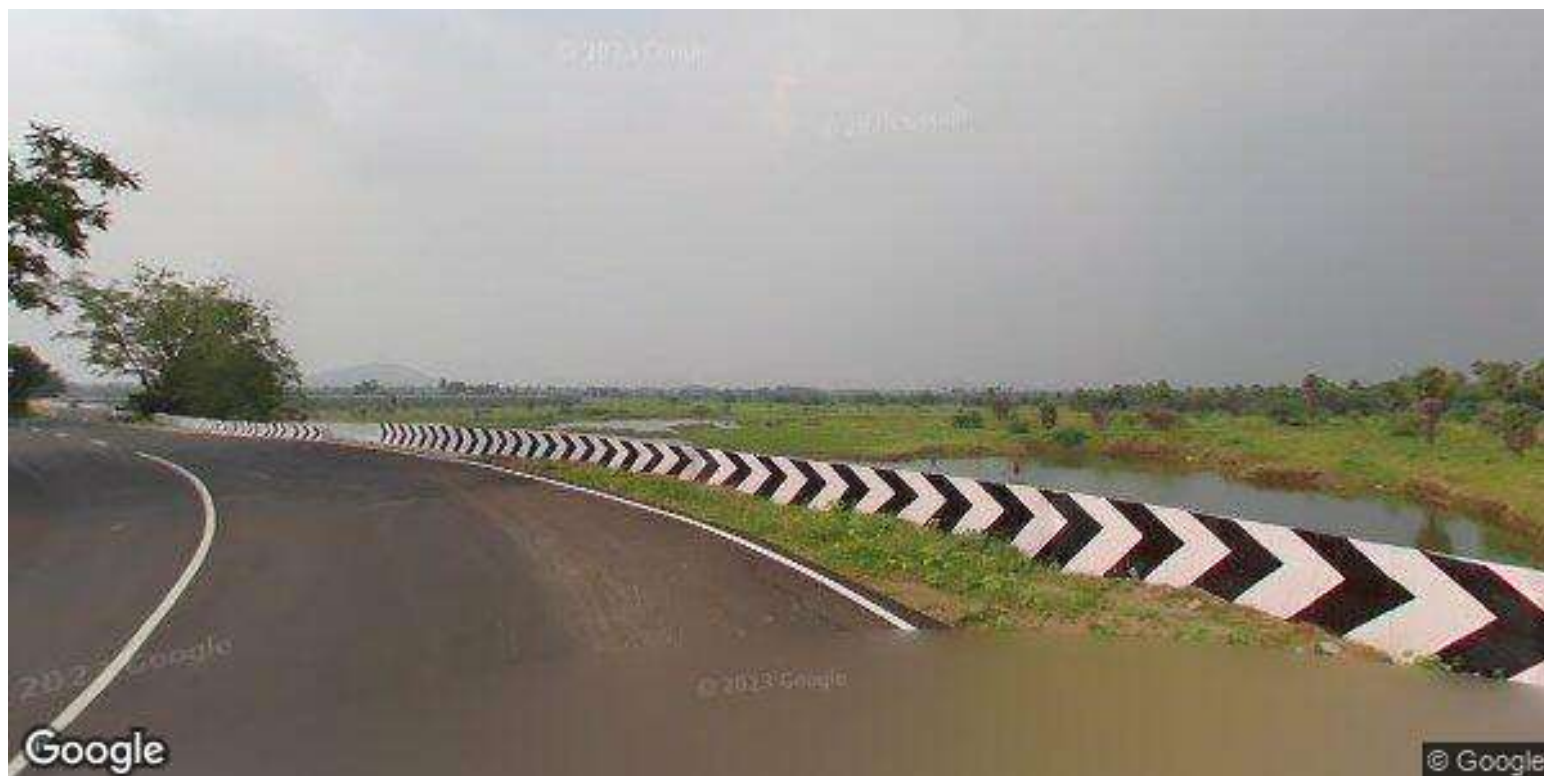
**Coordinates: 11.23086, 78.24171**

**Risk Type: Turn**

**Risk Level: High**

**Speed Limit: 15 KM/Hr**

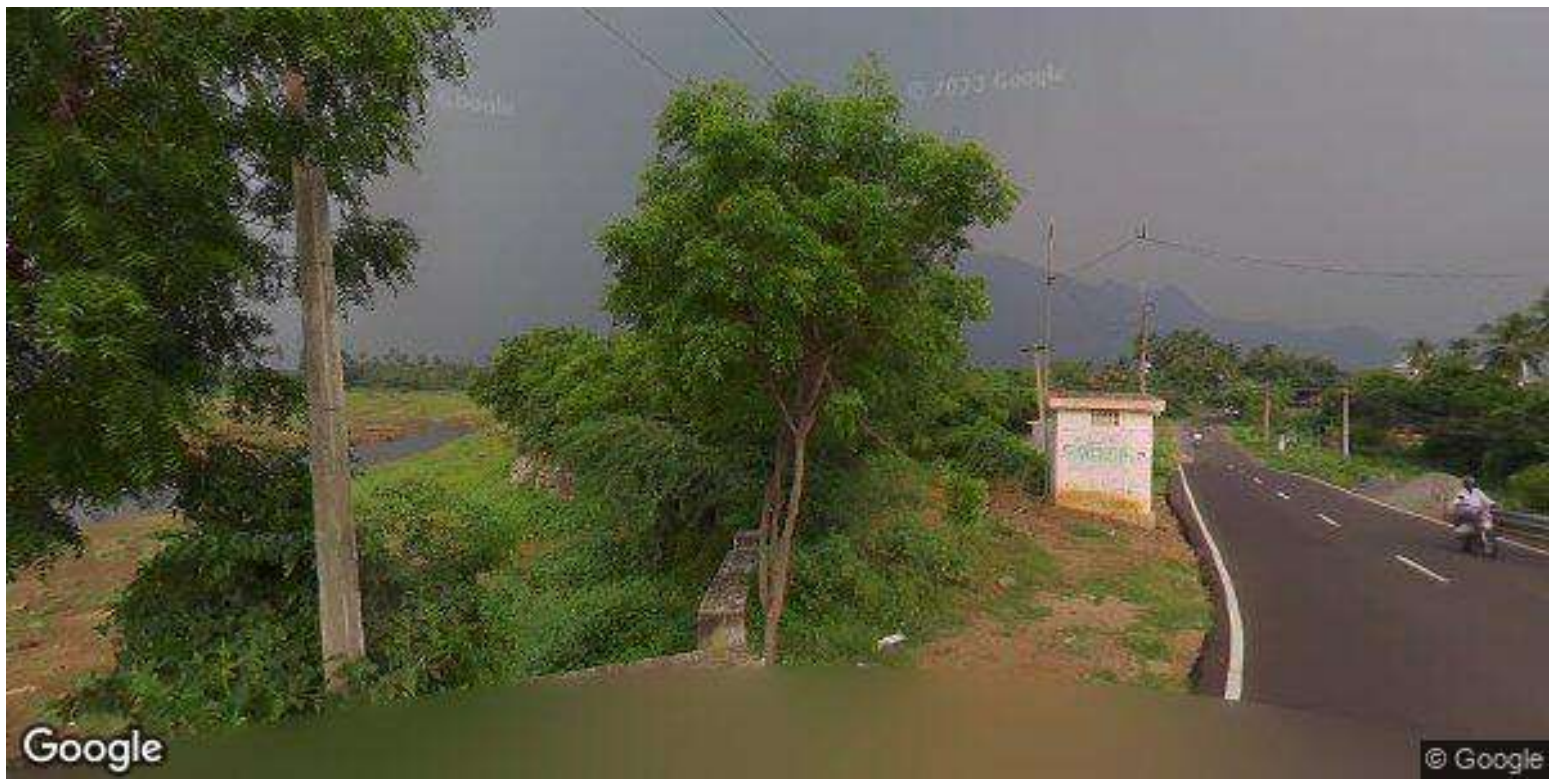
**Coordinates:** 11.22239, 78.24264

**Risk Type:** Turn

**Risk Level:** Medium

**Speed Limit:** 30 KM/Hr
