# IndianOil

## JOURNEY RISK MANAGEMENT (JRM) STUDY

### Salem Terminal TO K P MARKETING

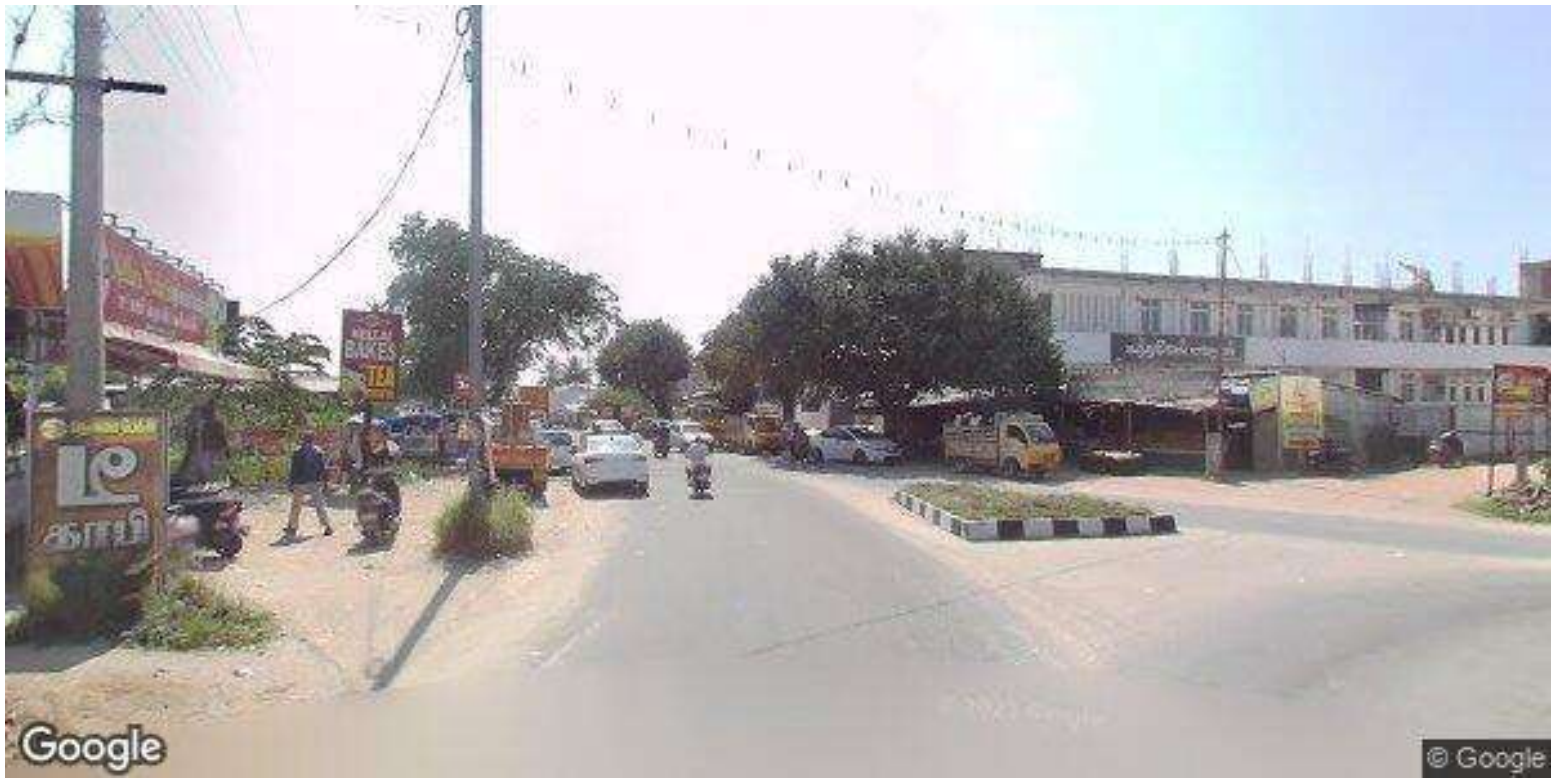
Risk Type: Roundabout  
Risk Level: High  
Speed Limit: 15 KM/Hr  
Coordinates: 11.17250, 77.26863

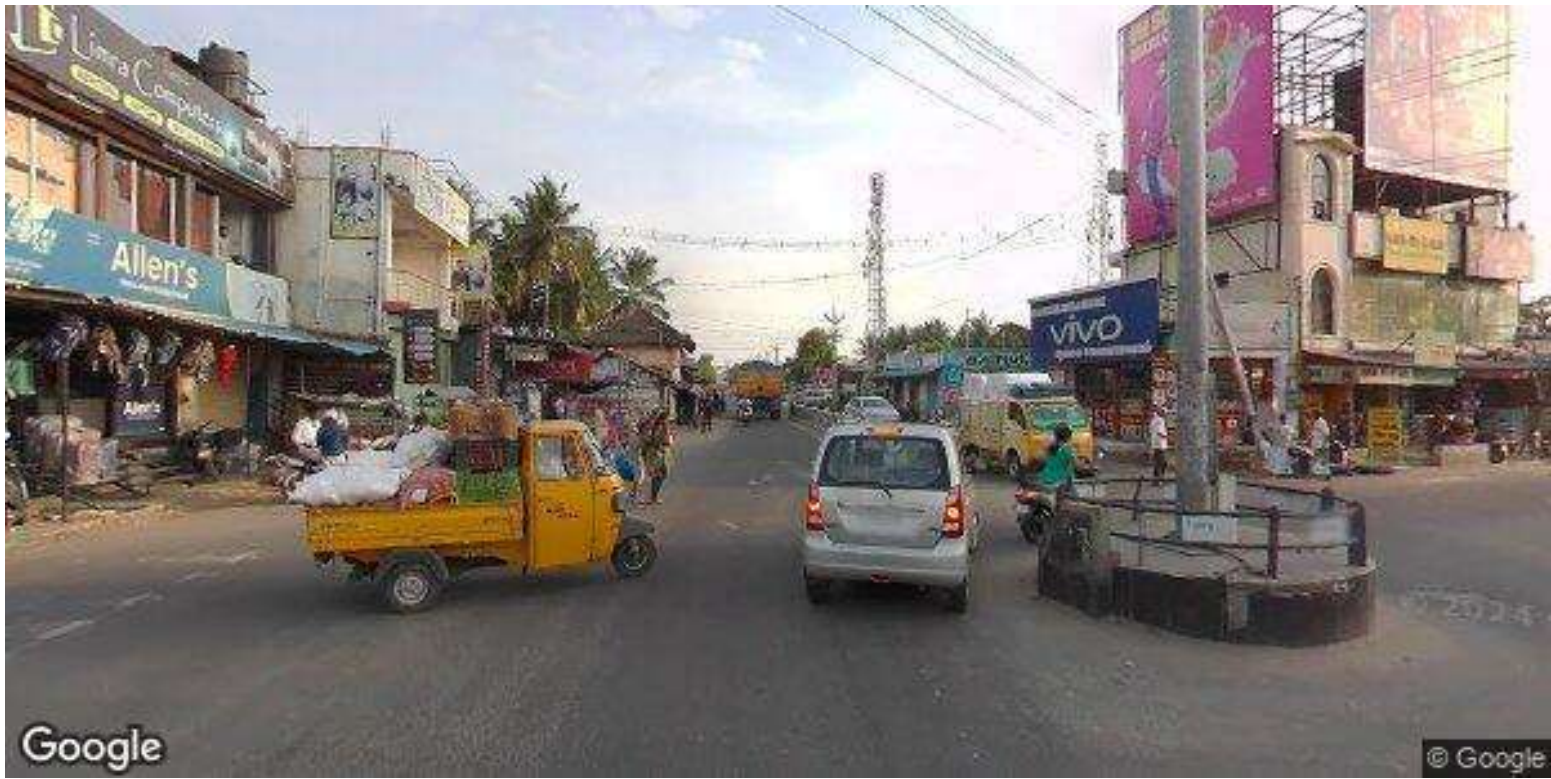
Risk Type: Roundabout  
Risk Level: High

**Speed Limit: 15 KM/Hr**  
**Coordinates: 11.10249, 77.27146**

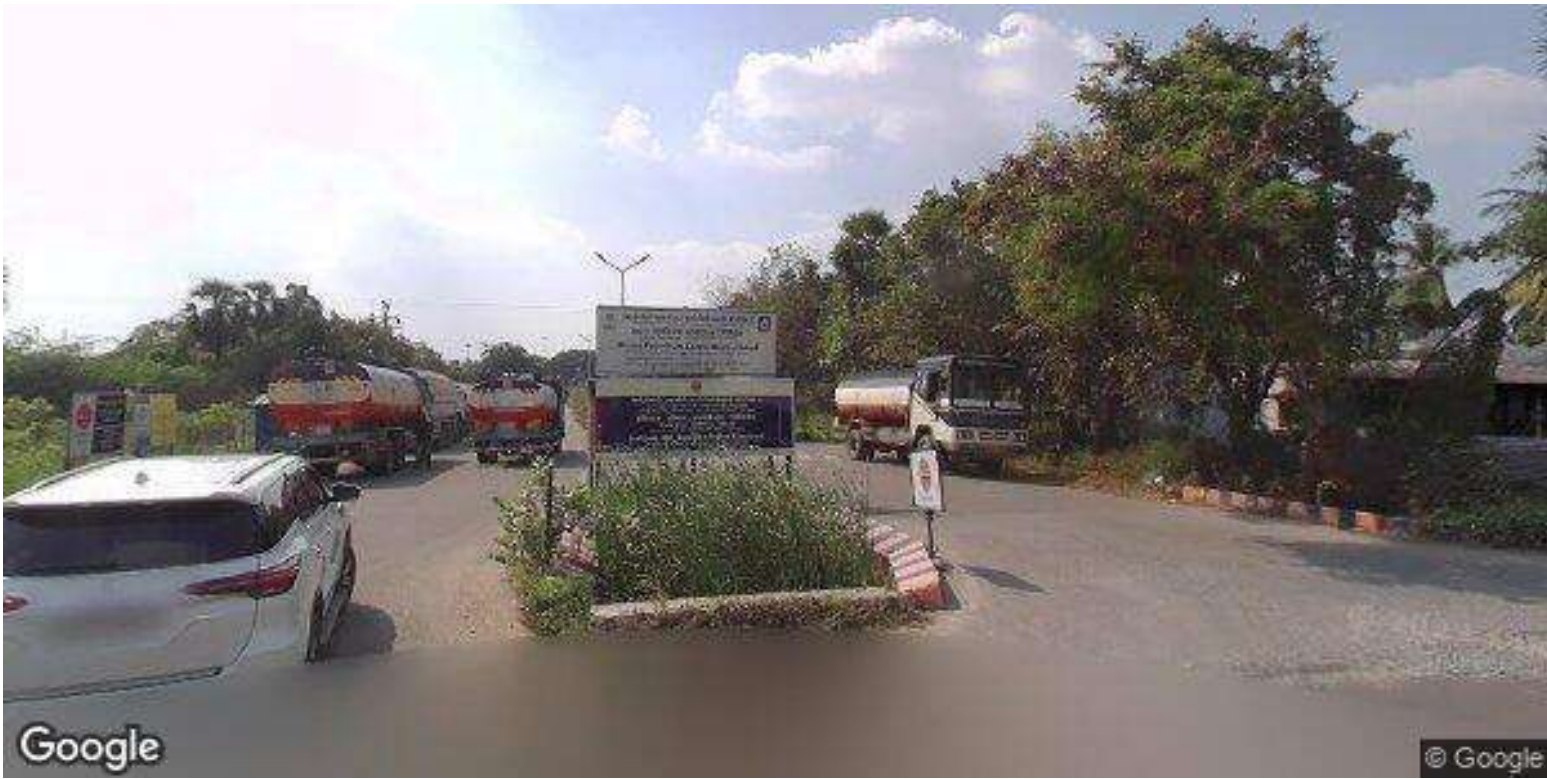
**Risk Type: Turn**  
**Risk Level: High**  
**Speed Limit: 15 KM/Hr**  
**Coordinates: 11.44024, 77.87528**

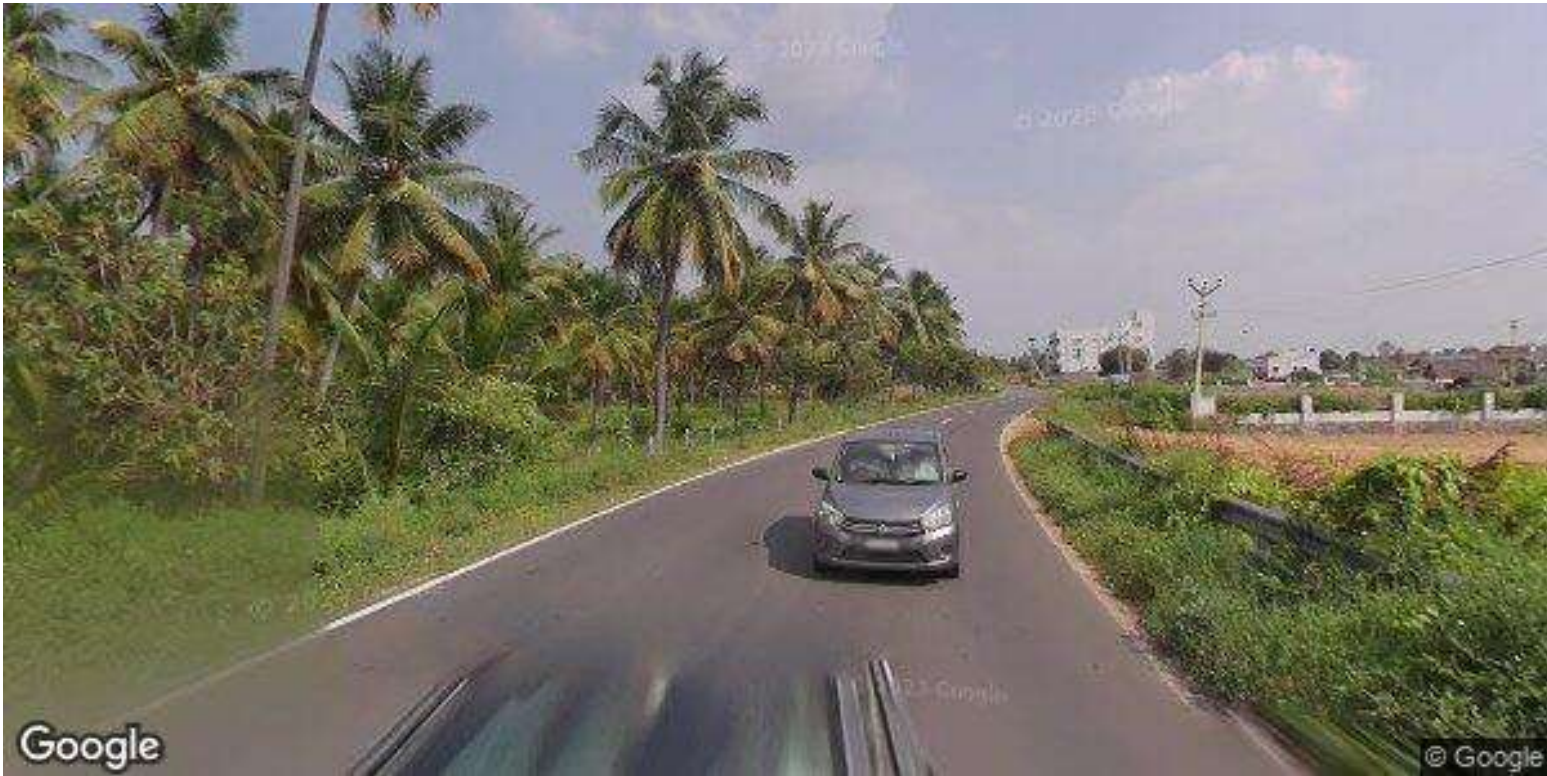
**Risk Type:** Turn  
**Risk Level:** Medium  
**Speed Limit:** 30 KM/Hr  
**Coordinates:** 11.45357, 77.85789

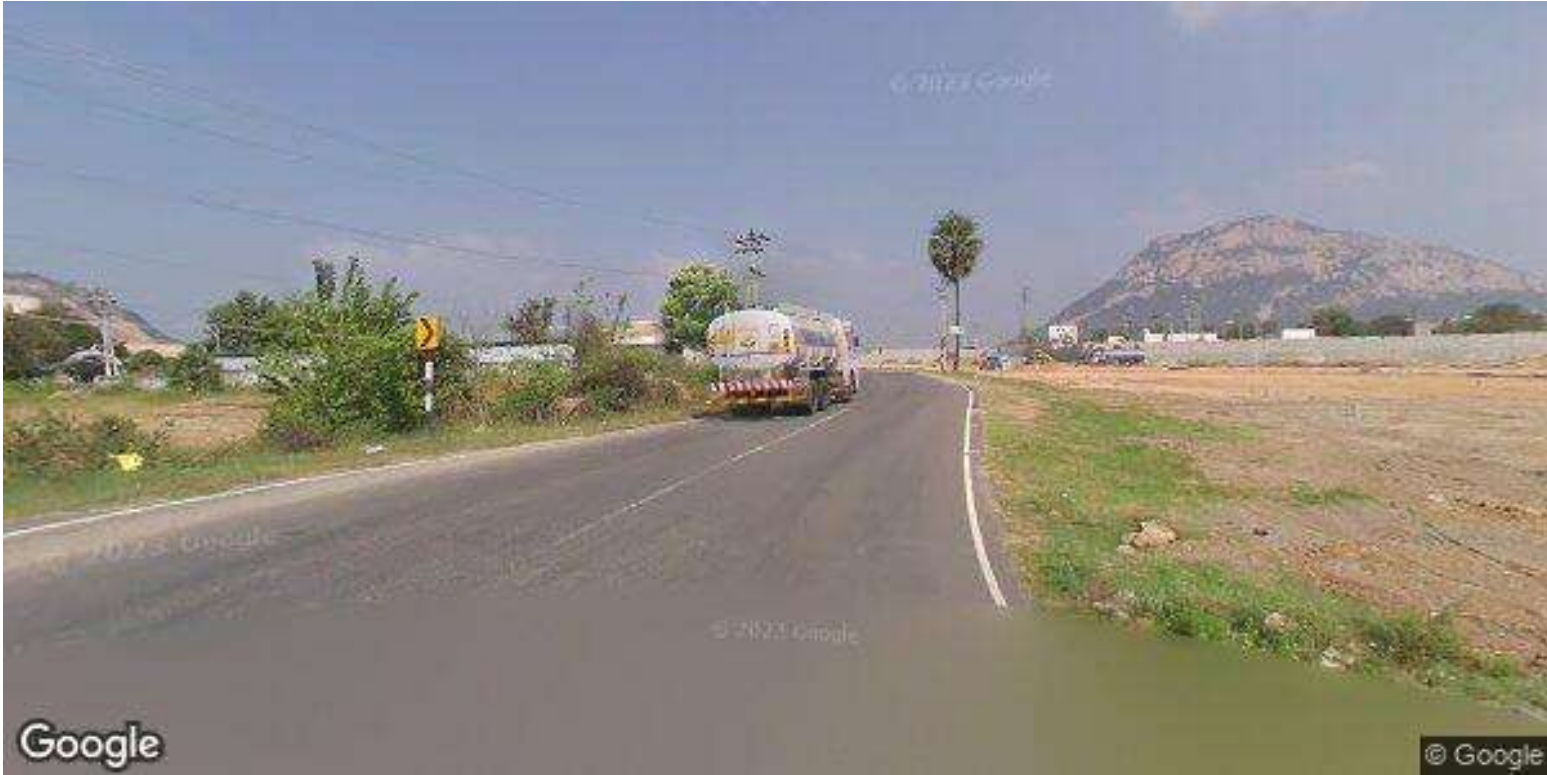
**Risk Type:** Turn  
**Risk Level:** Medium  
**Speed Limit:** 30 KM/Hr  
**Coordinates:** 11.45847, 77.85140

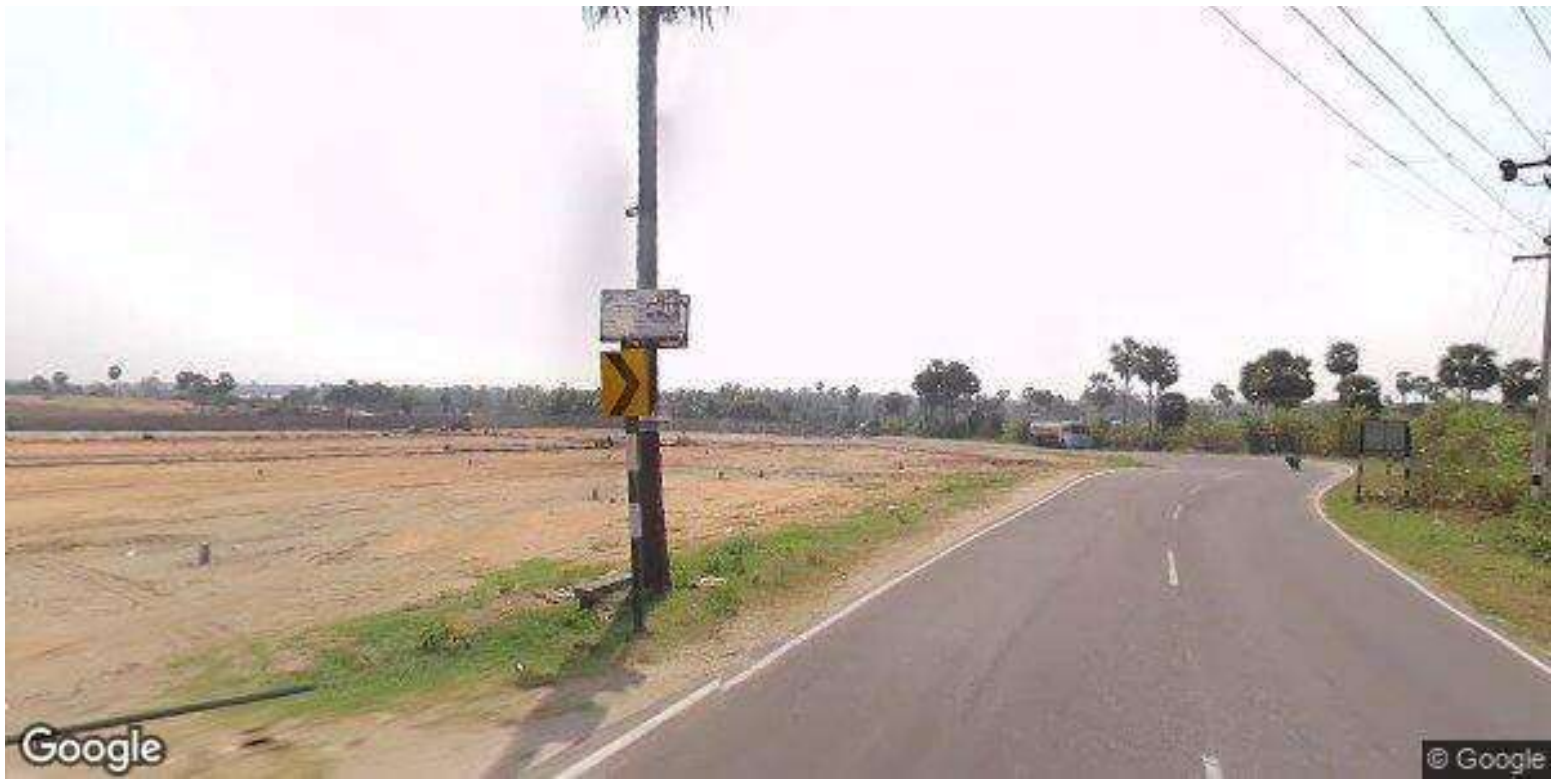
**Risk Type:** Turn  
**Risk Level:** Medium  
**Speed Limit:** 30 KM/Hr  
**Coordinates:** 11.45898, 77.85135

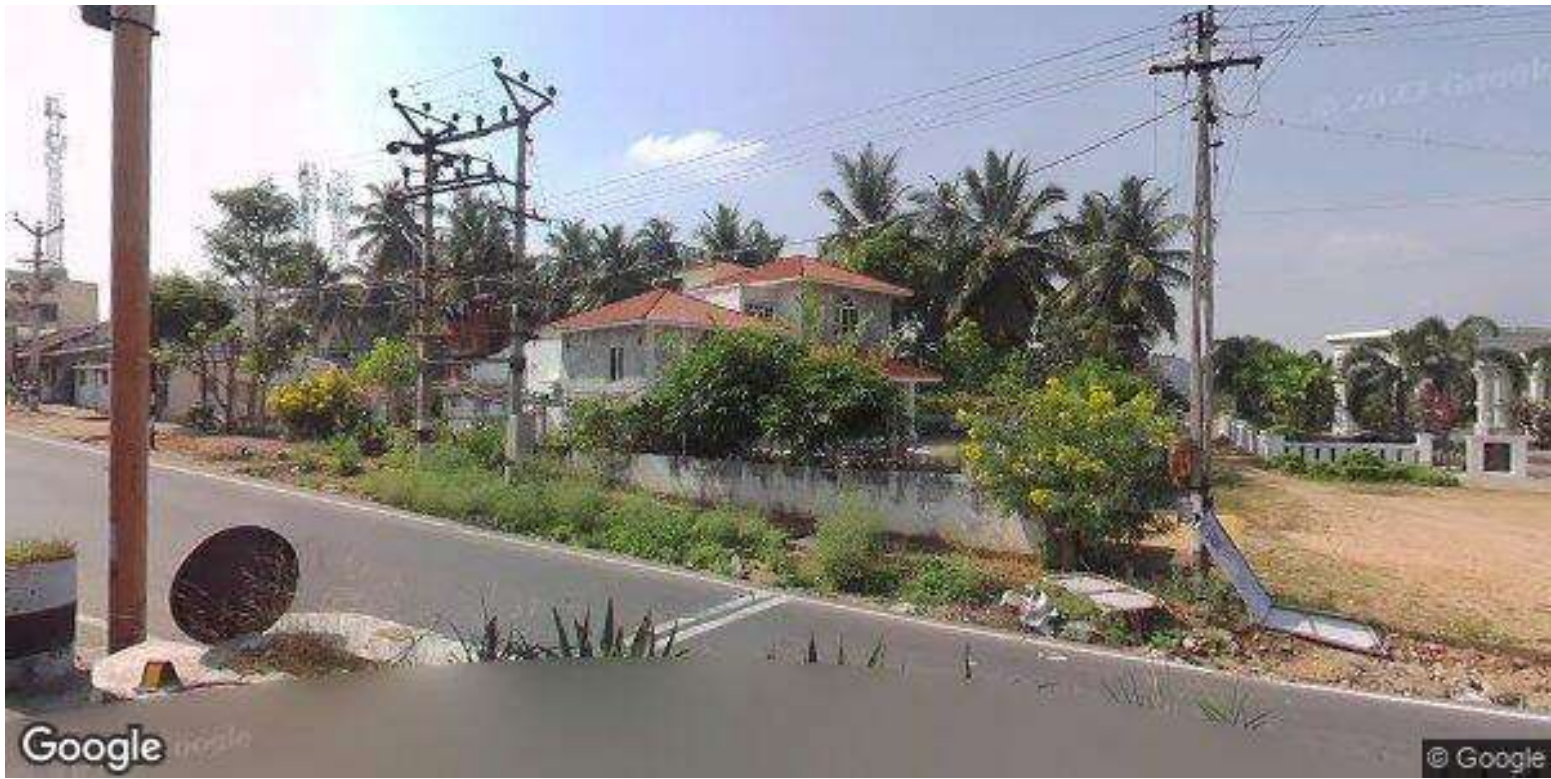
**Risk Type:** Turn  
**Risk Level:** High  
**Speed Limit:** 15 KM/Hr  
**Coordinates:** 11.46303, 77.84945

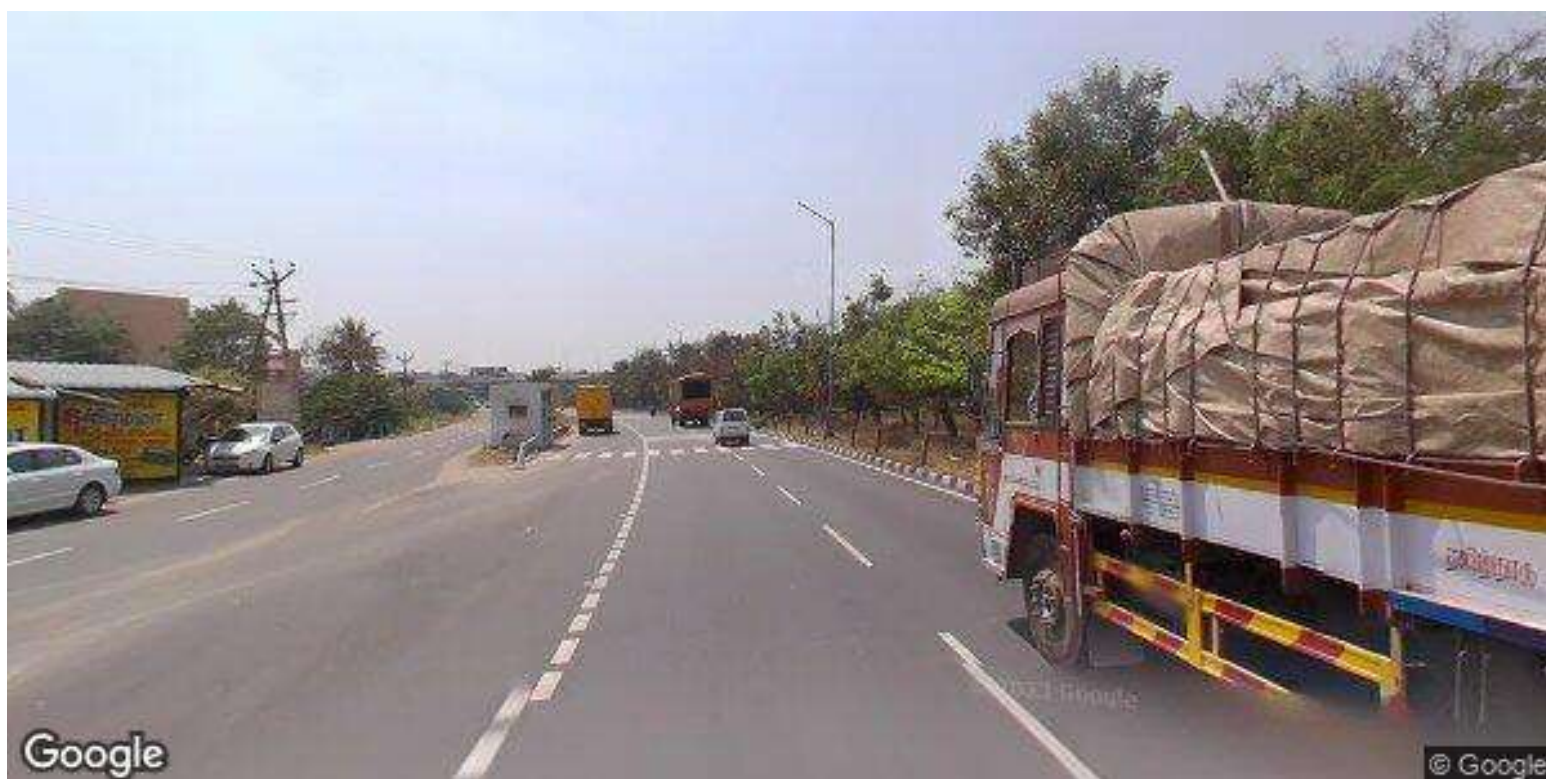
**Risk Type:** Turn  
**Risk Level:** Medium  
**Speed Limit:** 30 KM/Hr  
**Coordinates:** 11.43165, 77.67734

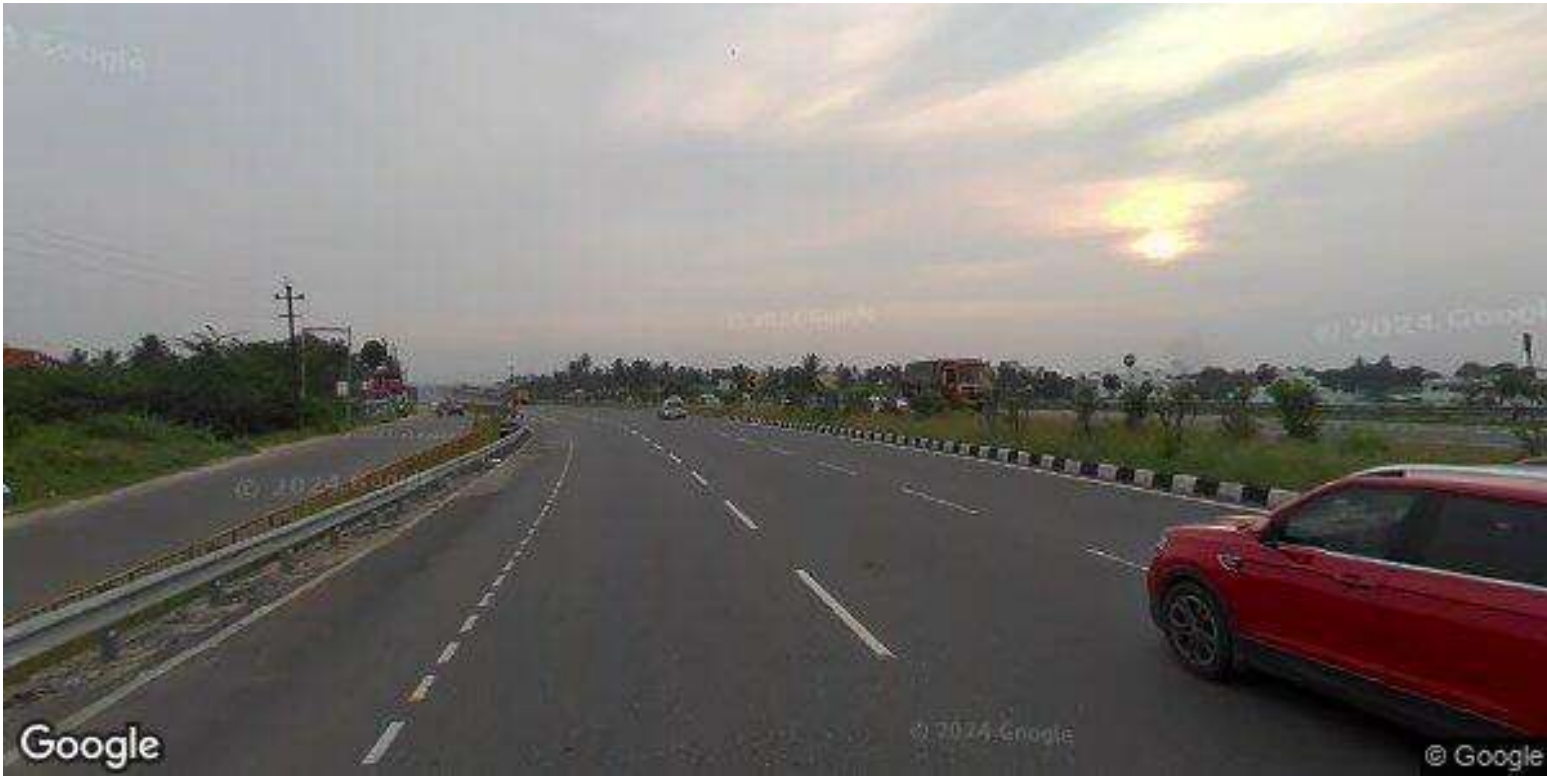
**Risk Type:** Turn  
**Risk Level:** Medium  
**Speed Limit:** 30 KM/Hr  
**Coordinates:** 11.18808, 77.28672

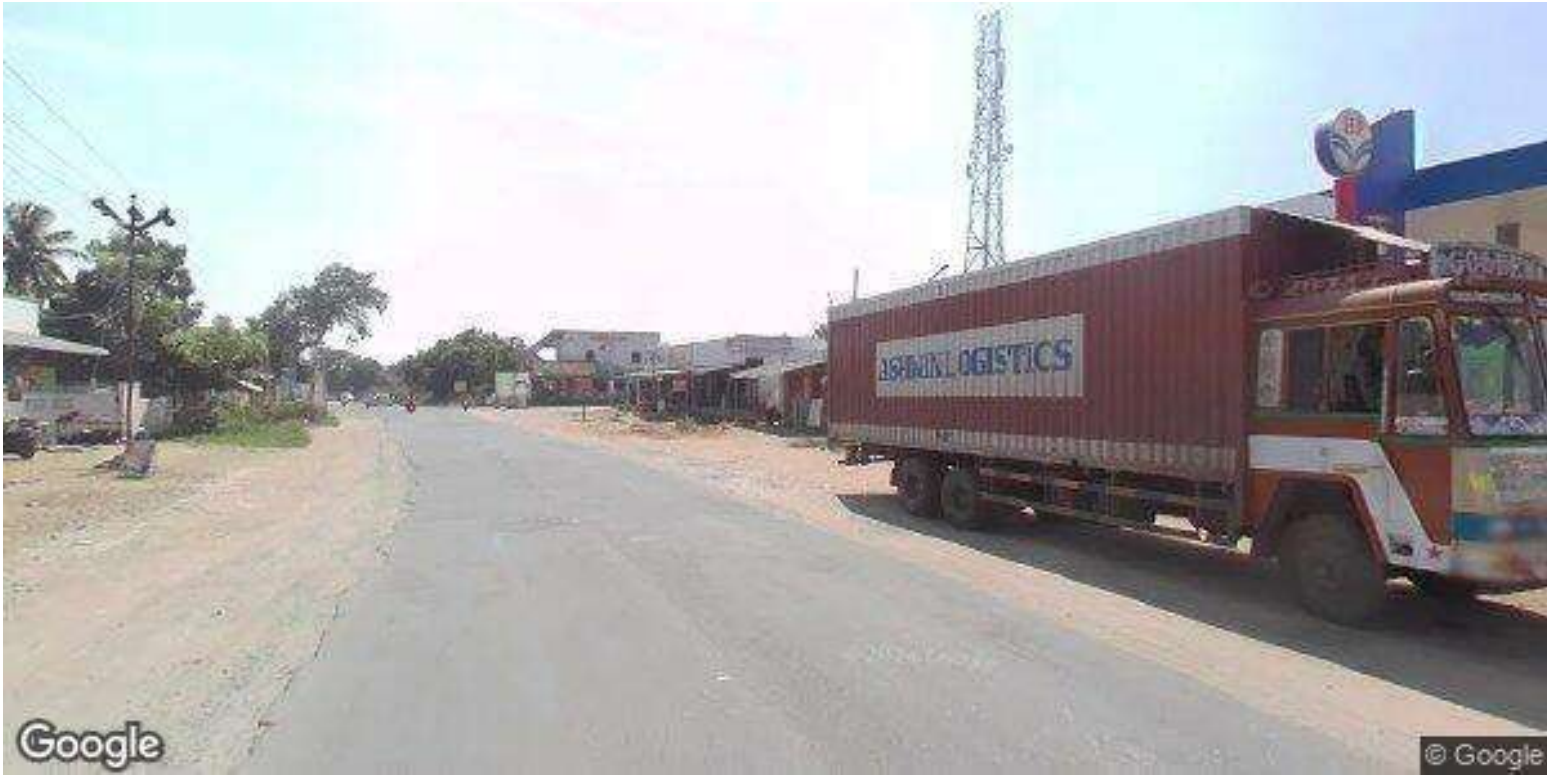
**Risk Type:** Turn  
**Risk Level:** Medium  
**Speed Limit:** 30 KM/Hr  
**Coordinates:** 11.16848, 77.26757

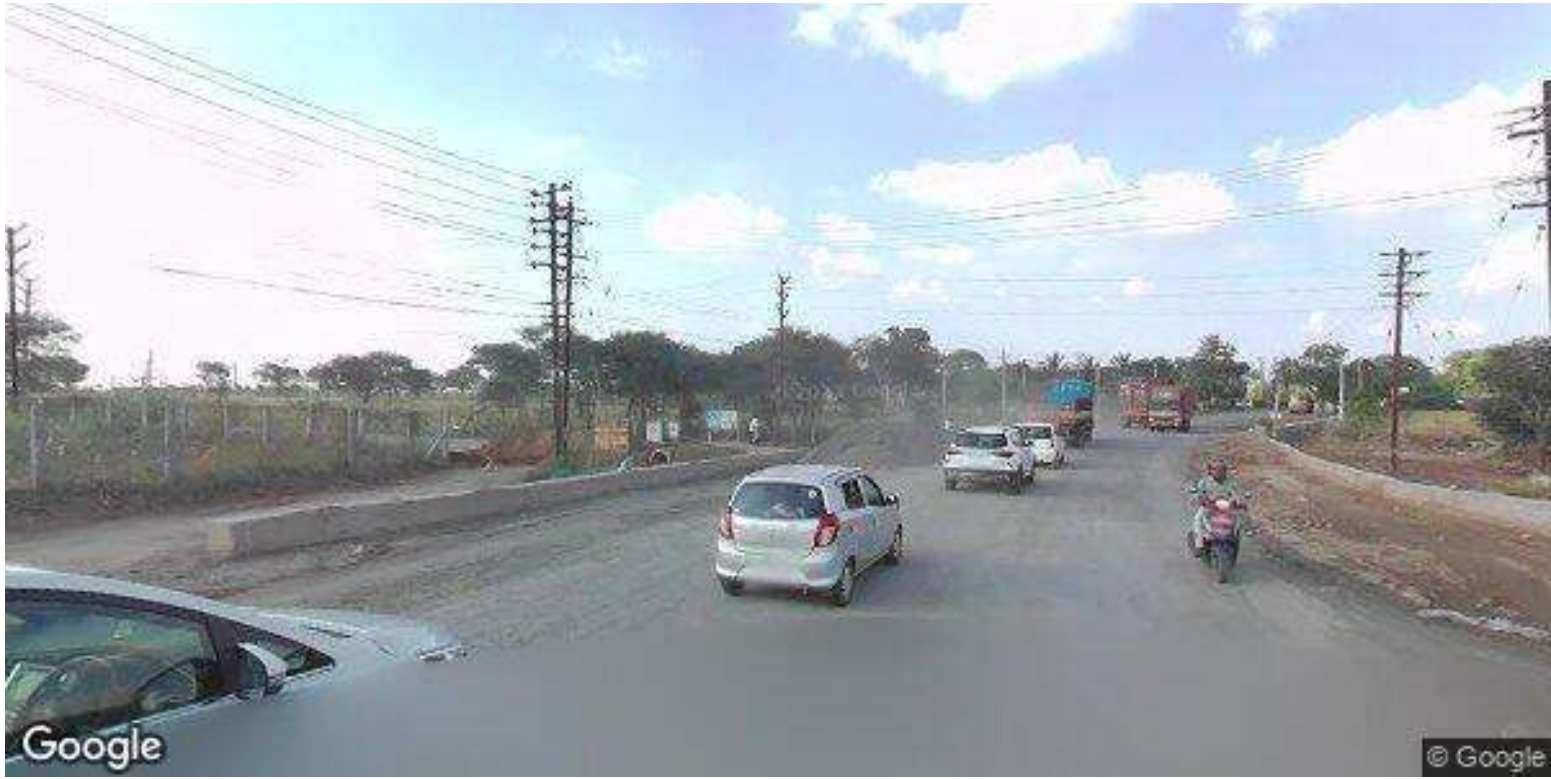
**Risk Type:** Turn  
**Risk Level:** Medium  
**Speed Limit:** 30 KM/Hr  
**Coordinates:** 11.14580, 77.26363

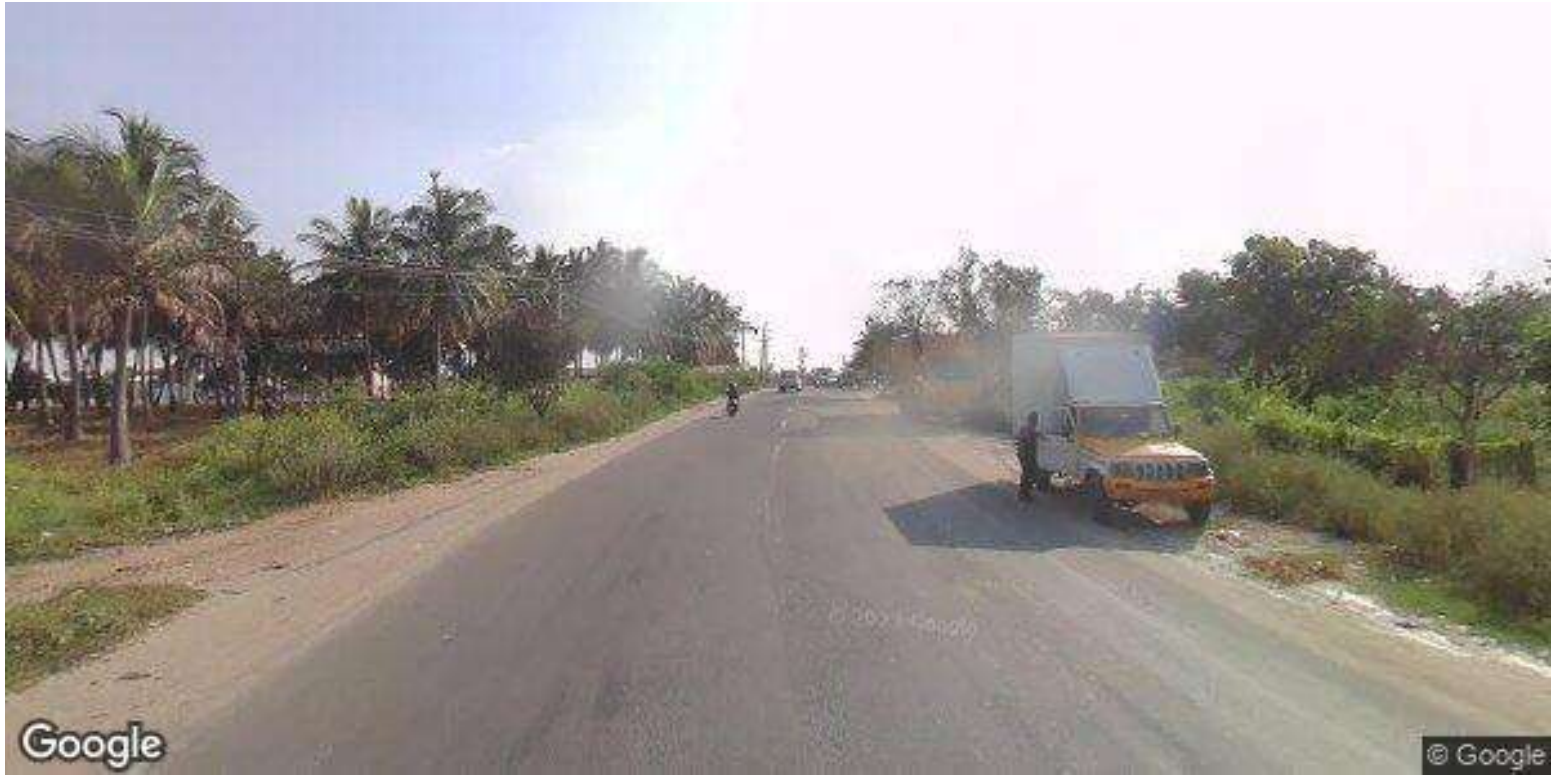
**Risk Type:** Turn  
**Risk Level:** Medium  
**Speed Limit:** 30 KM/Hr  
**Coordinates:** 11.10890, 77.27134

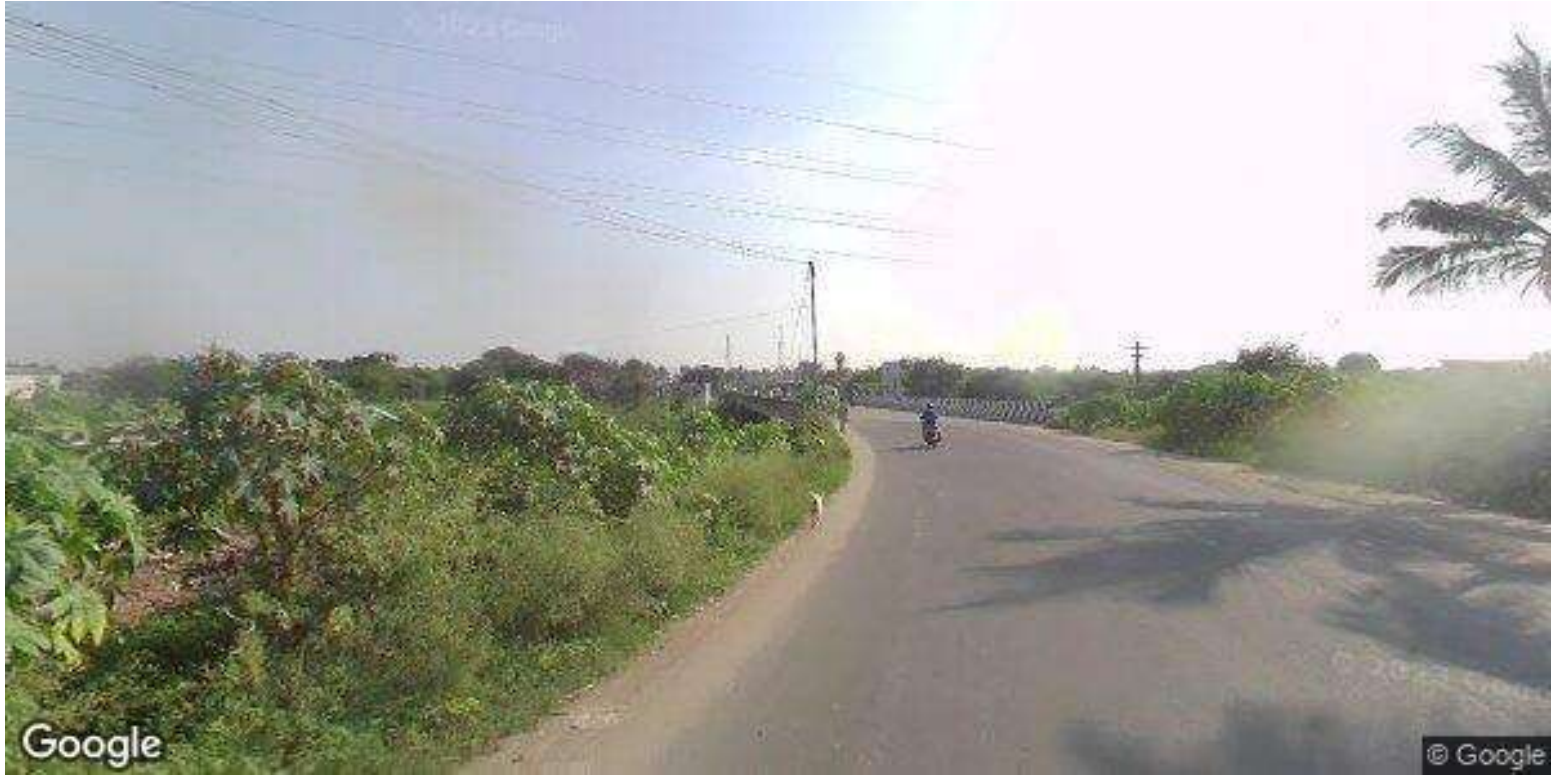
**Risk Type:** Turn  
**Risk Level:** Medium  
**Speed Limit:** 30 KM/Hr  
**Coordinates:** 11.10680, 77.27043

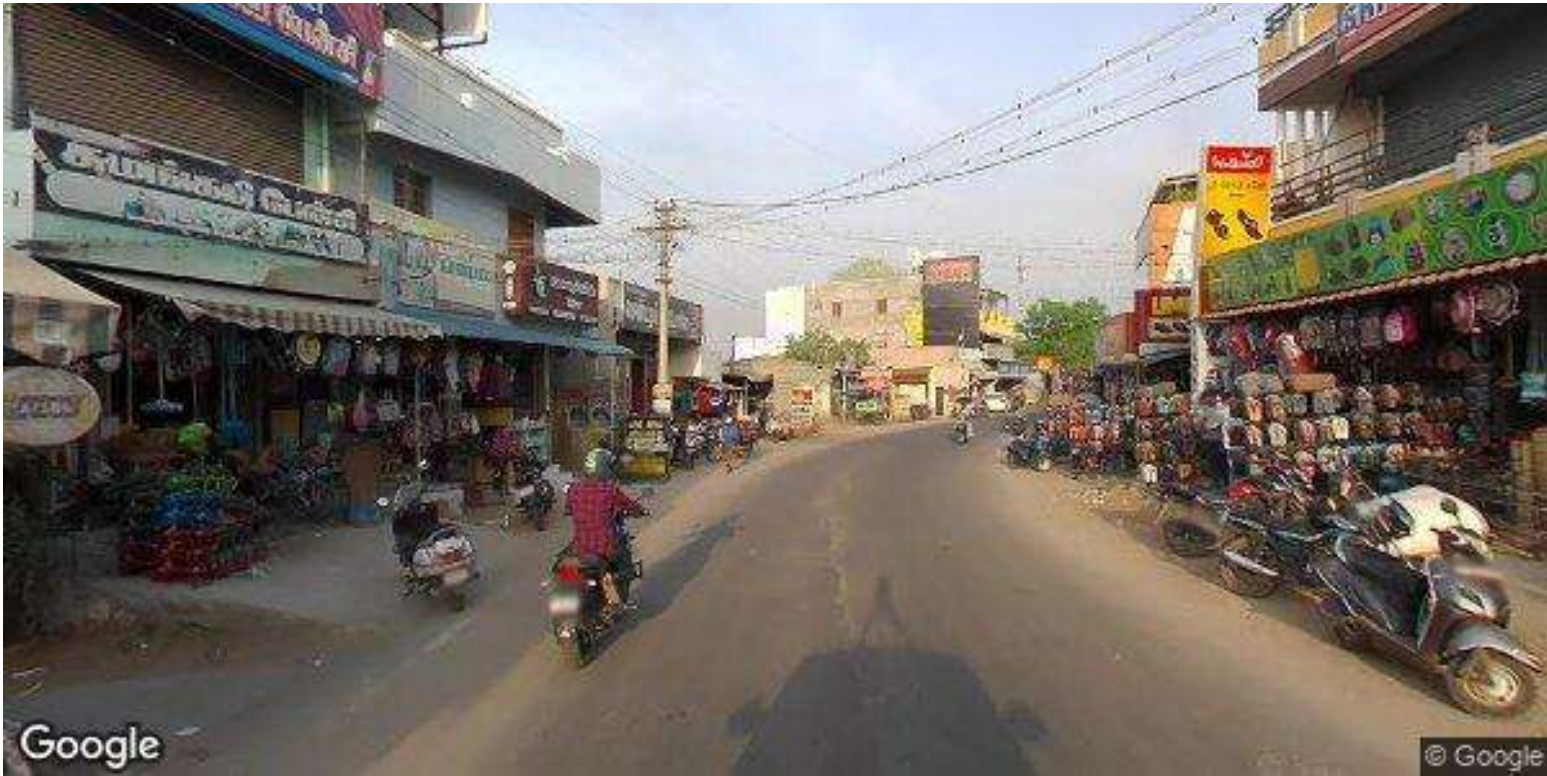
**Risk Type:** Turn  
**Risk Level:** Medium  
**Speed Limit:** 30 KM/Hr  
**Coordinates:** 11.10256, 77.27210

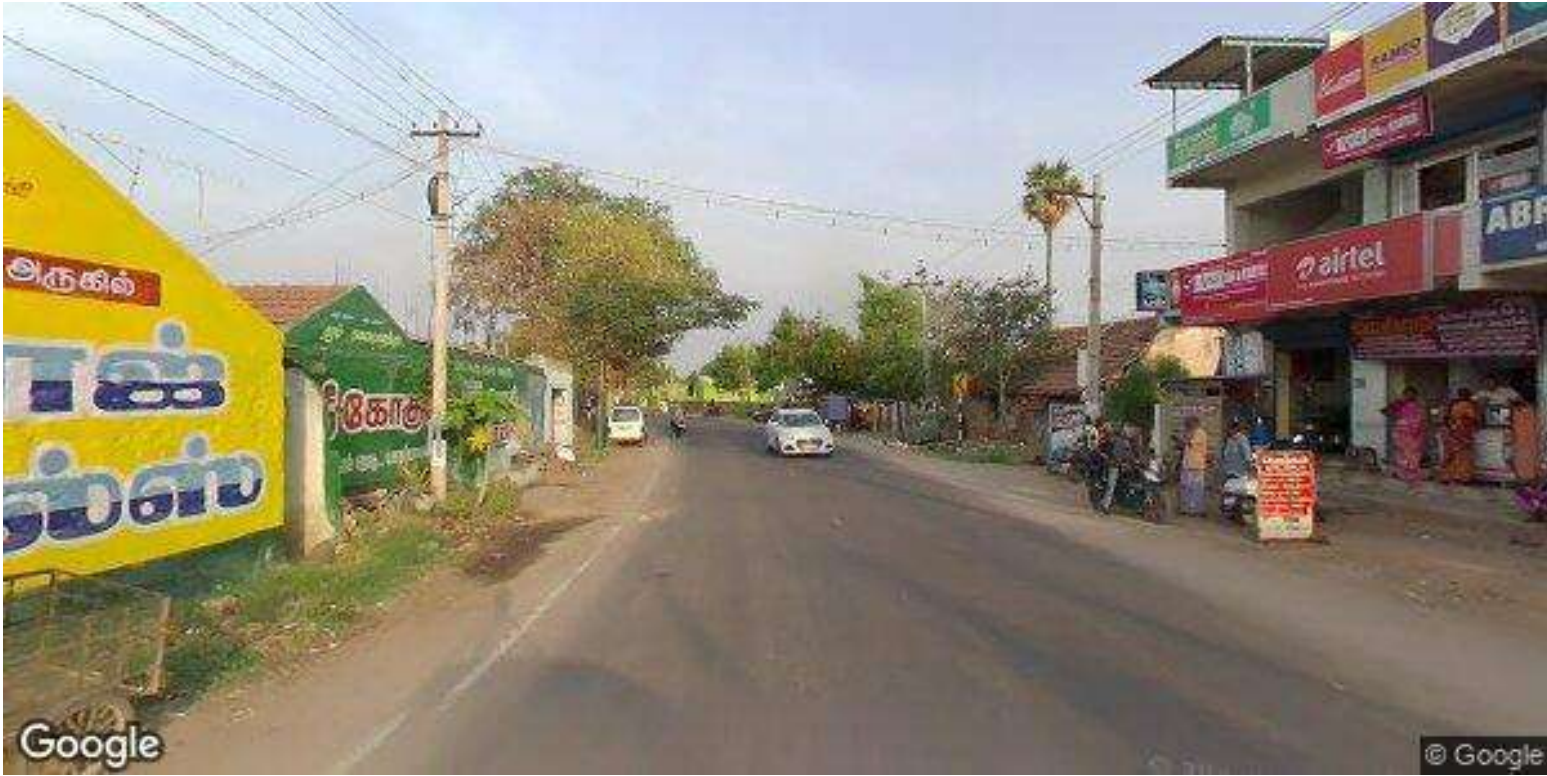
**Risk Type:** Turn  
**Risk Level:** Medium  
**Speed Limit:** 30 KM/Hr  
**Coordinates:** 11.10162, 77.27443

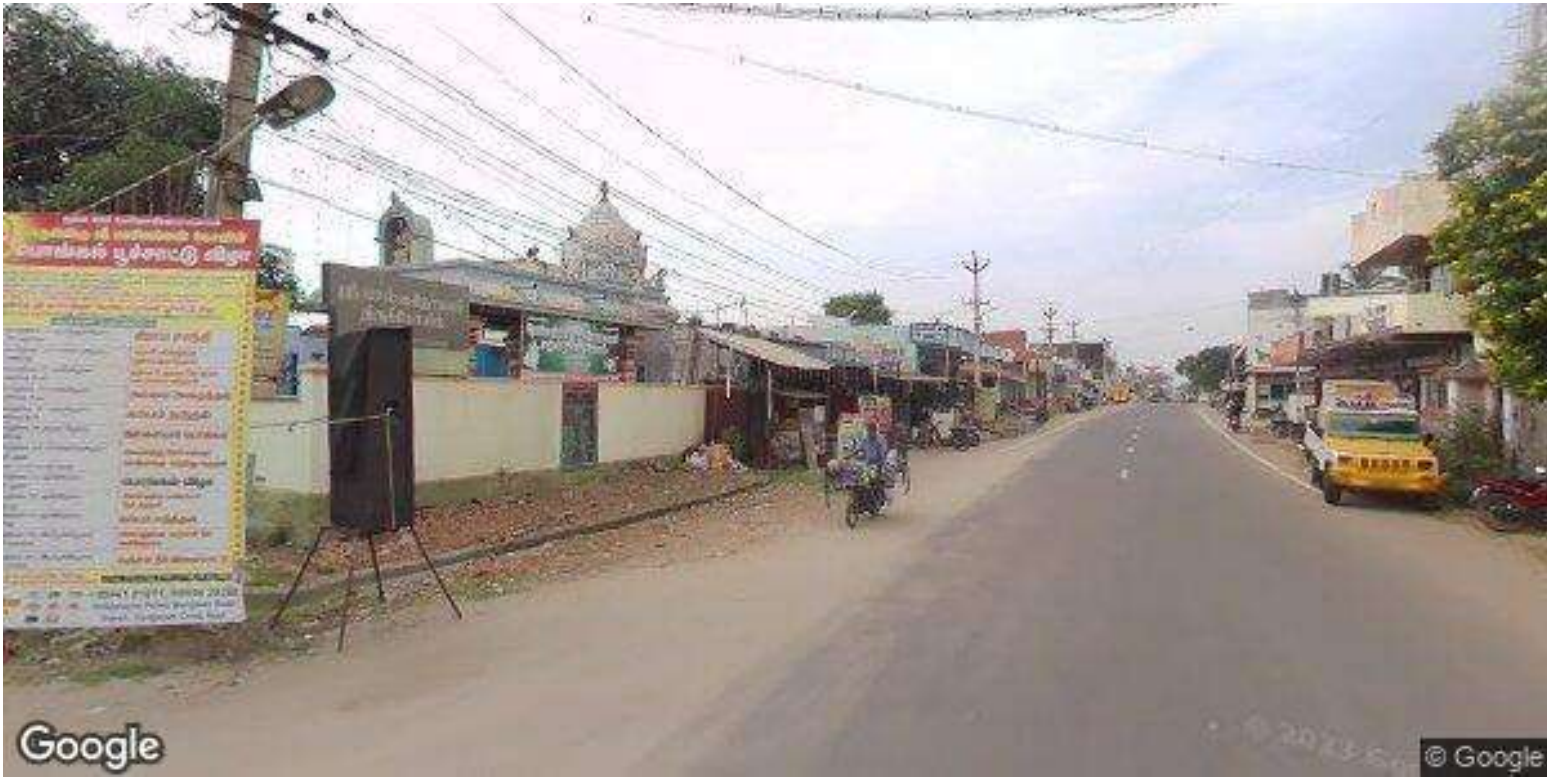
**Risk Type:** Turn  
**Risk Level:** Medium  
**Speed Limit:** 30 KM/Hr  
**Coordinates:** 11.10164, 77.29834

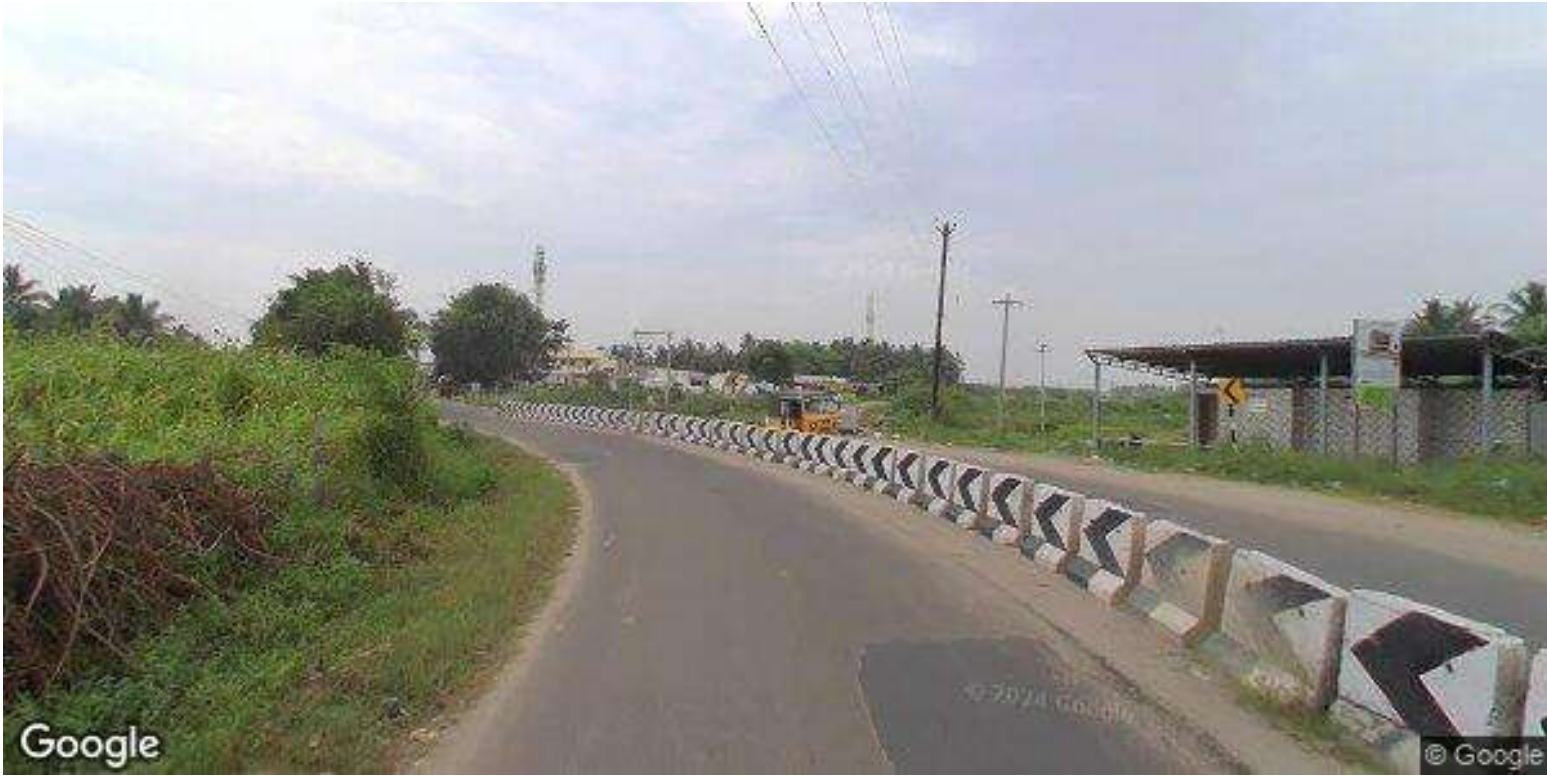
**Risk Type:** Turn  
**Risk Level:** High  
**Speed Limit:** 15 KM/Hr  
**Coordinates:** 11.10238, 77.29955
