# IndianOil

## JOURNEY RISK MANAGEMENT (JRM) STUDY

### Salem Terminal TO TVR FUELS STATION

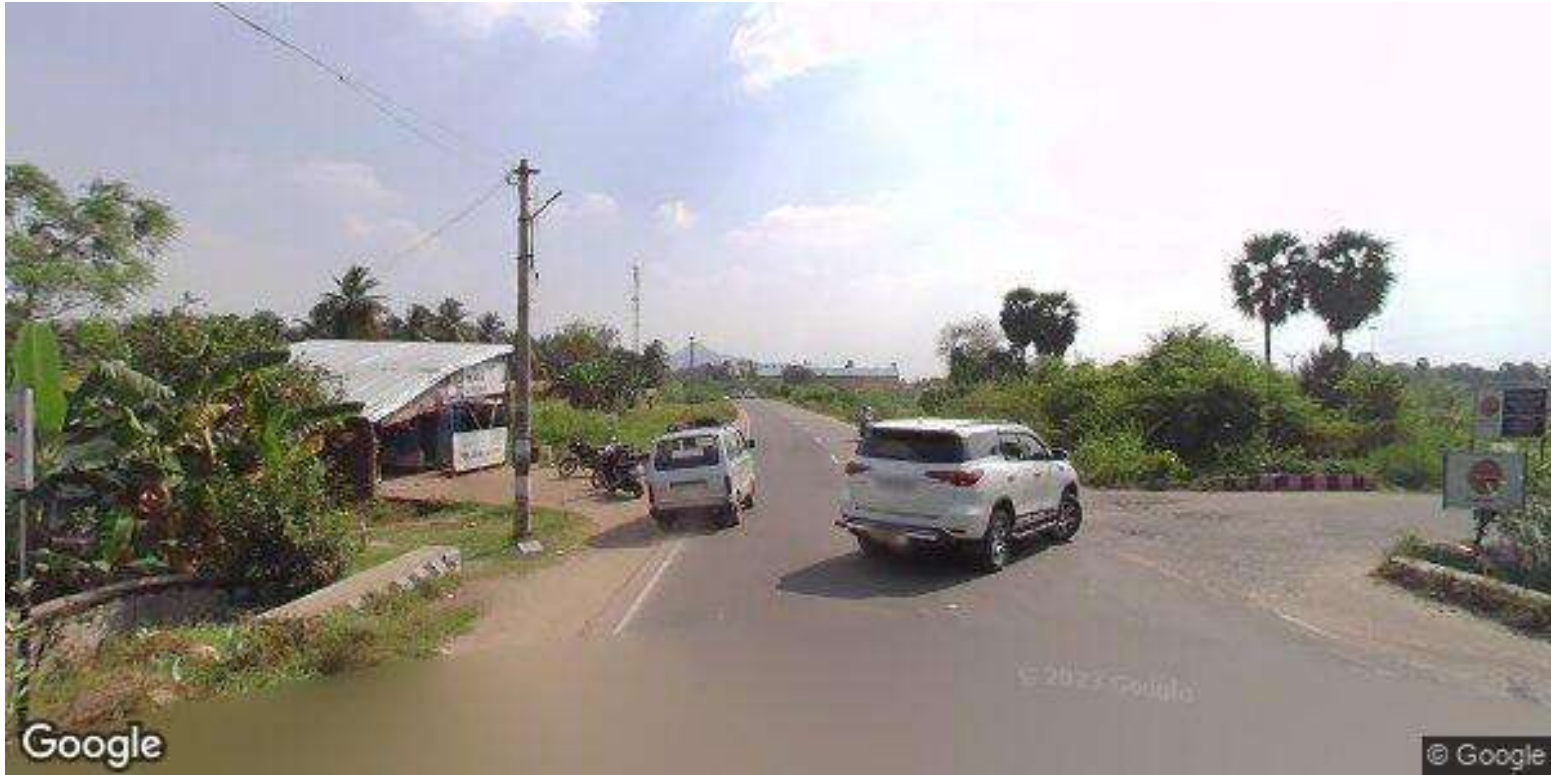
Risk Type: Turn

Risk Level: High

Speed Limit: 15 KM/Hr

Coordinates: 11.44029, 77.87544

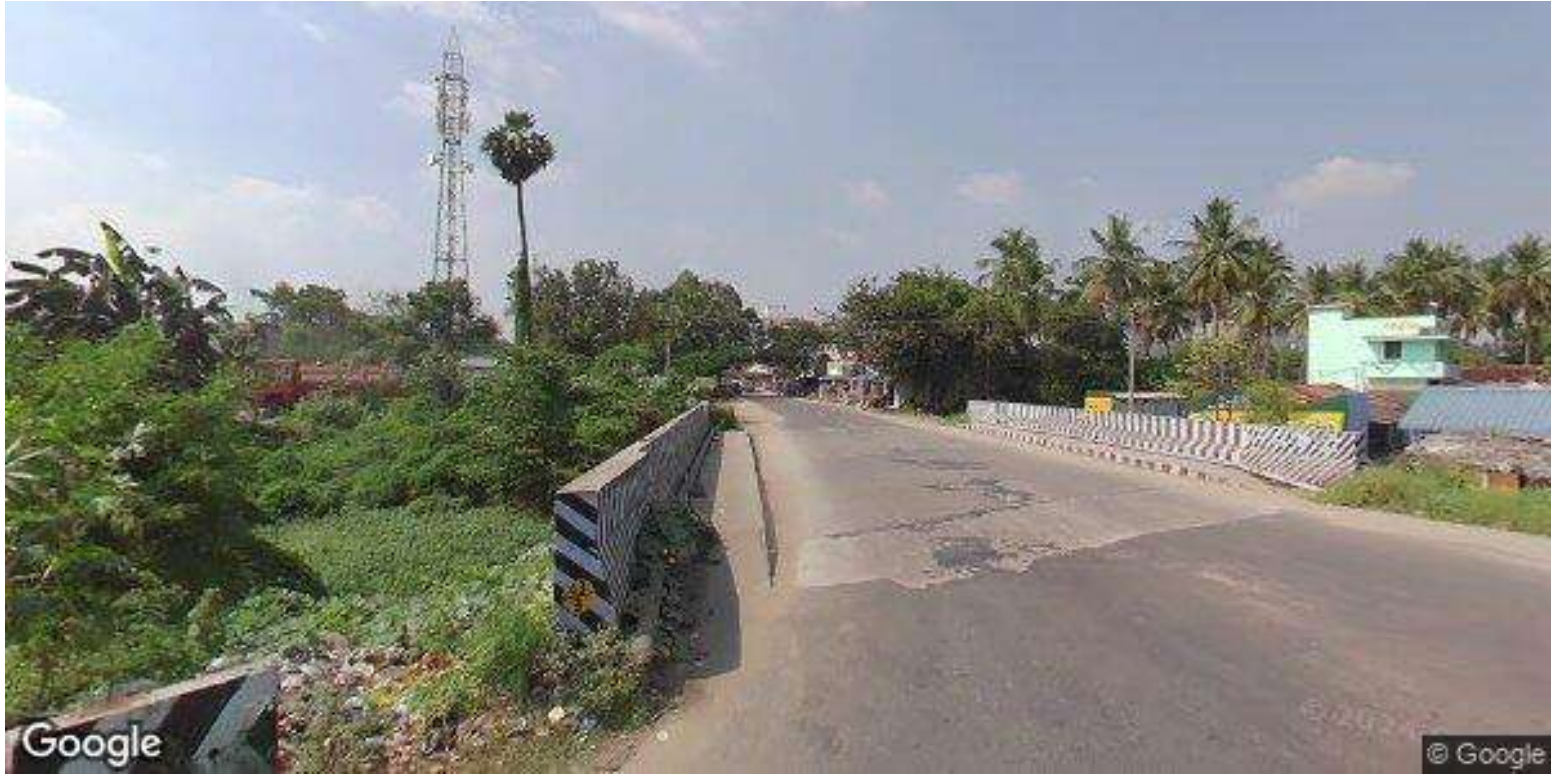
Risk Type: Turn

Risk Level: High

Speed Limit: 15 KM/Hr  
Coordinates: 11.44900, 77.87406

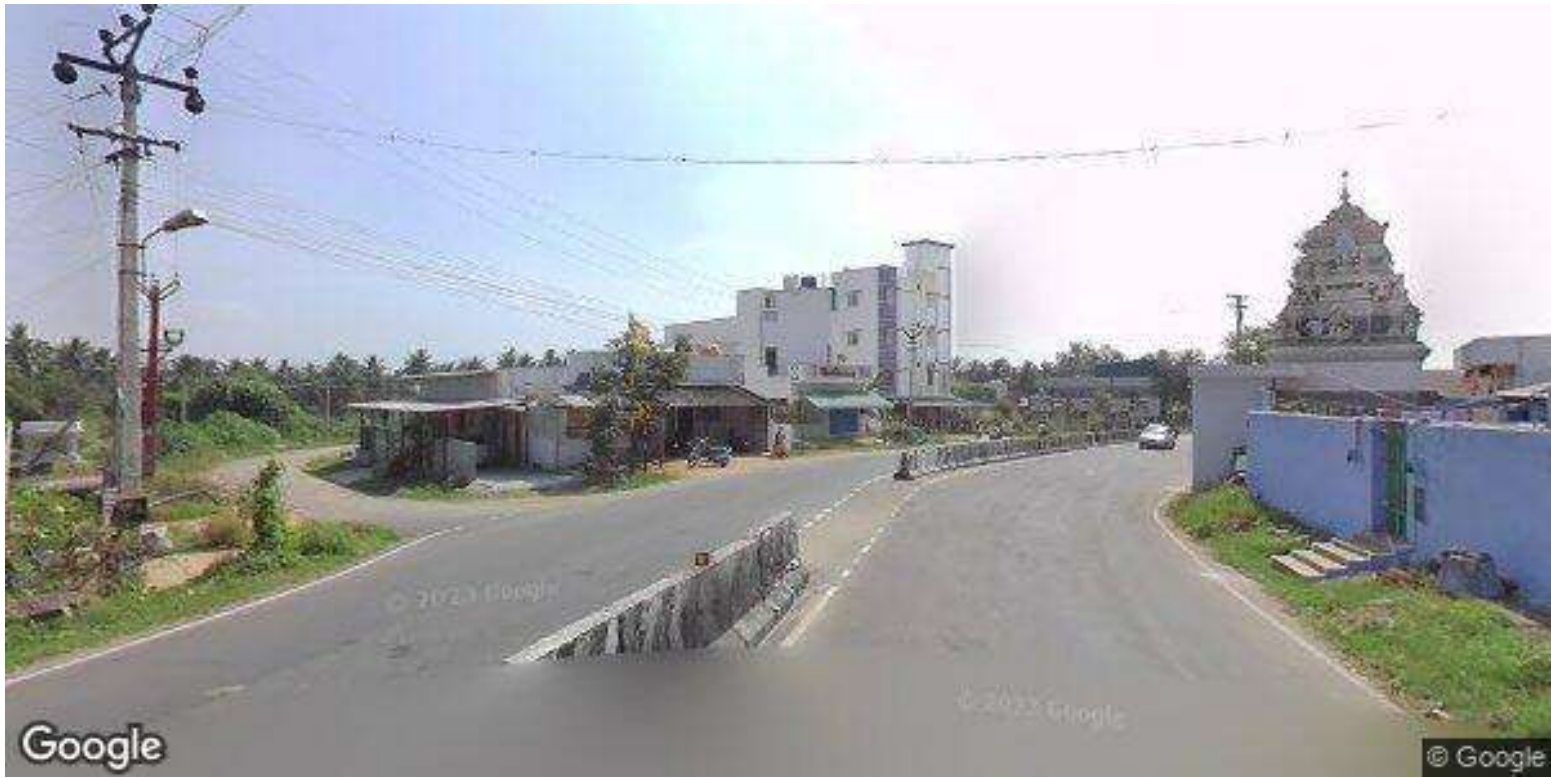
Risk Type: Turn  
Risk Level: Medium  
Speed Limit: 30 KM/Hr  
Coordinates: 11.46400, 77.87323

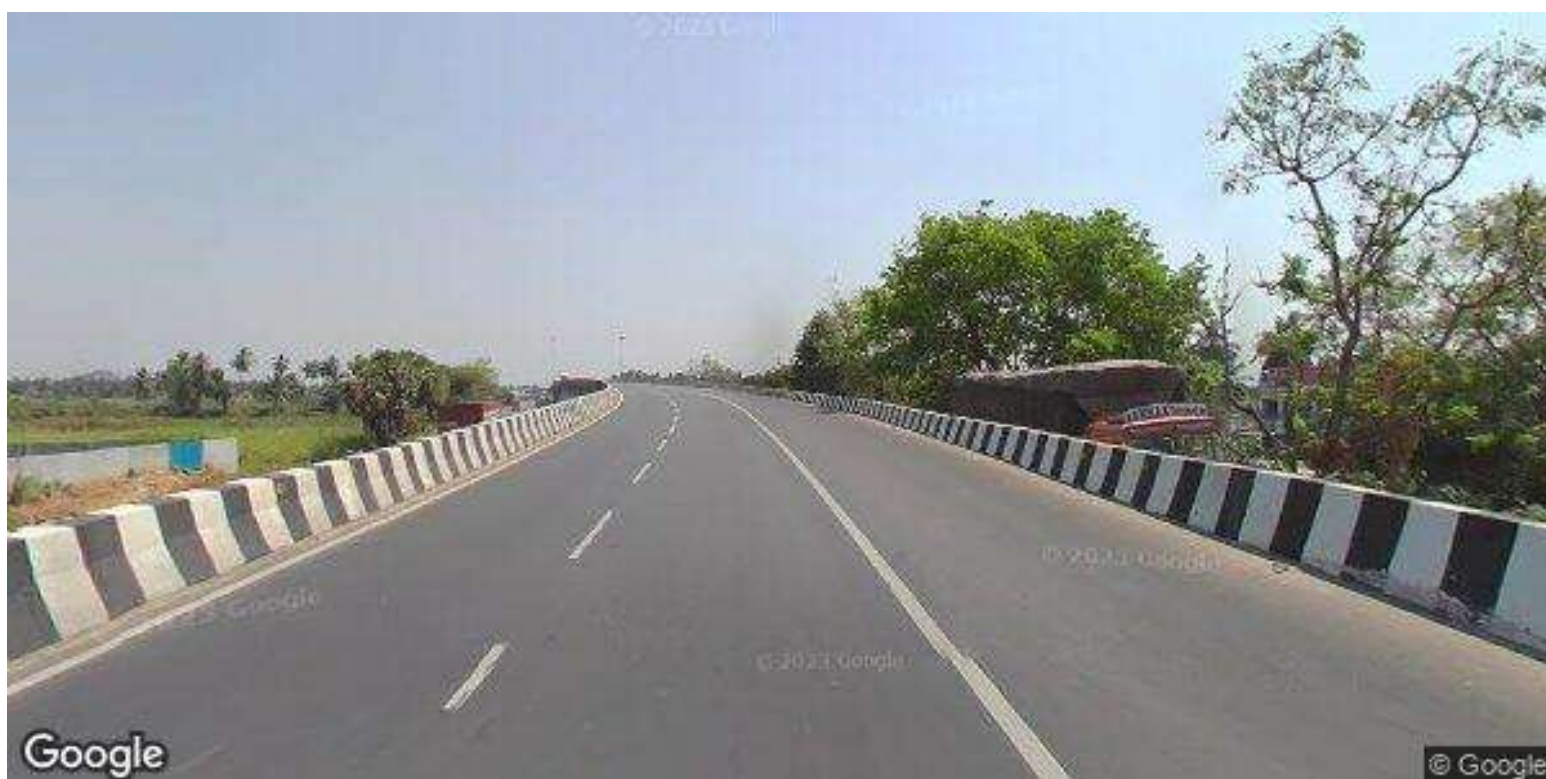
**Risk Type:** Turn

**Risk Level:** Medium

**Speed Limit:** 30 KM/Hr

**Coordinates:** 11.73958, 78.05105

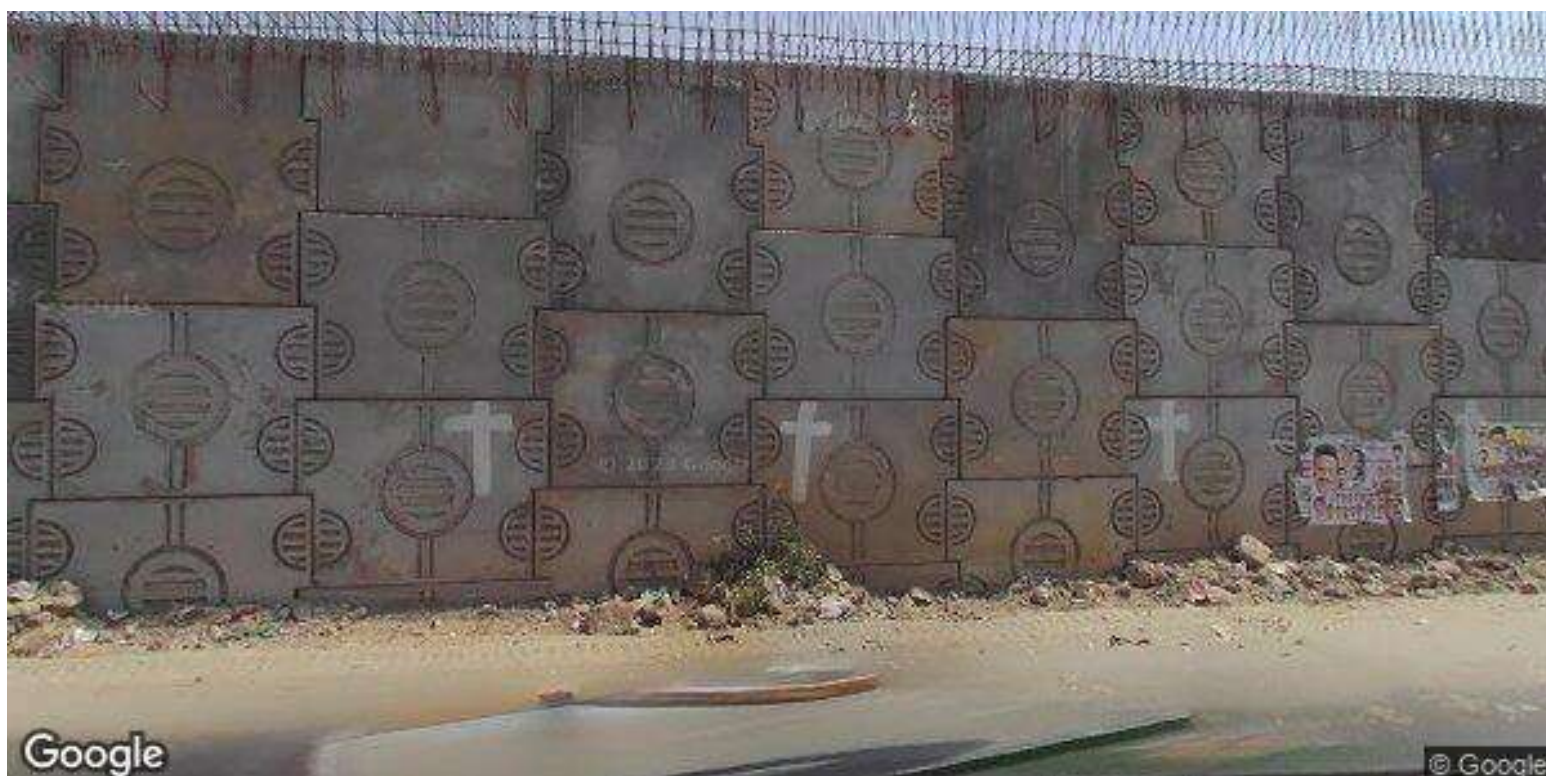
**Risk Type:** Turn  
**Risk Level:** Medium  
**Speed Limit:** 30 KM/Hr  
**Coordinates:** 11.75835, 78.05016

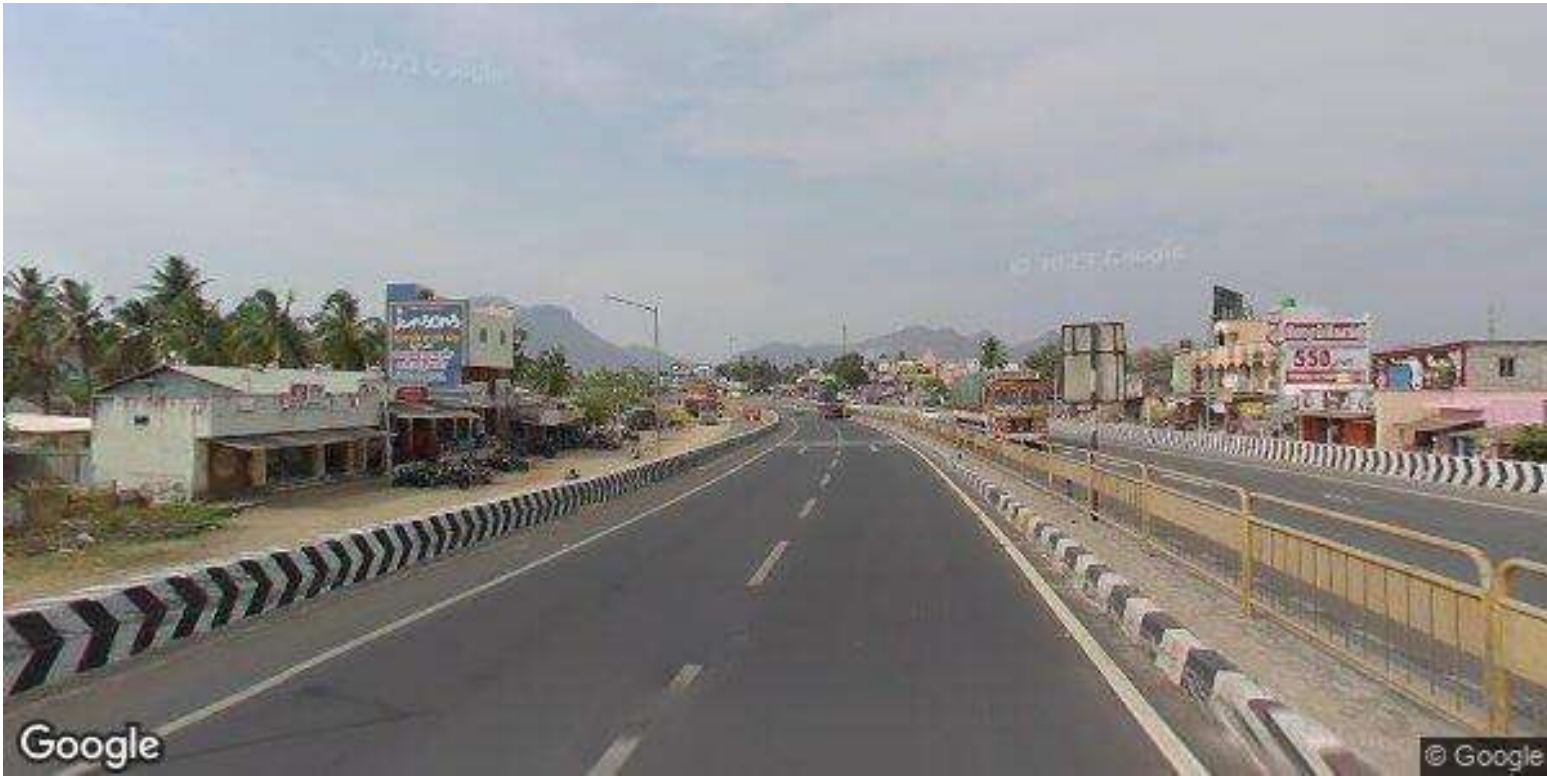
**Risk Type:** Turn  
**Risk Level:** Medium  
**Speed Limit:** 30 KM/Hr  
**Coordinates:** 11.86847, 78.08367

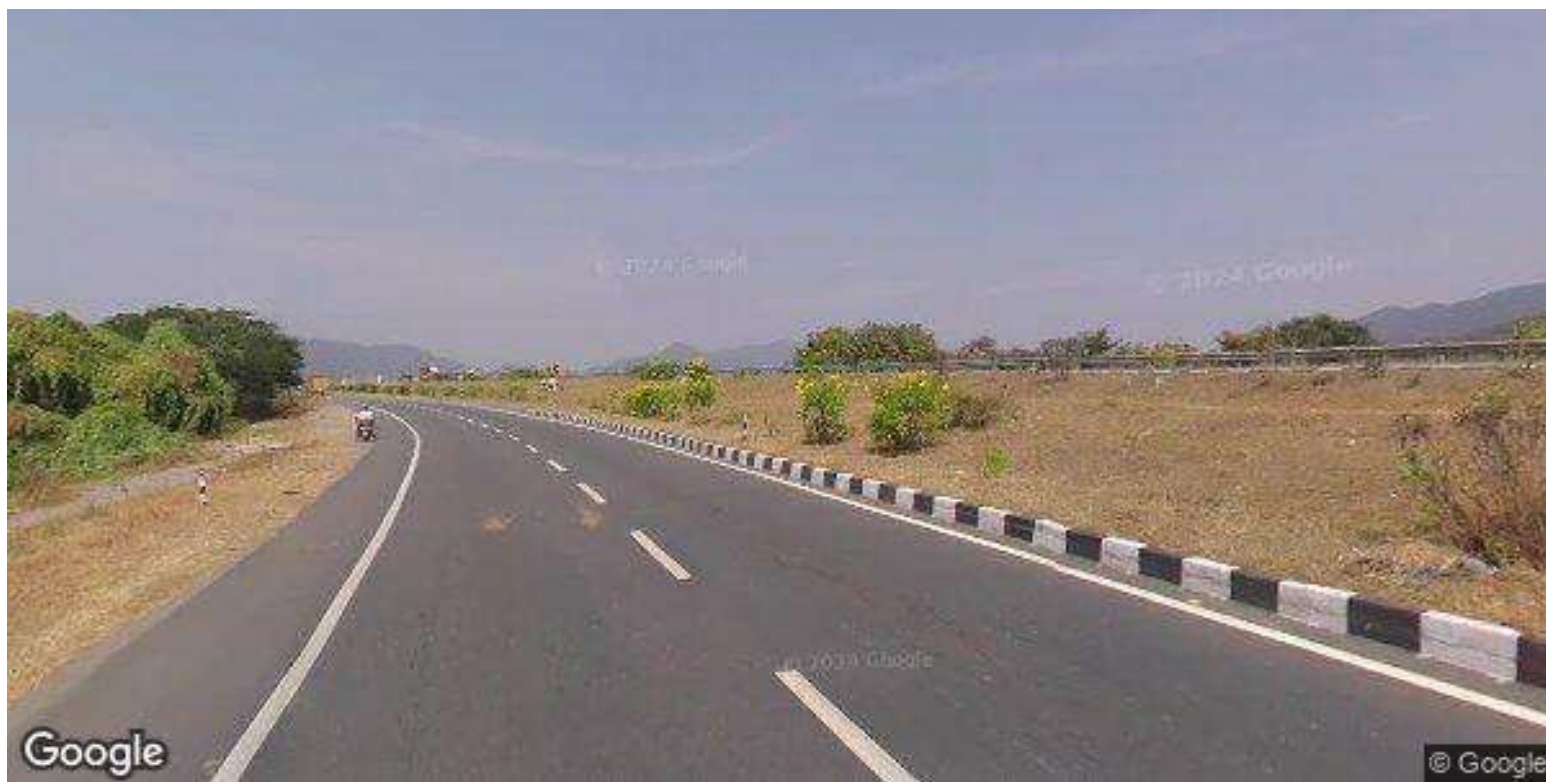
**Risk Type:** Turn

**Risk Level:** Medium

**Speed Limit:** 30 KM/Hr

**Coordinates:** 11.92585, 78.06507

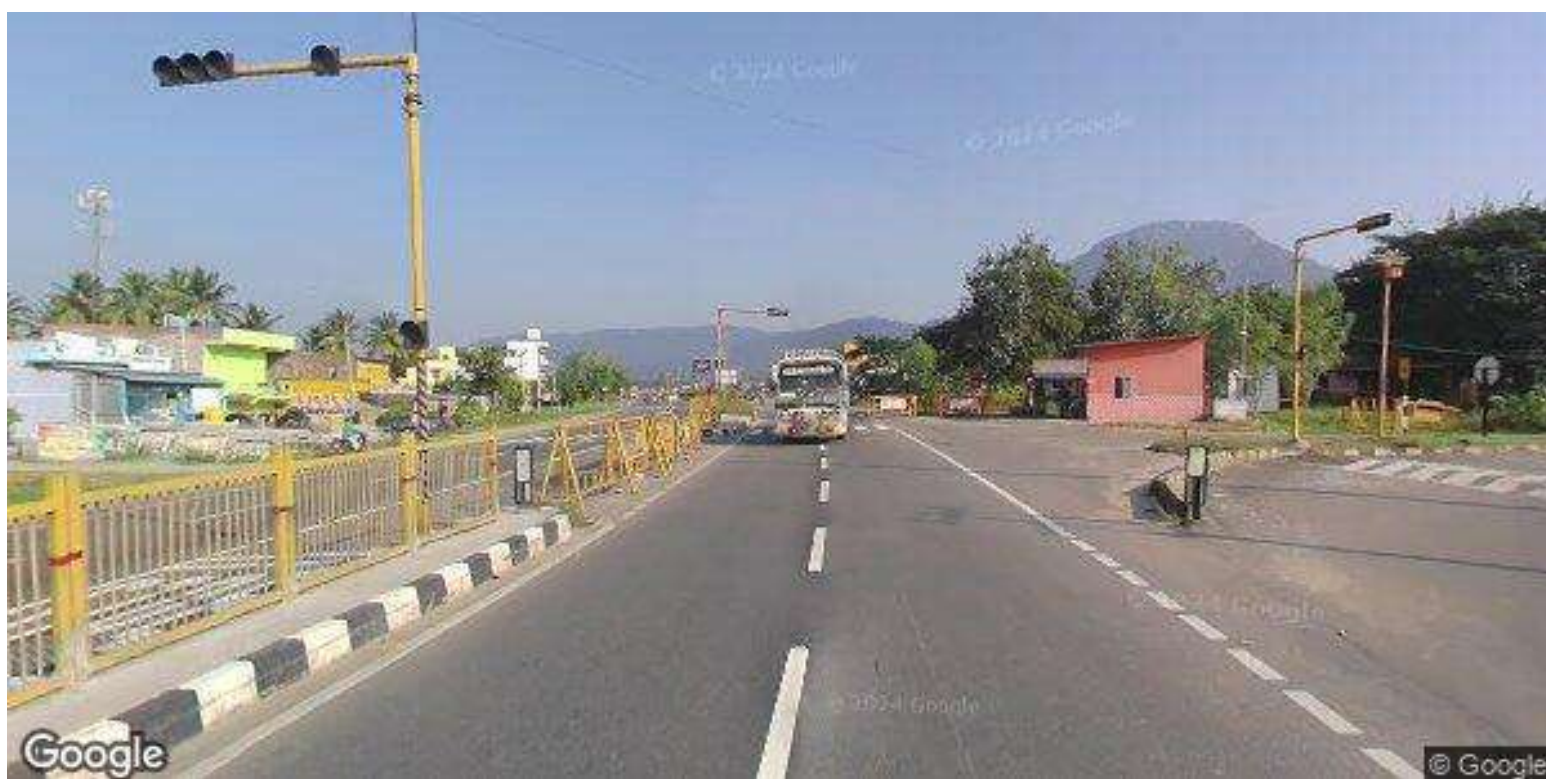
**Risk Type:** Turn

**Risk Level:** Medium

**Speed Limit:** 30 KM/Hr

**Coordinates:** 11.93704, 78.05402

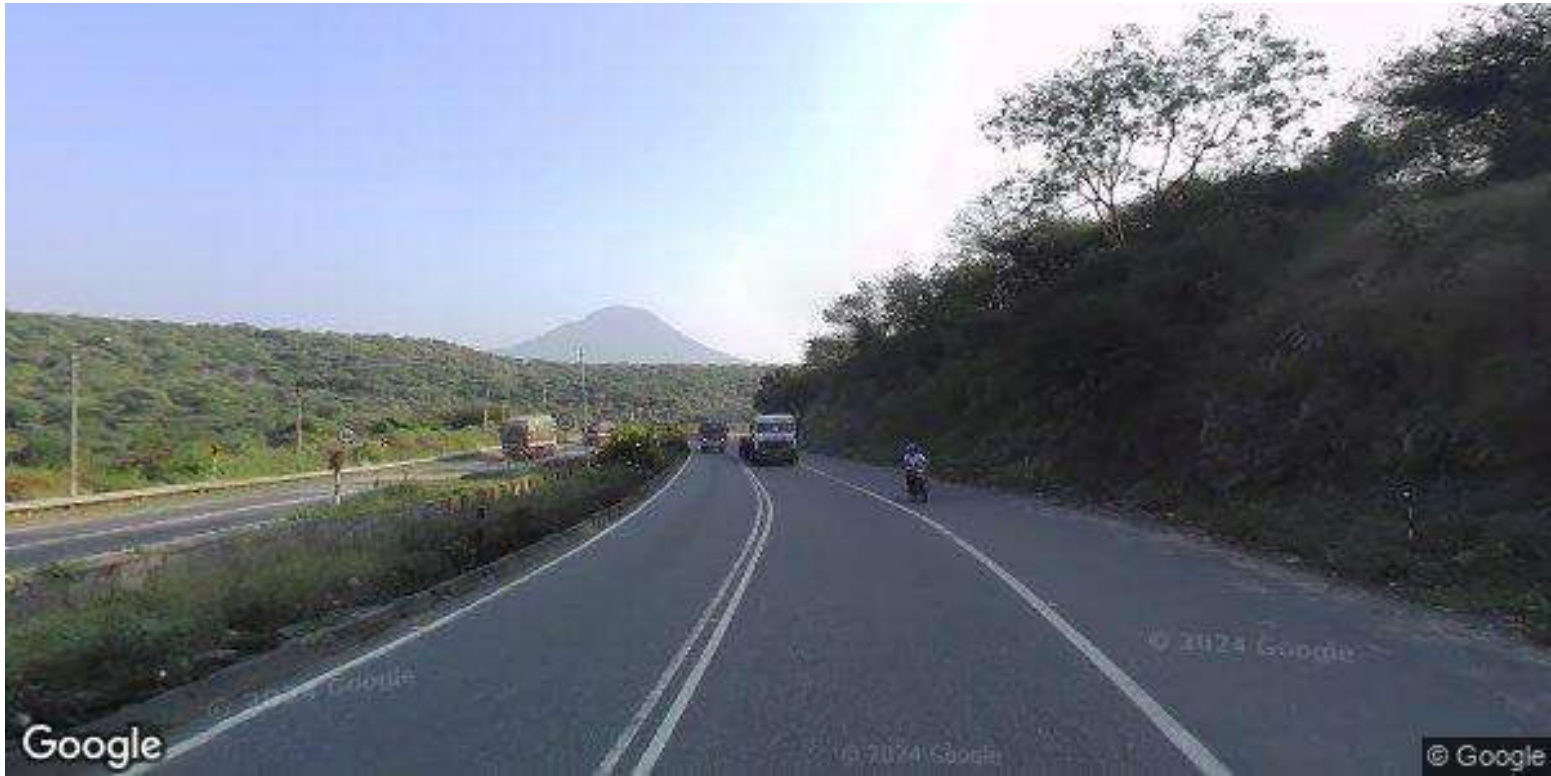
**Risk Type:** Turn  
**Risk Level:** Medium  
**Speed Limit:** 30 KM/Hr  
**Coordinates:** 11.95988, 78.04948

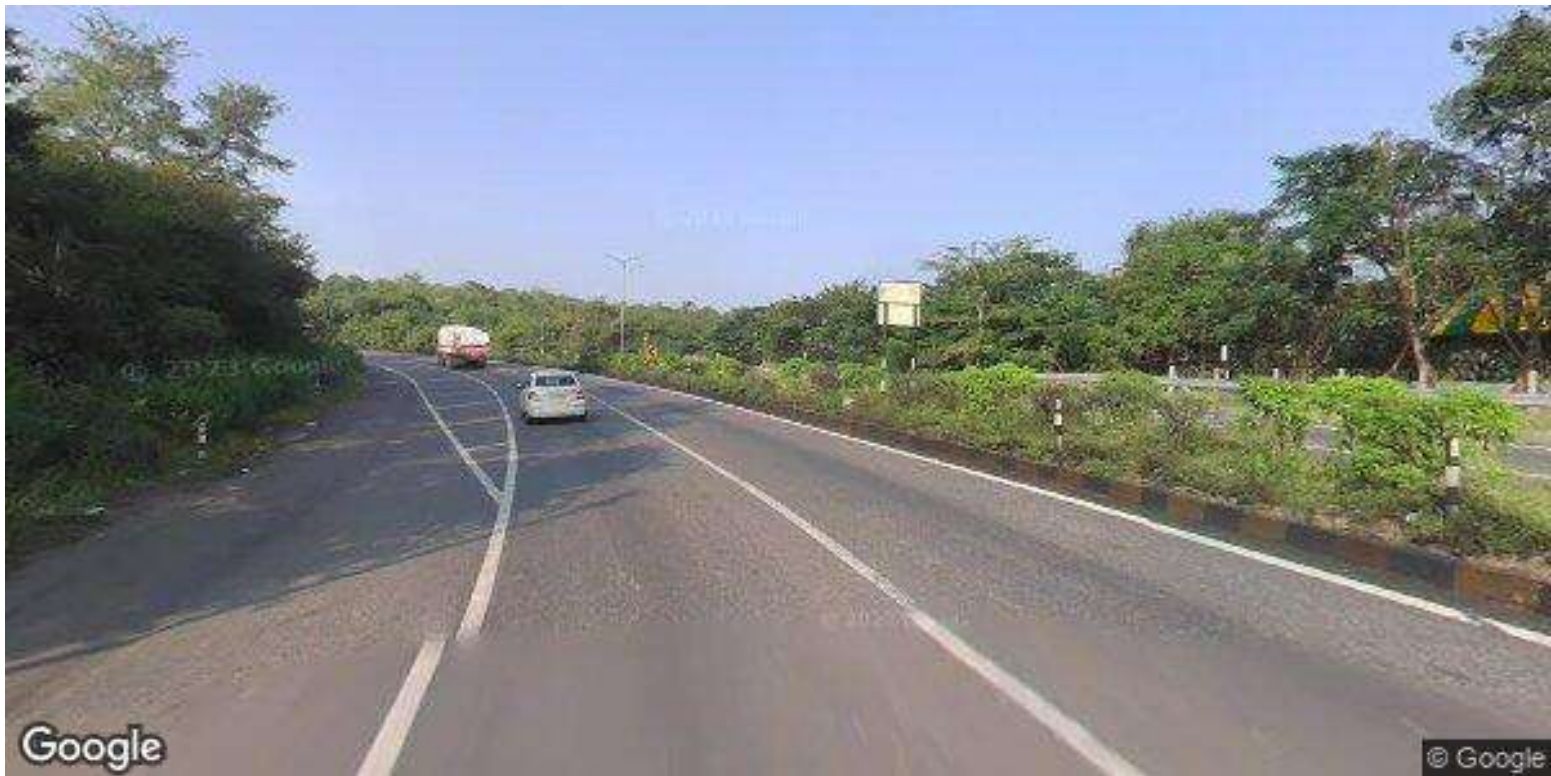
**Risk Type:** Turn  
**Risk Level:** Medium  
**Speed Limit:** 30 KM/Hr  
**Coordinates:** 11.96304, 78.05136

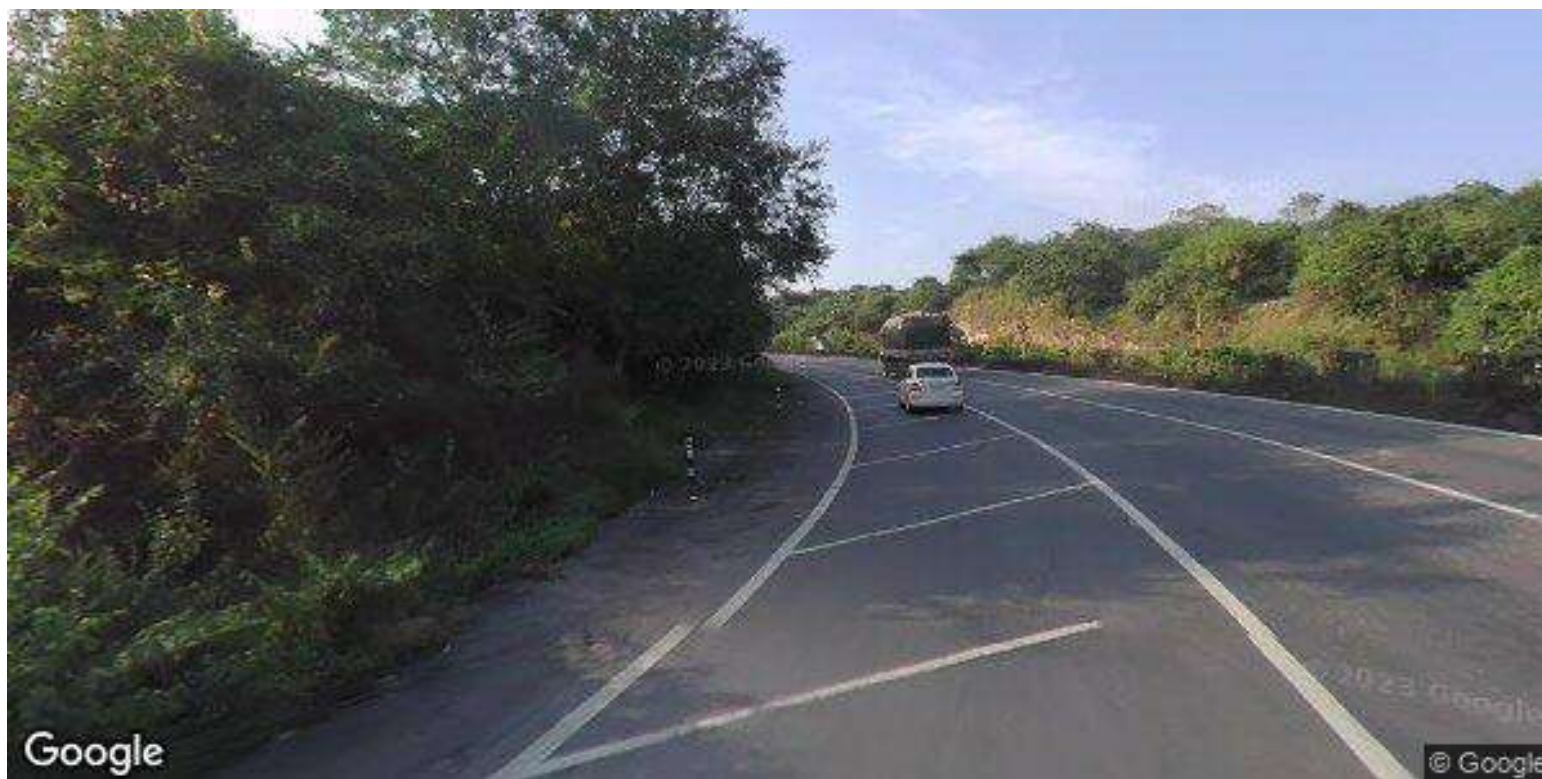
**Risk Type: Turn**

**Risk Level: High**

**Speed Limit: 15 KM/Hr**

**Coordinates: 11.96399, 78.05135**

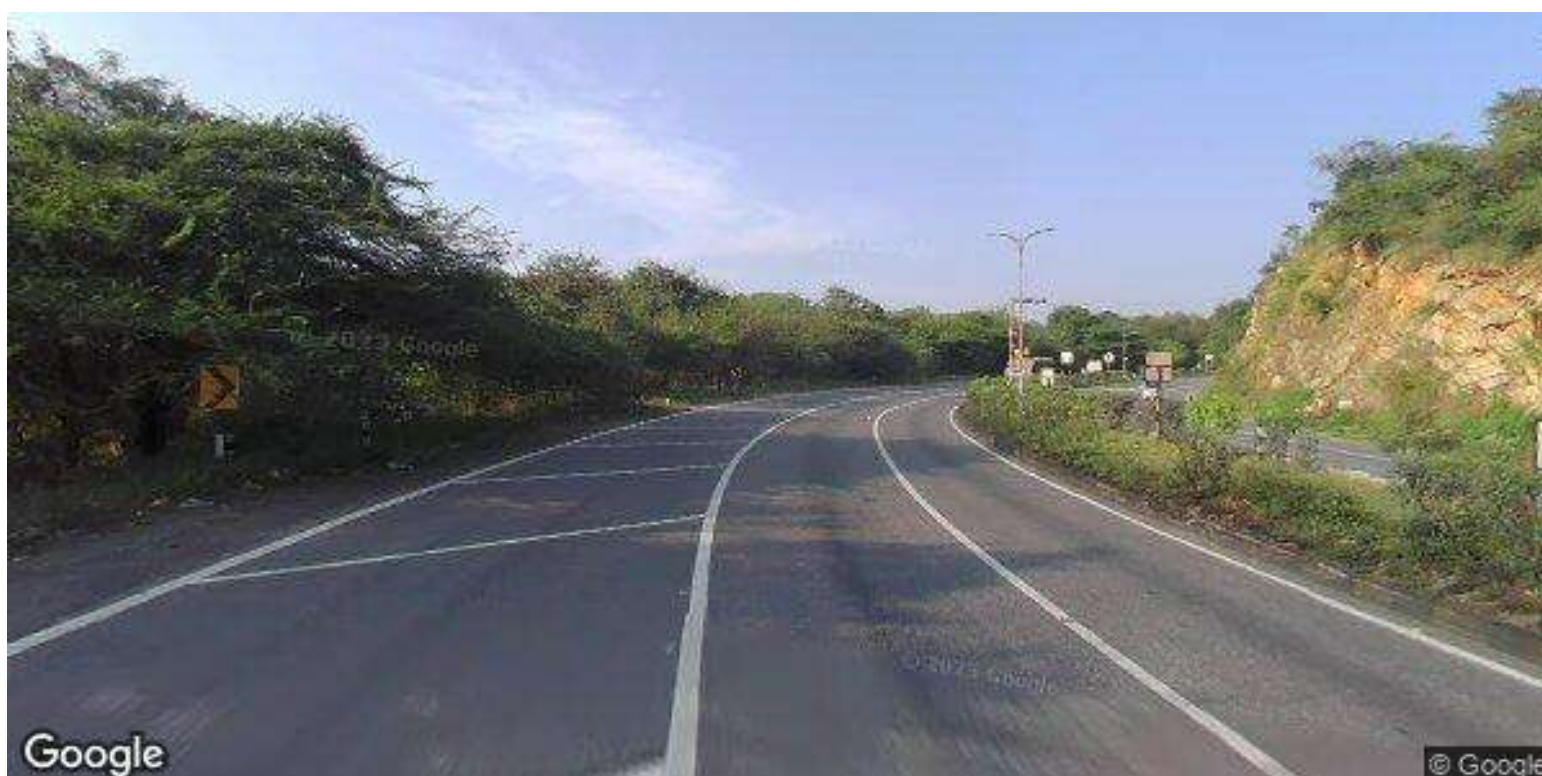
**Risk Type: Turn**

**Risk Level: High**

**Speed Limit: 15 KM/Hr**

**Coordinates: 11.96580, 78.04923**

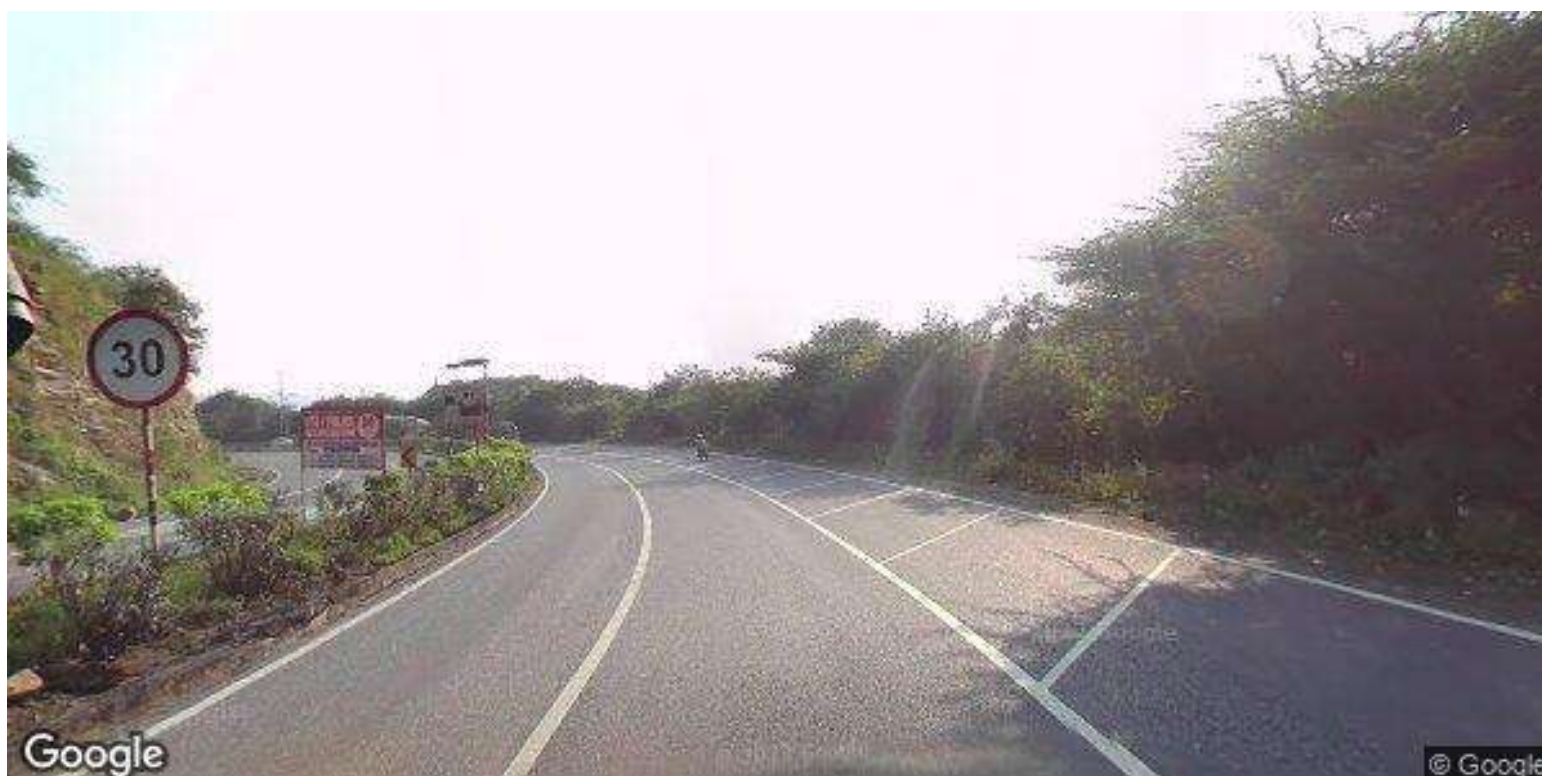
**Risk Type:** Turn  
**Risk Level:** Medium  
**Speed Limit:** 30 KM/Hr  
**Coordinates:** 11.96675, 78.04939

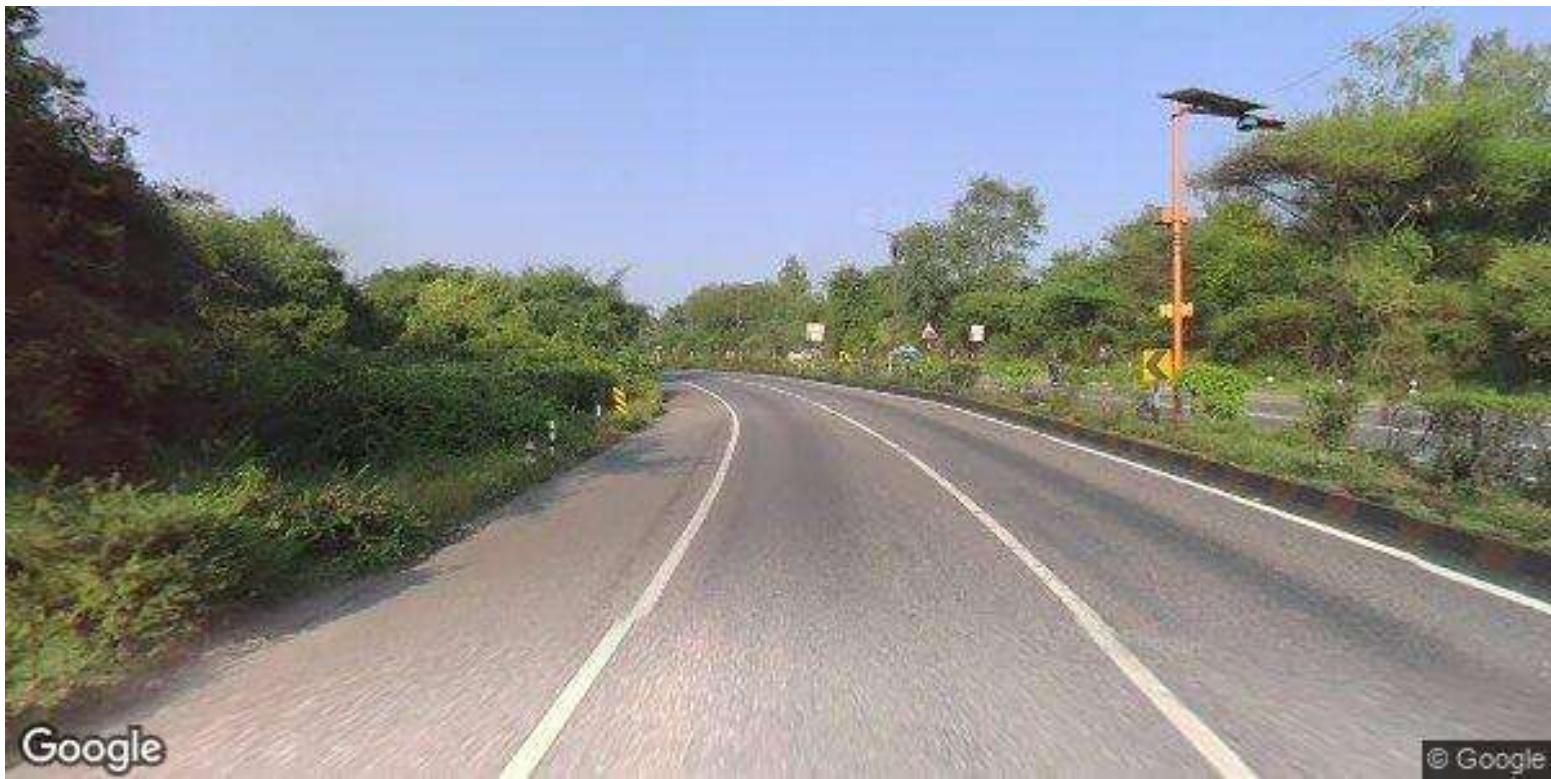
**Risk Type:** Turn  
**Risk Level:** Medium  
**Speed Limit:** 30 KM/Hr  
**Coordinates:** 11.96791, 78.05070

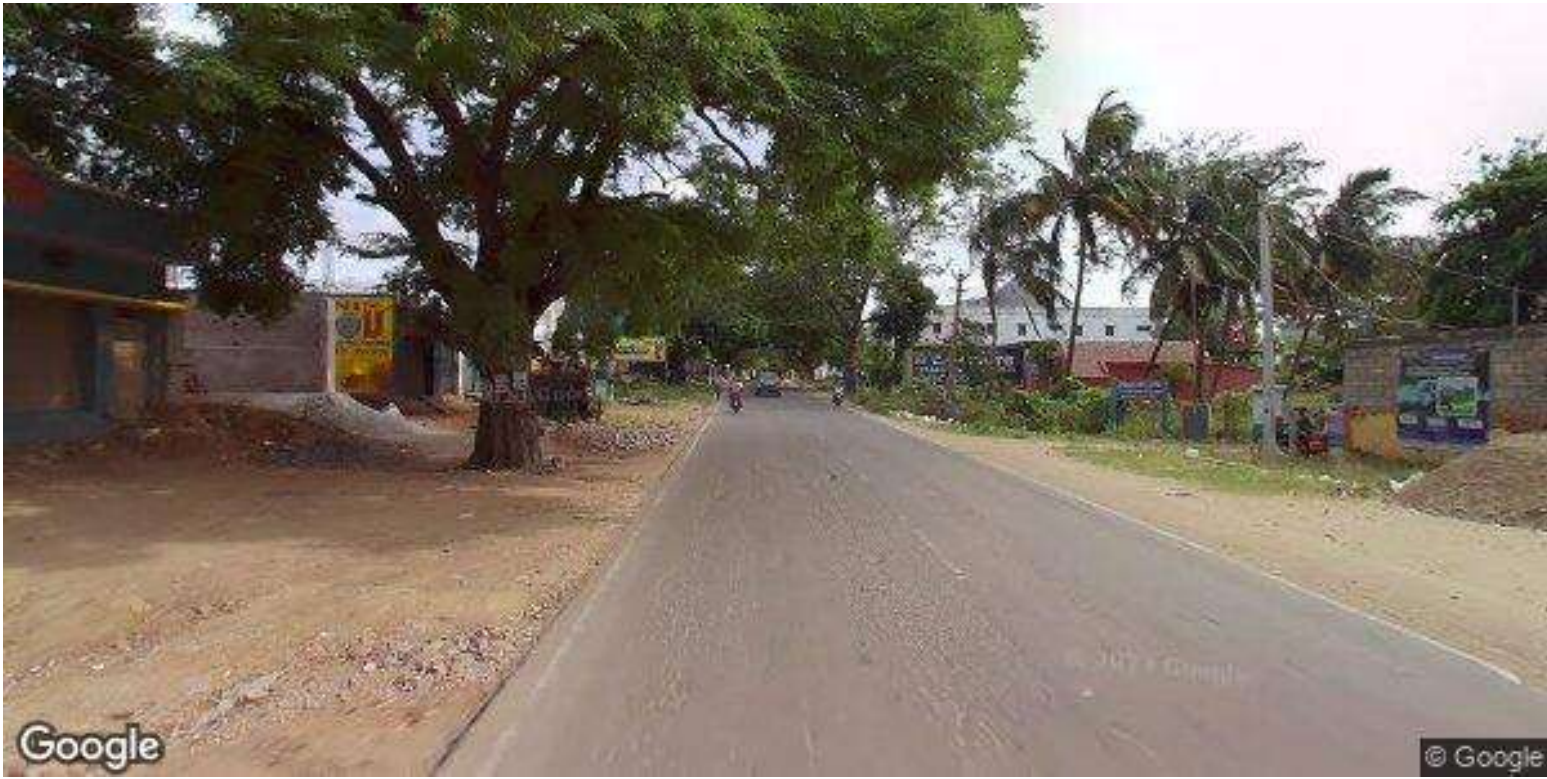
**Risk Type:** Turn  
**Risk Level:** Medium  
**Speed Limit:** 30 KM/Hr  
**Coordinates:** 12.50505, 78.03133

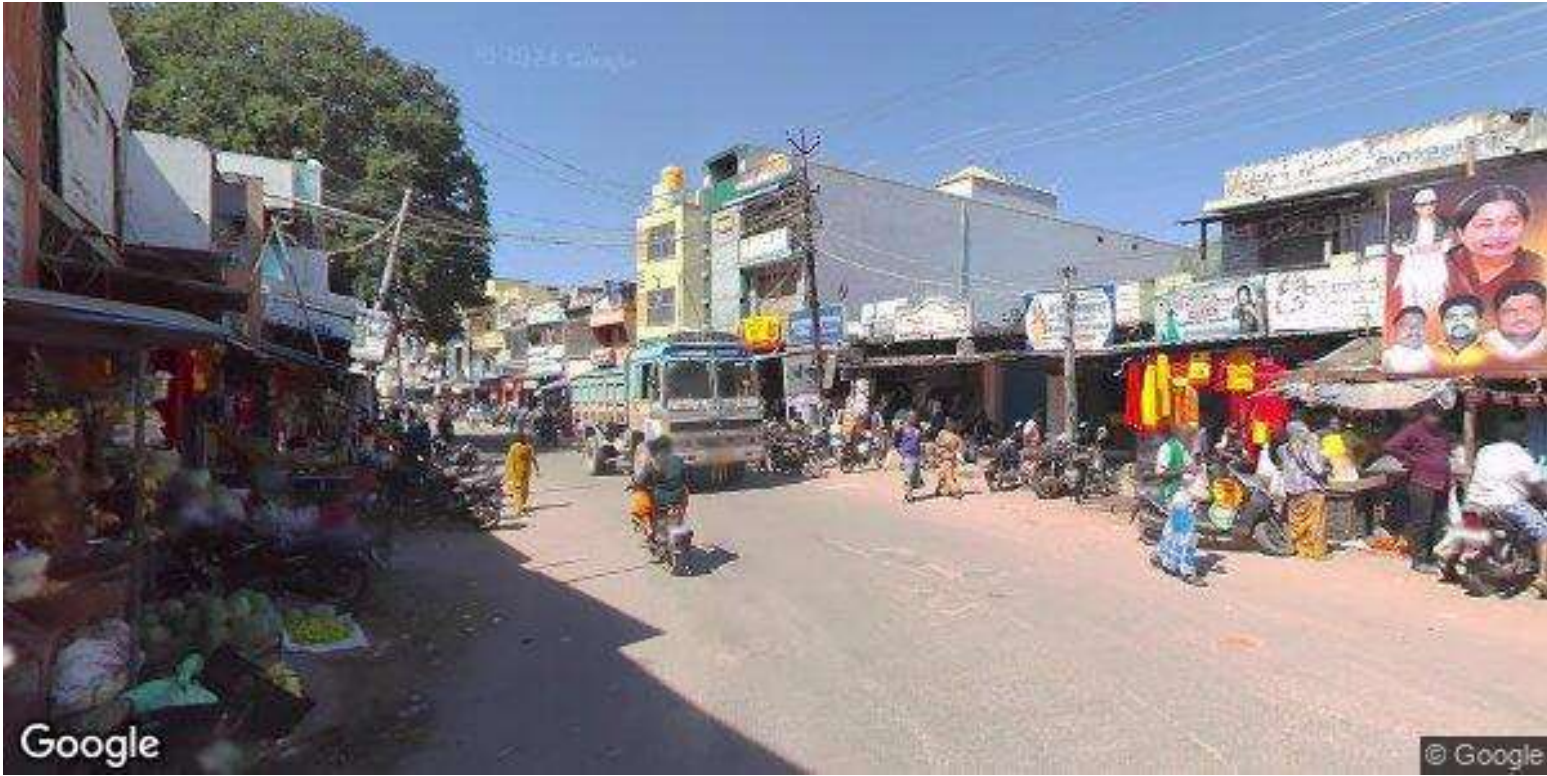
**Risk Type:** Blind Spot  
**Risk Level:** Blind Spot  
**Speed Limit:** 10 KM/Hr  
**Coordinates:** 12.51384, 78.03205

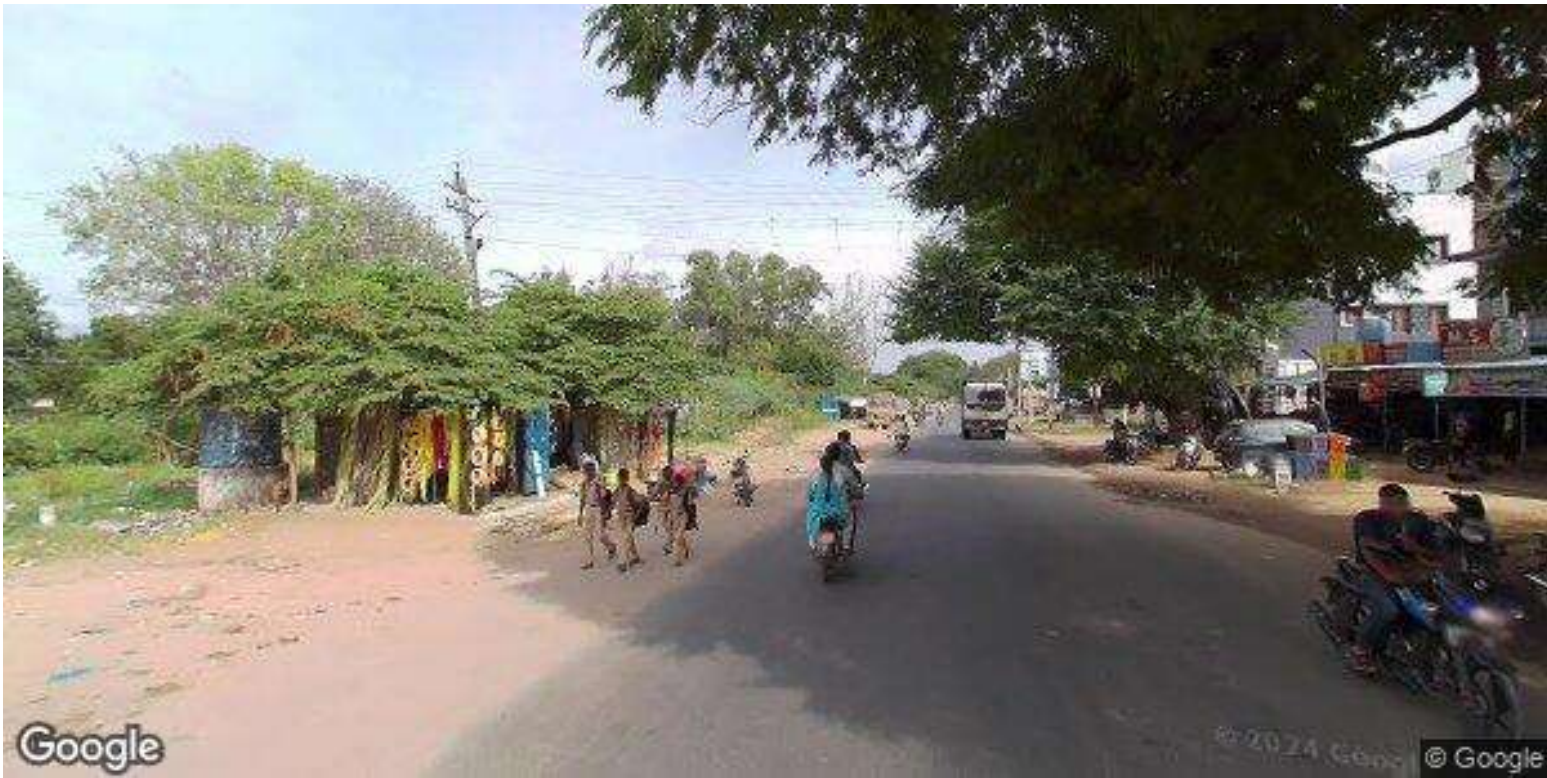
**Risk Type:** Turn  
**Risk Level:** Medium  
**Speed Limit:** 30 KM/Hr  
**Coordinates:** 12.51395, 78.02896

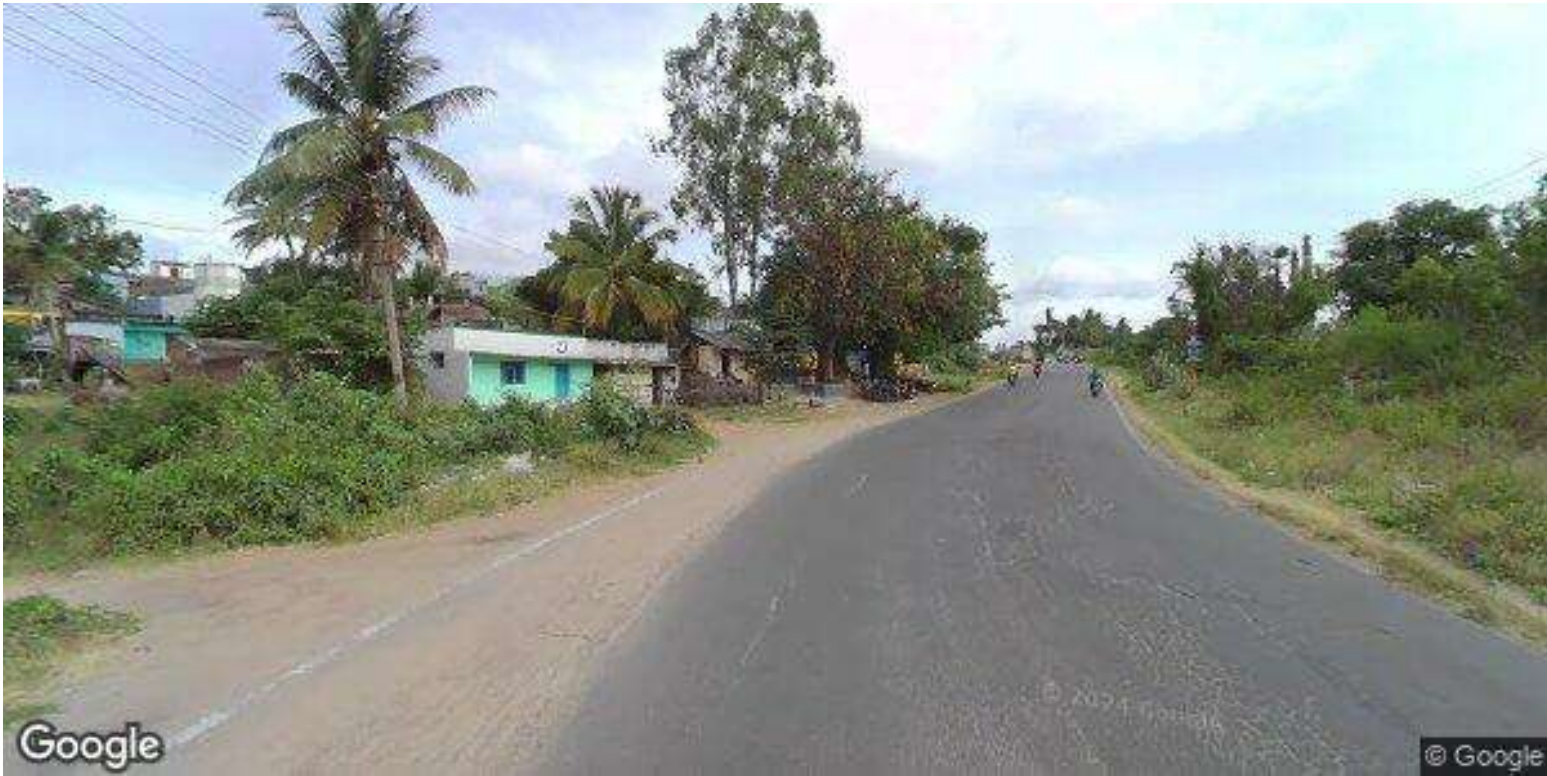
**Risk Type:** Turn  
**Risk Level:** Medium  
**Speed Limit:** 30 KM/Hr  
**Coordinates:** 12.51637, 78.02568
