# IndianOil

## JOURNEY RISK MANAGEMENT (JRM) STUDY

### Salem Terminal TO TVR FUELS STATION

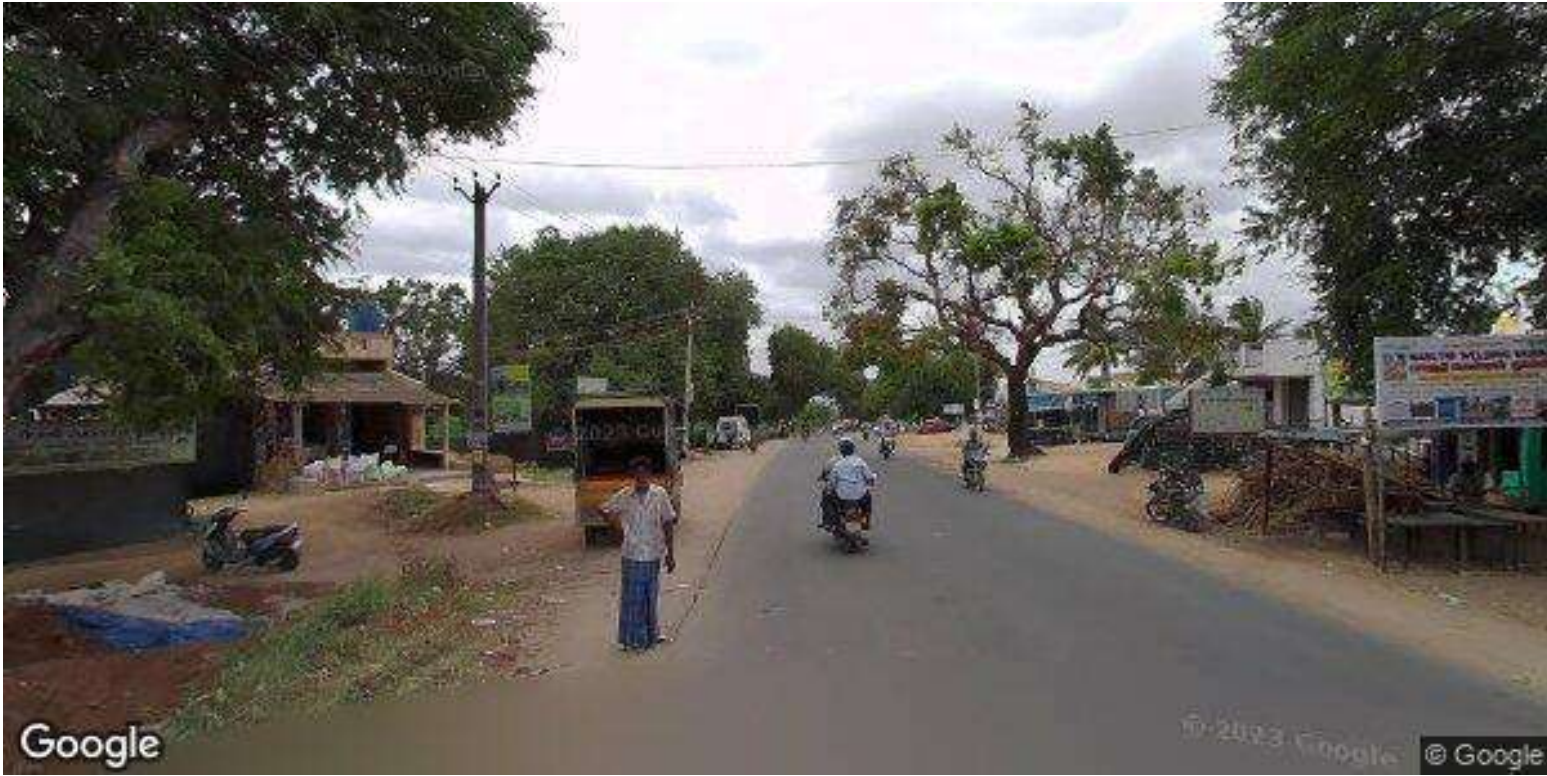
**Risk Type:** Turn  
**Risk Level:** Medium  
**Speed Limit:** 30 KM/Hr  
**Coordinates:** 12.52171, 78.02417

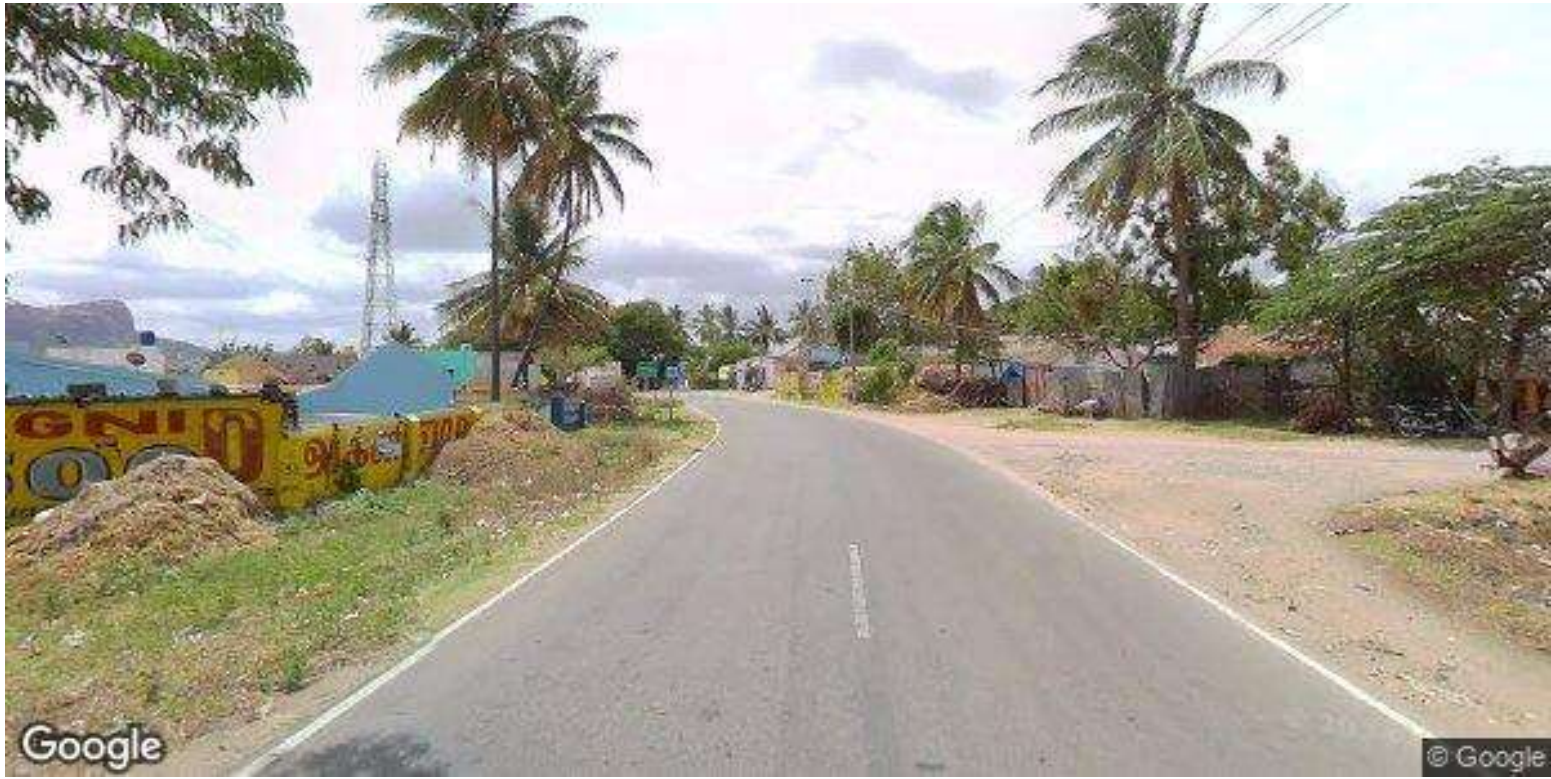
**Risk Type:** Turn  
**Risk Level:** Medium  
**Speed Limit:** 30 KM/Hr  
**Coordinates:** 12.52712, 78.00951

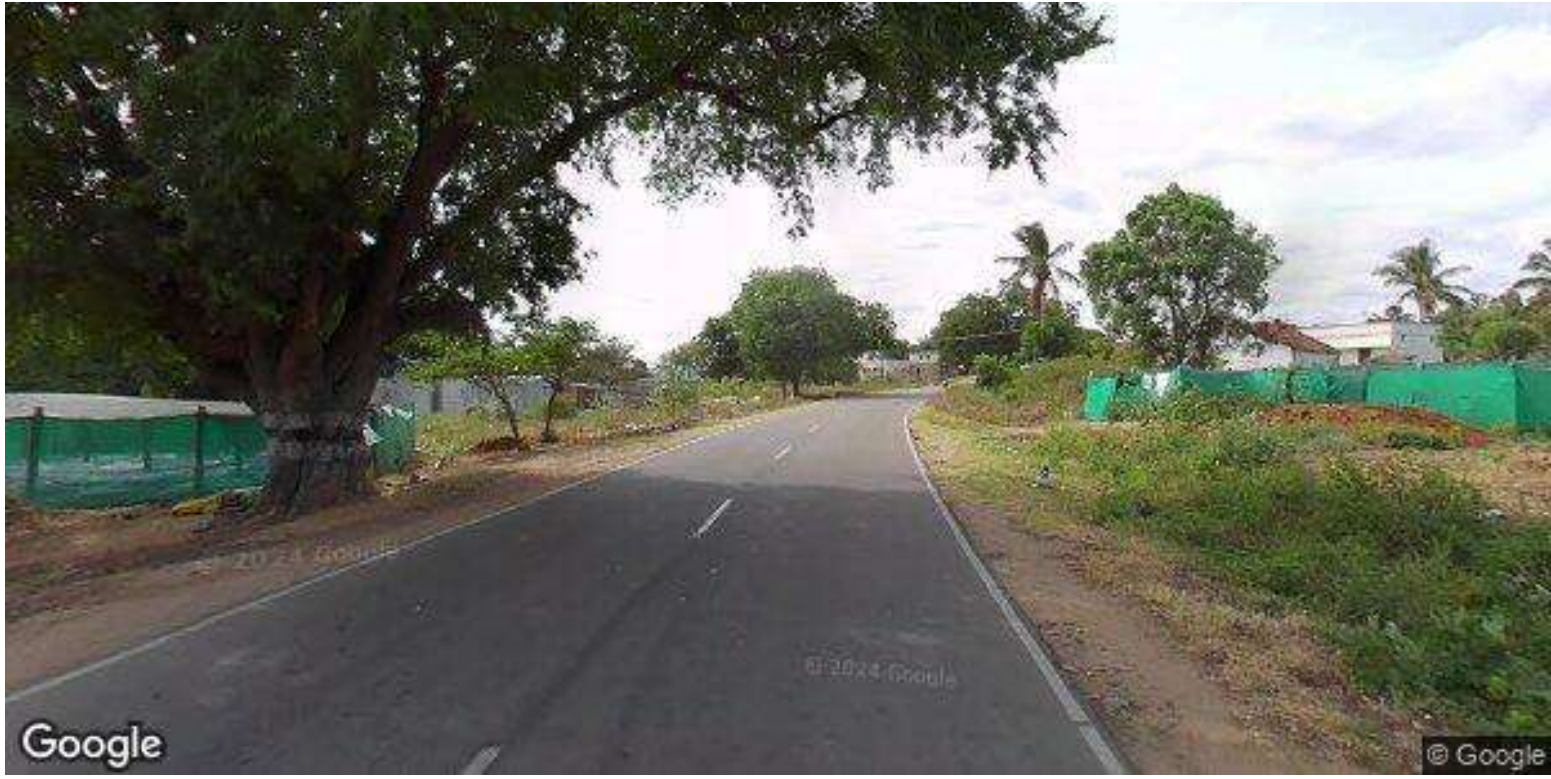
**Risk Type:** Turn  
**Risk Level:** Medium  
**Speed Limit:** 30 KM/Hr  
**Coordinates:** 12.52900, 78.00856

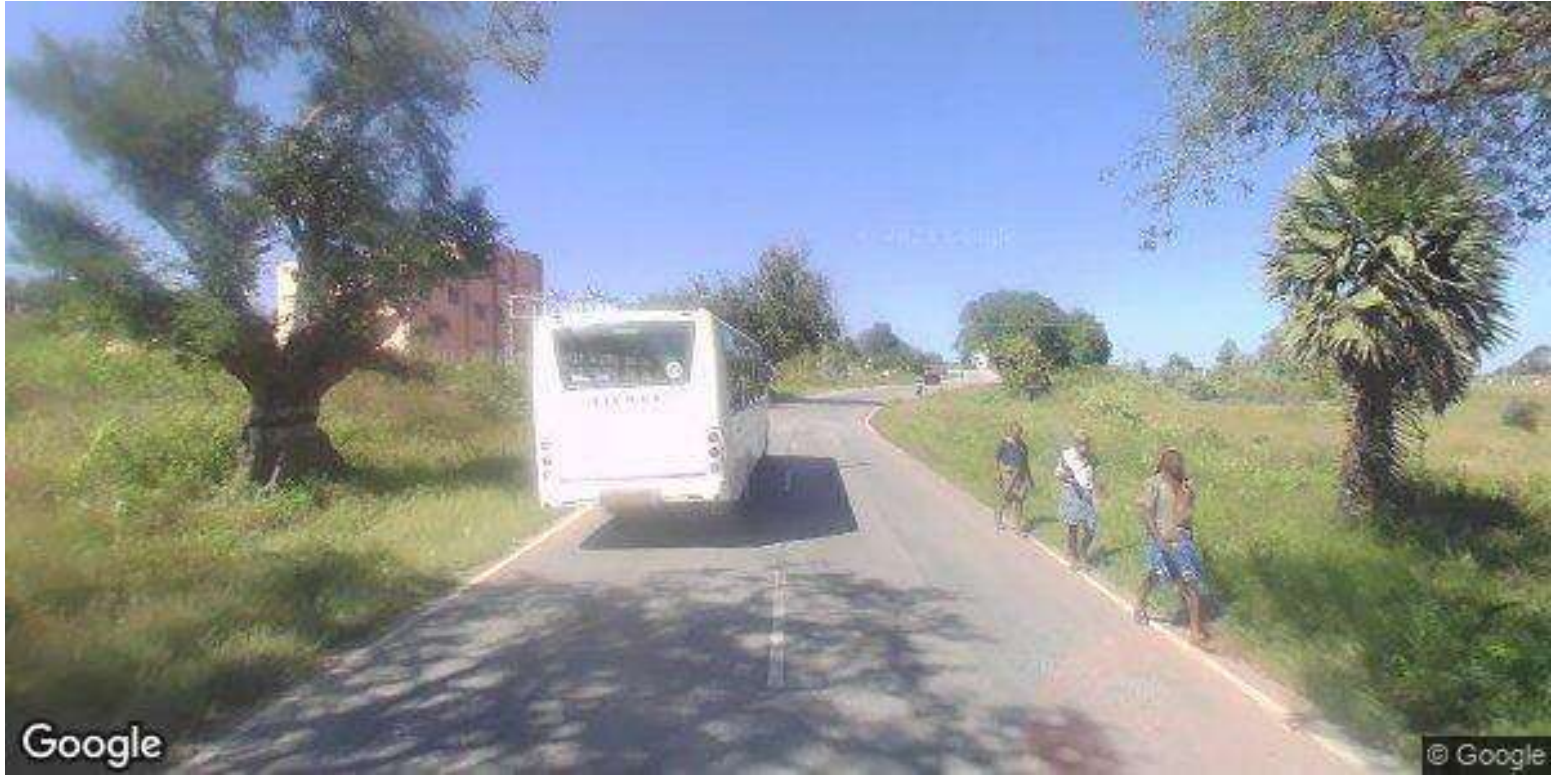
**Risk Type:** Turn  
**Risk Level:** Medium  
**Speed Limit:** 30 KM/Hr  
**Coordinates:** 12.54948, 77.97277

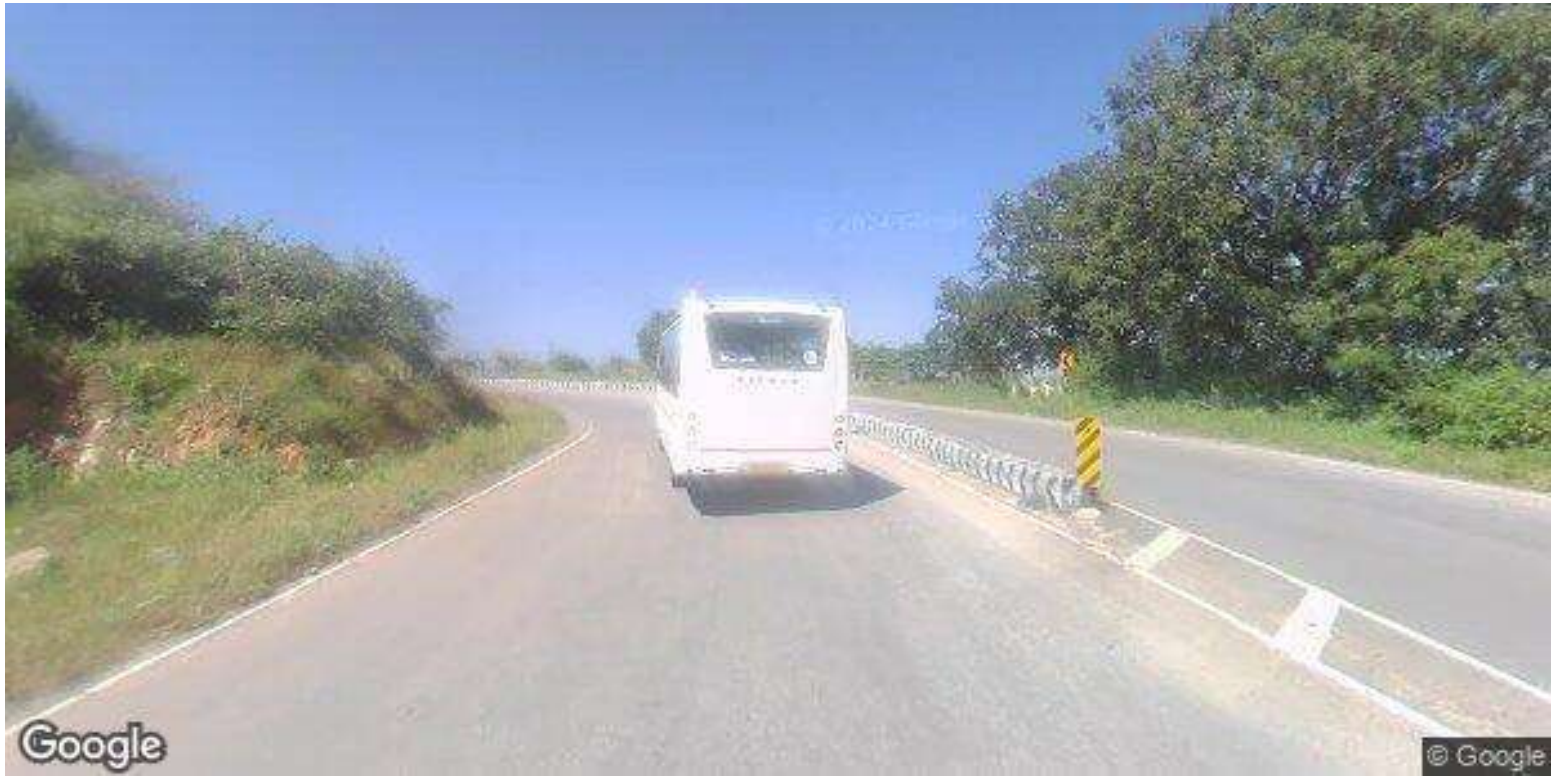
**Risk Type:** Turn  
**Risk Level:** Medium  
**Speed Limit:** 30 KM/Hr  
**Coordinates:** 12.55078, 77.97257

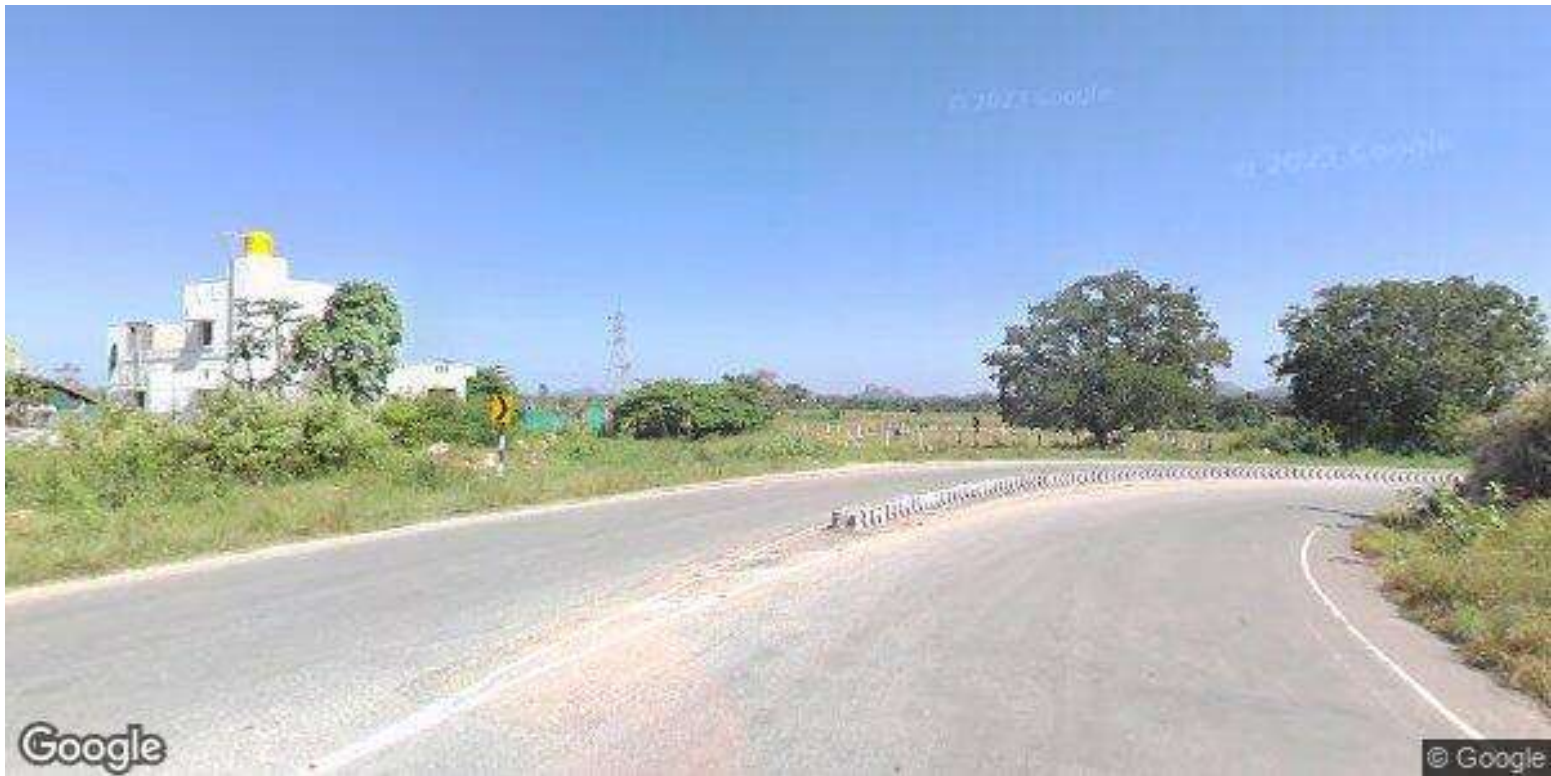
**Risk Type:** Turn  
**Risk Level:** Medium  
**Speed Limit:** 30 KM/Hr  
**Coordinates:** 12.55126, 77.97216

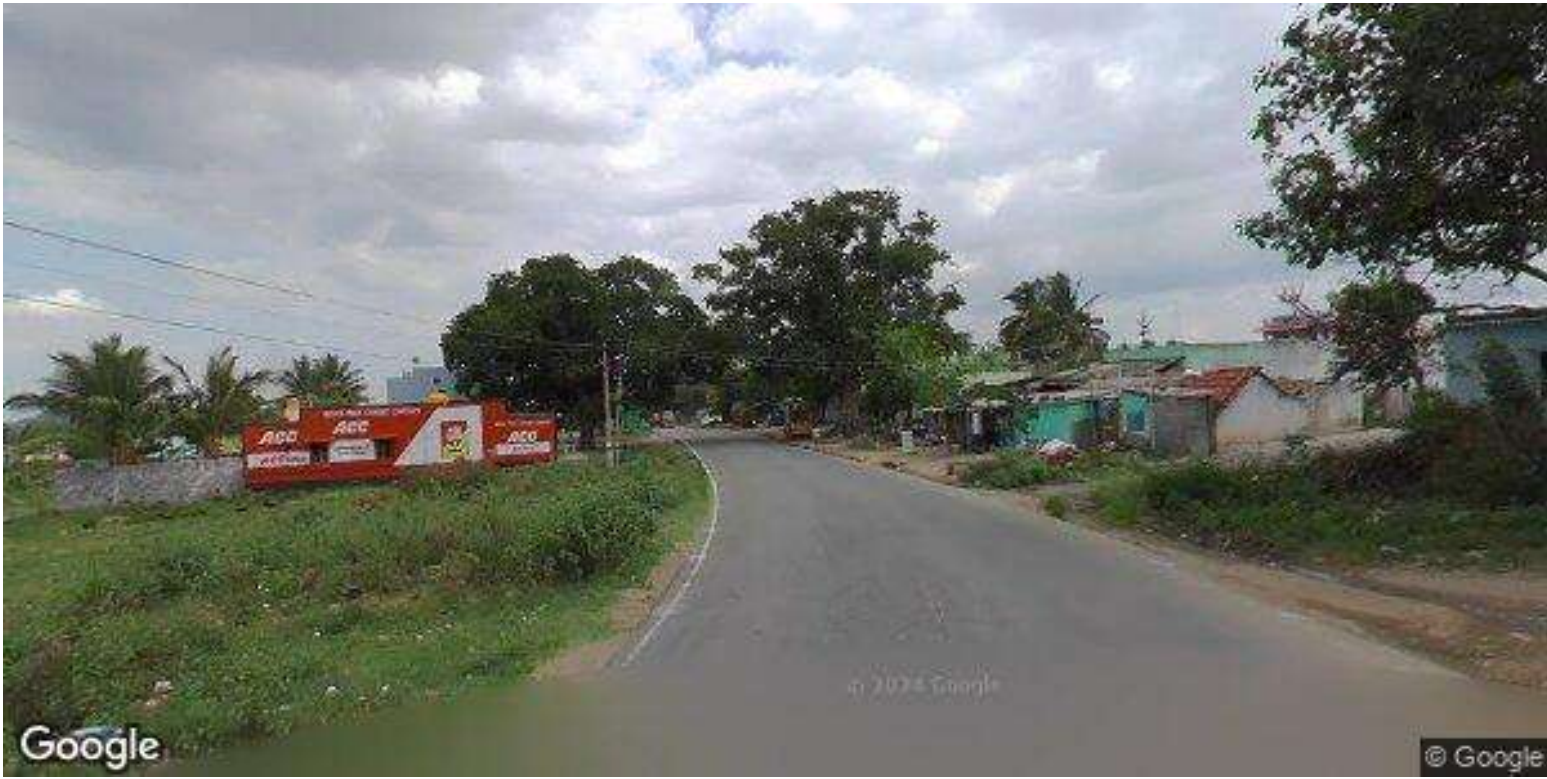
**Risk Type:** Turn  
**Risk Level:** Medium  
**Speed Limit:** 30 KM/Hr  
**Coordinates:** 12.55317, 77.96530

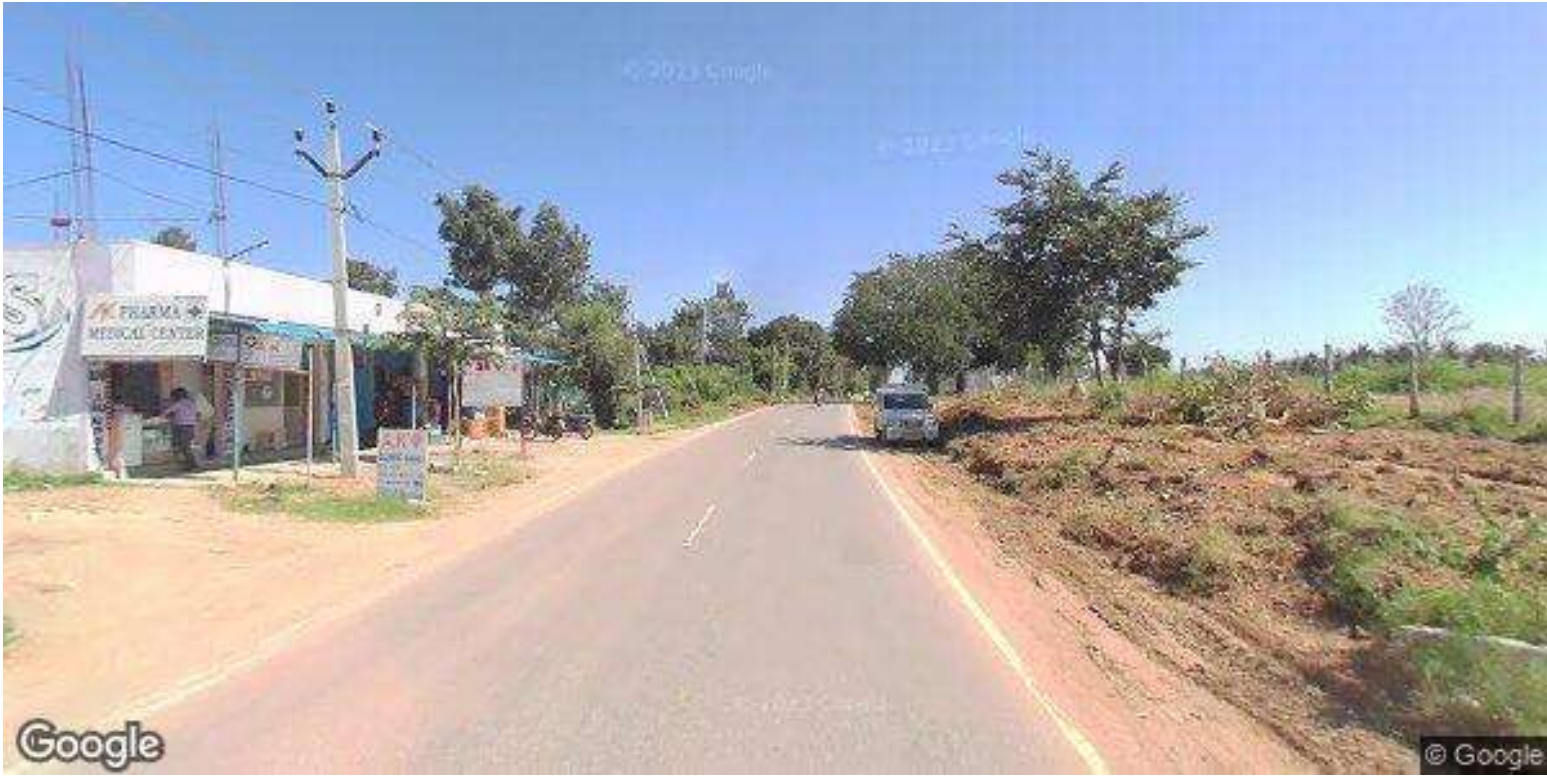
**Risk Type:** Turn  
**Risk Level:** Medium  
**Speed Limit:** 30 KM/Hr  
**Coordinates:** 12.56517, 77.95315
