# IndianOil

## JOURNEY RISK MANAGEMENT (JRM) STUDY

### Salem Terminal TO KPL FUELS

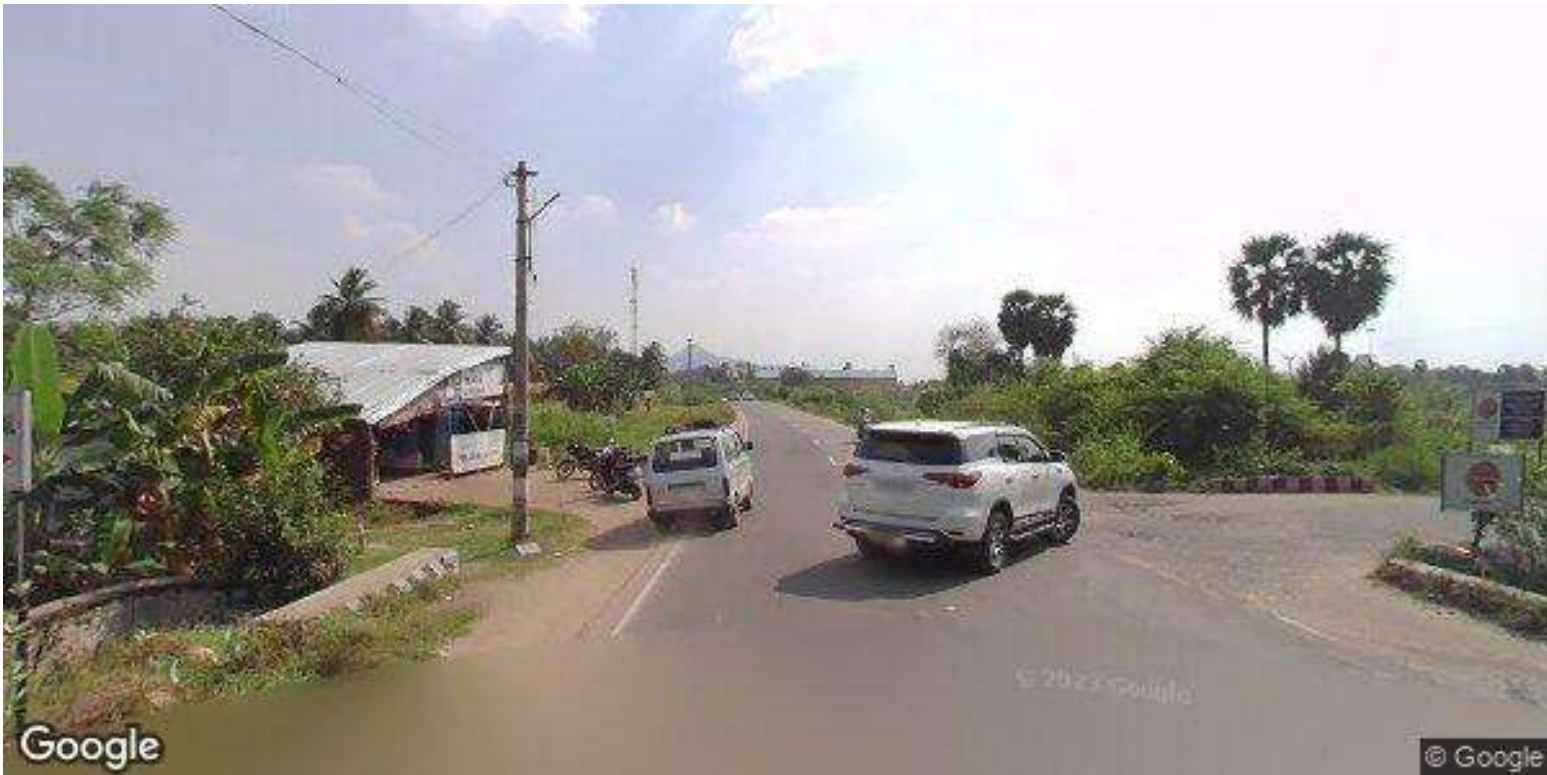
Coordinates: 11.44029, 77.87544

Risk Type: Turn

Risk Level: High

Speed Limit: 15 KM/Hr

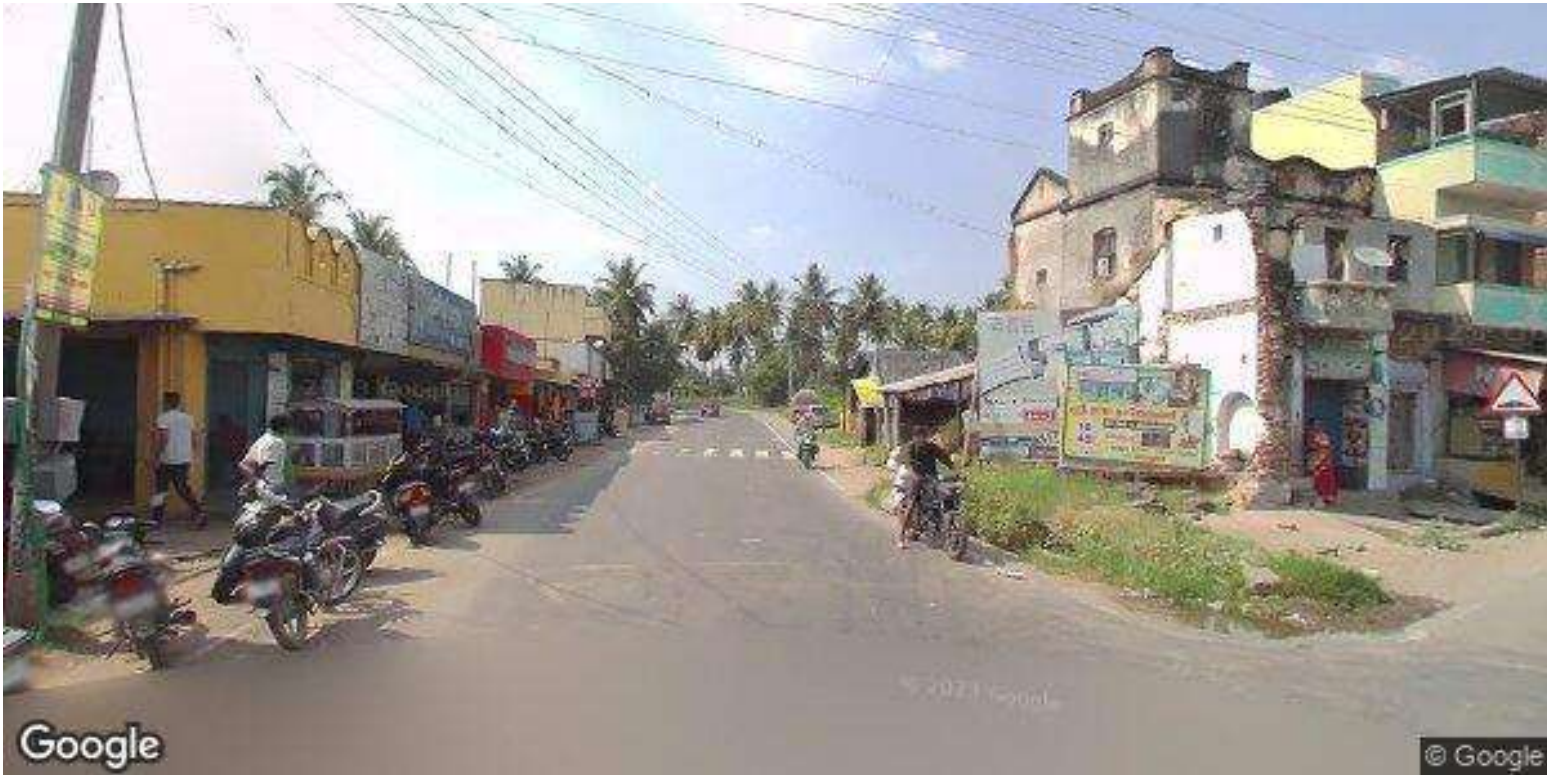
Coordinates: 11.45007, 77.87201

Risk Type: Turn

Risk Level: High

Speed Limit: 15 KM/Hr

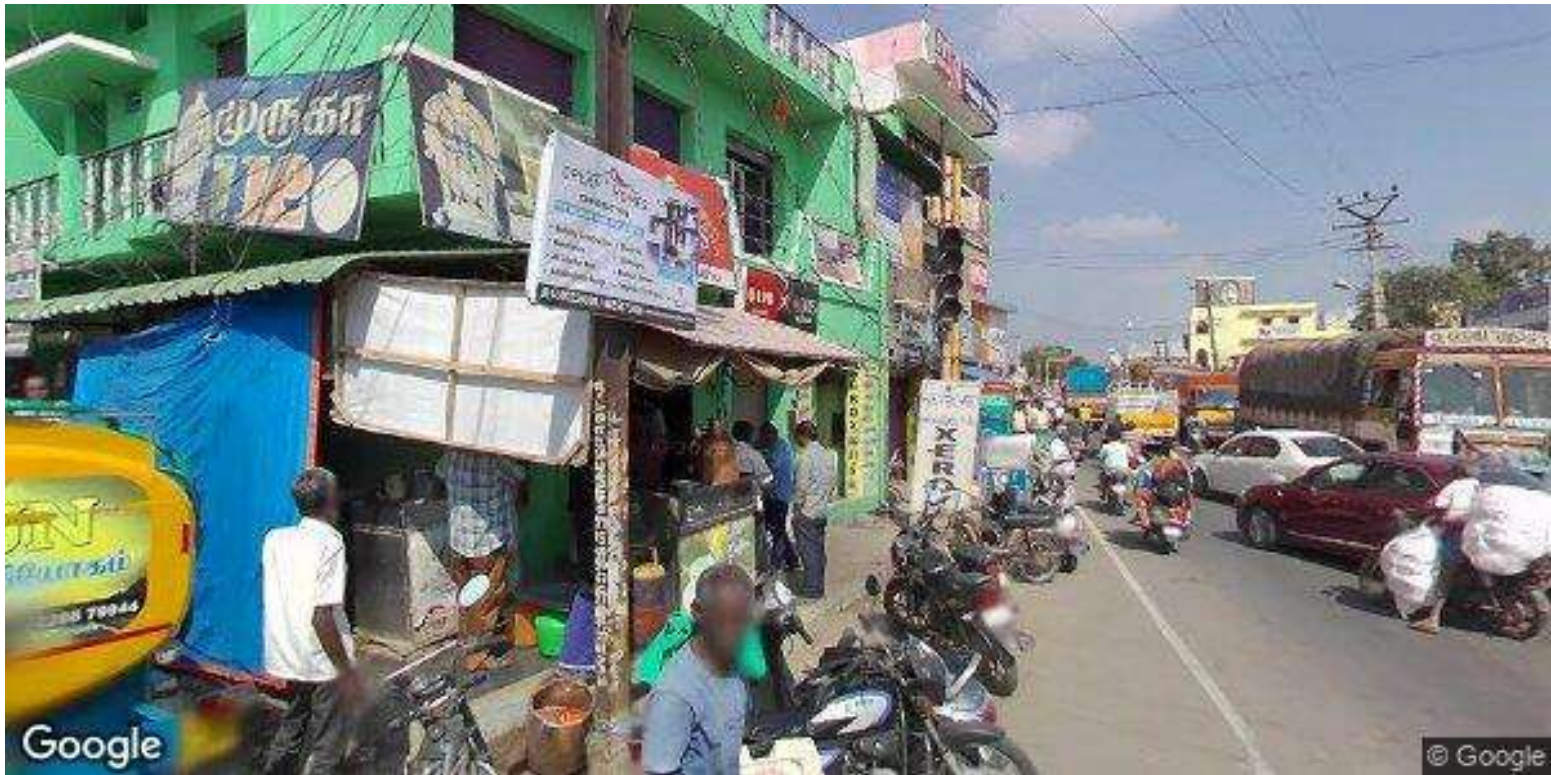
Coordinates: 11.47407, 77.86839

Risk Type: Turn

Risk Level: High

Speed Limit: 15 KM/Hr

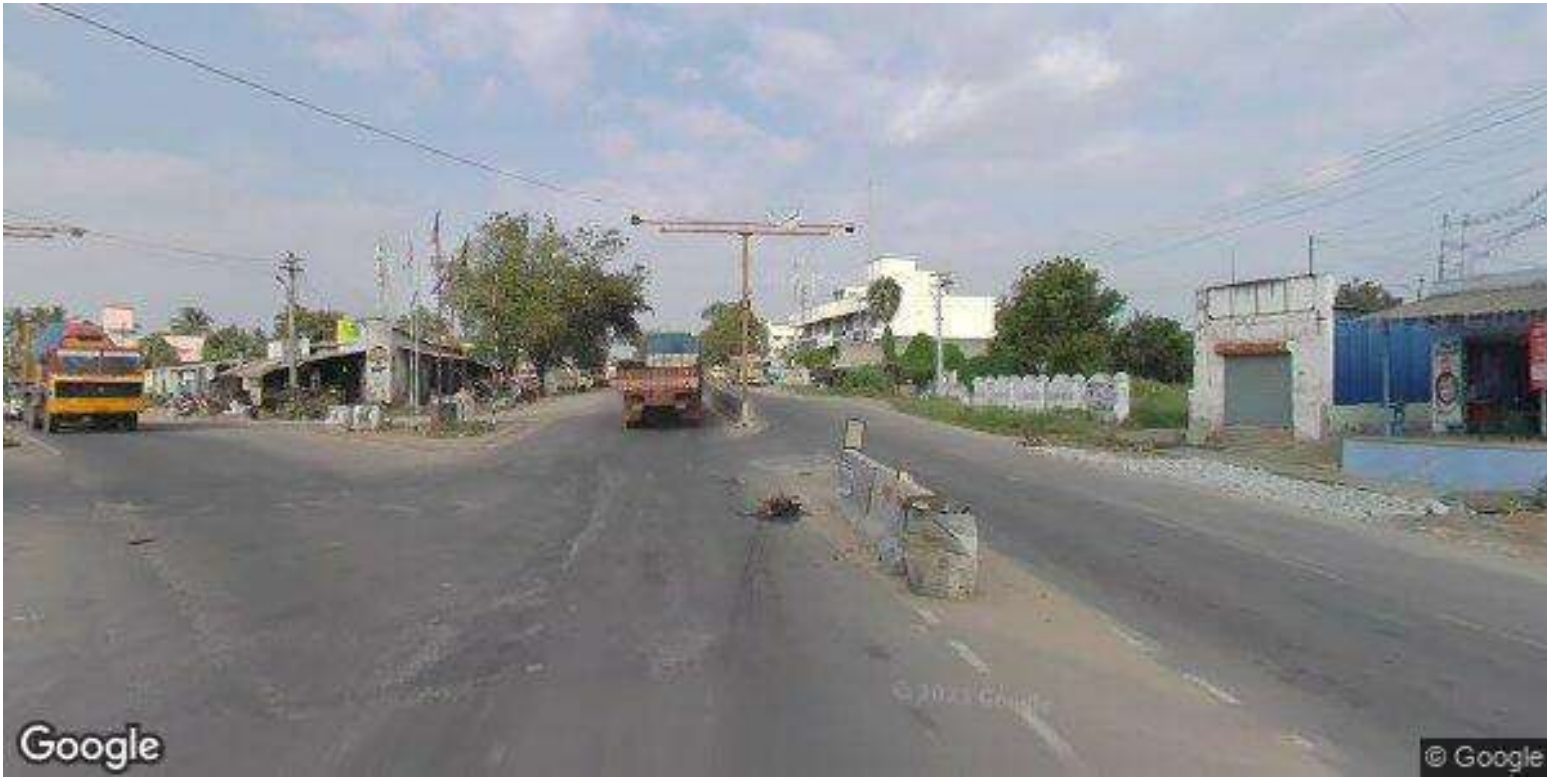
**Risk Type:** Turn  
**Risk Level:** Medium  
**Speed Limit:** 30 KM/Hr  
**Coordinates:** 11.48370, 77.88787

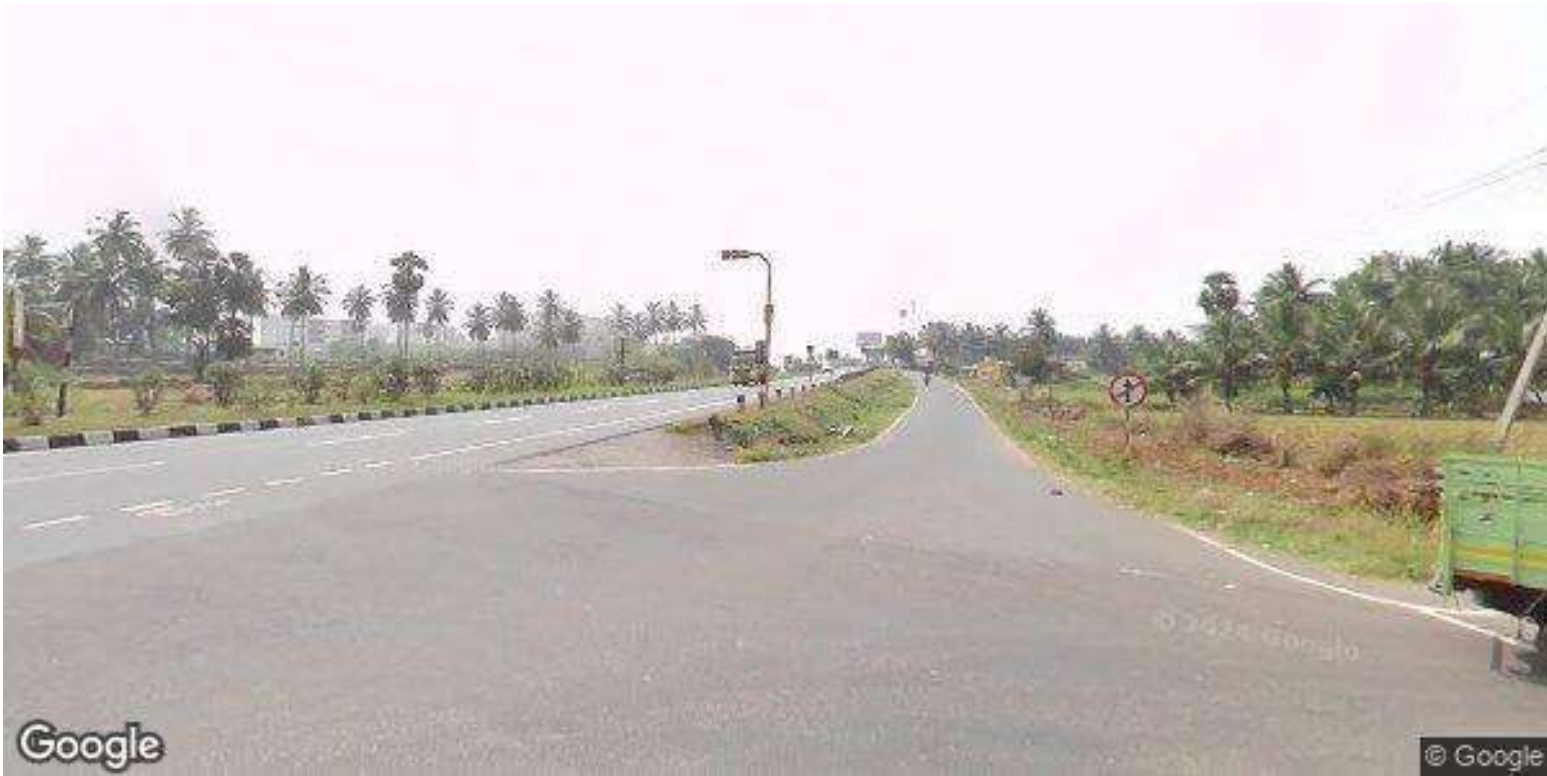
Coordinates: 11.57645, 78.04266

Risk Type: Blind Spot

Risk Level: Blind Spot

Speed Limit: 10 KM/Hr
