# IndianOil

## JOURNEY RISK MANAGEMENT (JRM) STUDY

### Salem Terminal to SS AGENCY

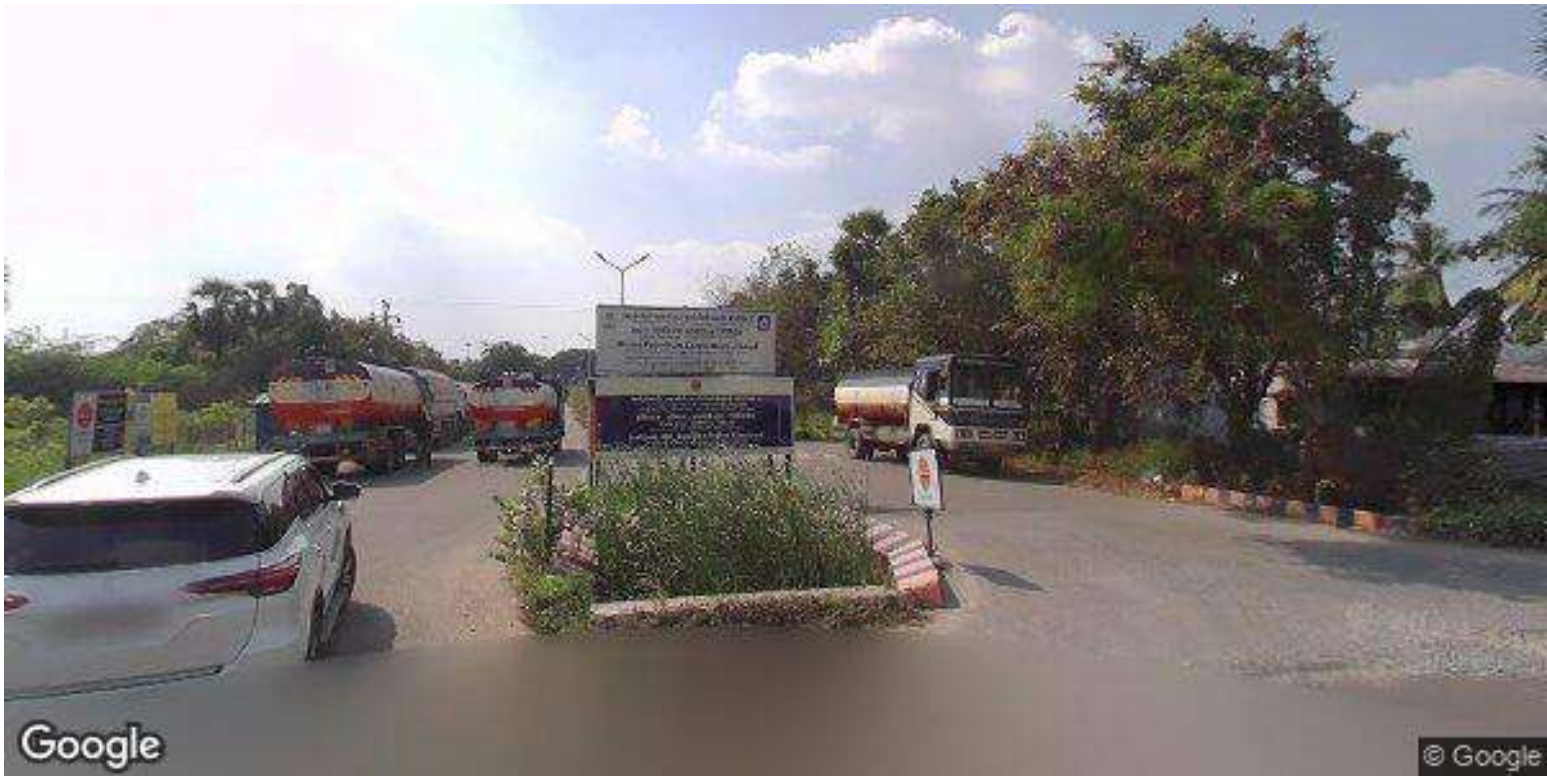
| | Risk Type | Risk Level | Coordinates | Speed Limit |
|---|---|---|---|---|
| 1 | Turn | High | 11.44024, 77.87528 | 15 KM/Hr |

Risk Type: Turn  
Risk Level: High

**Speed Limit: 15 KM/Hr**  
**Coordinates: 11.44024, 77.87528**

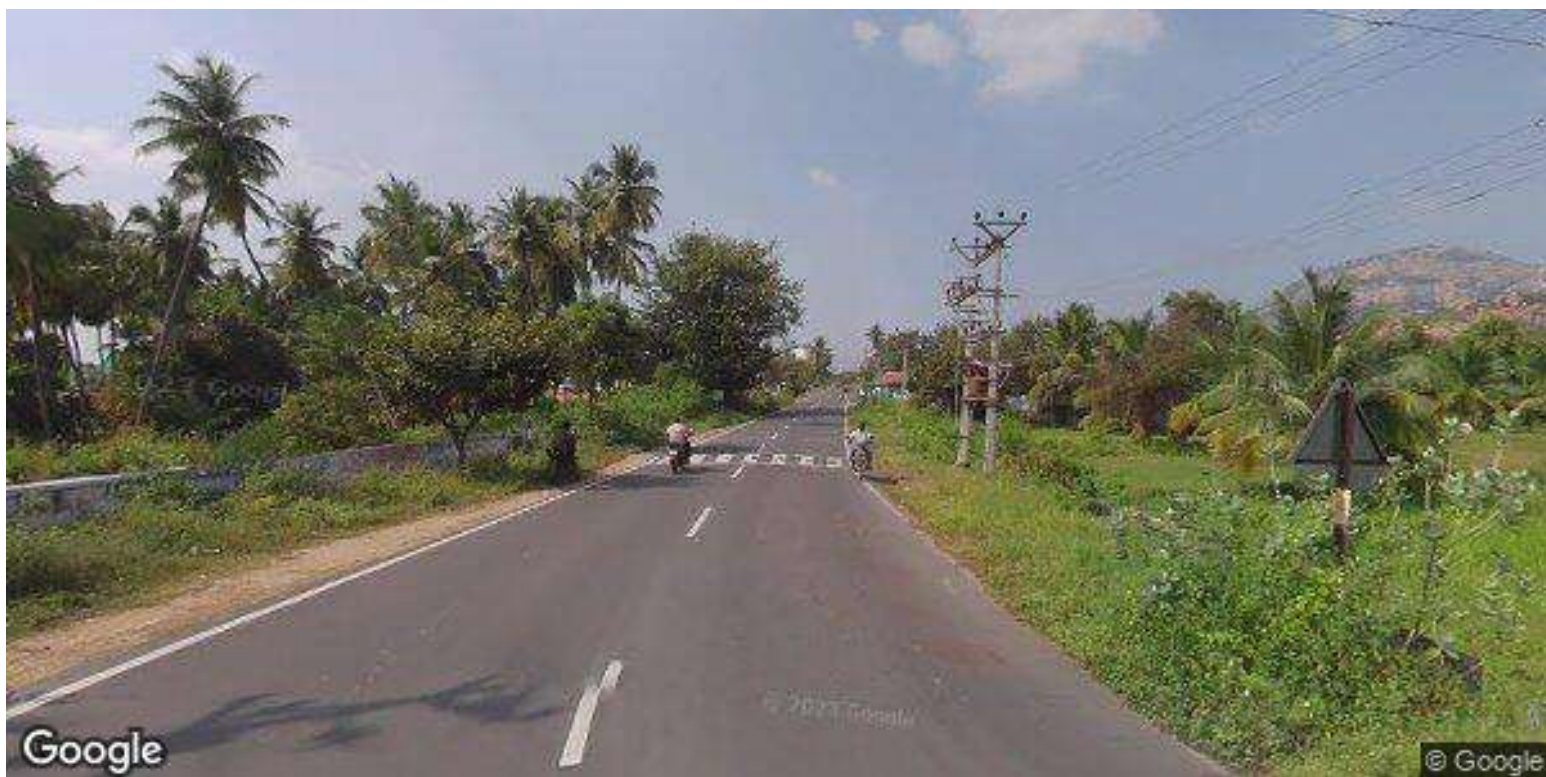
| | Risk Type | Risk Level | Coordinates | Speed Limit |
|---|---|---|---|---|
| 3 | Turn | High | 11.45352, 77.85698 | 15 KM/Hr |

**Risk Type: Turn**  
**Risk Level: High**  
**Speed Limit: 15 KM/Hr**  
**Coordinates: 11.45352, 77.85698**

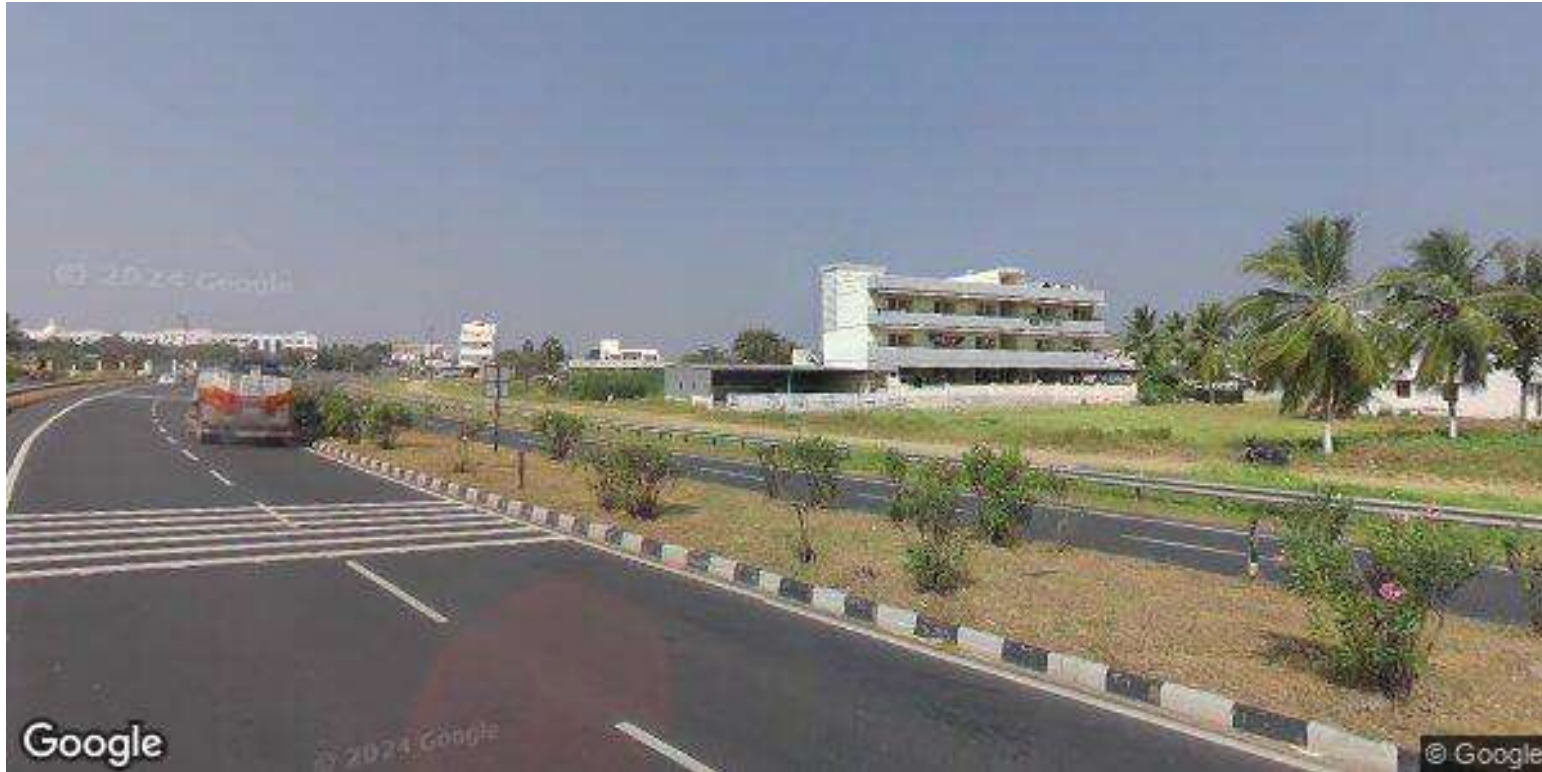
| | Risk Type | Risk Level | Coordinates | Speed Limit |
|---|---|---|---|---|
| 7 | Turn | Medium | 11.44965, 77.77565 | 30 KM/Hr |

**Risk Type:** Turn  
**Risk Level:** Medium  
**Speed Limit:** 30 KM/Hr  
**Coordinates:** 11.44965, 77.77565

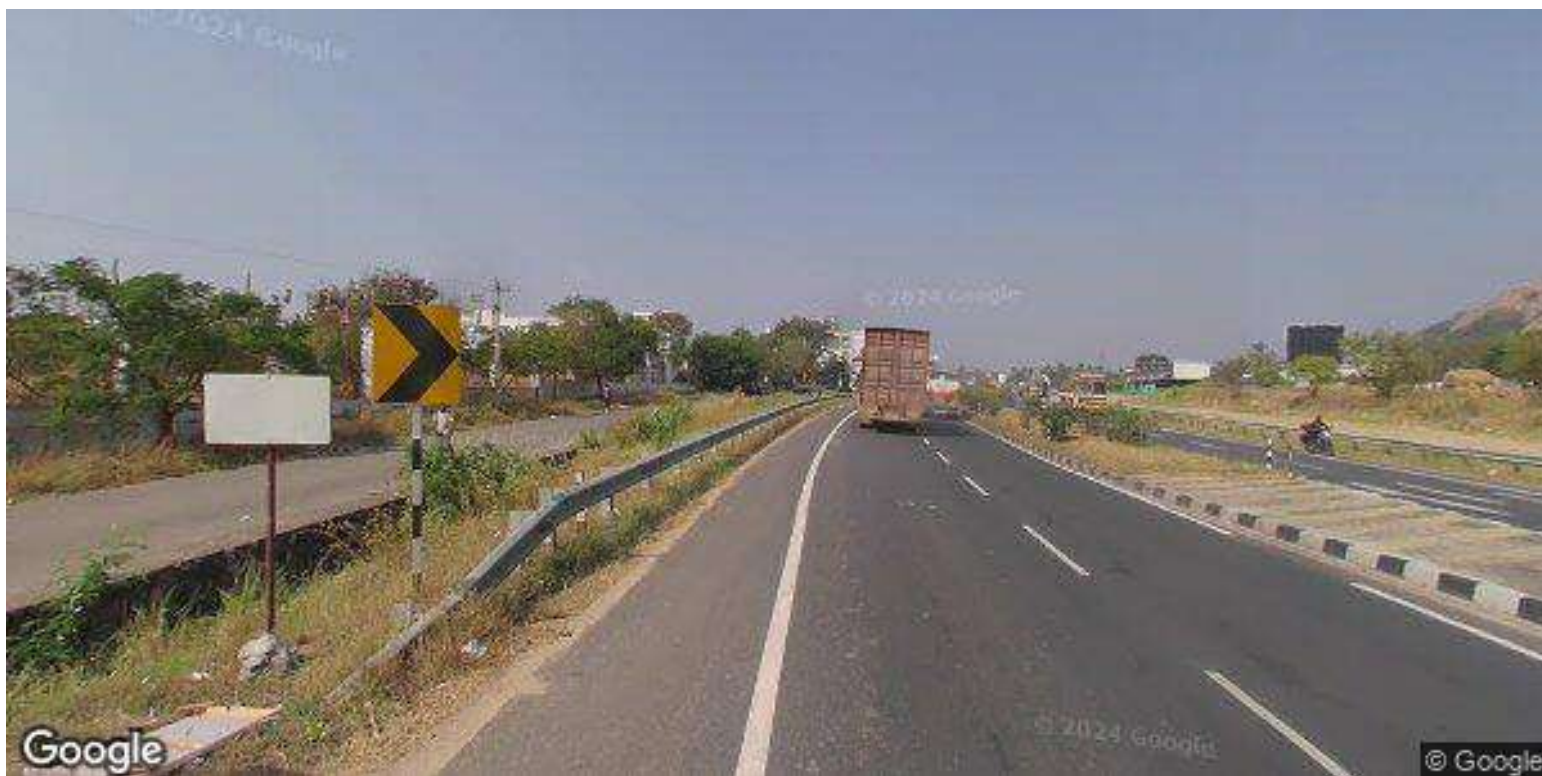
| | Risk Type | Risk Level | Coordinates | Speed Limit |
|---|---|---|---|---|
| 8 | Turn | Medium | 11.44953, 77.77344 | 30 KM/Hr |

**Risk Type:** Turn  
**Risk Level:** Medium  
**Speed Limit:** 30 KM/Hr  
**Coordinates:** 11.44953, 77.77344

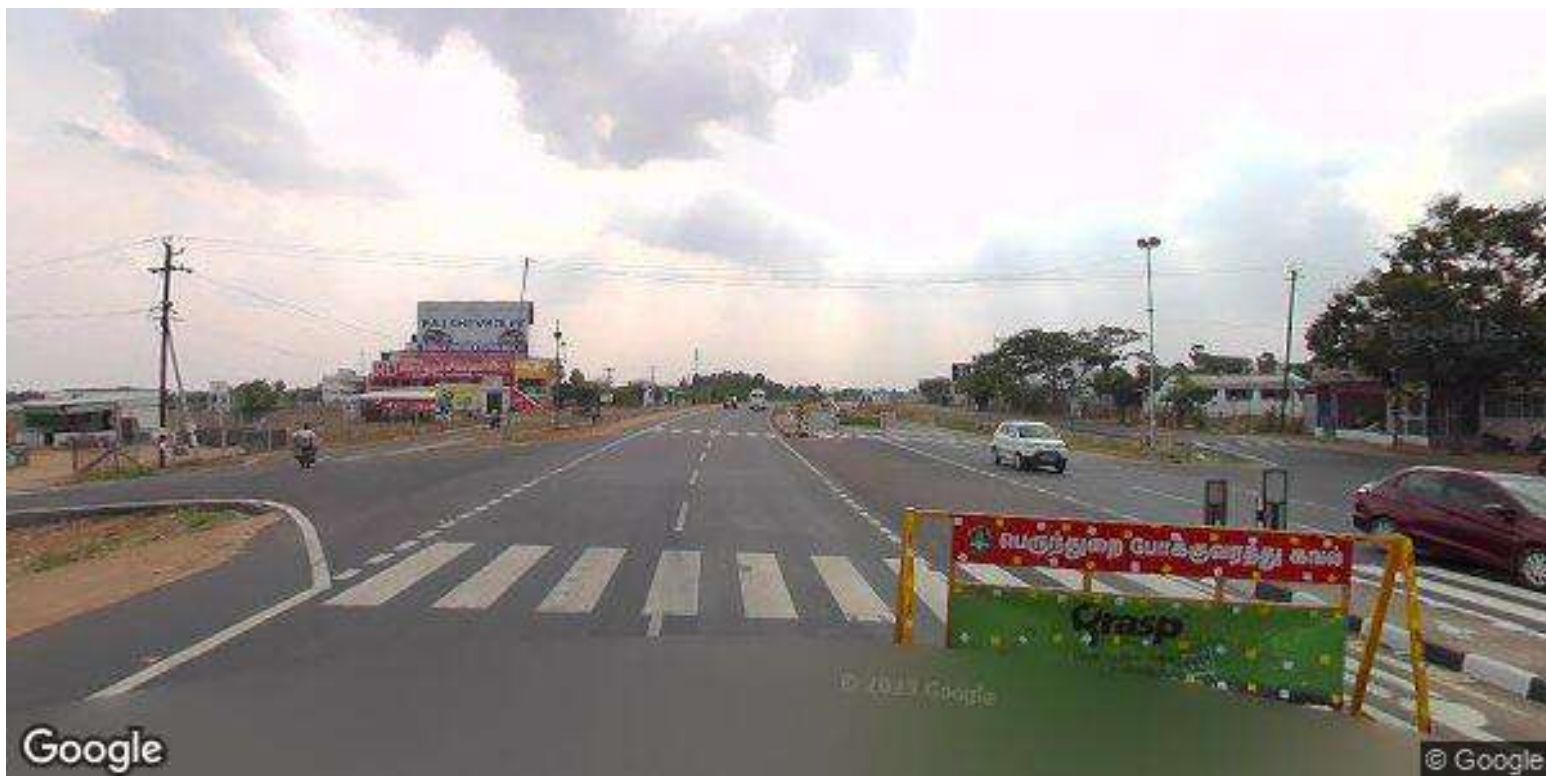
**Coordinates:** 11.23724, 77.50686

| | Risk Type | Risk Level | Coordinates | Speed Limit |
|---|---|---|---|---|
| 10 | Turn | Medium | 11.23724, 77.50686 | 30 KM/Hr |

**Risk Type:** Turn

**Risk Level:** Medium

**Speed Limit:** 30 KM/Hr

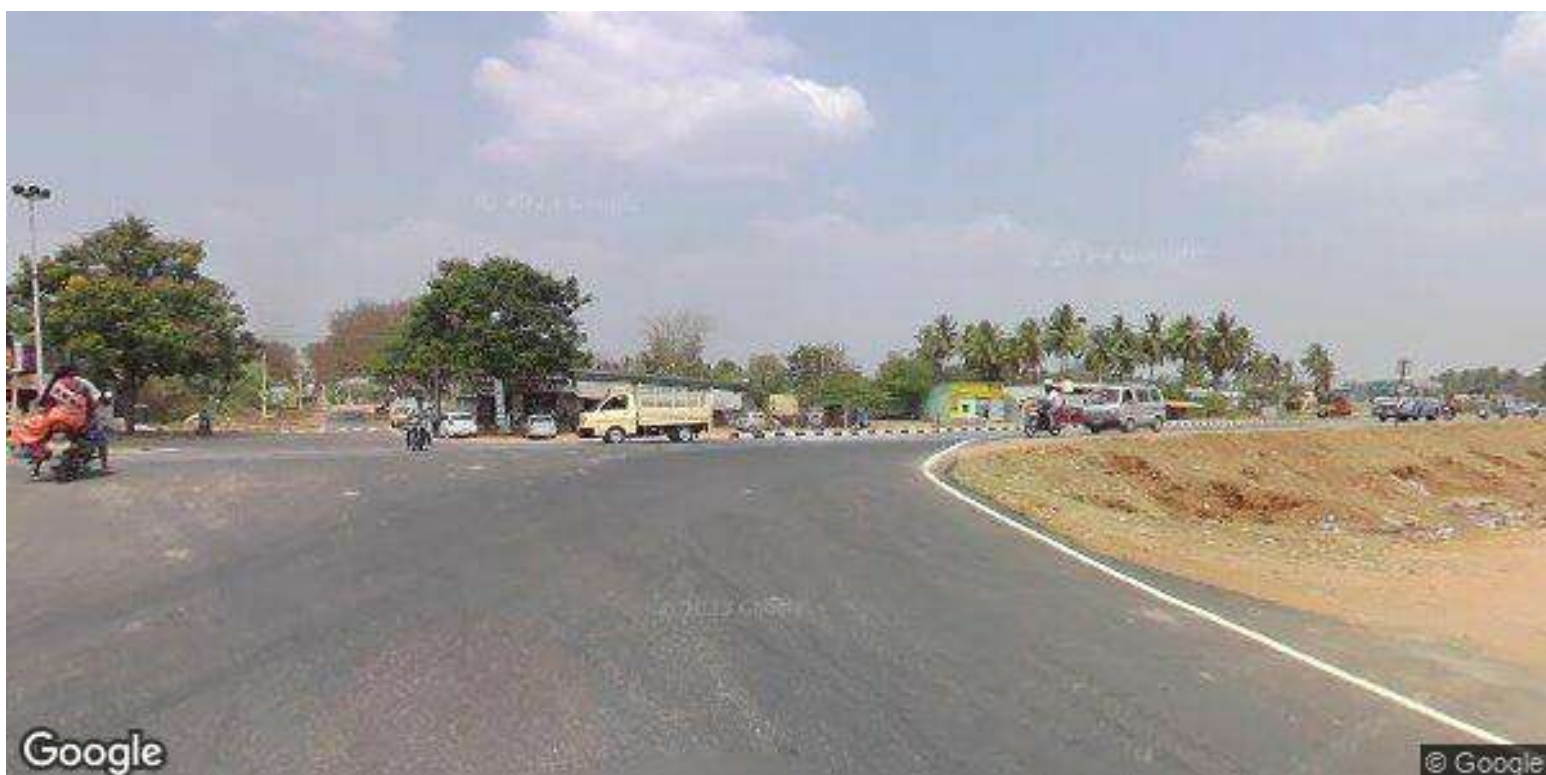
**Coordinates:** 11.23704, 77.50676

| | Risk Type | Risk Level | Coordinates | Speed Limit |
|---|---|---|---|---|
| 11 | Turn | High | 11.23704, 77.50676 | 15 KM/Hr |

**Risk Type:** Turn

**Risk Level:** High

**Speed Limit:** 15 KM/Hr

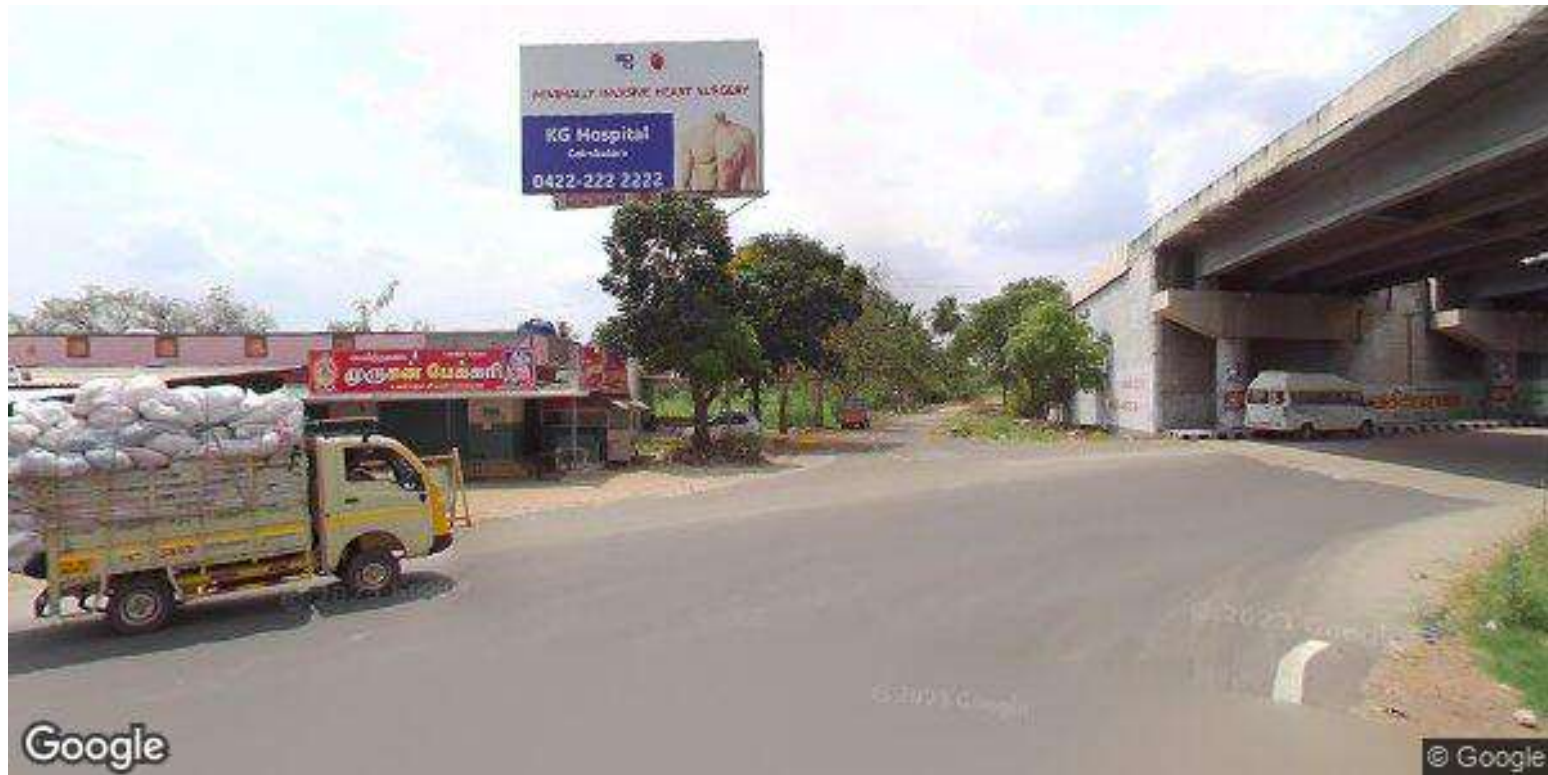
**Coordinates:** 11.23686, 77.50216

| | Risk Type | Risk Level | Coordinates | Speed Limit |
|---|---|---|---|---|
| 12 | Blind Spot | Blind Spot | 11.23686, 77.50216 | 10 KM/Hr |

**Risk Type:** Blind Spot

**Risk Level:** Blind Spot

**Speed Limit:** 10 KM/Hr

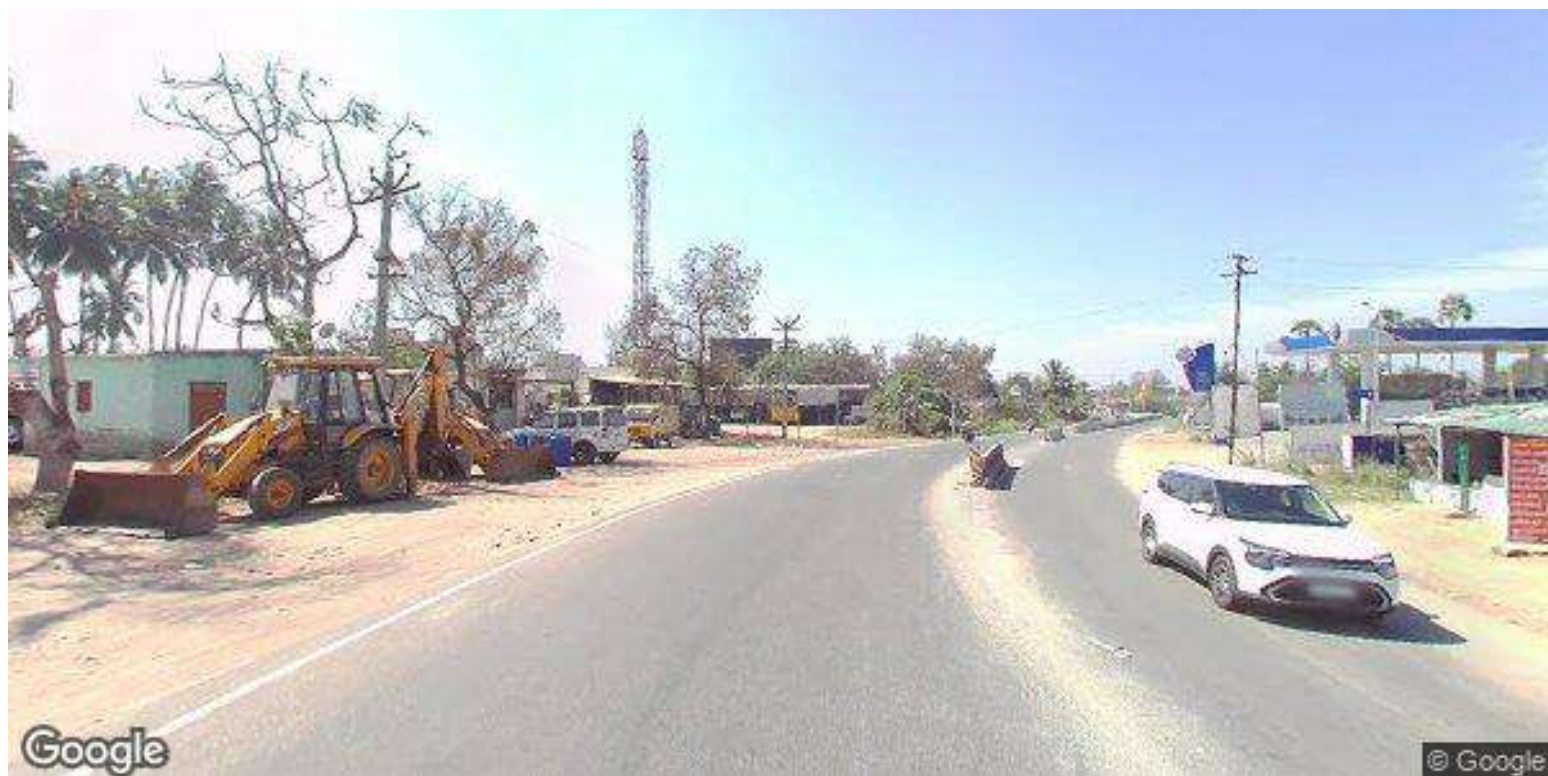
**Coordinates:** 11.23649, 77.50219

| | Risk Type | Risk Level | Coordinates | Speed Limit |
|---|---|---|---|---|
| 13 | Turn | Medium | 11.23649, 77.50219 | 30 KM/Hr |

**Risk Type:** Turn

**Risk Level:** Medium

**Speed Limit:** 30 KM/Hr

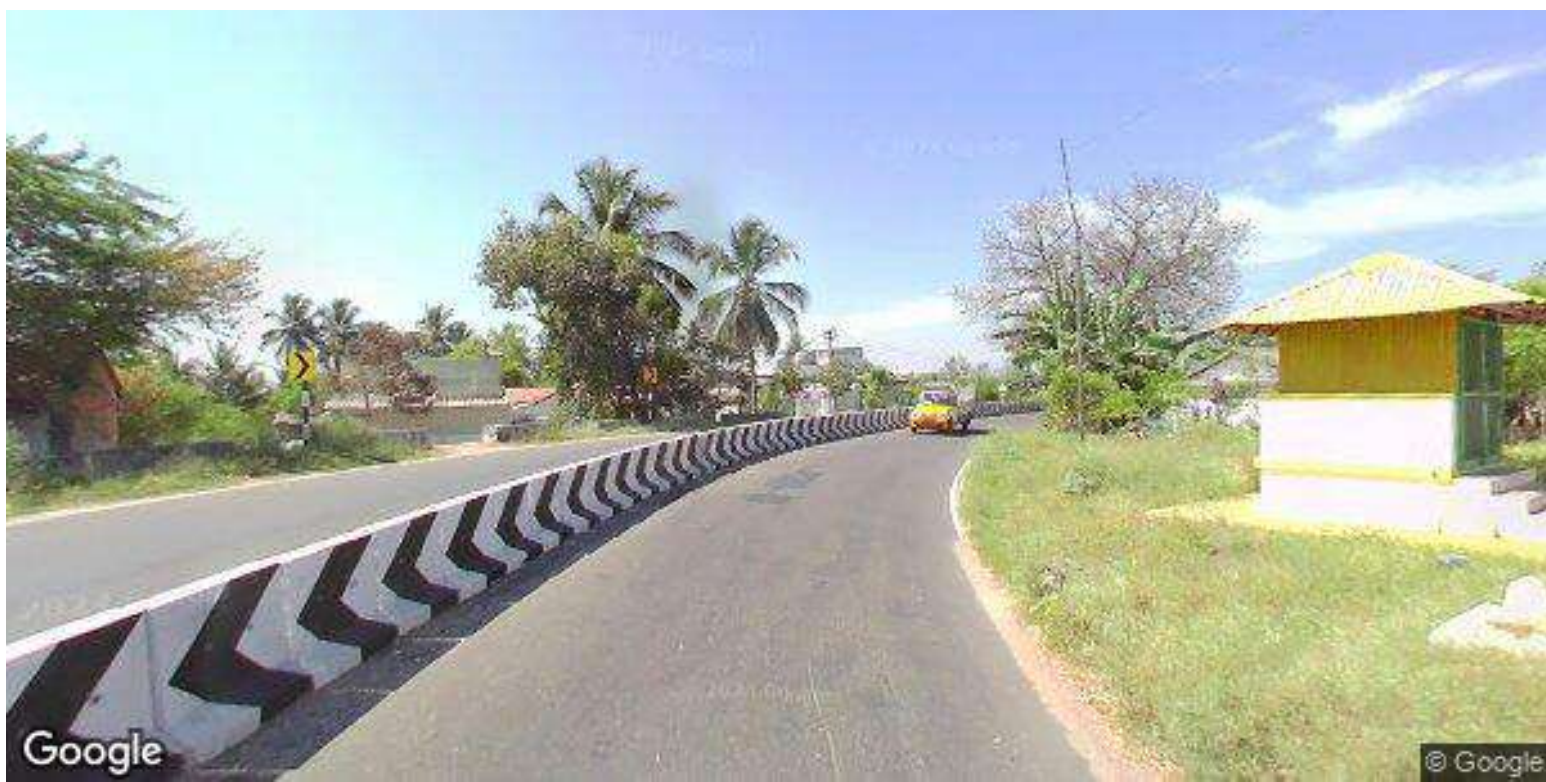
**Coordinates:** 11.23396, 77.50105

| | Risk Type | Risk Level | Coordinates | Speed Limit |
|---|---|---|---|---|
| 14 | Turn | High | 11.23396, 77.50105 | 15 KM/Hr |

**Risk Type:** Turn

**Risk Level:** High

**Speed Limit:** 15 KM/Hr

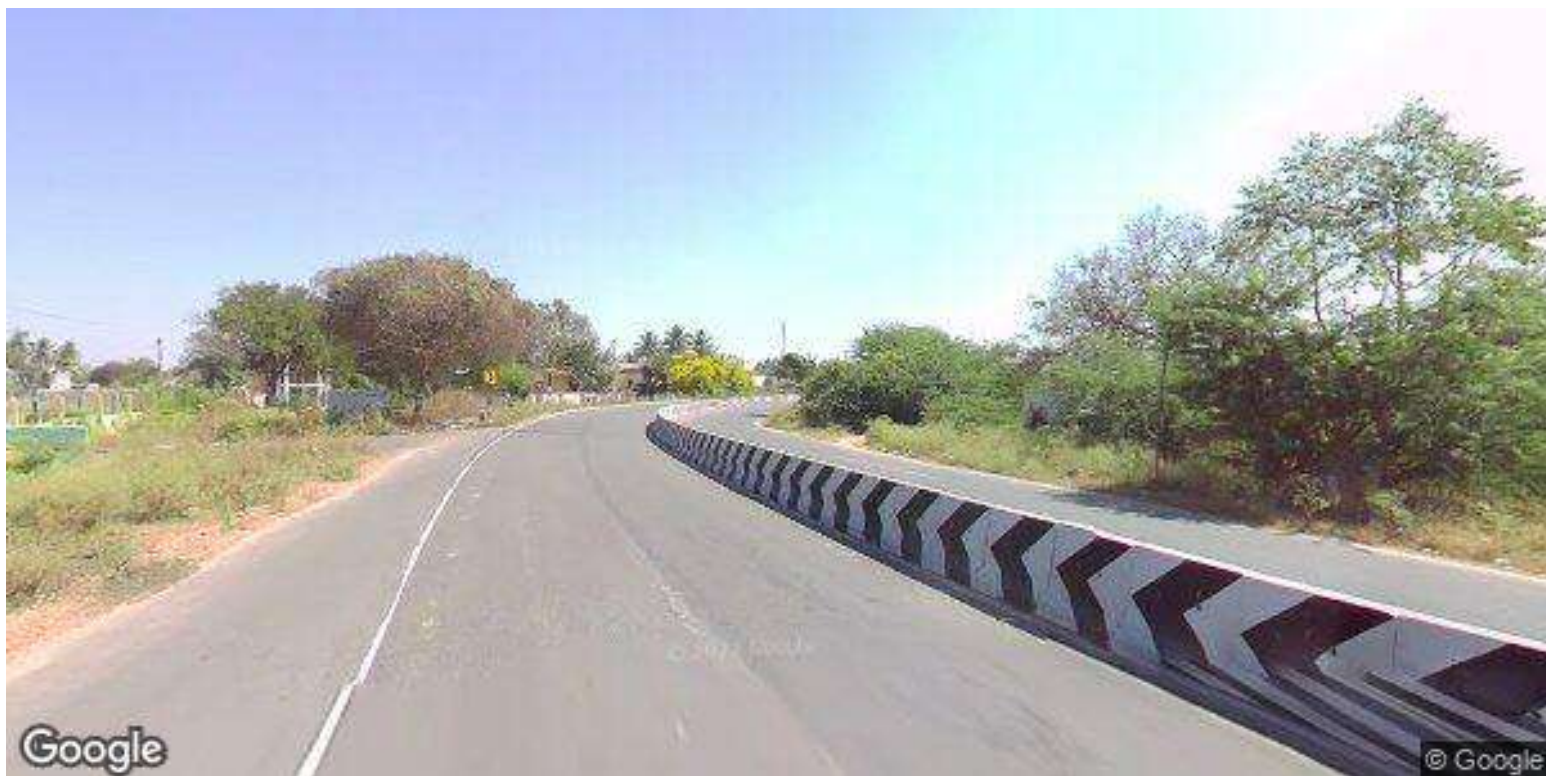
**Coordinates:** 11.23287, 77.49934

| | Risk Type | Risk Level | Coordinates | Speed Limit |
|---|---|---|---|---|
| 15 | Turn | Medium | 11.23287, 77.49934 | 30 KM/Hr |

**Risk Type:** Turn

**Risk Level:** Medium

**Speed Limit:** 30 KM/Hr

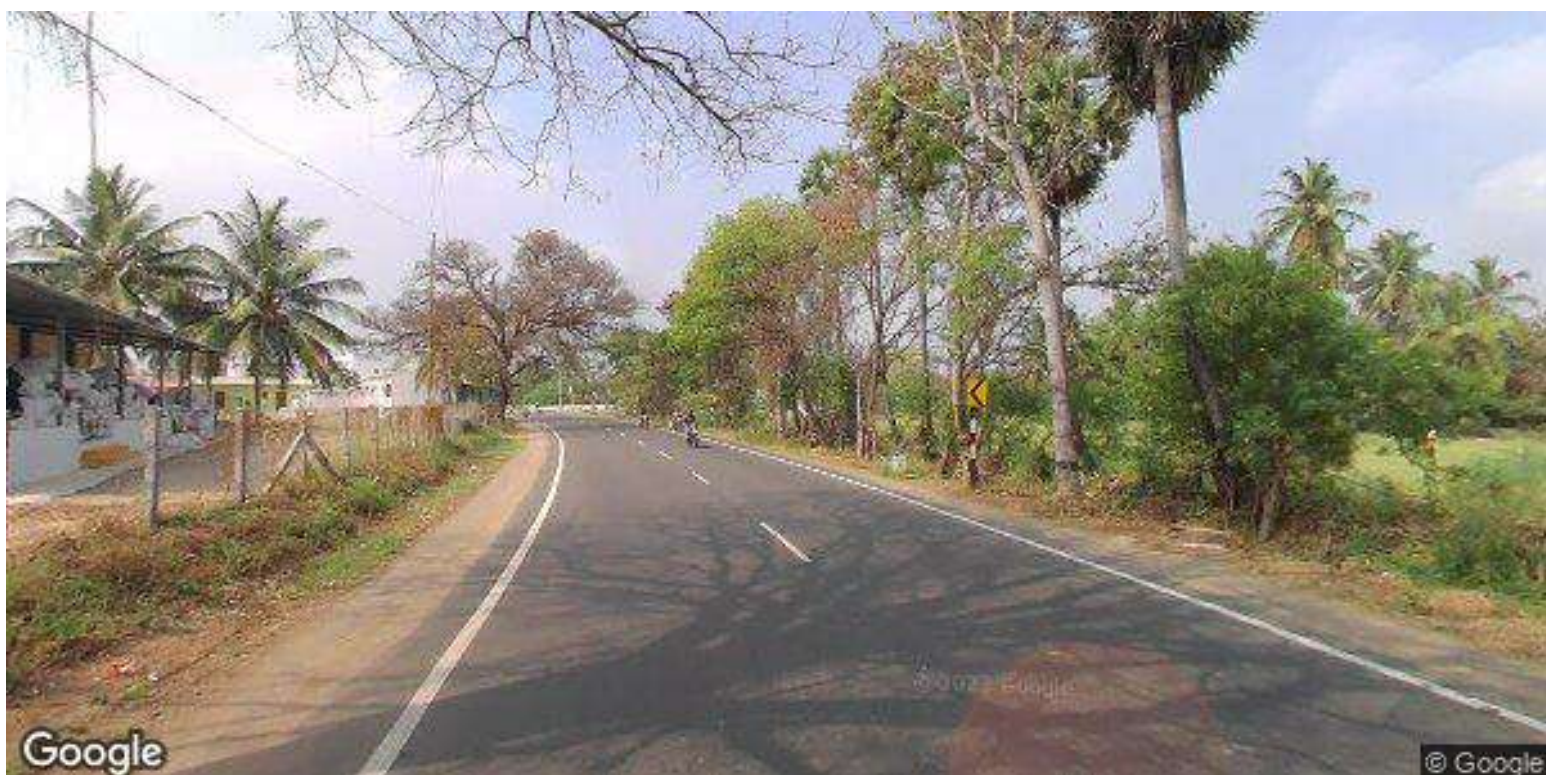
| | Risk Type | Risk Level | Coordinates | Speed Limit |
|---|---|---|---|---|
| 16 | Turn | Medium | 11.18407, 77.46330 | 30 KM/Hr |

**Risk Type:** Turn  
**Risk Level:** Medium  
**Speed Limit:** 30 KM/Hr  
**Coordinates:** 11.18407, 77.46330

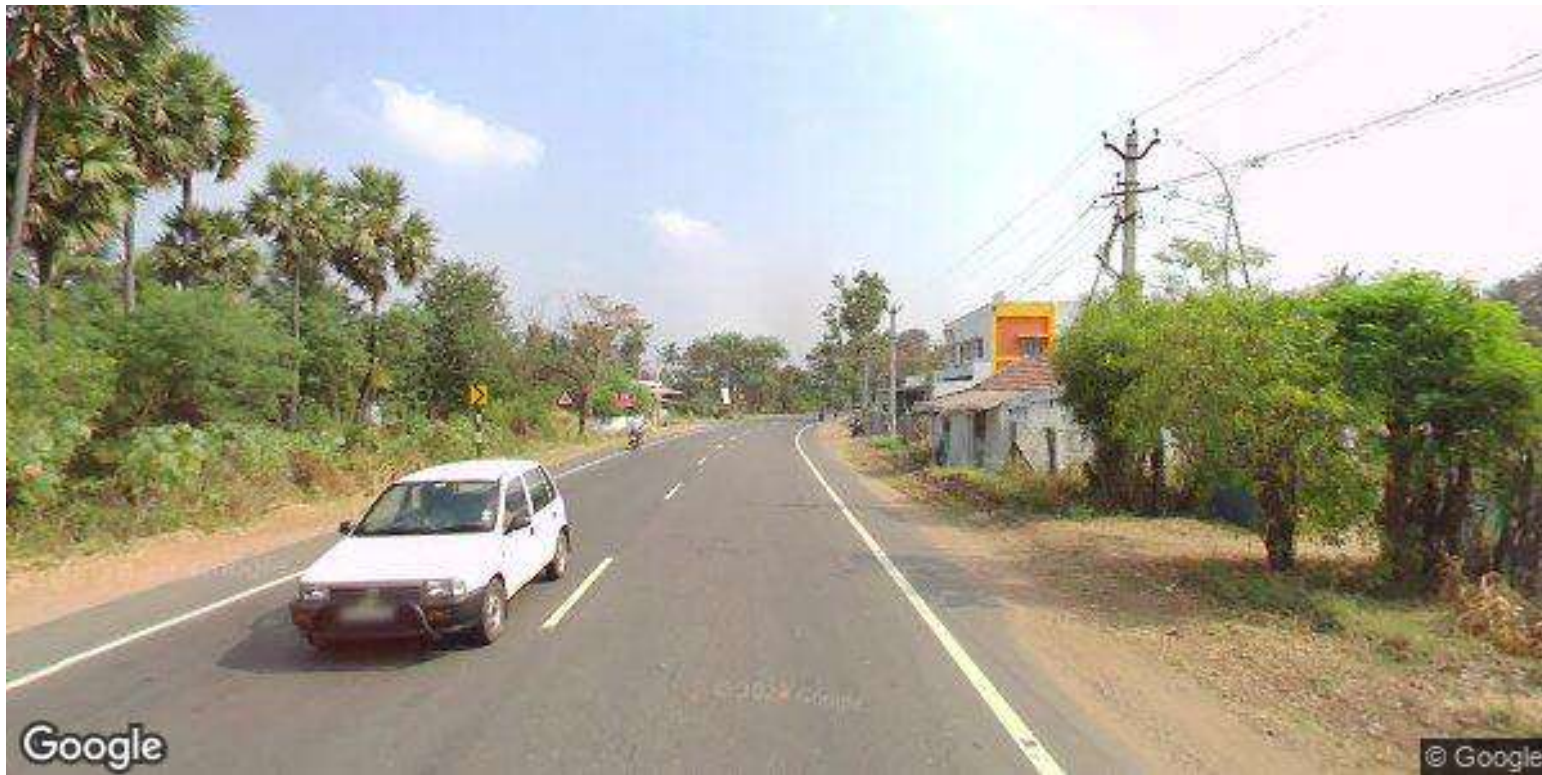
| | Risk Type | Risk Level | Coordinates | Speed Limit |
|---|---|---|---|---|
| 17 | Turn | Medium | 11.18273, 77.46224 | 30 KM/Hr |

**Risk Type:** Turn  
**Risk Level:** Medium  
**Speed Limit:** 30 KM/Hr  
**Coordinates:** 11.18273, 77.46224

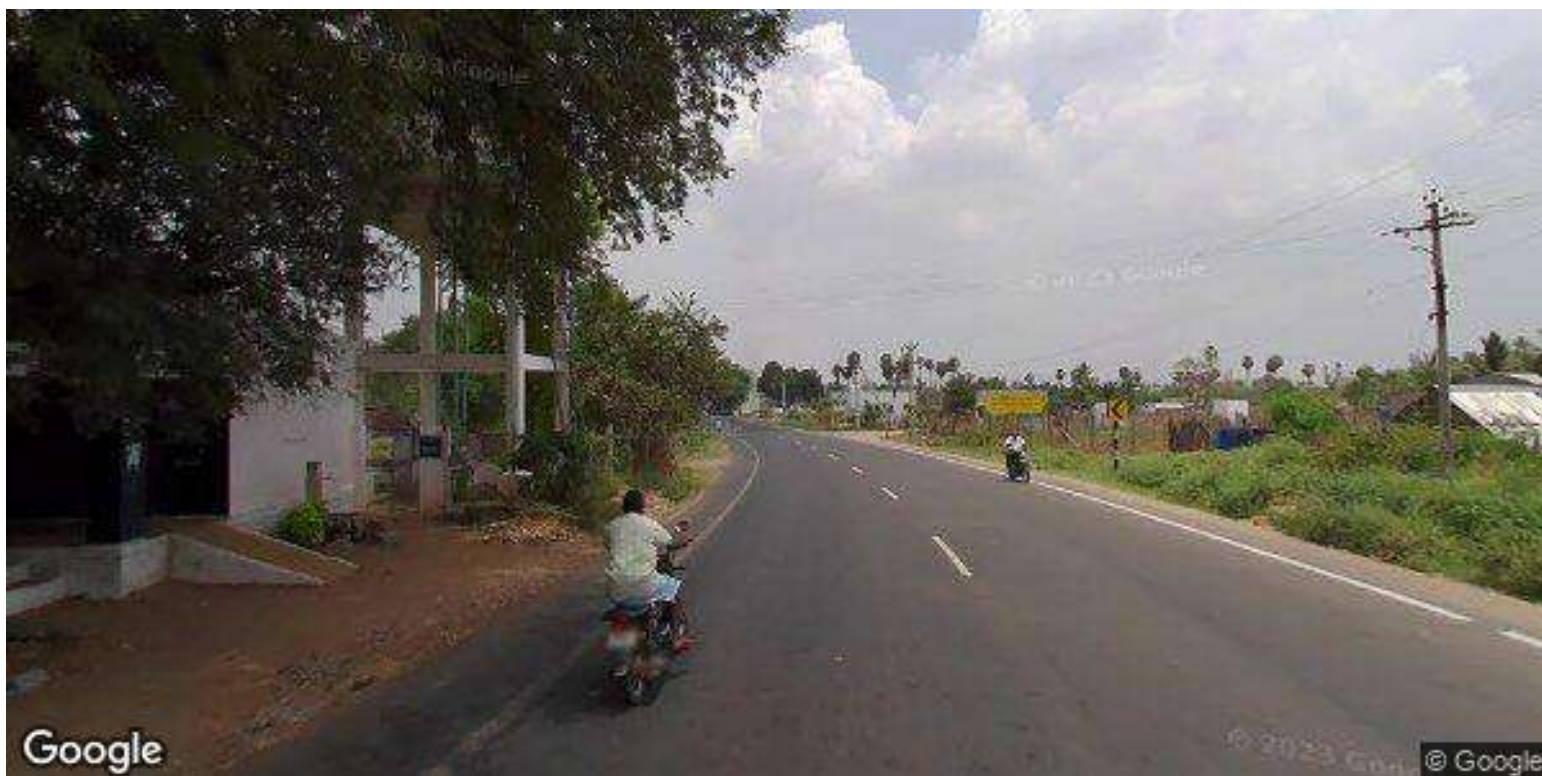
| | Risk Type | Risk Level | Coordinates | Speed Limit |
|---|---|---|---|---|
| 18 | Turn | Medium | 11.17521, 77.45978 | 30 KM/Hr |

**Risk Type:** Turn  
**Risk Level:** Medium  
**Speed Limit:** 30 KM/Hr  
**Coordinates:** 11.17521, 77.45978

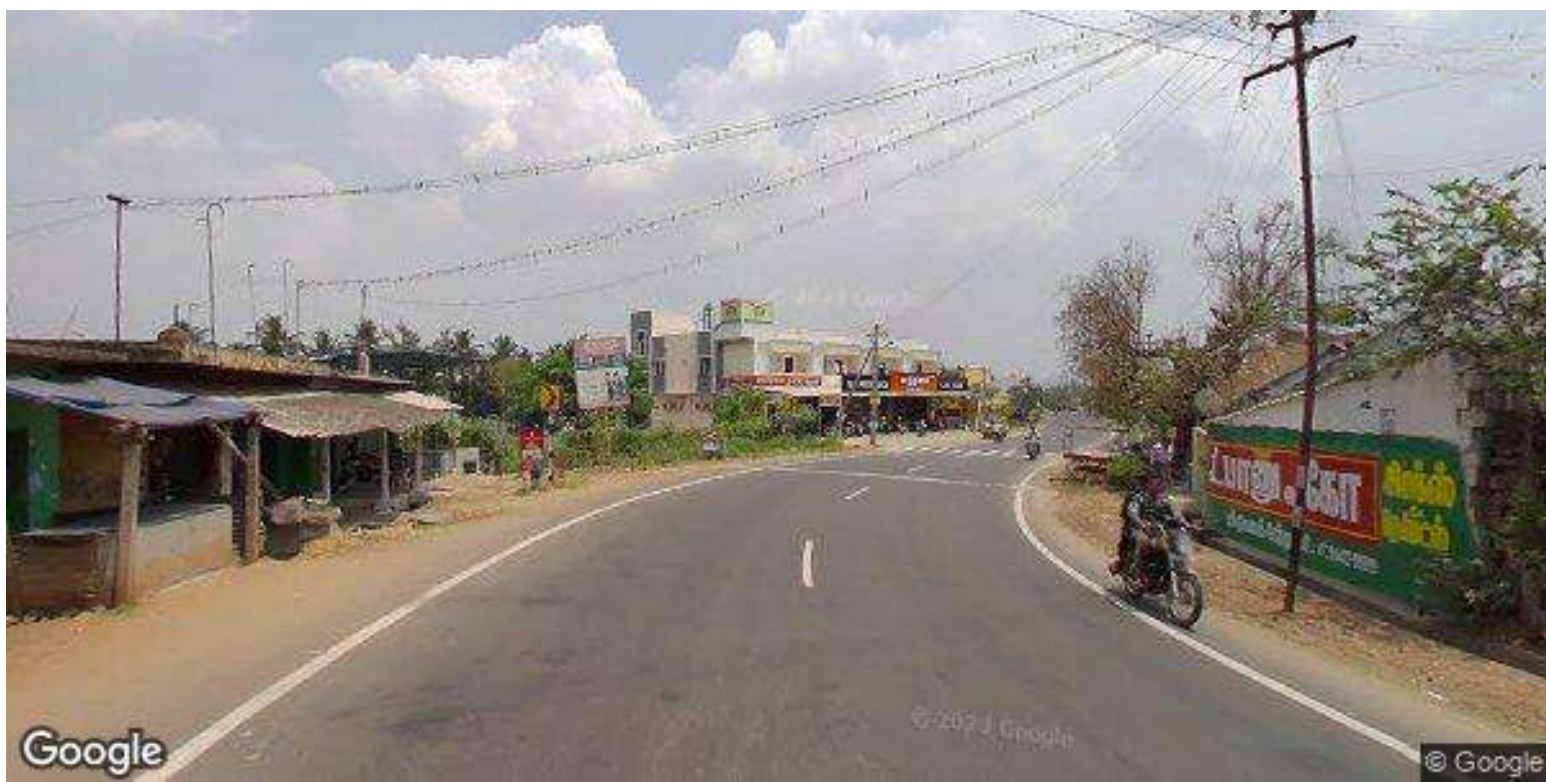
**Coordinates:** 11.17368, 77.45730

| | Risk Type | Risk Level | Coordinates | Speed Limit |
|---|---|---|---|---|
| 19 | Turn | Medium | 11.17368, 77.45730 | 30 KM/Hr |

**Risk Type:** Turn

**Risk Level:** Medium

**Speed Limit:** 30 KM/Hr

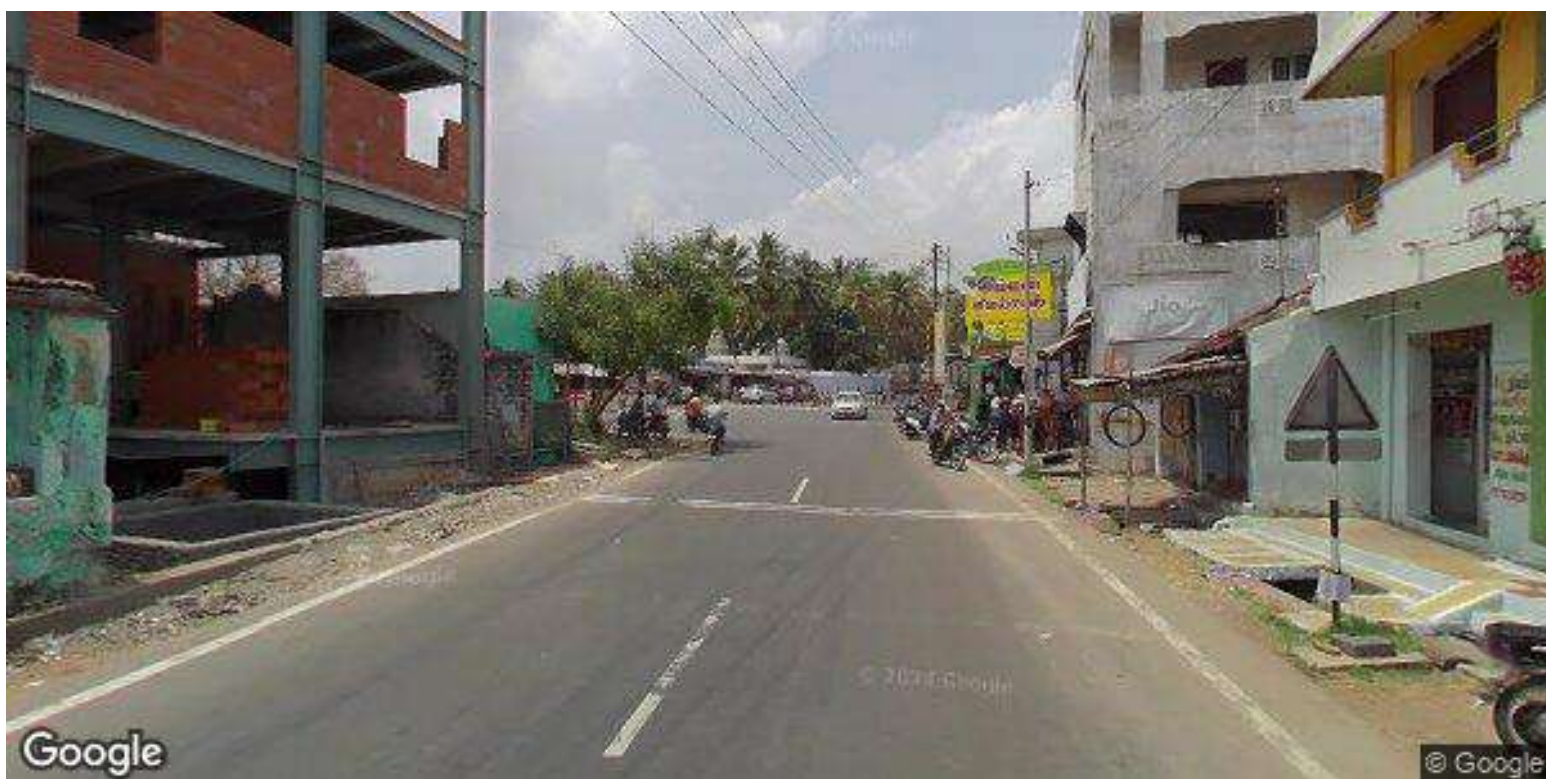
**Coordinates:** 11.17111, 77.45547

| | Risk Type | Risk Level | Coordinates | Speed Limit |
|---|---|---|---|---|
| 20 | Turn | Medium | 11.17111, 77.45547 | 30 KM/Hr |

**Risk Type:** Turn

**Risk Level:** Medium

**Speed Limit:** 30 KM/Hr

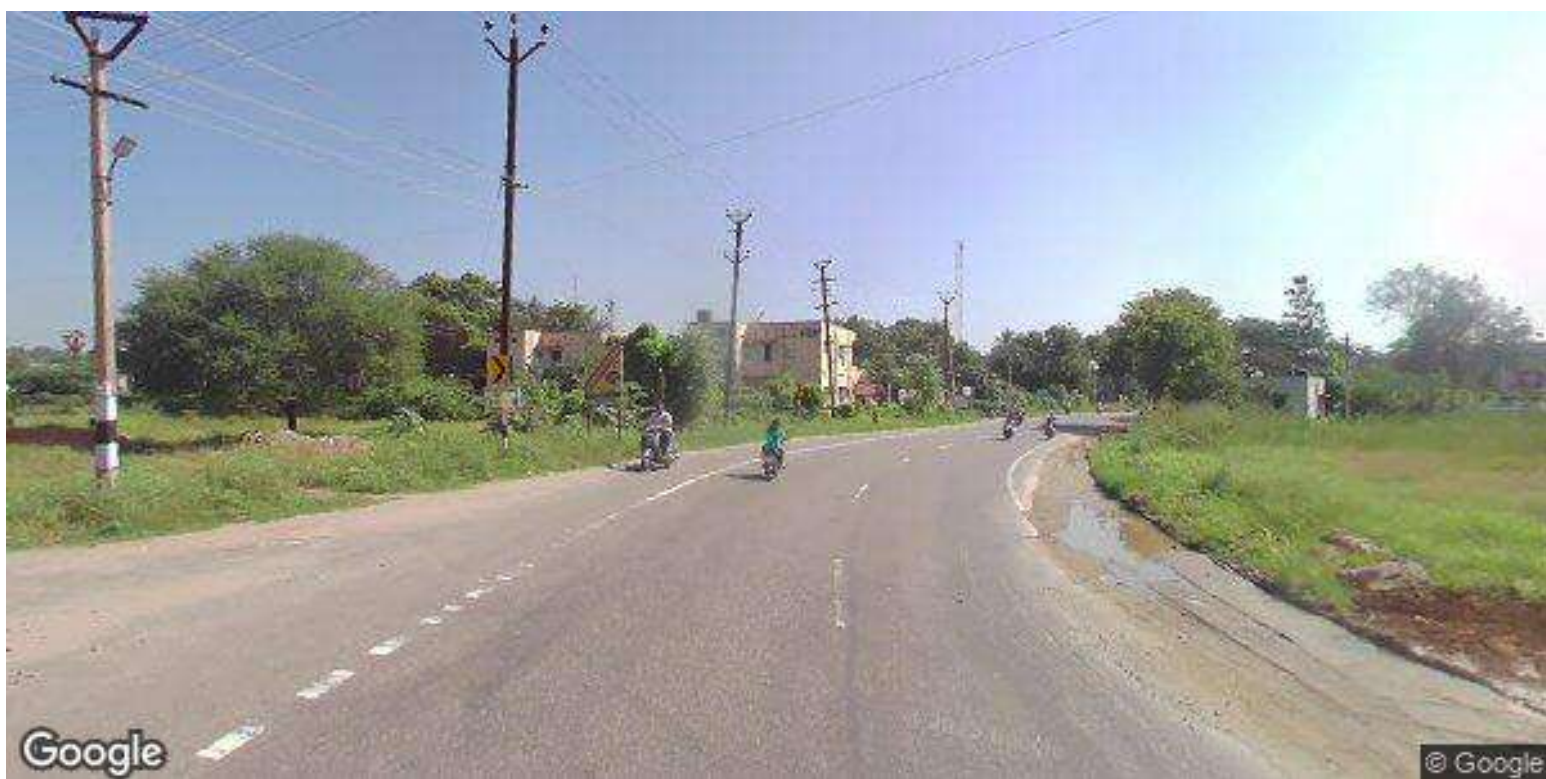
| | Risk Type | Risk Level | Coordinates | Speed Limit |
|---|---|---|---|---|
| 21 | Turn | High | 11.16959, 77.44396 | 15 KM/Hr |

**Risk Type:** Turn  
**Risk Level:** High  
**Speed Limit:** 15 KM/Hr  
**Coordinates:** 11.16959, 77.44396

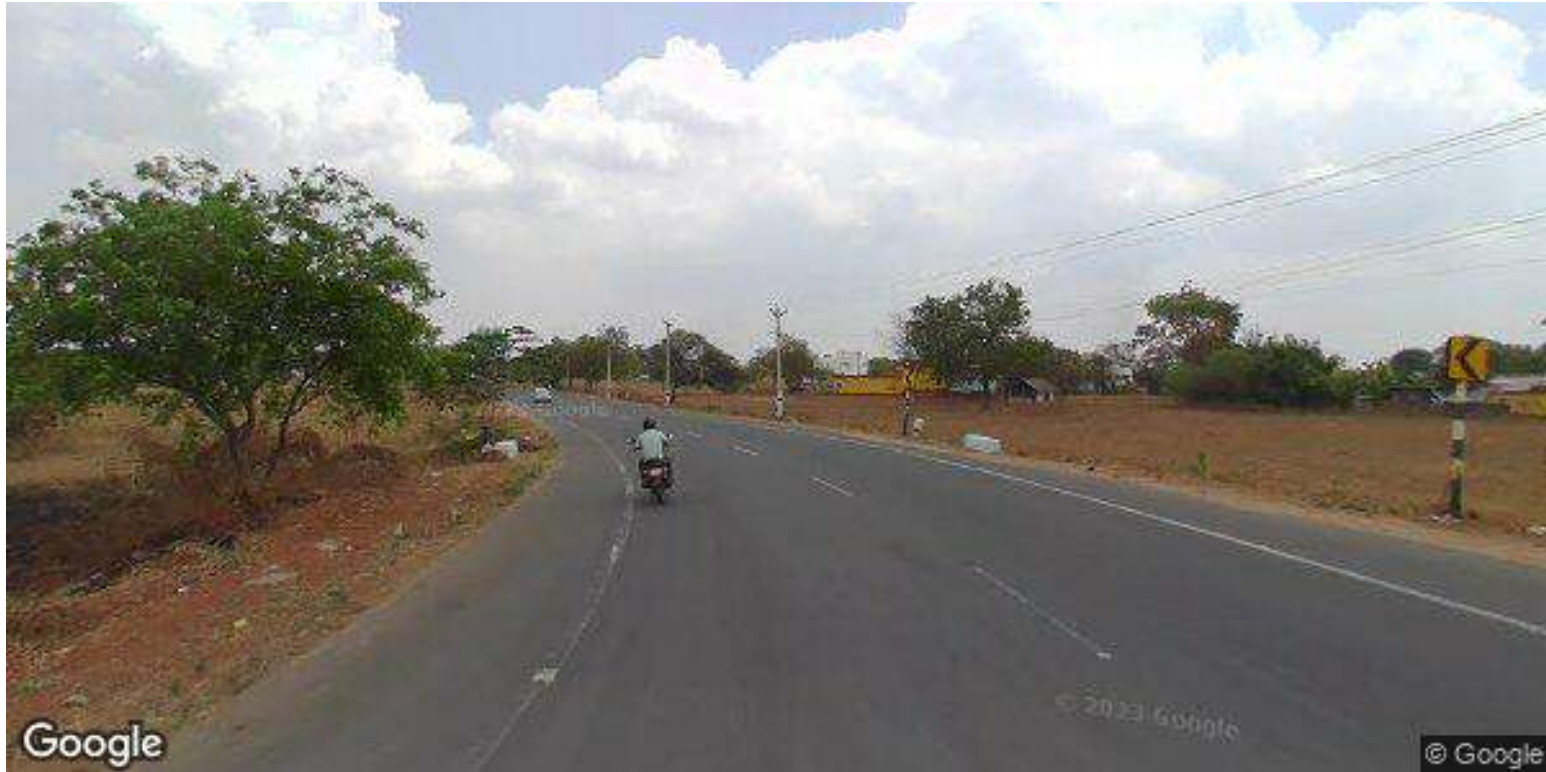
| | Risk Type | Risk Level | Coordinates | Speed Limit |
|---|---|---|---|---|
| 22 | Turn | Medium | 11.16381, 77.43700 | 30 KM/Hr |

**Risk Type:** Turn  
**Risk Level:** Medium  
**Speed Limit:** 30 KM/Hr  
**Coordinates:** 11.16381, 77.43700

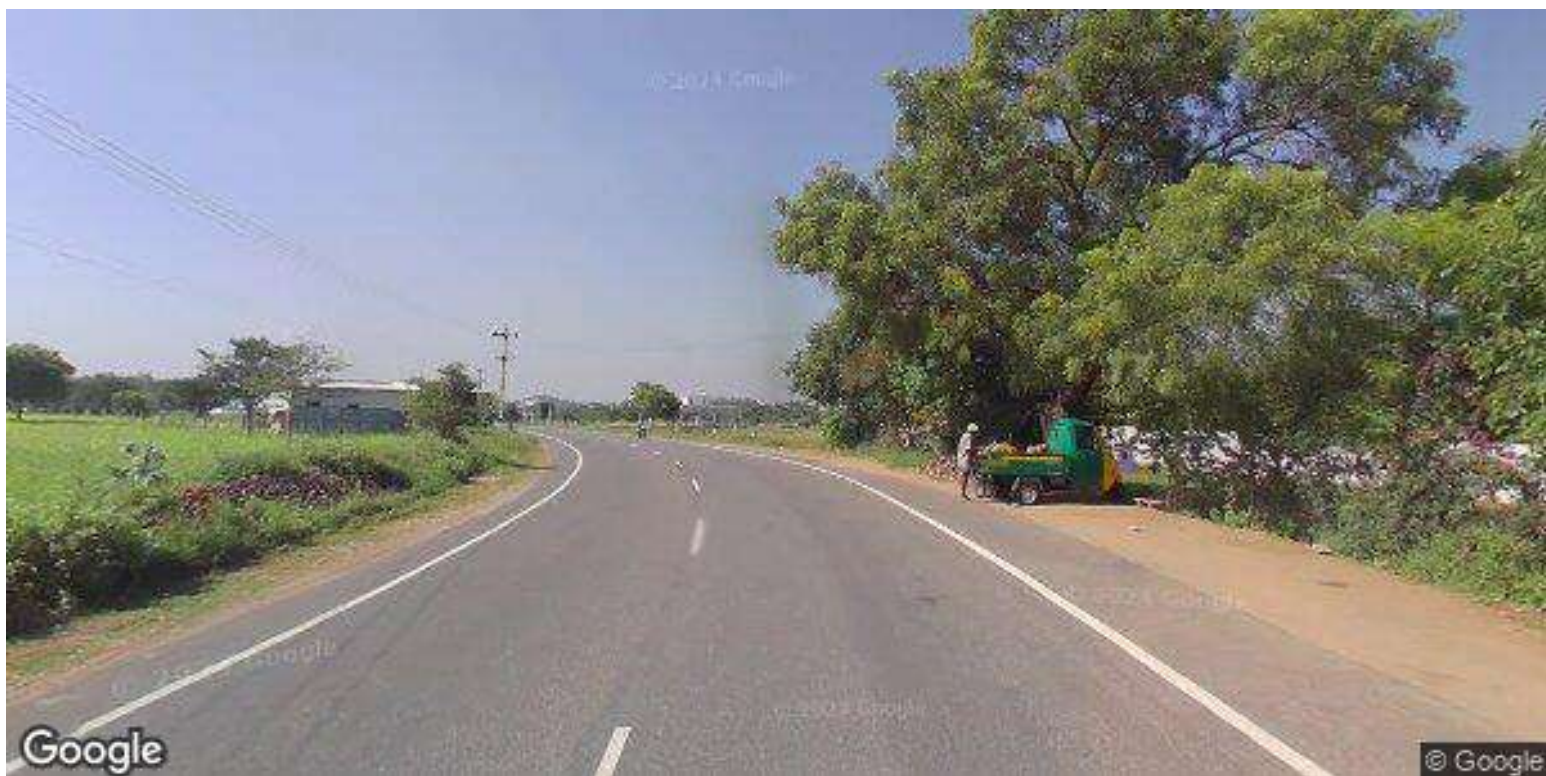
| | Risk Type | Risk Level | Coordinates | Speed Limit |
|---|---|---|---|---|
| 23 | Turn | Medium | 11.16280, 77.43139 | 30 KM/Hr |

**Risk Type:** Turn  
**Risk Level:** Medium  
**Speed Limit:** 30 KM/Hr  
**Coordinates:** 11.16280, 77.43139
