# IndianOil

## JOURNEY RISK MANAGEMENT (JRM) STUDY

### Salem Terminal to SS AGENCY

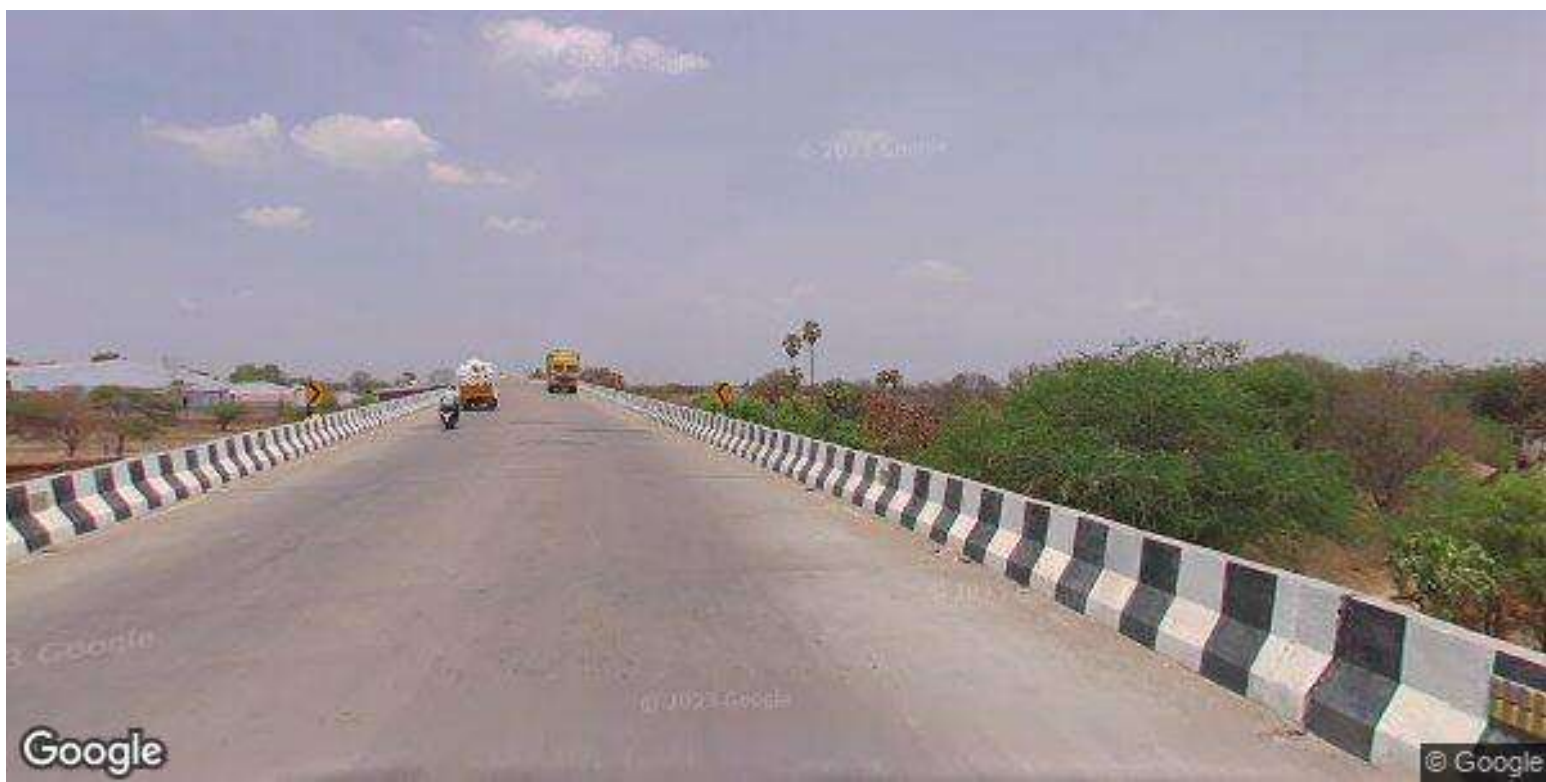
**Coordinates:** 11.15217, 77.42418

| | Risk Type | Risk Level | Coordinates | Speed Limit |
|---|---|---|---|---|
| 24 | Turn | Medium | 11.15217, 77.42418 | 30 KM/Hr |

**Risk Type:** Turn

**Risk Level:** Medium

**Speed Limit:** 30 KM/Hr

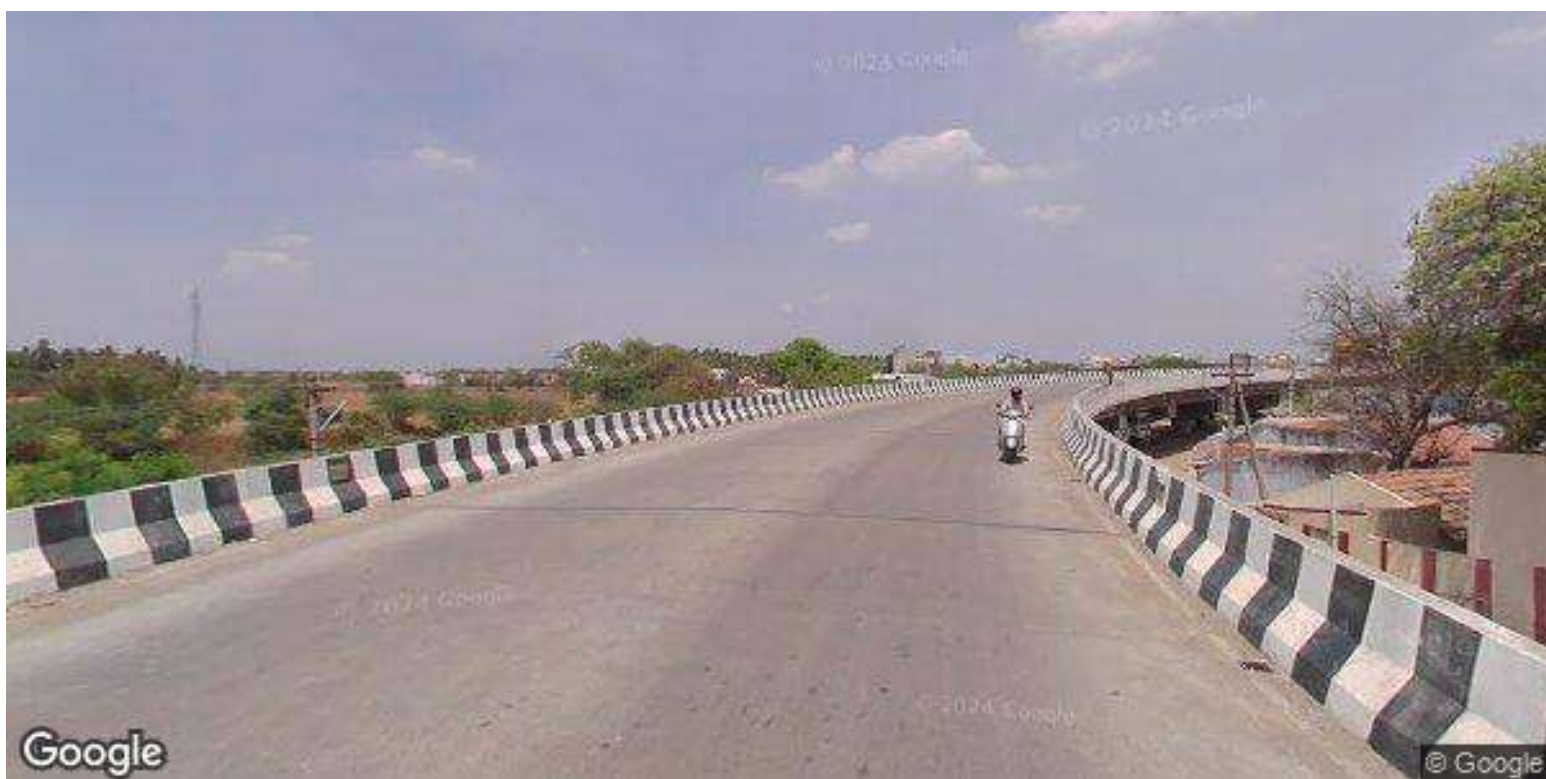
**Coordinates:** 11.15134, 77.42300

| | Risk Type | Risk Level | Coordinates | Speed Limit |
|---|---|---|---|---|
| 25 | Turn | Medium | 11.15134, 77.42300 | 30 KM/Hr |

**Risk Type:** Turn

**Risk Level:** Medium

**Speed Limit:** 30 KM/Hr

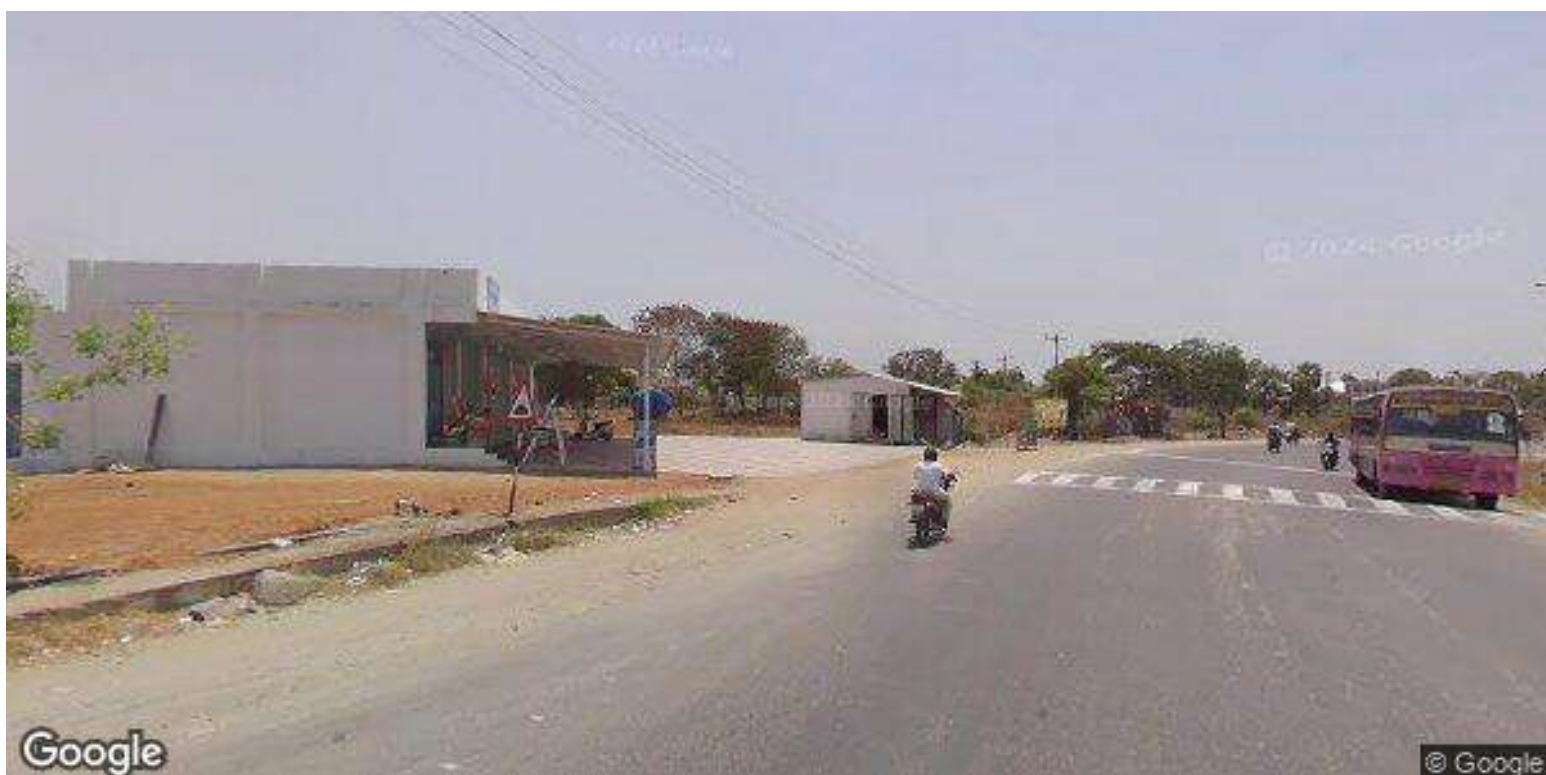
**Coordinates:** 11.15023, 77.42247

| | Risk Type | Risk Level | Coordinates | Speed Limit |
|---|---|---|---|---|
| 26 | Turn | Medium | 11.15023, 77.42247 | 30 KM/Hr |

**Risk Type:** Turn

**Risk Level:** Medium

**Speed Limit:** 30 KM/Hr

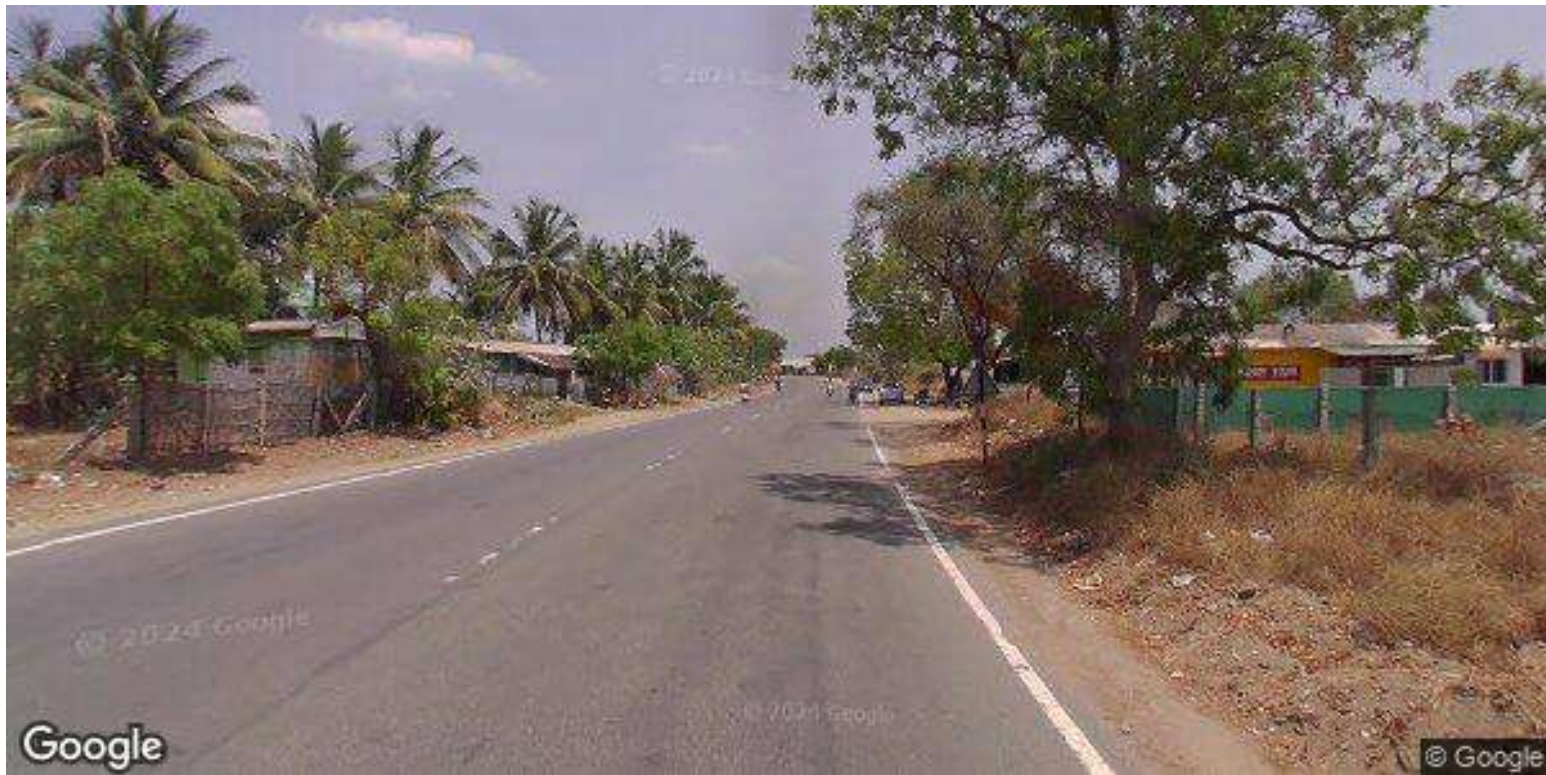
**Coordinates:** 11.14925, 77.42065

| | Risk Type | Risk Level | Coordinates | Speed Limit |
|---|---|---|---|---|
| 27 | Turn | Medium | 11.14925, 77.42065 | 30 KM/Hr |

**Risk Type:** Turn

**Risk Level:** Medium

**Speed Limit:** 30 KM/Hr

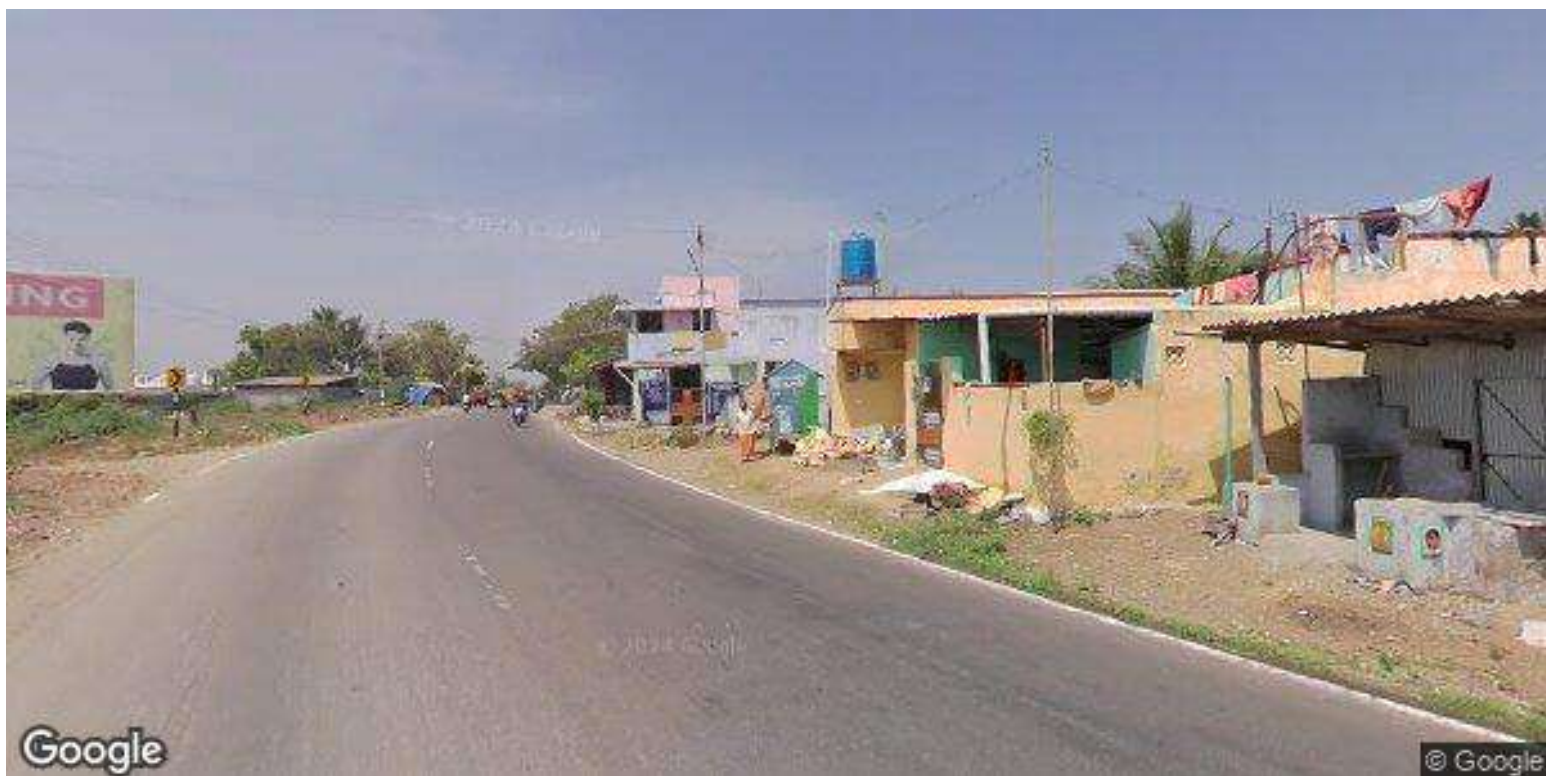
**Coordinates:** 11.13848, 77.41611

| | Risk Type | Risk Level | Coordinates | Speed Limit |
|---|---|---|---|---|
| 28 | Turn | Medium | 11.13848, 77.41611 | 30 KM/Hr |

**Risk Type:** Turn

**Risk Level:** Medium

**Speed Limit:** 30 KM/Hr

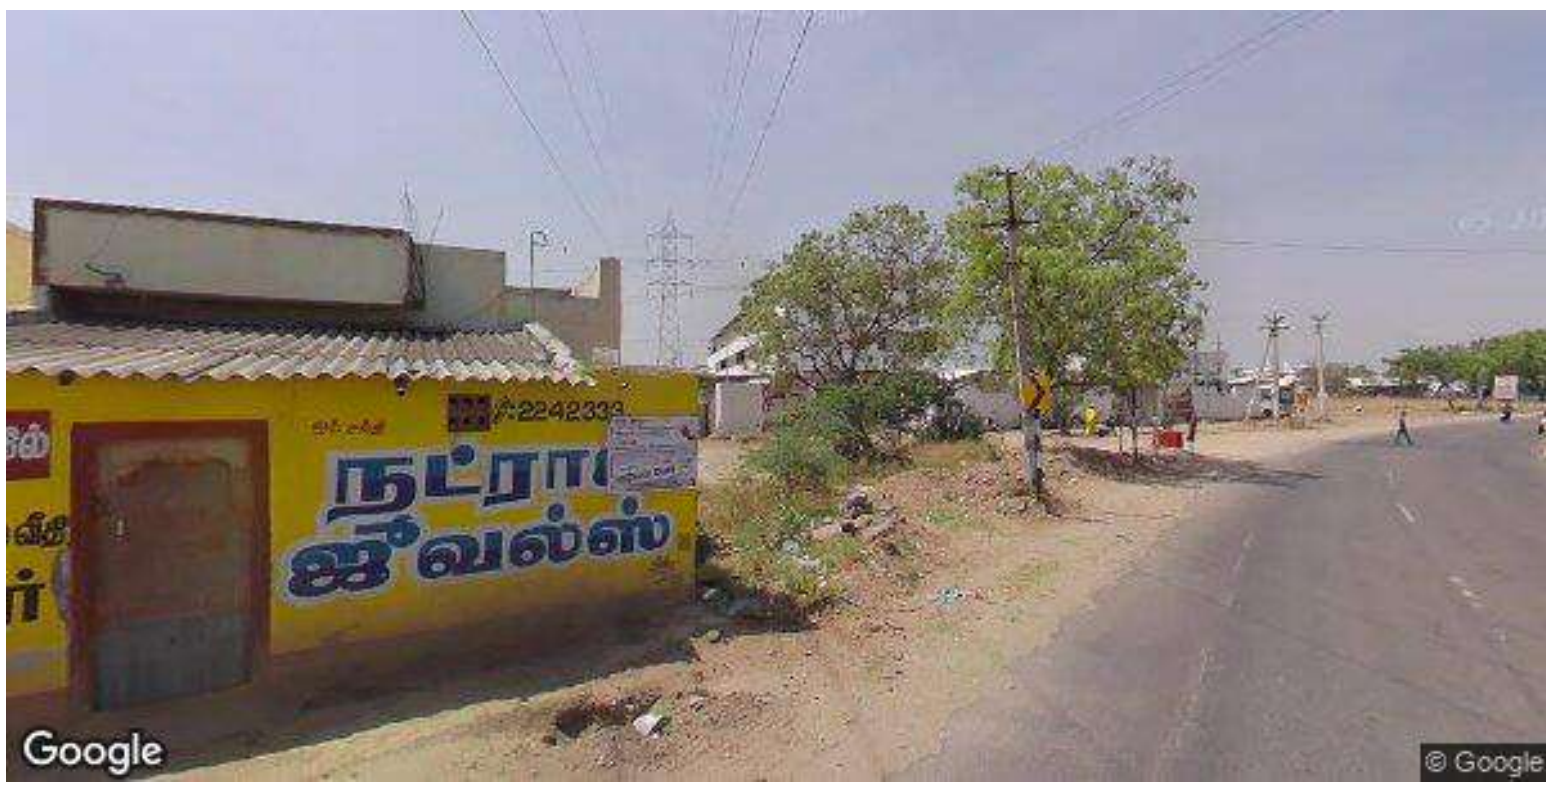
**Coordinates:** 11.13578, 77.41299

| | Risk Type | Risk Level | Coordinates | Speed Limit |
|---|---|---|---|---|
| 29 | Turn | Medium | 11.13578, 77.41299 | 30 KM/Hr |

**Risk Type:** Turn

**Risk Level:** Medium

**Speed Limit:** 30 KM/Hr

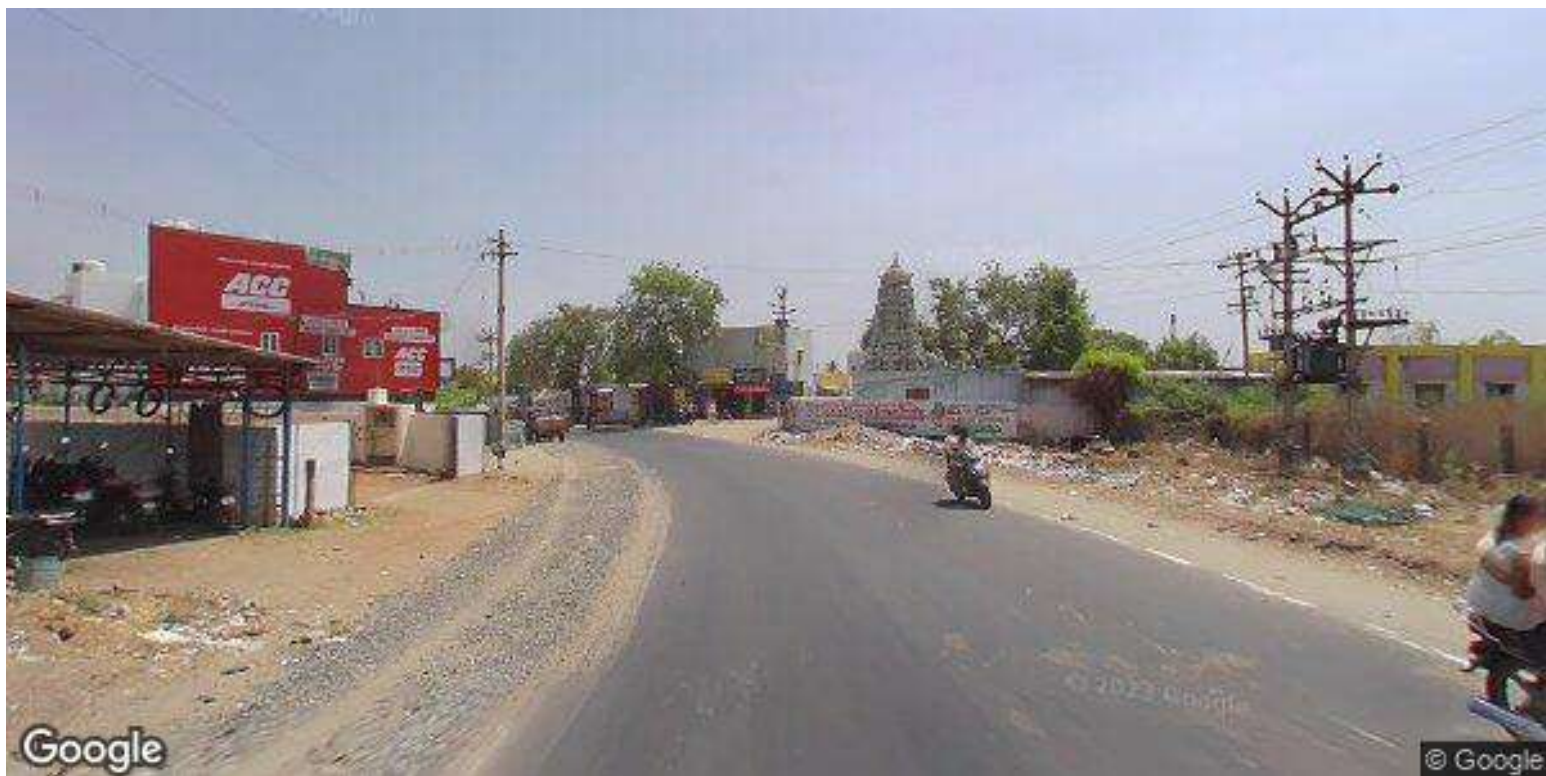
**Coordinates:** 11.12989, 77.40302

| | Risk Type | Risk Level | Coordinates | Speed Limit |
|---|---|---|---|---|
| 30 | Turn | Medium | 11.12989, 77.40302 | 30 KM/Hr |

**Risk Type:** Turn

**Risk Level:** Medium

**Speed Limit:** 30 KM/Hr

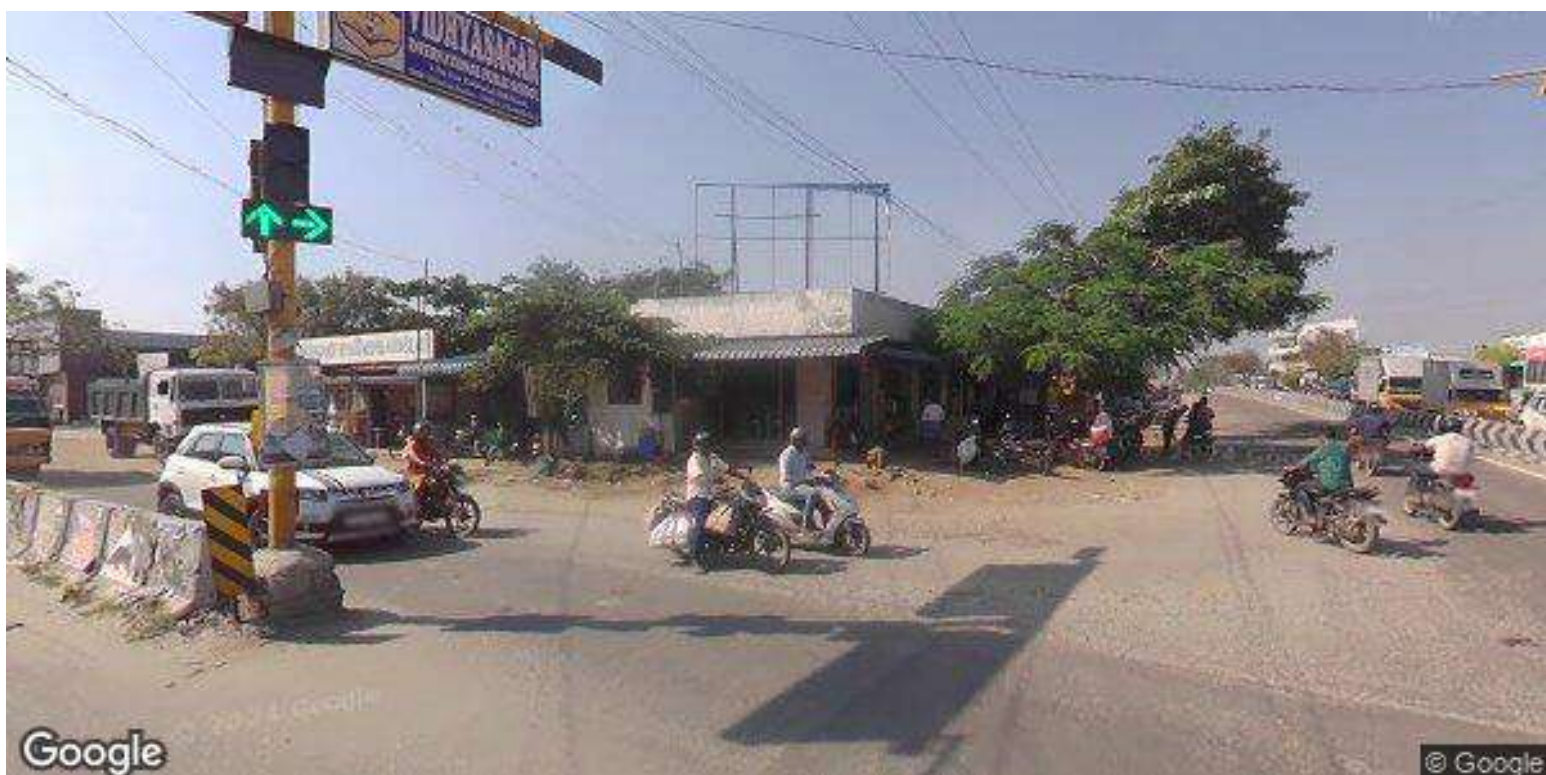
| | Risk Type | Risk Level | Coordinates | Speed Limit |
|---|---|---|---|---|
| 31 | Turn | High | 11.12775, 77.39347 | 15 KM/Hr |

**Risk Type:** Turn  
**Risk Level:** High  
**Speed Limit:** 15 KM/Hr  
**Coordinates:** 11.12775, 77.39347

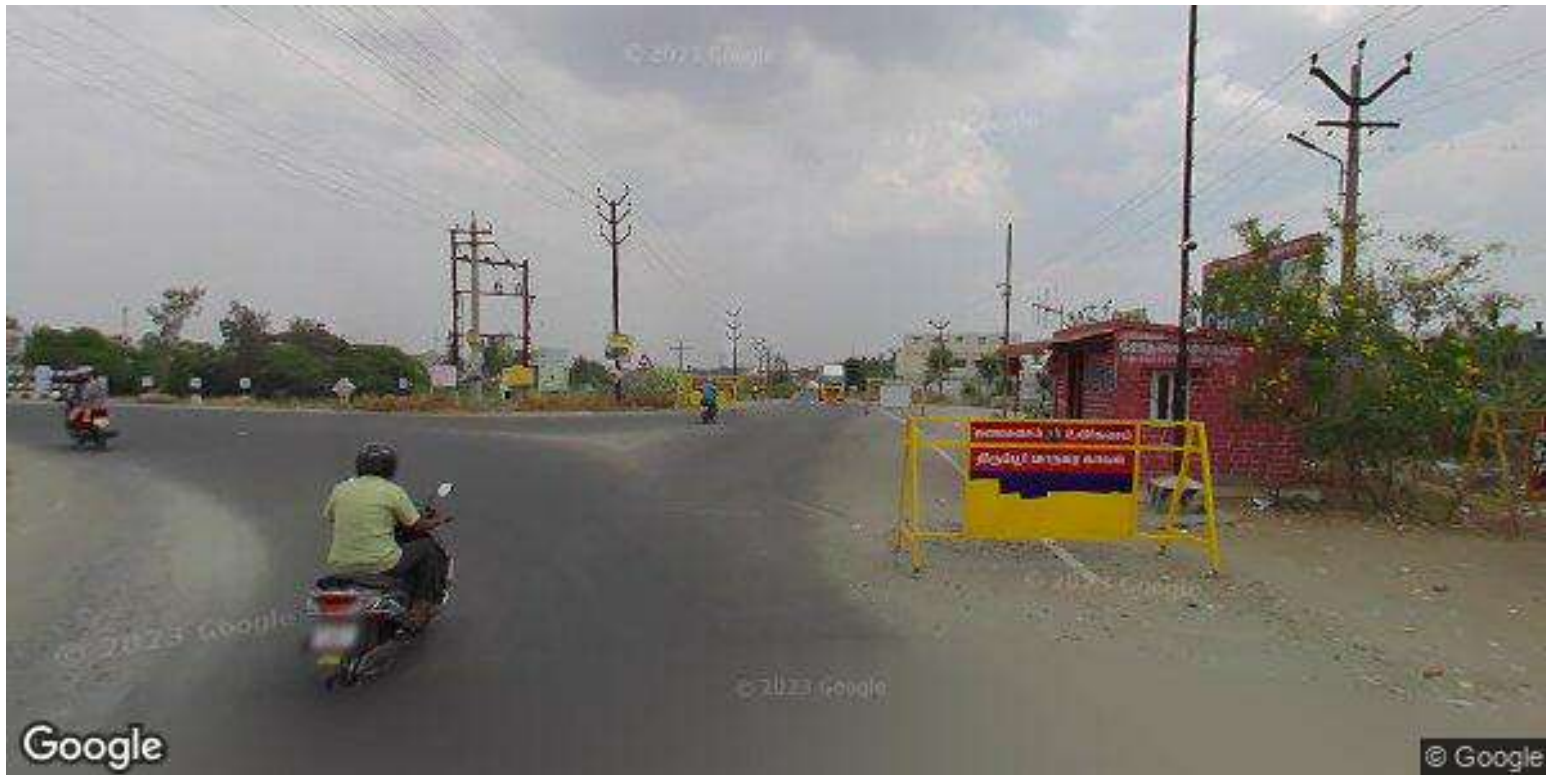
| | Risk Type | Risk Level | Coordinates | Speed Limit |
|---|---|---|---|---|
| 32 | Turn | High | 11.11846, 77.39460 | 15 KM/Hr |

**Risk Type:** Turn  
**Risk Level:** High  
**Speed Limit:** 15 KM/Hr  
**Coordinates:** 11.11846, 77.39460

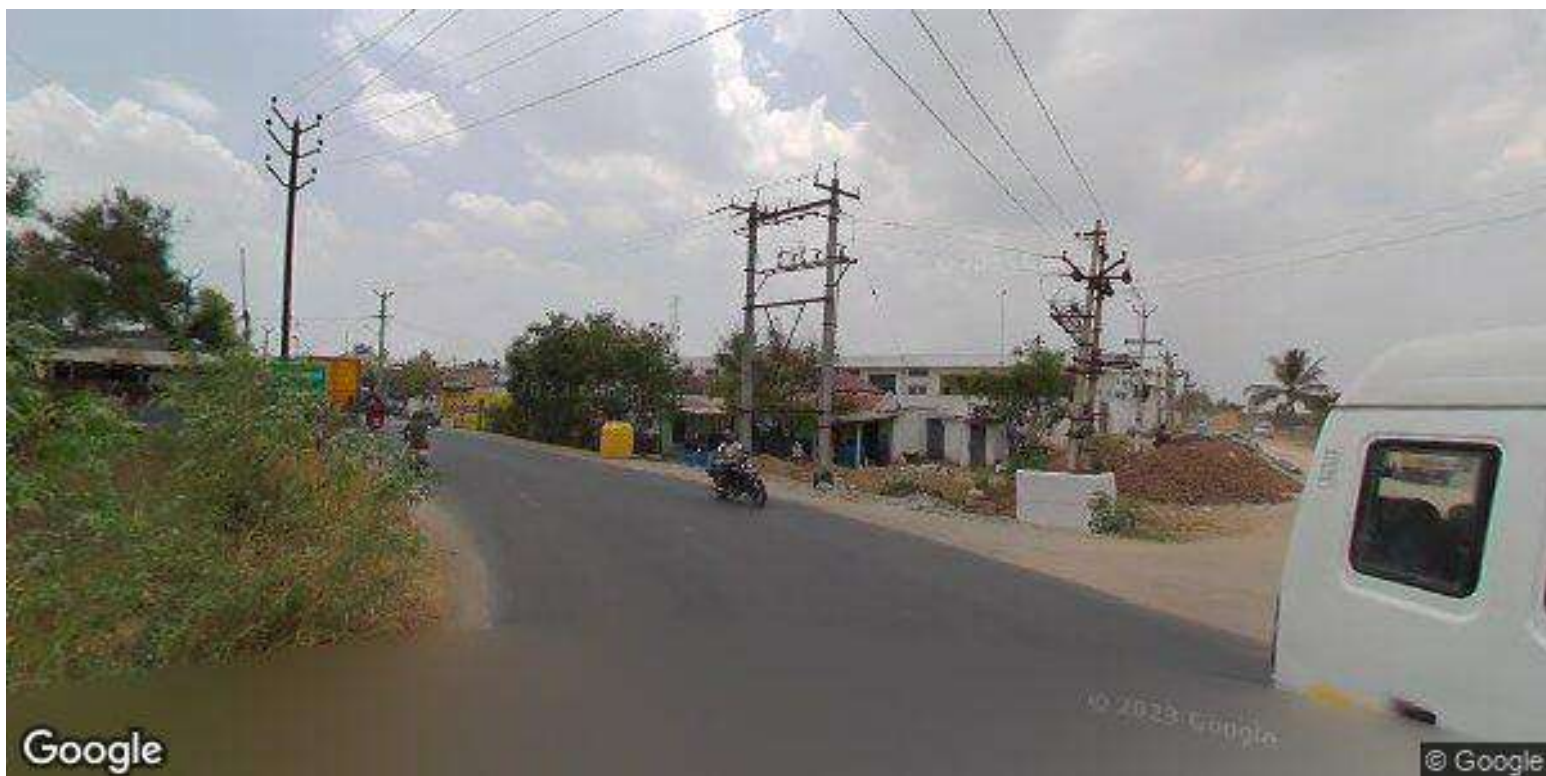
| | Risk Type | Risk Level | Coordinates | Speed Limit |
|---|---|---|---|---|
| 33 | Turn | High | 11.11833, 77.39390 | 15 KM/Hr |

**Risk Type:** Turn  
**Risk Level:** High  
**Speed Limit:** 15 KM/Hr  
**Coordinates:** 11.11833, 77.39390

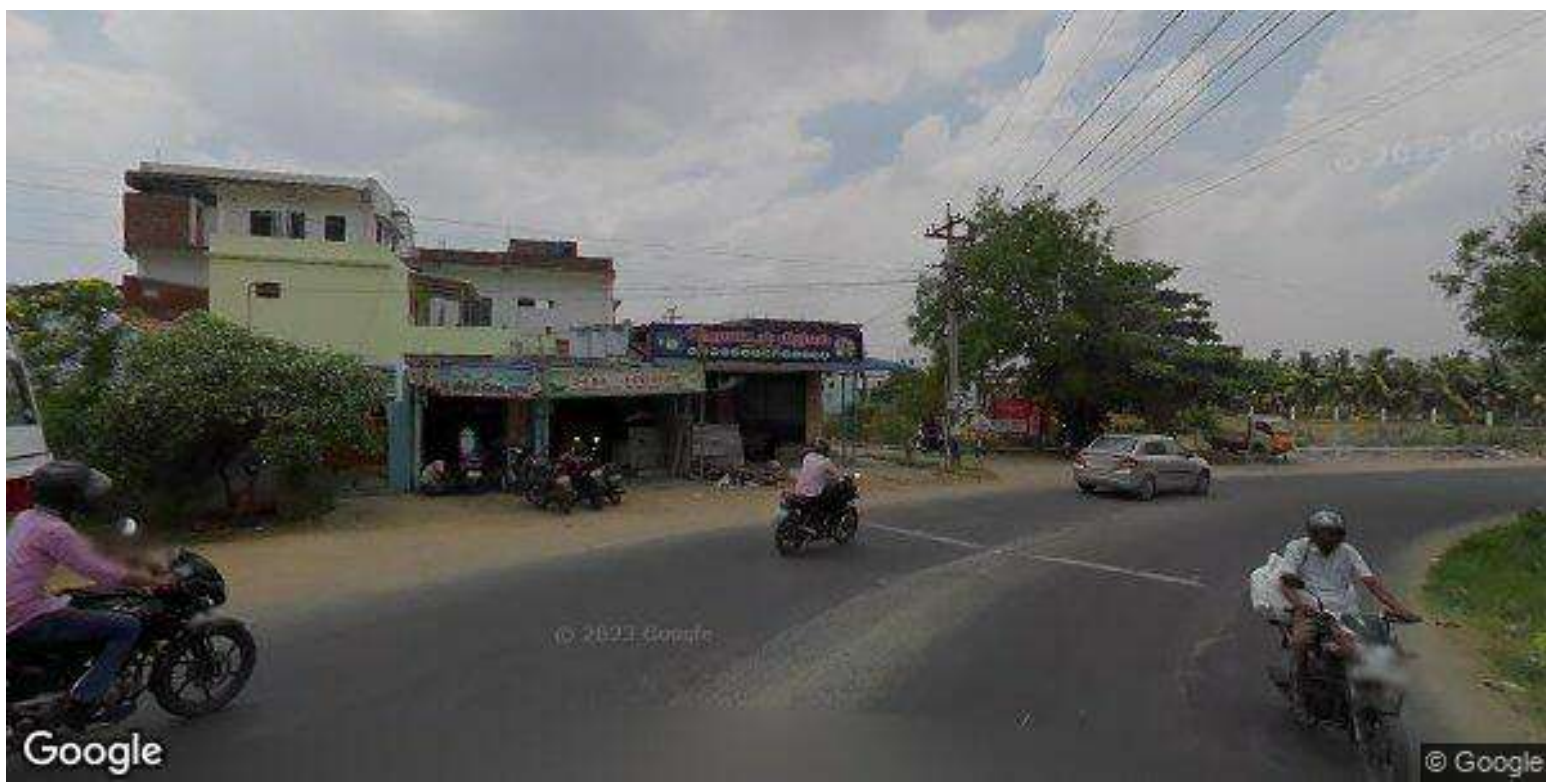
**Coordinates:** 11.10276, 77.39199

| | Risk Type | Risk Level | Coordinates | Speed Limit |
|---|---|---|---|---|
| 34 | Turn | High | 11.10276, 77.39199 | 15 KM/Hr |

**Risk Type:** Turn

**Risk Level:** High

**Speed Limit:** 15 KM/Hr

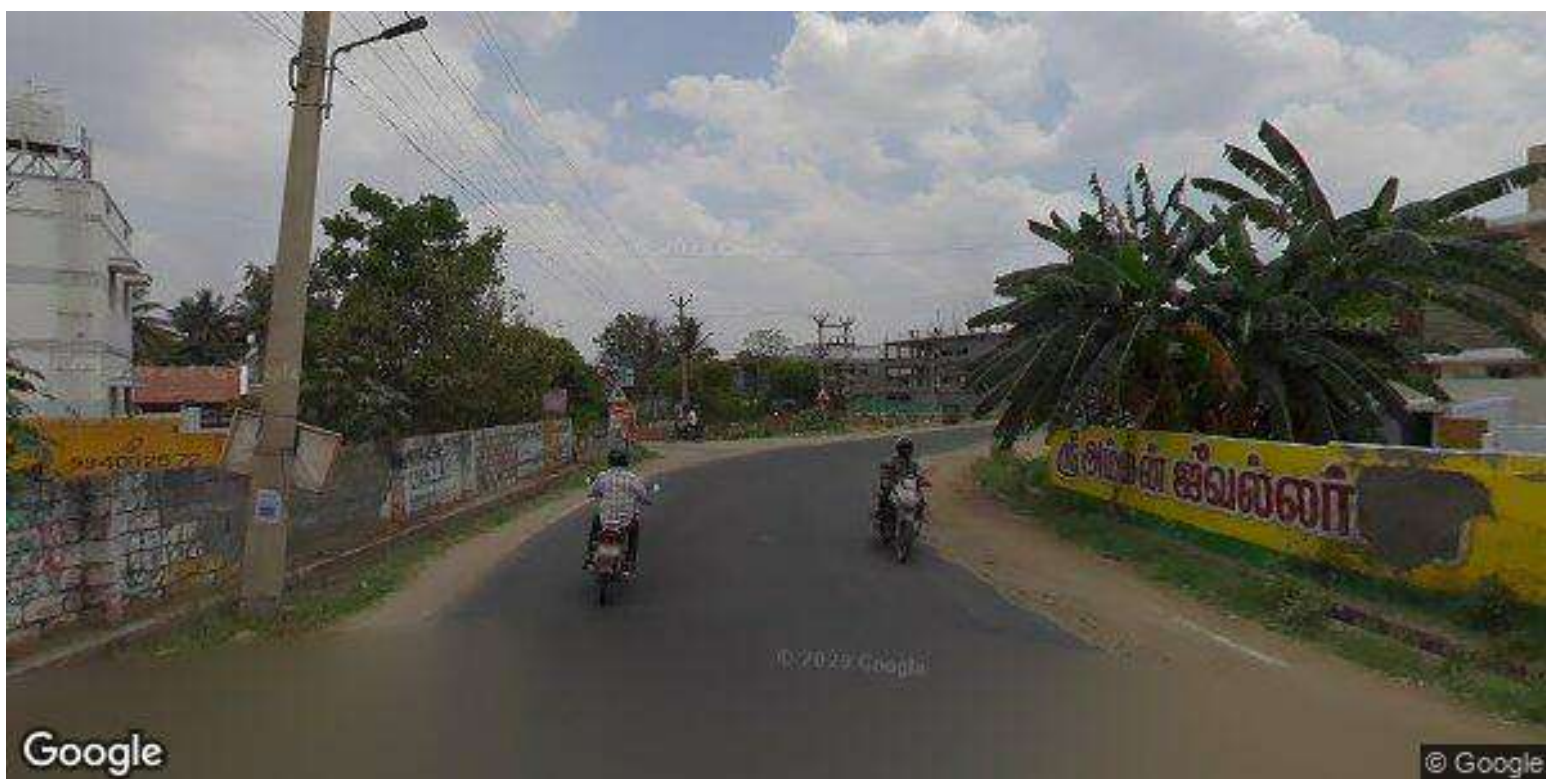
**Coordinates:** 11.10256, 77.39273

| | Risk Type | Risk Level | Coordinates | Speed Limit |
|---|---|---|---|---|
| 35 | Turn | High | 11.10256, 77.39273 | 15 KM/Hr |

**Risk Type:** Turn

**Risk Level:** High

**Speed Limit:** 15 KM/Hr

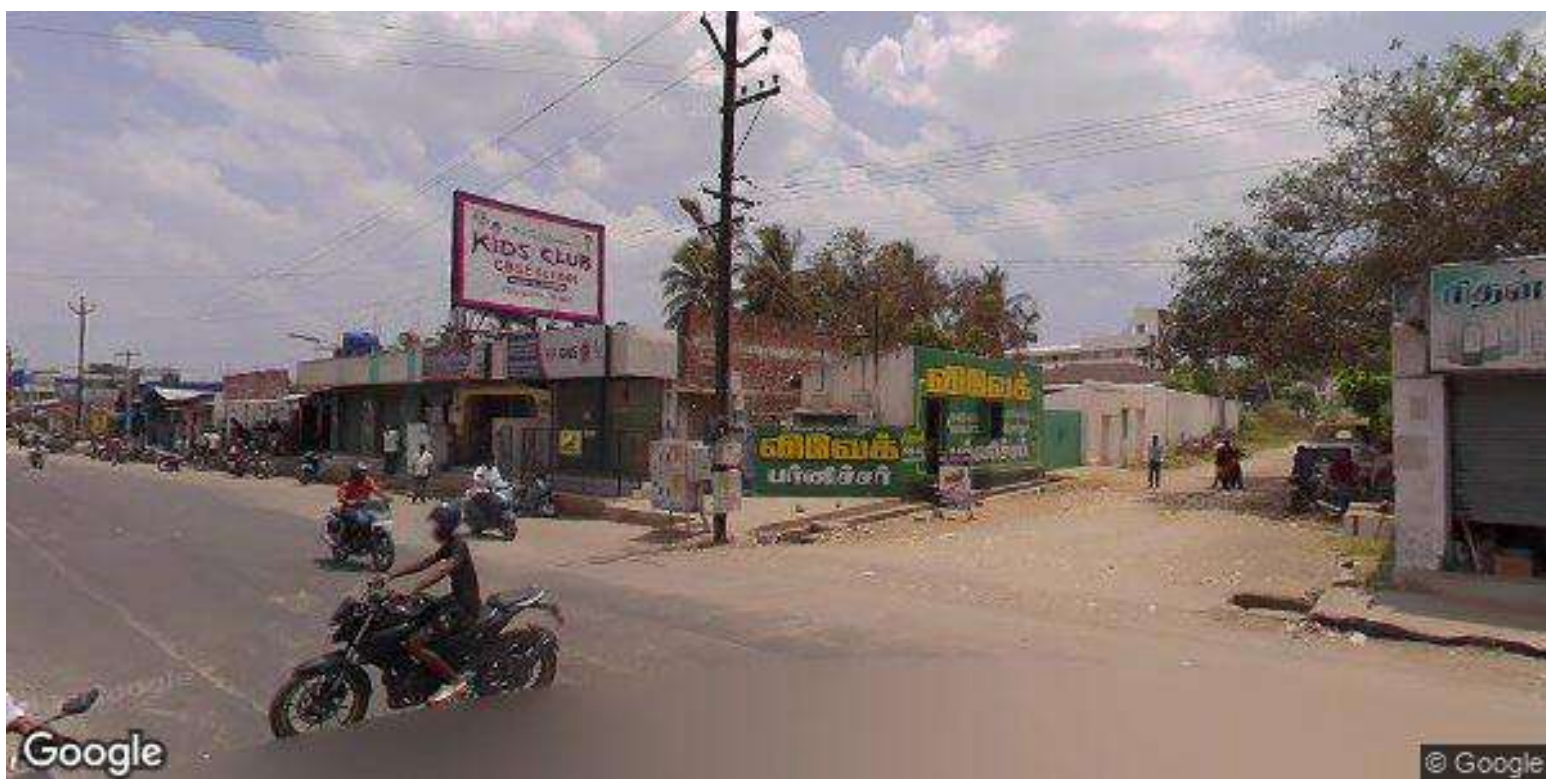
| | Risk Type | Risk Level | Coordinates | Speed Limit |
|---|---|---|---|---|
| 36 | Blind Spot | Blind Spot | 11.09882, 77.39312 | 10 KM/Hr |

**Risk Type:** Blind Spot  
**Risk Level:** Blind Spot  
**Speed Limit:** 10 KM/Hr  
**Coordinates:** 11.09882, 77.39312

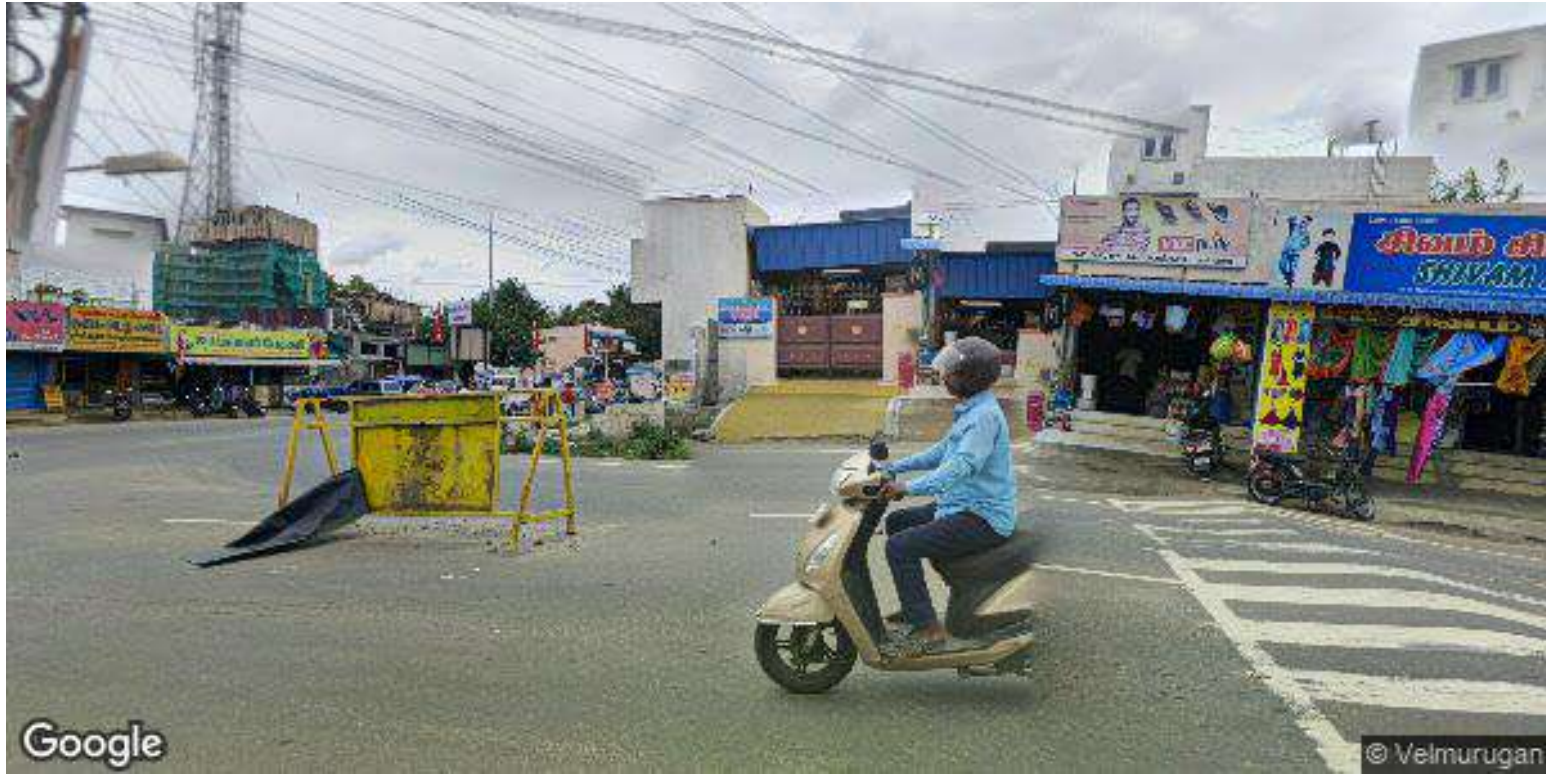
| | Risk Type | Risk Level | Coordinates | Speed Limit |
|---|---|---|---|---|
| 37 | Turn | High | 11.09898, 77.39028 | 15 KM/Hr |

**Risk Type:** Turn  
**Risk Level:** High  
**Speed Limit:** 15 KM/Hr  
**Coordinates:** 11.09898, 77.39028

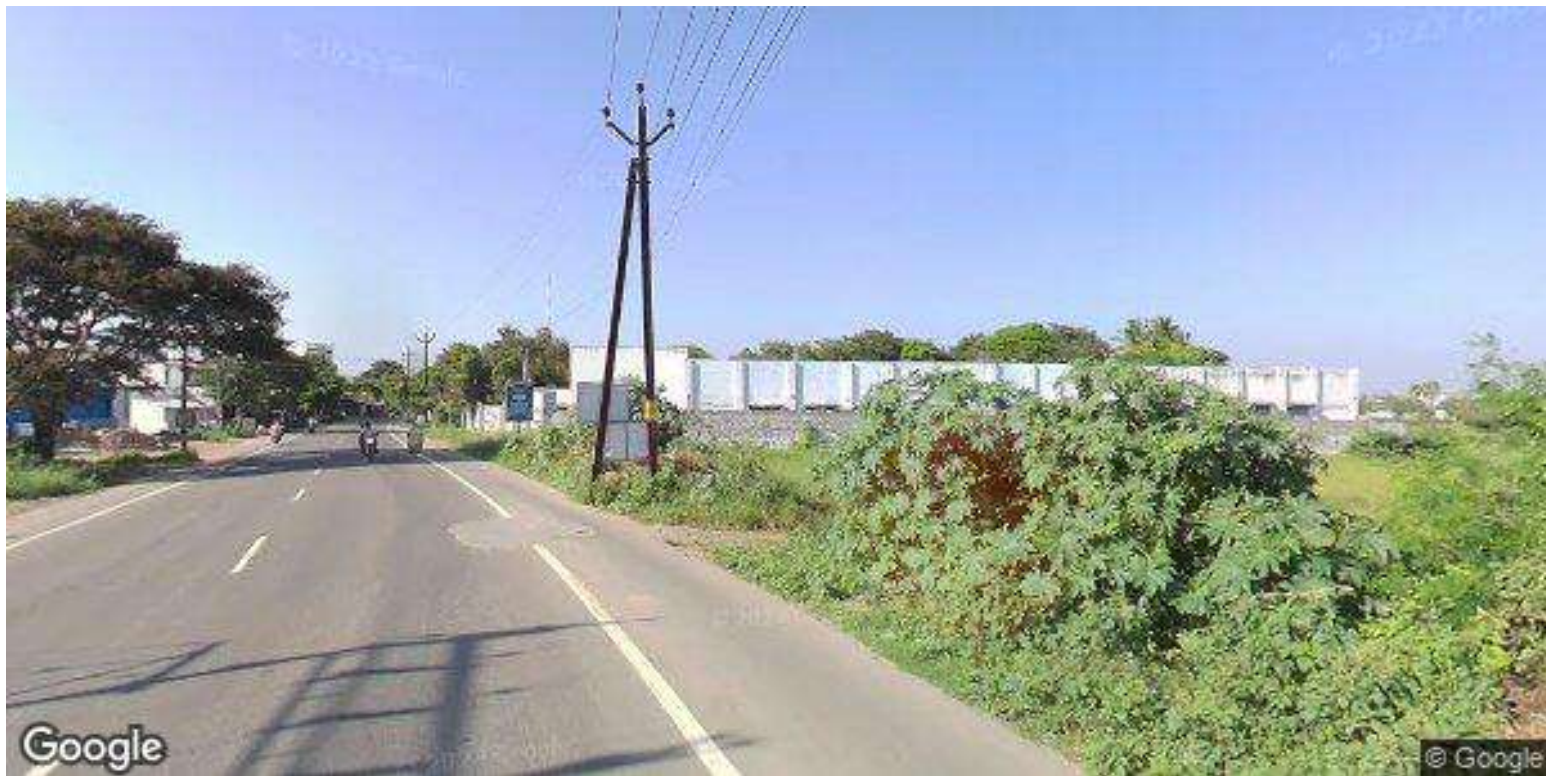
| | Risk Type | Risk Level | Coordinates | Speed Limit |
|---|---|---|---|---|
| 38 | Turn | Medium | 11.09456, 77.39233 | 30 KM/Hr |

**Risk Type:** Turn  
**Risk Level:** Medium  
**Speed Limit:** 30 KM/Hr  
**Coordinates:** 11.09456, 77.39233

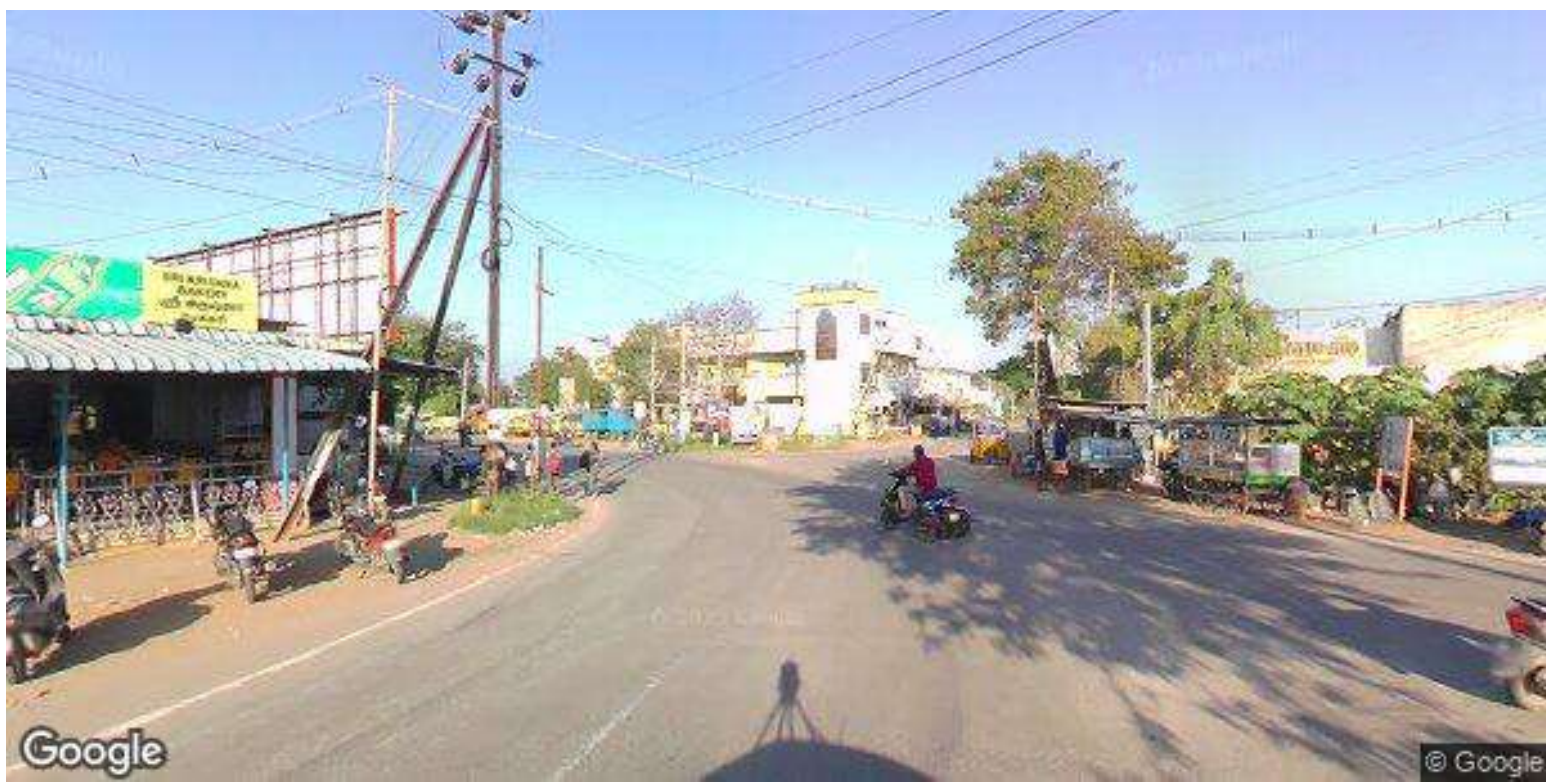
**Coordinates:** 11.08759, 77.39166

| | Risk Type | Risk Level | Coordinates | Speed Limit |
|---|---|---|---|---|
| 39 | Turn | High | 11.08759, 77.39166 | 15 KM/Hr |

**Risk Type:** Turn

**Risk Level:** High

**Speed Limit:** 15 KM/Hr

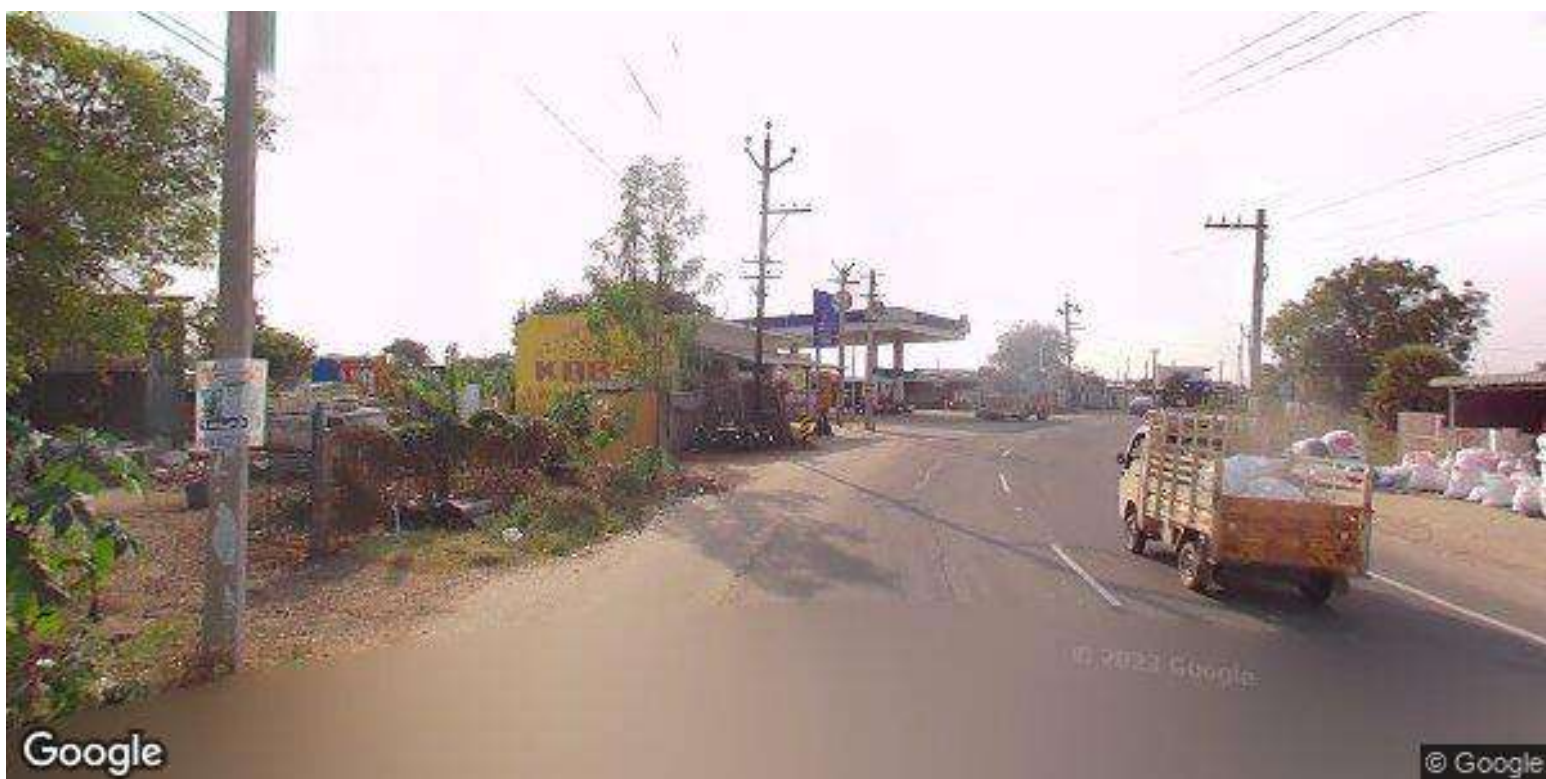
**Coordinates:** 11.08531, 77.38413

| | Risk Type | Risk Level | Coordinates | Speed Limit |
|---|---|---|---|---|
| 40 | Turn | Medium | 11.08531, 77.38413 | 30 KM/Hr |

**Risk Type:** Turn

**Risk Level:** Medium

**Speed Limit:** 30 KM/Hr

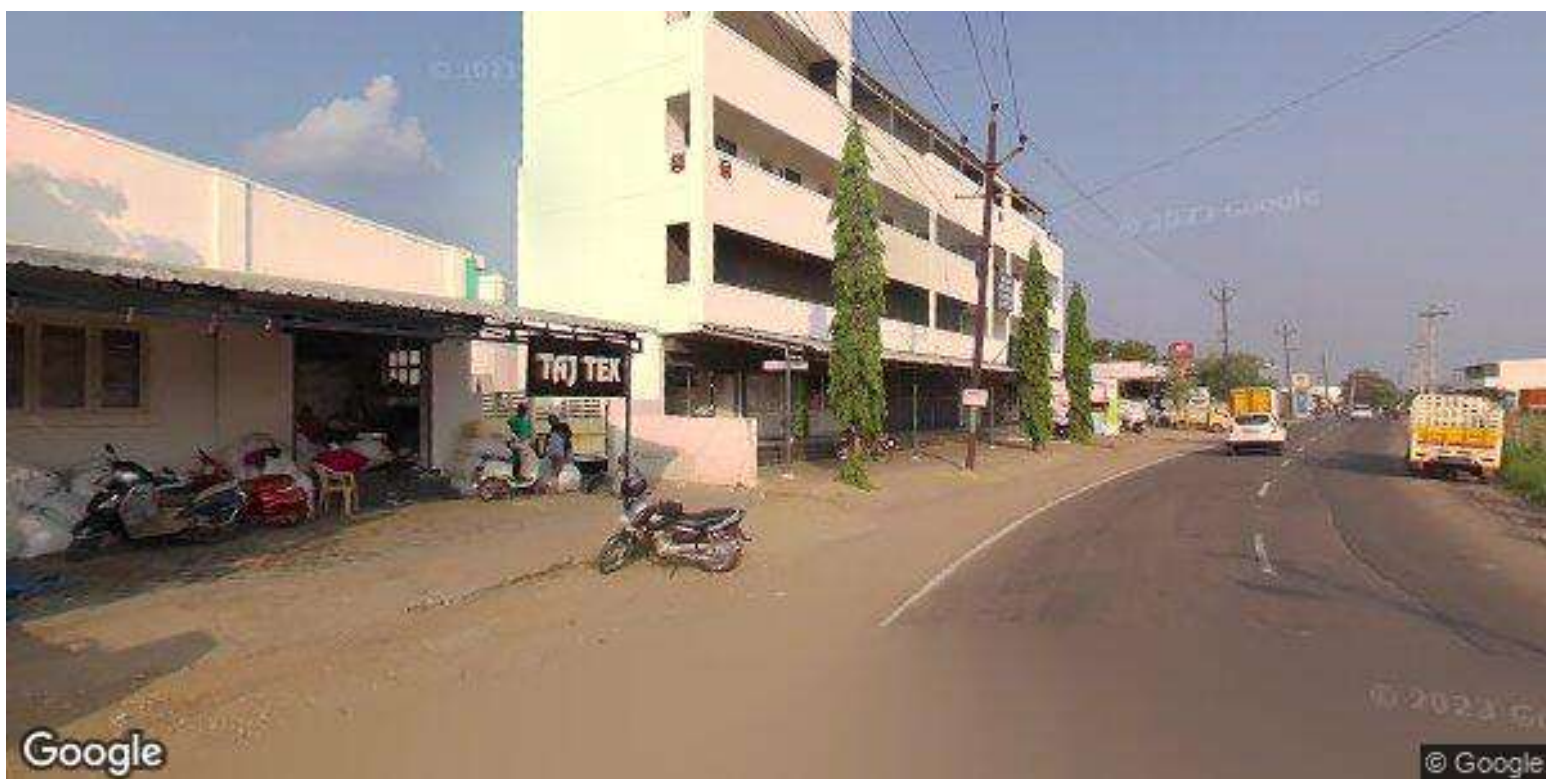
**Coordinates:** 11.08597, 77.38095

| | Risk Type | Risk Level | Coordinates | Speed Limit |
|---|---|---|---|---|
| 41 | Turn | Medium | 11.08597, 77.38095 | 30 KM/Hr |

**Risk Type:** Turn

**Risk Level:** Medium

**Speed Limit:** 30 KM/Hr
