# IndianOil

## JOURNEY RISK MANAGEMENT (JRM) STUDY

### Salem Terminal to SS AGENCY

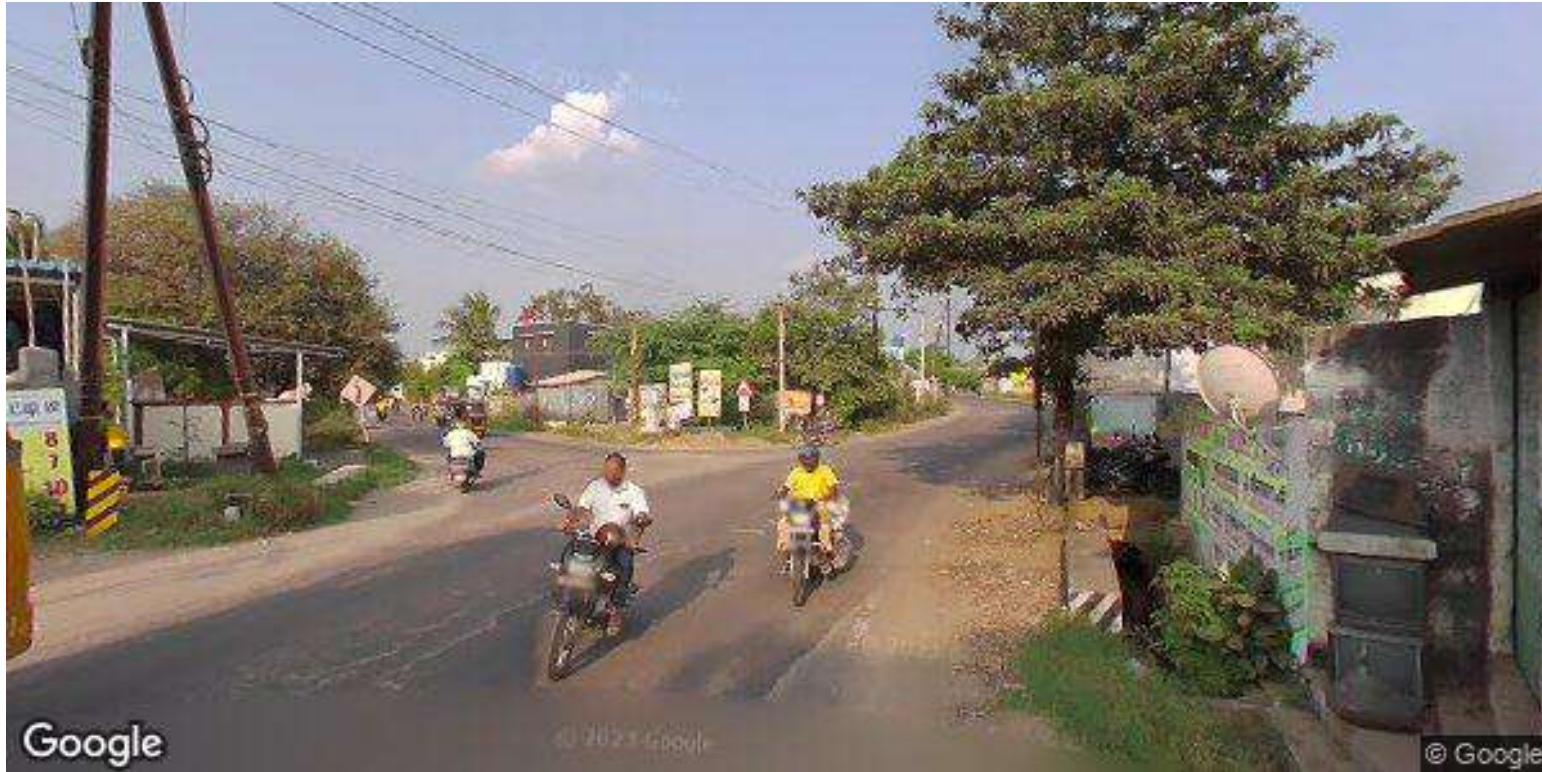
**Coordinates:** 11.08536, 77.37919

| | Risk Type | Risk Level | Coordinates | Speed Limit |
|---|---|---|---|---|
| 42 | Turn | High | 11.08536, 77.37919 | 15 KM/Hr |

**Risk Type:** Turn

**Risk Level:** High

**Speed Limit:** 15 KM/Hr

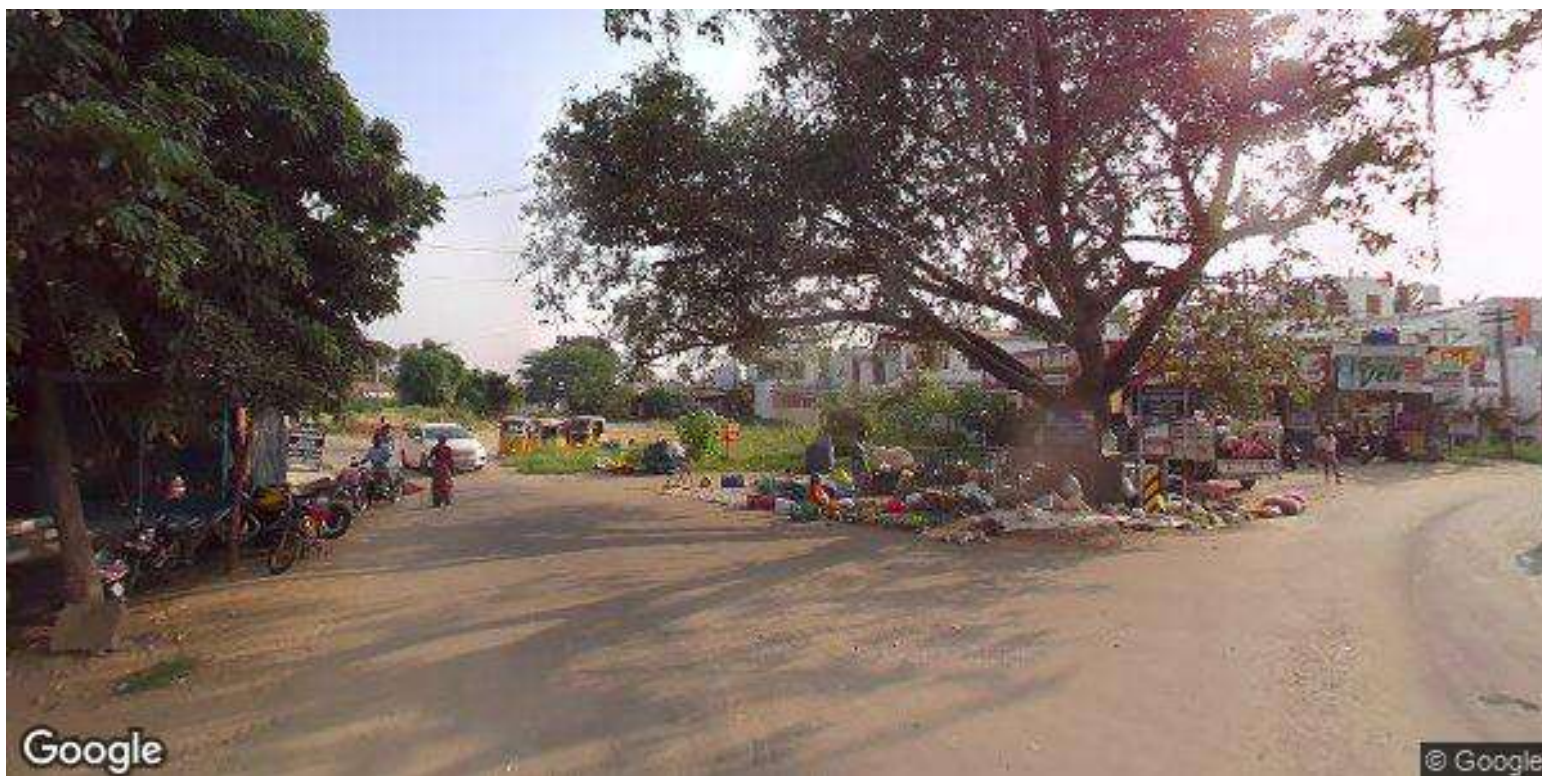
**Coordinates:** 11.08481, 77.37902

| | Risk Type | Risk Level | Coordinates | Speed Limit |
|---|---|---|---|---|
| 43 | Turn | Medium | 11.08481, 77.37902 | 30 KM/Hr |

**Risk Type:** Turn

**Risk Level:** Medium

**Speed Limit:** 30 KM/Hr

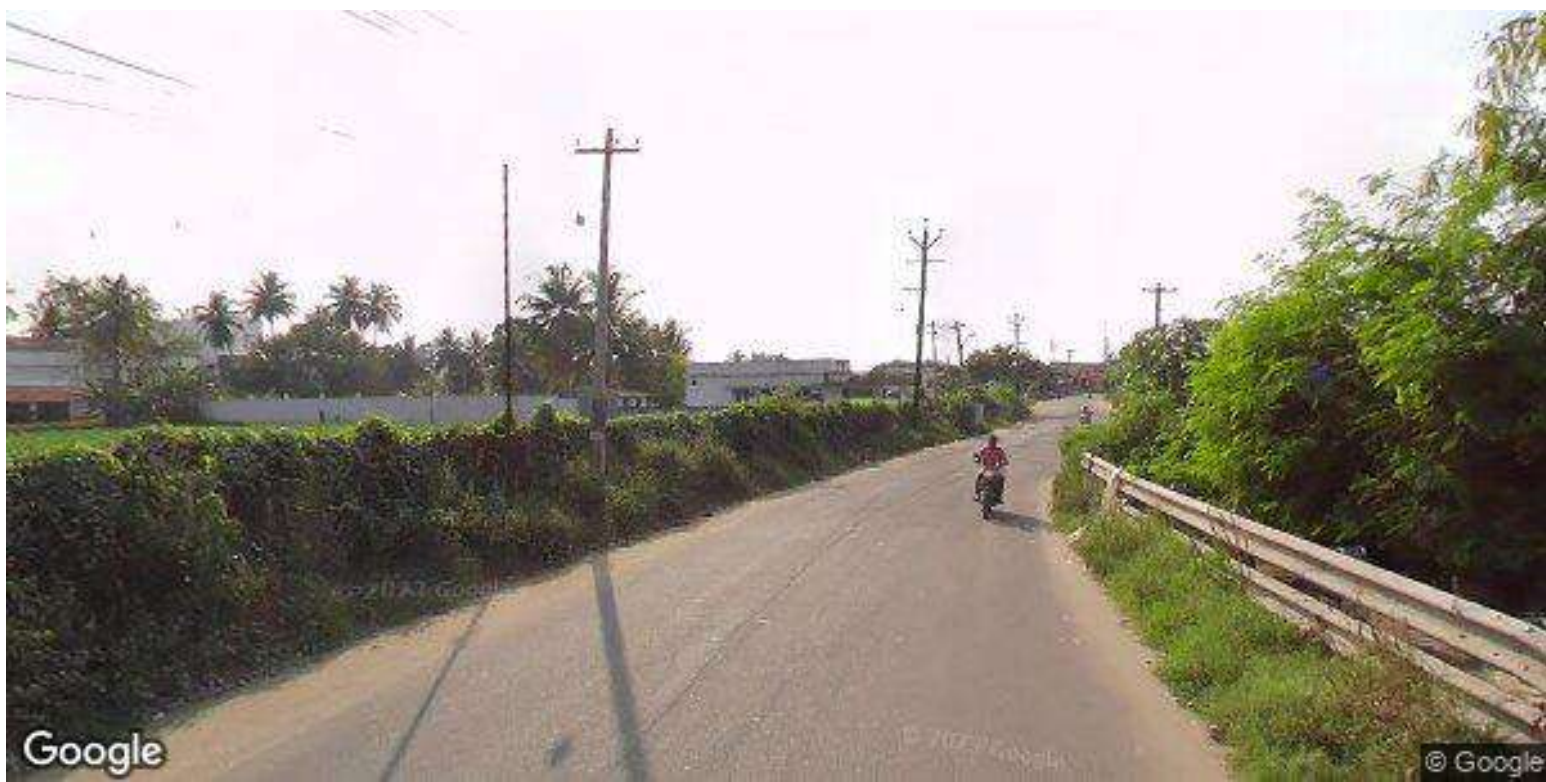
**Coordinates:** 11.08448, 77.37842

| | Risk Type | Risk Level | Coordinates | Speed Limit |
|---|---|---|---|---|
| 44 | Turn | Medium | 11.08448, 77.37842 | 30 KM/Hr |

**Risk Type:** Turn

**Risk Level:** Medium

**Speed Limit:** 30 KM/Hr

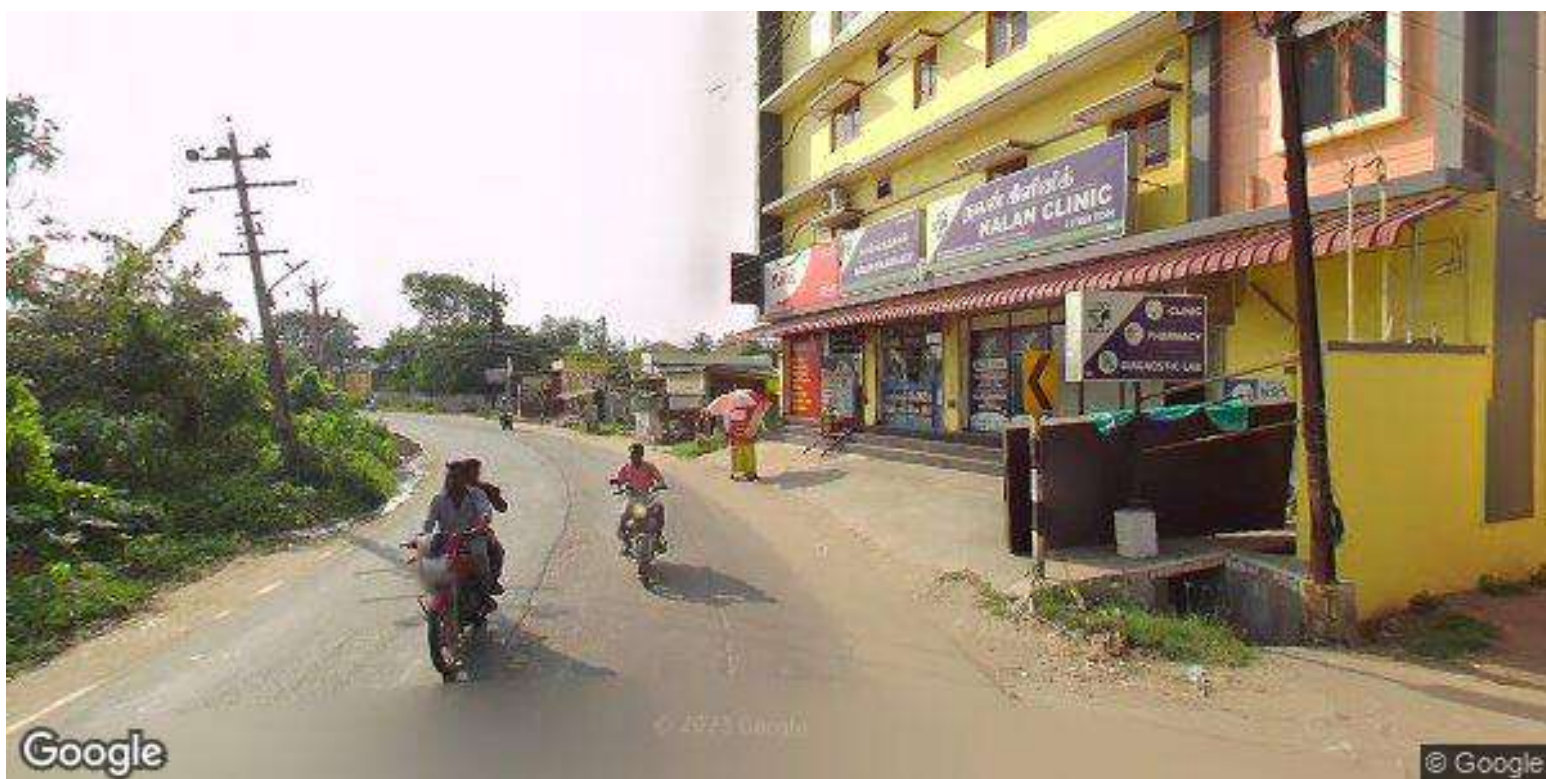
**Coordinates:** 11.08510, 77.37541

| | Risk Type | Risk Level | Coordinates | Speed Limit |
|---|---|---|---|---|
| 45 | Turn | Medium | 11.08510, 77.37541 | 30 KM/Hr |

**Risk Type:** Turn

**Risk Level:** Medium

**Speed Limit:** 30 KM/Hr

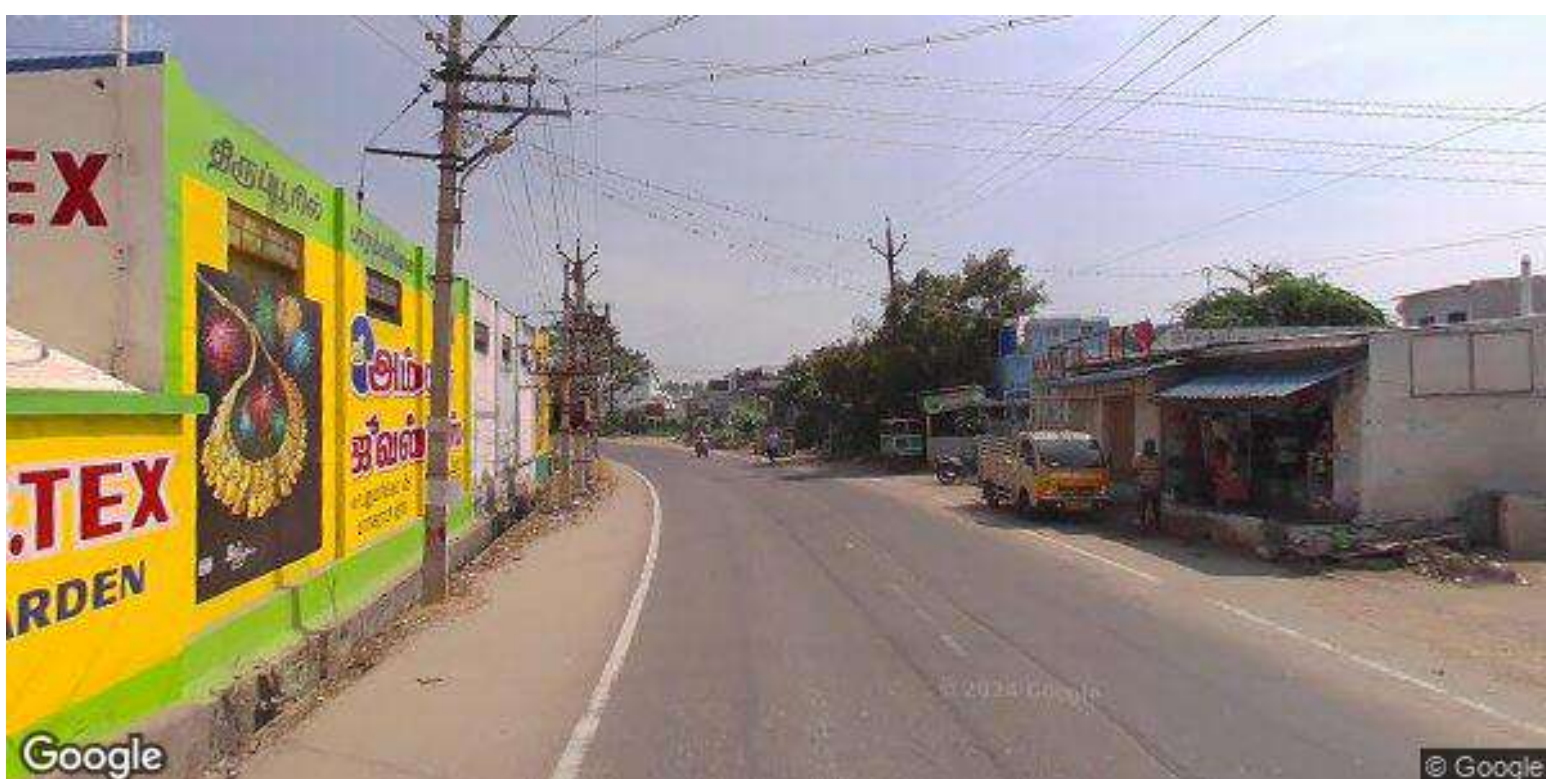
| | Risk Type | Risk Level | Coordinates | Speed Limit |
|---|---|---|---|---|
| 46 | Turn | Medium | 11.08463, 77.37378 | 30 KM/Hr |

**Risk Type:** Turn  
**Risk Level:** Medium  
**Speed Limit:** 30 KM/Hr  
**Coordinates:** 11.08463, 77.37378

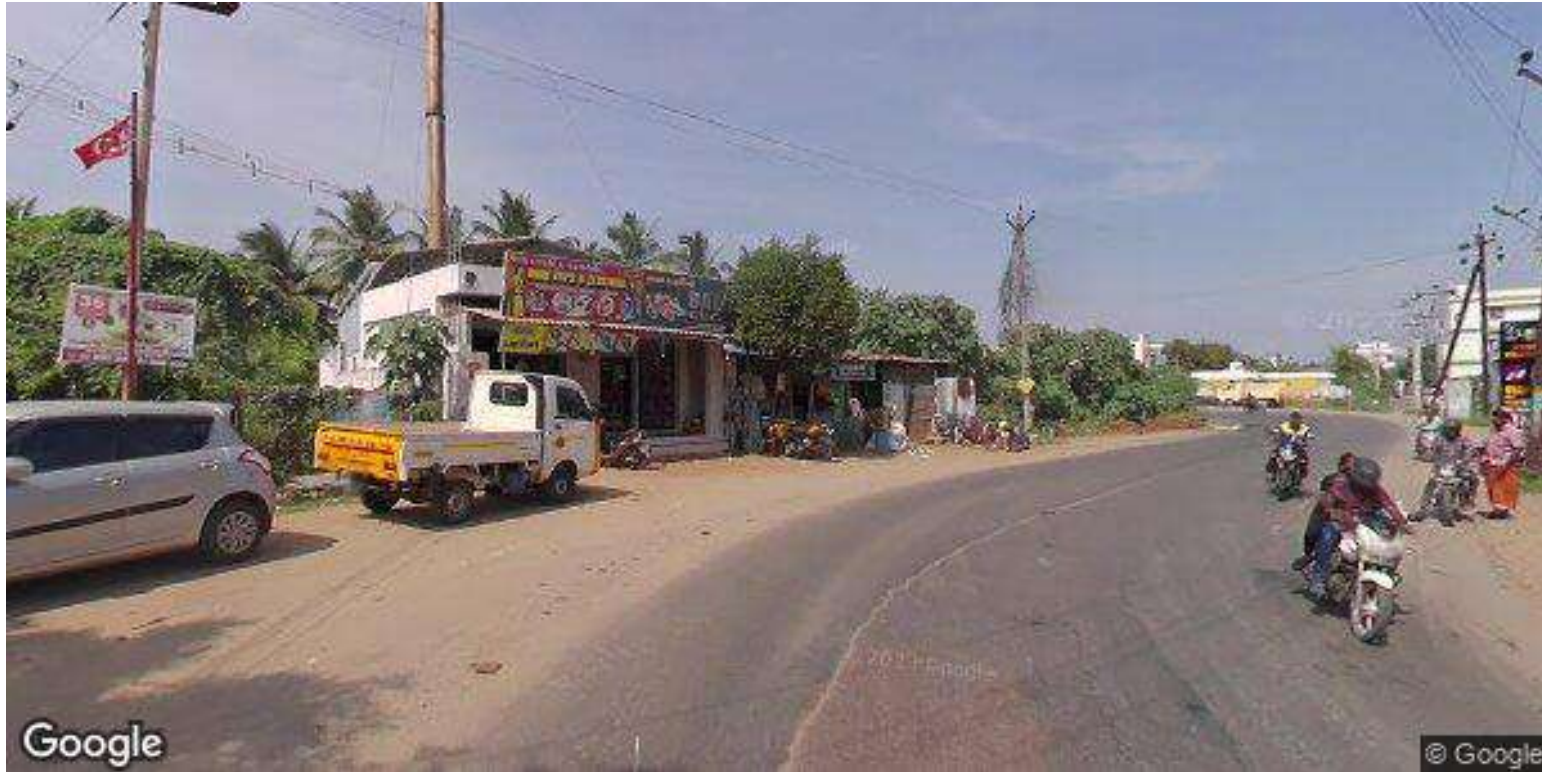
| | Risk Type | Risk Level | Coordinates | Speed Limit |
|---|---|---|---|---|
| 47 | Turn | High | 11.08497, 77.37234 | 15 KM/Hr |

**Risk Type:** Turn  
**Risk Level:** High  
**Speed Limit:** 15 KM/Hr  
**Coordinates:** 11.08497, 77.37234

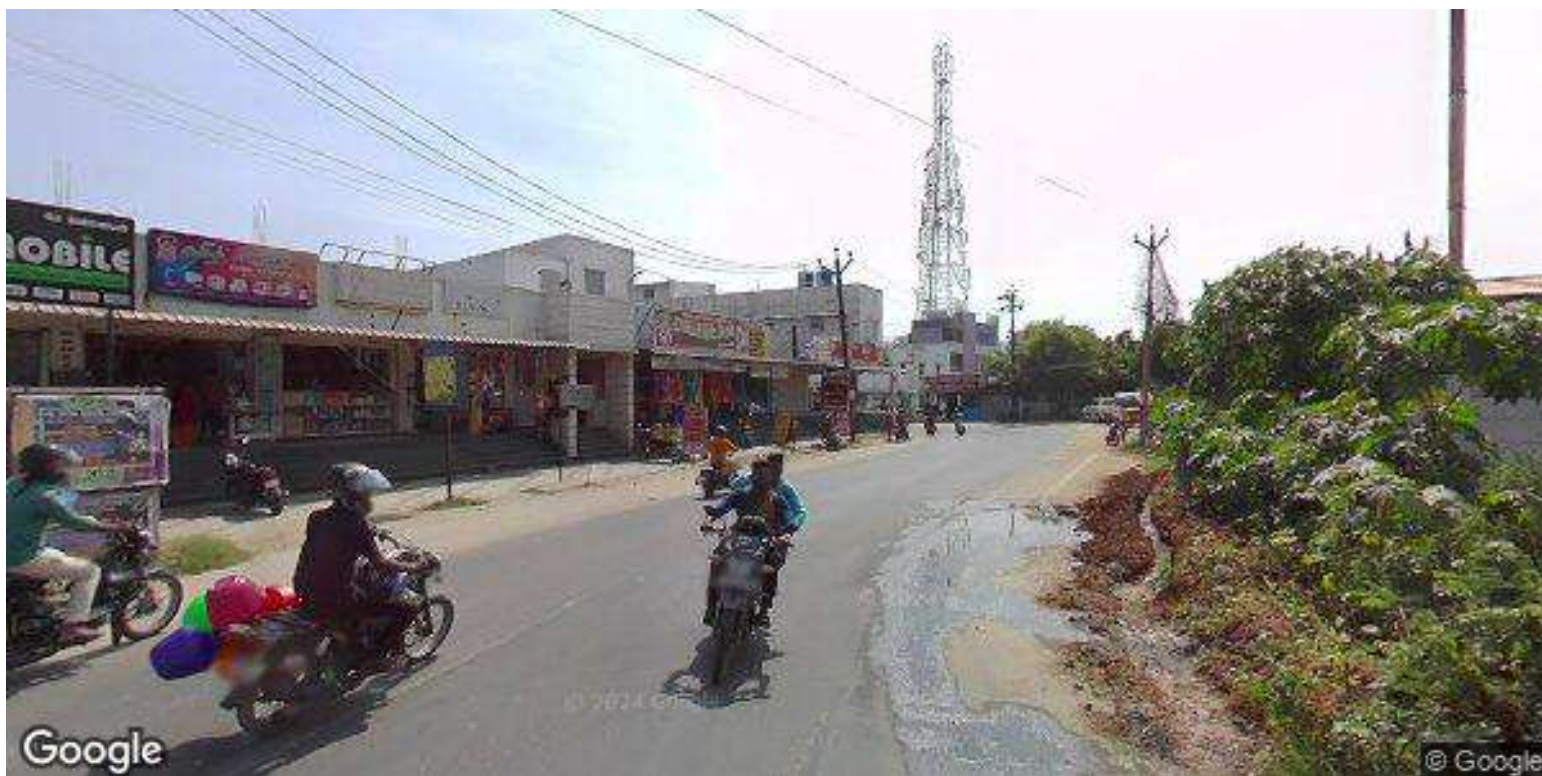
| | Risk Type | Risk Level | Coordinates | Speed Limit |
|---|---|---|---|---|
| 48 | Turn | High | 11.08544, 77.37228 | 15 KM/Hr |

**Risk Type:** Turn  
**Risk Level:** High  
**Speed Limit:** 15 KM/Hr  
**Coordinates:** 11.08544, 77.37228

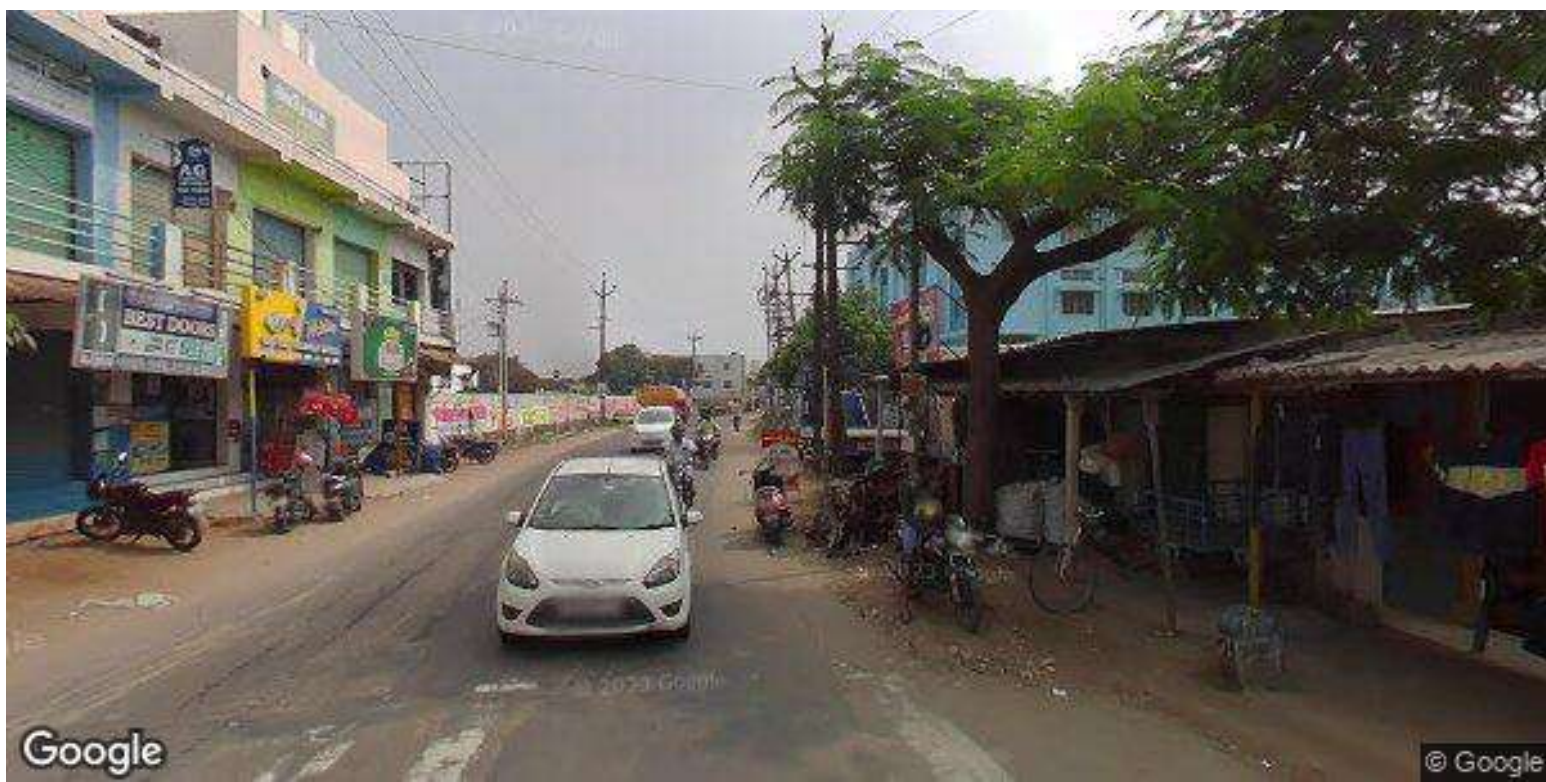
**Coordinates:** 11.08604, 77.36377

| | Risk Type | Risk Level | Coordinates | Speed Limit |
|---|---|---|---|---|
| 49 | Turn | High | 11.08604, 77.36377 | 15 KM/Hr |

**Risk Type:** Turn

**Risk Level:** High

**Speed Limit:** 15 KM/Hr

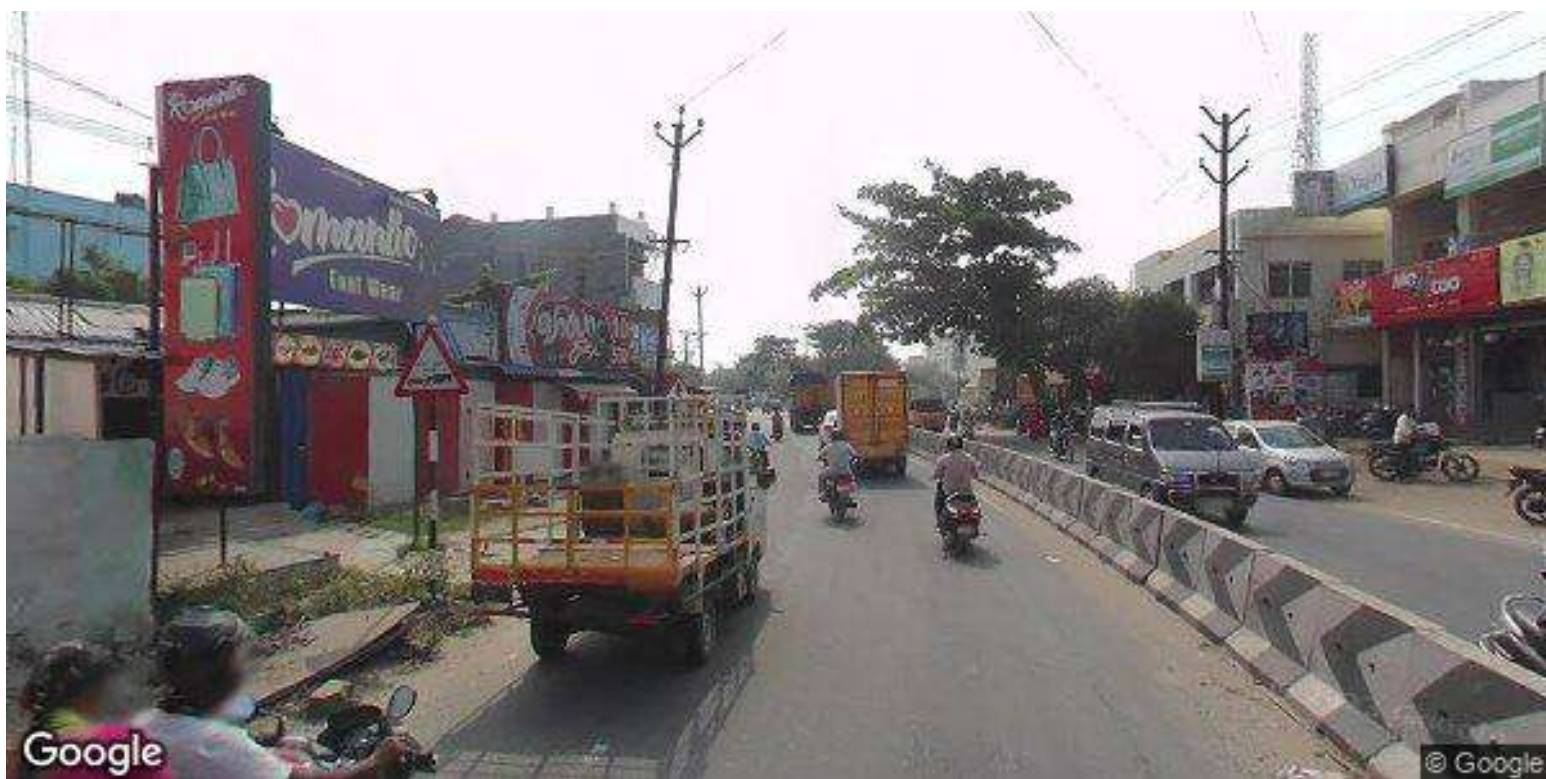
**Coordinates:** 11.08583, 77.36360

| | Risk Type | Risk Level | Coordinates | Speed Limit |
|---|---|---|---|---|
| 50 | Turn | High | 11.08583, 77.36360 | 15 KM/Hr |

**Risk Type:** Turn

**Risk Level:** High

**Speed Limit:** 15 KM/Hr

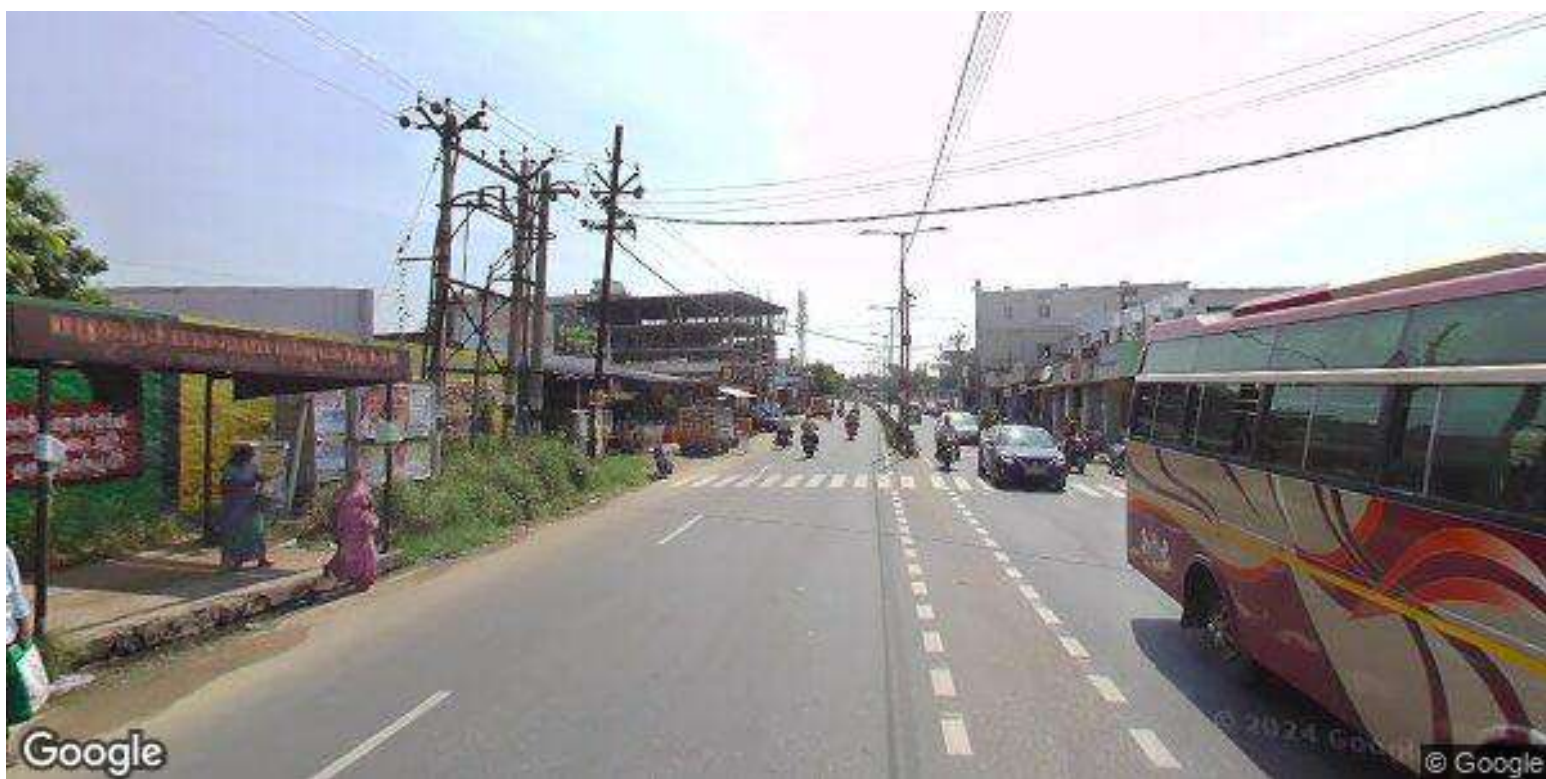
| | Risk Type | Risk Level | Coordinates | Speed Limit |
|---|---|---|---|---|
| 51 | Turn | High | 11.07888, 77.36793 | 15 KM/Hr |

**Risk Type:** Turn  
**Risk Level:** High  
**Speed Limit:** 15 KM/Hr  
**Coordinates:** 11.07888, 77.36793

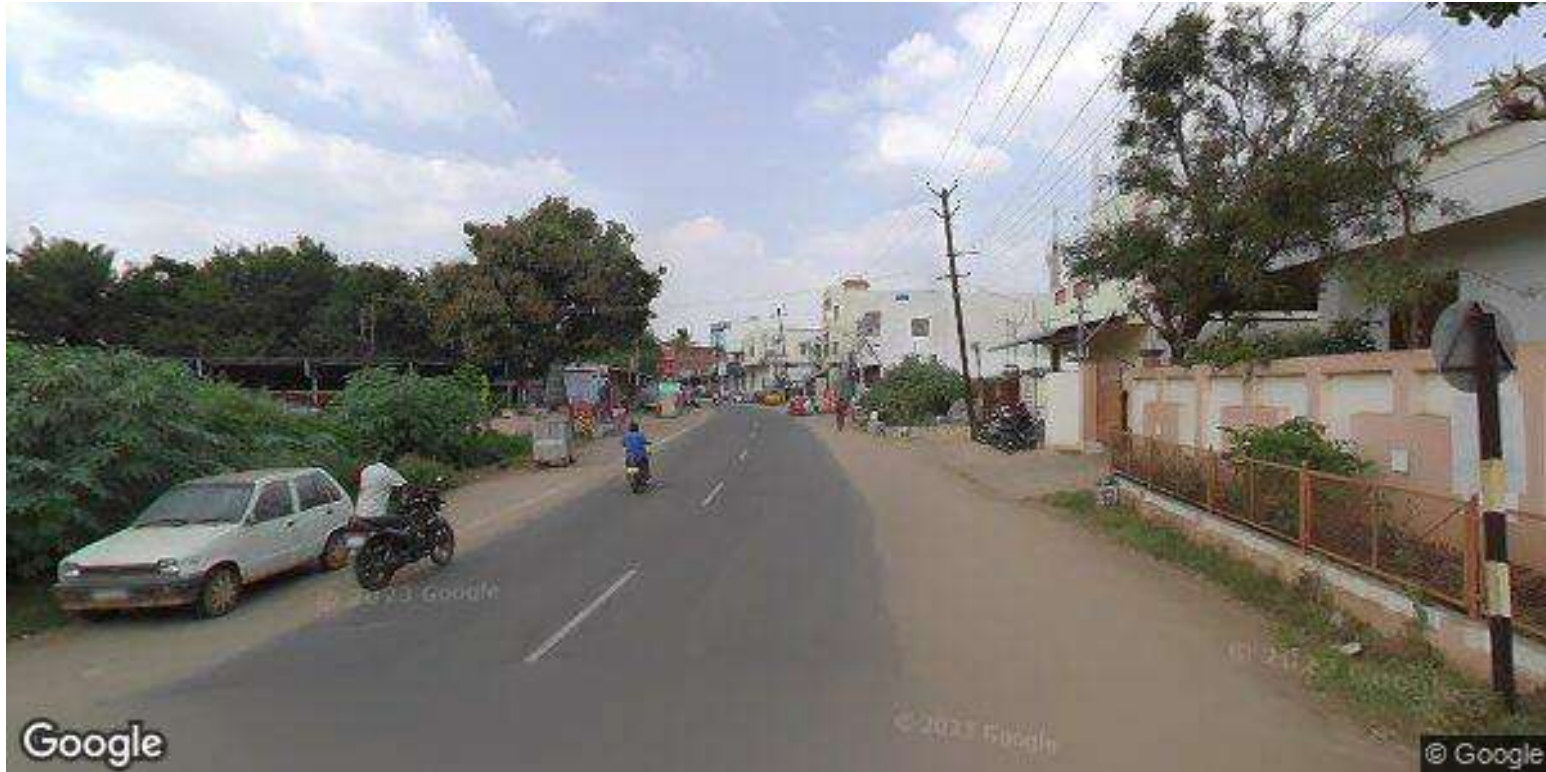
| | Risk Type | Risk Level | Coordinates | Speed Limit |
|---|---|---|---|---|
| 52 | Turn | Medium | 11.07037, 77.36701 | 30 KM/Hr |

**Risk Type:** Turn  
**Risk Level:** Medium  
**Speed Limit:** 30 KM/Hr  
**Coordinates:** 11.07037, 77.36701

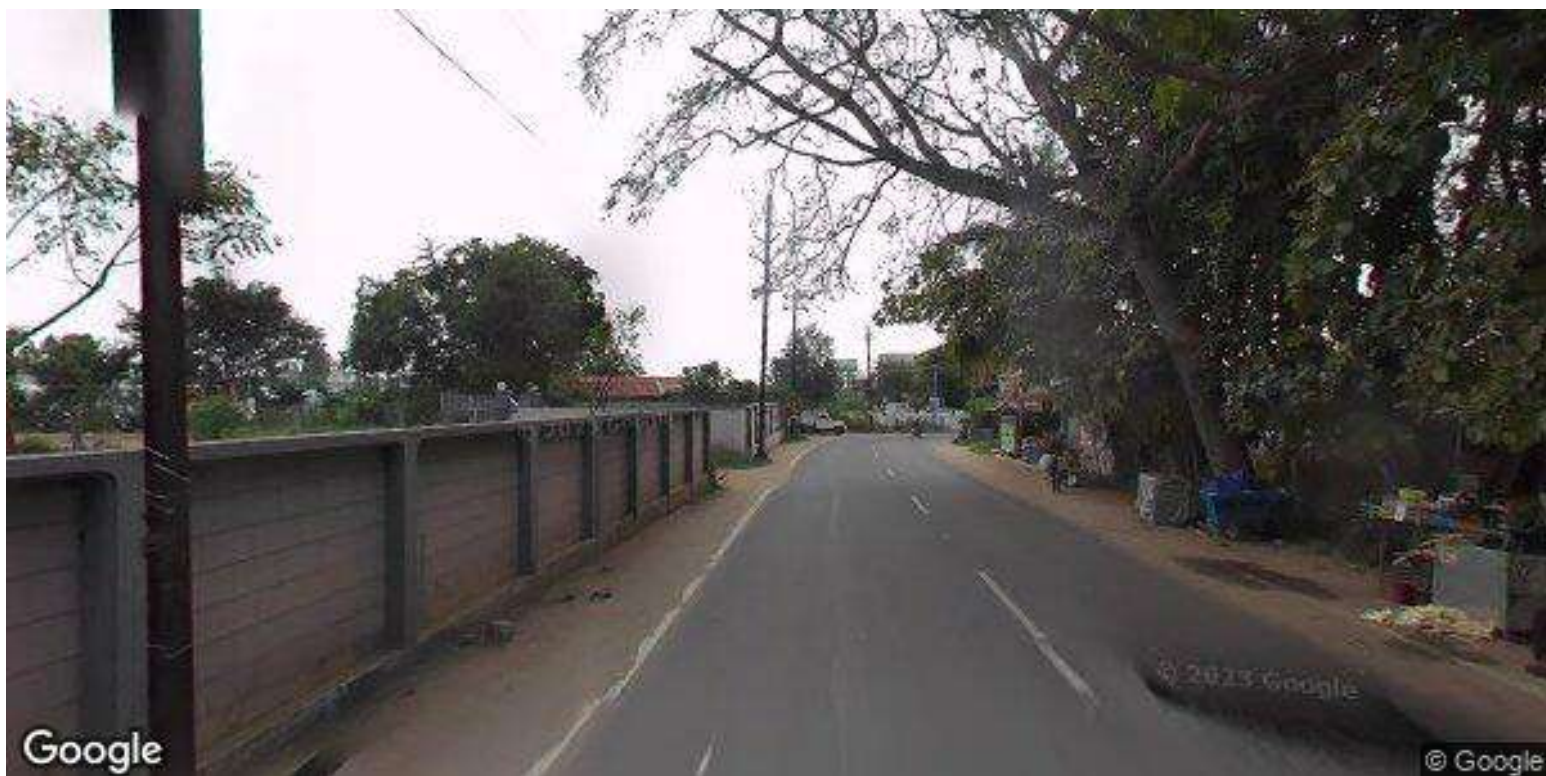
| | Risk Type | Risk Level | Coordinates | Speed Limit |
|---|---|---|---|---|
| 53 | Turn | Medium | 11.06962, 77.36676 | 30 KM/Hr |

**Risk Type:** Turn  
**Risk Level:** Medium  
**Speed Limit:** 30 KM/Hr  
**Coordinates:** 11.06962, 77.36676

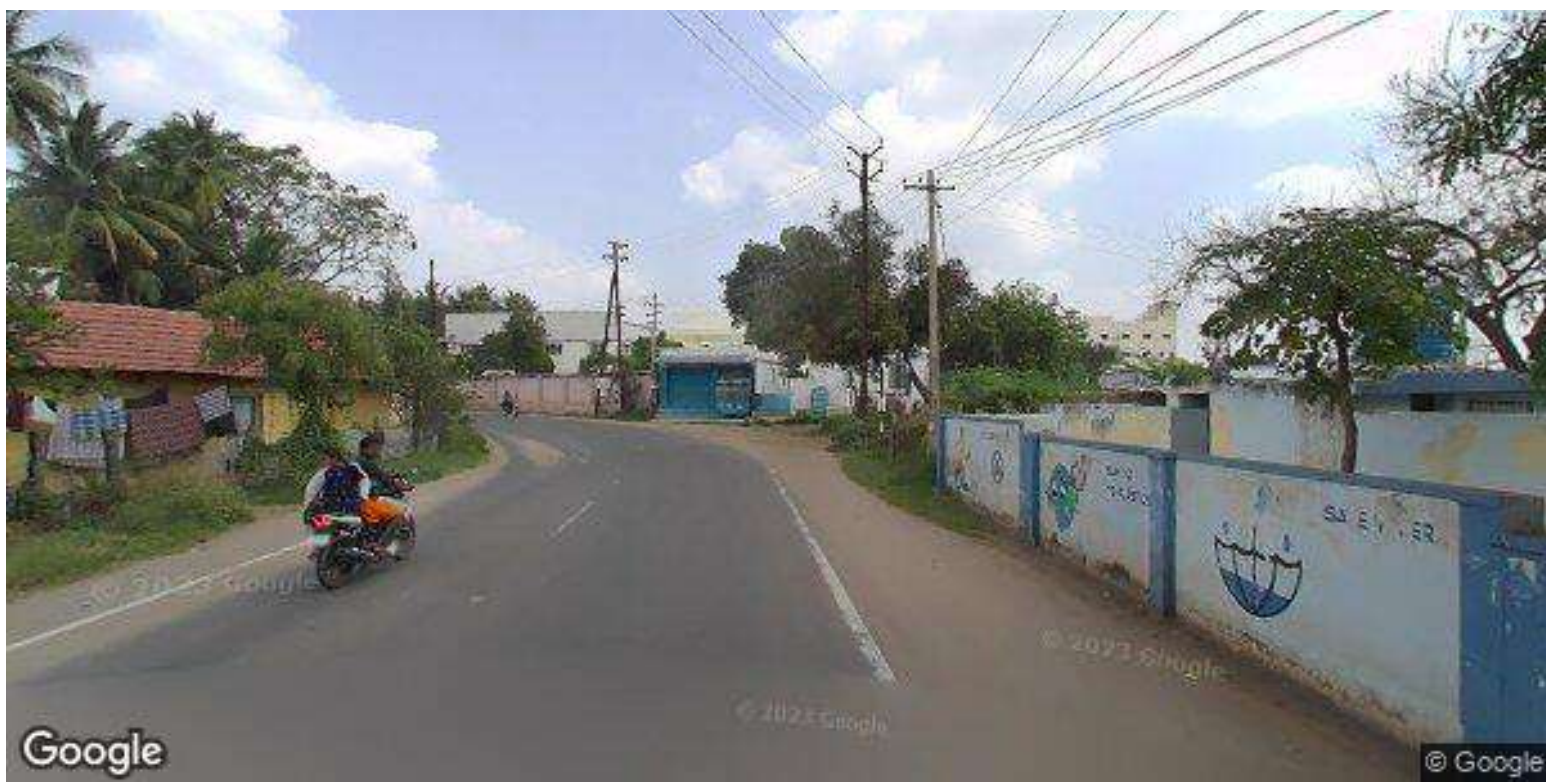
**Coordinates:** 11.06907, 77.36623

| | Risk Type | Risk Level | Coordinates | Speed Limit |
|---|---|---|---|---|
| 54 | Turn | Medium | 11.06907, 77.36623 | 30 KM/Hr |

**Risk Type:** Turn

**Risk Level:** Medium

**Speed Limit:** 30 KM/Hr

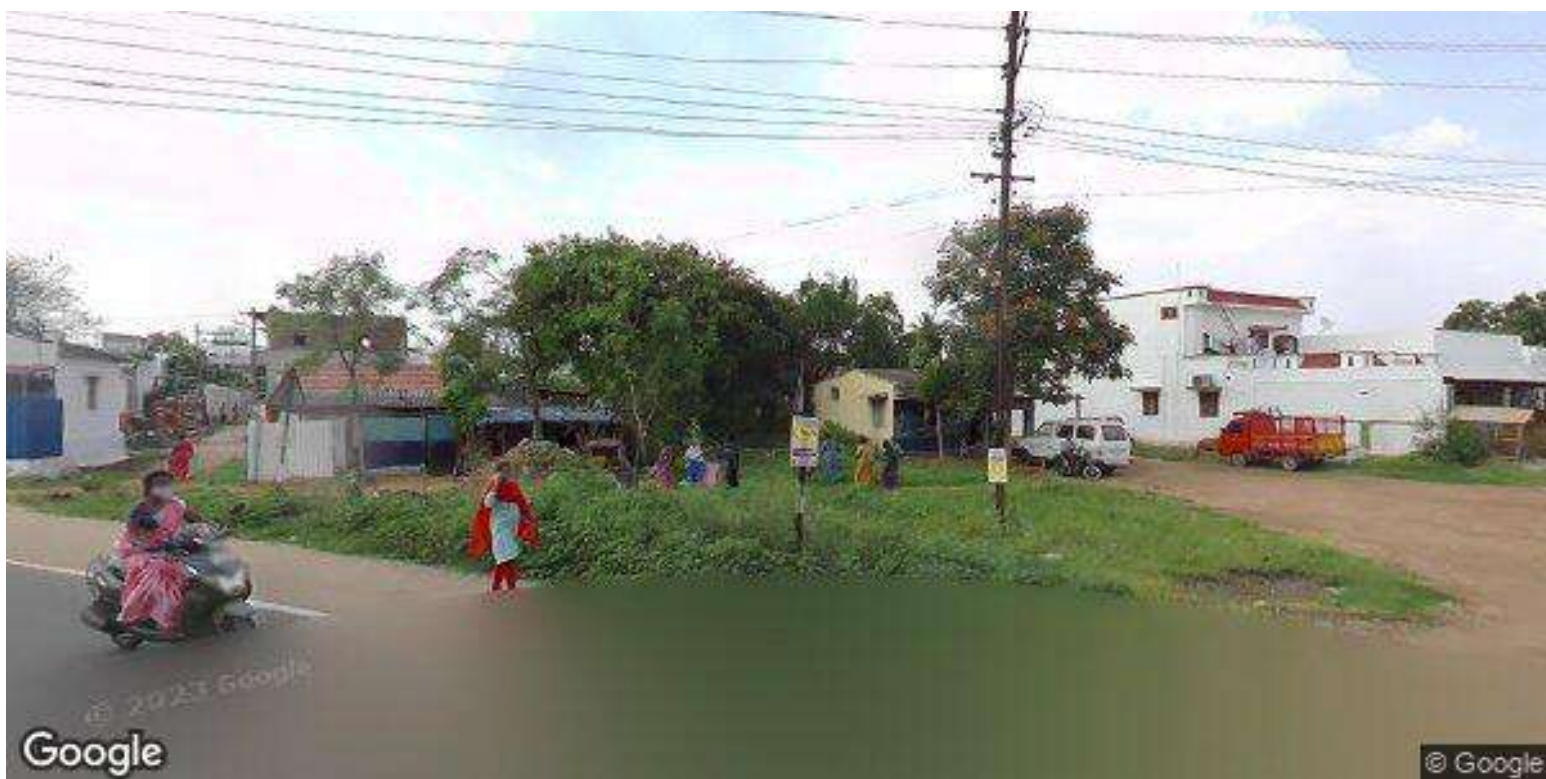
**Coordinates:** 11.06888, 77.36568

| | Risk Type | Risk Level | Coordinates | Speed Limit |
|---|---|---|---|---|
| 55 | Turn | Medium | 11.06888, 77.36568 | 30 KM/Hr |

**Risk Type:** Turn

**Risk Level:** Medium

**Speed Limit:** 30 KM/Hr

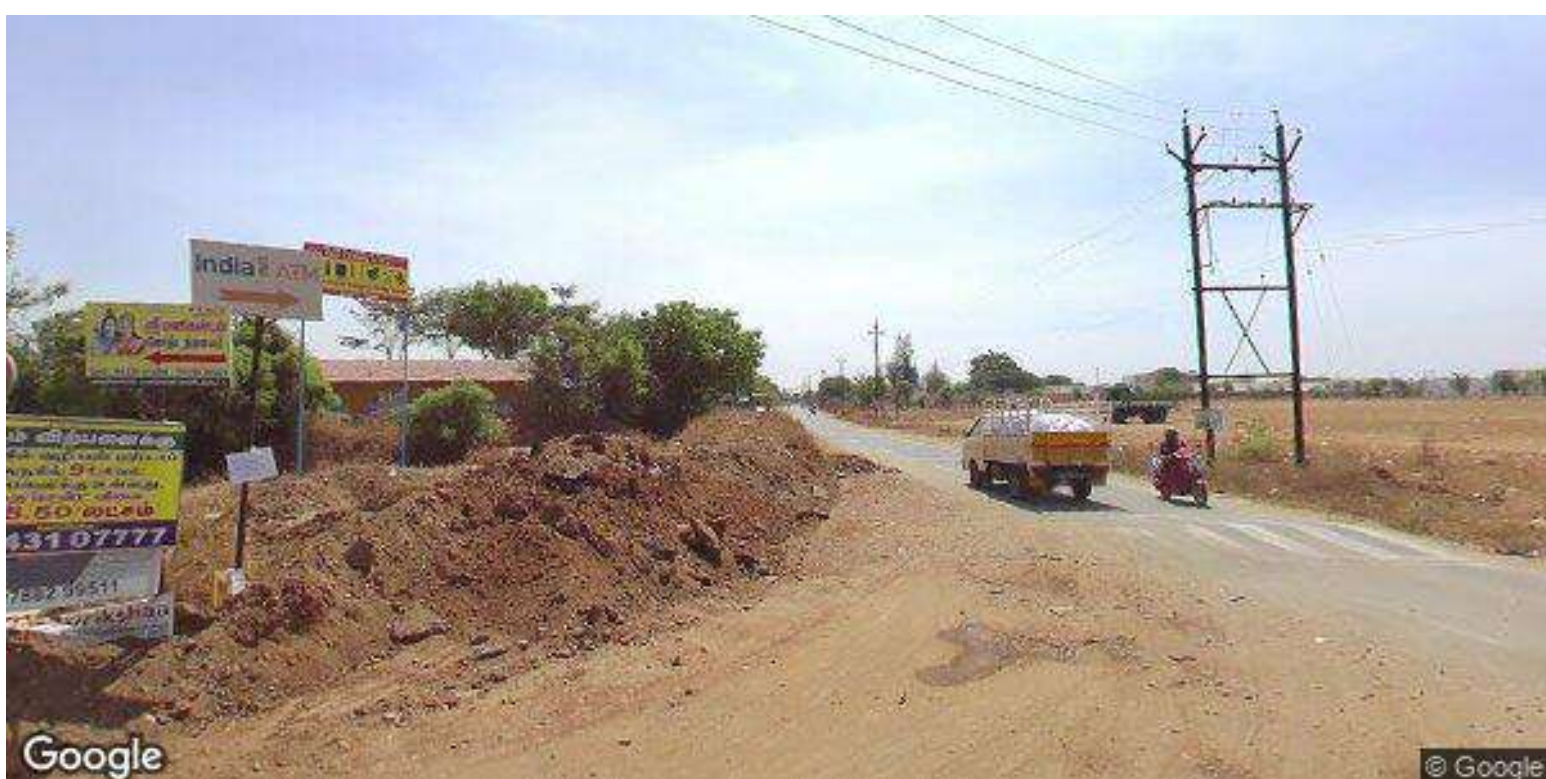
| | Risk Type | Risk Level | Coordinates | Speed Limit |
|---|---|---|---|---|
| 56 | Blind Spot | Blind Spot | 11.06421, 77.36175 | 10 KM/Hr |

**Risk Type:** Blind Spot  
**Risk Level:** Blind Spot  
**Speed Limit:** 10 KM/Hr  
**Coordinates:** 11.06421, 77.36175
