# IndianOil

## JOURNEY RISK MANAGEMENT (JRM) STUDY

### Salem Terminal to SESHASAYEE PAPER AND BOARDS LTD-RO

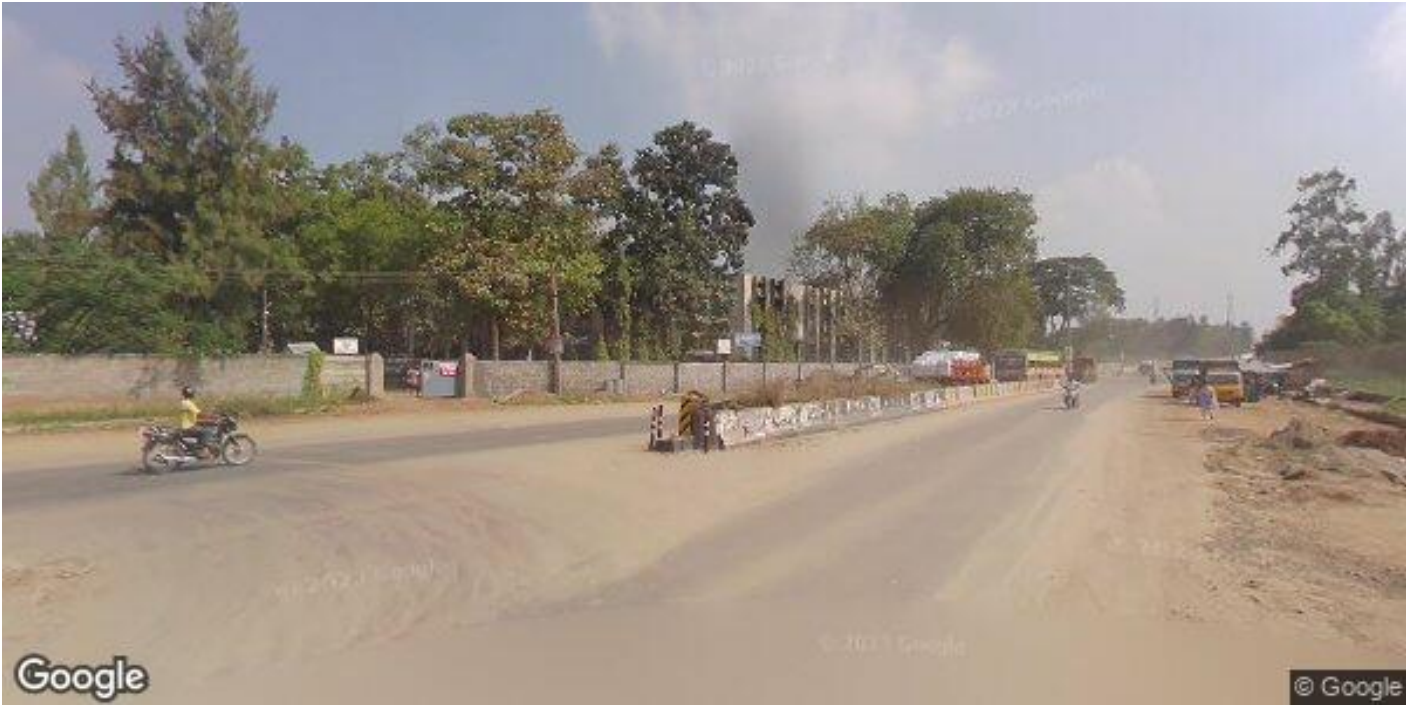
Coordinates: 11.36373, 77.78567

Risk Type: Roundabout

Risk Level: High

Speed Limit: 15 KM/Hr

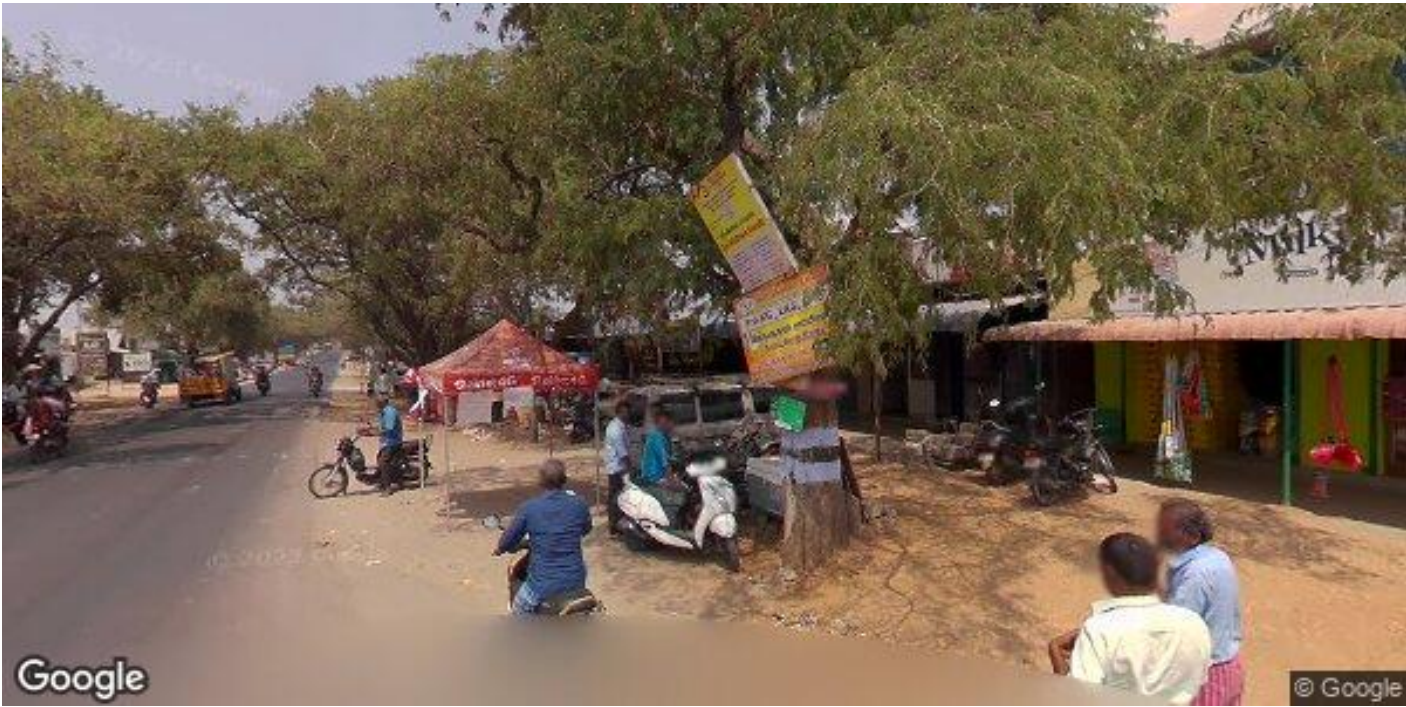
**Risk Type:** Blind Spot  
**Risk Level:** Blind Spot  
**Speed Limit:** 10 KM/Hr  
**Coordinates:** 11.41981, 77.88078

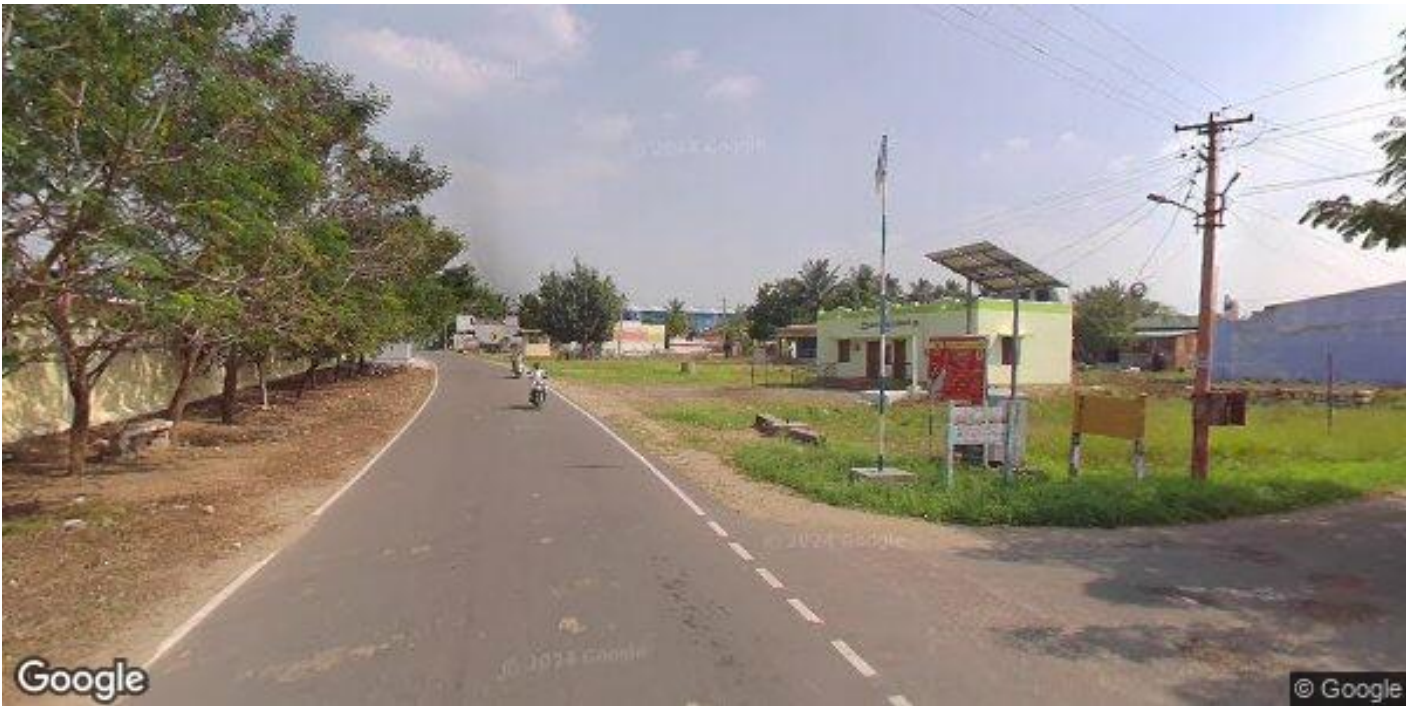
**Risk Type:** Blind Spot  
**Risk Level:** Blind Spot  
**Speed Limit:** 10 KM/Hr  
**Coordinates:** 11.42333, 77.87394

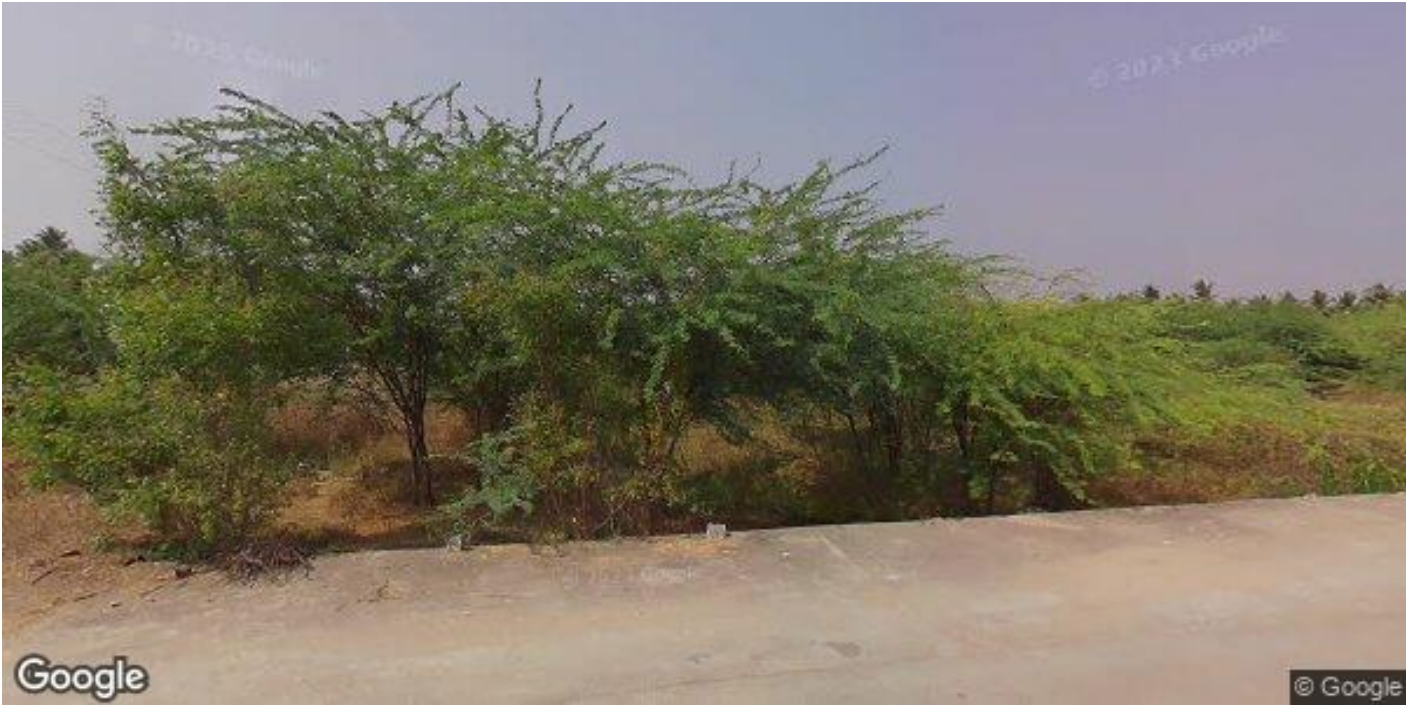
**Risk Type:** Turn  
**Risk Level:** High  
**Speed Limit:** 15 KM/Hr  
**Coordinates:** 11.41917, 77.87022

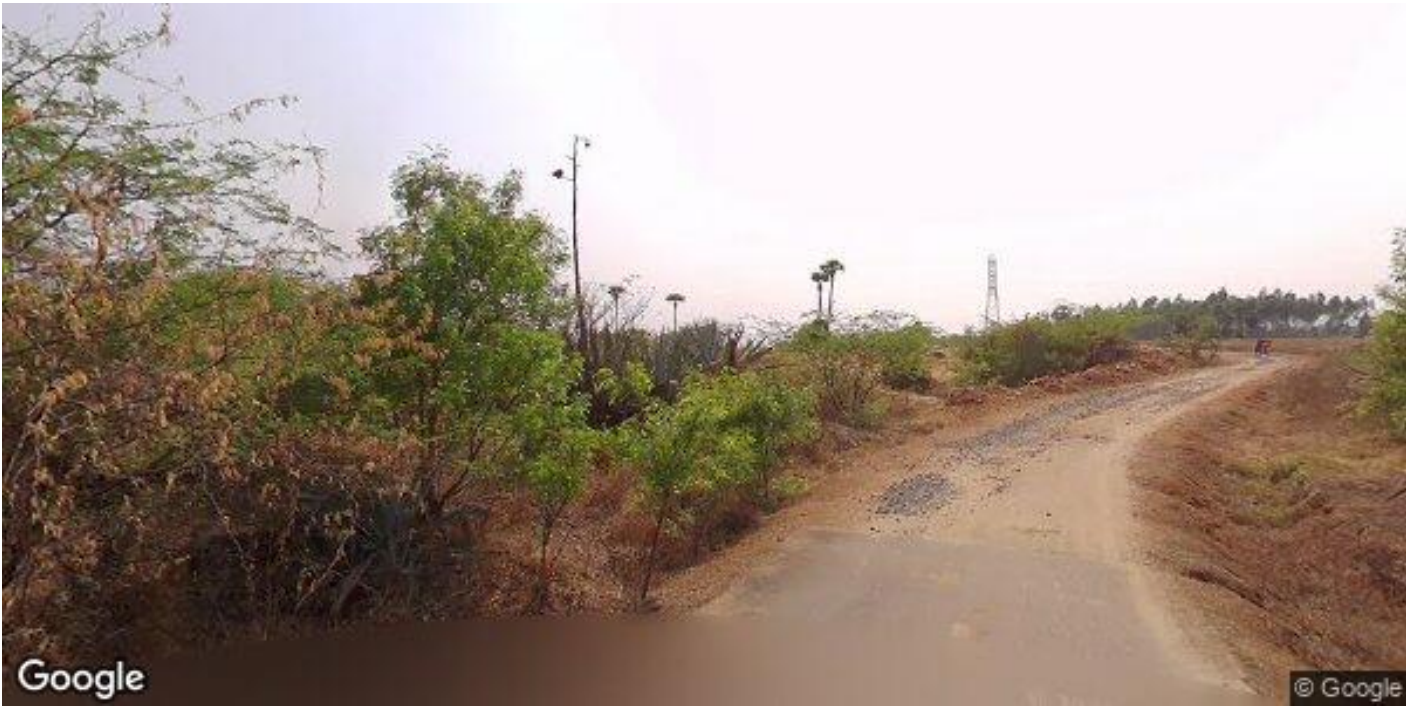
**Risk Type:** Turn  
**Risk Level:** Medium  
**Speed Limit:** 30 KM/Hr  
**Coordinates:** 11.41642, 77.86800

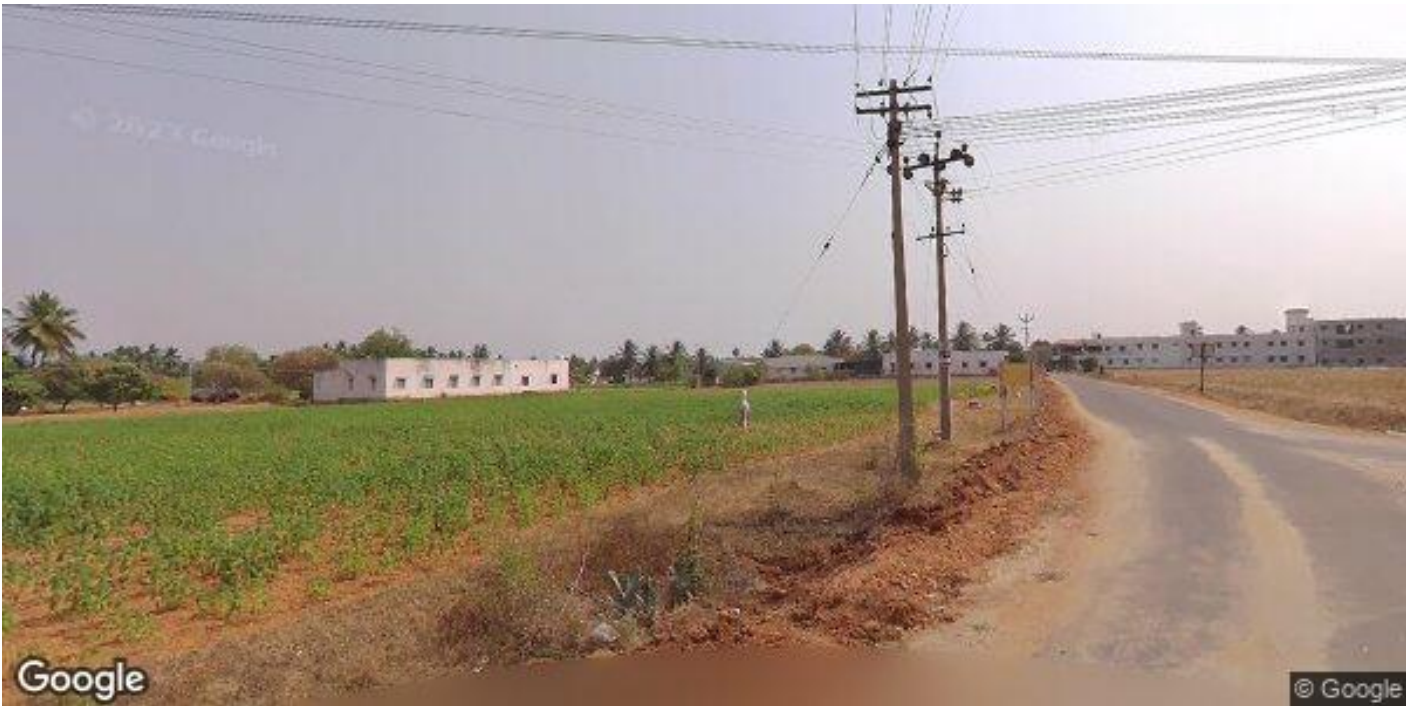
**Risk Type:** Turn  
**Risk Level:** High  
**Speed Limit:** 15 KM/Hr  
**Coordinates:** 11.40478, 77.86020

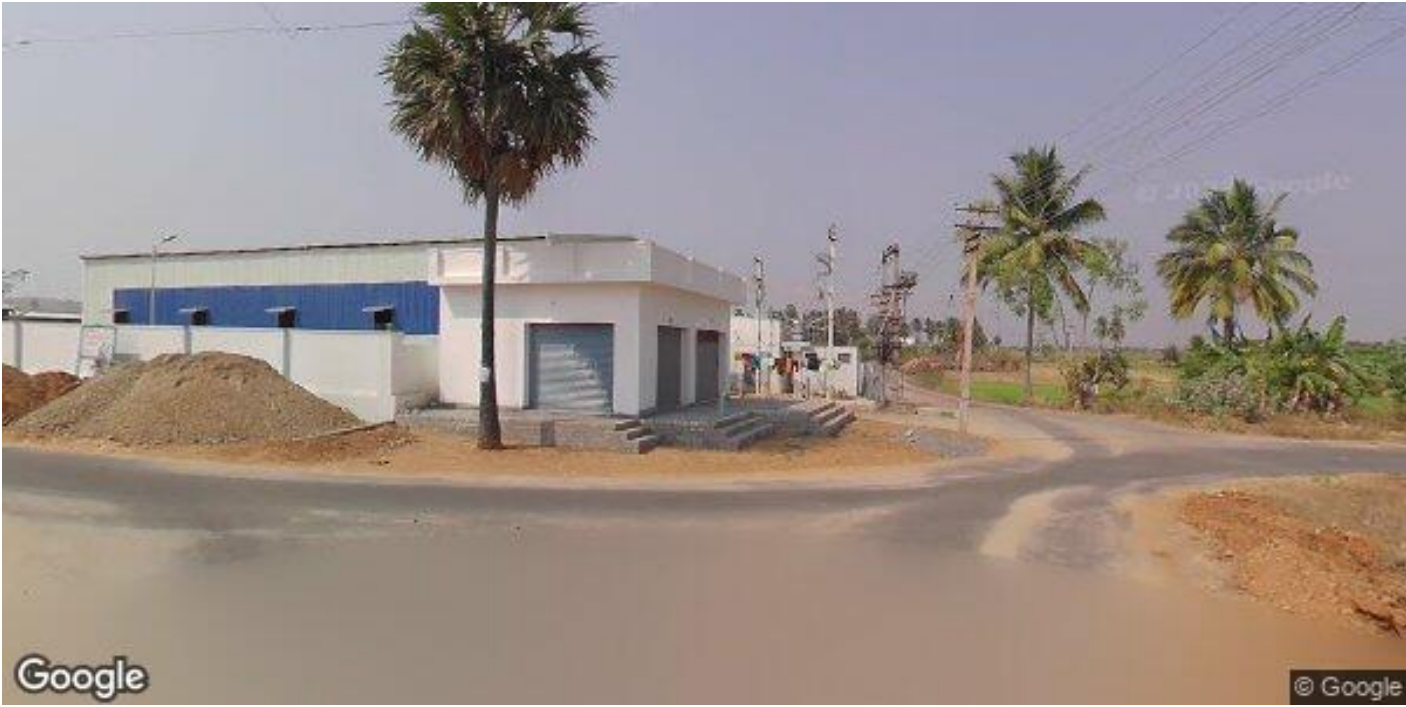
**Risk Type:** Turn  
**Risk Level:** High  
**Speed Limit:** 15 KM/Hr  
**Coordinates:** 11.40471, 77.86004

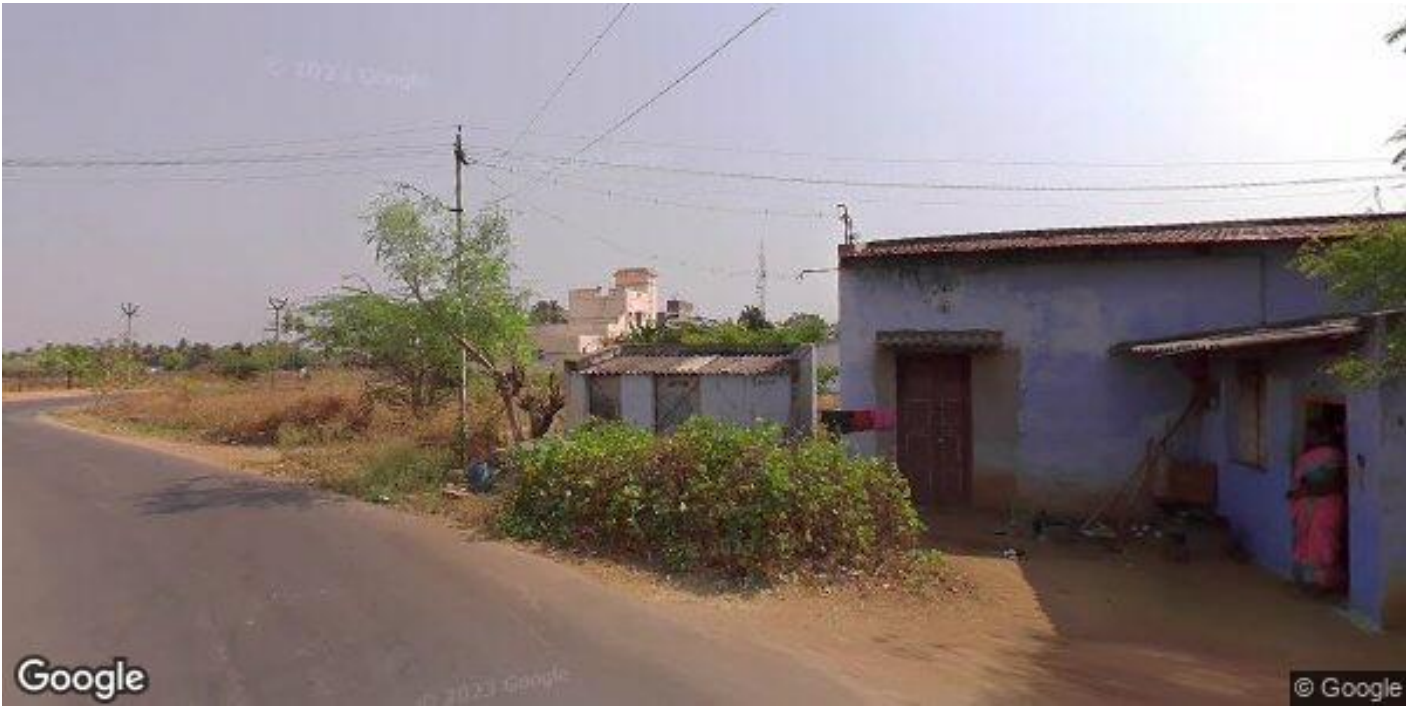
**Risk Type:** Turn  
**Risk Level:** Medium  
**Speed Limit:** 30 KM/Hr  
**Coordinates:** 11.39360, 77.85502

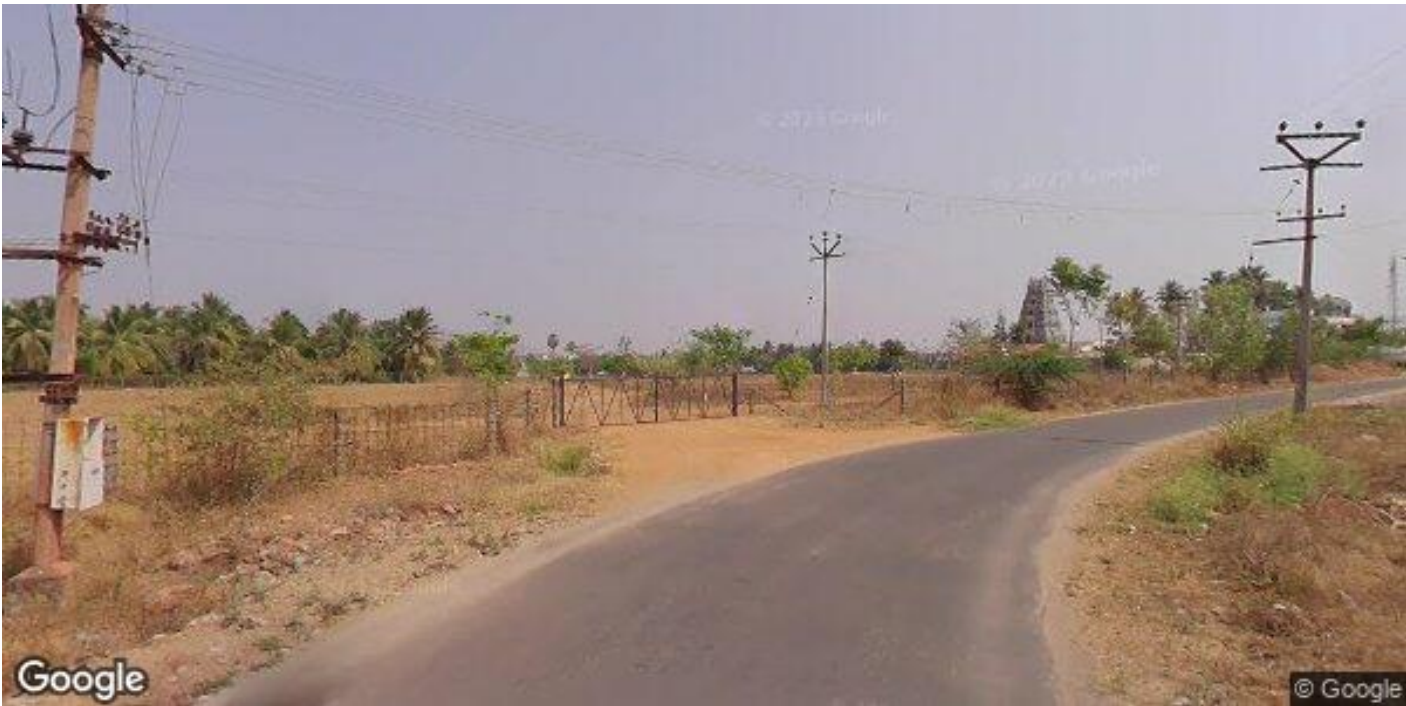
**Risk Type:** Turn  
**Risk Level:** Medium  
**Speed Limit:** 30 KM/Hr  
**Coordinates:** 11.39325, 77.85538

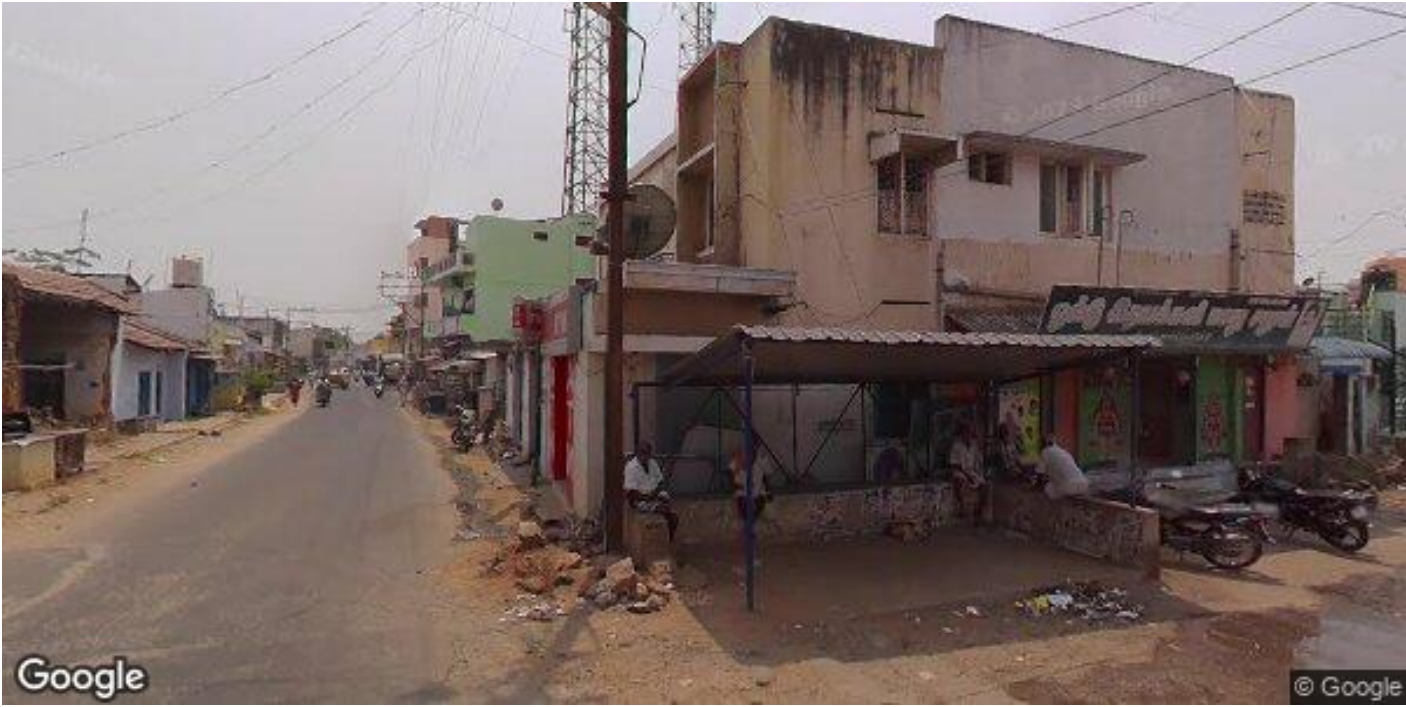
**Risk Type:** Turn  
**Risk Level:** High  
**Speed Limit:** 15 KM/Hr  
**Coordinates:** 11.39047, 77.85509

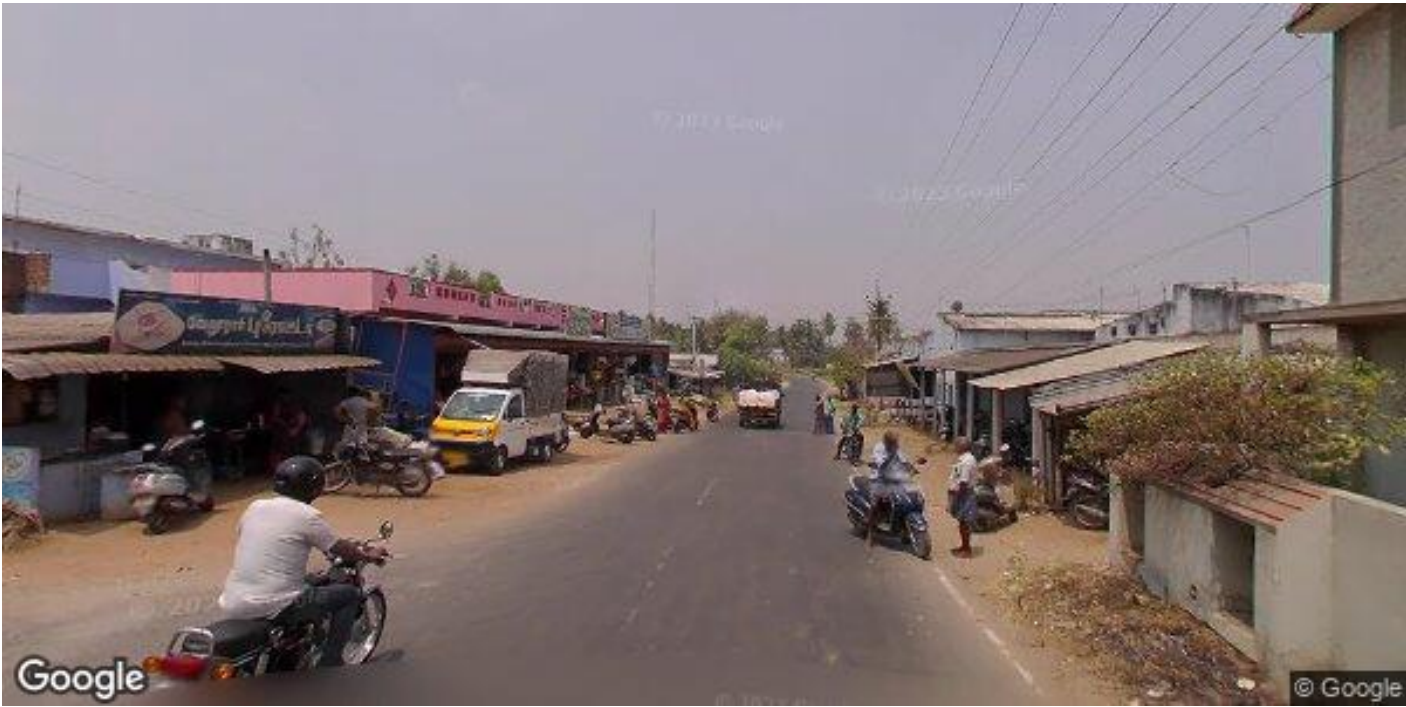
**Risk Type:** Turn  
**Risk Level:** High  
**Speed Limit:** 15 KM/Hr  
**Coordinates:** 11.39076, 77.85379

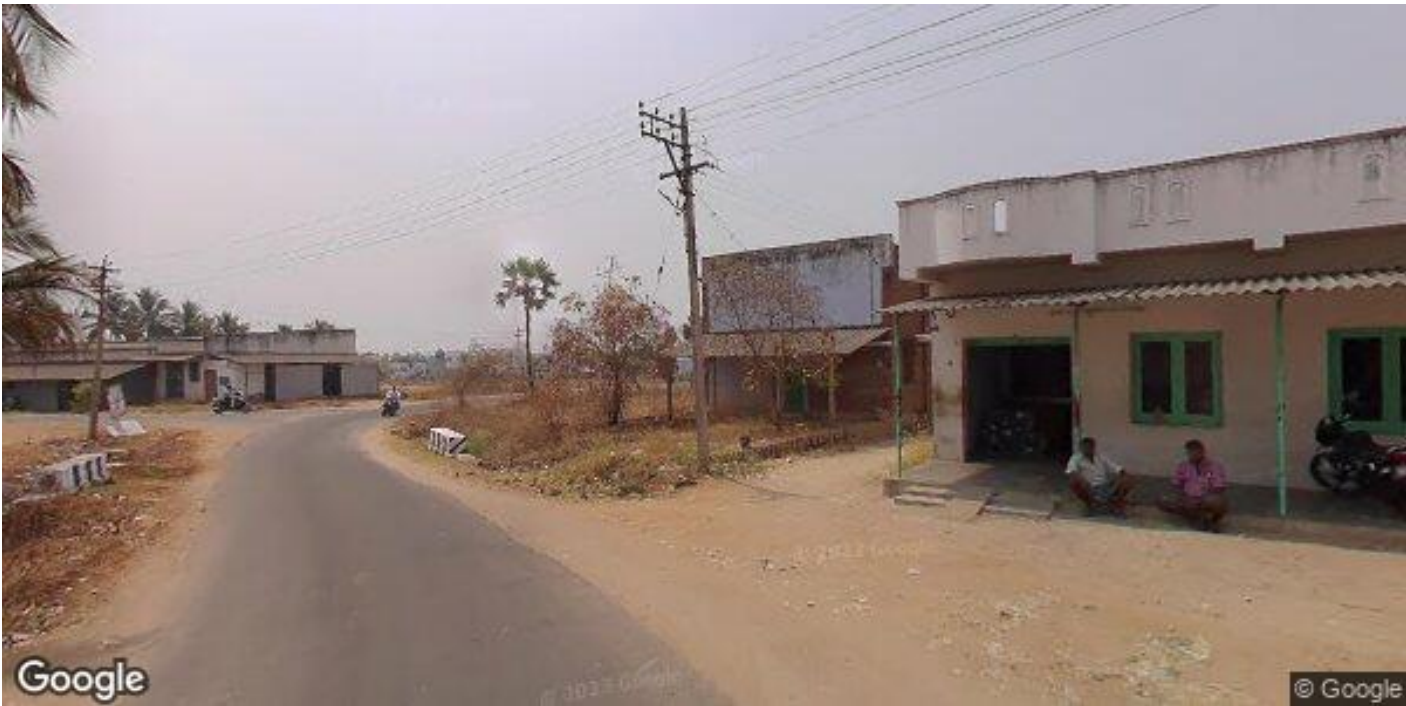
**Risk Type:** Turn  
**Risk Level:** Medium  
**Speed Limit:** 30 KM/Hr  
**Coordinates:** 11.38629, 77.85258

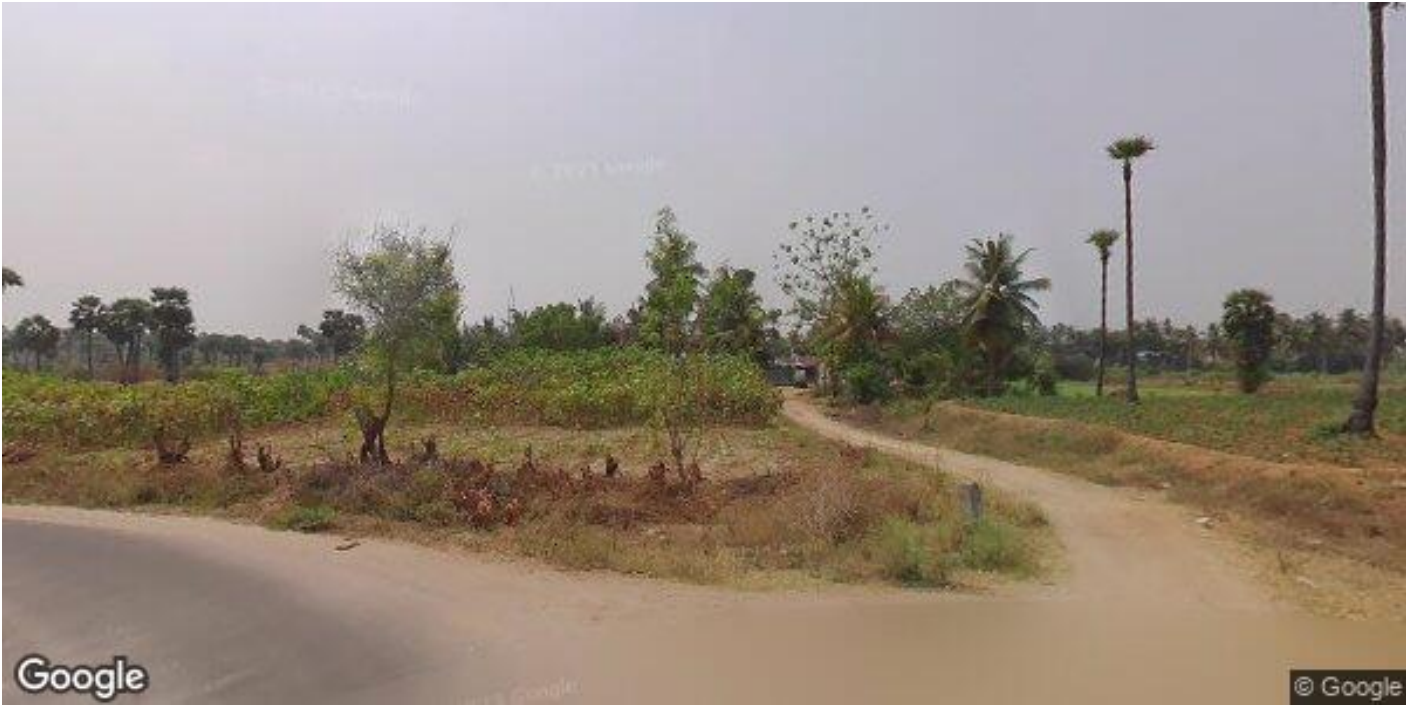
**Risk Type:** Turn  
**Risk Level:** High  
**Speed Limit:** 15 KM/Hr  
**Coordinates:** 11.38255, 77.85172

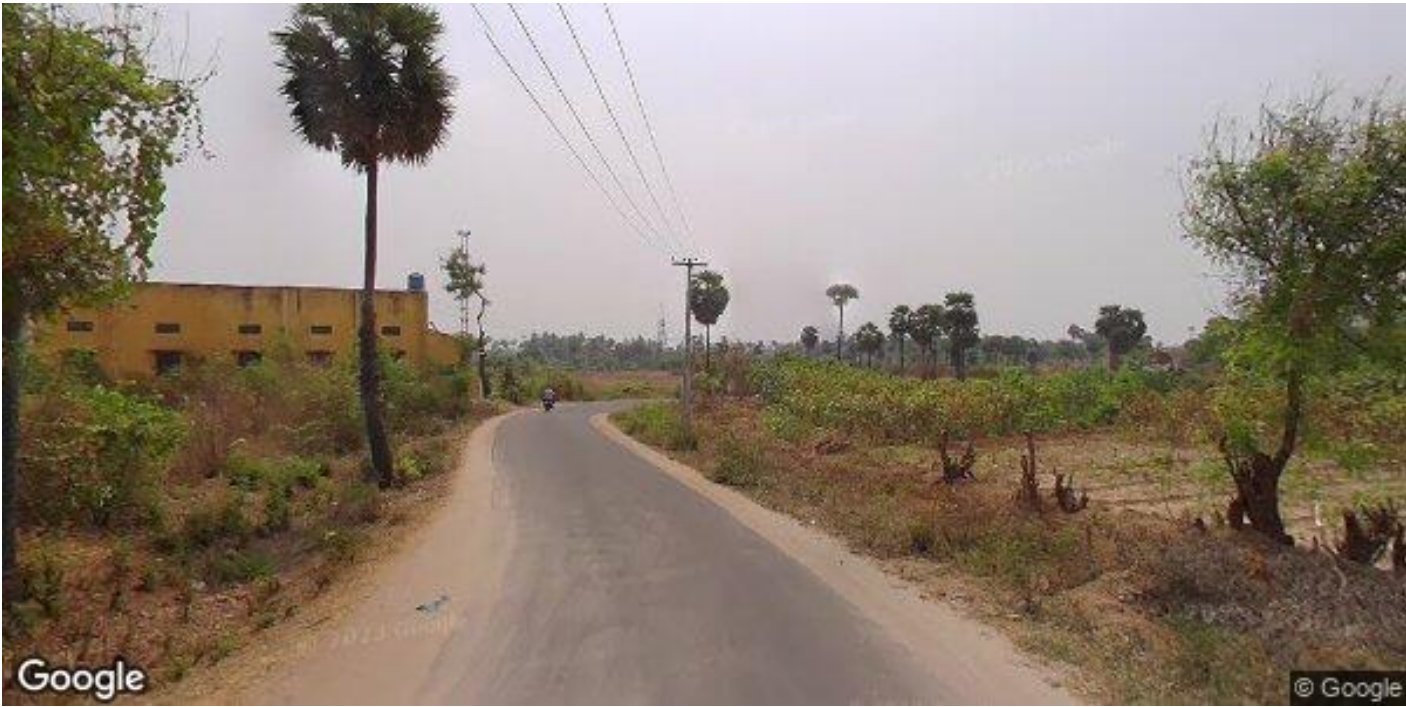
**Risk Type:** Turn  
**Risk Level:** Medium  
**Speed Limit:** 30 KM/Hr  
**Coordinates:** 11.38244, 77.85179

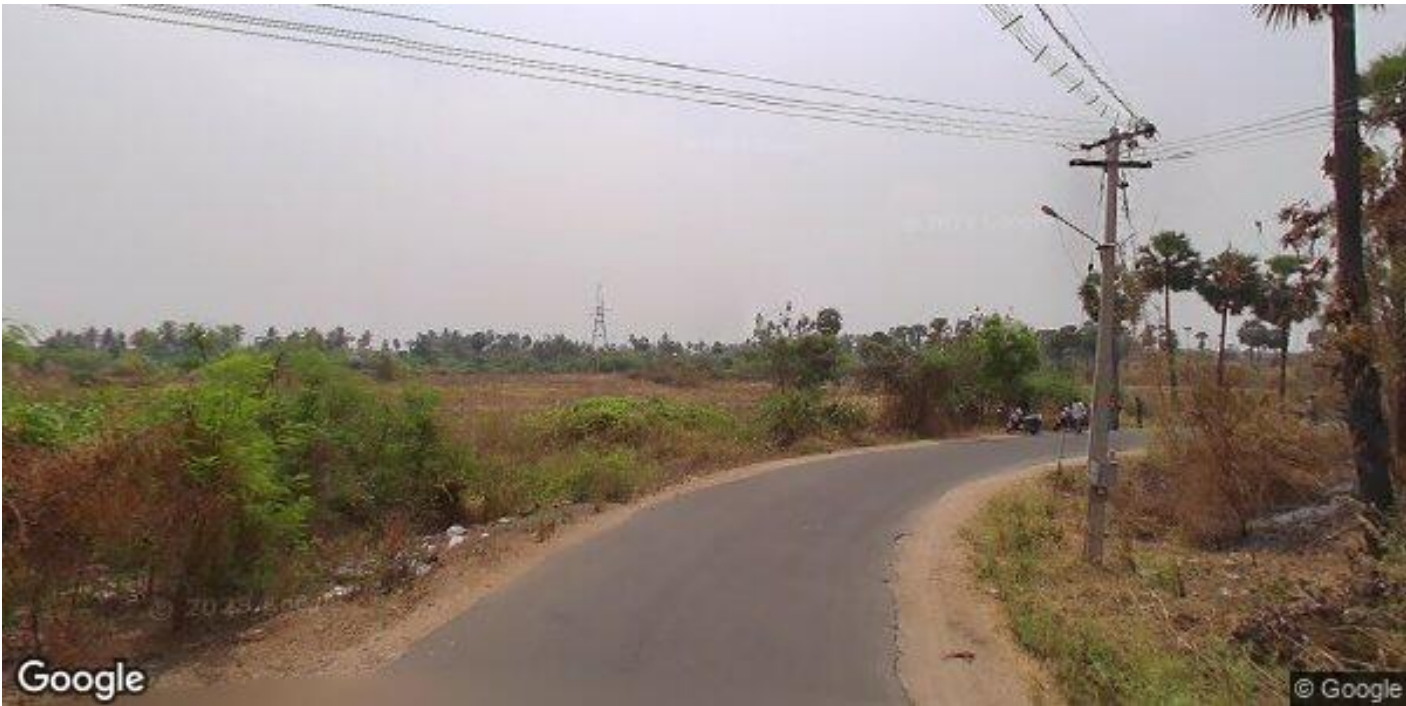
**Risk Type:** Turn  
**Risk Level:** Medium  
**Speed Limit:** 30 KM/Hr  
**Coordinates:** 11.38221, 77.85219

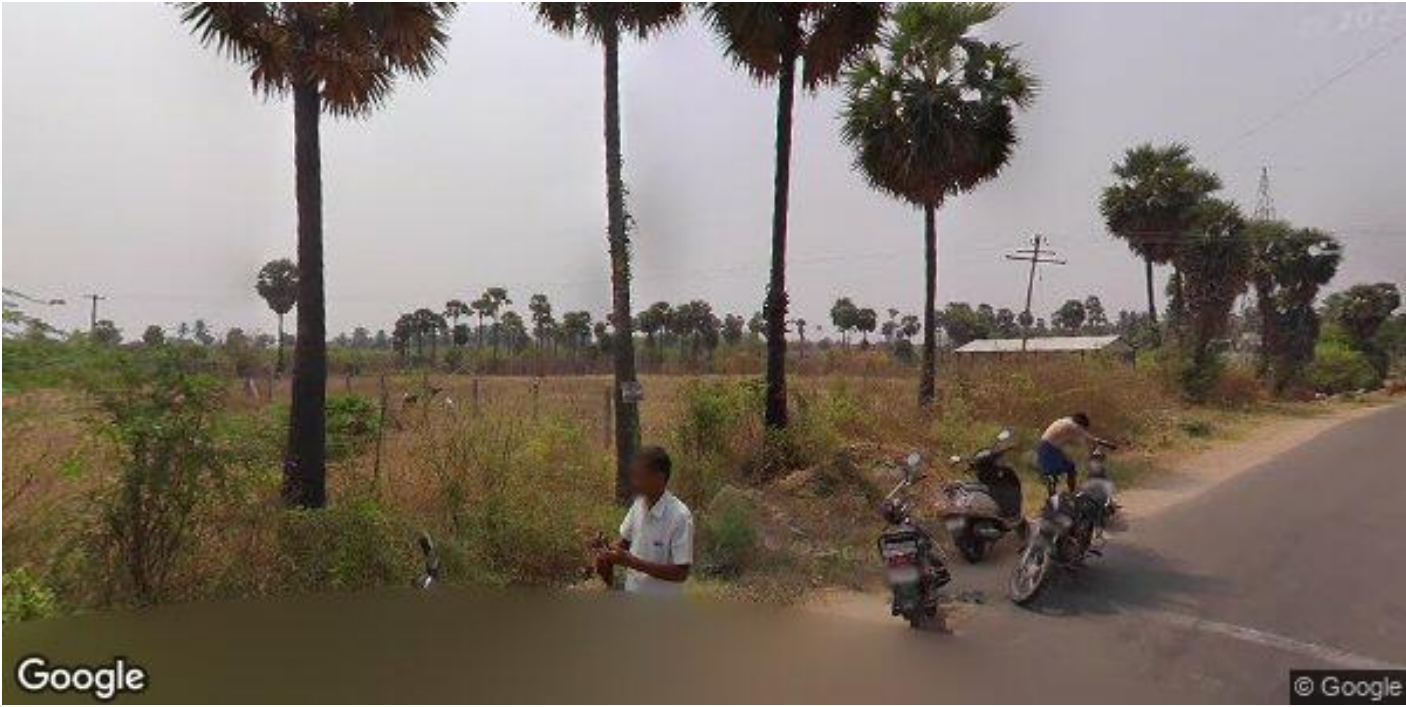
**Risk Type:** Turn  
**Risk Level:** Medium  
**Speed Limit:** 30 KM/Hr  
**Coordinates:** 11.38189, 77.85225

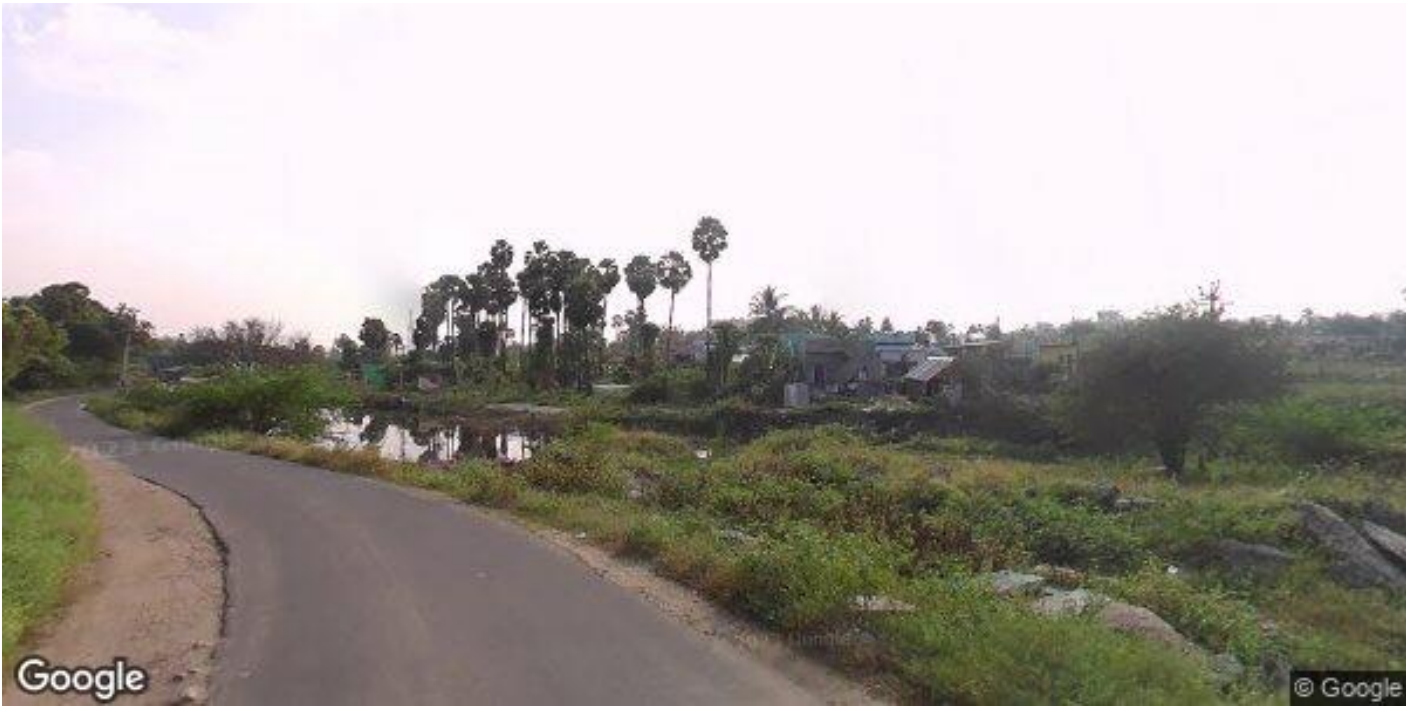
**Risk Type:** Turn  
**Risk Level:** Medium  
**Speed Limit:** 30 KM/Hr  
**Coordinates:** 11.37019, 77.84376

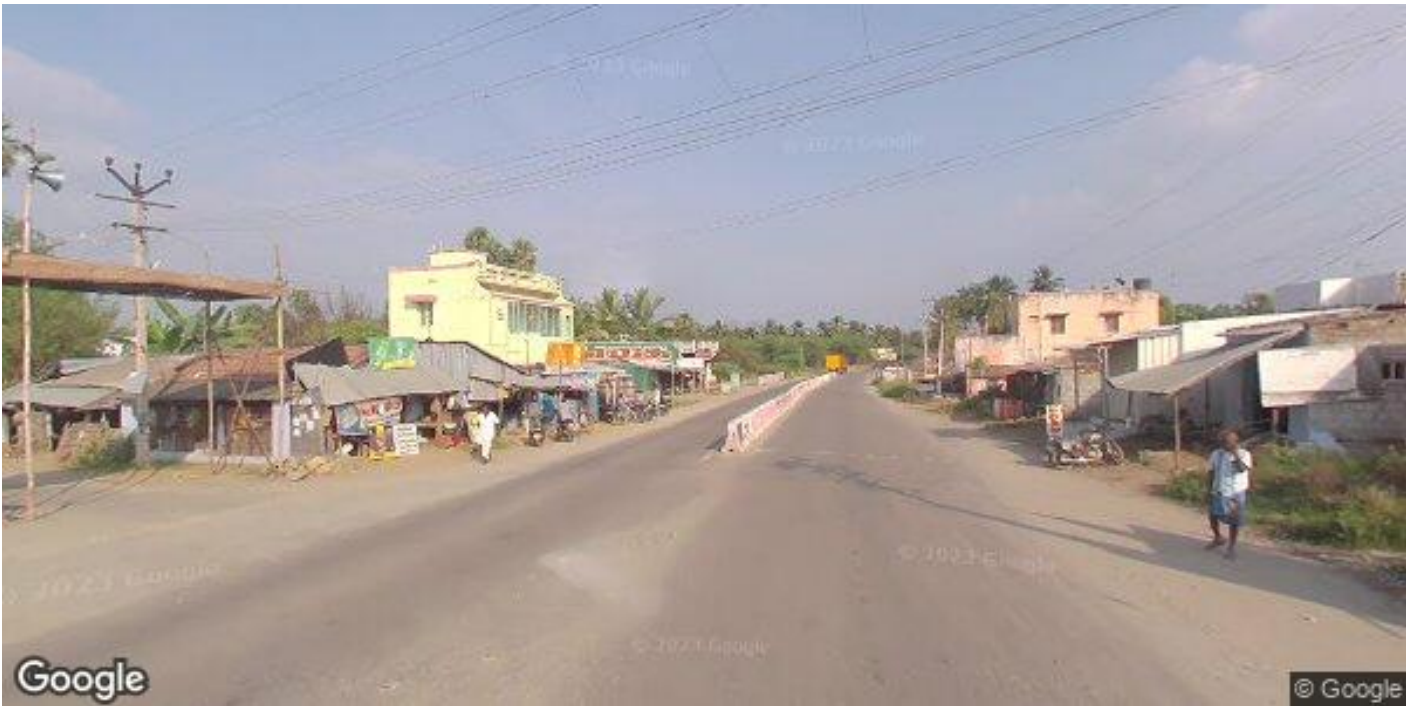
**Risk Type:** Turn  
**Risk Level:** High  
**Speed Limit:** 15 KM/Hr  
**Coordinates:** 11.36568, 77.84272

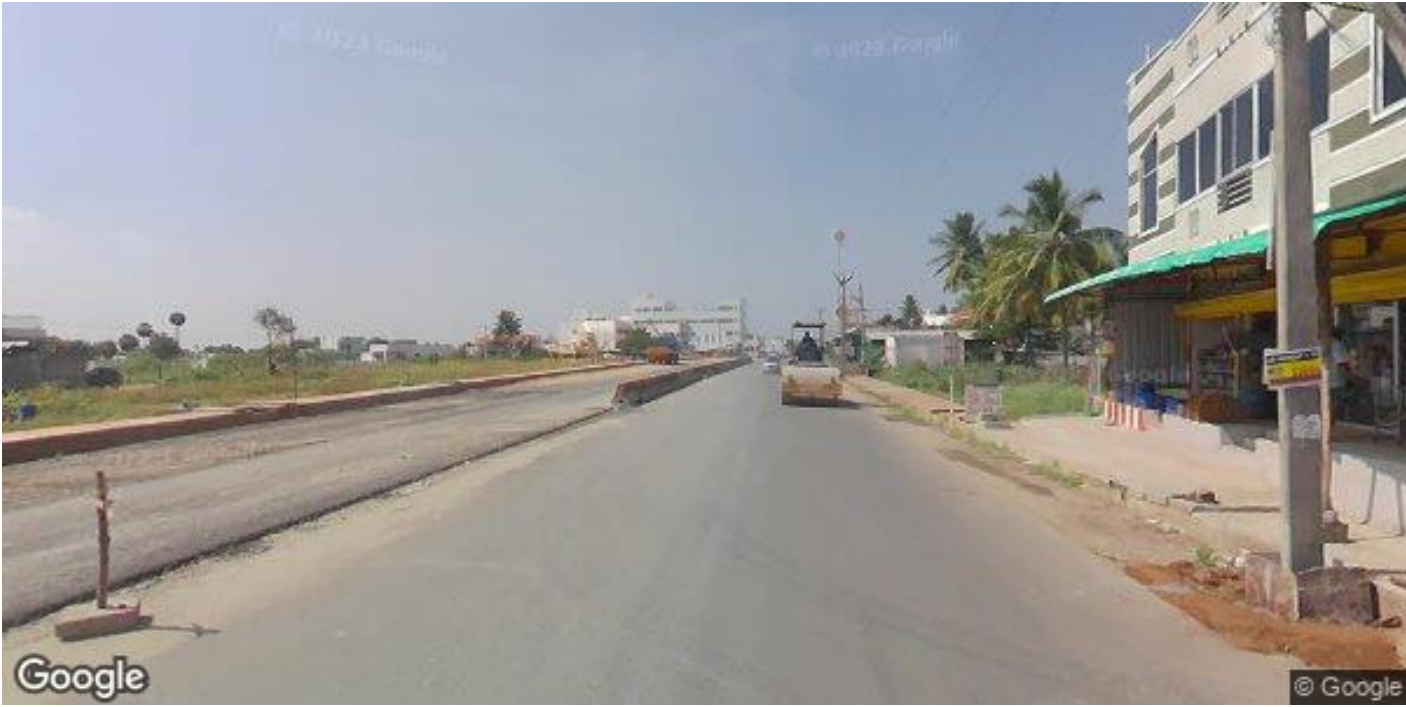
**Risk Type:** Turn  
**Risk Level:** High  
**Speed Limit:** 15 KM/Hr  
**Coordinates:** 11.36438, 77.80523

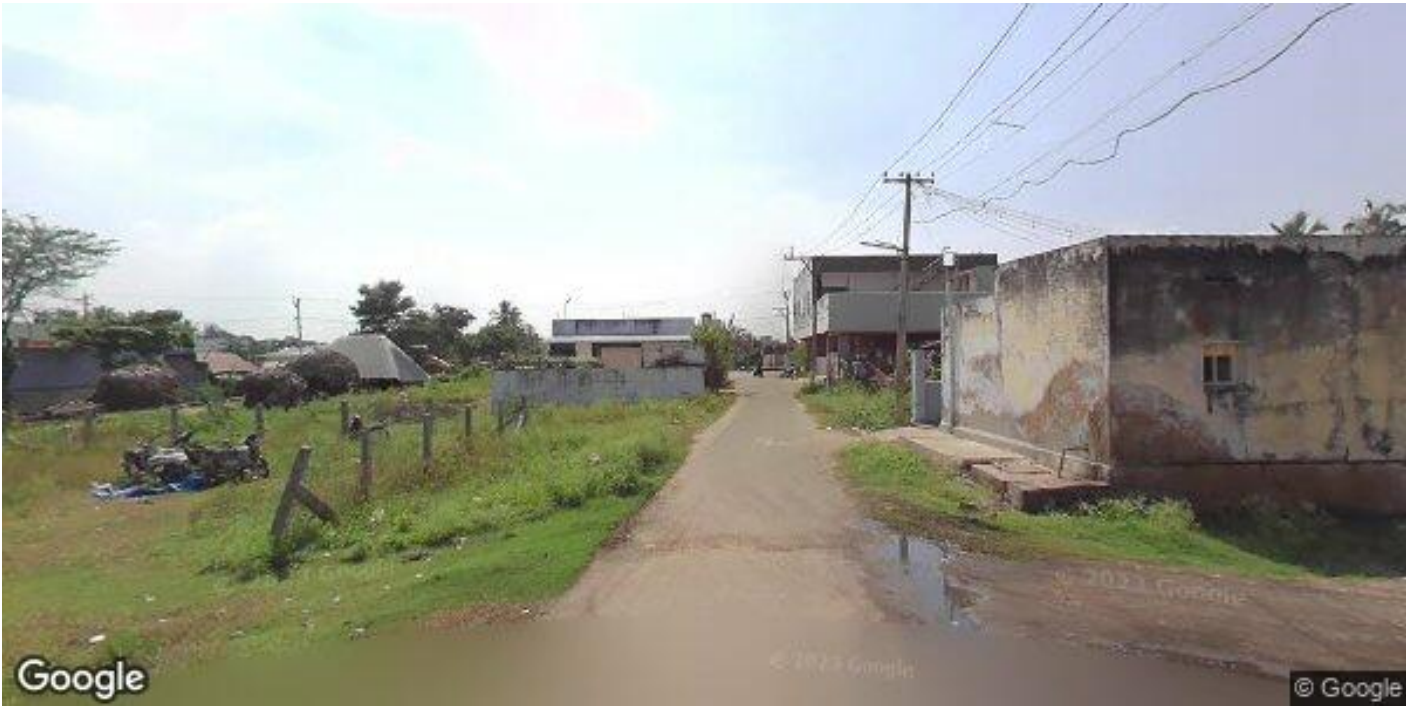
**Risk Type:** Blind Spot  
**Risk Level:** Blind Spot  
**Speed Limit:** 10 KM/Hr  
**Coordinates:** 11.36494, 77.80546
