# IndianOil

## JOURNEY RISK MANAGEMENT (JRM) STUDY

### Salem Terminal to LAKSHMI AGENCIES

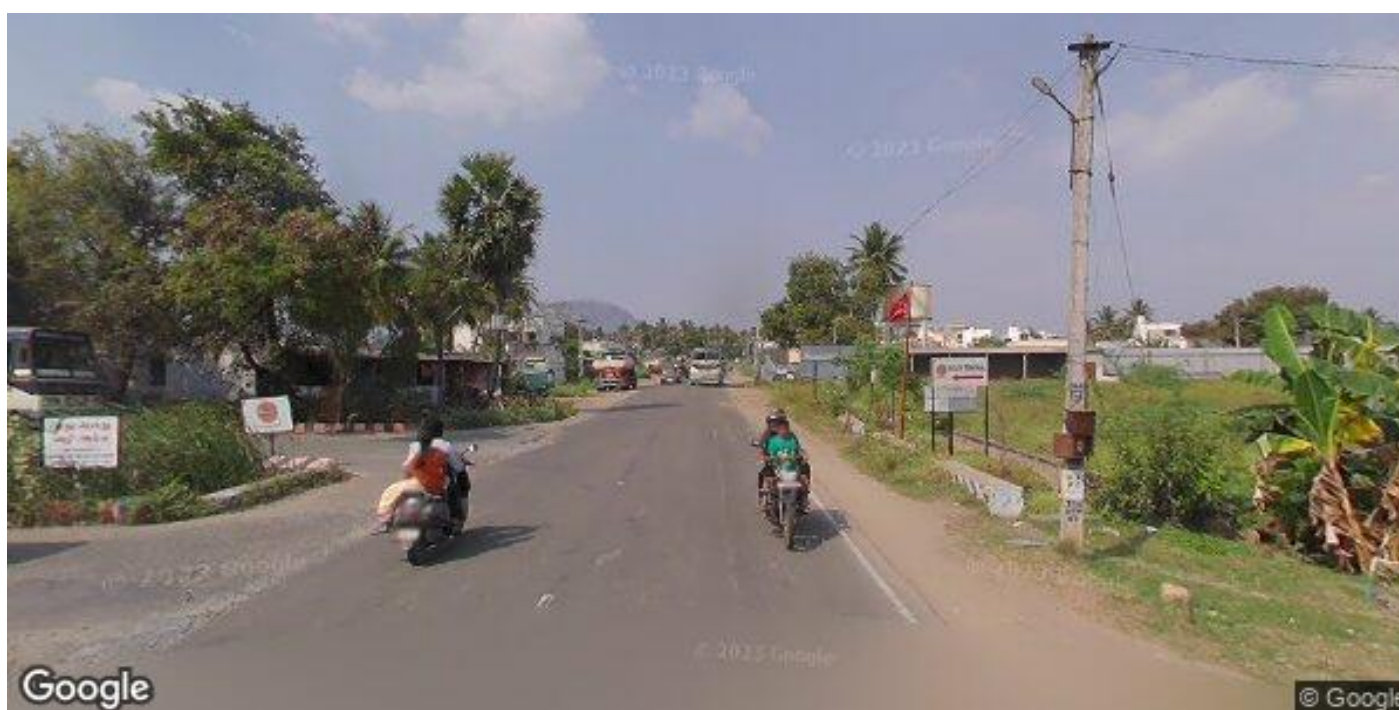
**Risk Type:** Turn  
**Risk Level:** High  
**Speed Limit:** 15 KM/Hr  
**Coordinates:** 11.44019, 77.87547

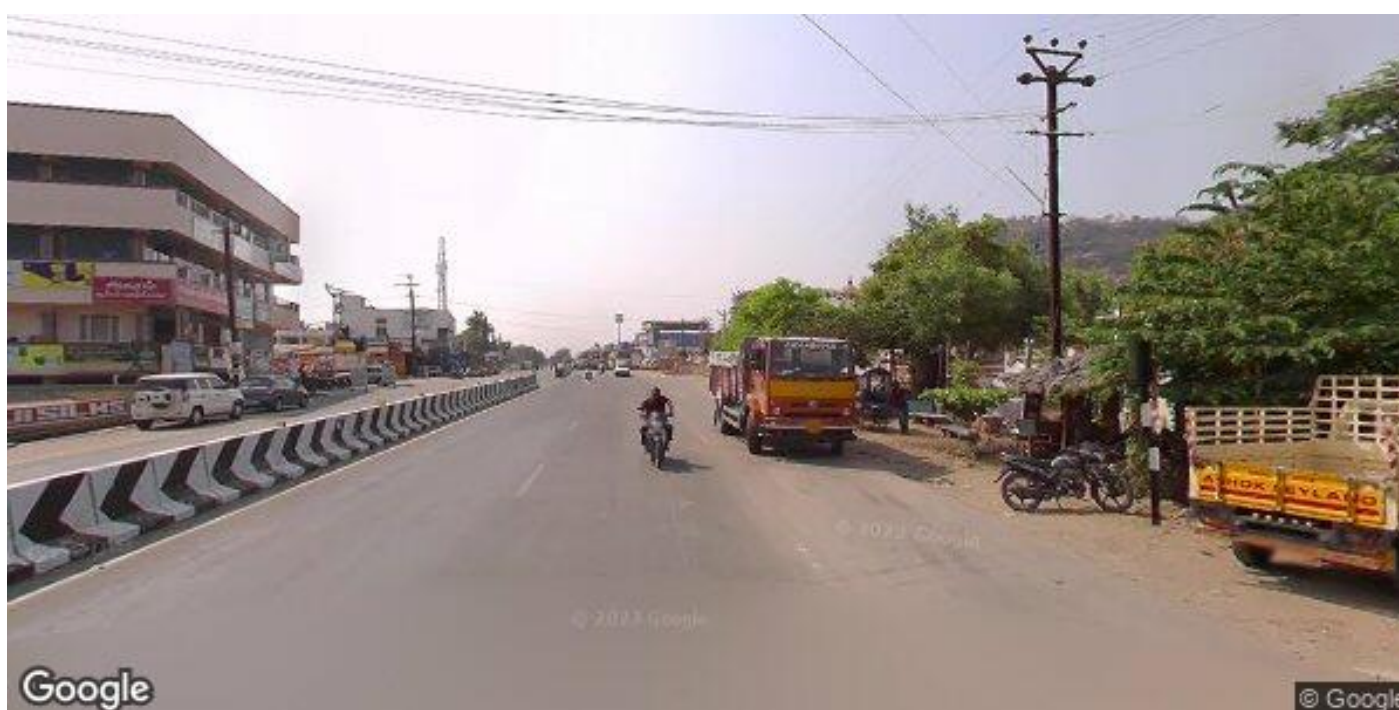
**Risk Type:** Turn  
**Risk Level:** Medium  
**Speed Limit:** 30 KM/Hr  
**Coordinates:** 11.39685, 77.88861

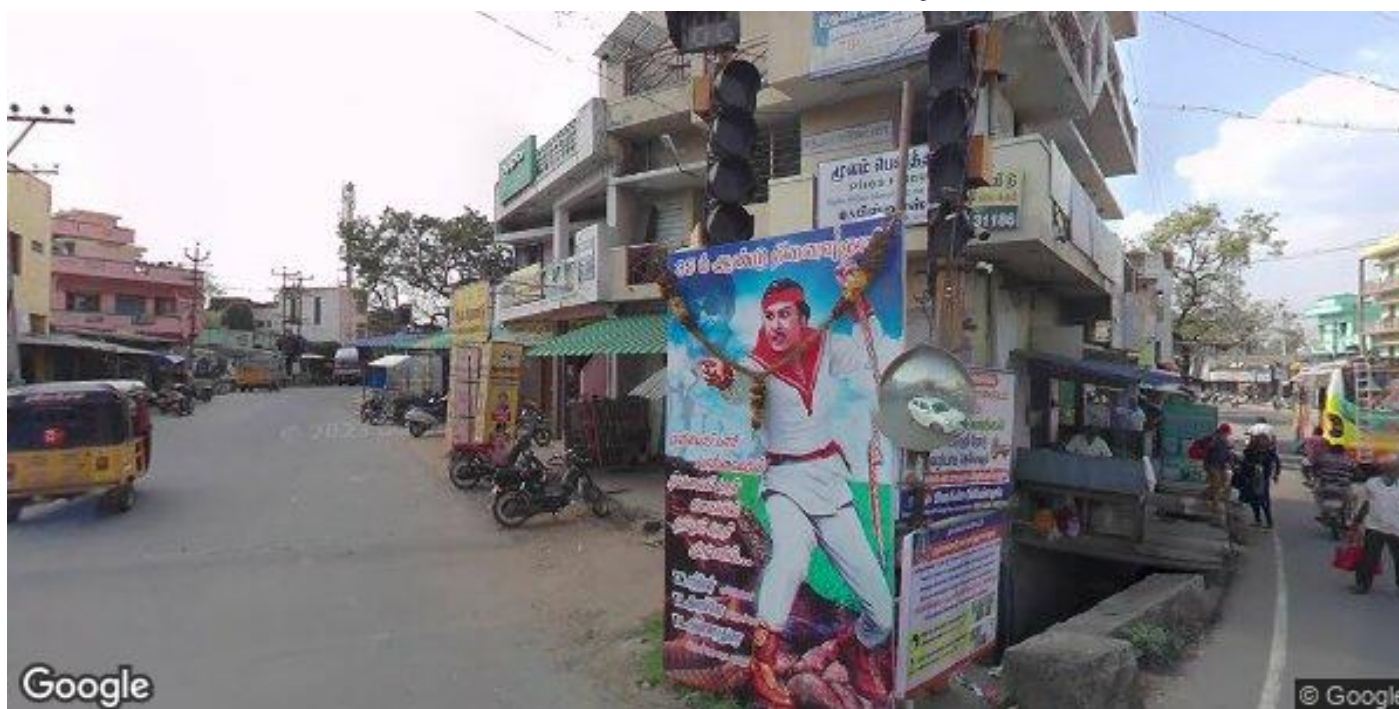
**Risk Type:** Turn  
**Risk Level:** Medium  
**Speed Limit:** 30 KM/Hr  
**Coordinates:** 11.38342, 77.89975

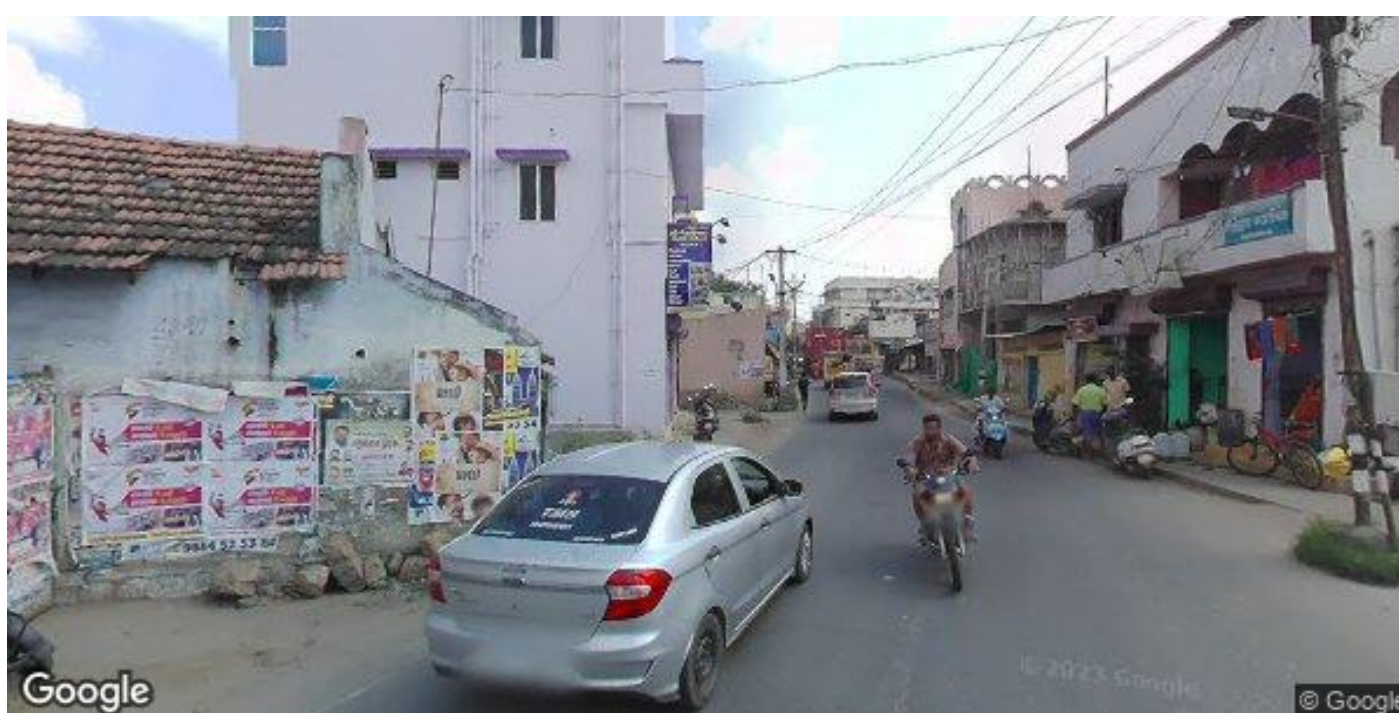
**Risk Type:** Turn  
**Risk Level:** Medium  
**Speed Limit:** 30 KM/Hr  
**Coordinates:** 11.38295, 77.90001

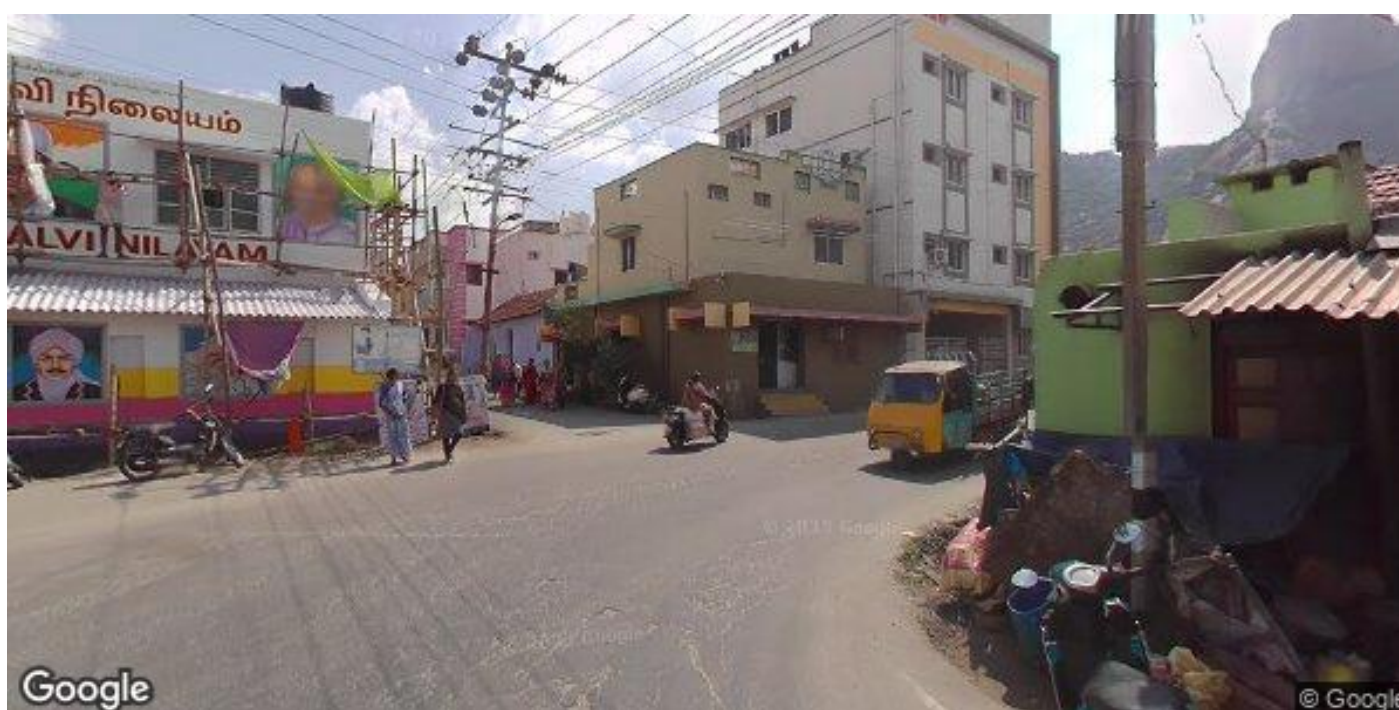
**Risk Type:** Turn  
**Risk Level:** High  
**Speed Limit:** 15 KM/Hr  
**Coordinates:** 11.38186, 77.90258

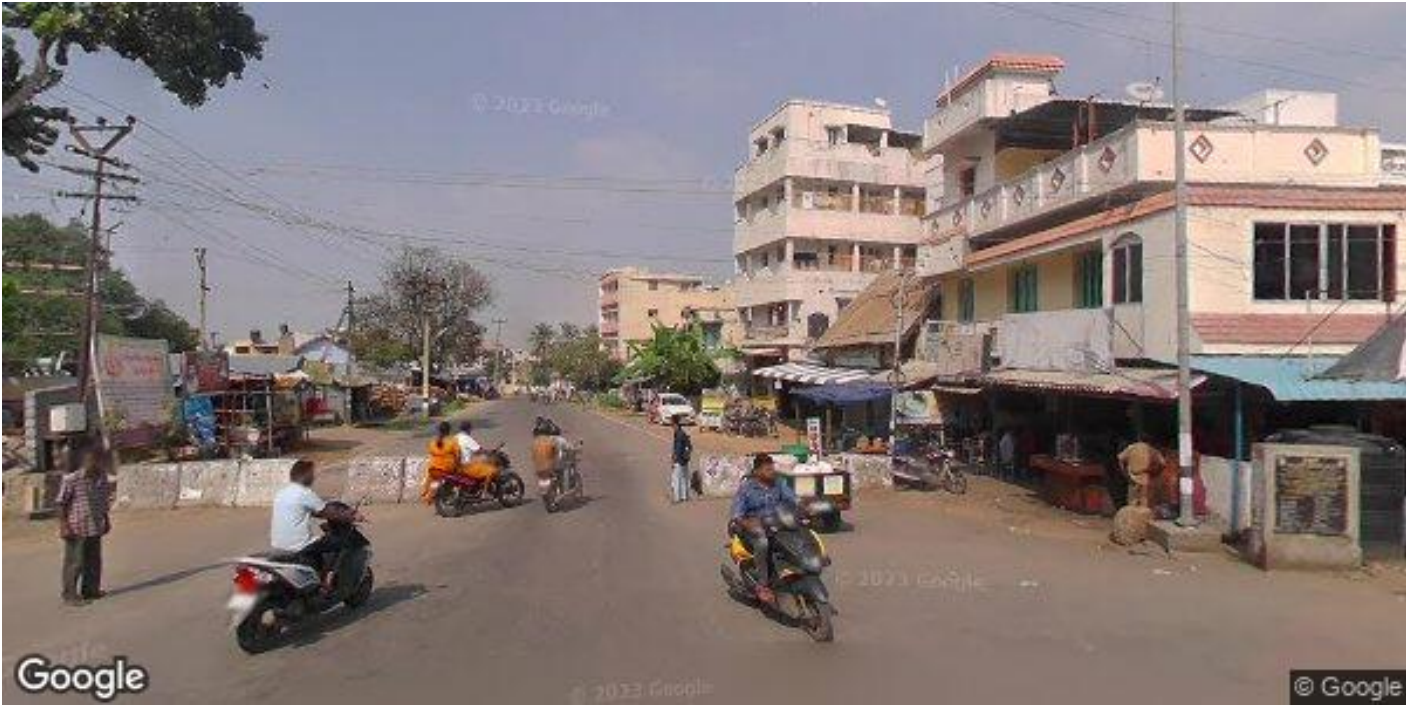
**Risk Type:** Blind Spot  
**Risk Level:** Blind Spot  
**Speed Limit:** 10 KM/Hr  
**Coordinates:** 11.37841, 77.90140

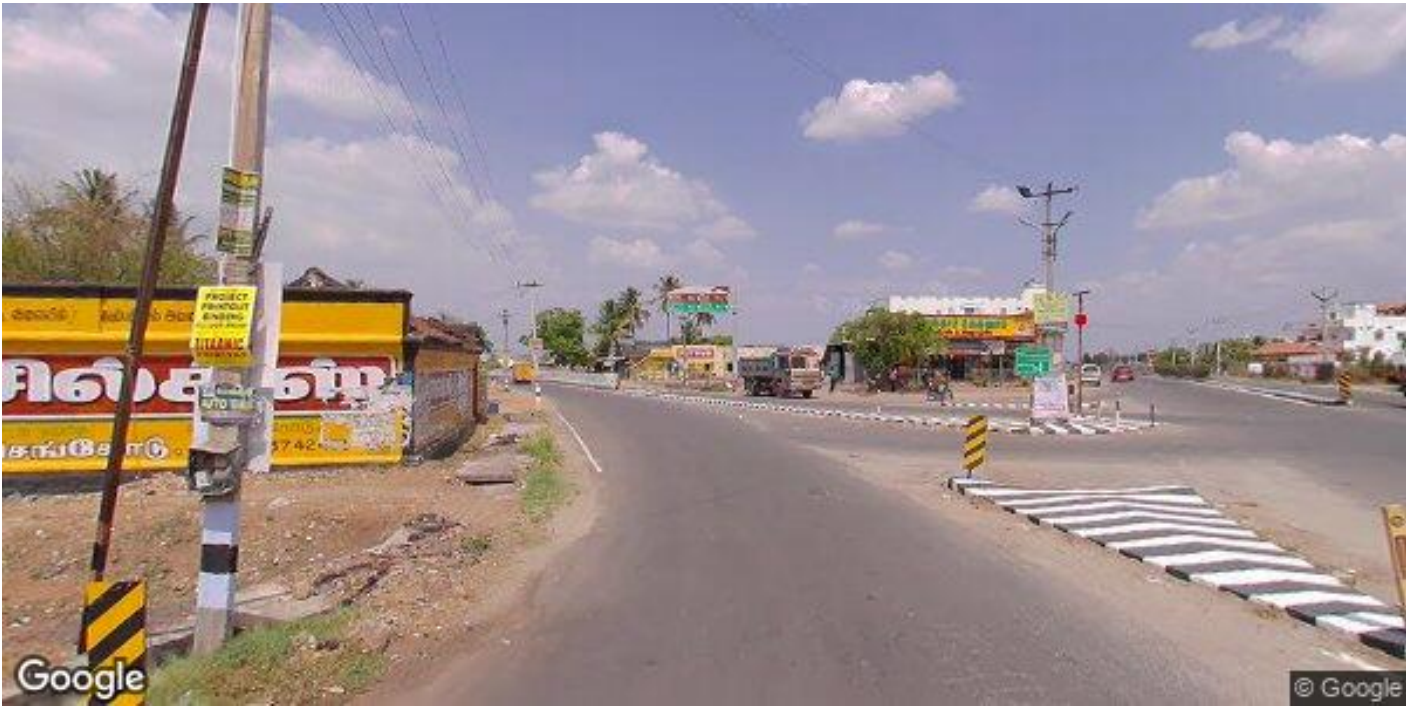
**Risk Type:** Turn  
**Risk Level:** Medium  
**Speed Limit:** 30 KM/Hr  
**Coordinates:** 11.36745, 77.93951

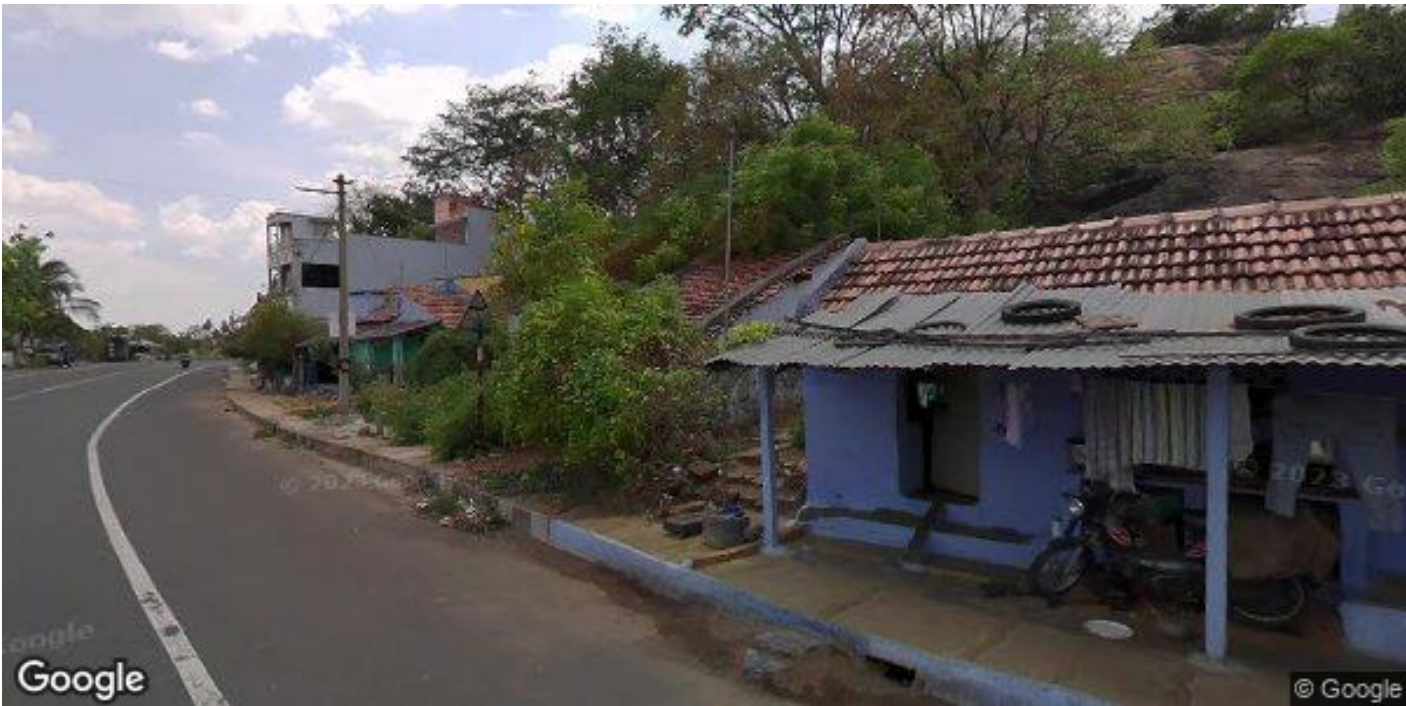
**Risk Type:** Turn  
**Risk Level:** Medium  
**Speed Limit:** 30 KM/Hr  
**Coordinates:** 11.41321, 78.08067

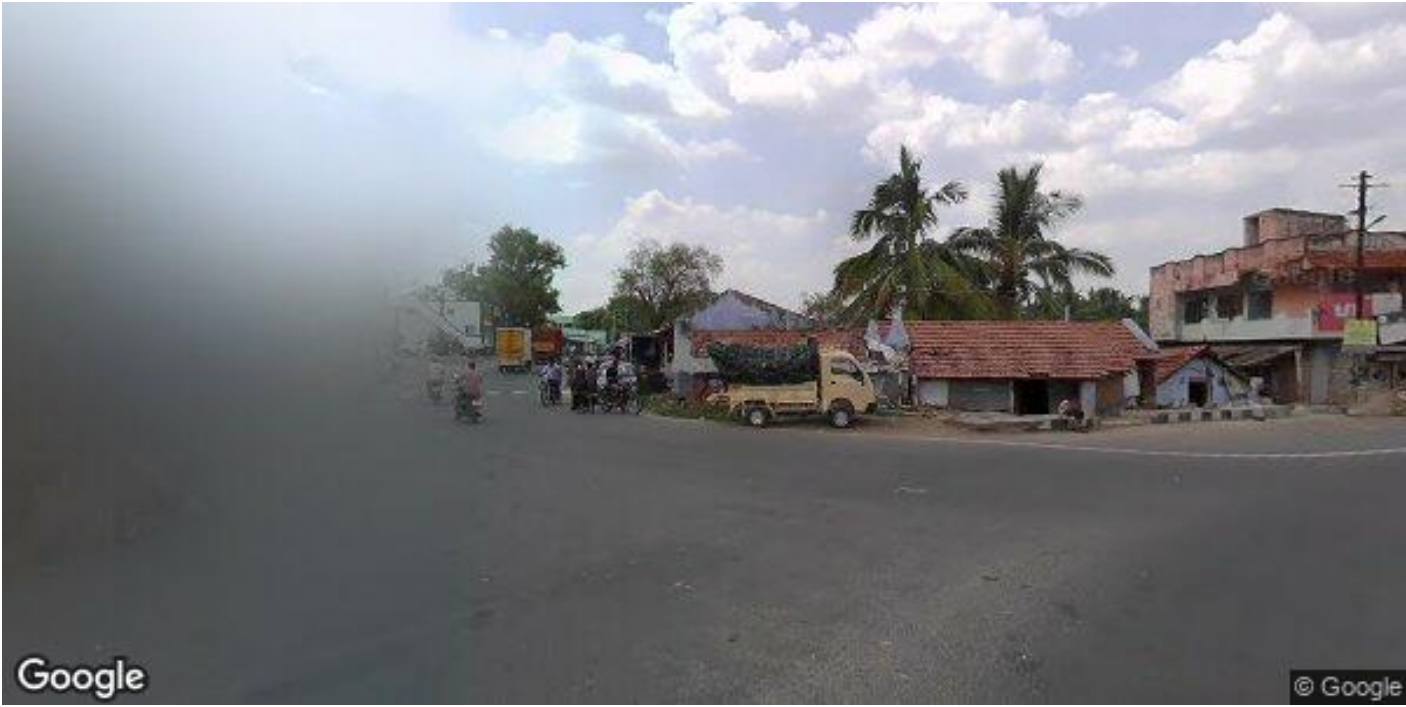
**Risk Type:** Turn  
**Risk Level:** High  
**Speed Limit:** 15 KM/Hr  
**Coordinates:** 11.41453, 78.08062

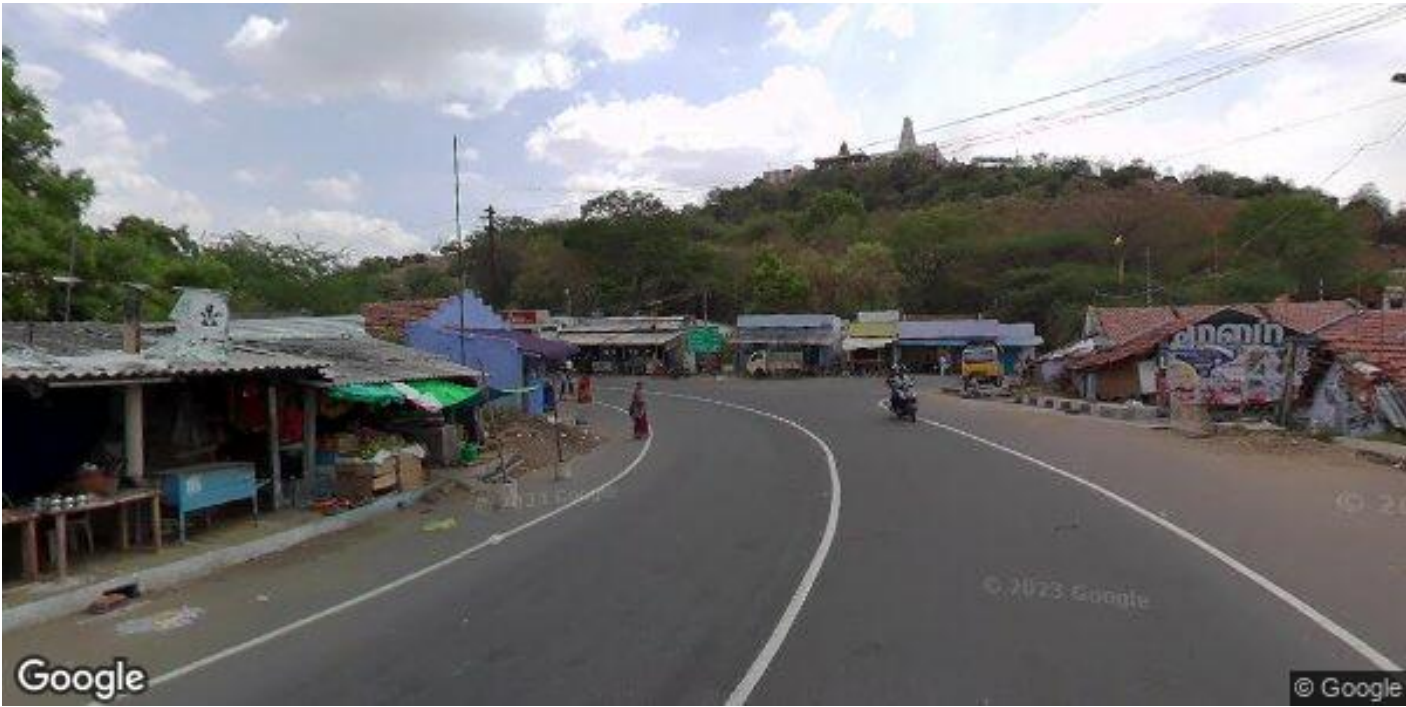
**Risk Type:** Turn  
**Risk Level:** Medium  
**Speed Limit:** 30 KM/Hr  
**Coordinates:** 11.41476, 78.08094

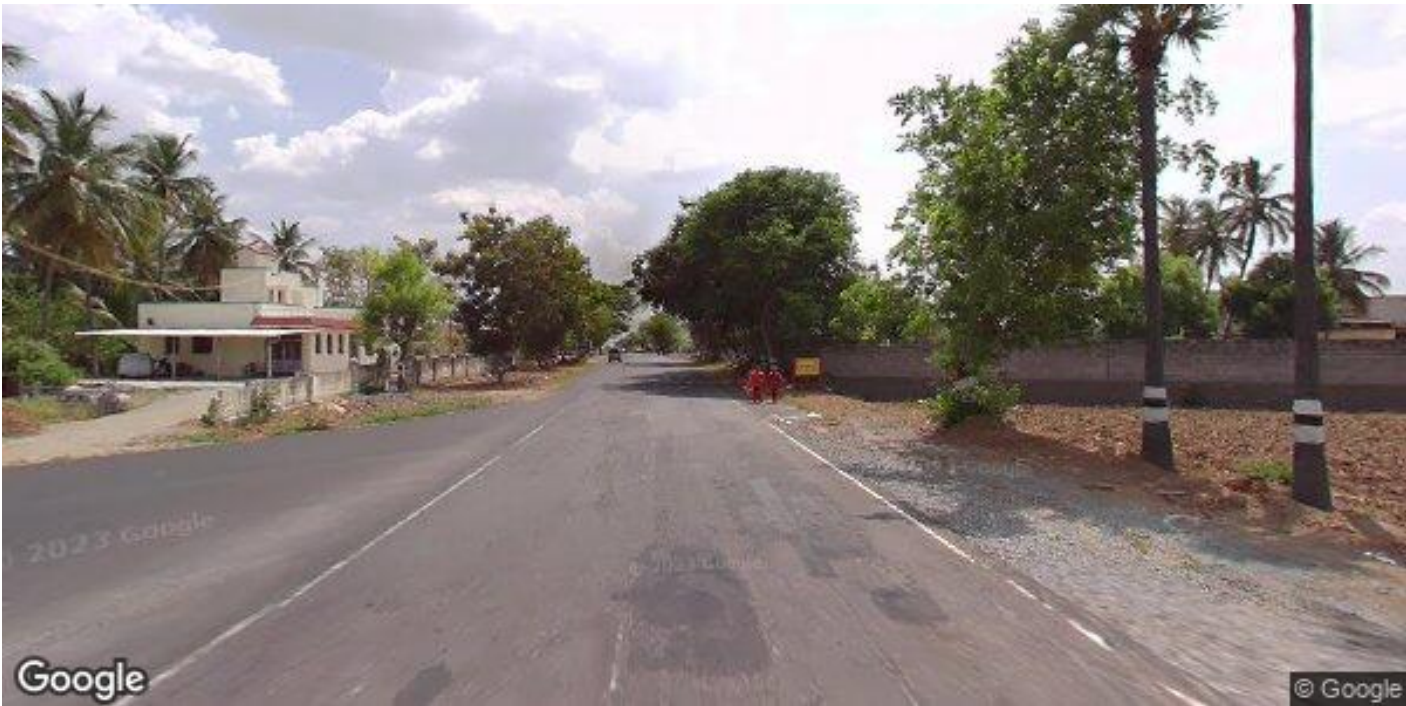
**Risk Type:** Turn  
**Risk Level:** High  
**Speed Limit:** 15 KM/Hr  
**Coordinates:** 11.42962, 78.11578

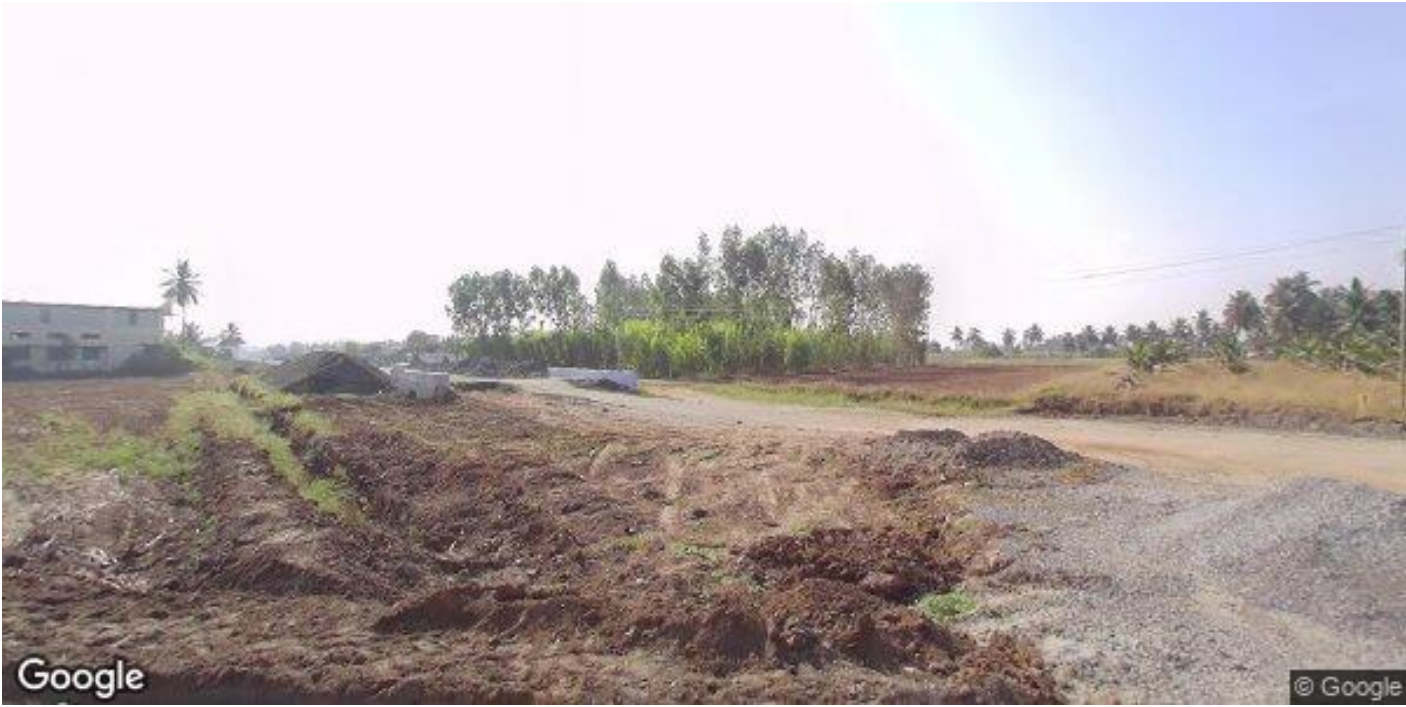
**Risk Type:** Turn  
**Risk Level:** Medium  
**Speed Limit:** 30 KM/Hr  
**Coordinates:** 11.42943, 78.11608

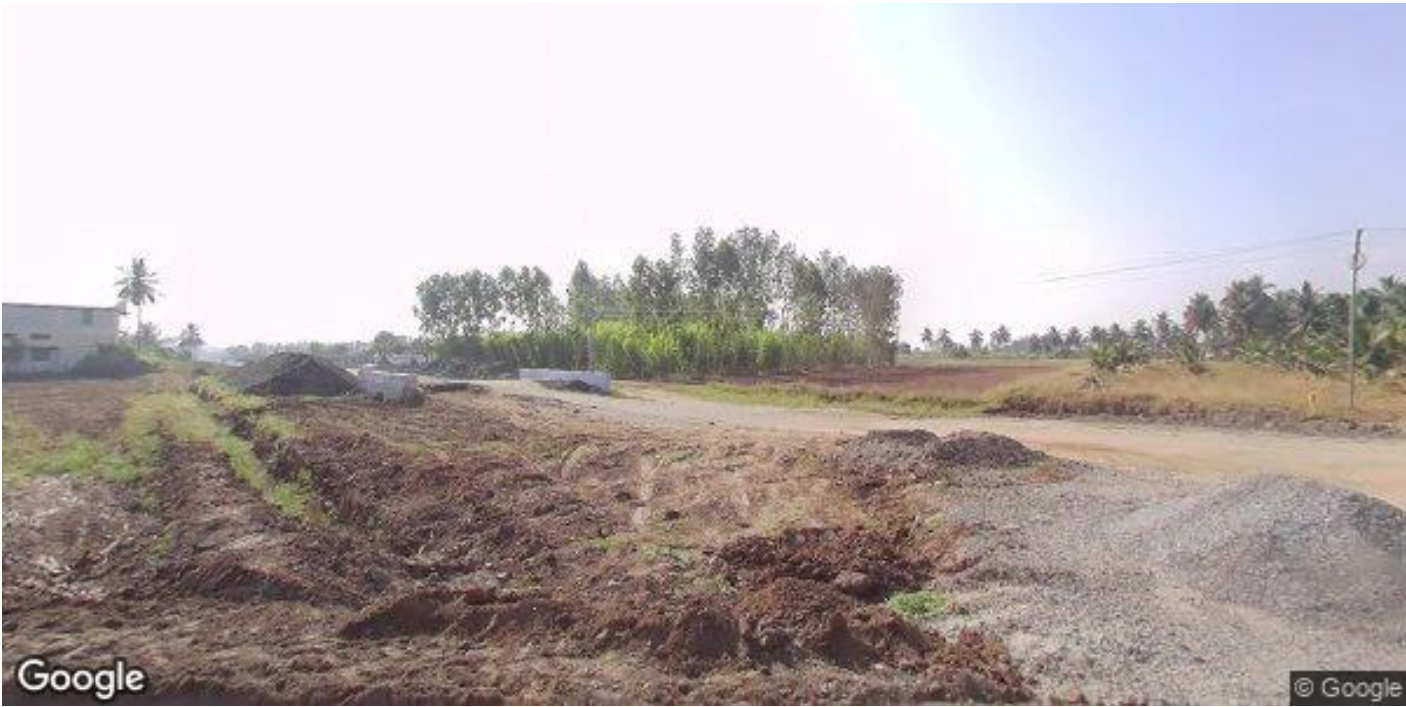
**Risk Type:** Turn  
**Risk Level:** High  
**Speed Limit:** 15 KM/Hr  
**Coordinates:** 11.42938, 78.11609

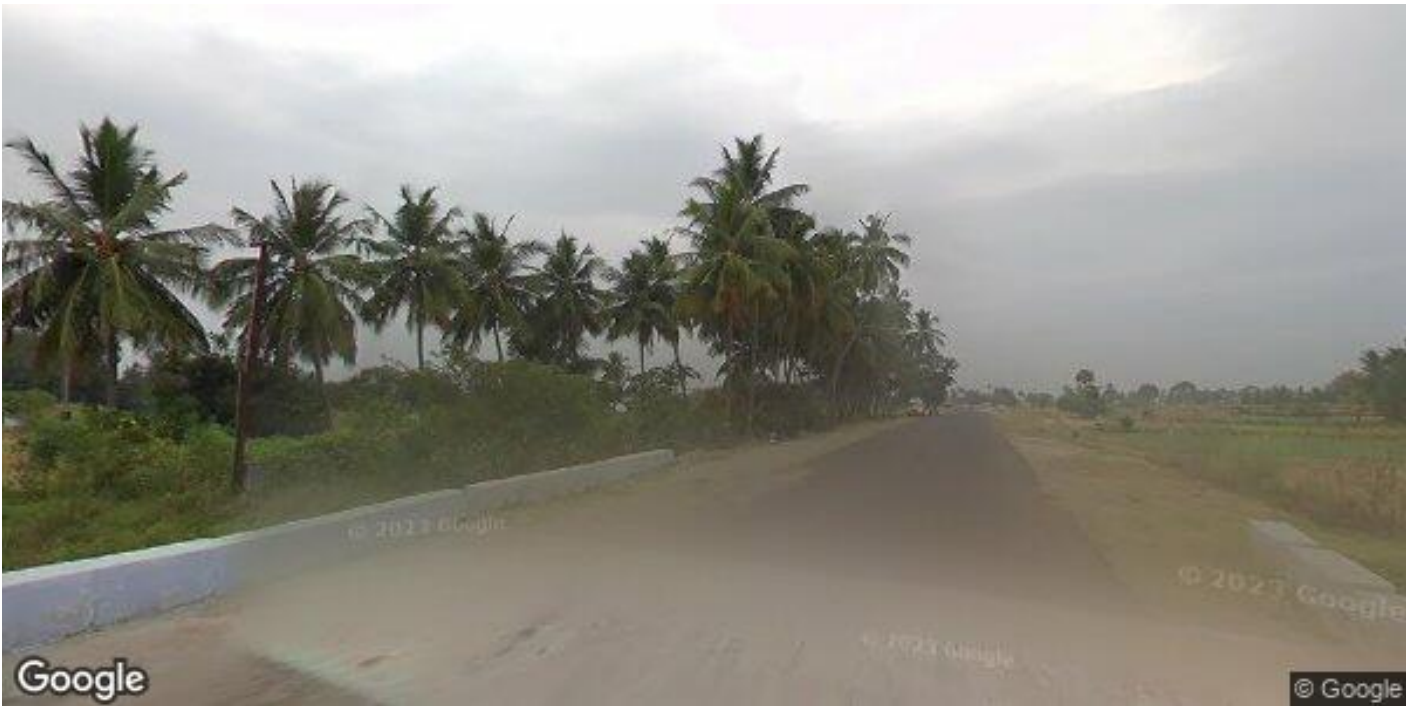
**Risk Type:** Turn  
**Risk Level:** Medium  
**Speed Limit:** 30 KM/Hr  
**Coordinates:** 11.42450, 78.15278

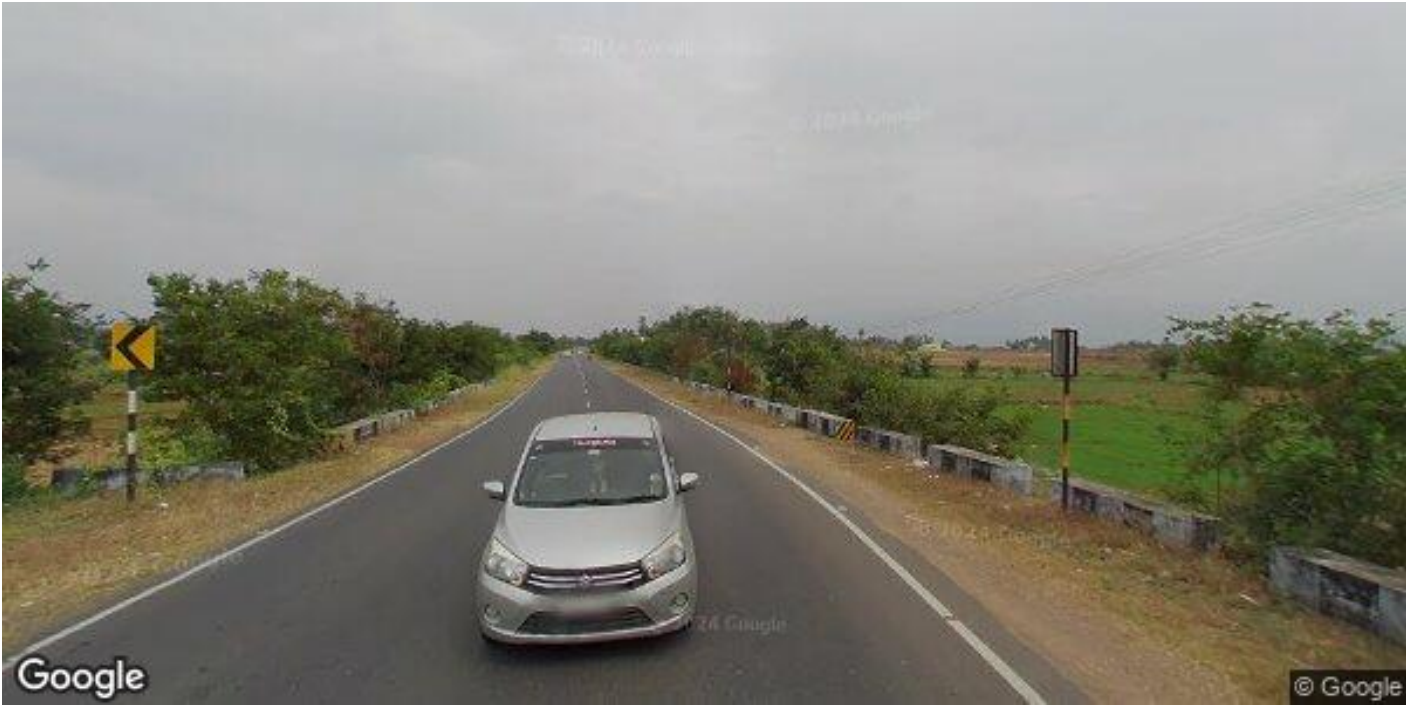
**Risk Type:** Turn  
**Risk Level:** Medium  
**Speed Limit:** 30 KM/Hr  
**Coordinates:** 11.43142, 78.18808

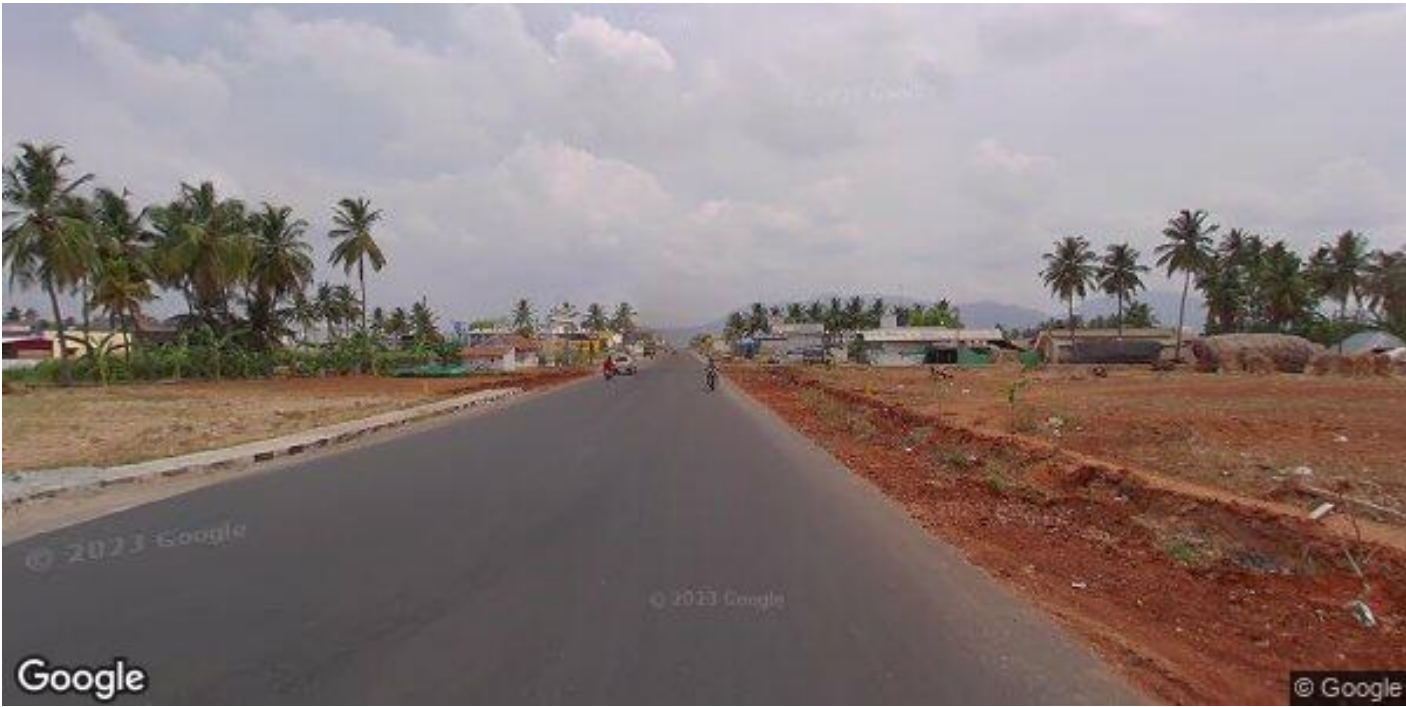
**Risk Type:** Blind Spot  
**Risk Level:** Blind Spot  
**Speed Limit:** 10 KM/Hr  
**Coordinates:** 11.43542, 78.20754

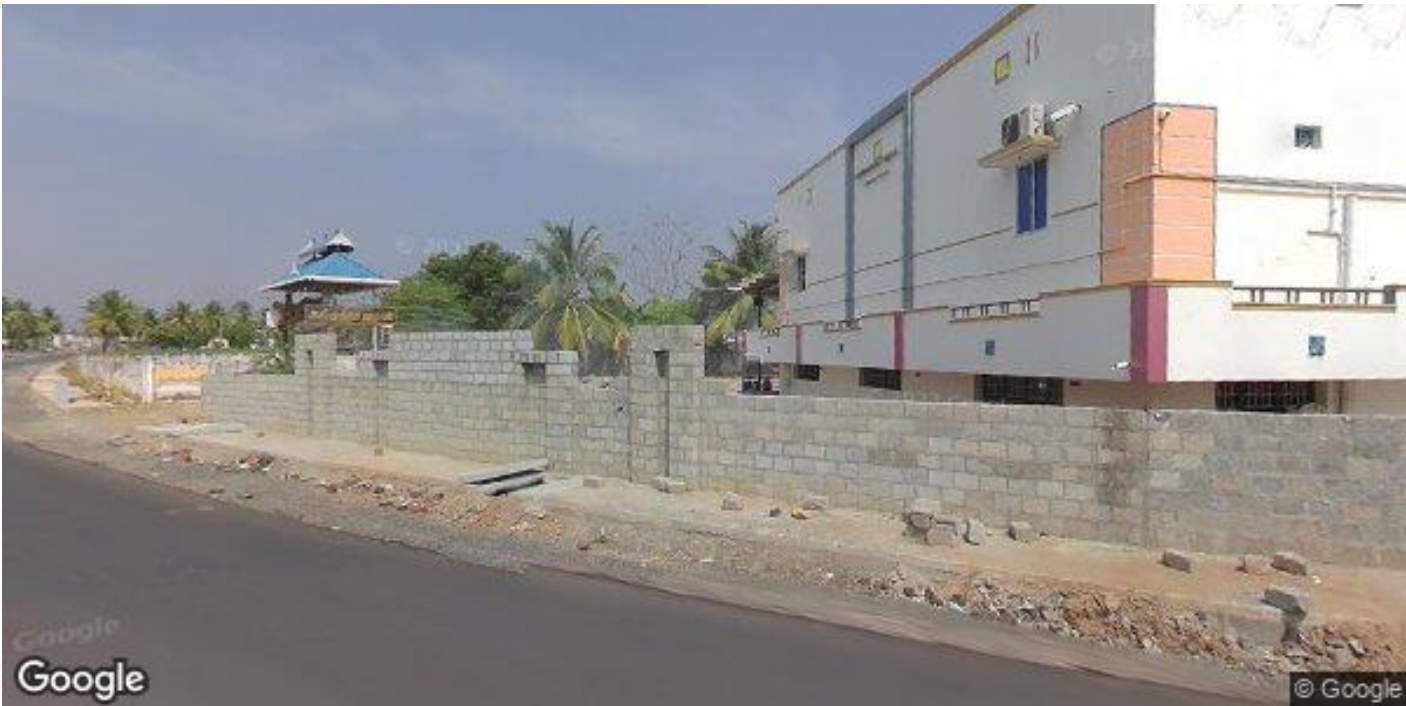
**Risk Type:** Turn  
**Risk Level:** Medium  
**Speed Limit:** 30 KM/Hr  
**Coordinates:** 11.43050, 78.20854

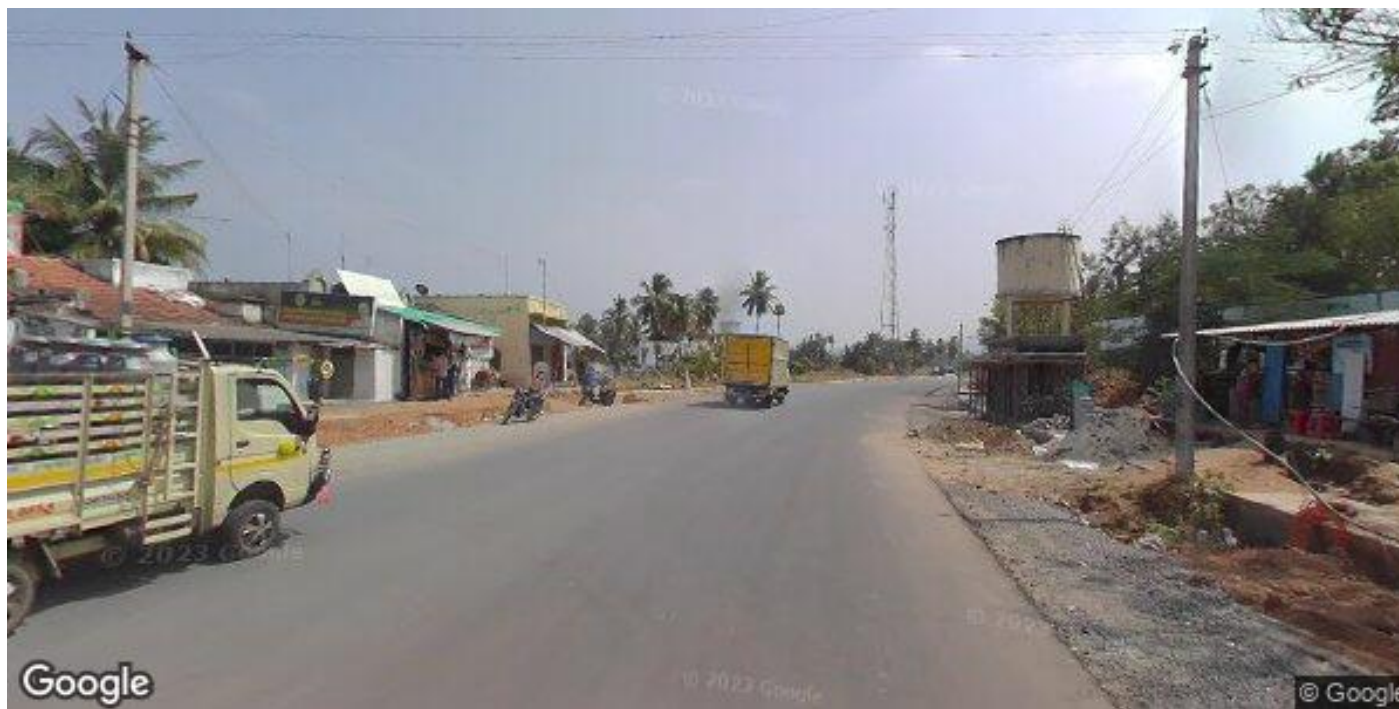
**Risk Type:** Turn  
**Risk Level:** Medium  
**Speed Limit:** 30 KM/Hr  
**Coordinates:** 11.42751, 78.21298

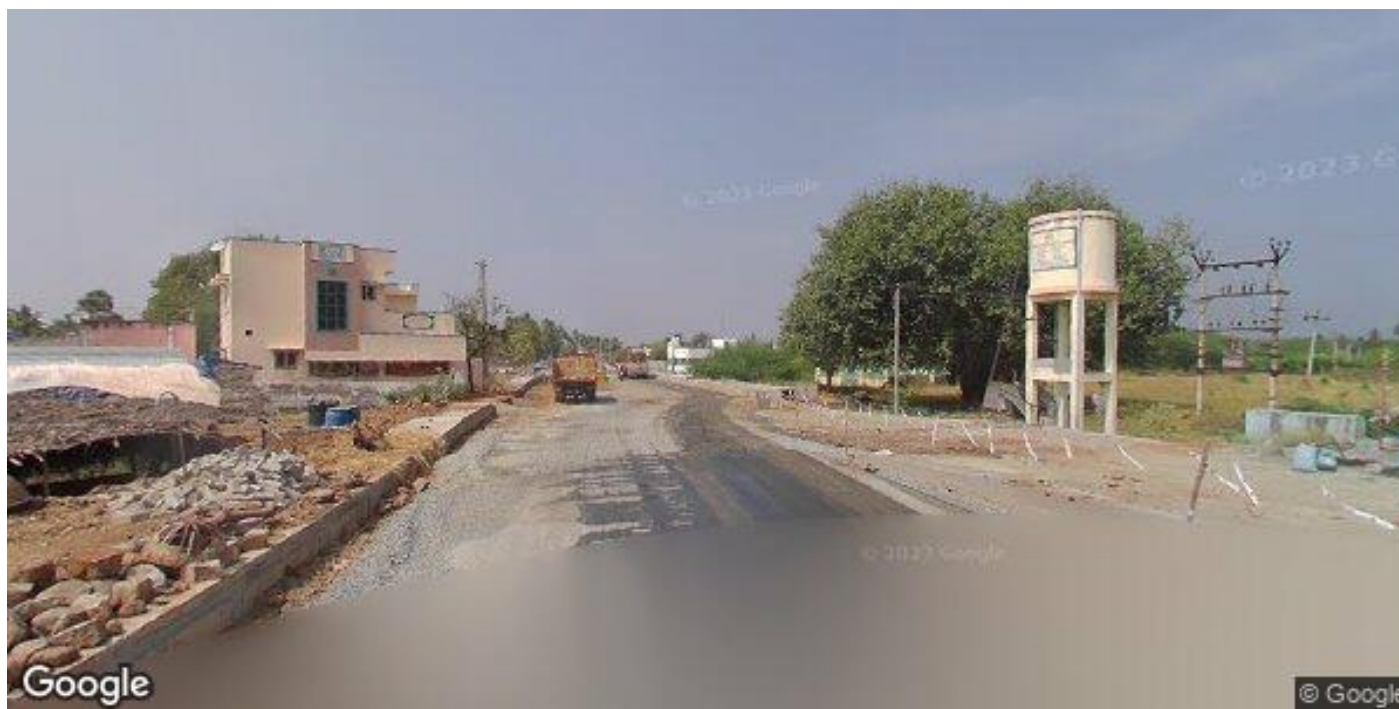
**Risk Type:** Turn  
**Risk Level:** High  
**Speed Limit:** 15 KM/Hr  
**Coordinates:** 11.42178, 78.21699

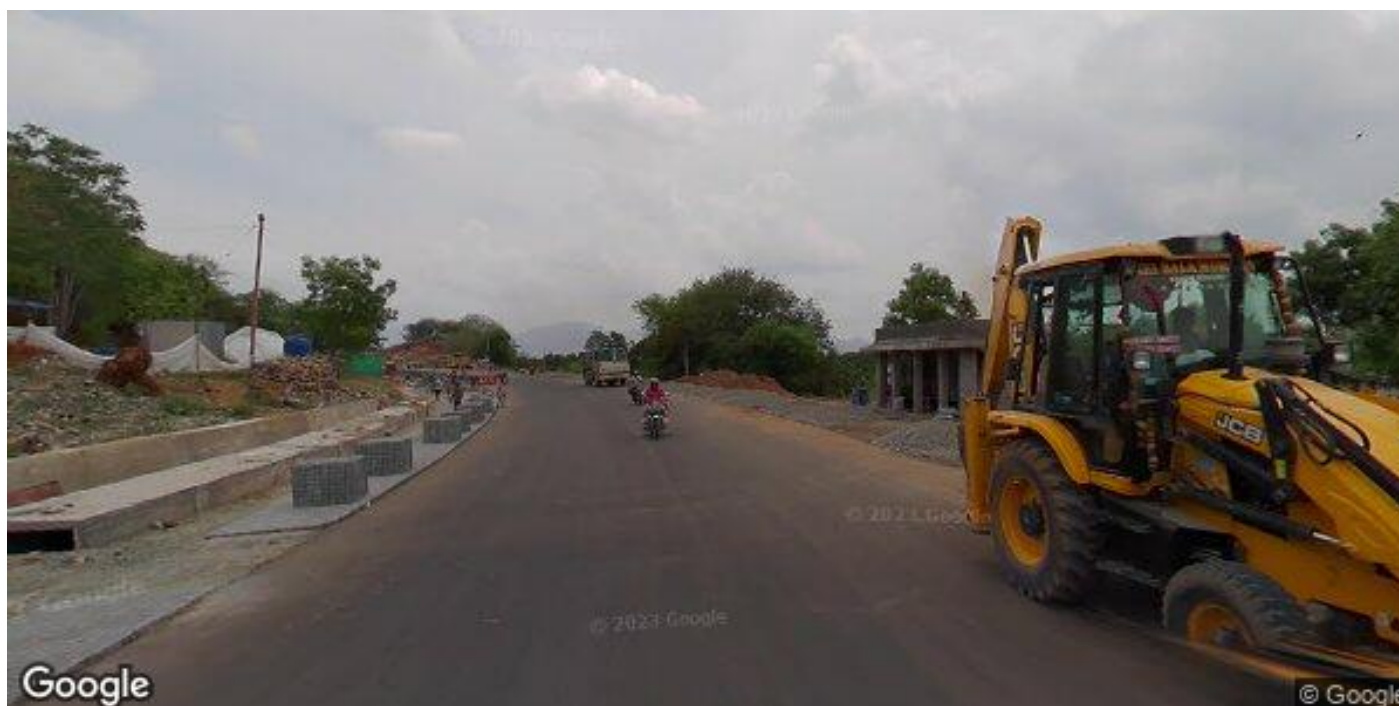
**Risk Type:** Turn  
**Risk Level:** High  
**Speed Limit:** 15 KM/Hr  
**Coordinates:** 11.39529, 78.25156

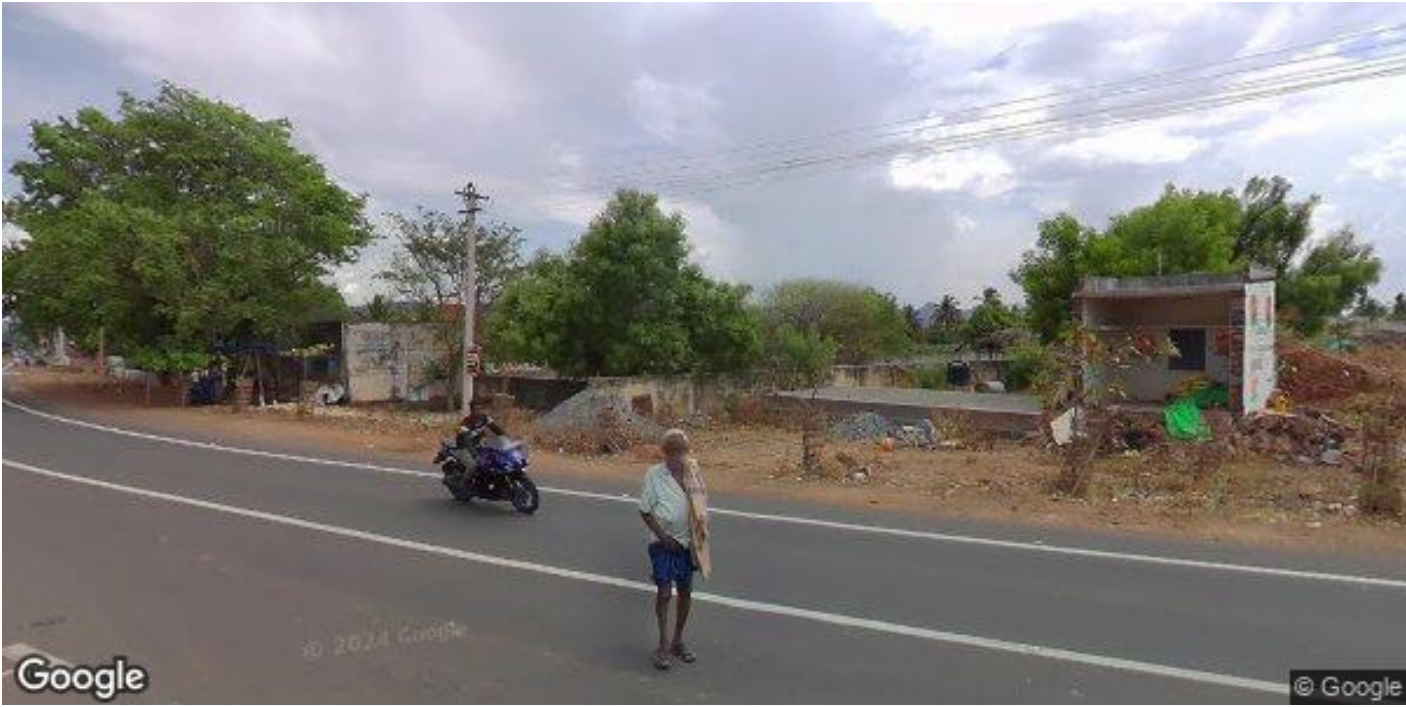
**Risk Type:** Turn  
**Risk Level:** Medium  
**Speed Limit:** 30 KM/Hr  
**Coordinates:** 11.38226, 78.25407

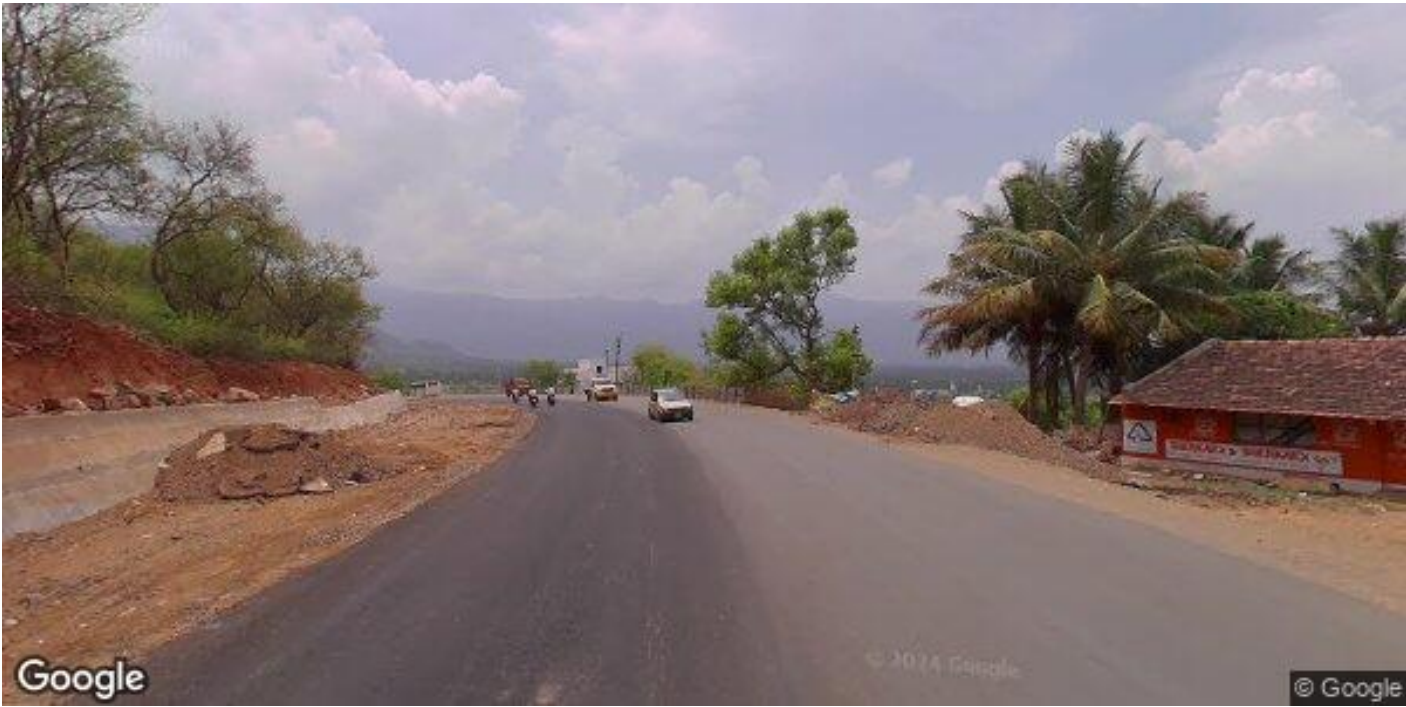
**Risk Type:** Turn  
**Risk Level:** Medium  
**Speed Limit:** 30 KM/Hr  
**Coordinates:** 11.36047, 78.25982
