# IndianOil

## JOURNEY RISK MANAGEMENT (JRM) STUDY

### Salem Terminal to LAKSHMI AGENCIES

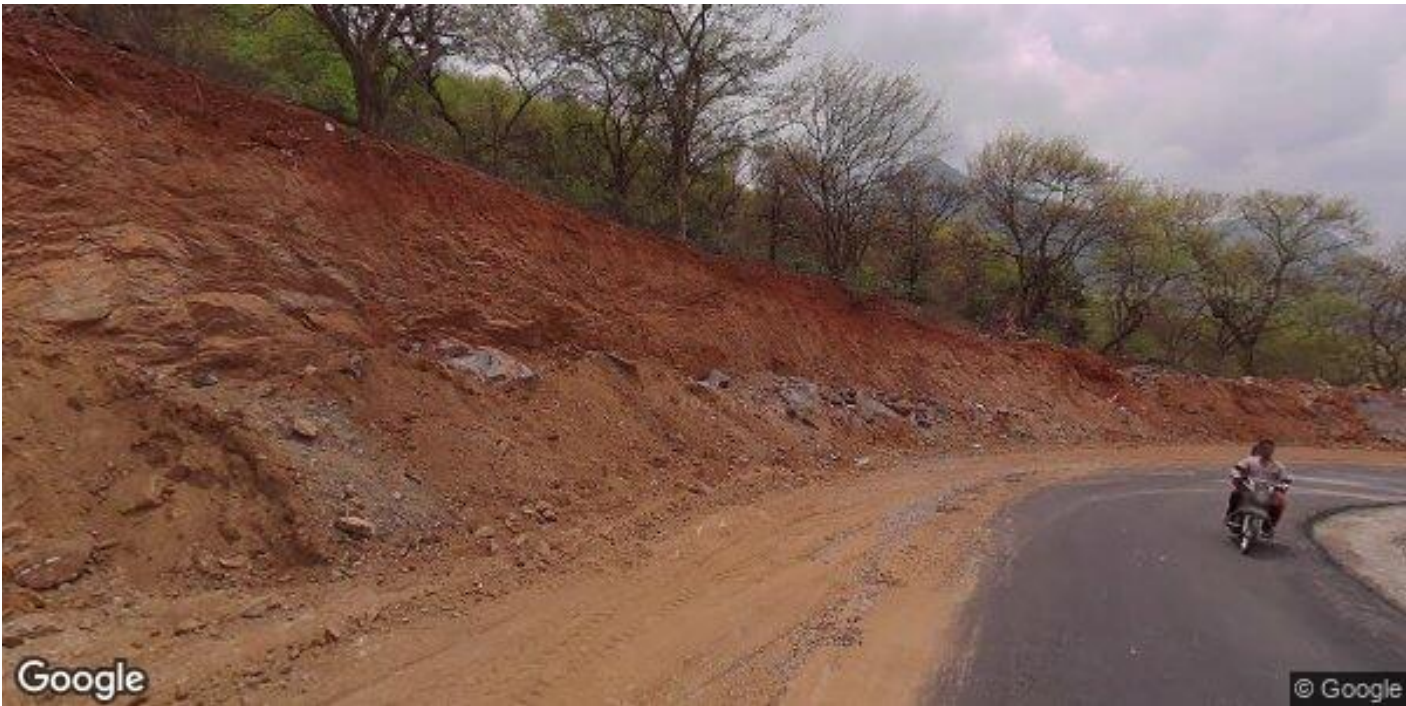
**Risk Type:** Turn  
**Risk Level:** Medium  
**Speed Limit:** 30 KM/Hr  
**Coordinates:** 11.35997, 78.26190

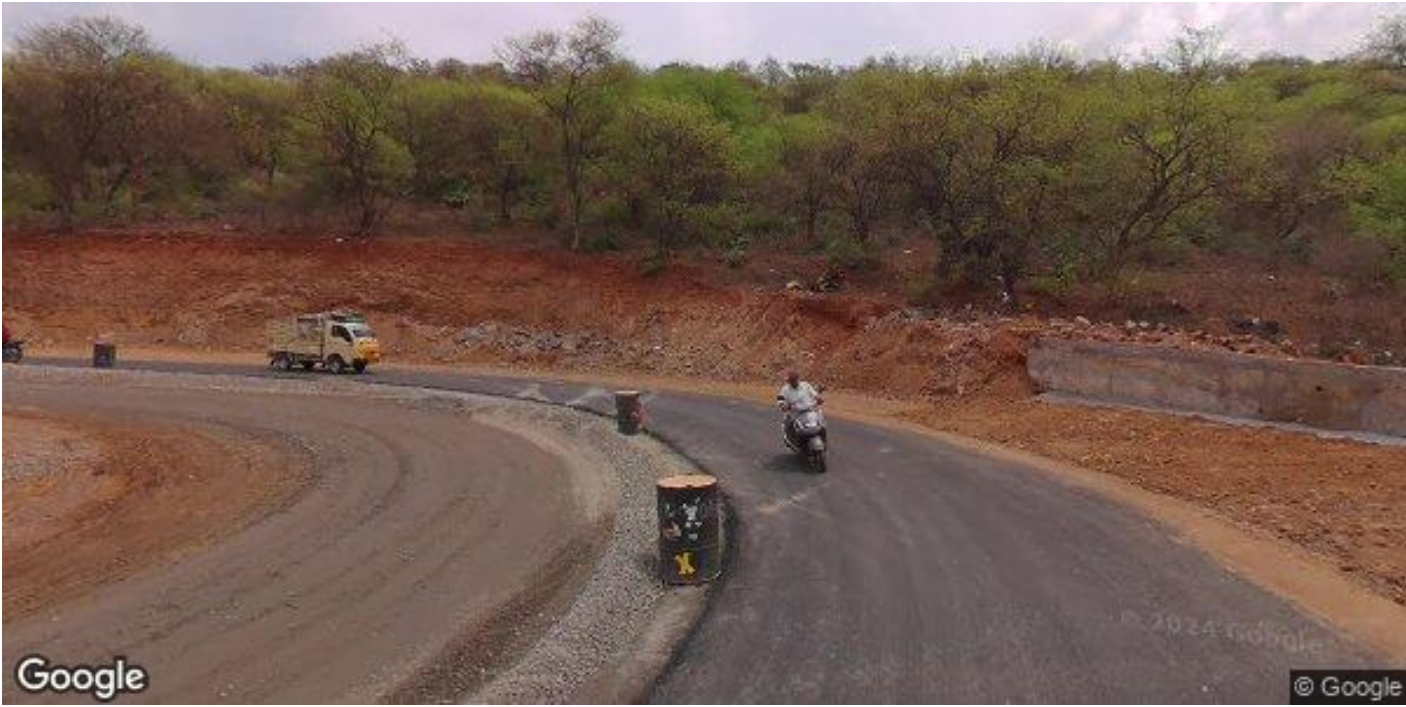
**Risk Type:** Blind Spot  
**Risk Level:** Blind Spot  
**Speed Limit:** 10 KM/Hr  
**Coordinates:** 11.35989, 78.26201

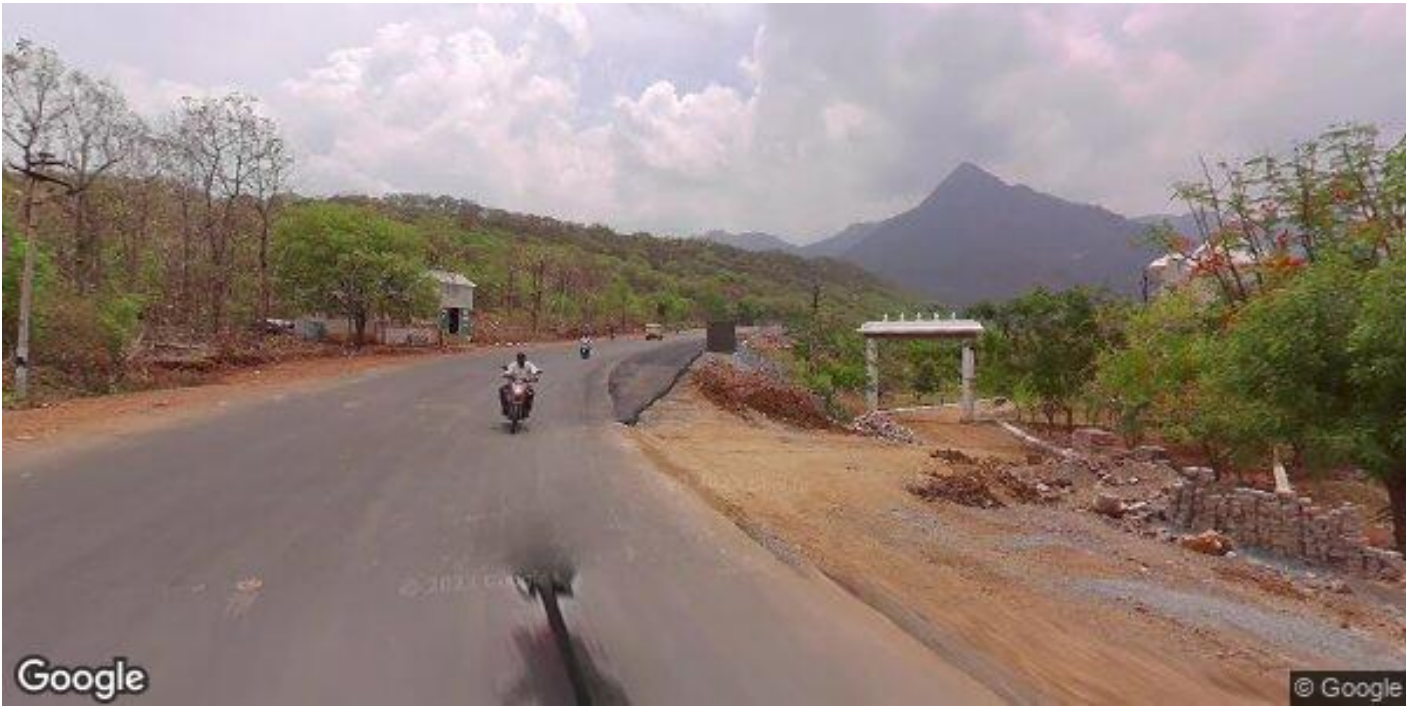
**Risk Type:** Turn  
**Risk Level:** Medium  
**Speed Limit:** 30 KM/Hr  
**Coordinates:** 11.35862, 78.25971

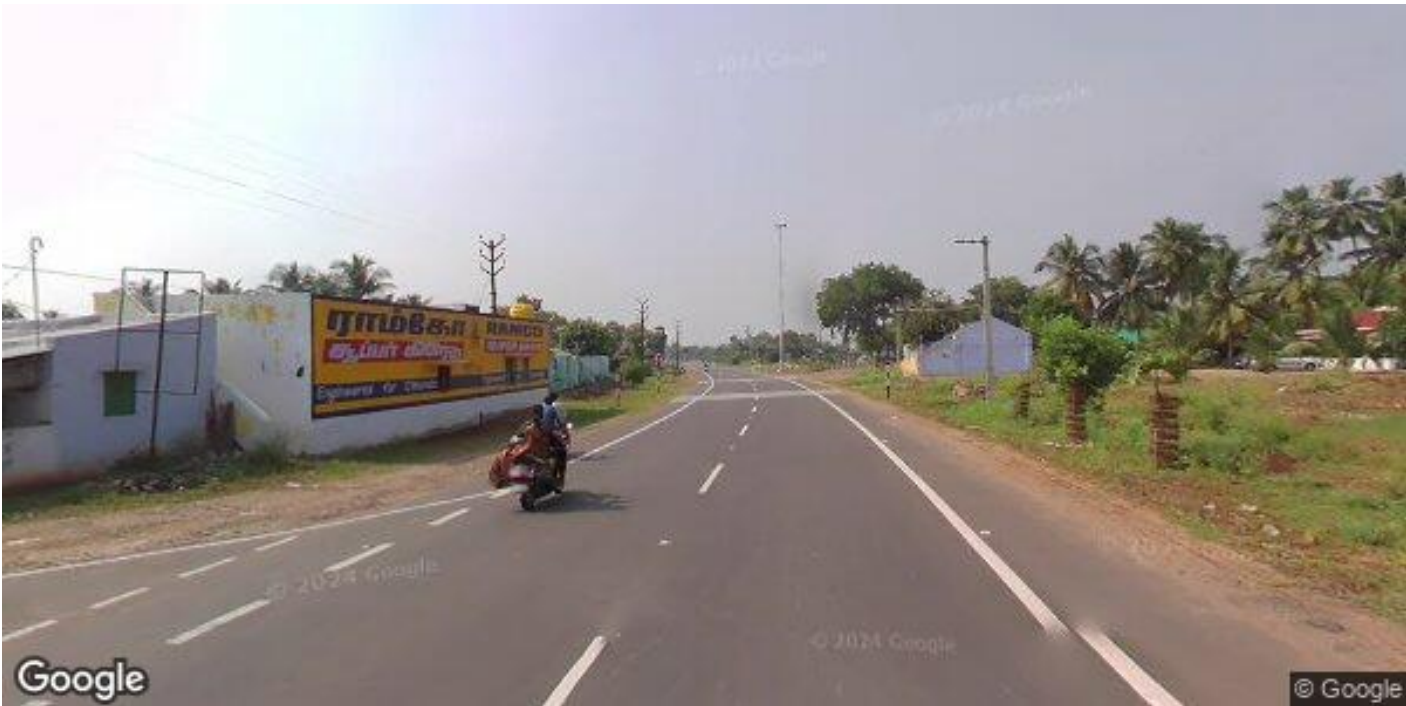
**Risk Type:** Blind Spot  
**Risk Level:** Blind Spot  
**Speed Limit:** 10 KM/Hr  
**Coordinates:** 11.33761, 78.25054

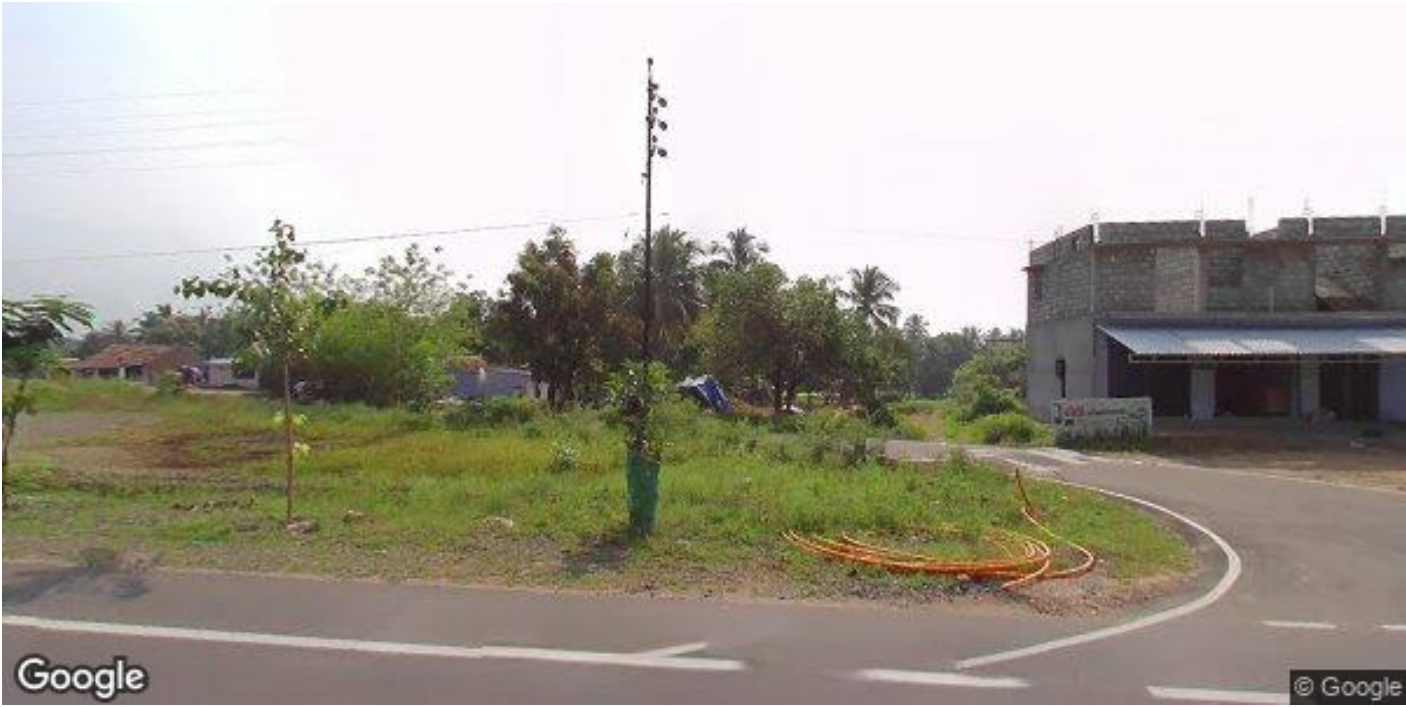
**Risk Type:** Turn  
**Risk Level:** Medium  
**Speed Limit:** 30 KM/Hr  
**Coordinates:** 11.33765, 78.25083

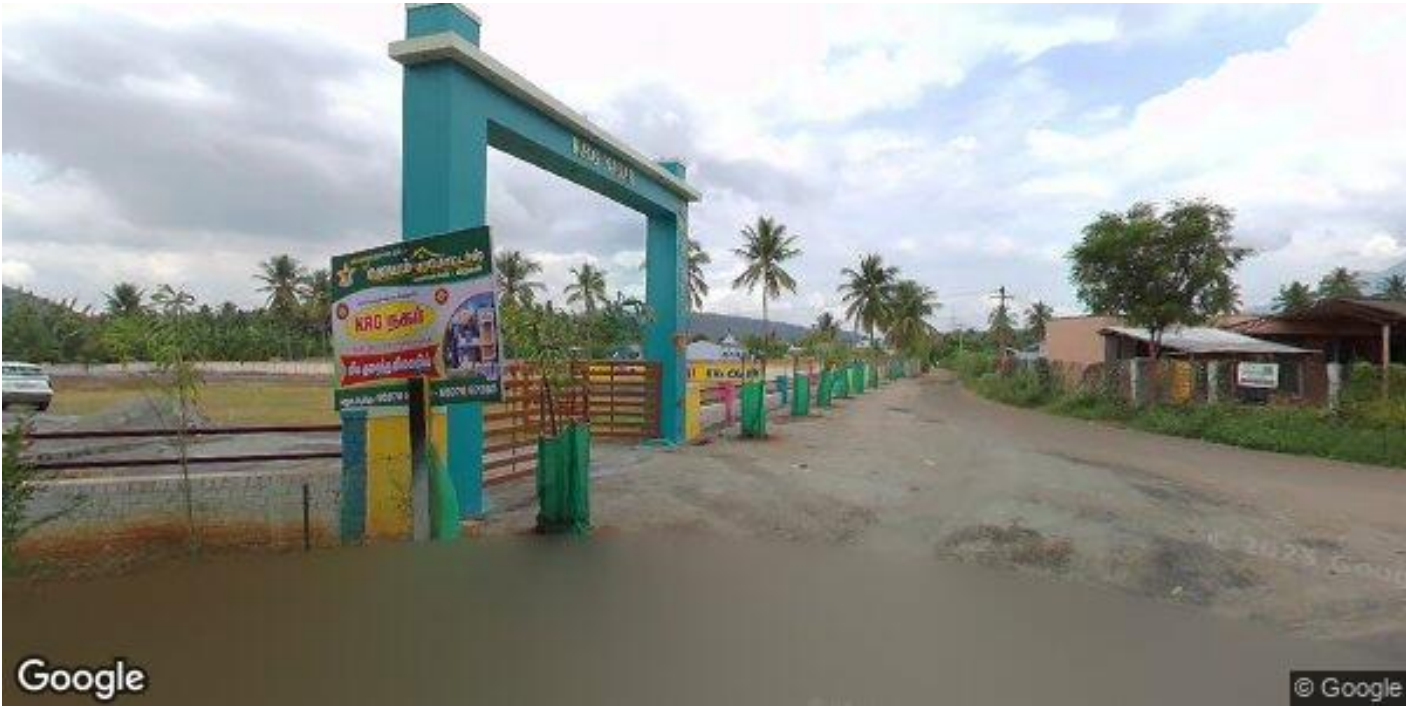
**Risk Type:** Blind Spot  
**Risk Level:** Blind Spot  
**Speed Limit:** 10 KM/Hr  
**Coordinates:** 11.33448, 78.25806

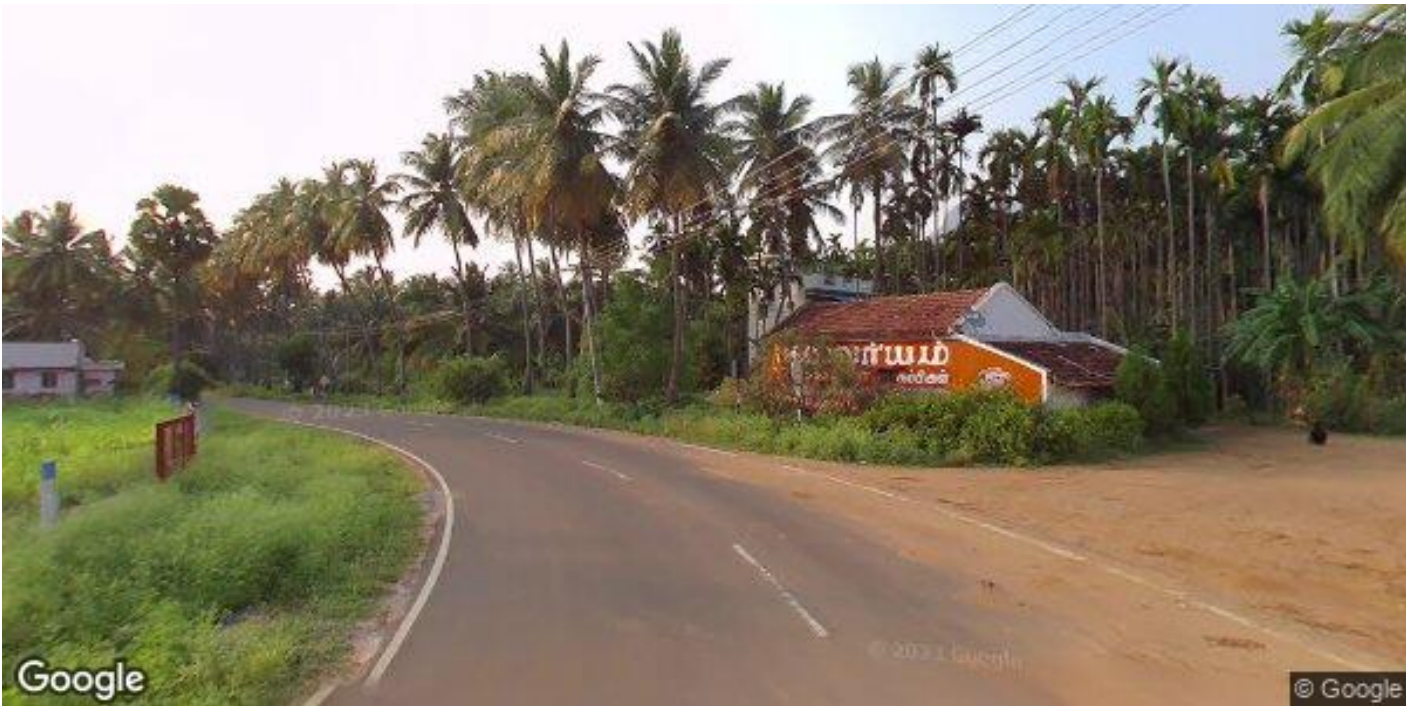
**Risk Type:** Turn  
**Risk Level:** Medium  
**Speed Limit:** 30 KM/Hr  
**Coordinates:** 11.32983, 78.29999

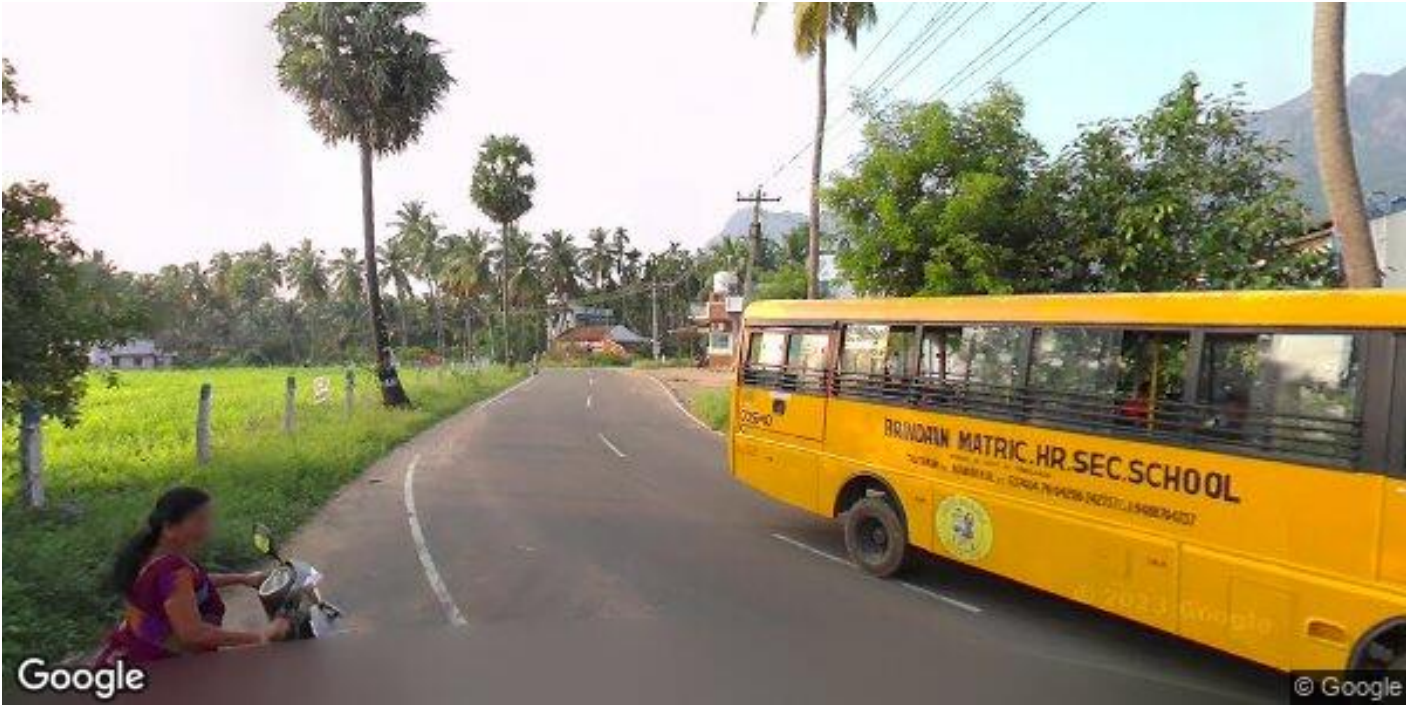
**Risk Type:** Turn  
**Risk Level:** High  
**Speed Limit:** 15 KM/Hr  
**Coordinates:** 11.32944, 78.30032
