# IndianOil

## JOURNEY RISK MANAGEMENT (JRM) STUDY

### Salem Terminal TO HARI AGENCY

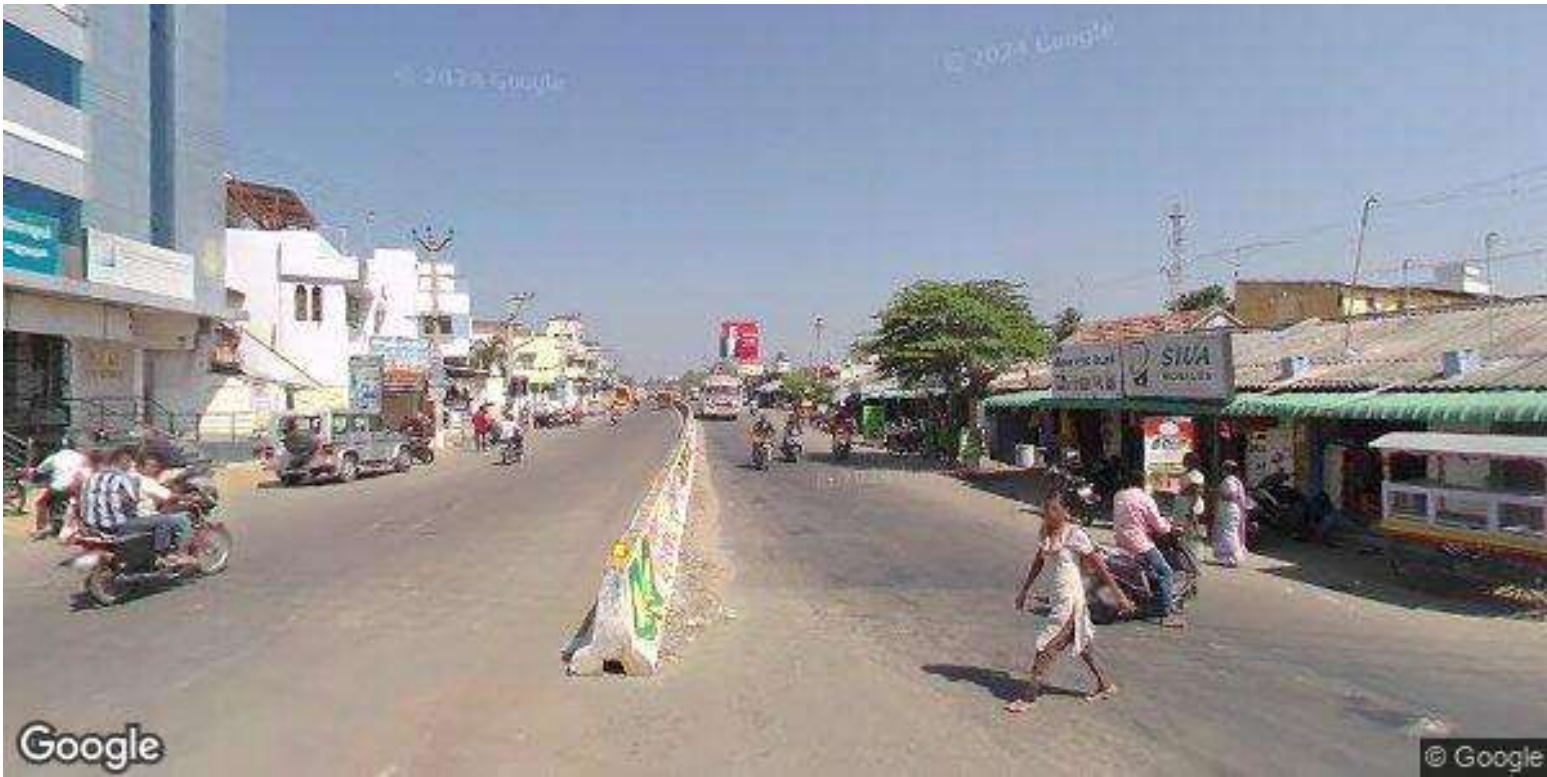
Risk Type: Roundabout  
Risk Level: High

**Speed Limit: 15 KM/Hr**  
**Coordinates: 11.37086, 77.74828**

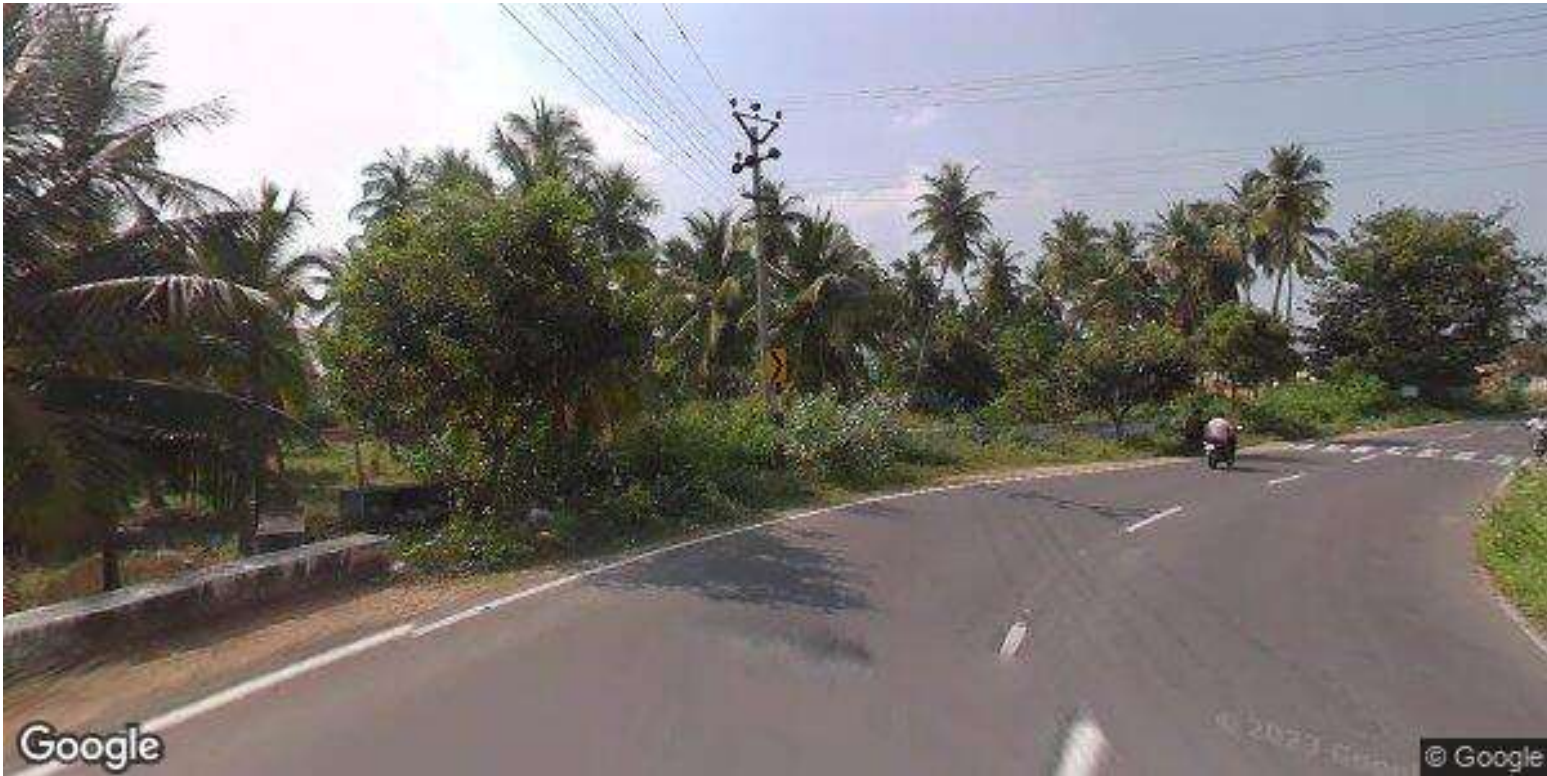
**Risk Type:** Turn  
**Risk Level:** Medium  
**Speed Limit:** 30 KM/Hr  
**Coordinates:** 11.45348, 77.85706

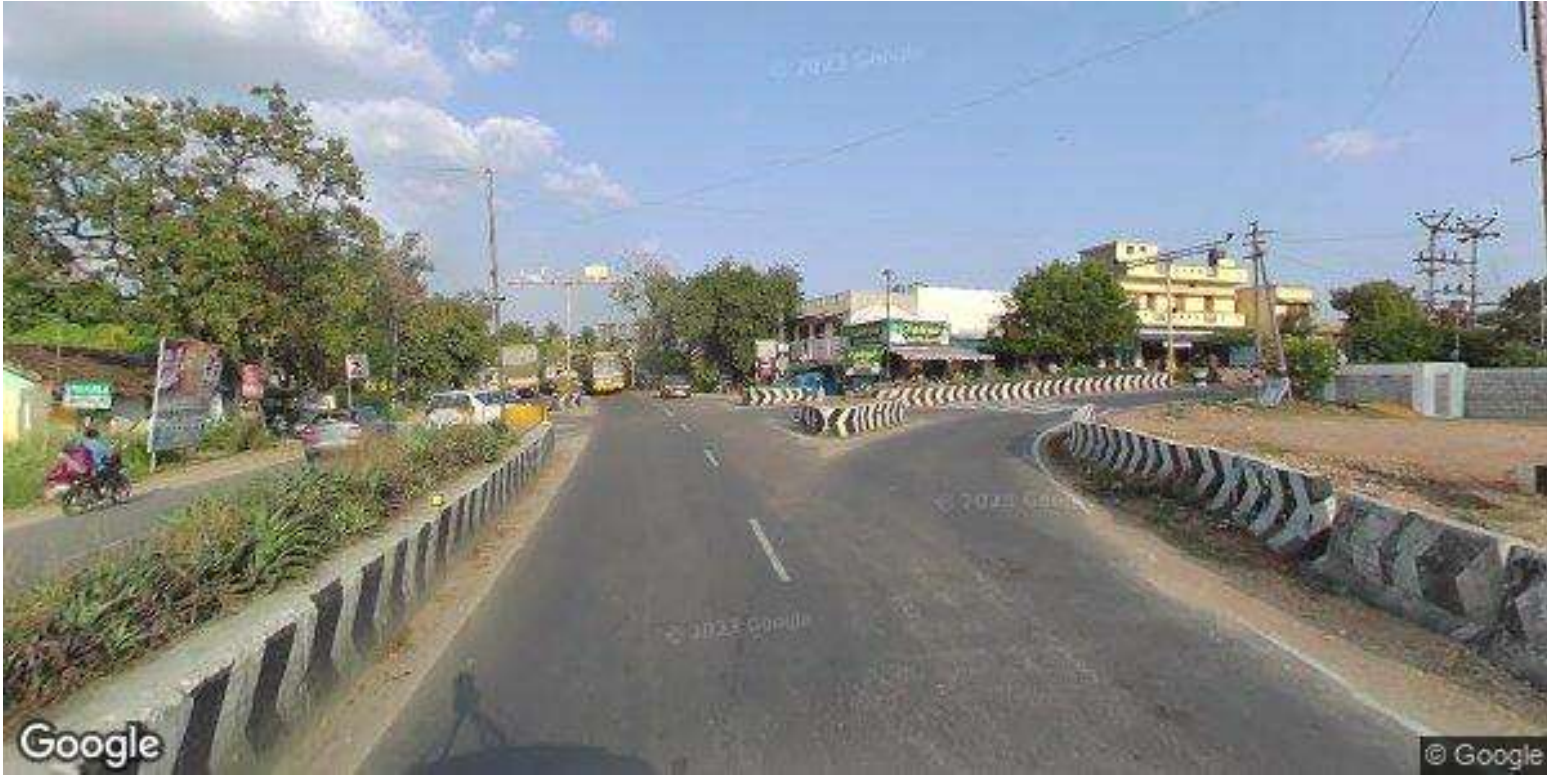
**Risk Type:** Turn  
**Risk Level:** Medium  
**Speed Limit:** 30 KM/Hr  
**Coordinates:** 11.46318, 77.84913

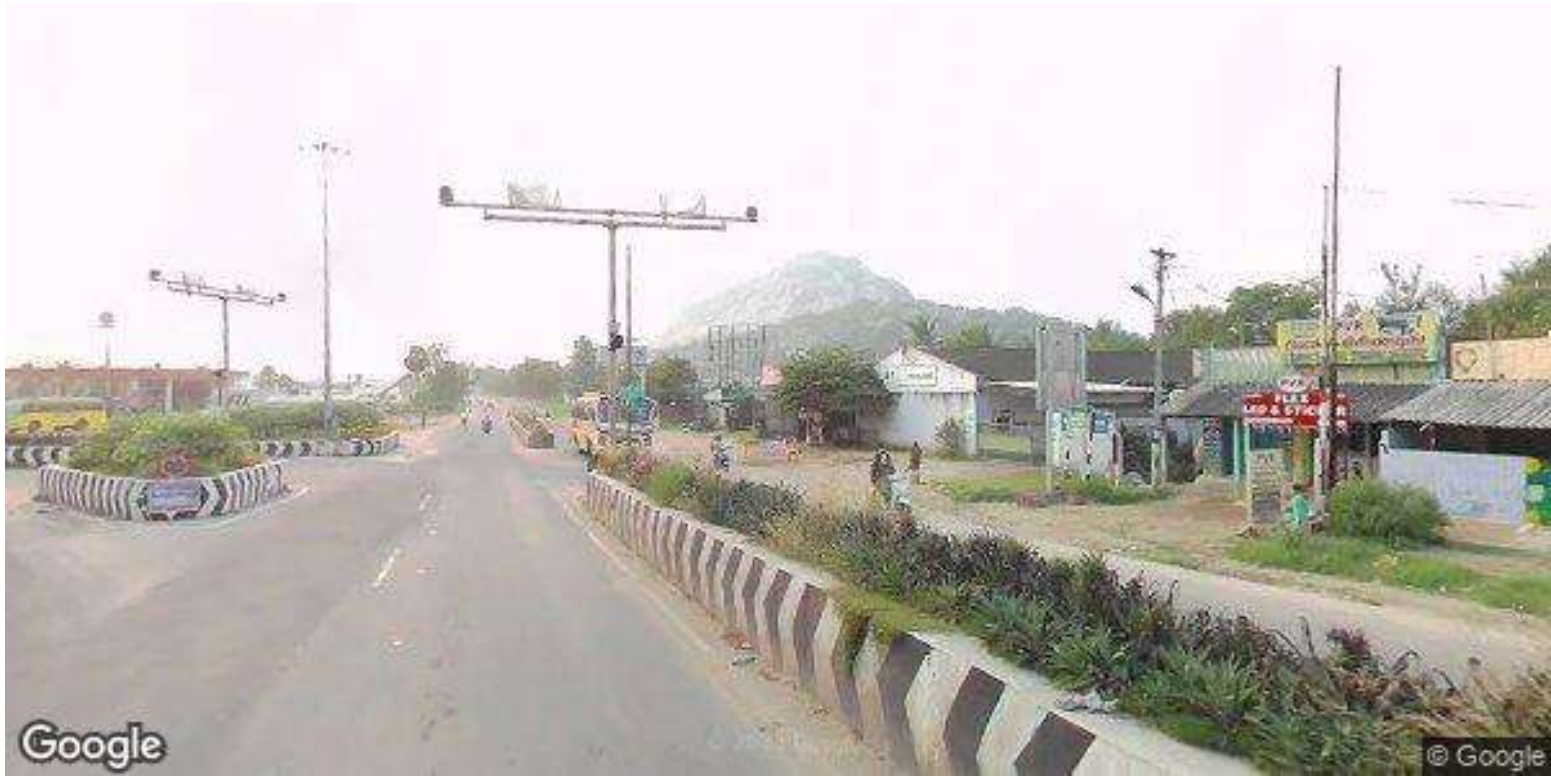
**Risk Type:** Turn  
**Risk Level:** Medium  
**Speed Limit:** 30 KM/Hr  
**Coordinates:** 11.46312, 77.84886

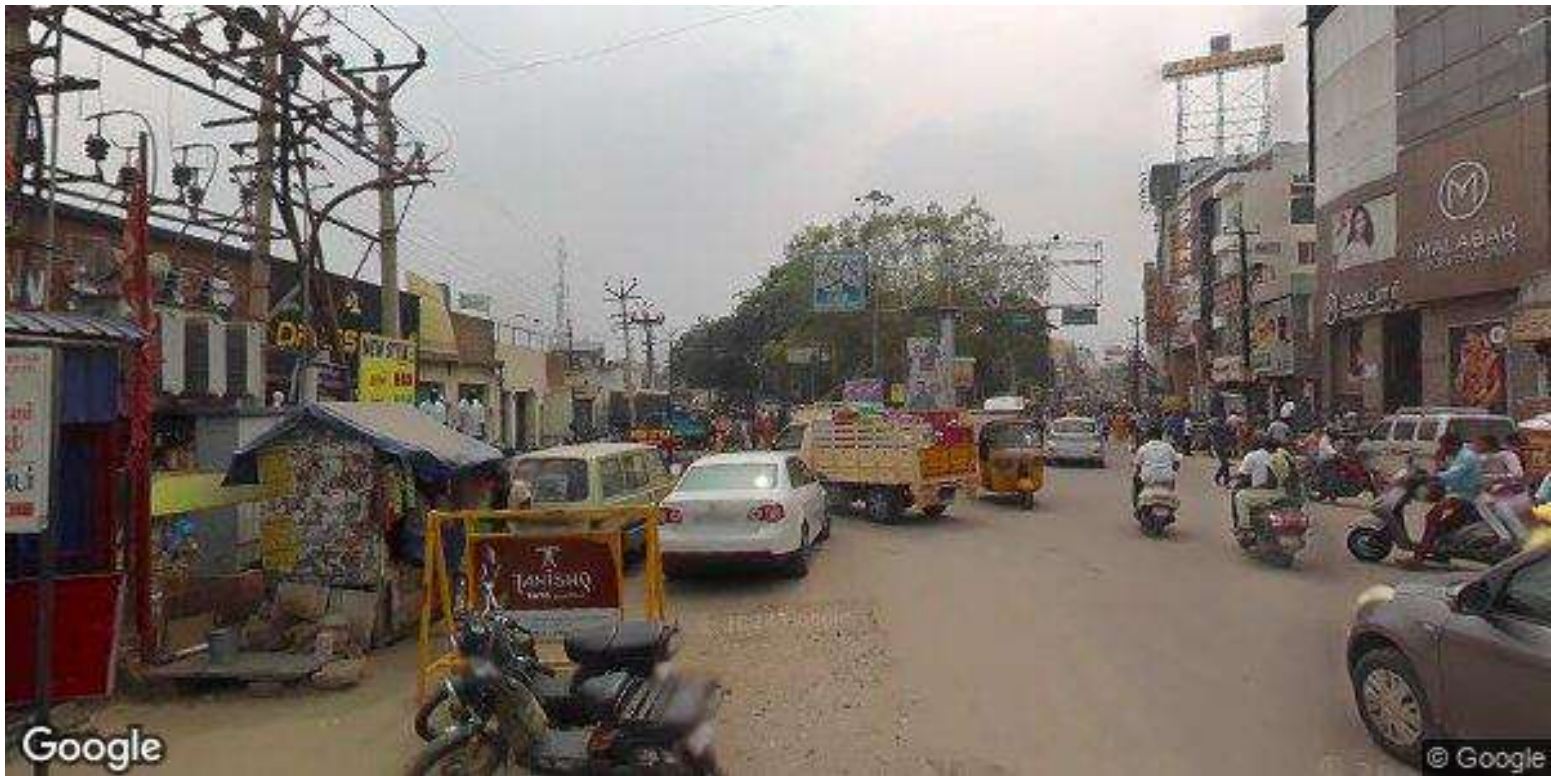
**Risk Type:** Turn  
**Risk Level:** Medium  
**Speed Limit:** 30 KM/Hr  
**Coordinates:** 11.34493, 77.73032

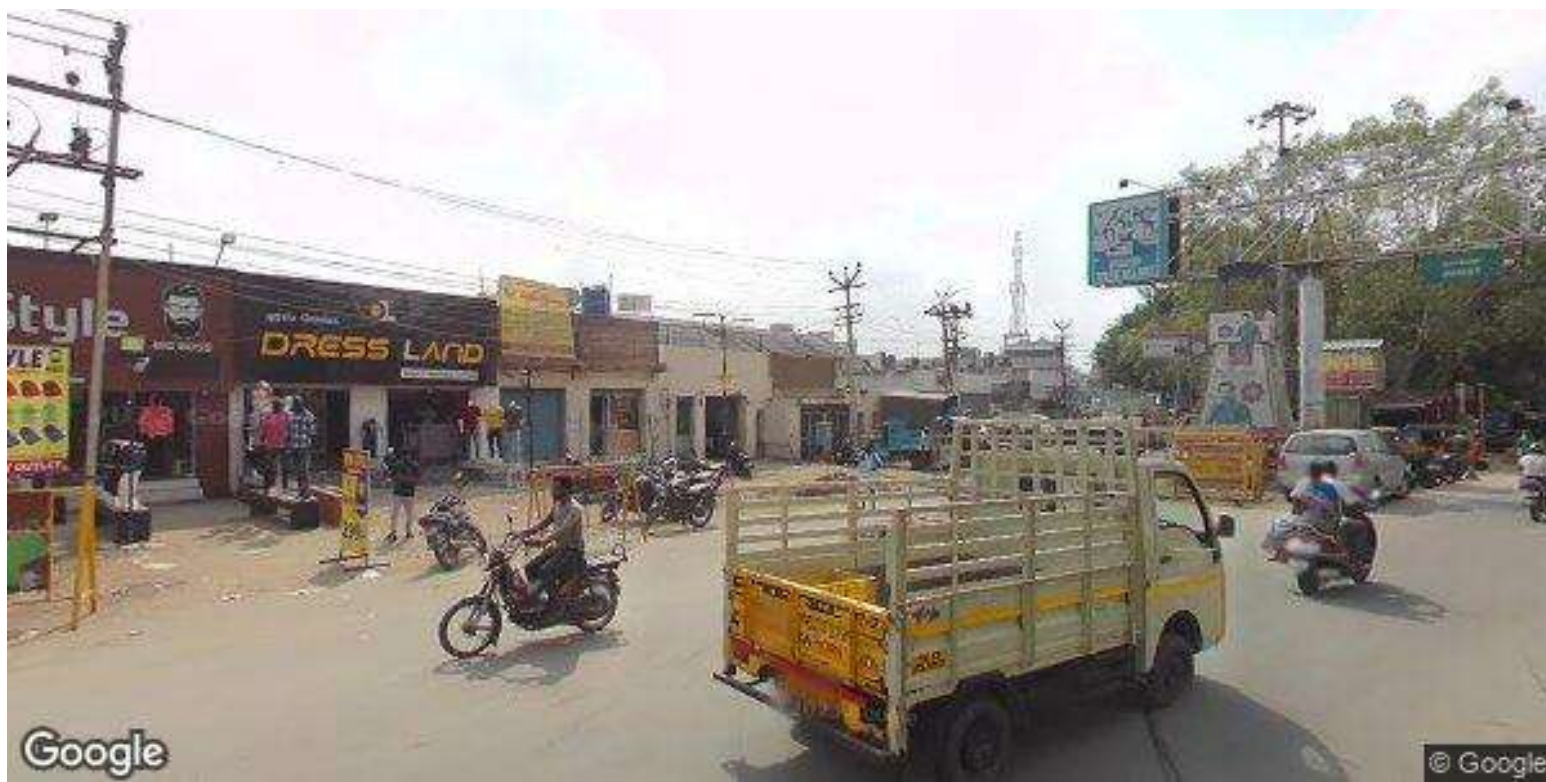
**Risk Type:** Turn

**Risk Level:** Medium

**Speed Limit:** 30 KM/Hr

**Coordinates:** 11.34483, 77.73022

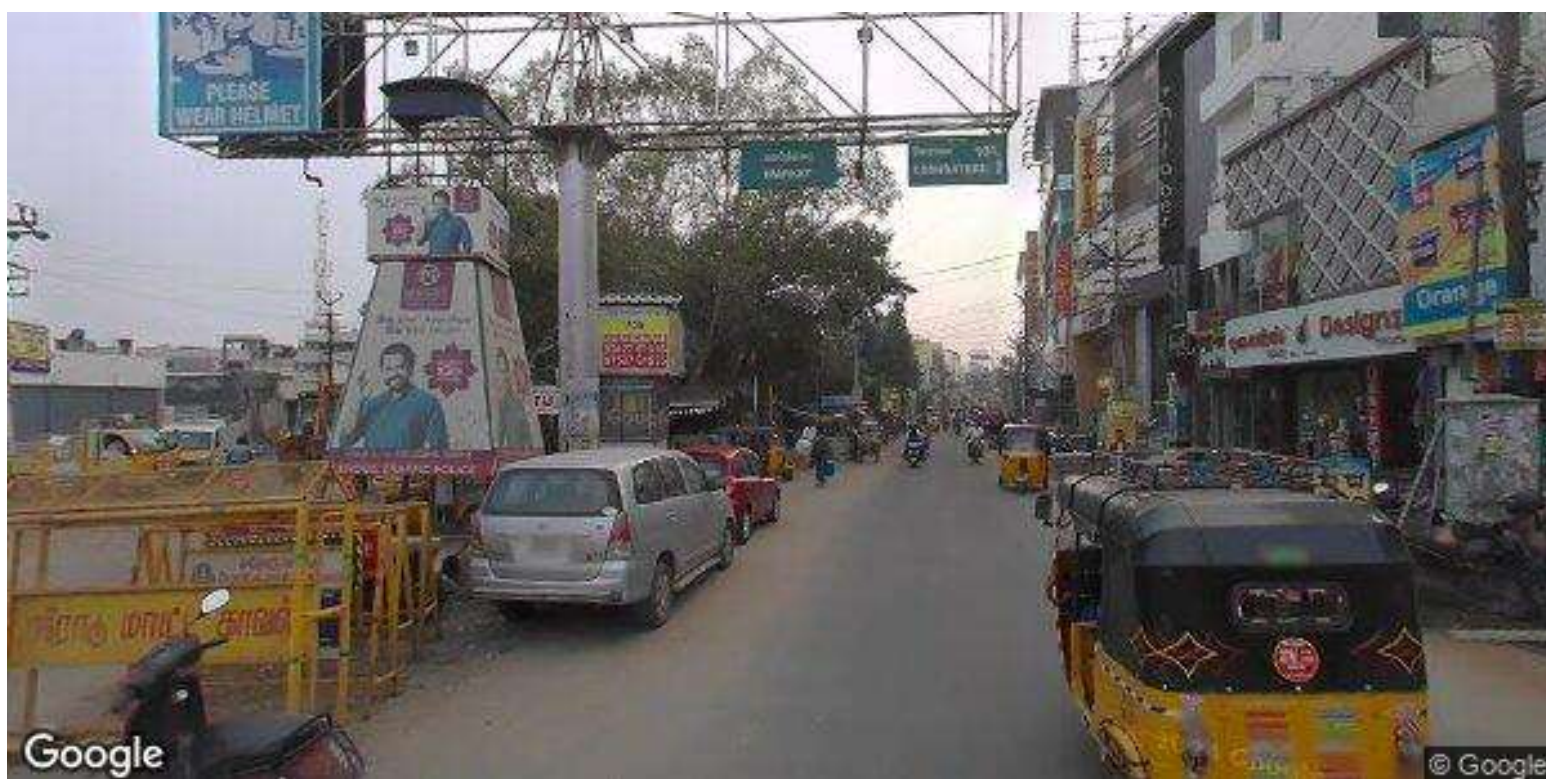
**Risk Type:** Turn

**Risk Level:** Medium

**Speed Limit:** 30 KM/Hr

**Coordinates:** 11.34470, 77.73018

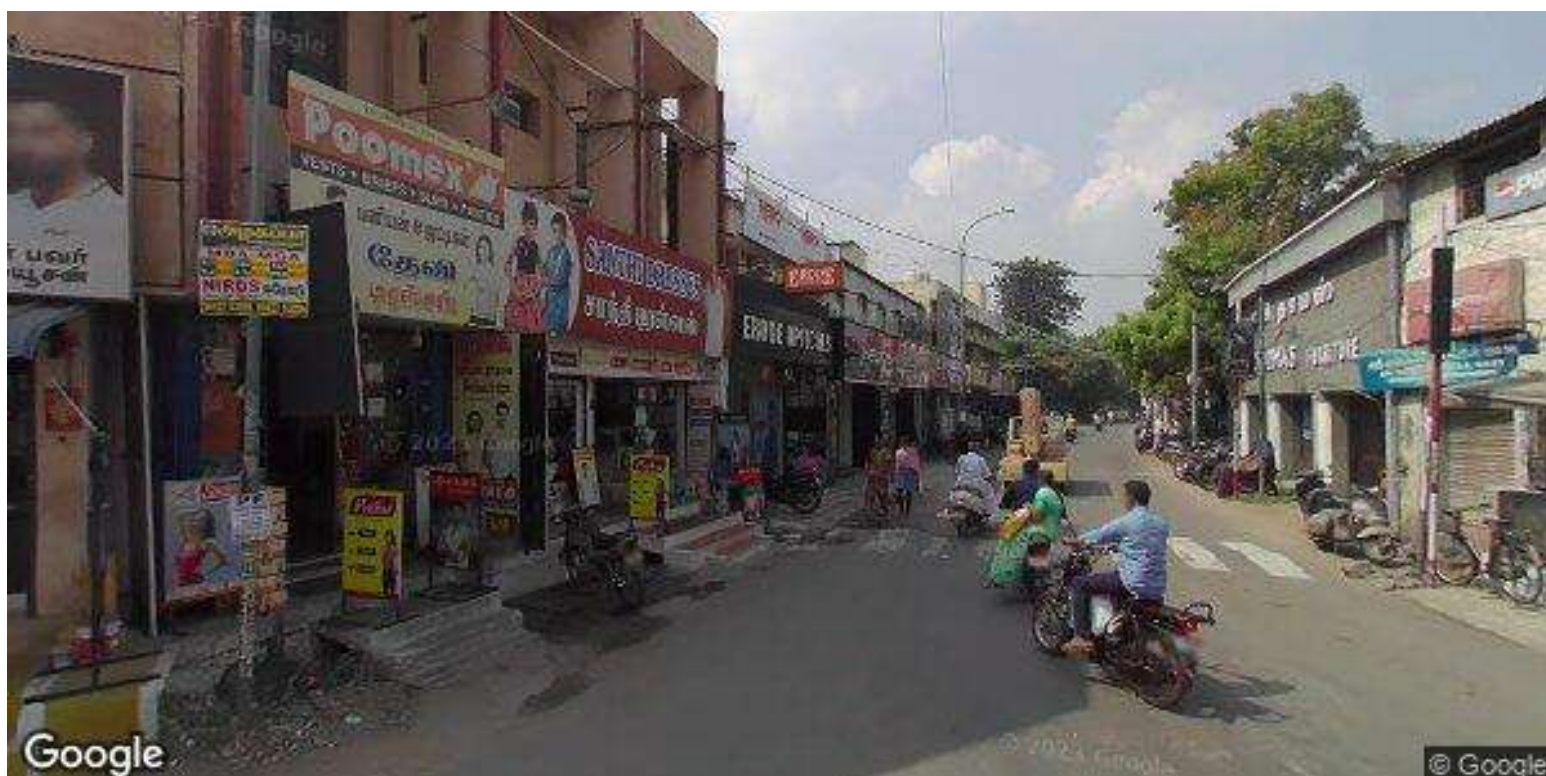
**Risk Type:** Blind Spot  
**Risk Level:** Blind Spot  
**Speed Limit:** 10 KM/Hr  
**Coordinates:** 11.33920, 77.72902

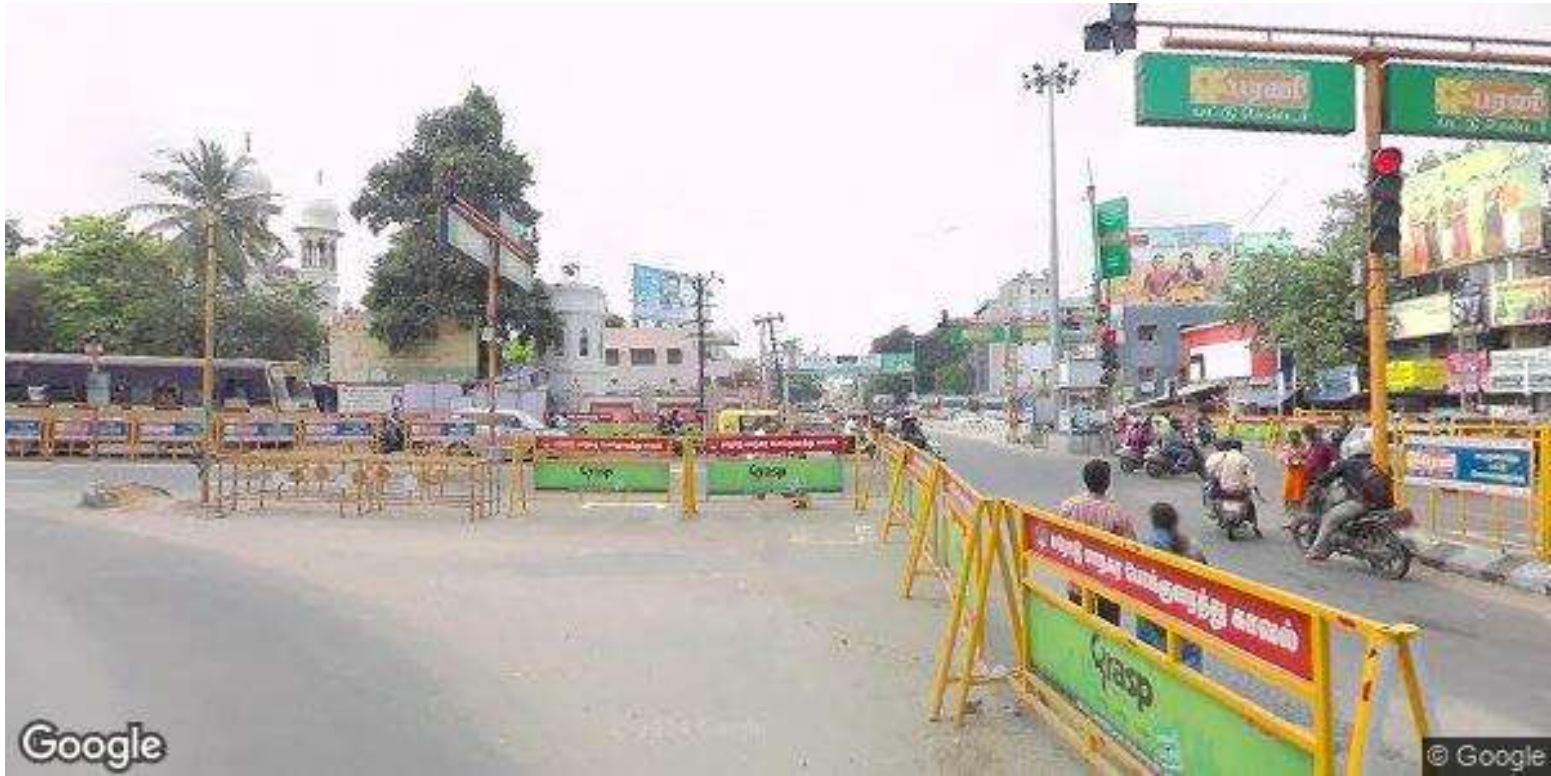
**Risk Type:** Turn  
**Risk Level:** Medium  
**Speed Limit:** 30 KM/Hr  
**Coordinates:** 11.33914, 77.72659

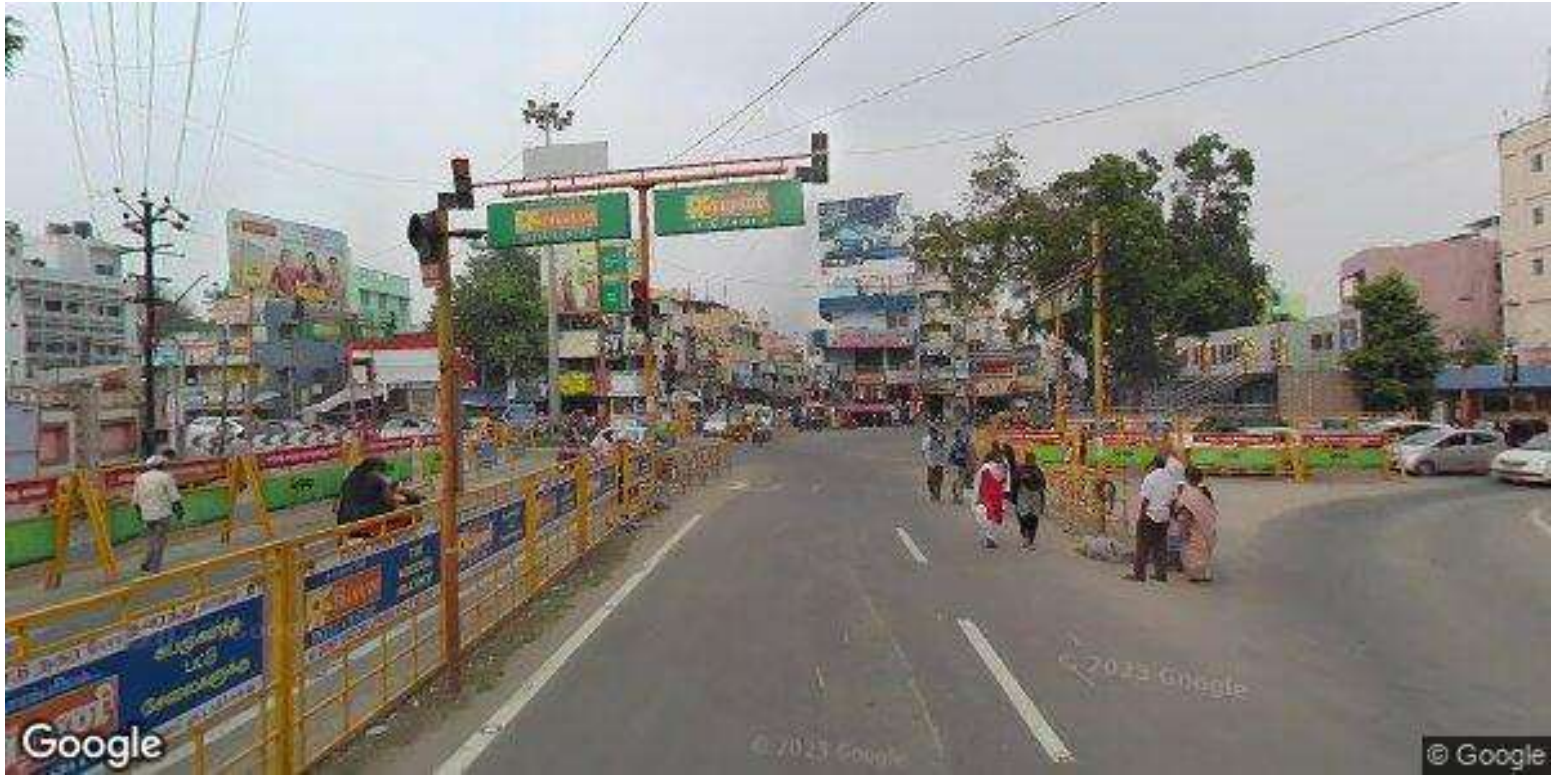
**Risk Type:** Turn  
**Risk Level:** High  
**Speed Limit:** 15 KM/Hr  
**Coordinates:** 11.33890, 77.72637

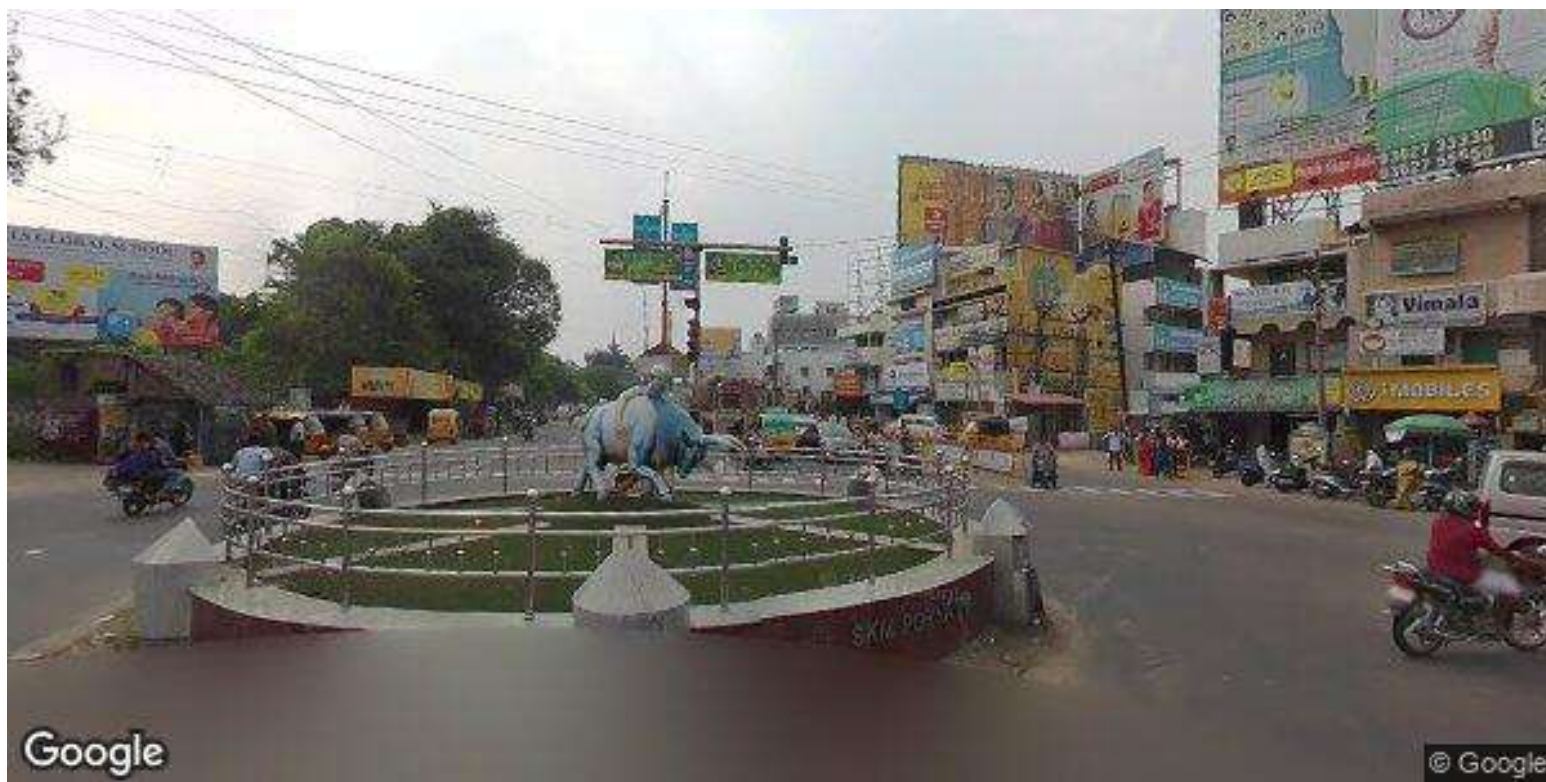
**Risk Type:** Turn

**Risk Level:** Medium

**Speed Limit:** 30 KM/Hr

**Coordinates:** 11.33097, 77.72747

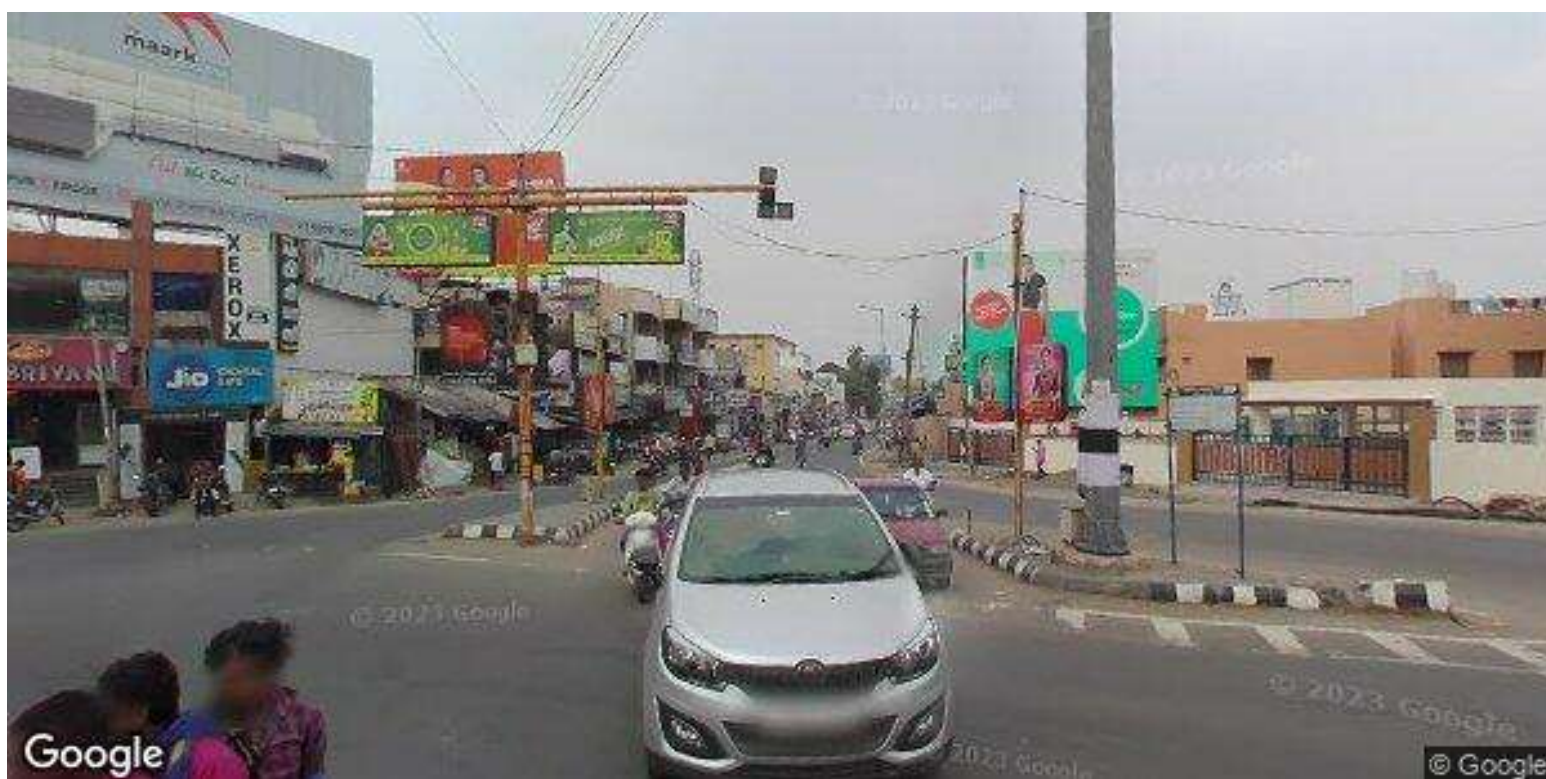
**Risk Type:** Turn

**Risk Level:** Medium

**Speed Limit:** 30 KM/Hr

**Coordinates:** 11.33095, 77.72748

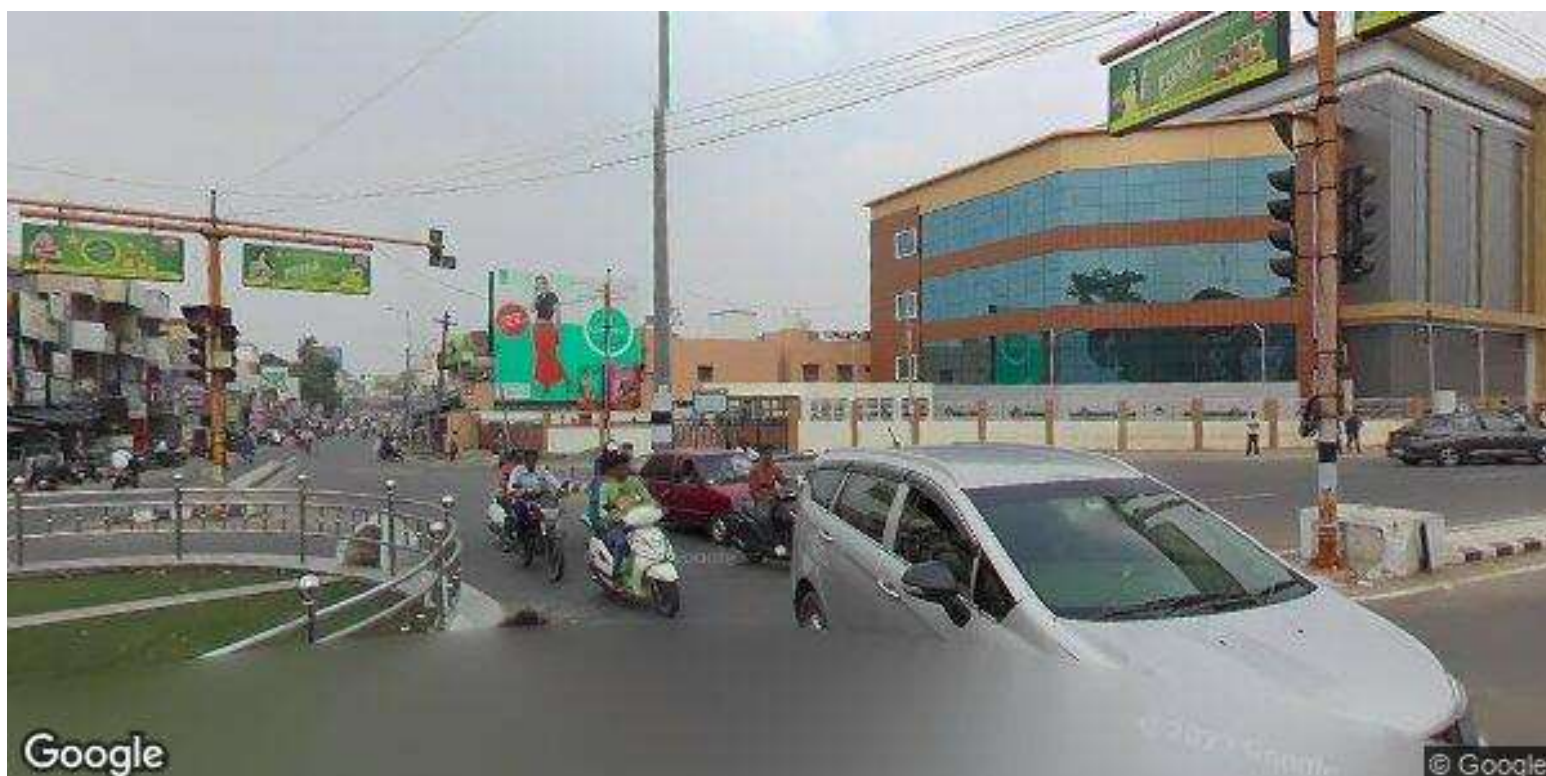
**Risk Type: Turn**

**Risk Level: High**

**Speed Limit: 15 KM/Hr**

**Coordinates: 11.33090, 77.72748**

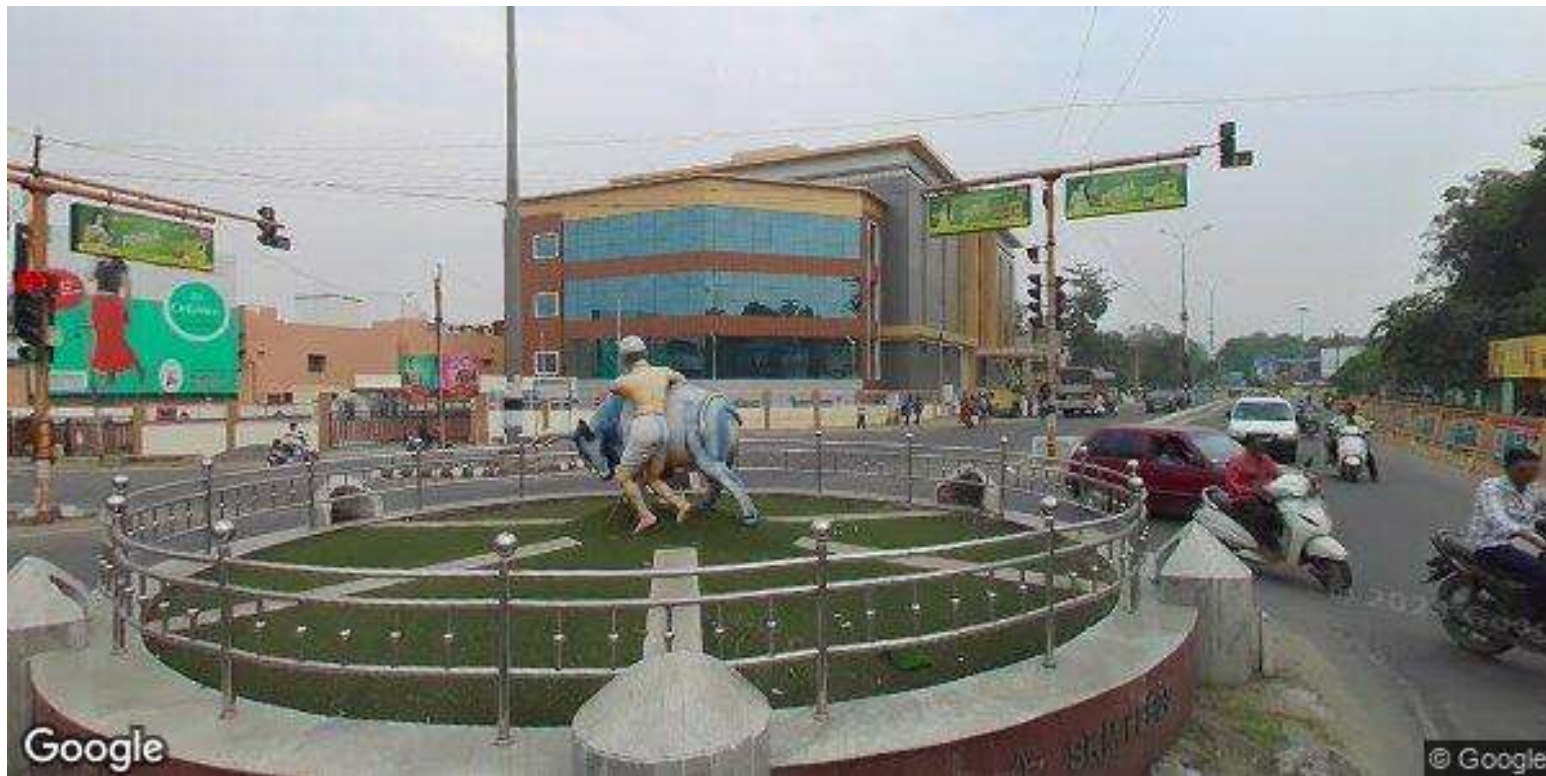
**Risk Type: Turn**

**Risk Level: Medium**

**Speed Limit: 30 KM/Hr**

**Coordinates: 11.33084, 77.72742**

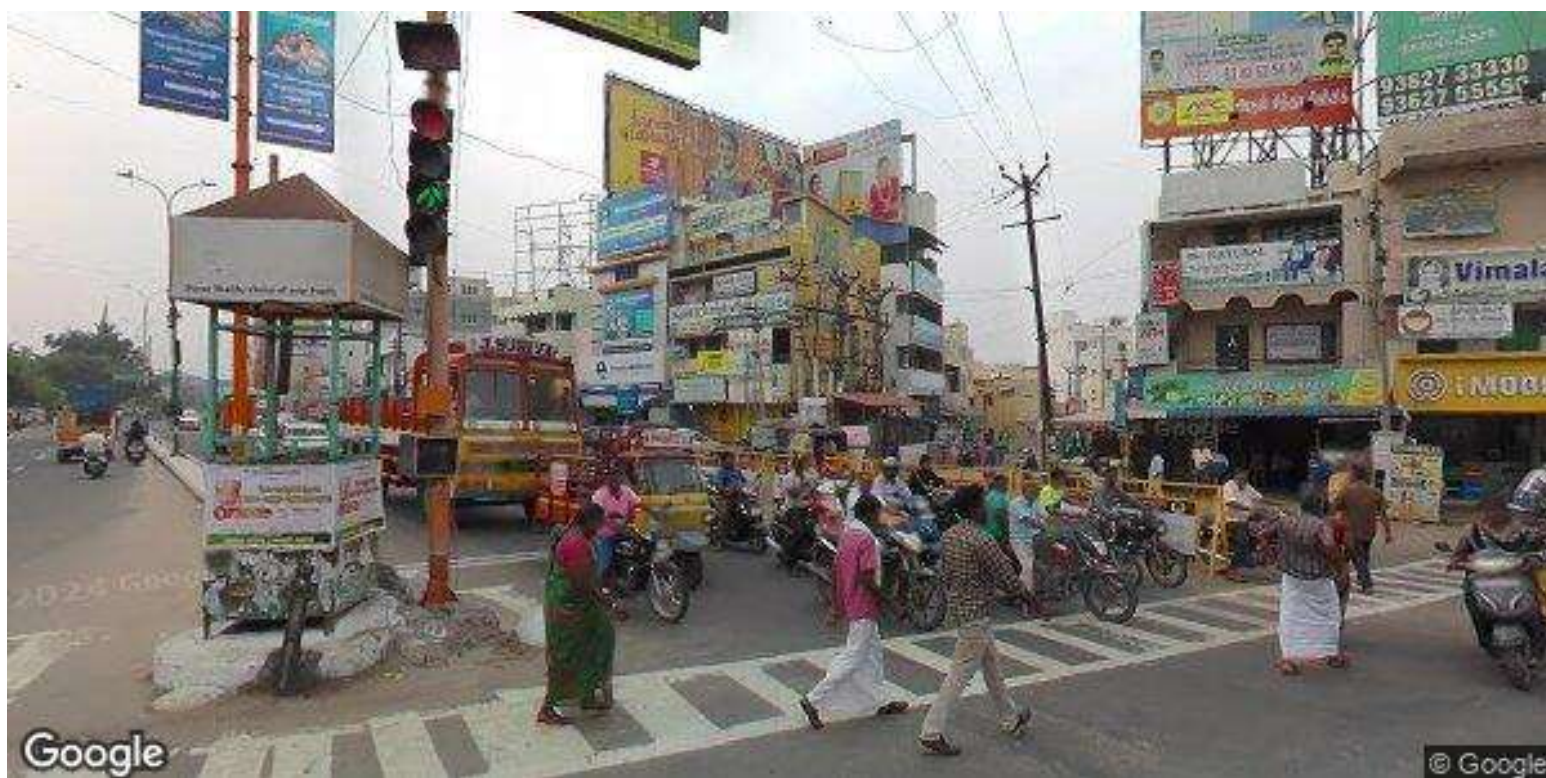
**Risk Type: Turn**

**Risk Level: Medium**

**Speed Limit: 30 KM/Hr**

**Coordinates: 11.33083, 77.72734**

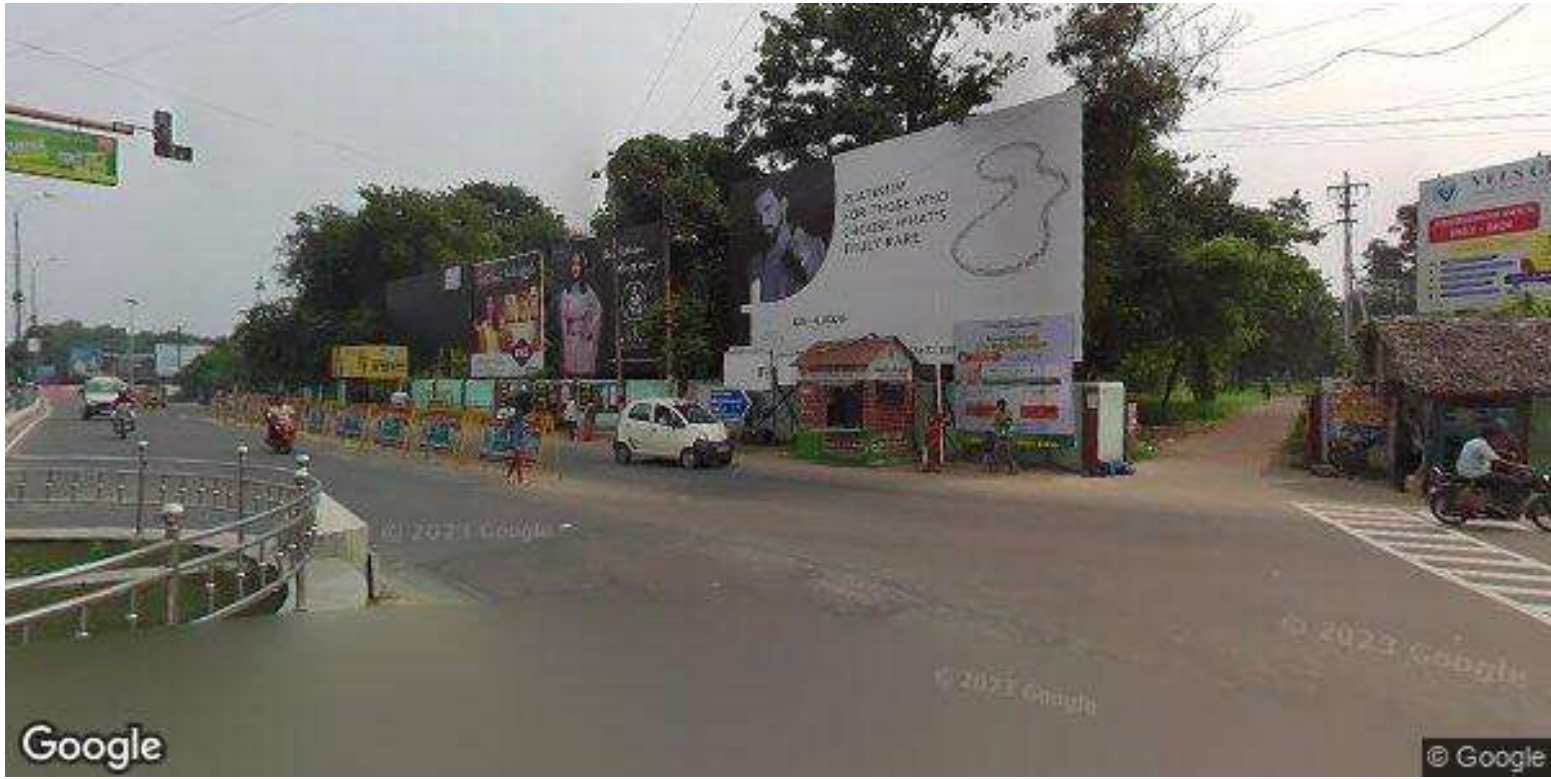
Risk Type: Turn

Risk Level: High

Speed Limit: 15 KM/Hr

Coordinates: 11.33084, 77.72731
