# IndianOil

## JOURNEY RISK MANAGEMENT (JRM) STUDY

### Salem Terminal to SREE ANNAMARR AGENCY

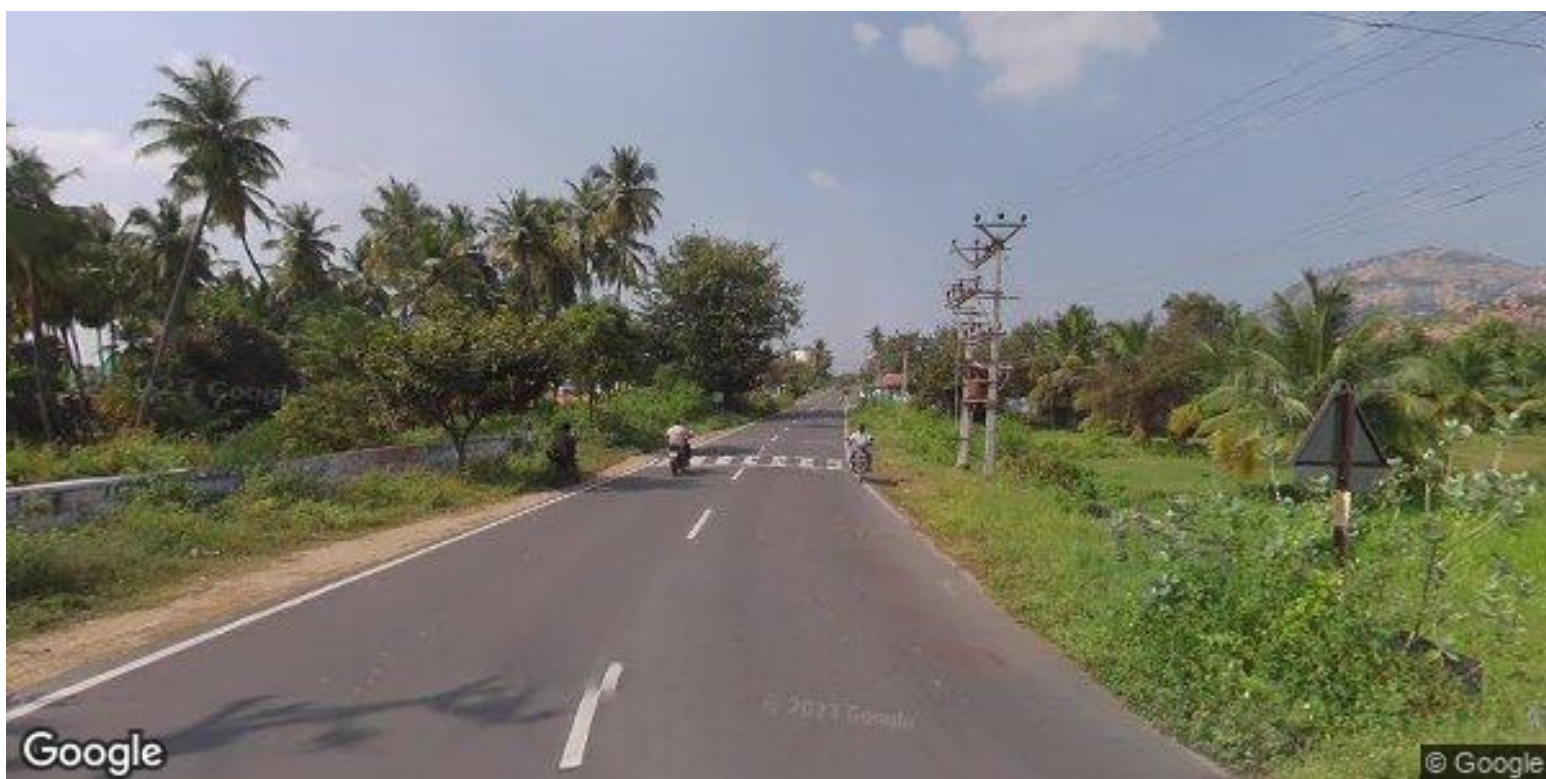
**Risk Type:** Turn  
**Risk Level:** Medium  
**Speed Limit:** 30 KM/Hr  
**Coordinates:** 11.45352, 77.85698

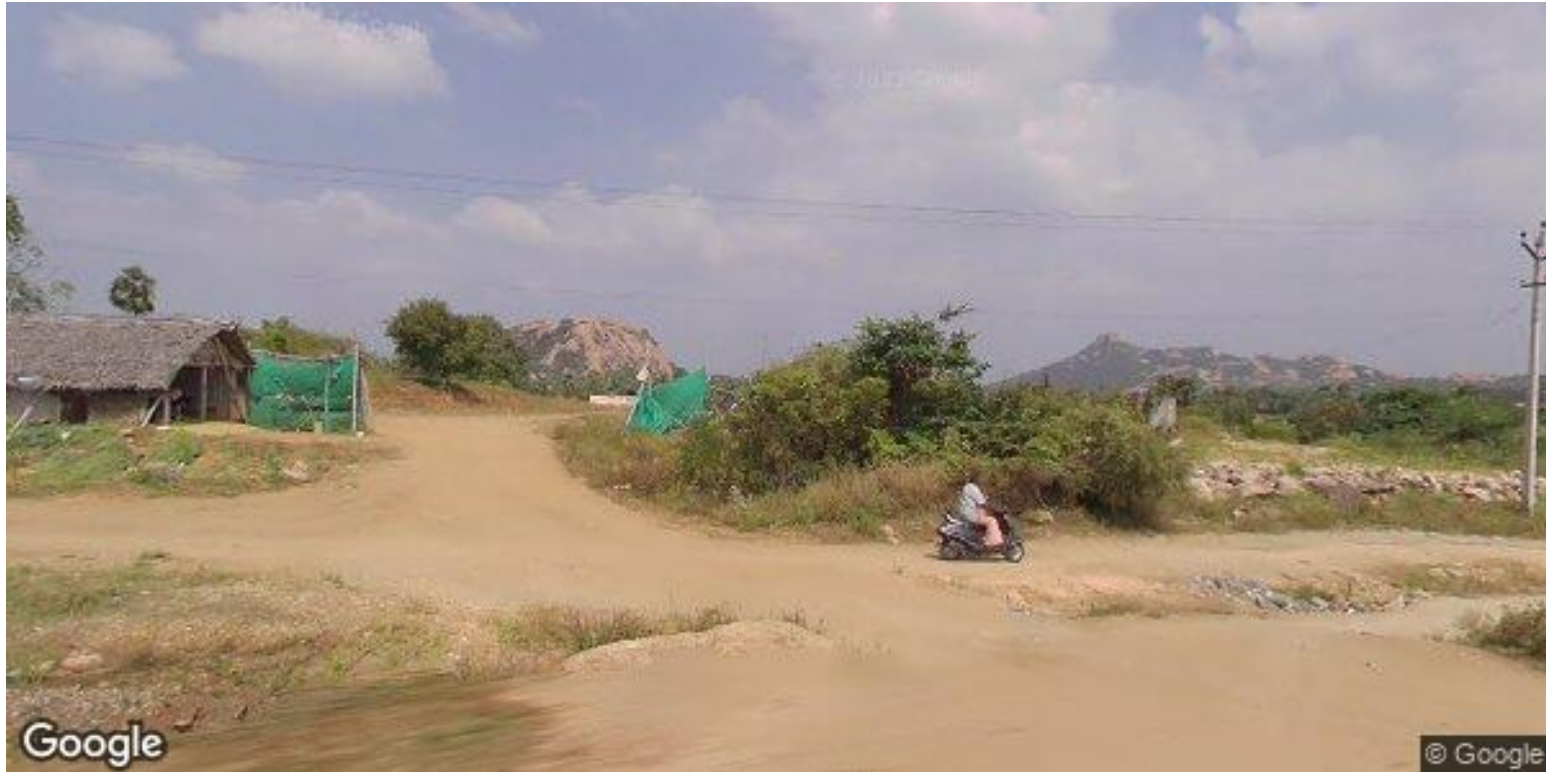
**Risk Type:** Turn  
**Risk Level:** Medium  
**Speed Limit:** 30 KM/Hr  
**Coordinates:** 11.49421, 77.88021

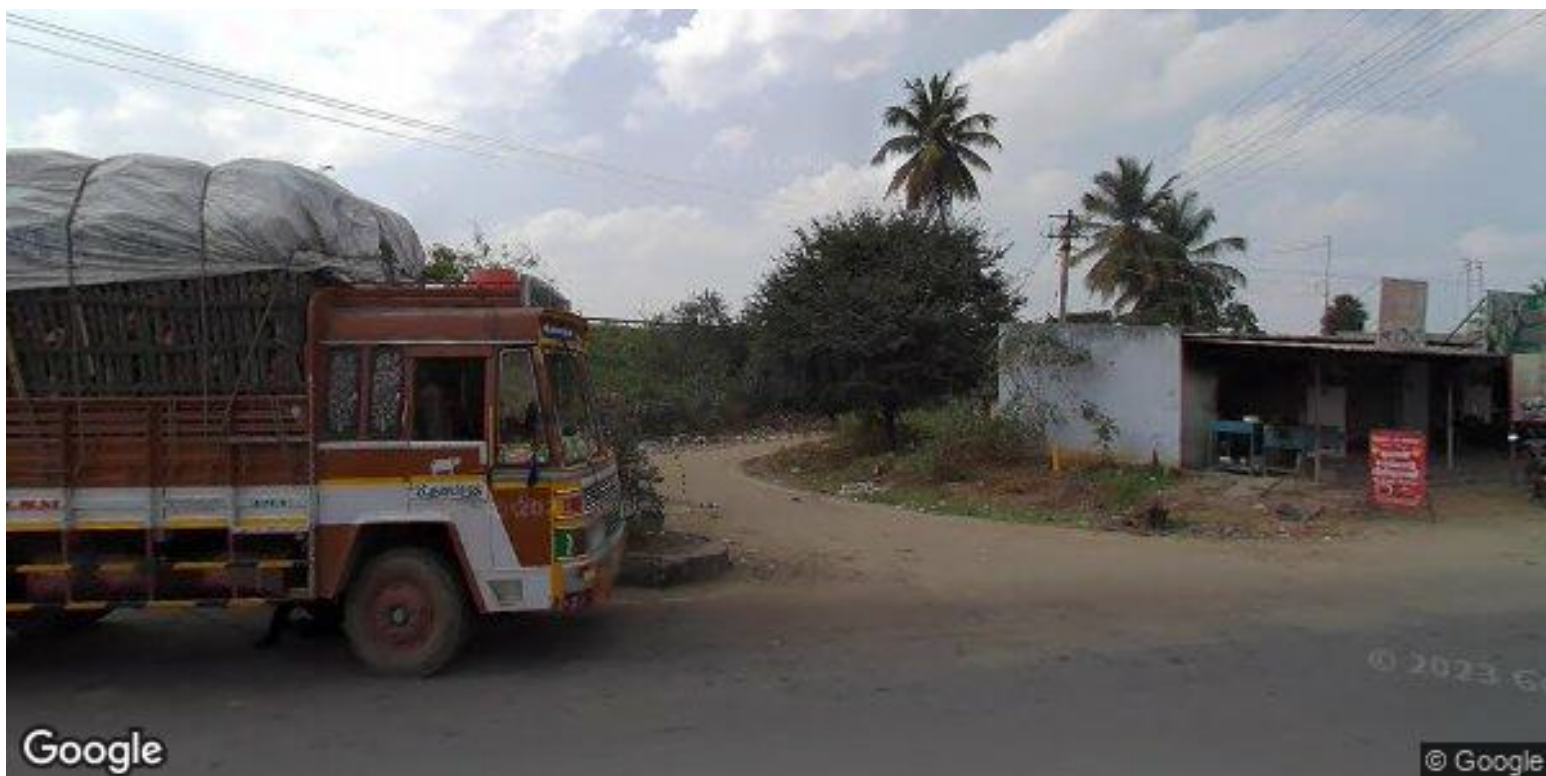
**Risk Type:** Turn  
**Risk Level:** High  
**Speed Limit:** 15 KM/Hr  
**Coordinates:** 11.49383, 77.88526

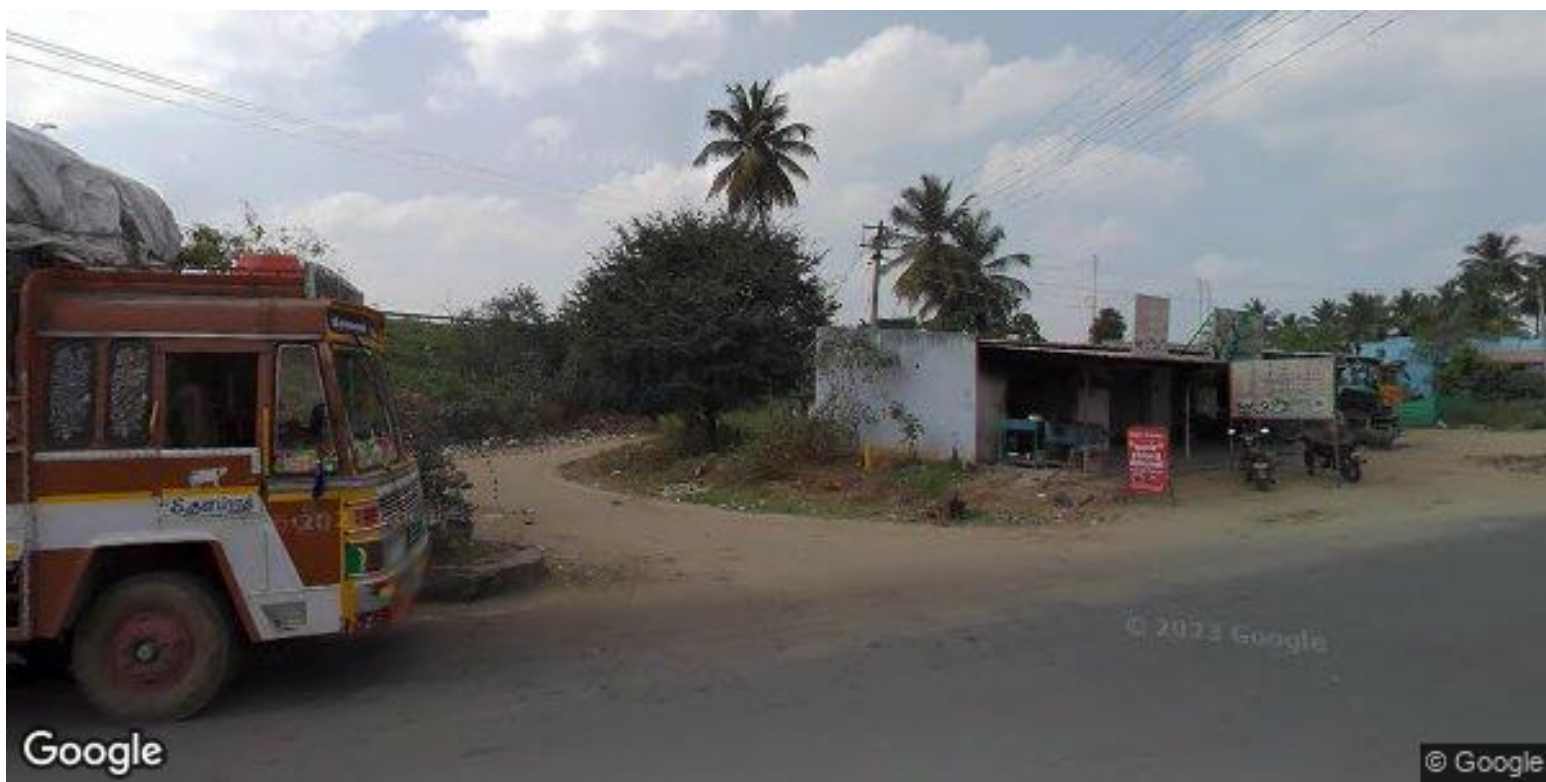
**Coordinates:** 11.49395, 77.88537

**Risk Type:** Turn

**Risk Level:** High

**Speed Limit:** 15 KM/Hr

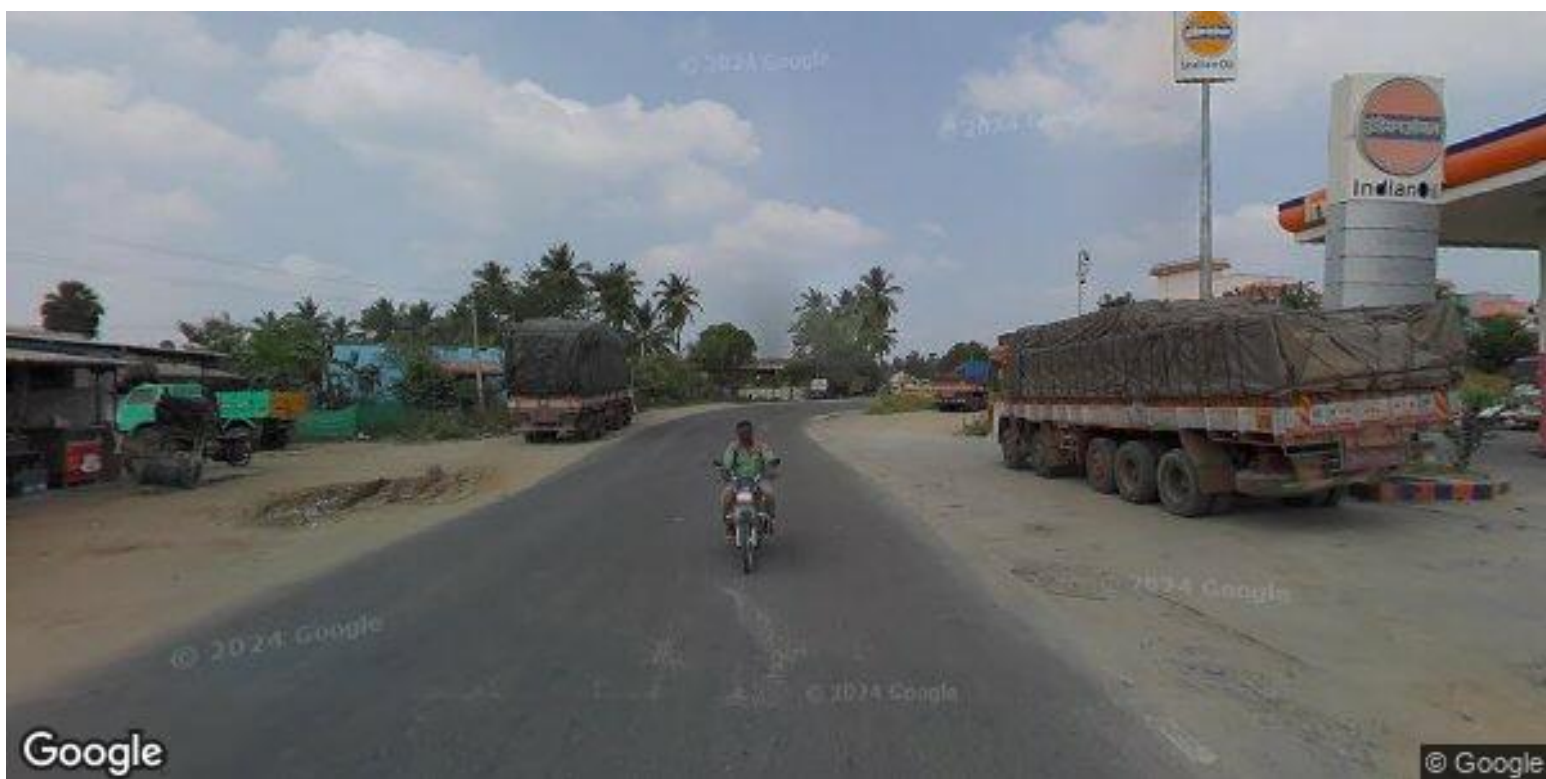
**Coordinates:** 11.49409, 77.88536

**Risk Type:** Turn

**Risk Level:** High

**Speed Limit:** 15 KM/Hr

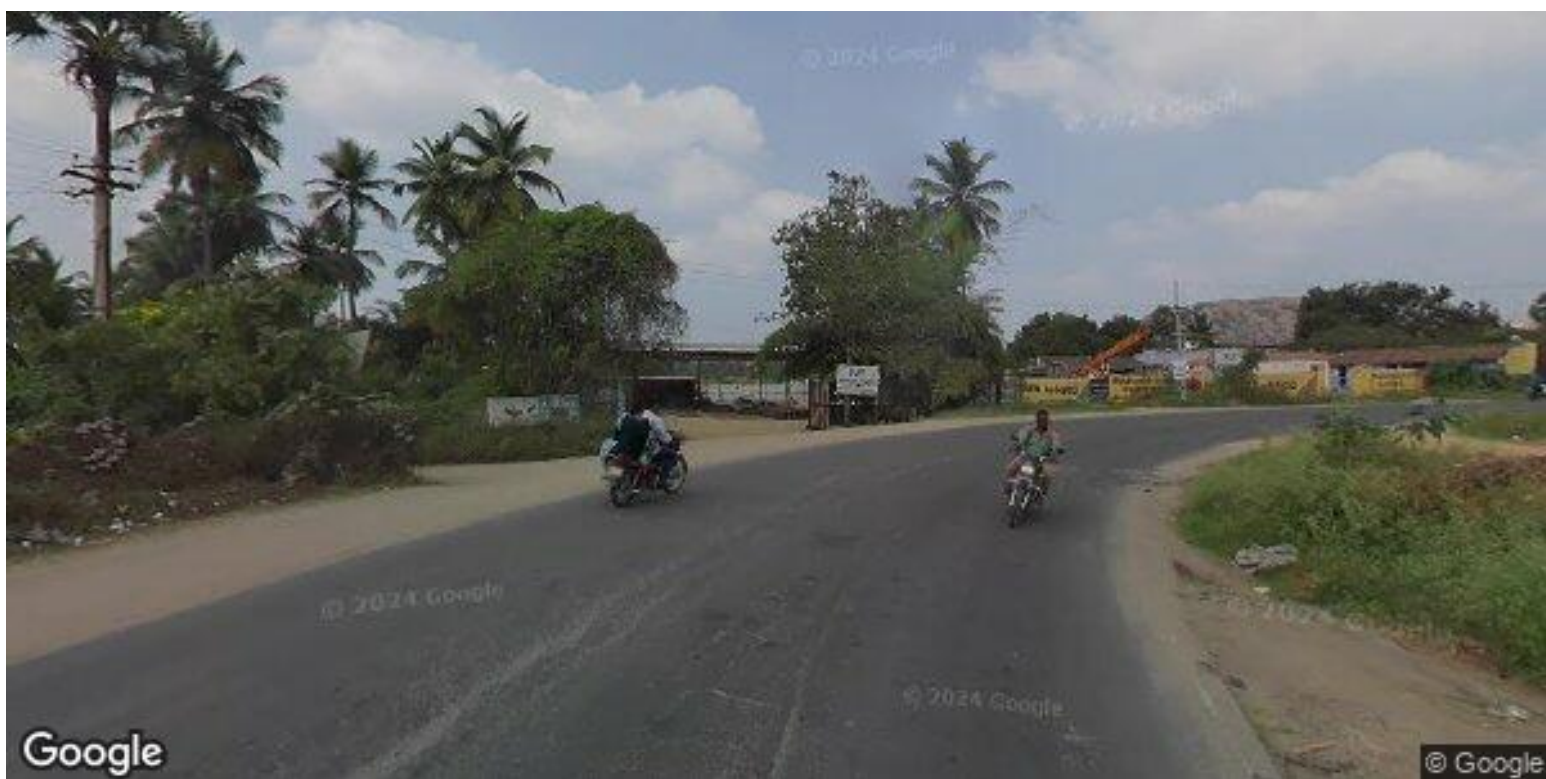
**Risk Type:** Turn  
**Risk Level:** Medium  
**Speed Limit:** 30 KM/Hr  
**Coordinates:** 11.49435, 77.88499

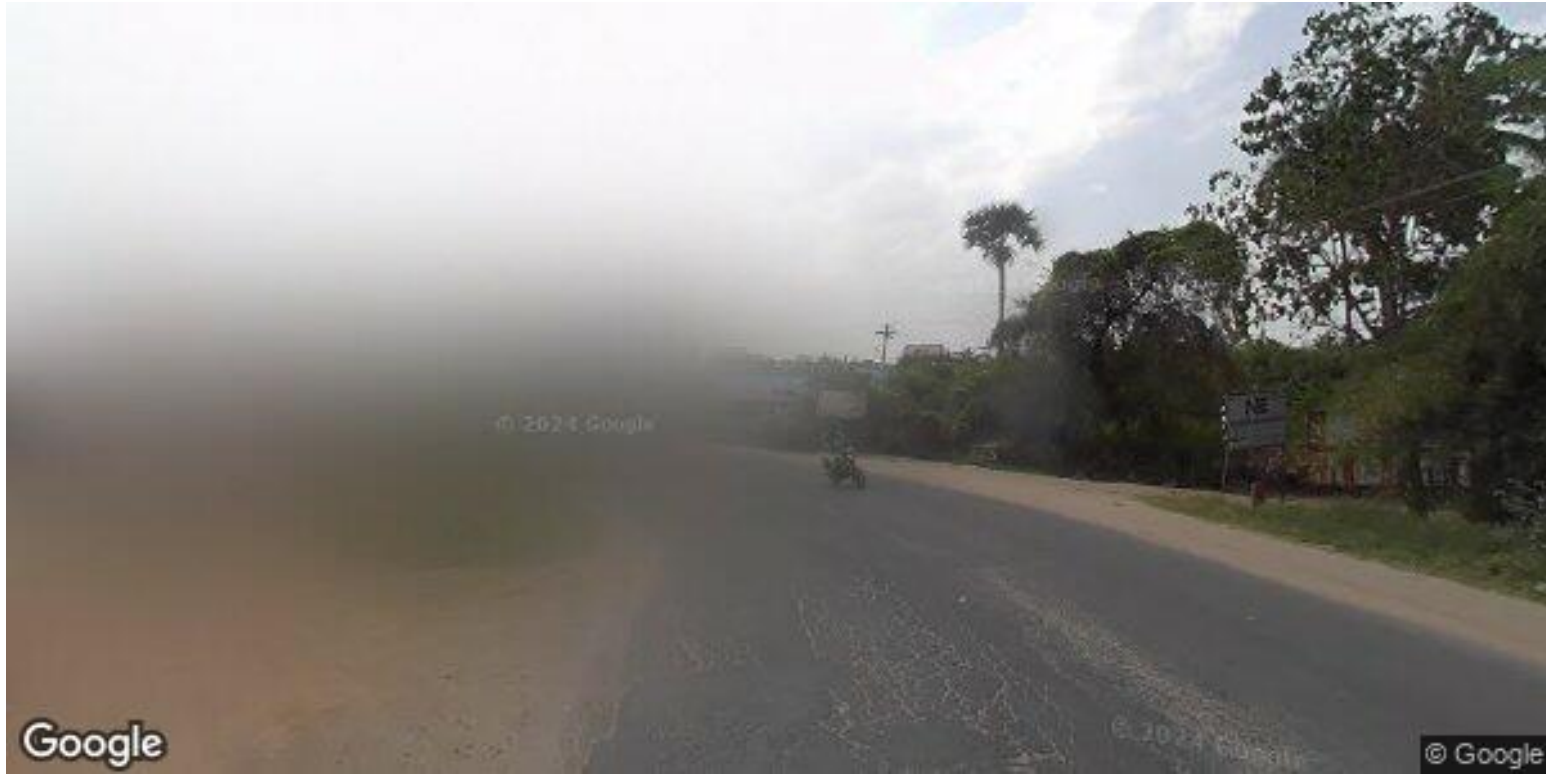
**Risk Type:** Turn  
**Risk Level:** Medium  
**Speed Limit:** 30 KM/Hr  
**Coordinates:** 11.49465, 77.88488

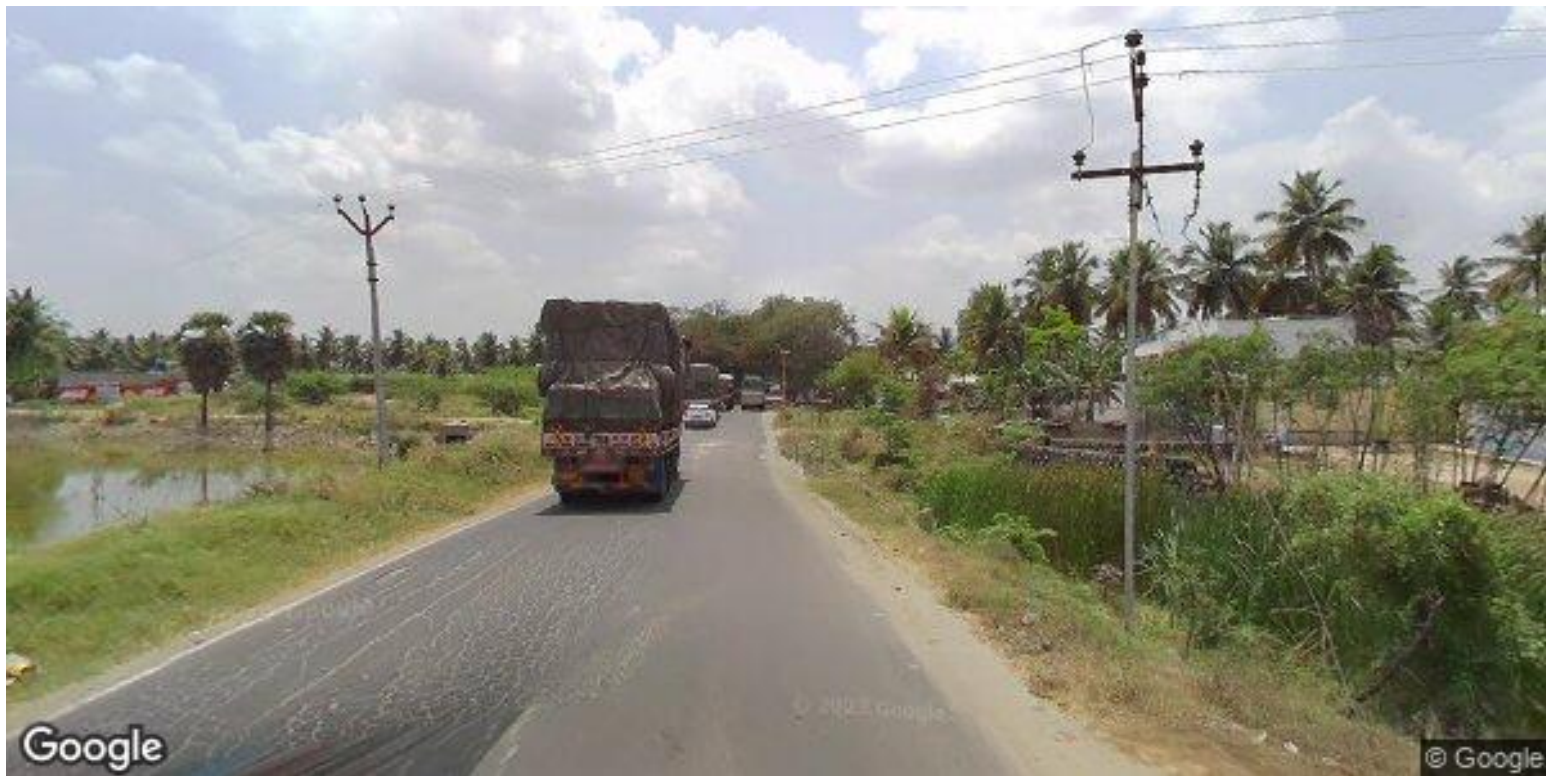
**Risk Type:** Turn  
**Risk Level:** Medium  
**Speed Limit:** 30 KM/Hr  
**Coordinates:** 11.56072, 77.89919

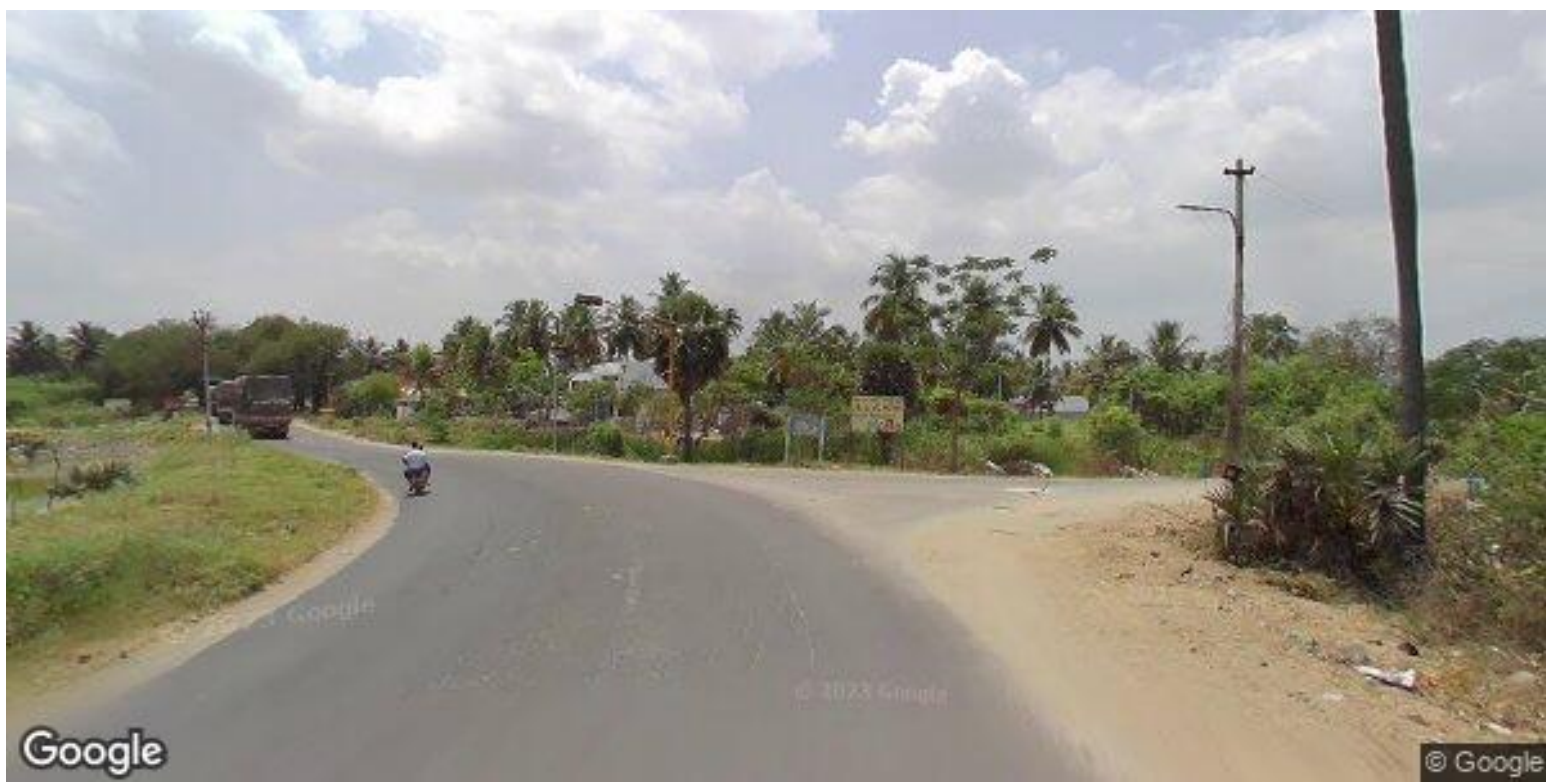
**Coordinates:** 11.56096, 77.89931

**Risk Type:** Turn

**Risk Level:** Medium

**Speed Limit:** 30 KM/Hr

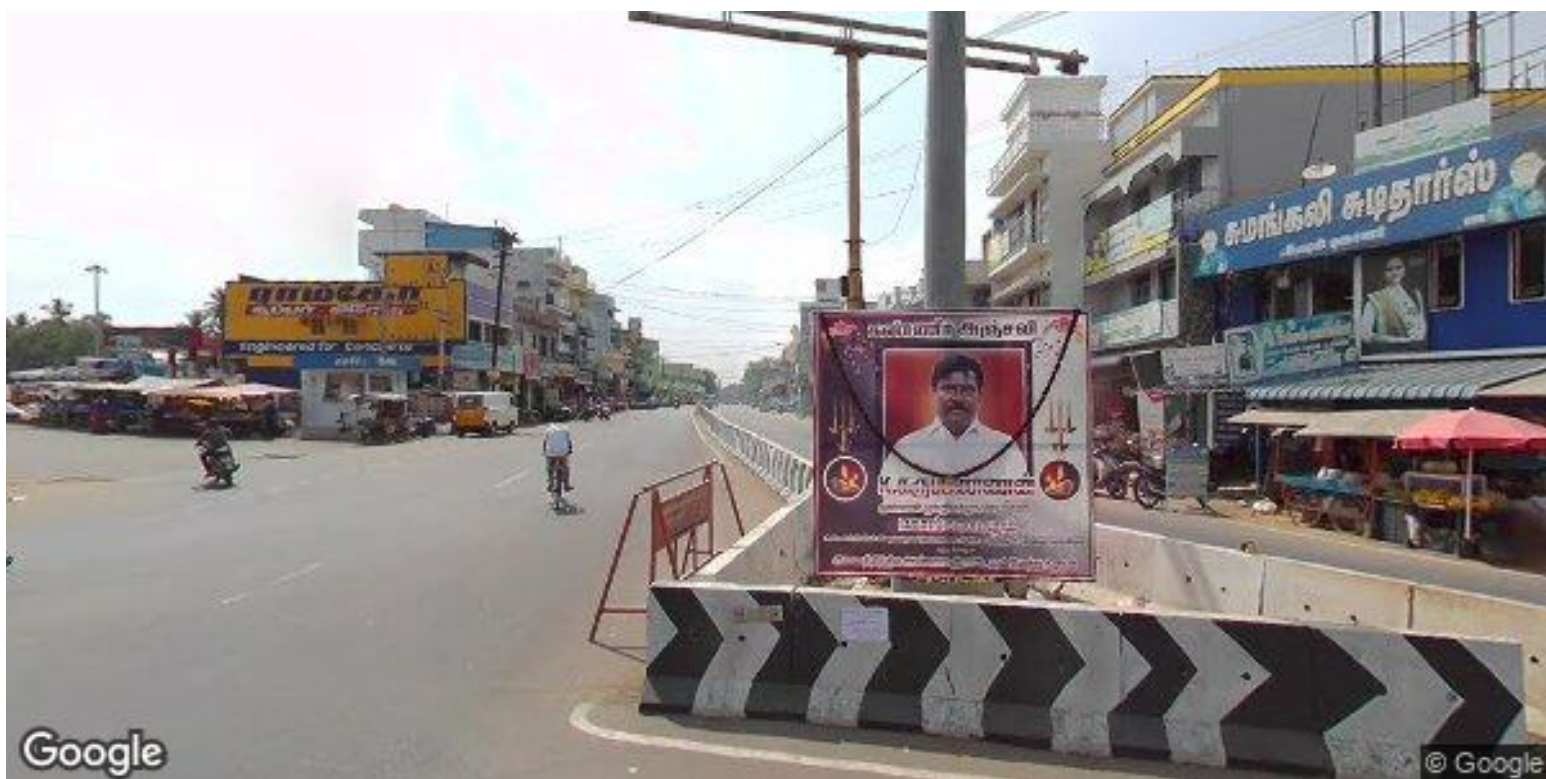
**Coordinates:** 11.57035, 77.90223

**Risk Type:** Turn

**Risk Level:** High

**Speed Limit:** 15 KM/Hr

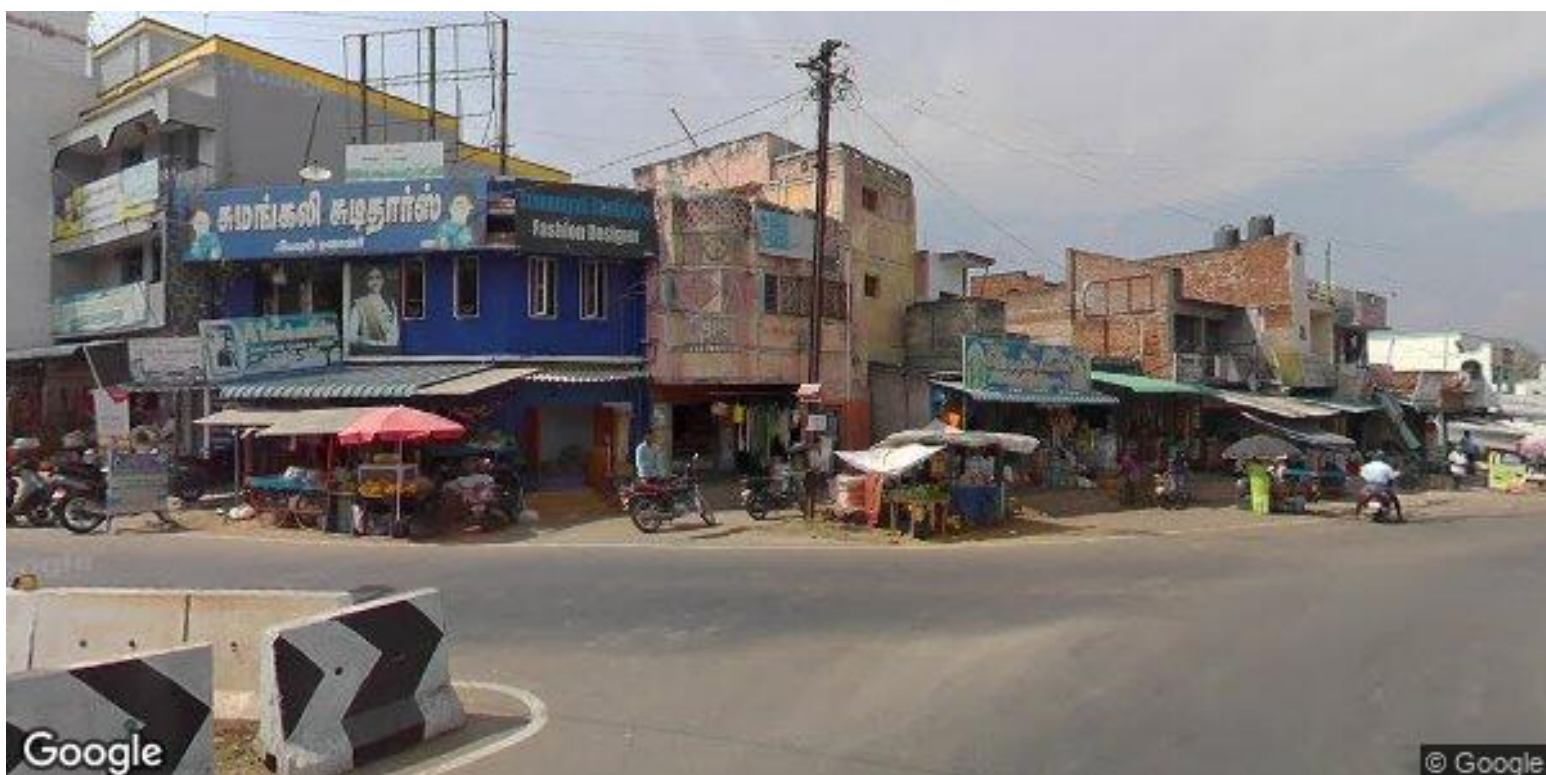
**Risk Type:** Turn  
**Risk Level:** Medium  
**Speed Limit:** 30 KM/Hr  
**Coordinates:** 11.57041, 77.90221

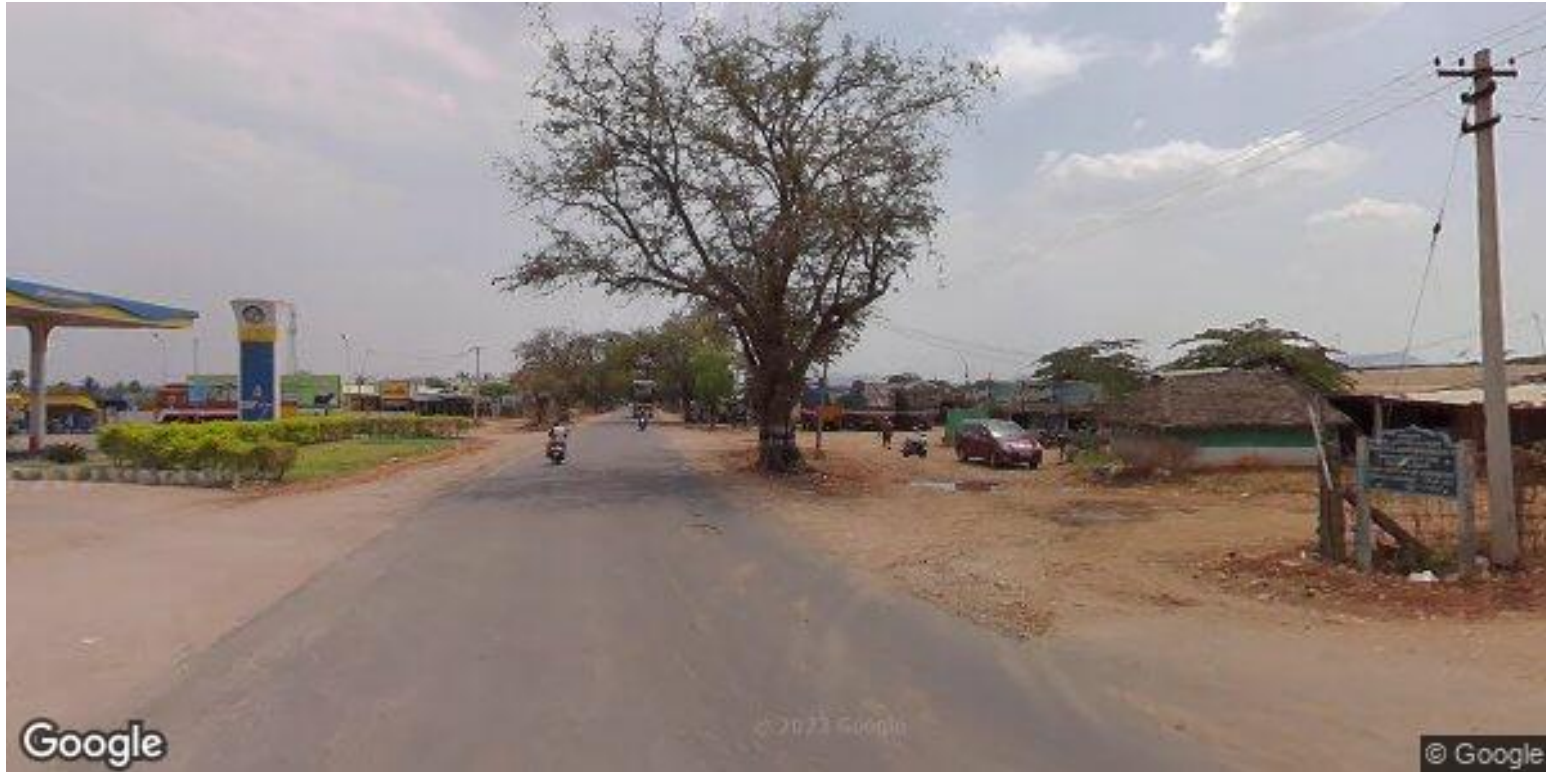
**Risk Type:** Turn  
**Risk Level:** Medium  
**Speed Limit:** 30 KM/Hr  
**Coordinates:** 11.58279, 77.90658

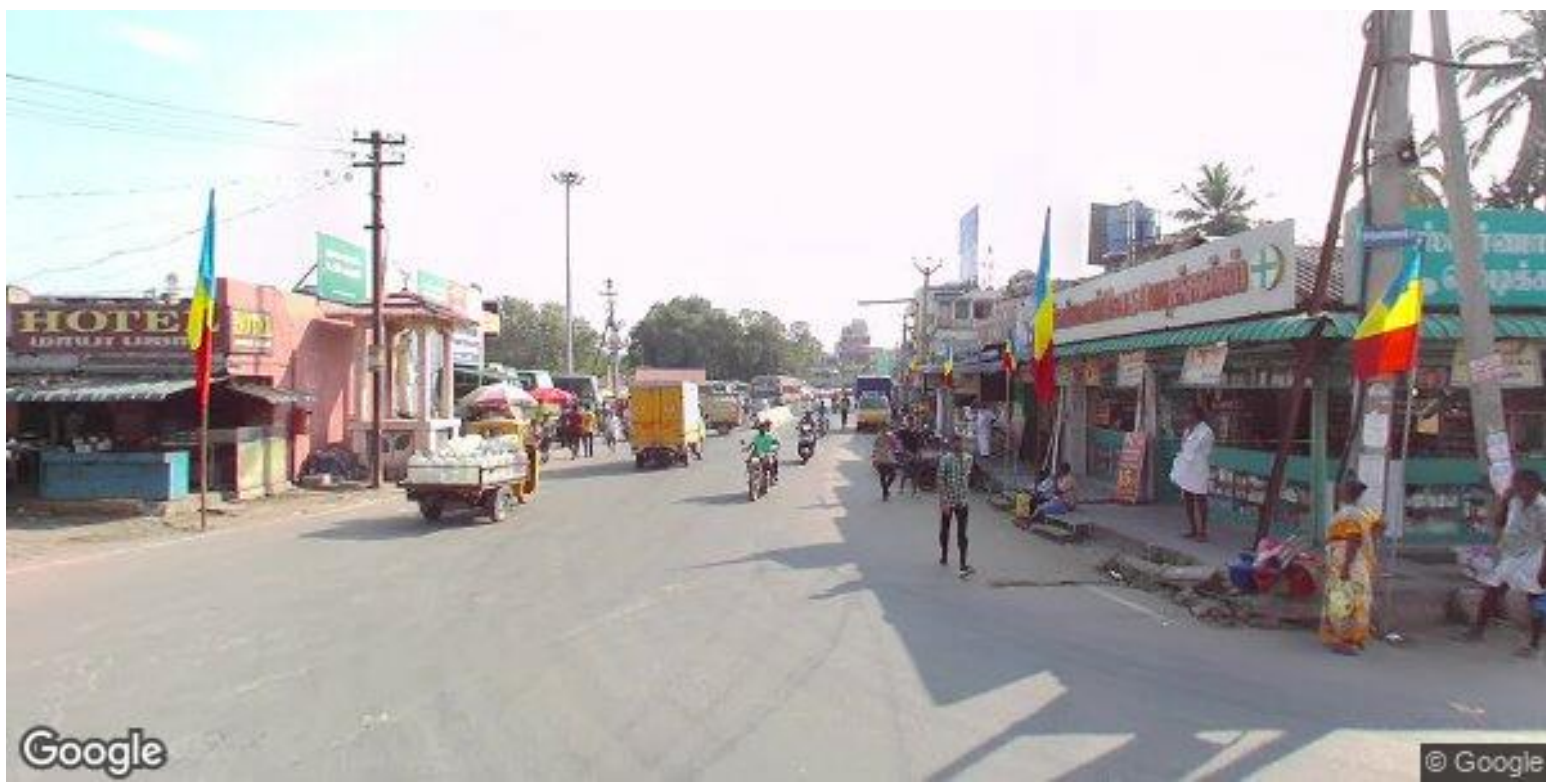
**Coordinates:** 11.69590, 77.97114

**Risk Type:** Blind Spot

**Risk Level:** Blind Spot

**Speed Limit:** 10 KM/Hr

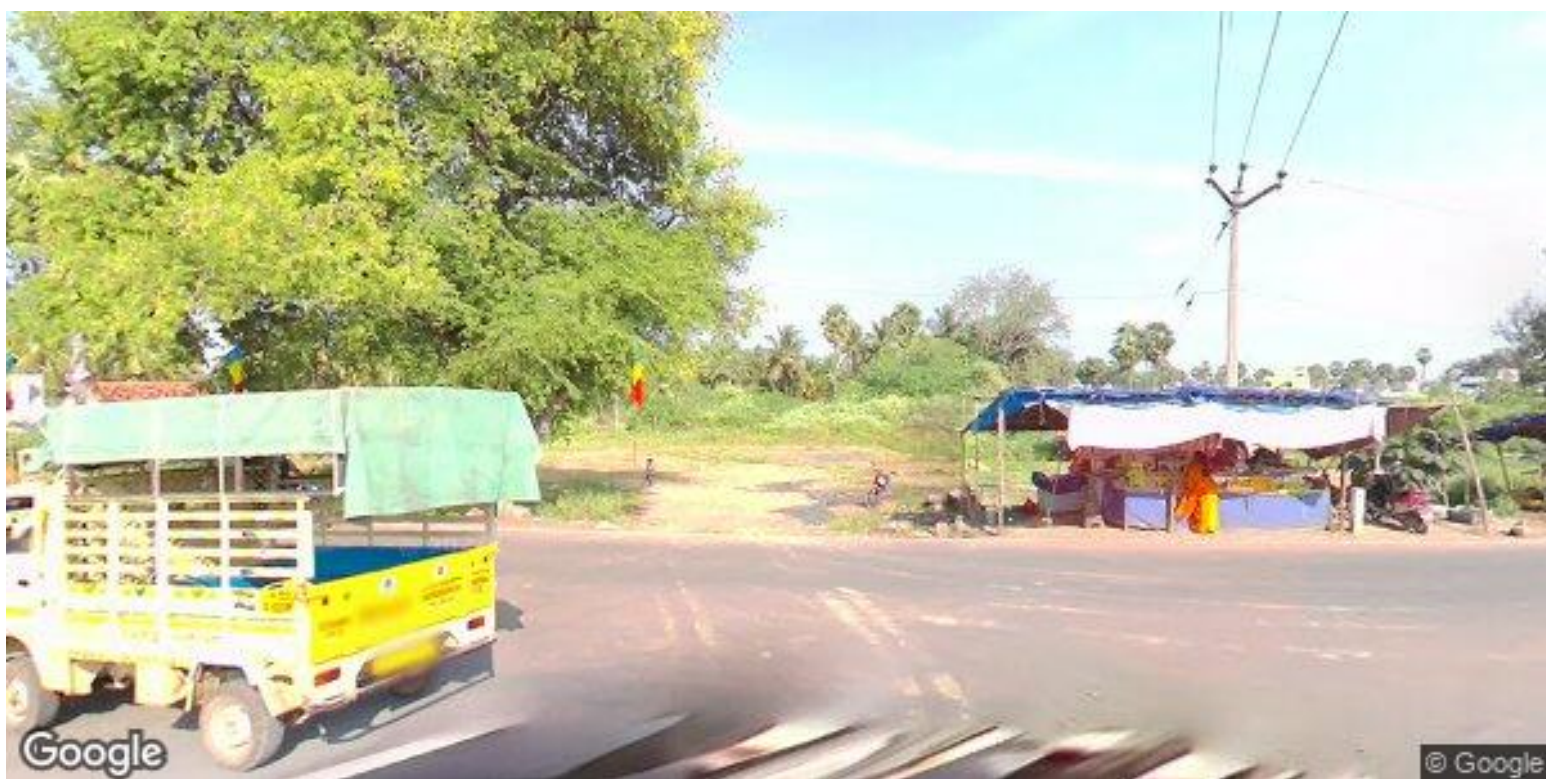
**Coordinates:** 11.70133, 77.96363

**Risk Type:** Turn

**Risk Level:** High

**Speed Limit:** 15 KM/Hr

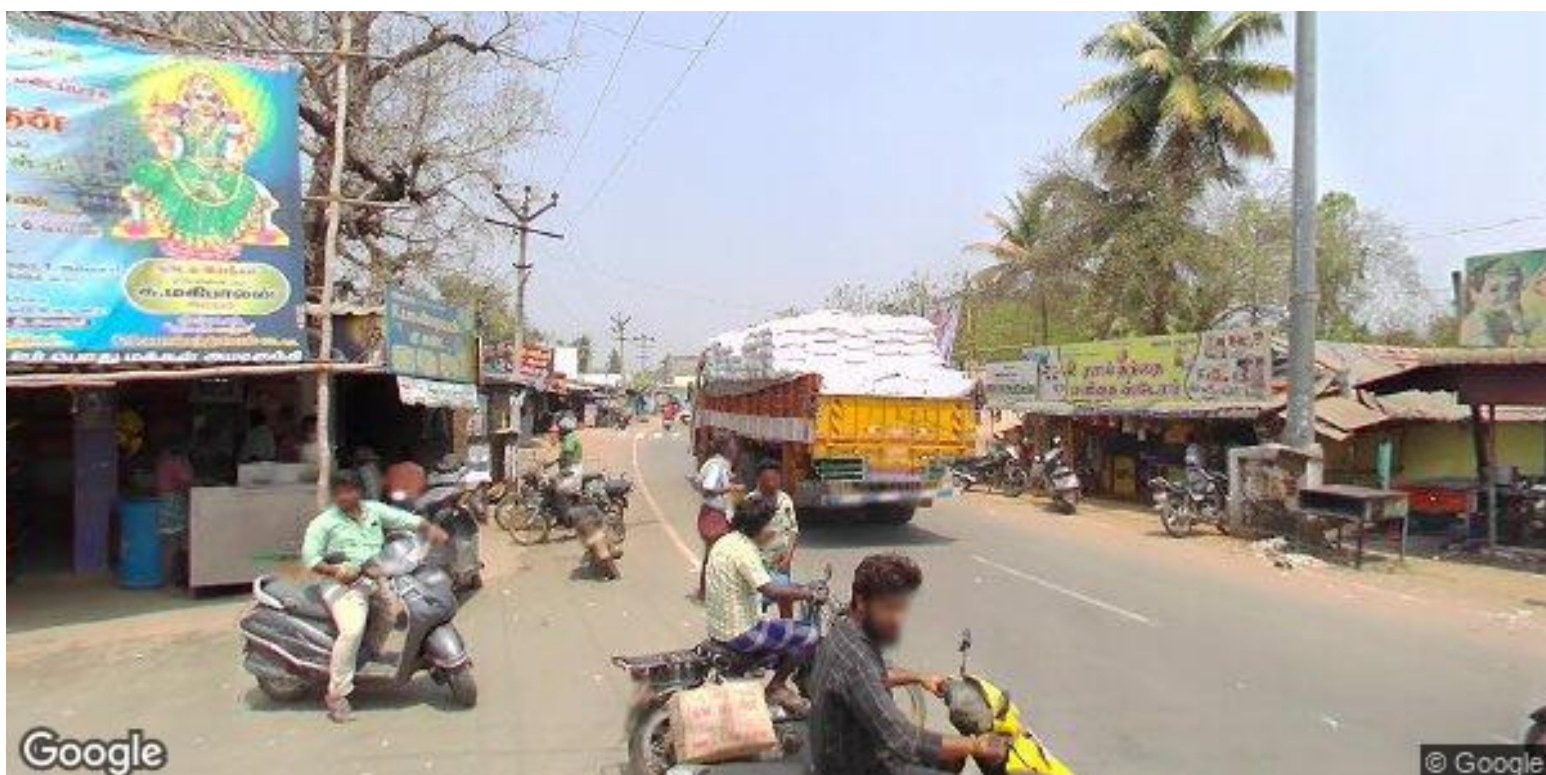
**Risk Type:** Turn  
**Risk Level:** Medium  
**Speed Limit:** 30 KM/Hr  
**Coordinates:** 11.73427, 77.96723

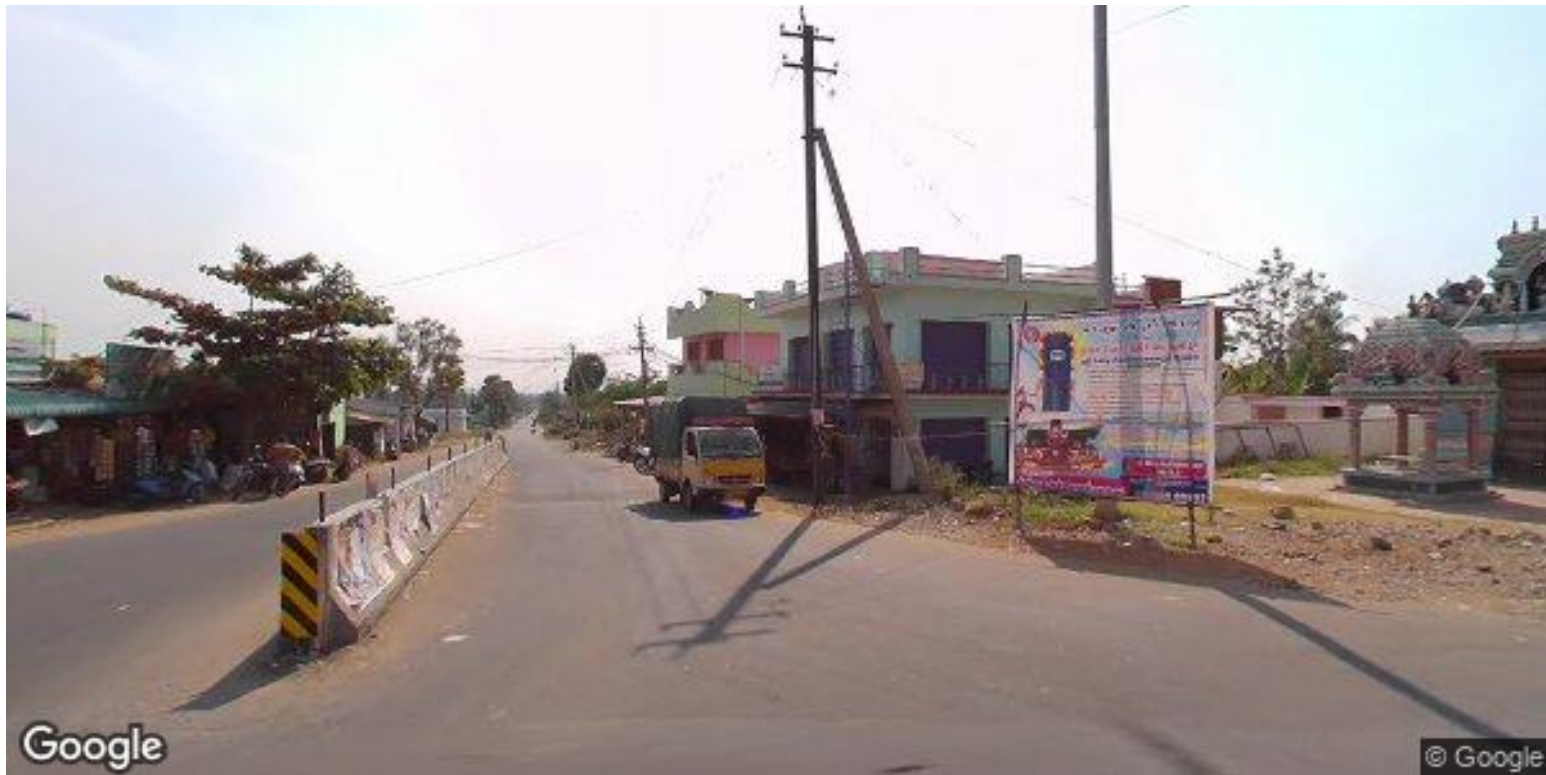
**Risk Type:** Turn  
**Risk Level:** High  
**Speed Limit:** 15 KM/Hr  
**Coordinates:** 11.77772, 77.99628

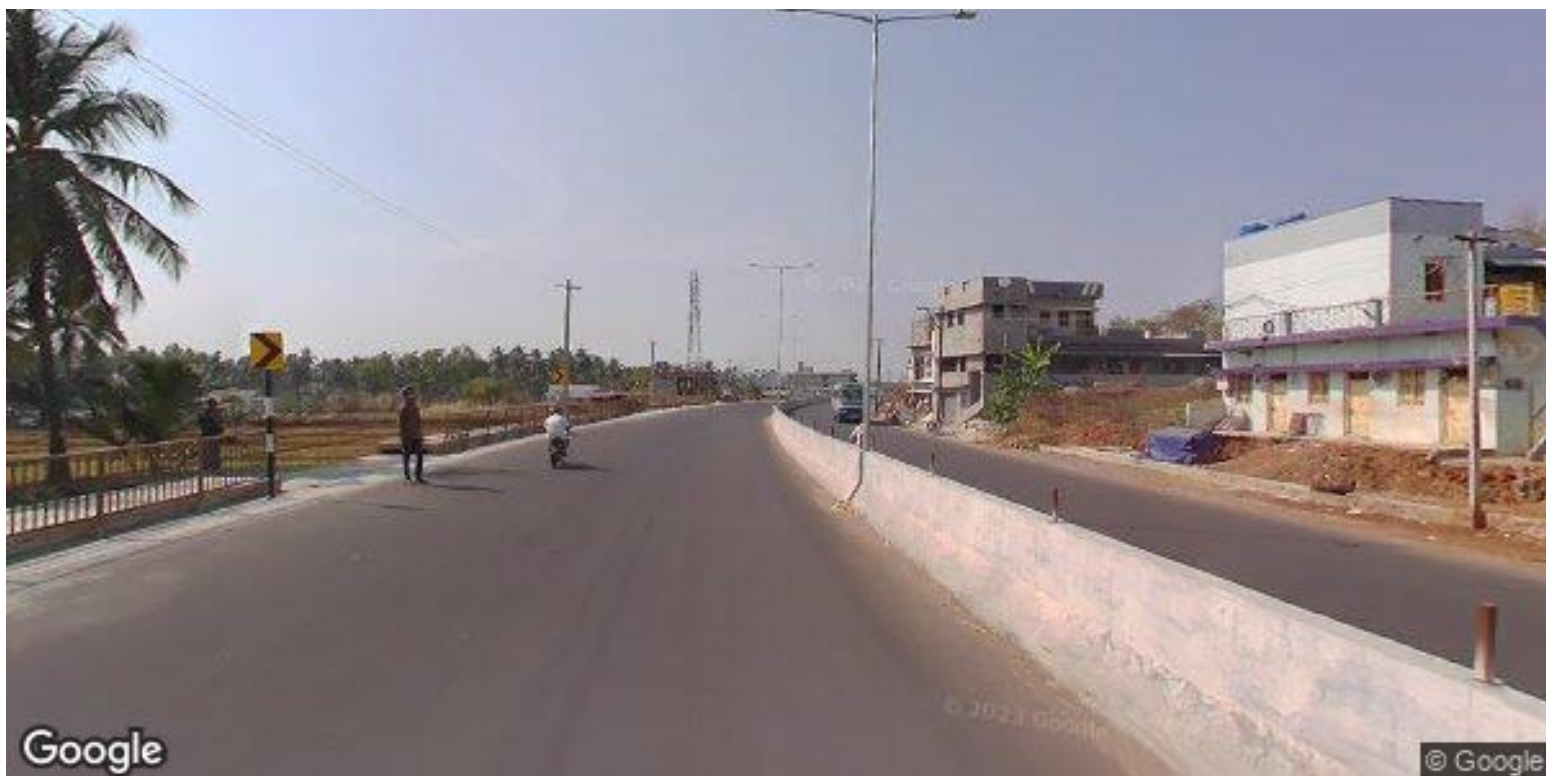
**Risk Type:** Blind Spot  
**Risk Level:** Blind Spot  
**Speed Limit:** 10 KM/Hr  
**Coordinates:** 11.78535, 77.98924
