## JOURNEY RISK MANAGEMENT (JRM) STUDY

### Salem Terminal to PARAMATHY-VELUR TALUK LOA

### Route Safety Analysis Report: Sangagiri to Vasanthapuram, Tamil Nadu

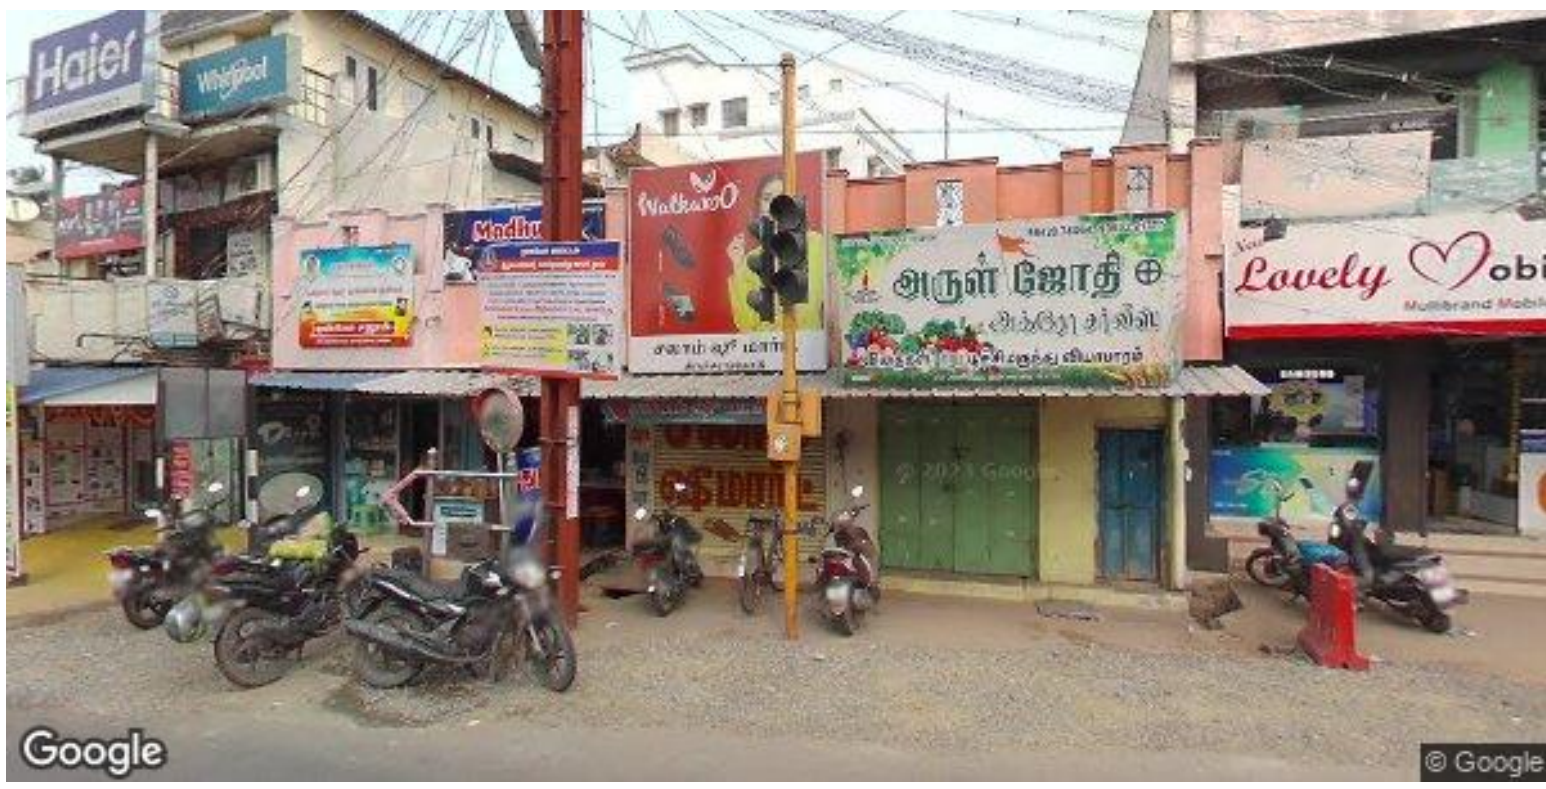
| | Risk Type | Risk Level | Coordinates | Speed Limit |
|---|---|---|---|---|
| 6 | Turn | High | 11.37850, 77.89453 | 15 KM/Hr |

Risk Type: Turn

Risk Level: High

Speed Limit: 15 KM/Hr

Coordinates: 11.37850, 77.89453
