# IndianOil

## JOURNEY RISK MANAGEMENT (JRM) STUDY

### Salem Terminal TO SUBRAMANIAM PETROLEUMS

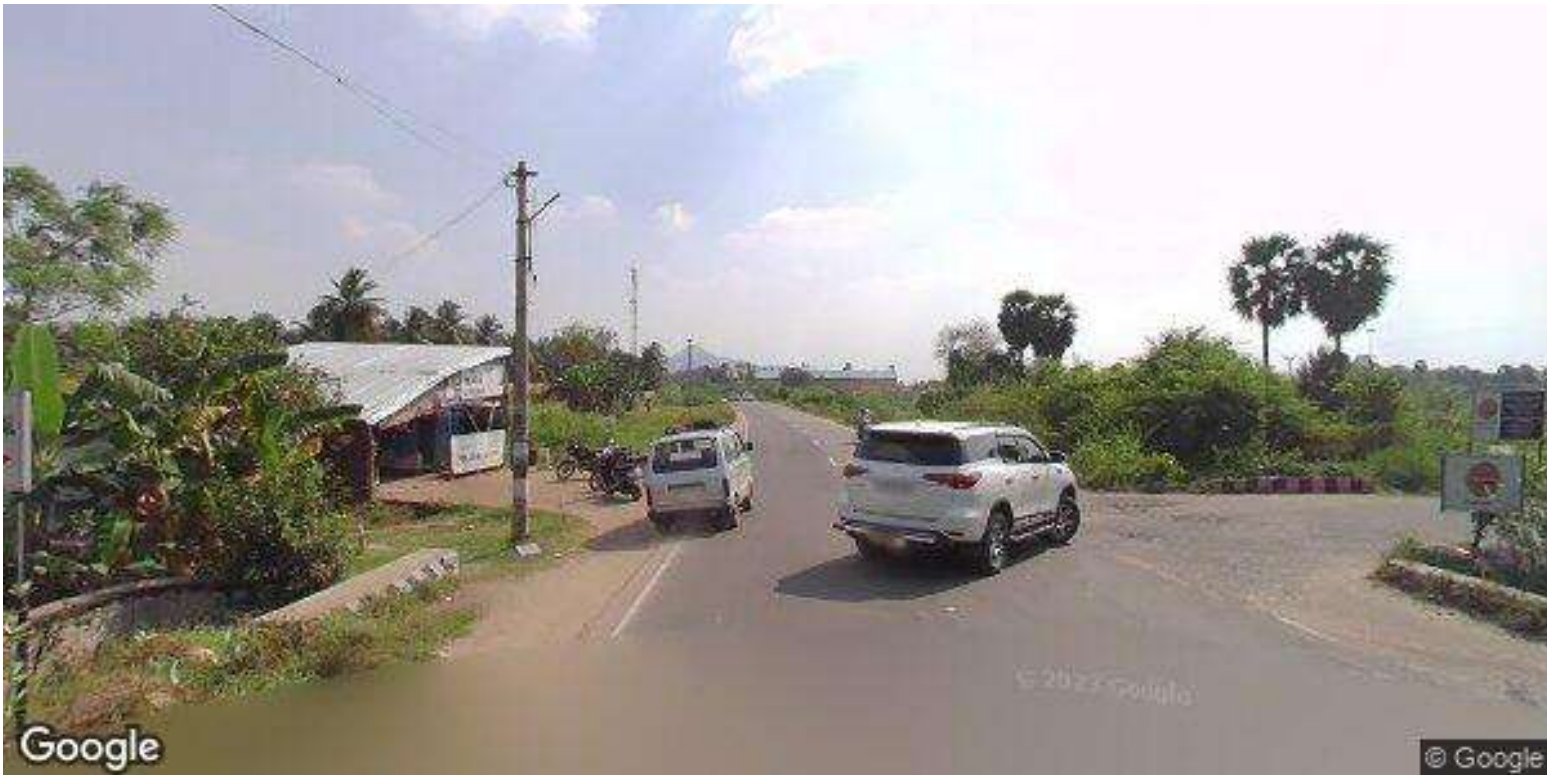
Coordinates: 11.44029, 77.87544

Risk Type: Turn

Risk Level: High

Speed Limit: 15 KM/Hr

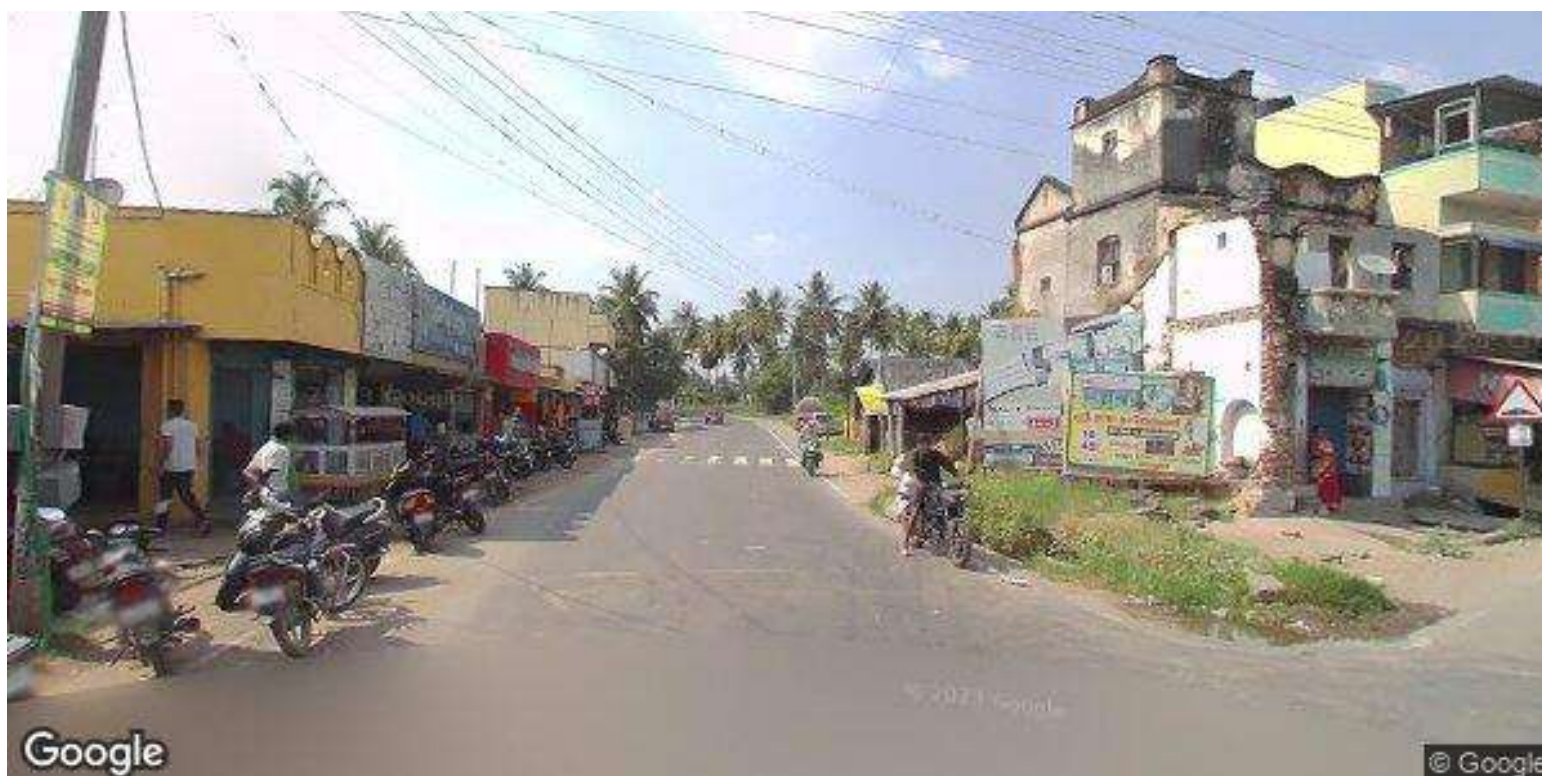
**Coordinates:** 11.45007, 77.87201

**Risk Type:** Turn

**Risk Level:** High

**Speed Limit:** 15 KM/Hr

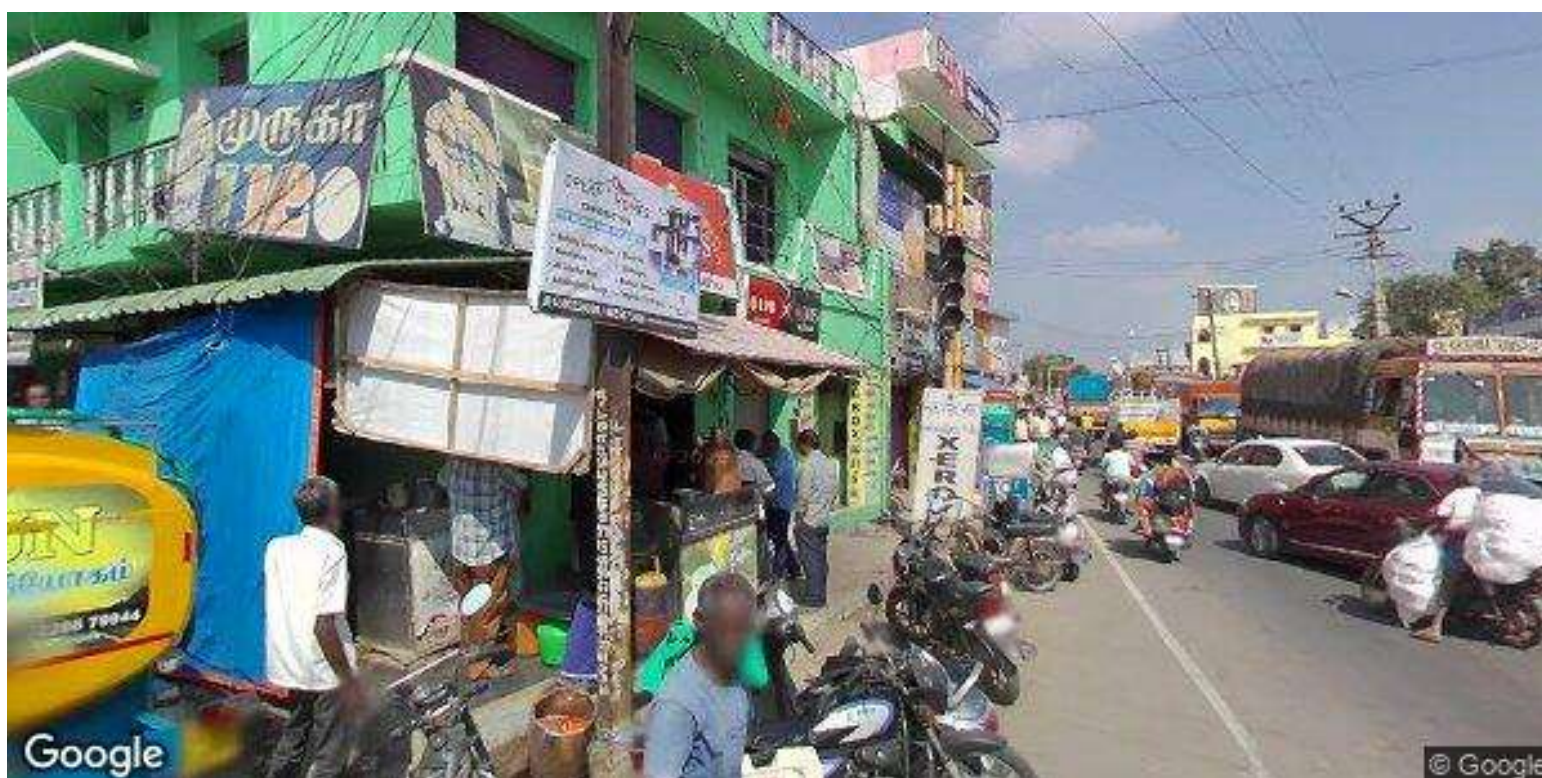
**Coordinates:** 11.47407, 77.86839

**Risk Type:** Turn

**Risk Level:** High

**Speed Limit:** 15 KM/Hr

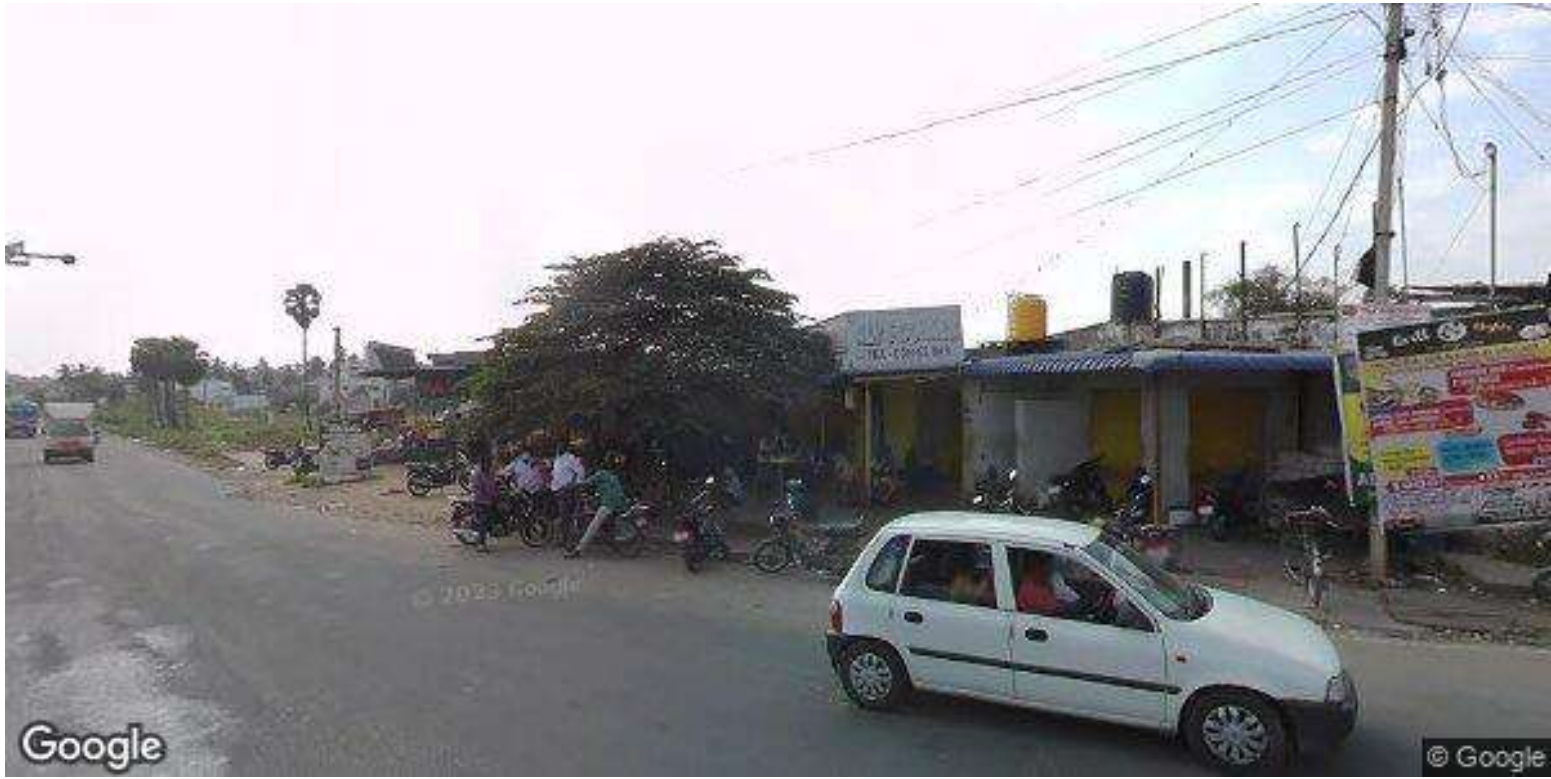
**Risk Type:** Turn  
**Risk Level:** High  
**Speed Limit:** 15 KM/Hr  
**Coordinates:** 11.48369, 77.88781

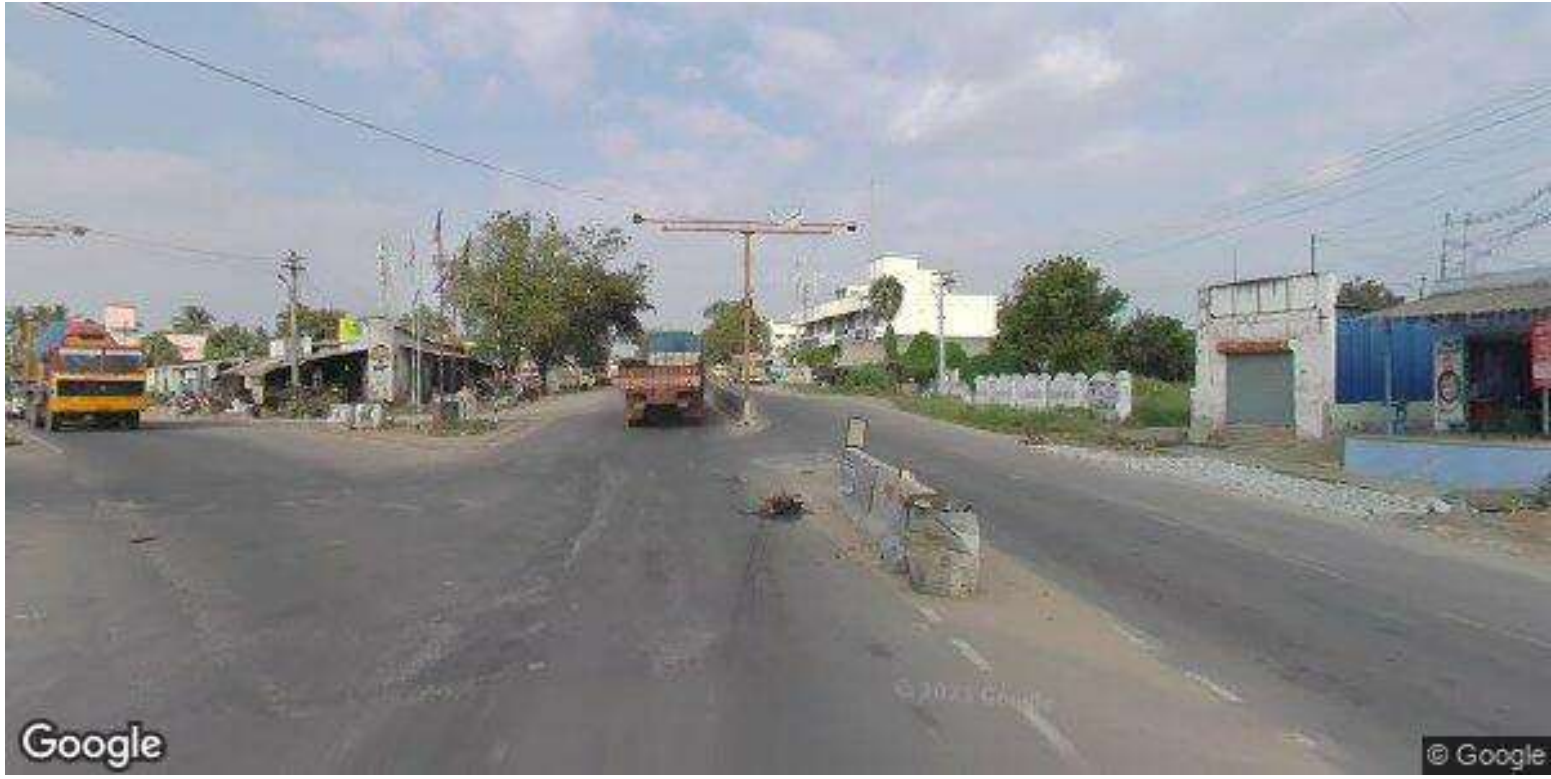
**Risk Type:** Turn  
**Risk Level:** Medium  
**Speed Limit:** 30 KM/Hr  
**Coordinates:** 11.48370, 77.88787

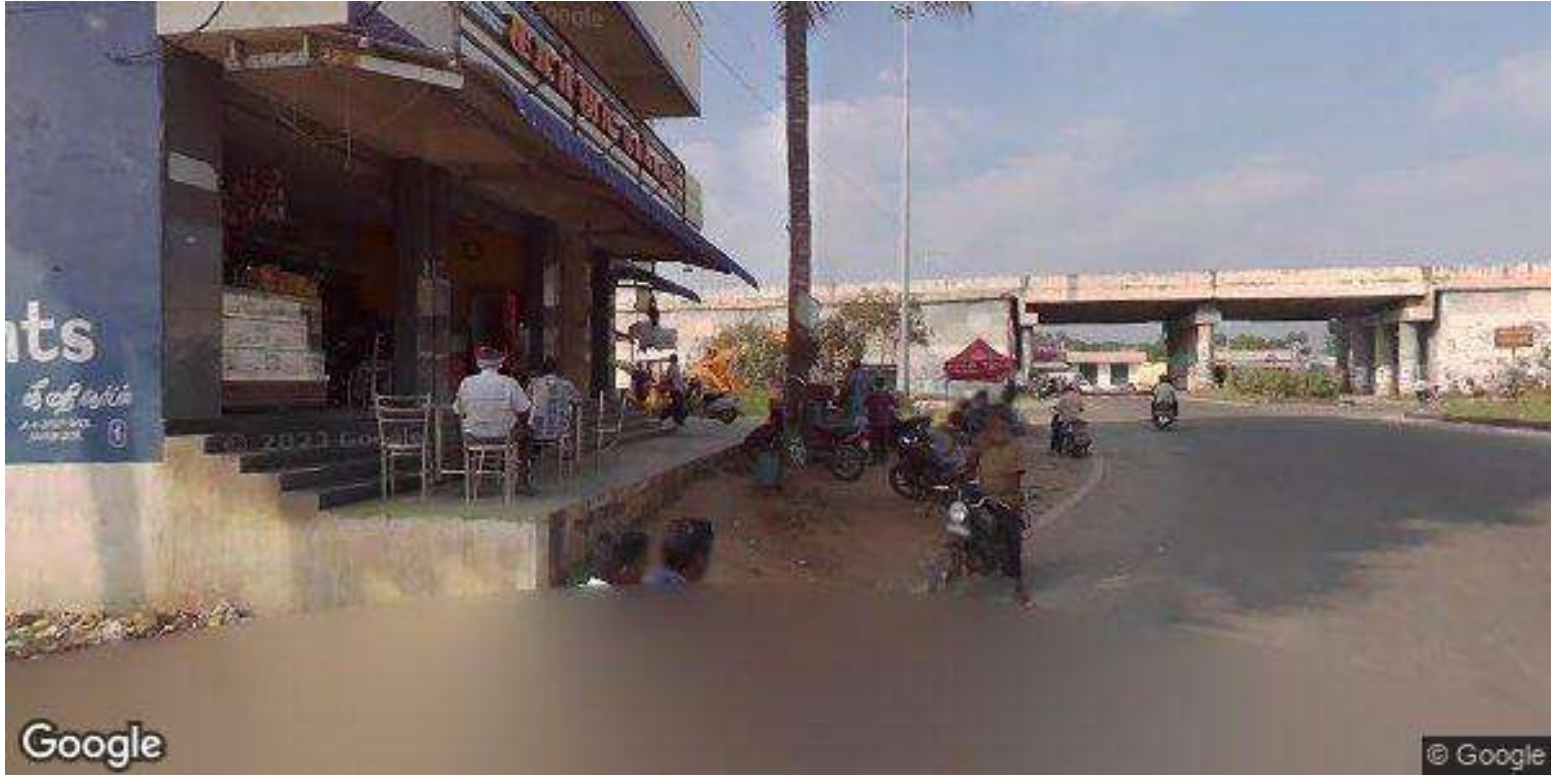
**Risk Type:** Turn  
**Risk Level:** Medium  
**Speed Limit:** 30 KM/Hr  
**Coordinates:** 11.49149, 77.89601

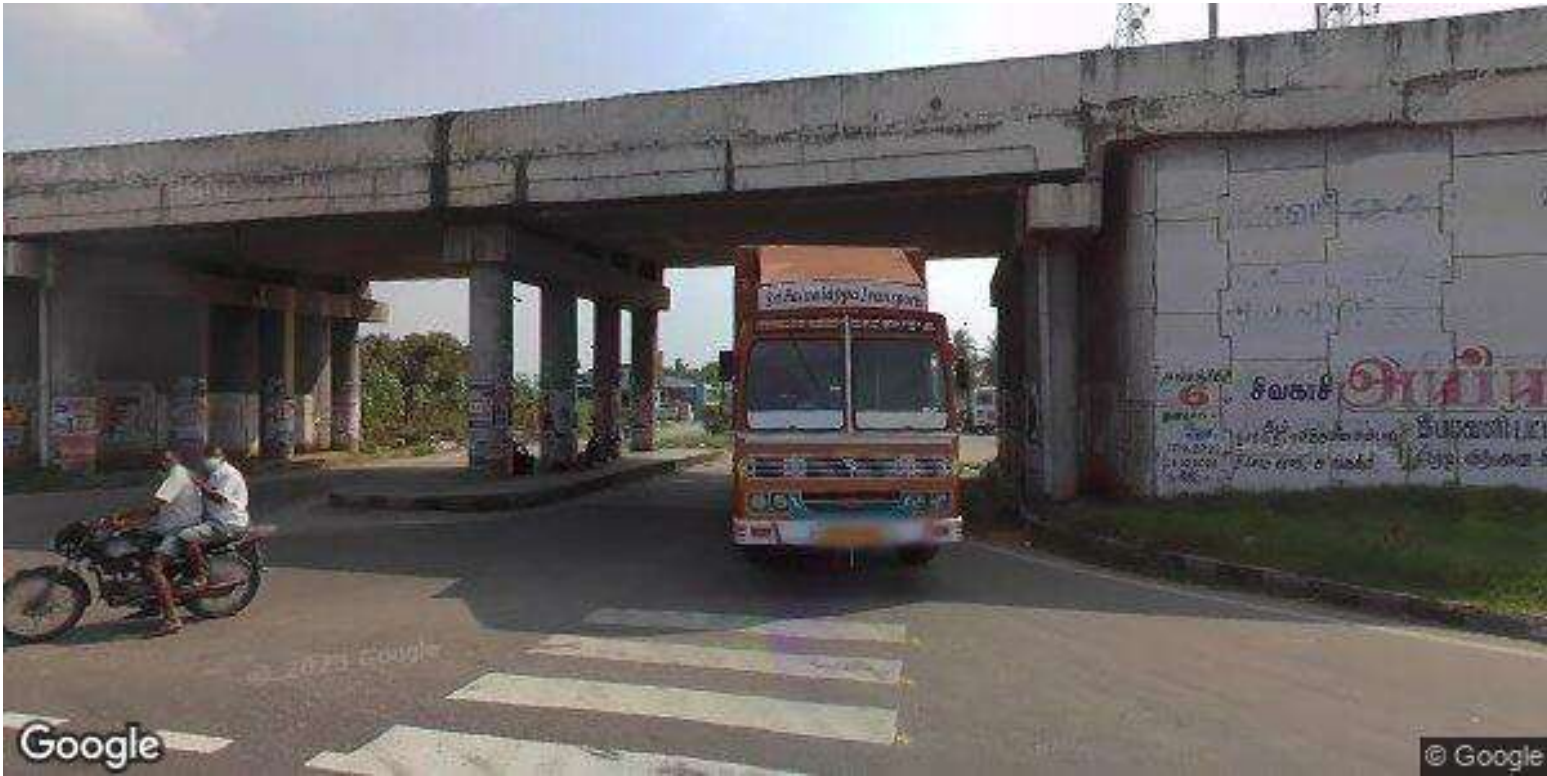
**Risk Type:** Turn  
**Risk Level:** High  
**Speed Limit:** 15 KM/Hr  
**Coordinates:** 11.49224, 77.89601

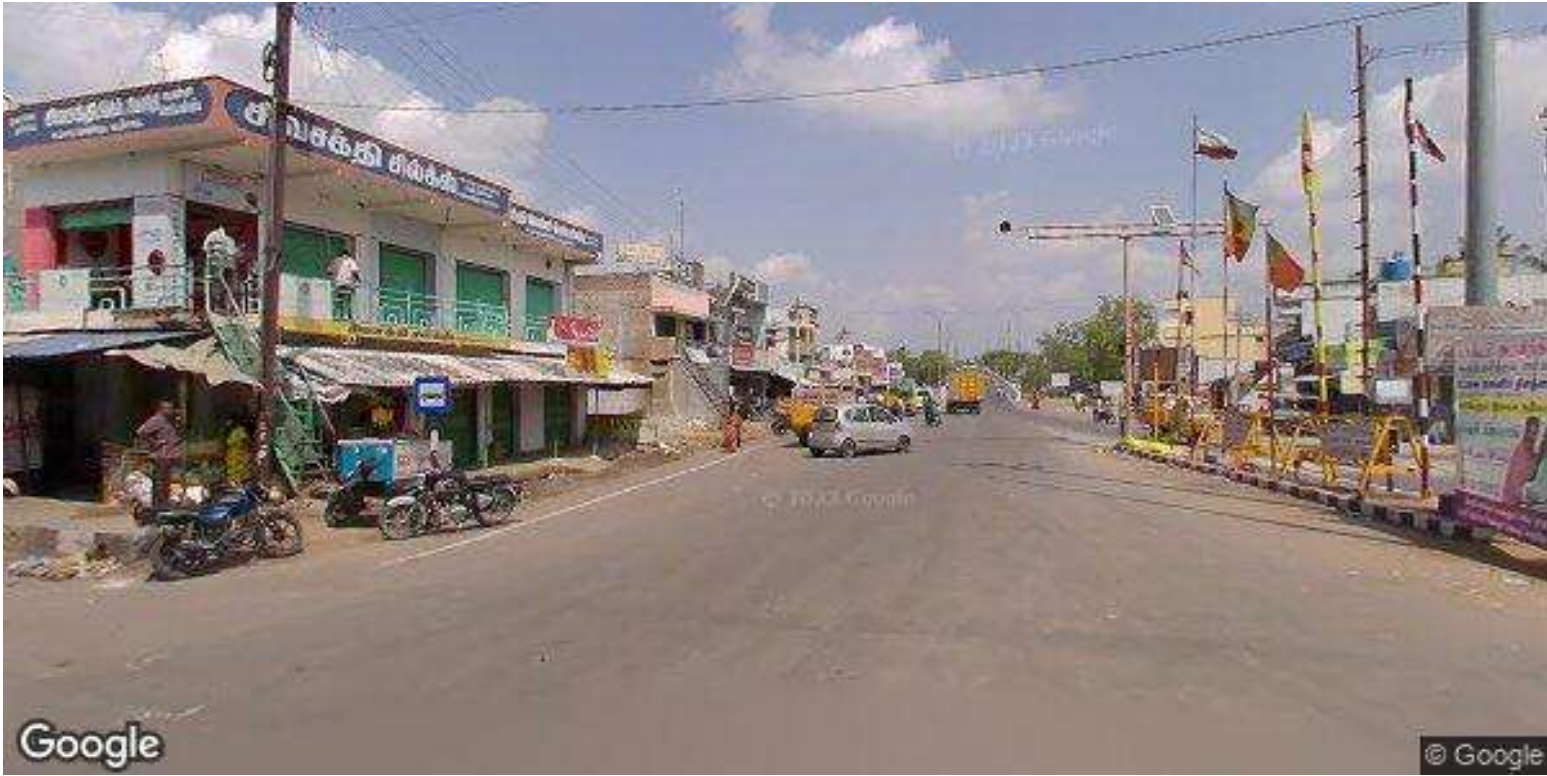
**Risk Type:** Blind Spot  
**Risk Level:** Blind Spot  
**Speed Limit:** 10 KM/Hr  
**Coordinates:** 11.54736, 77.98881
