## JOURNEY RISK MANAGEMENT (JRM) STUDY

### Salem Terminal to AVS AGENCIES

### Route Safety Analysis: Sangagiri to Tiruppur via SH 19A

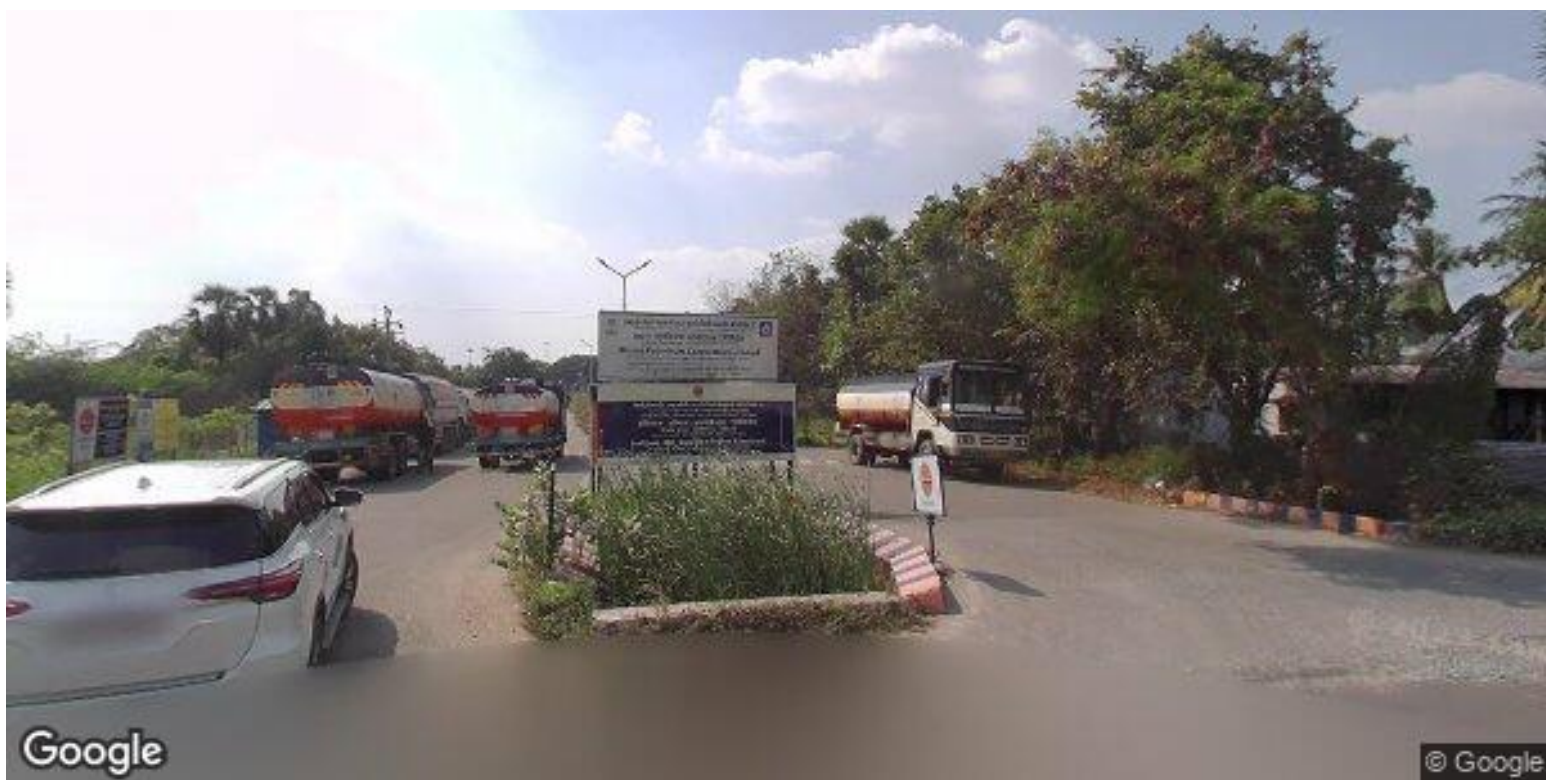
**Coordinates:** 11.44024, 77.87528

**Risk Type:** Turn

**Risk Level:** High

**Speed Limit:** 15 KM/Hr

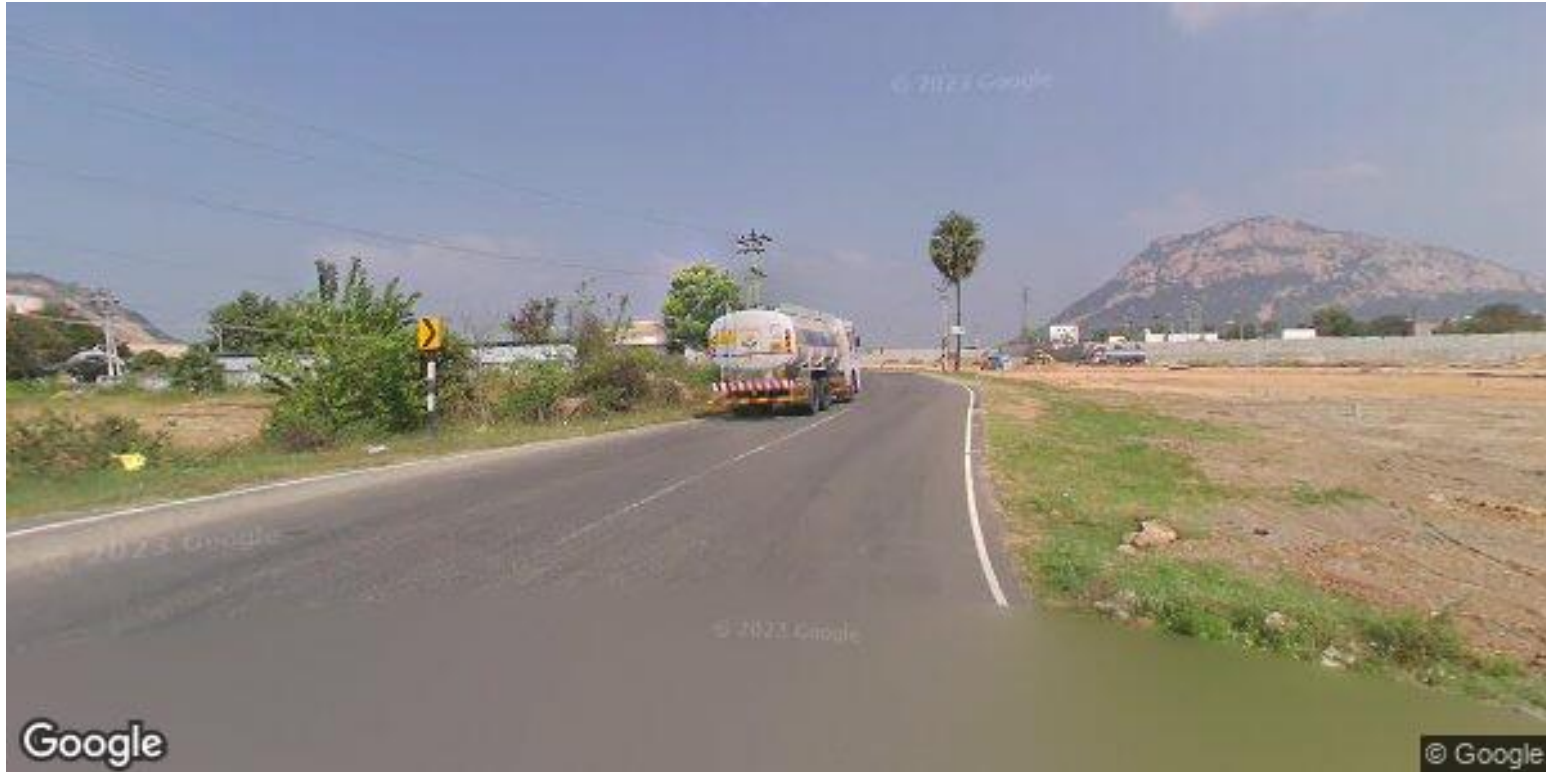
**Risk Type:** Turn  
**Risk Level:** Medium  
**Speed Limit:** 30 KM/Hr  
**Coordinates:** 11.45847, 77.85140

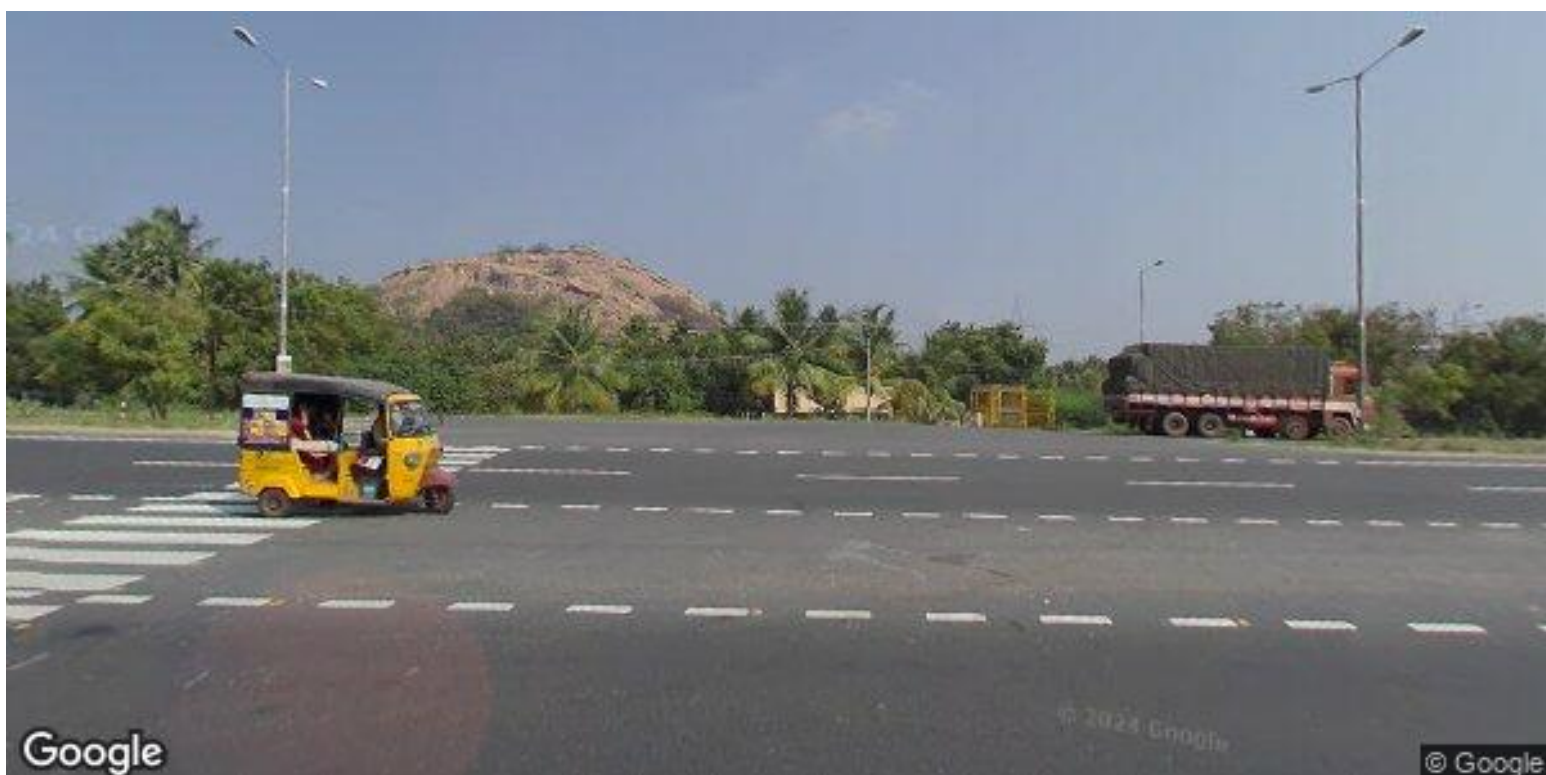
**Coordinates:** 11.45085, 77.77020

**Risk Type:** Turn

**Risk Level:** Medium

**Speed Limit:** 30 KM/Hr

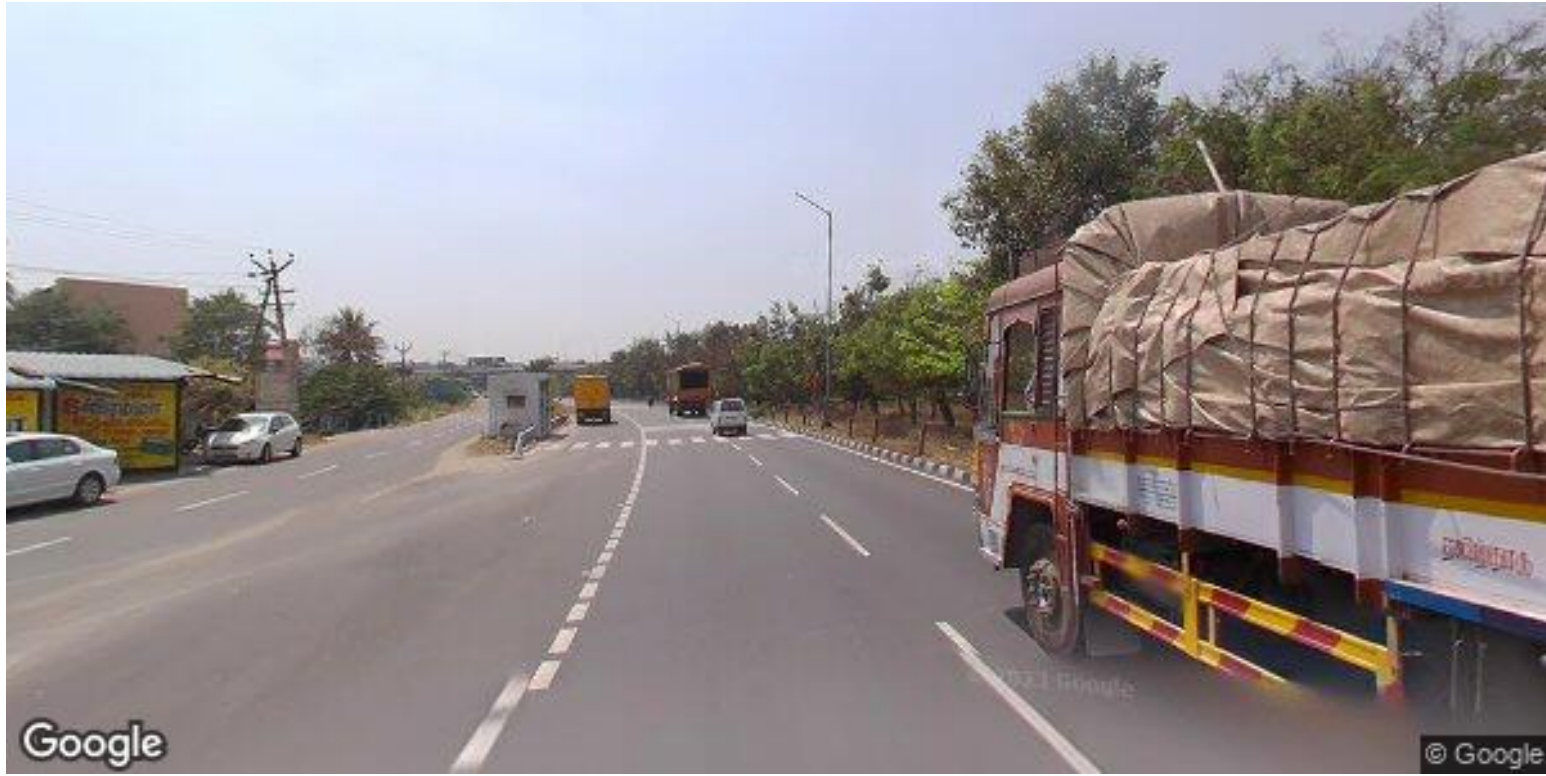
**Coordinates:** 11.43165, 77.67734

**Risk Type:** Turn

**Risk Level:** Medium

**Speed Limit:** 30 KM/Hr

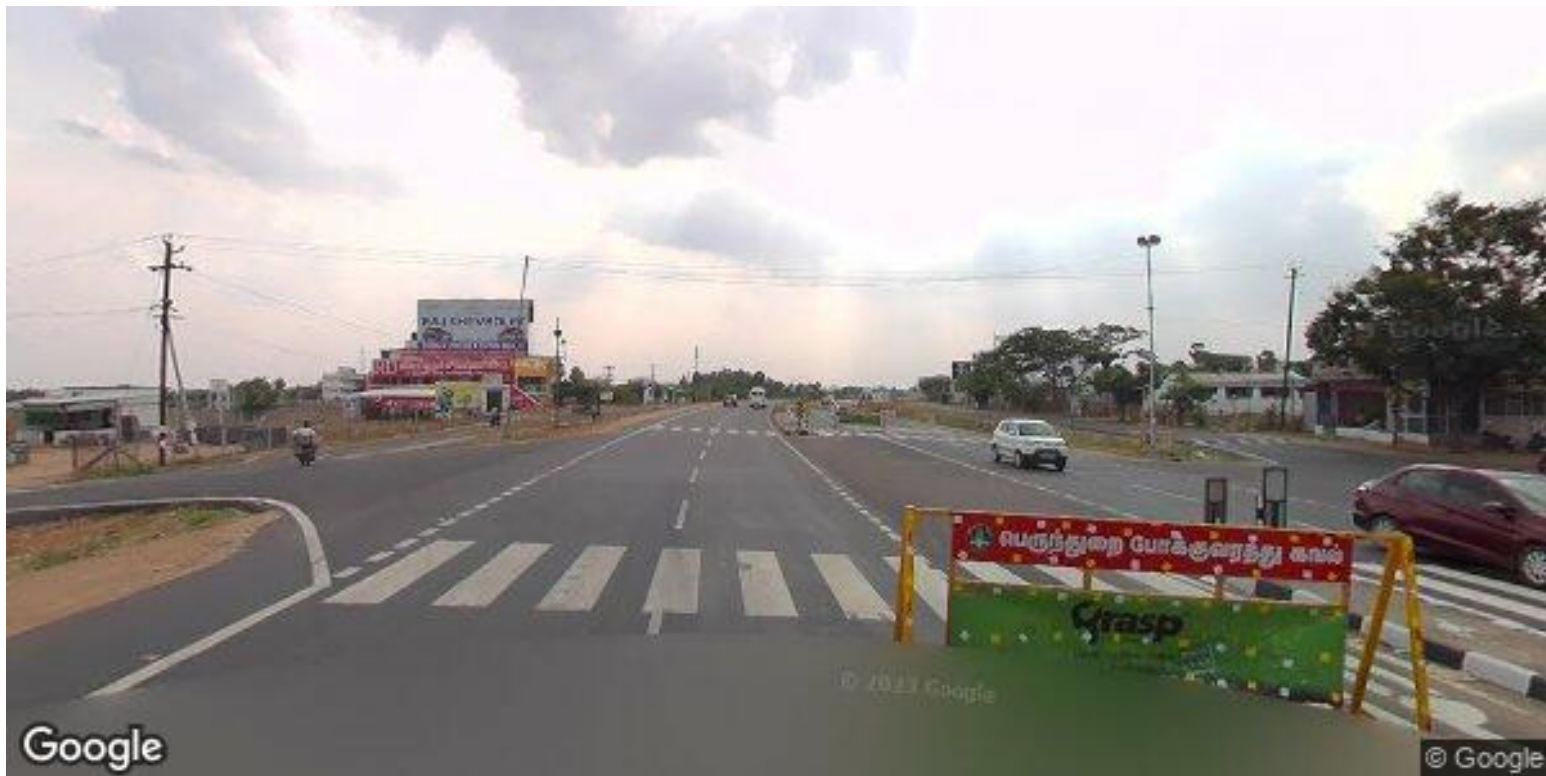
**Coordinates:** 11.23724, 77.50686

**Risk Type:** Turn

**Risk Level:** Medium

**Speed Limit:** 30 KM/Hr

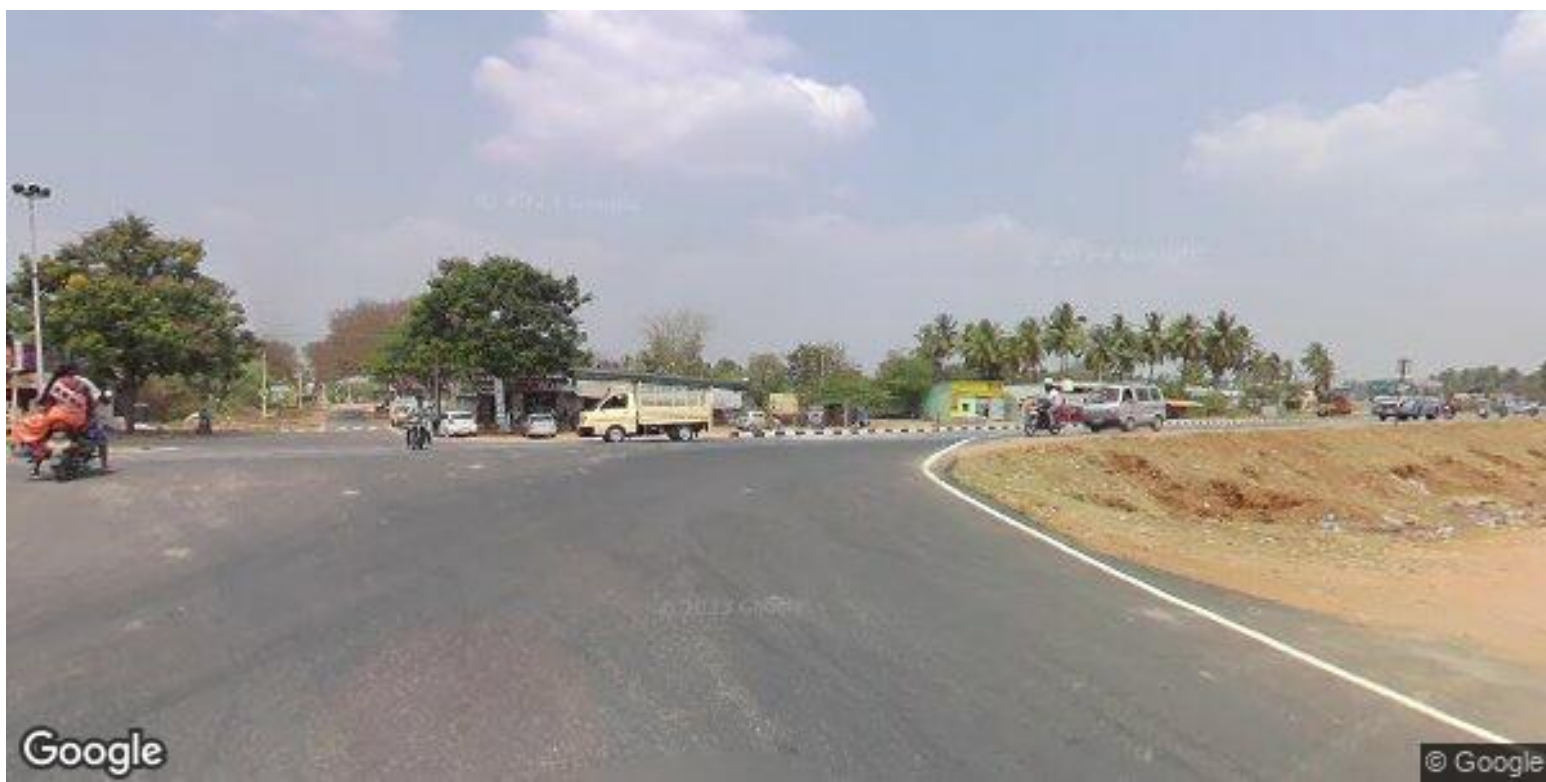
**Coordinates:** 11.23704, 77.50676

**Risk Type:** Turn

**Risk Level:** High

**Speed Limit:** 15 KM/Hr

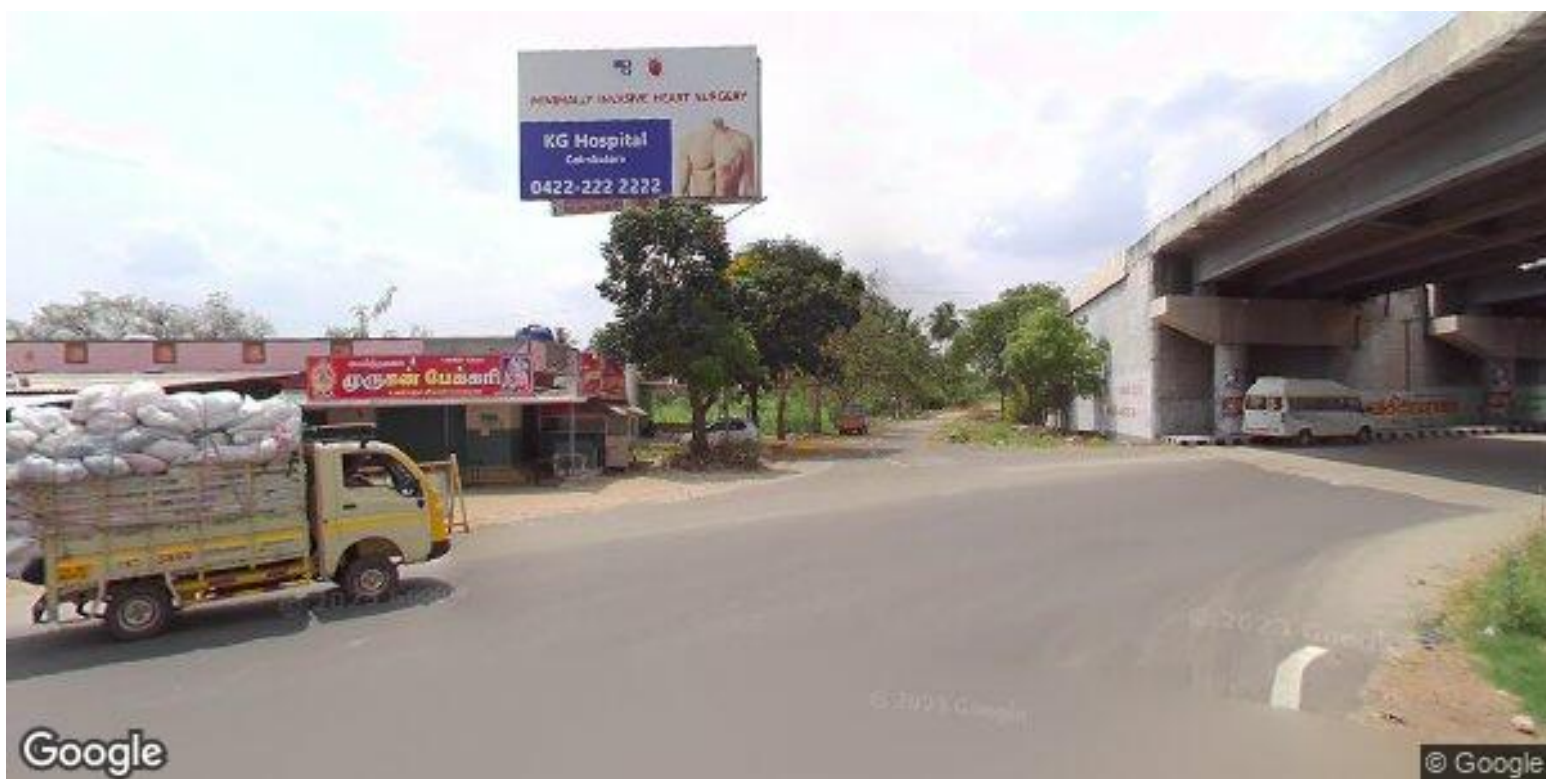
**Coordinates:** 11.23686, 77.50216

**Risk Type:** Blind Spot

**Risk Level:** Blind Spot

**Speed Limit:** 10 KM/Hr

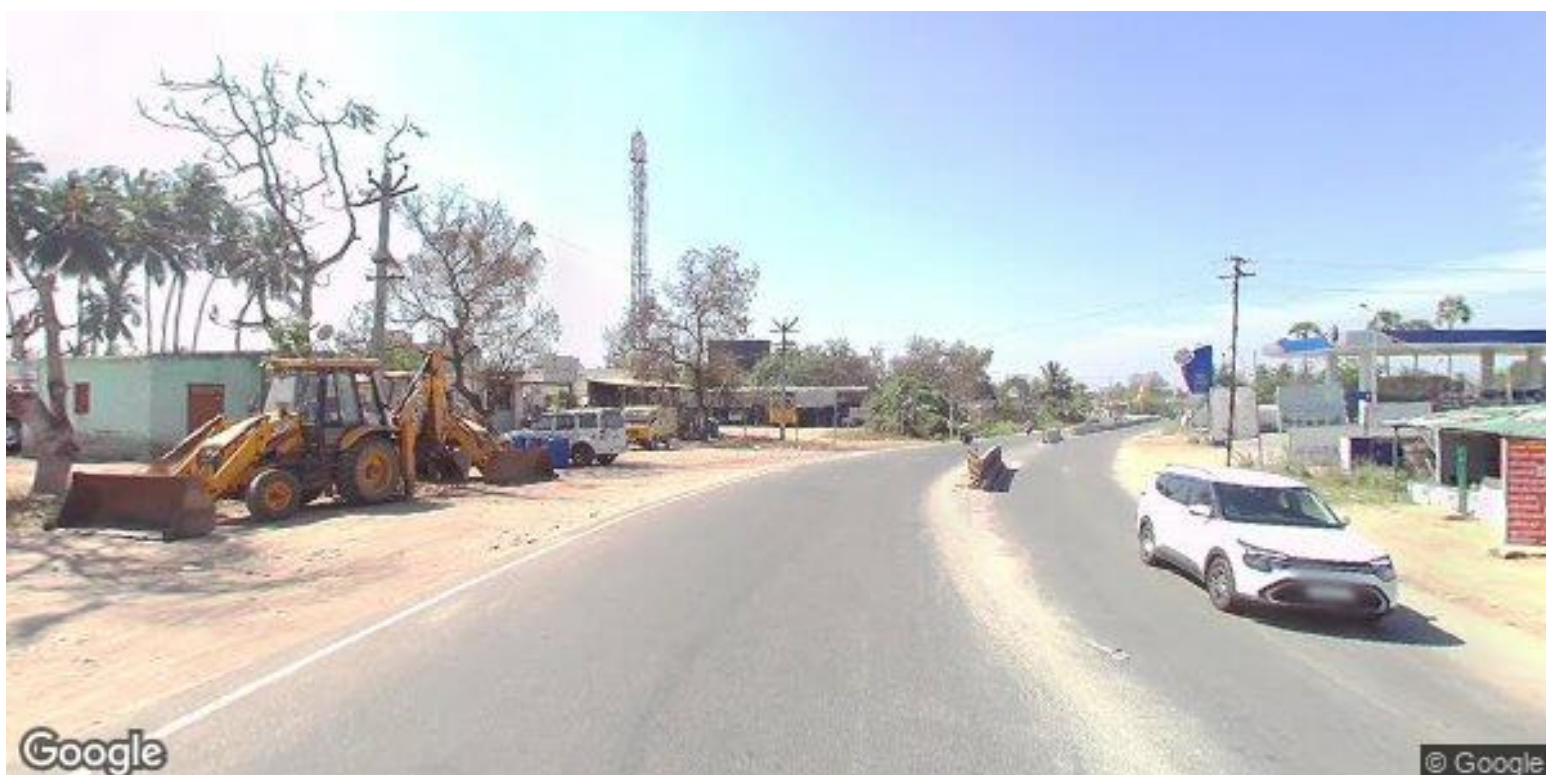
**Risk Type:** Turn  
**Risk Level:** Medium  
**Speed Limit:** 30 KM/Hr  
**Coordinates:** 11.23649, 77.50219

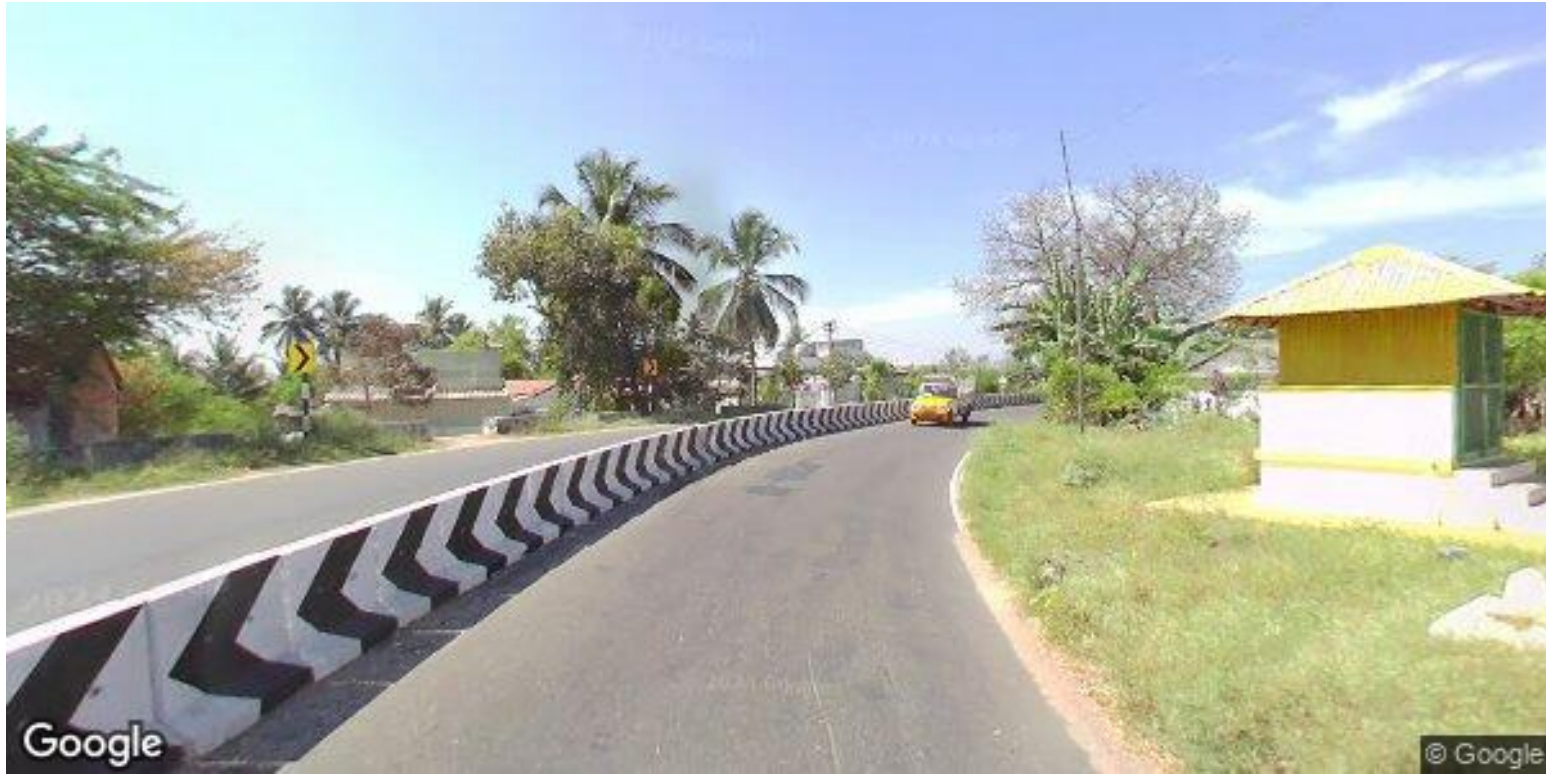
**Risk Type:** Turn  
**Risk Level:** High  
**Speed Limit:** 15 KM/Hr  
**Coordinates:** 11.23396, 77.50105

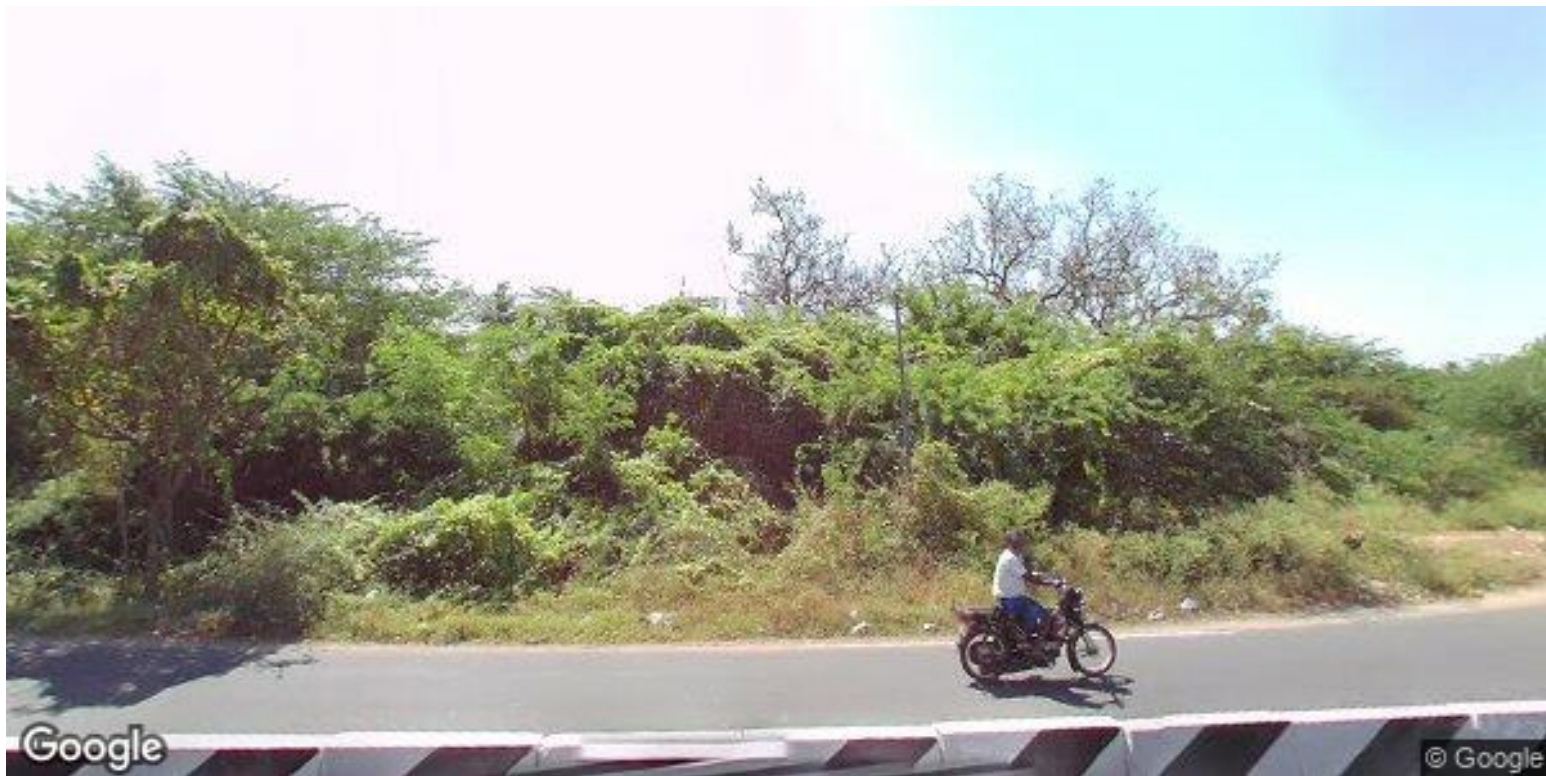
**Risk Type:** Turn  
**Risk Level:** Medium  
**Speed Limit:** 30 KM/Hr  
**Coordinates:** 11.23329, 77.49966

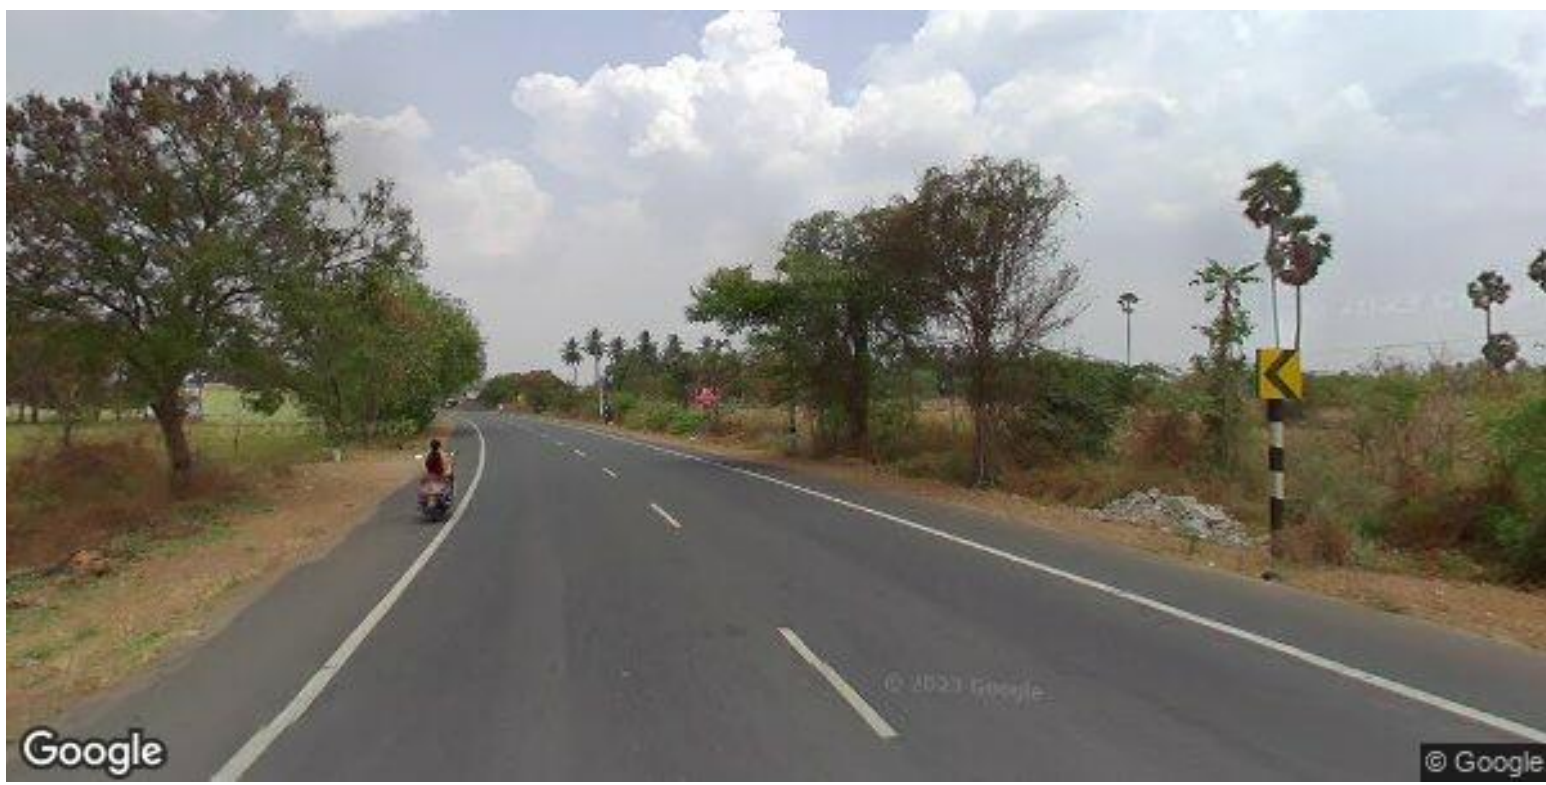
**Coordinates:** 11.17869, 77.46175

**Risk Type:** Turn

**Risk Level:** Medium

**Speed Limit:** 30 KM/Hr

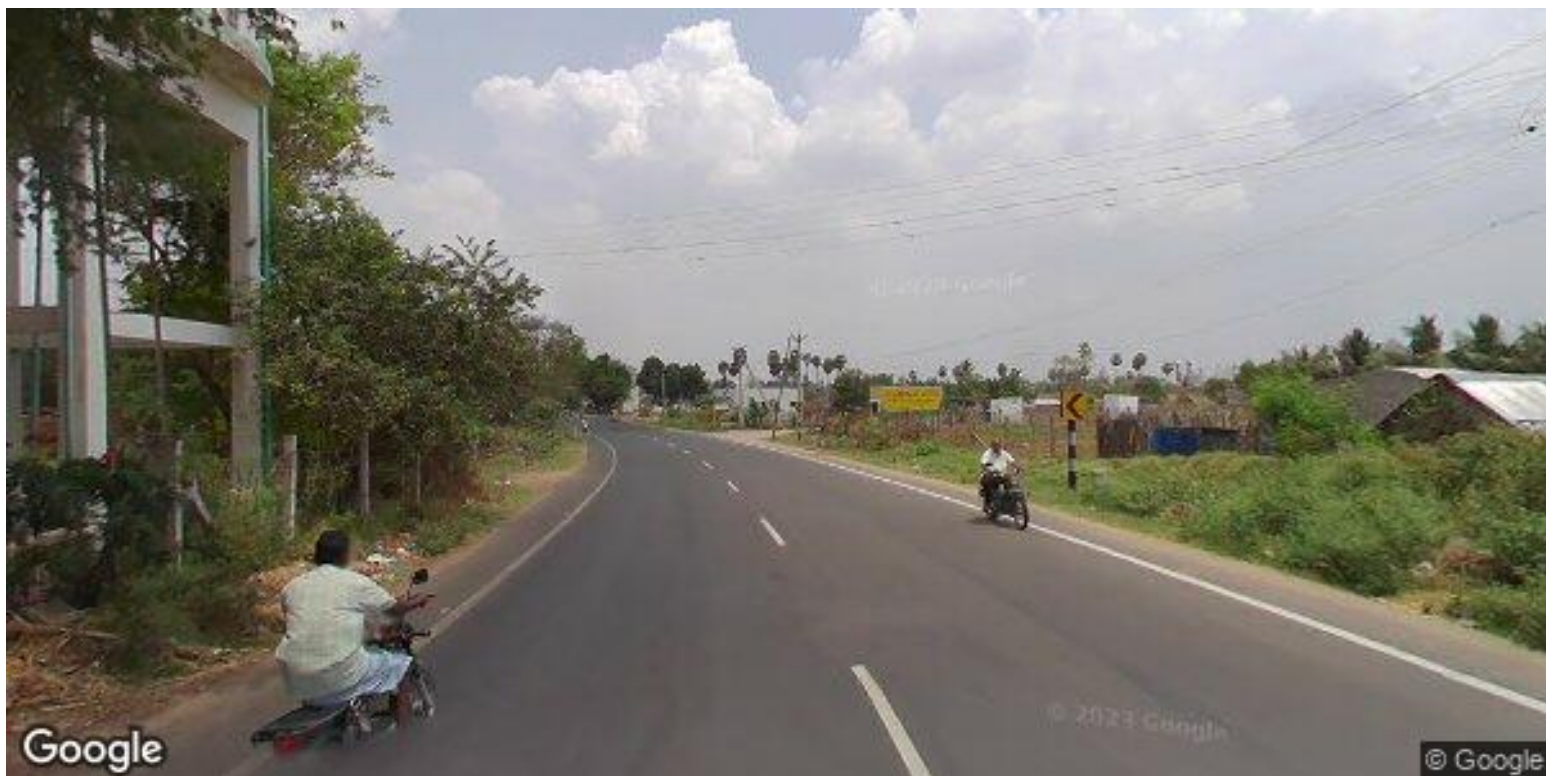
**Coordinates:** 11.17528, 77.45982

**Risk Type:** Turn

**Risk Level:** Medium

**Speed Limit:** 30 KM/Hr

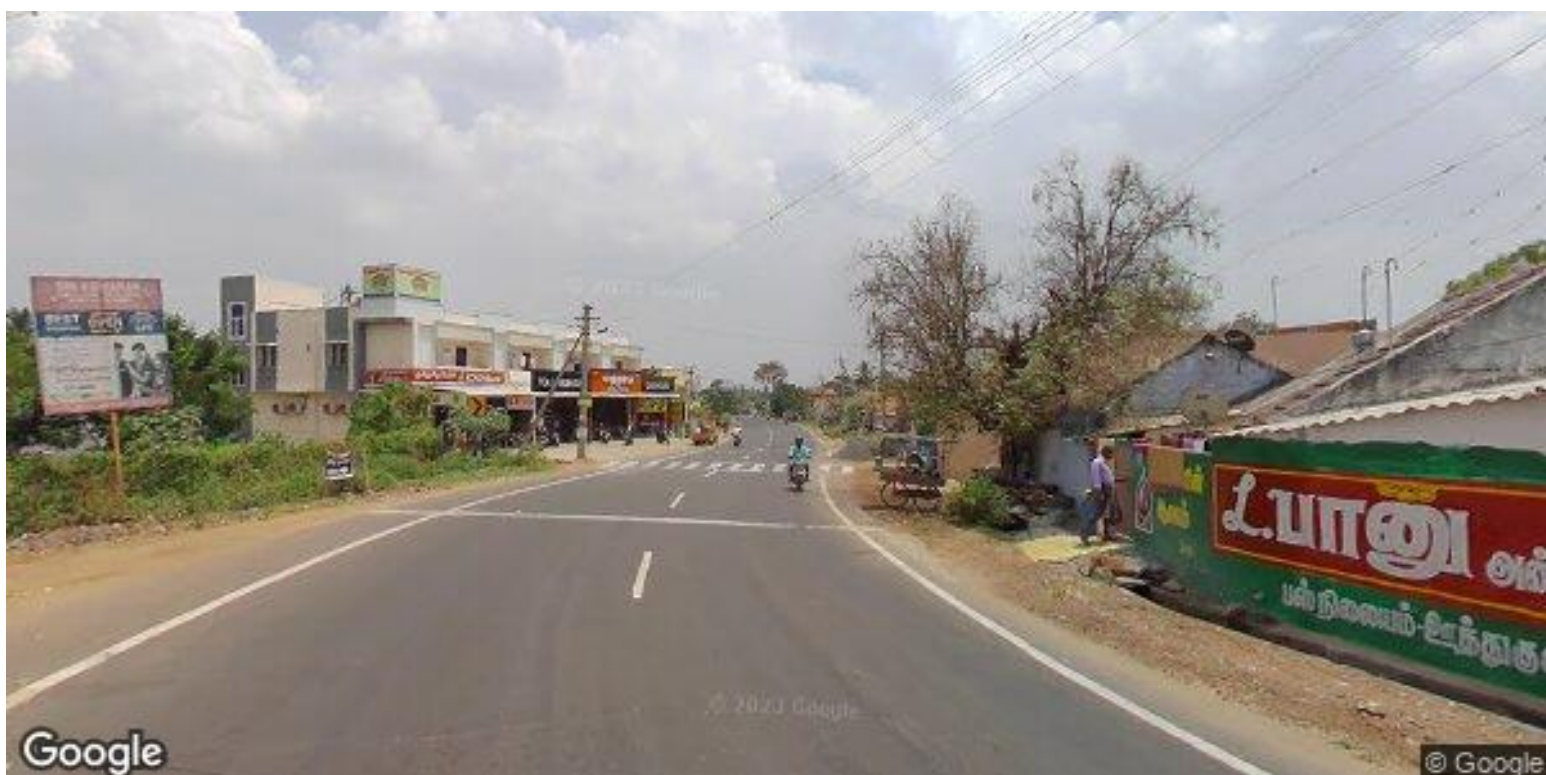
**Risk Type:** Turn  
**Risk Level:** Medium  
**Speed Limit:** 30 KM/Hr  
**Coordinates:** 11.17373, 77.45734

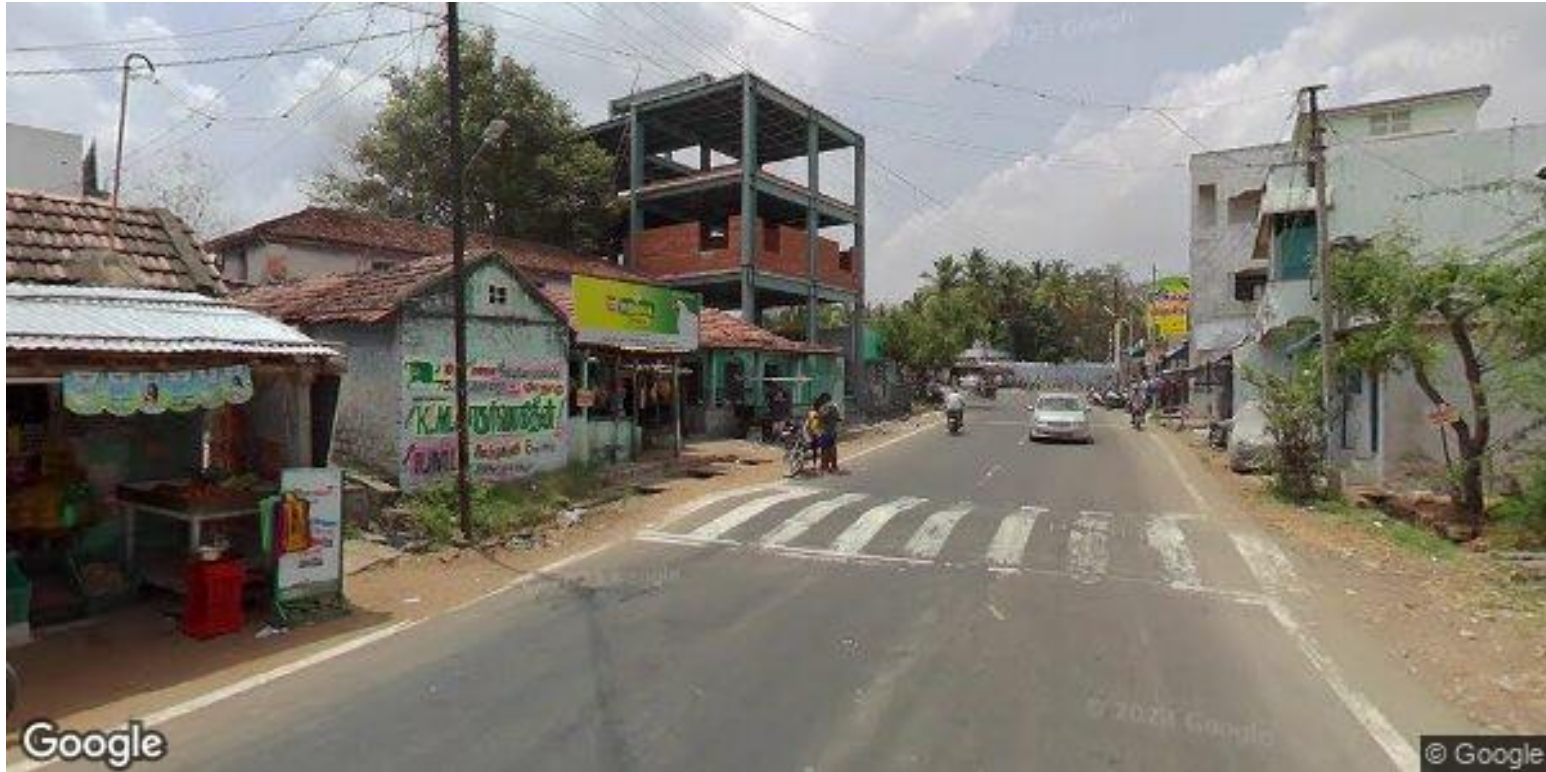
**Risk Type:** Turn  
**Risk Level:** Medium  
**Speed Limit:** 30 KM/Hr  
**Coordinates:** 11.17120, 77.45567

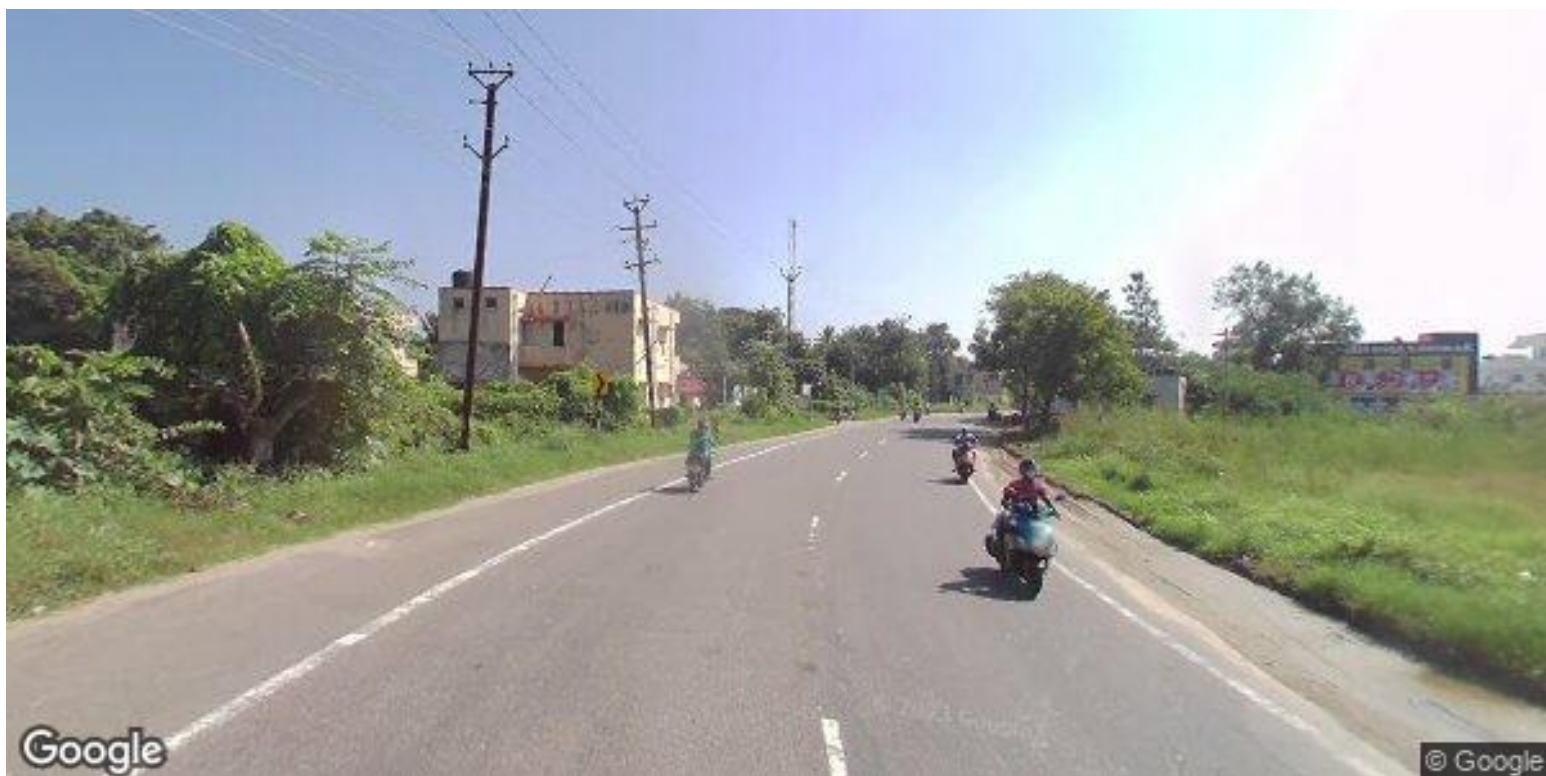
**Risk Type:** Turn  
**Risk Level:** High  
**Speed Limit:** 15 KM/Hr  
**Coordinates:** 11.16960, 77.44406

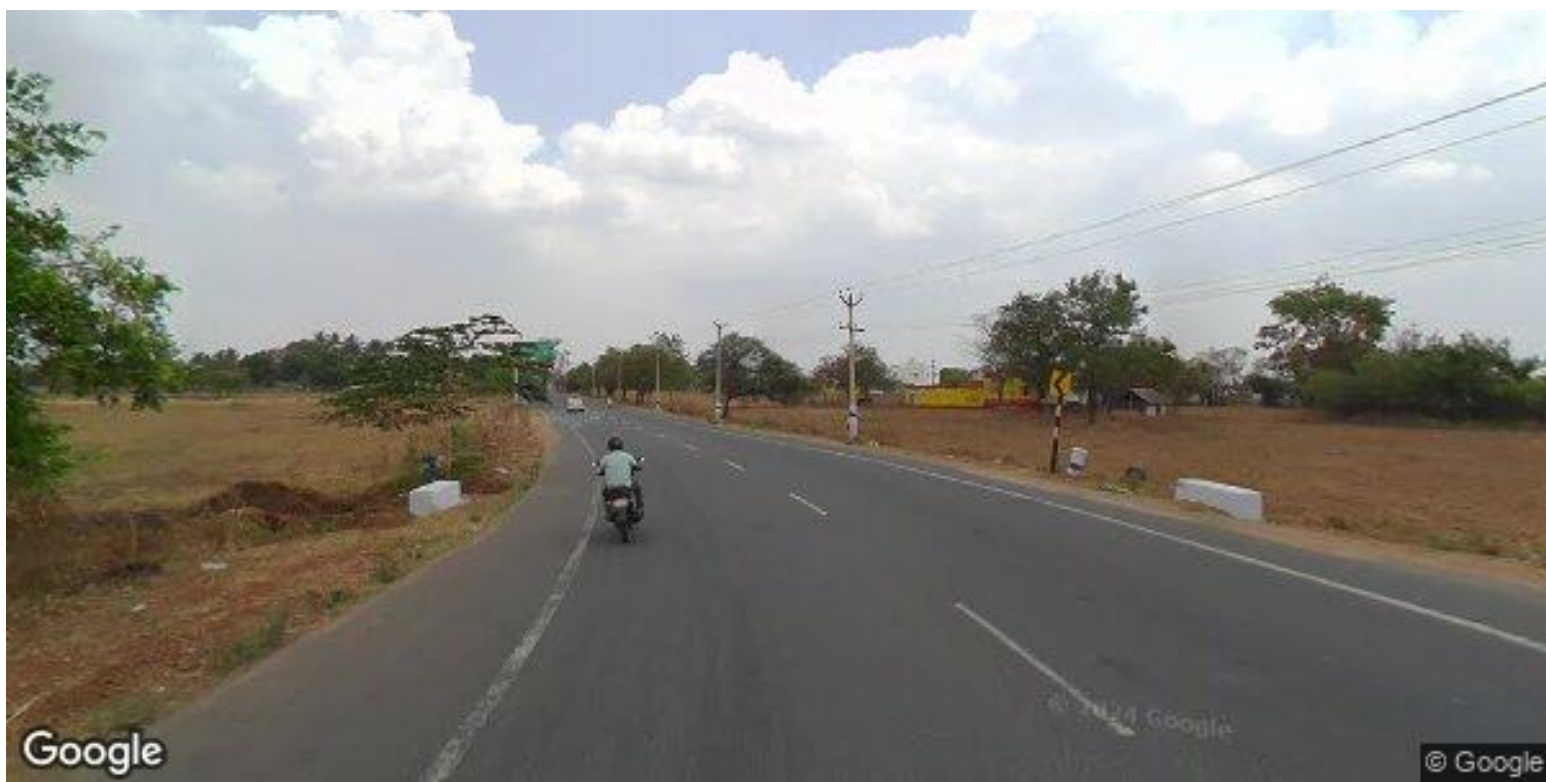
**Coordinates:** 11.16385, 77.43707

**Risk Type:** Turn

**Risk Level:** Medium

**Speed Limit:** 30 KM/Hr

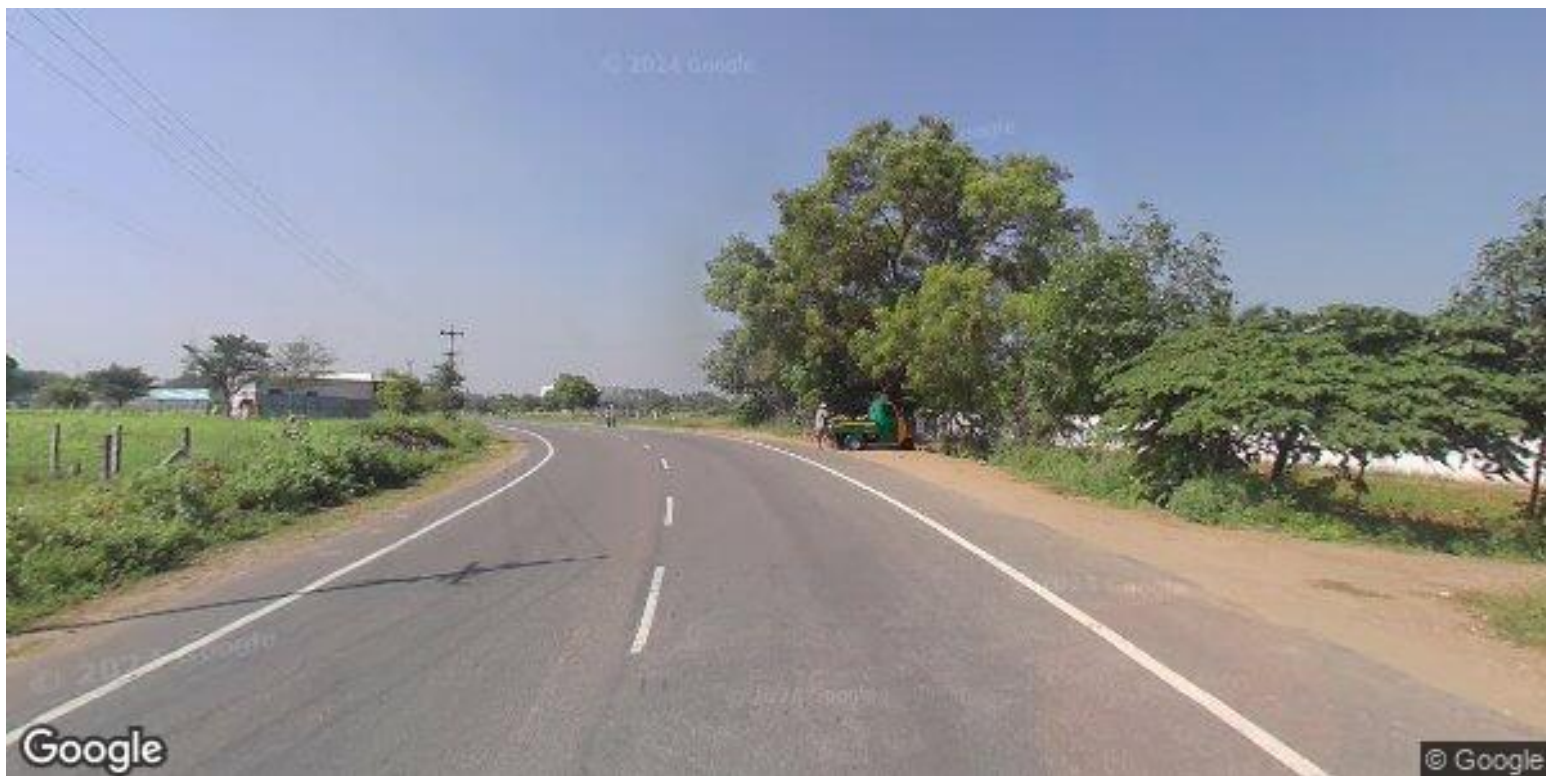
**Coordinates:** 11.16282, 77.43145

**Risk Type:** Turn

**Risk Level:** Medium

**Speed Limit:** 30 KM/Hr

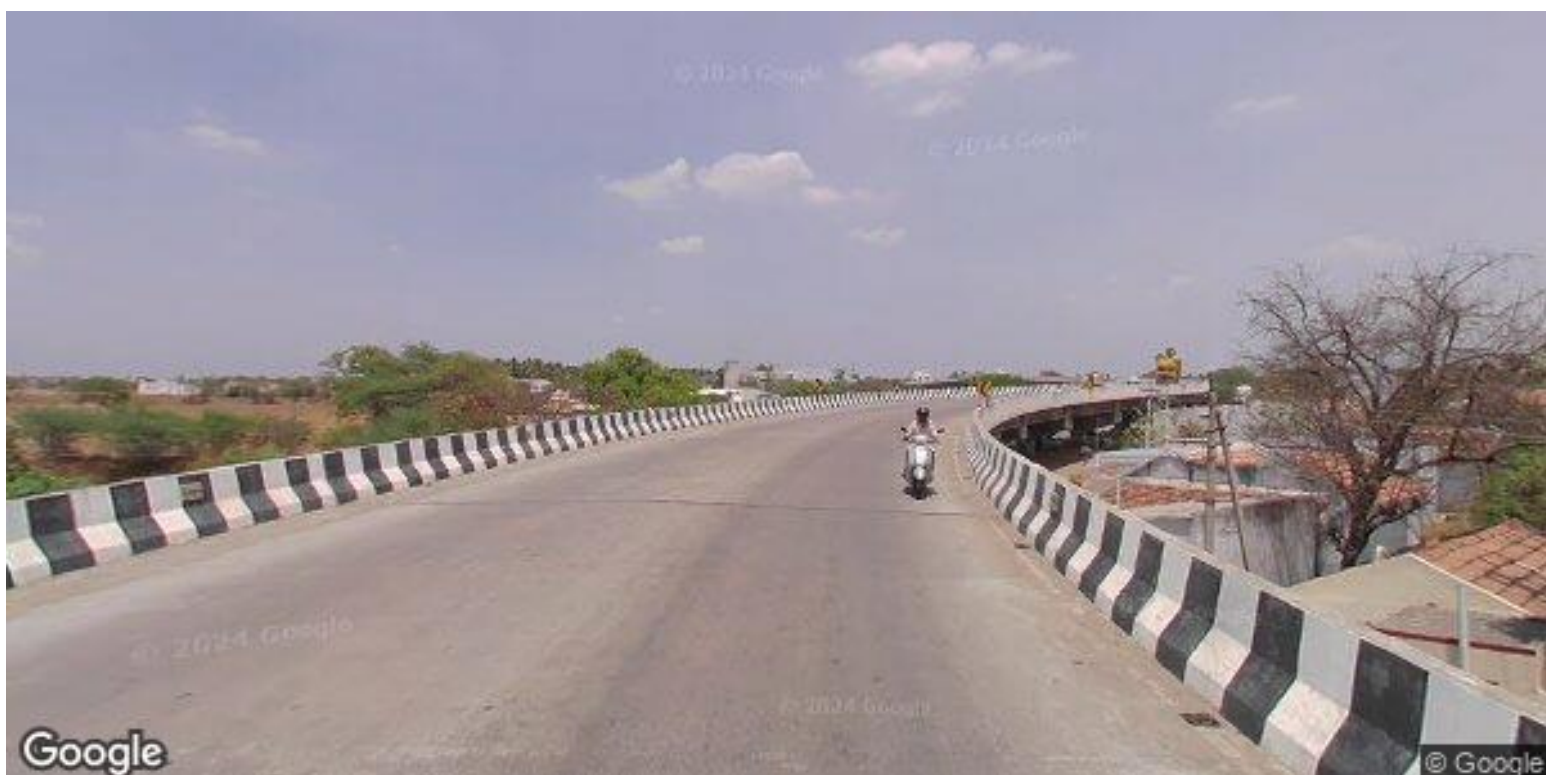
**Risk Type:** Turn  
**Risk Level:** Medium  
**Speed Limit:** 30 KM/Hr  
**Coordinates:** 11.15141, 77.42304

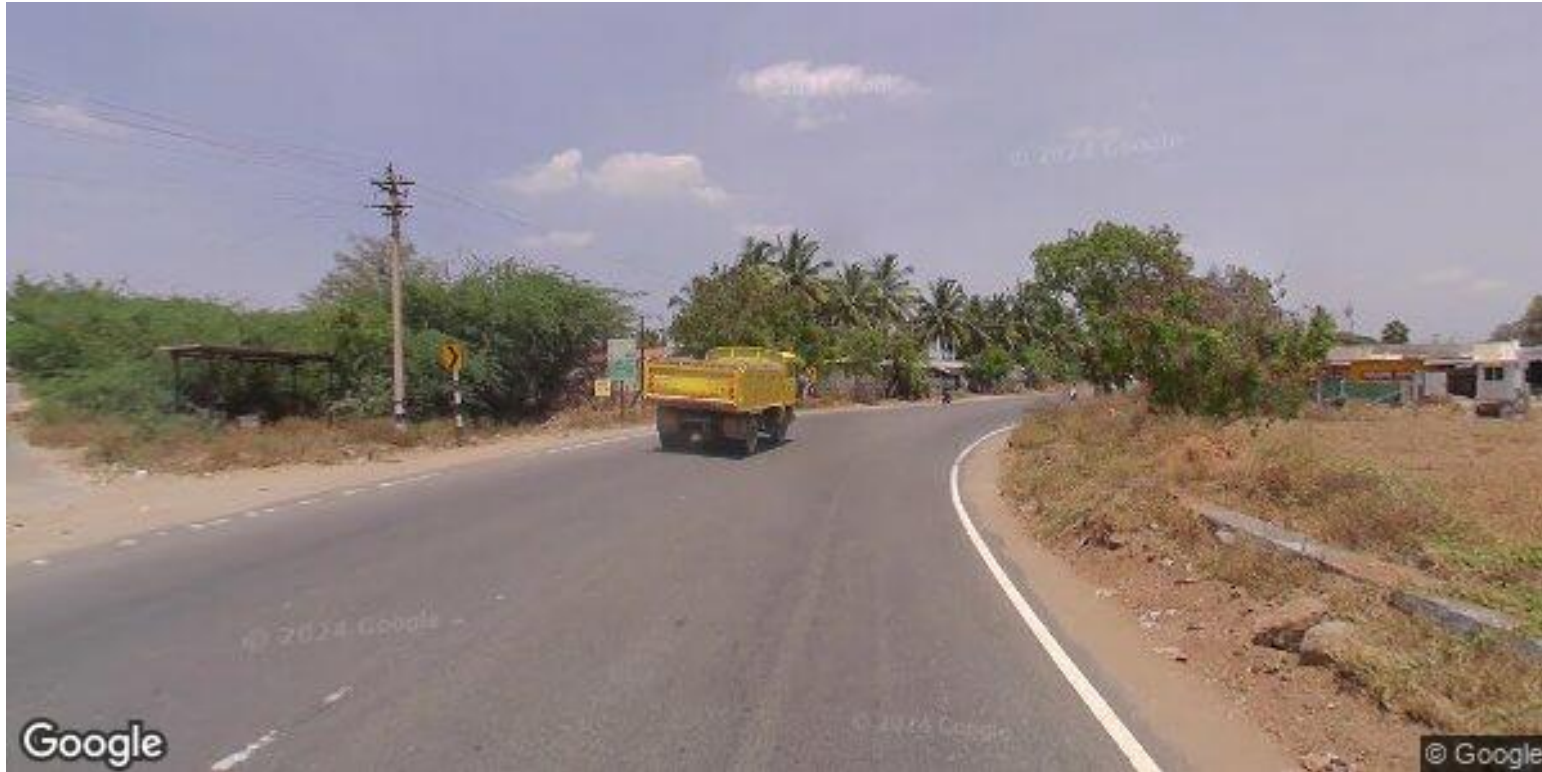
**Risk Type:** Turn  
**Risk Level:** Medium  
**Speed Limit:** 30 KM/Hr  
**Coordinates:** 11.14904, 77.42031
