## JOURNEY RISK MANAGEMENT (JRM) STUDY

### Salem Terminal to AVS AGENCIES

### Route Safety Analysis: Sangagiri to Tiruppur via SH 19A

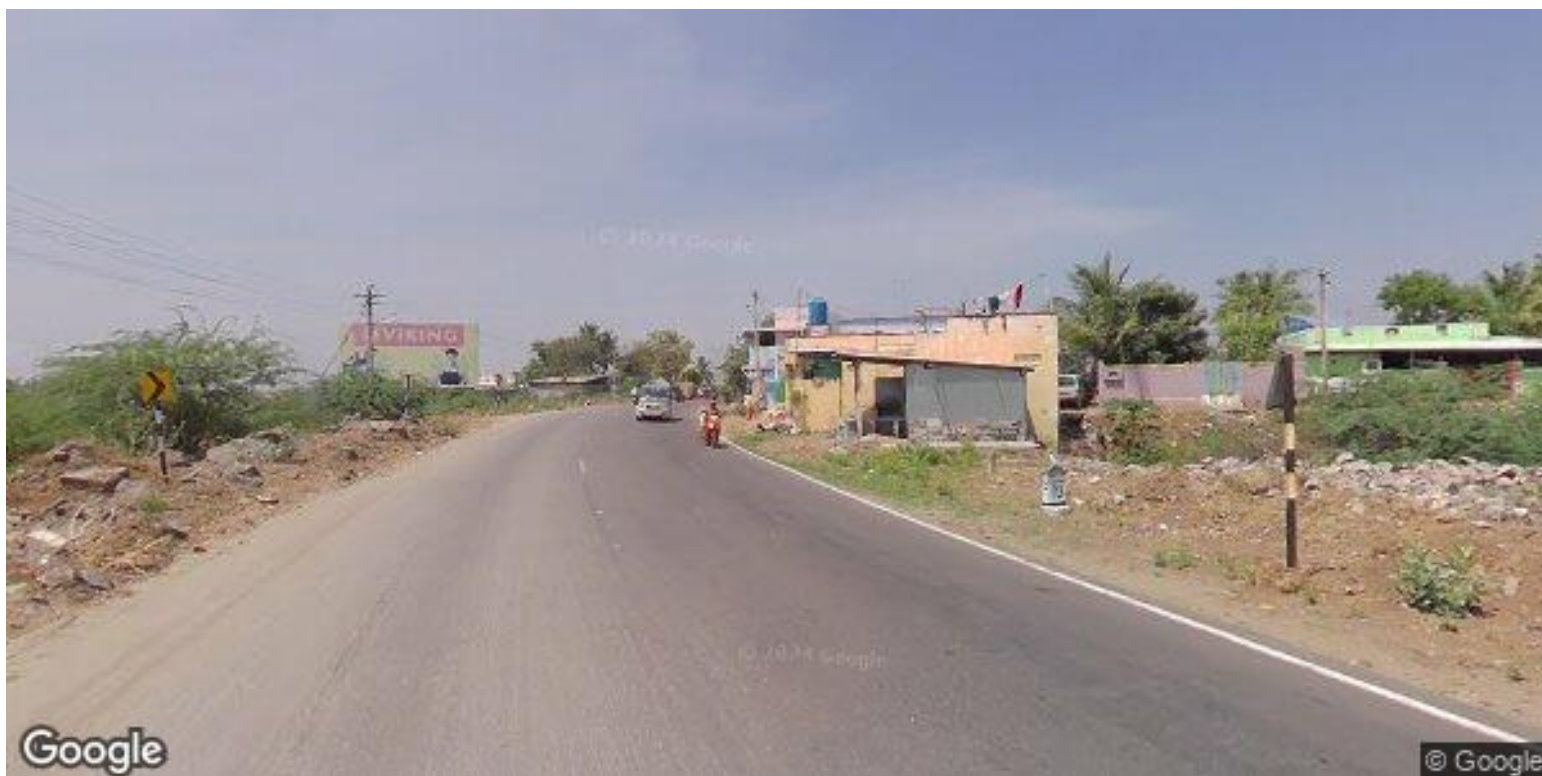
**Risk Type:** Turn  
**Risk Level:** Medium  
**Speed Limit:** 30 KM/Hr  
**Coordinates:** 11.13860, 77.41623

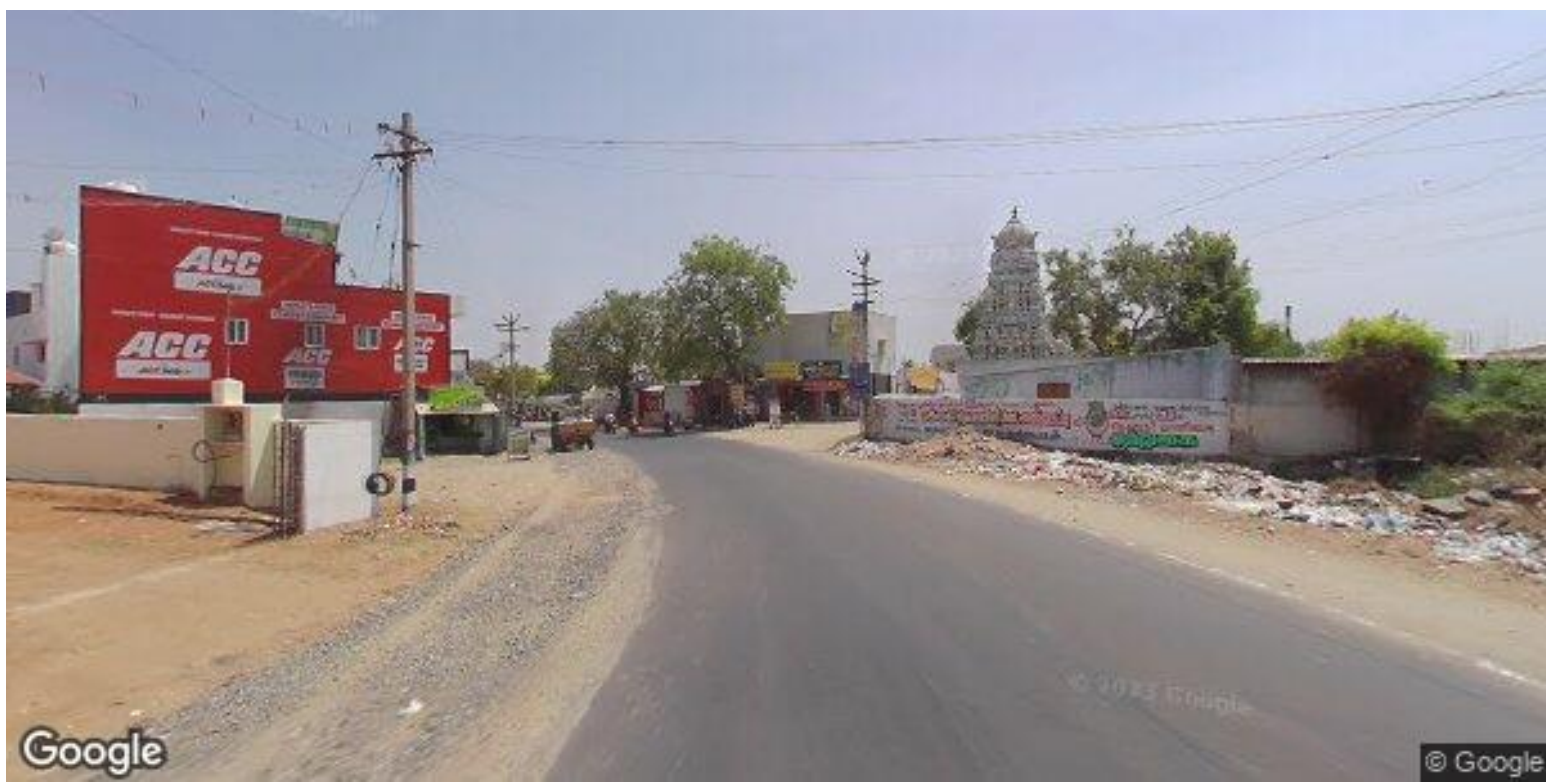
**Coordinates:** 11.12993, 77.40310

**Risk Type:** Turn

**Risk Level:** Medium

**Speed Limit:** 30 KM/Hr

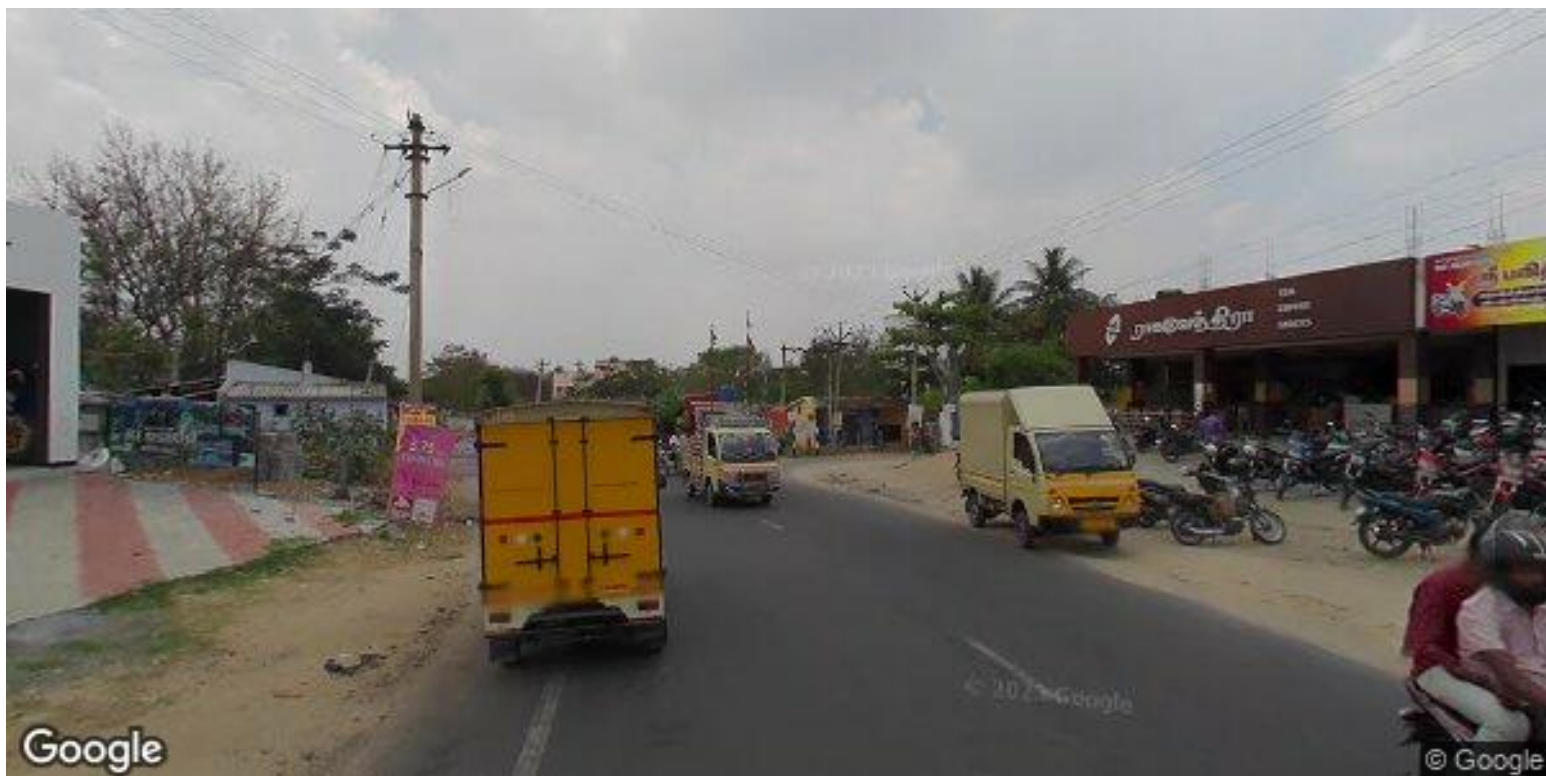
**Coordinates:** 11.12467, 77.38652

**Risk Type:** Turn

**Risk Level:** Medium

**Speed Limit:** 30 KM/Hr

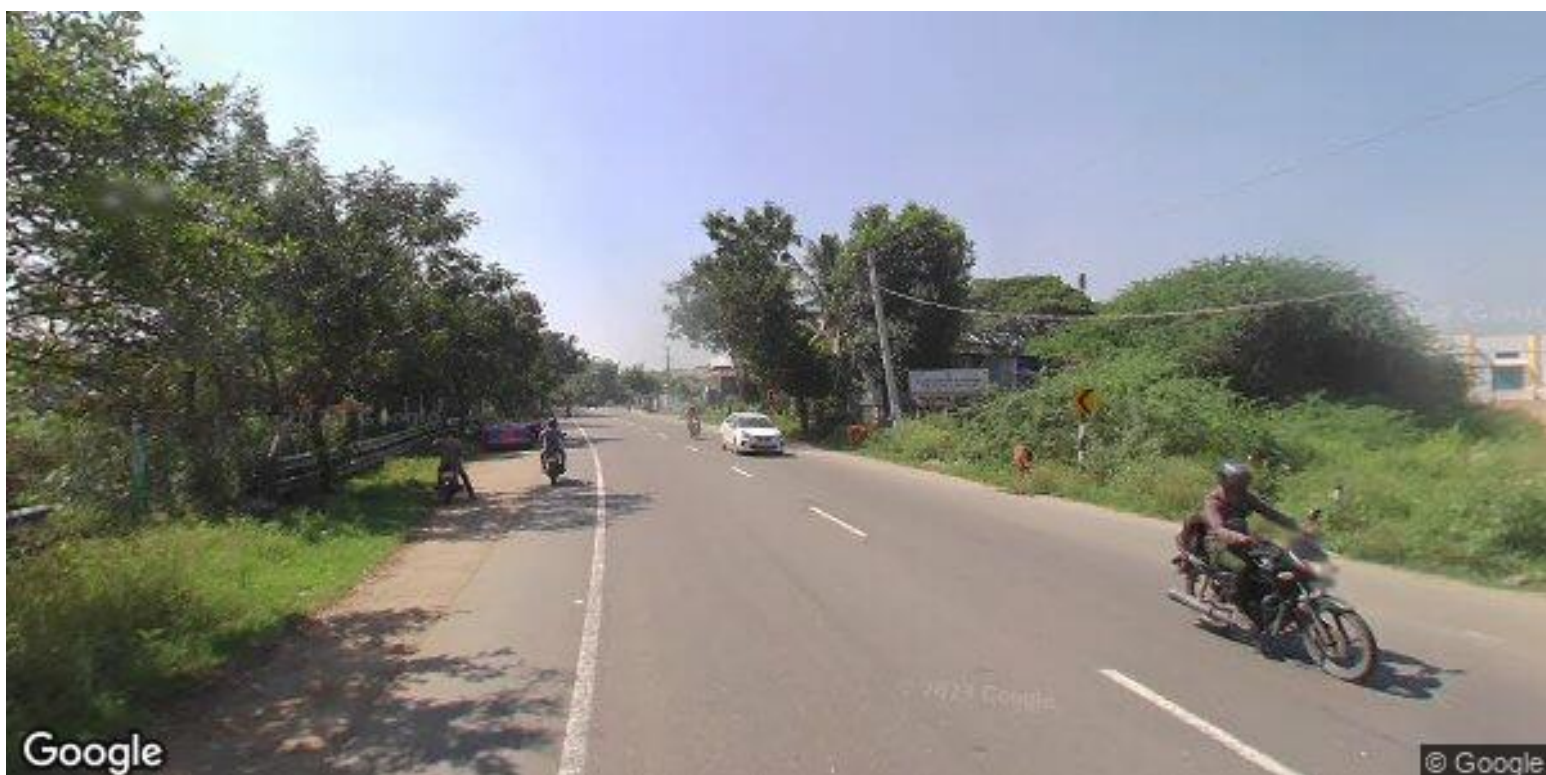
**Risk Type:** Turn  
**Risk Level:** Medium  
**Speed Limit:** 30 KM/Hr  
**Coordinates:** 11.12236, 77.38293

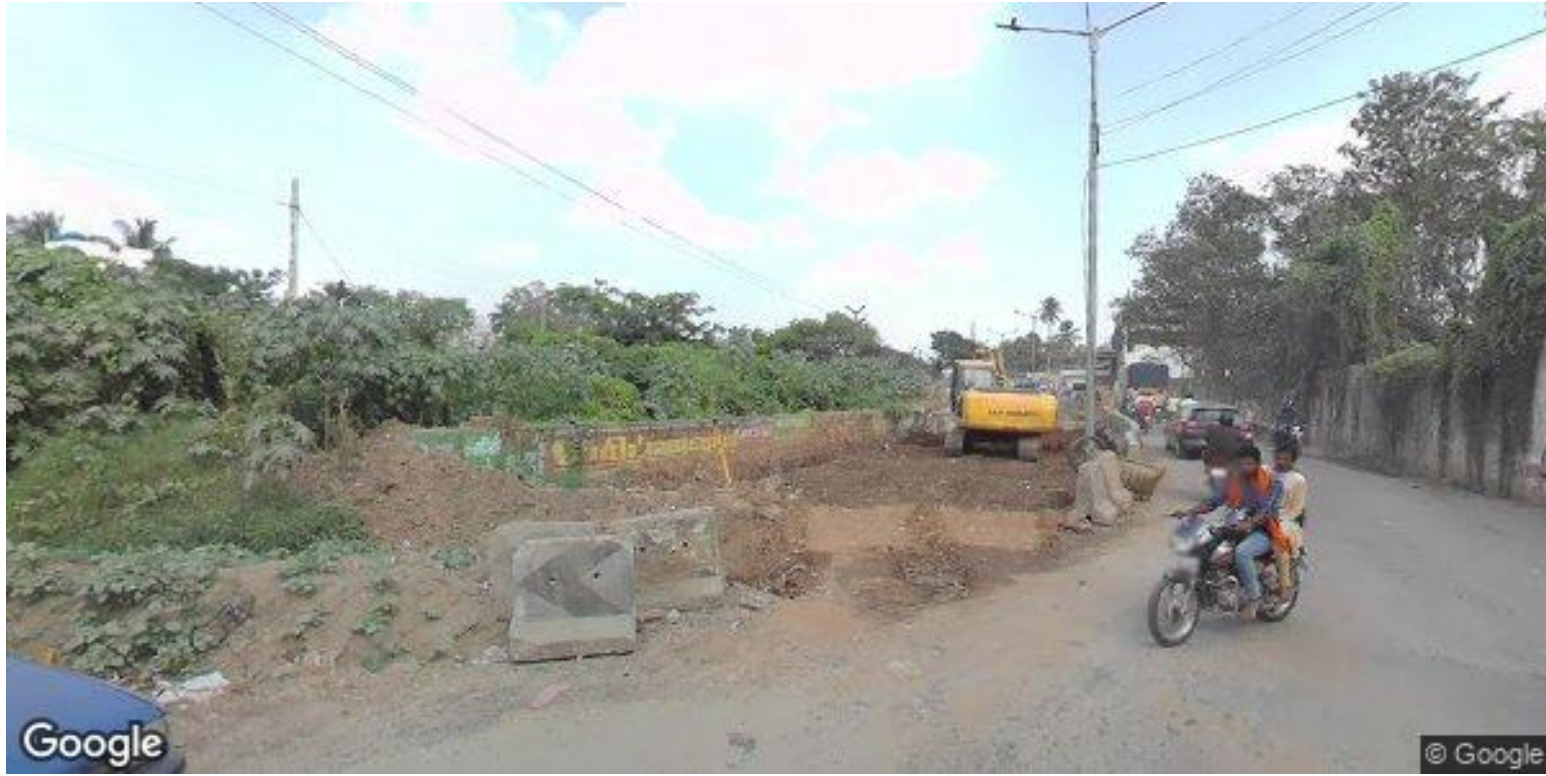
**Risk Type:** Turn  
**Risk Level:** High  
**Speed Limit:** 15 KM/Hr  
**Coordinates:** 11.11160, 77.35231

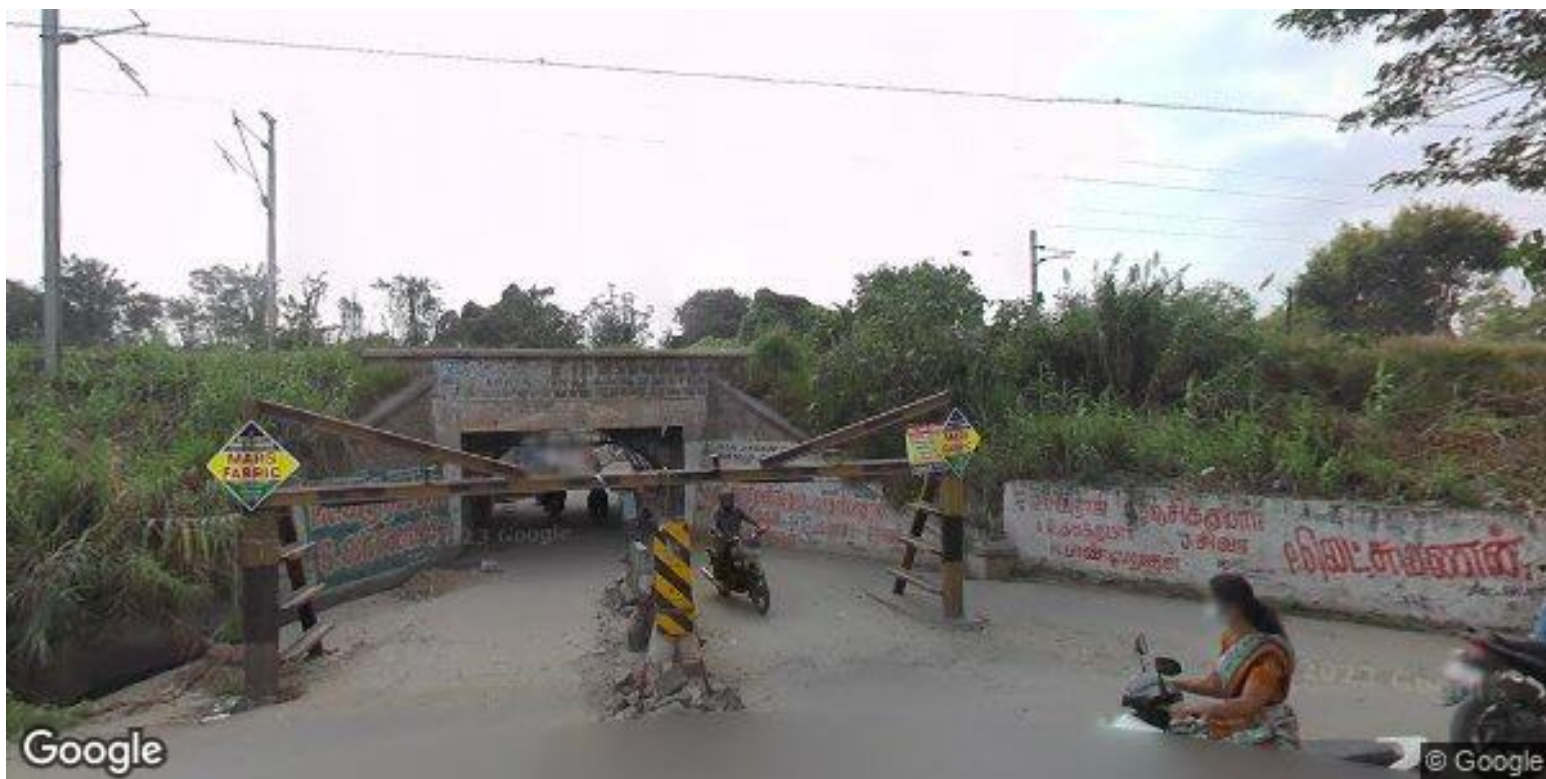
**Risk Type:** Turn  
**Risk Level:** High  
**Speed Limit:** 15 KM/Hr  
**Coordinates:** 11.11209, 77.35220

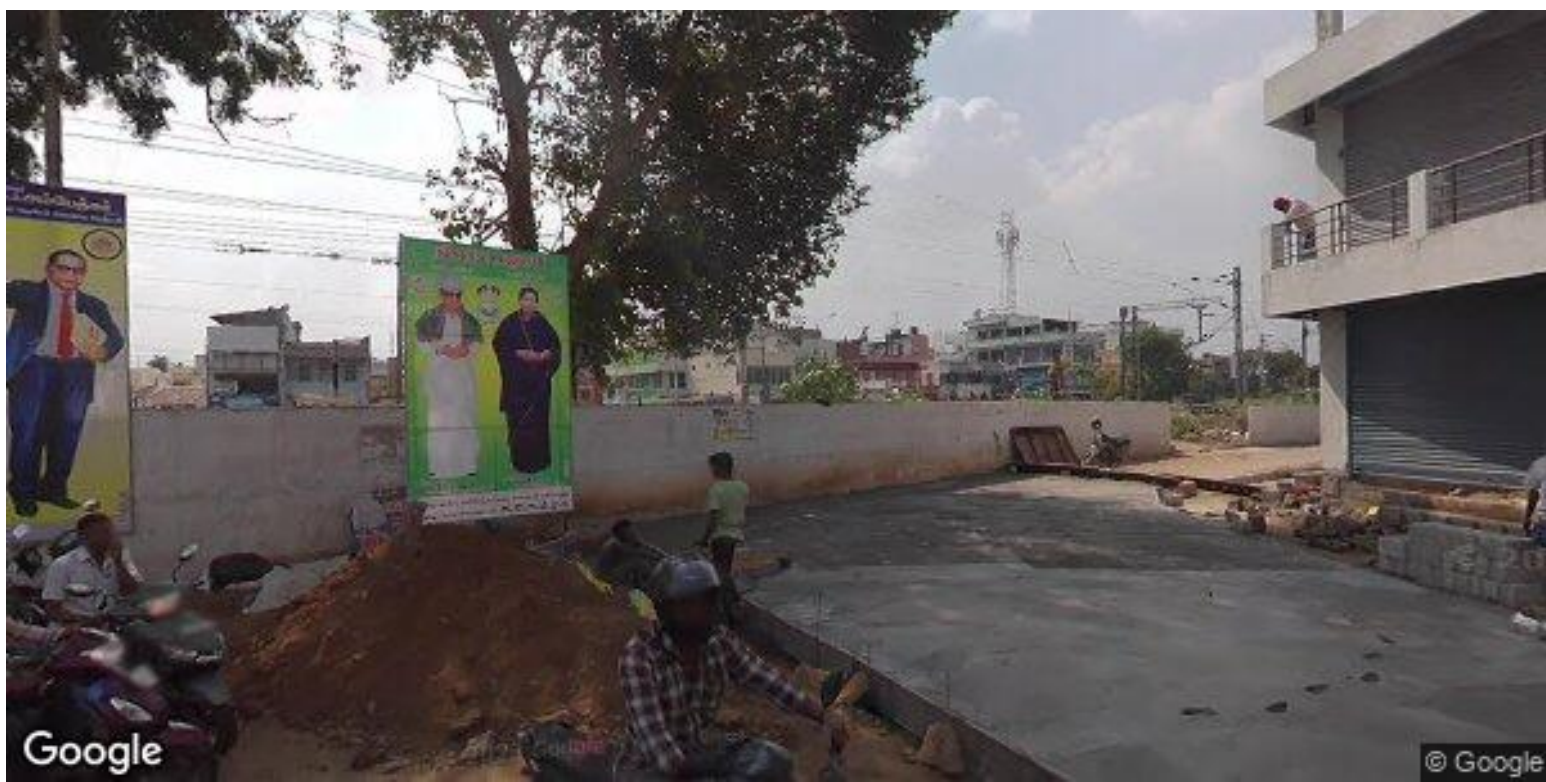
**Coordinates:** 11.11159, 77.34993

**Risk Type:** Blind Spot

**Risk Level:** Blind Spot

**Speed Limit:** 10 KM/Hr

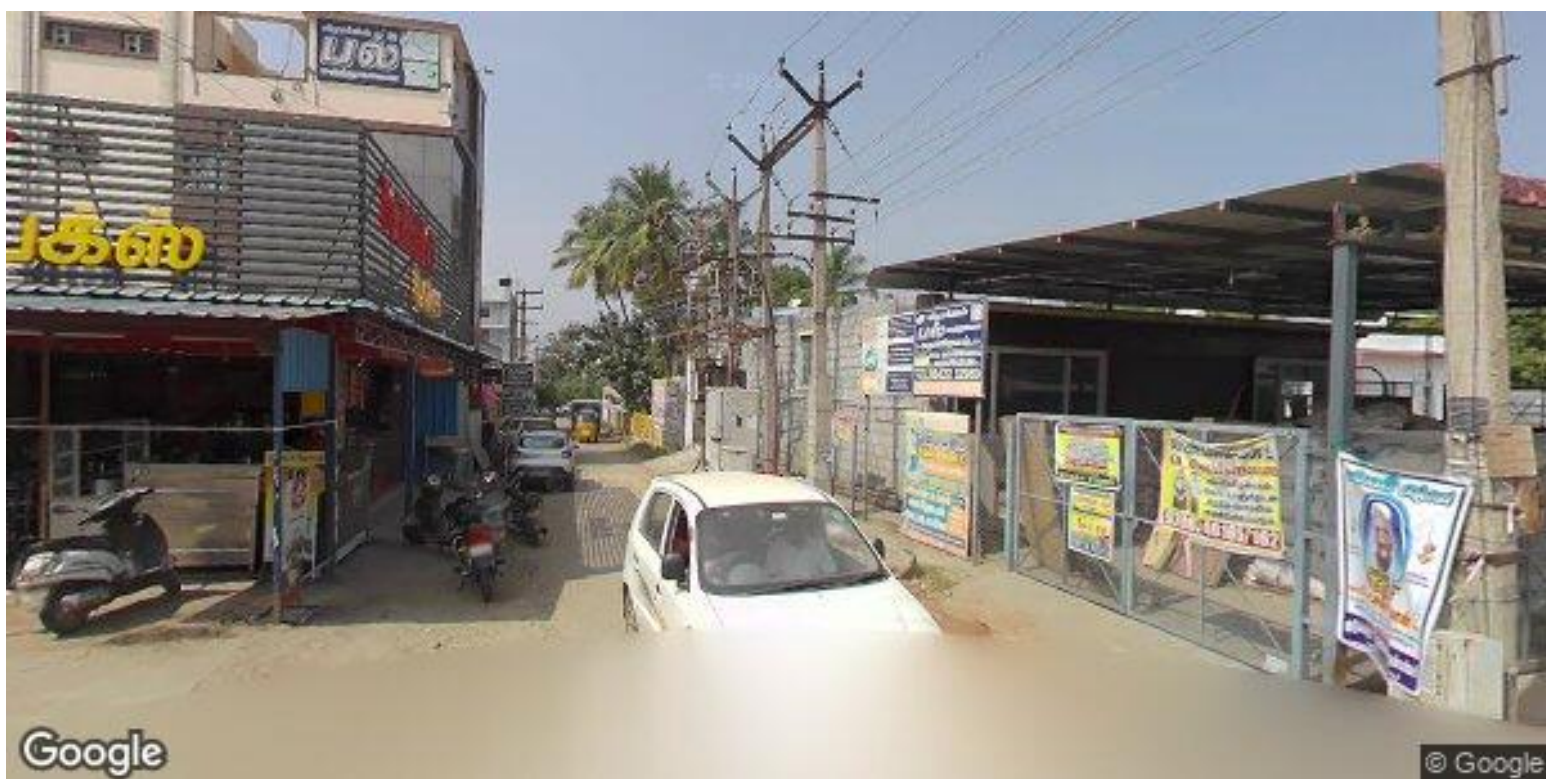
**Coordinates:** 11.11840, 77.34951

**Risk Type:** Turn

**Risk Level:** High

**Speed Limit:** 15 KM/Hr

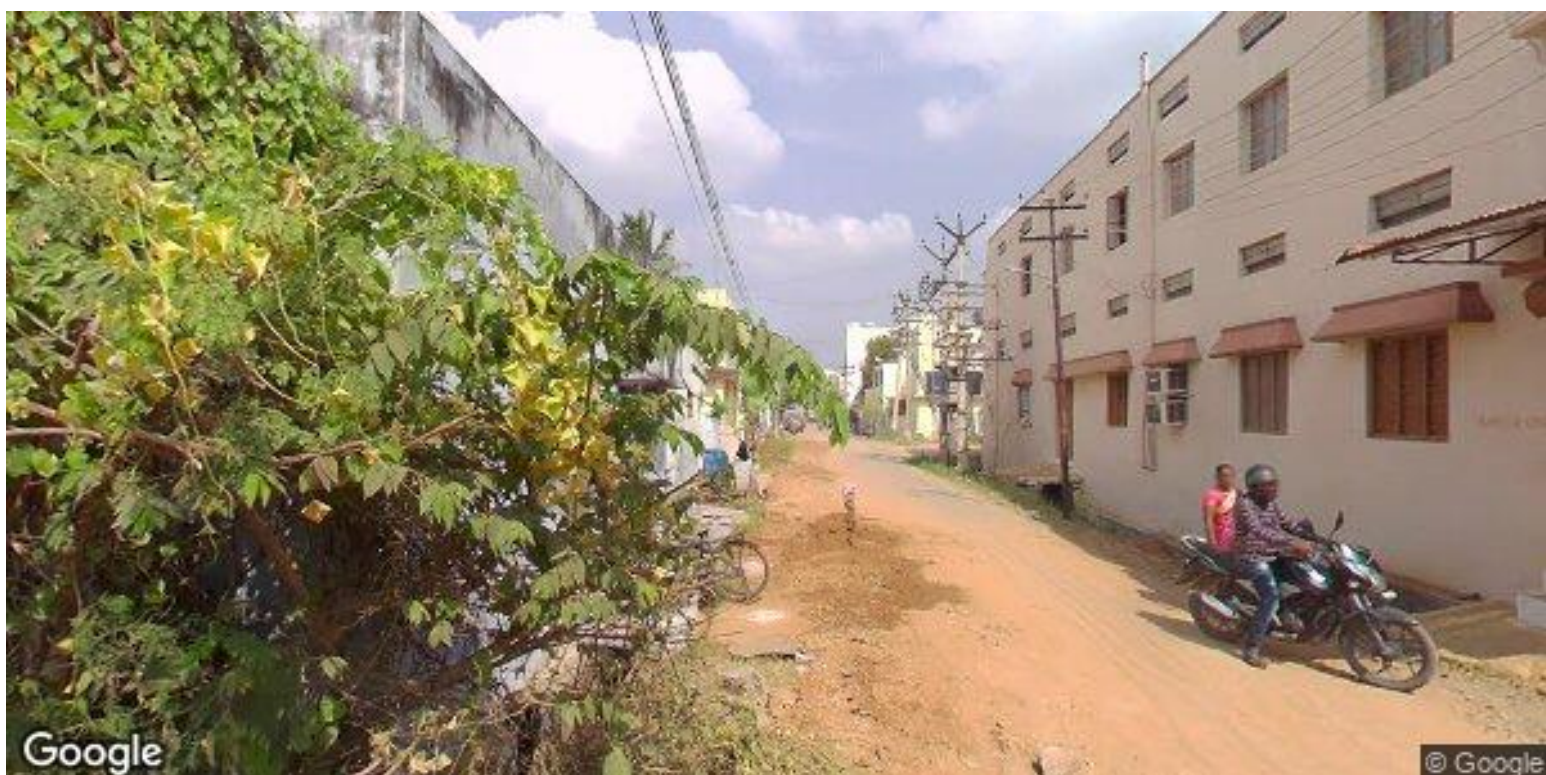
**Coordinates:** 11.11837, 77.34764

**Risk Type:** Turn

**Risk Level:** High

**Speed Limit:** 15 KM/Hr
