## JOURNEY RISK MANAGEMENT (JRM) STUDY

### Salem Terminal TO JAYAM & CO

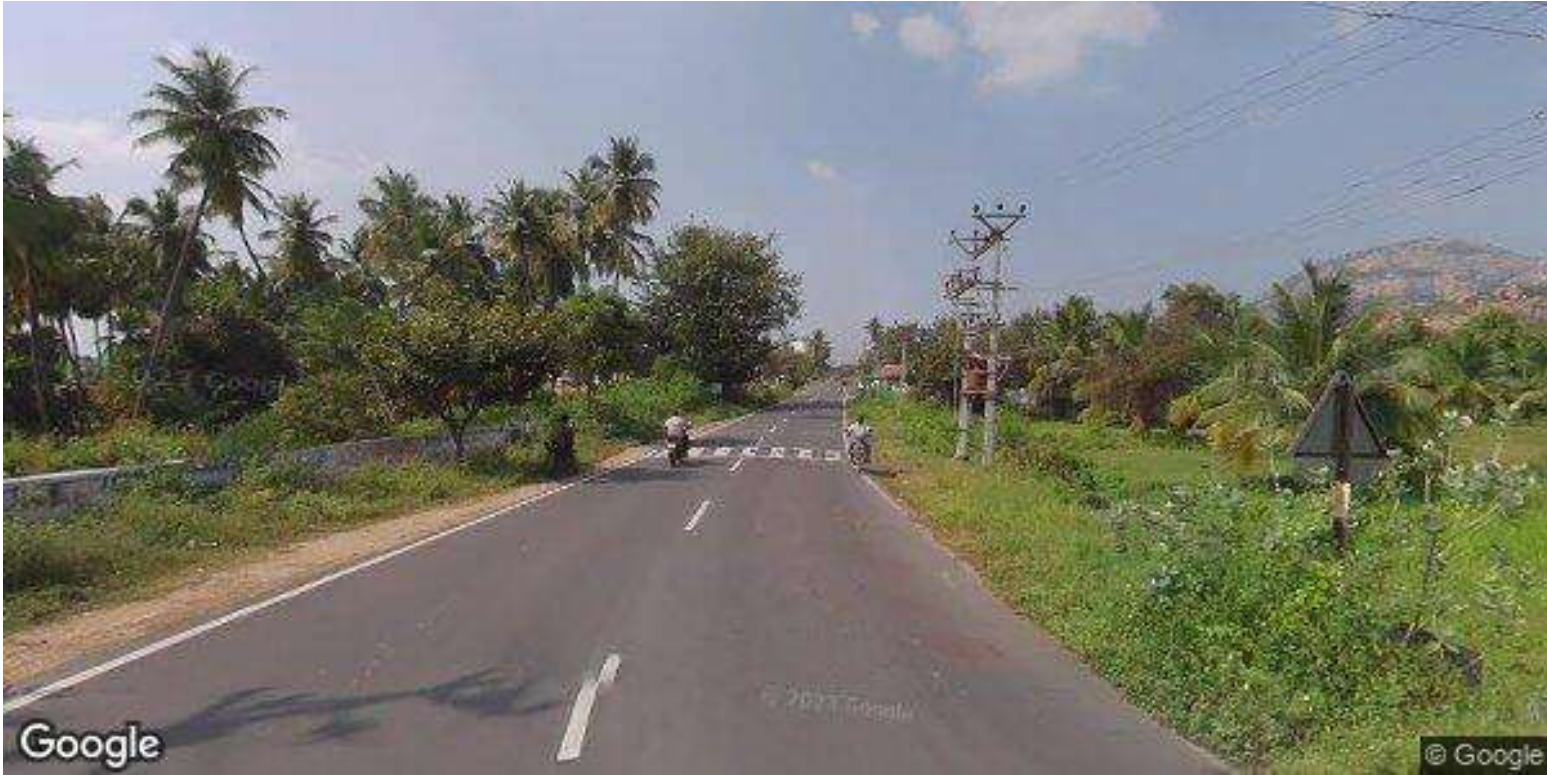
**Risk Type:** Turn  
**Risk Level:** High  
**Speed Limit:** 15 KM/Hr  
**Coordinates:** 11.45352, 77.85698

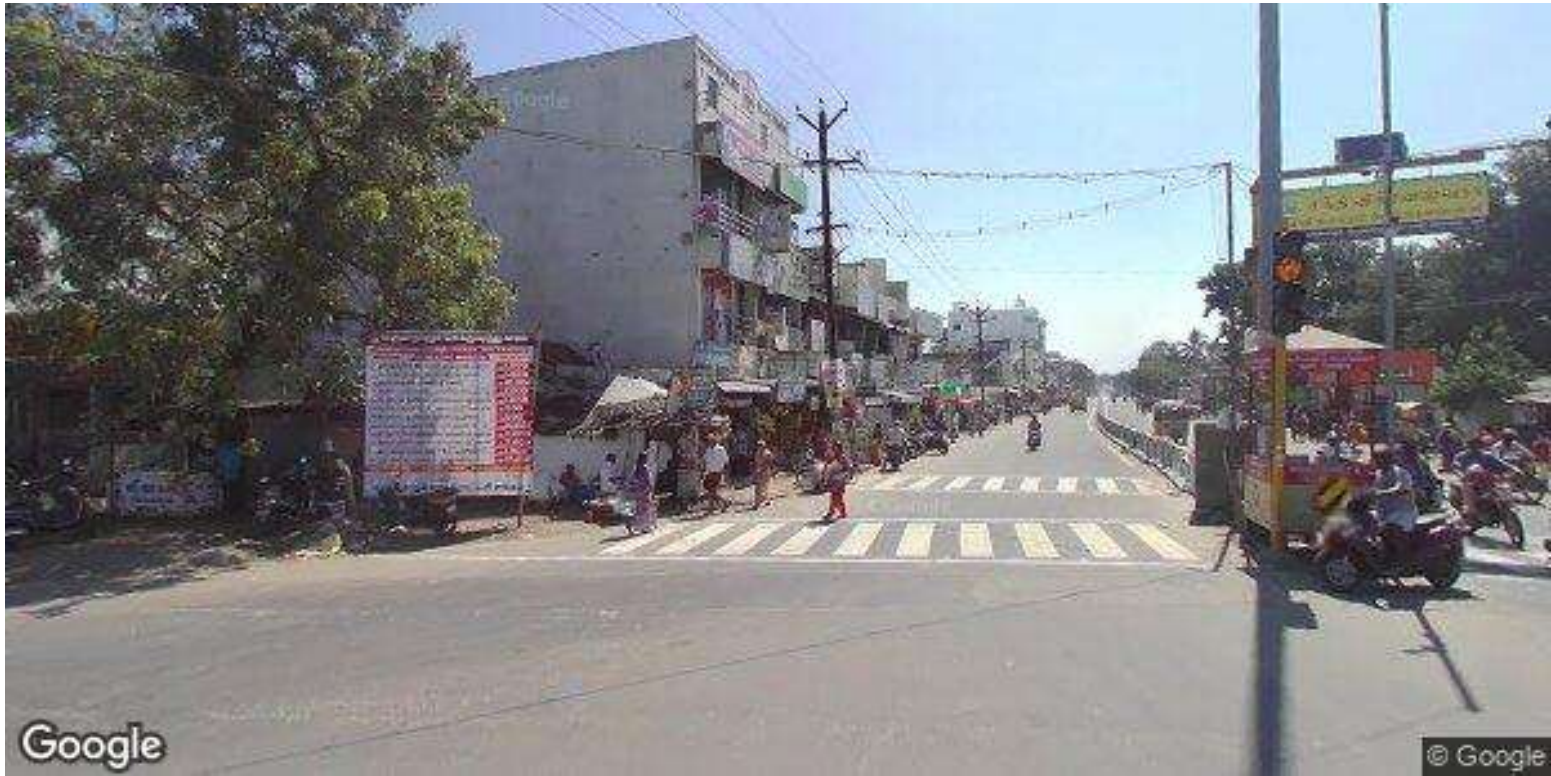
**Risk Type:** Turn  
**Risk Level:** High  
**Speed Limit:** 15 KM/Hr  
**Coordinates:** 11.20728, 77.35914

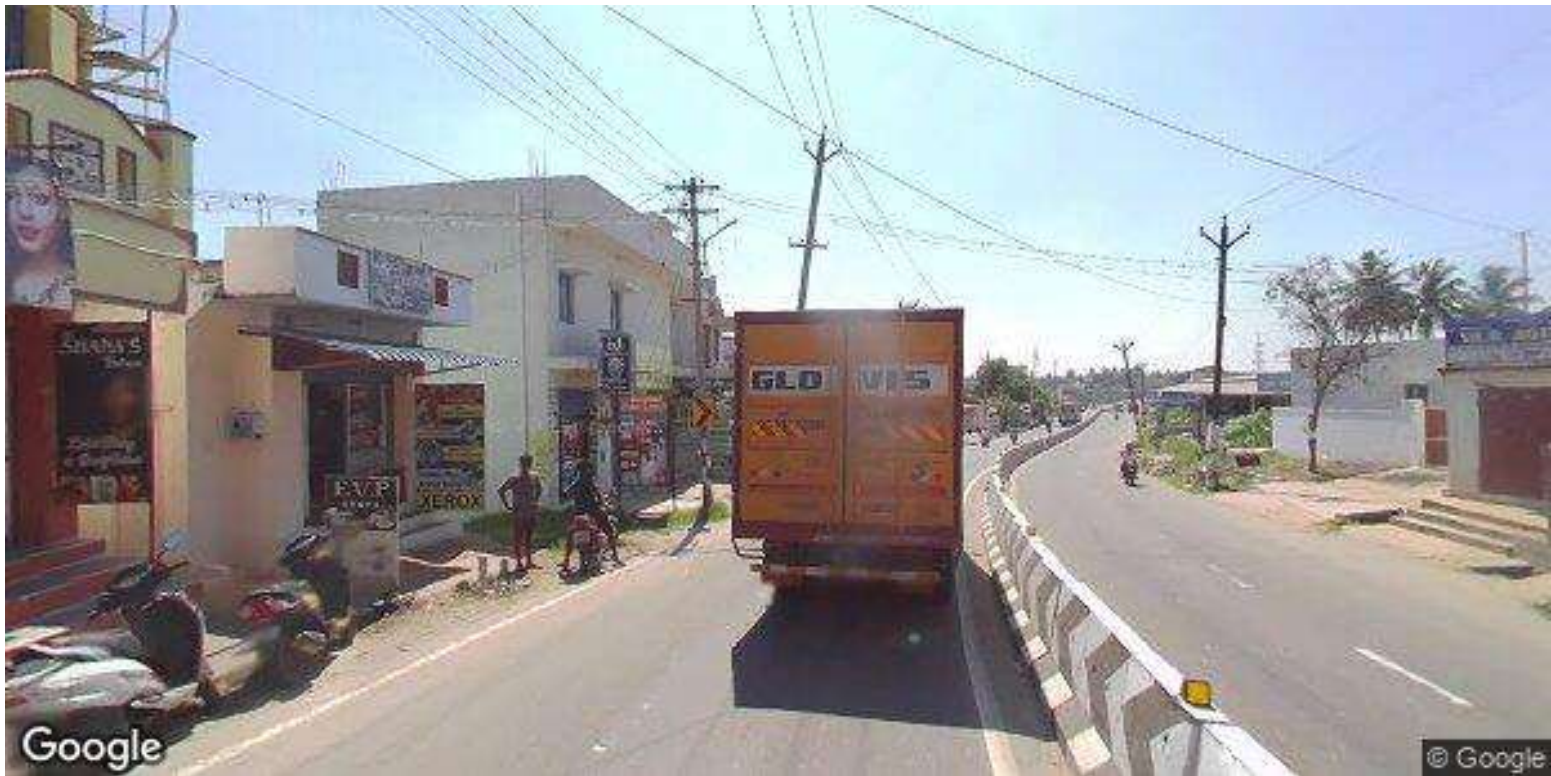
**Risk Type:** Turn  
**Risk Level:** Medium  
**Speed Limit:** 30 KM/Hr  
**Coordinates:** 11.20246, 77.35895

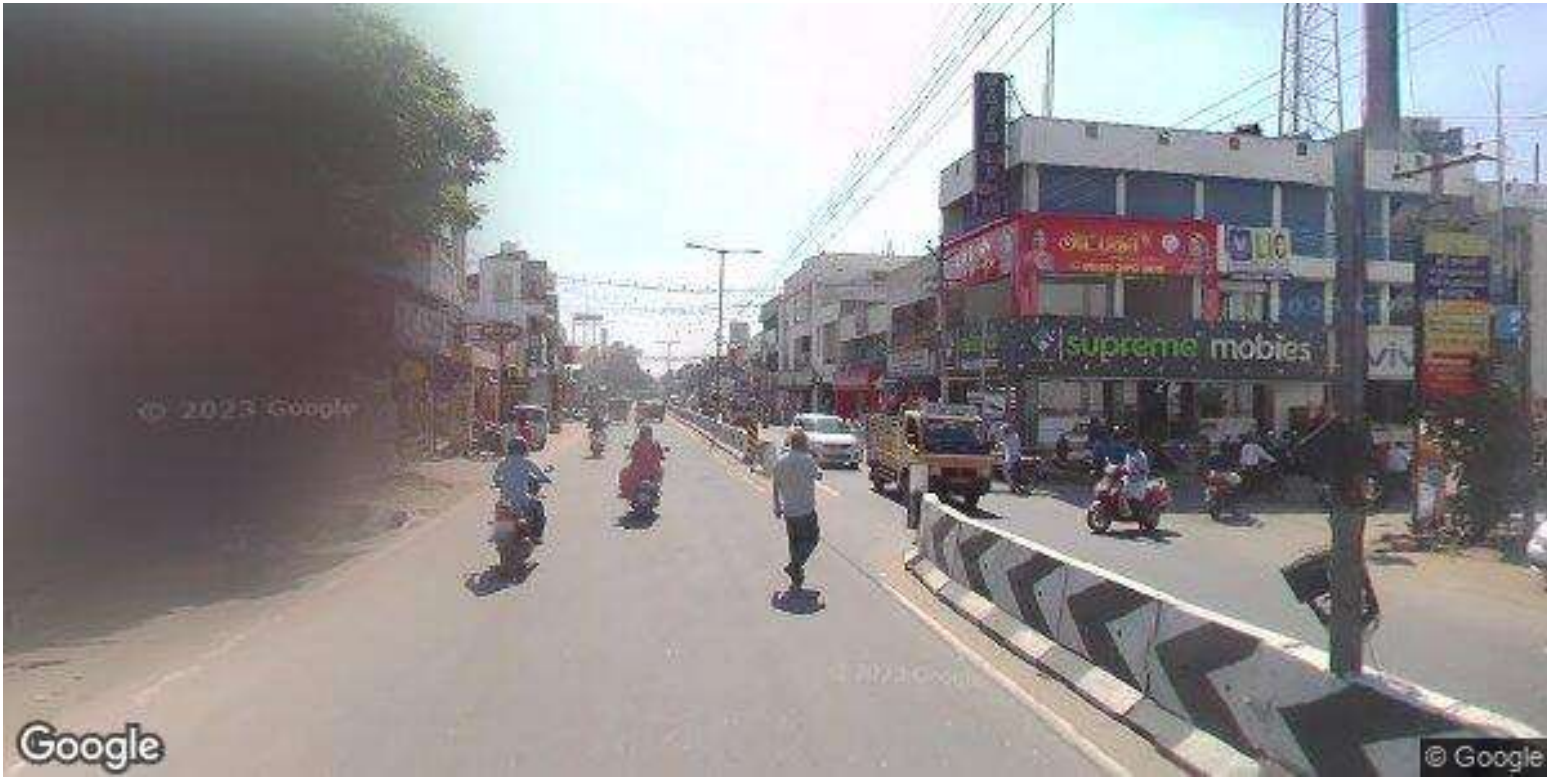
**Risk Type:** Turn  
**Risk Level:** Medium  
**Speed Limit:** 30 KM/Hr  
**Coordinates:** 11.13132, 77.34190

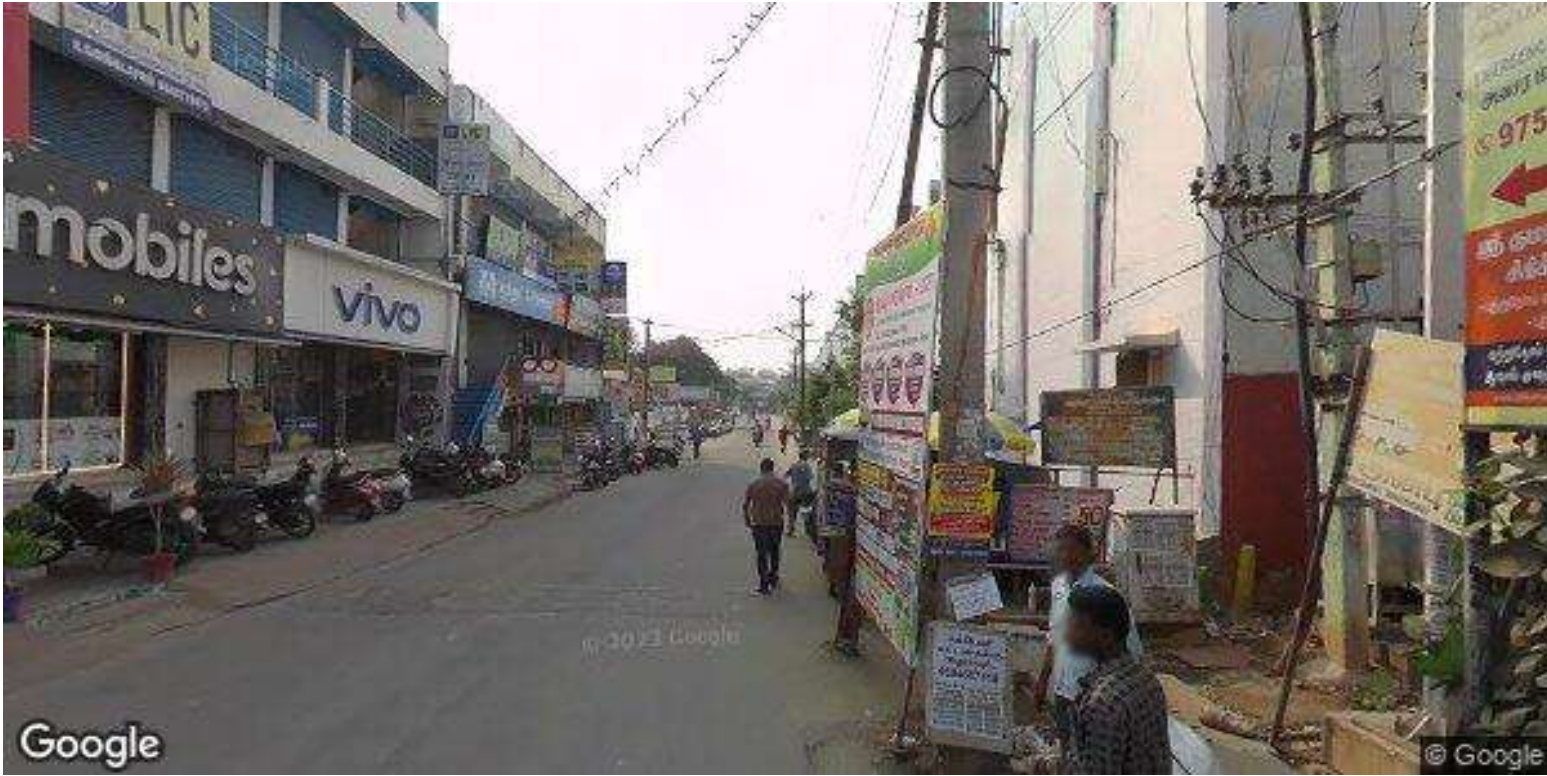
**Risk Type:** Turn  
**Risk Level:** High  
**Speed Limit:** 15 KM/Hr  
**Coordinates:** 11.13122, 77.34181

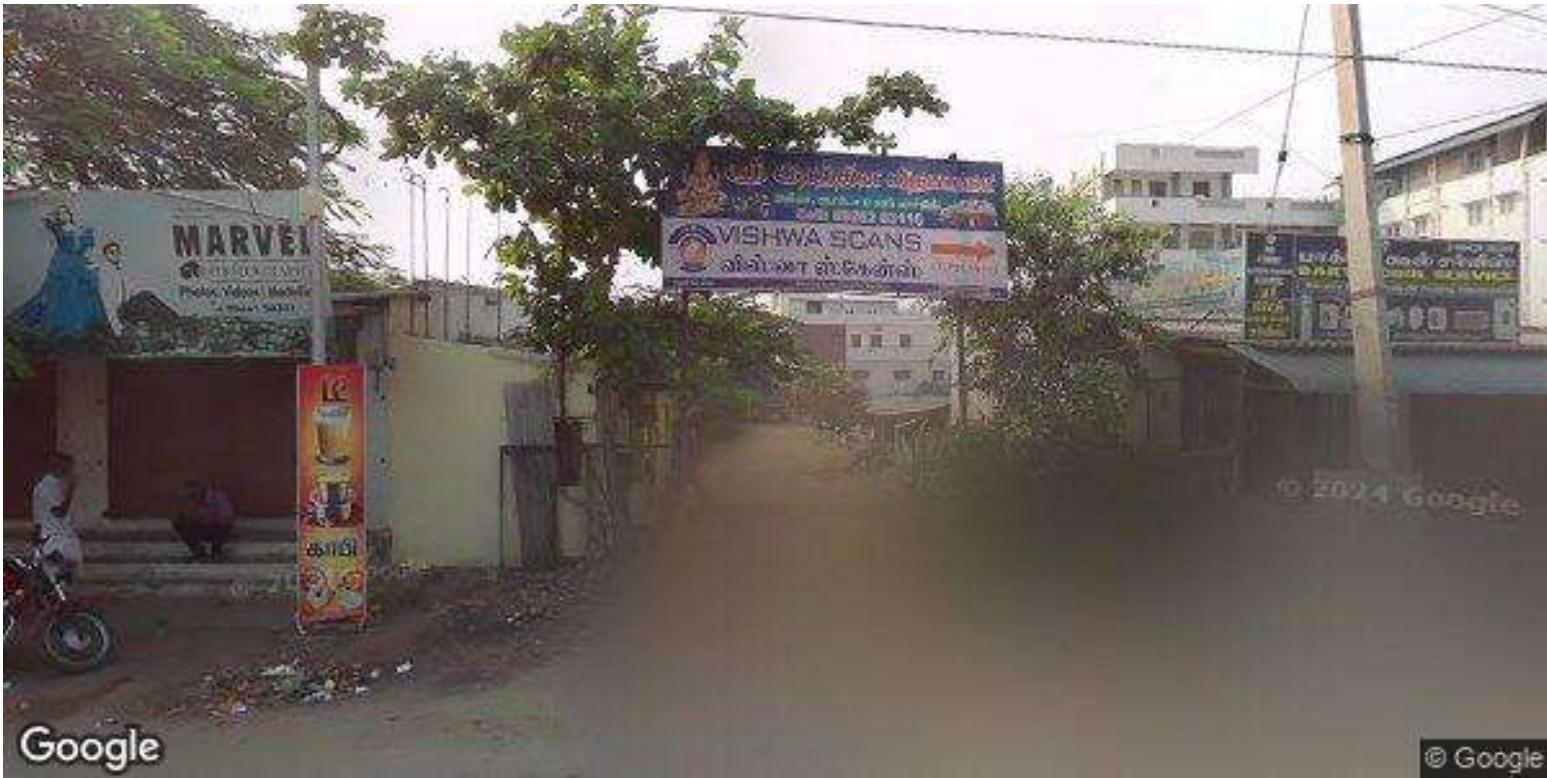
Coordinates: 11.13131, 77.34033

Risk Type: Turn

Risk Level: High

Speed Limit: 15 KM/Hr

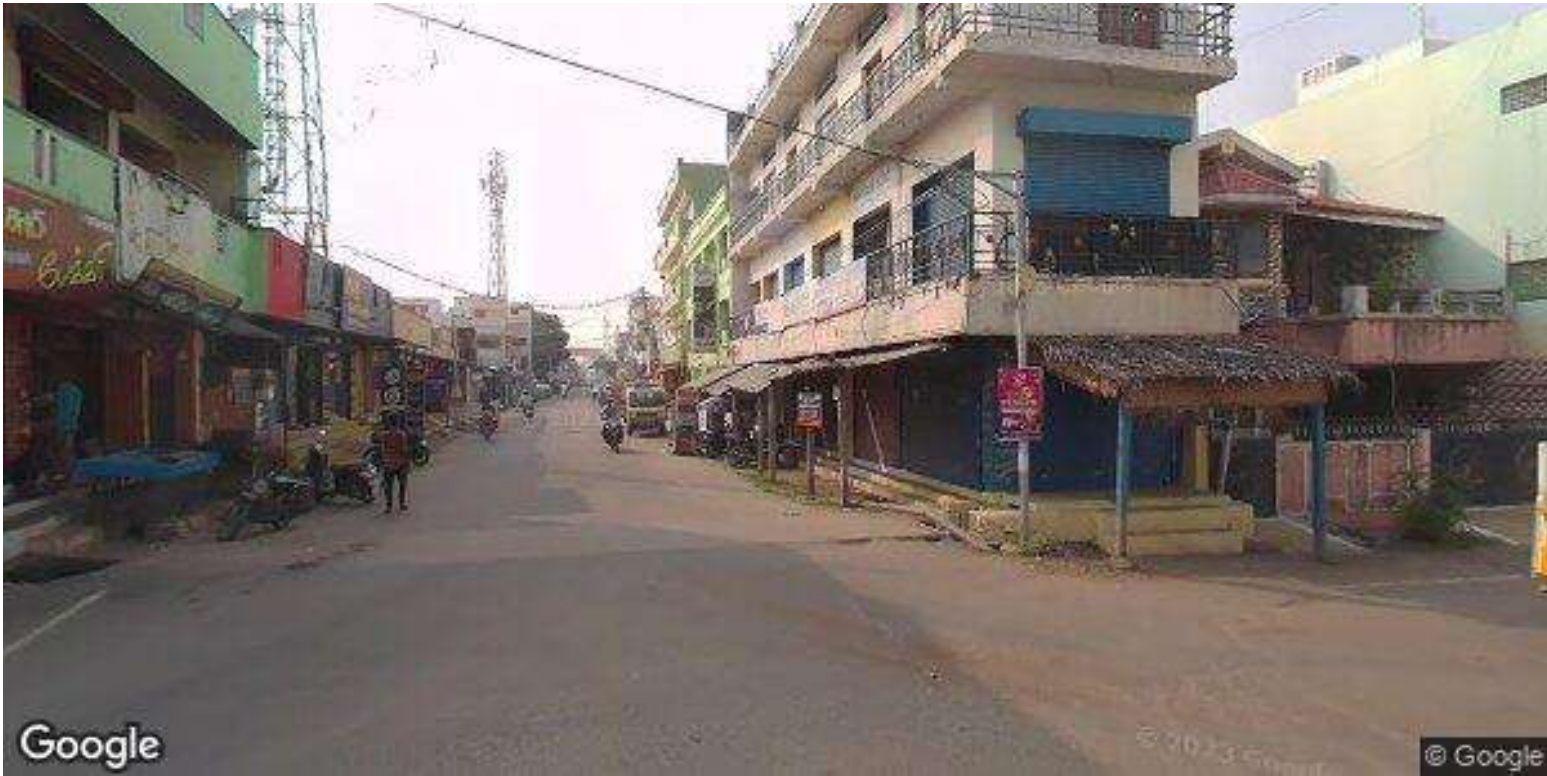
Coordinates: 11.12933, 77.34007

Risk Type: Blind Spot

Risk Level: Blind Spot

Speed Limit: 10 KM/Hr

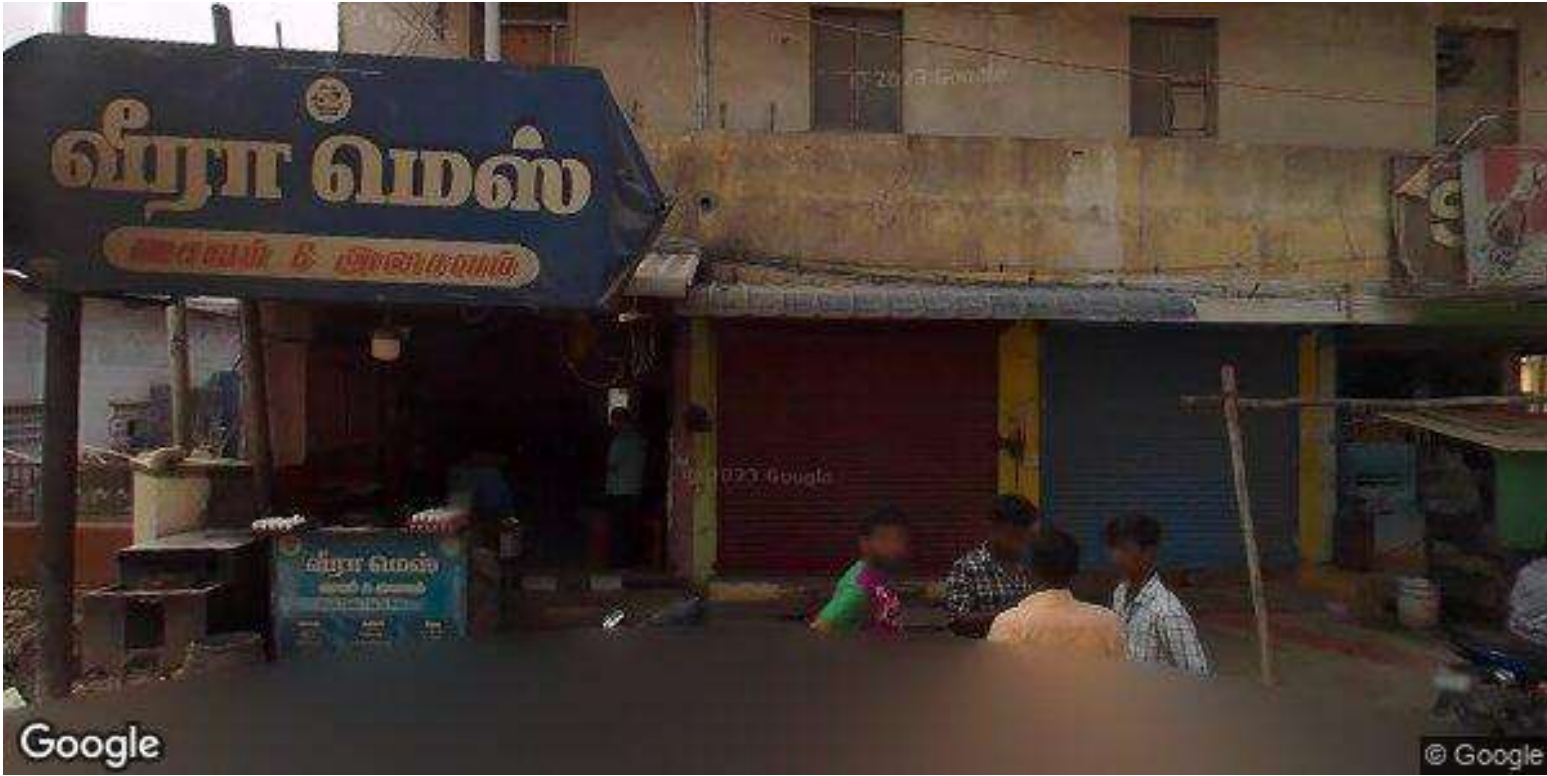
Coordinates: 11.12918, 77.33333

Risk Type: Turn

Risk Level: High

Speed Limit: 15 KM/Hr

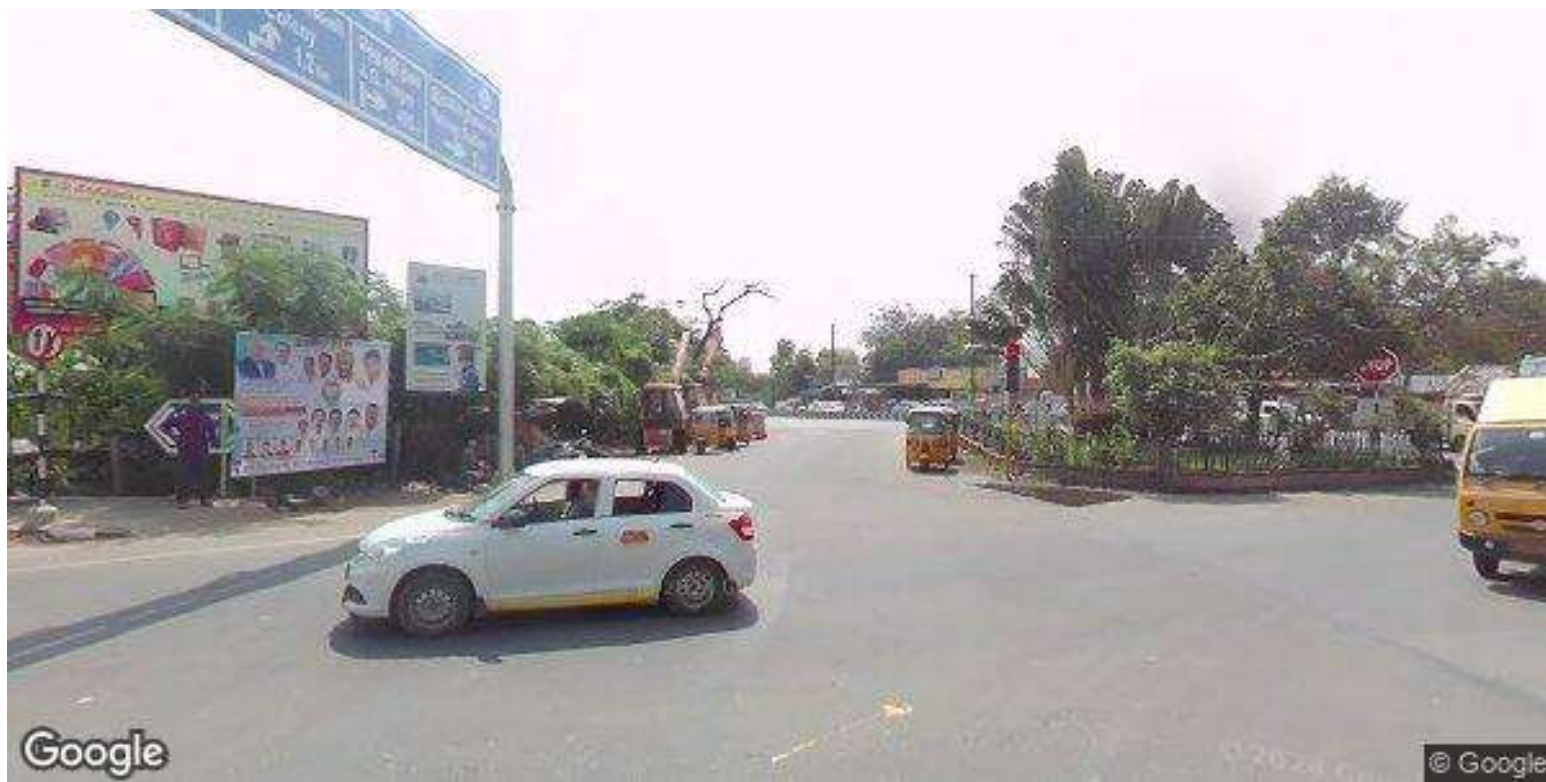
**Coordinates: 11.12201, 77.33196**

**Risk Type: Turn**

**Risk Level: High**

**Speed Limit: 15 KM/Hr**

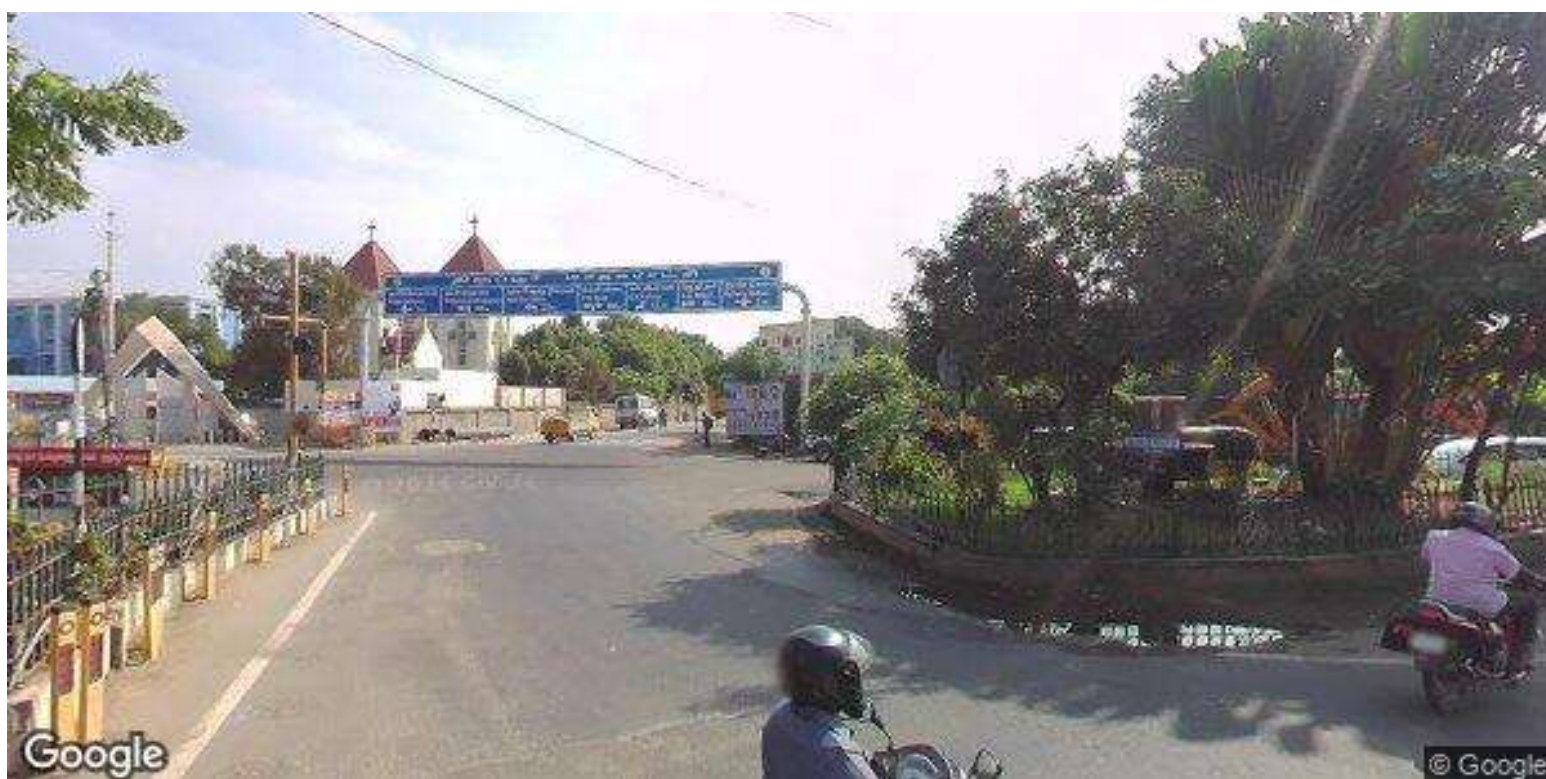
**Coordinates: 11.12187, 77.33169**

**Risk Type: Turn**

**Risk Level: High**

**Speed Limit: 15 KM/Hr**
