# IndianOil

## JOURNEY RISK MANAGEMENT (JRM) STUDY

**Salem Terminal TO GOPALAKRISHNA AGENCY**

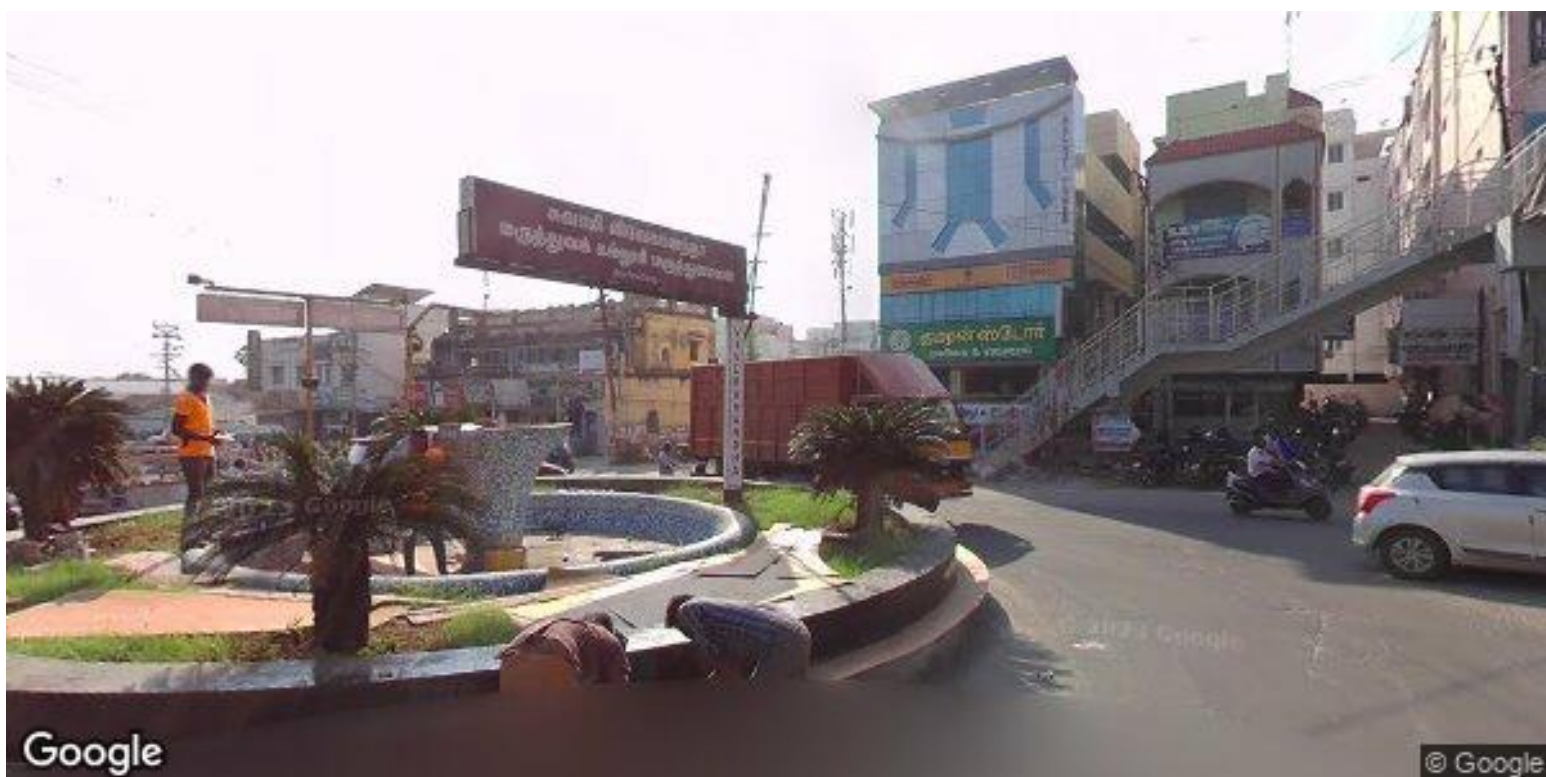
**Coordinates:** 11.38395, 77.89480

| | Risk Type | Risk Level | Coordinates | Speed Limit |
|---|---|---|---|---|
| 0 | Roundabout | High | 11.38395, 77.89480 | 15 KM/Hr |

**Risk Type:** Roundabout

**Risk Level:** High

**Speed Limit:** 15 KM/Hr

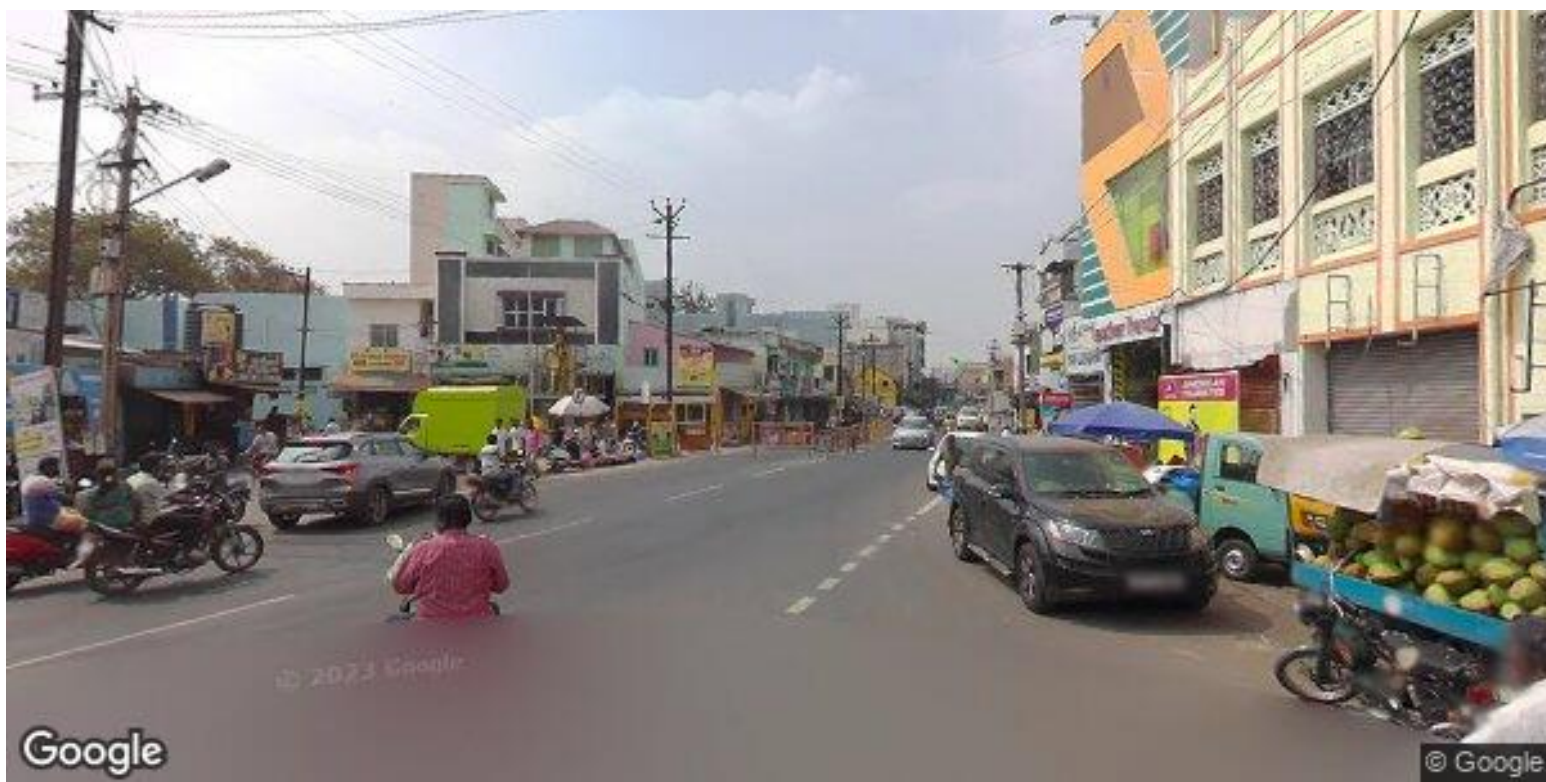
**Coordinates:** 11.22481, 78.16539

| | Risk Type | Risk Level | Coordinates | Speed Limit |
|---|---|---|---|---|
| 9 | Turn | Medium | 11.22481, 78.16539 | 30 KM/Hr |

**Risk Type:** Turn

**Risk Level:** Medium

**Speed Limit:** 30 KM/Hr

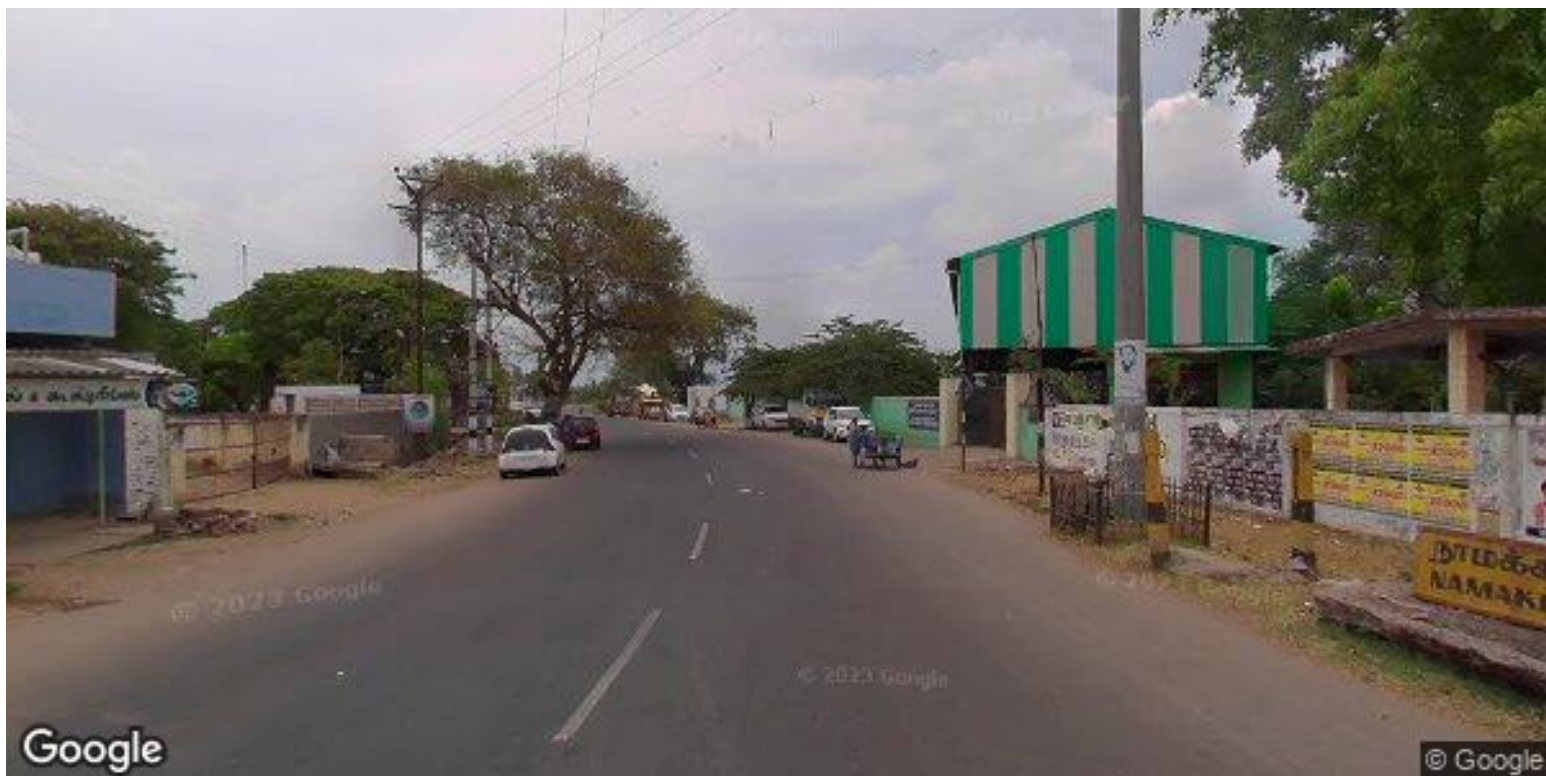
**Coordinates:** 11.22408, 78.17204

| | Risk Type | Risk Level | Coordinates | Speed Limit |
|---|---|---|---|---|
| 10 | Turn | Medium | 11.22408, 78.17204 | 30 KM/Hr |

**Risk Type:** Turn

**Risk Level:** Medium

**Speed Limit:** 30 KM/Hr

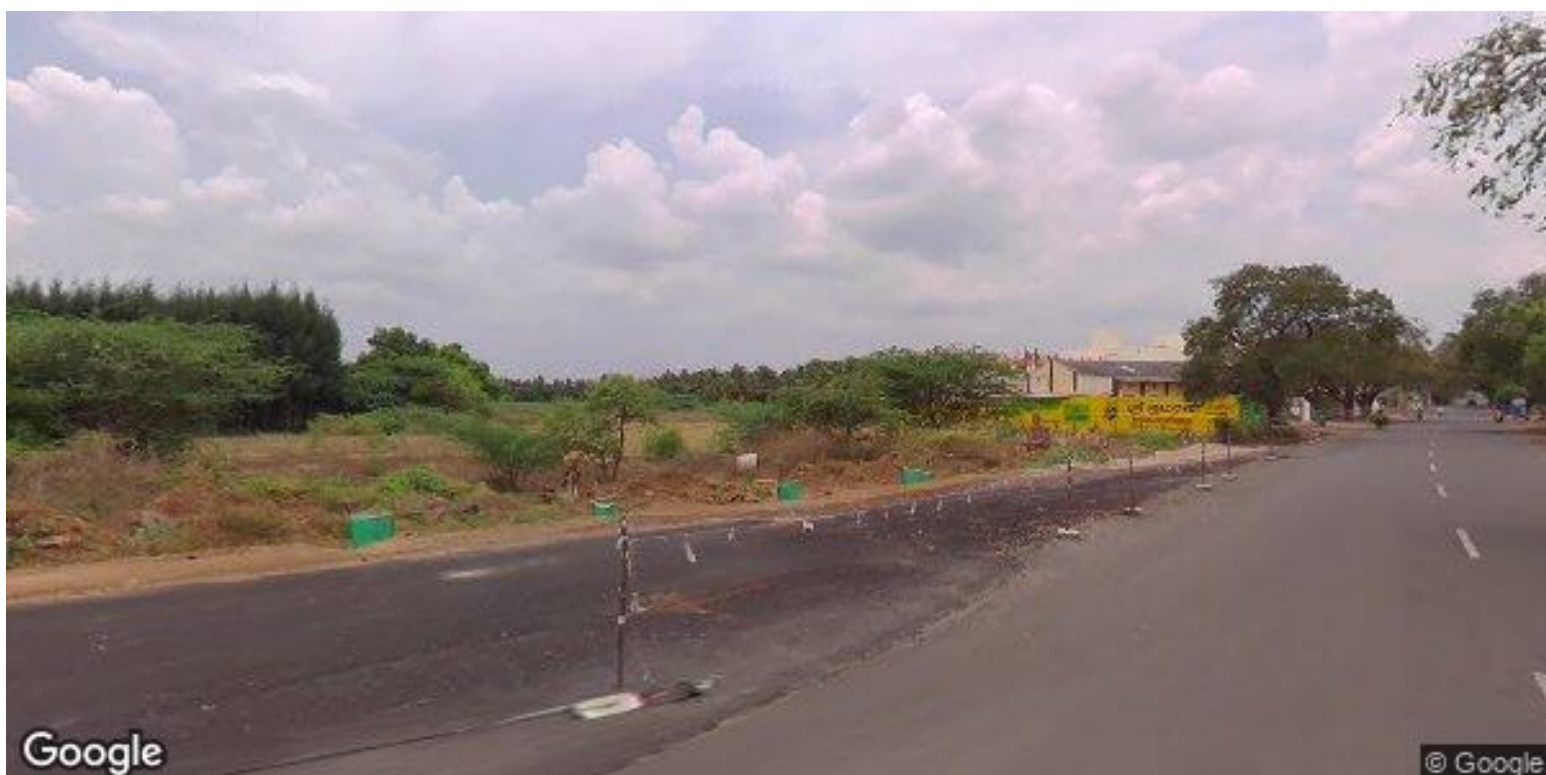
**Coordinates:** 11.23996, 78.21411

| | Risk Type | Risk Level | Coordinates | Speed Limit |
|---|---|---|---|---|
| 11 | Turn | Medium | 11.23996, 78.21411 | 30 KM/Hr |

**Risk Type:** Turn

**Risk Level:** Medium

**Speed Limit:** 30 KM/Hr
