# IndianOil

## JOURNEY RISK MANAGEMENT (JRM) STUDY

### Salem Terminal TO SHREE VIGNESHWARA FUELS

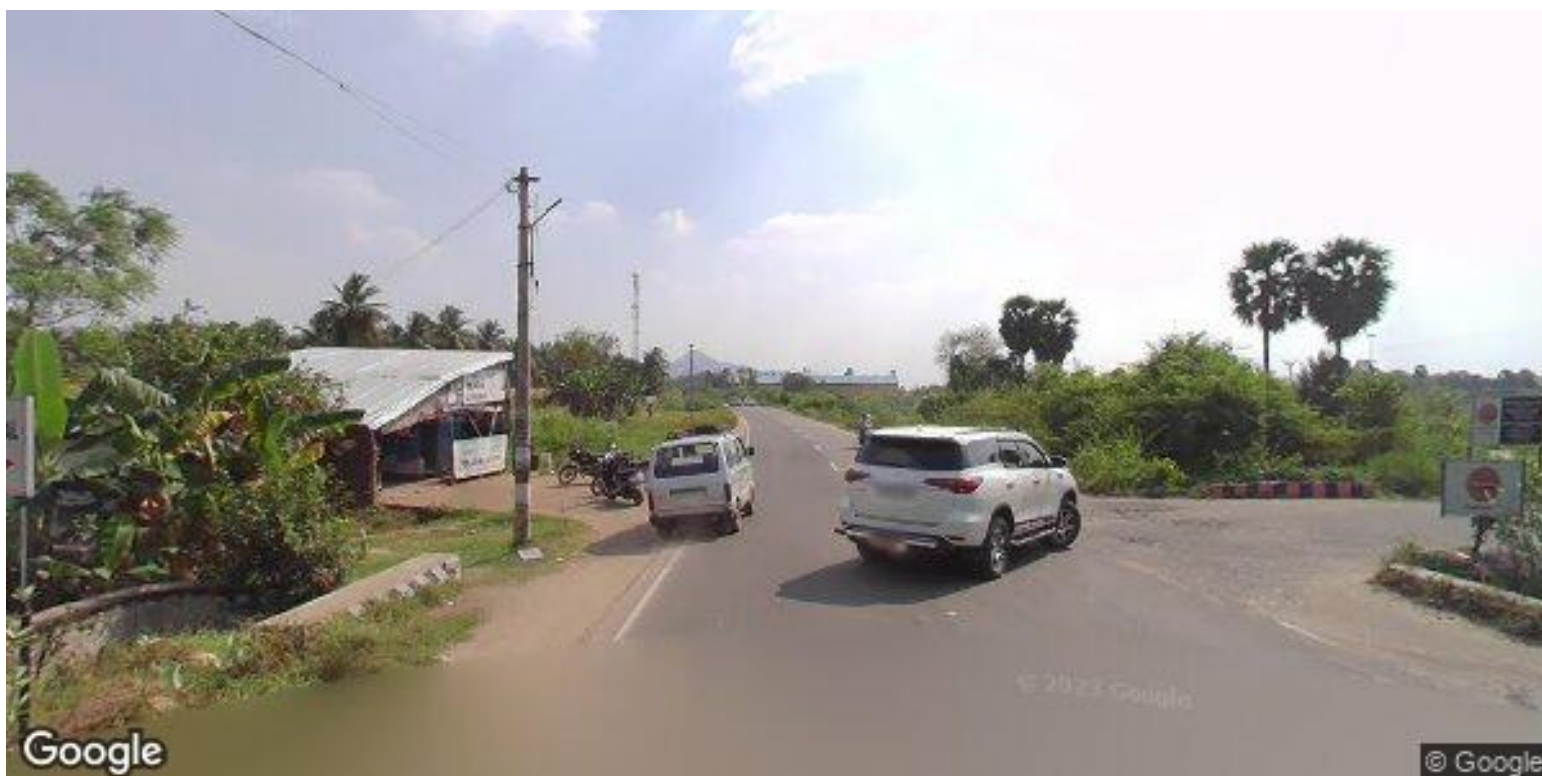
**Coordinates:** 11.44029, 77.87544

**Risk Type:** Turn

**Risk Level:** High

**Speed Limit:** 15 KM/Hr

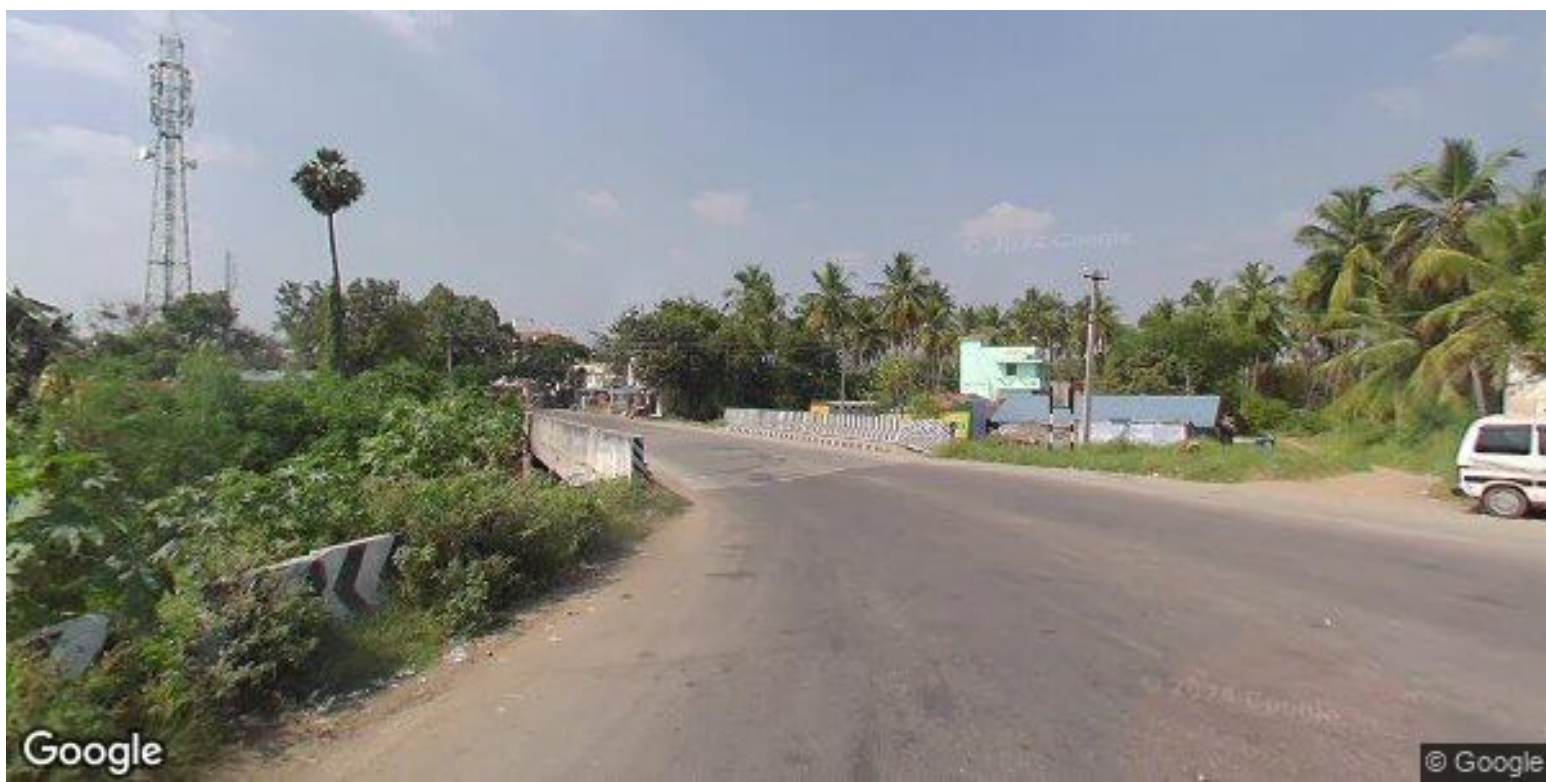
**Coordinates:** 11.44893, 77.87413

**Risk Type:** Turn

**Risk Level:** Medium

**Speed Limit:** 30 KM/Hr

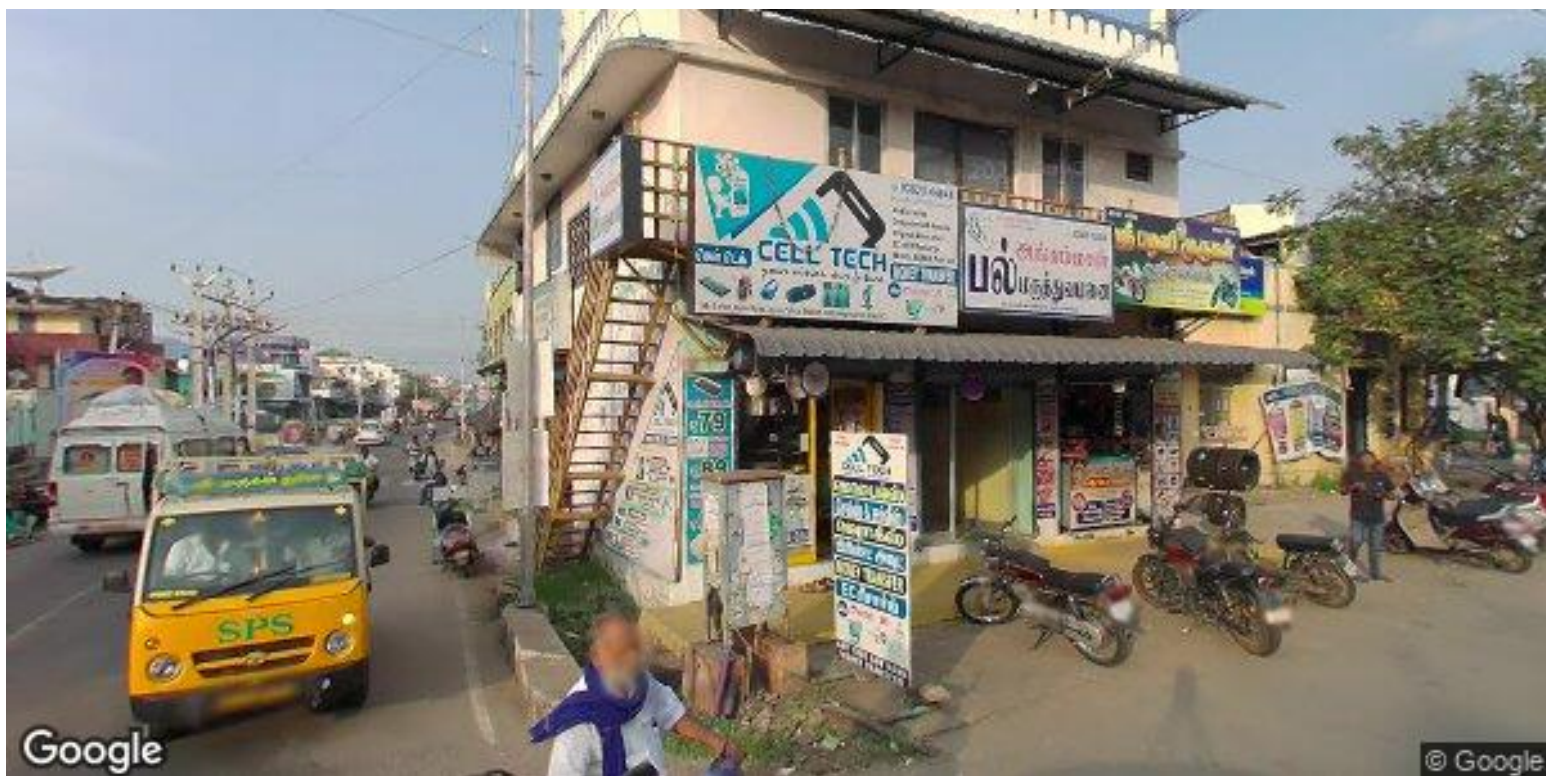
**Risk Type:** Turn  
**Risk Level:** High  
**Speed Limit:** 15 KM/Hr  
**Coordinates:** 11.44111, 77.69331

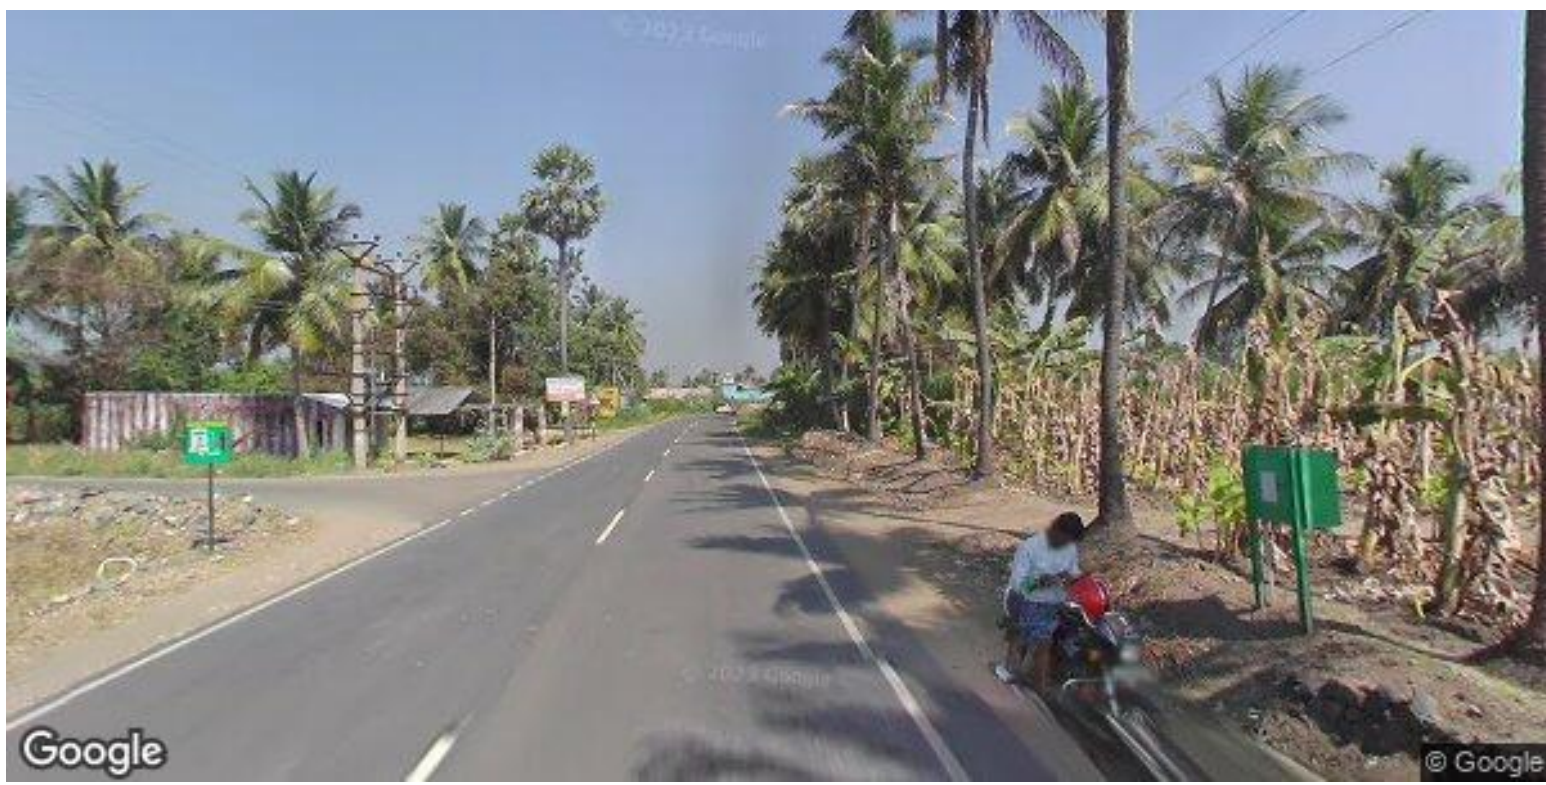
**Coordinates:** 11.48173, 77.70723

**Risk Type:** Blind Spot

**Risk Level:** Blind Spot

**Speed Limit:** 10 KM/Hr

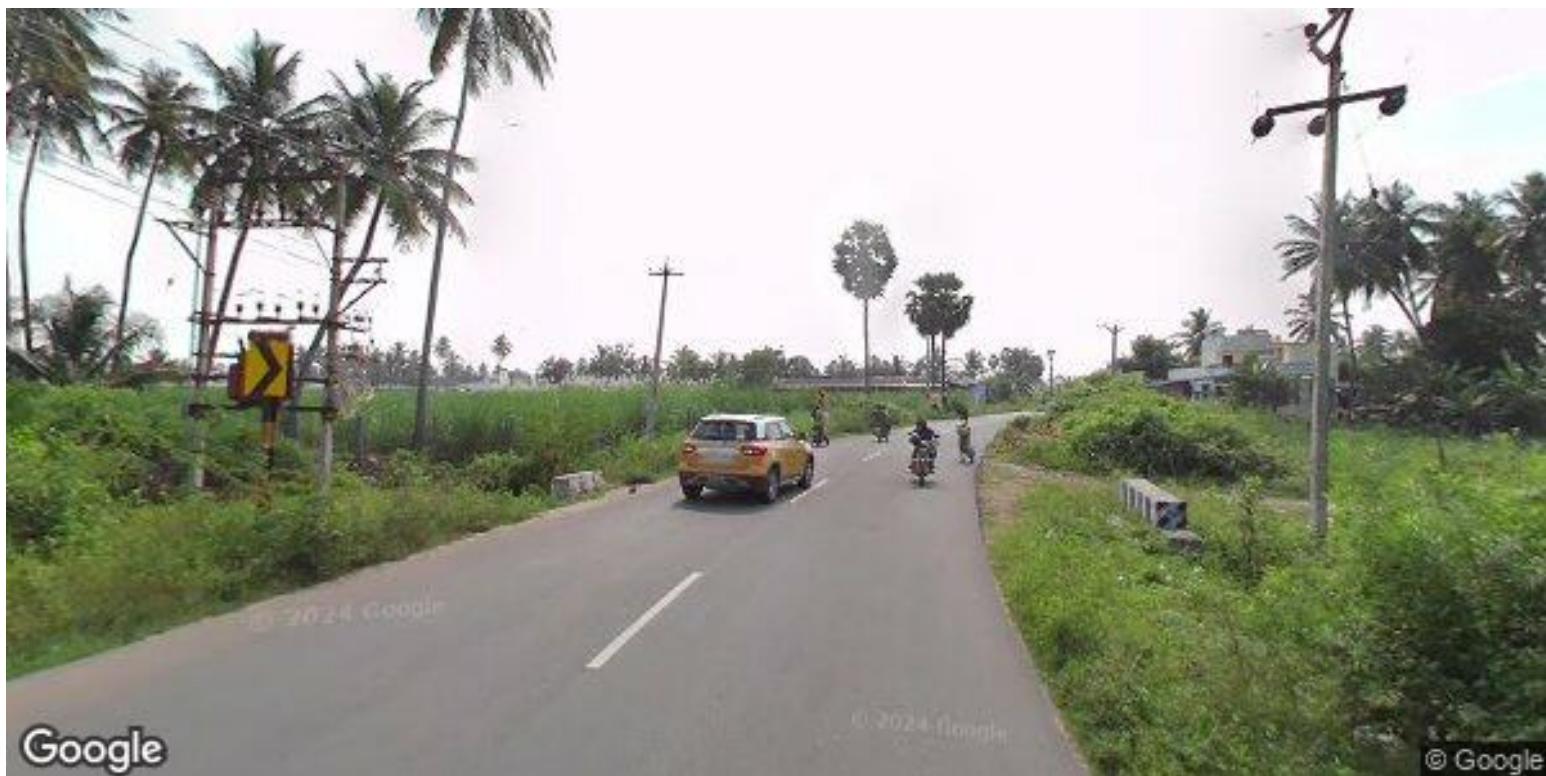
**Coordinates:** 11.46090, 77.69969

**Risk Type:** Turn

**Risk Level:** Medium

**Speed Limit:** 30 KM/Hr

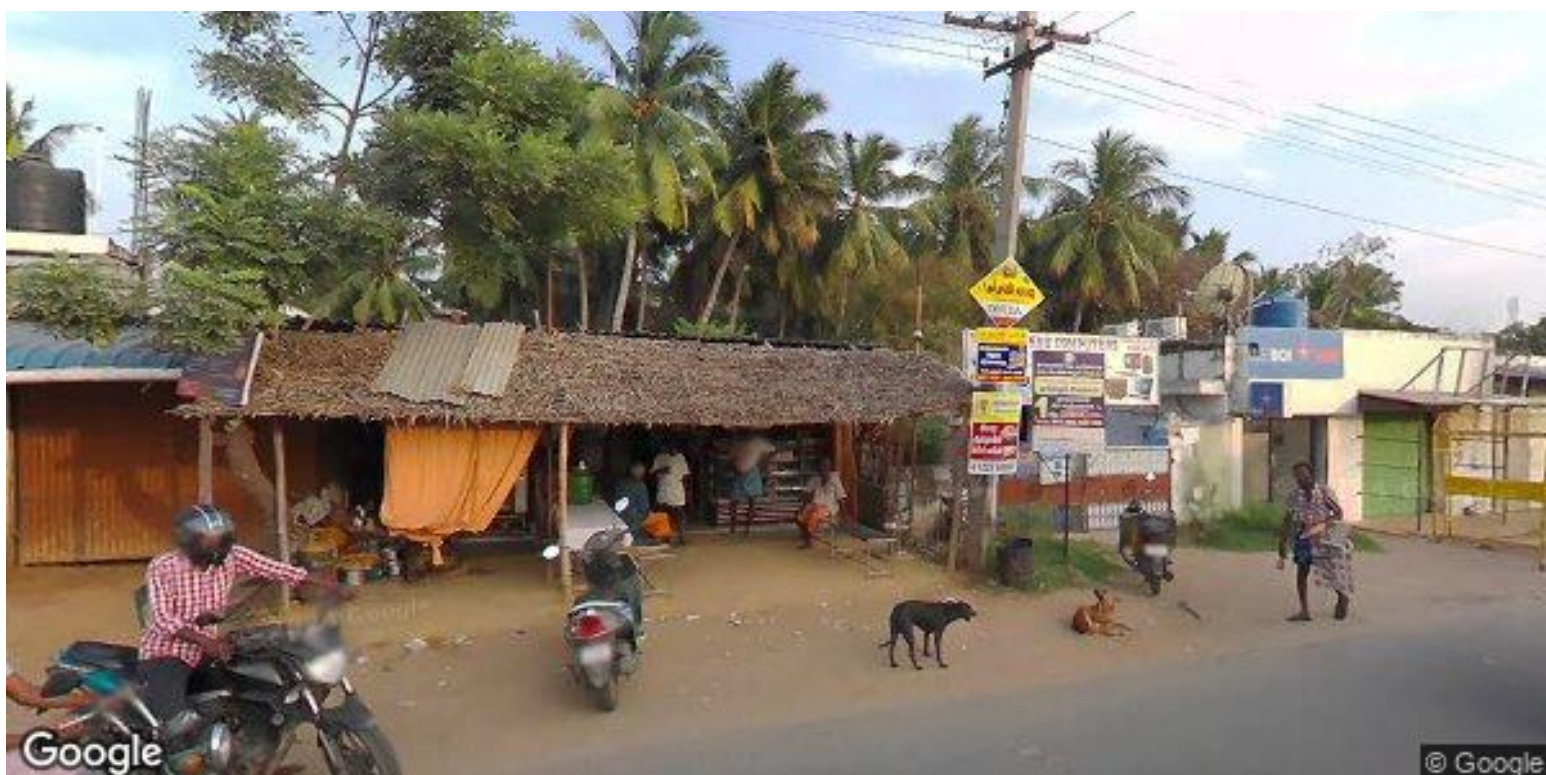
**Risk Type:** Blind Spot  
**Risk Level:** Blind Spot  
**Speed Limit:** 10 KM/Hr  
**Coordinates:** 11.44985, 77.69520

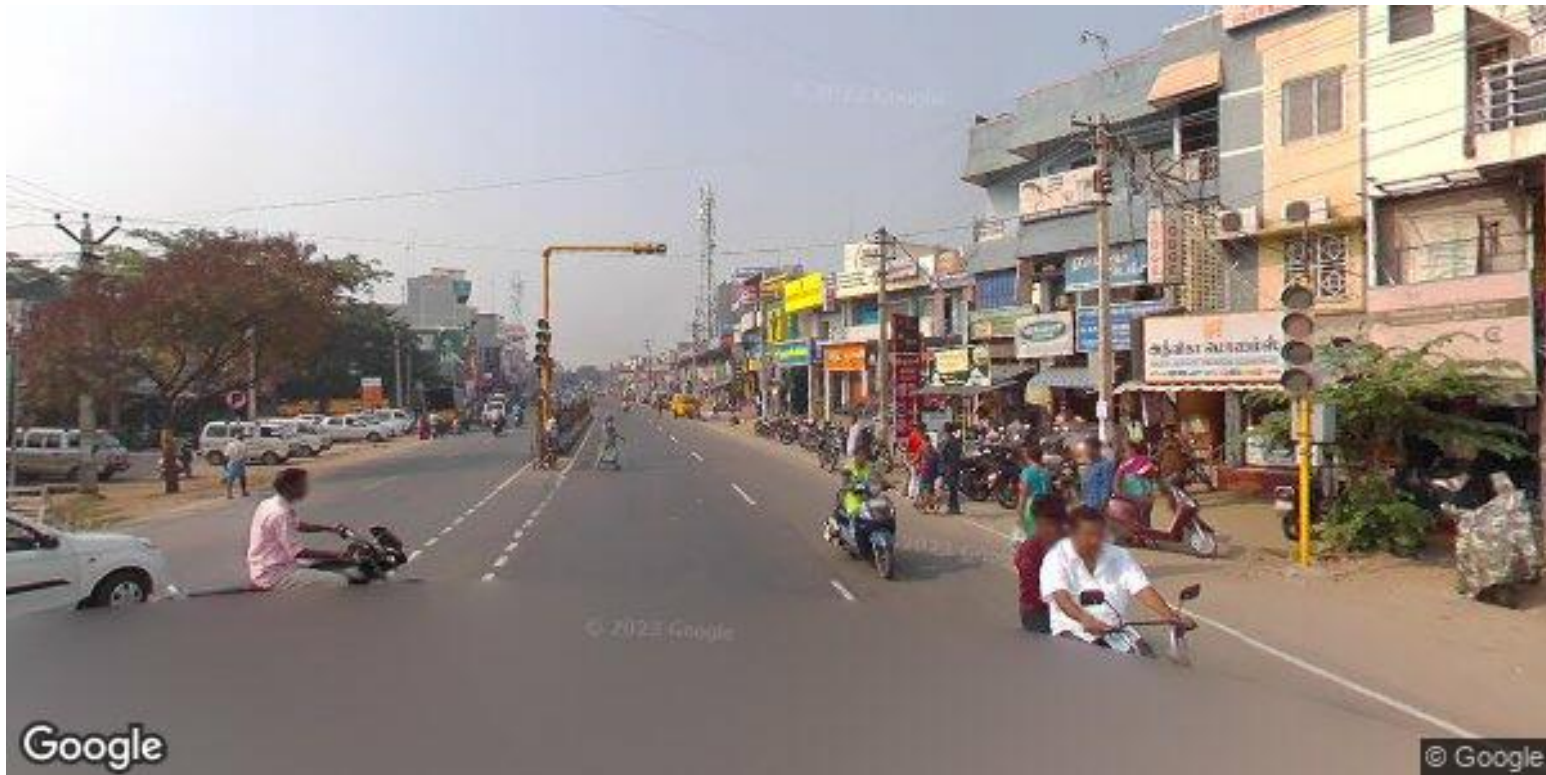
**Risk Type:** Turn  
**Risk Level:** High  
**Speed Limit:** 15 KM/Hr  
**Coordinates:** 11.45331, 77.68803

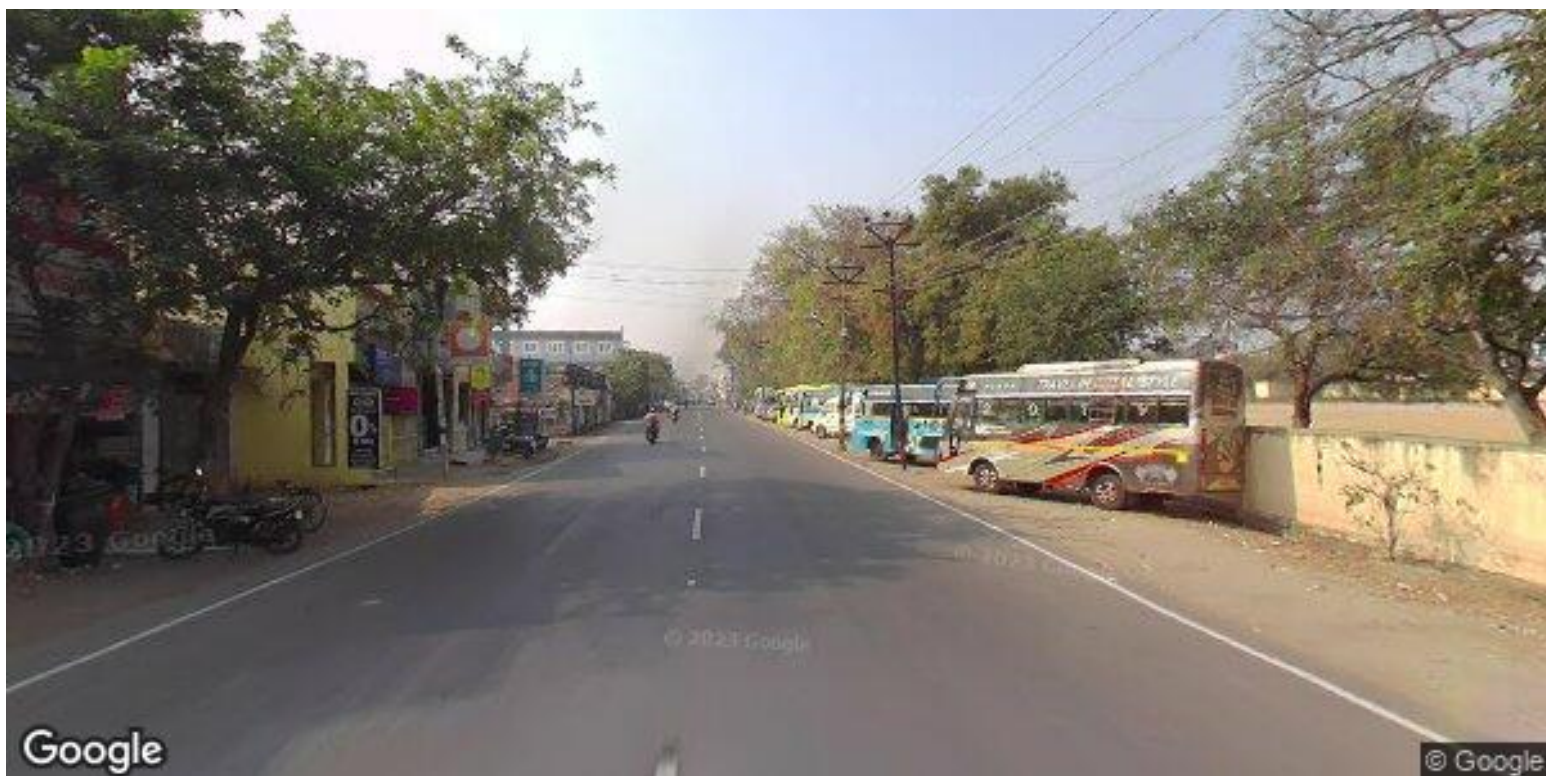
**Risk Type:** Blind Spot  
**Risk Level:** Blind Spot  
**Speed Limit:** 10 KM/Hr  
**Coordinates:** 11.44979, 77.68549

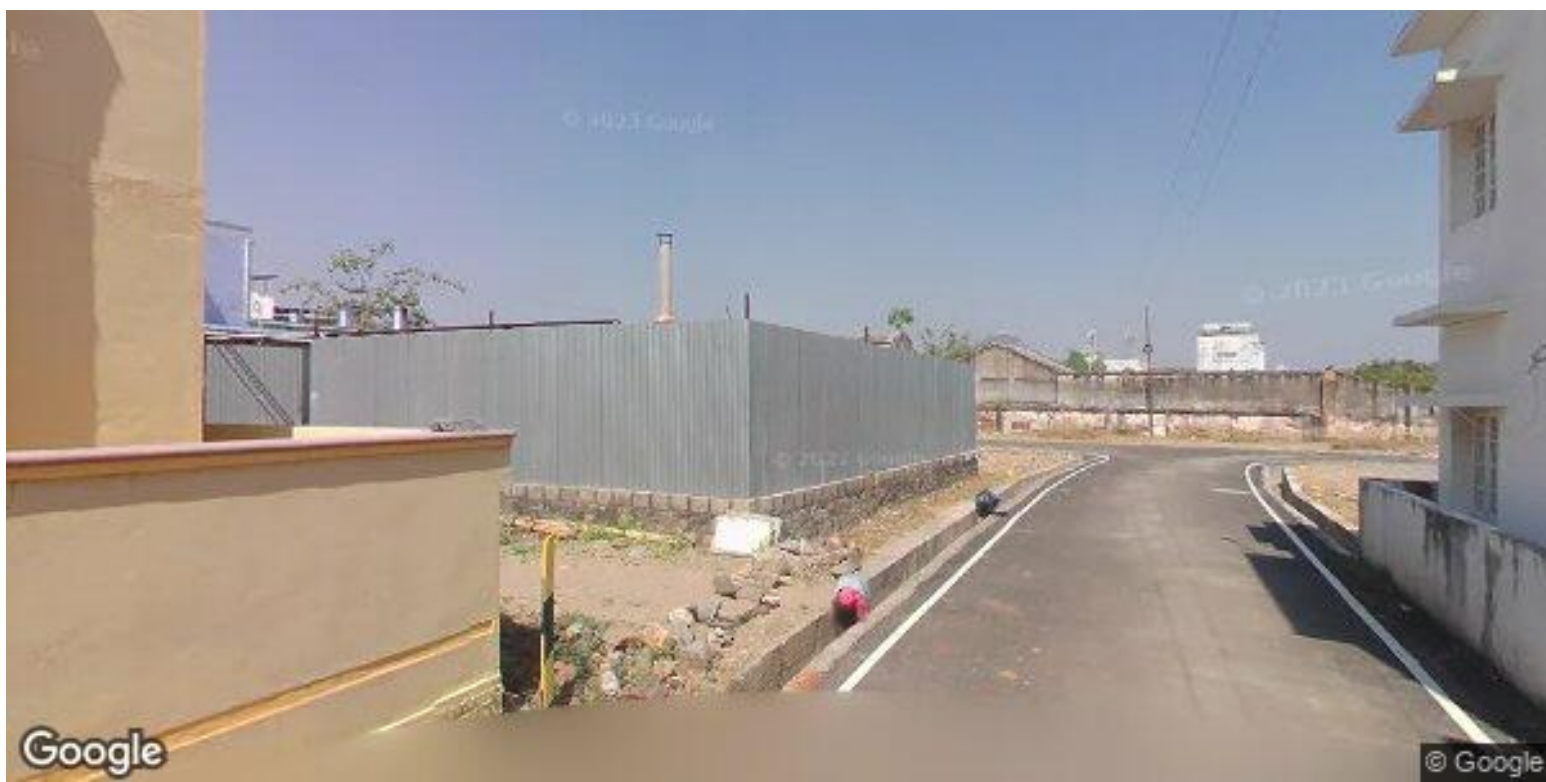
**Coordinates:** 11.44948, 77.68645

**Risk Type:** Turn

**Risk Level:** High

**Speed Limit:** 15 KM/Hr

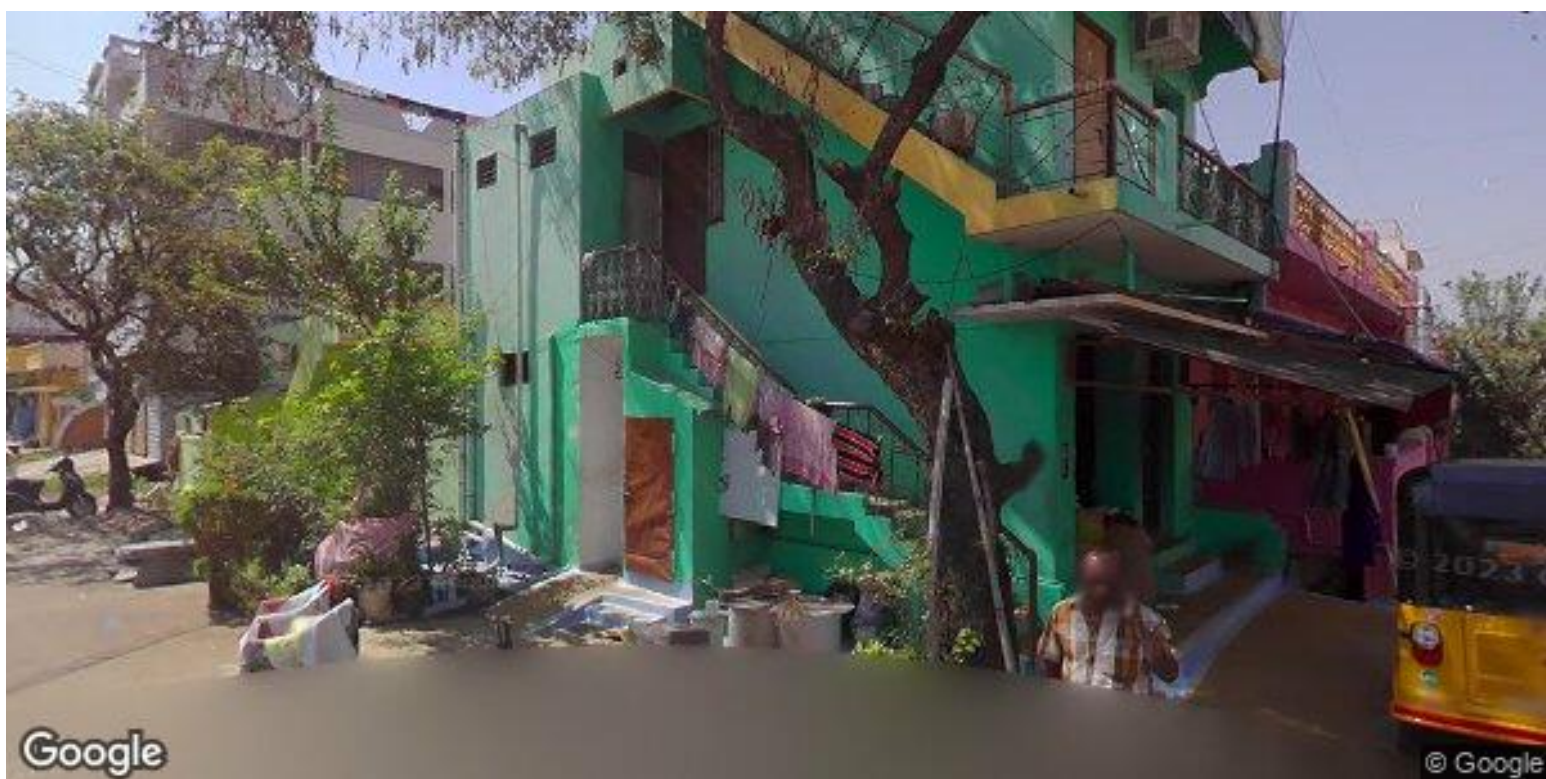
**Coordinates:** 11.44801, 77.68596

**Risk Type:** Turn

**Risk Level:** High

**Speed Limit:** 15 KM/Hr

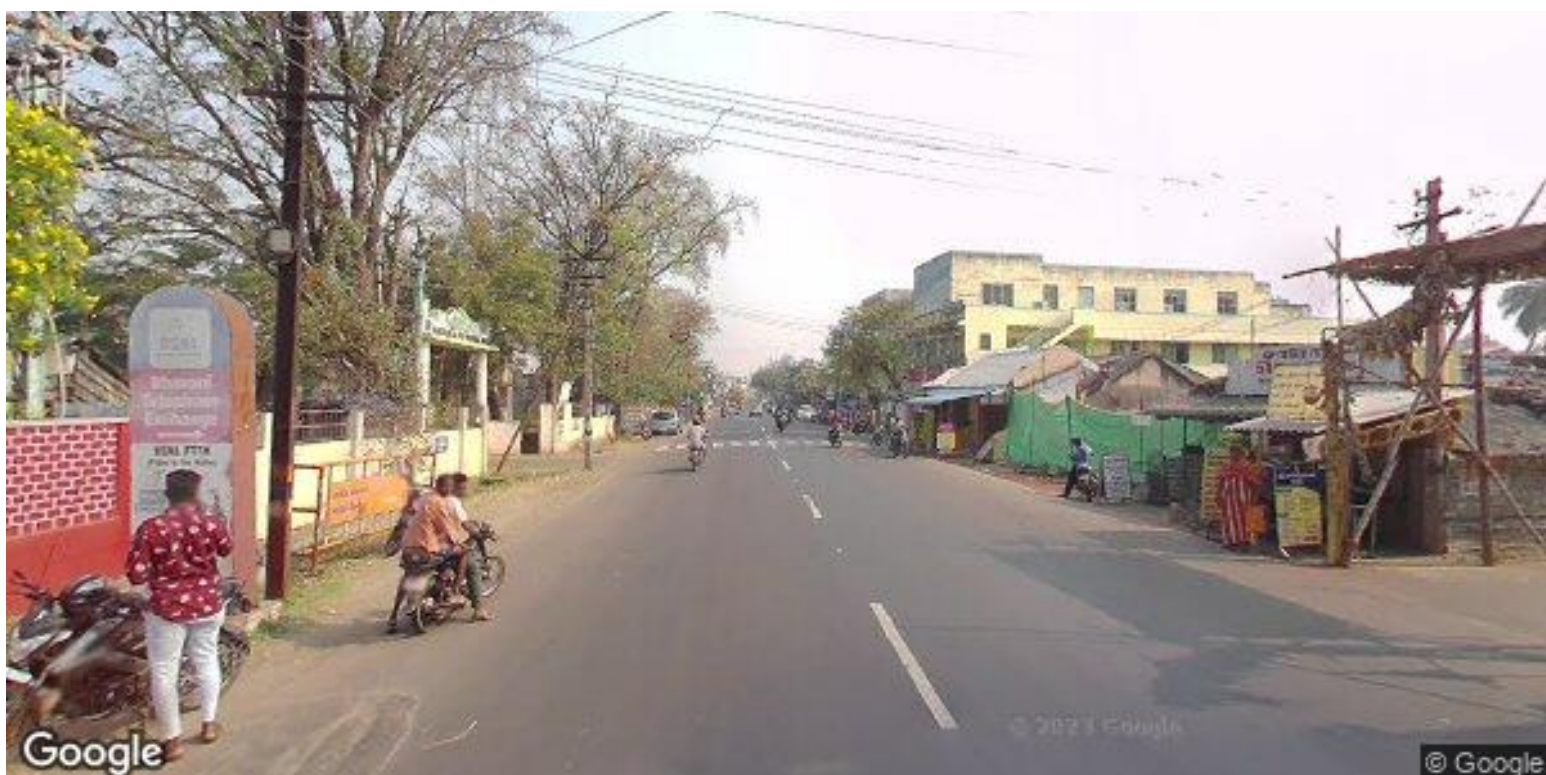
**Risk Type:** Blind Spot  
**Risk Level:** Blind Spot  
**Speed Limit:** 10 KM/Hr  
**Coordinates:** 11.44842, 77.68473

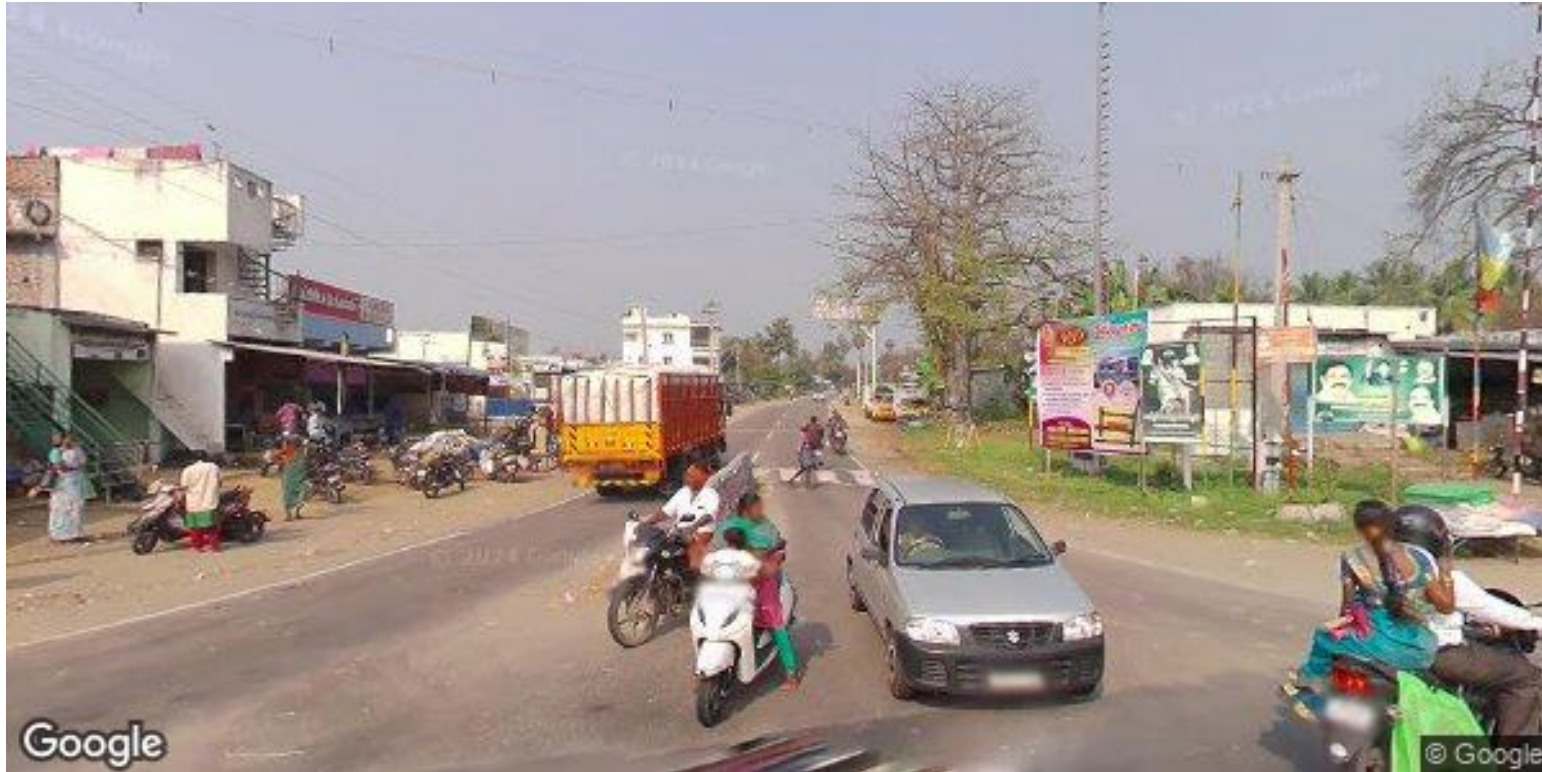
**Risk Type:** Turn  
**Risk Level:** High  
**Speed Limit:** 15 KM/Hr  
**Coordinates:** 11.49333, 77.69855

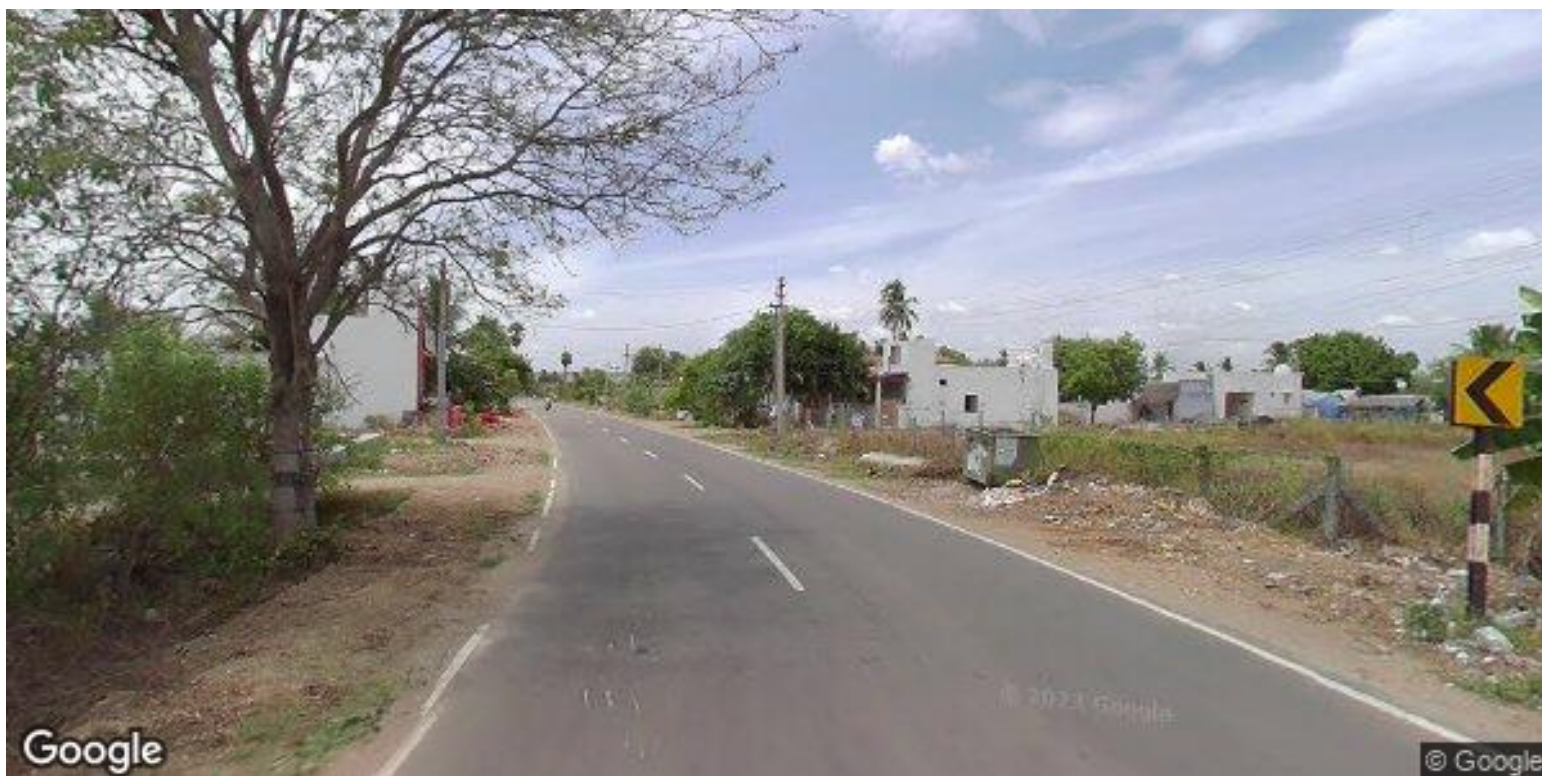
**Risk Type:** Turn  
**Risk Level:** Medium  
**Speed Limit:** 30 KM/Hr  
**Coordinates:** 11.49531, 77.69212

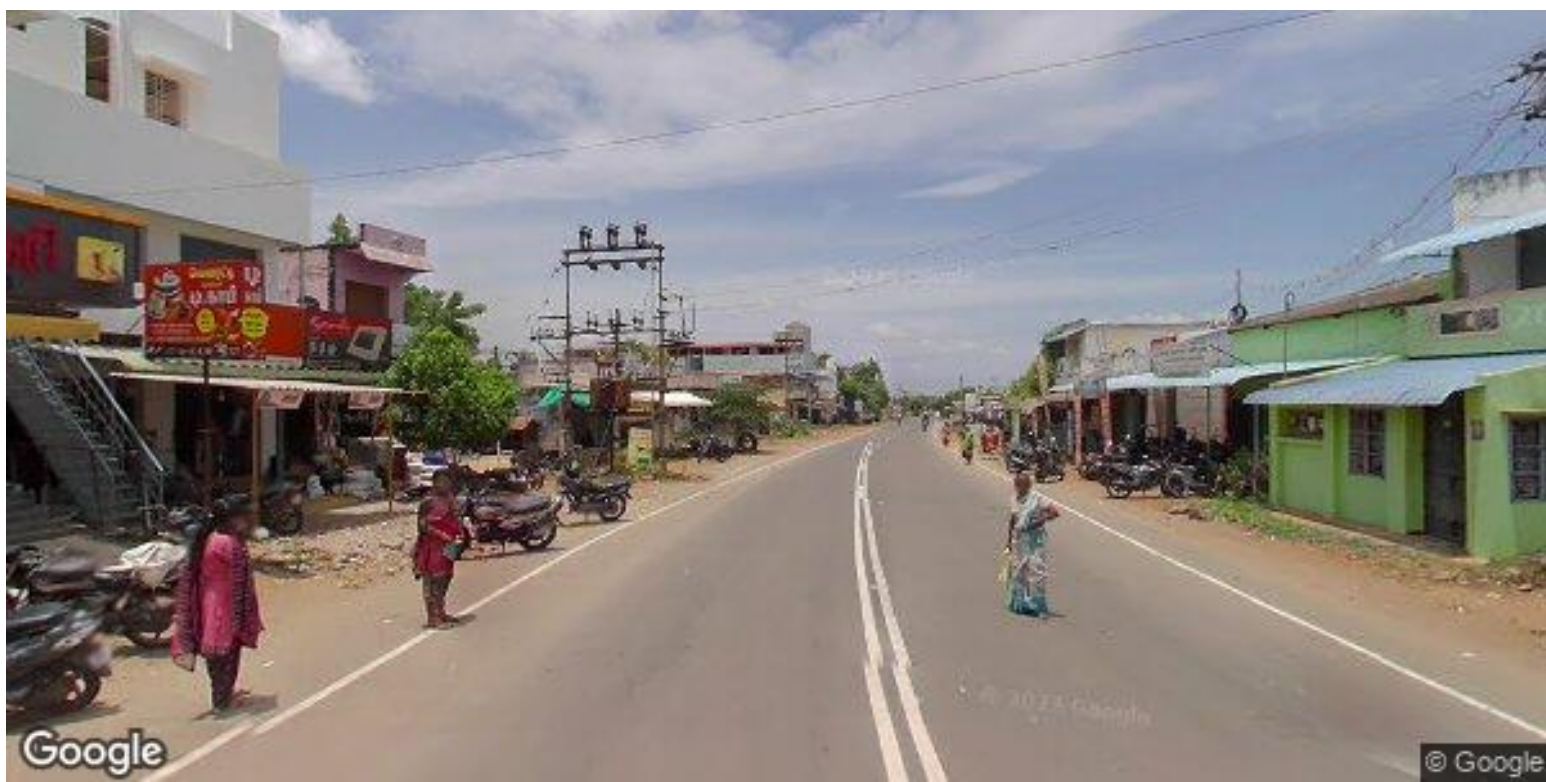
**Coordinates:** 11.52412, 77.67994

**Risk Type:** Turn

**Risk Level:** Medium

**Speed Limit:** 30 KM/Hr

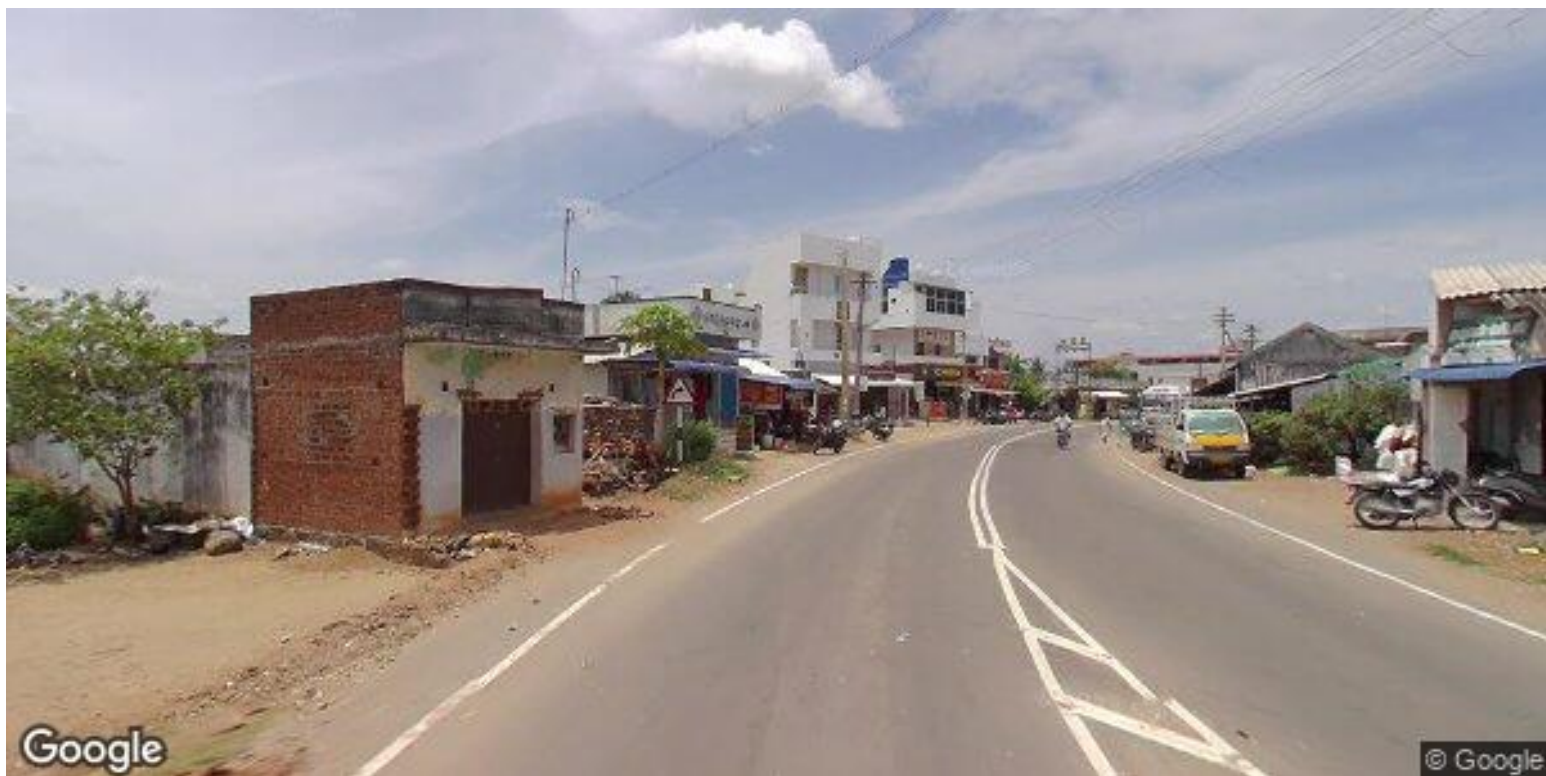
**Coordinates:** 11.52455, 77.67971

**Risk Type:** Turn

**Risk Level:** Medium

**Speed Limit:** 30 KM/Hr

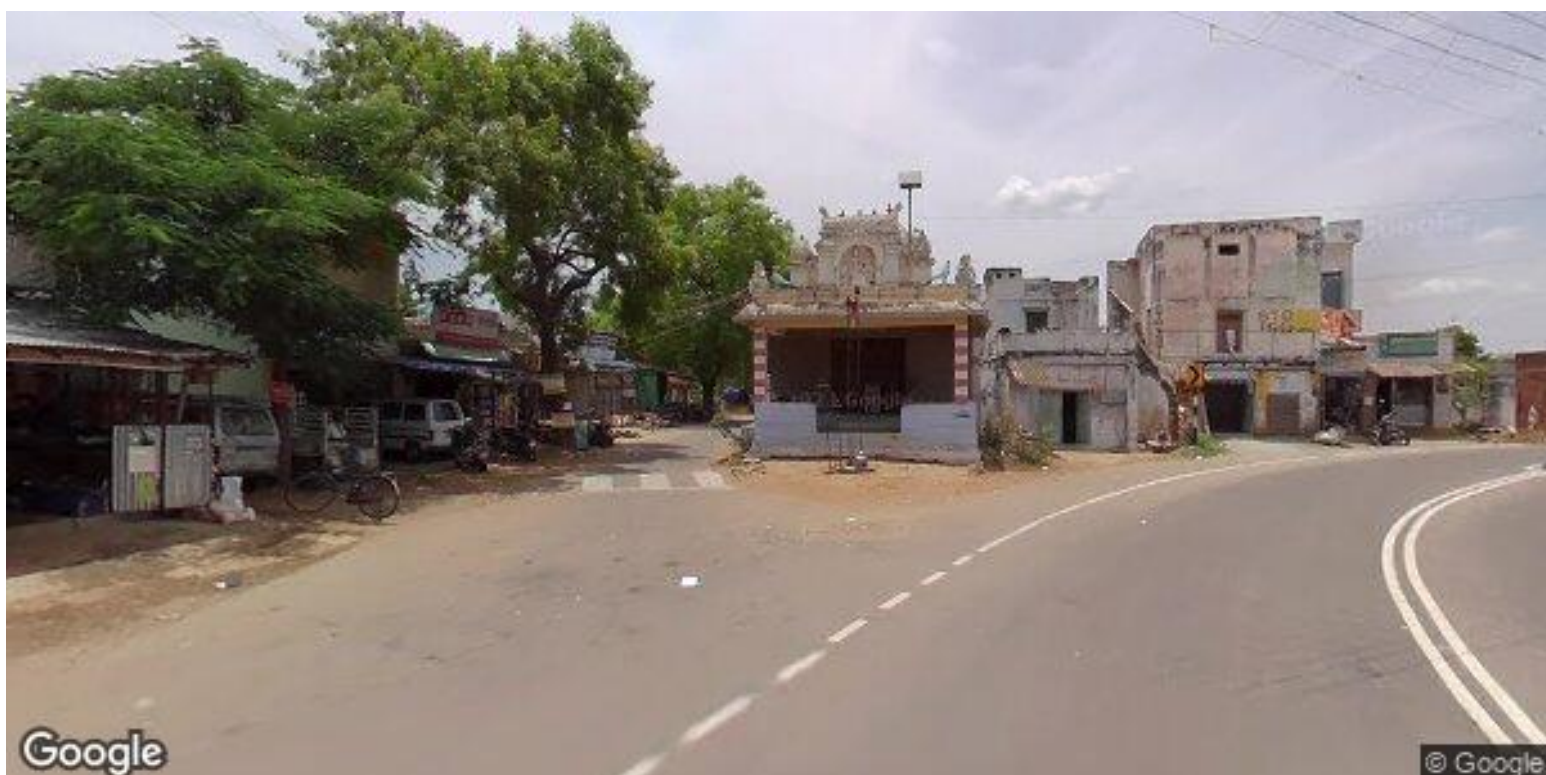
**Coordinates:** 11.52466, 77.67945

**Risk Type:** Turn

**Risk Level:** Medium

**Speed Limit:** 30 KM/Hr

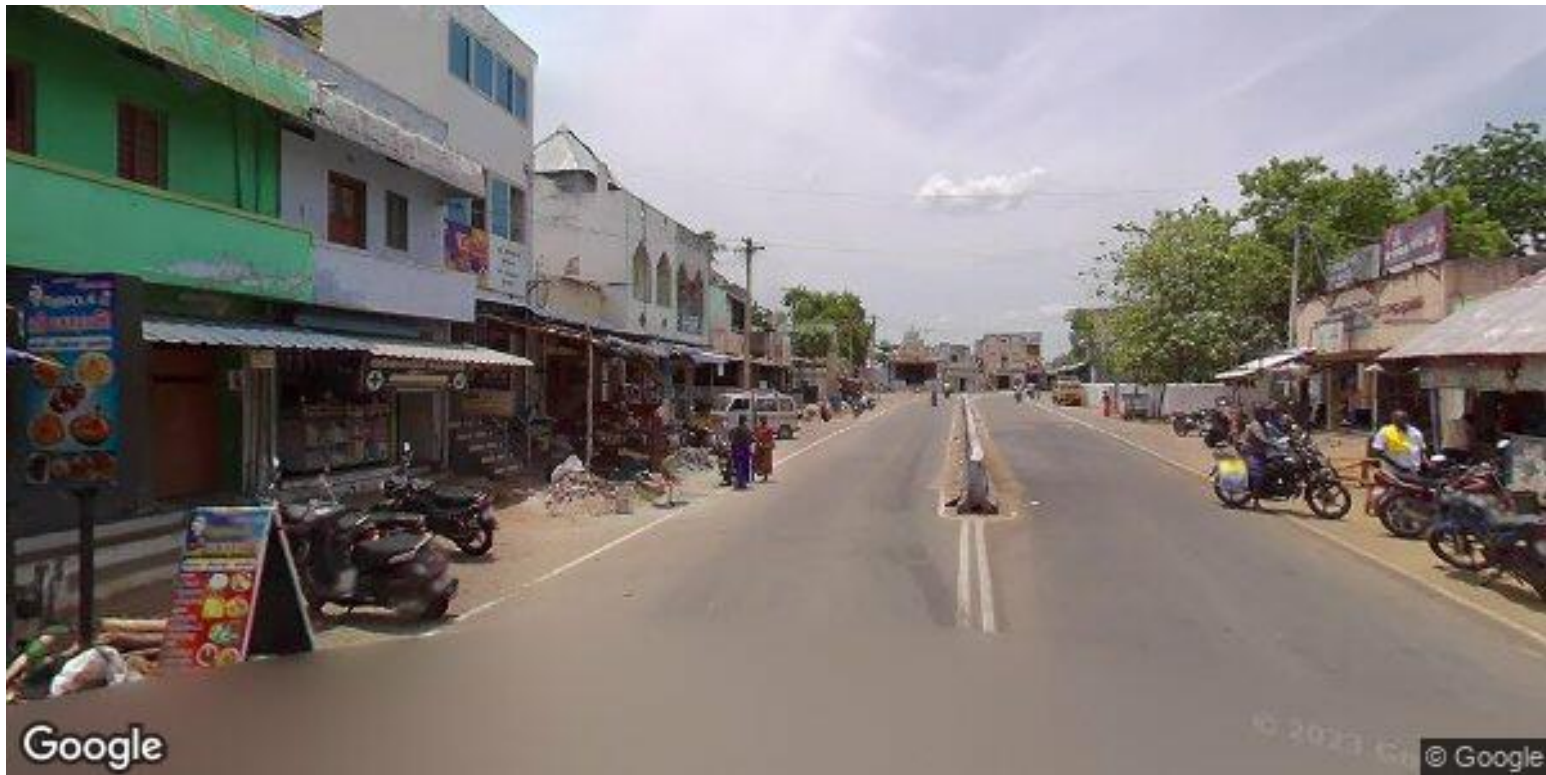
**Coordinates:** 11.52455, 77.67875

**Risk Type:** Turn

**Risk Level:** Medium

**Speed Limit:** 30 KM/Hr

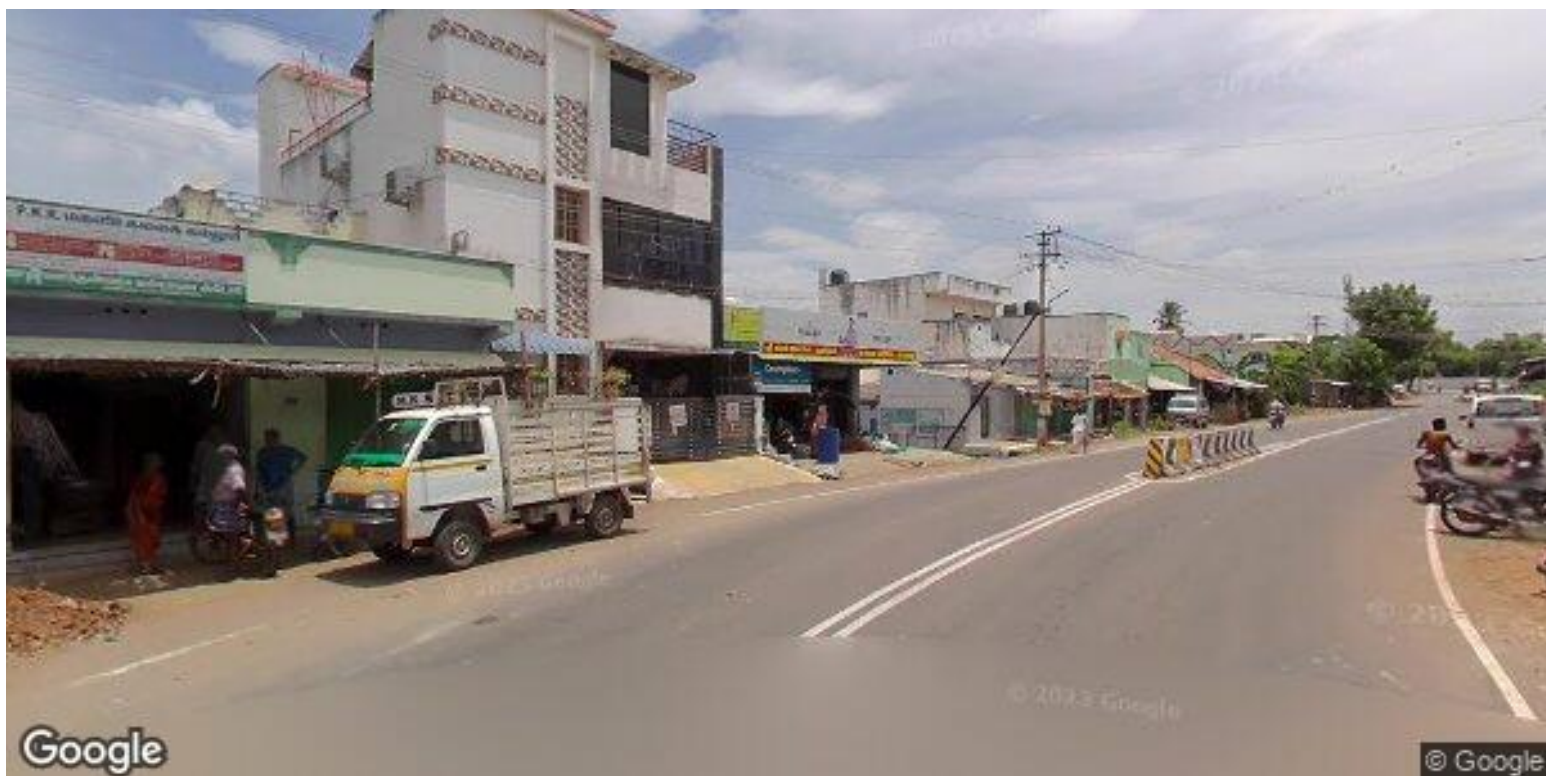
**Coordinates:** 11.52463, 77.67853

**Risk Type:** Turn

**Risk Level:** High

**Speed Limit:** 15 KM/Hr

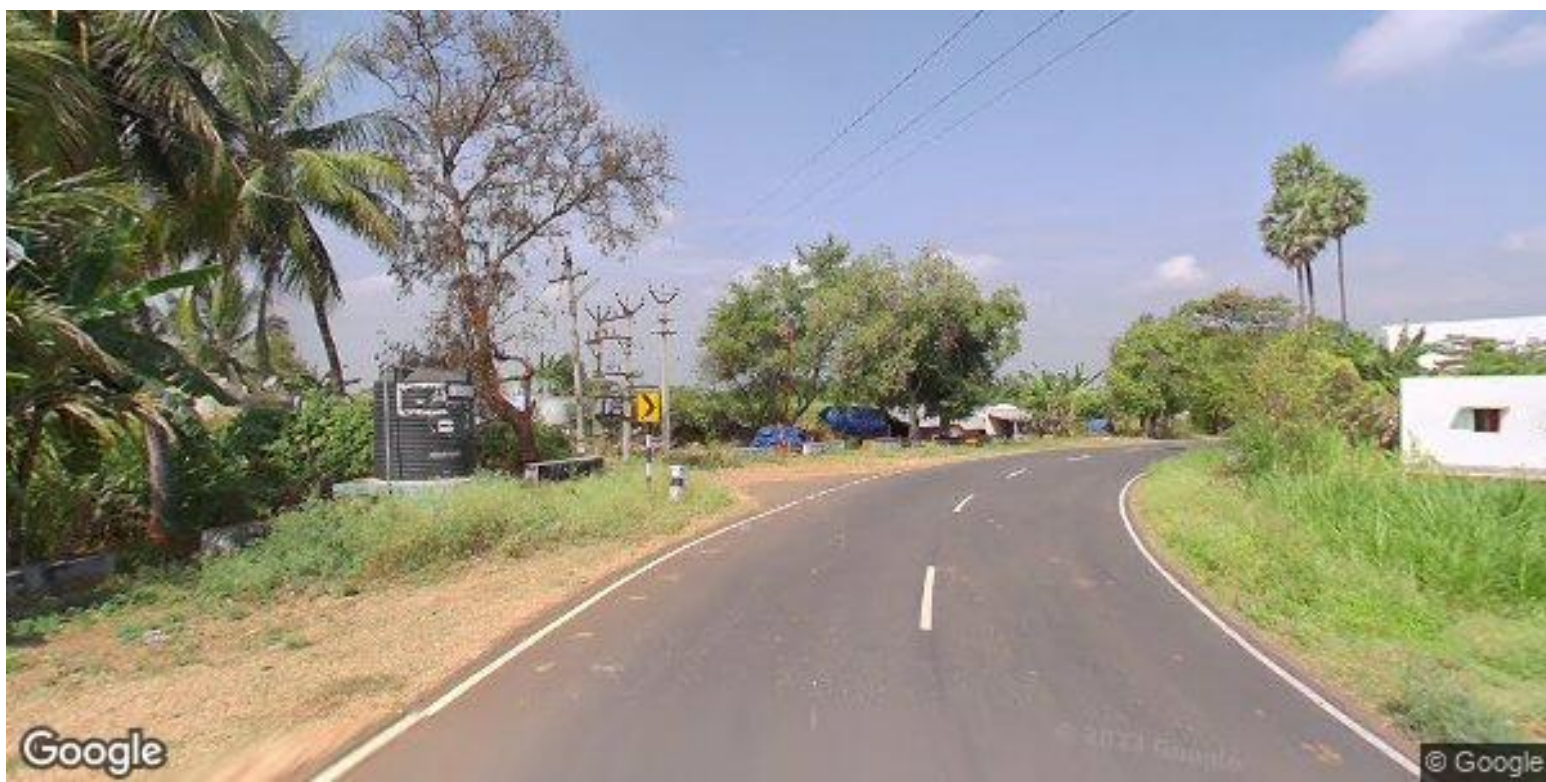
**Coordinates:** 11.55323, 77.66321

**Risk Type:** Turn

**Risk Level:** Medium

**Speed Limit:** 30 KM/Hr
