# IndianOil

## JOURNEY RISK MANAGEMENT (JRM) STUDY

### Salem Terminal TO SHREE VIGNESHWARA FUELS

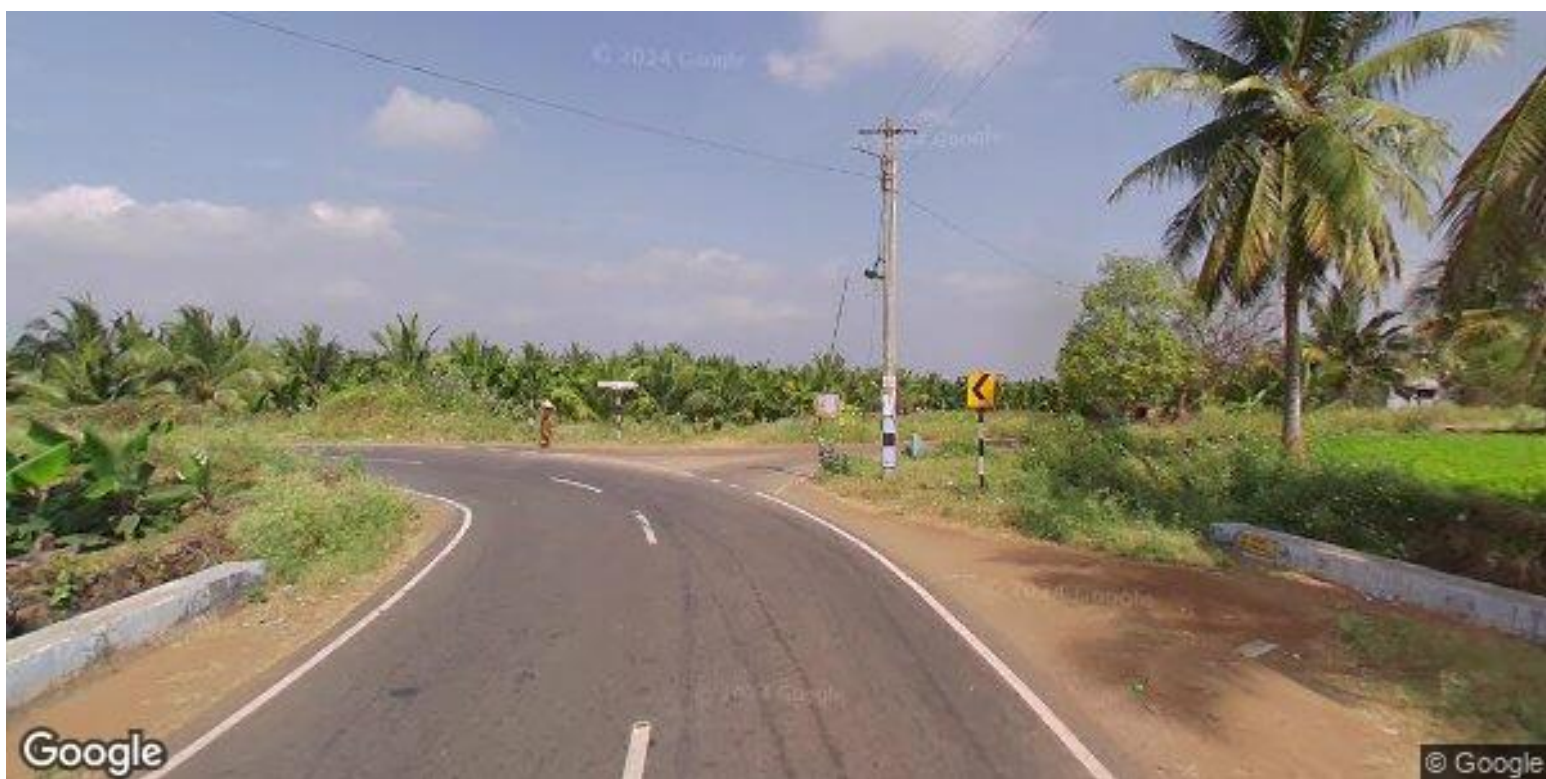
**Coordinates:** 11.56078, 77.66166

**Risk Type:** Turn

**Risk Level:** Medium

**Speed Limit:** 30 KM/Hr

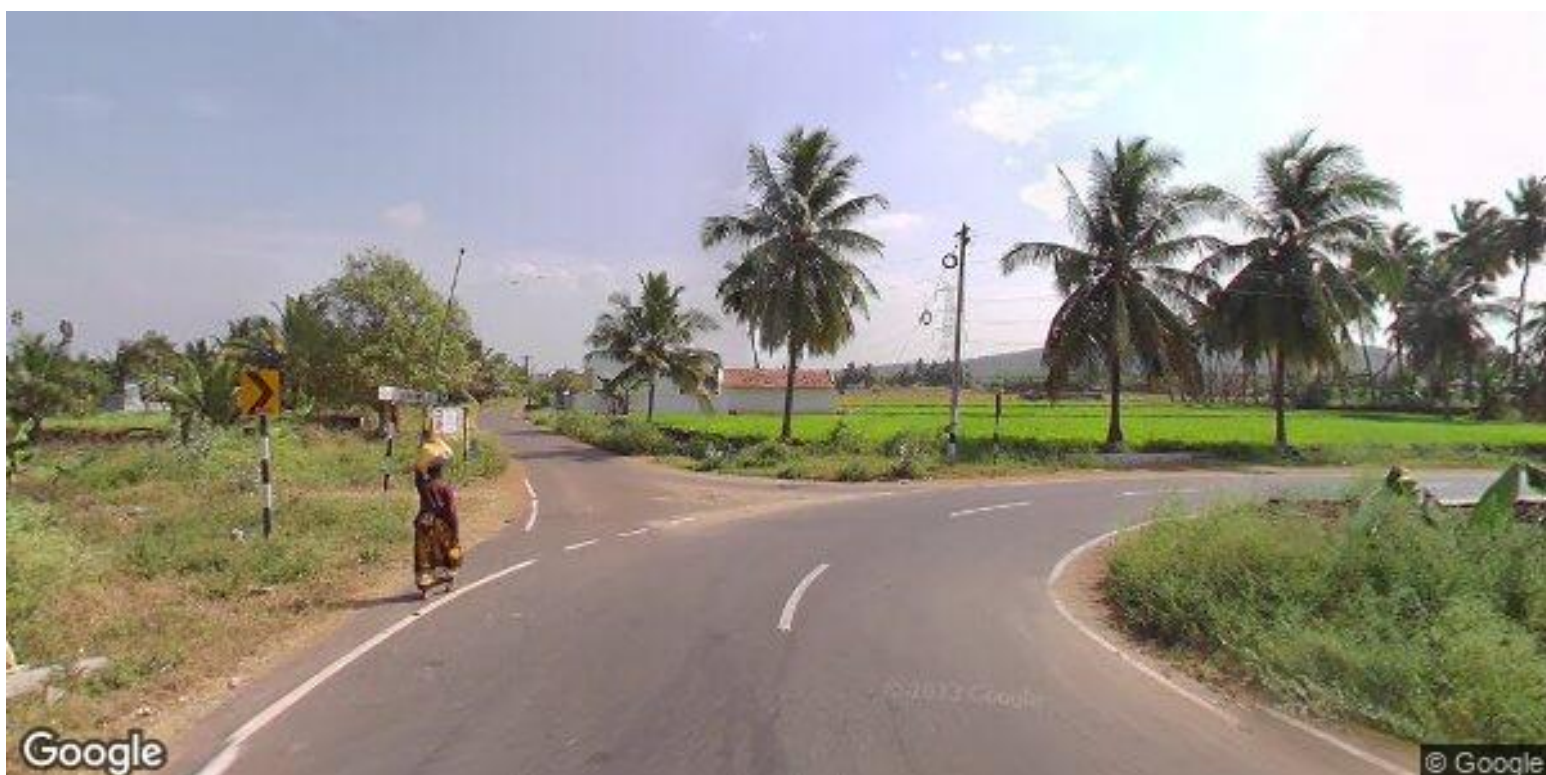
**Risk Type:** Turn  
**Risk Level:** High  
**Speed Limit:** 15 KM/Hr  
**Coordinates:** 11.56090, 77.66151

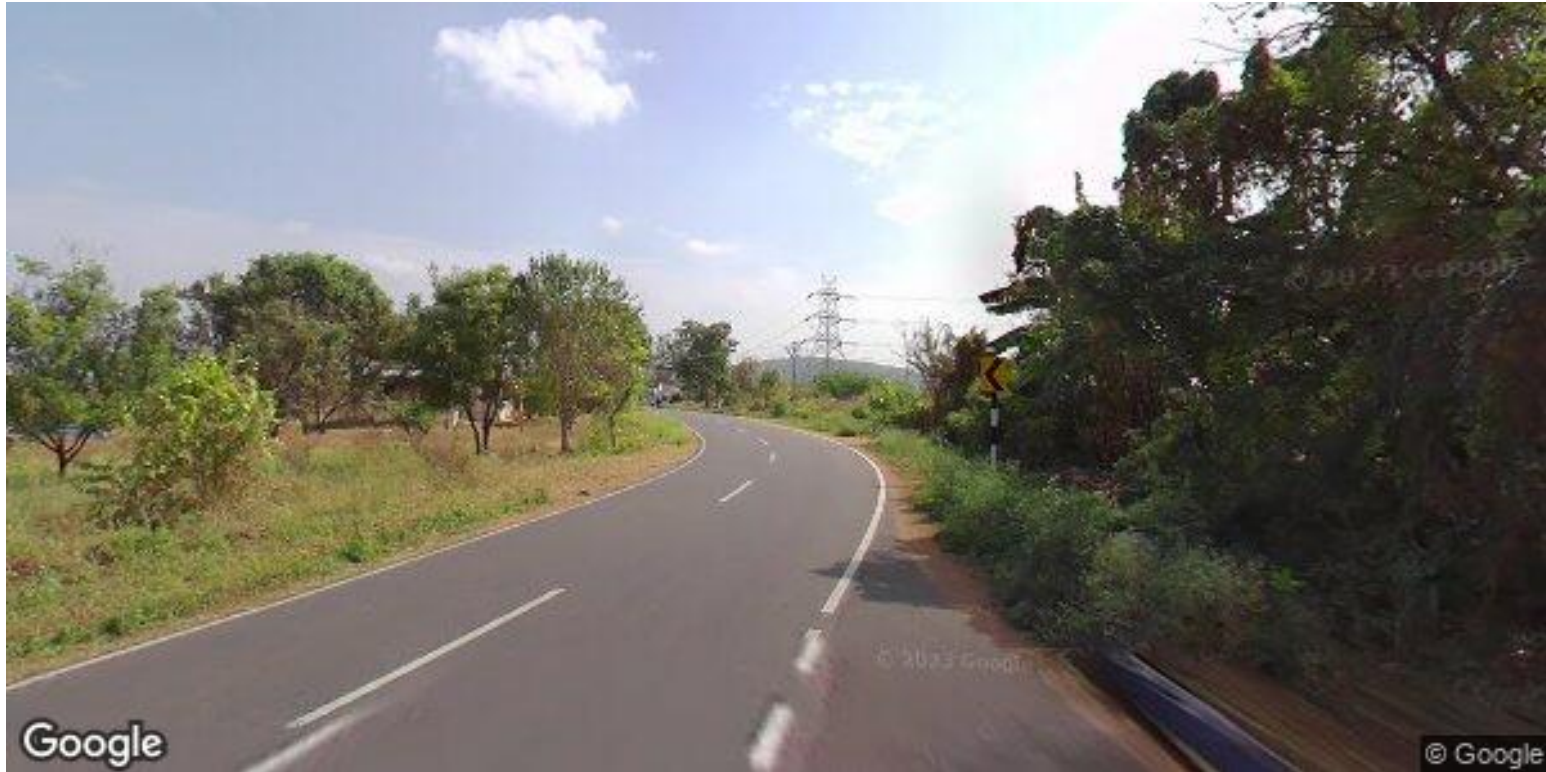
**Risk Type:** Turn  
**Risk Level:** Medium  
**Speed Limit:** 30 KM/Hr  
**Coordinates:** 11.55836, 77.65483

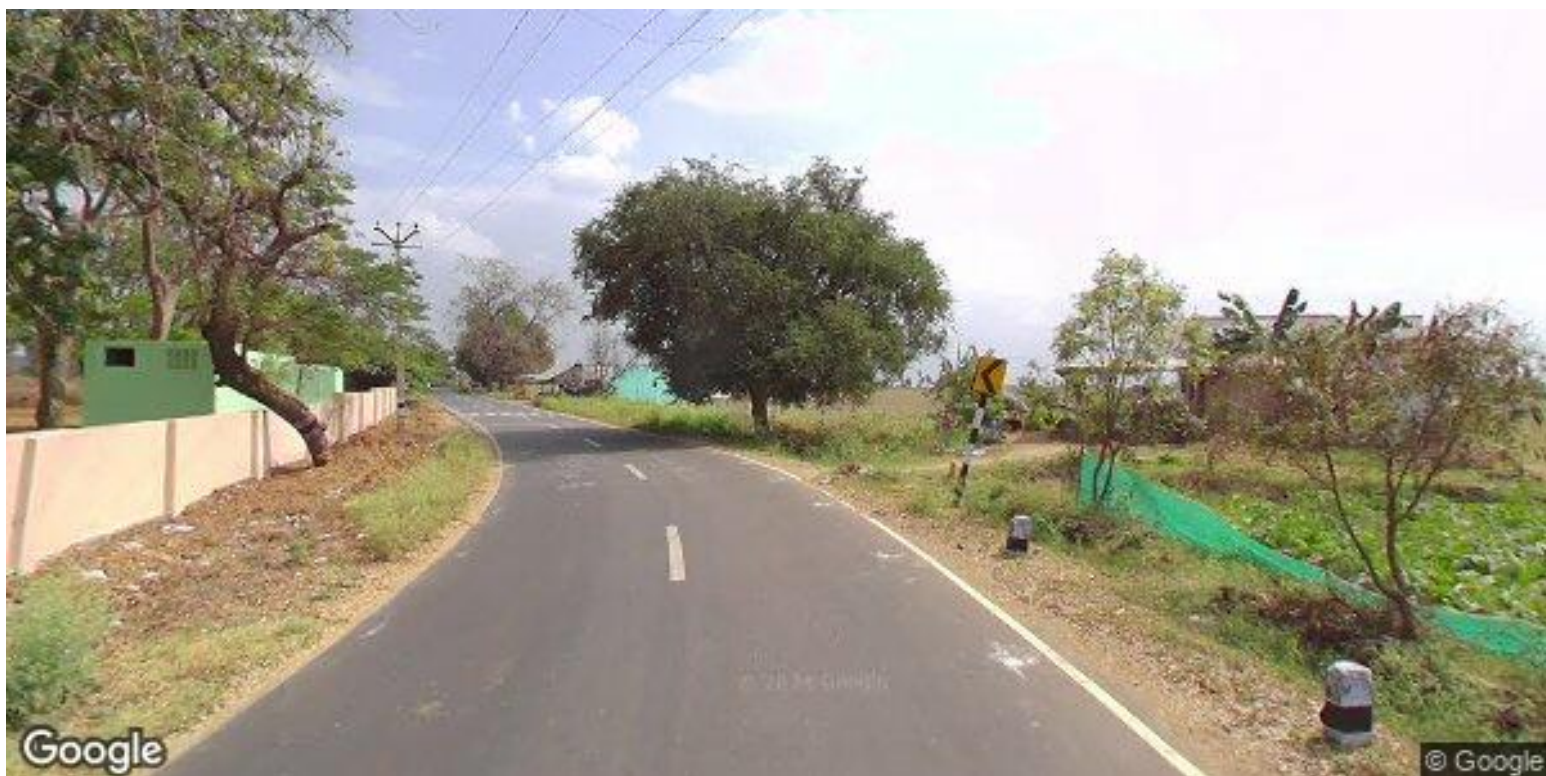
**Risk Type:** Turn  
**Risk Level:** Medium  
**Speed Limit:** 30 KM/Hr  
**Coordinates:** 11.56246, 77.64507

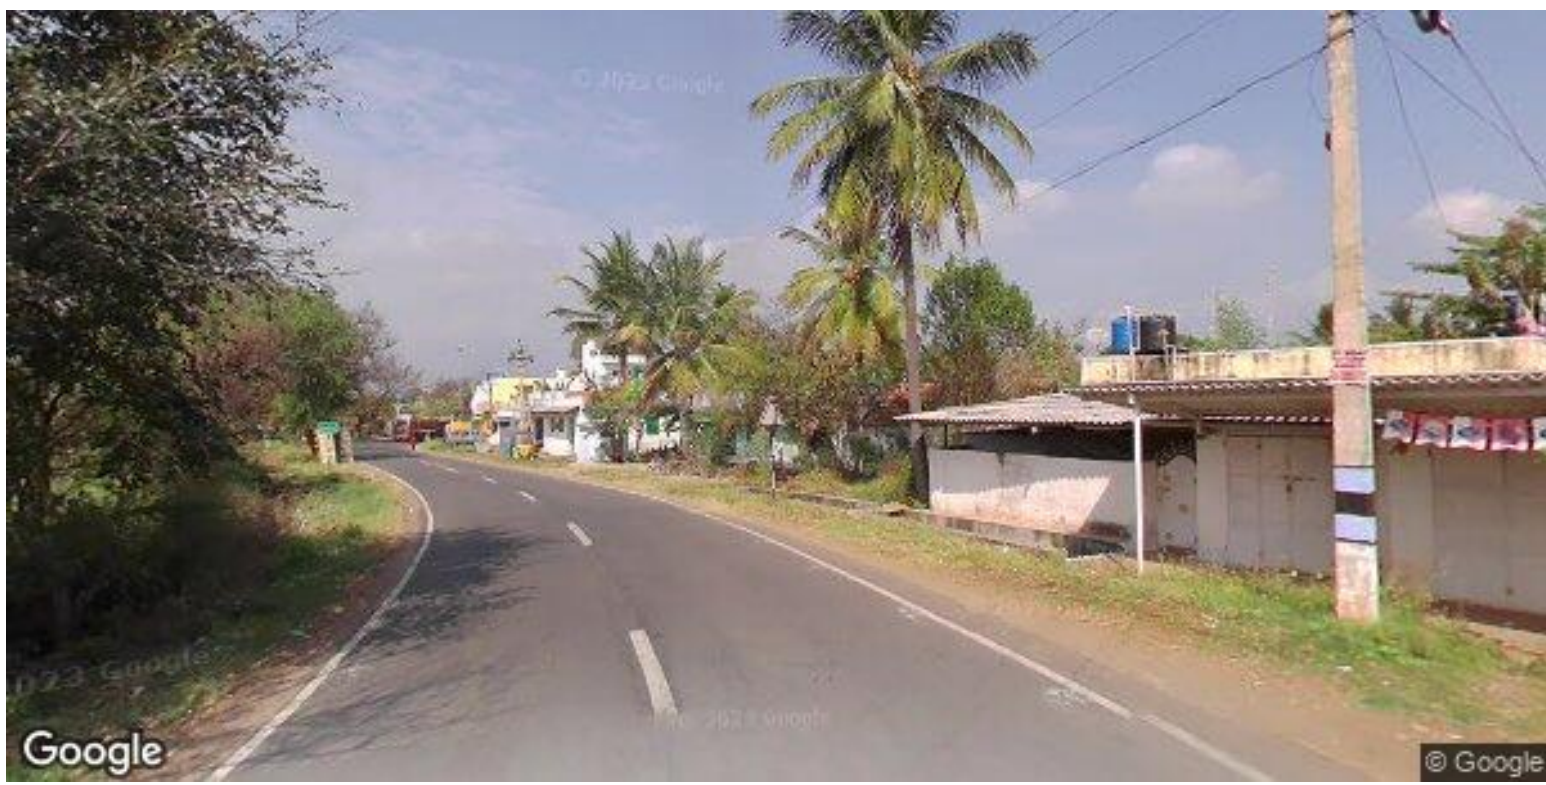
**Coordinates:** 11.56360, 77.64467

**Risk Type:** Turn

**Risk Level:** High

**Speed Limit:** 15 KM/Hr

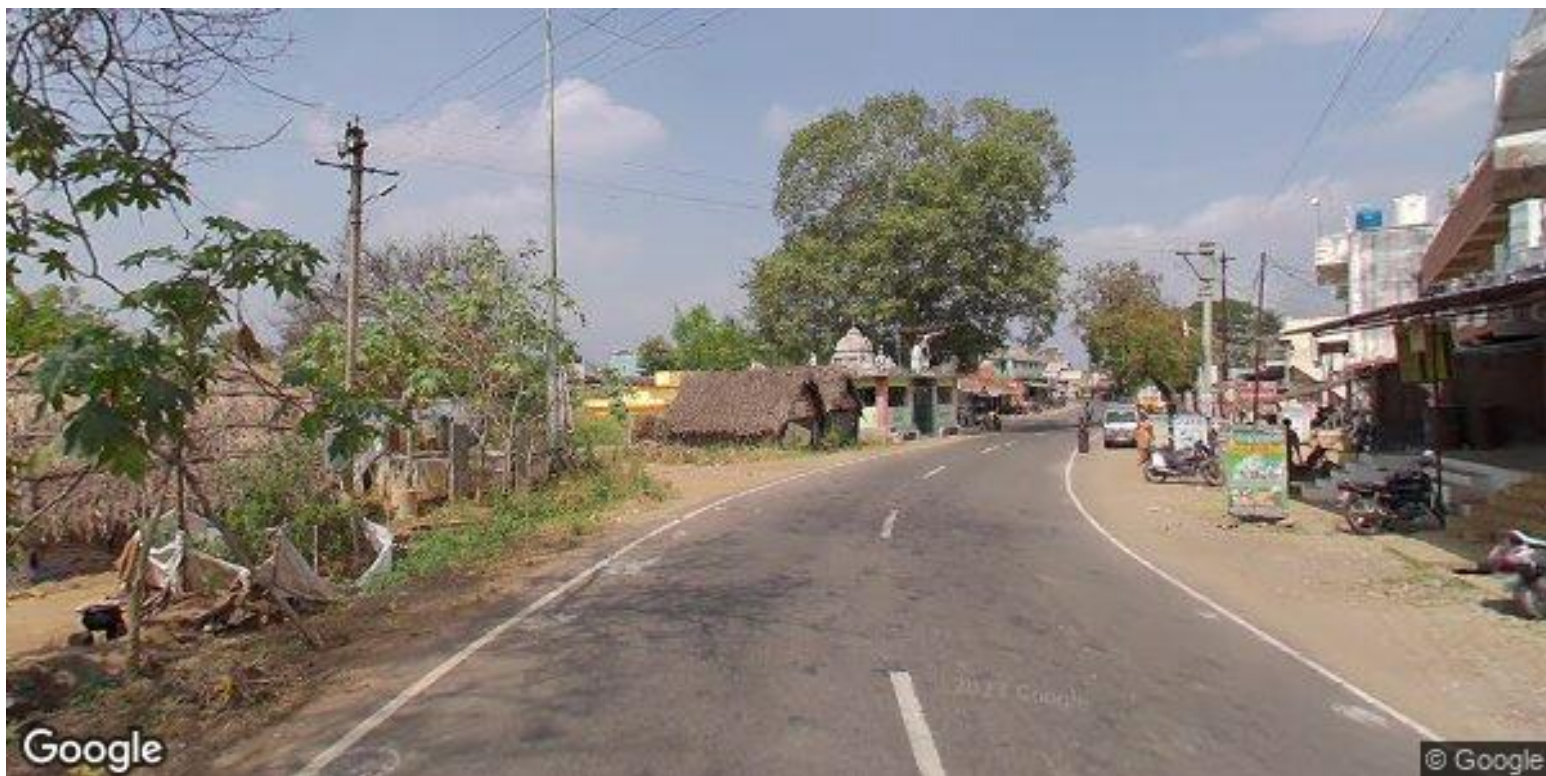
**Coordinates:** 11.56385, 77.64370

**Risk Type:** Turn

**Risk Level:** Medium

**Speed Limit:** 30 KM/Hr

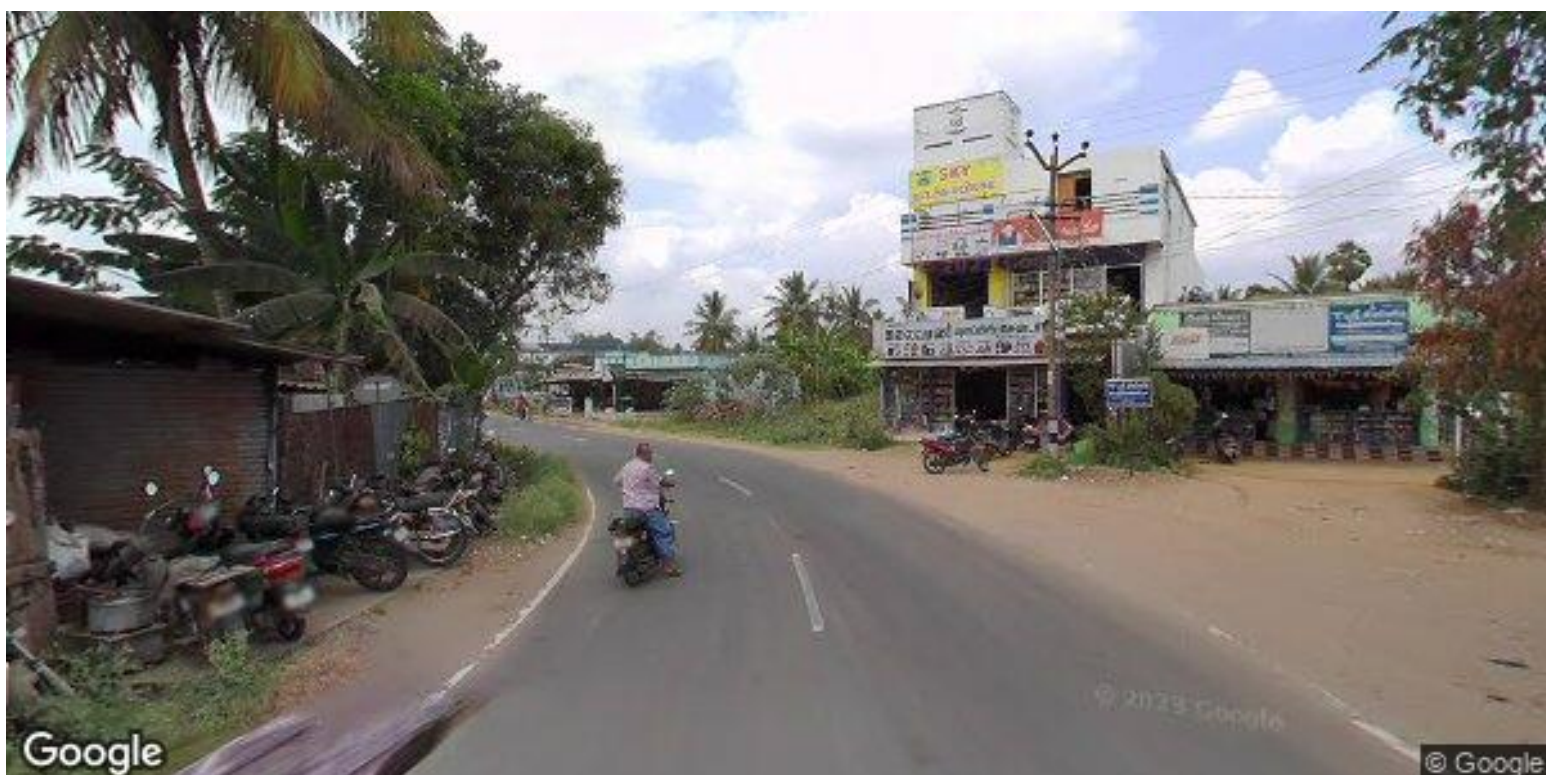
**Coordinates:** 11.56828, 77.64184

**Risk Type:** Turn

**Risk Level:** Medium

**Speed Limit:** 30 KM/Hr

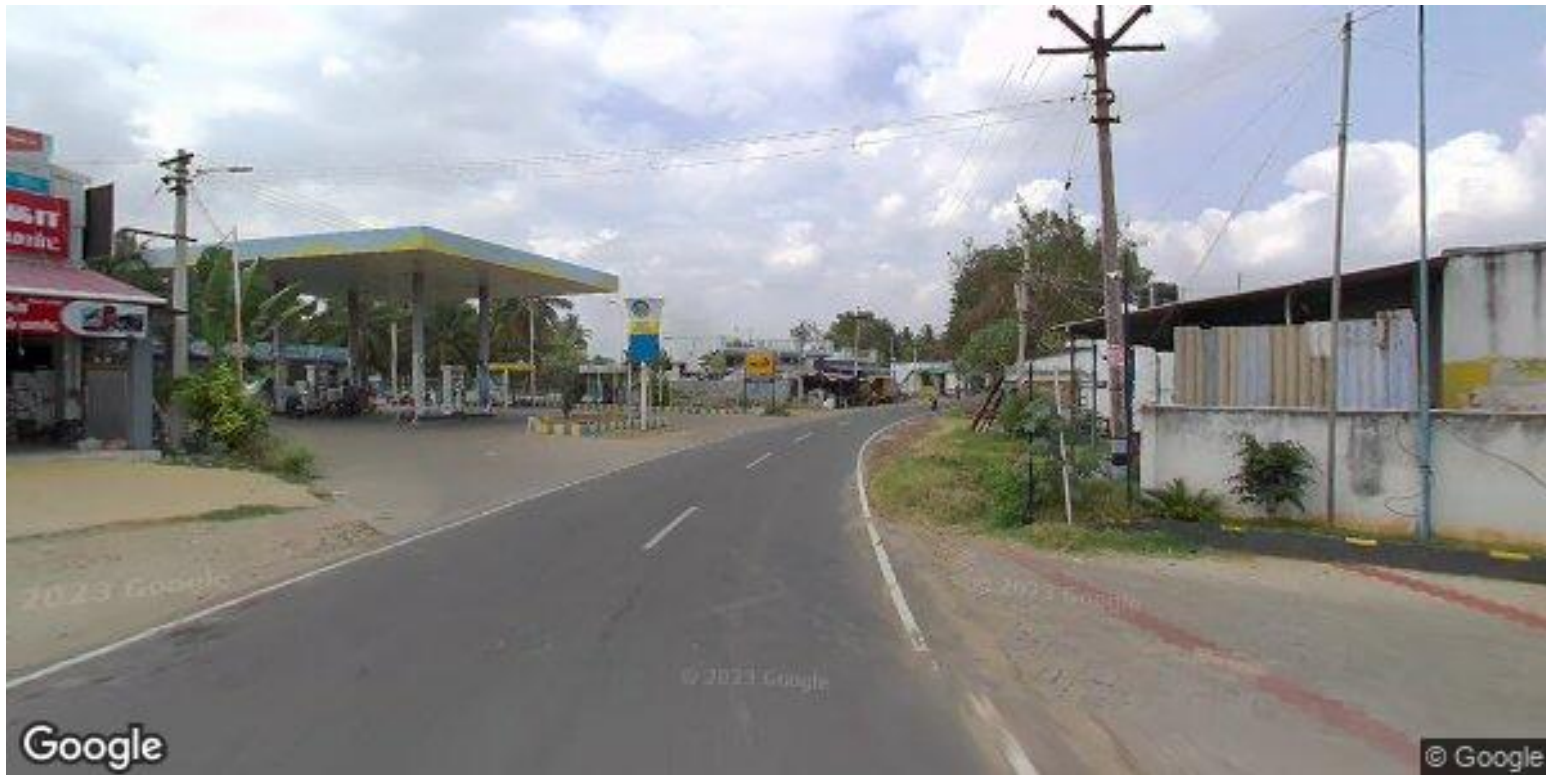
**Coordinates:** 11.56883, 77.64088

**Risk Type:** Turn

**Risk Level:** Medium

**Speed Limit:** 30 KM/Hr

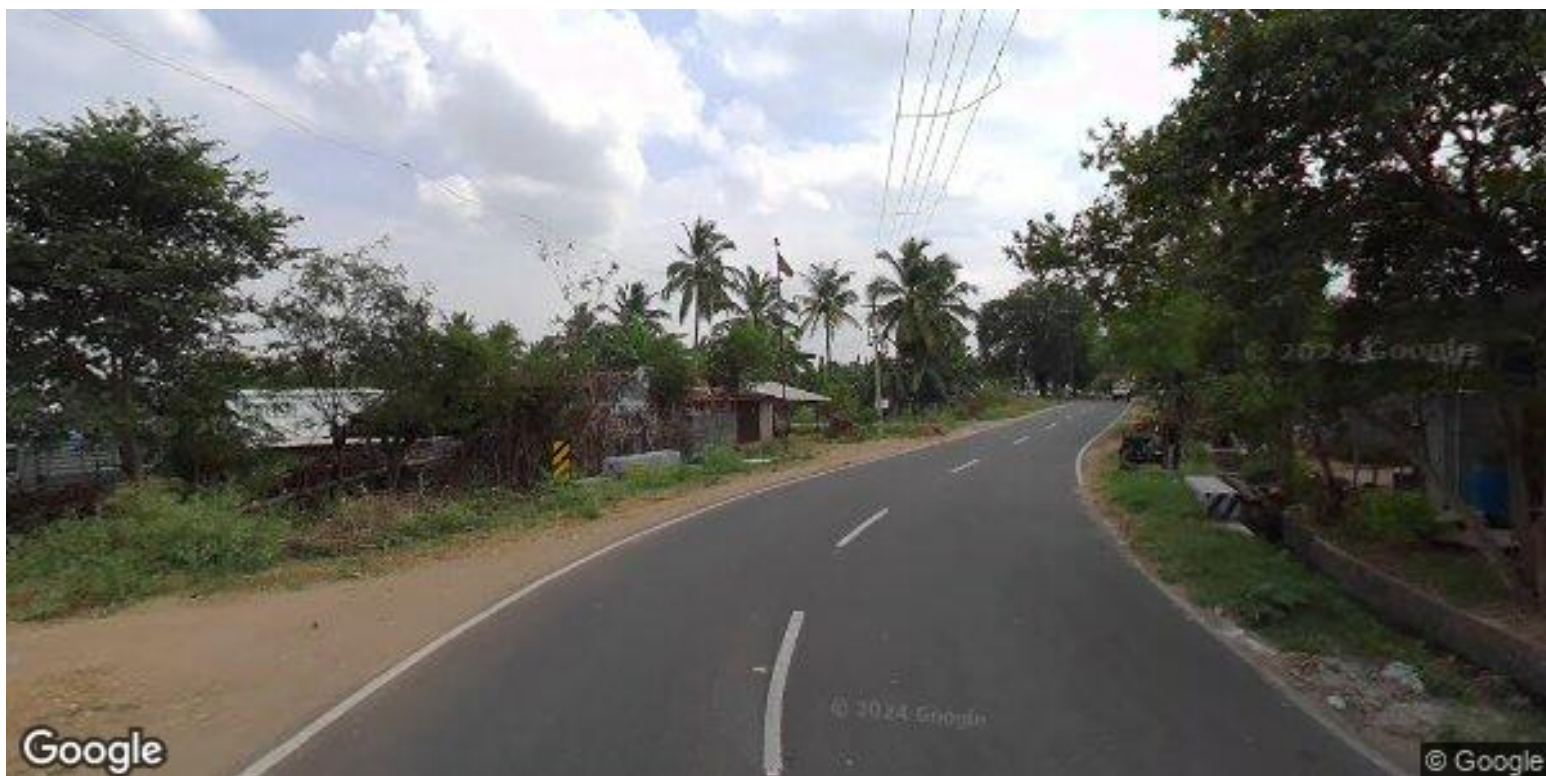
**Coordinates:** 11.57445, 77.63827

**Risk Type:** Turn

**Risk Level:** High

**Speed Limit:** 15 KM/Hr

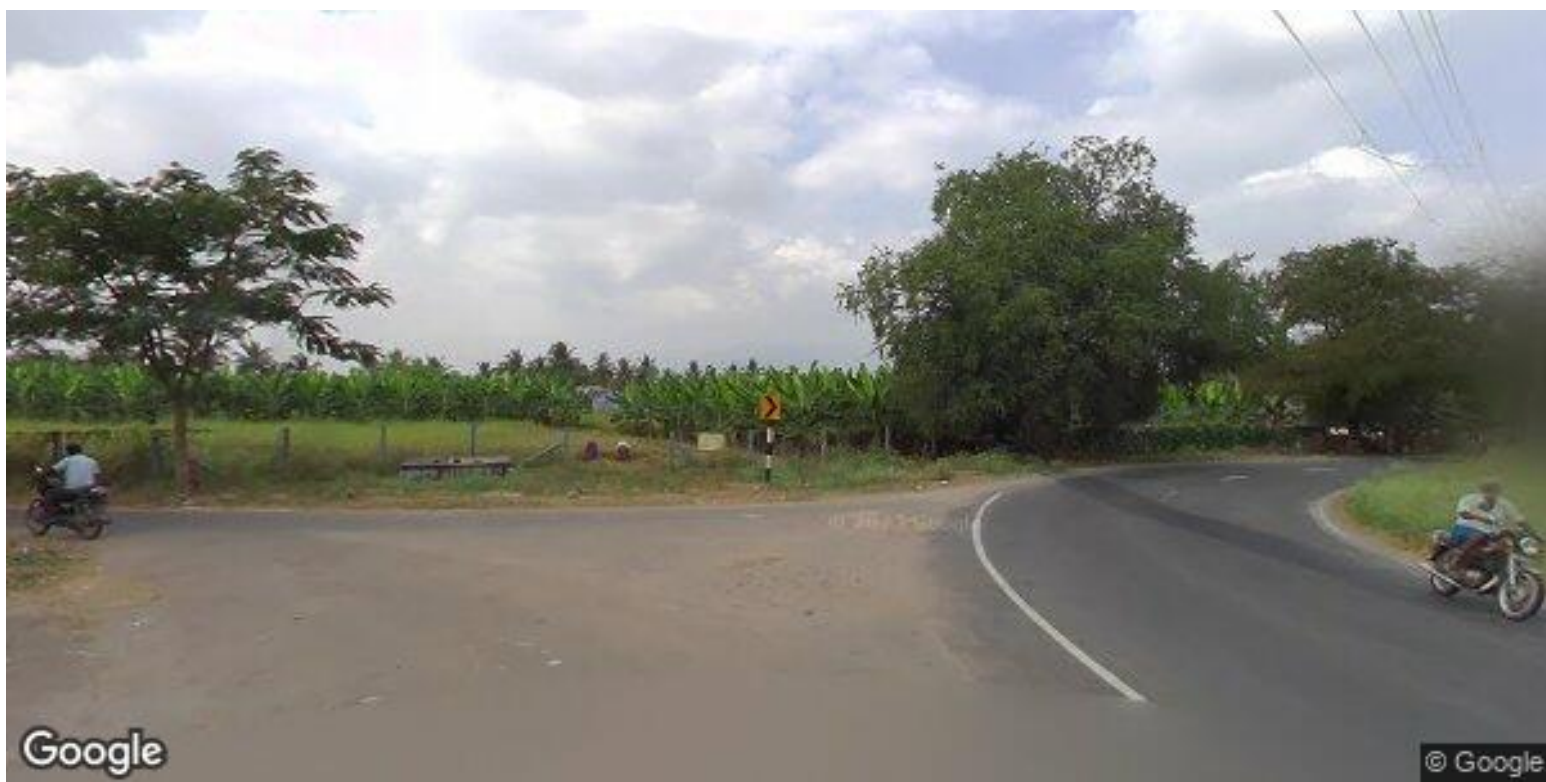
**Coordinates:** 11.57447, 77.63706

**Risk Type:** Turn

**Risk Level:** High

**Speed Limit:** 15 KM/Hr

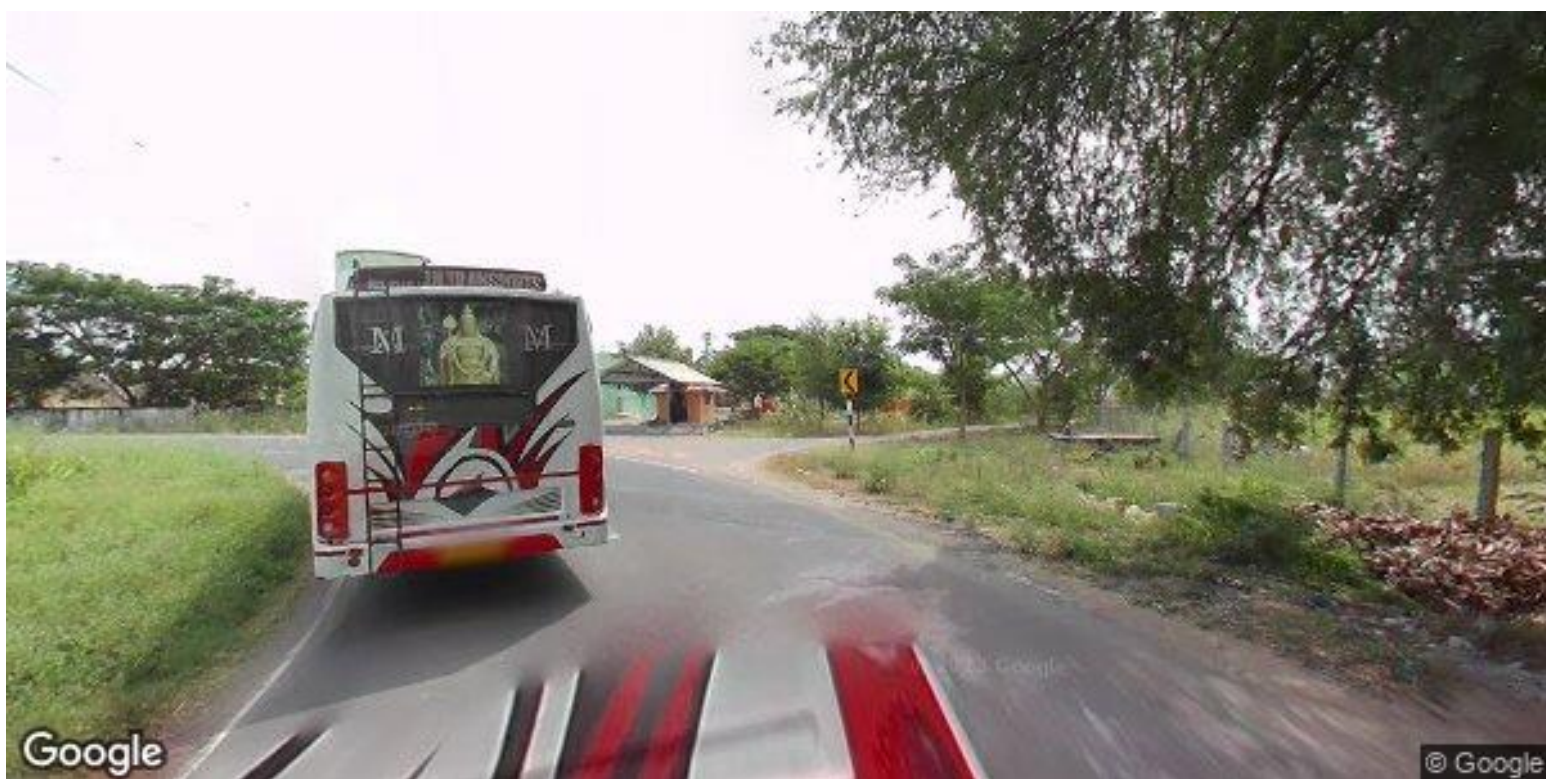
**Coordinates:** 11.57467, 77.63691

**Risk Type:** Turn

**Risk Level:** Medium

**Speed Limit:** 30 KM/Hr

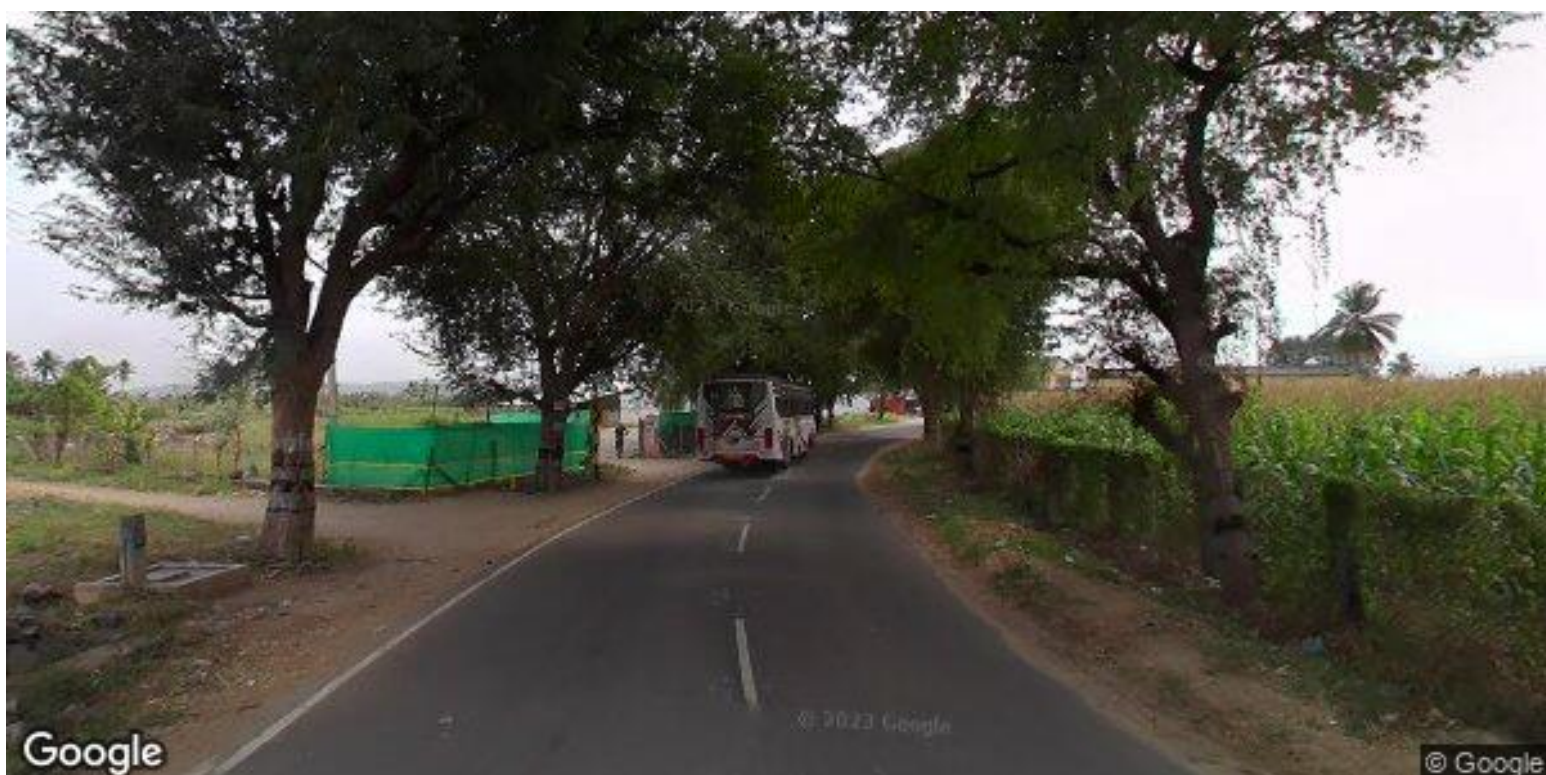
**Coordinates: 11.57975, 77.63548**

**Risk Type: Turn**

**Risk Level: Medium**

**Speed Limit: 30 KM/Hr**

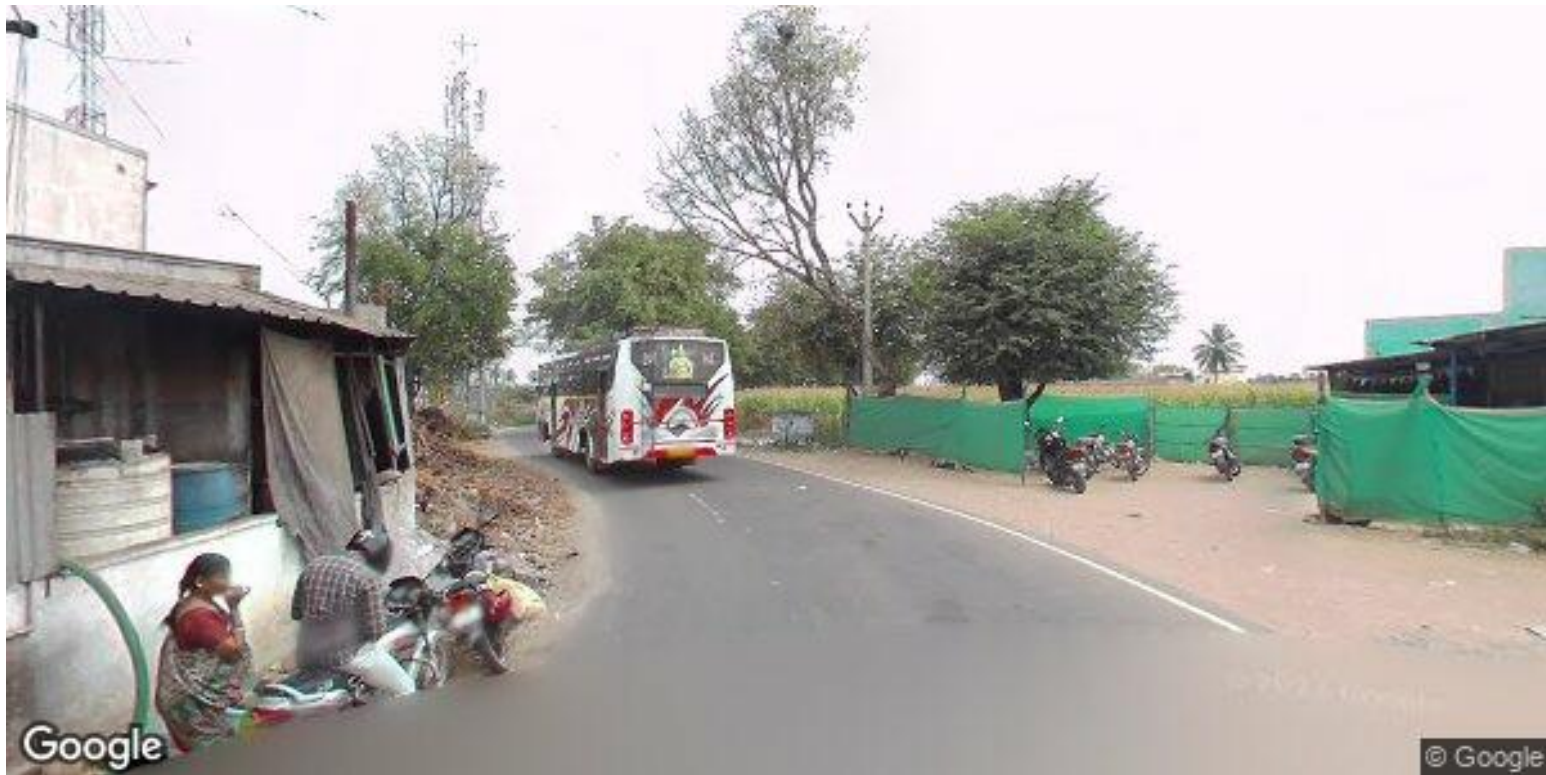
**Coordinates: 11.57991, 77.63495**

**Risk Type: Turn**

**Risk Level: High**

**Speed Limit: 15 KM/Hr**

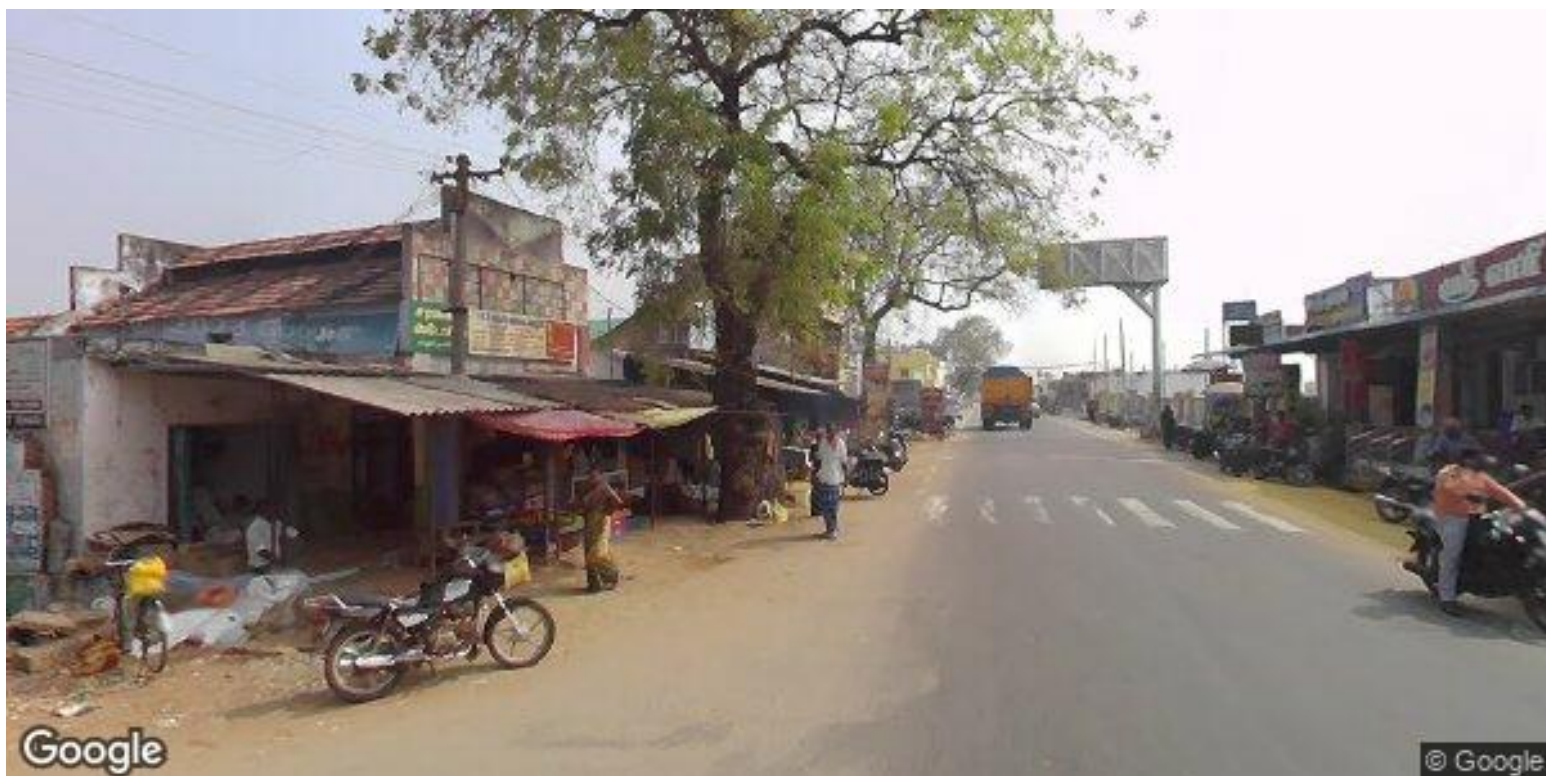
**Coordinates: 11.58056, 77.63456**

**Risk Type: Turn**

**Risk Level: High**

**Speed Limit: 15 KM/Hr**
