# IndianOil

## **JOURNEY RISK MANAGEMENT (JRM) STUDY**

### **Salem Terminal TO SAMIAPPA ENTERPRISES**

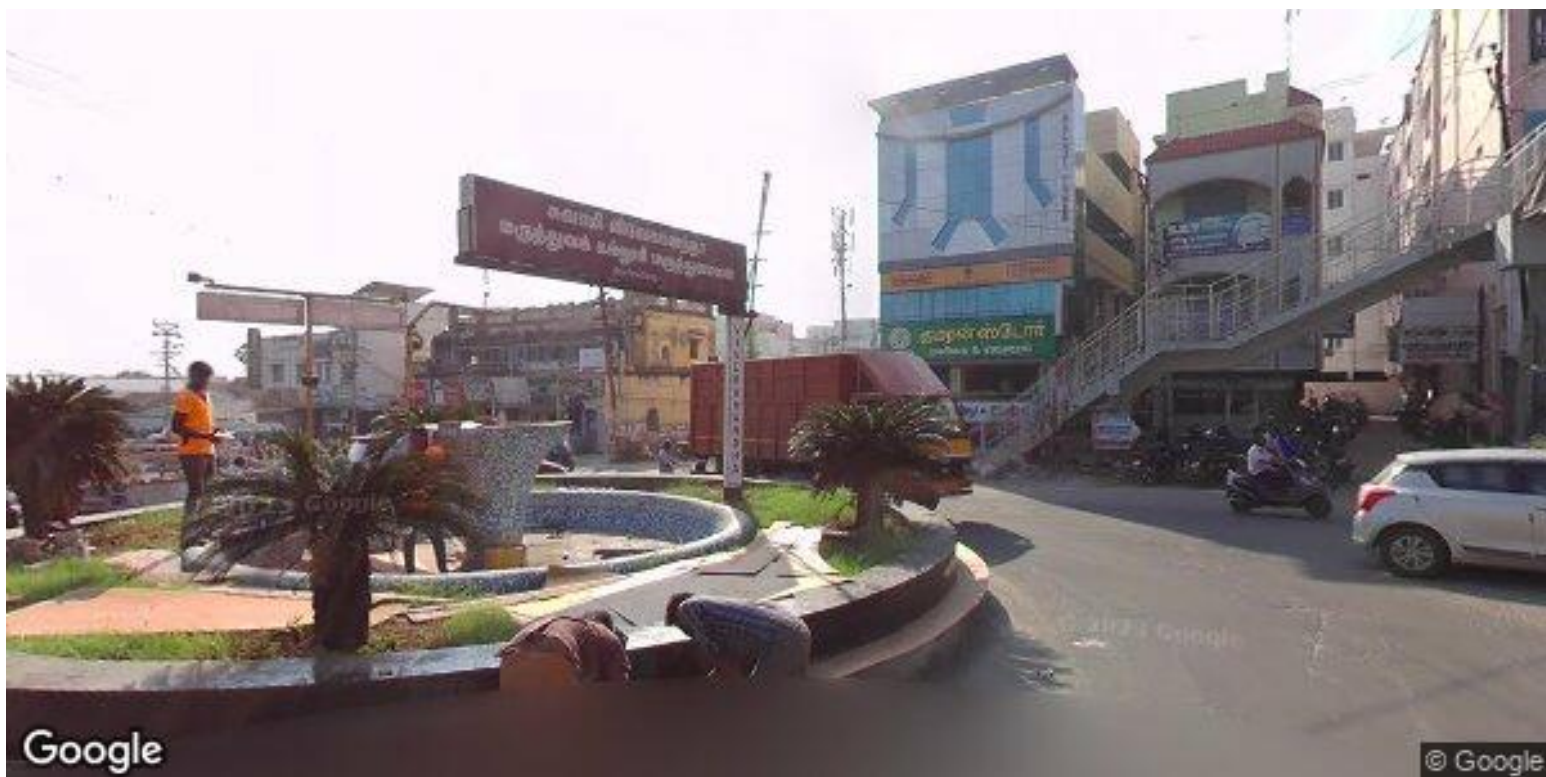
**Coordinates:** 11.38395, 77.89480

**Risk Type:** Roundabout

**Risk Level:** High

**Speed Limit:** 15 KM/Hr

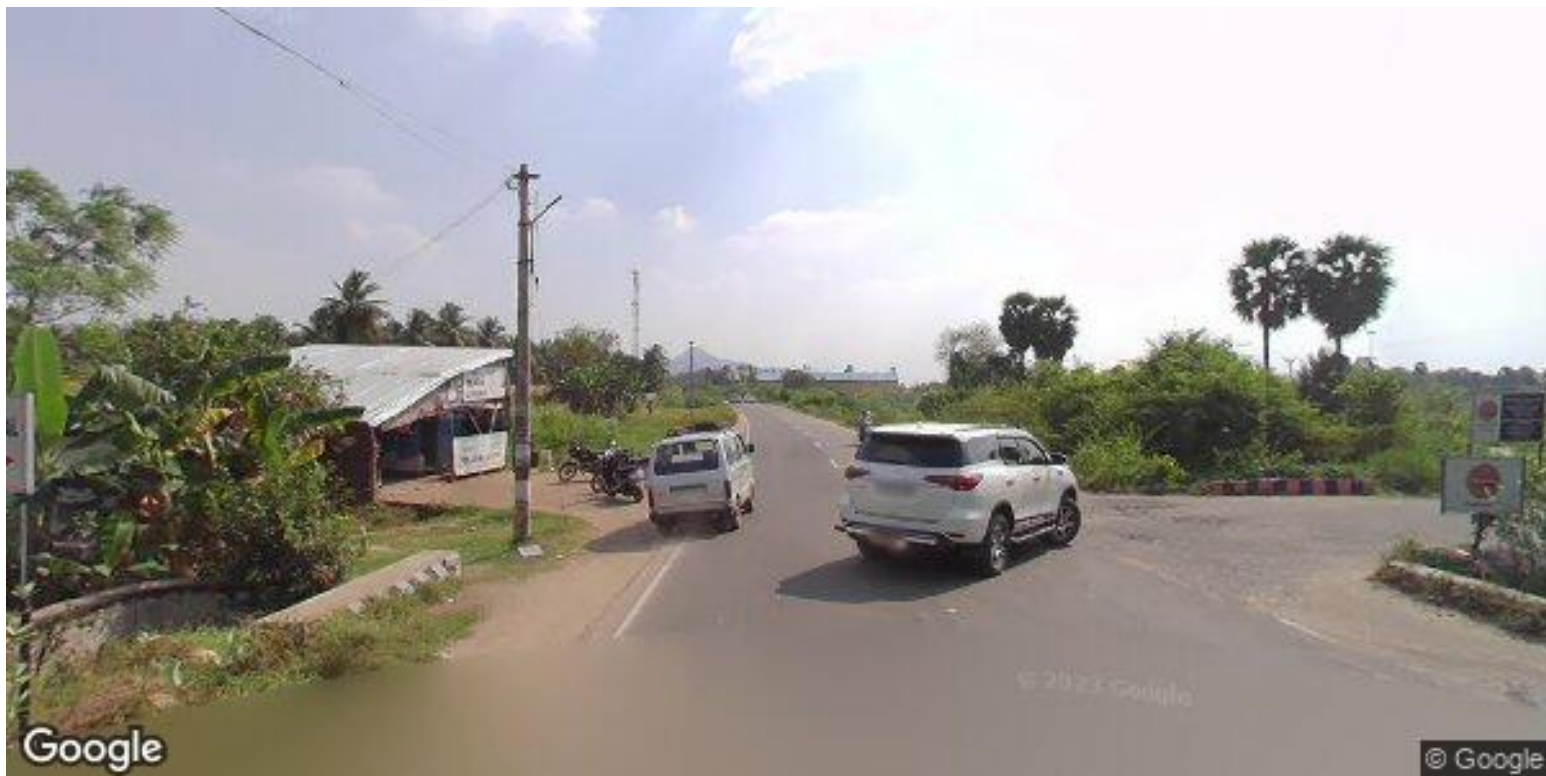
**Coordinates:** 11.44029, 77.87544

**Risk Type:** Blind Spot

**Risk Level:** Blind Spot

**Speed Limit:** 10 KM/Hr

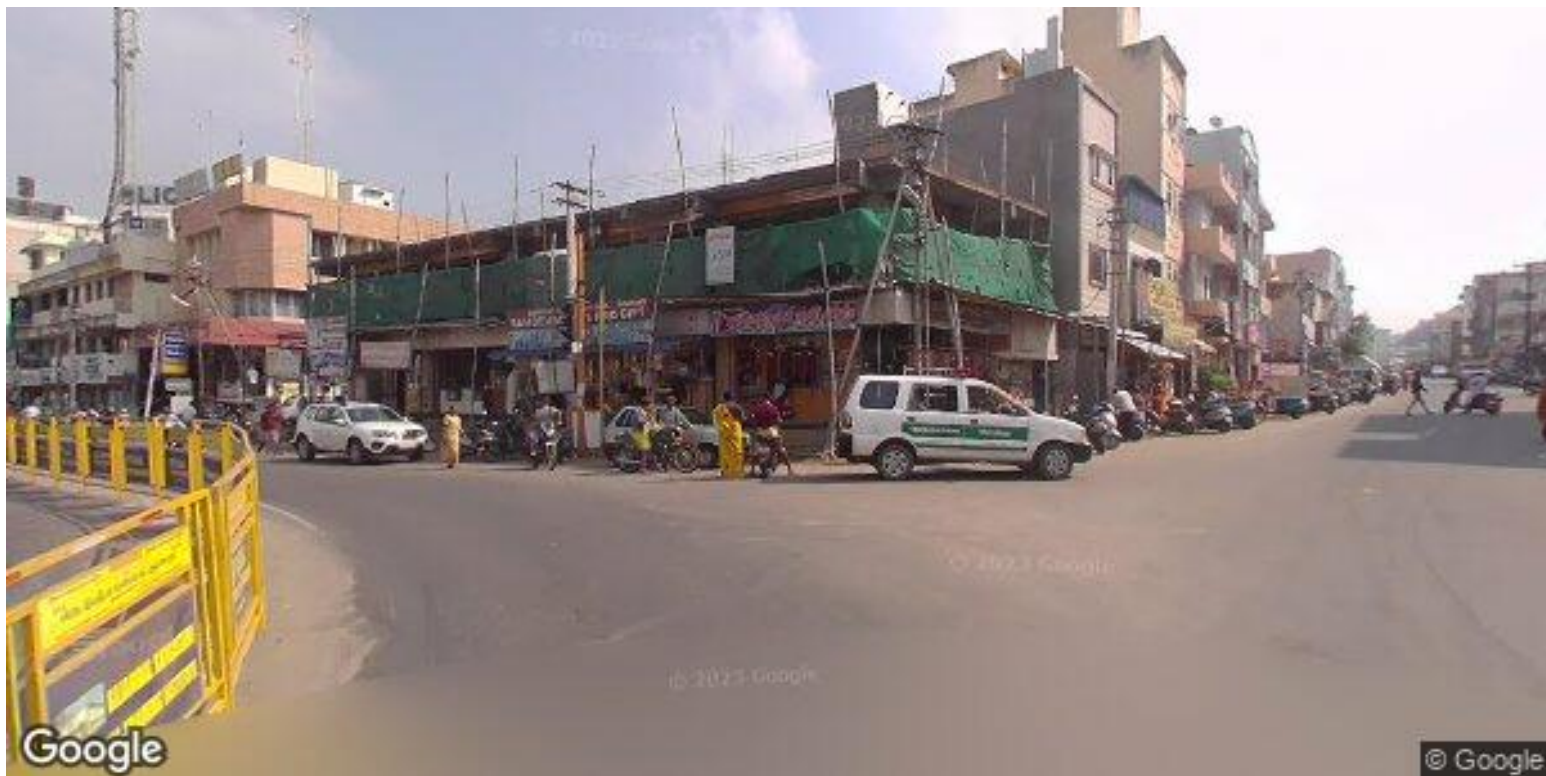
**Coordinates:** 11.37868, 77.89498

**Risk Type:** Turn

**Risk Level:** High

**Speed Limit:** 15 KM/Hr

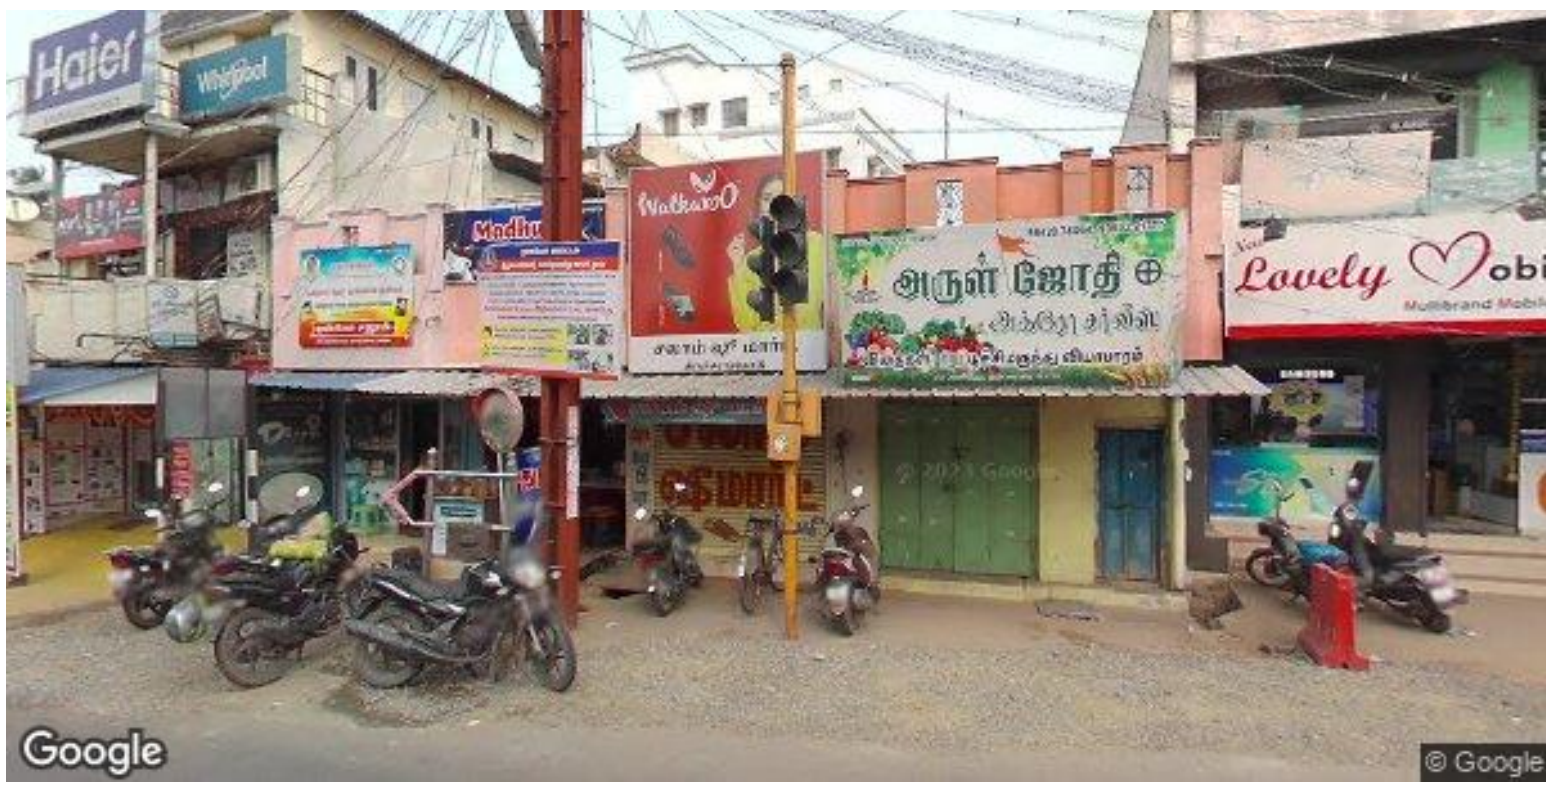
Coordinates: 11.37850, 77.89453

Risk Type: Turn

Risk Level: High

Speed Limit: 15 KM/Hr

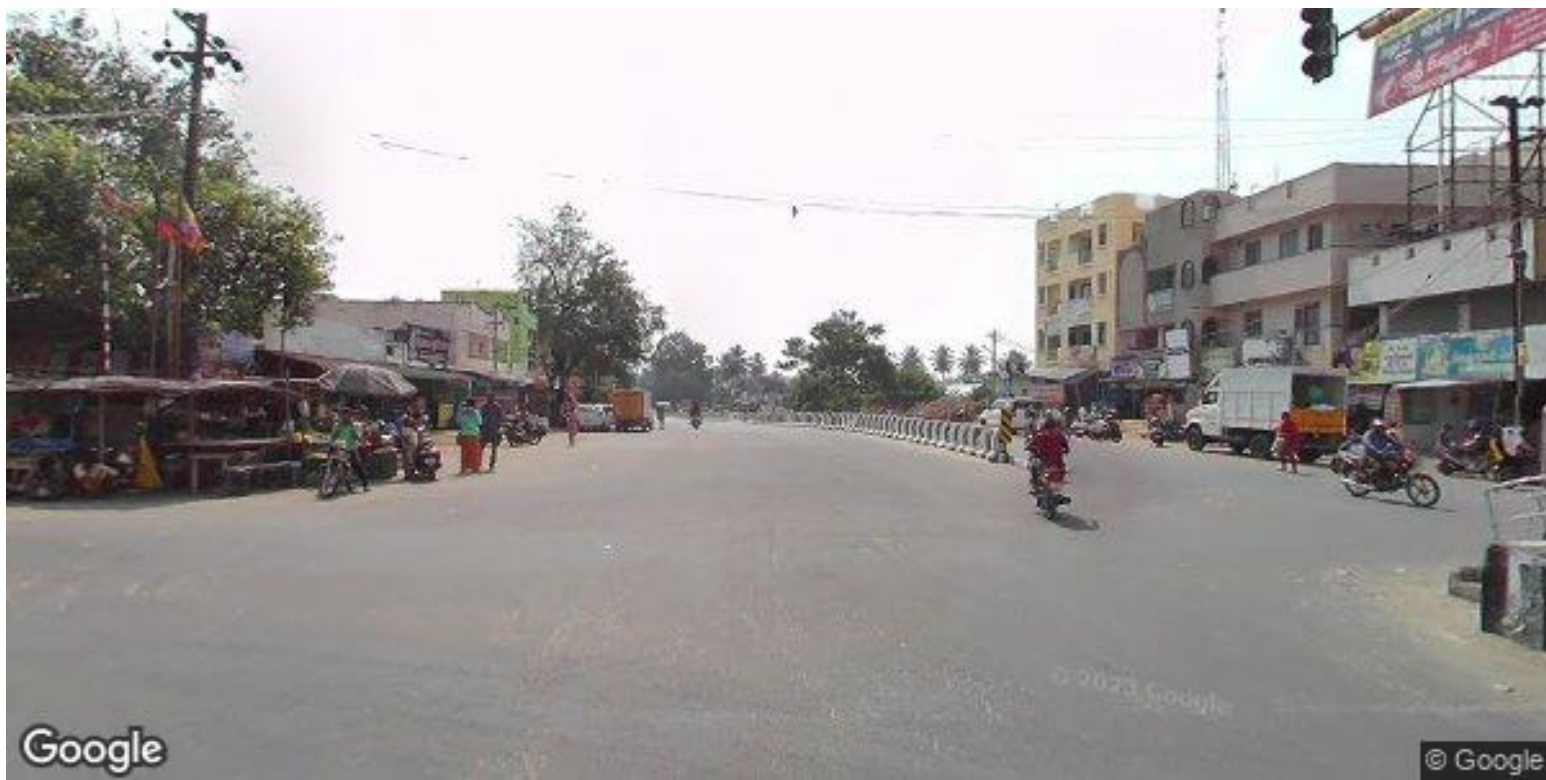
Coordinates: 11.36604, 77.88887

Risk Type: Turn

Risk Level: High

Speed Limit: 15 KM/Hr

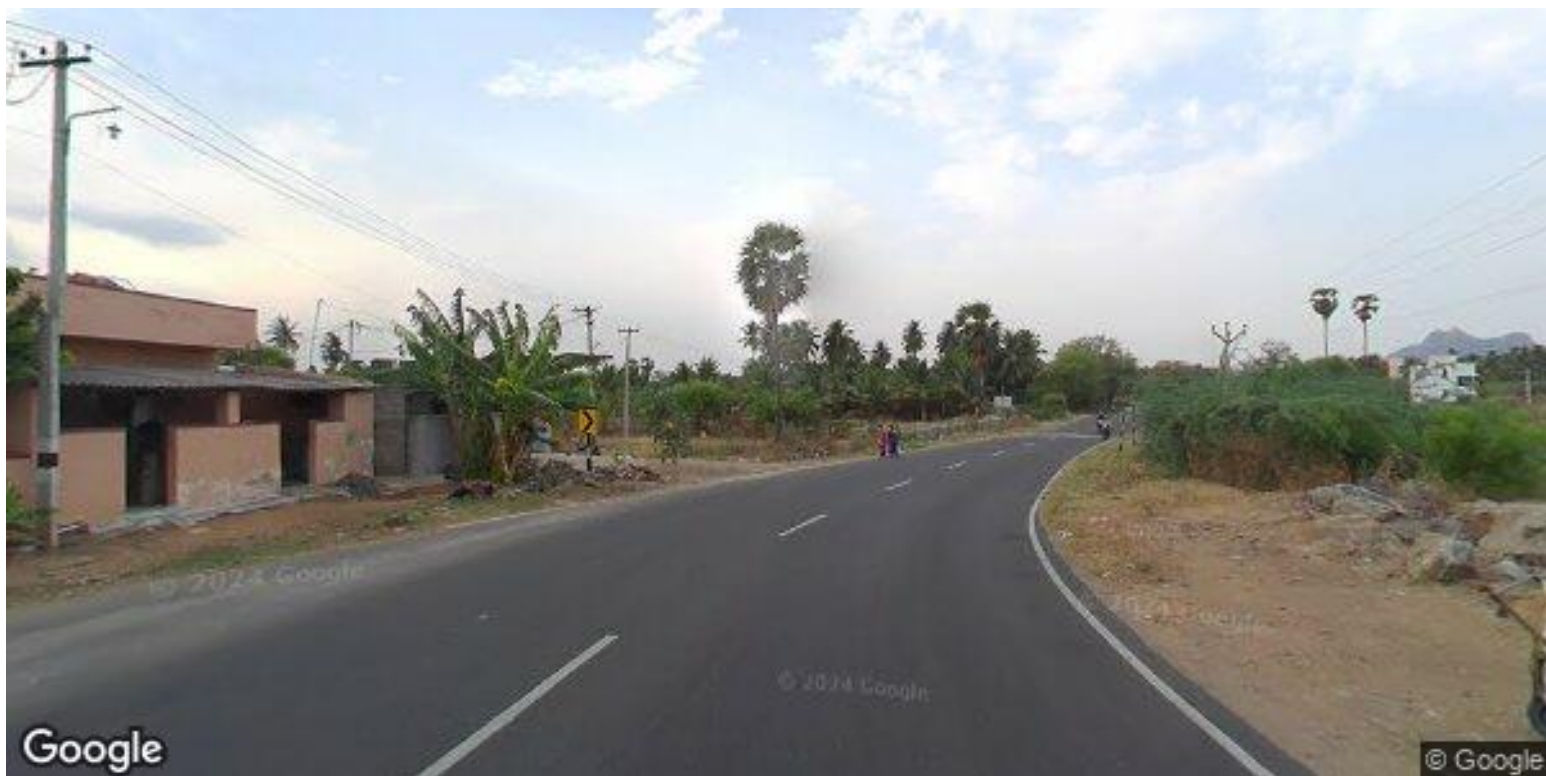
**Risk Type:** Turn  
**Risk Level:** Medium  
**Speed Limit:** 30 KM/Hr  
**Coordinates:** 11.33882, 77.86218

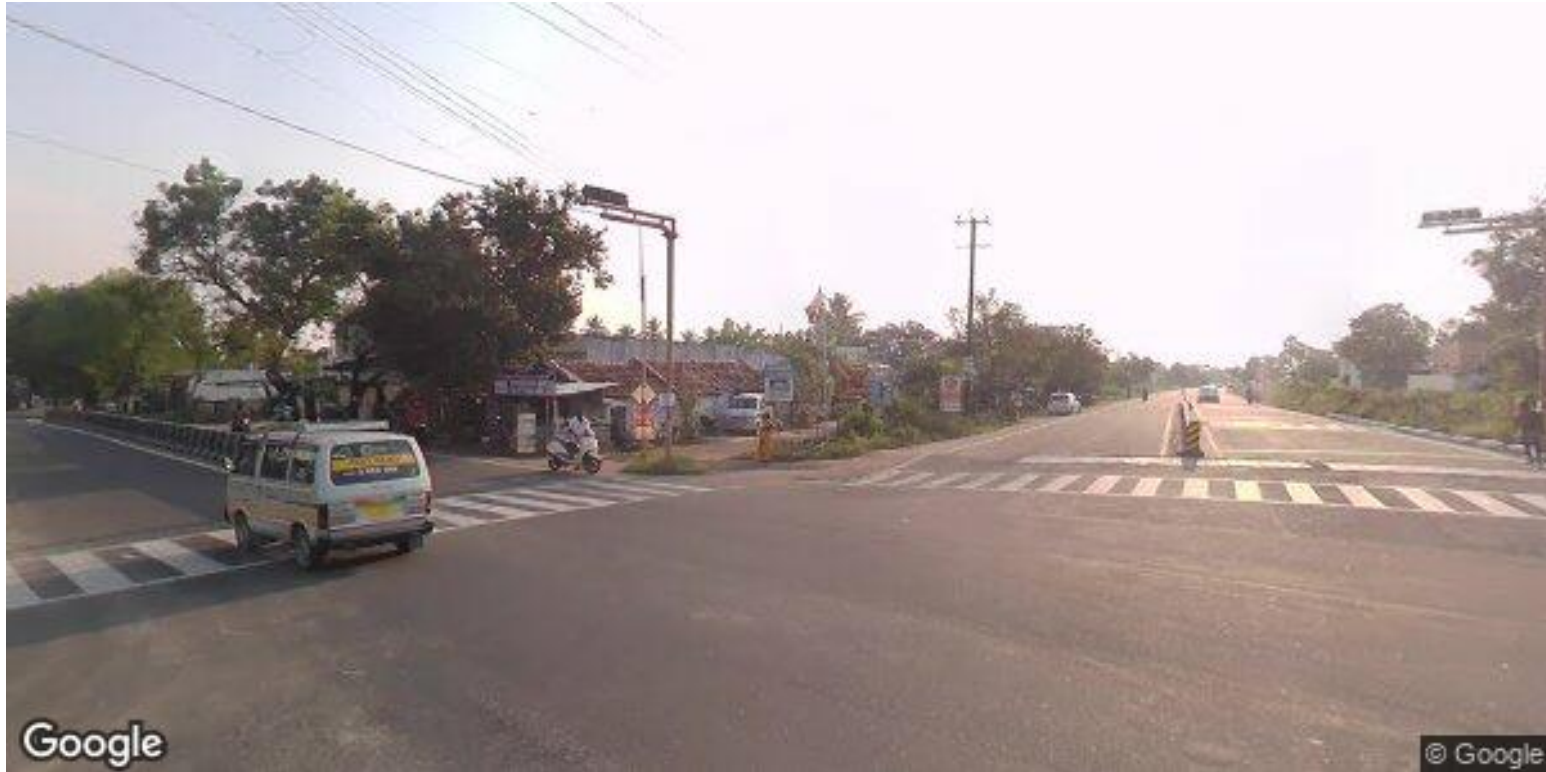
**Risk Type:** Turn  
**Risk Level:** High  
**Speed Limit:** 15 KM/Hr  
**Coordinates:** 11.29899, 77.75806

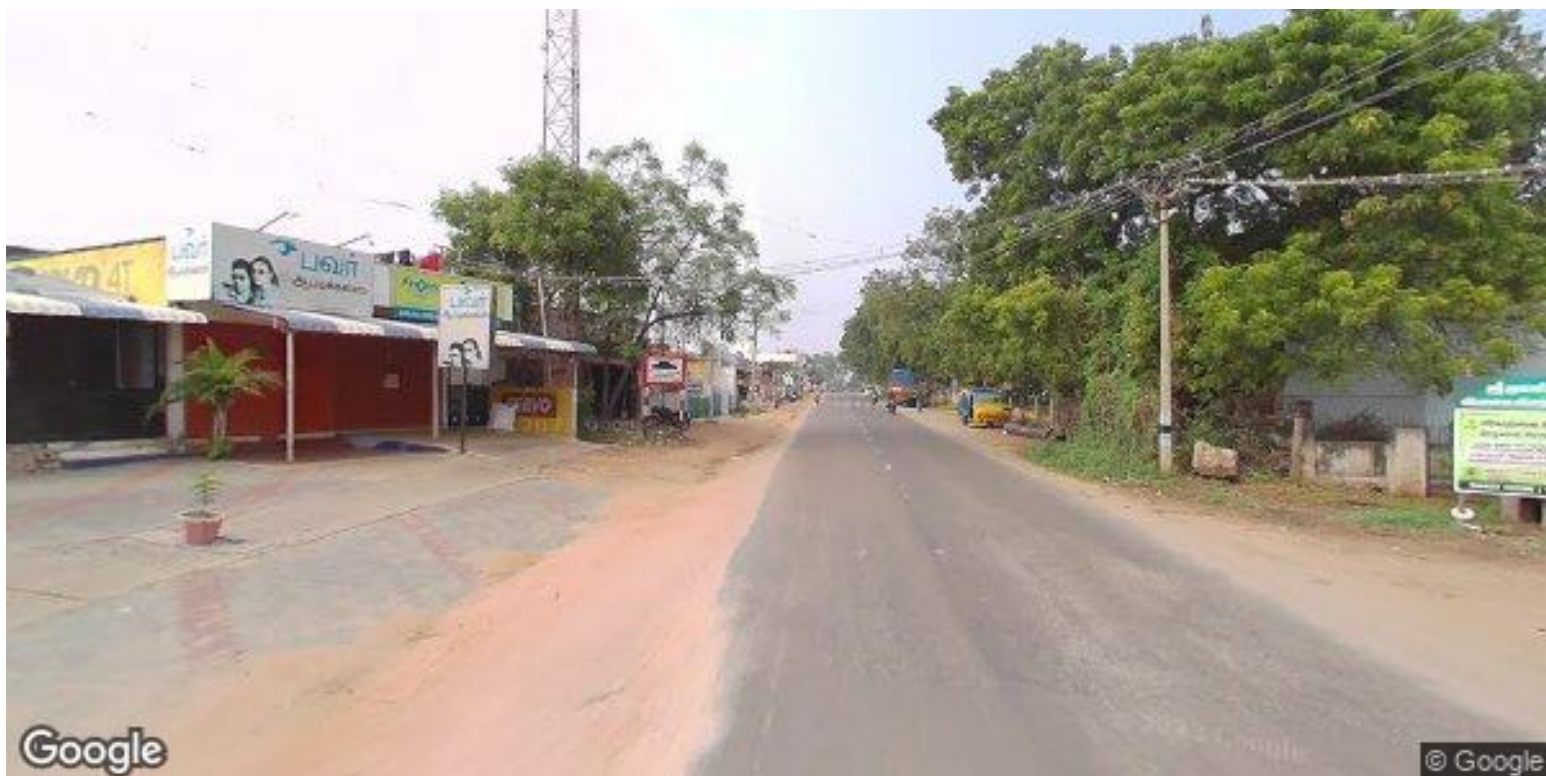
**Risk Type:** Blind Spot  
**Risk Level:** Blind Spot  
**Speed Limit:** 10 KM/Hr  
**Coordinates:** 11.23890, 77.77738

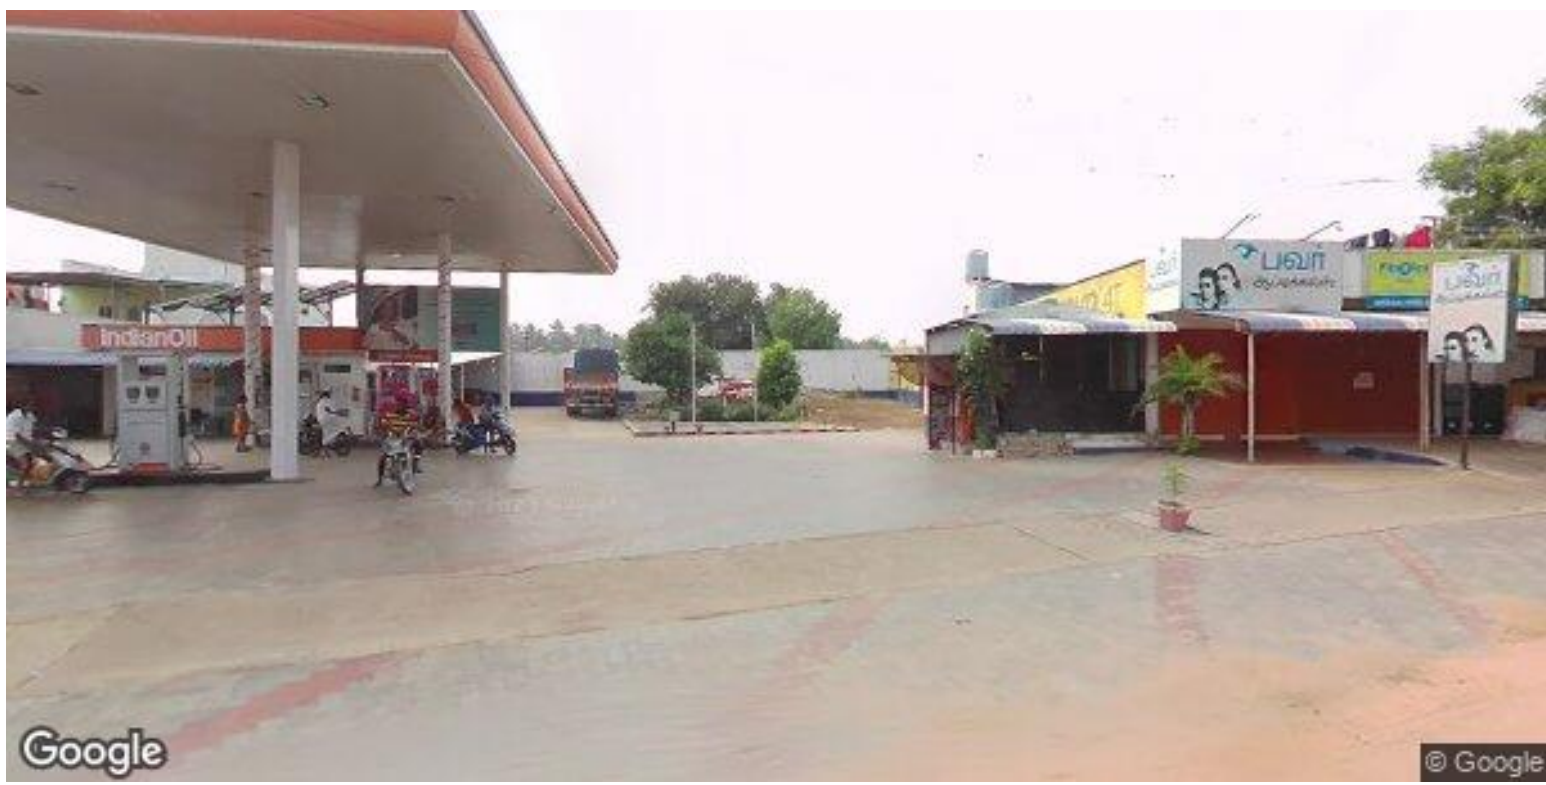
**Coordinates:** 11.23890, 77.77725

**Risk Type:** Turn

**Risk Level:** Medium

**Speed Limit:** 30 KM/Hr

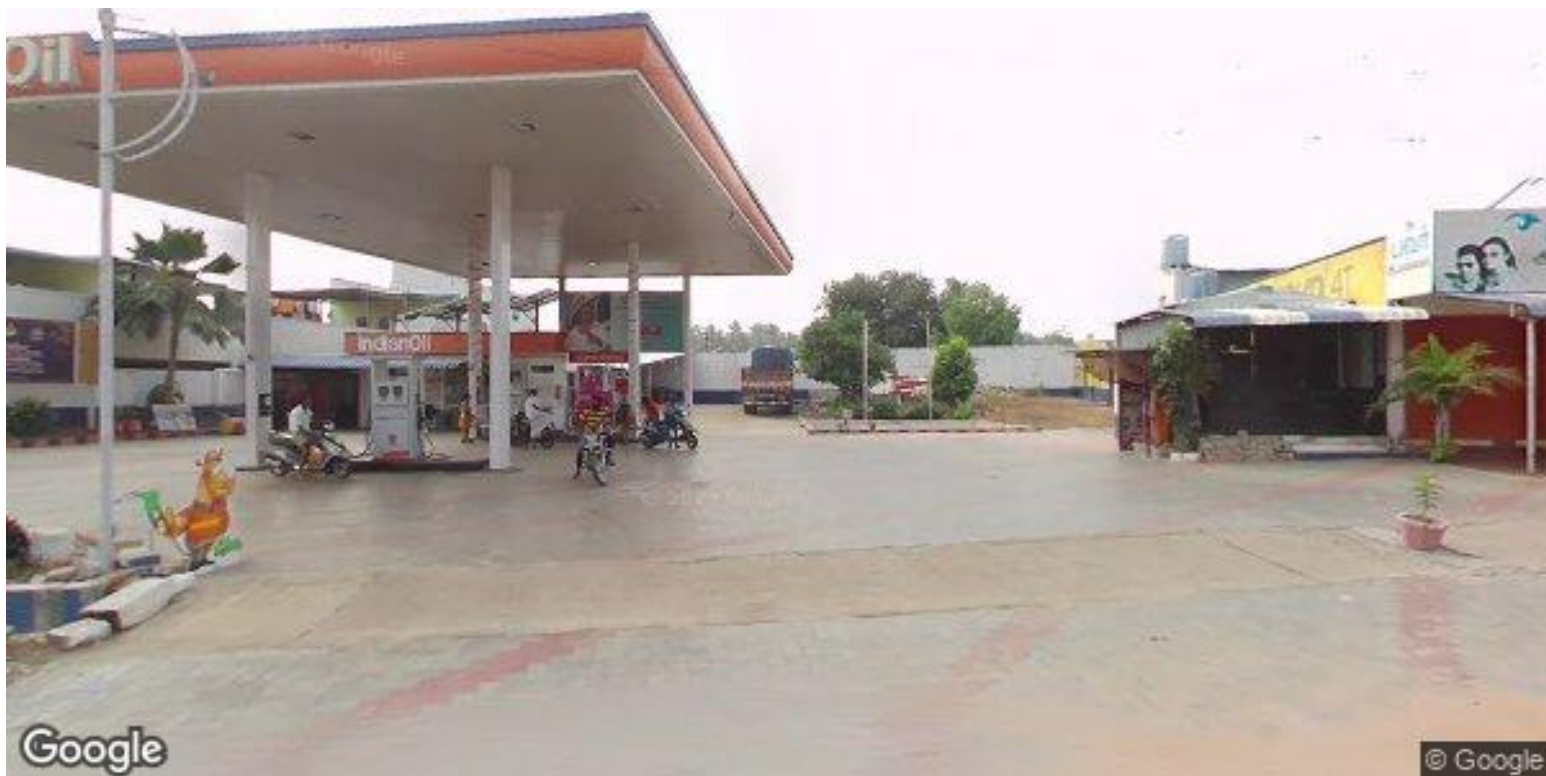
**Coordinates:** 11.23887, 77.77720

**Risk Type:** Turn

**Risk Level:** Medium

**Speed Limit:** 30 KM/Hr
