# IndianOil

## JOURNEY RISK MANAGEMENT (JRM) STUDY

### Salem Terminal to SANKAGIRI LORRY OWENER'S ASSOCIAATI

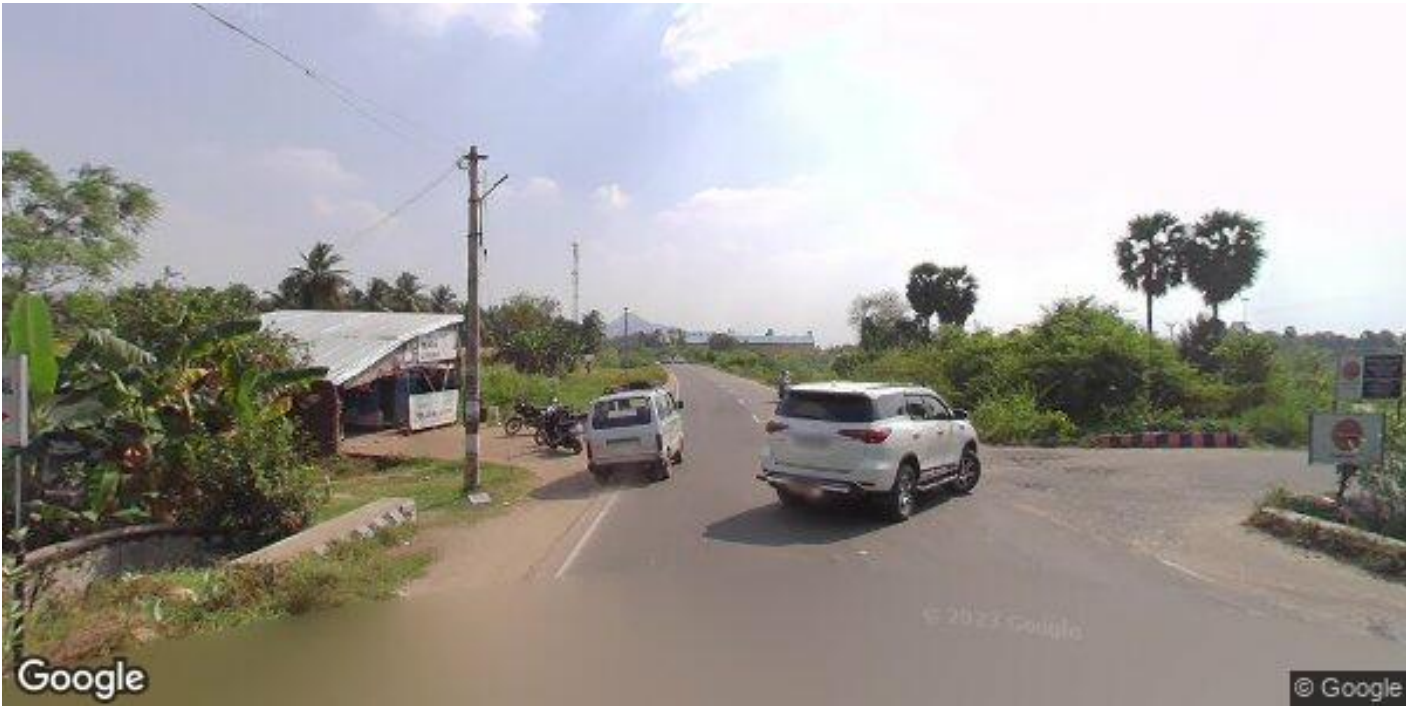
| | Risk Type | Risk Level | Coordinates | Speed Limit |
|---|---|---|---|---|
| 3 | Turn | High | 11.44029, 77.87544 | 15 KM/Hr |

Risk Type: Turn  
Risk Level: High  
Speed Limit: 15 KM/Hr  
Coordinates: 11.44029, 77.87544

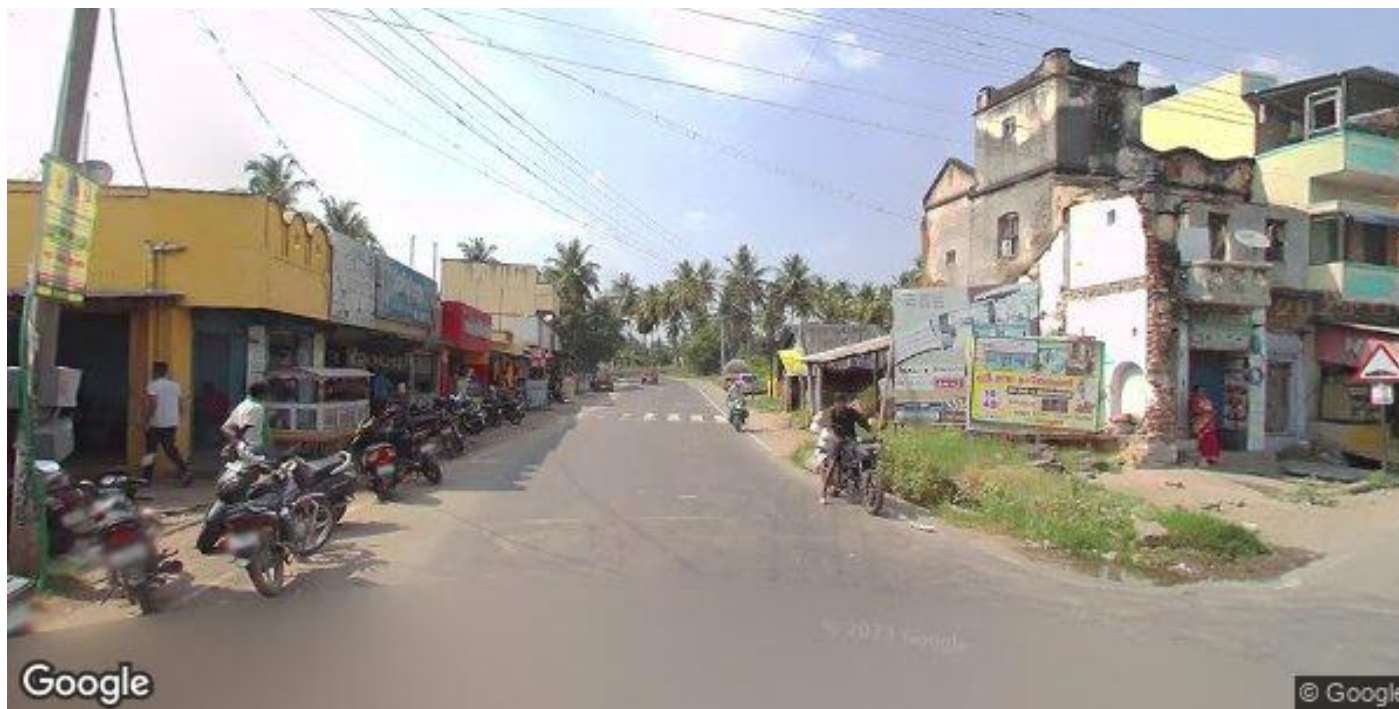
| | Risk Type | Risk Level | Coordinates | Speed Limit |
|---|---|---|---|---|
| 4 | Turn | High | 11.45007, 77.87201 | 15 KM/Hr |

**Risk Type:** Turn  
**Risk Level:** High  
**Speed Limit:** 15 KM/Hr  
**Coordinates:** 11.45007, 77.87201

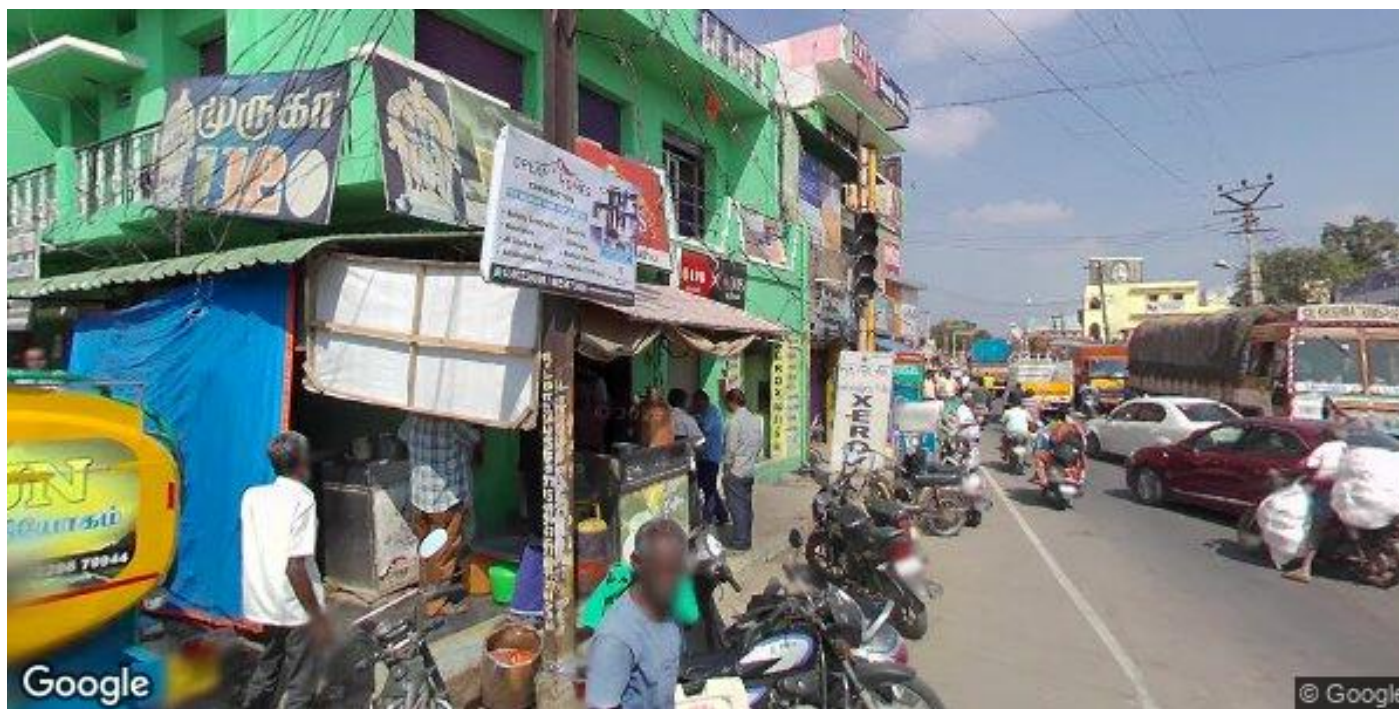
| | Risk Type | Risk Level | Coordinates | Speed Limit |
|---|---|---|---|---|
| 5 | Turn | High | 11.47407, 77.86839 | 15 KM/Hr |

**Risk Type:** Turn  
**Risk Level:** High  
**Speed Limit:** 15 KM/Hr  
**Coordinates:** 11.47407, 77.86839

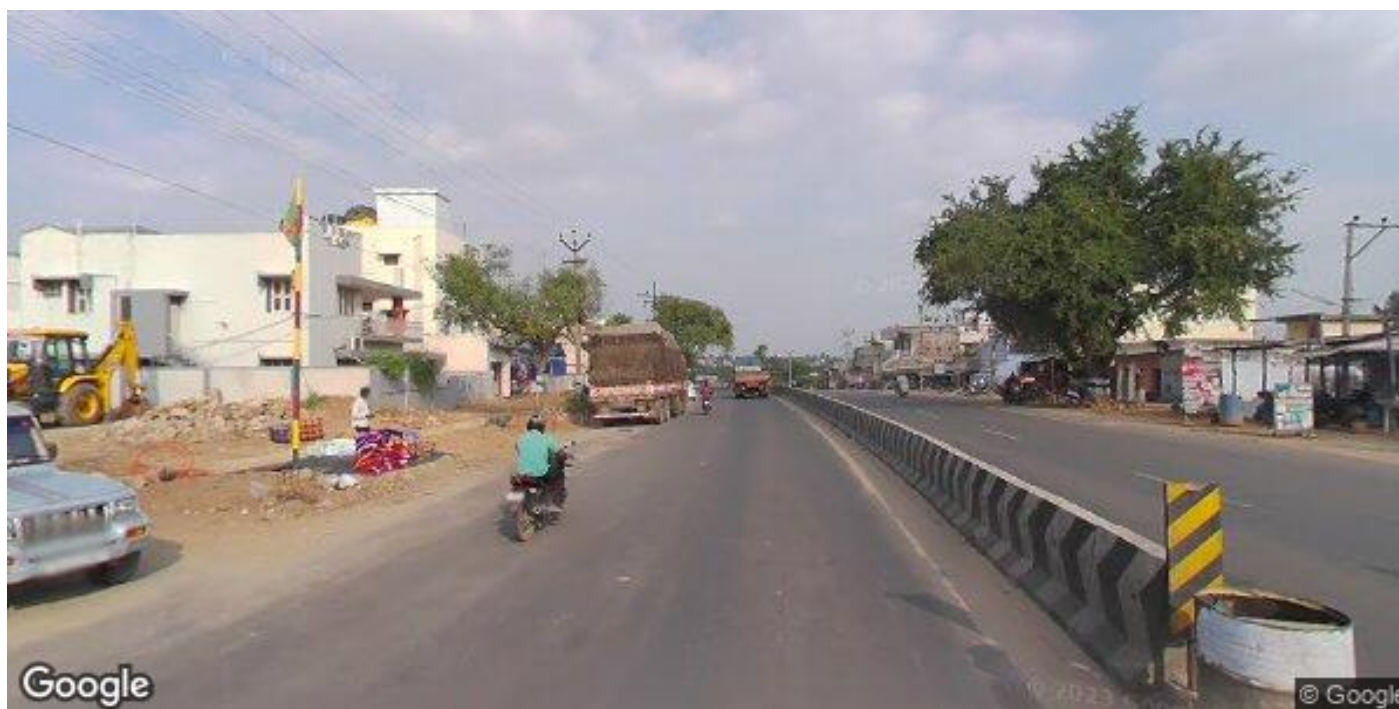
| | Risk Type | Risk Level | Coordinates | Speed Limit |
|---|---|---|---|---|
| 6 | Blind Spot | Blind Spot | 11.47946, 77.88218 | 10 KM/Hr |

**Risk Type:** Blind Spot  
**Risk Level:** Blind Spot  
**Speed Limit:** 10 KM/Hr  
**Coordinates:** 11.47946, 77.88218
