# IndianOil

## **JOURNEY RISK MANAGEMENT (JRM) STUDY**

### **Salem Terminal to SANKAGIRI LORRY OWENER'S ASSOCIAATI**

Route Safety Analysis: CVQF+23W, Sangagiri to FR34+R2F, Virachchipalayam

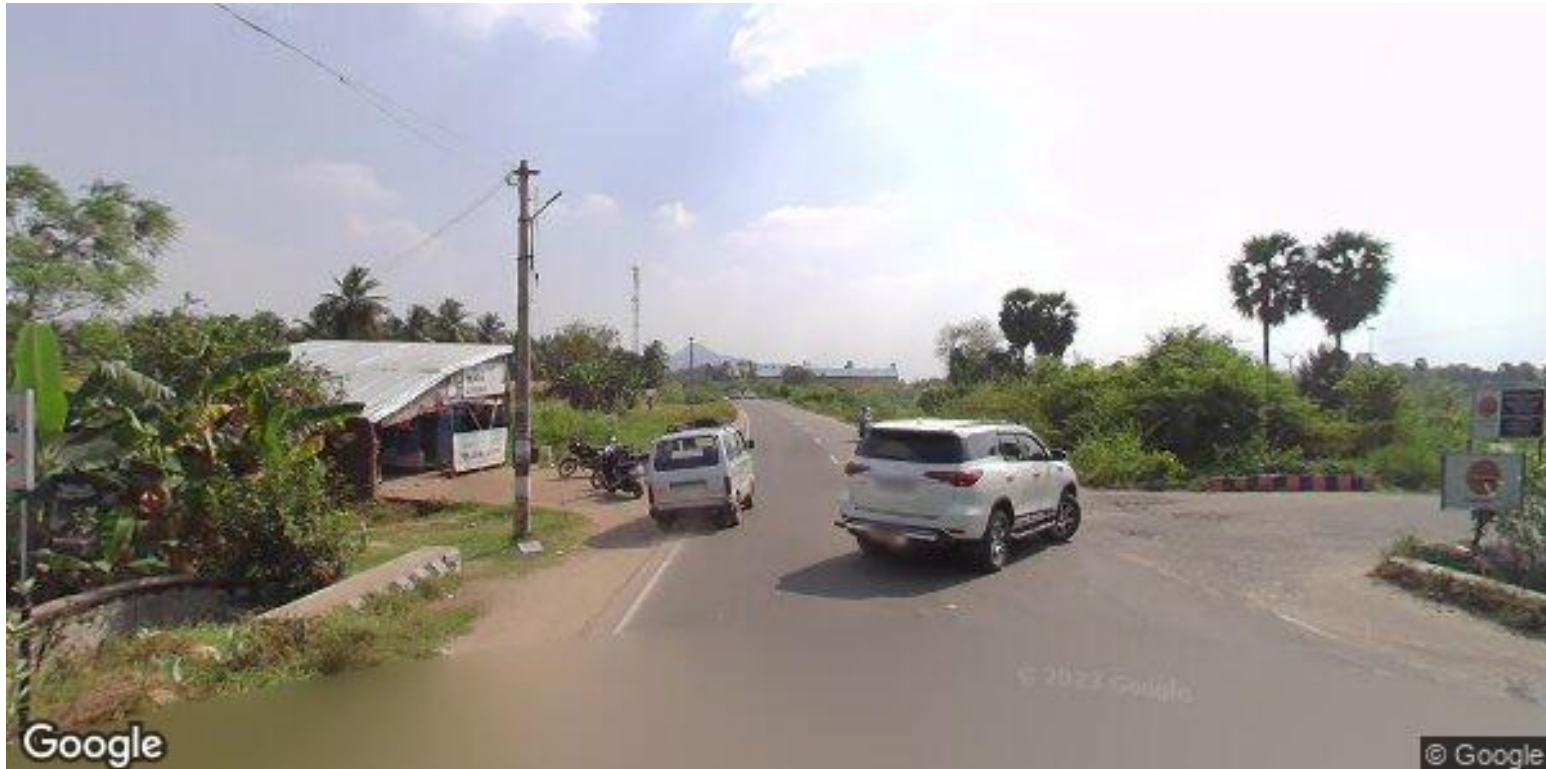
**Coordinates:** 11.44029, 77.87544

**Risk Type:** Turn

**Risk Level:** High

**Speed Limit:** 15 KM/Hr

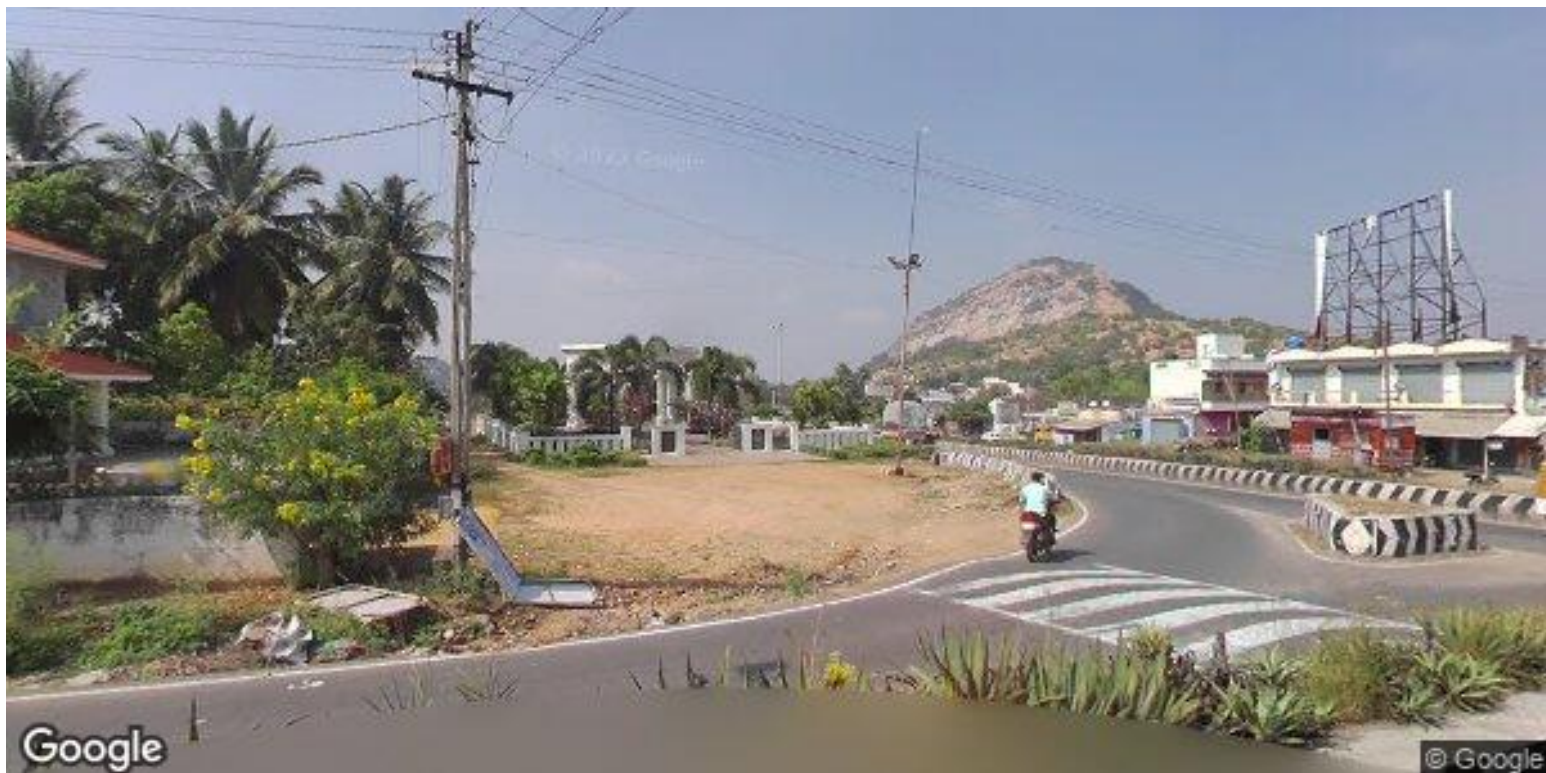
**Coordinates:** 11.46307, 77.84941

**Risk Type:** Turn

**Risk Level:** Medium

**Speed Limit:** 30 KM/Hr

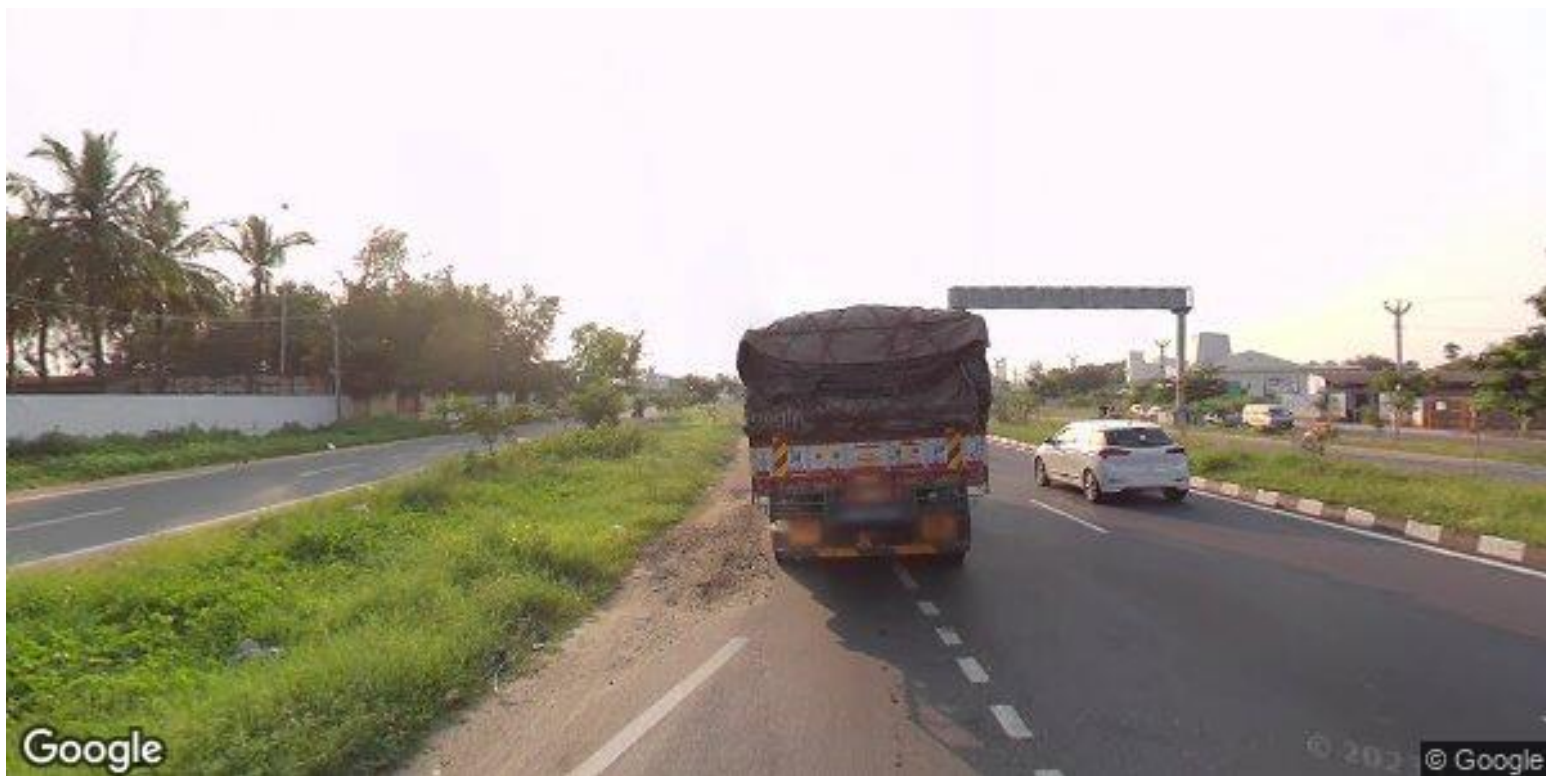
**Coordinates:** 11.45517, 77.81345

**Risk Type:** Turn

**Risk Level:** High

**Speed Limit:** 15 KM/Hr

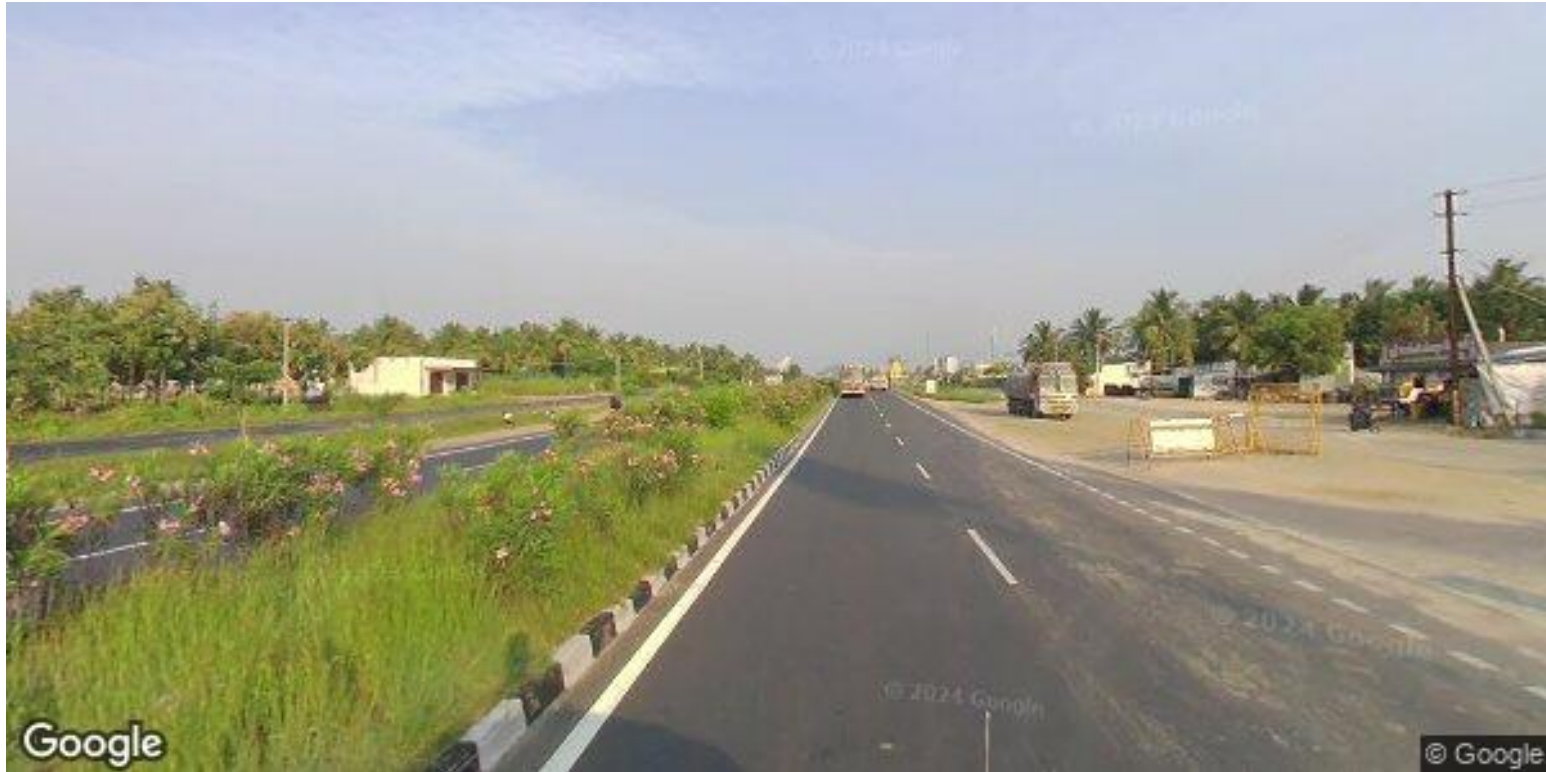
**Risk Type:** Blind Spot  
**Risk Level:** Blind Spot  
**Speed Limit:** 10 KM/Hr  
**Coordinates:** 11.45481, 77.80540

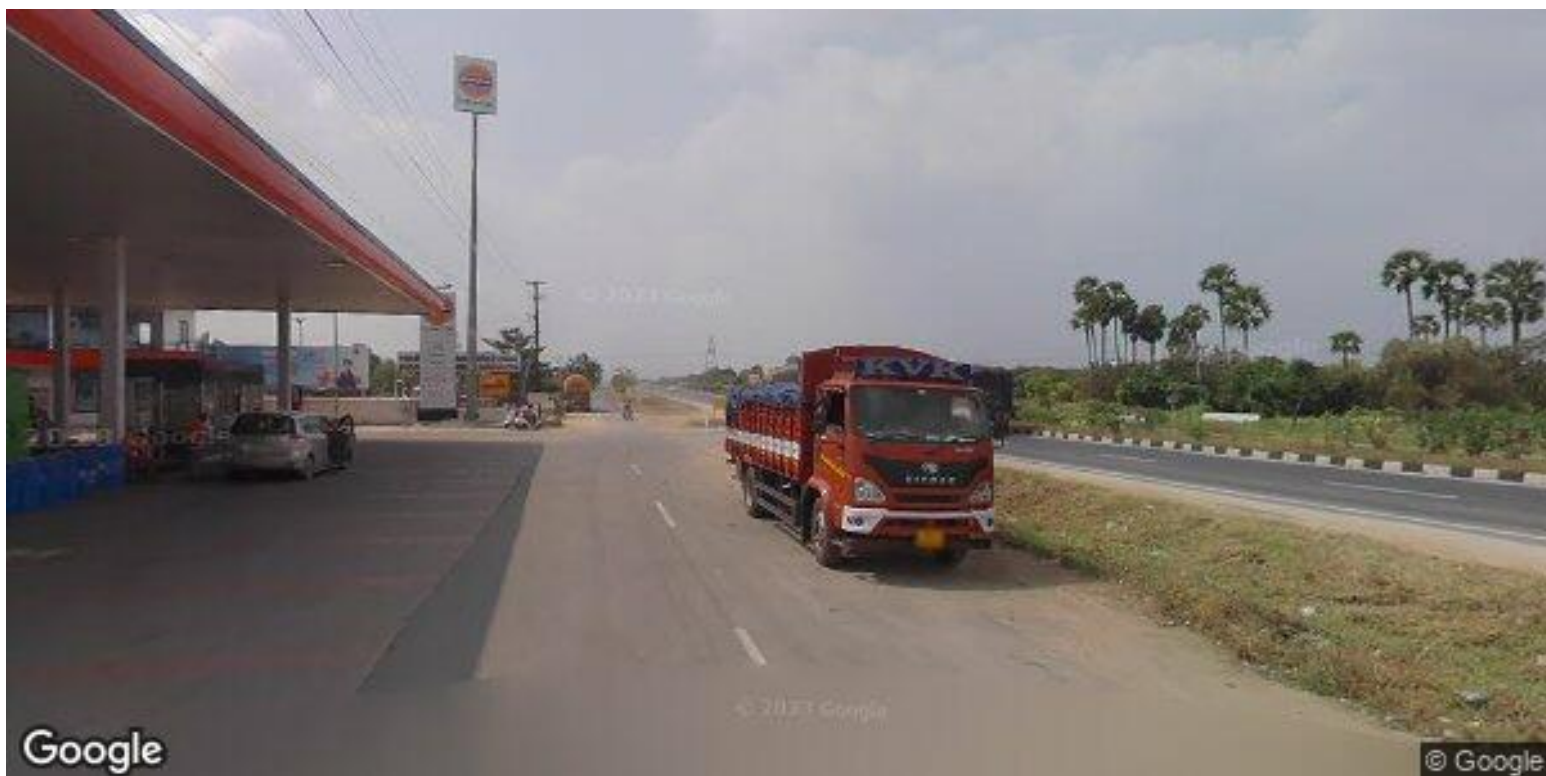
**Risk Type:** Turn  
**Risk Level:** High  
**Speed Limit:** 15 KM/Hr  
**Coordinates:** 11.45465, 77.80541

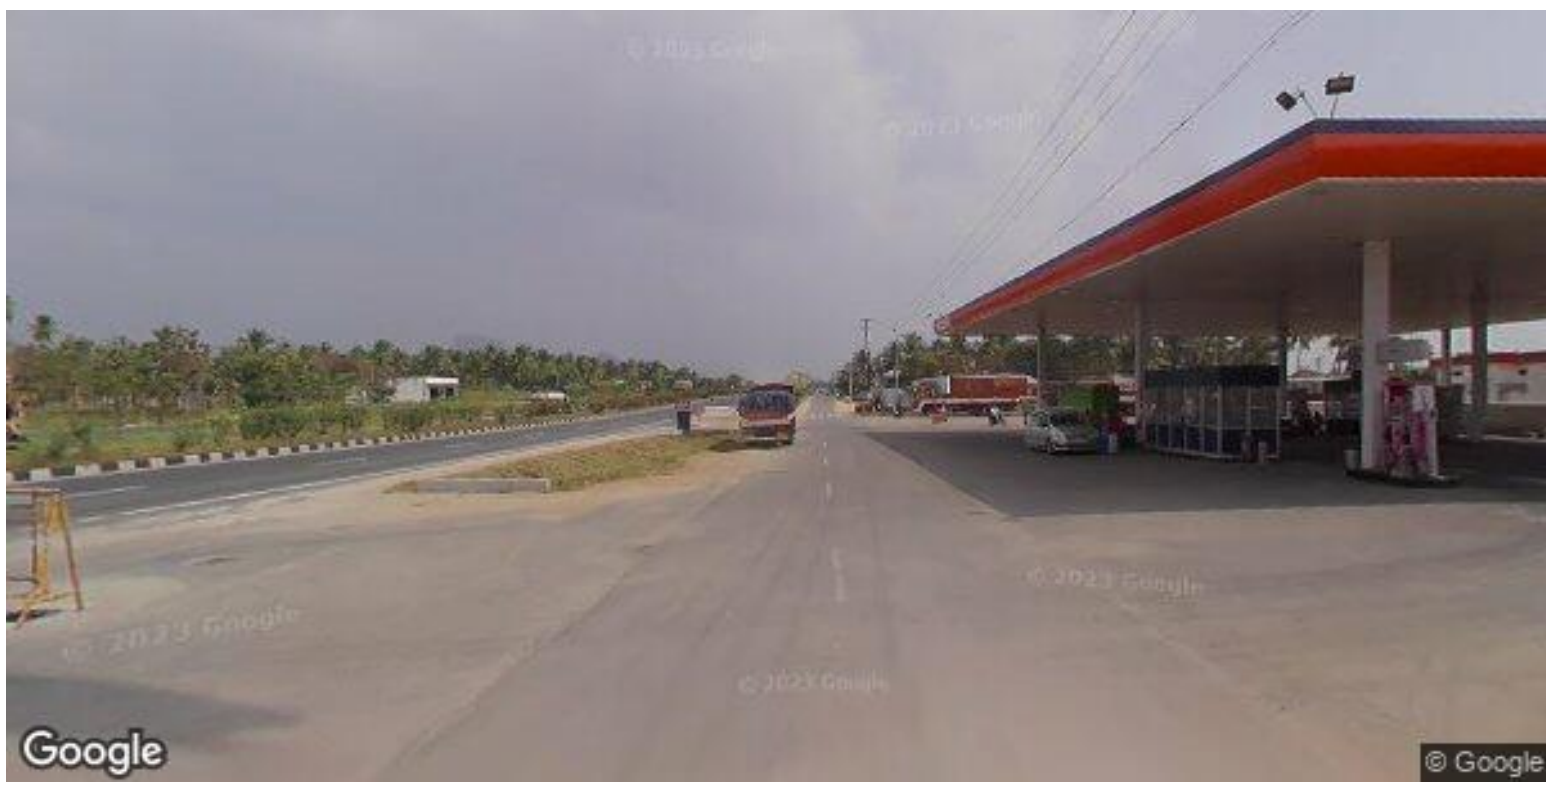
**Coordinates:** 11.45464, 77.80498

**Risk Type:** Blind Spot

**Risk Level:** Blind Spot

**Speed Limit:** 10 KM/Hr
