## **JOURNEY RISK MANAGEMENT (JRM) STUDY**

### **Salem Terminal To SHREE CHANDIKA AGENCIES**

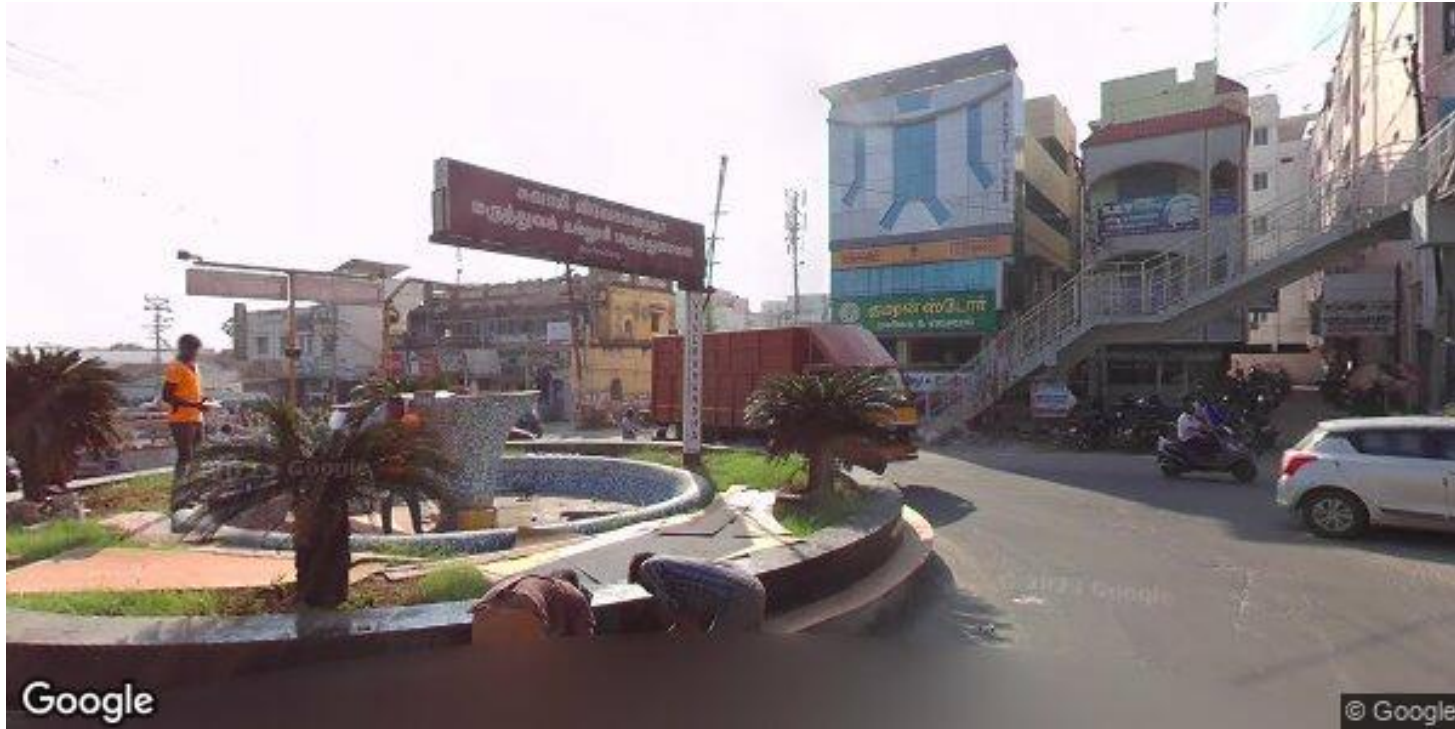
**Coordinates:** 11.38395, 77.89480

**Risk Type:** Roundabout

**Risk Level:** High

**Speed Limit:** 15 KM/Hr

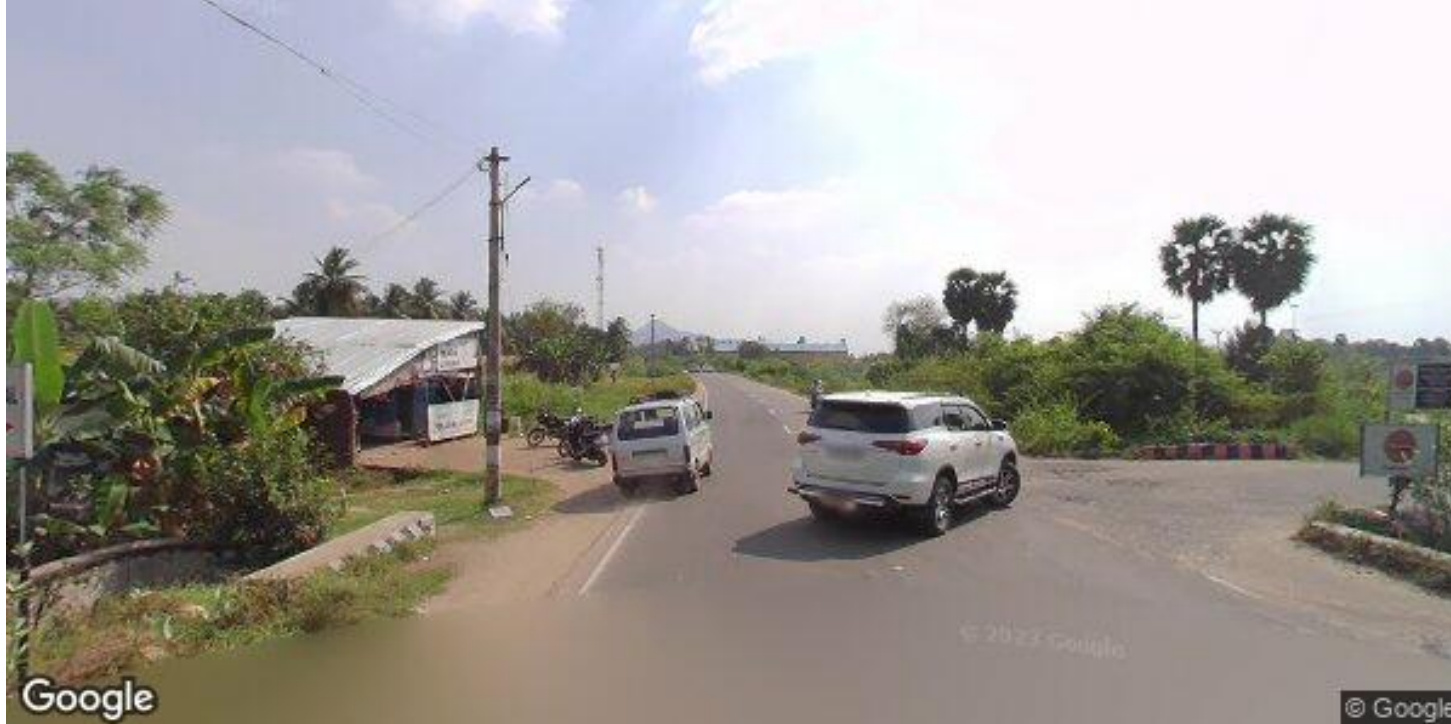
**Coordinates:** 11.44029, 77.87544

**Risk Type:** Turn

**Risk Level:** High

**Speed Limit:** 15 KM/Hr

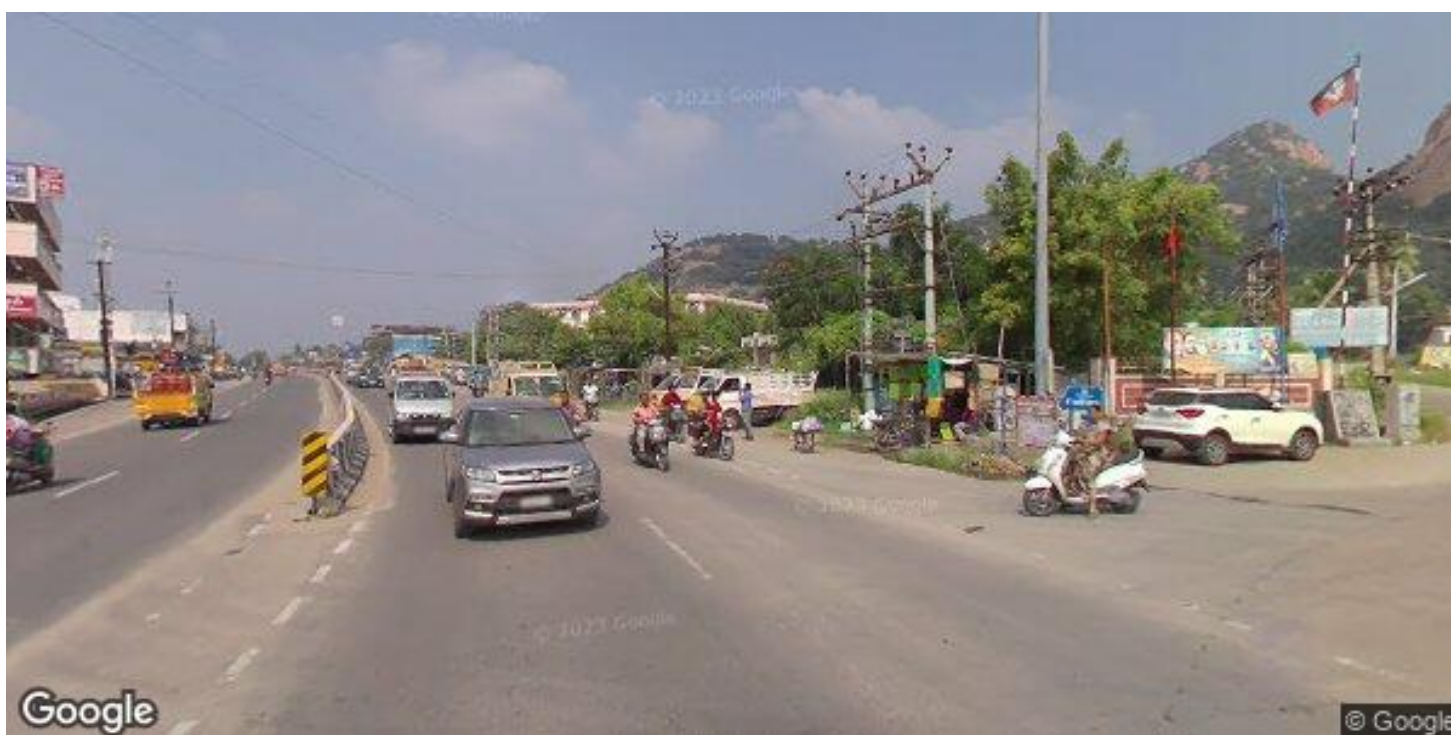
**Coordinates:** 11.39671, 77.88878

**Risk Type:** Turn

**Risk Level:** Medium

**Speed Limit:** 30 KM/Hr

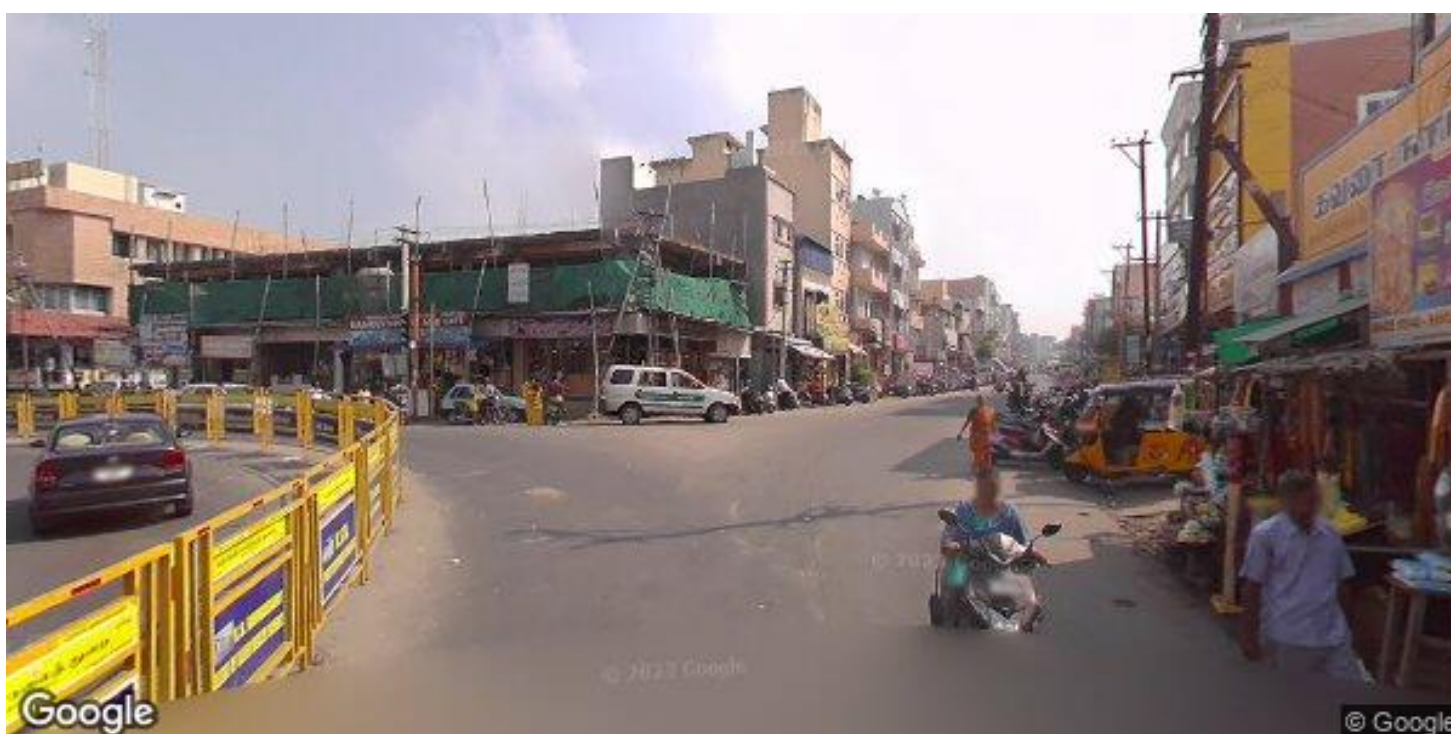
Coordinates: 11.37862, 77.89488

**Risk Type:** Turn

**Risk Level:** High

Speed Limit: 15 KM/Hr

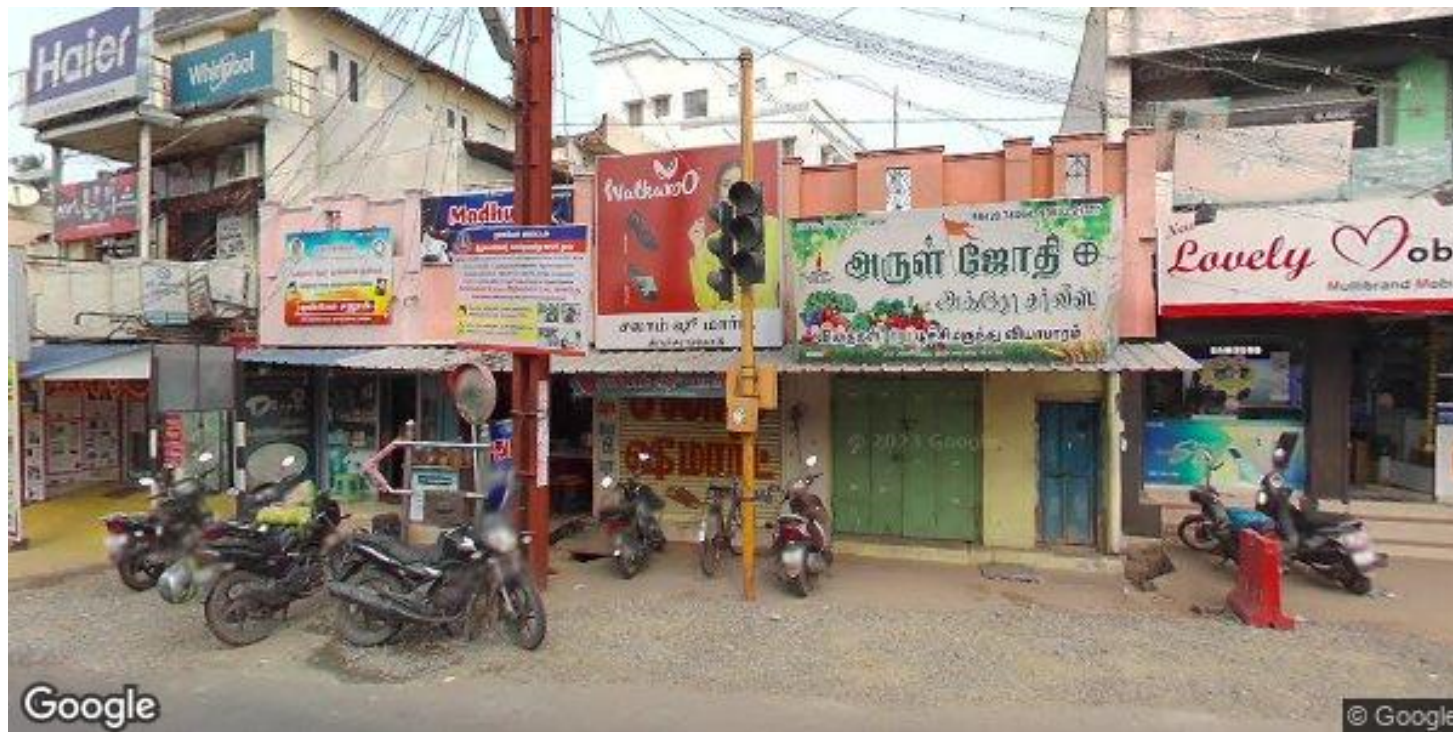
Coordinates: 11.37850, 77.89453

Risk Type: Turn

Risk Level: High

Speed Limit: 15 KM/Hr

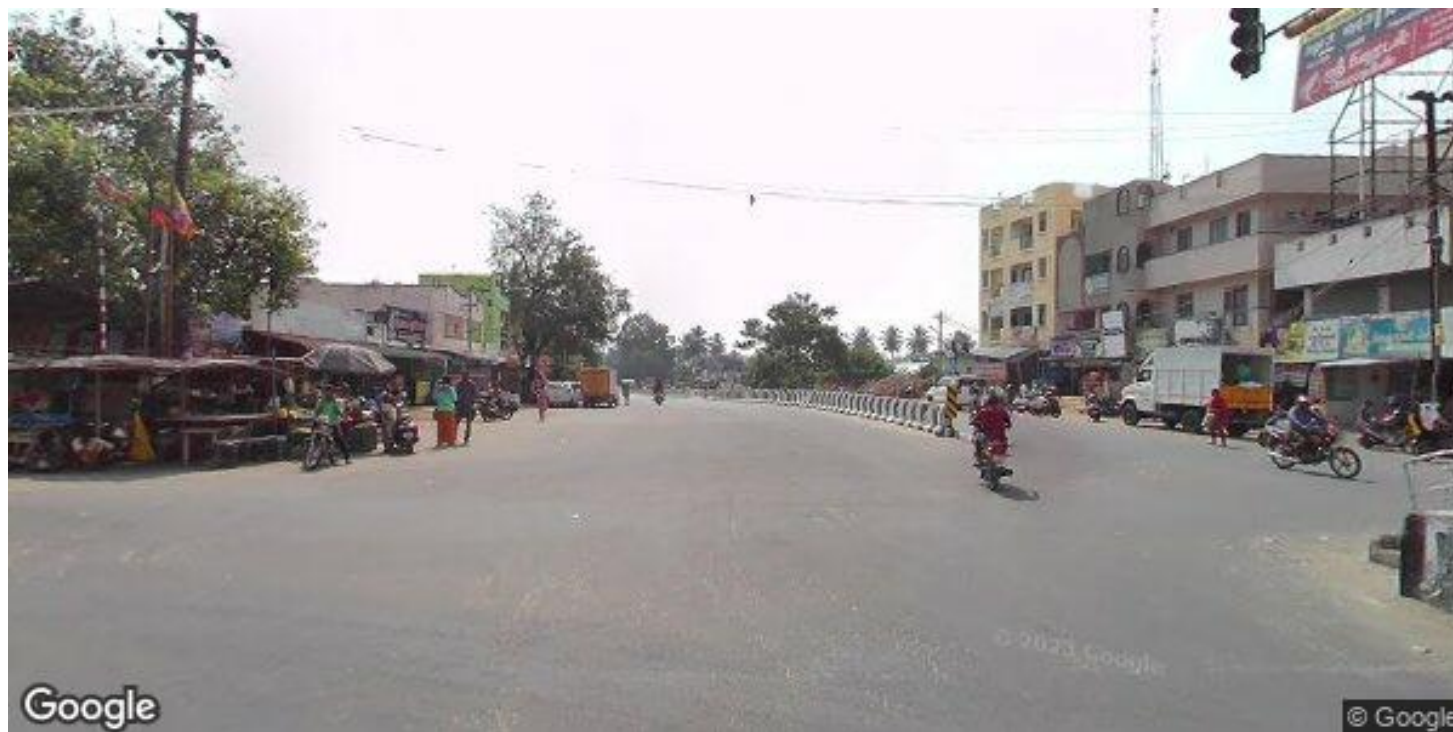
Coordinates: 11.36604, 77.88887

Risk Type: Turn

Risk Level: High

Speed Limit: 15 KM/Hr

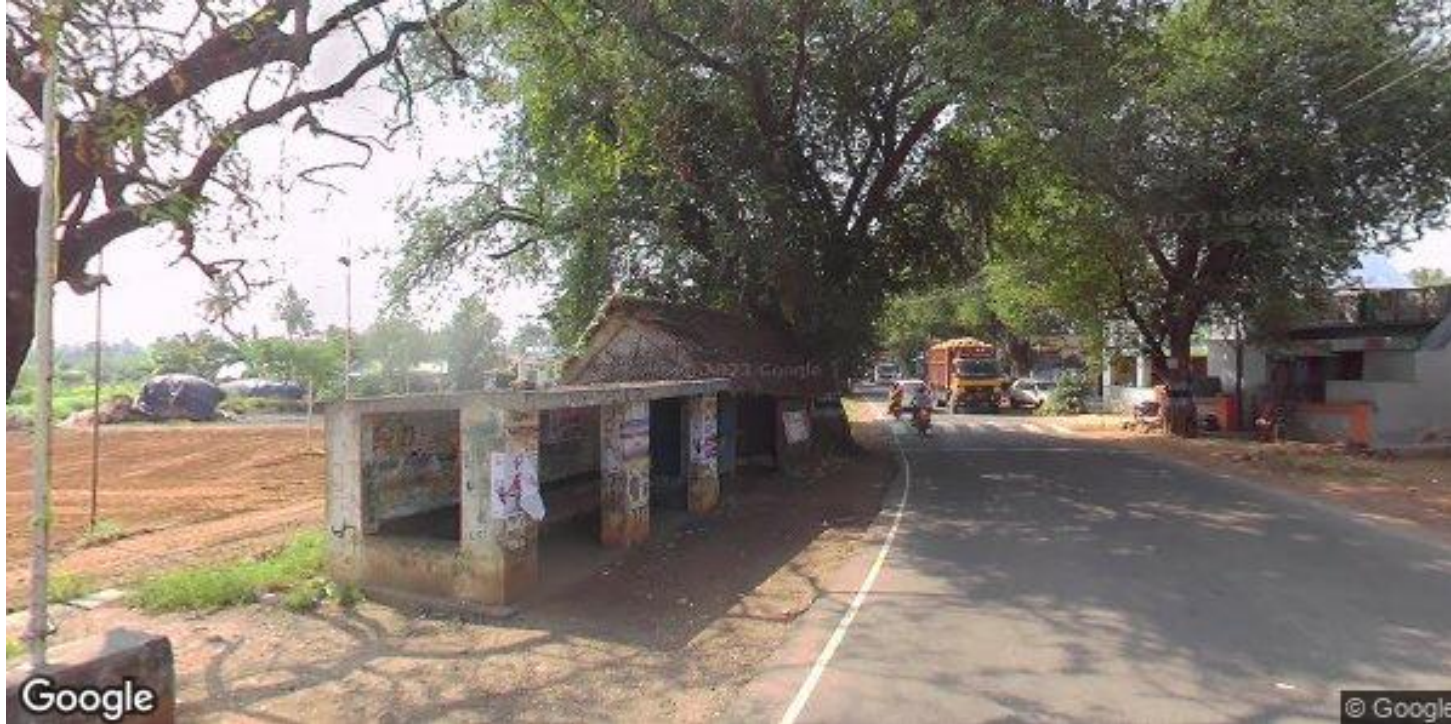
**Coordinates:** 11.34632, 77.86836

**Risk Type:** Turn

**Risk Level:** Medium

**Speed Limit:** 30 KM/Hr

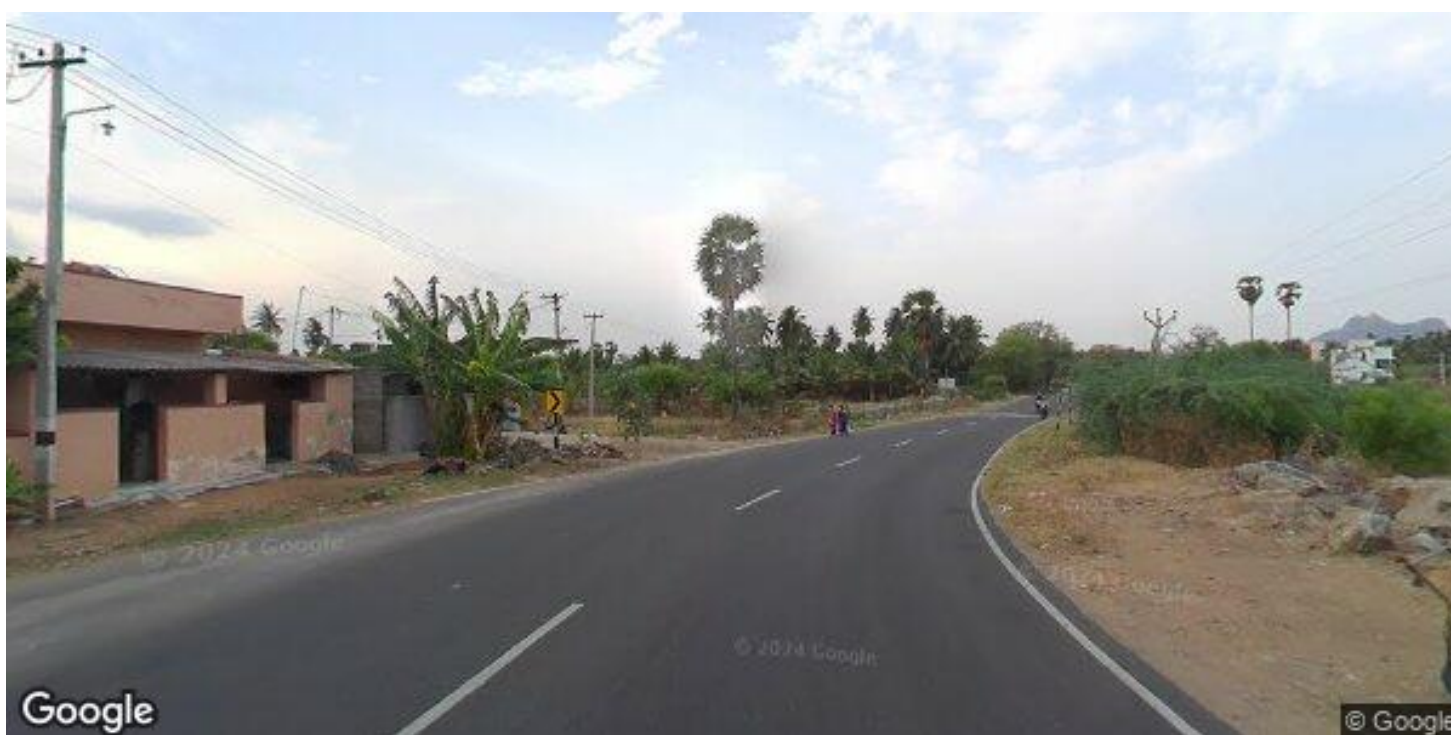
**Coordinates:** 11.33882, 77.86218

**Risk Type:** Turn

**Risk Level:** Medium

**Speed Limit:** 30 KM/Hr

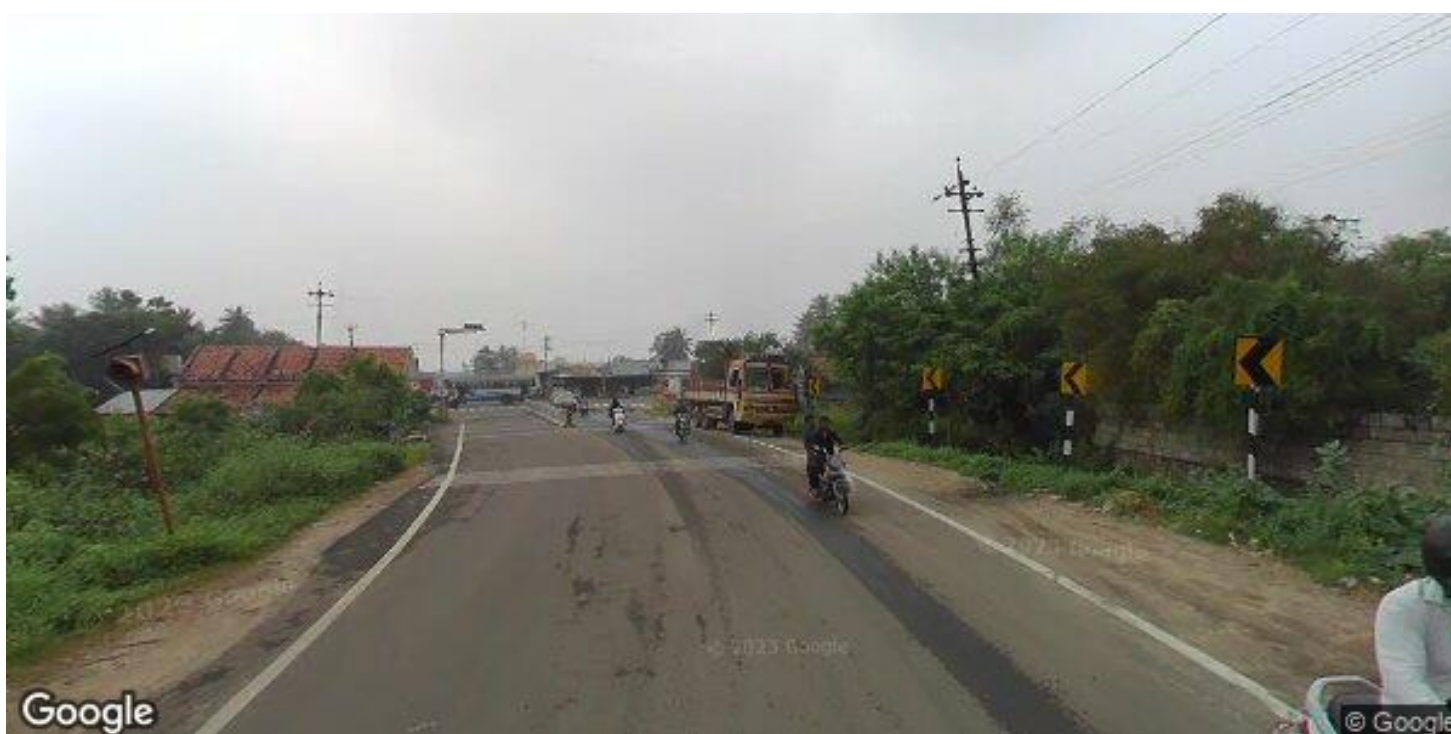
**Coordinates: 11.30970, 77.76705**

**Risk Type:** Turn

**Risk Level:** Medium

**Speed Limit: 30 KM/Hr**

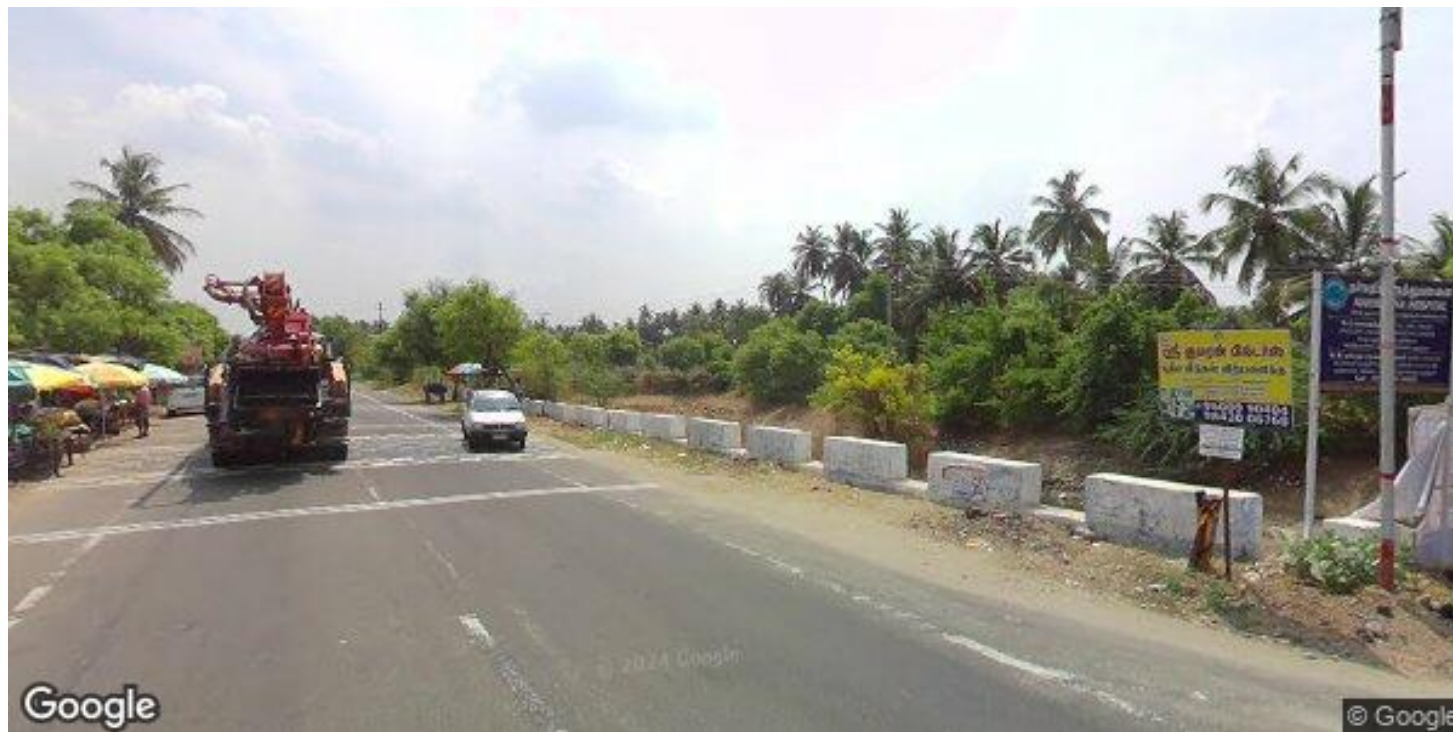
**Coordinates: 11.29490, 77.74685**

**Risk Type: Turn**

**Risk Level: High**

**Speed Limit: 15 KM/Hr**

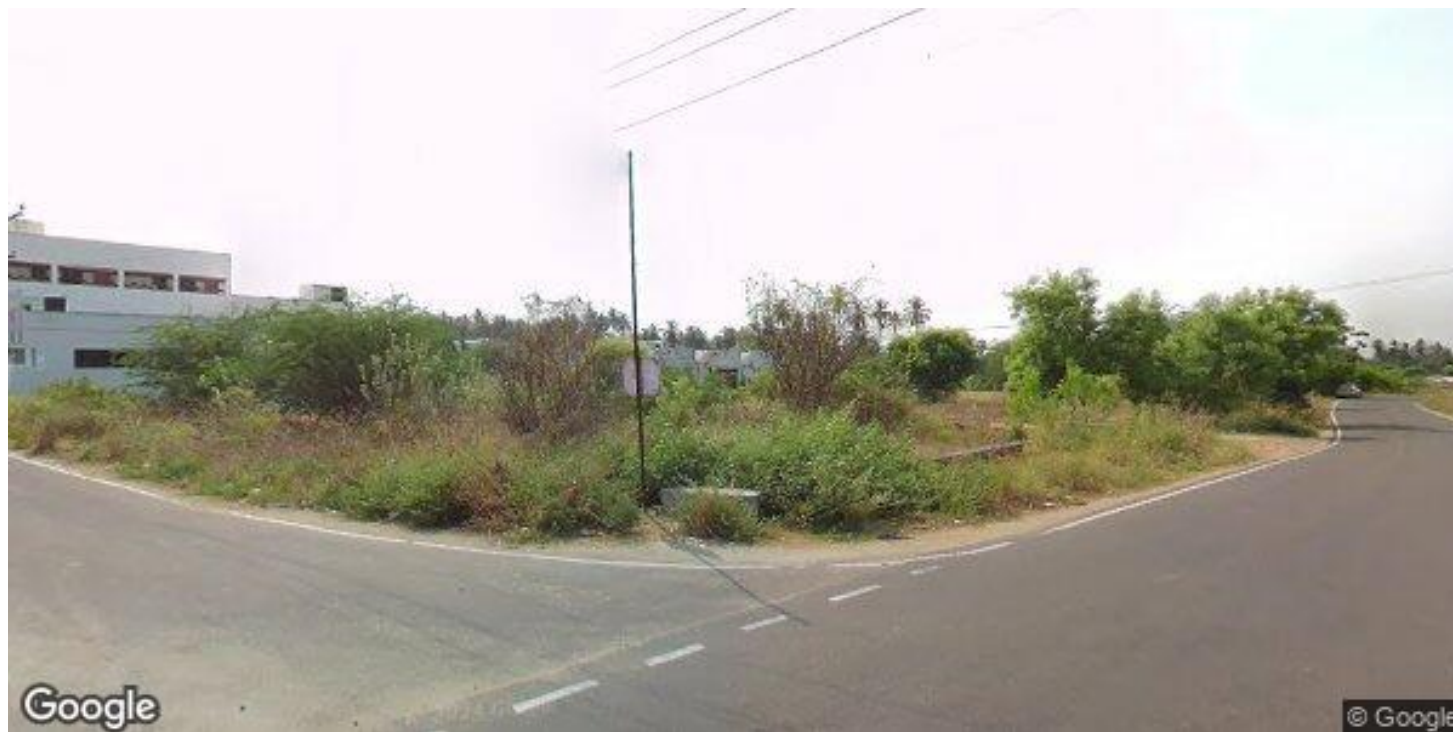
**Coordinates: 11.29133, 77.74660**

**Risk Type: Turn**

**Risk Level: High**

**Speed Limit: 15 KM/Hr**

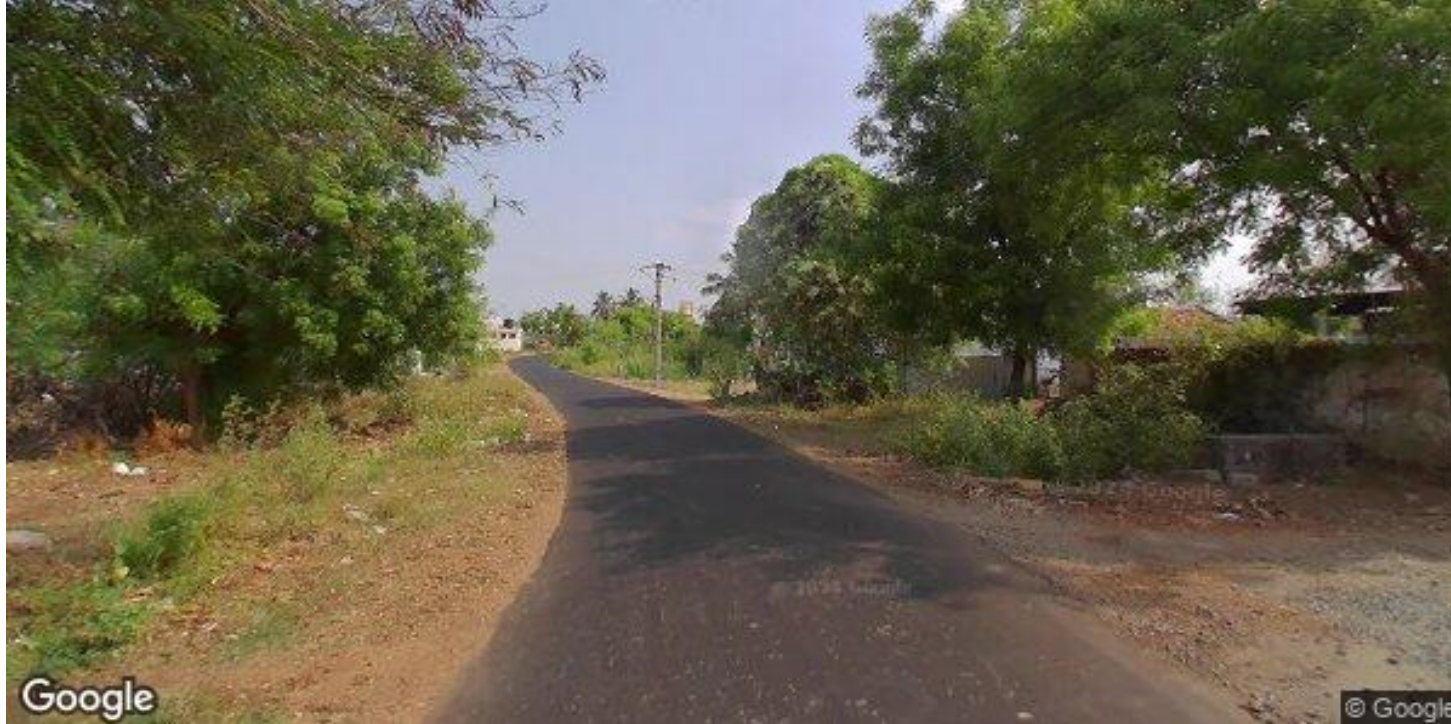
**Coordinates:** 11.28844, 77.74319

**Risk Type:** Turn

**Risk Level:** Medium

**Speed Limit:** 30 KM/Hr

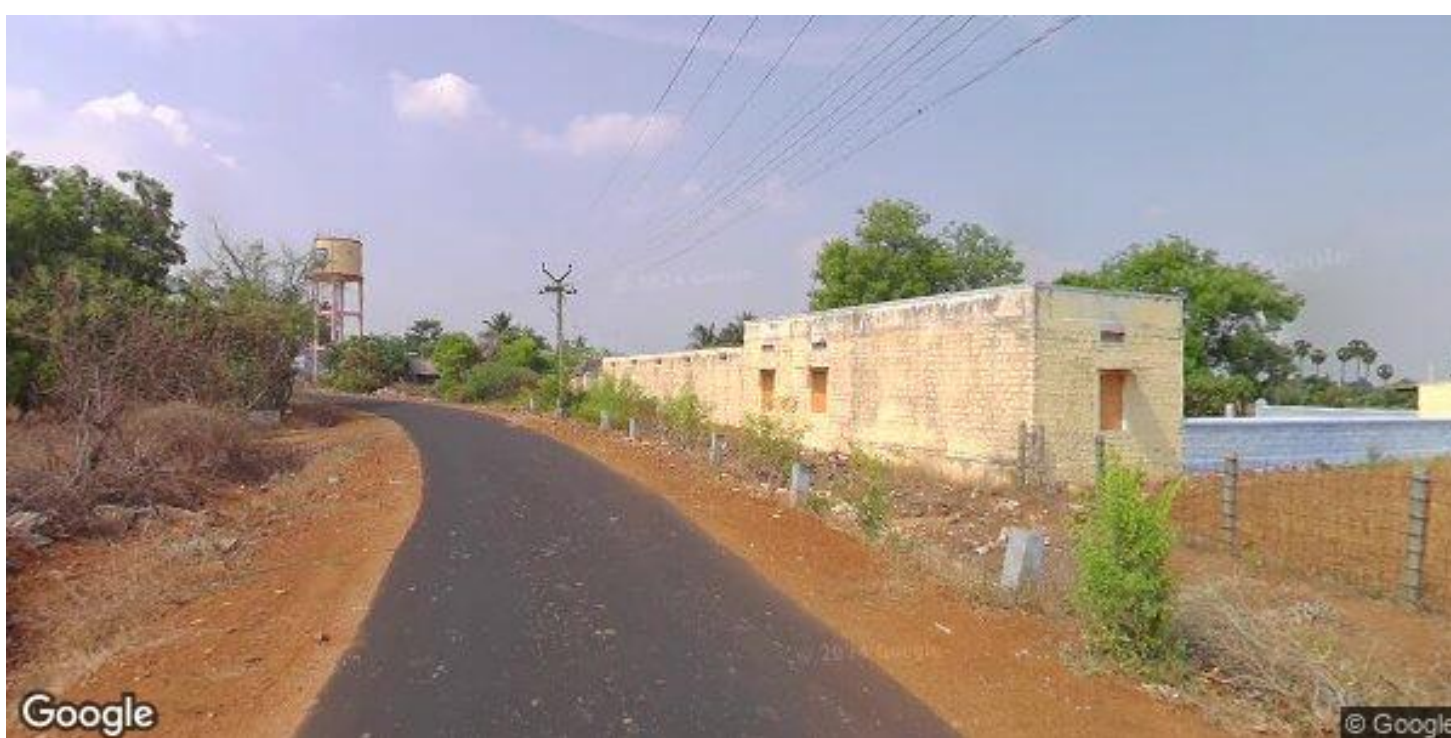
**Coordinates:** 11.28558, 77.74271

**Risk Type:** Turn

**Risk Level:** Medium

**Speed Limit:** 30 KM/Hr

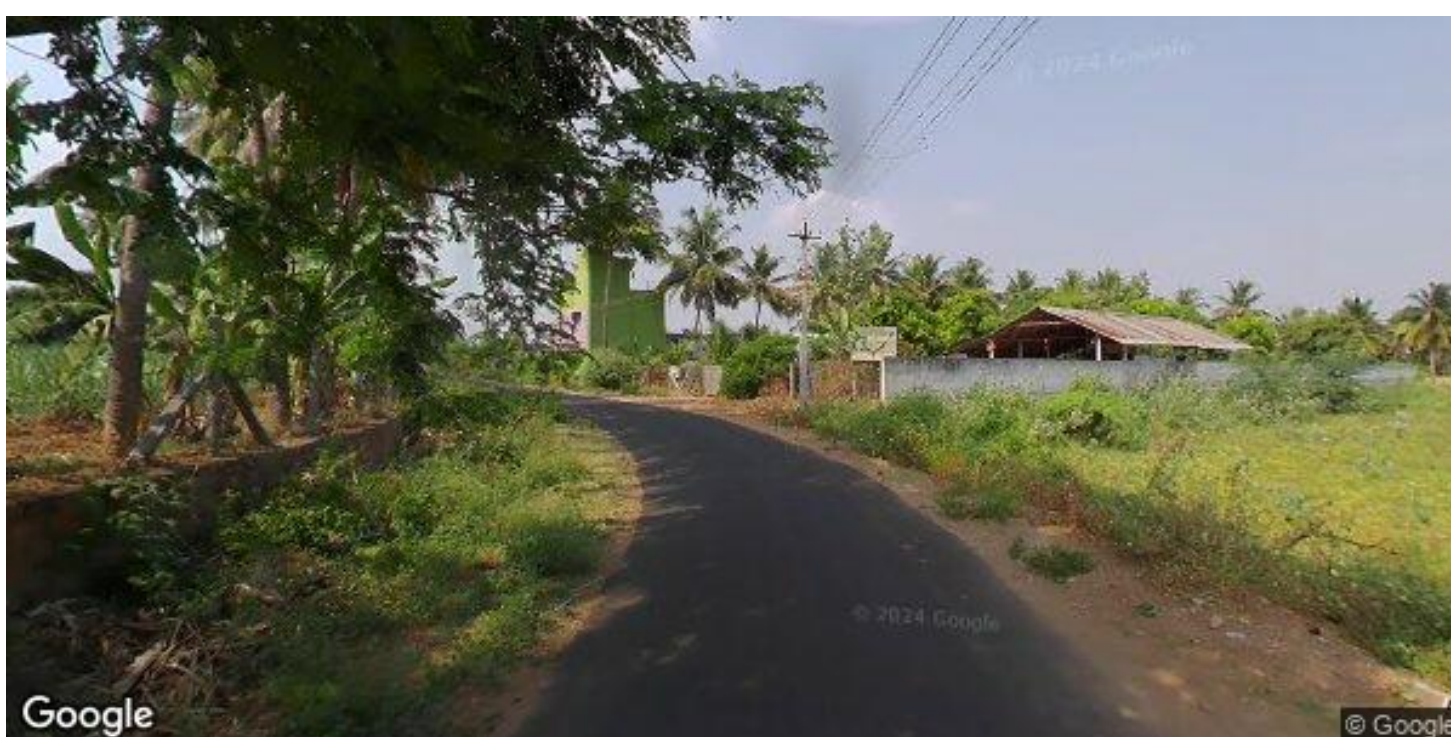
**Coordinates: 11.27326, 77.72991**

**Risk Type:** Turn

**Risk Level:** Medium

**Speed Limit: 30 KM/Hr**

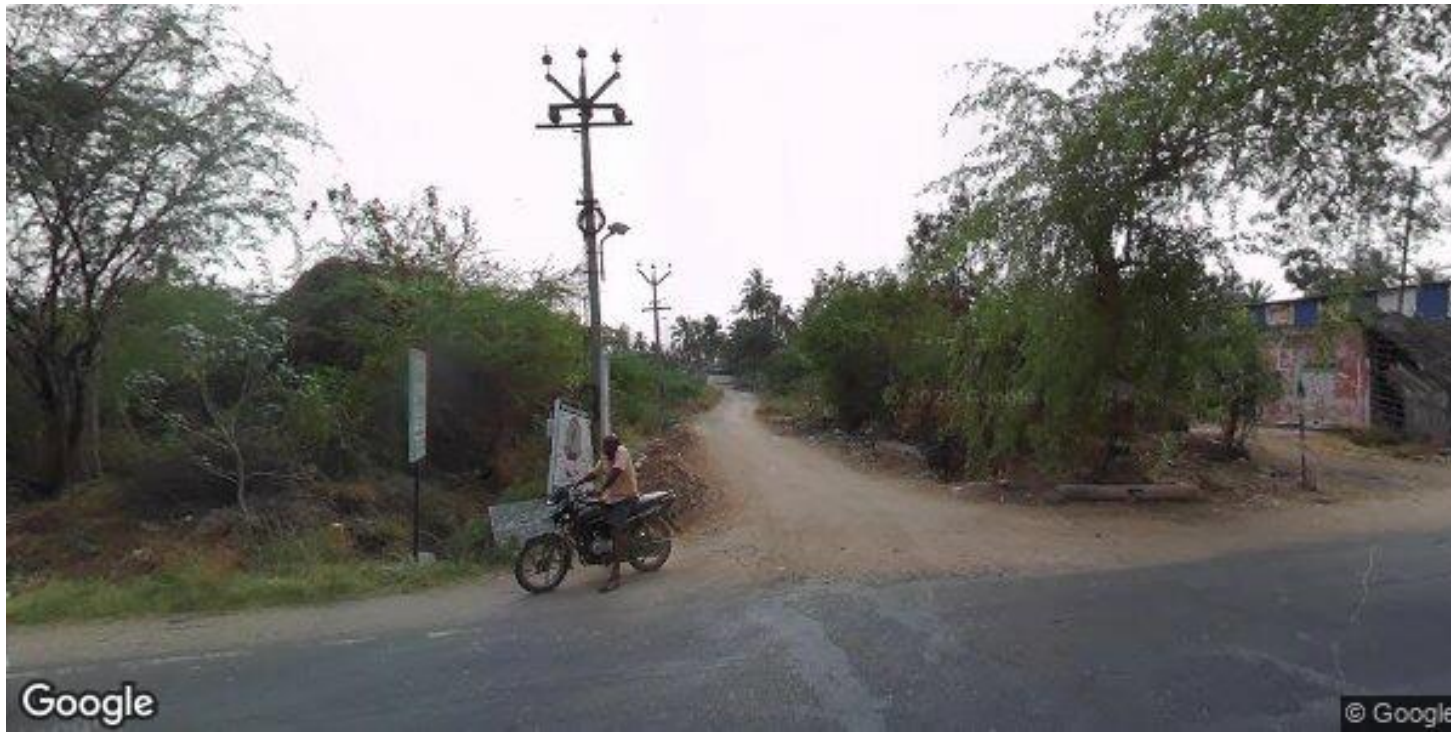
**Coordinates: 11.27330, 77.72711**

**Risk Type: Turn**

**Risk Level: High**

**Speed Limit: 15 KM/Hr**

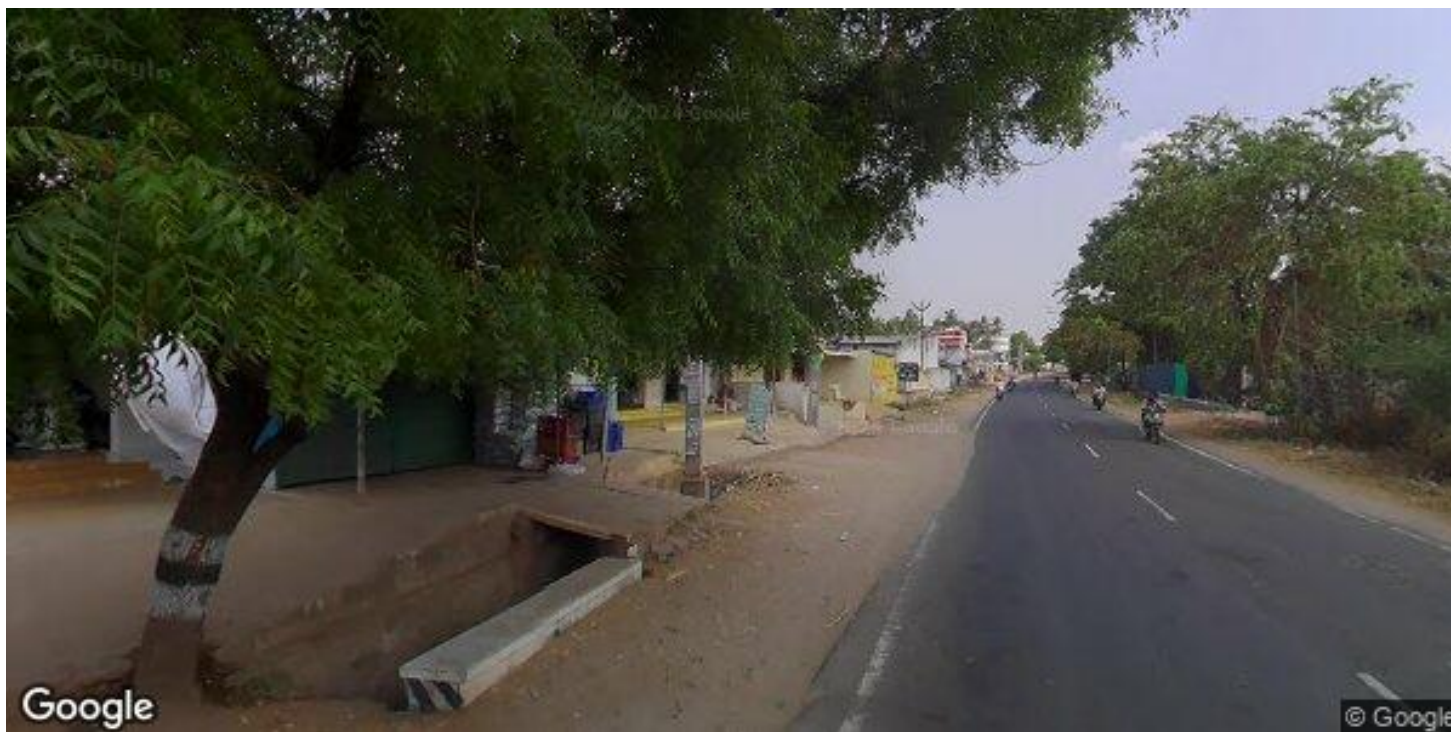
**Coordinates: 11.27322, 77.72706**

**Risk Type: Turn**

**Risk Level: Medium**

**Speed Limit: 30 KM/Hr**

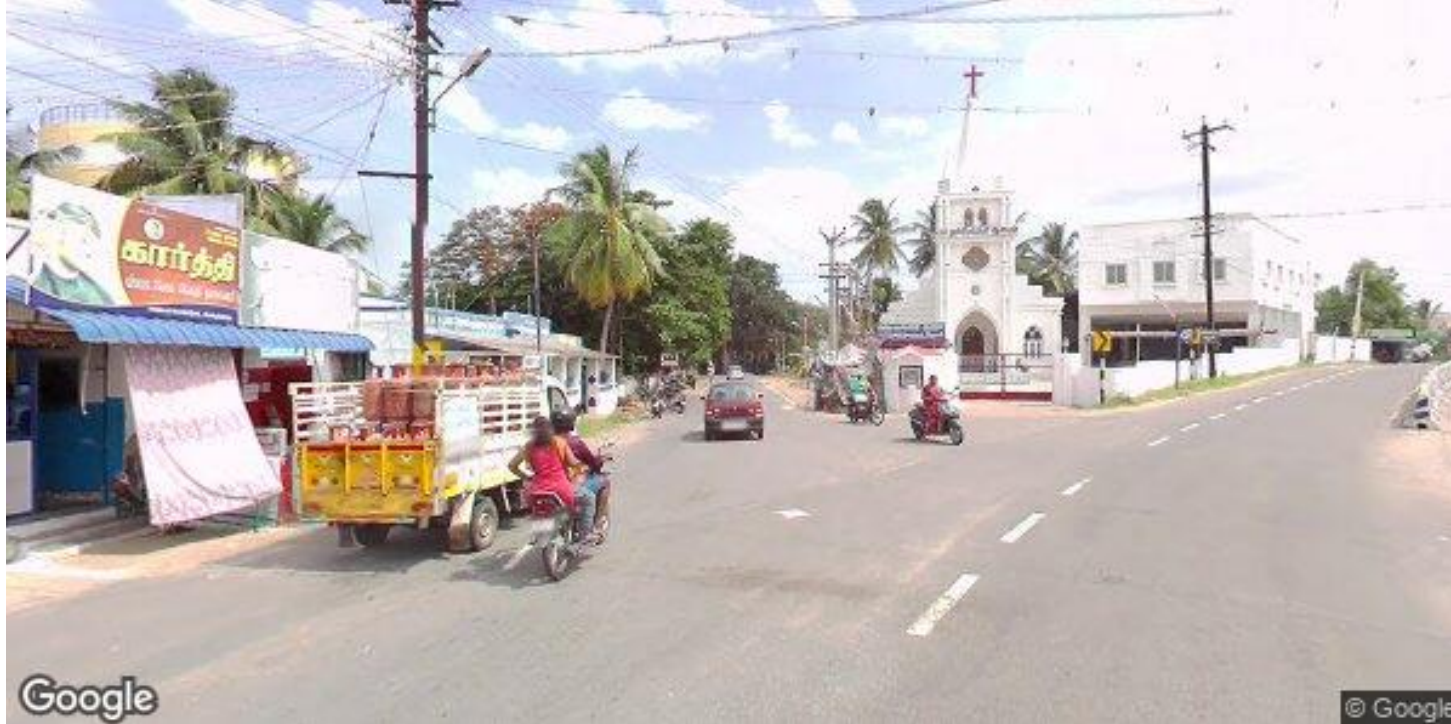
**Coordinates:** 11.23054, 77.71796

**Risk Type:** Turn

**Risk Level:** Medium

**Speed Limit:** 30 KM/Hr

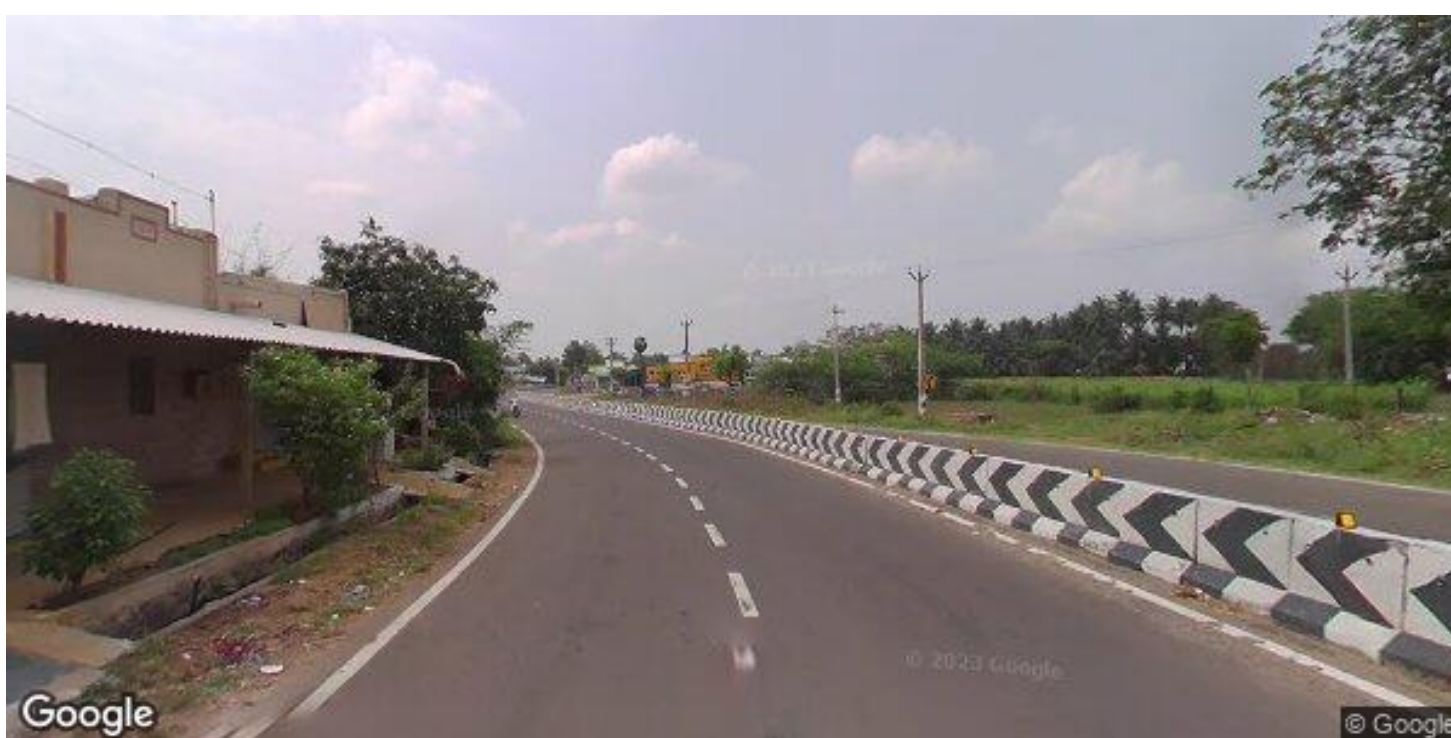
**Coordinates:** 11.22387, 77.71385

**Risk Type:** Turn

**Risk Level:** Medium

**Speed Limit:** 30 KM/Hr

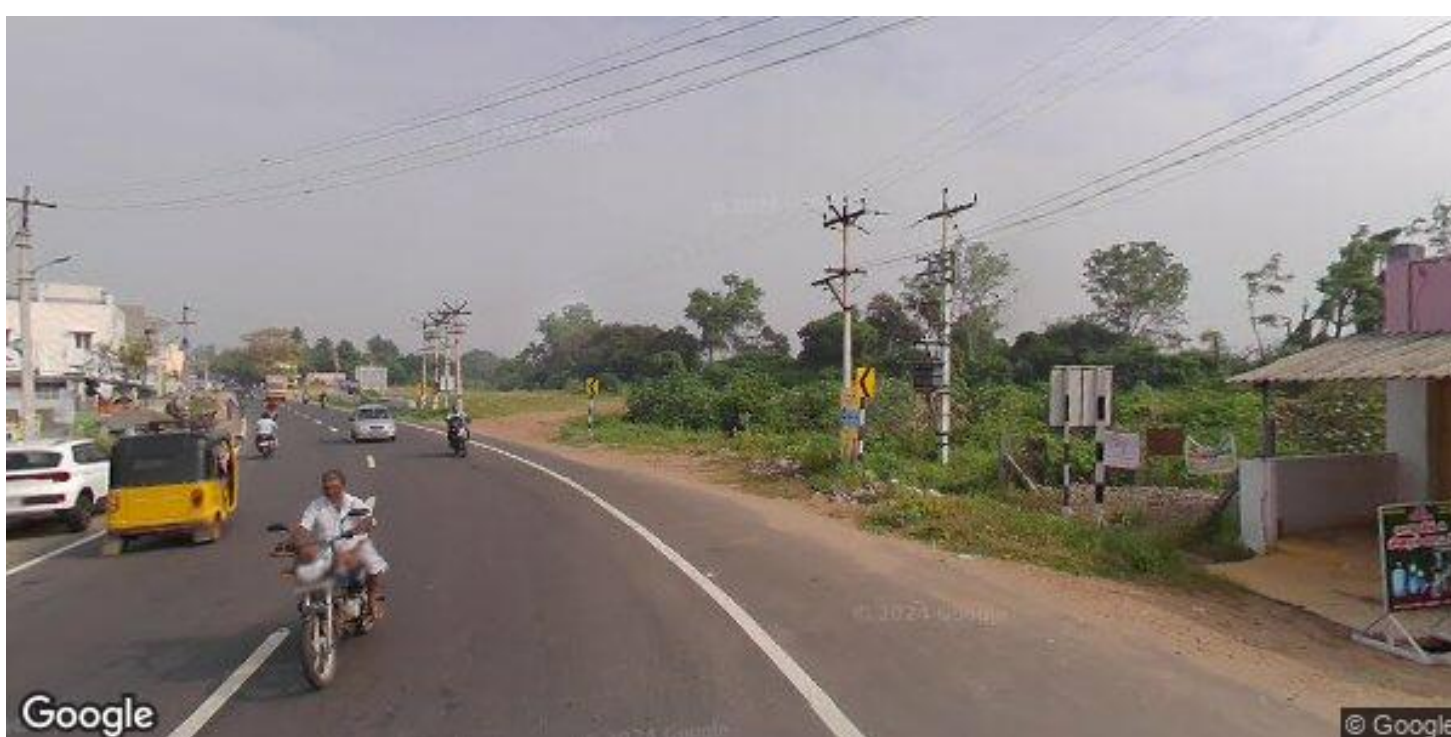
Coordinates: 11.16078, 77.70122

**Risk Type:** Turn

**Risk Level:** Medium

Speed Limit: 30 KM/Hr

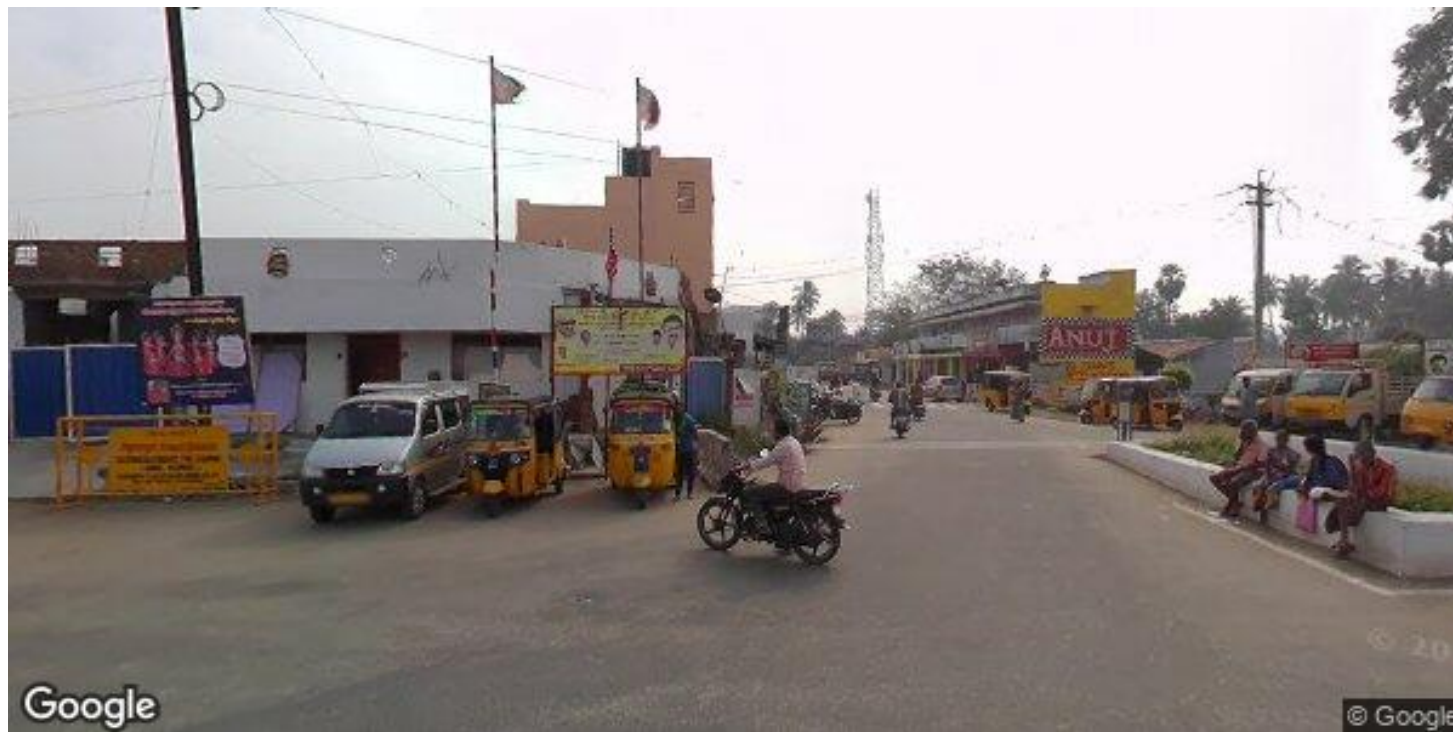
Coordinates: 11.15953, 77.70067

Risk Type: Turn

Risk Level: Medium

Speed Limit: 30 KM/Hr

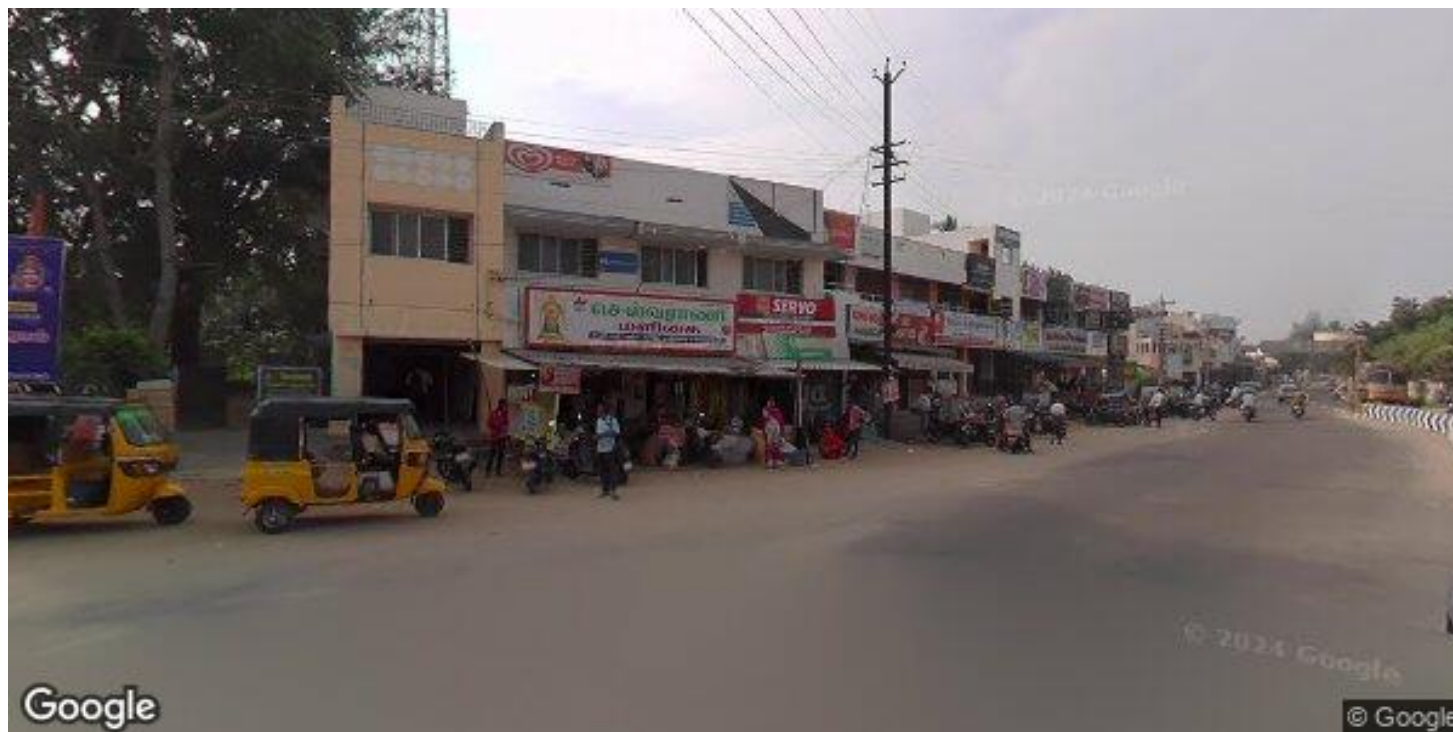
Coordinates: 11.15944, 77.70068

Risk Type: Turn

Risk Level: High

Speed Limit: 15 KM/Hr
