## **JOURNEY RISK MANAGEMENT (JRM) STUDY**

### **Salem Terminal To SHREE CHANDIKA AGENCIES**

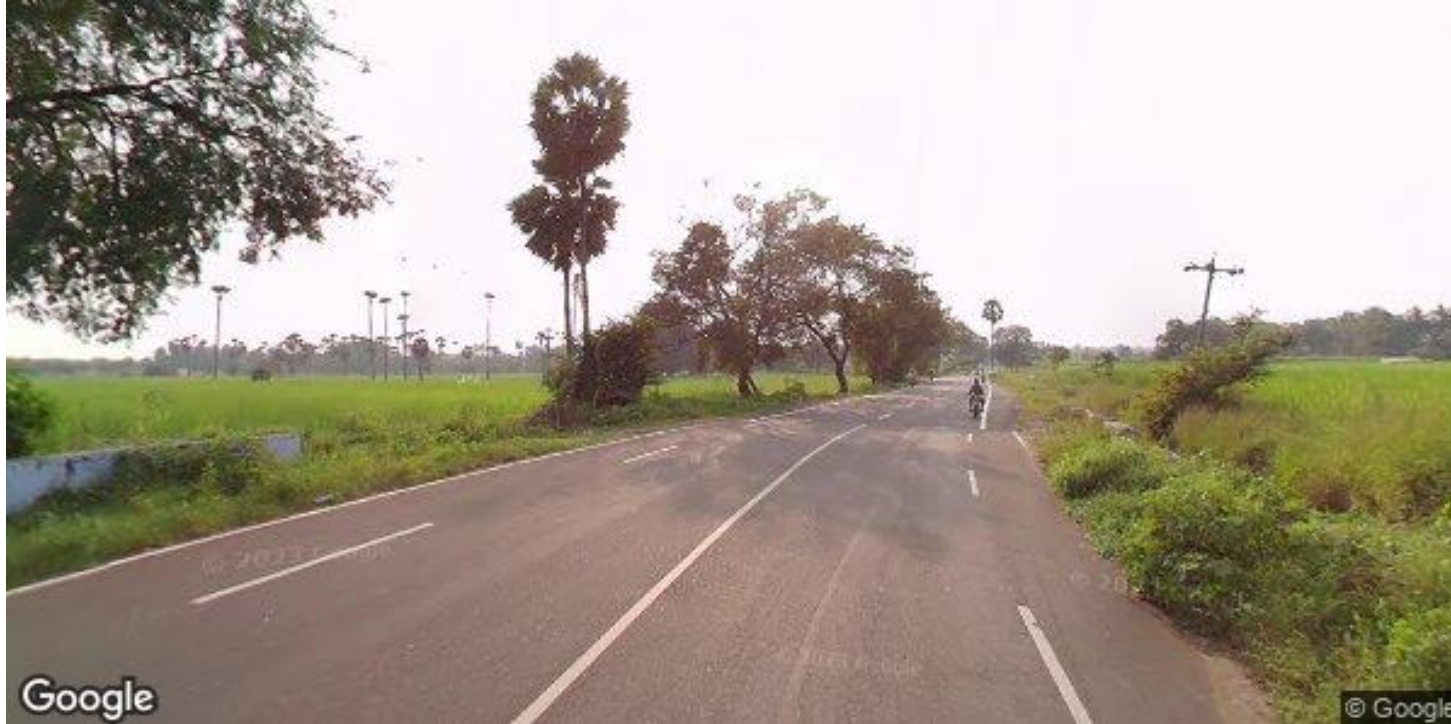
**Coordinates:** 11.11918, 77.67766

**Risk Type:** Turn

**Risk Level:** Medium

**Speed Limit:** 30 KM/Hr

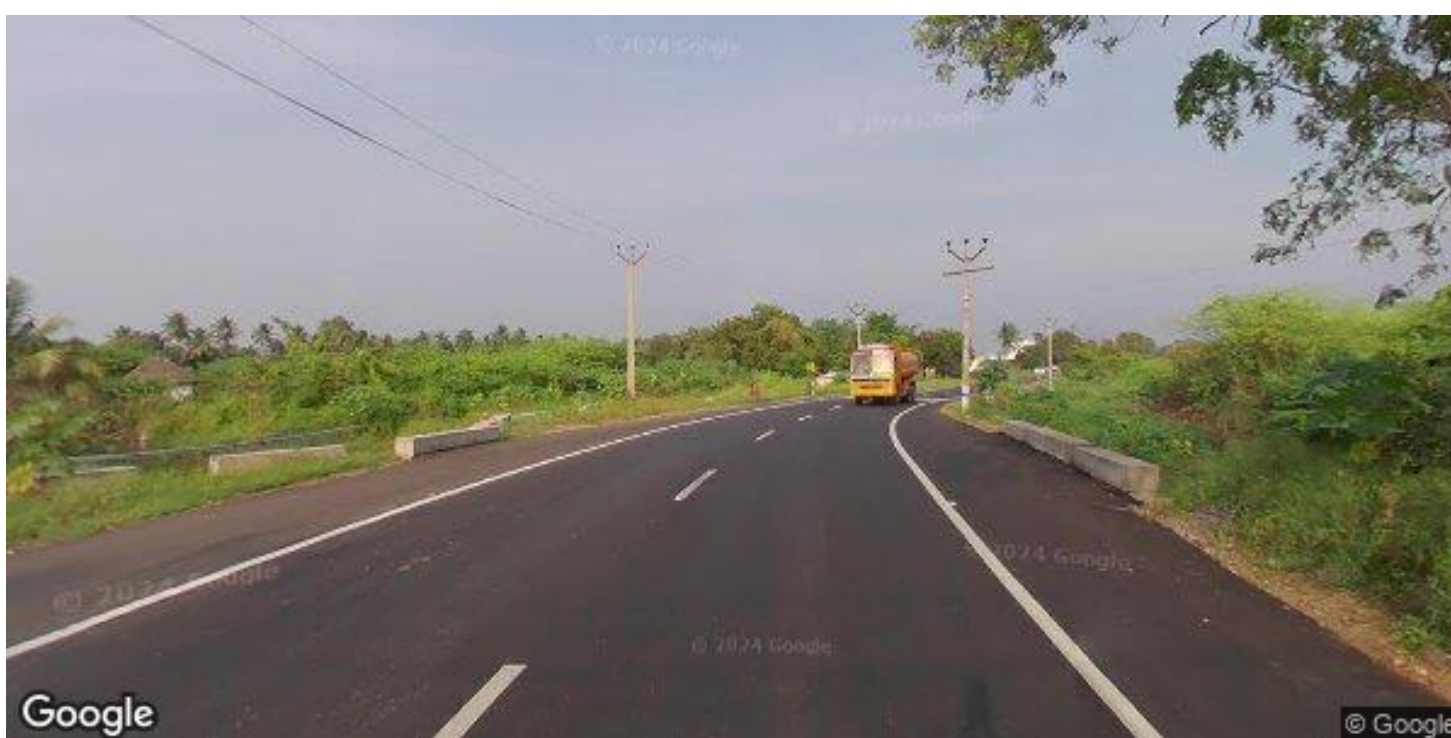
**Coordinates:** 11.11740, 77.67198

**Risk Type:** Turn

**Risk Level:** Medium

**Speed Limit:** 30 KM/Hr

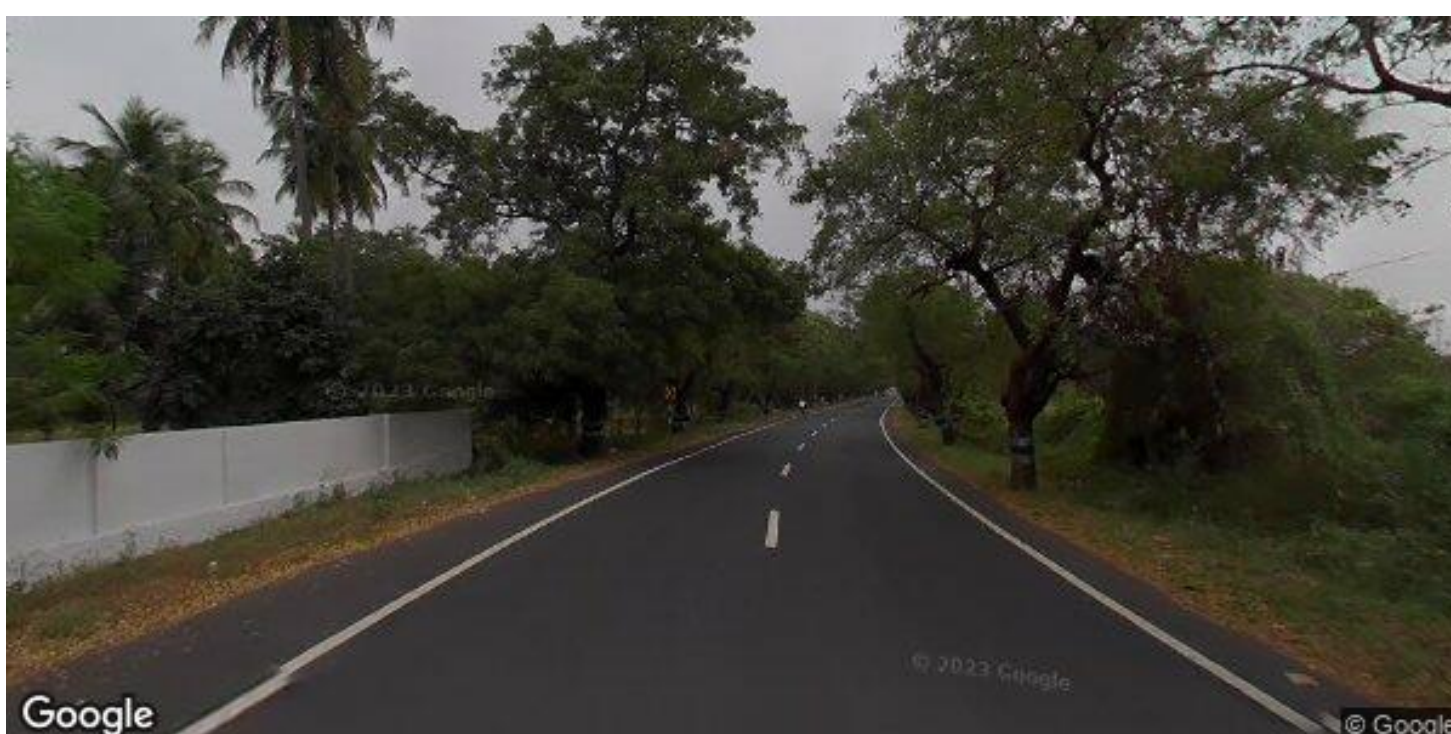
**Coordinates: 11.10481, 77.67060**

**Risk Type:** Turn

**Risk Level:** Medium

**Speed Limit: 30 KM/Hr**

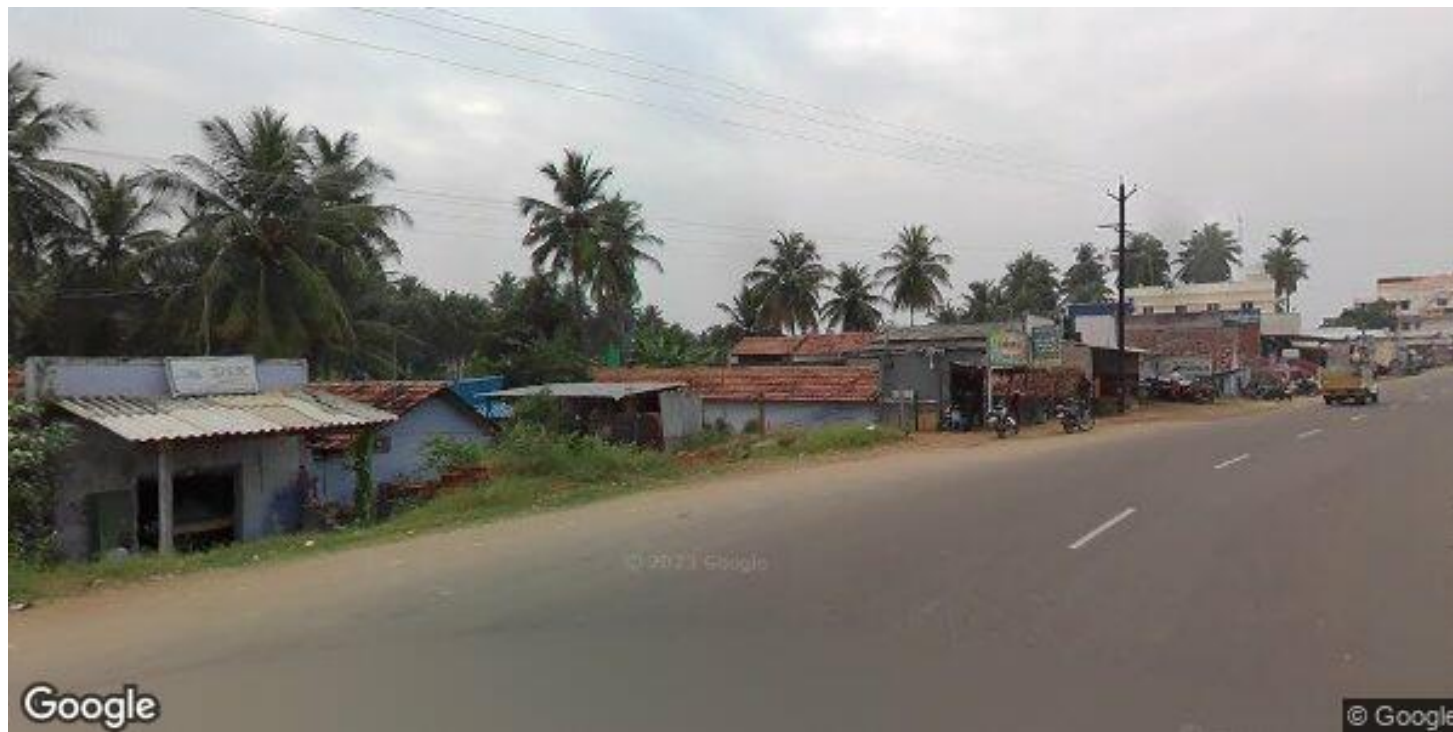
**Coordinates: 11.08730, 77.66436**

**Risk Type: Turn**

**Risk Level: Medium**

**Speed Limit: 30 KM/Hr**

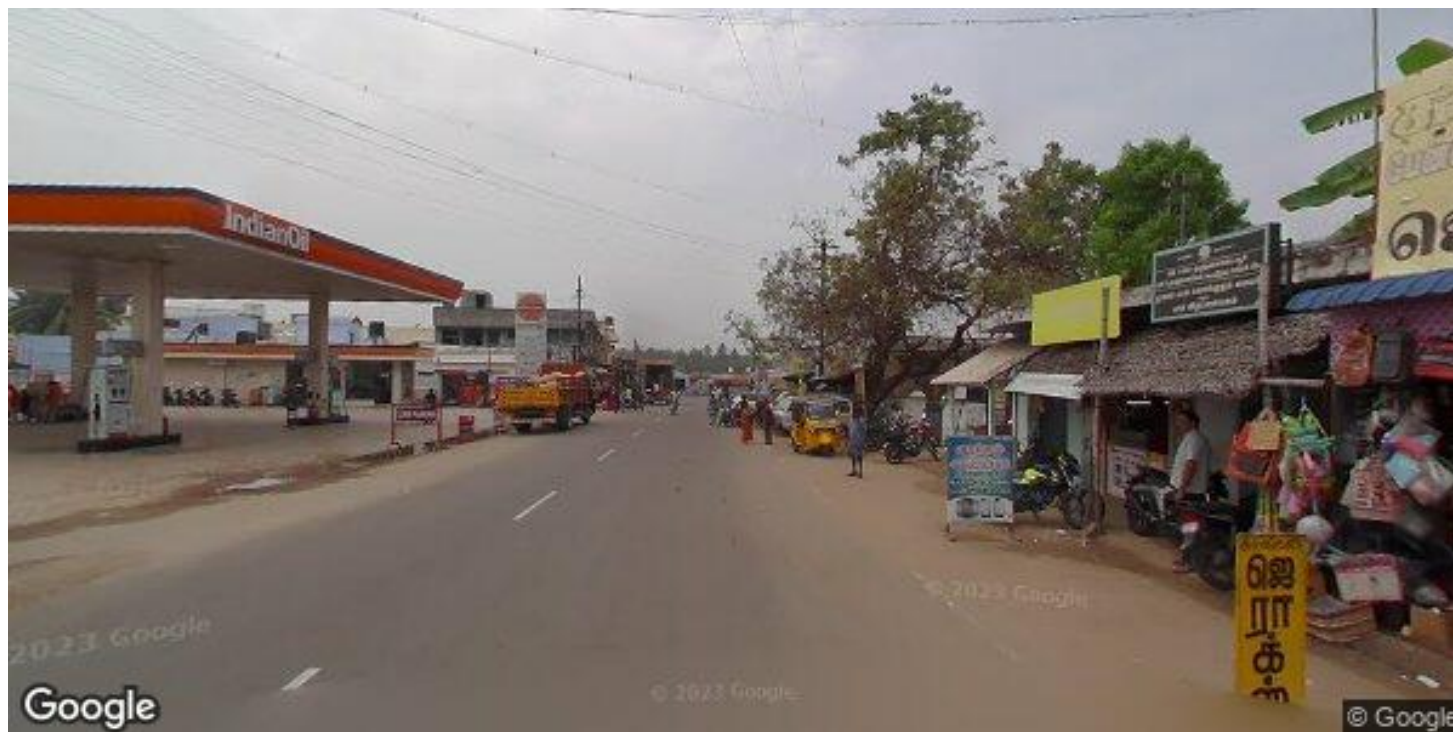
**Coordinates: 11.08565, 77.66268**

**Risk Type: Blind Spot**

**Risk Level: Blind Spot**

**Speed Limit: 10 KM/Hr**
