# IndianOil

## JOURNEY RISK MANAGEMENT (JRM) STUDY

### Salem Terminal TO LAKSHMI AGENCIES

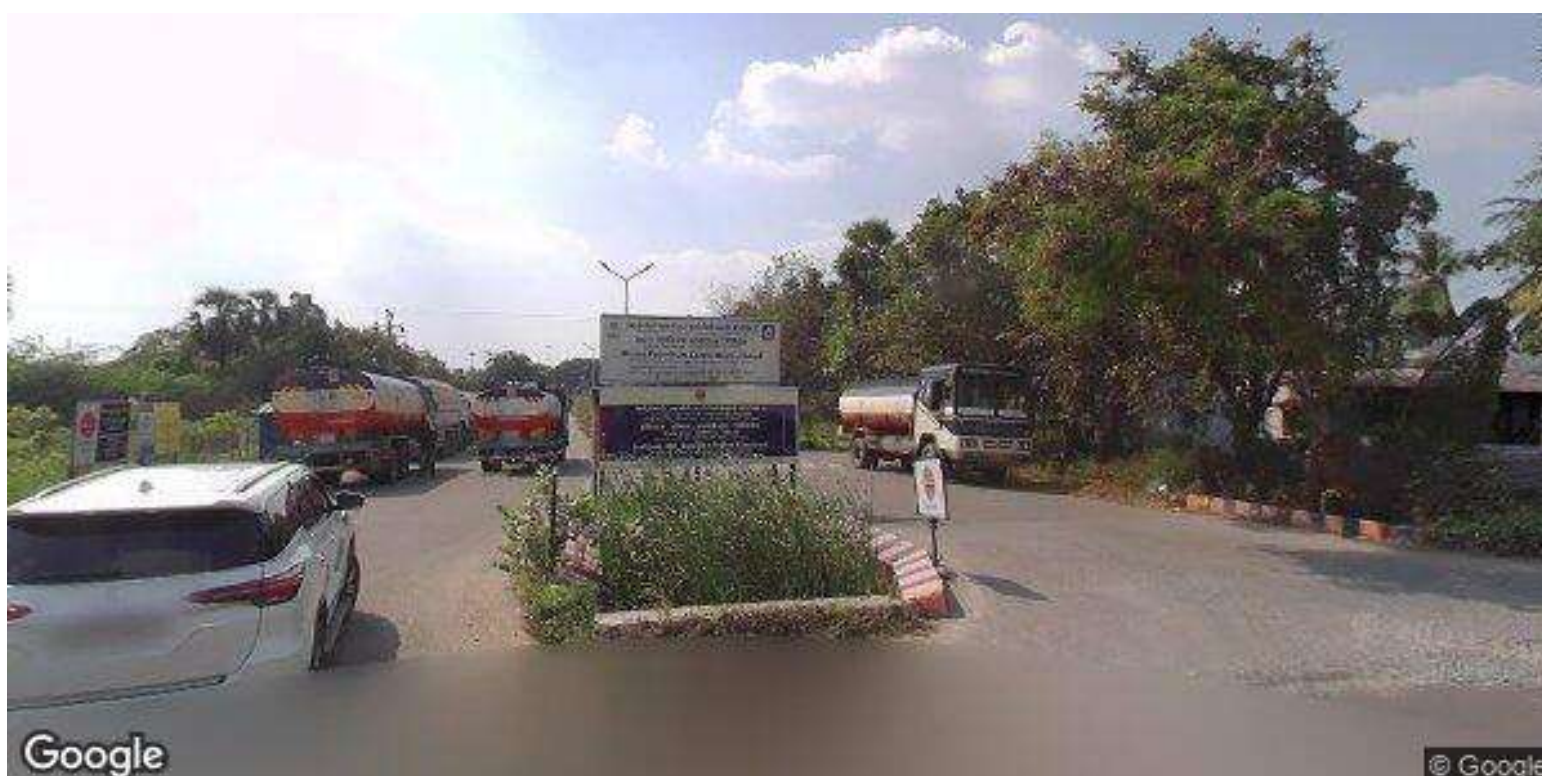
**Coordinates:** 11.44024, 77.87528

**Risk Type:** Turn

**Risk Level:** High

**Speed Limit:** 15 KM/Hr

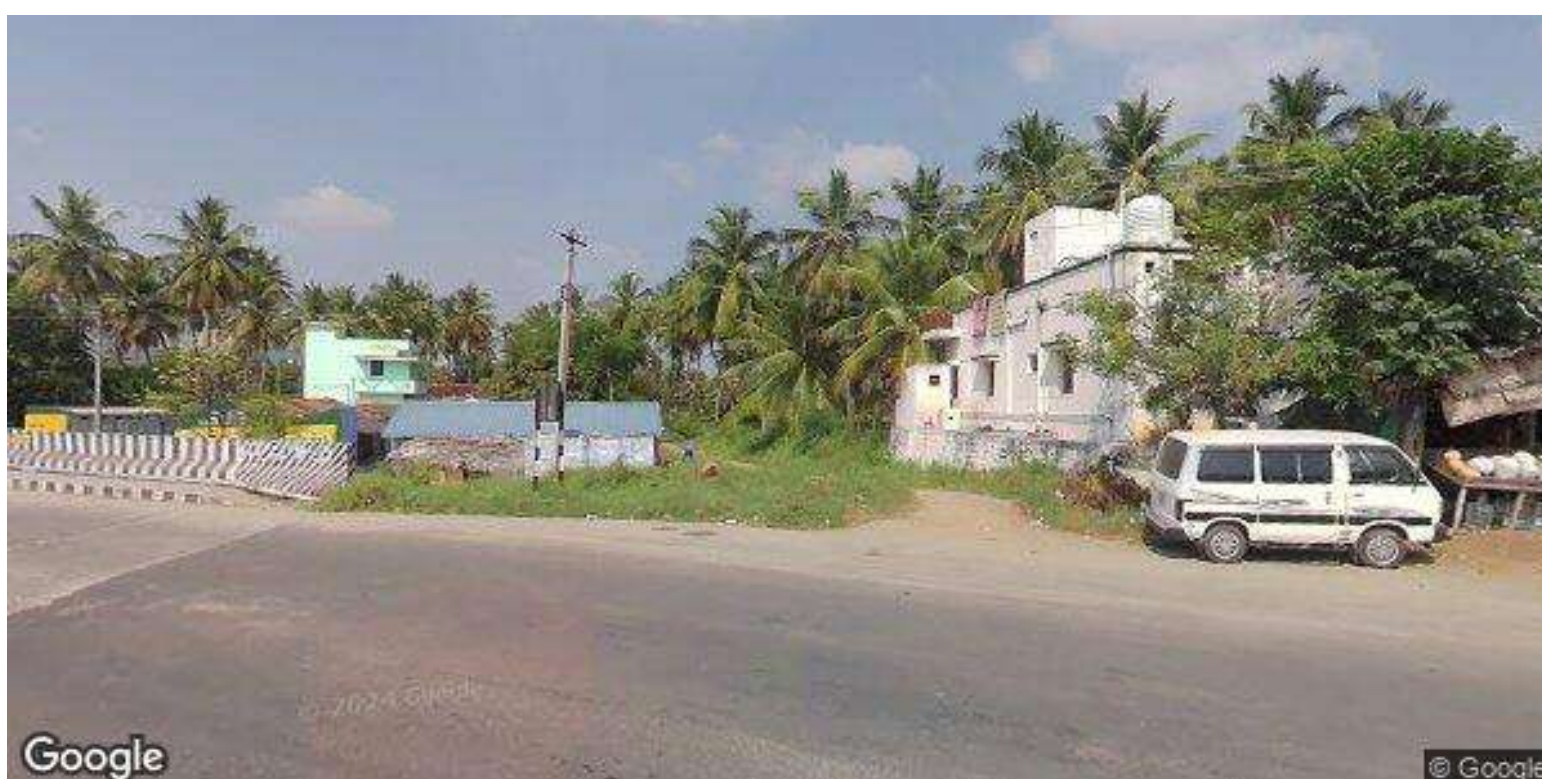
**Coordinates:** 11.44898, 77.87410

**Risk Type:** Turn

**Risk Level:** High

**Speed Limit:** 15 KM/Hr

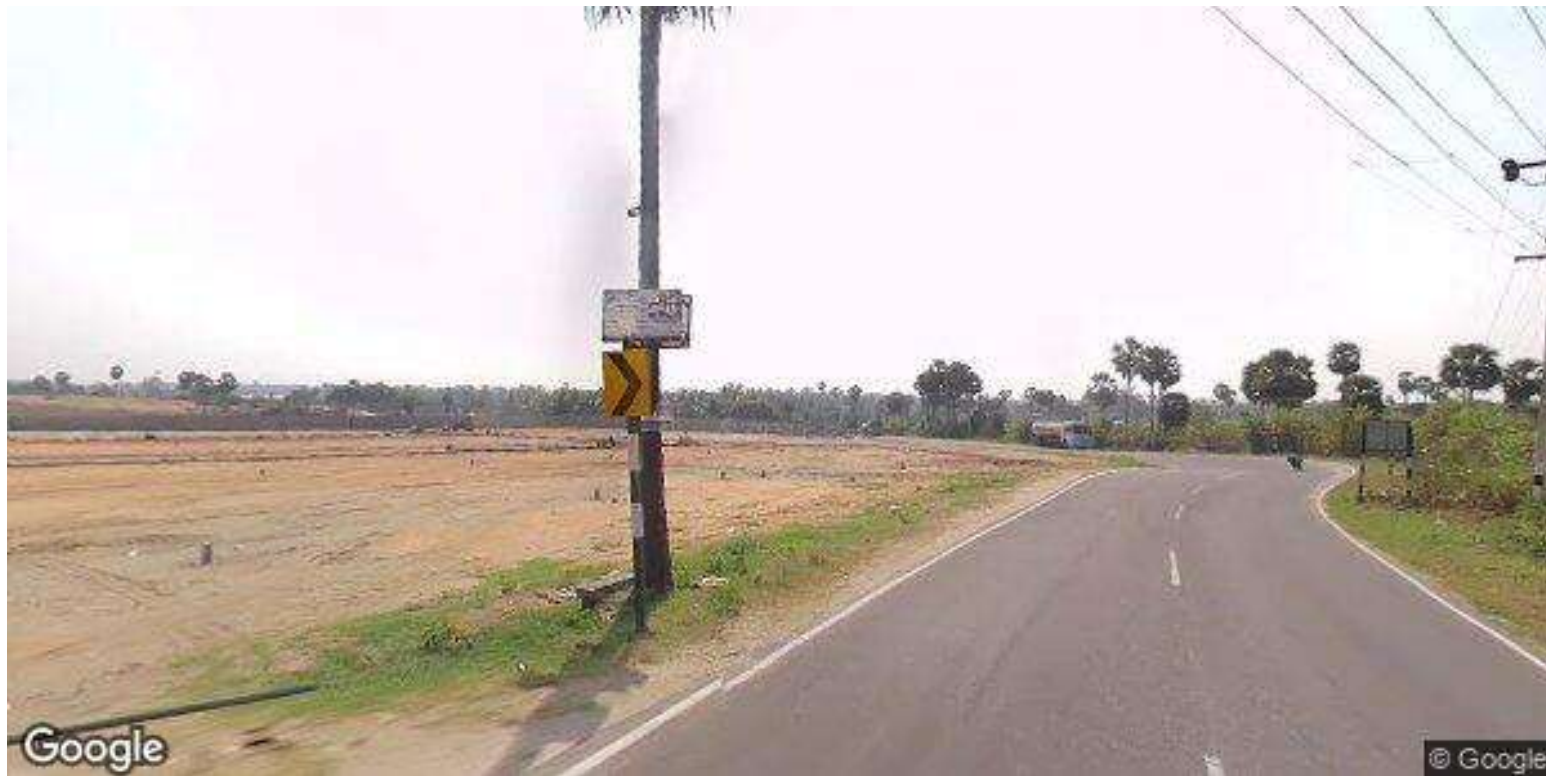
**Coordinates: 11.45898, 77.85135**

**Risk Type: Turn**

**Risk Level: Medium**

**Speed Limit: 30 KM/Hr**

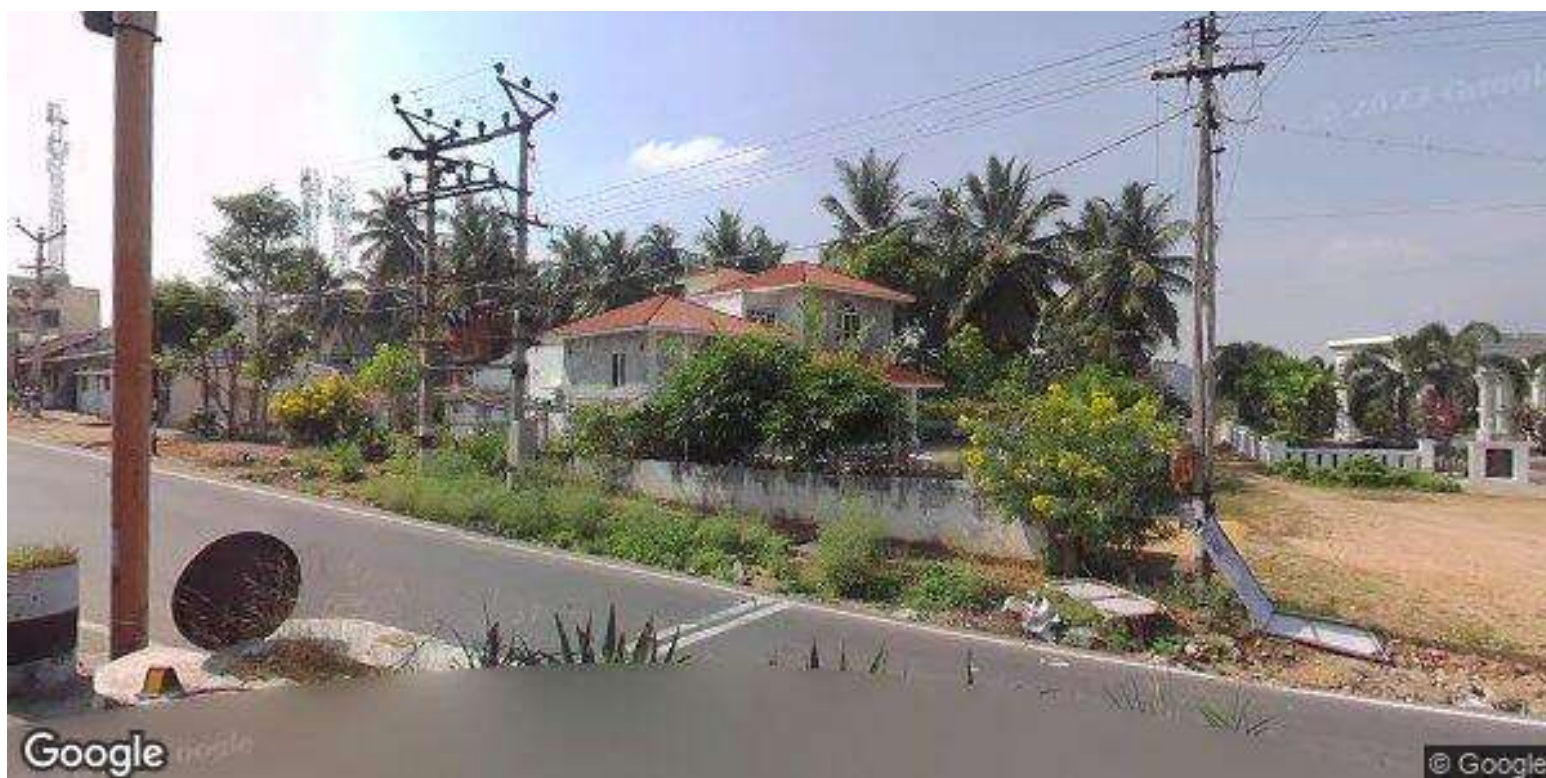
**Coordinates: 11.46303, 77.84945**

**Risk Type: Turn**

**Risk Level: High**

**Speed Limit: 15 KM/Hr**

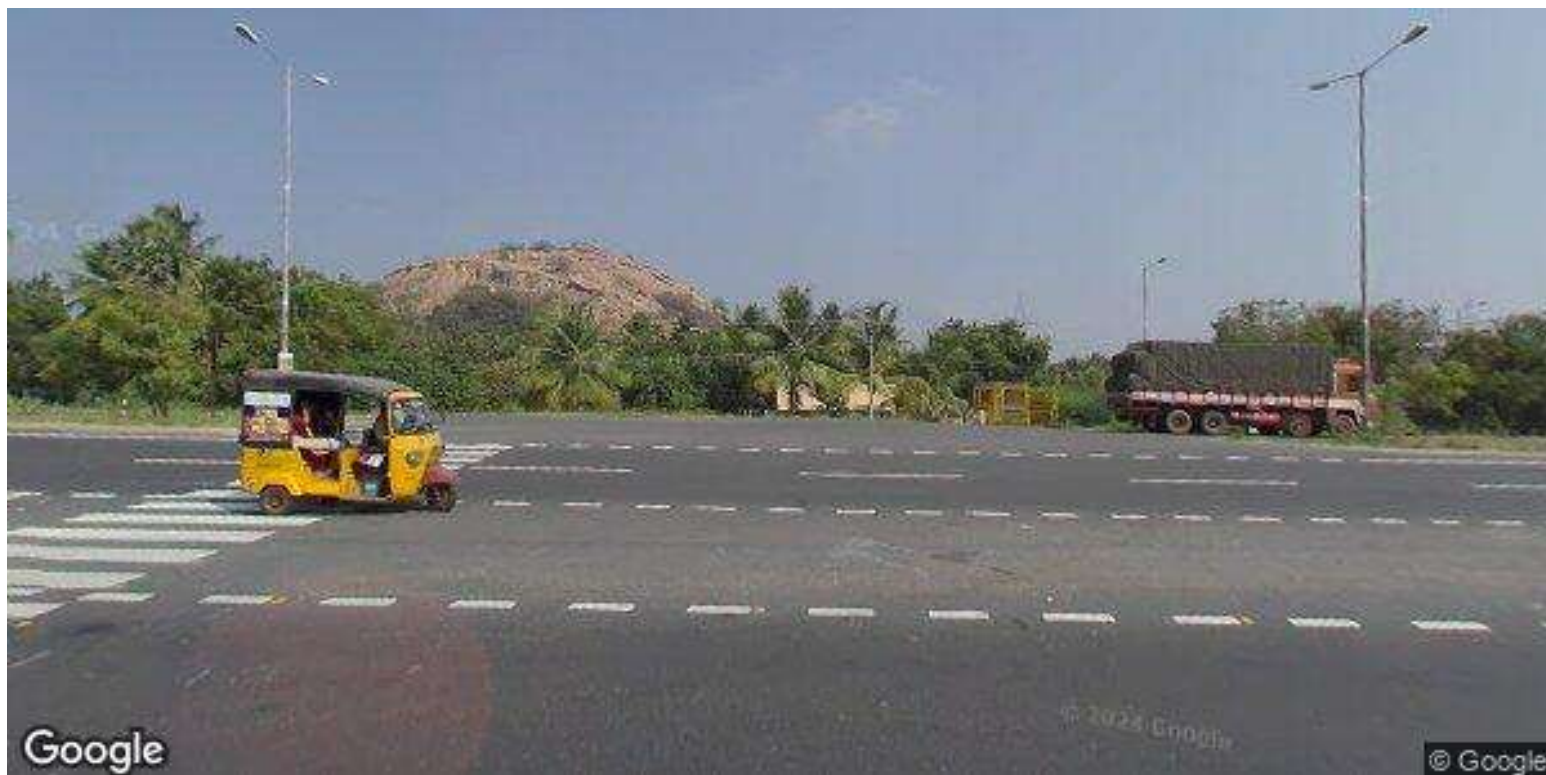
**Coordinates:** 11.45085, 77.77020

**Risk Type:** Turn

**Risk Level:** Medium

**Speed Limit:** 30 KM/Hr

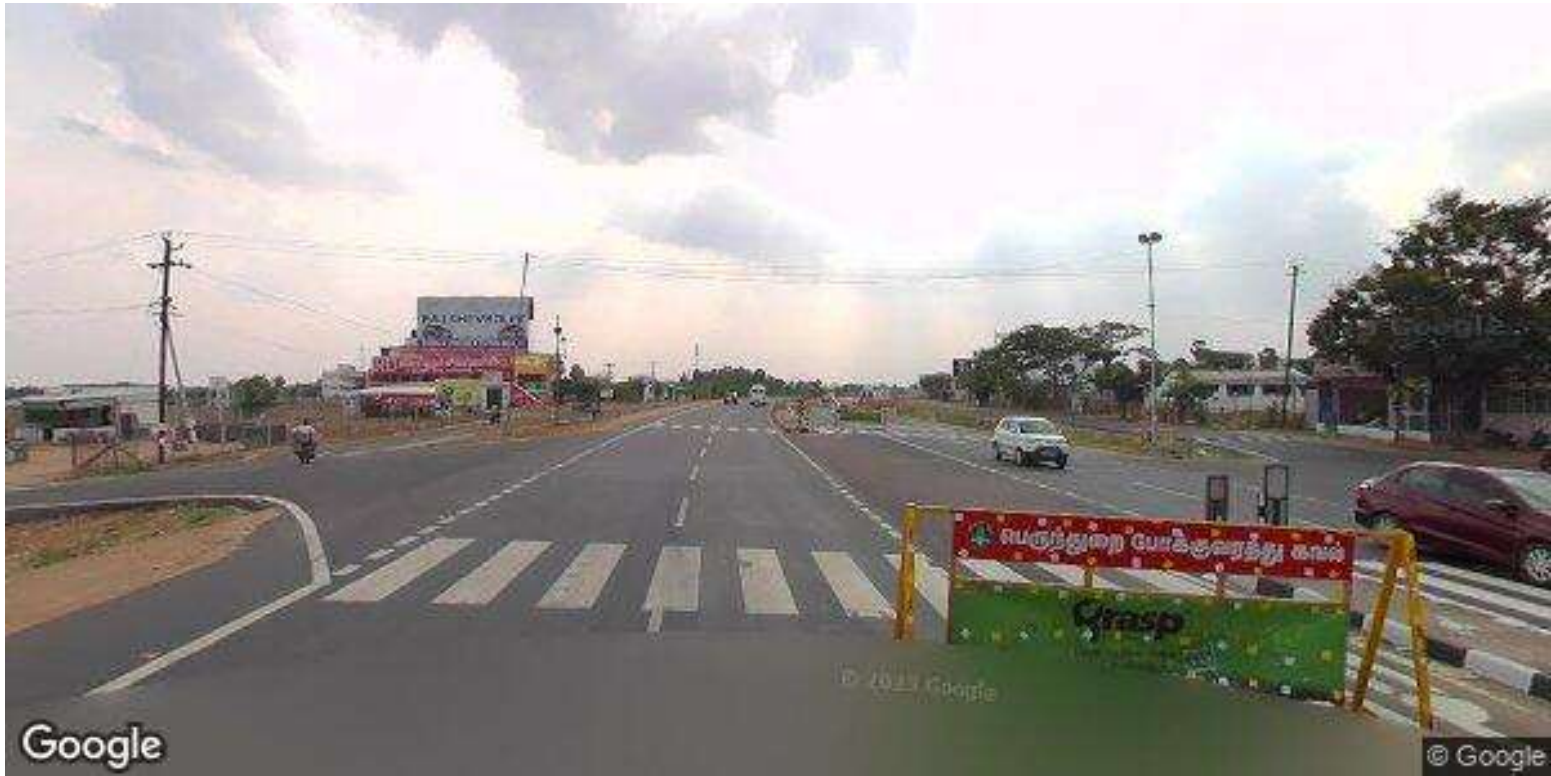
**Risk Type:** Turn  
**Risk Level:** Medium  
**Speed Limit:** 30 KM/Hr  
**Coordinates:** 11.23724, 77.50686

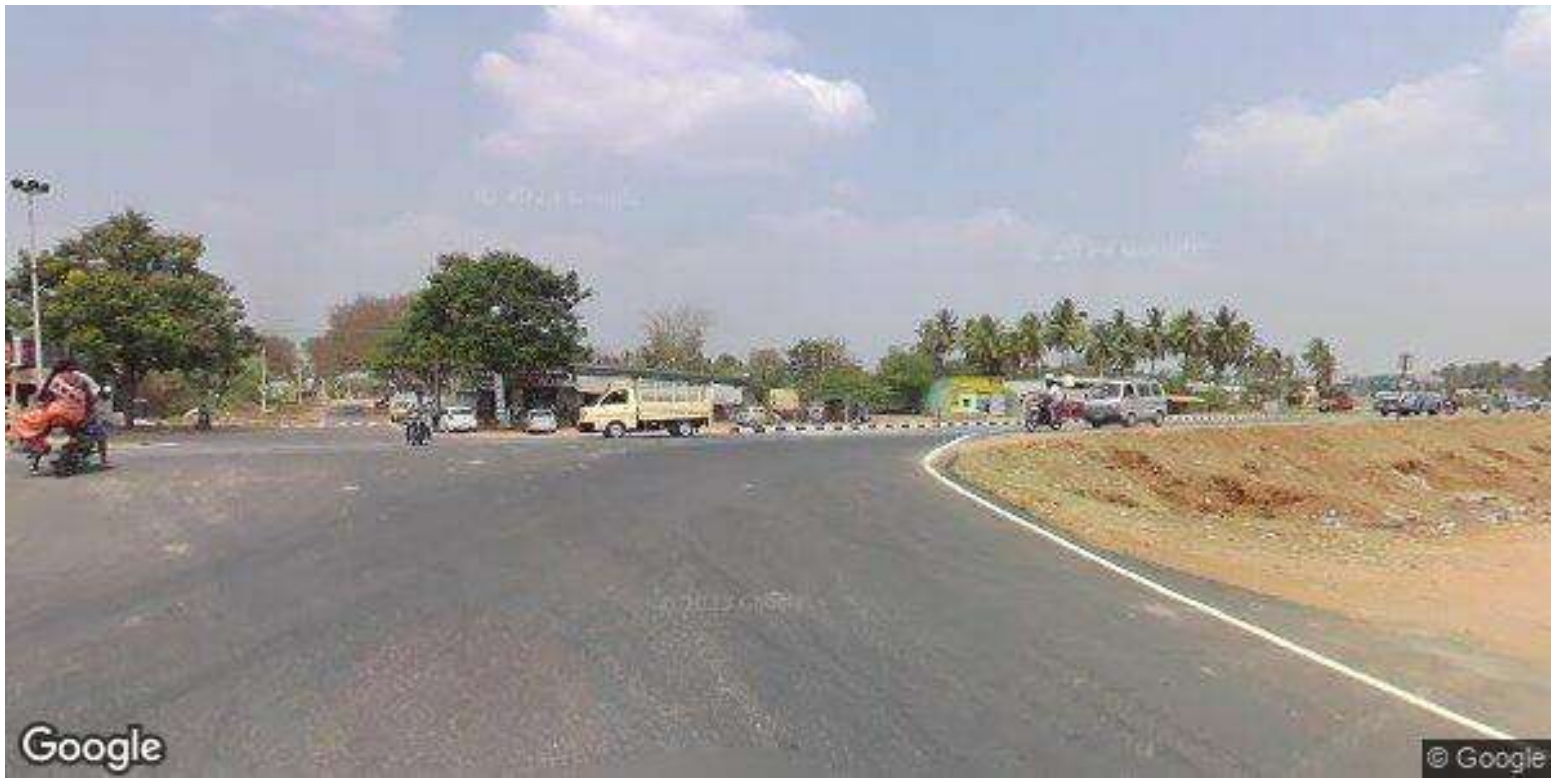
**Risk Type:** Turn  
**Risk Level:** High  
**Speed Limit:** 15 KM/Hr  
**Coordinates:** 11.23704, 77.50676

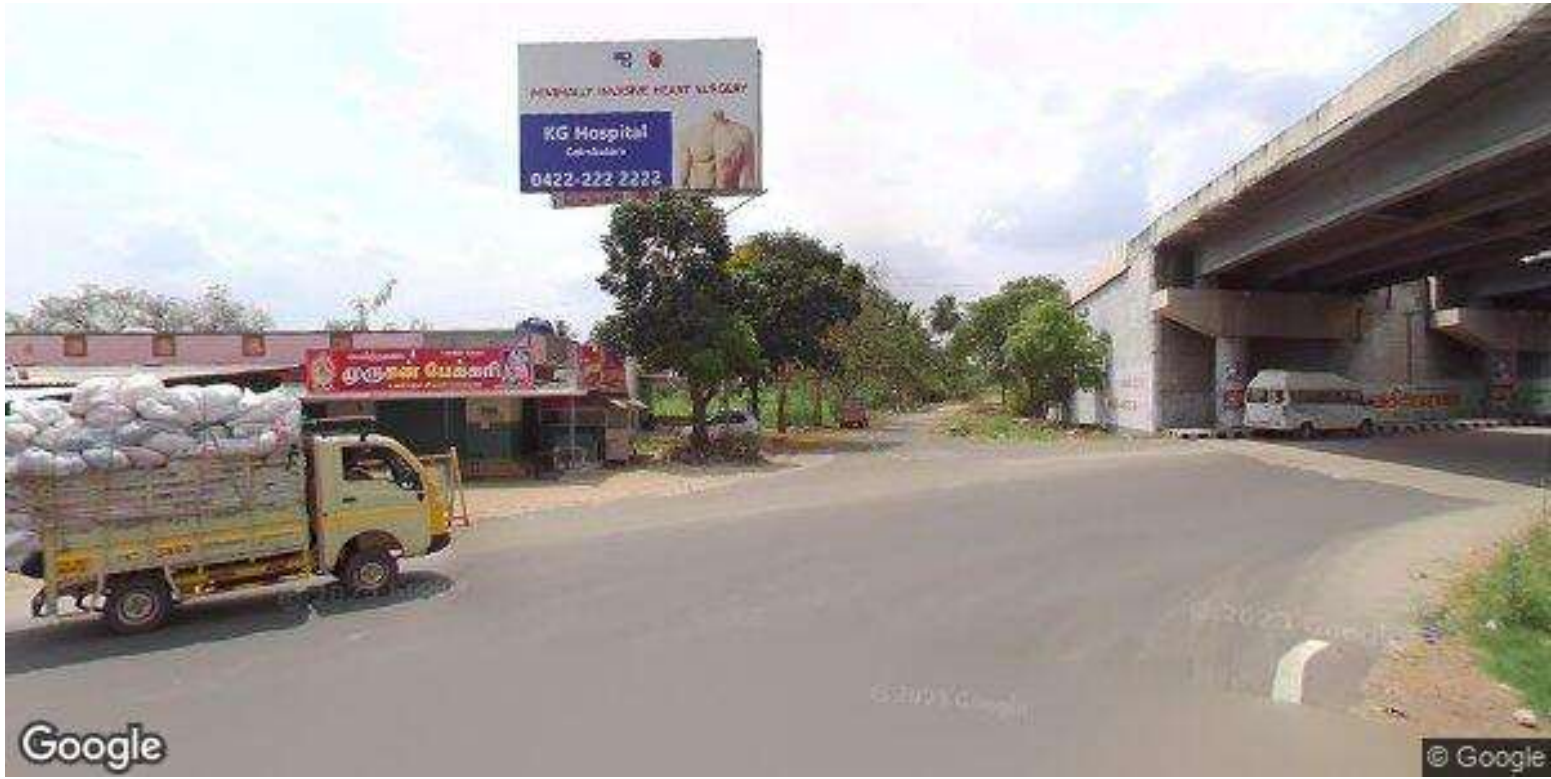
**Risk Type:** Blind Spot  
**Risk Level:** Blind Spot  
**Speed Limit:** 10 KM/Hr  
**Coordinates:** 11.23686, 77.50216

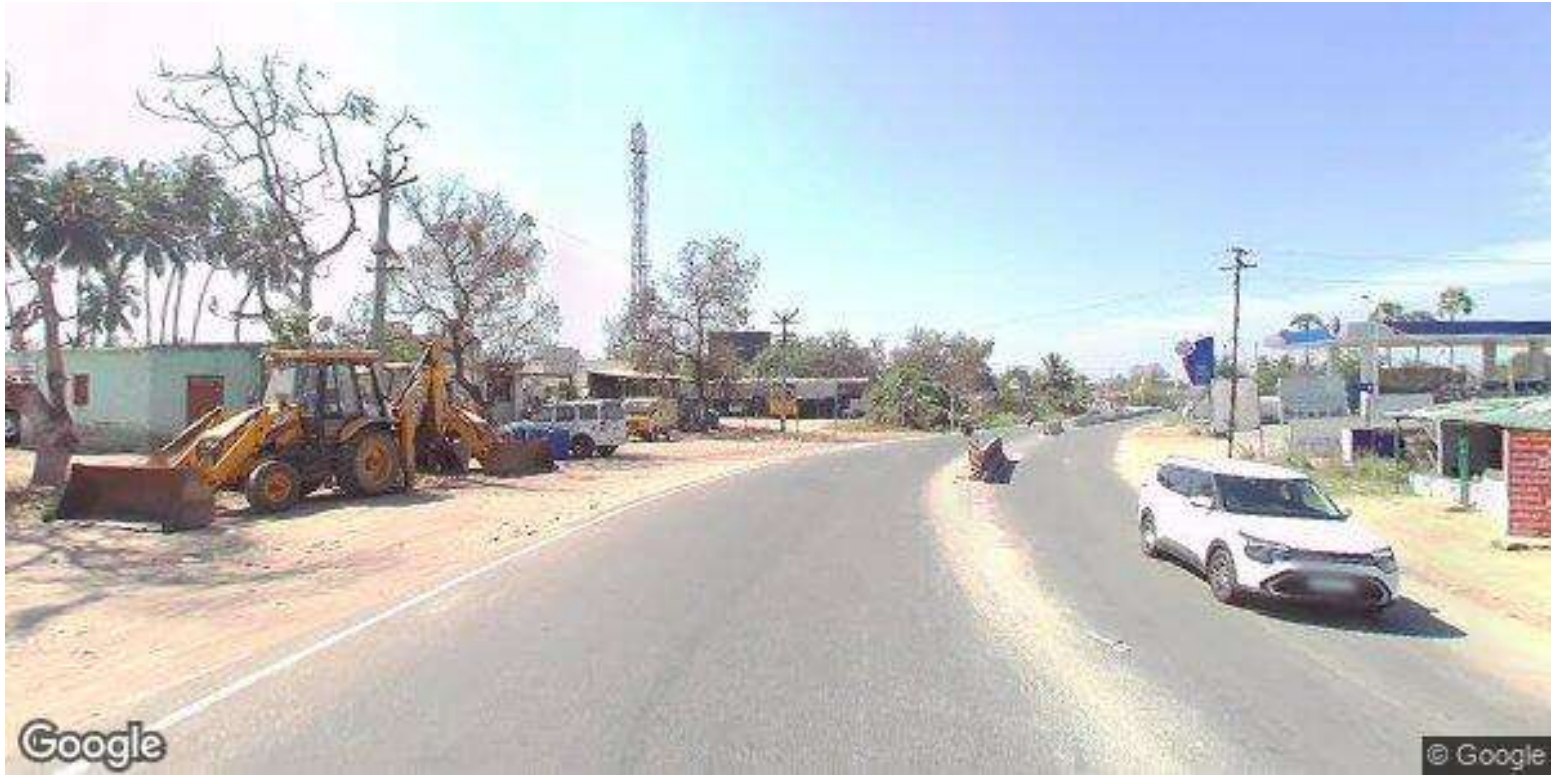
**Risk Type:** Turn  
**Risk Level:** Medium  
**Speed Limit:** 30 KM/Hr  
**Coordinates:** 11.23649, 77.50219

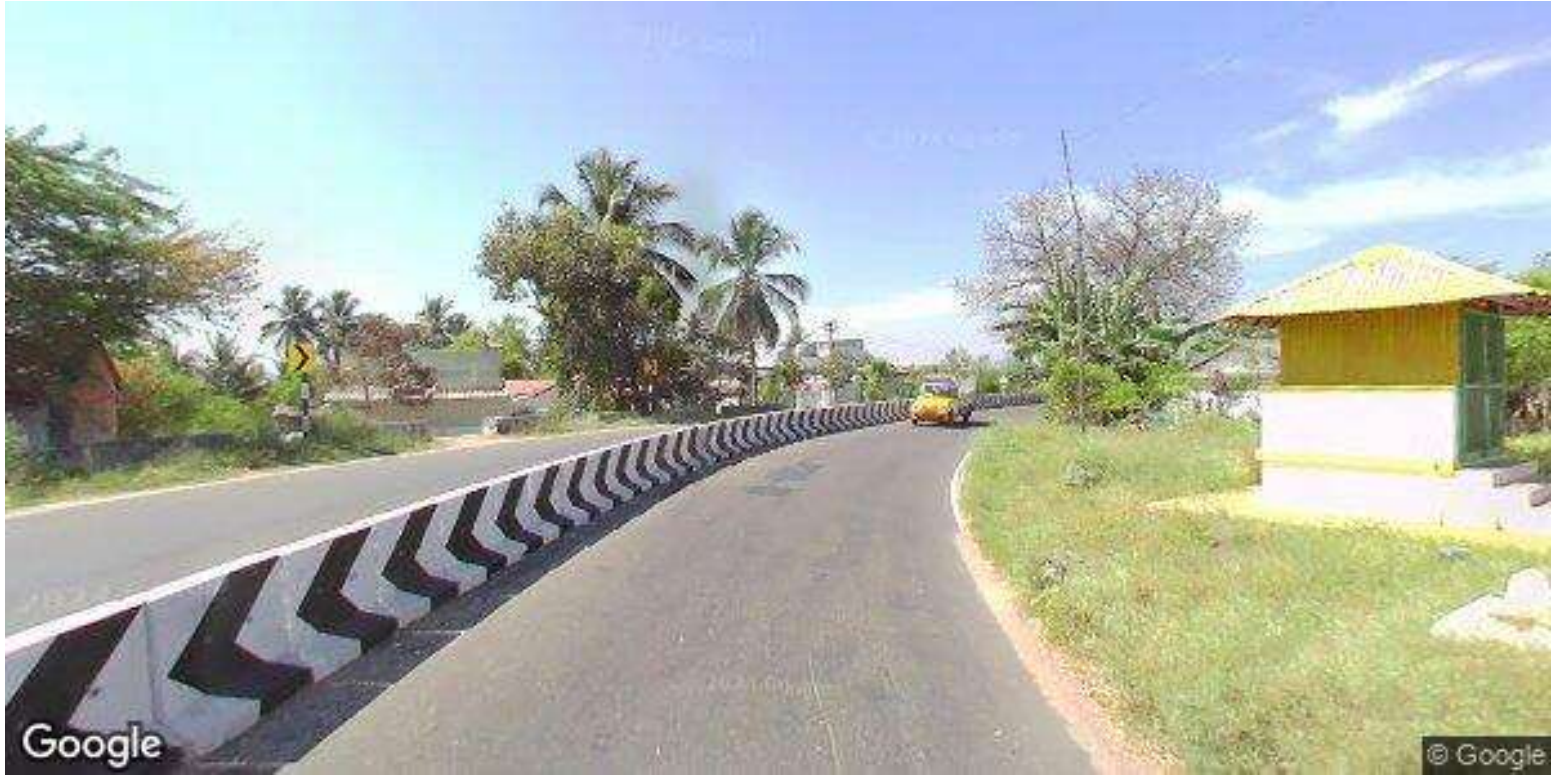
**Risk Type:** Turn  
**Risk Level:** High  
**Speed Limit:** 15 KM/Hr  
**Coordinates:** 11.23396, 77.50105

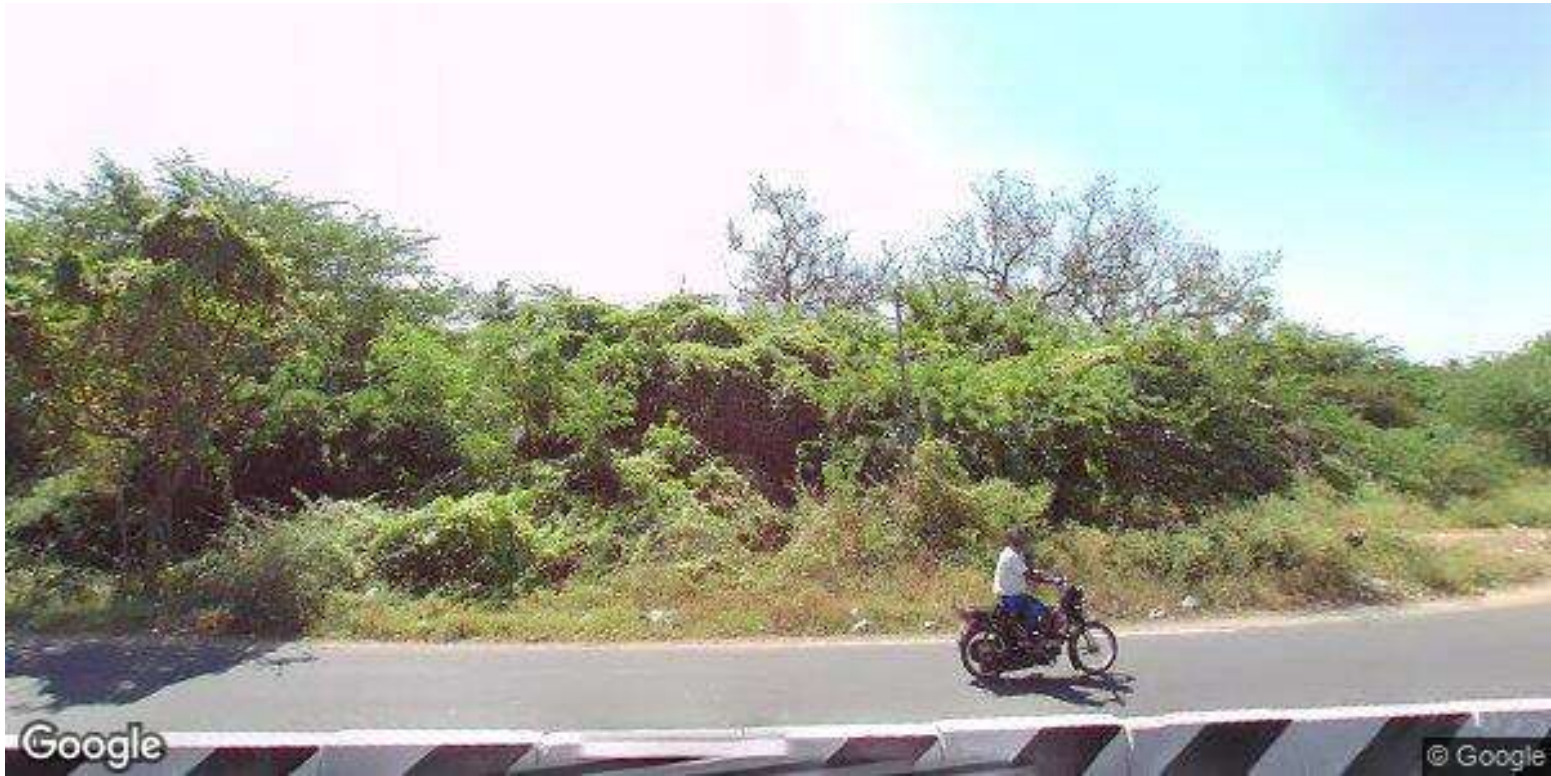
**Risk Type:** Turn  
**Risk Level:** Medium  
**Speed Limit:** 30 KM/Hr  
**Coordinates:** 11.23329, 77.49966

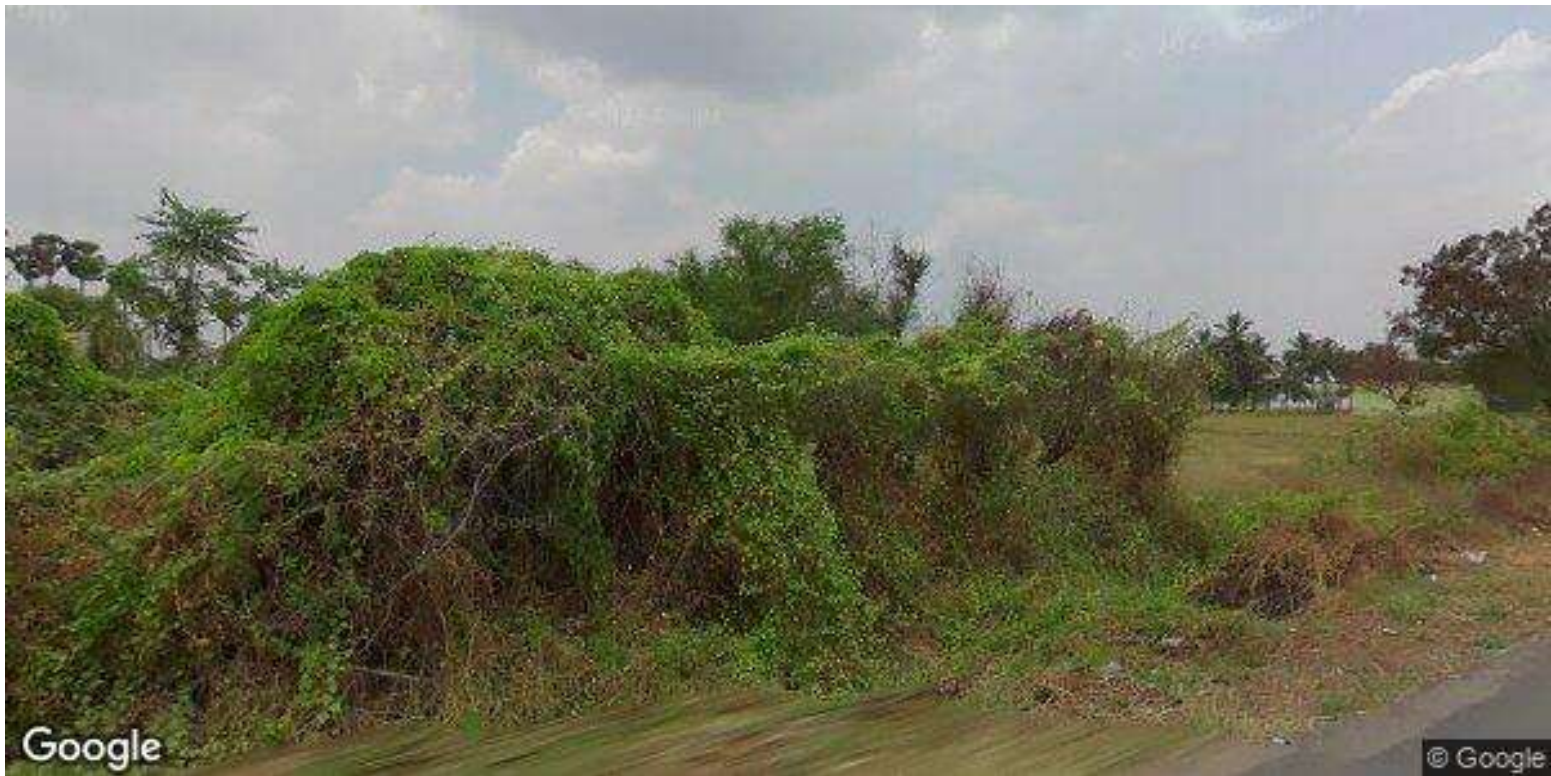
**Risk Type:** Turn  
**Risk Level:** Medium  
**Speed Limit:** 30 KM/Hr  
**Coordinates:** 11.17851, 77.46169

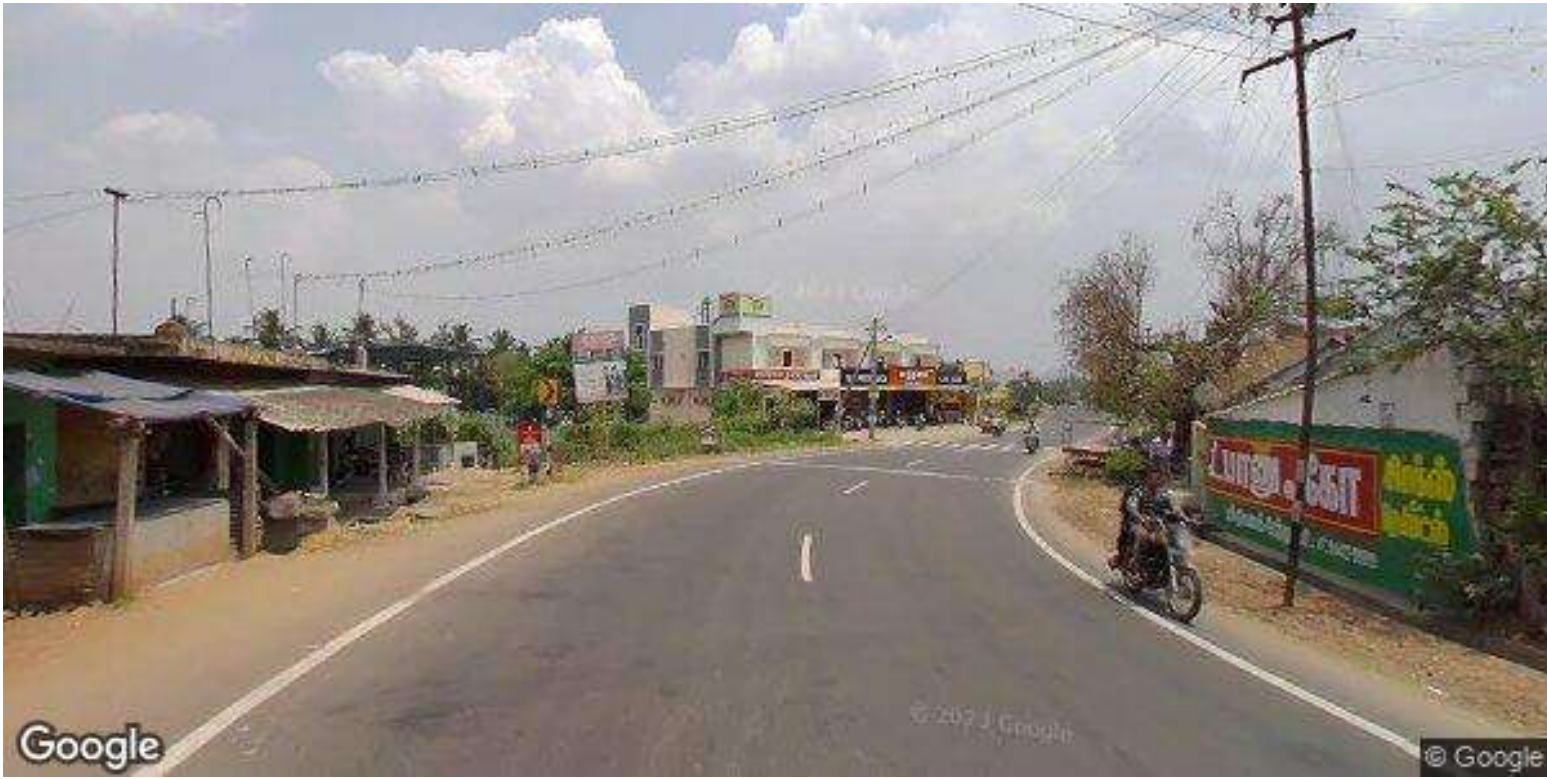
**Risk Type:** Turn  
**Risk Level:** Medium  
**Speed Limit:** 30 KM/Hr  
**Coordinates:** 11.17368, 77.45730

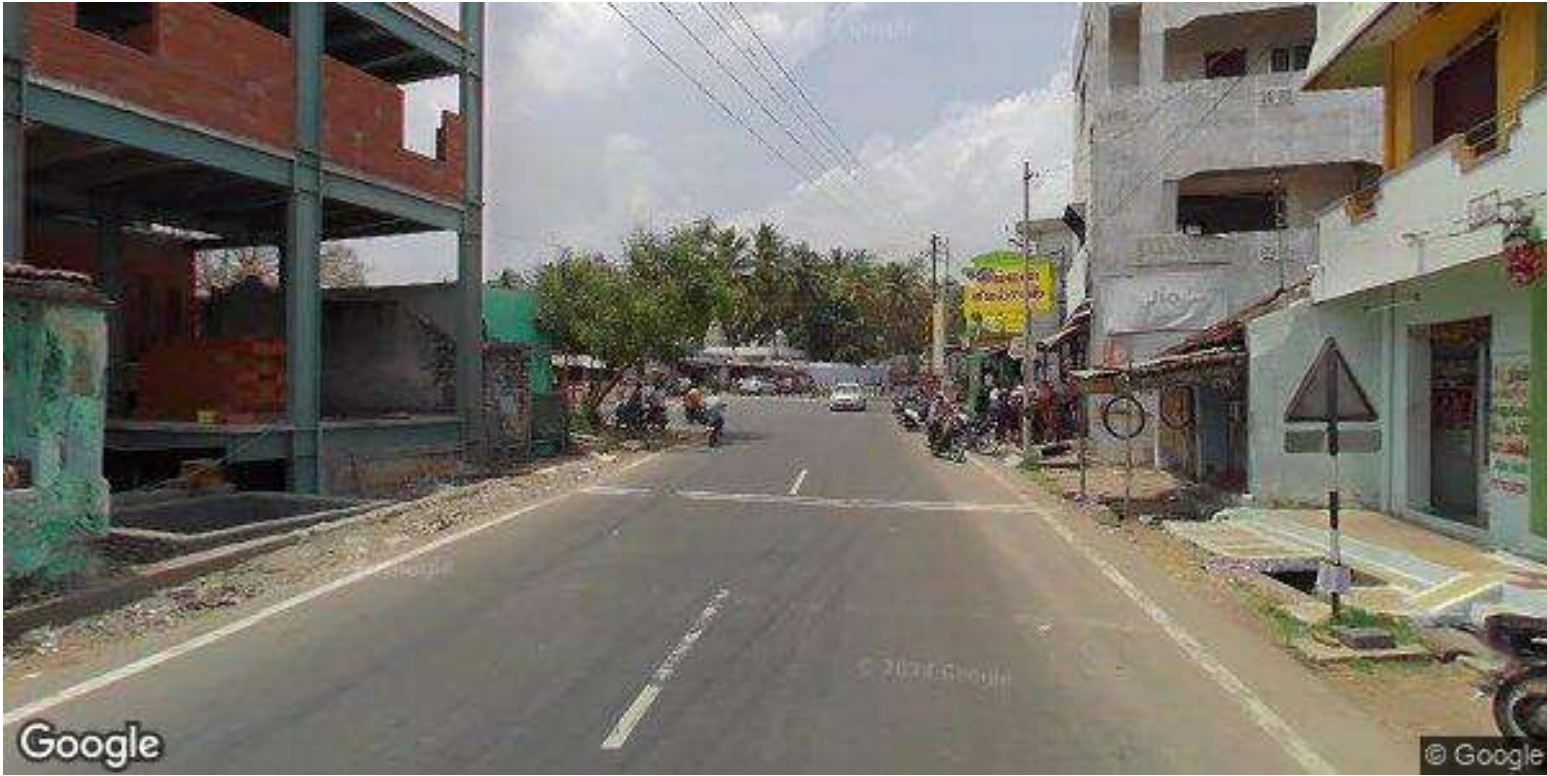
**Risk Type:** Turn  
**Risk Level:** Medium  
**Speed Limit:** 30 KM/Hr  
**Coordinates:** 11.17111, 77.45547

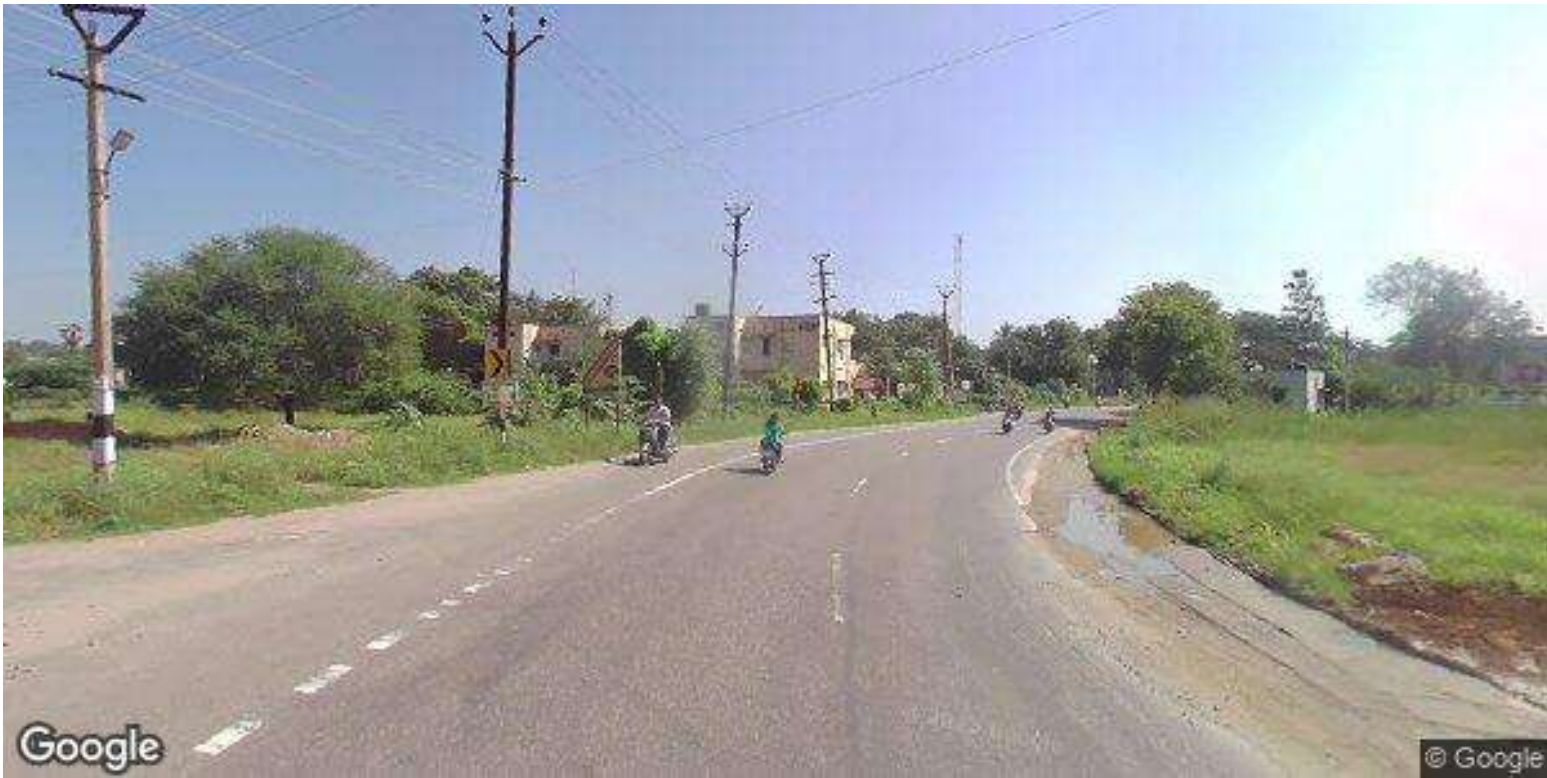
**Risk Type:** Turn  
**Risk Level:** High  
**Speed Limit:** 15 KM/Hr  
**Coordinates:** 11.16959, 77.44396

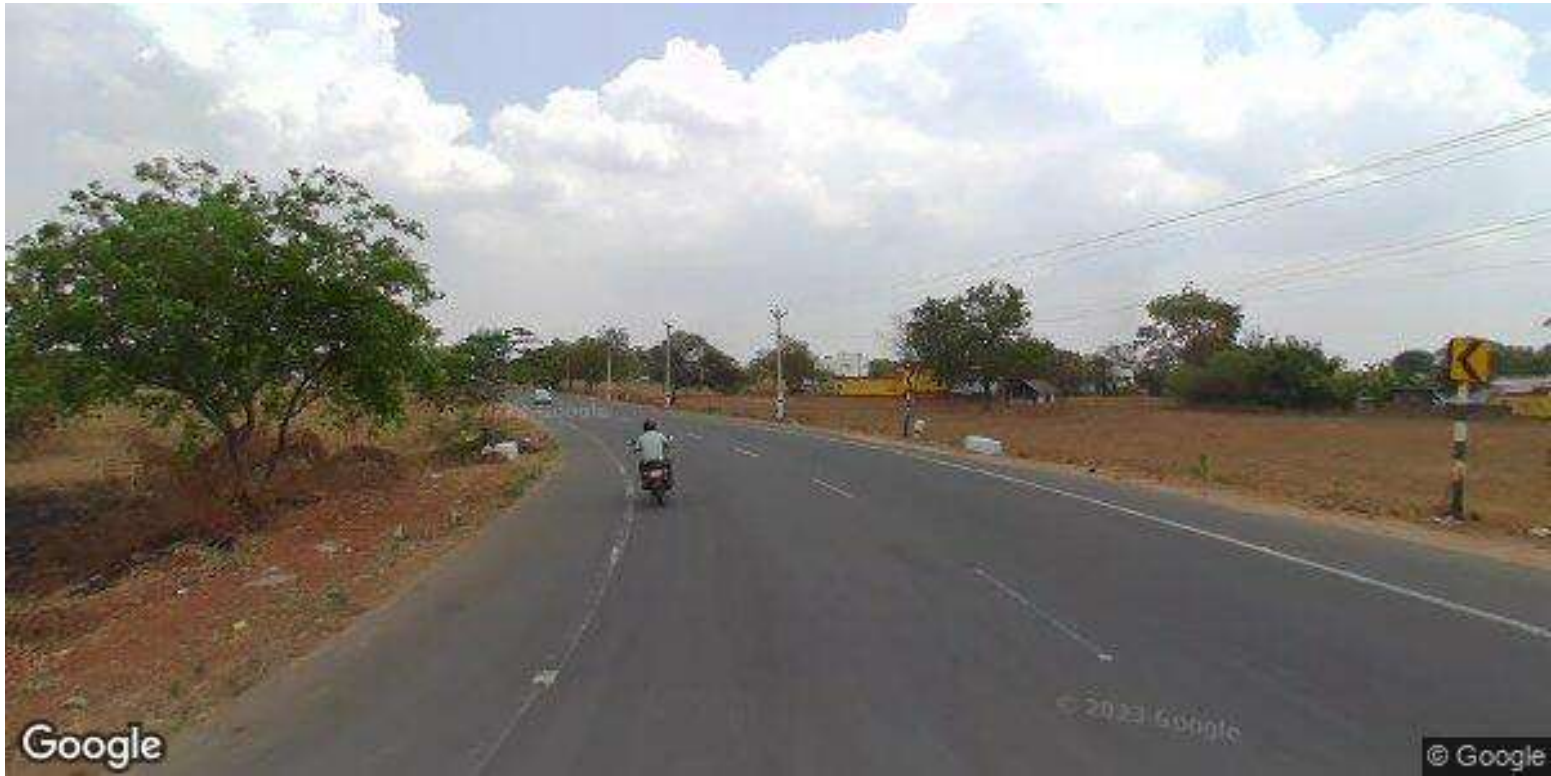
**Risk Type:** Turn  
**Risk Level:** Medium  
**Speed Limit:** 30 KM/Hr  
**Coordinates:** 11.16381, 77.43700

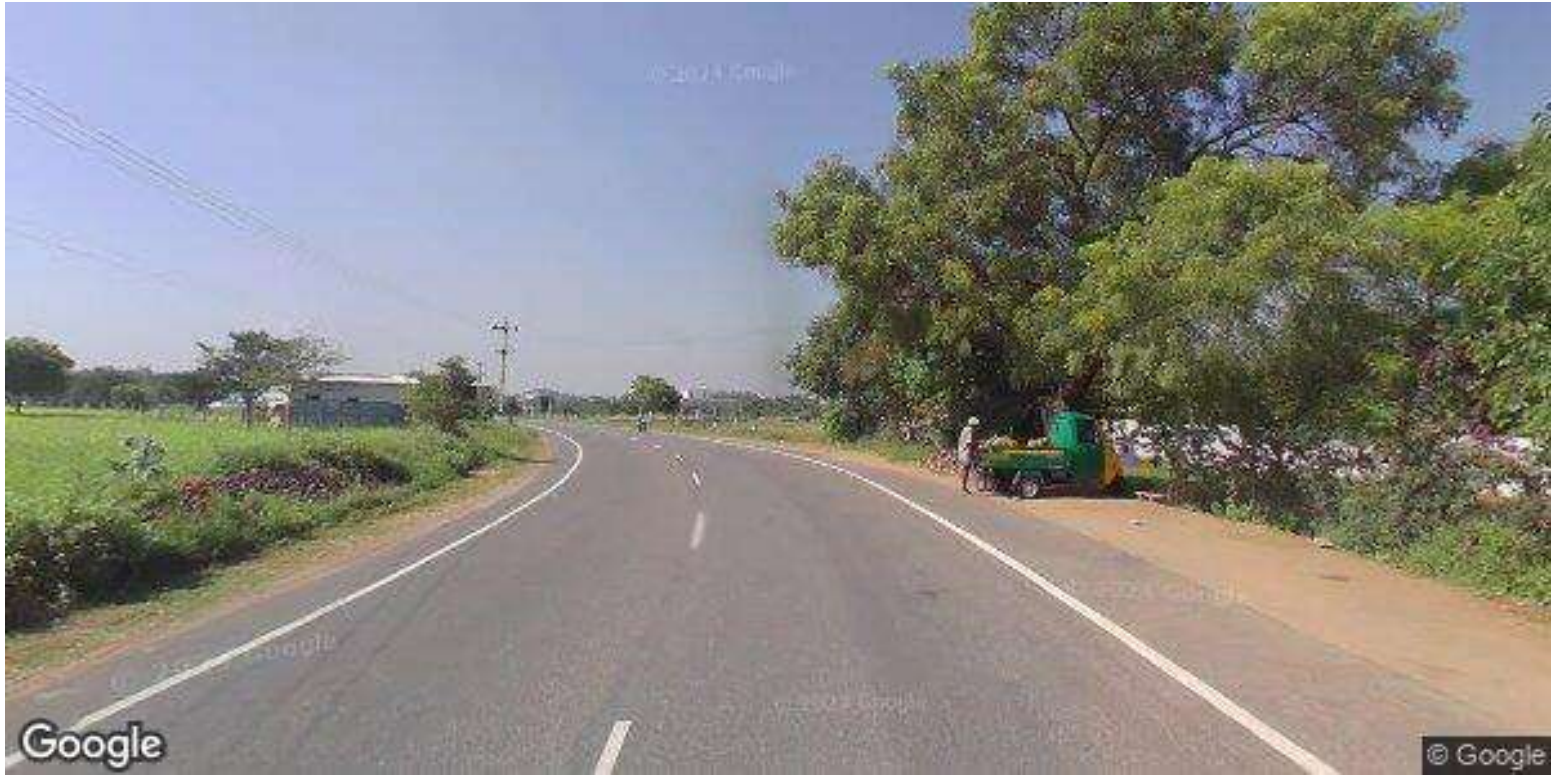
**Risk Type:** Turn  
**Risk Level:** Medium  
**Speed Limit:** 30 KM/Hr  
**Coordinates:** 11.16280, 77.43139

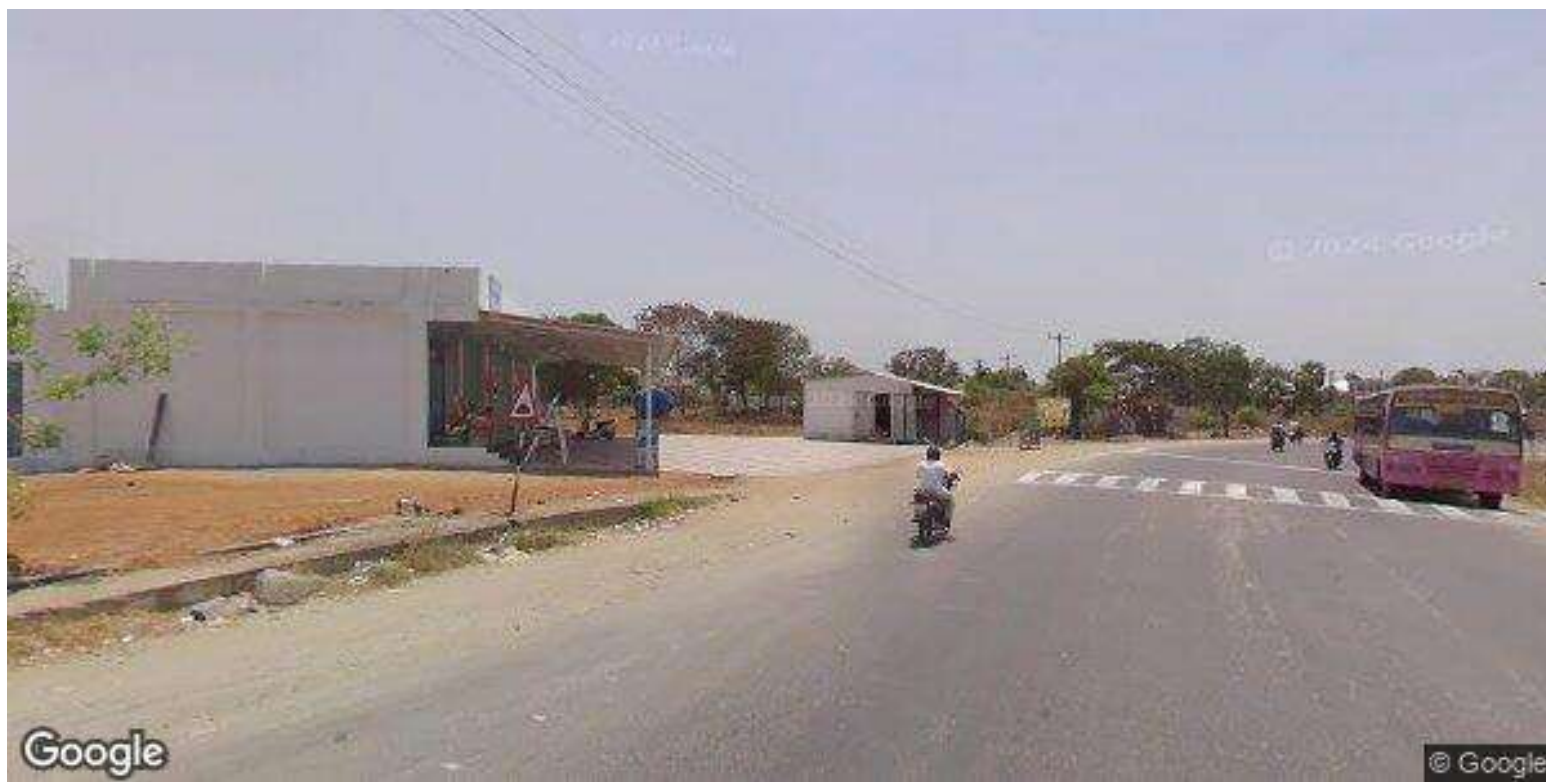
**Coordinates:** 11.15023, 77.42247

**Risk Type:** Turn

**Risk Level:** Medium

**Speed Limit:** 30 KM/Hr
