# IndianOil

## JOURNEY RISK MANAGEMENT (JRM) STUDY

### Salem Terminal TO LAKSHMI AGENCIES

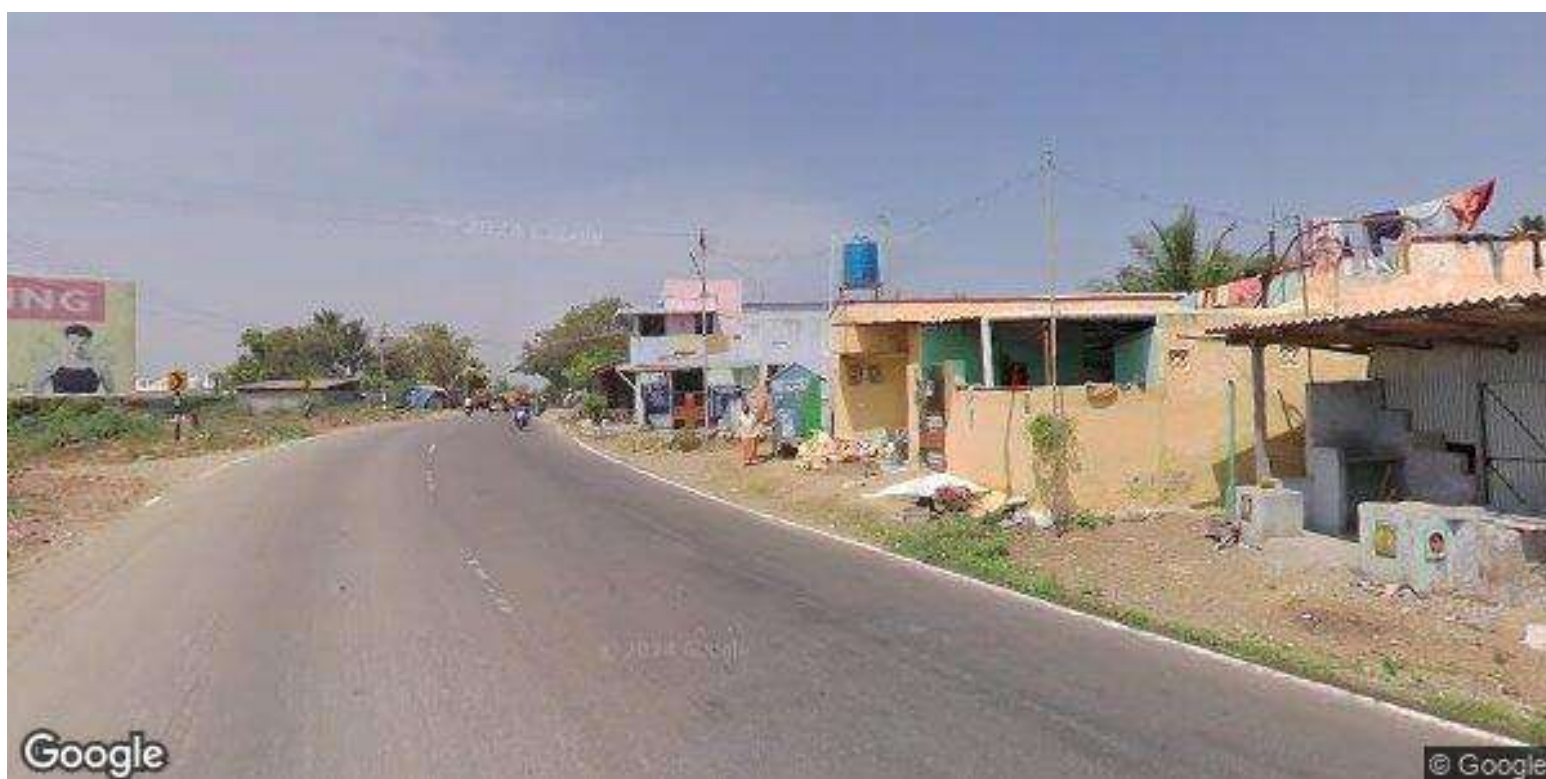
**Coordinates:** 11.13848, 77.41611

**Risk Type:** Turn

**Risk Level:** Medium

**Speed Limit:** 30 KM/Hr

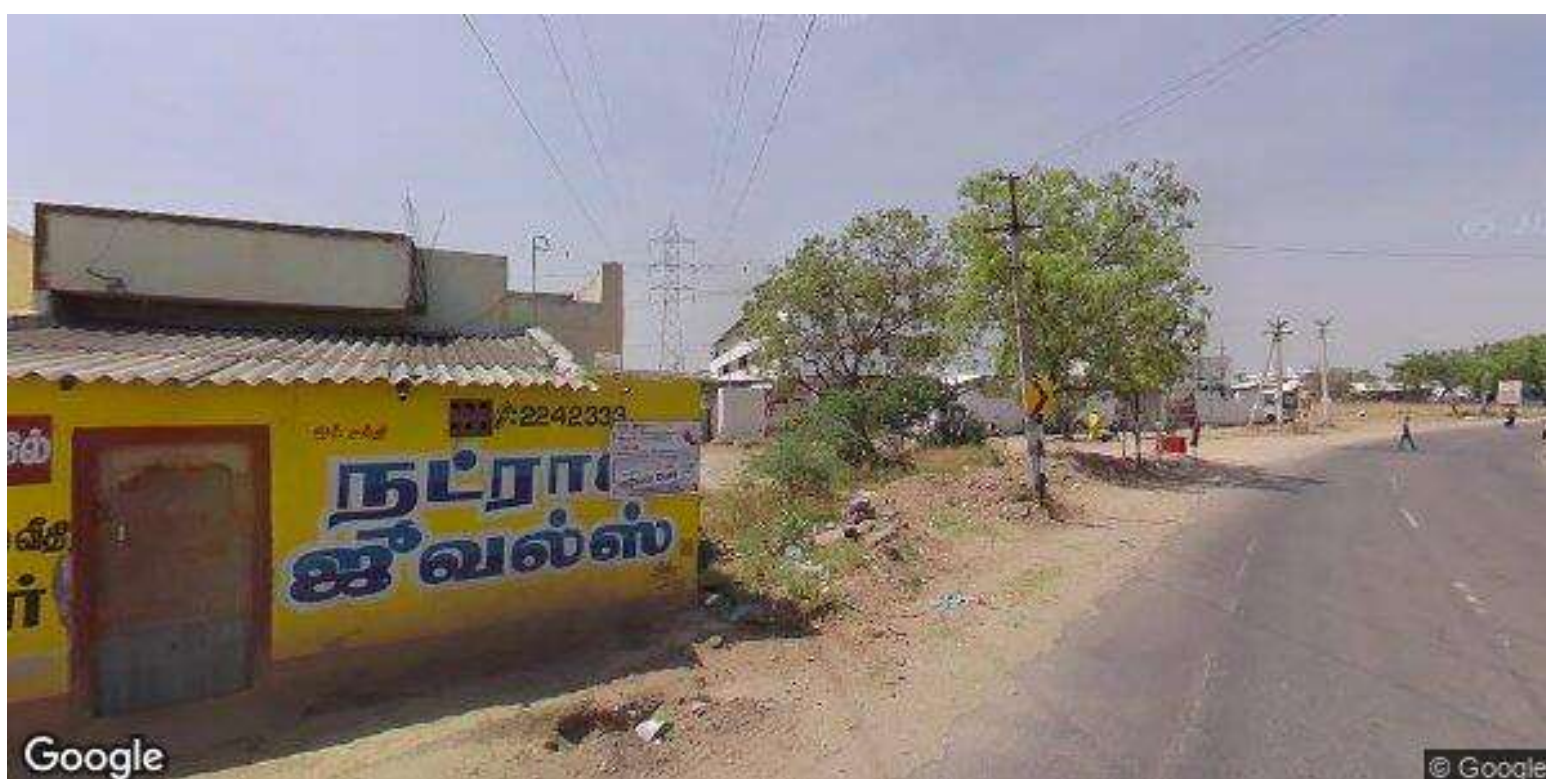
**Risk Type:** Turn  
**Risk Level:** Medium  
**Speed Limit:** 30 KM/Hr  
**Coordinates:** 11.13578, 77.41299

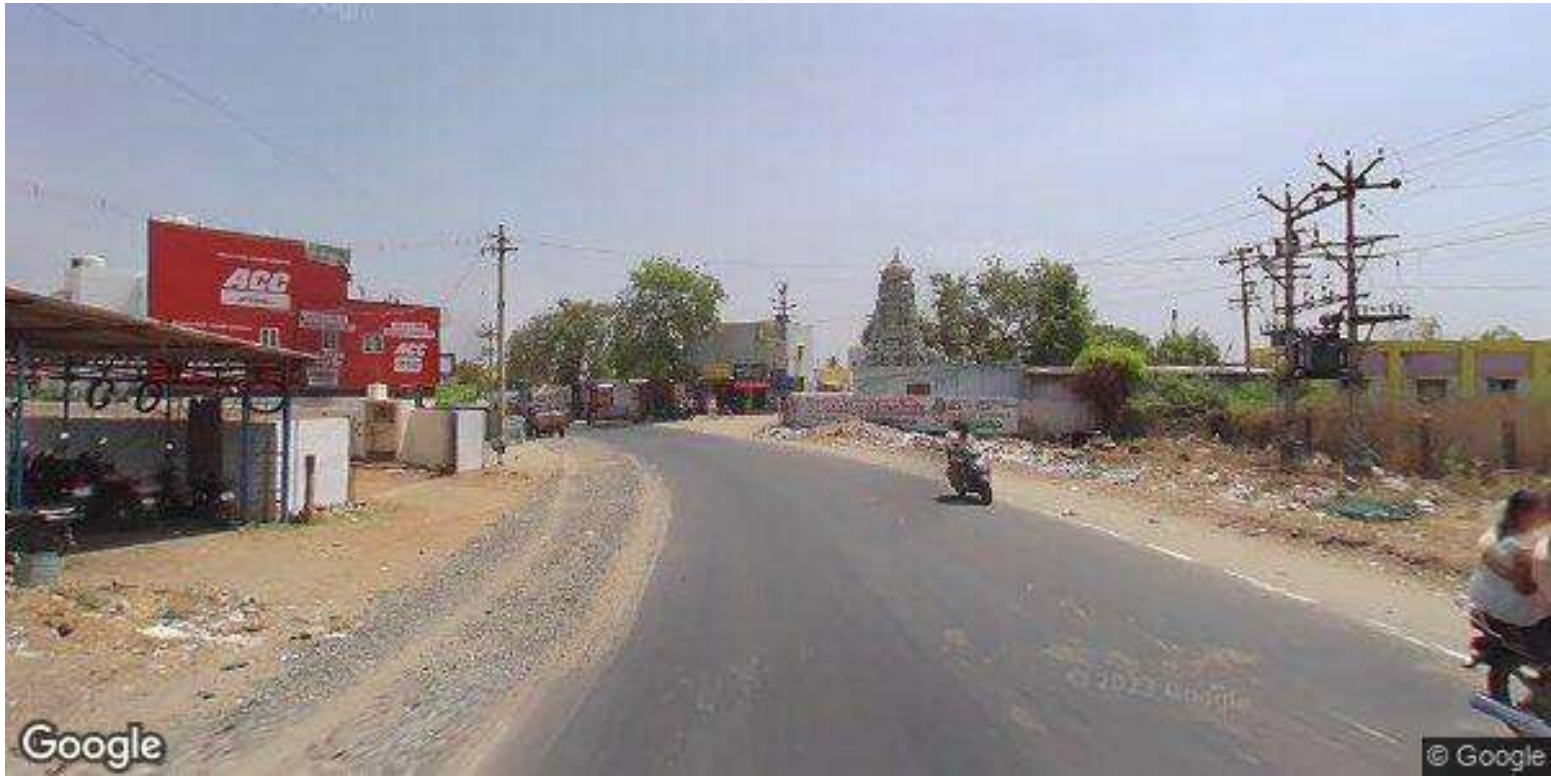
**Risk Type:** Turn  
**Risk Level:** Medium  
**Speed Limit:** 30 KM/Hr  
**Coordinates:** 11.12989, 77.40302

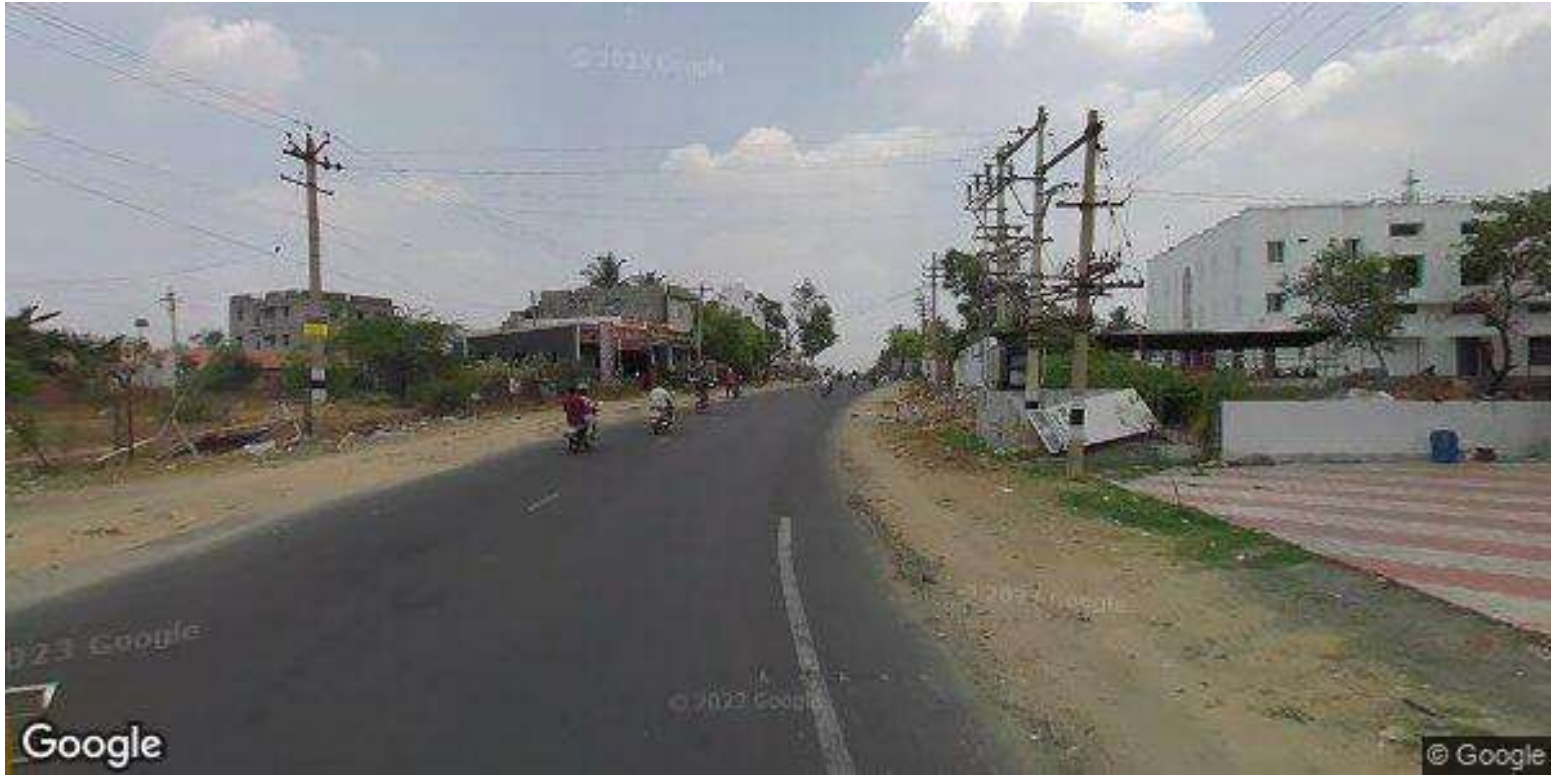
**Risk Type:** Turn  
**Risk Level:** Medium  
**Speed Limit:** 30 KM/Hr  
**Coordinates:** 11.12465, 77.38649

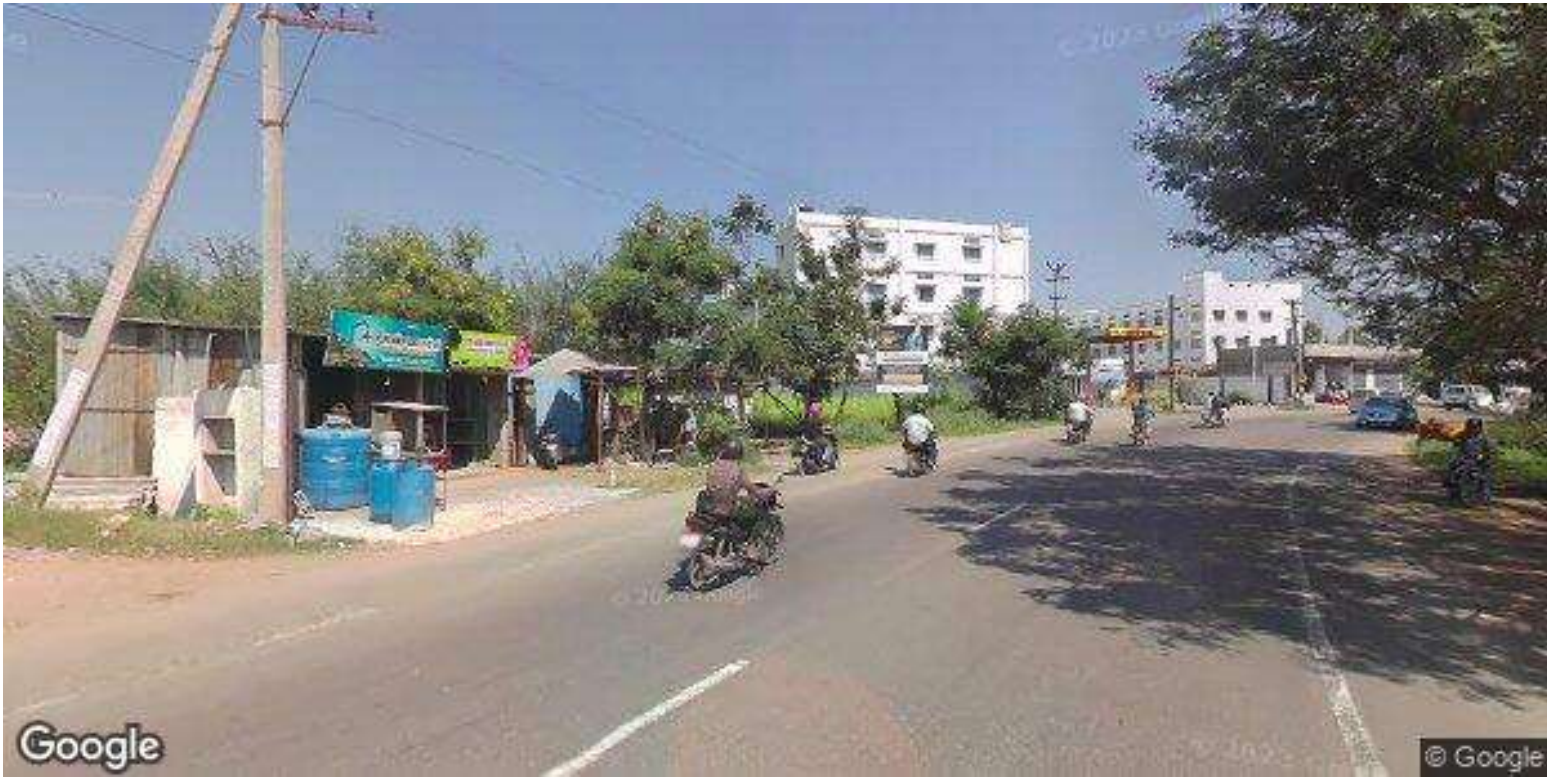
**Risk Type:** Turn  
**Risk Level:** Medium  
**Speed Limit:** 30 KM/Hr  
**Coordinates:** 11.12232, 77.38291

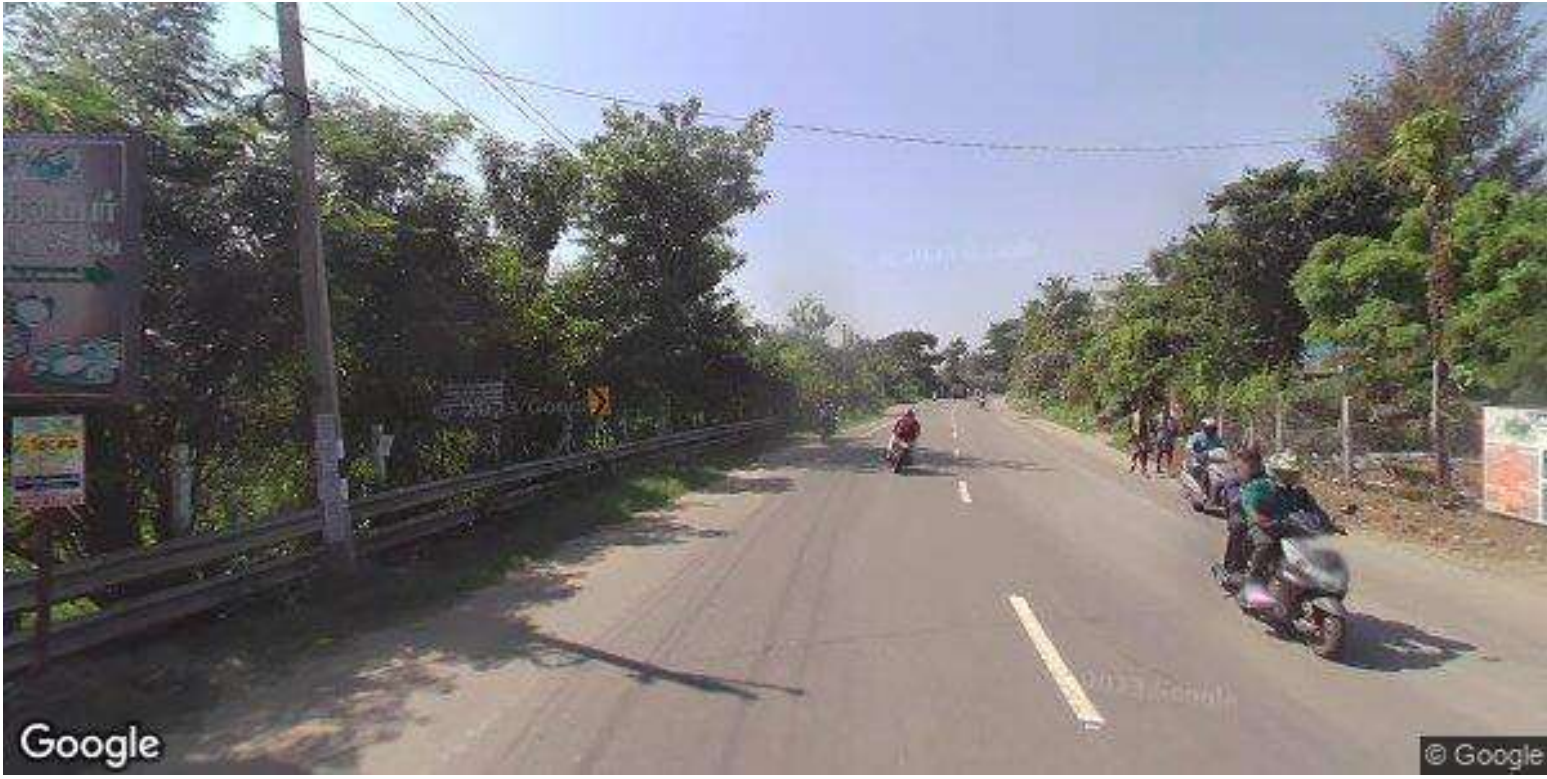
**Risk Type:** Turn  
**Risk Level:** Medium  
**Speed Limit:** 30 KM/Hr  
**Coordinates:** 11.12104, 77.38220

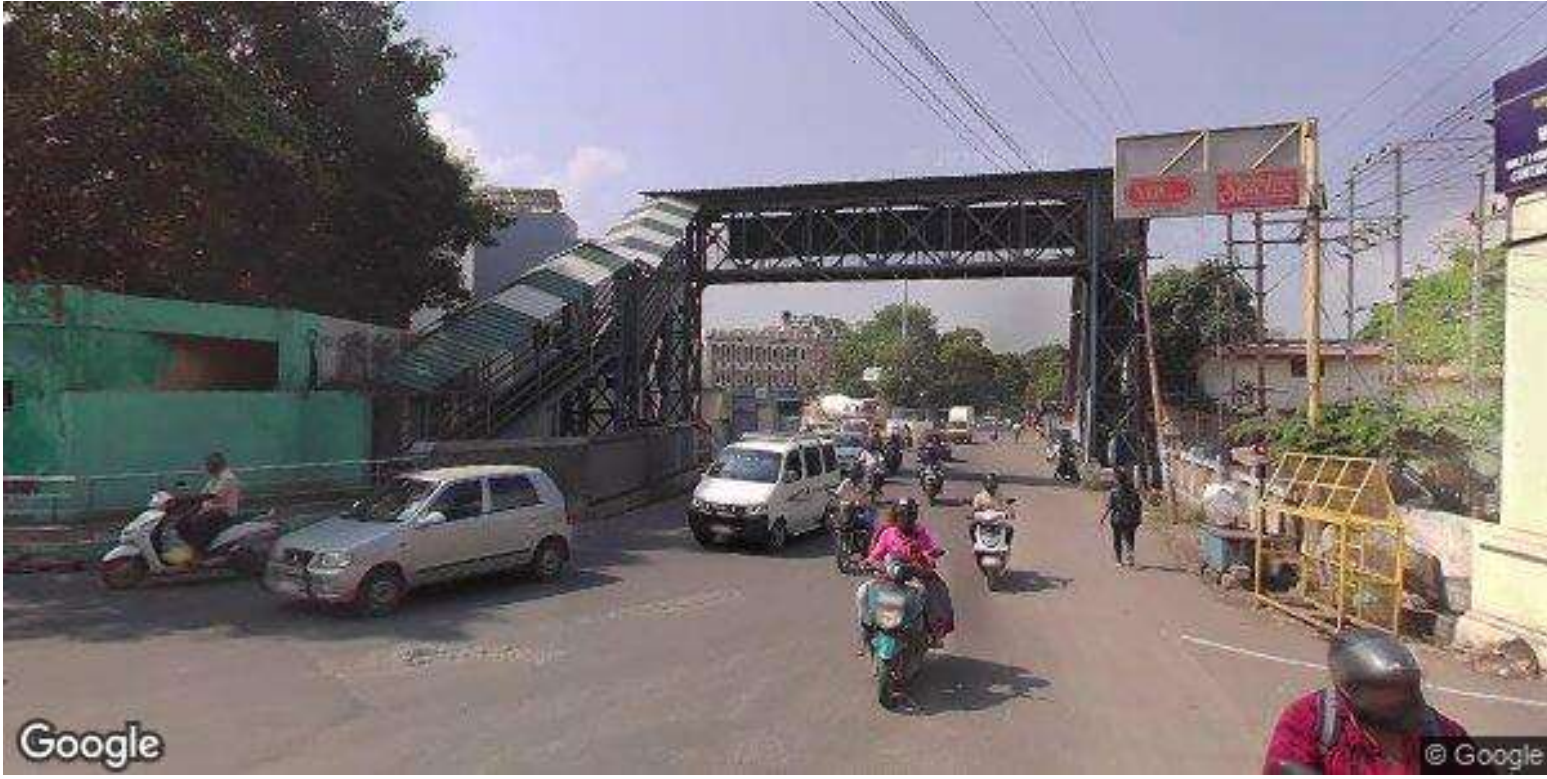
**Coordinates: 11.10798, 77.34071**

**Risk Type: Blind Spot**

**Risk Level: Blind Spot**

**Speed Limit: 10 KM/Hr**

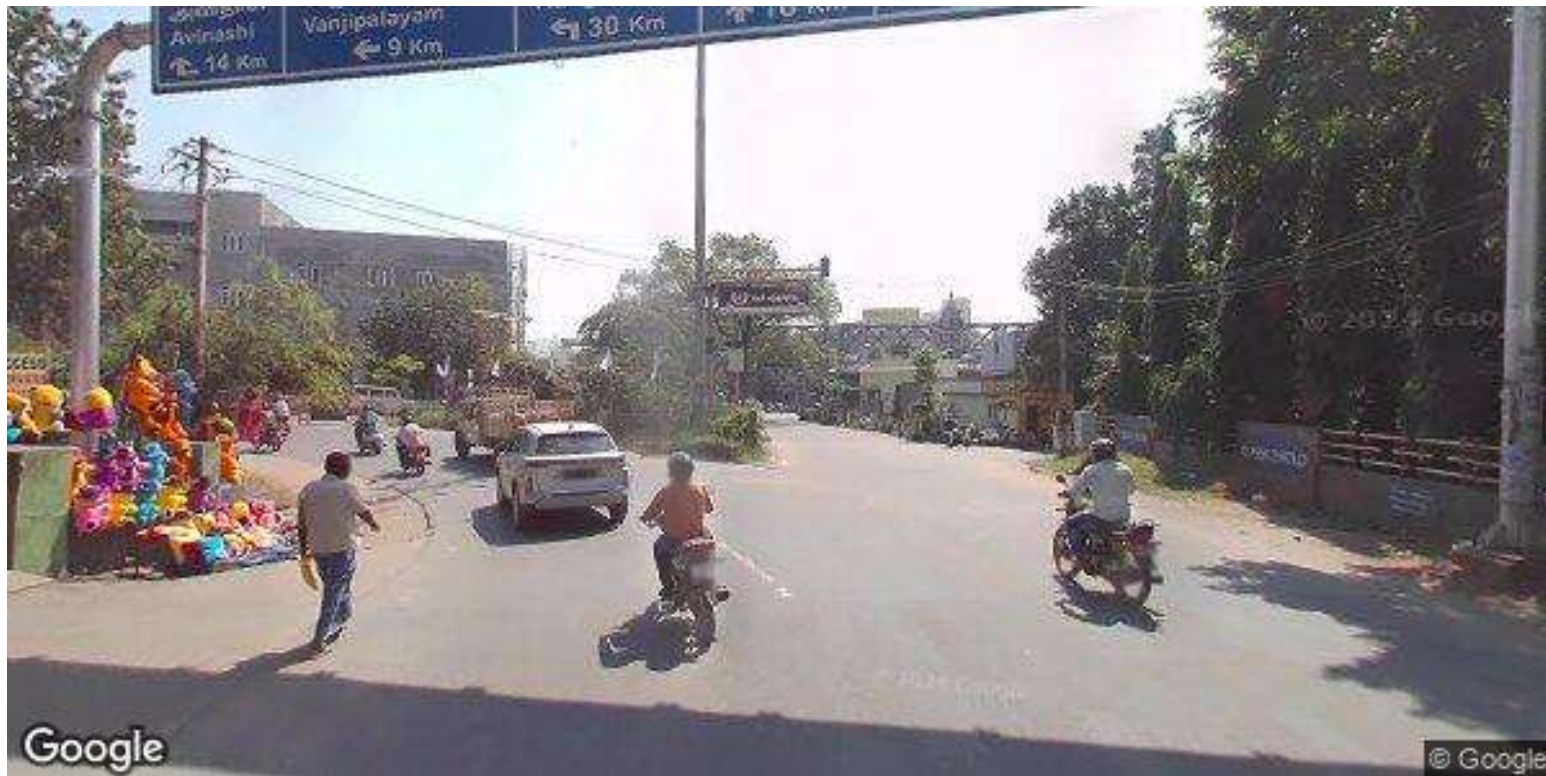
**Coordinates: 11.10746, 77.34098**

**Risk Type: Turn**

**Risk Level: Medium**

**Speed Limit: 30 KM/Hr**

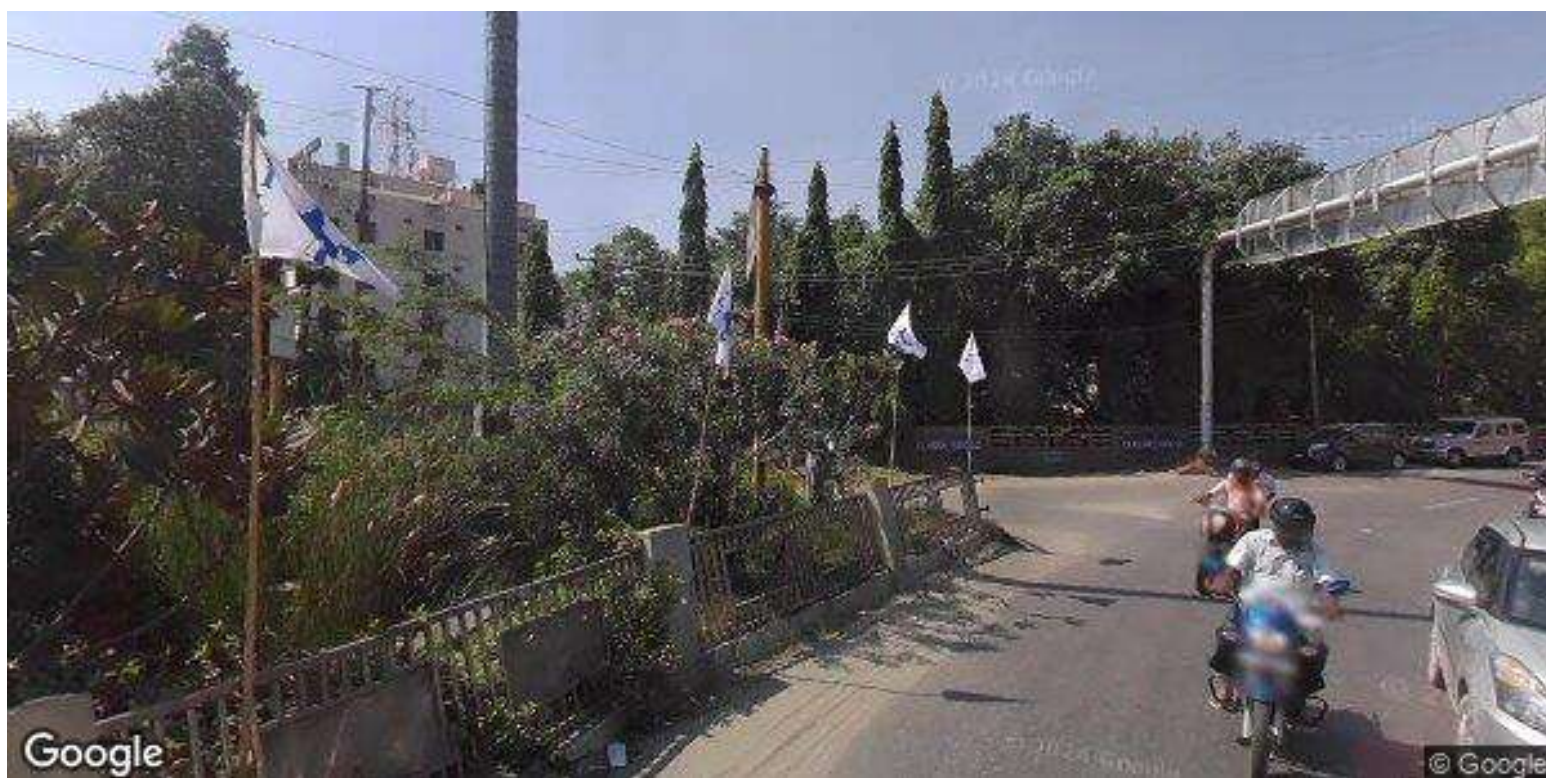
**Coordinates: 11.10736, 77.34122**

**Risk Type: Turn**

**Risk Level: Medium**

**Speed Limit: 30 KM/Hr**

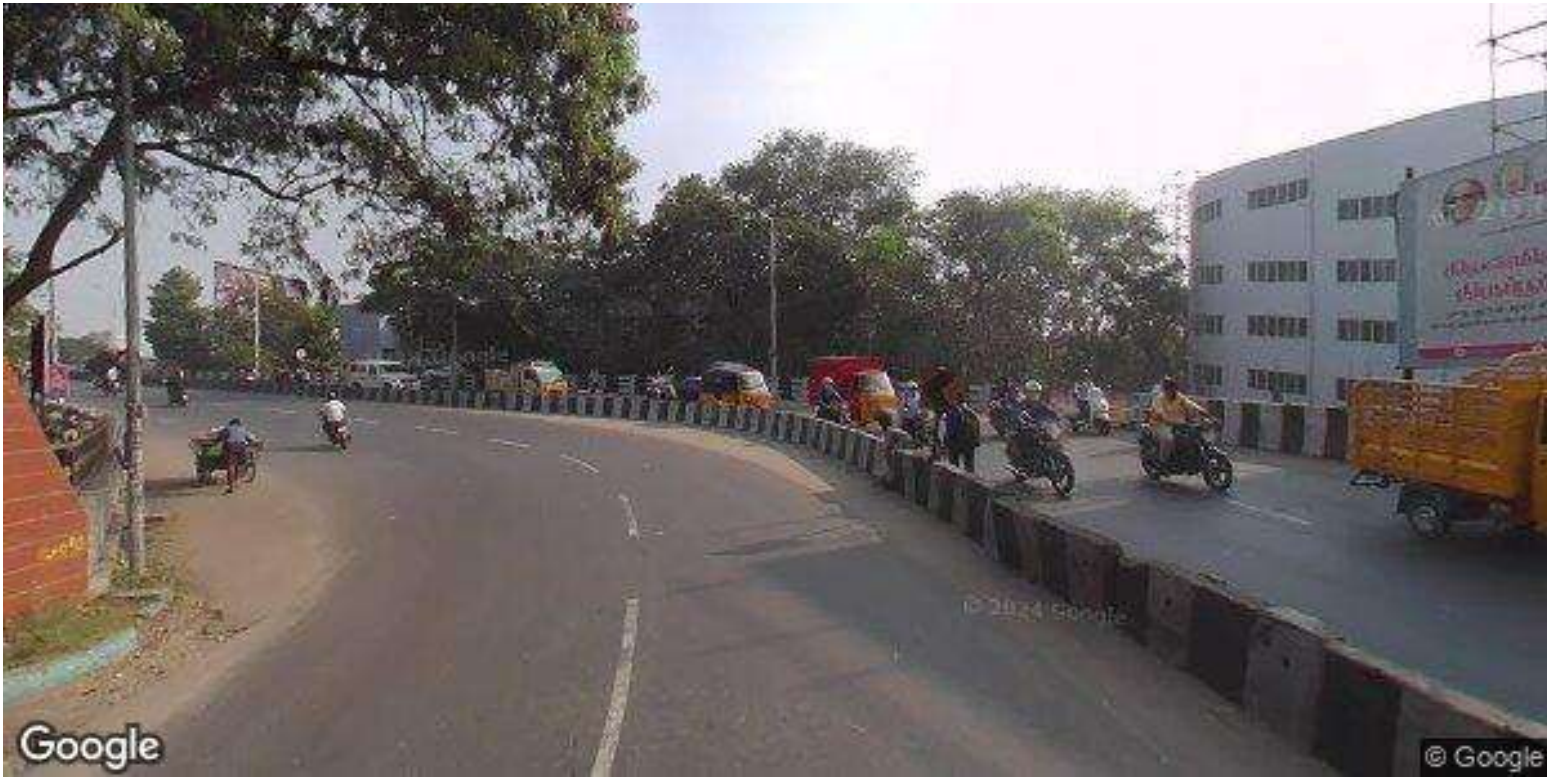
**Risk Type:** Turn  
**Risk Level:** Medium  
**Speed Limit:** 30 KM/Hr  
**Coordinates:** 11.10748, 77.34161

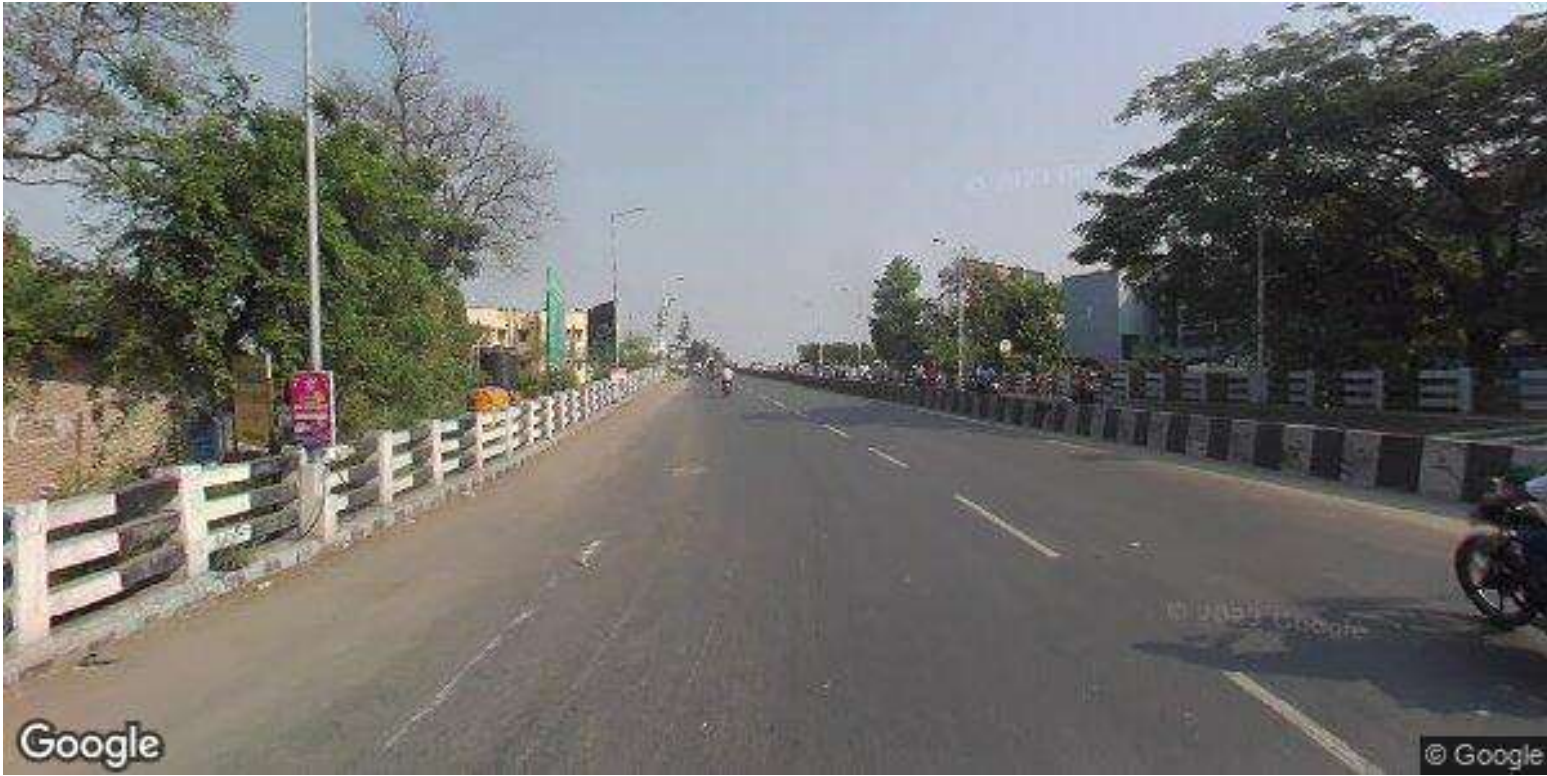
**Risk Type:** Turn  
**Risk Level:** Medium  
**Speed Limit:** 30 KM/Hr  
**Coordinates:** 11.10764, 77.34174

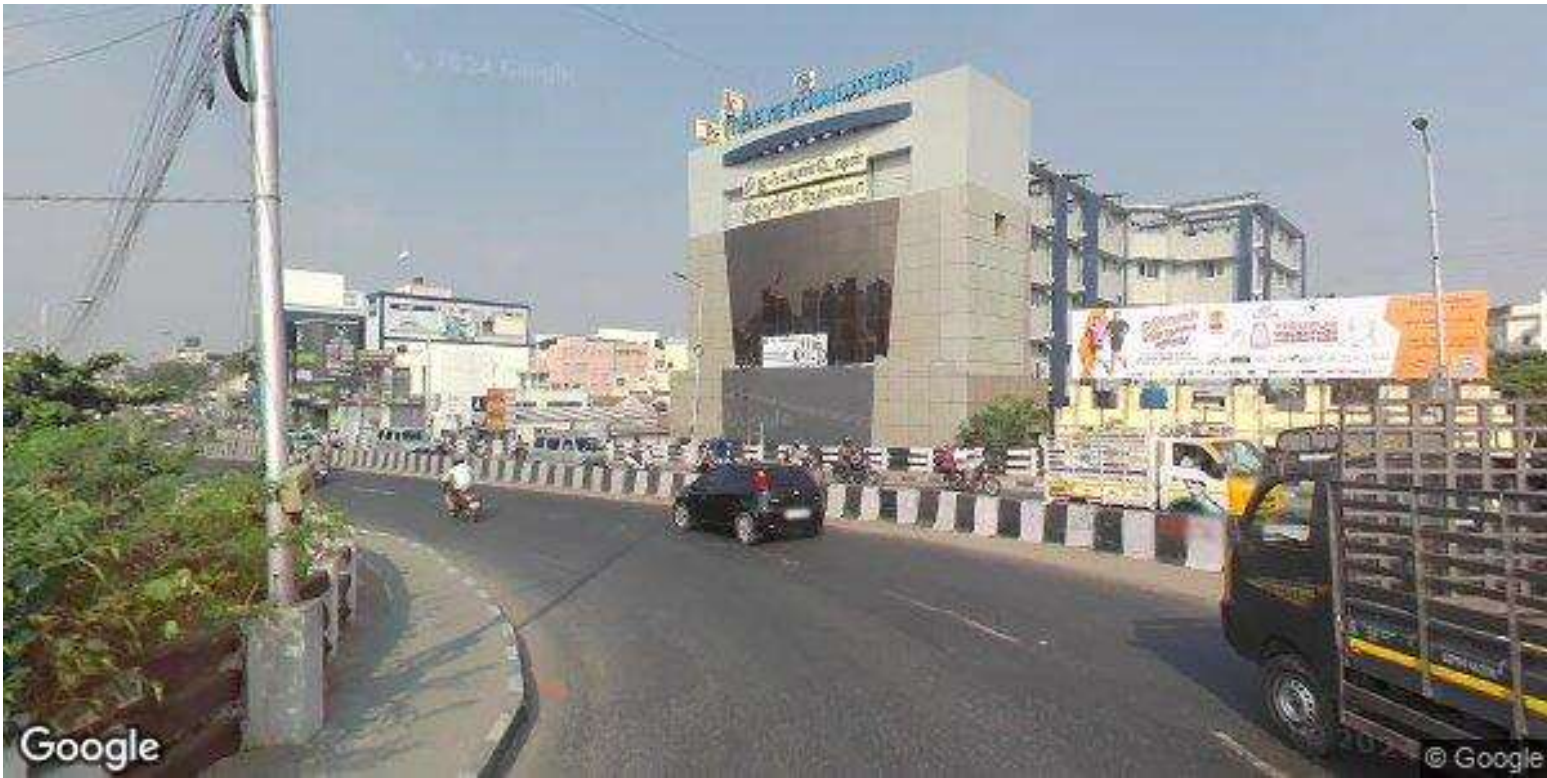
Coordinates: 11.10982, 77.34146

| | Risk Type | Risk Level | Coordinates | Speed Limit |
|---|---|---|---|---|
| 35 | Turn | High | 11.10982, 77.34146 | 15 KM/Hr |

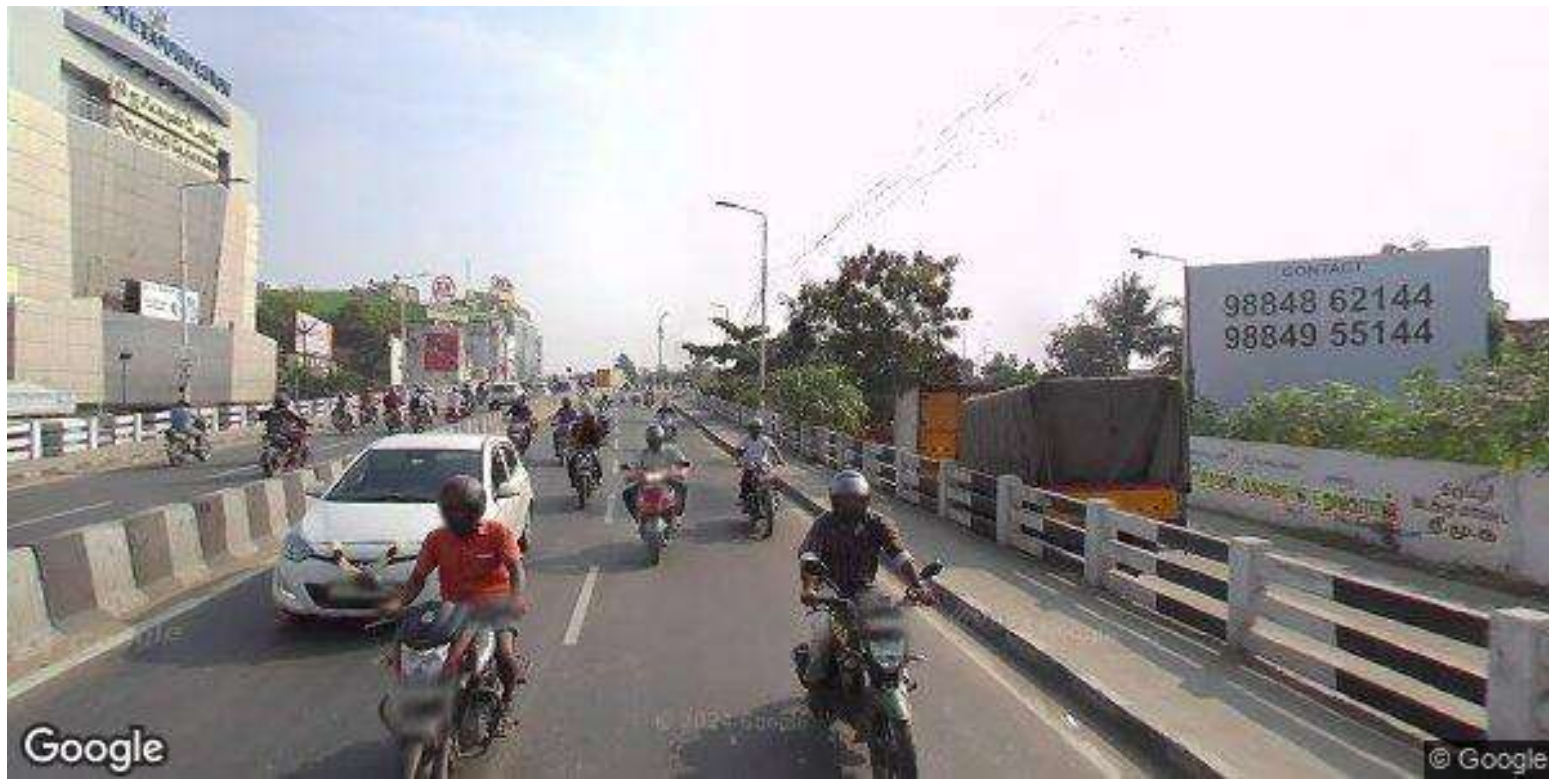
Coordinates: 11.10971, 77.34076

| | Risk Type | Risk Level | Coordinates | Speed Limit |
|---|---|---|---|---|
| 36 | Turn | Medium | 11.10971, 77.34076 | 30 KM/Hr |
