# IndianOil

## JOURNEY RISK MANAGEMENT (JRM) STUDY

**Salem Terminal to AKM NATARAJAN CHETTY**

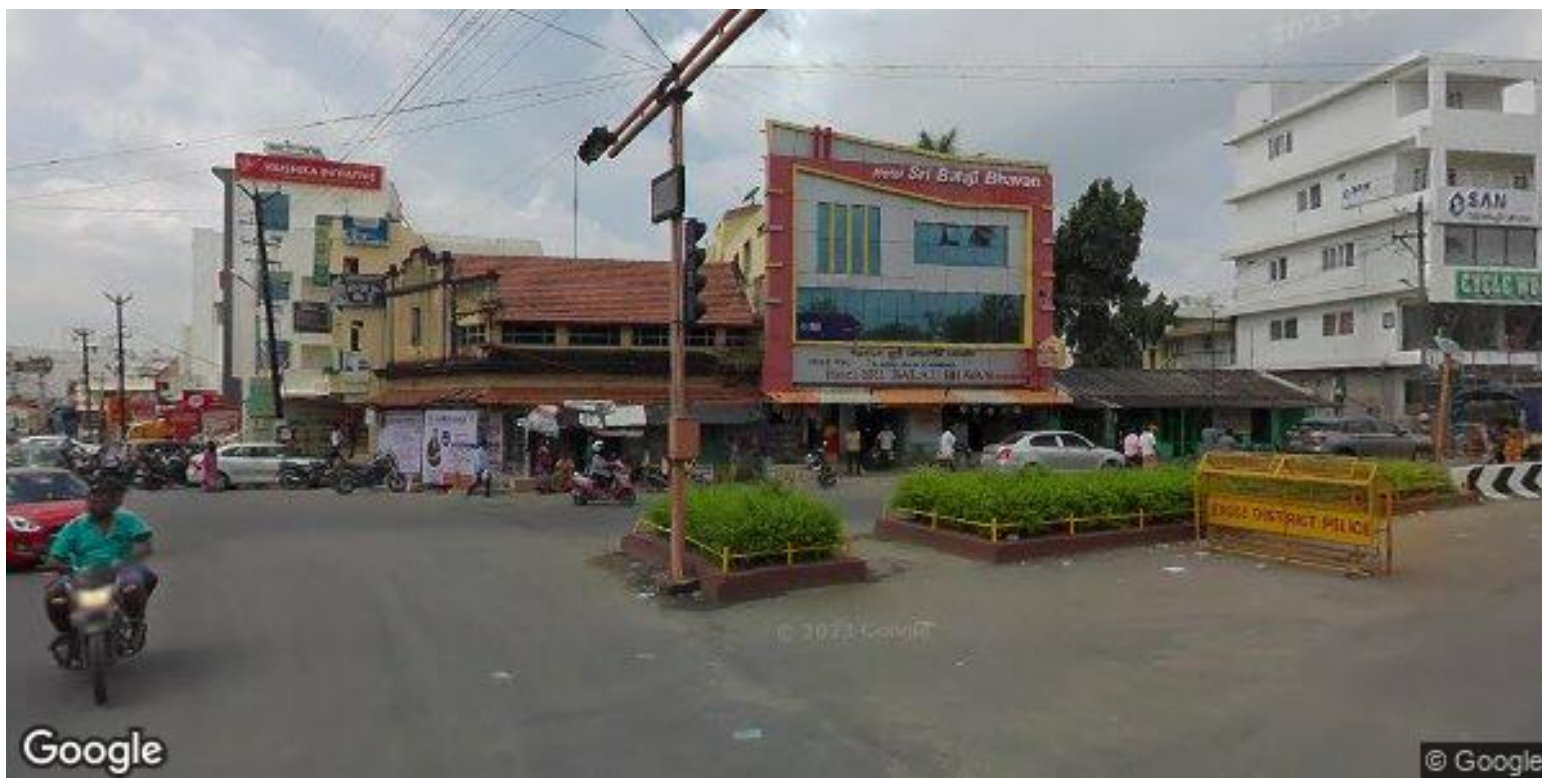
**Coordinates:** 11.27925, 77.58494

**Risk Type:** Roundabout

**Risk Level:** High

**Speed Limit:** 15 KM/Hr

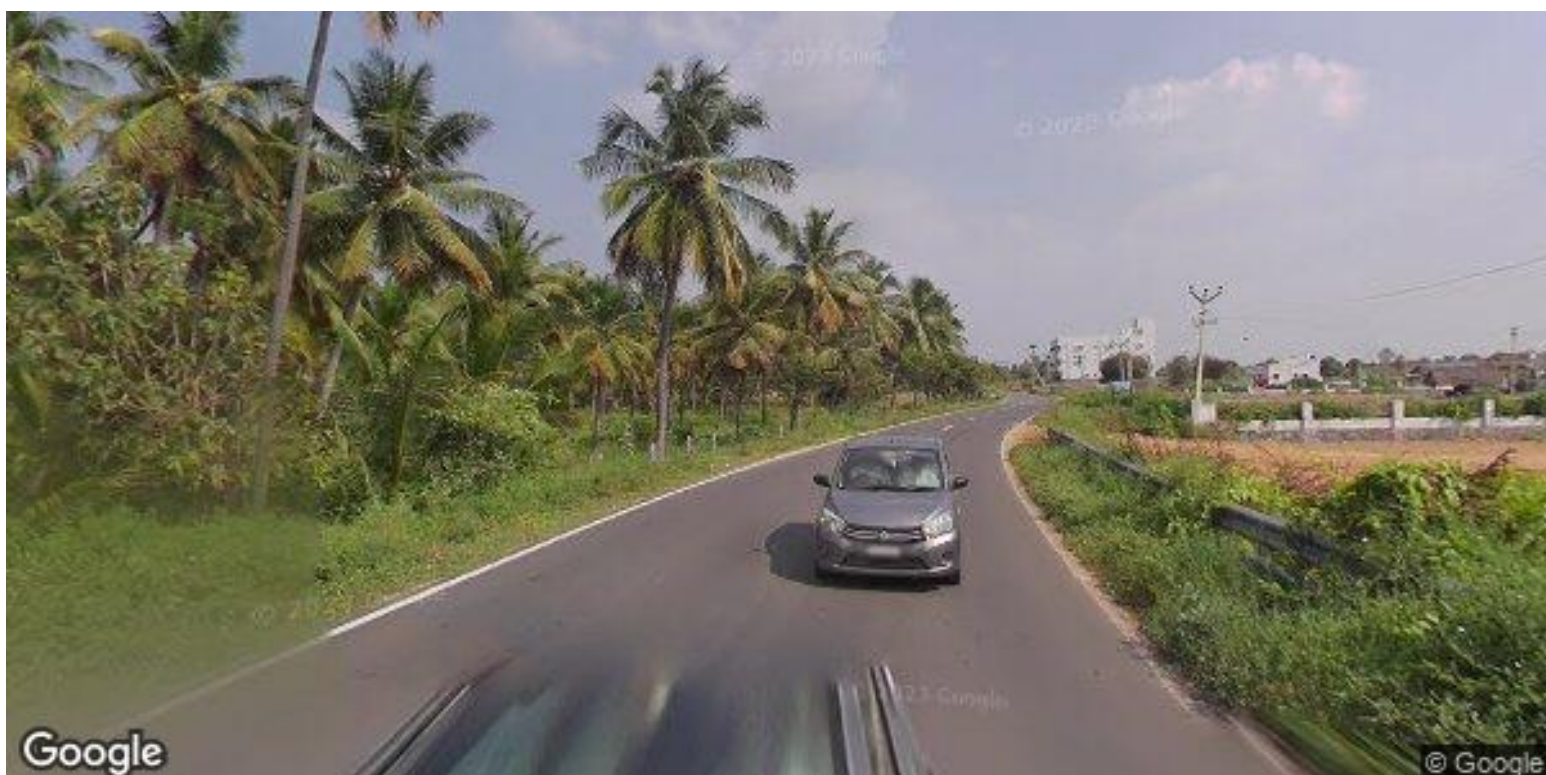
**Risk Type:** Turn  
**Risk Level:** Medium  
**Speed Limit:** 30 KM/Hr  
**Coordinates:** 11.45357, 77.85789

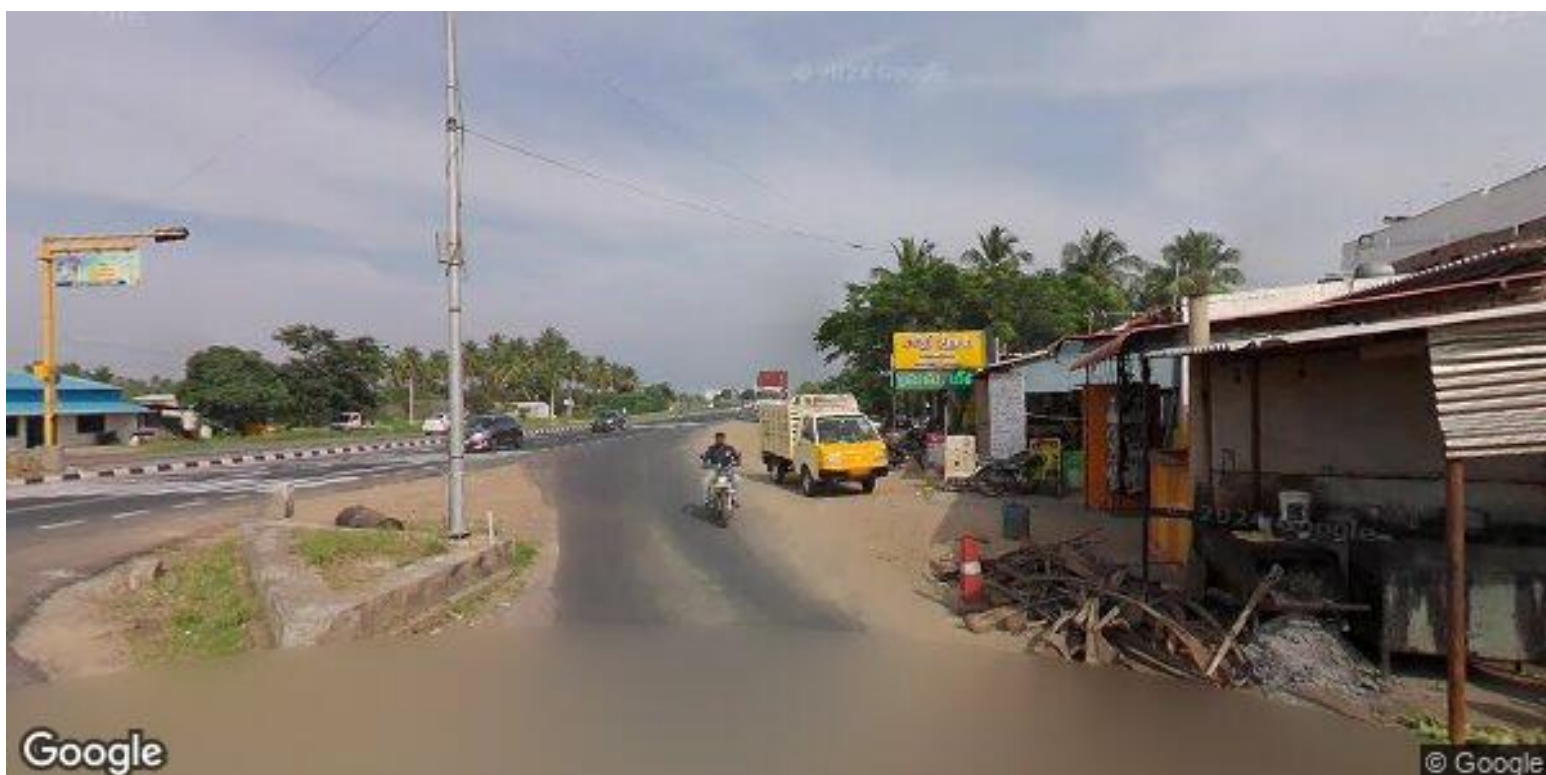
**Coordinates:** 11.29164, 77.58610

**Risk Type:** Turn

**Risk Level:** Medium

**Speed Limit:** 30 KM/Hr

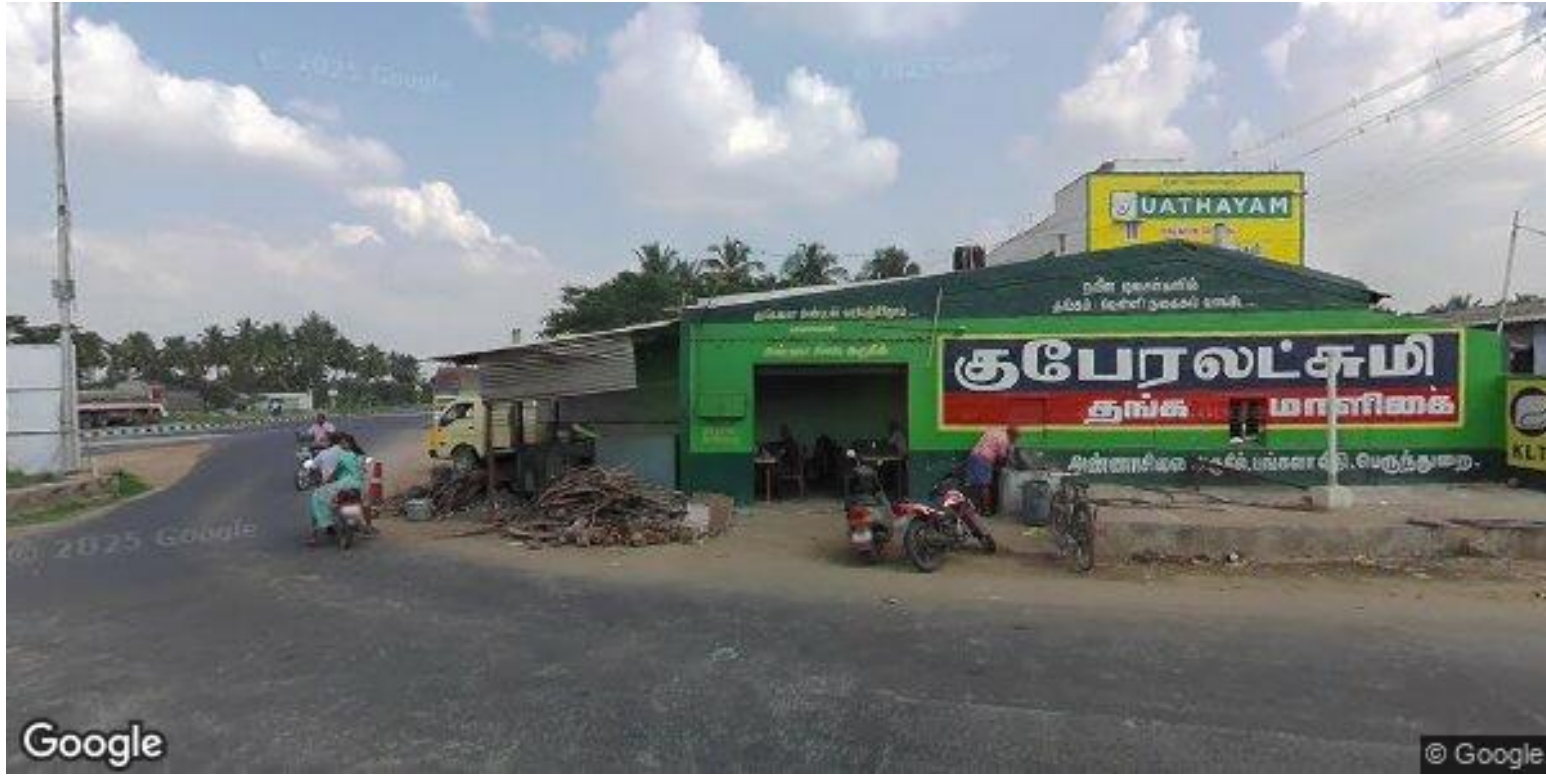
**Coordinates:** 11.29158, 77.58600

**Risk Type:** Turn

**Risk Level:** Medium

**Speed Limit:** 30 KM/Hr

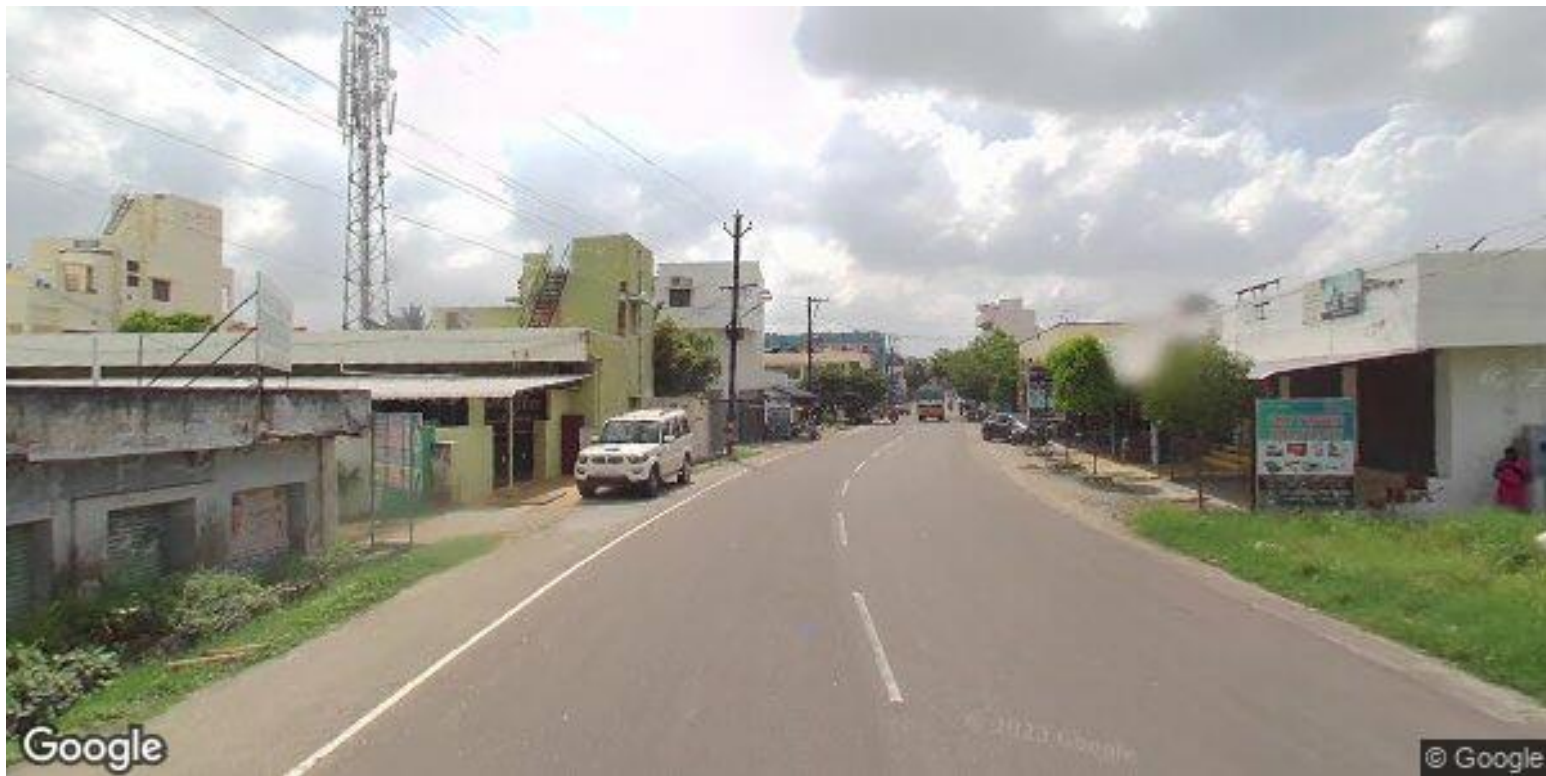
**Coordinates:** 11.28223, 77.58511

**Risk Type:** Turn

**Risk Level:** Medium

**Speed Limit:** 30 KM/Hr

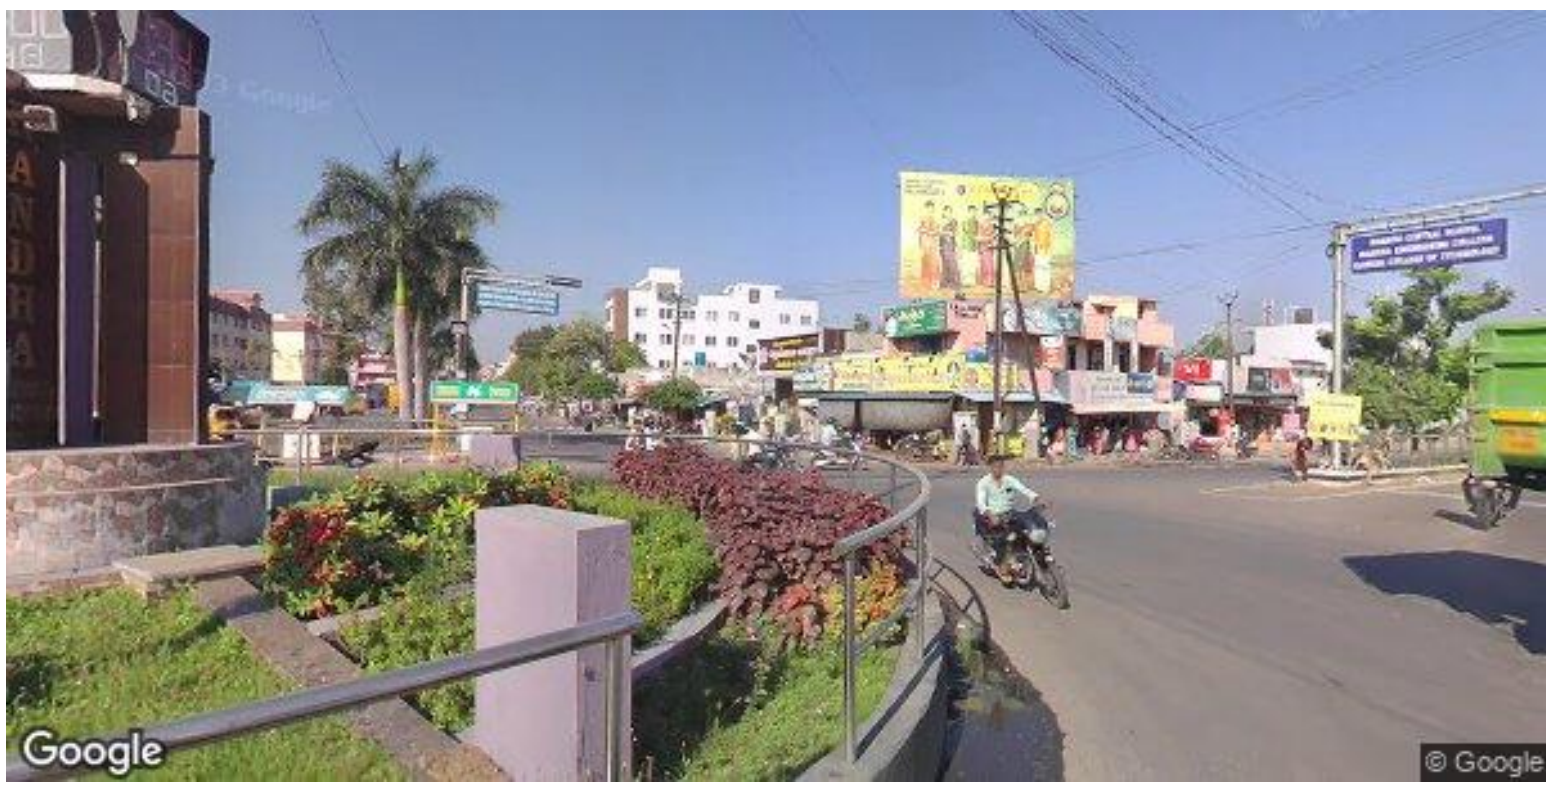
**Coordinates:** 11.27446, 77.58267

**Risk Type:** Turn

**Risk Level:** High

**Speed Limit:** 15 KM/Hr

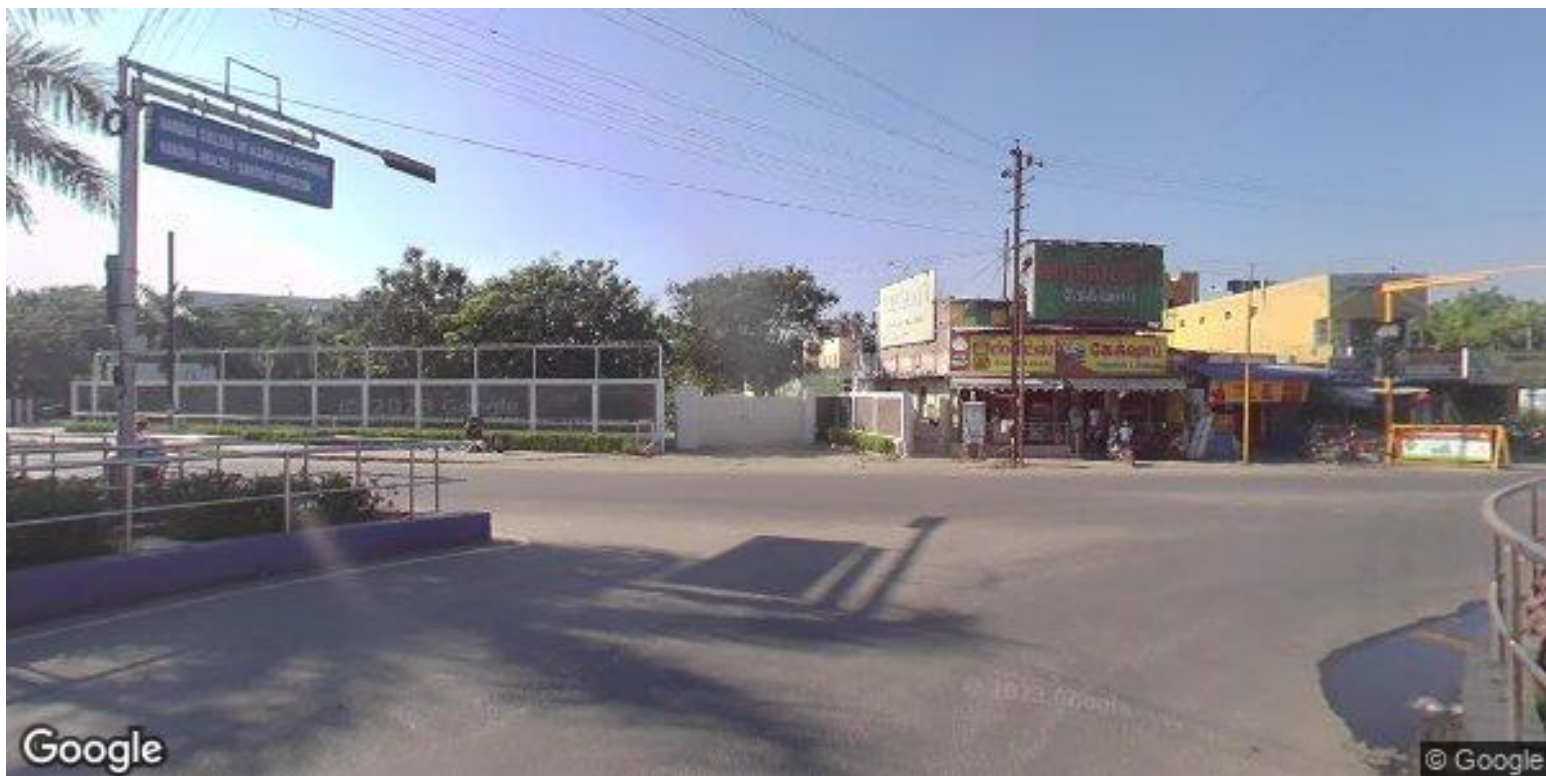
**Coordinates:** 11.27446, 77.58255

**Risk Type:** Turn

**Risk Level:** Medium

**Speed Limit:** 30 KM/Hr
