## **JOURNEY RISK MANAGEMENT (JRM) STUDY**

### **Salem Terminal To SREE SUNTHARAM AGENCIES**

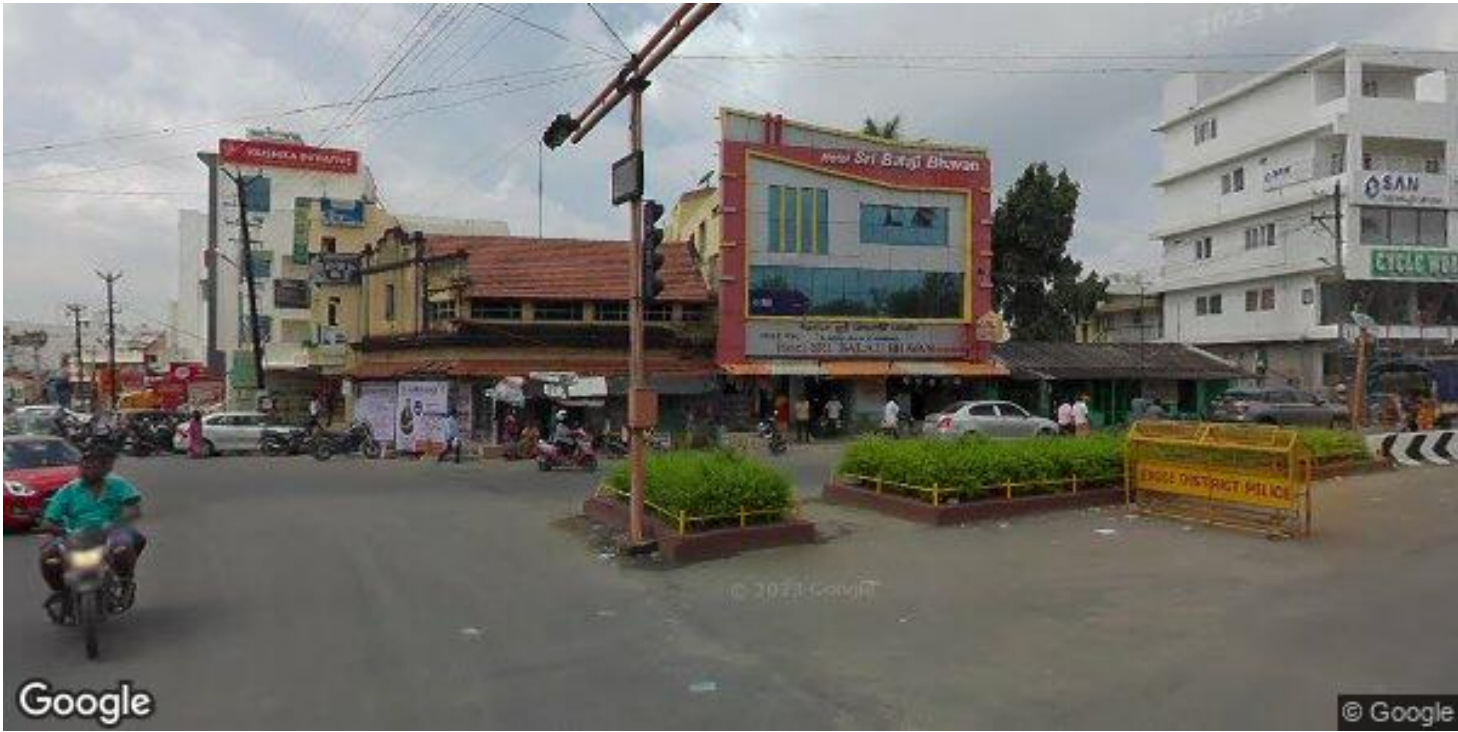
| | Risk Type | Risk Level | Coordinates | Speed Limit |
|---|---|---|---|---|
| 0 | Roundabout | High | 11.27925, 77.58494 | 15 KM/Hr |

**Risk Type:** Roundabout  
**Risk Level:** High  
**Speed Limit:** 15 KM/Hr  
**Coordinates:** 11.27925, 77.58494

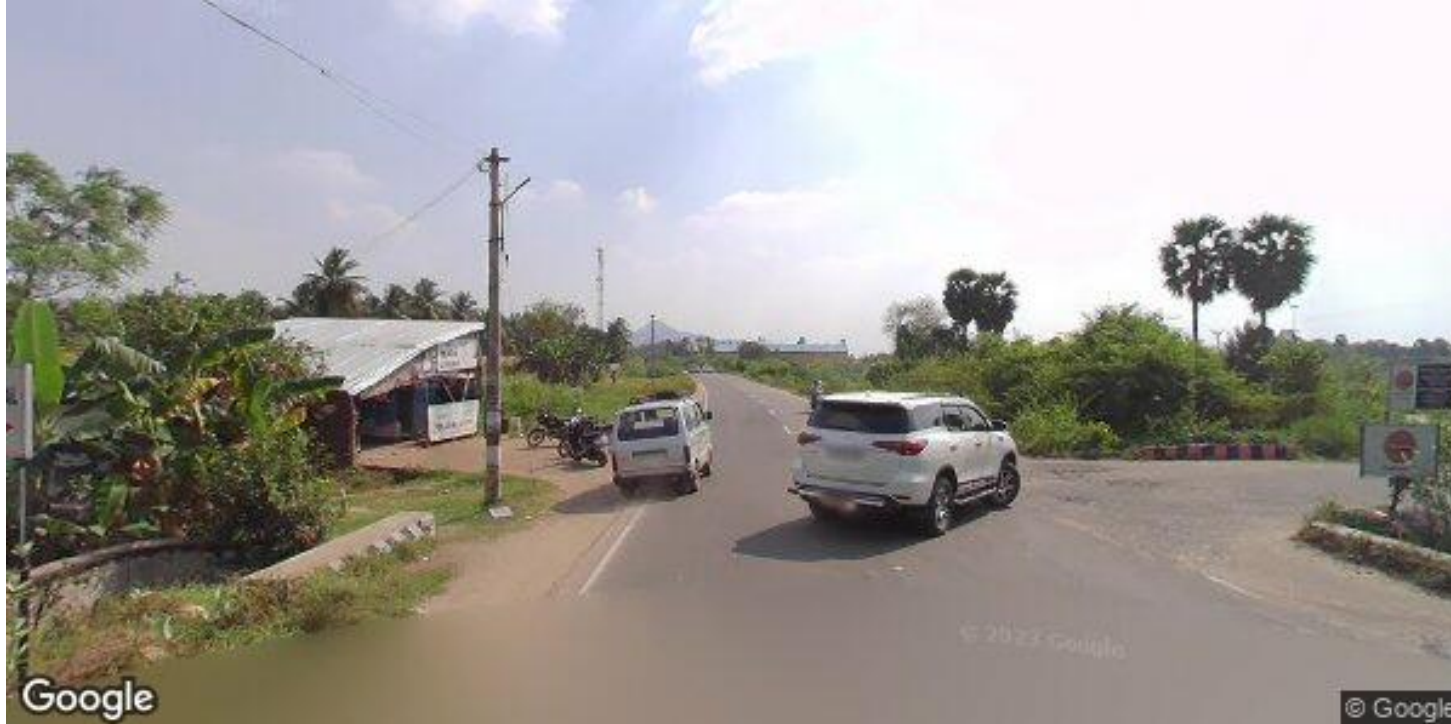
**Coordinates:** 11.44029, 77.87544

| | Risk Type | Risk Level | Coordinates | Speed Limit |
|---|---|---|---|---|
| 3 | Turn | High | 11.44029, 77.87544 | 15 KM/Hr |

**Risk Type:** Turn

**Risk Level:** High

**Speed Limit:** 15 KM/Hr

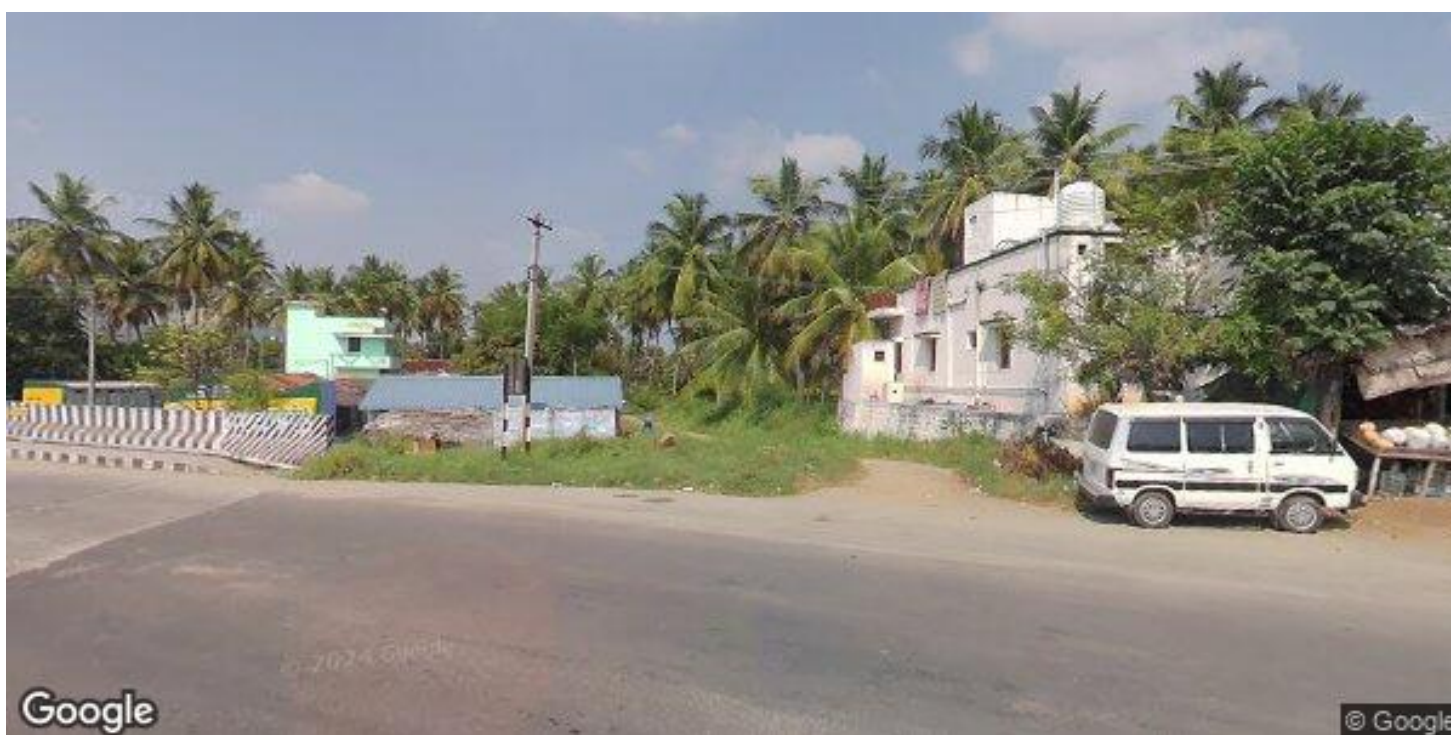
**Coordinates:** 11.44898, 77.87410

| | Risk Type | Risk Level | Coordinates | Speed Limit |
|---|---|---|---|---|
| 4 | Turn | Medium | 11.44898, 77.87410 | 30 KM/Hr |

**Risk Type:** Turn

**Risk Level:** Medium

**Speed Limit:** 30 KM/Hr

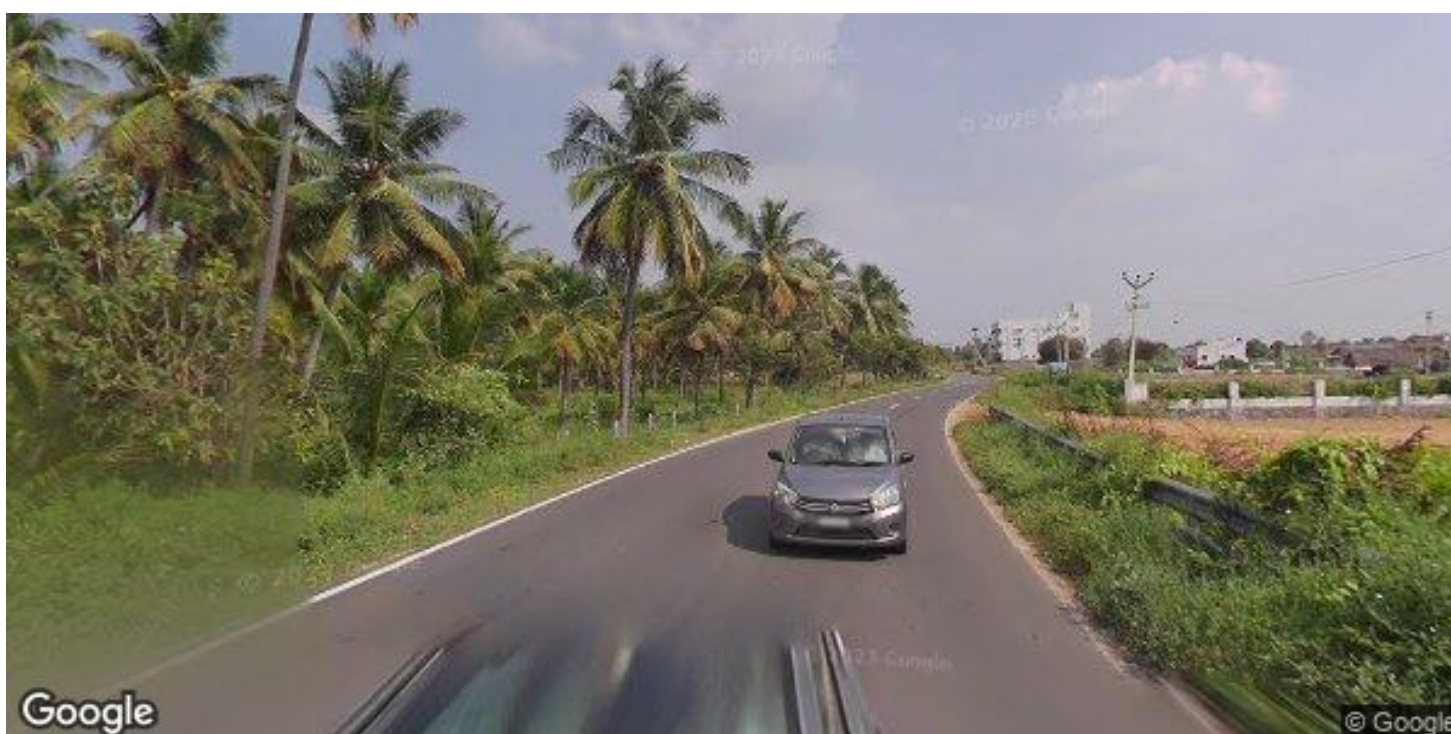
**Coordinates: 11.45357, 77.85789**

| | Risk Type | Risk Level | Coordinates | Speed Limit |
|---|---|---|---|---|
| 5 | Turn | Medium | 11.45357, 77.85789 | 30 KM/Hr |

**Risk Type:** Turn

**Risk Level:** Medium

**Speed Limit: 30 KM/Hr**

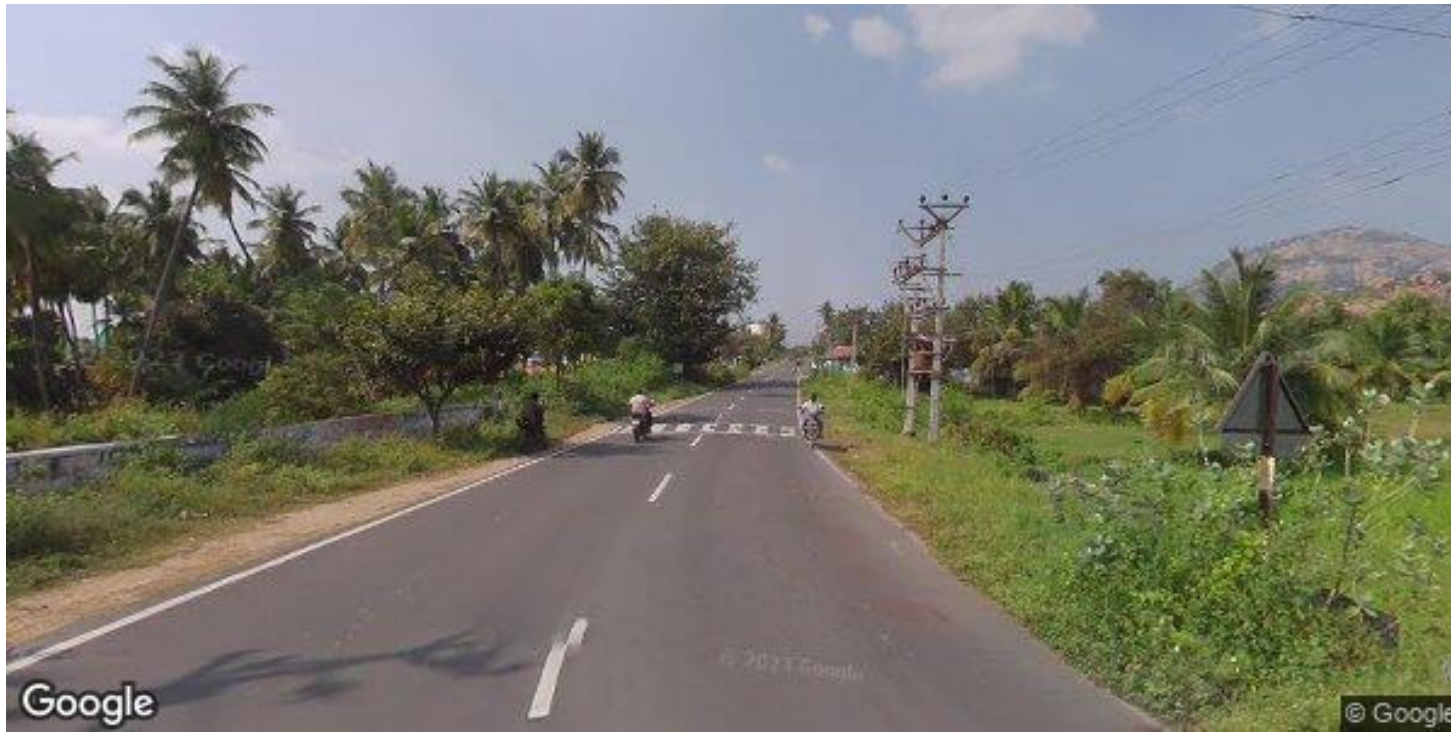
**Coordinates: 11.45352, 77.85698**

| | Risk Type | Risk Level | Coordinates | Speed Limit |
|---|---|---|---|---|
| 6 | Turn | Medium | 11.45352, 77.85698 | 30 KM/Hr |

**Risk Type: Turn**

**Risk Level: Medium**

**Speed Limit: 30 KM/Hr**

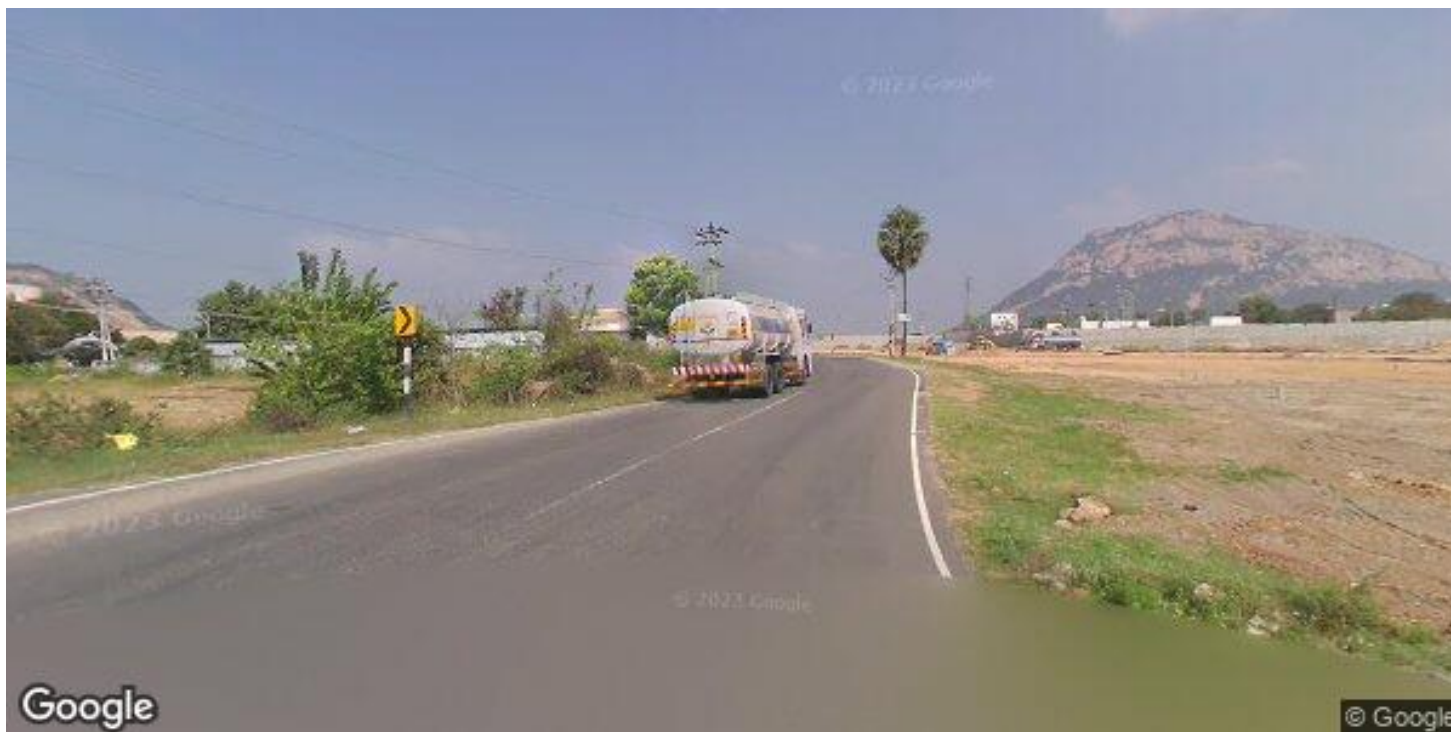
**Coordinates: 11.45847, 77.85140**

| | Risk Type | Risk Level | Coordinates | Speed Limit |
|---|---|---|---|---|
| 7 | Turn | Medium | 11.45847, 77.85140 | 30 KM/Hr |

**Risk Type: Turn**

**Risk Level: Medium**

**Speed Limit: 30 KM/Hr**

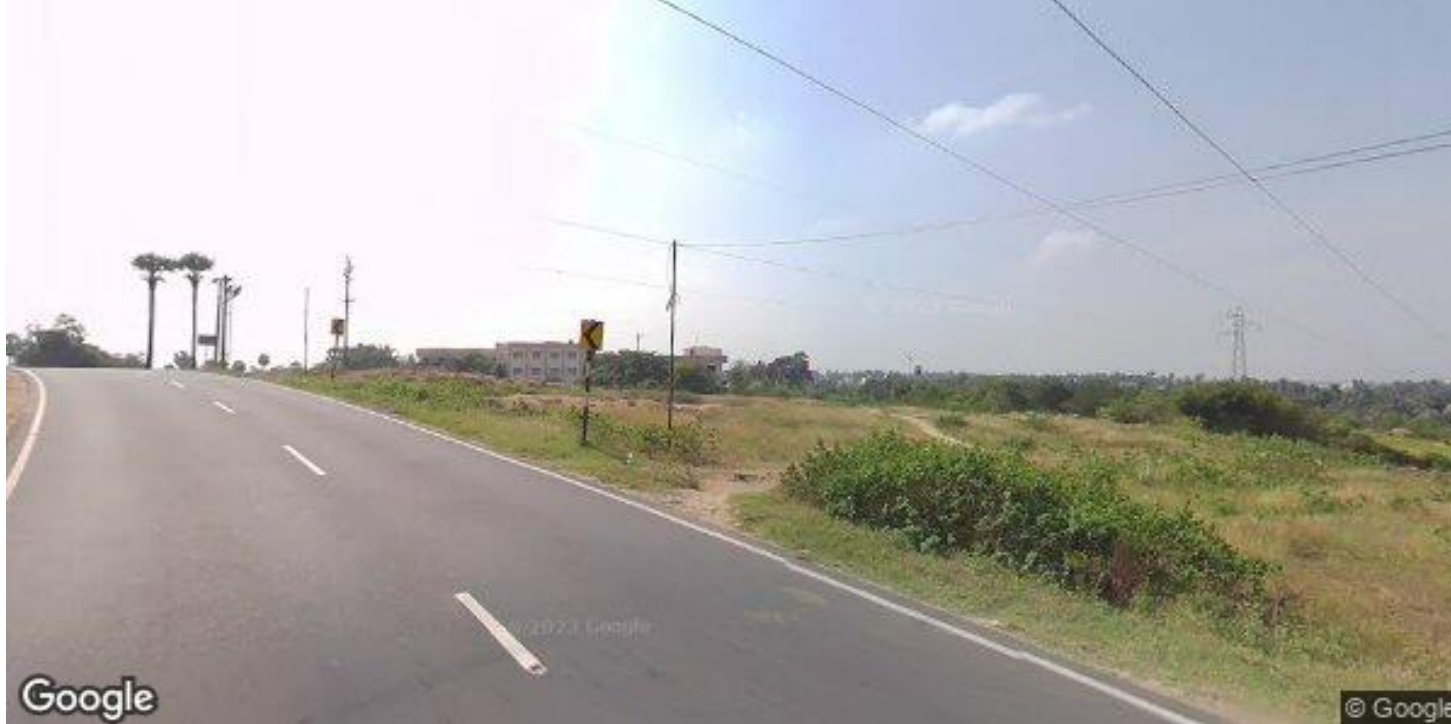
| | Risk Type | Risk Level | Coordinates | Speed Limit |
|---|---|---|---|---|
| 8 | Turn | Medium | 11.46048, 77.85036 | 30 KM/Hr |

**Risk Type:** Turn  
**Risk Level:** Medium  
**Speed Limit:** 30 KM/Hr  
**Coordinates:** 11.46048, 77.85036

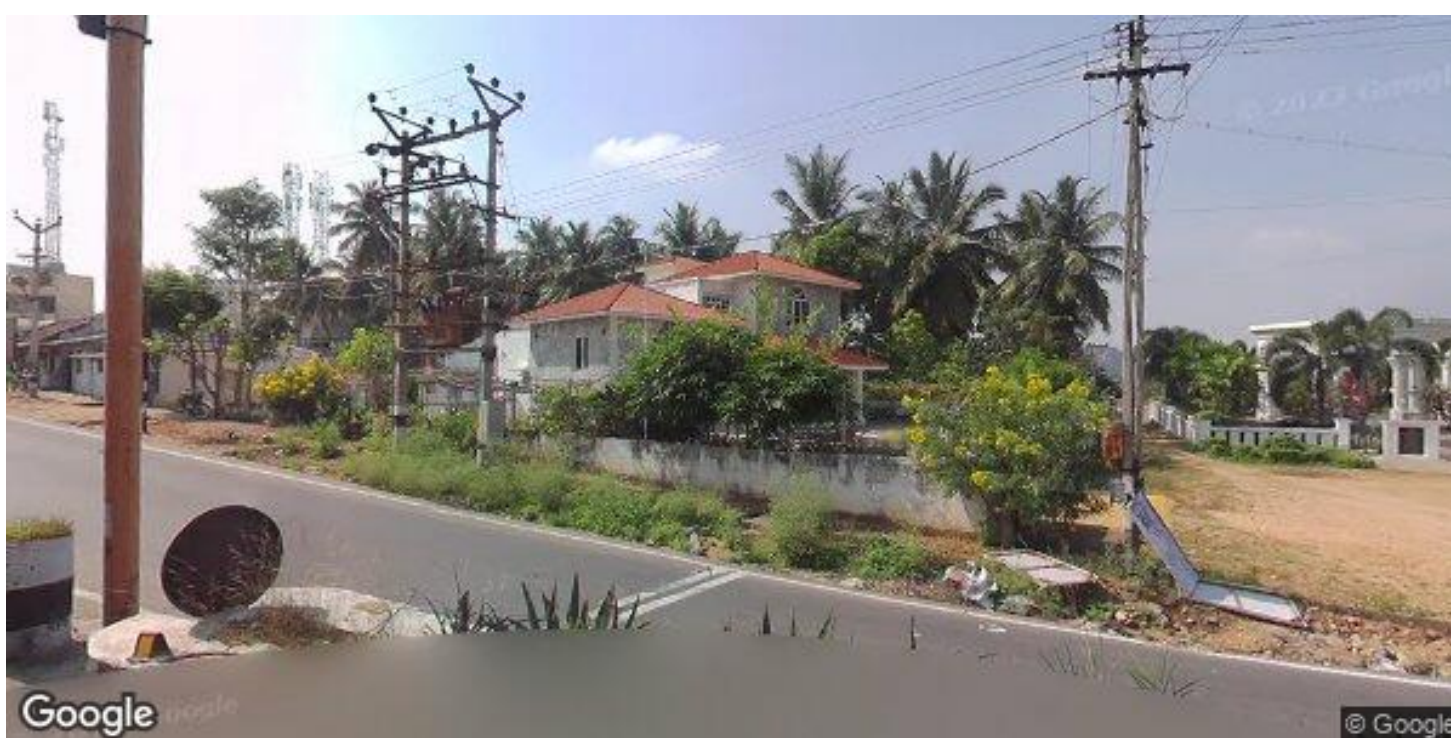
| | Risk Type | Risk Level | Coordinates | Speed Limit |
|---|---|---|---|---|
| 9 | Turn | Medium | 11.46303, 77.84945 | 30 KM/Hr |

**Risk Type:** Turn  
**Risk Level:** Medium  
**Speed Limit:** 30 KM/Hr  
**Coordinates:** 11.46303, 77.84945

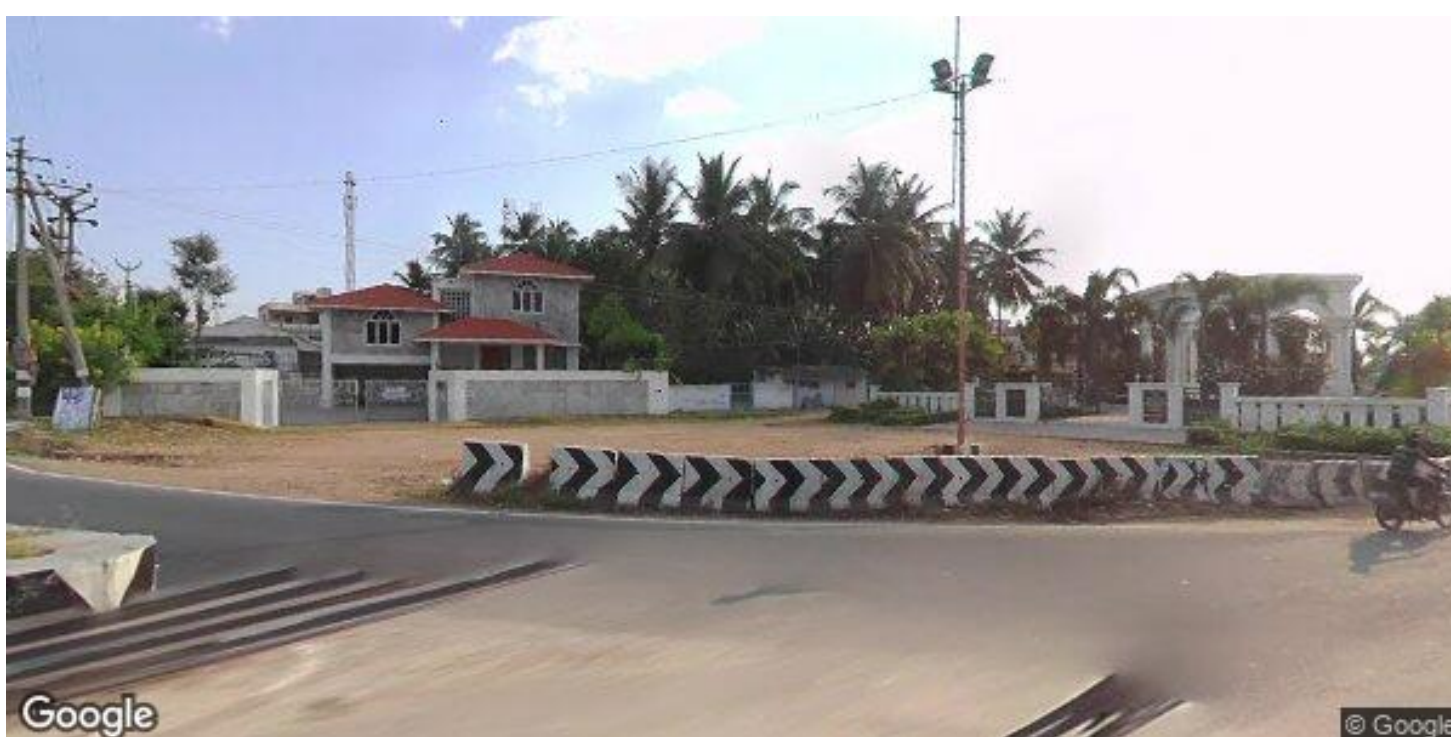
**Coordinates: 11.46314, 77.84928**

| | Risk Type | Risk Level | Coordinates | Speed Limit |
|---|---|---|---|---|
| 10 | Turn | Medium | 11.46314, 77.84928 | 30 KM/Hr |

**Risk Type:** Turn  
**Risk Level:** Medium

**Speed Limit: 30 KM/Hr**

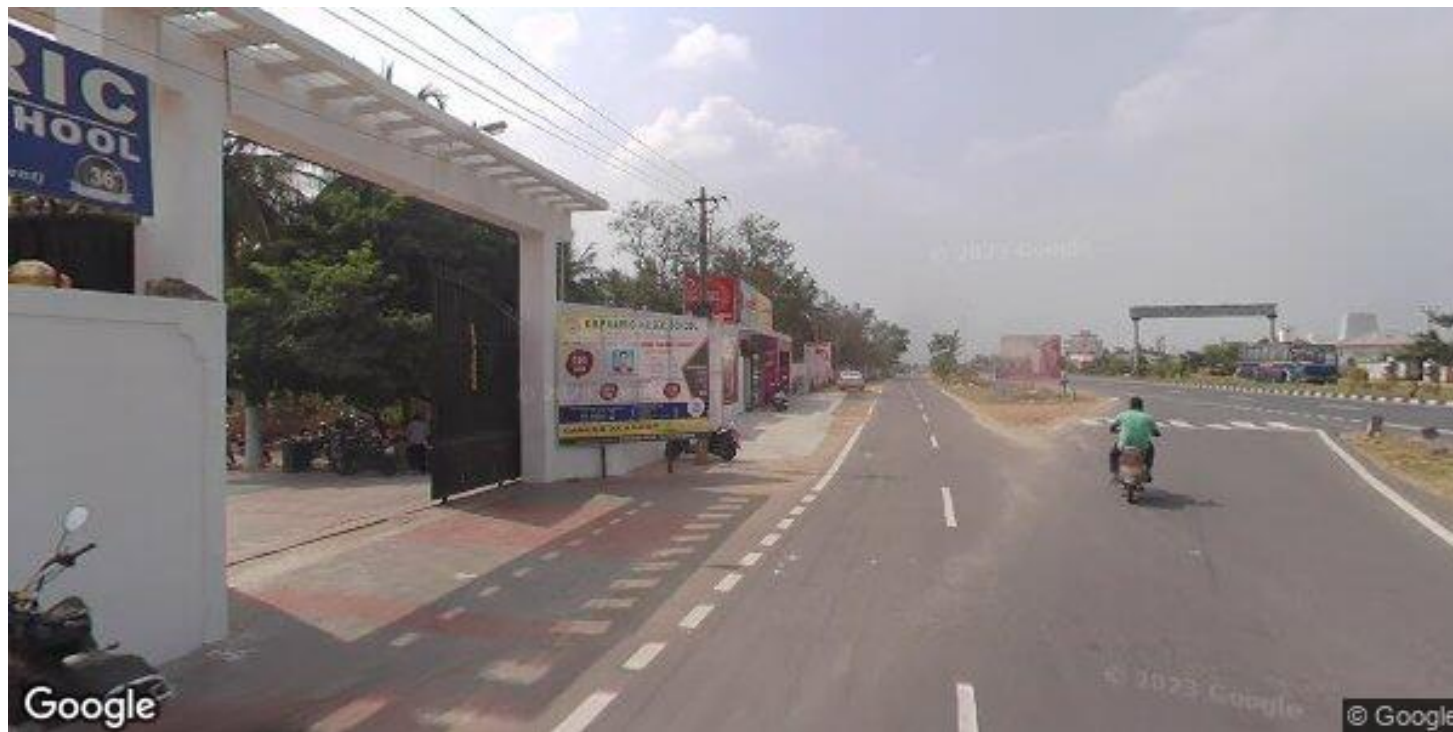
**Coordinates: 11.45509, 77.81383**

| | Risk Type | Risk Level | Coordinates | Speed Limit |
|---|---|---|---|---|
| 11 | Turn | Medium | 11.45509, 77.81383 | 30 KM/Hr |

**Risk Type: Turn**

**Risk Level: Medium**

**Speed Limit: 30 KM/Hr**

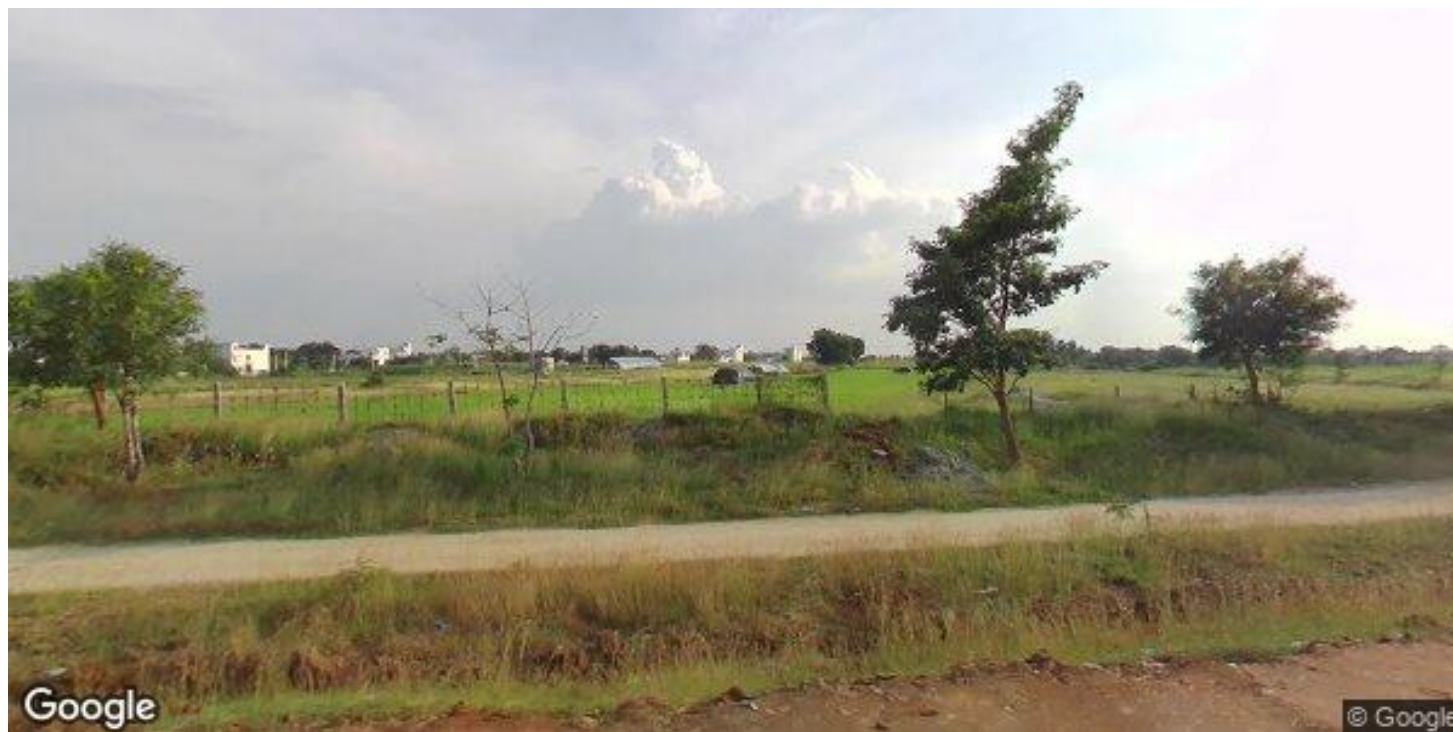
**Coordinates: 11.29288, 77.59029**

| | Risk Type | Risk Level | Coordinates | Speed Limit |
|---|---|---|---|---|
| 12 | Turn | Medium | 11.29288, 77.59029 | 30 KM/Hr |

**Risk Type: Turn**

**Risk Level: Medium**

**Speed Limit: 30 KM/Hr**

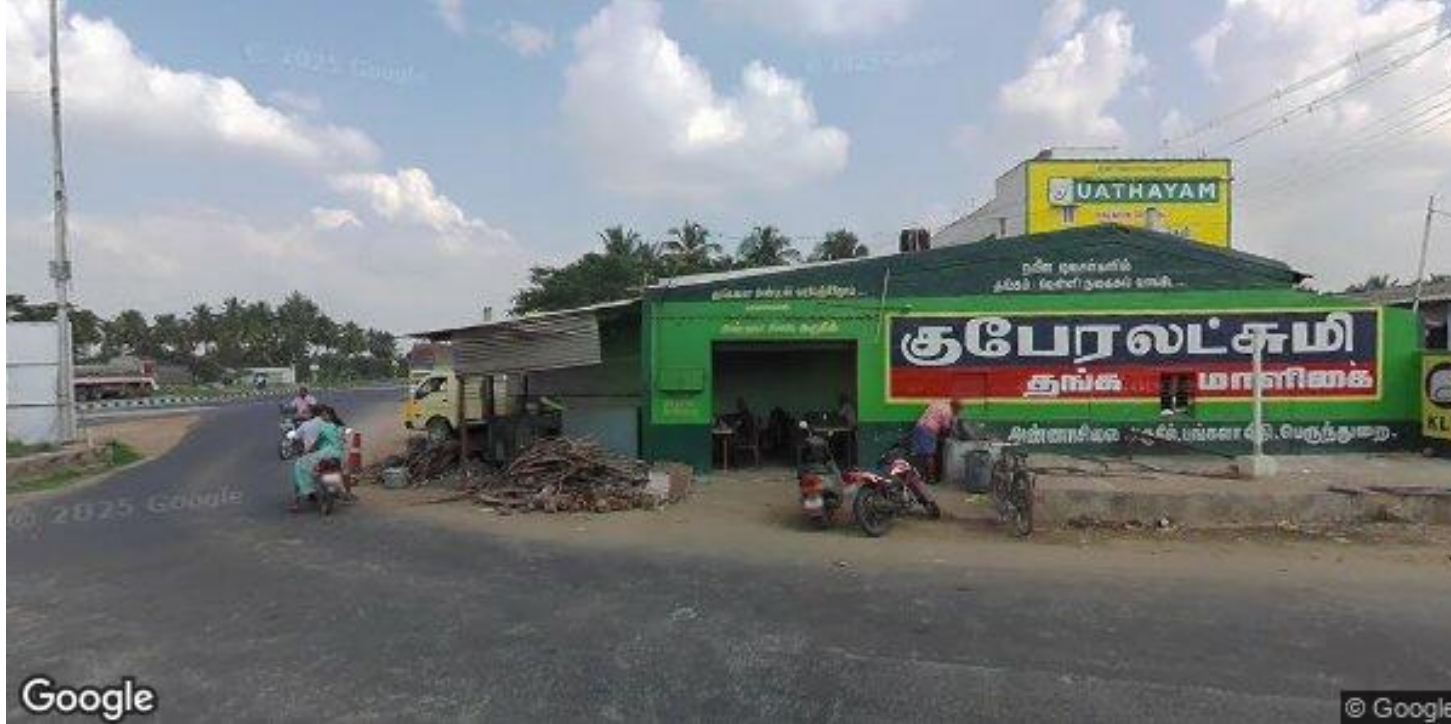
**Coordinates:** 11.29158, 77.58600

| | Risk Type | Risk Level | Coordinates | Speed Limit |
|---|---|---|---|---|
| 13 | Turn | High | 11.29158, 77.58600 | 15 KM/Hr |

**Risk Type:** Turn

**Risk Level:** High

**Speed Limit:** 15 KM/Hr

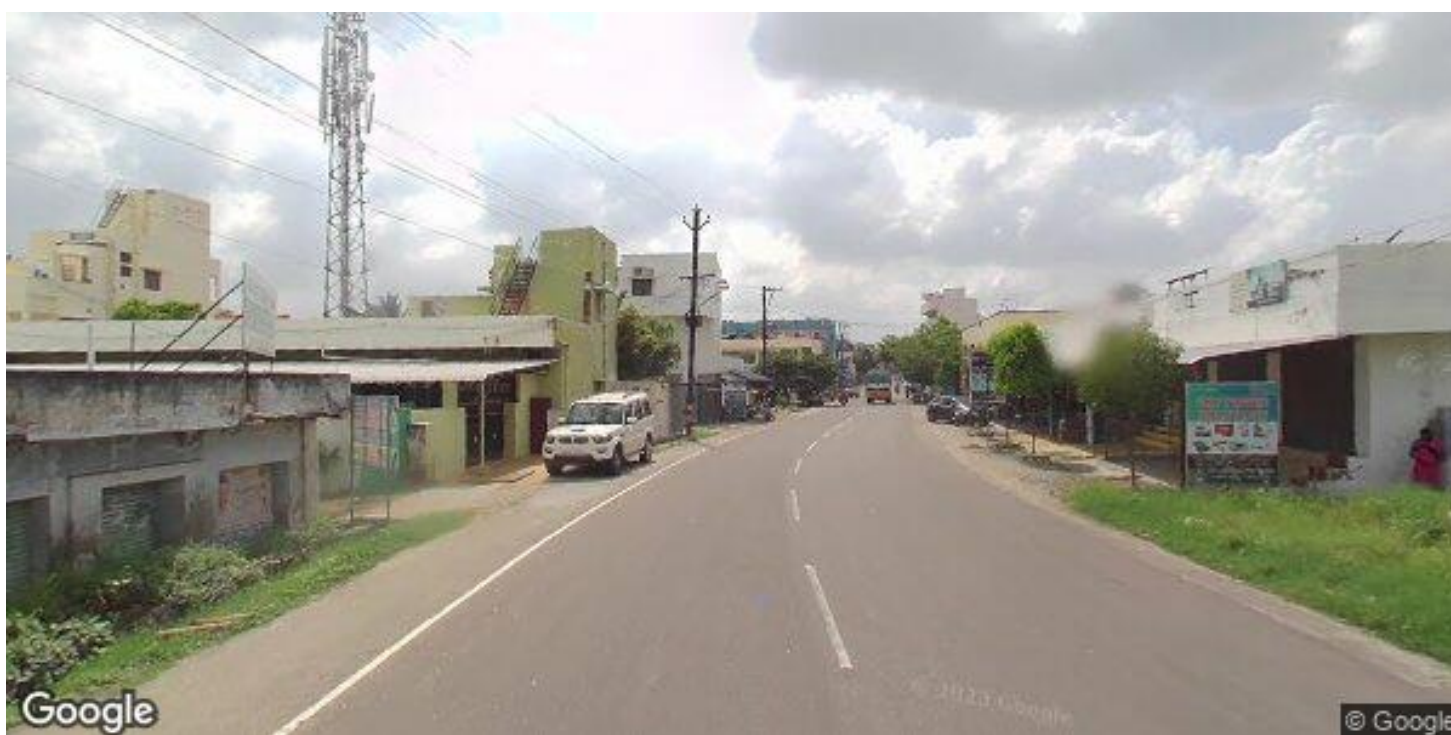
**Coordinates:** 11.28223, 77.58511

| | Risk Type | Risk Level | Coordinates | Speed Limit |
|---|---|---|---|---|
| 14 | Turn | Medium | 11.28223, 77.58511 | 30 KM/Hr |

**Risk Type:** Turn

**Risk Level:** Medium

**Speed Limit:** 30 KM/Hr

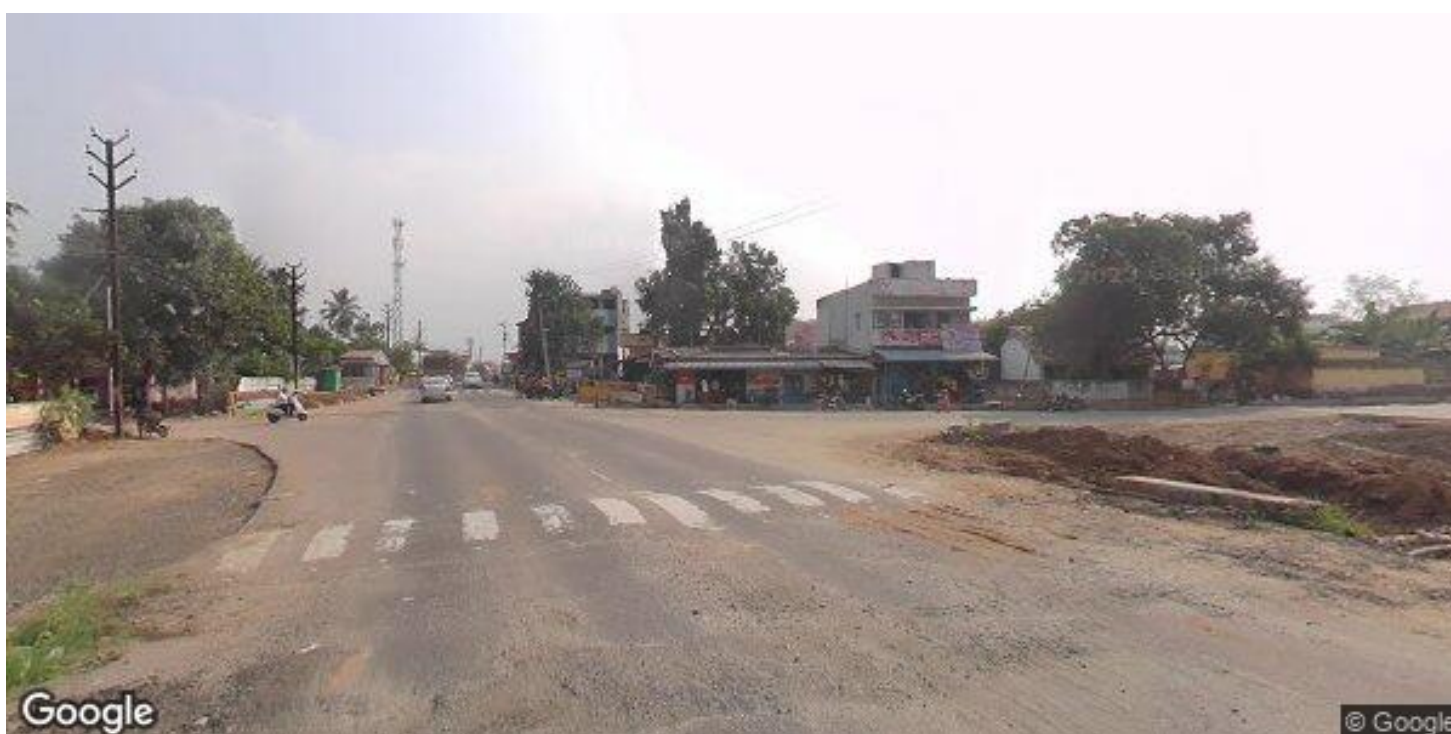
Coordinates: 11.22673, 77.58027

| | Risk Type | Risk Level | Coordinates | Speed Limit |
|---|---|---|---|---|
| 15 | Turn | Medium | 11.22673, 77.58027 | 30 KM/Hr |

**Risk Type:** Turn

**Risk Level:** Medium

Speed Limit: 30 KM/Hr

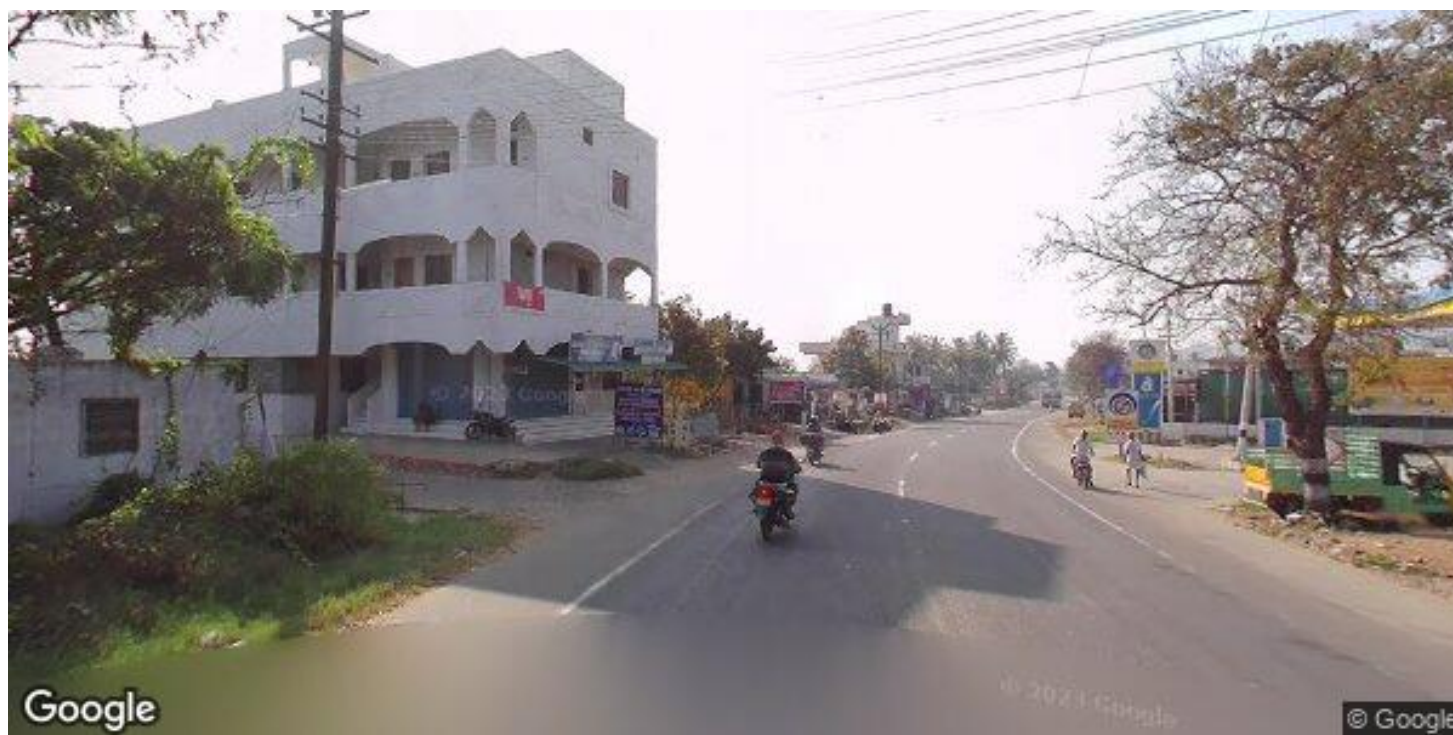
Coordinates: 11.17652, 77.59985

| | Risk Type | Risk Level | Coordinates | Speed Limit |
|---|---|---|---|---|
| 16 | Turn | Medium | 11.17652, 77.59985 | 30 KM/Hr |

Risk Type: Turn

Risk Level: Medium

Speed Limit: 30 KM/Hr

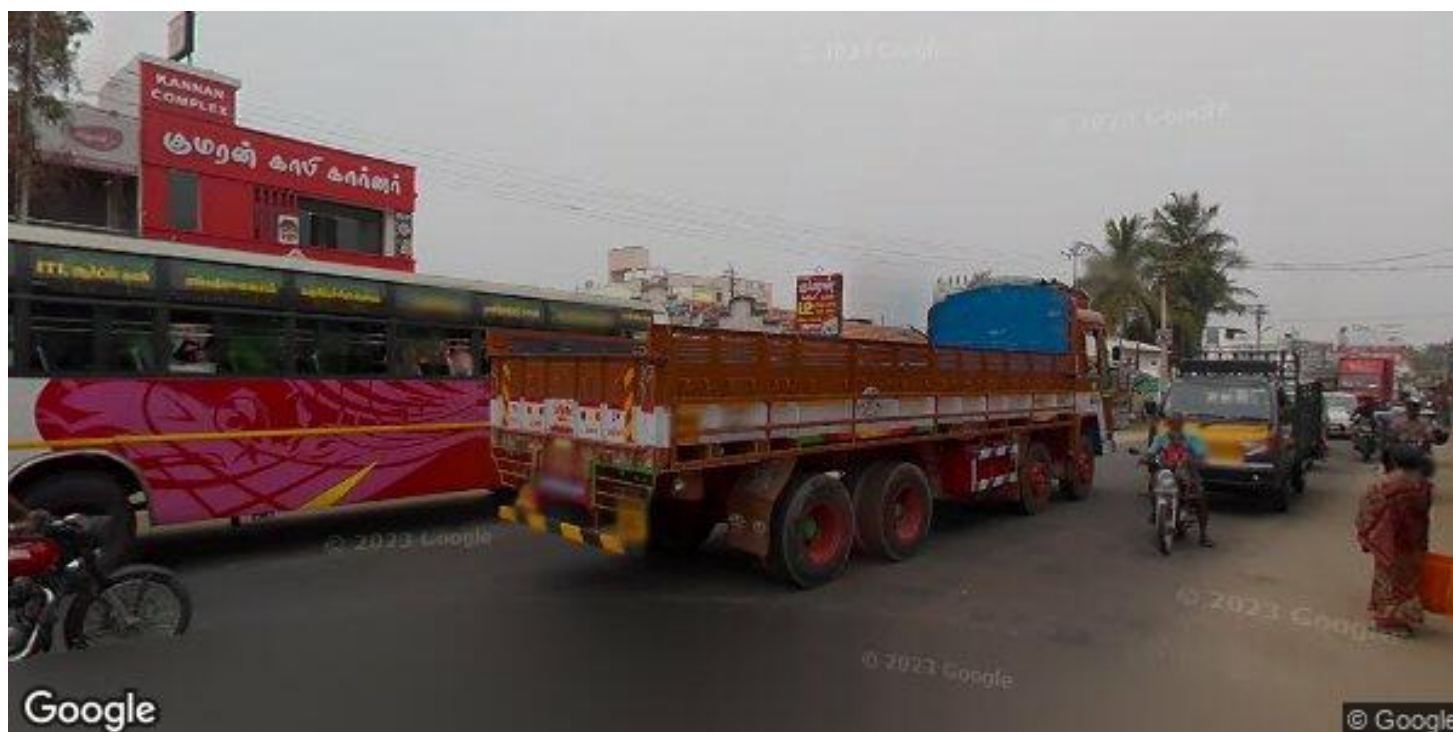
Coordinates: 11.16555, 77.60233

| | Risk Type | Risk Level | Coordinates | Speed Limit |
|---|---|---|---|---|
| 17 | Turn | Medium | 11.16555, 77.60233 | 30 KM/Hr |

Risk Type: Turn

Risk Level: Medium

Speed Limit: 30 KM/Hr

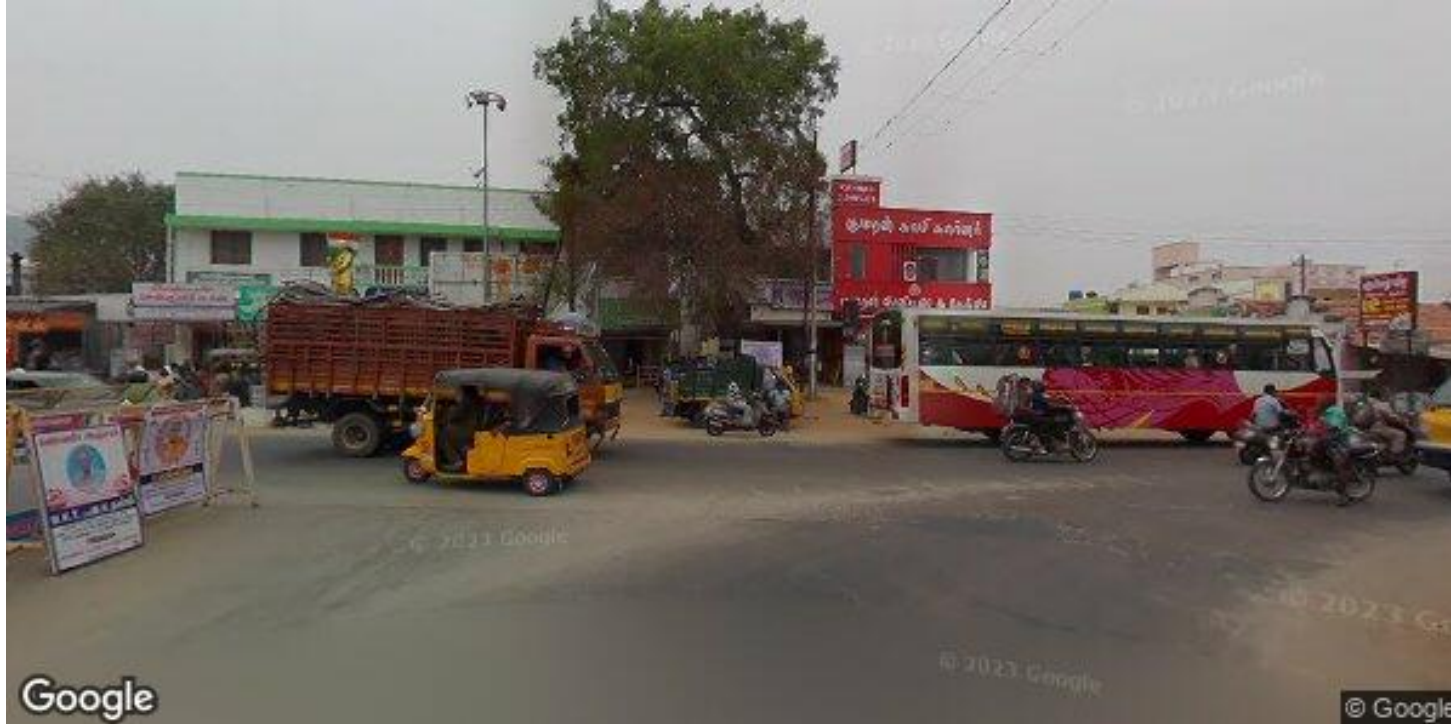
**Coordinates:** 11.16547, 77.60241

| | Risk Type | Risk Level | Coordinates | Speed Limit |
|---|---|---|---|---|
| 18 | Turn | Medium | 11.16547, 77.60241 | 30 KM/Hr |

**Risk Type:** Turn

**Risk Level:** Medium

**Speed Limit:** 30 KM/Hr

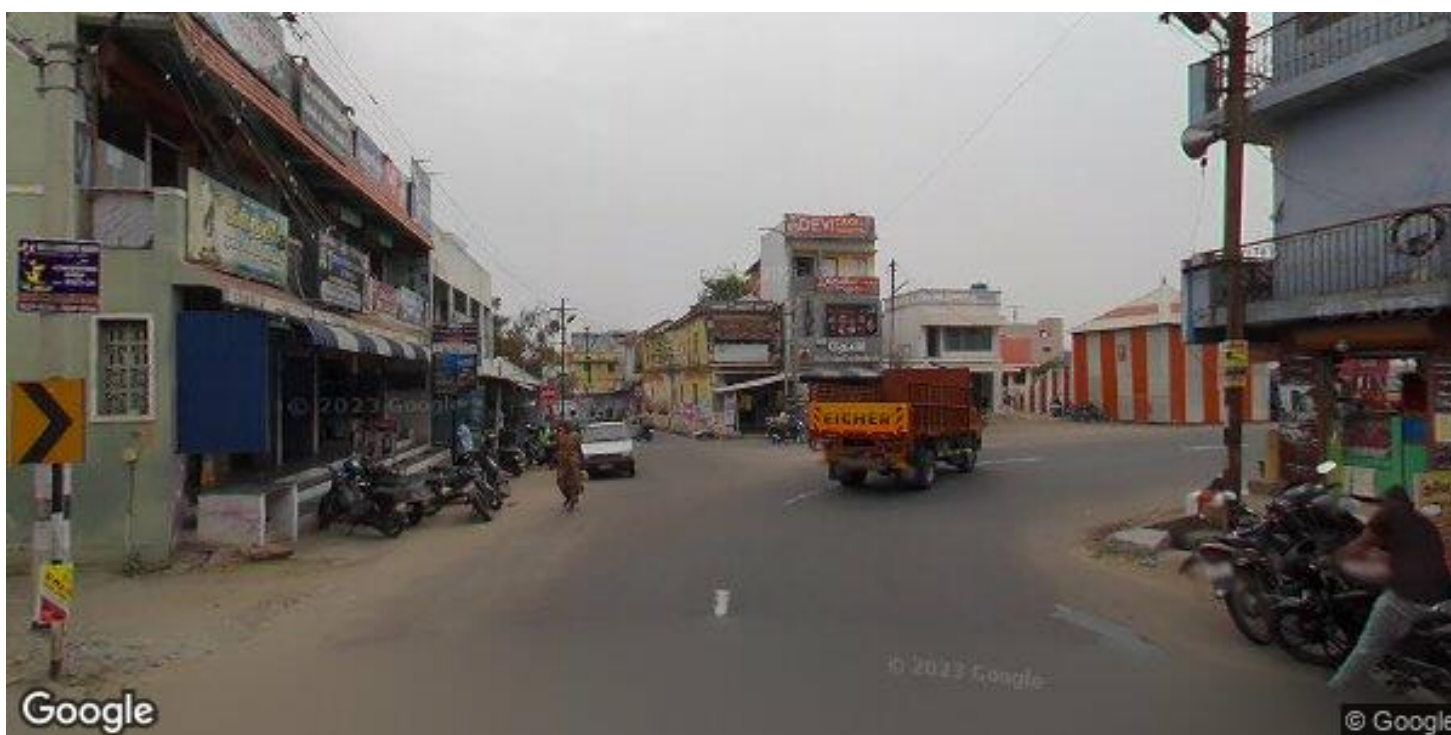
**Coordinates:** 11.16531, 77.60369

| | Risk Type | Risk Level | Coordinates | Speed Limit |
|---|---|---|---|---|
| 19 | Turn | Medium | 11.16531, 77.60369 | 30 KM/Hr |

**Risk Type:** Turn

**Risk Level:** Medium

**Speed Limit:** 30 KM/Hr

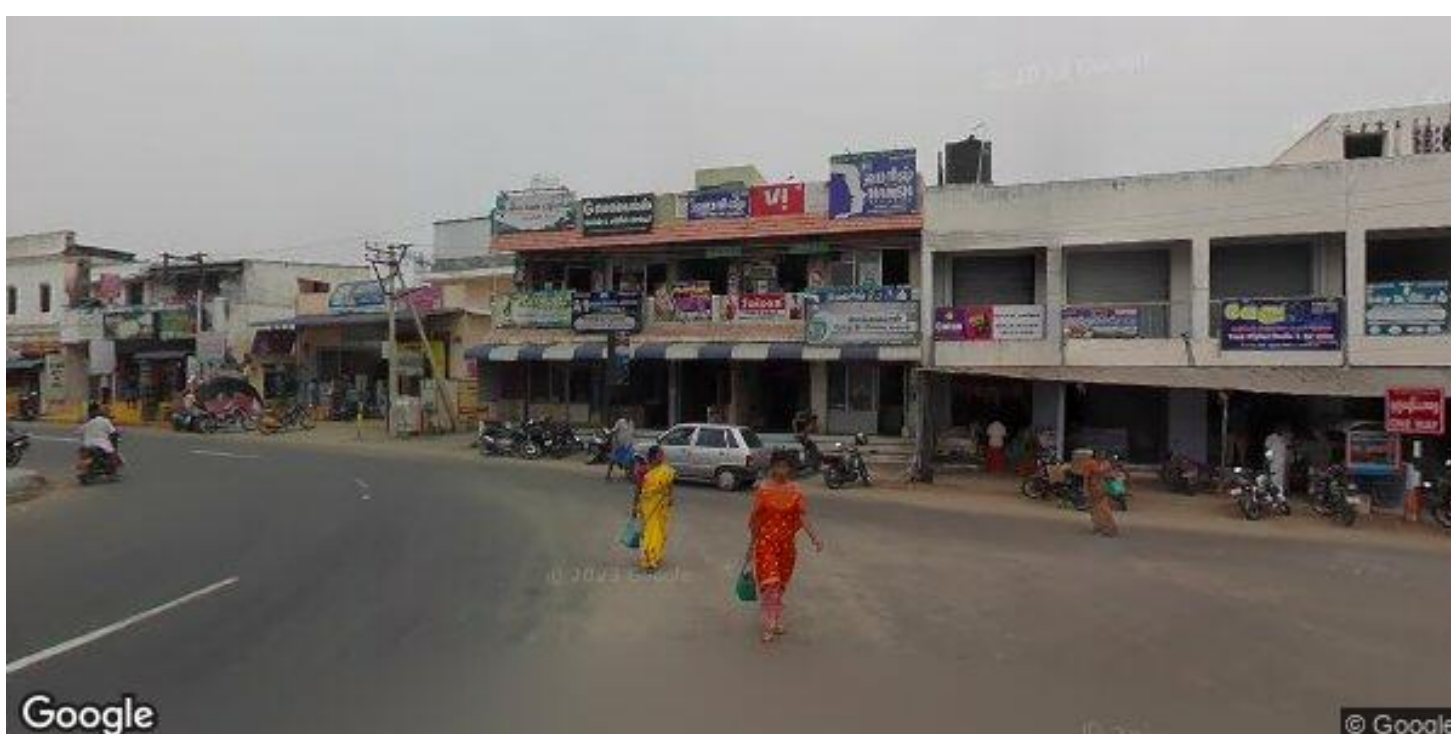
| | Risk Type | Risk Level | Coordinates | Speed Limit |
|---|---|---|---|---|
| 20 | Turn | High | 11.16521, 77.60379 | 15 KM/Hr |

**Risk Type:** Turn

**Risk Level:** High

**Speed Limit: 15 KM/Hr**  
**Coordinates: 11.16521, 77.60379**
