# IndianOil

## JOURNEY RISK MANAGEMENT (JRM) STUDY

### Salem Terminal TO KATHIRESWAR & CO

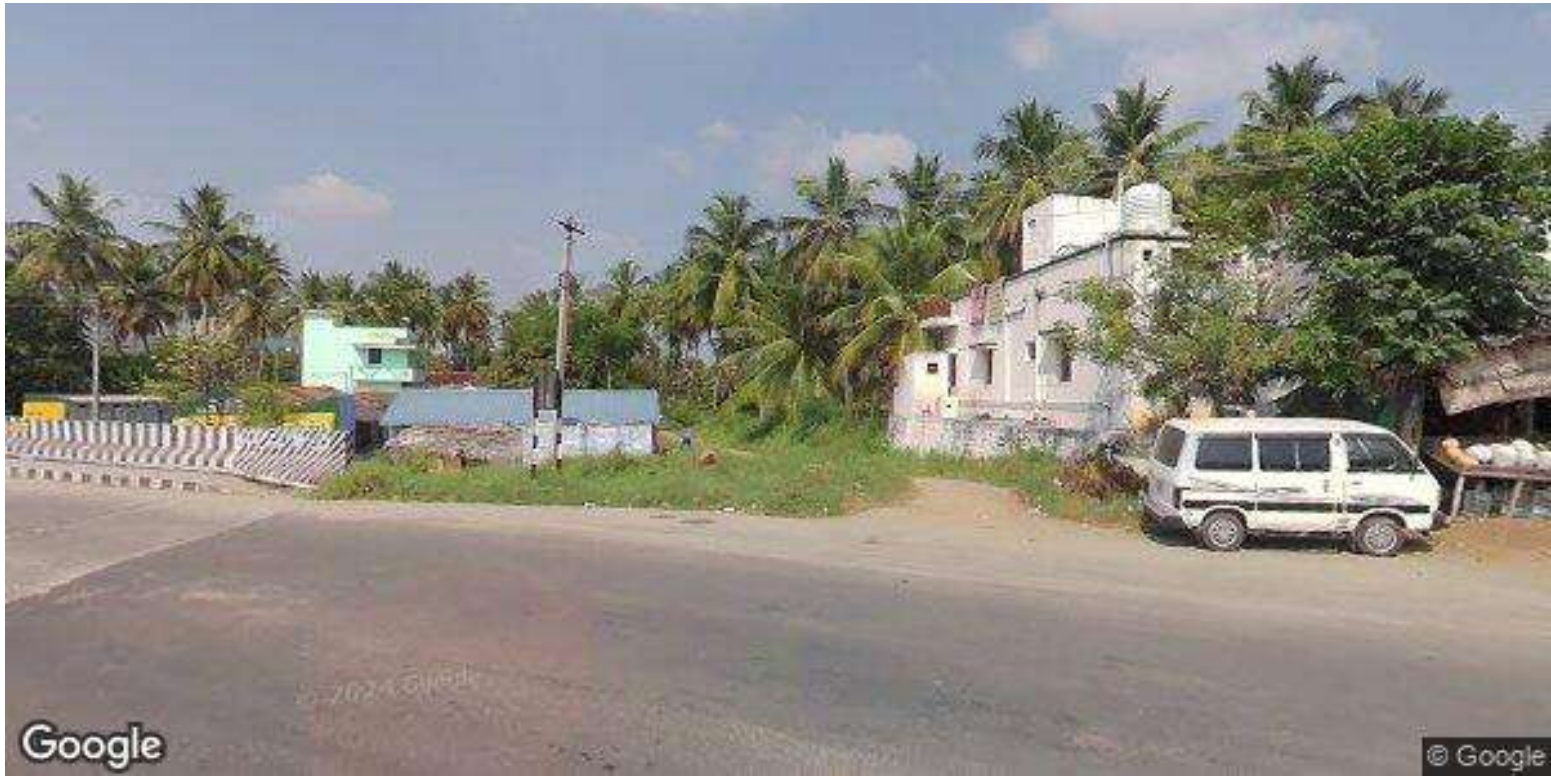
| | Risk Type | Risk Level | Coordinates | Speed Limit |
|---|---|---|---|---|
| 3 | Turn | Medium | 11.44898, 77.87410 | 30 KM/Hr |

**Risk Type:** Turn  
**Risk Level:** Medium  
**Speed Limit:** 30 KM/Hr  
**Coordinates:** 11.44898, 77.87410

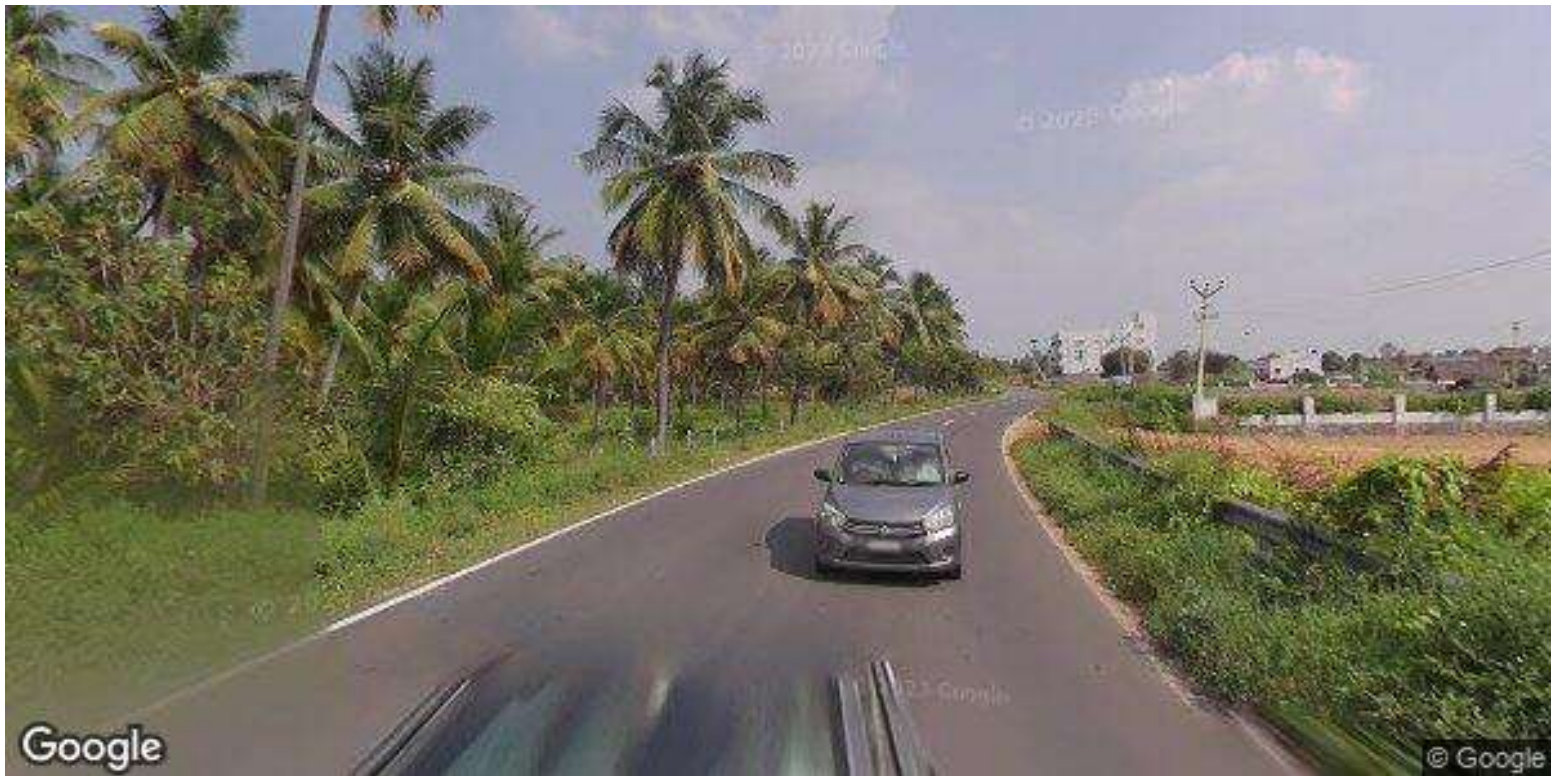
| | Risk Type | Risk Level | Coordinates | Speed Limit |
|---|---|---|---|---|
| 4 | Turn | Medium | 11.45357, 77.85789 | 30 KM/Hr |

**Risk Type:** Turn  
**Risk Level:** Medium  
**Speed Limit:** 30 KM/Hr  
**Coordinates:** 11.45357, 77.85789

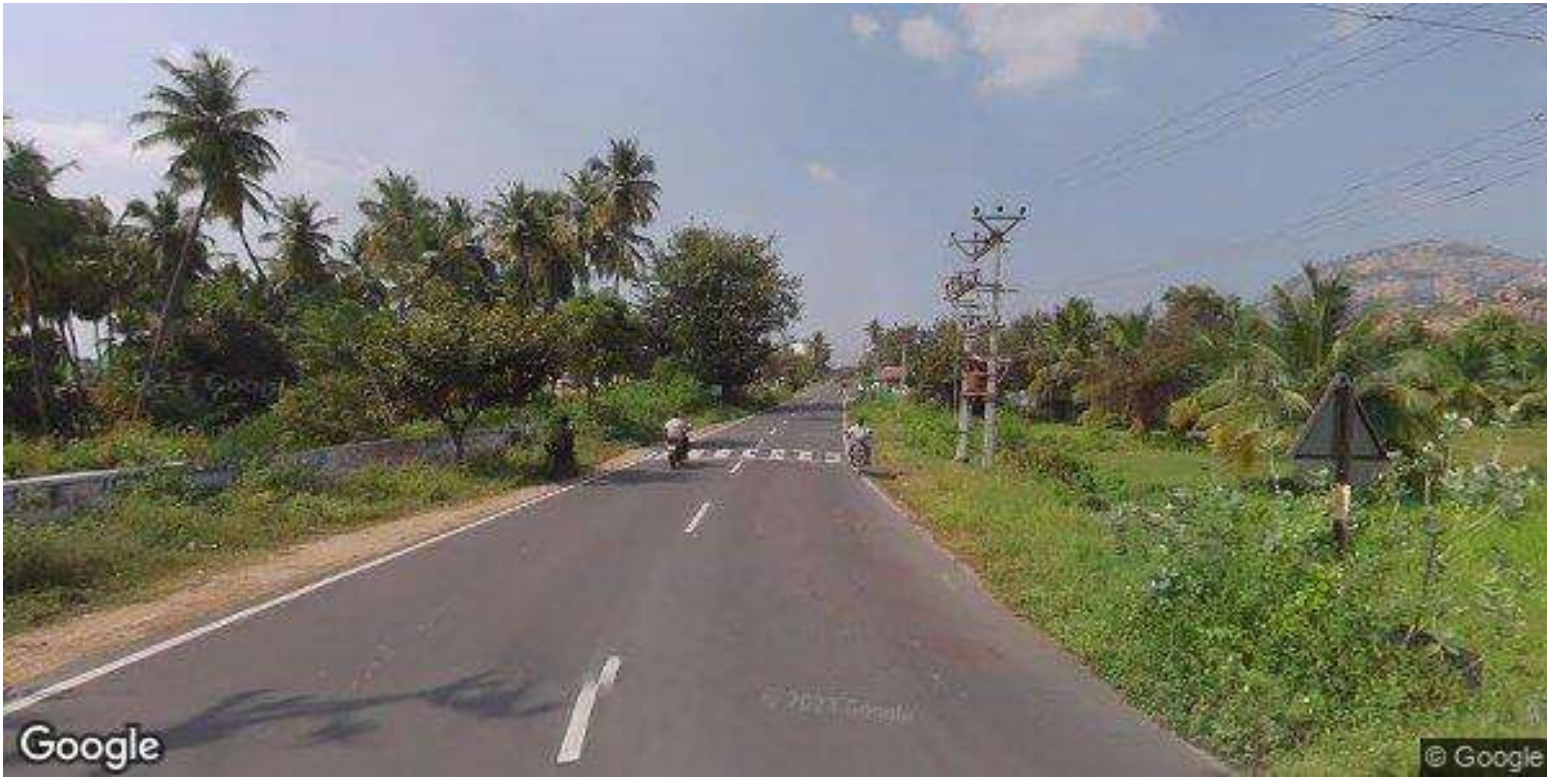
| | Risk Type | Risk Level | Coordinates | Speed Limit |
|---|---|---|---|---|
| 5 | Turn | Medium | 11.45352, 77.85698 | 30 KM/Hr |

**Risk Type:** Turn  
**Risk Level:** Medium  
**Speed Limit:** 30 KM/Hr  
**Coordinates:** 11.45352, 77.85698

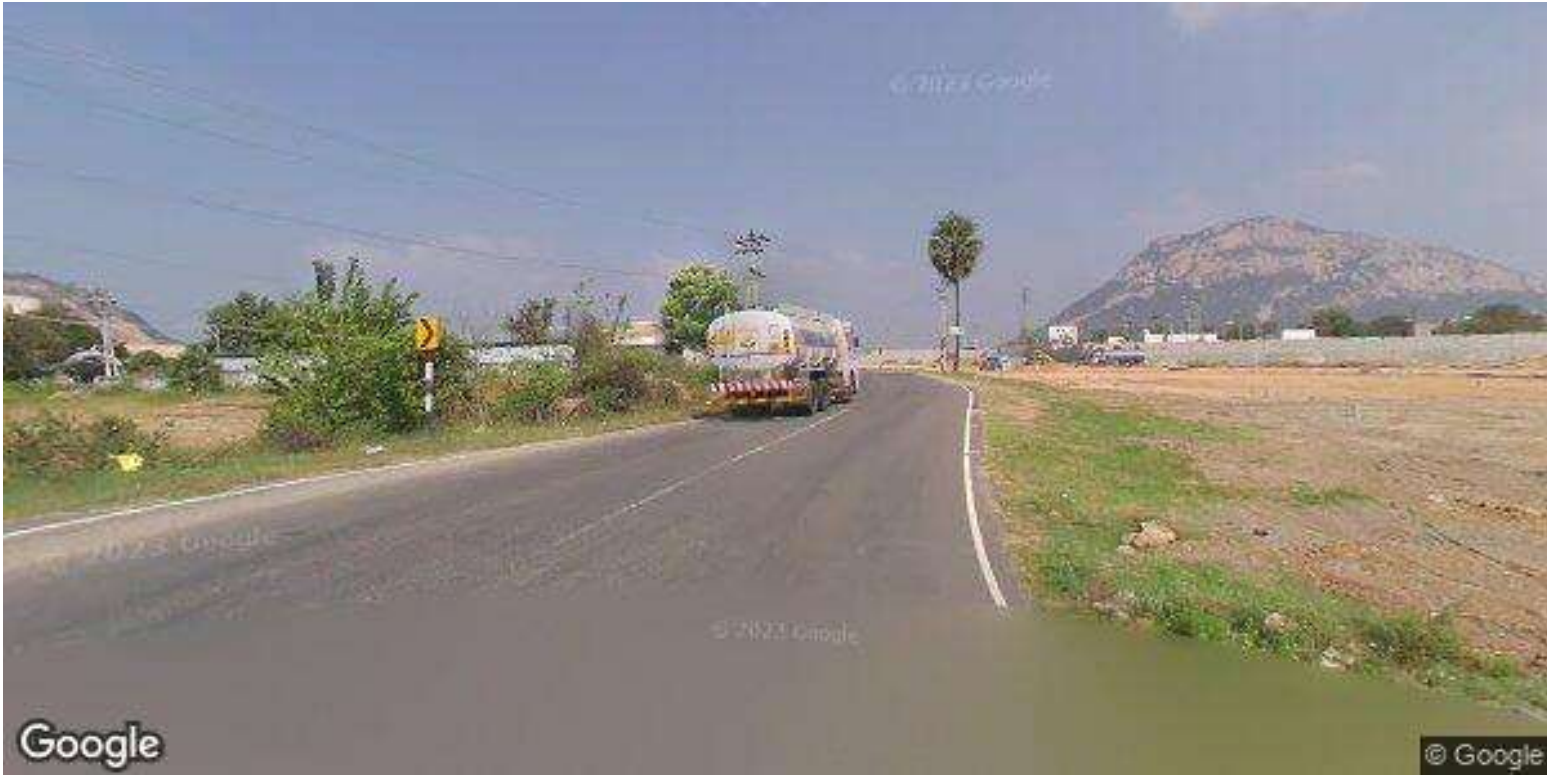
| | Risk Type | Risk Level | Coordinates | Speed Limit |
|---|---|---|---|---|
| 6 | Turn | Medium | 11.45847, 77.85140 | 30 KM/Hr |

**Risk Type:** Turn  
**Risk Level:** Medium  
**Speed Limit:** 30 KM/Hr  
**Coordinates:** 11.45847, 77.85140

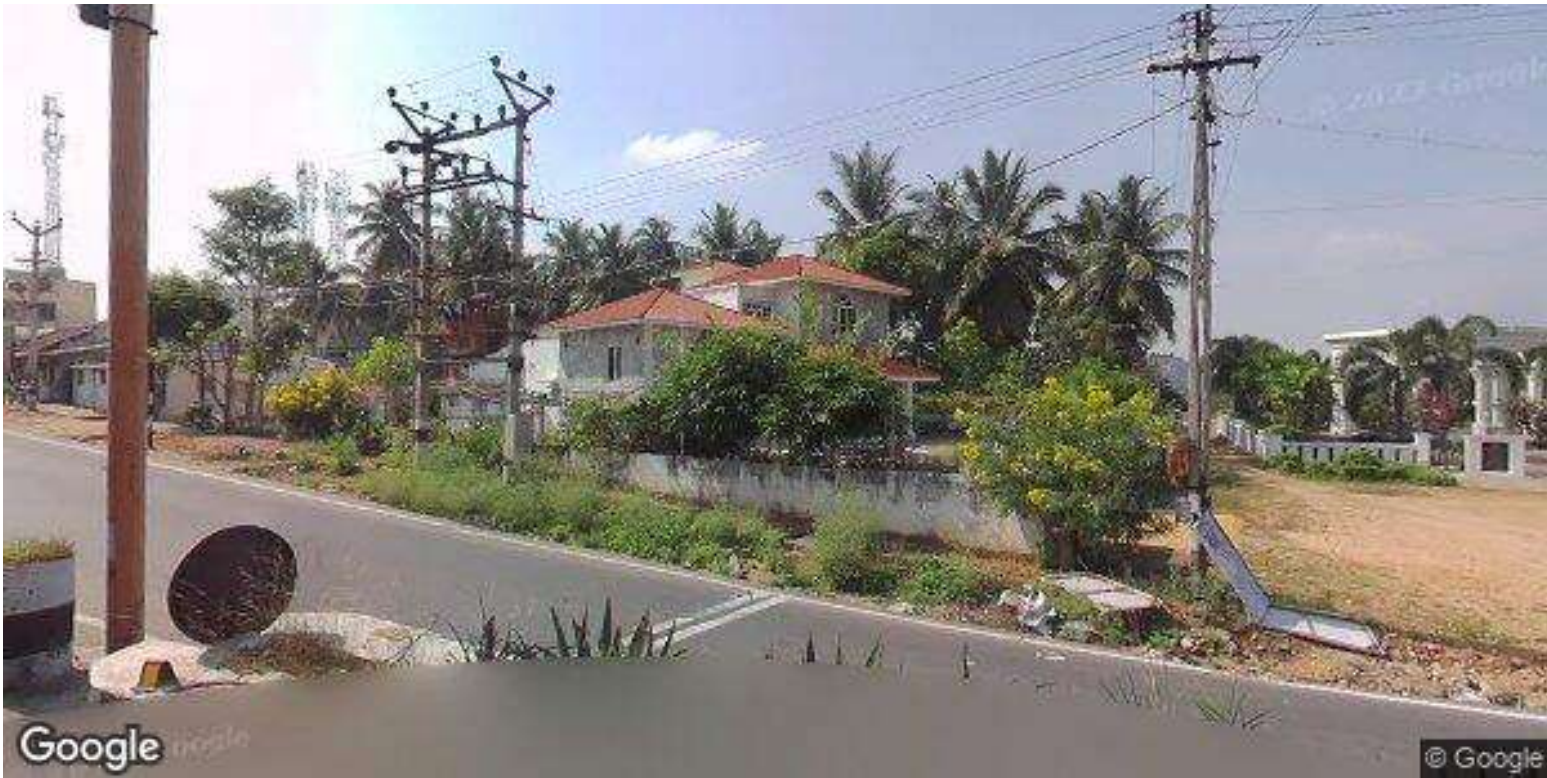
| | Risk Type | Risk Level | Coordinates | Speed Limit |
|---|---|---|---|---|
| 7 | Turn | Medium | 11.46303, 77.84945 | 30 KM/Hr |

**Risk Type:** Turn  
**Risk Level:** Medium  
**Speed Limit:** 30 KM/Hr  
**Coordinates:** 11.46303, 77.84945

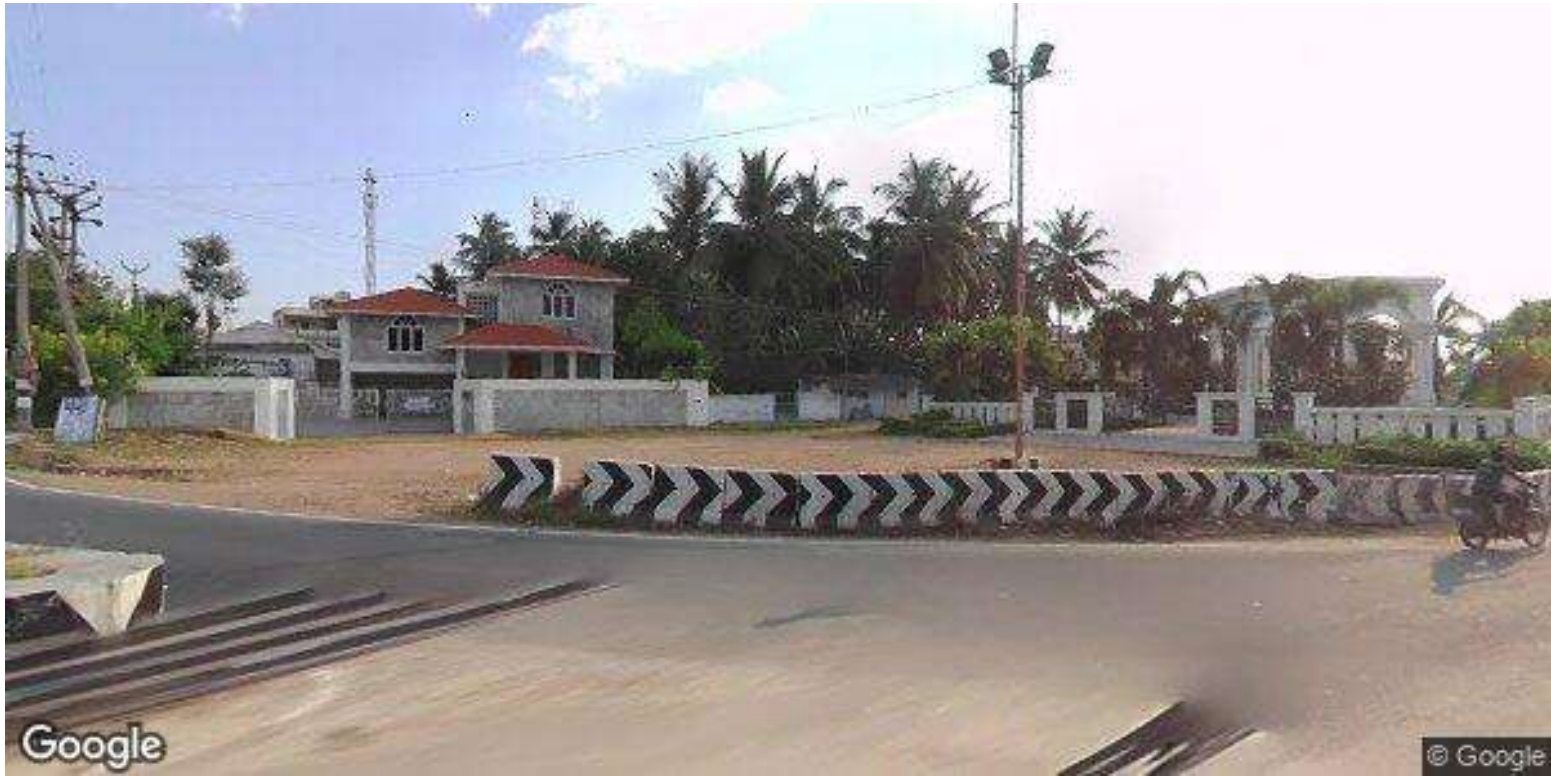
| | Risk Type | Risk Level | Coordinates | Speed Limit |
|---|---|---|---|---|
| 8 | Turn | Medium | 11.46314, 77.84928 | 30 KM/Hr |

**Risk Type:** Turn  
**Risk Level:** Medium  
**Speed Limit:** 30 KM/Hr  
**Coordinates:** 11.46314, 77.84928

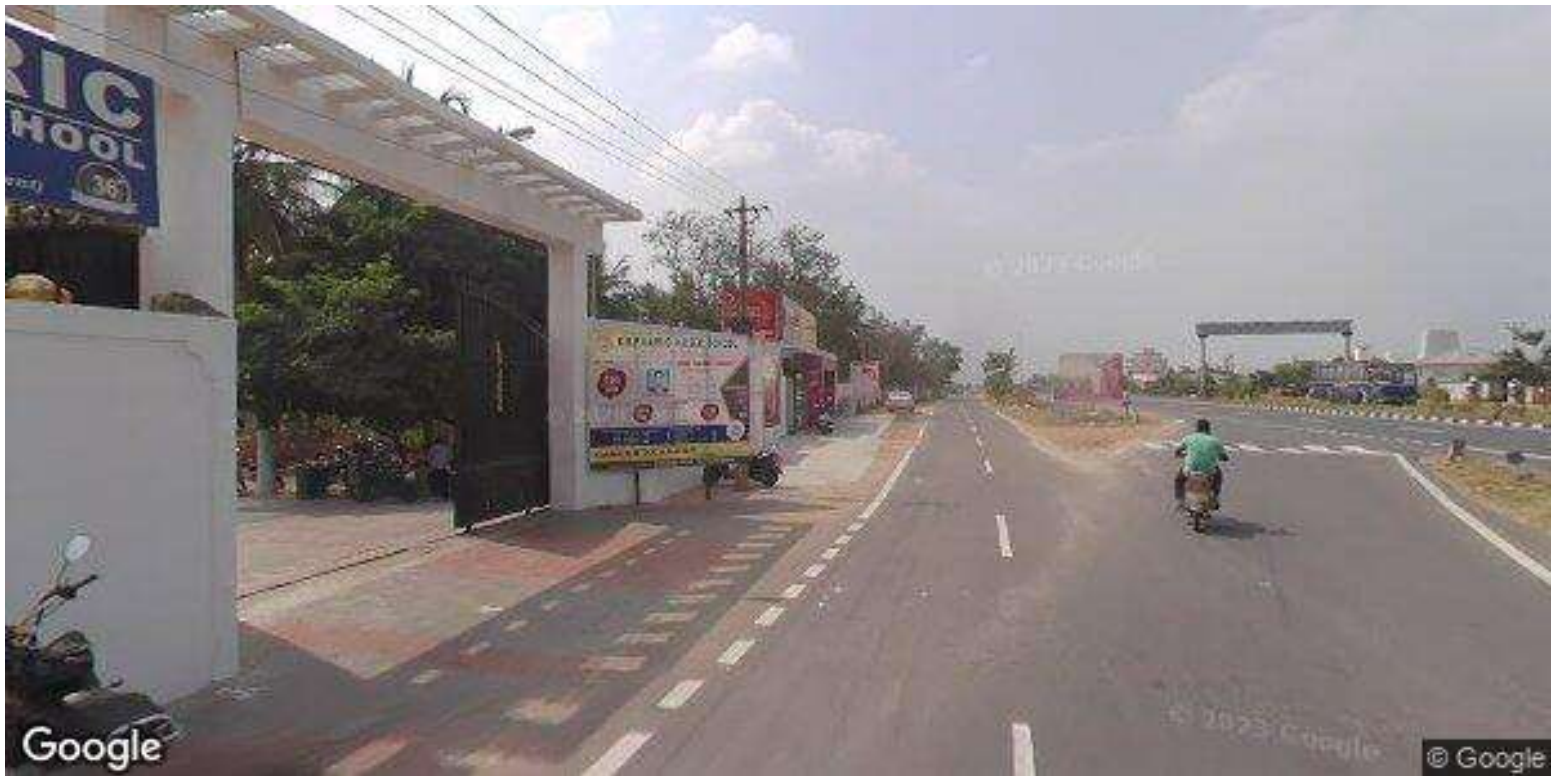
| | Risk Type | Risk Level | Coordinates | Speed Limit |
|---|---|---|---|---|
| 9 | Turn | Medium | 11.45509, 77.81383 | 30 KM/Hr |

**Risk Type:** Turn  
**Risk Level:** Medium  
**Speed Limit:** 30 KM/Hr  
**Coordinates:** 11.45509, 77.81383

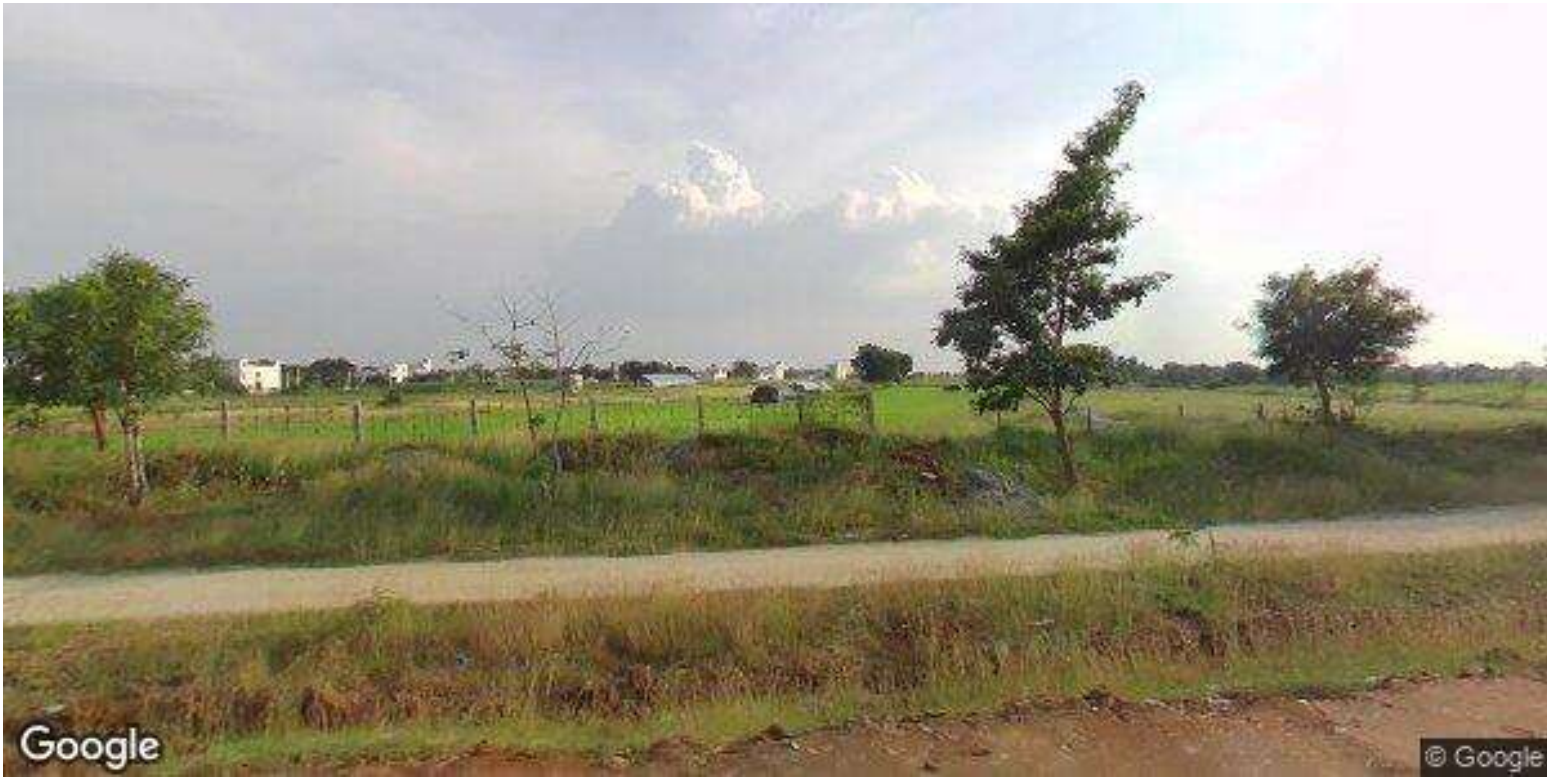
| | Risk Type | Risk Level | Coordinates | Speed Limit |
|---|---|---|---|---|
| 10 | Turn | Medium | 11.29288, 77.59029 | 30 KM/Hr |

**Risk Type:** Turn  
**Risk Level:** Medium  
**Speed Limit:** 30 KM/Hr  
**Coordinates:** 11.29288, 77.59029

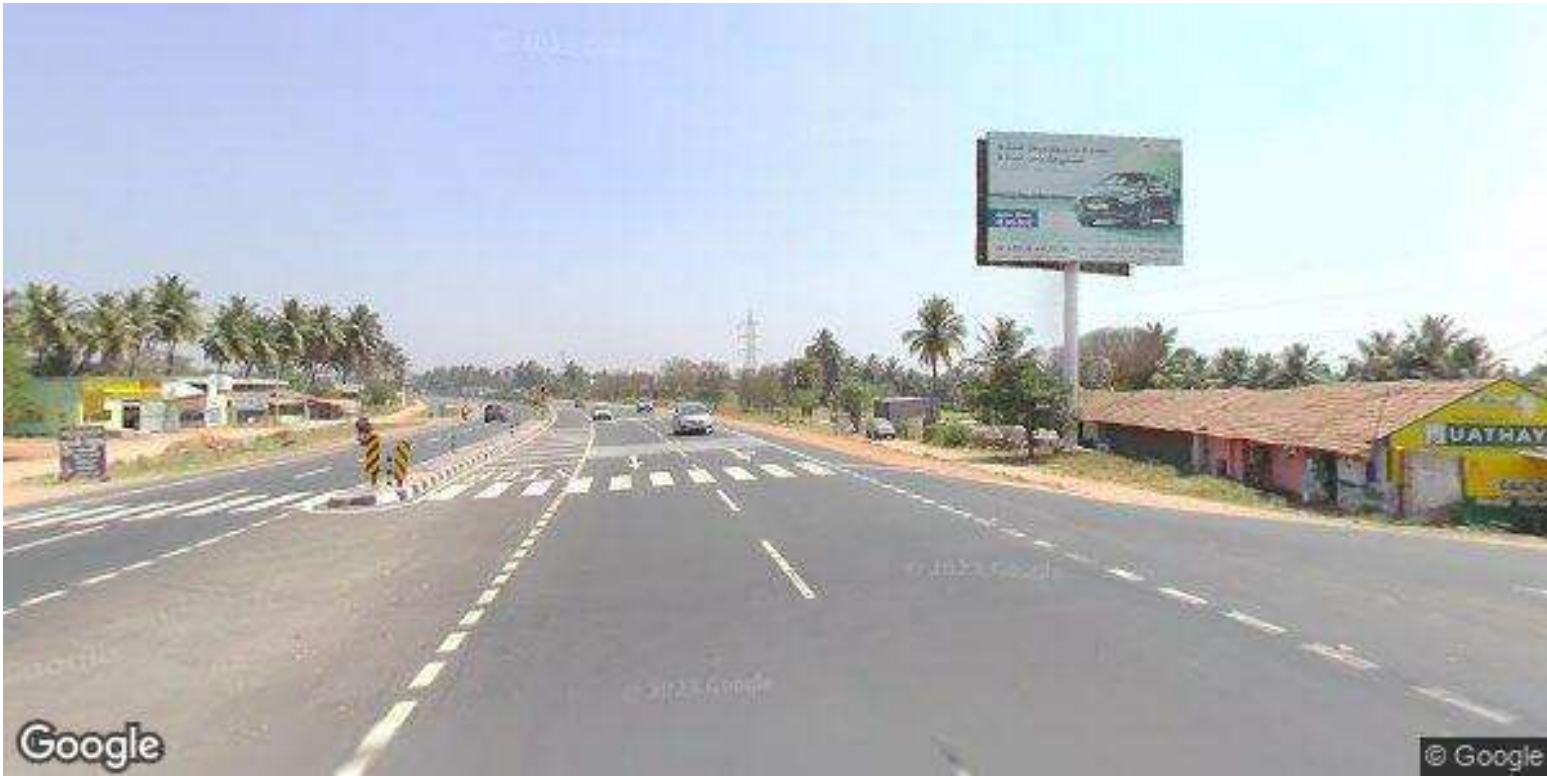
| | Risk Type | Risk Level | Coordinates | Speed Limit |
|---|---|---|---|---|
| 13 | Blind Spot | Blind Spot | 11.23716, 77.50666 | 10 KM/Hr |

Risk Type: Blind Spot

Risk Level: Blind Spot

Speed Limit: 10 KM/Hr

Coordinates: 11.23716, 77.50666
