## **JOURNEY RISK MANAGEMENT (JRM) STUDY**

### **Salem Terminal To SREE PARANI AGENCIES**

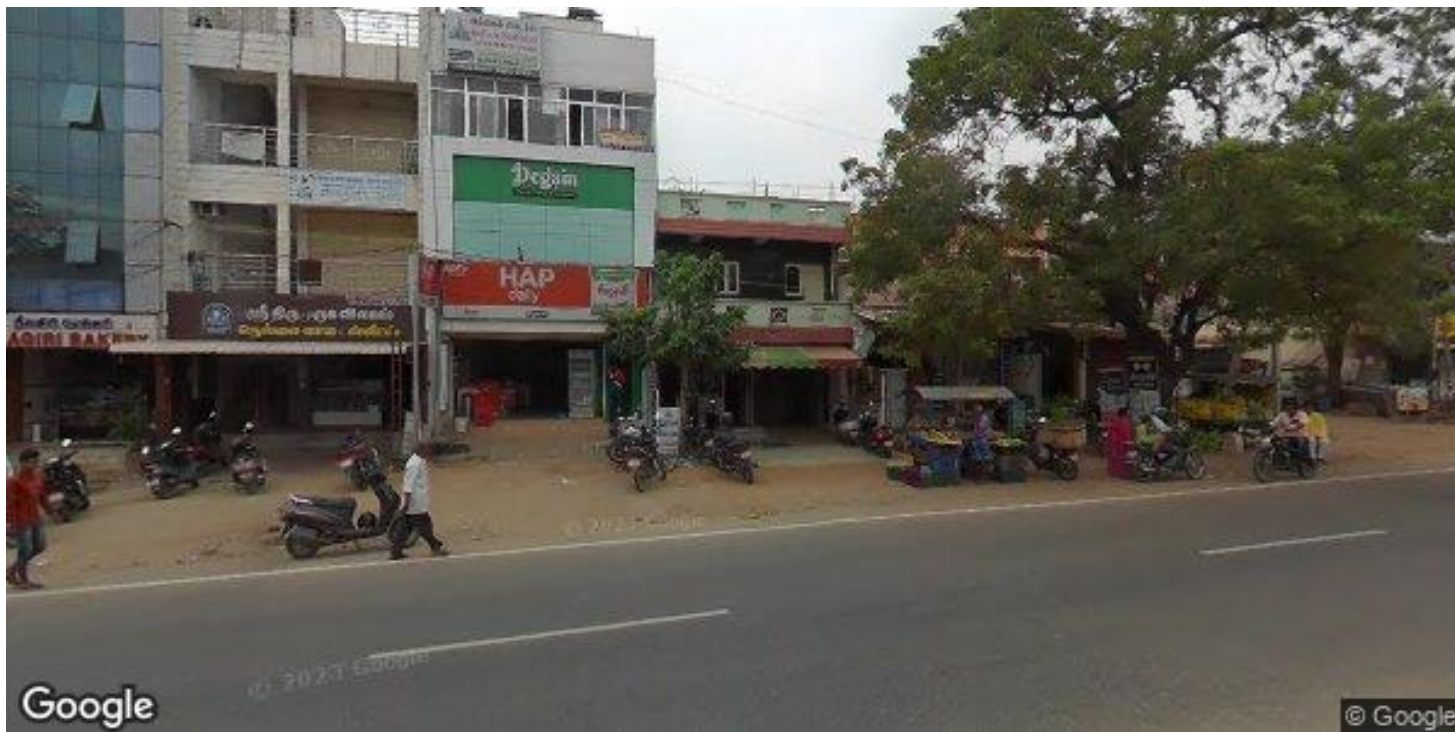
**Coordinates:** 11.1365755, 77.3224245

**Risk Type:** U-Turn

**Risk Level:** High

**Speed Limit:** 10 KM/Hr

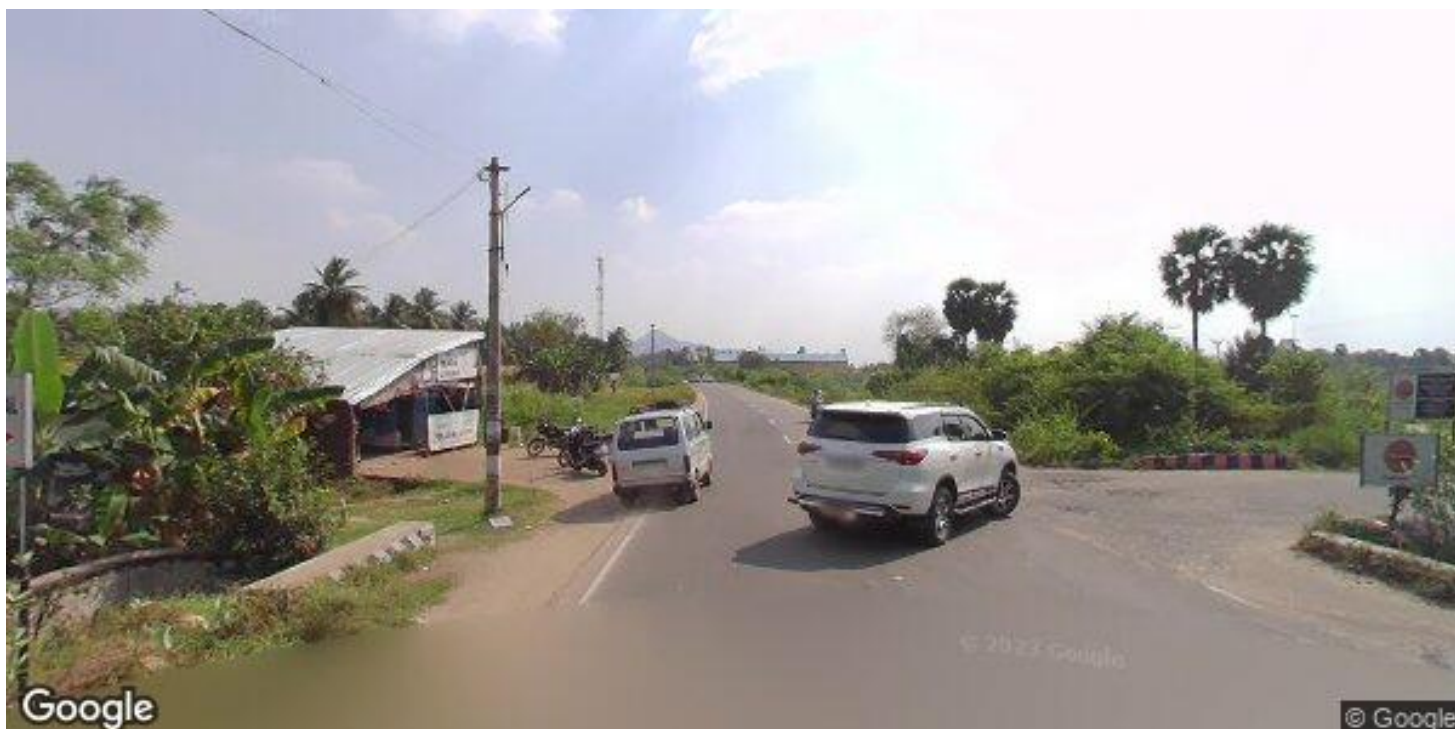
**Risk Type:** Turn  
**Risk Level:** High  
**Speed Limit:** 15 KM/Hr  
**Coordinates:** 11.44029, 77.87544

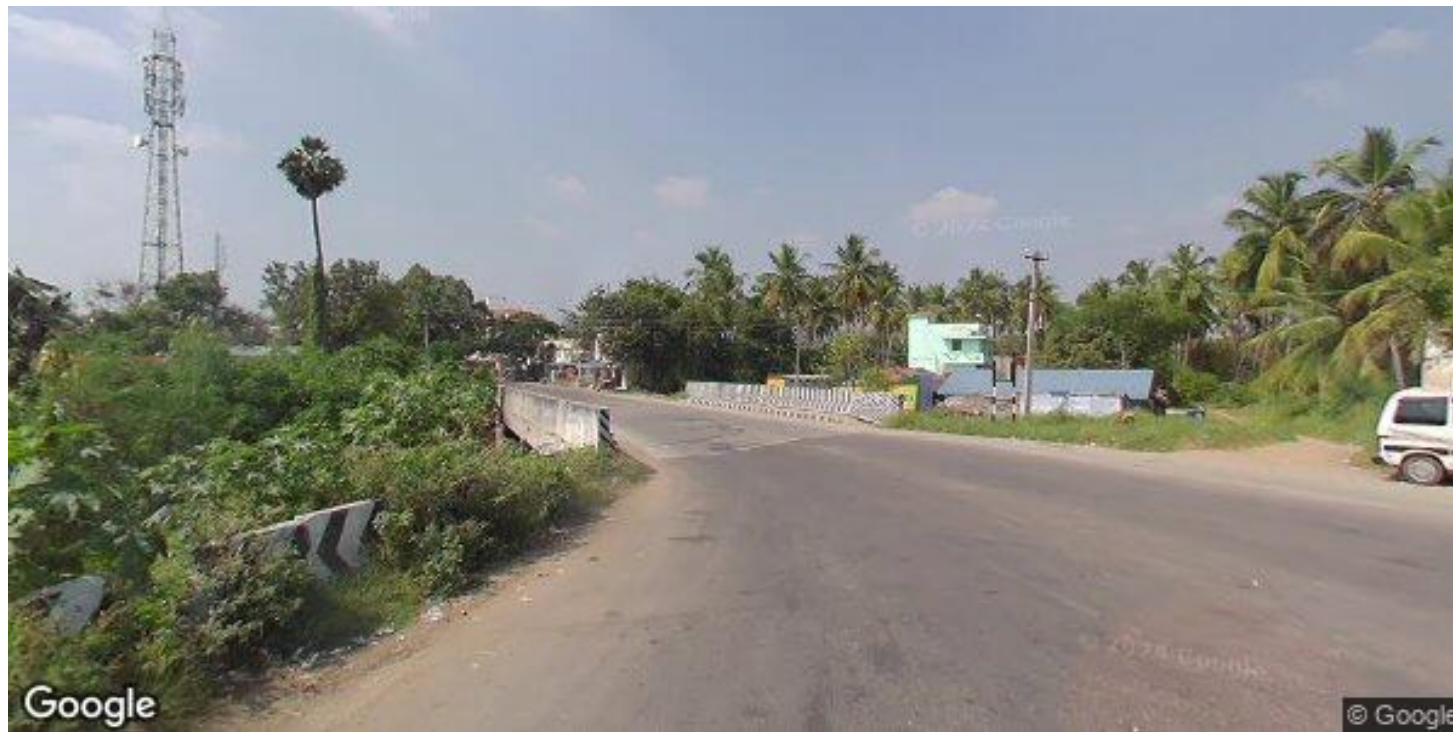
**Risk Type:** Turn  
**Risk Level:** High  
**Speed Limit:** 15 KM/Hr  
**Coordinates:** 11.44893, 77.87413

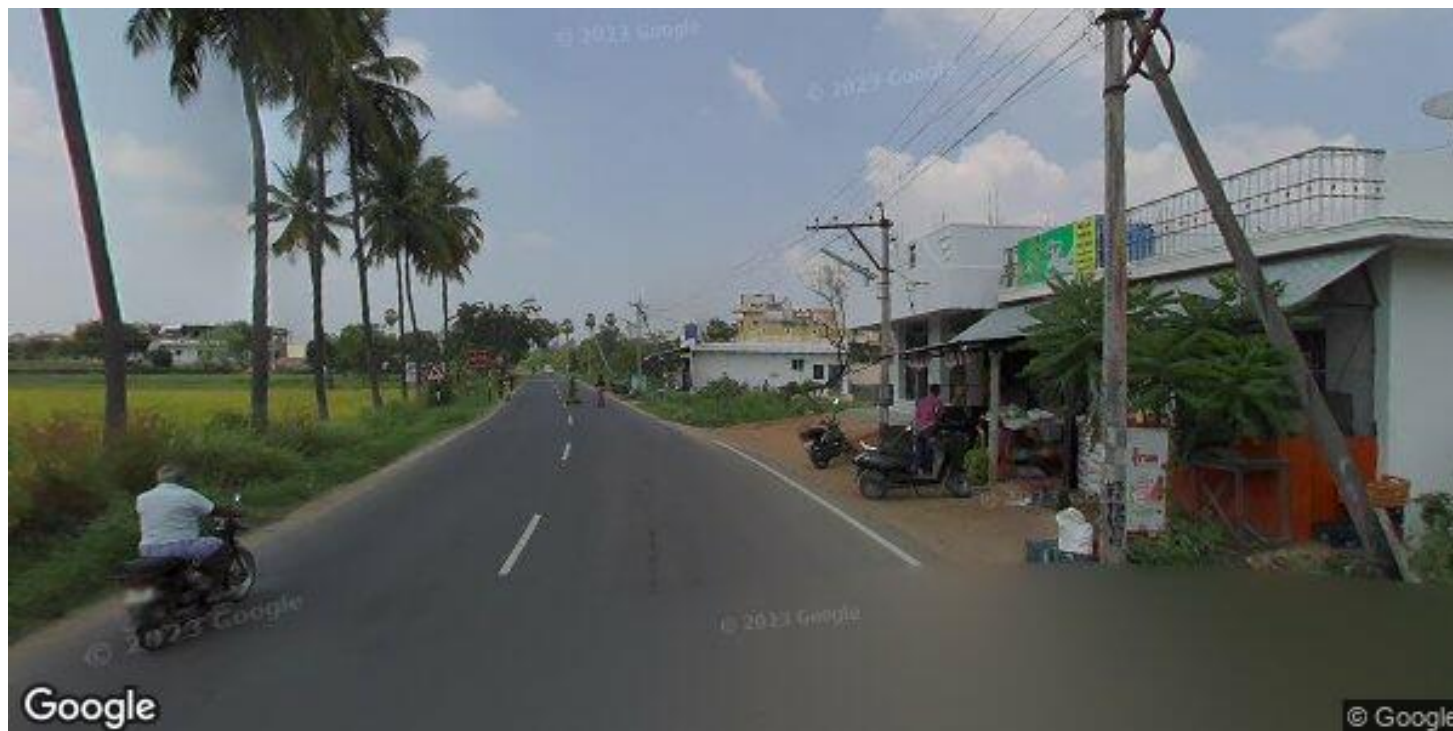
**Risk Type:** Turn  
**Risk Level:** Medium  
**Speed Limit:** 30 KM/Hr  
**Coordinates:** 11.45127, 77.86734

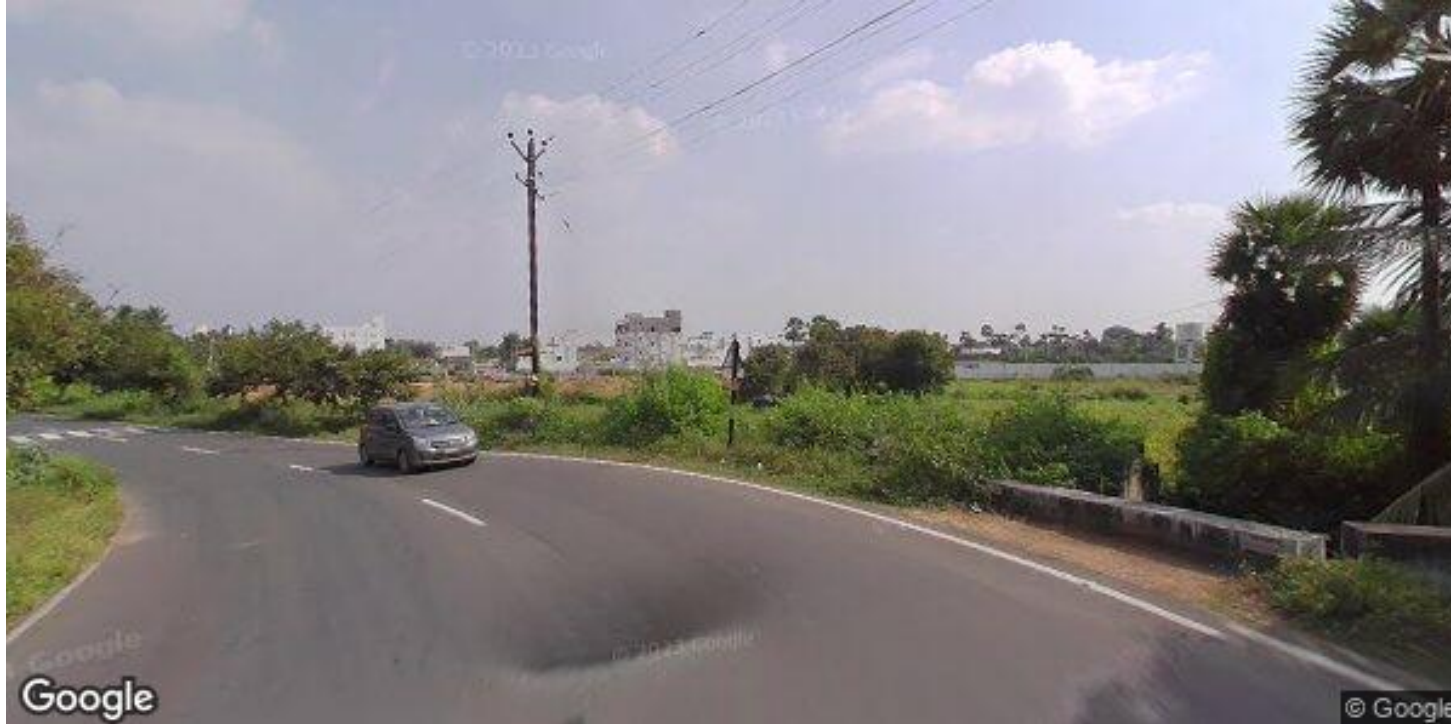
**Risk Type:** Turn  
**Risk Level:** High  
**Speed Limit:** 15 KM/Hr  
**Coordinates:** 11.45350, 77.85700

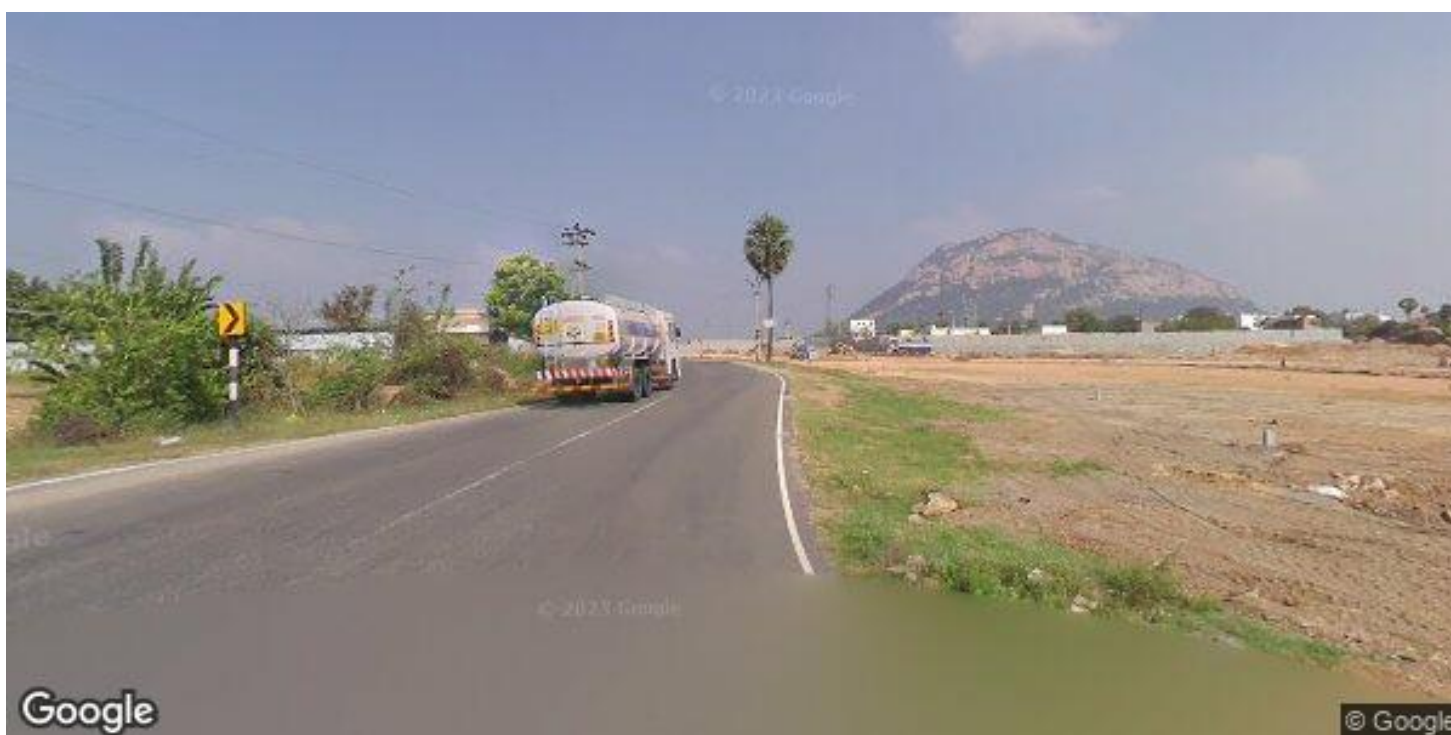
**Risk Type:** Turn  
**Risk Level:** Medium  
**Speed Limit:** 30 KM/Hr  
**Coordinates:** 11.45845, 77.85141

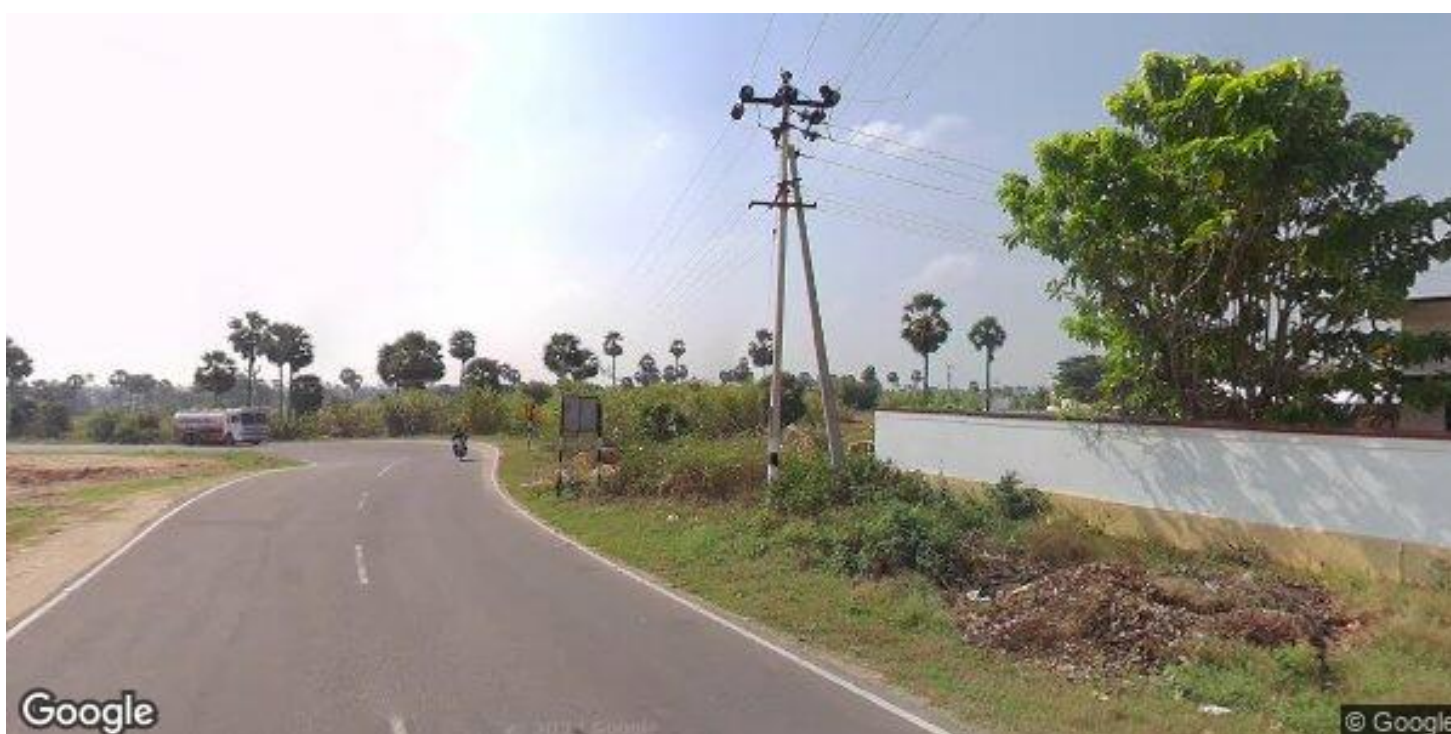
**Coordinates: 11.45889, 77.85136**

**Risk Type:** Turn  
**Risk Level:** Medium

**Speed Limit: 30 KM/Hr**

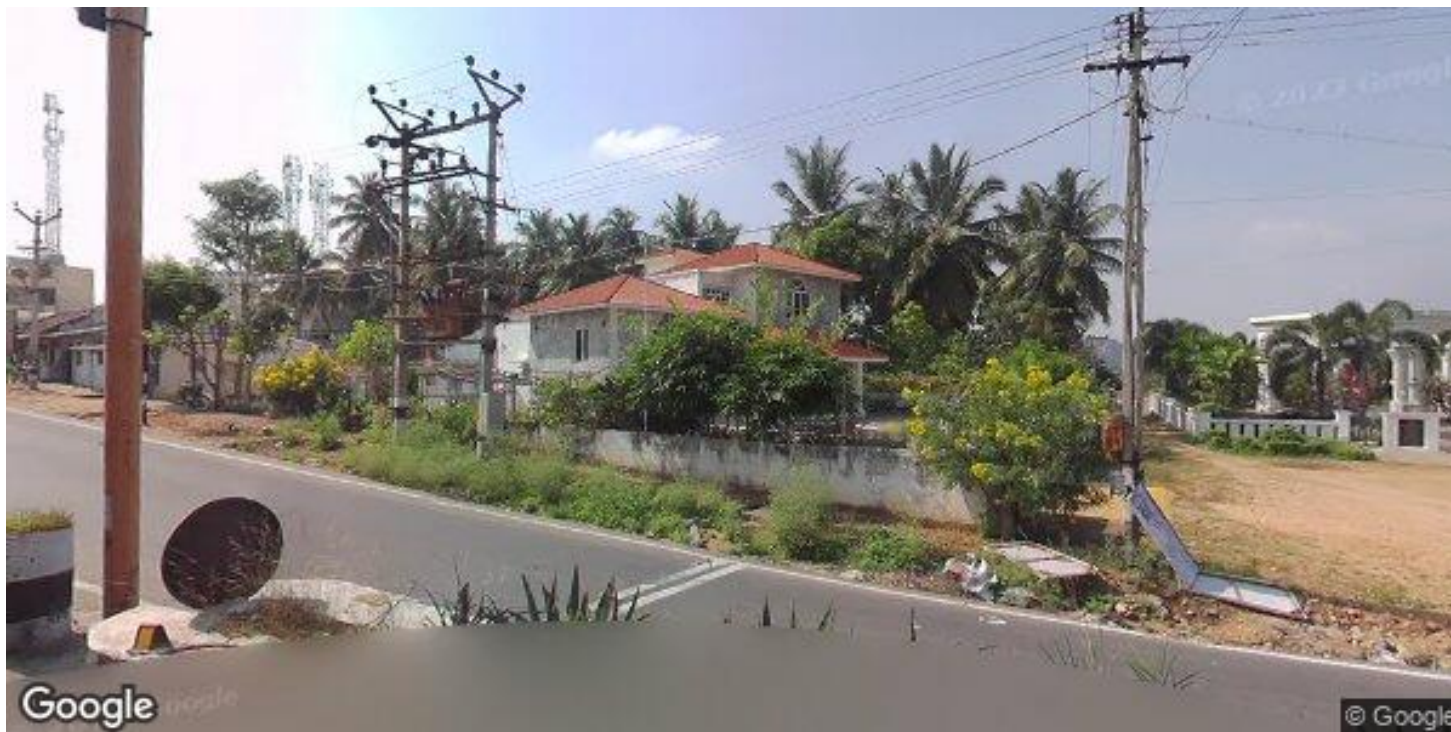
**Coordinates: 11.46303, 77.84945**

**Risk Type: Turn**

**Risk Level: High**

**Speed Limit: 15 KM/Hr**

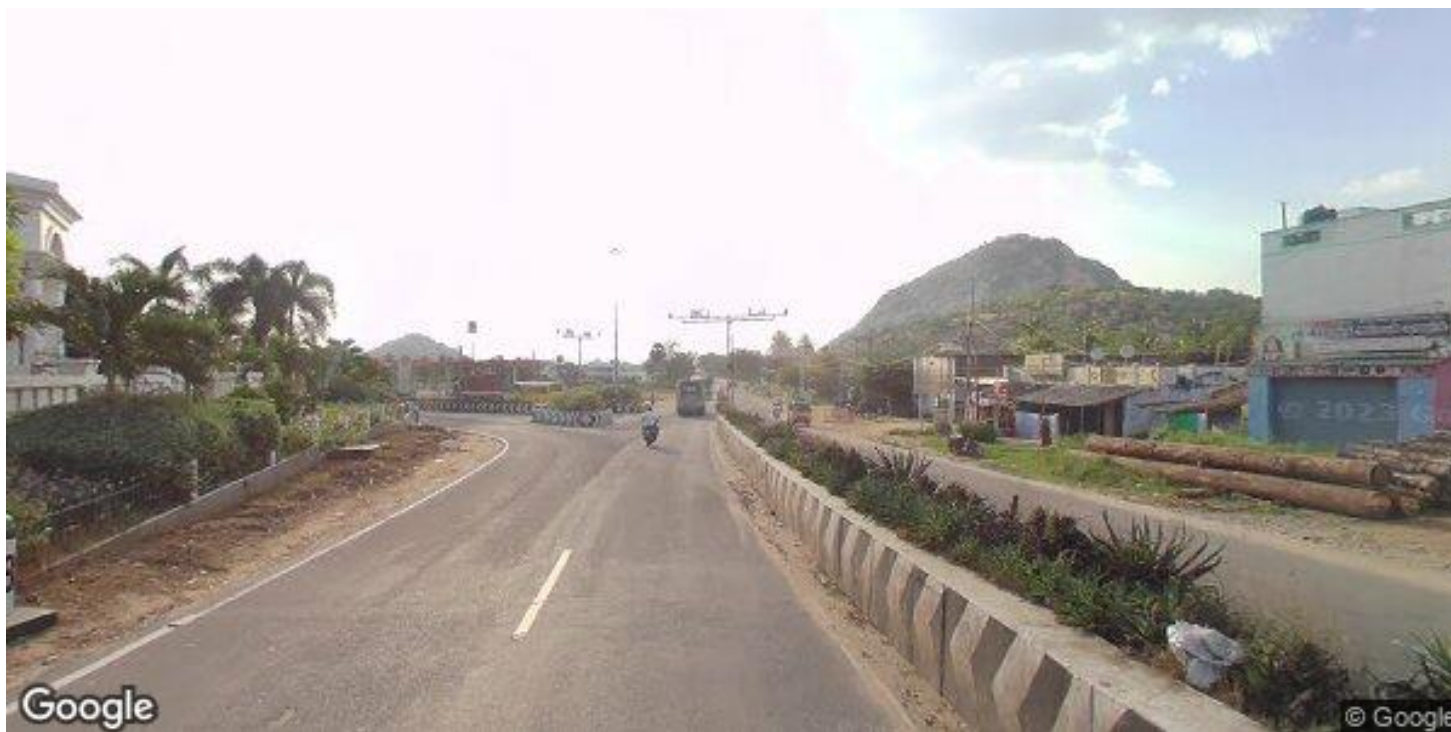
**Coordinates: 11.46317, 77.84906**

**Risk Type: Turn**

**Risk Level: Medium**

**Speed Limit: 30 KM/Hr**

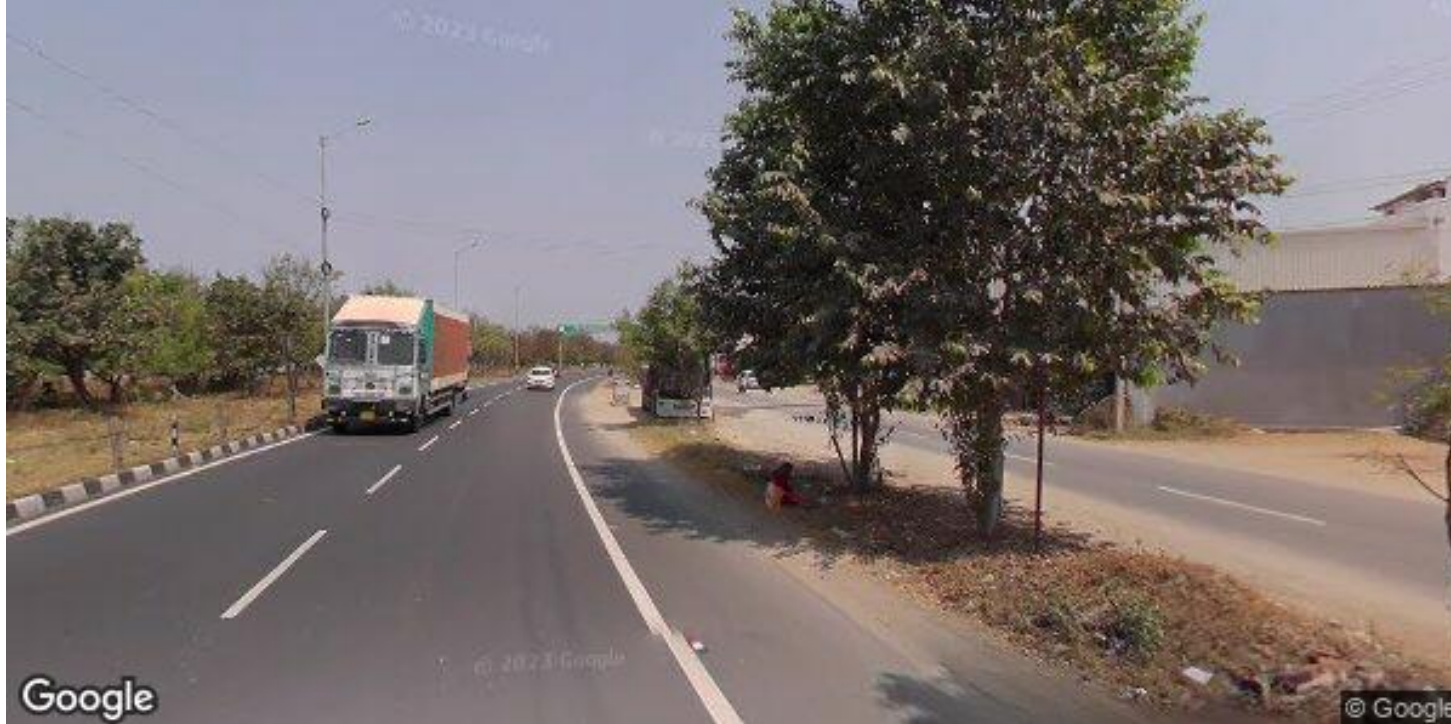
**Coordinates:** 11.43175, 77.67757

**Risk Type:** Turn

**Risk Level:** Medium

**Speed Limit:** 30 KM/Hr

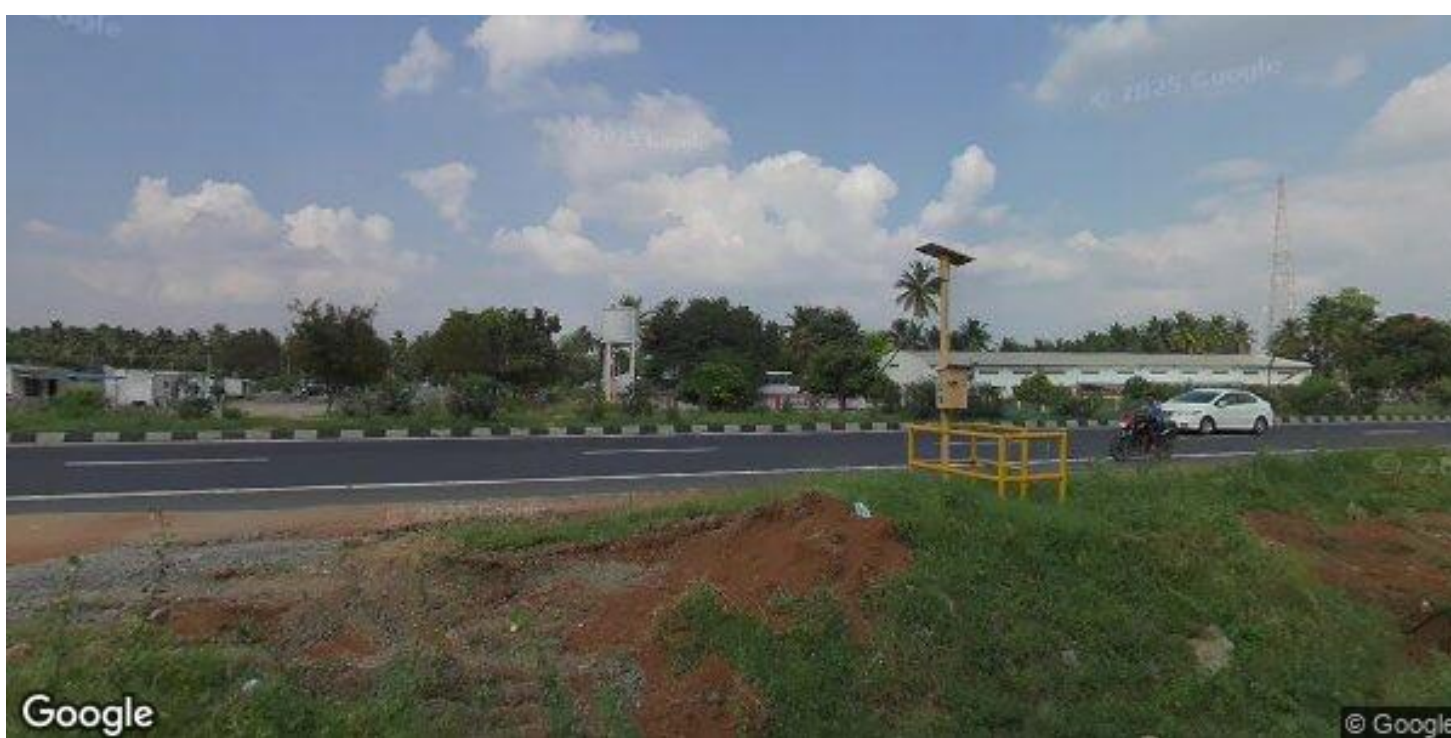
**Coordinates:** 11.29141, 77.58266

**Risk Type:** Turn

**Risk Level:** Medium

**Speed Limit:** 30 KM/Hr

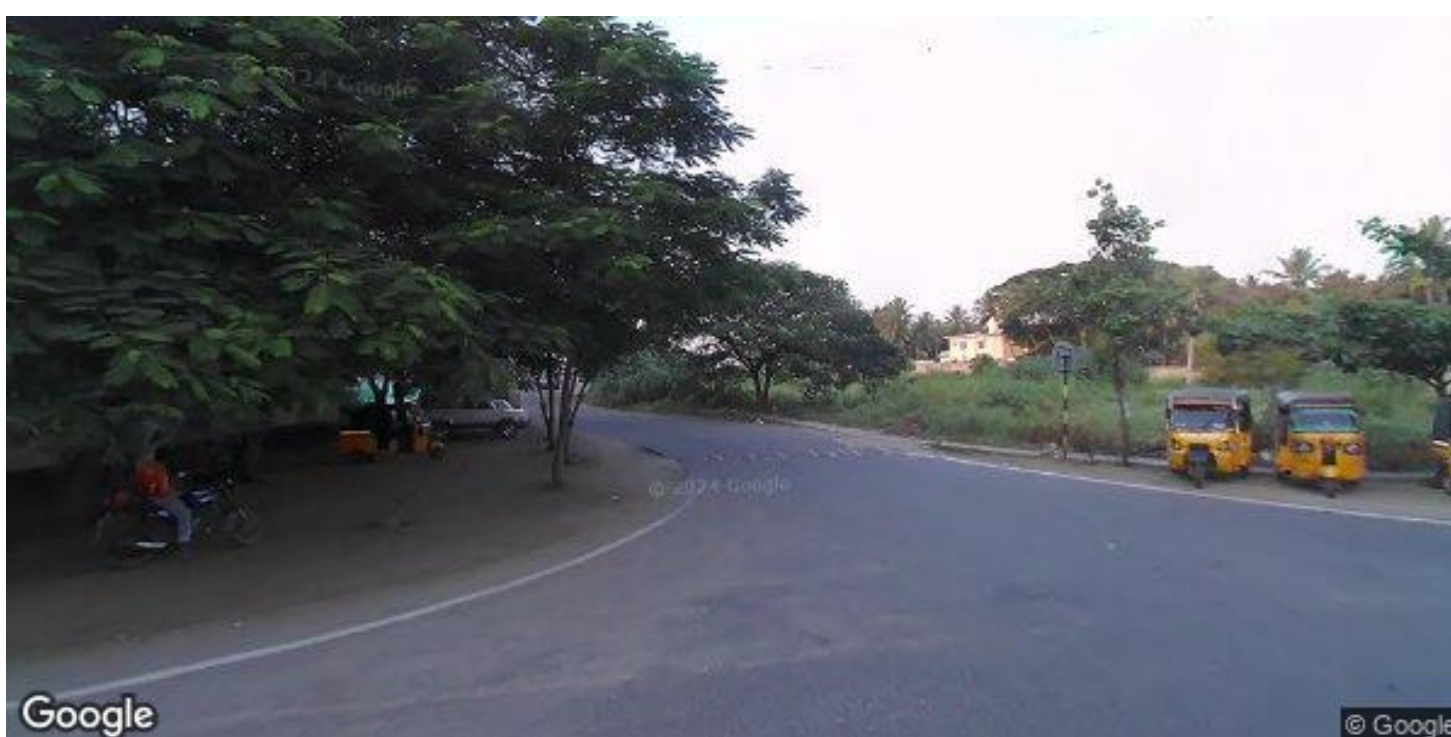
Coordinates: 11.18267, 77.28532

**Risk Type:** Turn

**Risk Level:** High

Speed Limit: 15 KM/Hr

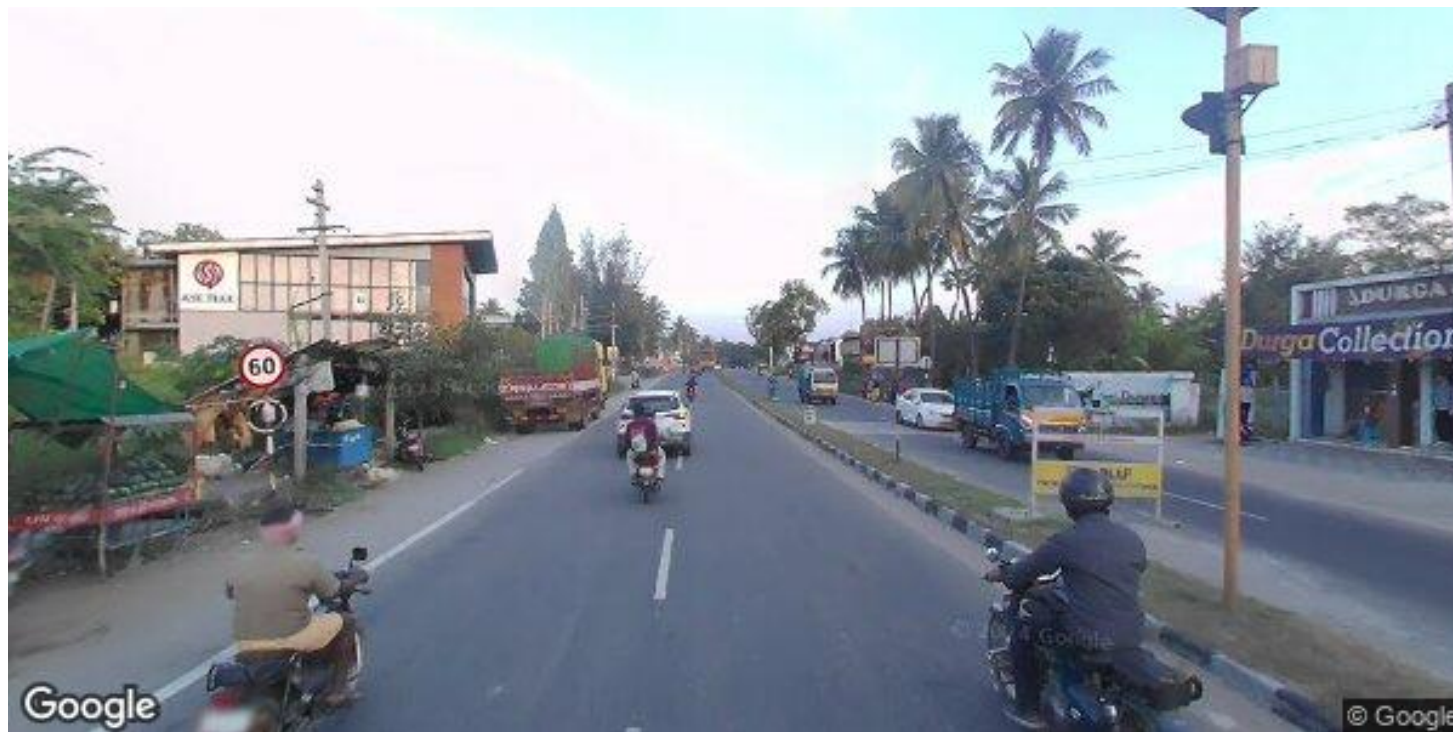
Coordinates: 11.18242, 77.28553

Risk Type: Turn

Risk Level: Medium

Speed Limit: 30 KM/Hr

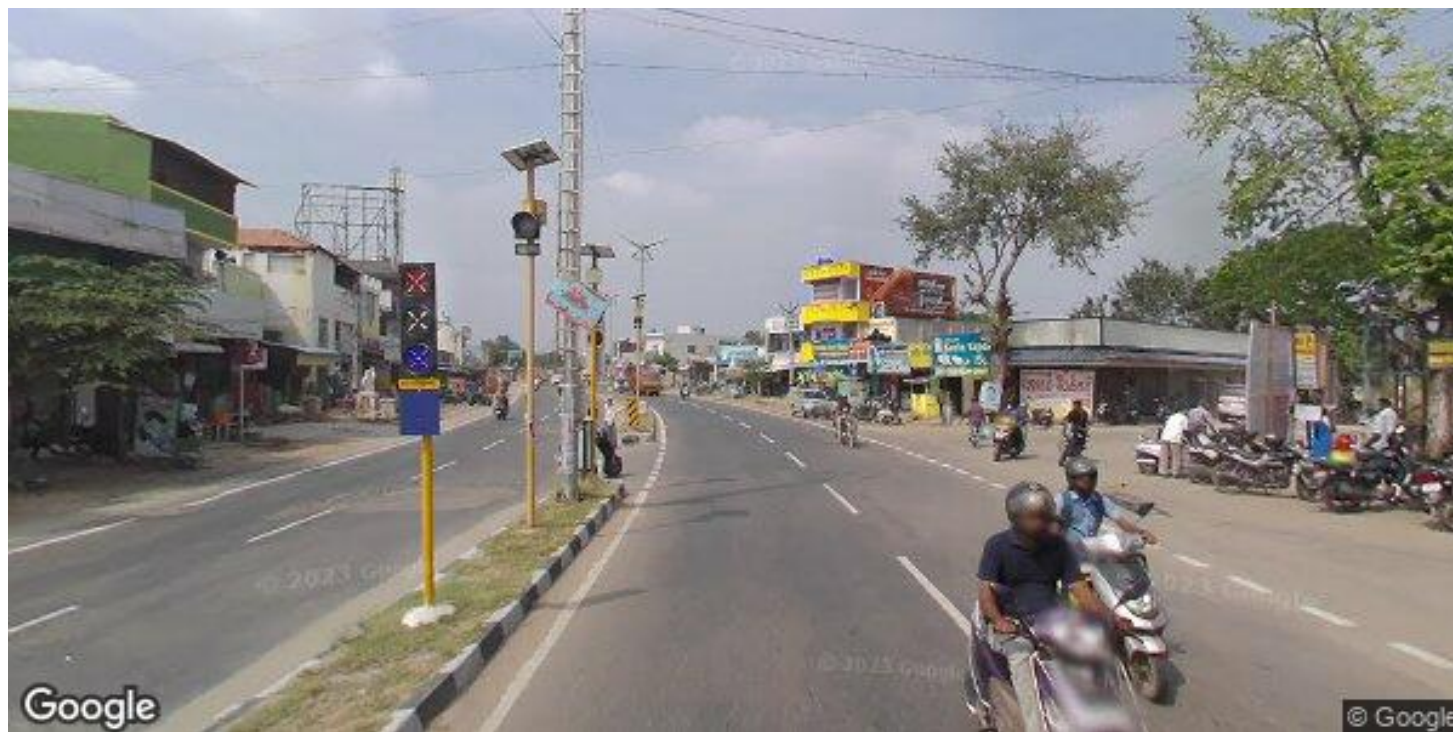
Coordinates: 11.16527, 77.30700

Risk Type: Turn

Risk Level: Medium

Speed Limit: 30 KM/Hr

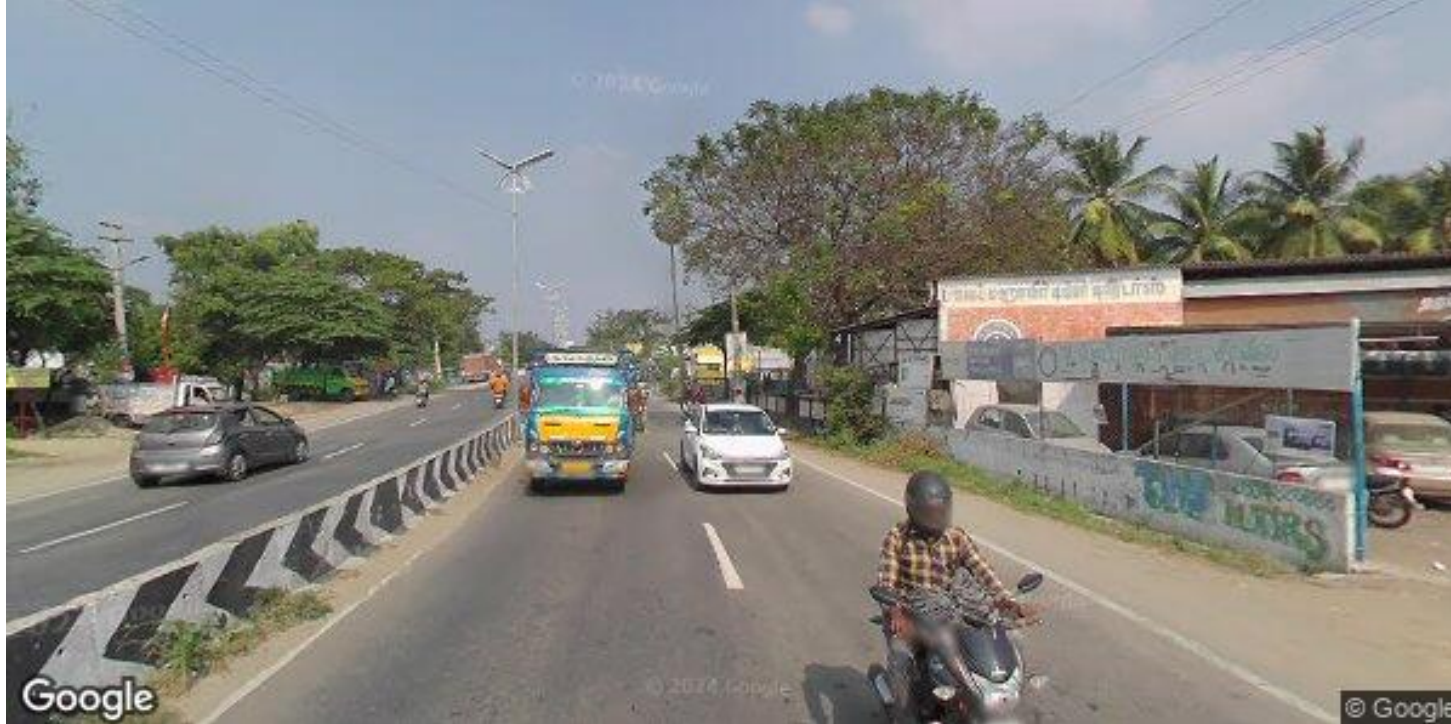
**Coordinates:** 11.16093, 77.30955

**Risk Type:** Turn

**Risk Level:** Medium

**Speed Limit:** 30 KM/Hr

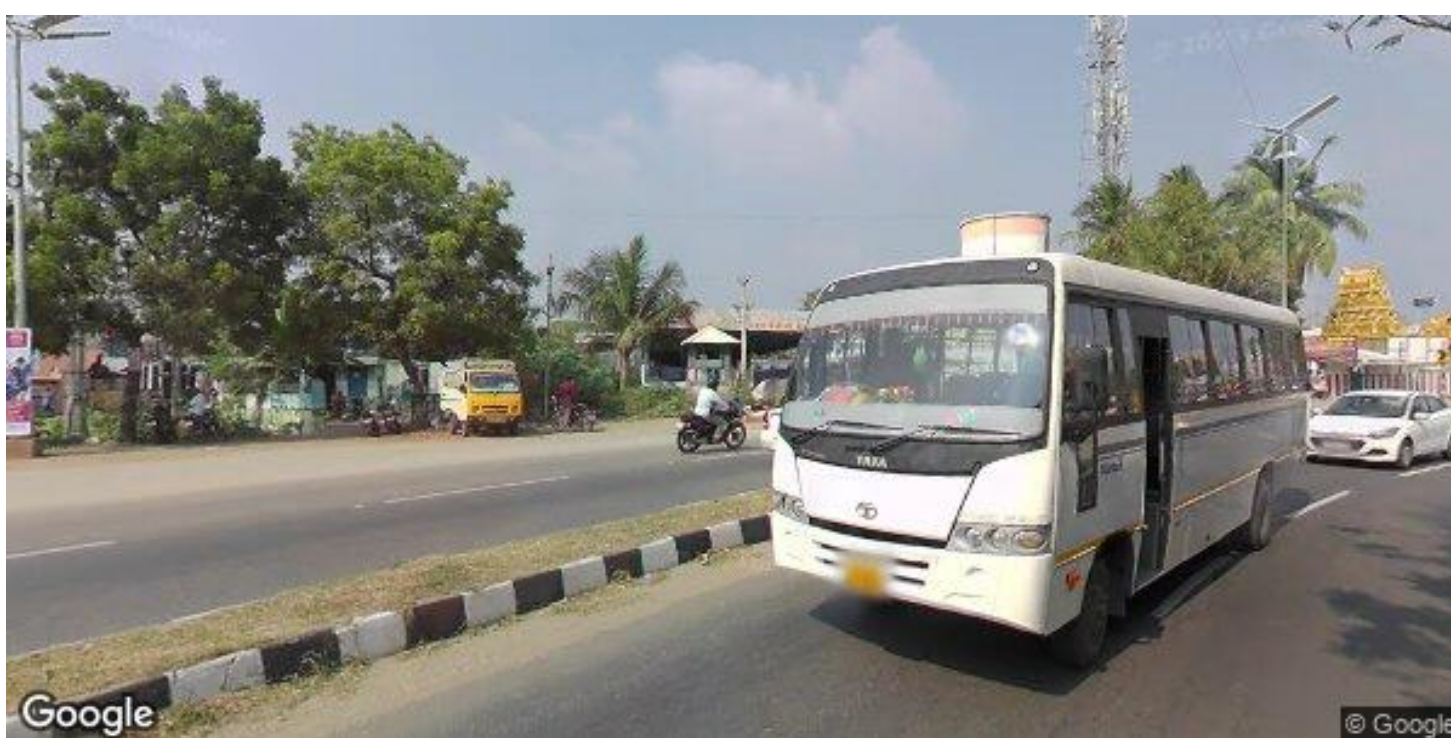
**Coordinates:** 11.15180, 77.30889

**Risk Type:** Turn

**Risk Level:** High

**Speed Limit:** 15 KM/Hr

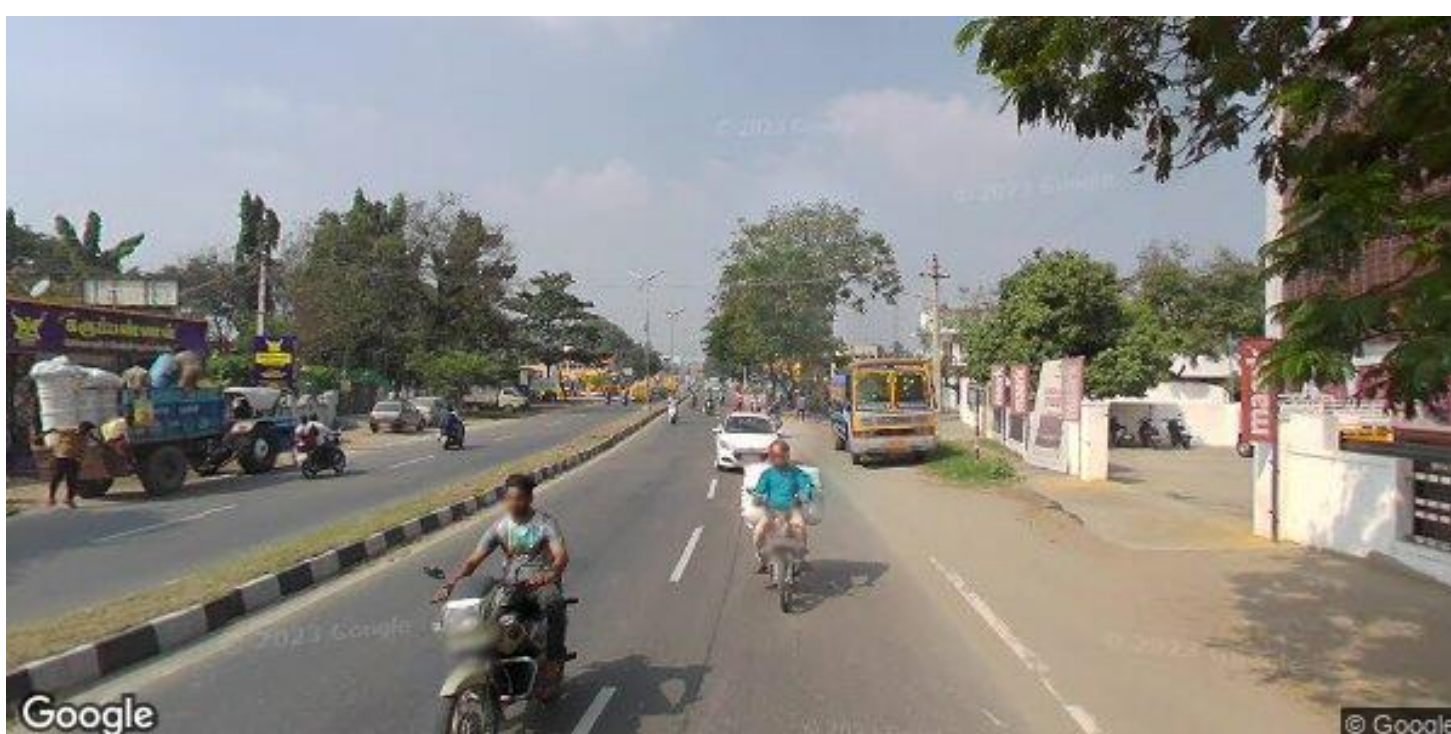
Coordinates: 11.15175, 77.31121

**Risk Type:** Turn

**Risk Level:** Medium

Speed Limit: 30 KM/Hr

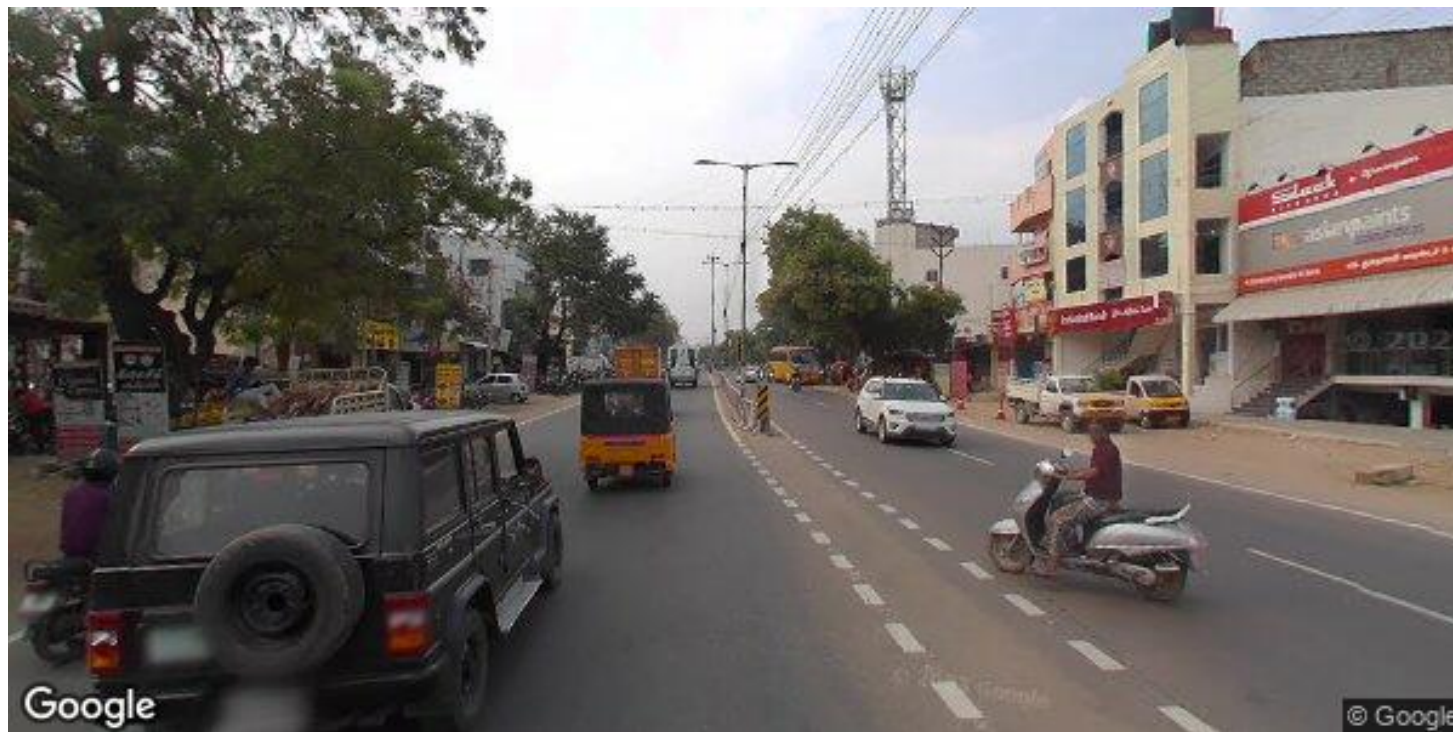
Coordinates: 11.13653, 77.32237

Risk Type: Blind Spot

Risk Level: Blind Spot

Speed Limit: 10 KM/Hr

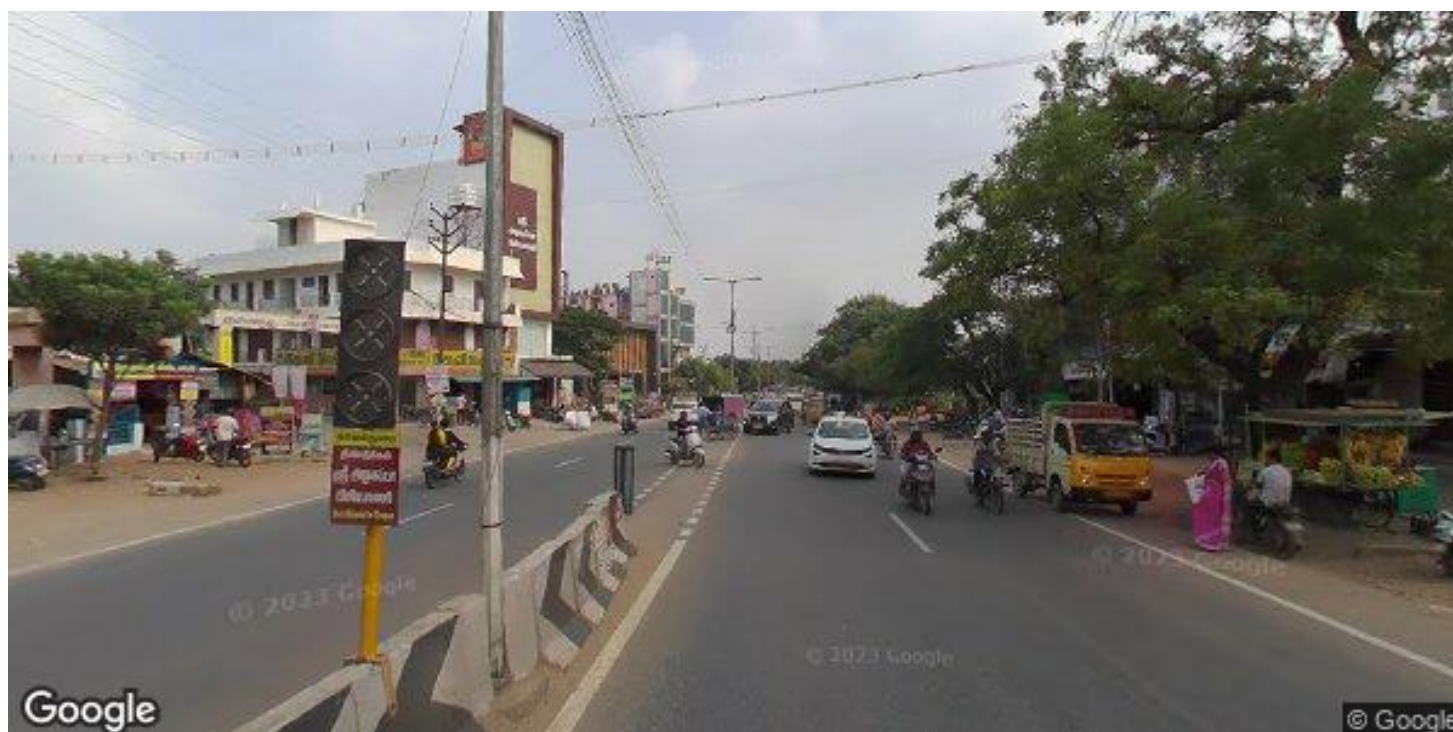
Coordinates: 11.13664, 77.32220

Risk Type: Turn

Risk Level: High

Speed Limit: 15 KM/Hr
