# IndianOil

## JOURNEY RISK MANAGEMENT (JRM) STUDY

### Salem Terminal TO SRI MURUGAN AGENCIES

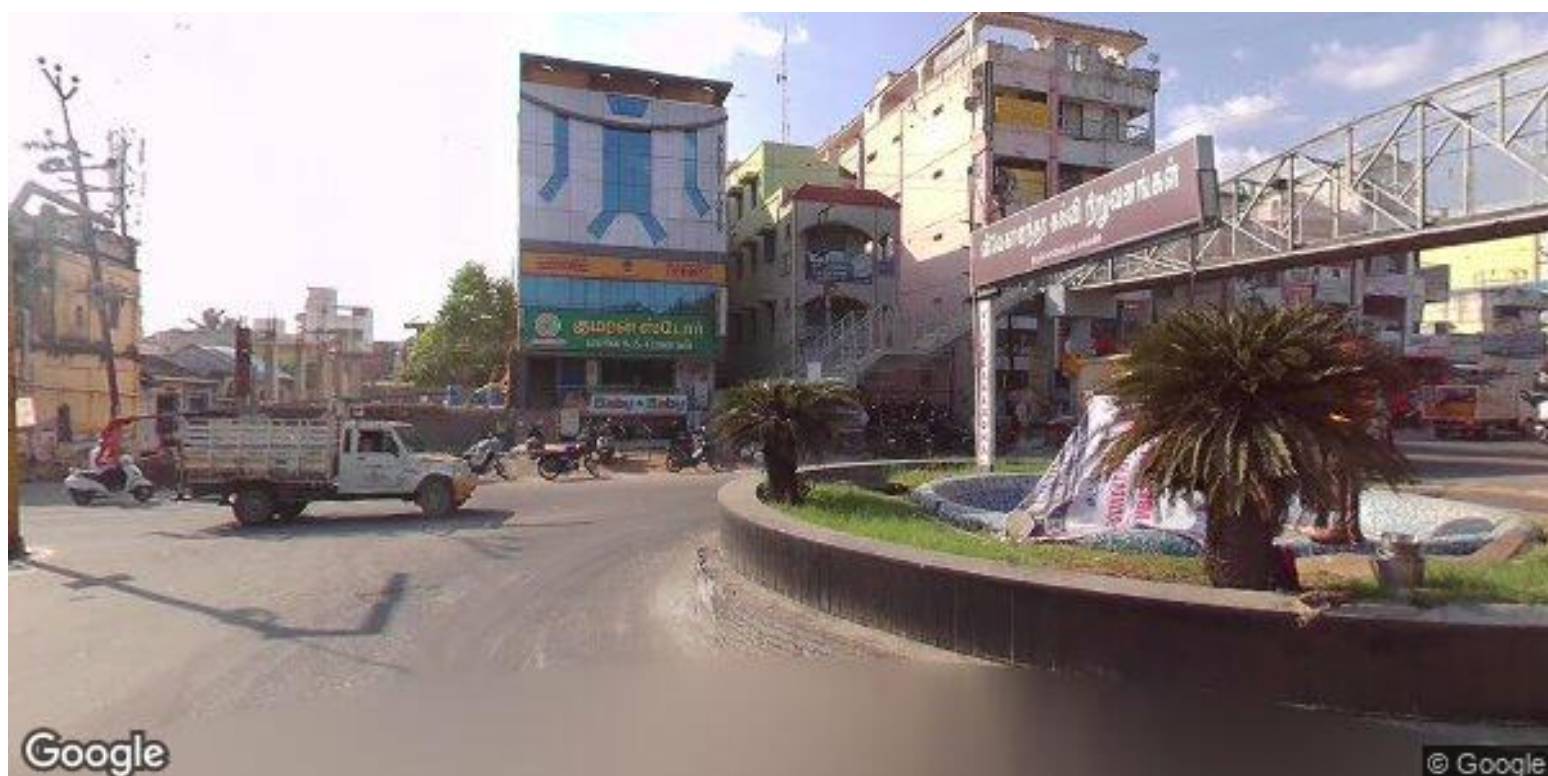
**Risk Type:** Roundabout

**Risk Level:** High

**Speed Limit: 15 KM/Hr**  
**Coordinates: 11.38386, 77.89482**

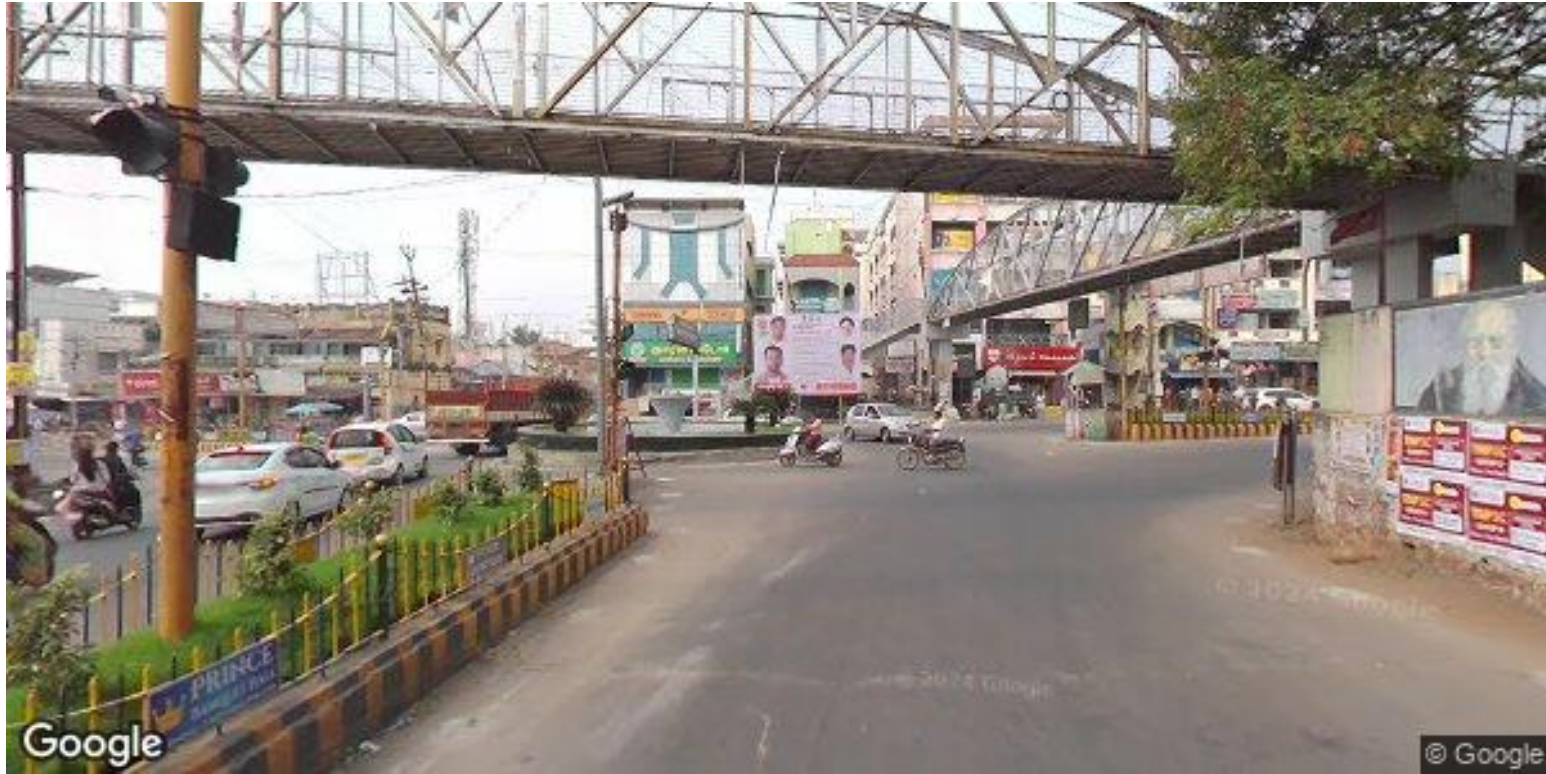
**Risk Type: U-Turn**  
**Risk Level: High**  
**Speed Limit: 10 KM/Hr**  
**Coordinates: 11.3839218, 77.8950042**

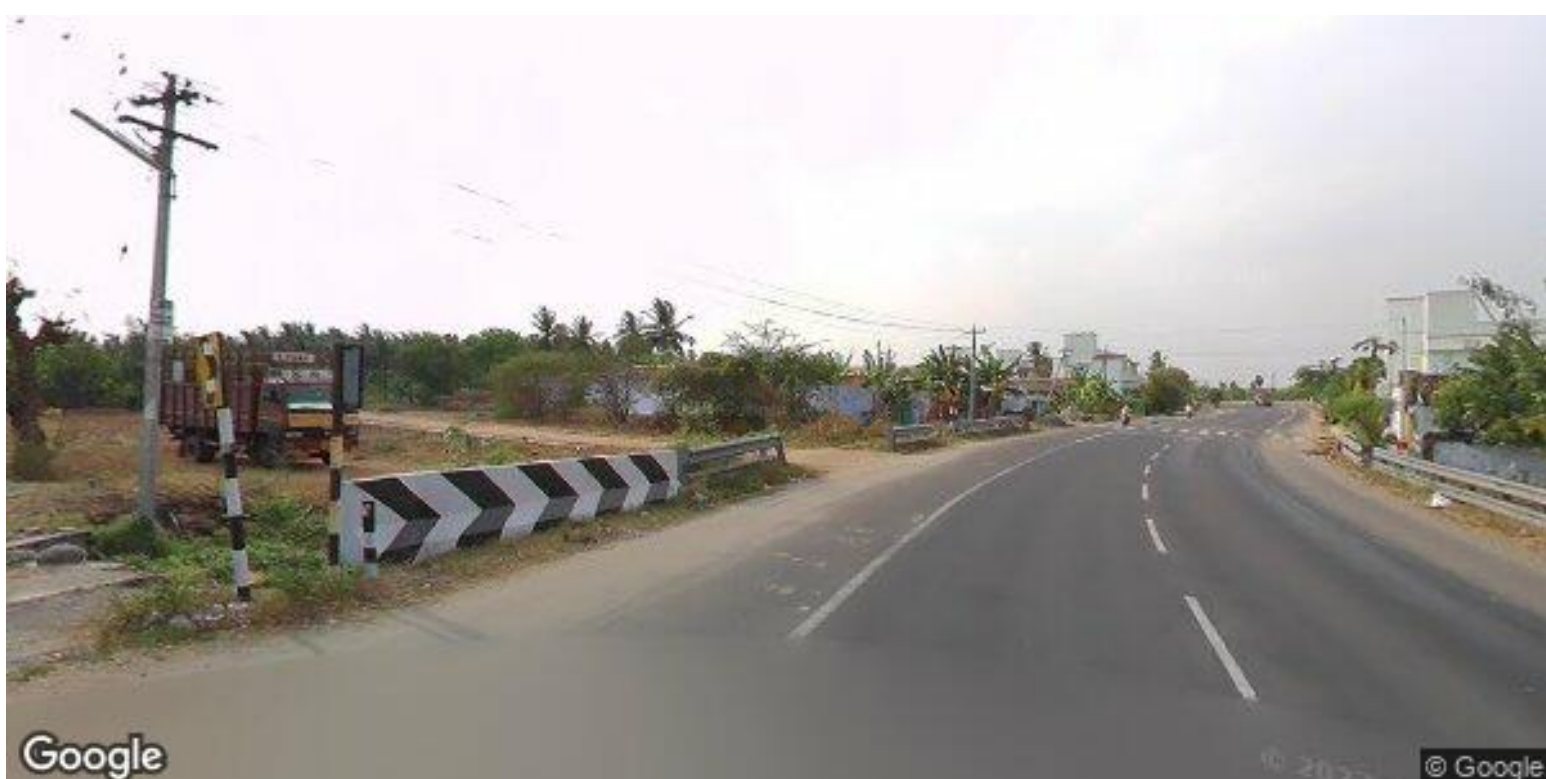
**Risk Type:** Turn  
**Risk Level:** Medium  
**Speed Limit:** 30 KM/Hr  
**Coordinates:** 11.16755, 78.01568

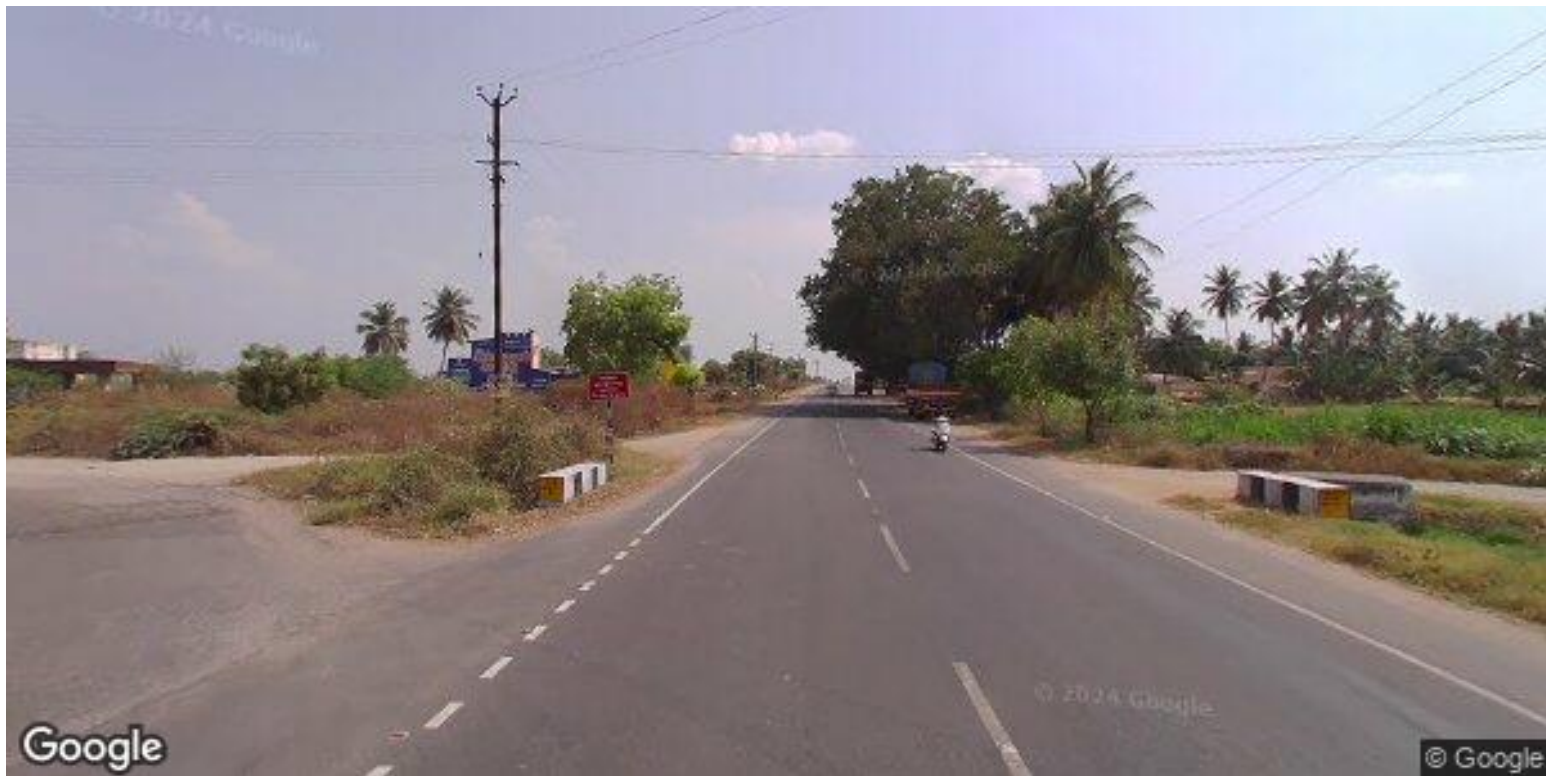
**Risk Type:** Turn  
**Risk Level:** High  
**Speed Limit:** 15 KM/Hr  
**Coordinates:** 11.14545, 78.02208

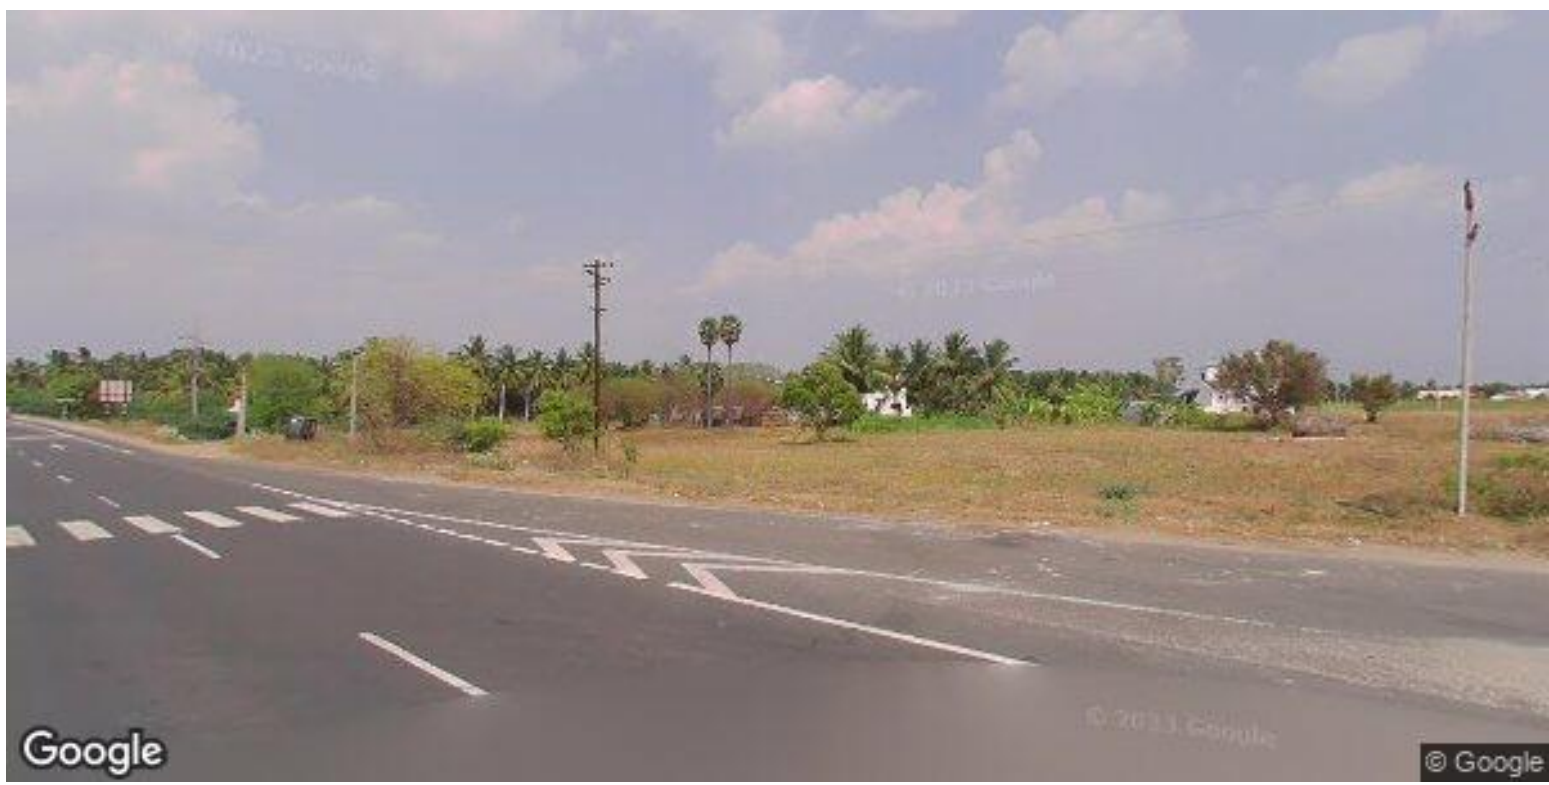
**Coordinates:** 11.14480, 78.02291

**Risk Type:** Turn

**Risk Level:** High

**Speed Limit:** 15 KM/Hr
