## JOURNEY RISK MANAGEMENT (JRM) STUDY

**Salem Terminal to SRI GOUNDER & CO.**

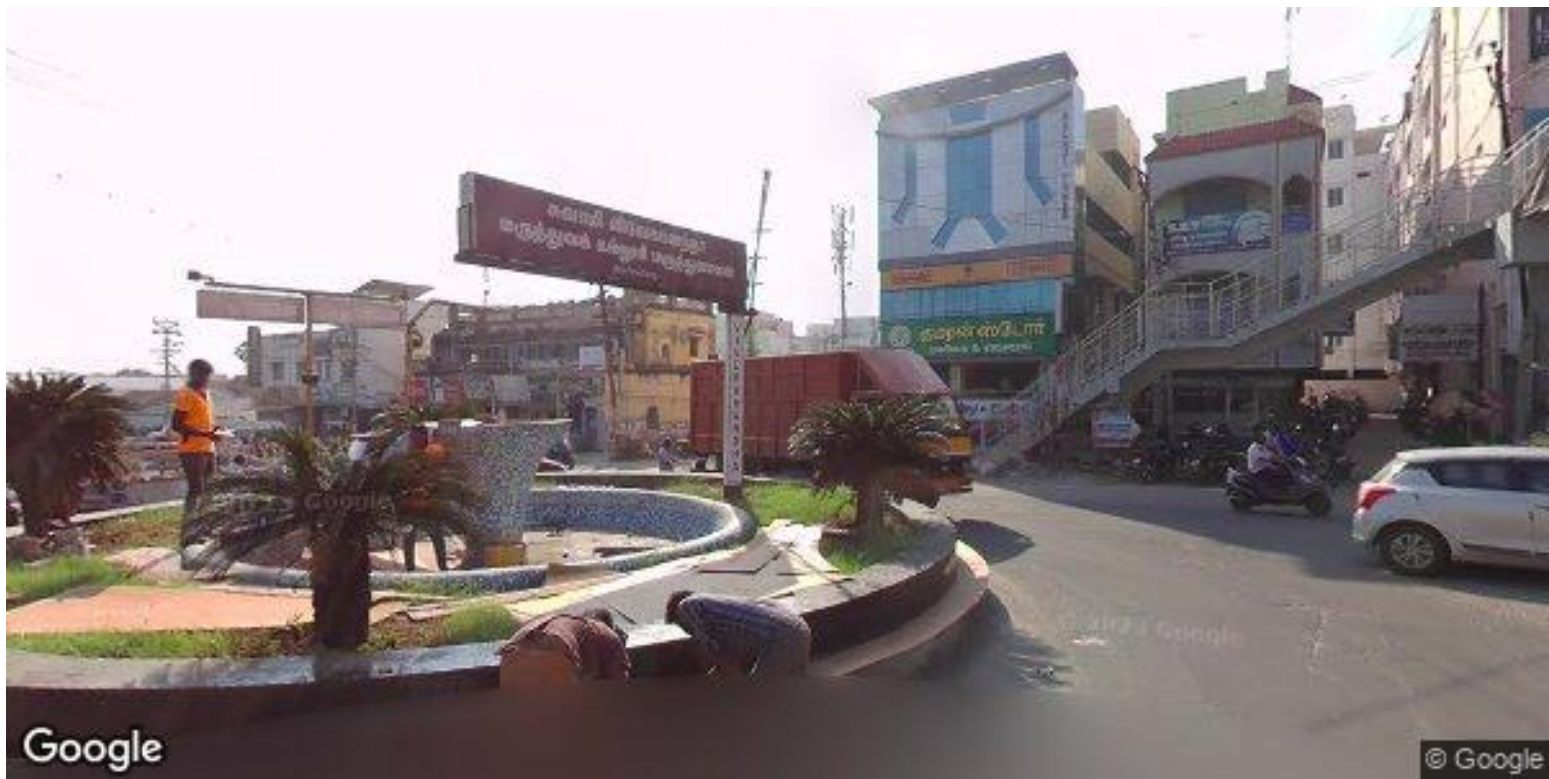
**Risk Type:** Roundabout  
**Risk Level:** High  
**Speed Limit:** 15 KM/Hr  
**Coordinates:** 11.38395, 77.89480

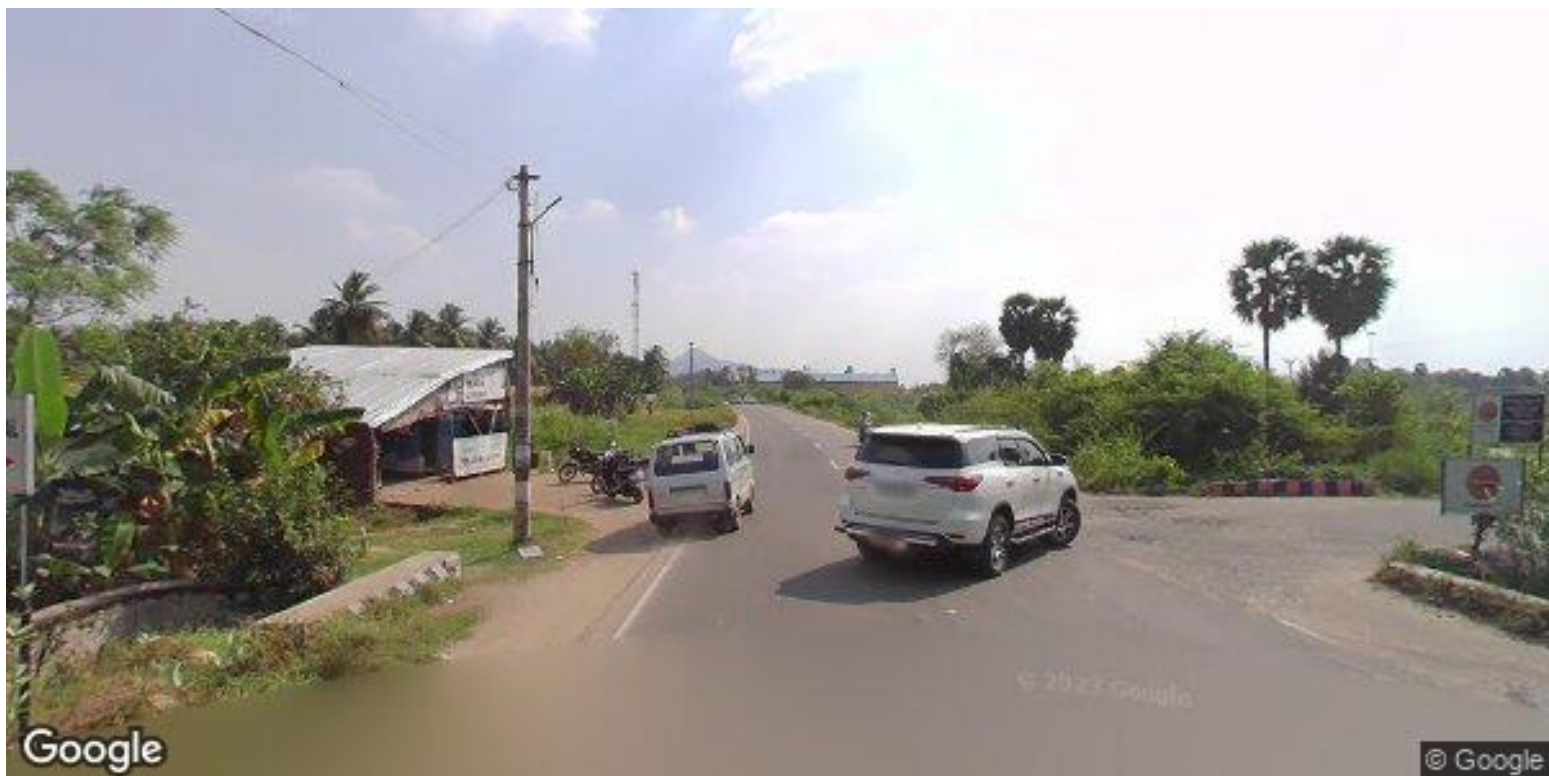
**Risk Type:** Blind Spot  
**Risk Level:** Blind Spot  
**Speed Limit:** 10 KM/Hr  
**Coordinates:** 11.44029, 77.87544

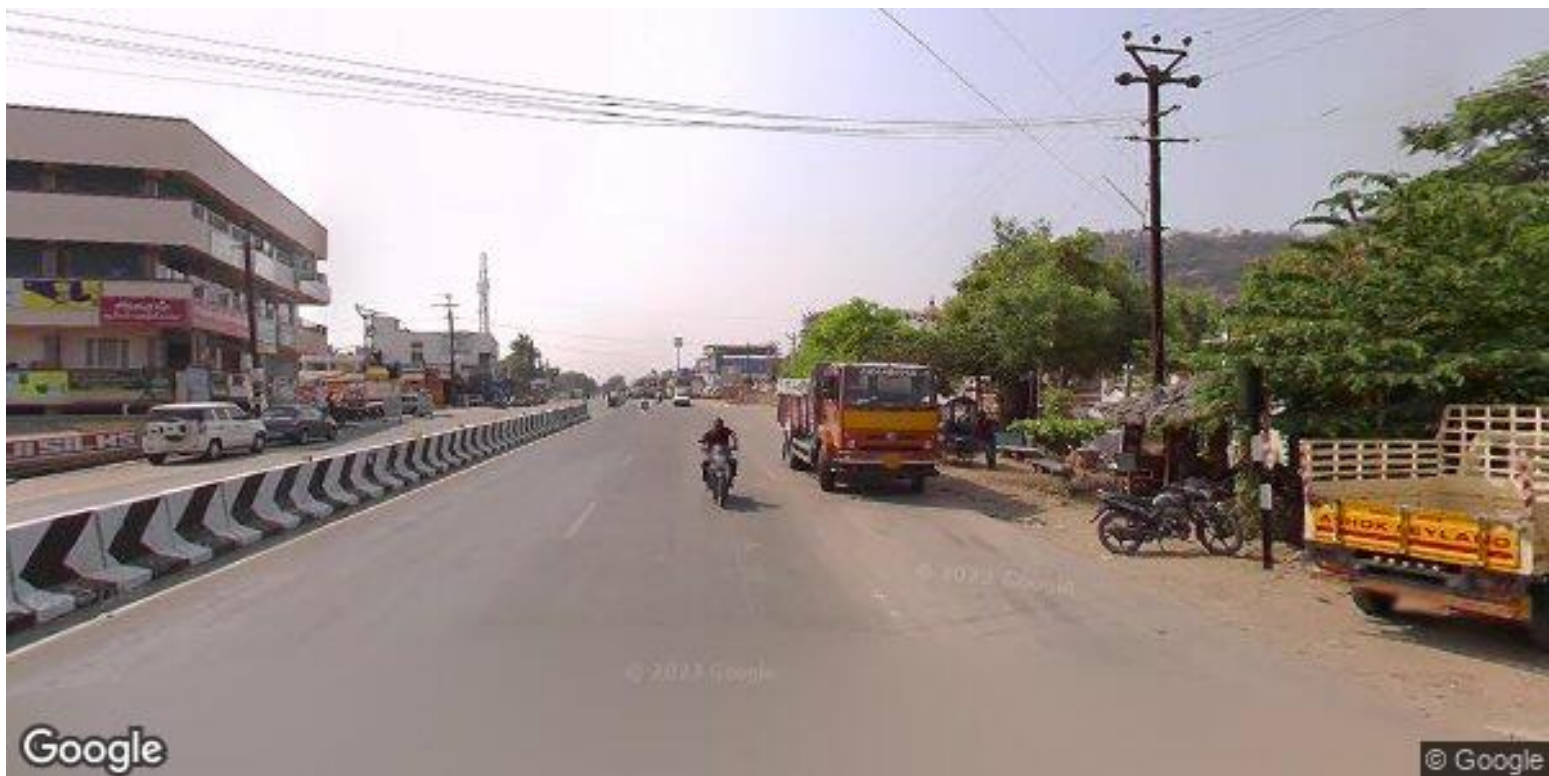
Risk Type: Turn

Risk Level: Medium

Speed Limit: 30 KM/Hr

Coordinates: 11.39685, 77.88861

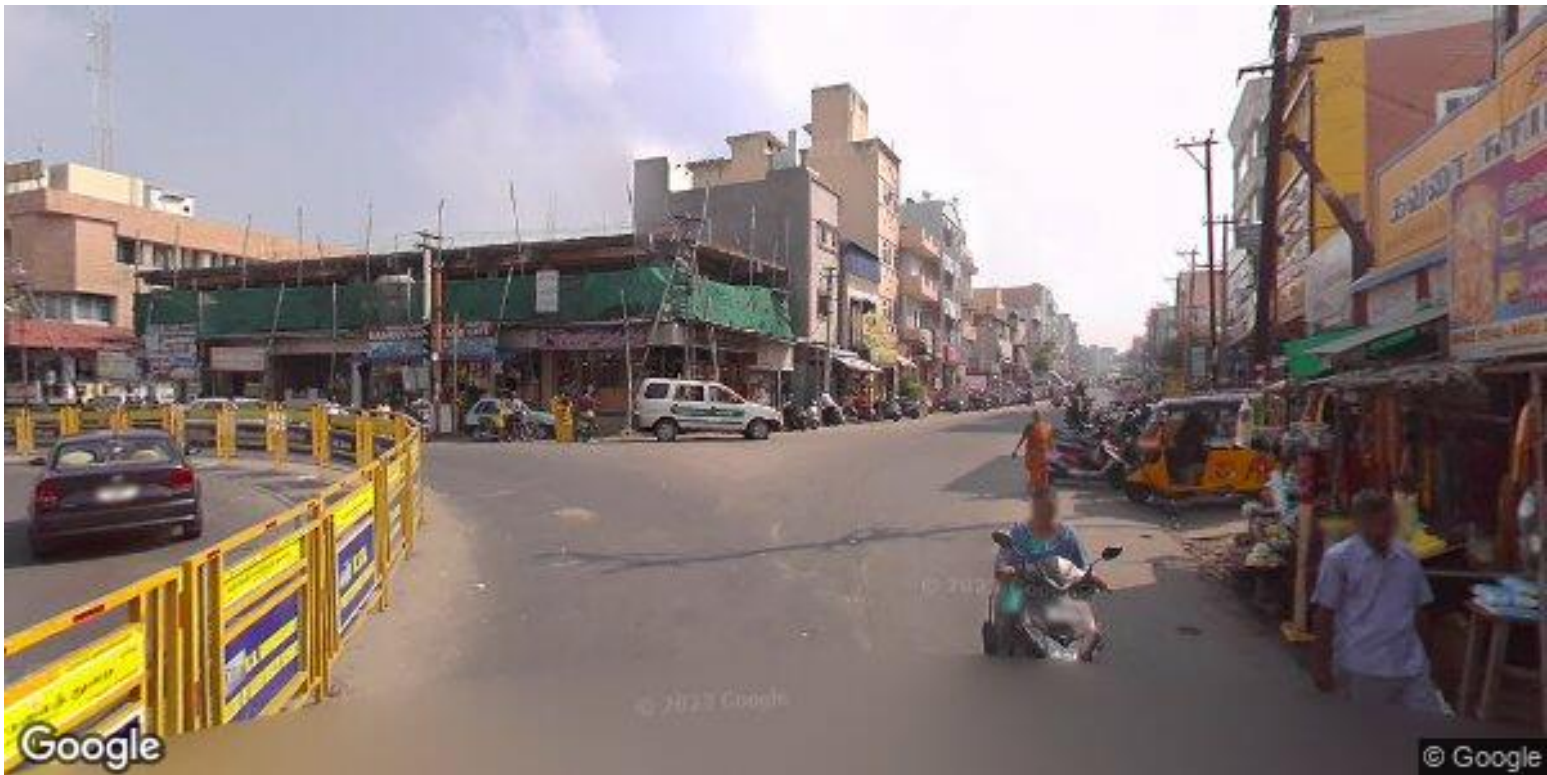
Risk Type: Turn

Risk Level: High

Speed Limit: 15 KM/Hr

Coordinates: 11.37862, 77.89488

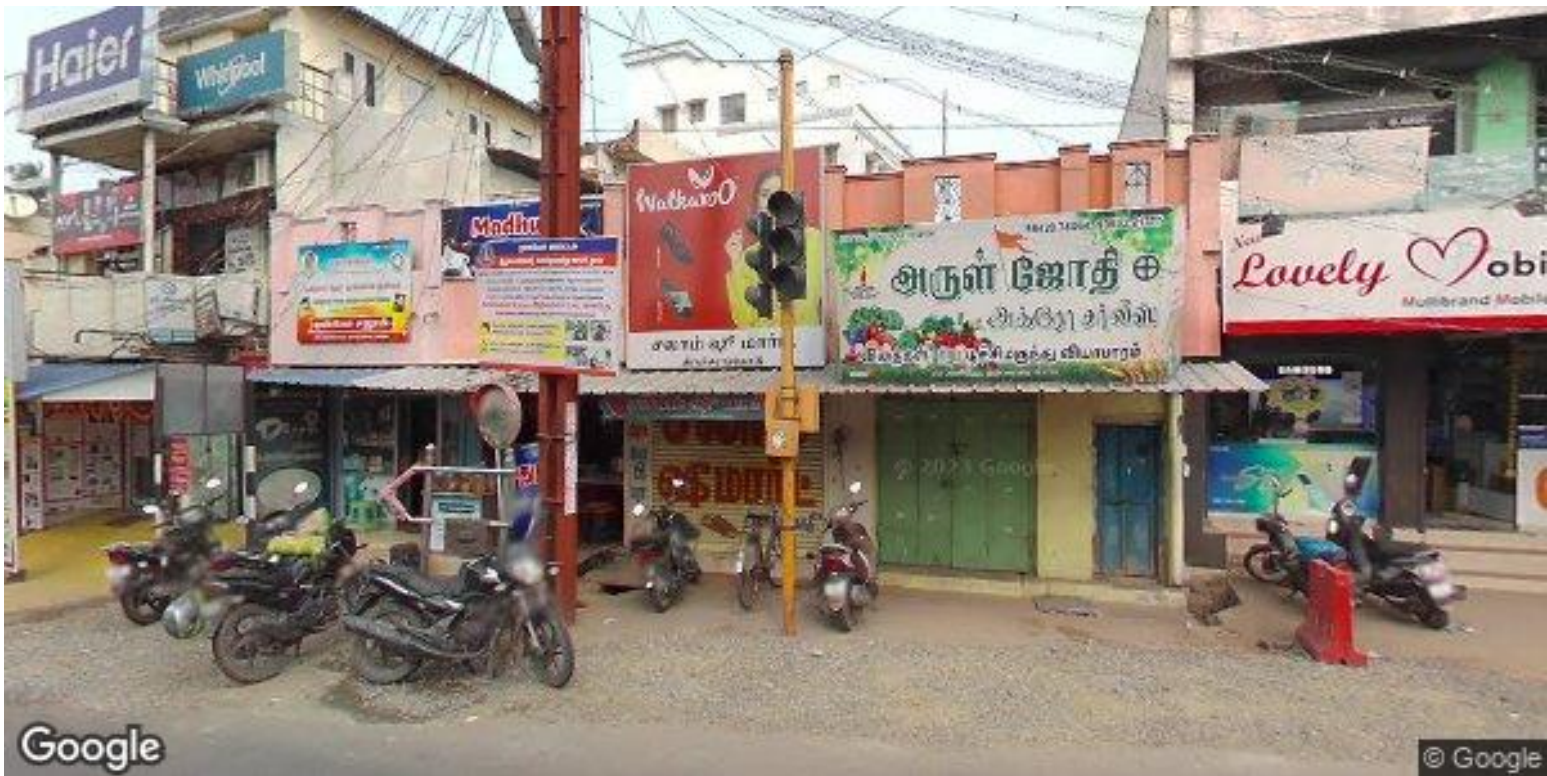
Risk Type: Turn

Risk Level: High

Speed Limit: 15 KM/Hr

Coordinates: 11.37850, 77.89453

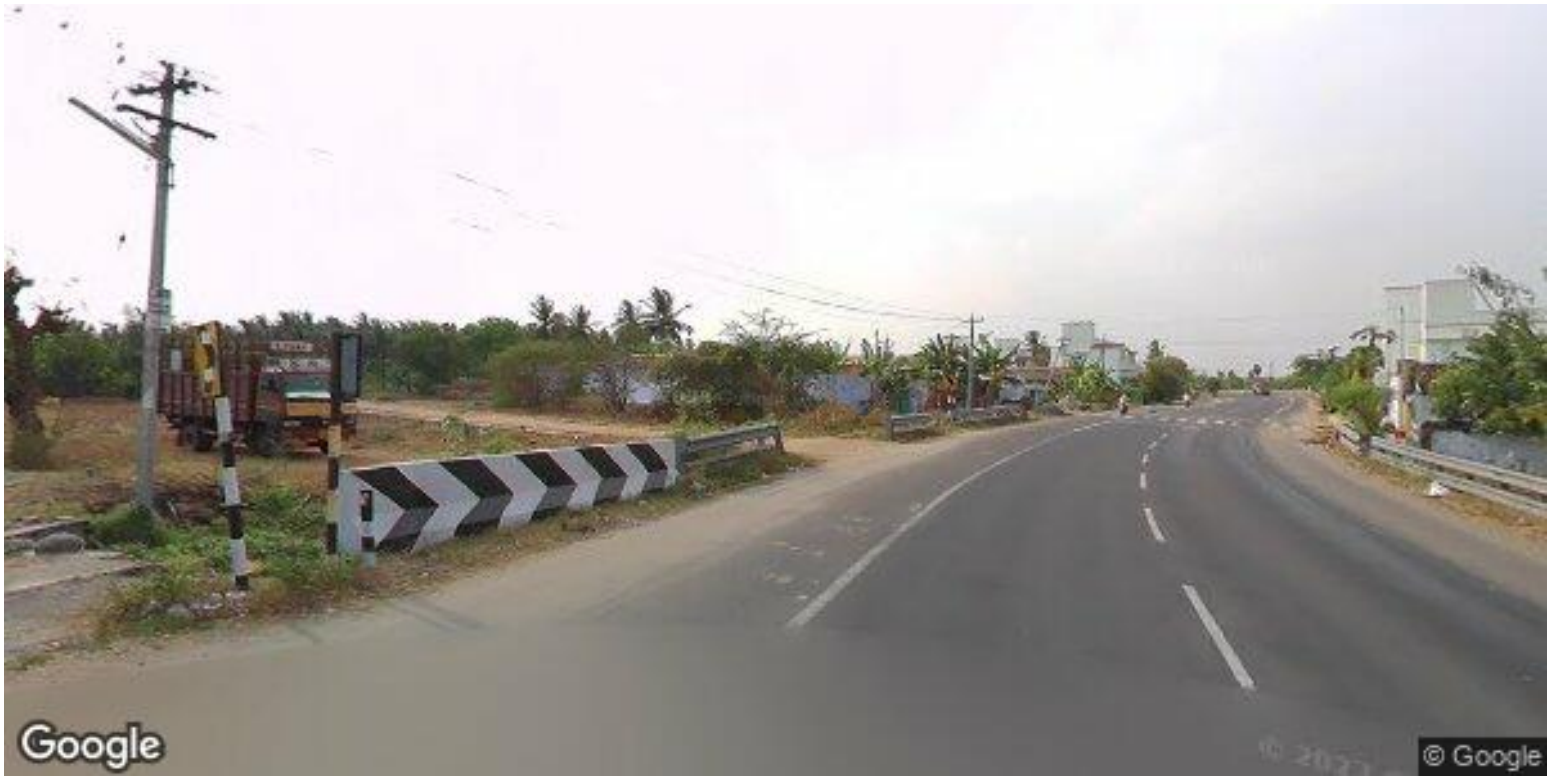
**Risk Type:** Turn  
**Risk Level:** Medium  
**Speed Limit:** 30 KM/Hr  
**Coordinates:** 11.16755, 78.01568

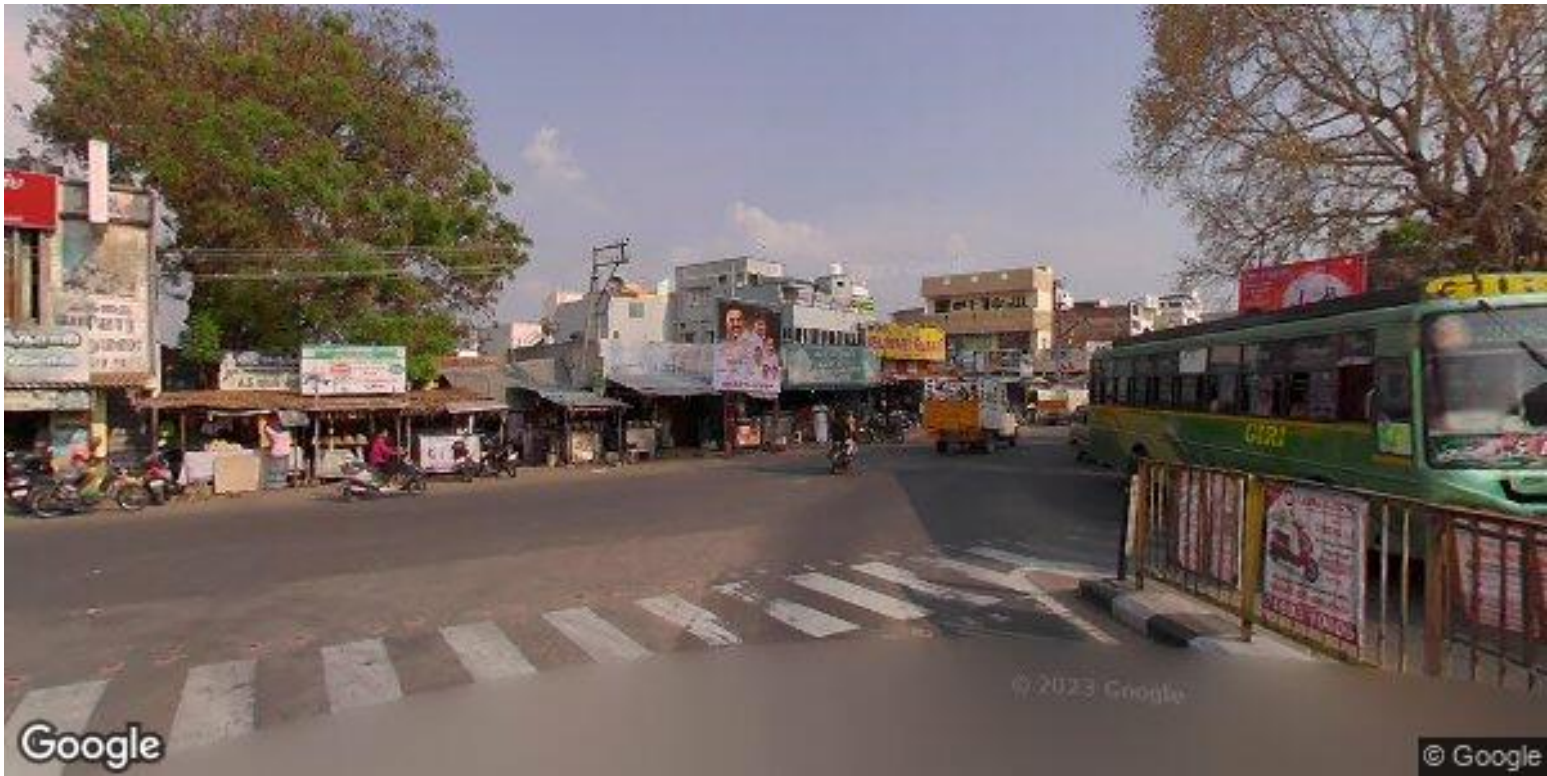
**Risk Type:** Turn  
**Risk Level:** Medium  
**Speed Limit:** 30 KM/Hr  
**Coordinates:** 11.15579, 78.02169

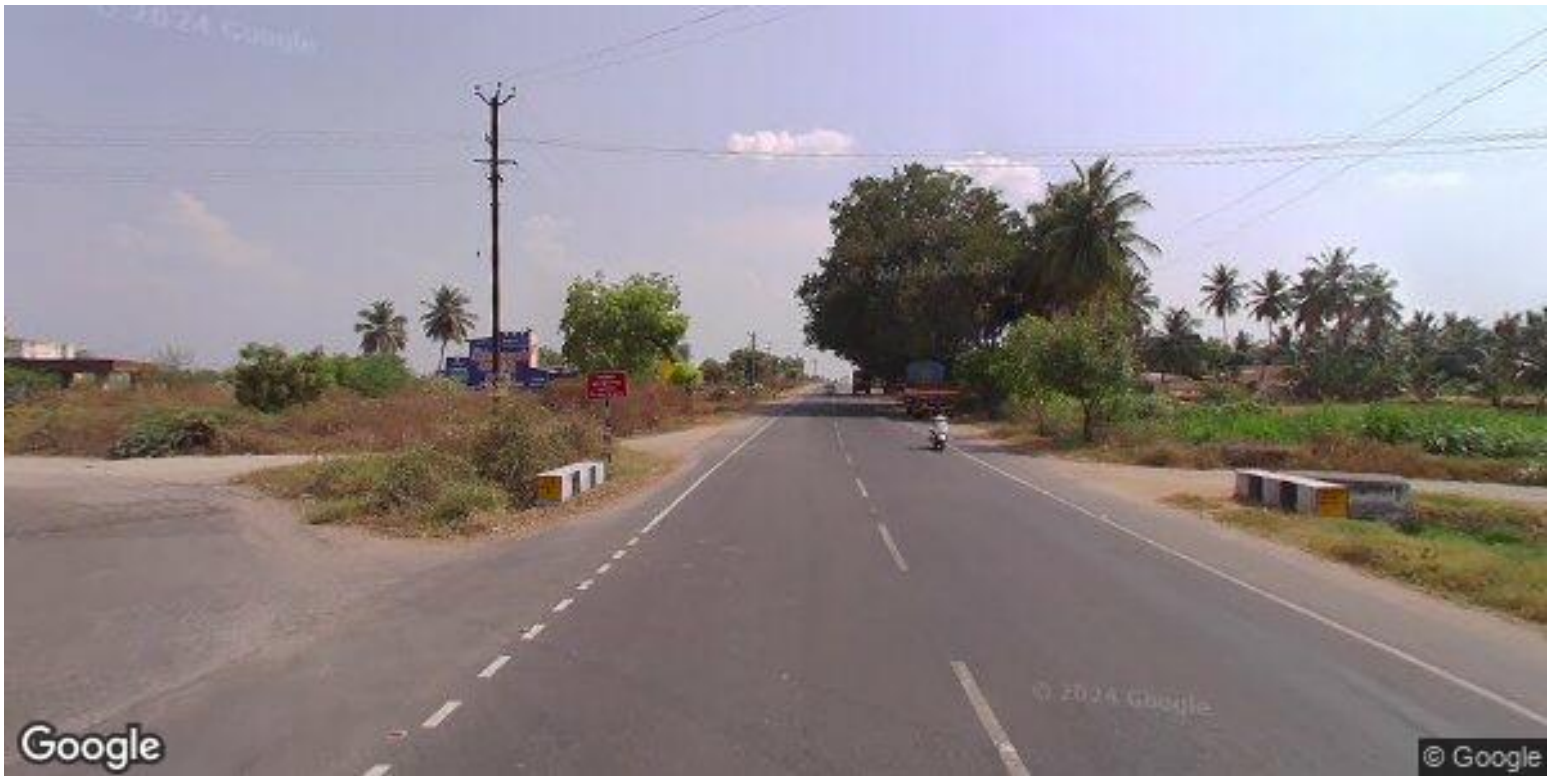
**Risk Type:** Turn  
**Risk Level:** High  
**Speed Limit:** 15 KM/Hr  
**Coordinates:** 11.14545, 78.02208

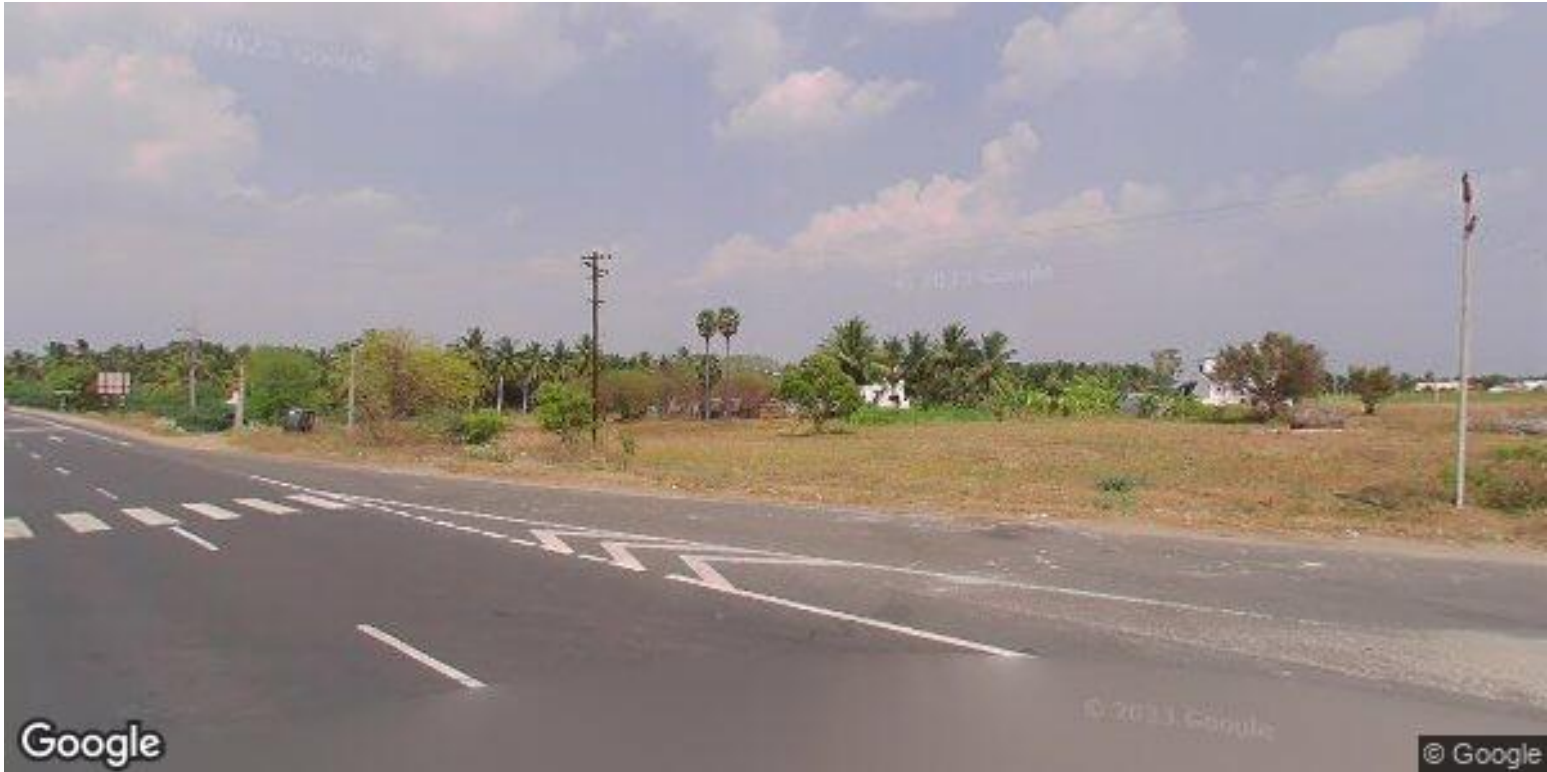
**Risk Type:** Blind Spot  
**Risk Level:** Blind Spot  
**Speed Limit:** 10 KM/Hr  
**Coordinates:** 11.14480, 78.02291

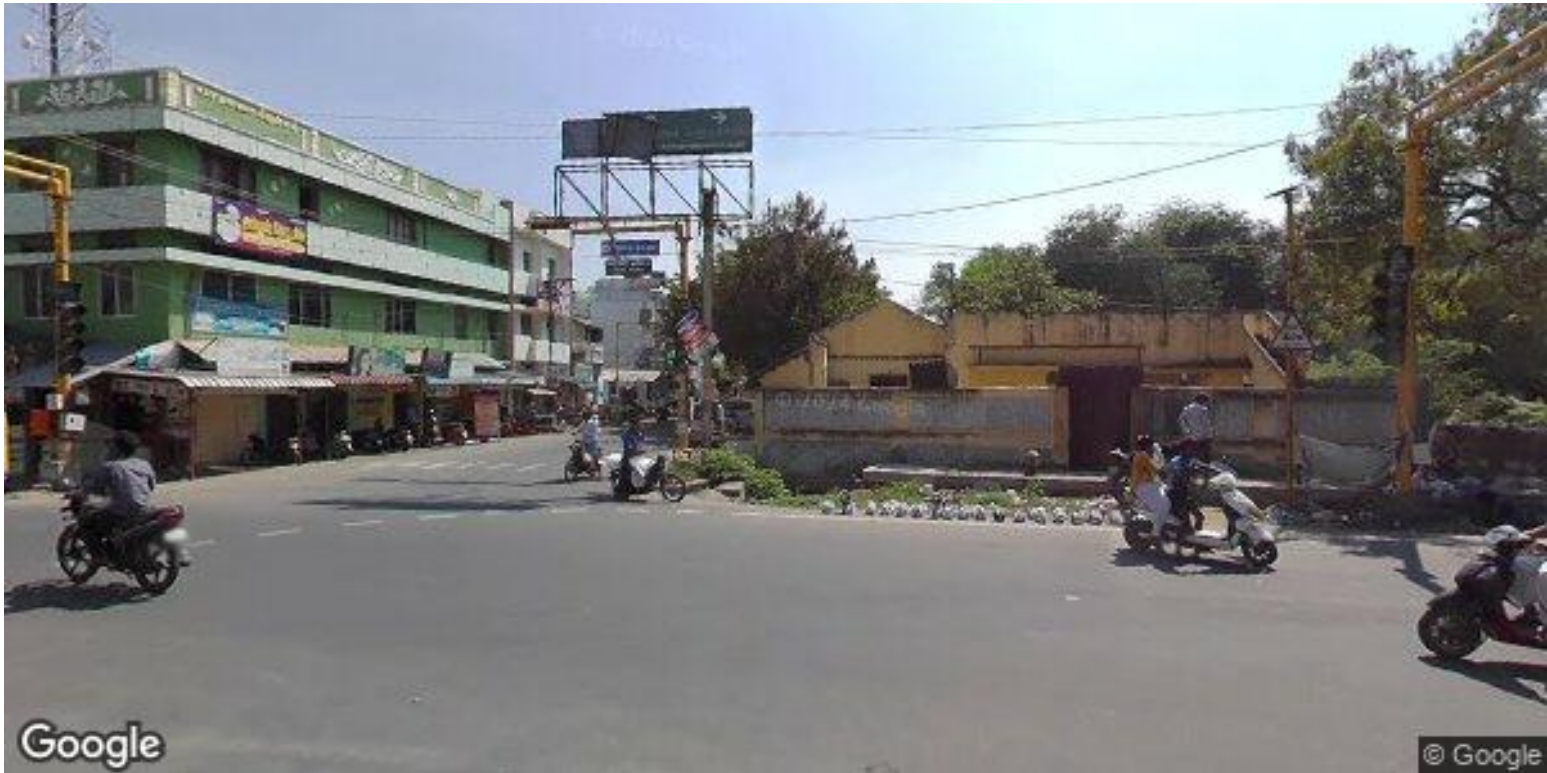
**Risk Type:** Turn  
**Risk Level:** High  
**Speed Limit:** 15 KM/Hr  
**Coordinates:** 10.96264, 78.08183

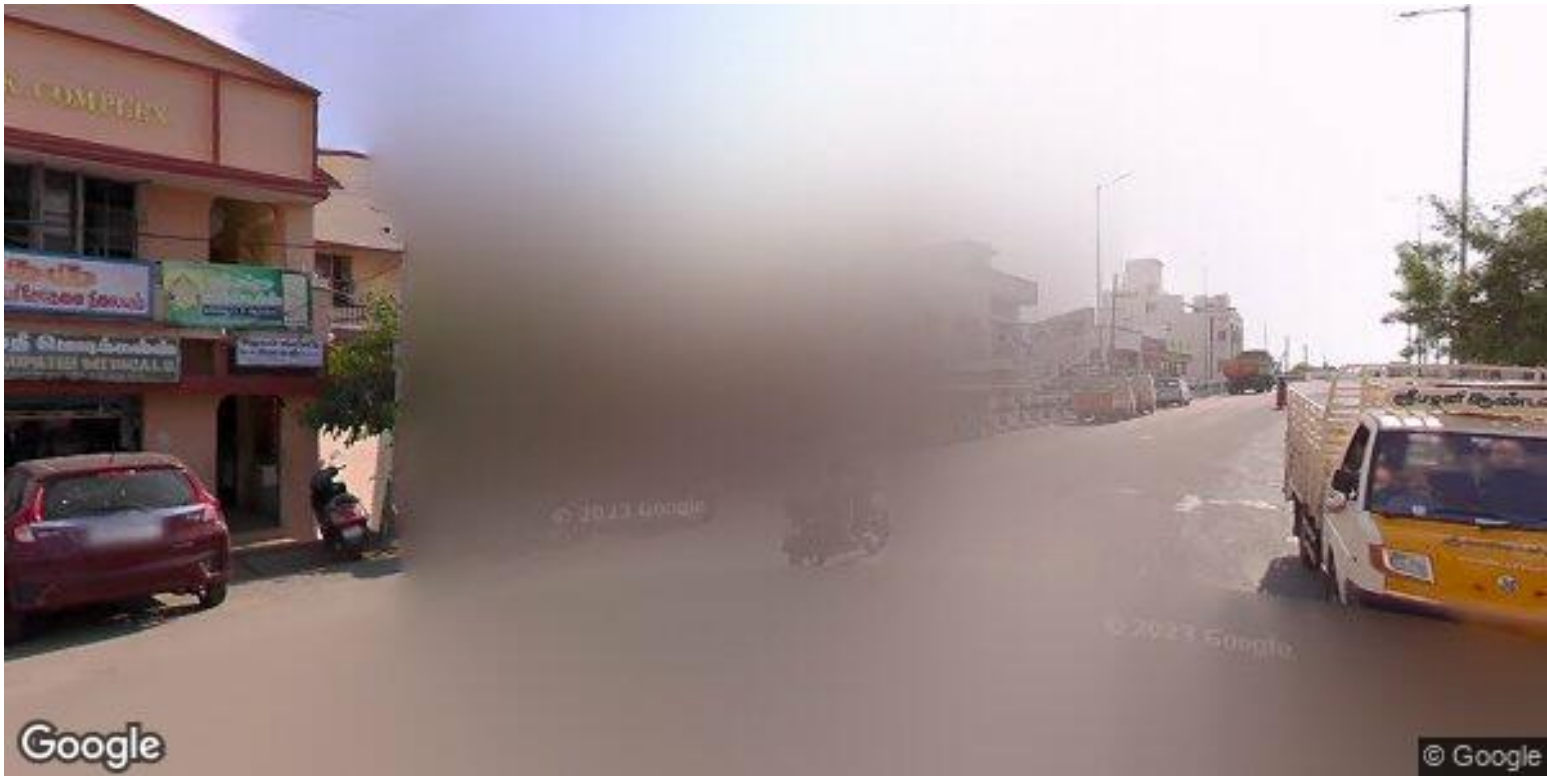
**Risk Type:** Turn  
**Risk Level:** Medium  
**Speed Limit:** 30 KM/Hr  
**Coordinates:** 10.96221, 78.09641

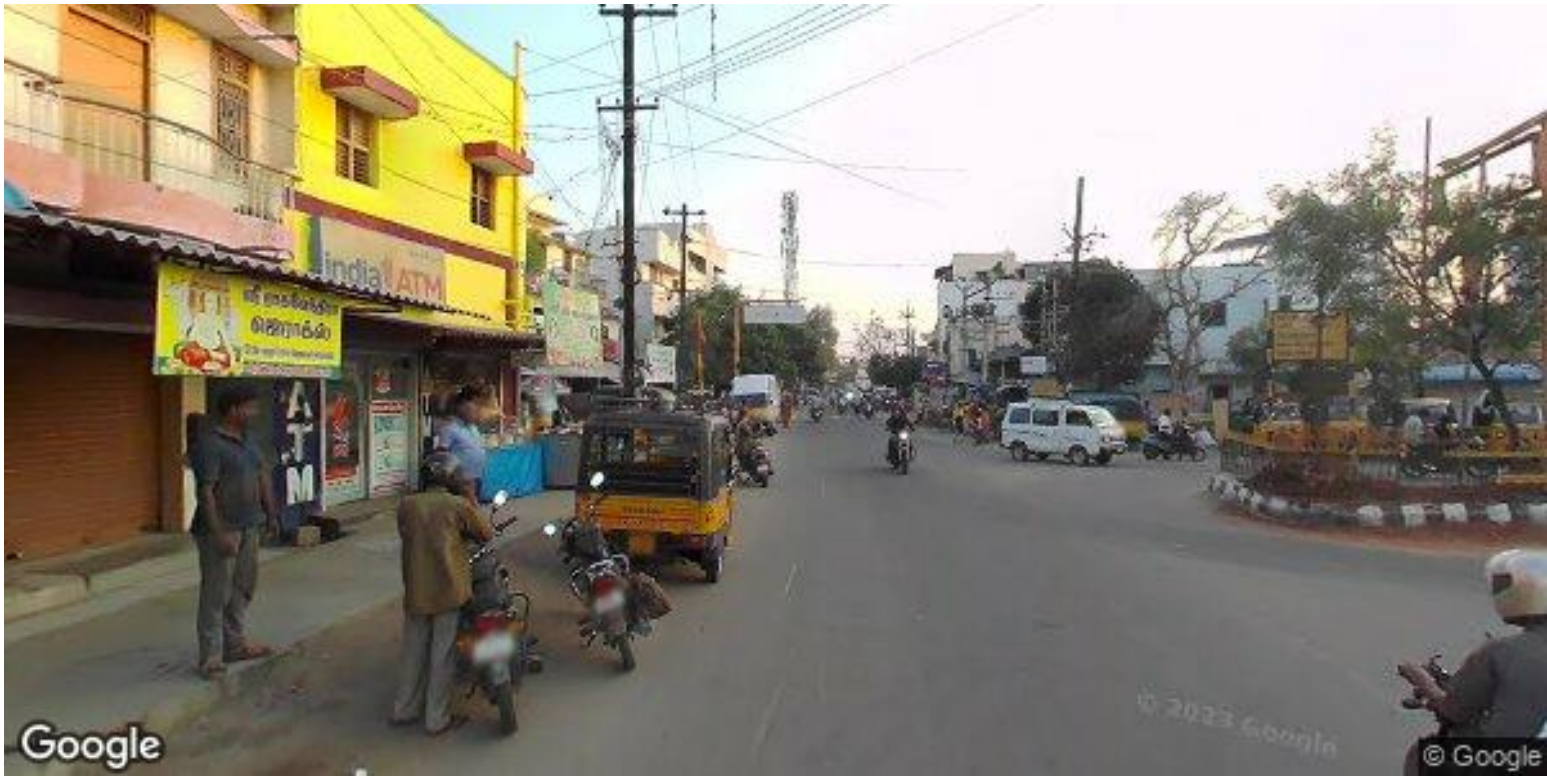
**Risk Type:** Turn  
**Risk Level:** High  
**Speed Limit:** 15 KM/Hr  
**Coordinates:** 10.96229, 78.09658

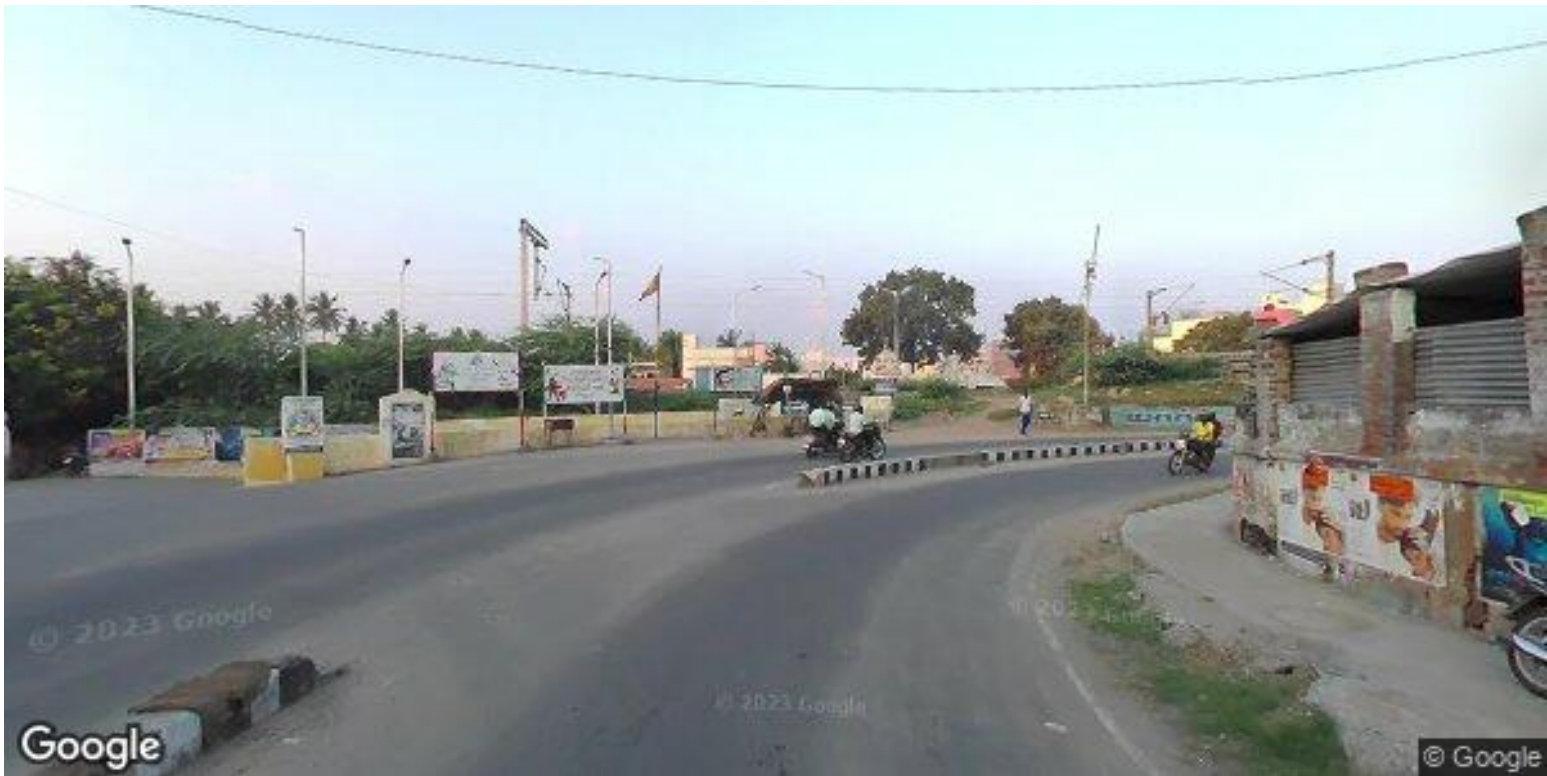
**Risk Type:** Turn  
**Risk Level:** High  
**Speed Limit:** 15 KM/Hr  
**Coordinates:** 10.96314, 78.09655

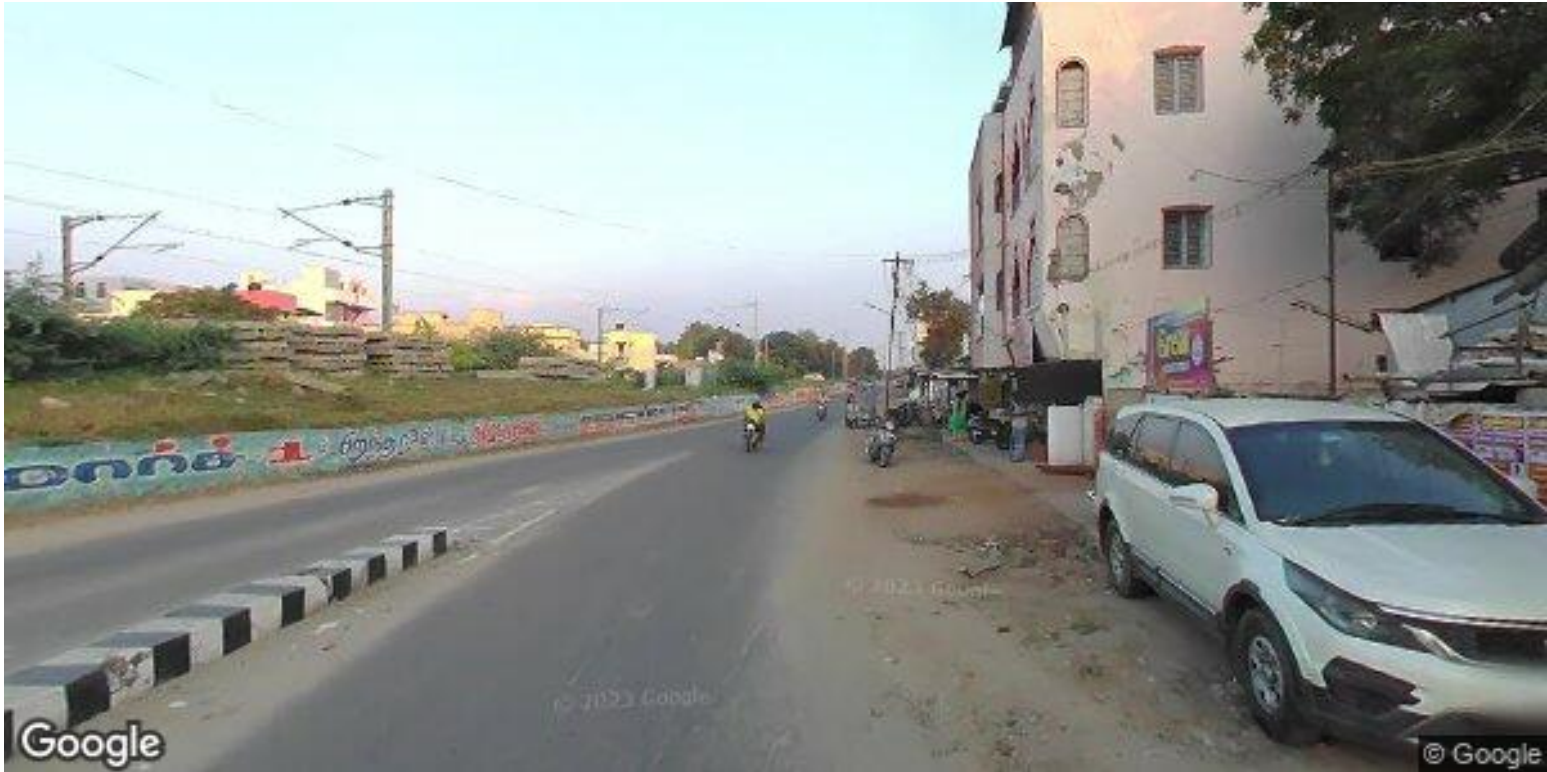
**Risk Type:** Turn  
**Risk Level:** Medium  
**Speed Limit:** 30 KM/Hr  
**Coordinates:** 10.96323, 78.09676

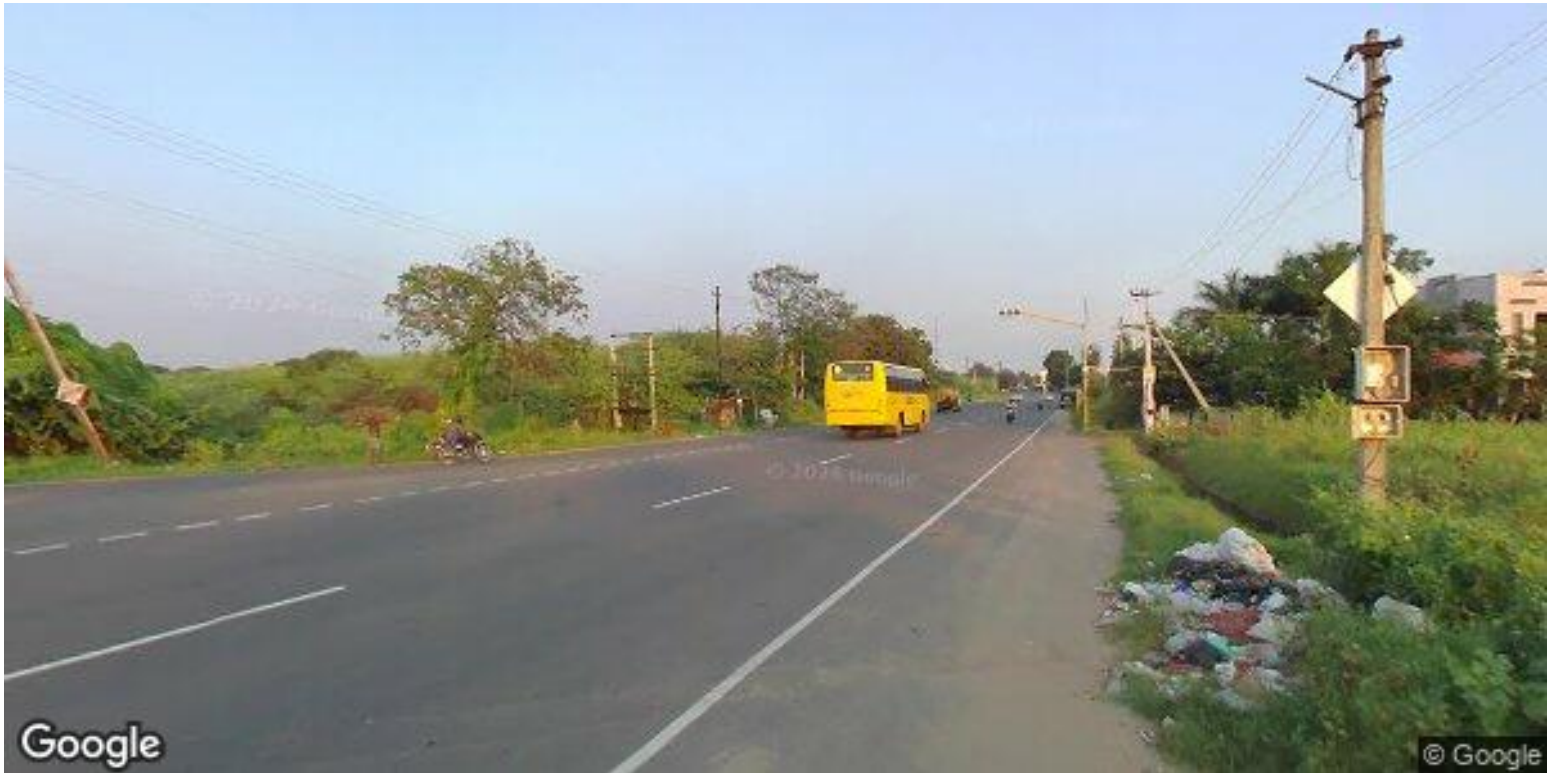
**Risk Type:** Turn  
**Risk Level:** High  
**Speed Limit:** 15 KM/Hr  
**Coordinates:** 10.94214, 78.13025

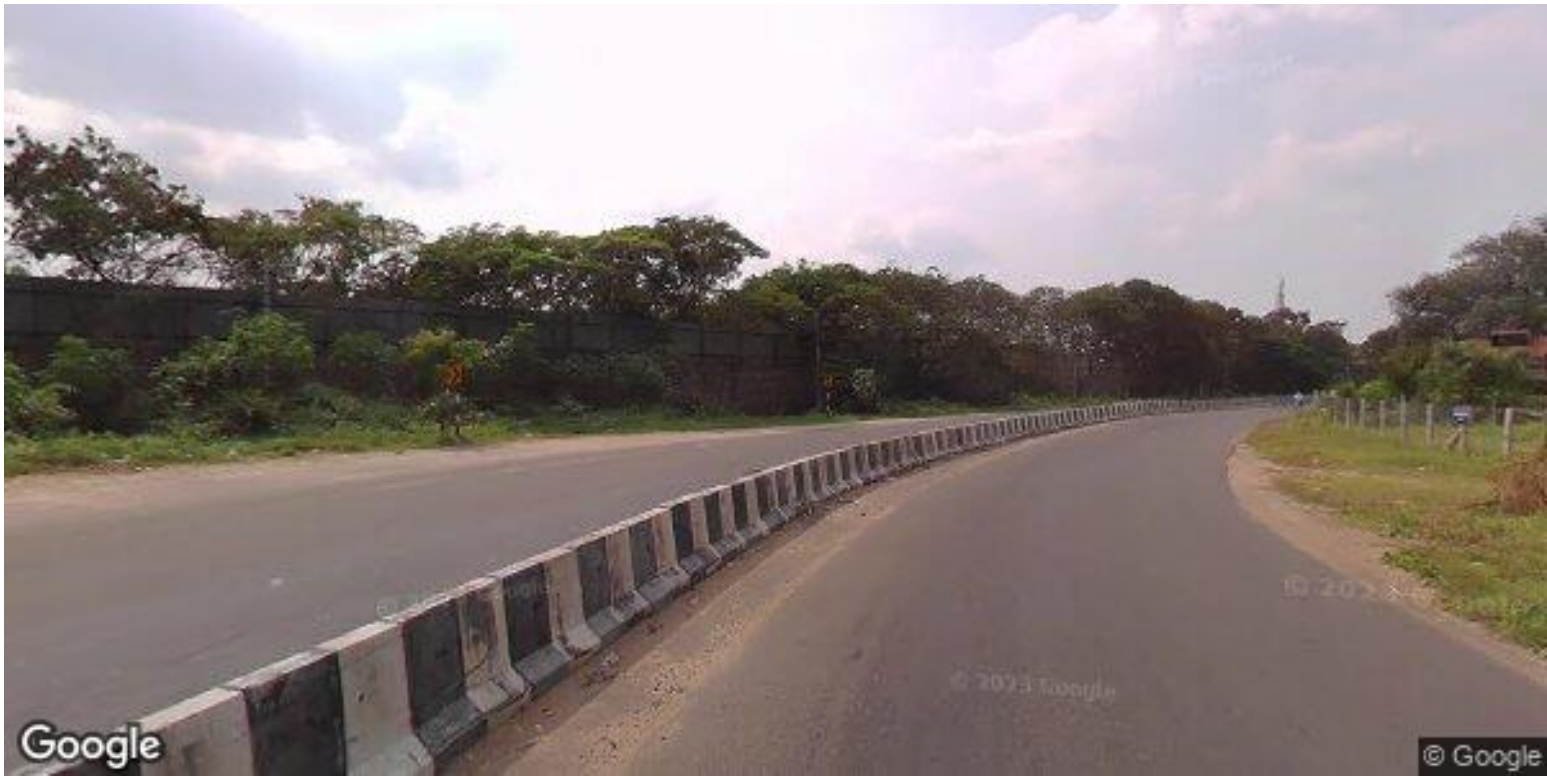
**Risk Type:** Turn

**Risk Level:** Medium

**Speed Limit:** 30 KM/Hr

**Coordinates:** 10.93847, 78.14871
