# IndianOil

## JOURNEY RISK MANAGEMENT (JRM) STUDY

### Salem Terminal to JASMINE ENTERPRISES

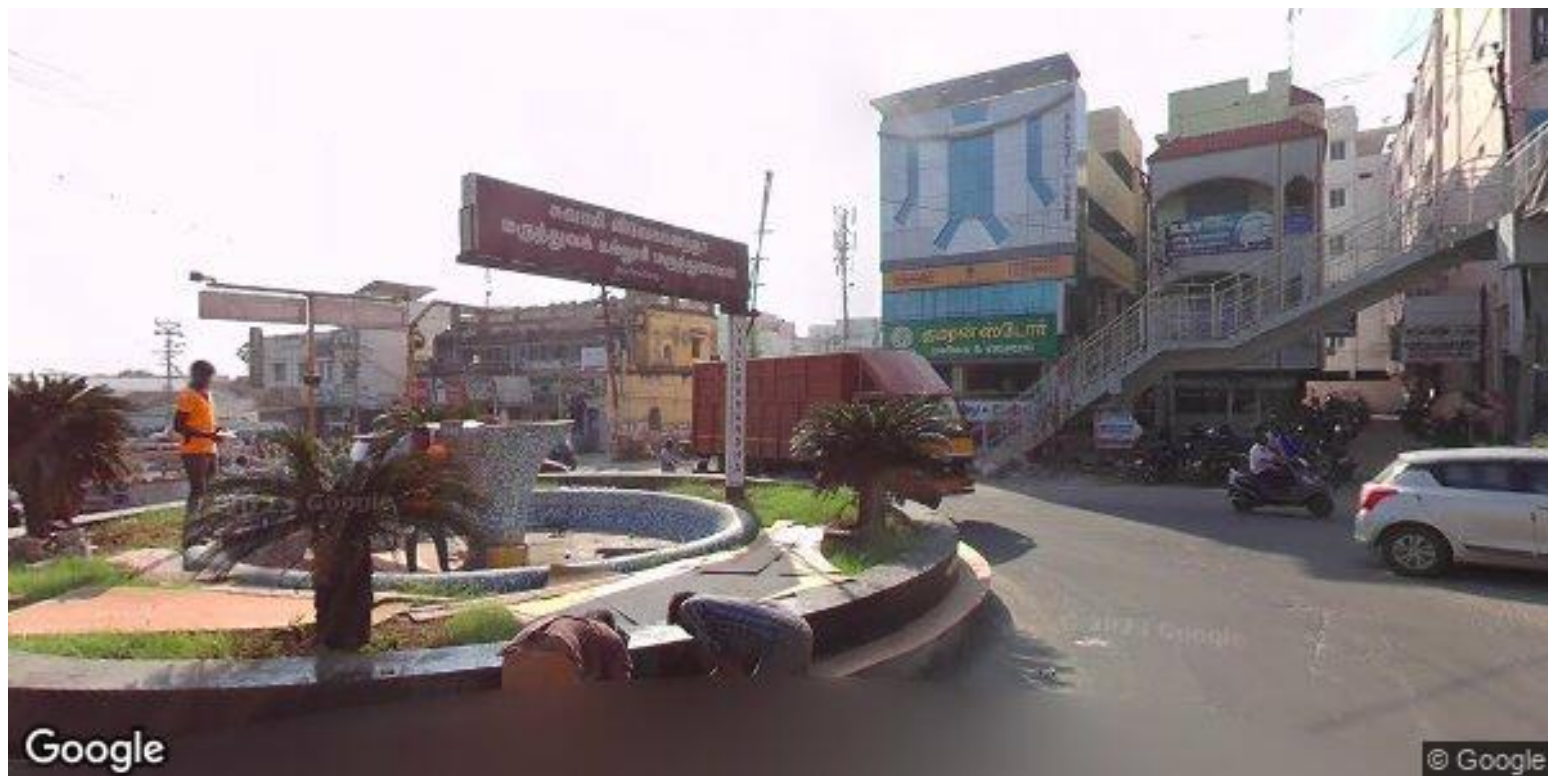
**Coordinates:** 11.38395, 77.89480

**Risk Type:** Roundabout

**Risk Level:** High

**Speed Limit:** 15 KM/Hr

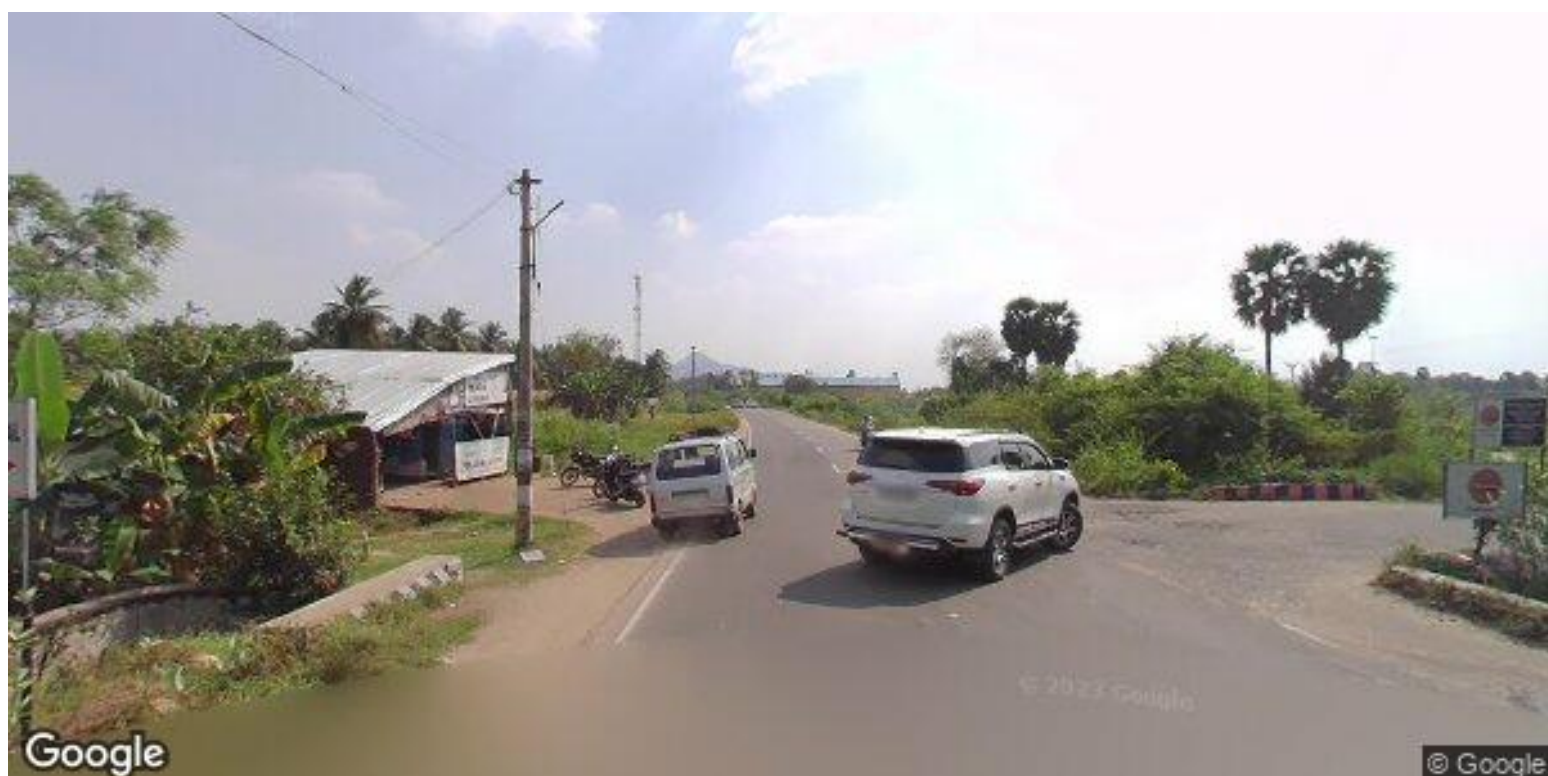
**Coordinates: 11.44029, 77.87544**

**Risk Type:** Blind Spot

**Risk Level:** Blind Spot

**Speed Limit: 10 KM/Hr**

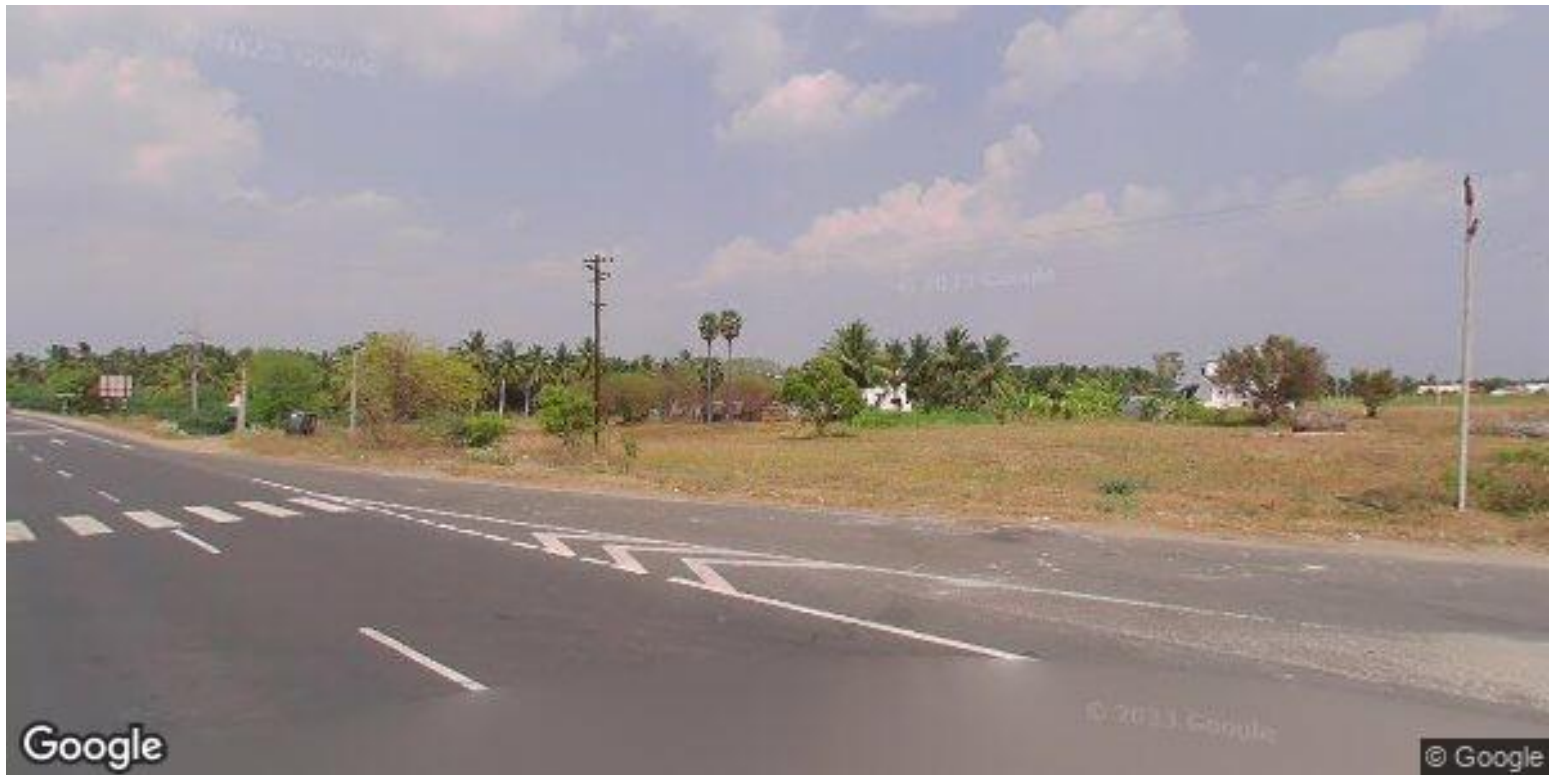
**Risk Type:** Turn  
**Risk Level:** High  
**Speed Limit:** 15 KM/Hr  
**Coordinates:** 11.14480, 78.02291

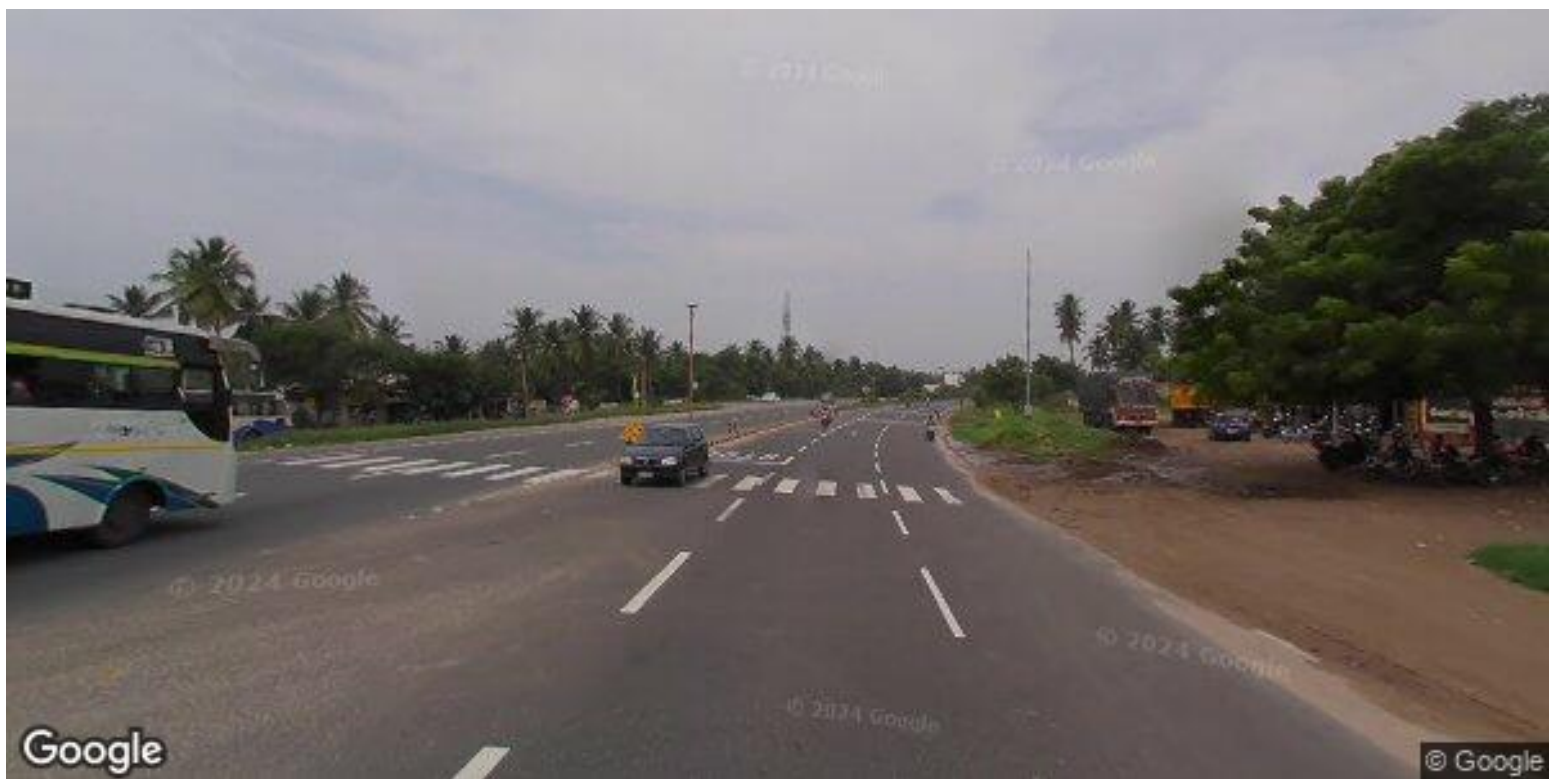
**Risk Type:** Turn  
**Risk Level:** High  
**Speed Limit:** 15 KM/Hr  
**Coordinates:** 11.12555, 78.01664

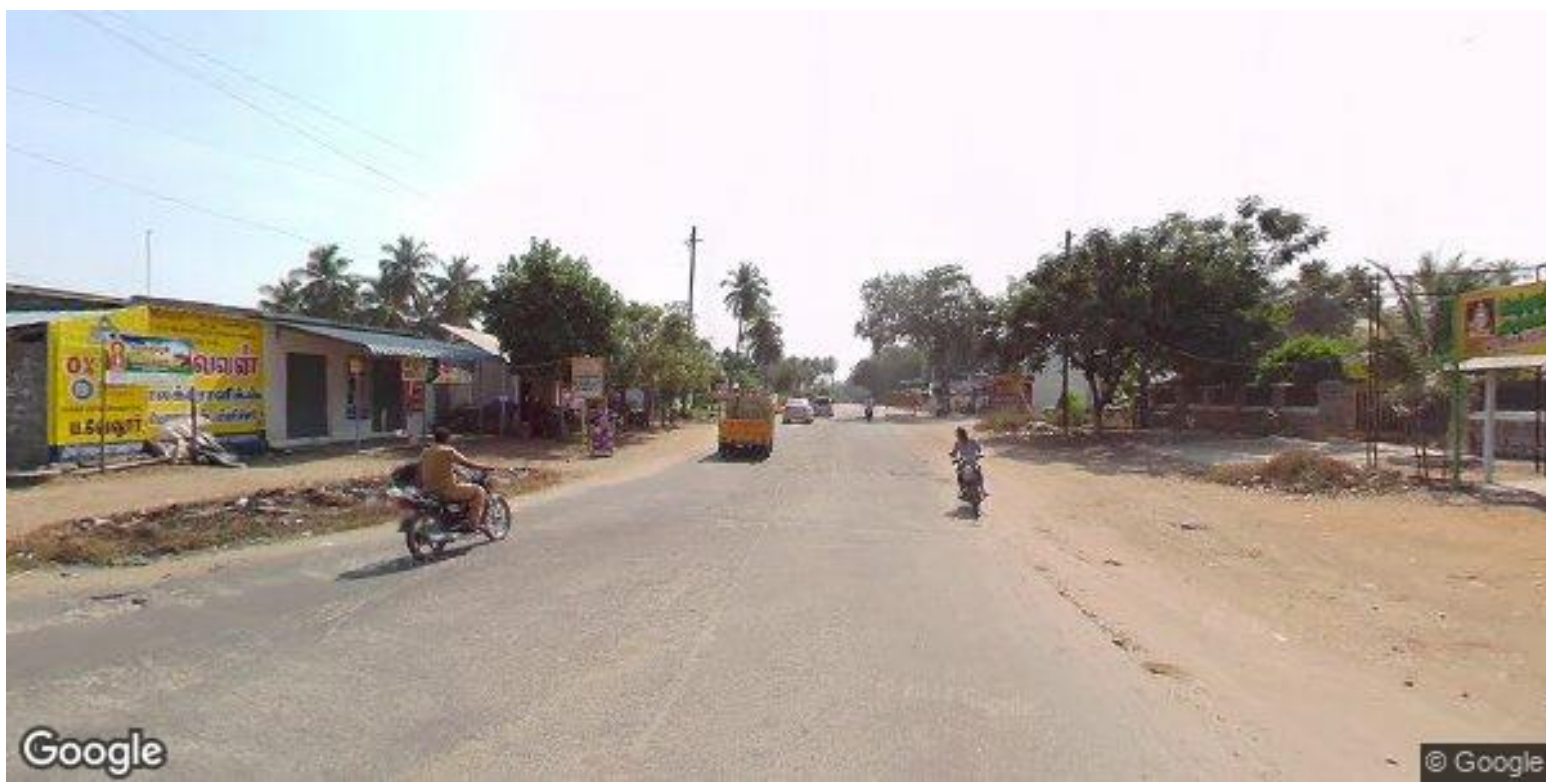
**Coordinates:** 11.12540, 78.01613

**Risk Type:** Turn

**Risk Level:** High

**Speed Limit:** 15 KM/Hr

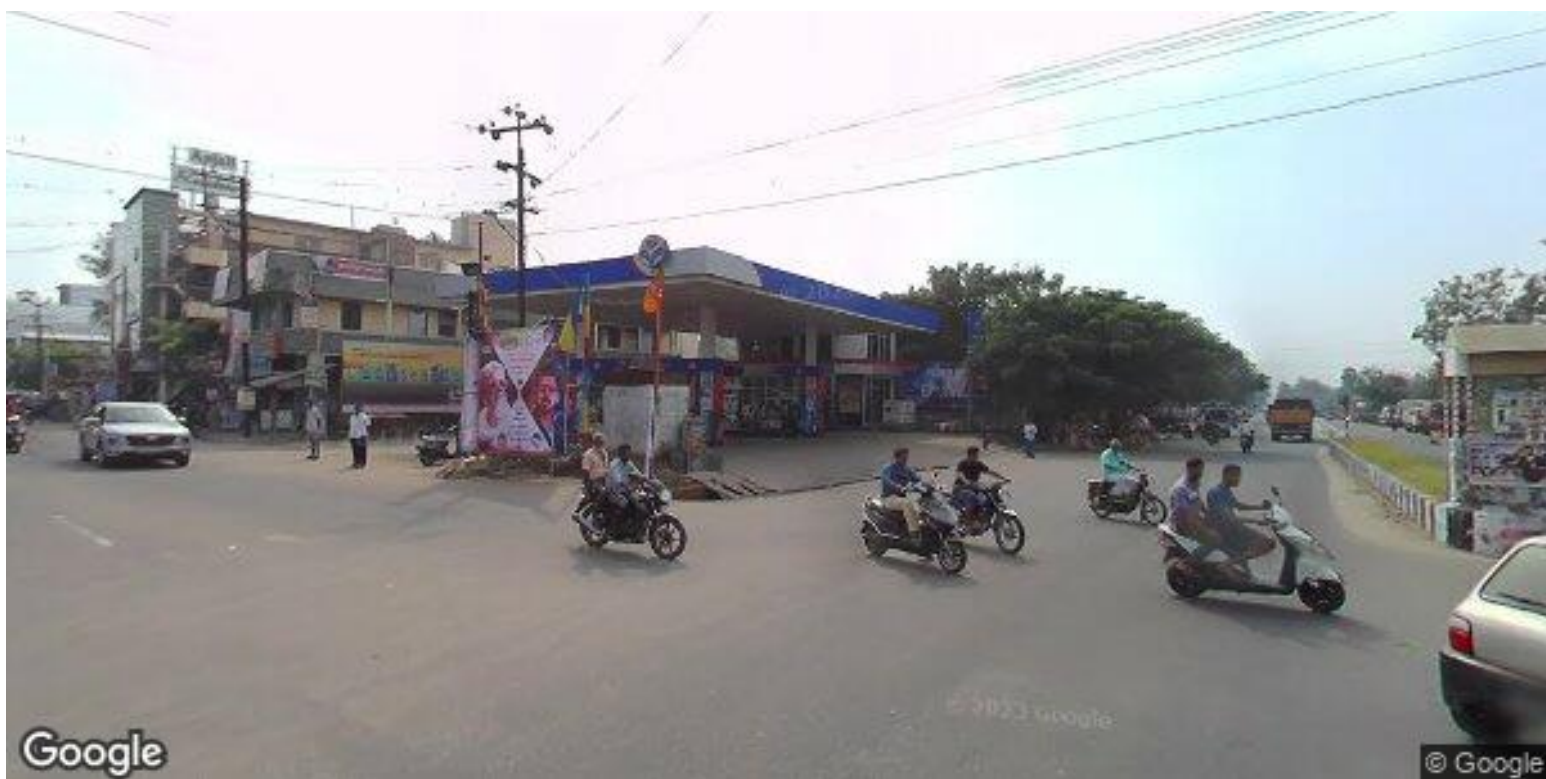
**Coordinates:** 11.10777, 78.00425

**Risk Type:** Turn

**Risk Level:** Medium

**Speed Limit:** 30 KM/Hr

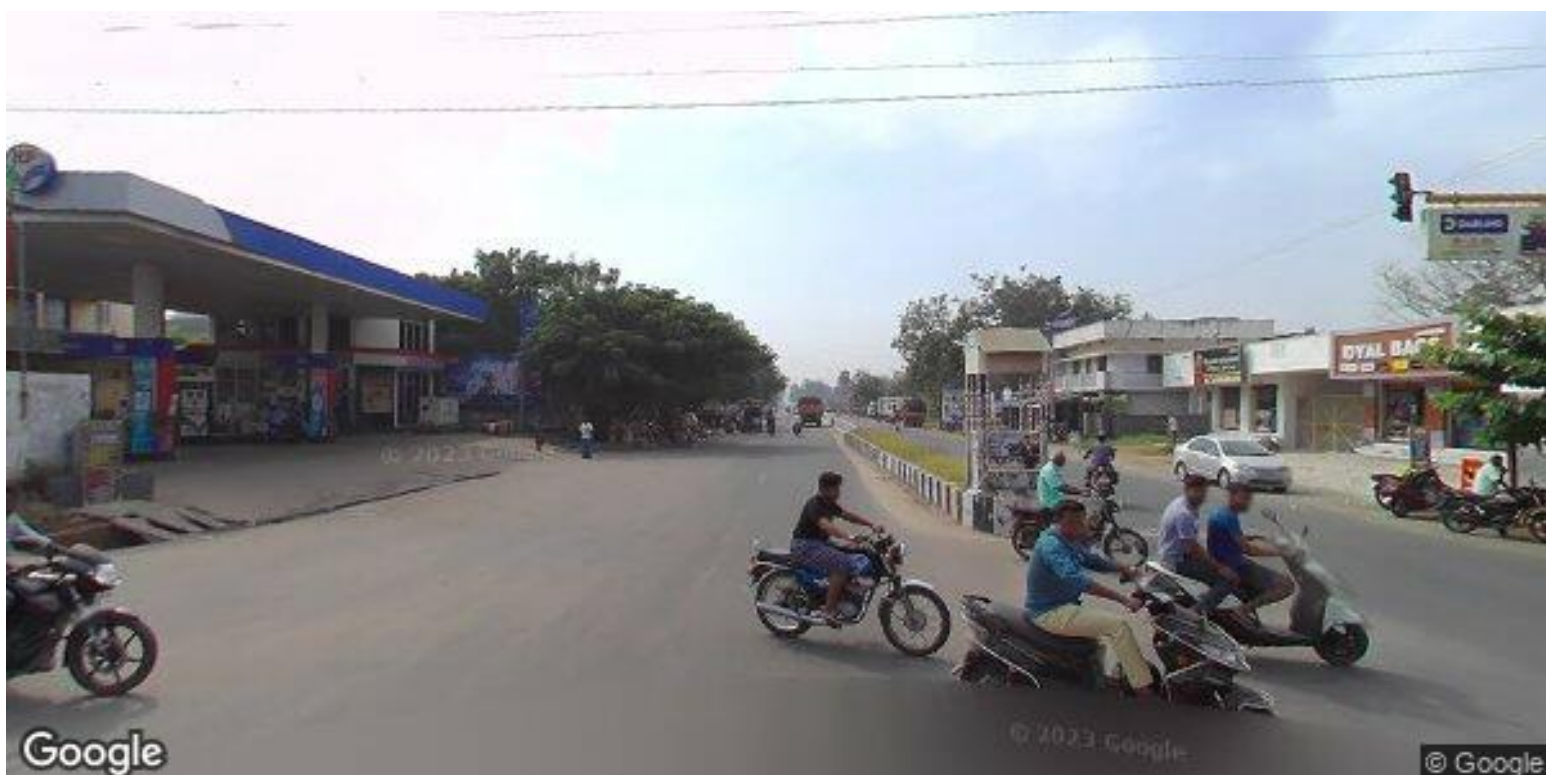
**Coordinates:** 11.10772, 78.00425

**Risk Type:** Turn

**Risk Level:** Medium

**Speed Limit:** 30 KM/Hr

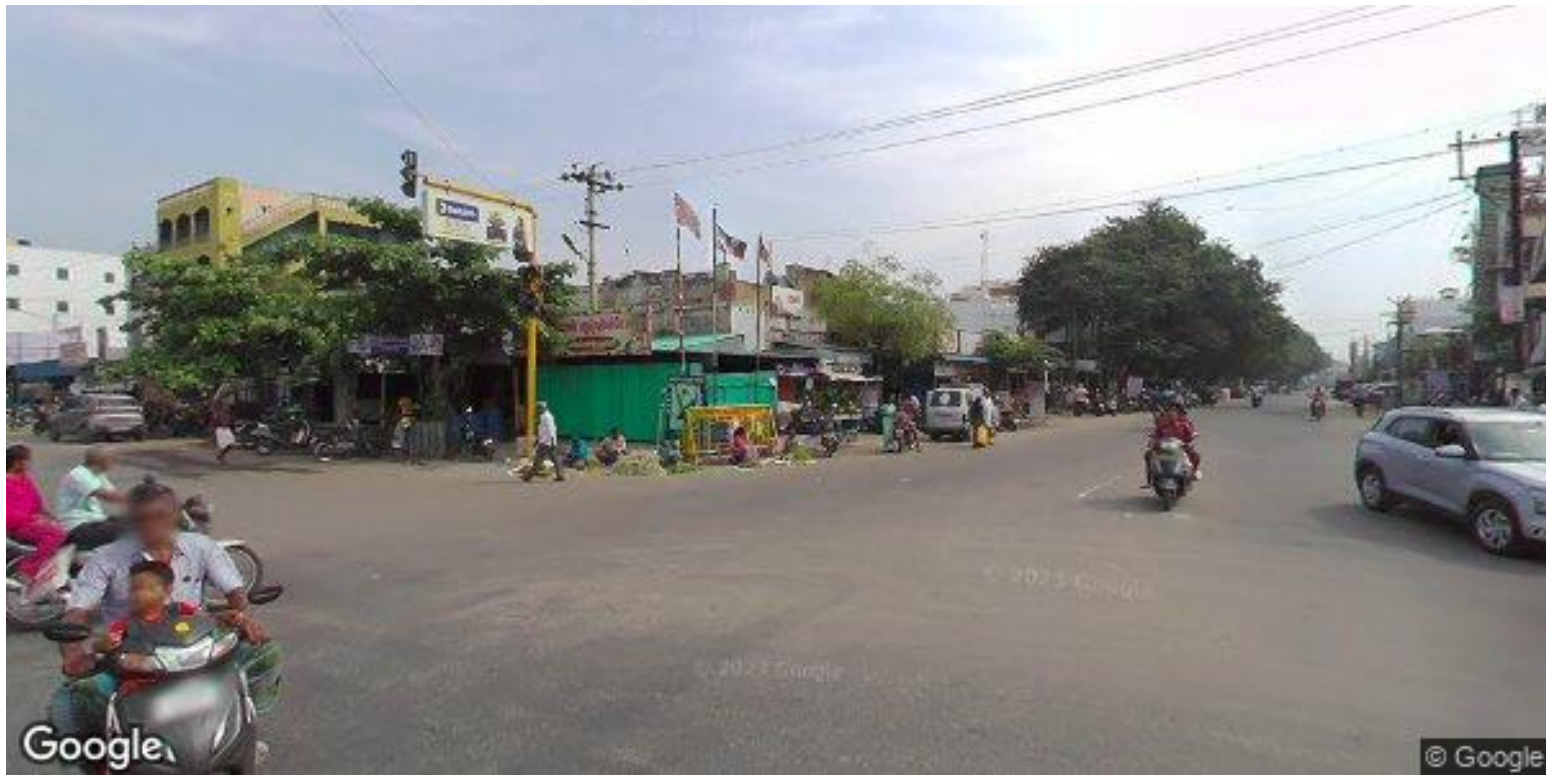
**Coordinates:** 11.10768, 78.00422

**Risk Type:** Turn

**Risk Level:** Medium

**Speed Limit:** 30 KM/Hr
