## JOURNEY RISK MANAGEMENT (JRM) STUDY

### Salem Terminal to VKG & BROTHERS

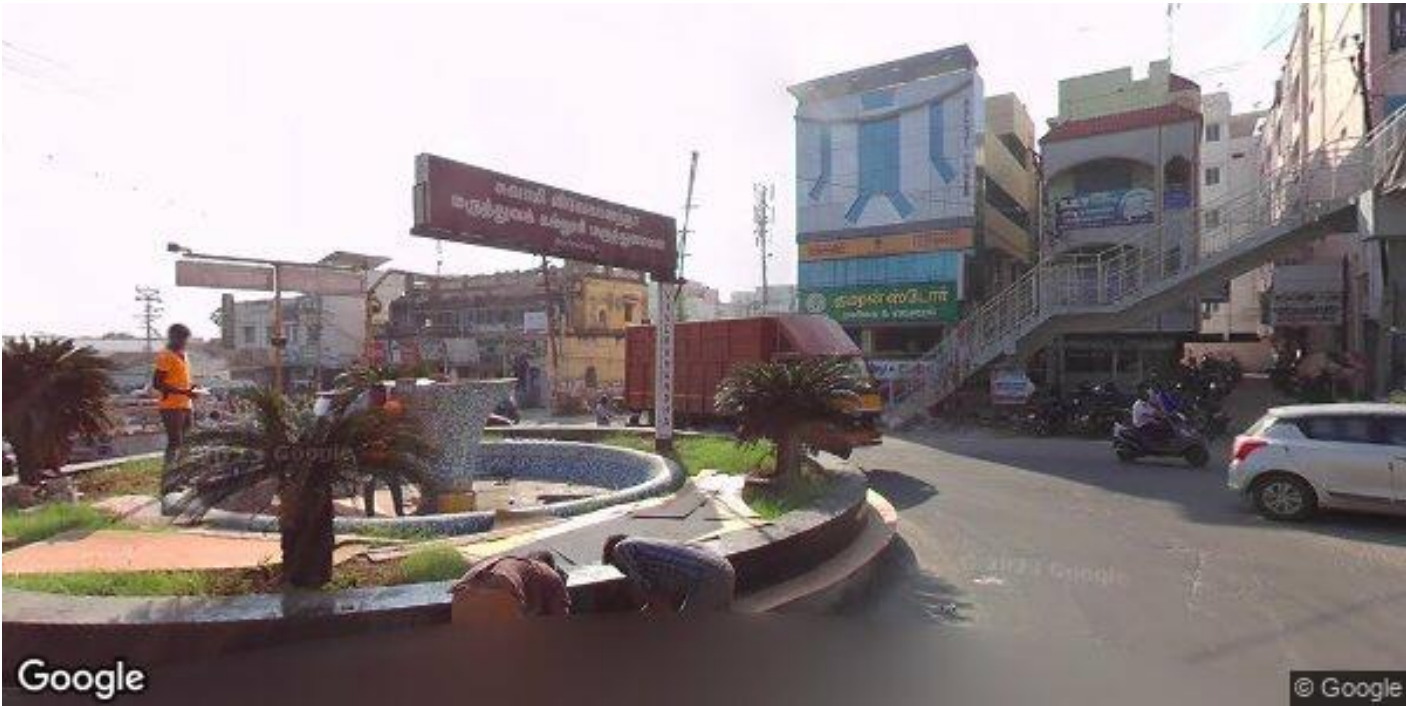
Coordinates: 11.38395, 77.89480

Risk Type: Roundabout

Risk Level: High

Speed Limit: 15 KM/Hr

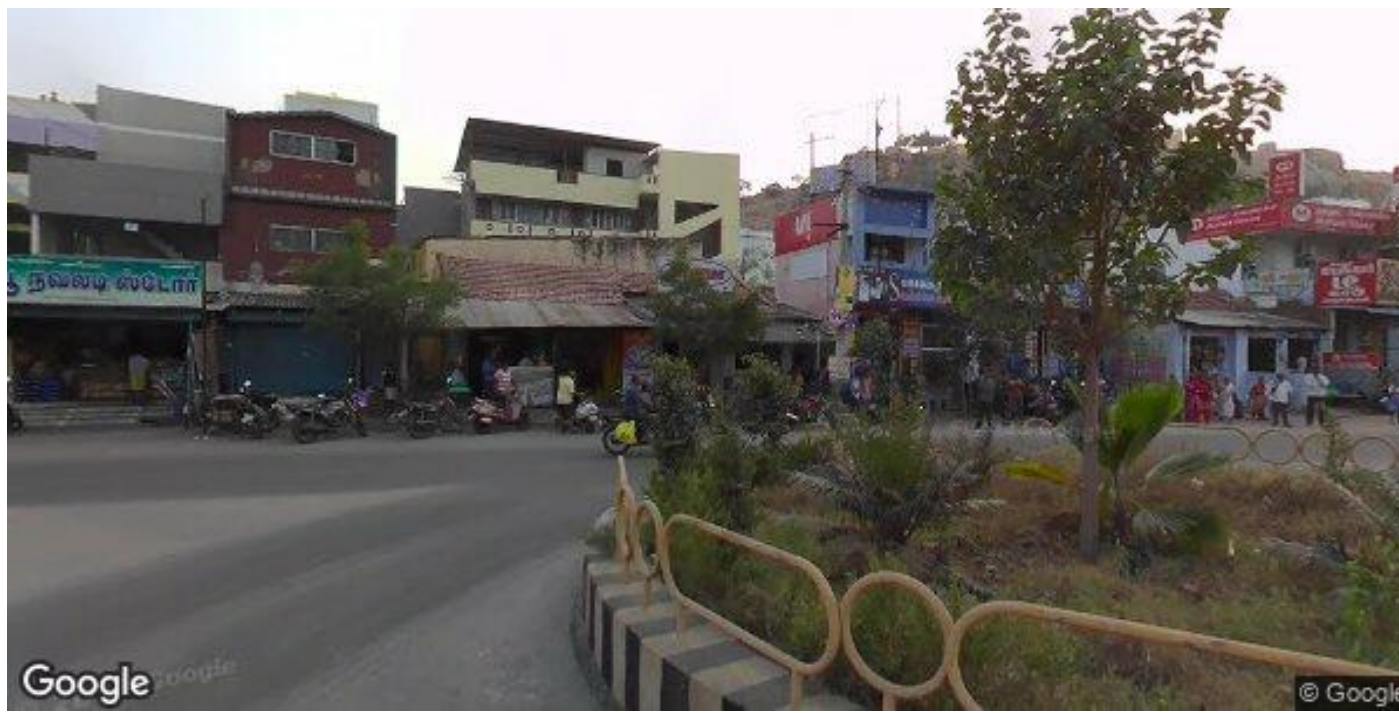
**Coordinates:** 11.07495, 78.00165

**Risk Type:** Roundabout

**Risk Level:** High

**Speed Limit:** 15 KM/Hr

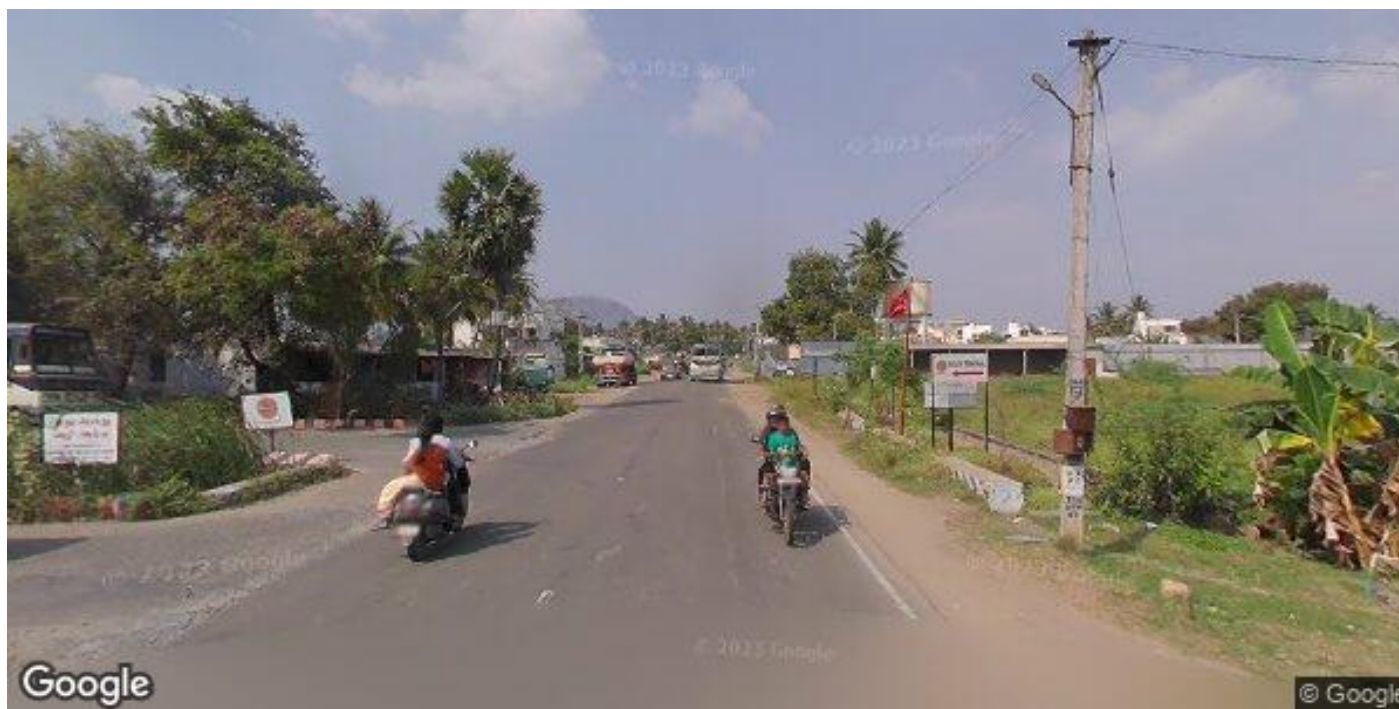
**Coordinates:** 11.44019, 77.87547

**Risk Type:** Turn

**Risk Level:** High

**Speed Limit:** 15 KM/Hr

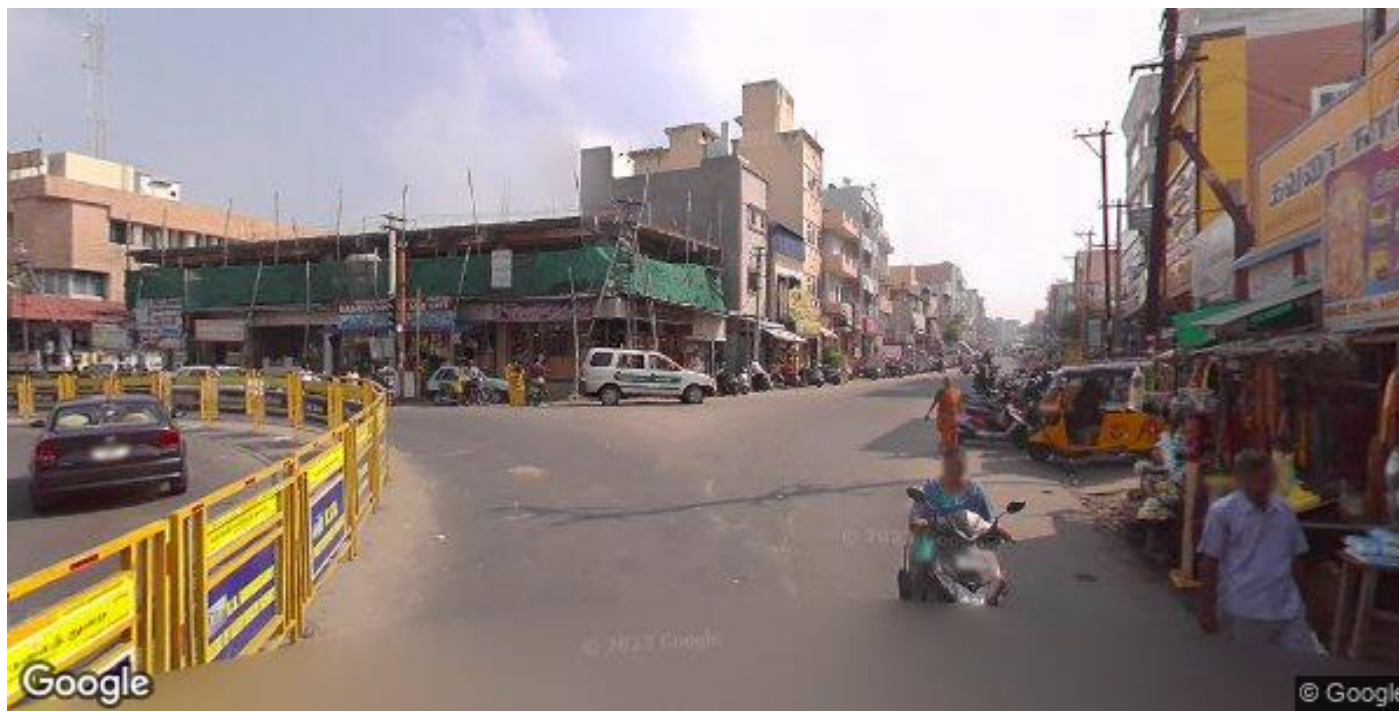
**Risk Type:** Turn  
**Risk Level:** High  
**Speed Limit:** 15 KM/Hr  
**Coordinates:** 11.37862, 77.89488

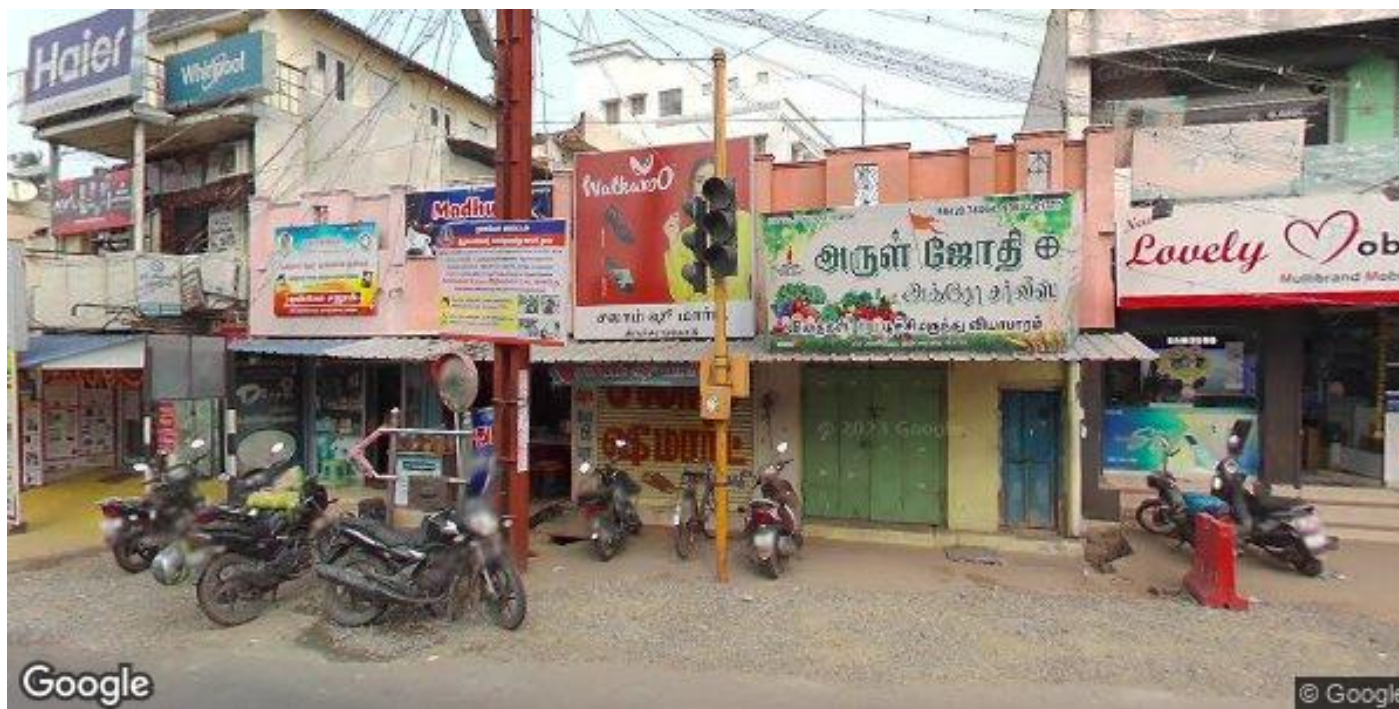
**Risk Type:** Turn  
**Risk Level:** High  
**Speed Limit:** 15 KM/Hr  
**Coordinates:** 11.37850, 77.89453

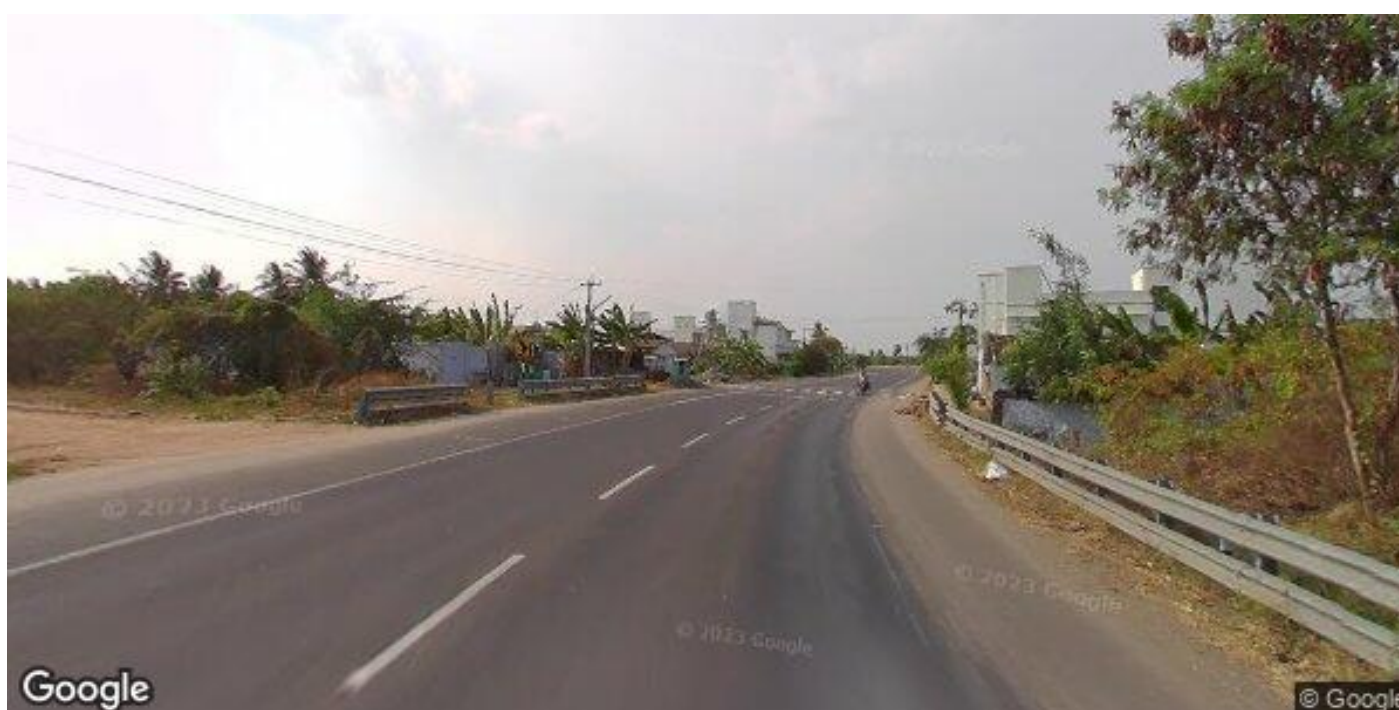
**Risk Type:** Turn  
**Risk Level:** Medium  
**Speed Limit:** 30 KM/Hr  
**Coordinates:** 11.16764, 78.01565

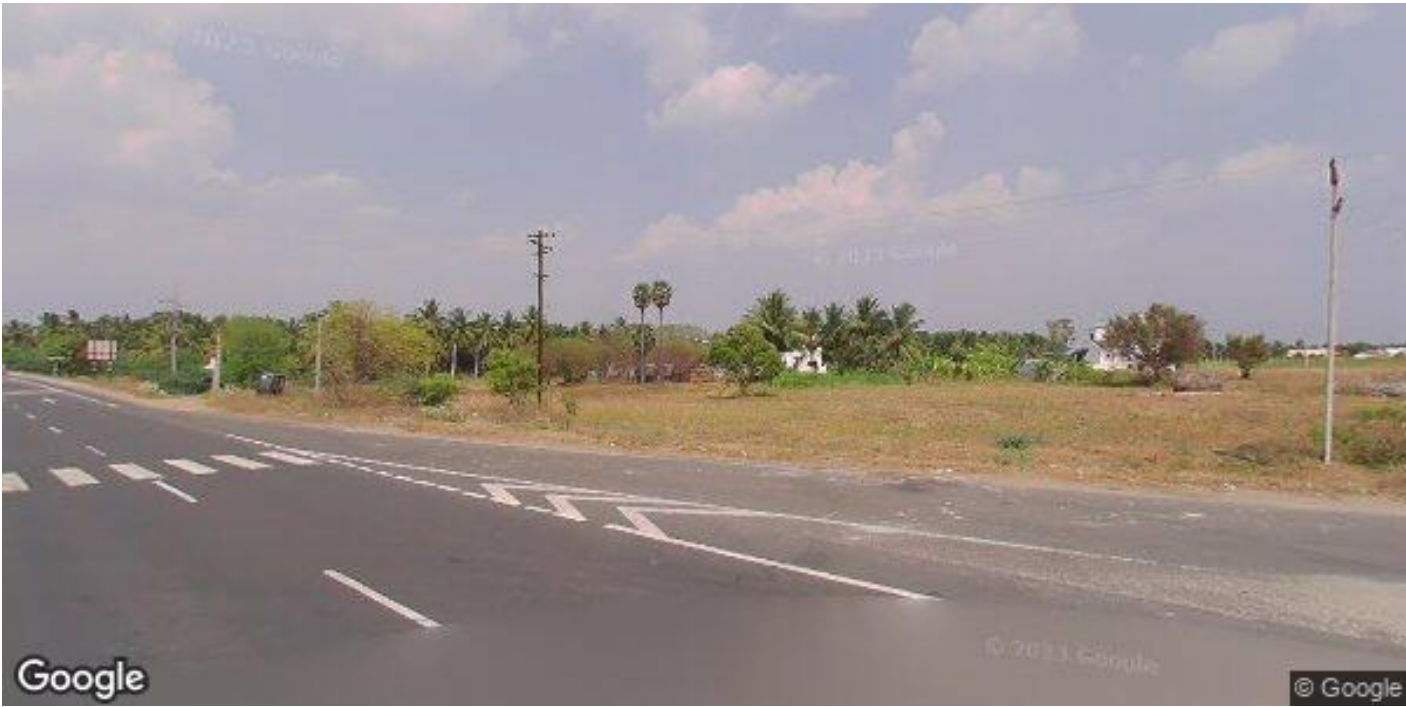
**Risk Type:** Turn  
**Risk Level:** High  
**Speed Limit:** 15 KM/Hr  
**Coordinates:** 11.14480, 78.02291

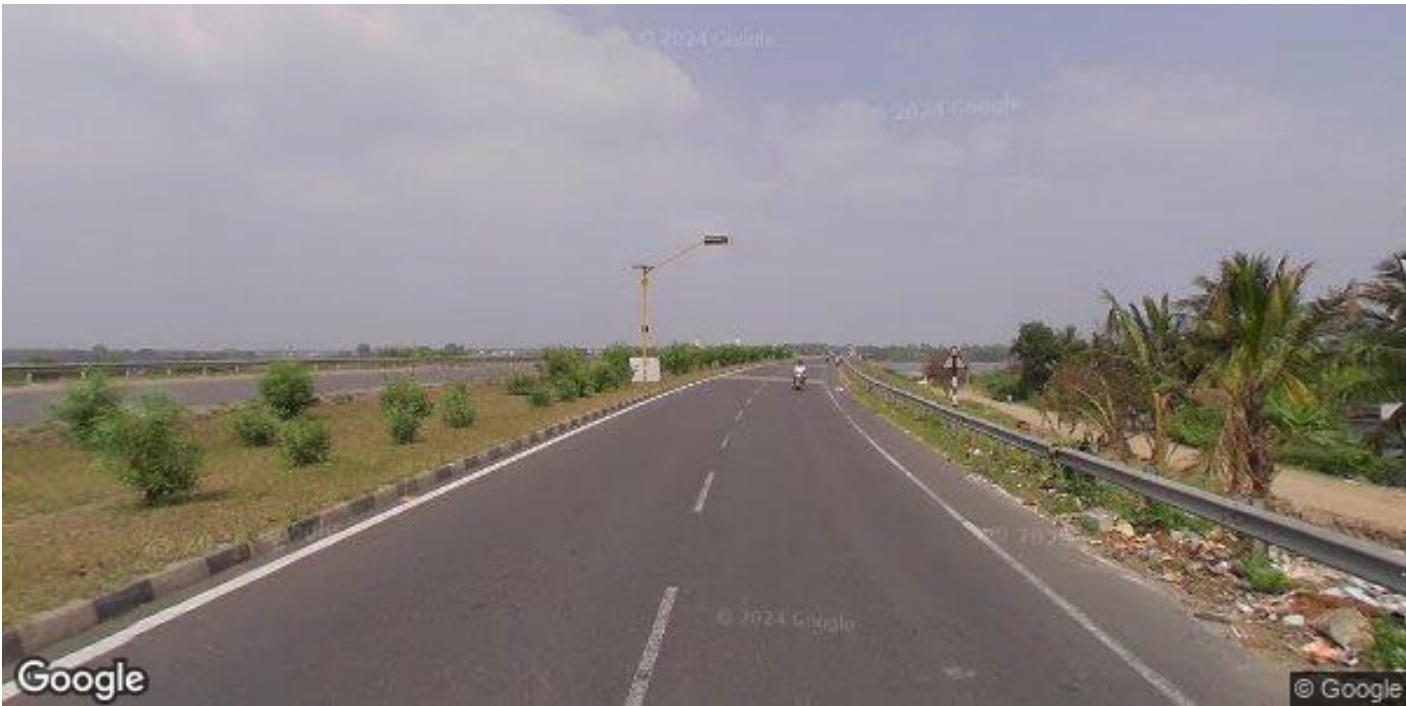
**Risk Type:** Turn  
**Risk Level:** Medium  
**Speed Limit:** 30 KM/Hr  
**Coordinates:** 11.09026, 78.00252

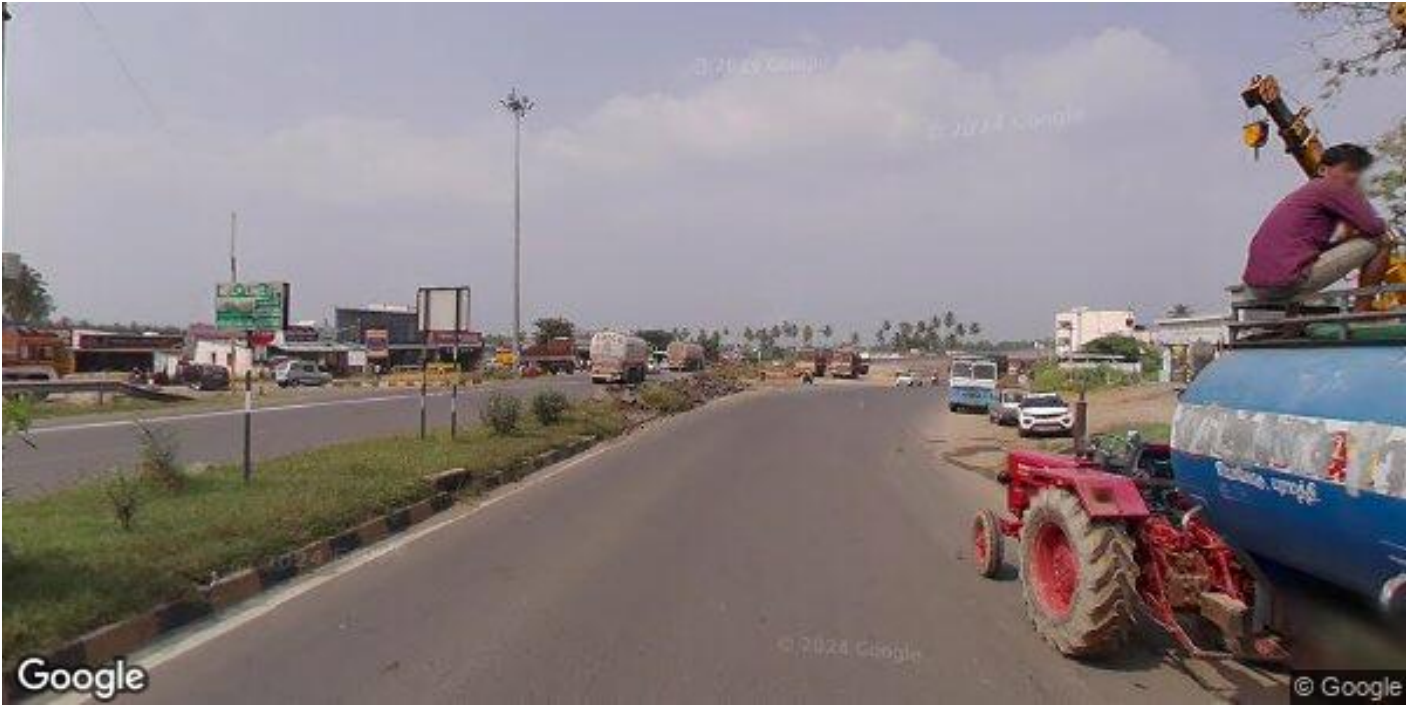
**Risk Type:** Turn  
**Risk Level:** Medium  
**Speed Limit:** 30 KM/Hr  
**Coordinates:** 11.08187, 78.00379

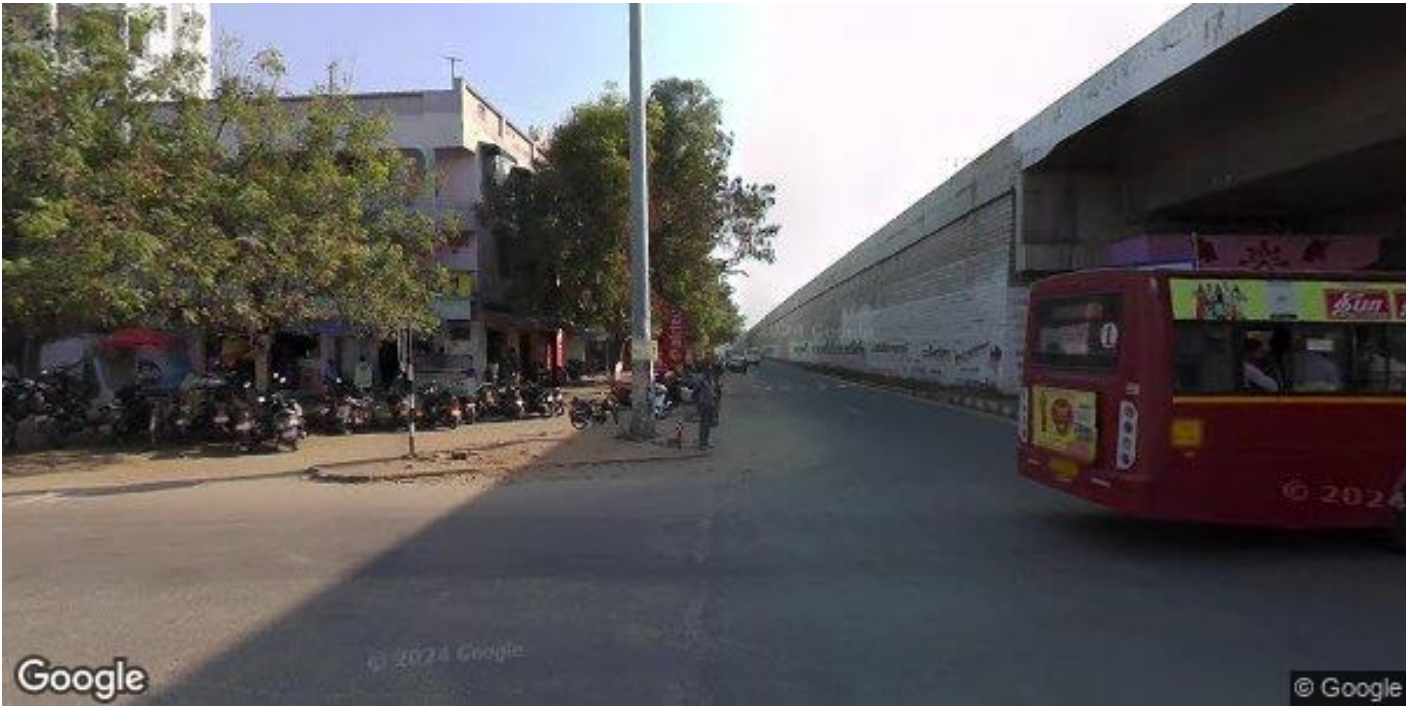
**Risk Type:** Turn  
**Risk Level:** High  
**Speed Limit:** 15 KM/Hr  
**Coordinates:** 11.07466, 78.00842

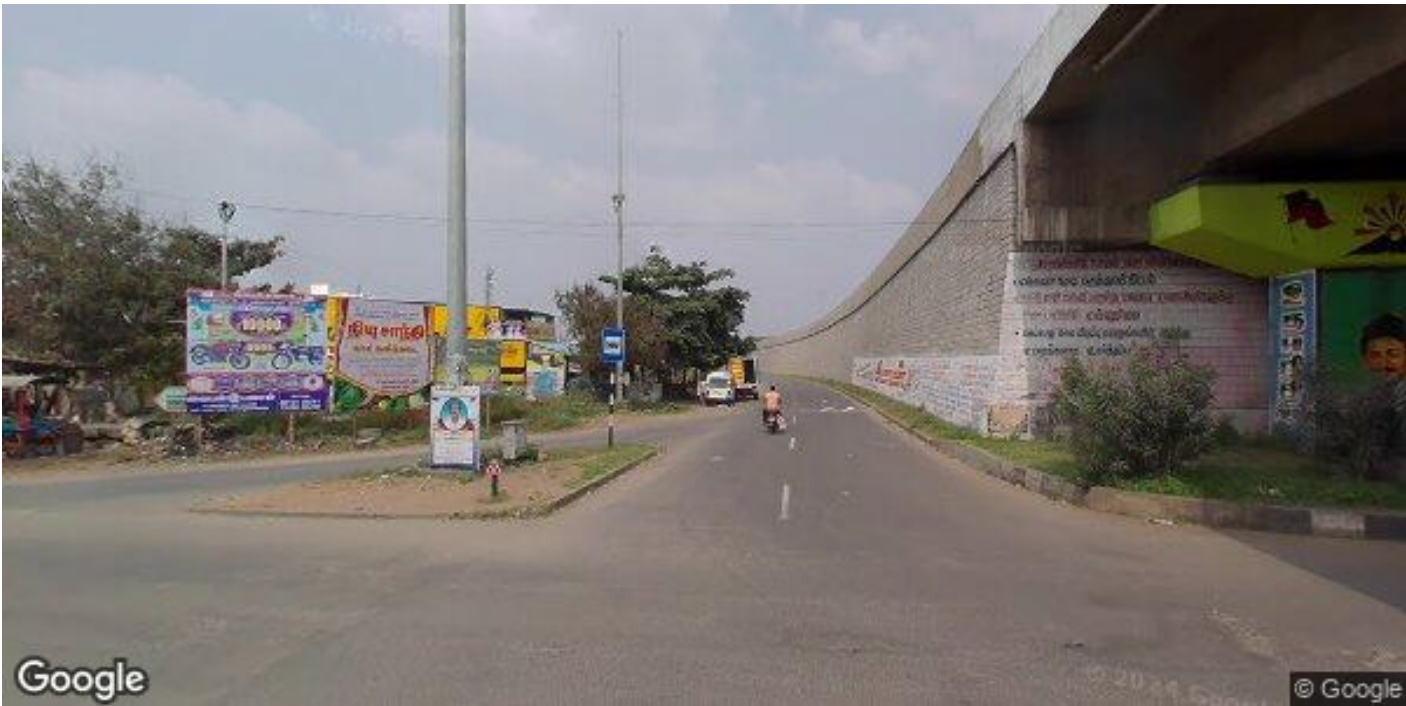
**Risk Type:** Blind Spot  
**Risk Level:** Blind Spot  
**Speed Limit:** 10 KM/Hr  
**Coordinates:** 11.07466, 78.00808

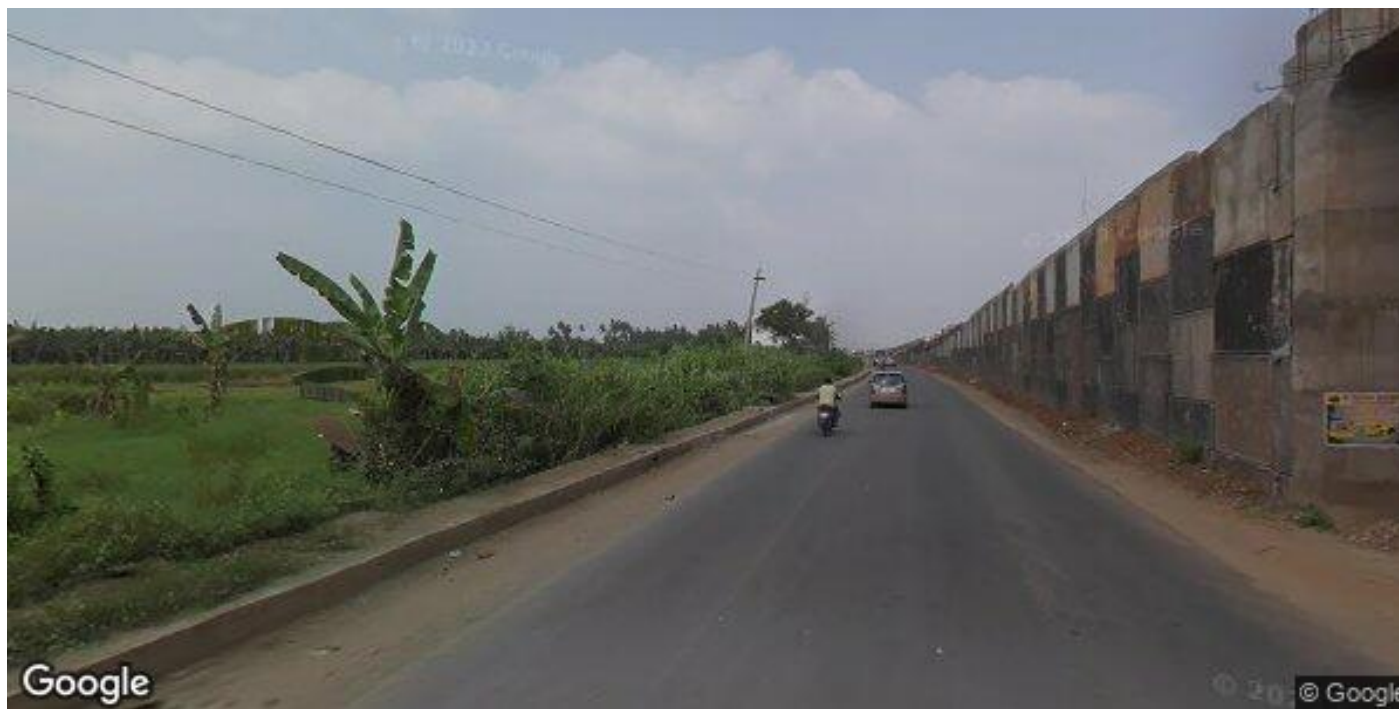
**Risk Type:** Turn  
**Risk Level:** High  
**Speed Limit:** 15 KM/Hr  
**Coordinates:** 11.08580, 78.00283

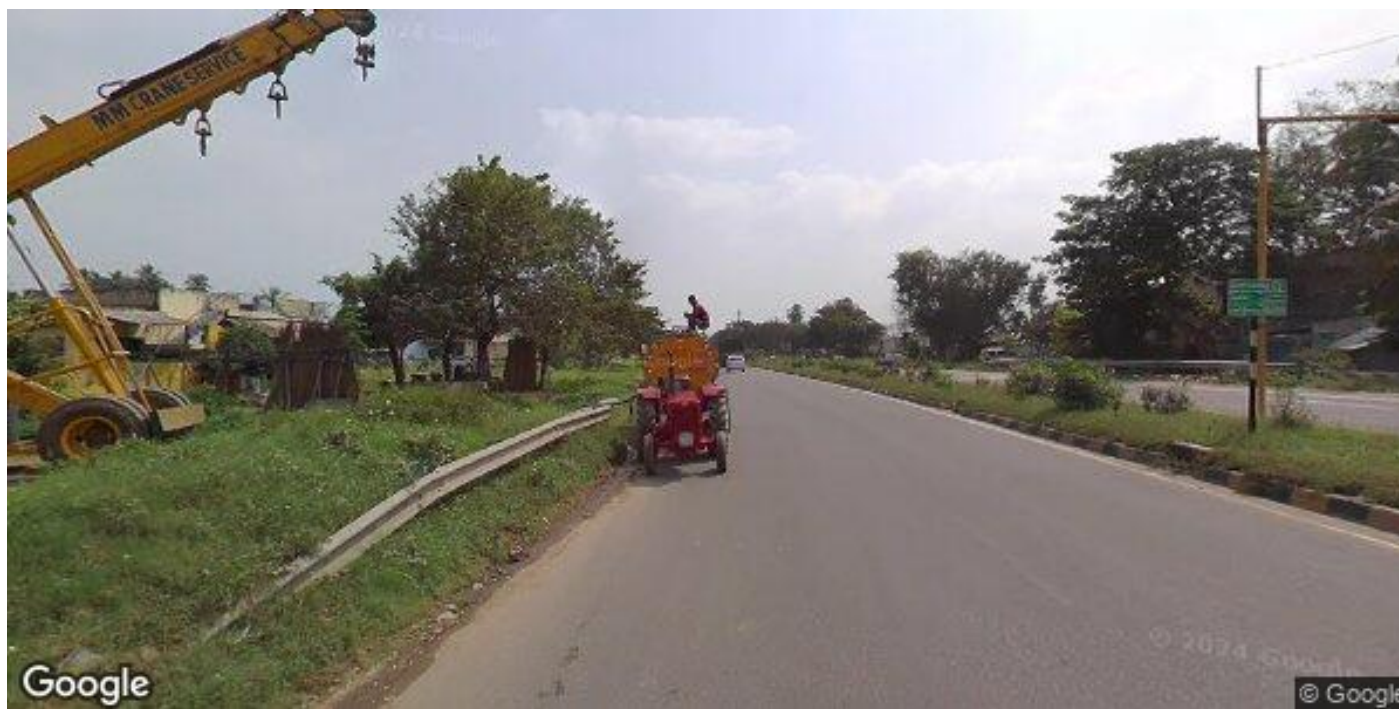
**Risk Type:** Turn  
**Risk Level:** Medium  
**Speed Limit:** 30 KM/Hr  
**Coordinates:** 11.08198, 78.00373

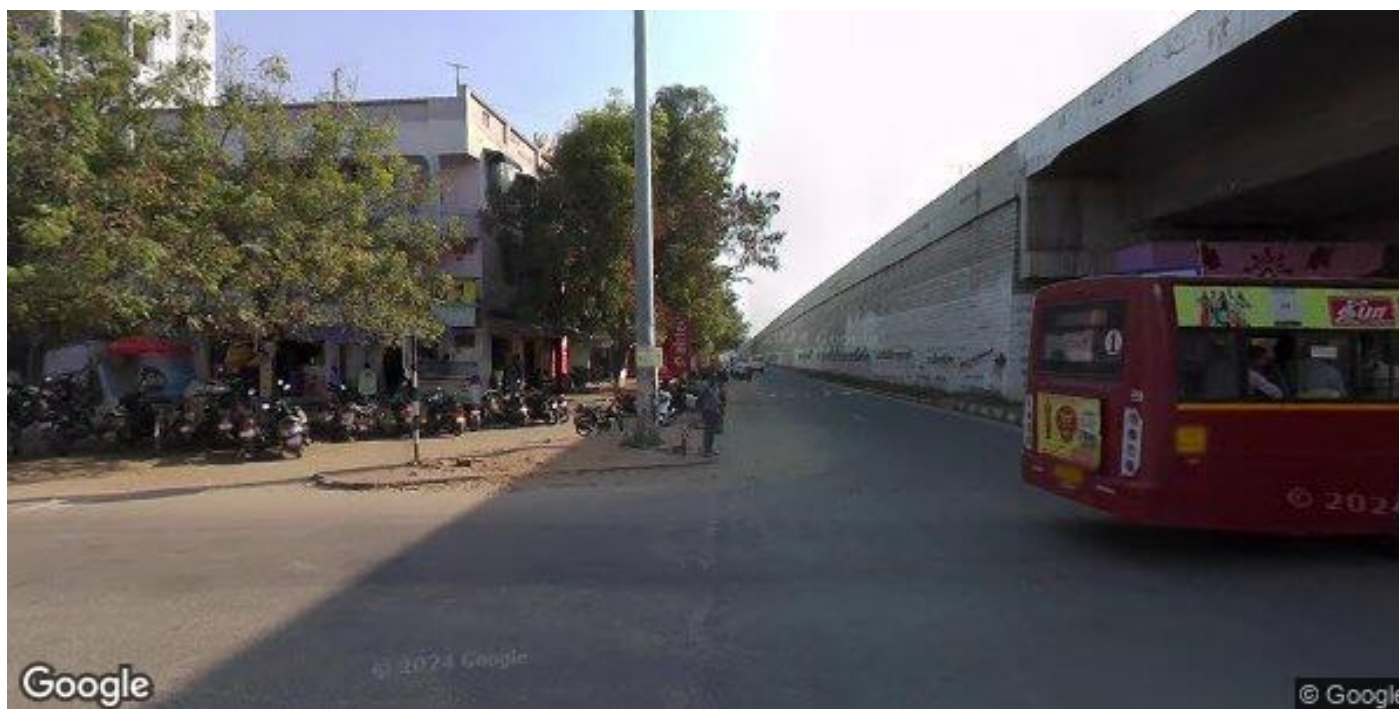
**Risk Type:** Turn  
**Risk Level:** High  
**Speed Limit:** 15 KM/Hr  
**Coordinates:** 11.07467, 78.00842

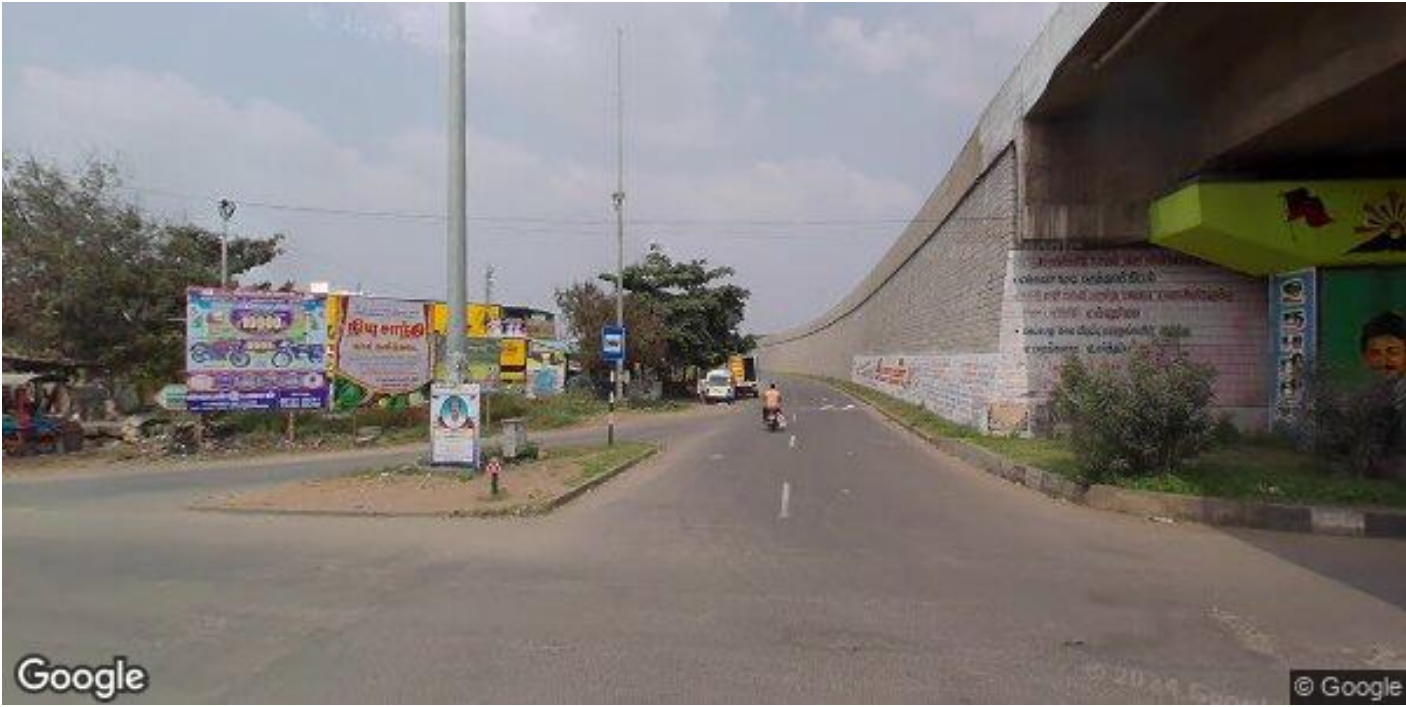
**Risk Type:** Turn  
**Risk Level:** High  
**Speed Limit:** 15 KM/Hr  
**Coordinates:** 11.07466, 78.00808

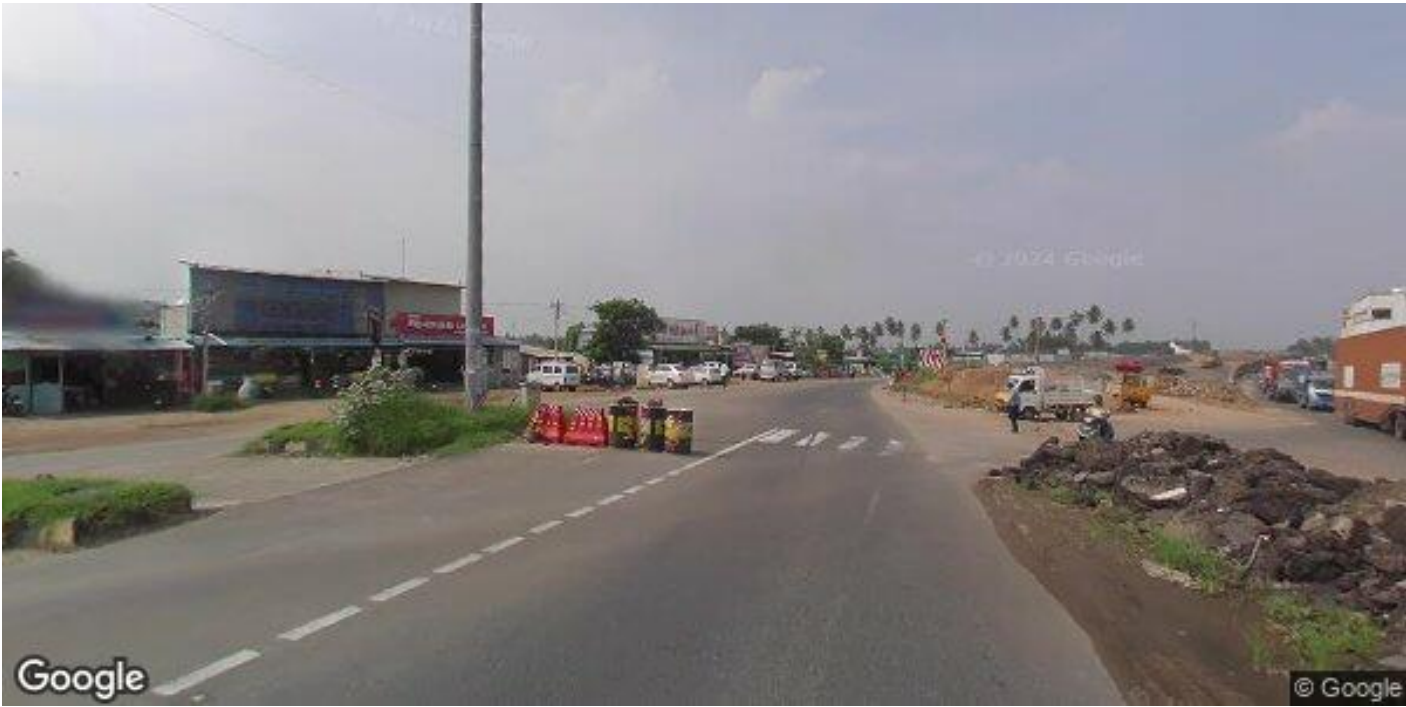
**Risk Type:** Blind Spot  
**Risk Level:** Blind Spot  
**Speed Limit:** 10 KM/Hr  
**Coordinates:** 11.08205, 78.00354

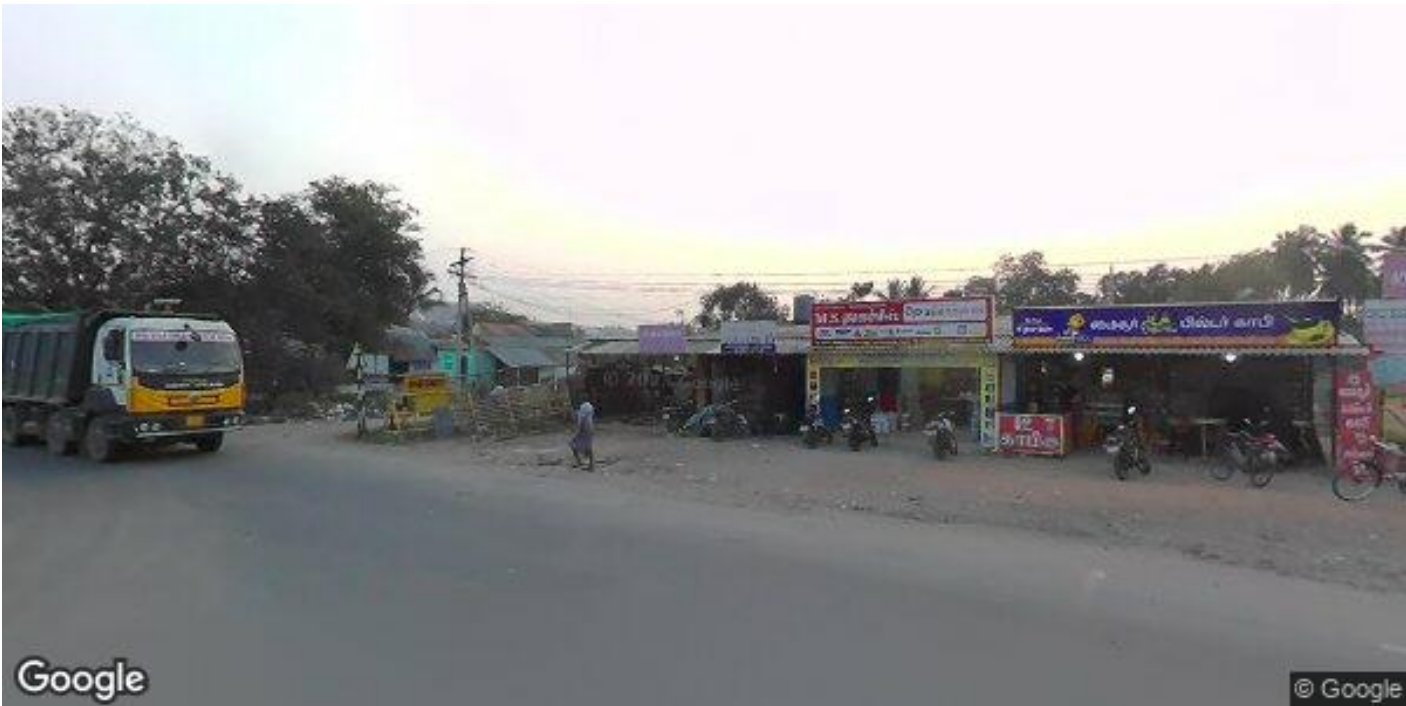
**Risk Type:** Turn  
**Risk Level:** High  
**Speed Limit:** 15 KM/Hr  
**Coordinates:** 11.08195, 78.00343

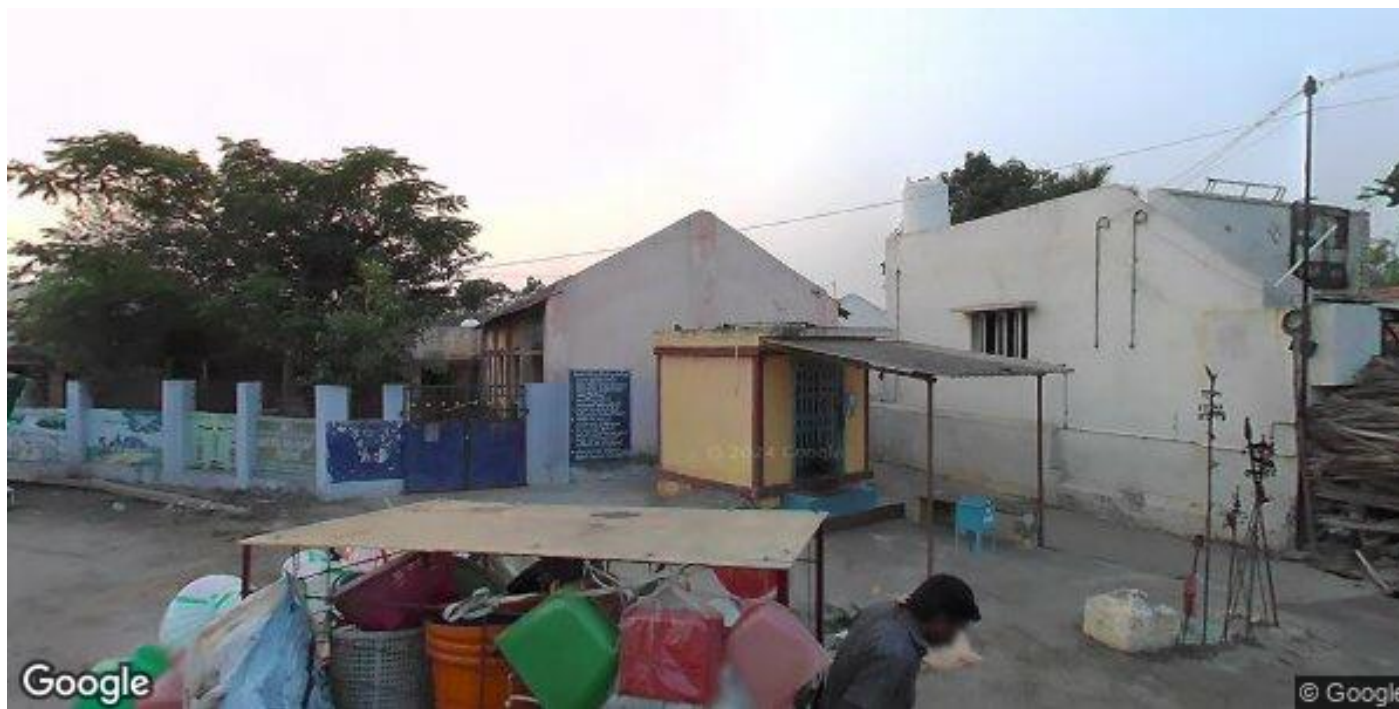
**Risk Type:** Turn  
**Risk Level:** High  
**Speed Limit:** 15 KM/Hr  
**Coordinates:** 11.08035, 78.00356

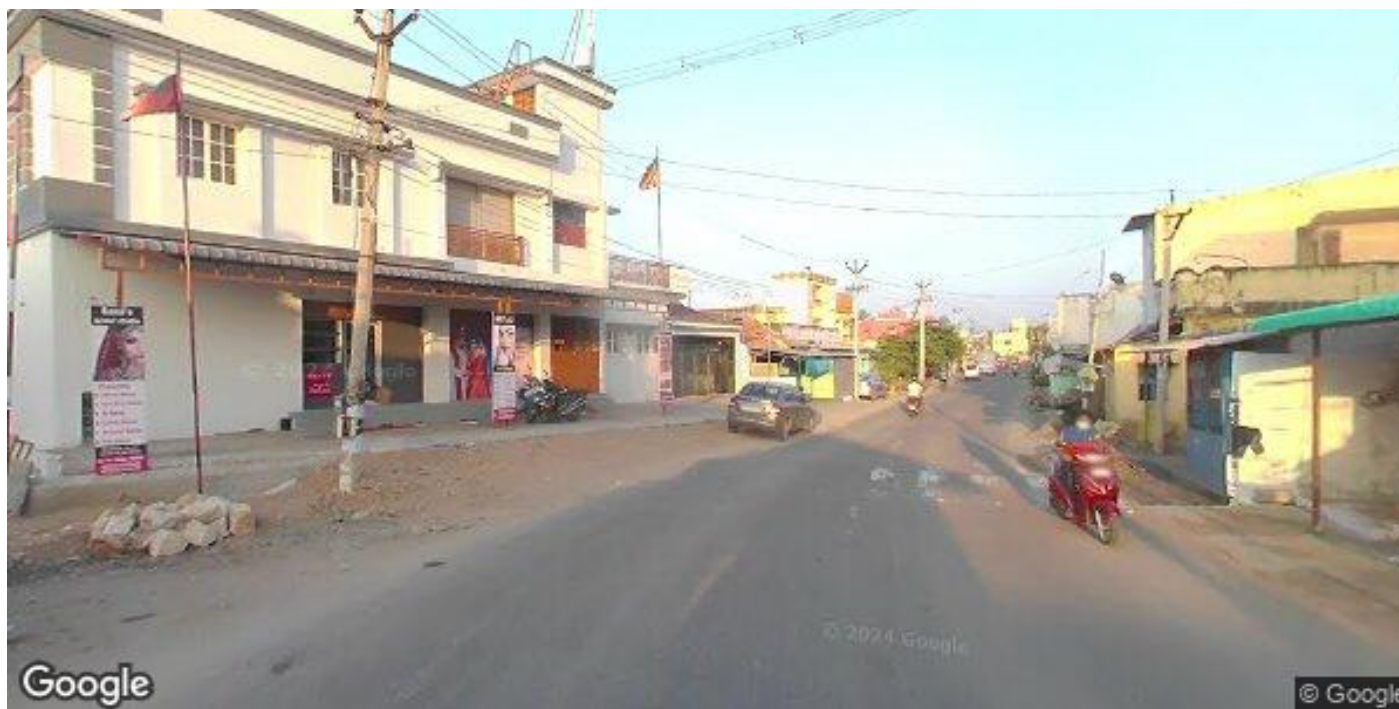
**Risk Type:** Turn  
**Risk Level:** High  
**Speed Limit:** 15 KM/Hr  
**Coordinates:** 11.07982, 78.00194

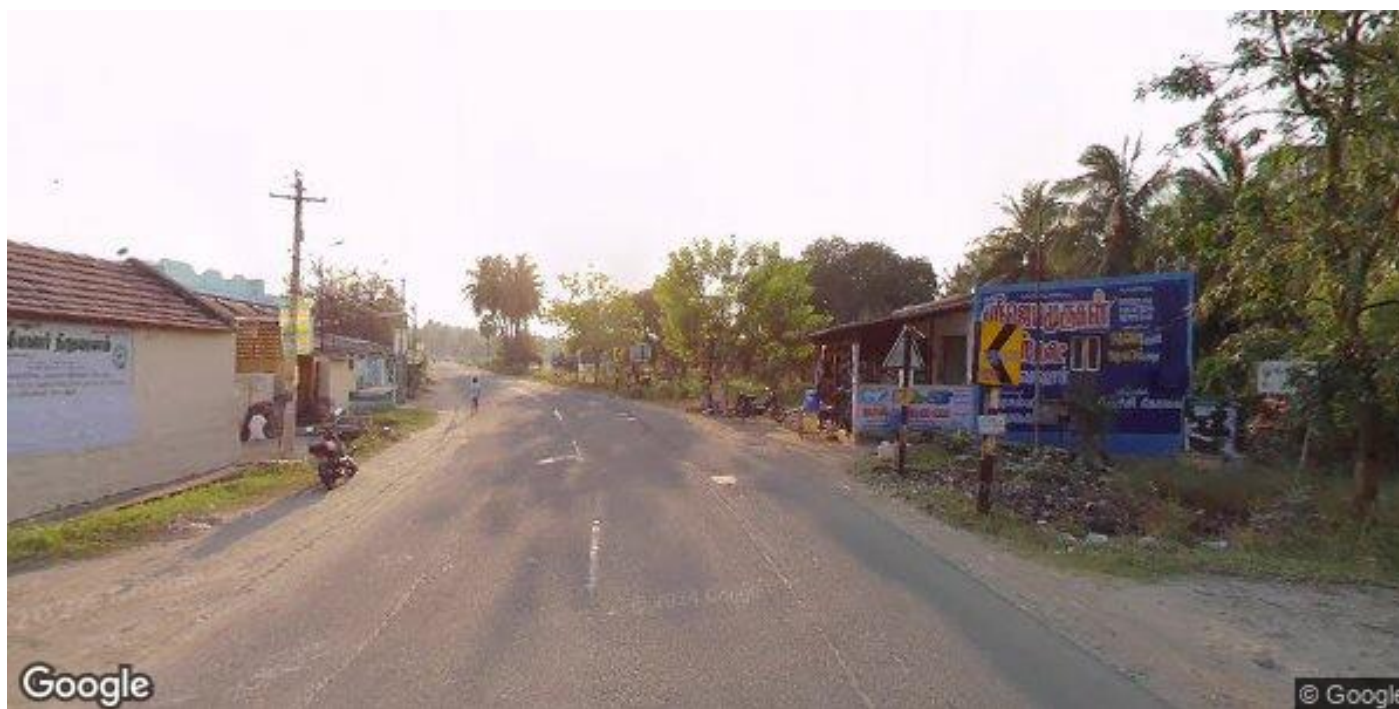
**Risk Type:** Turn  
**Risk Level:** Medium  
**Speed Limit:** 30 KM/Hr  
**Coordinates:** 11.07586, 77.97536

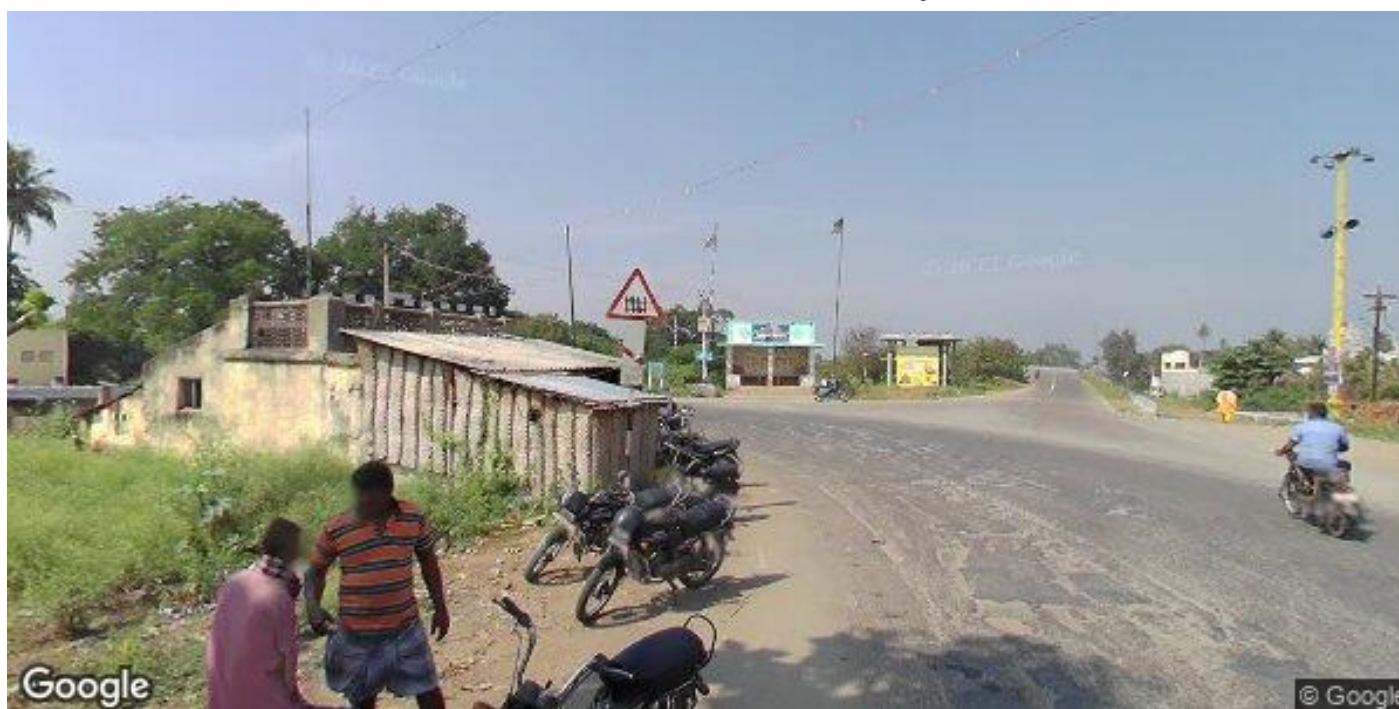
**Risk Type:** Turn  
**Risk Level:** Medium  
**Speed Limit:** 30 KM/Hr  
**Coordinates:** 11.06102, 77.93084

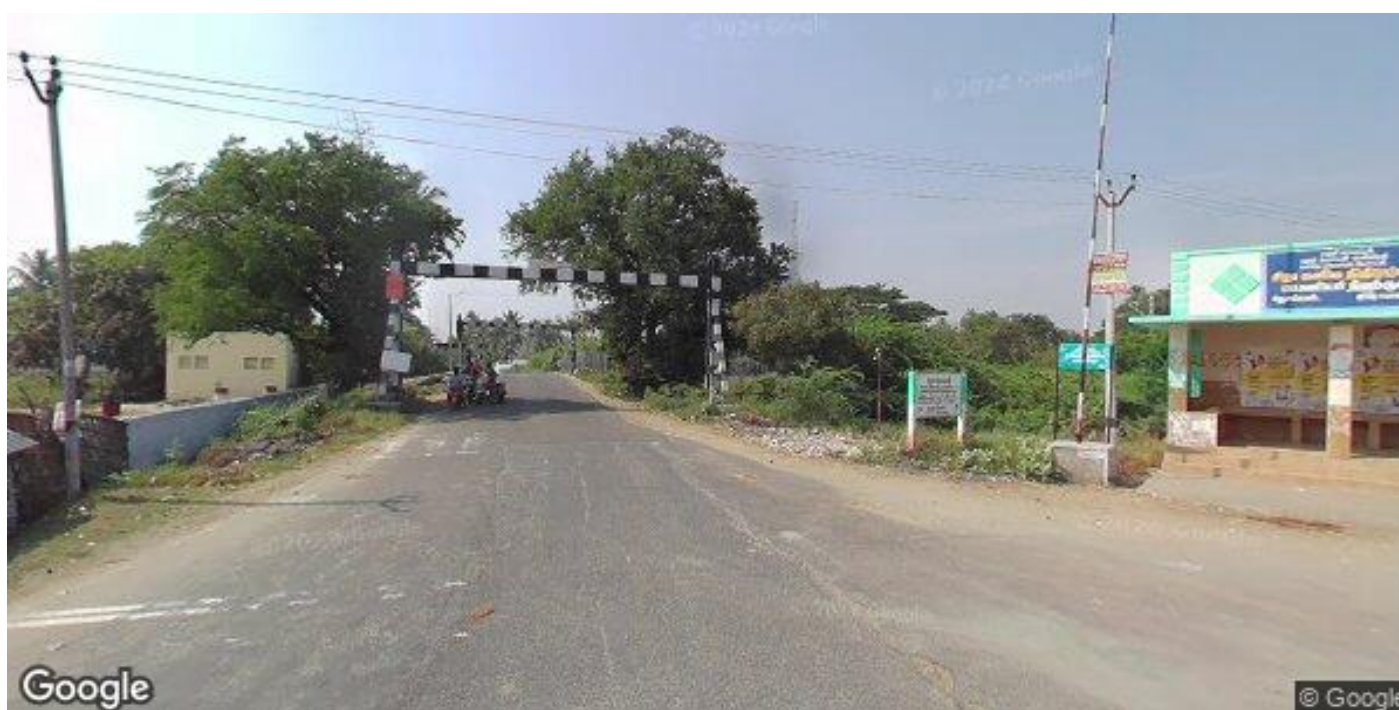
**Risk Type:** Turn  
**Risk Level:** Medium  
**Speed Limit:** 30 KM/Hr  
**Coordinates:** 11.06096, 77.93064
