## JOURNEY RISK MANAGEMENT (JRM) STUDY

### Salem Terminal to VKG & BROTHERS

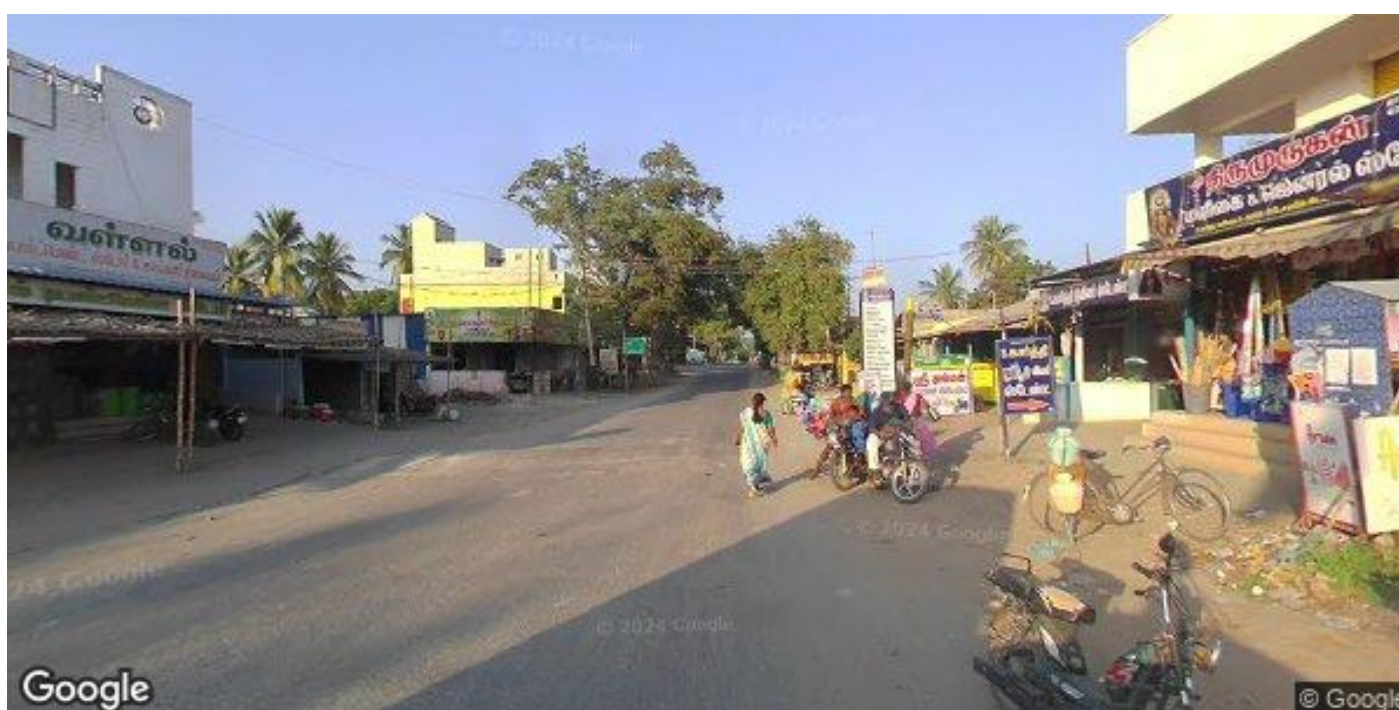
**Risk Type:** Turn  
**Risk Level:** Medium  
**Speed Limit:** 30 KM/Hr  
**Coordinates:** 11.05170, 77.92440

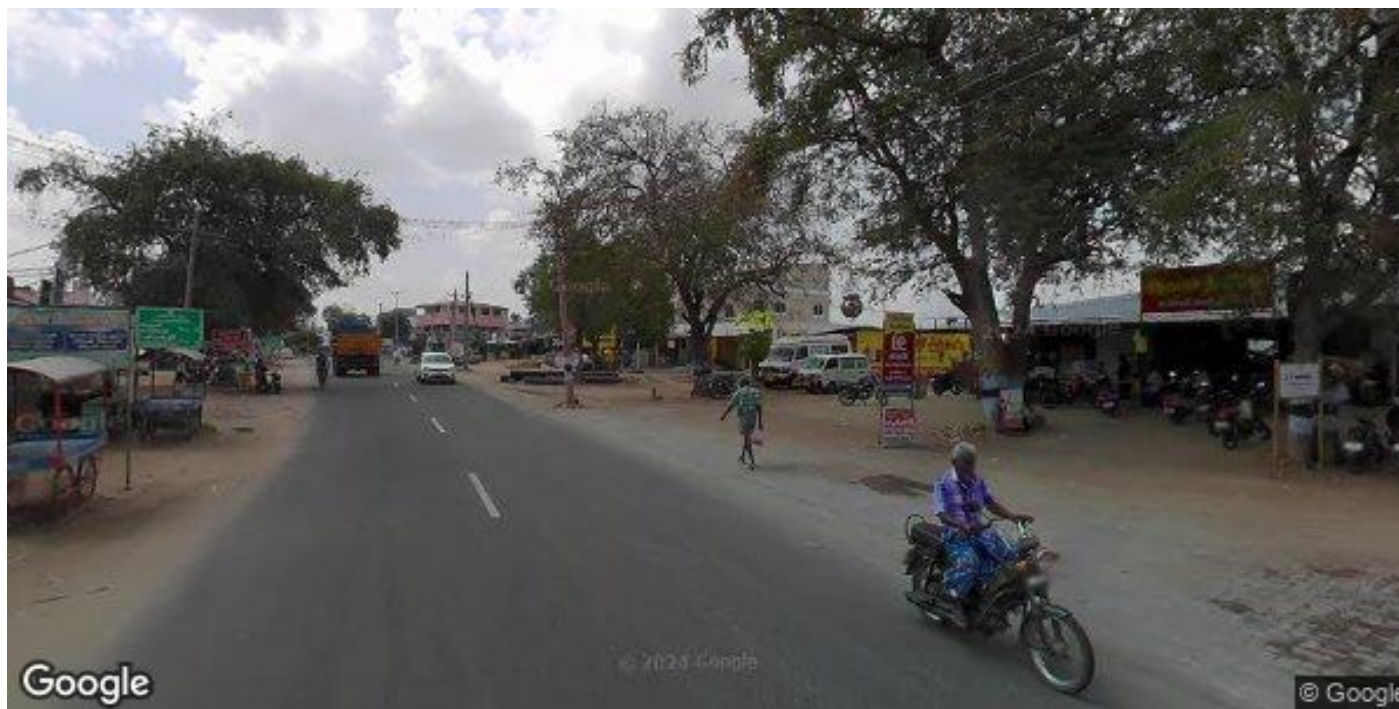
**Risk Type:** Turn  
**Risk Level:** Medium  
**Speed Limit:** 30 KM/Hr  
**Coordinates:** 11.05118, 77.92452

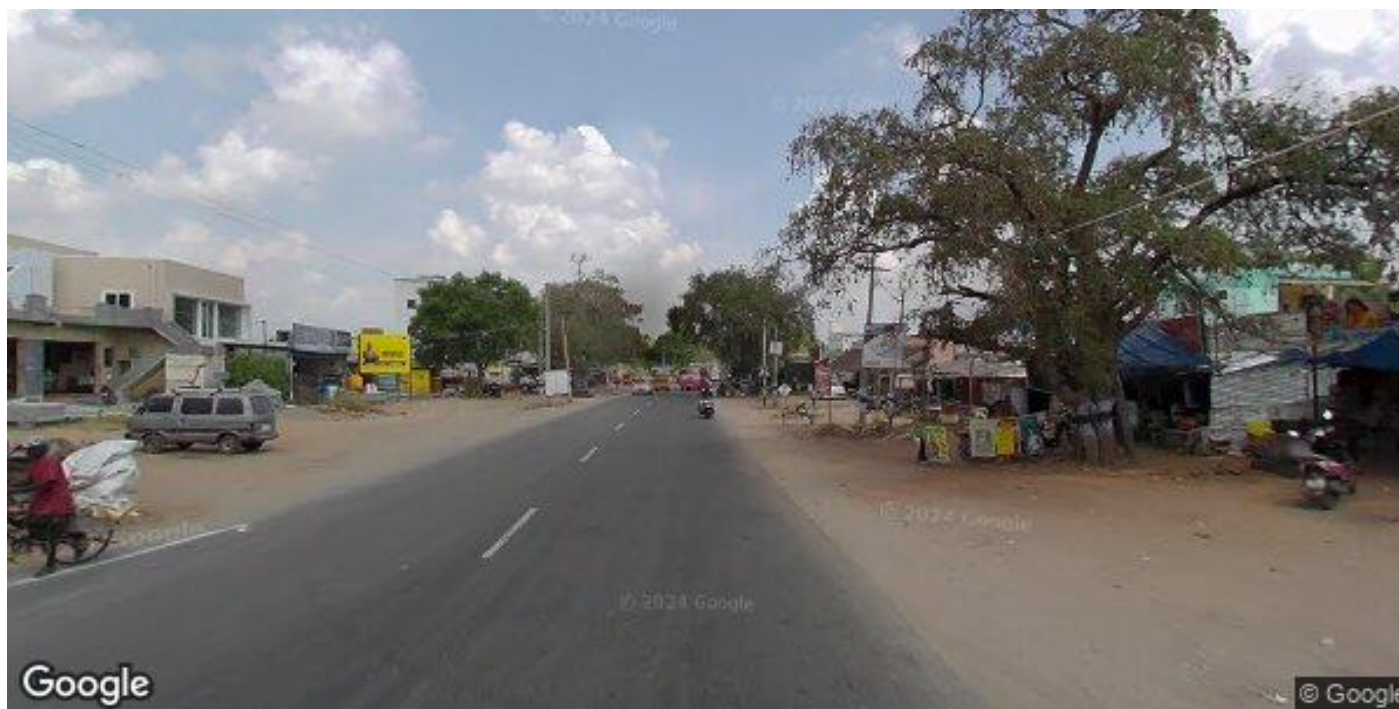
**Risk Type:** Turn  
**Risk Level:** High  
**Speed Limit:** 15 KM/Hr  
**Coordinates:** 11.05061, 77.92520

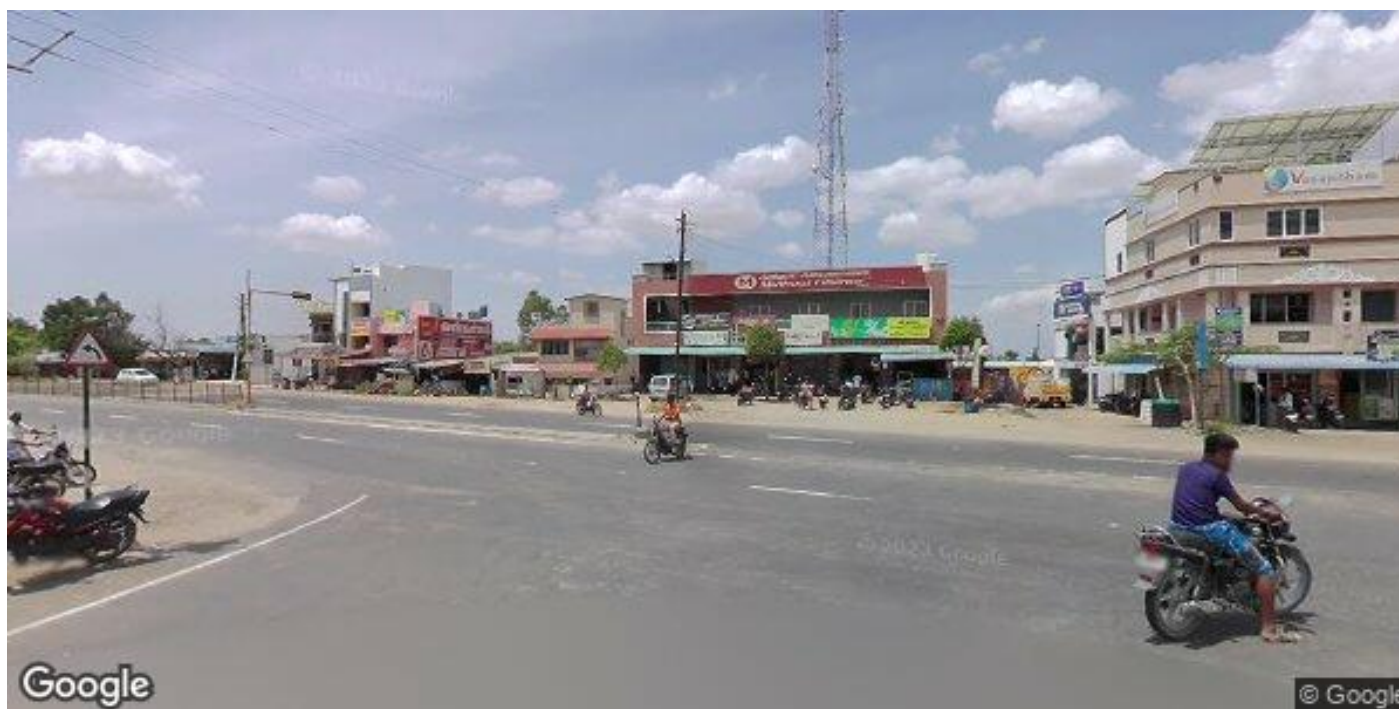
**Risk Type:** Turn  
**Risk Level:** High  
**Speed Limit:** 15 KM/Hr  
**Coordinates:** 10.95905, 77.91206

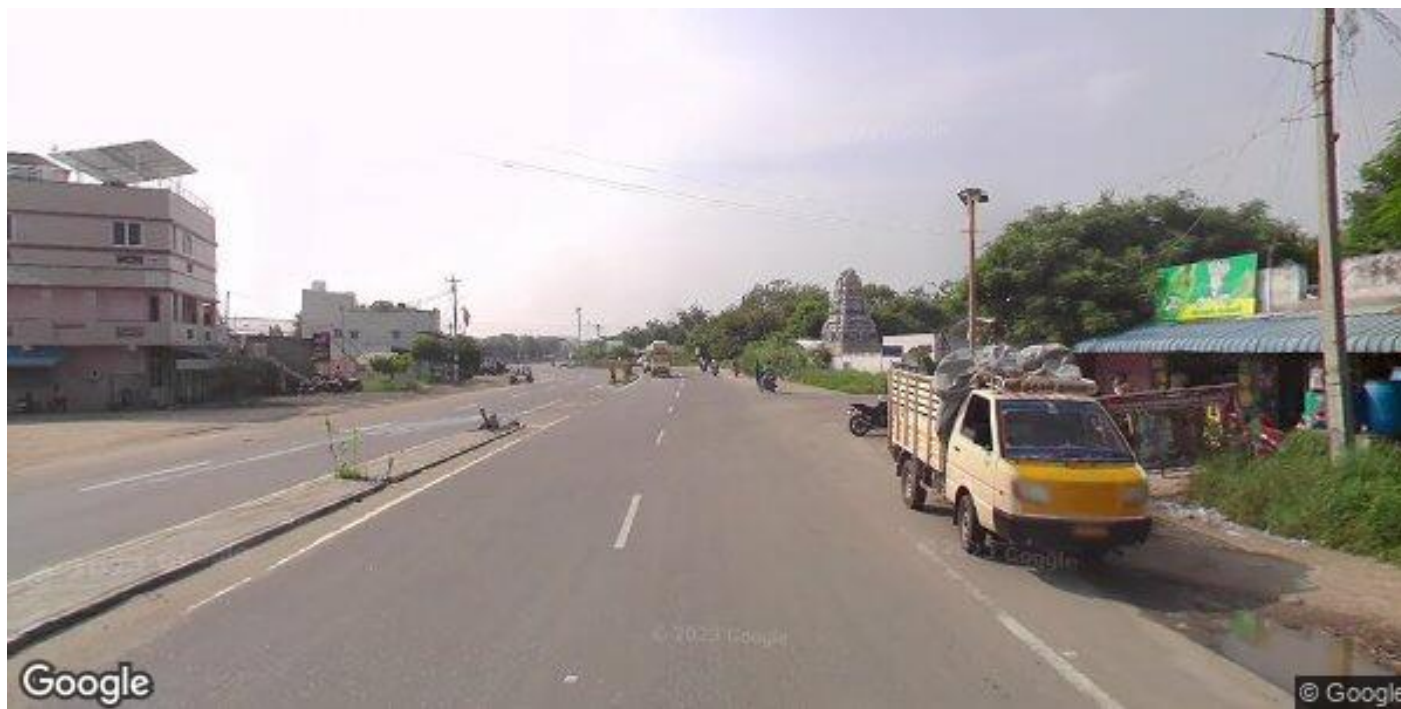
**Risk Type:** Turn  
**Risk Level:** Medium  
**Speed Limit:** 30 KM/Hr  
**Coordinates:** 10.95889, 77.91232

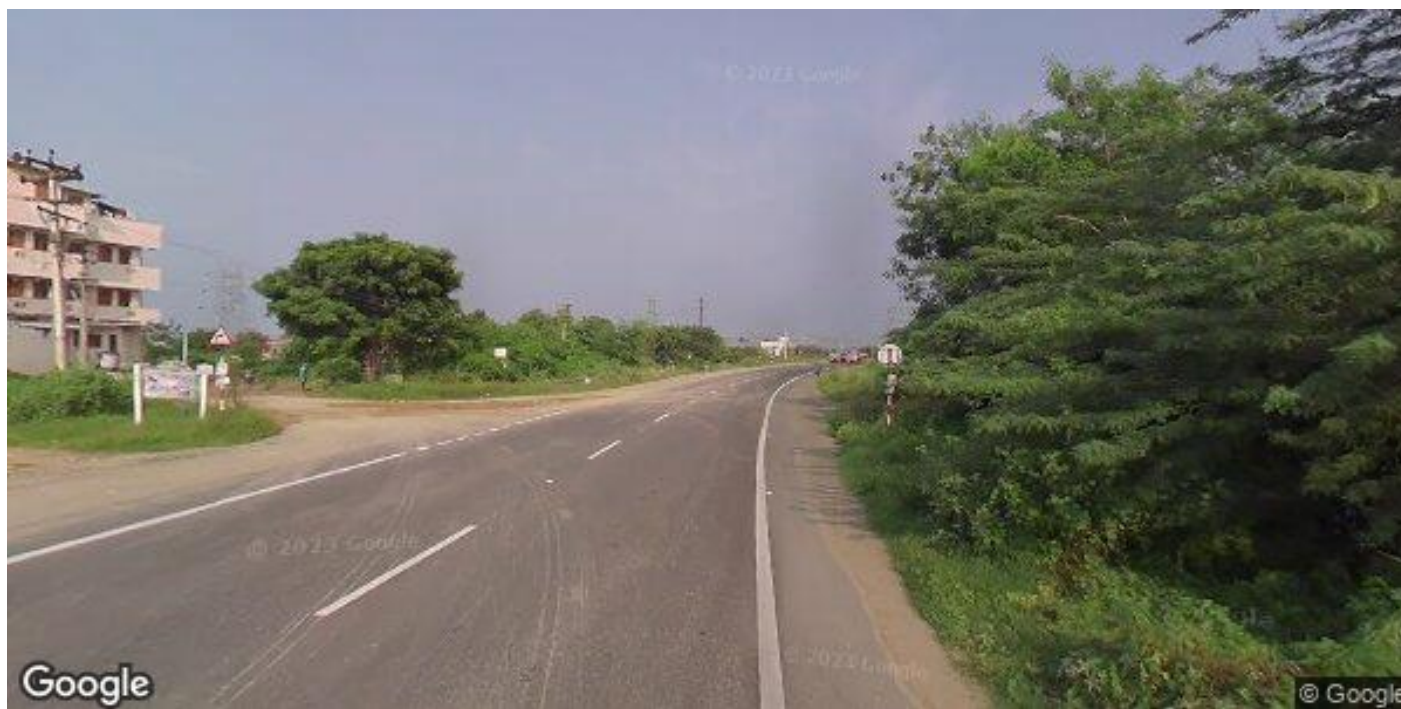
**Risk Type:** Turn  
**Risk Level:** Medium  
**Speed Limit:** 30 KM/Hr  
**Coordinates:** 10.95988, 77.91591

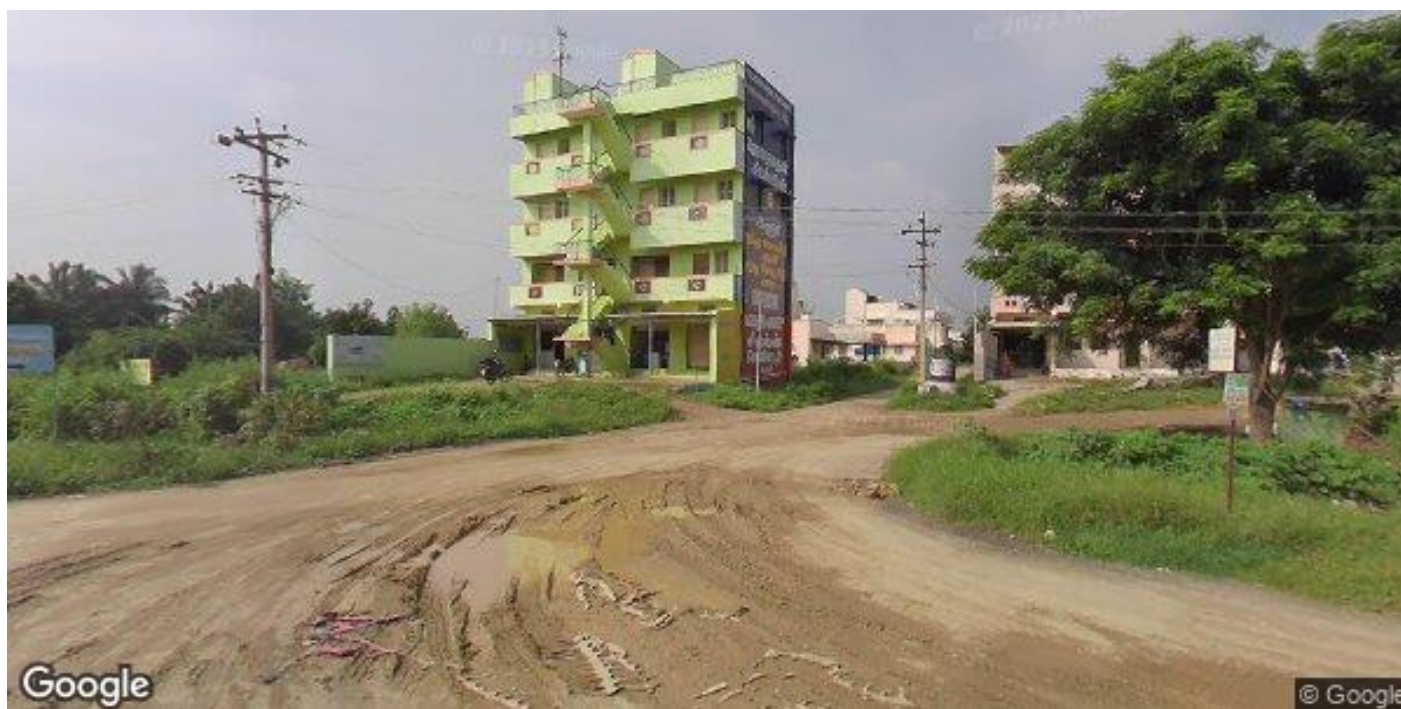
**Risk Type:** Blind Spot  
**Risk Level:** Blind Spot  
**Speed Limit:** 10 KM/Hr  
**Coordinates:** 10.96011, 77.91611

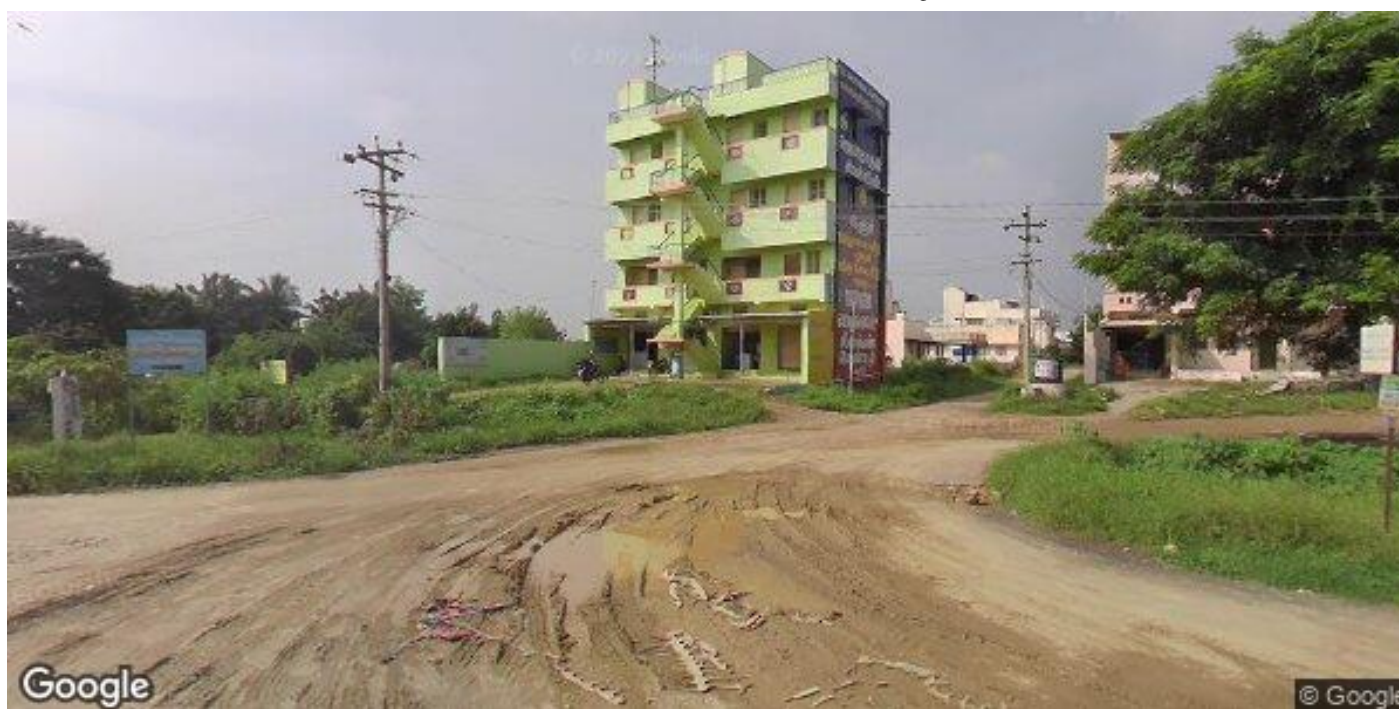
**Risk Type:** Turn  
**Risk Level:** High  
**Speed Limit:** 15 KM/Hr  
**Coordinates:** 10.96001, 77.91614

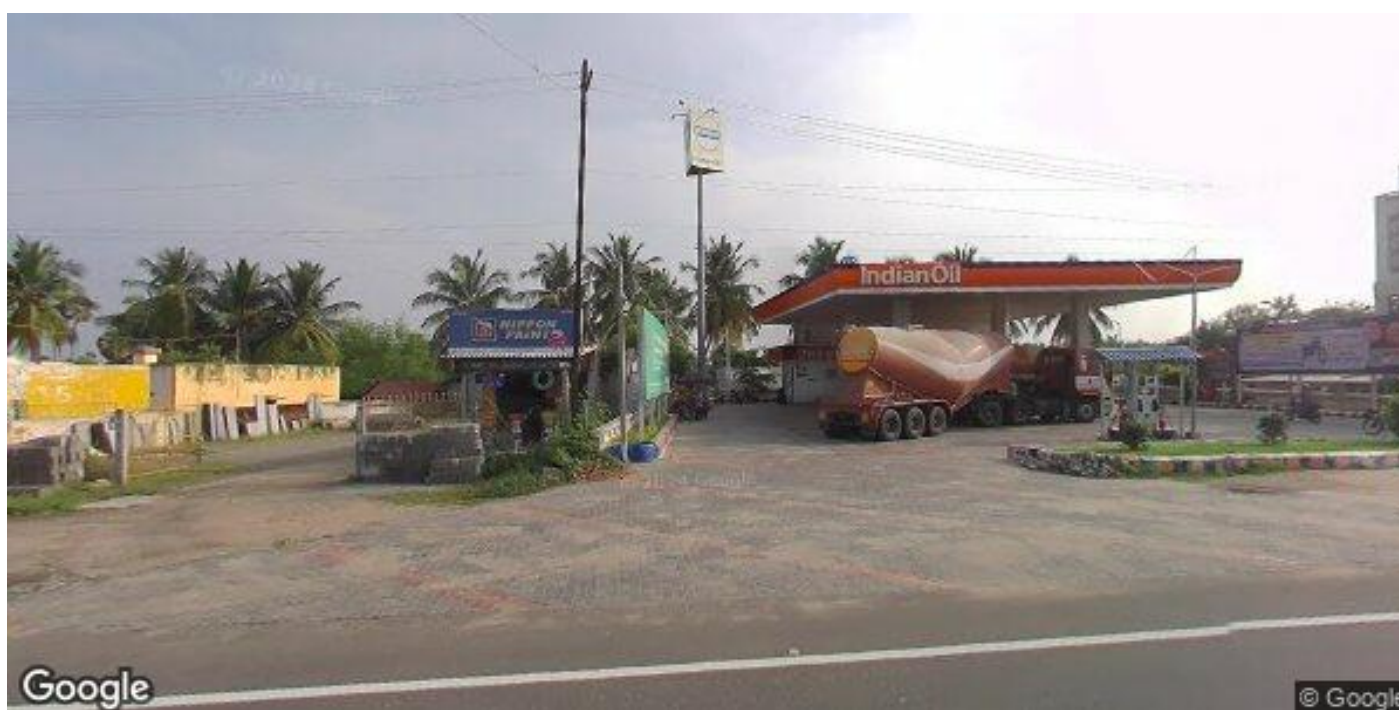
**Risk Type:** Turn  
**Risk Level:** High  
**Speed Limit:** 15 KM/Hr  
**Coordinates:** 10.95907, 77.91387

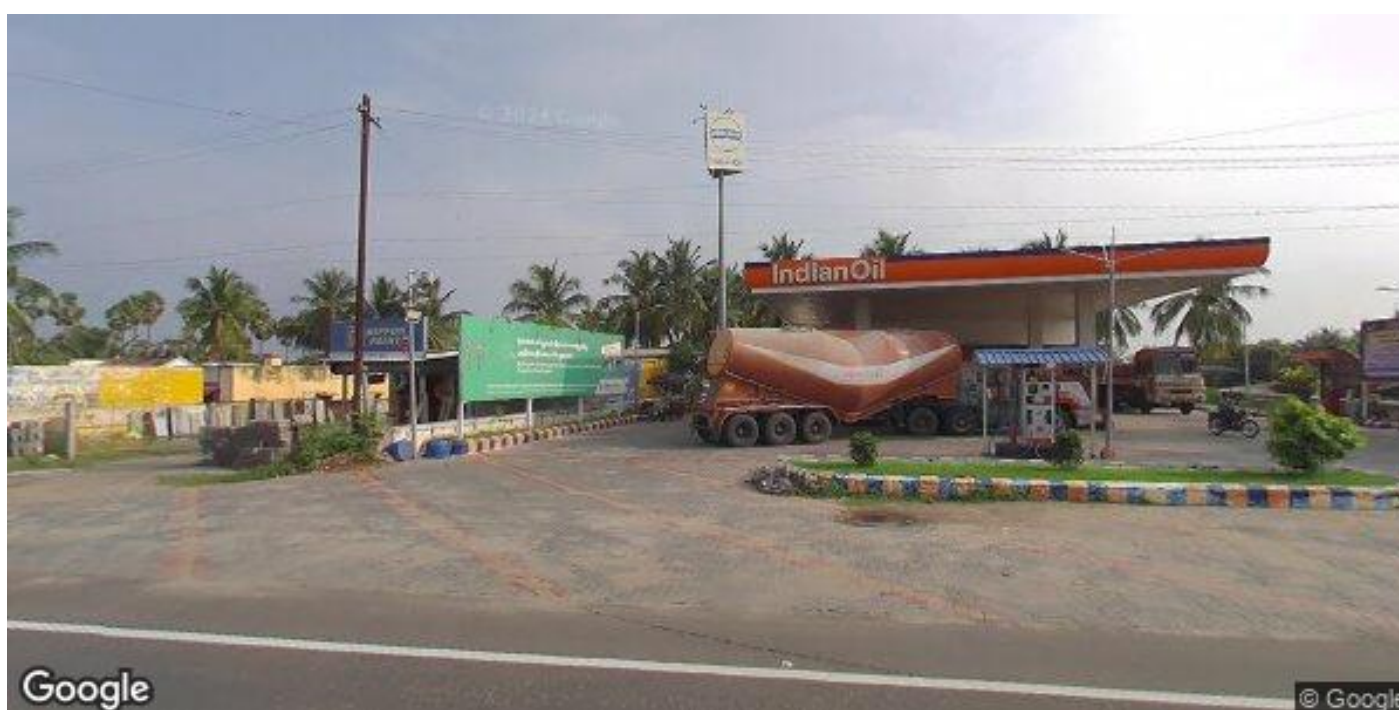
**Risk Type:** Turn  
**Risk Level:** High  
**Speed Limit:** 15 KM/Hr  
**Coordinates:** 10.95883, 77.91393

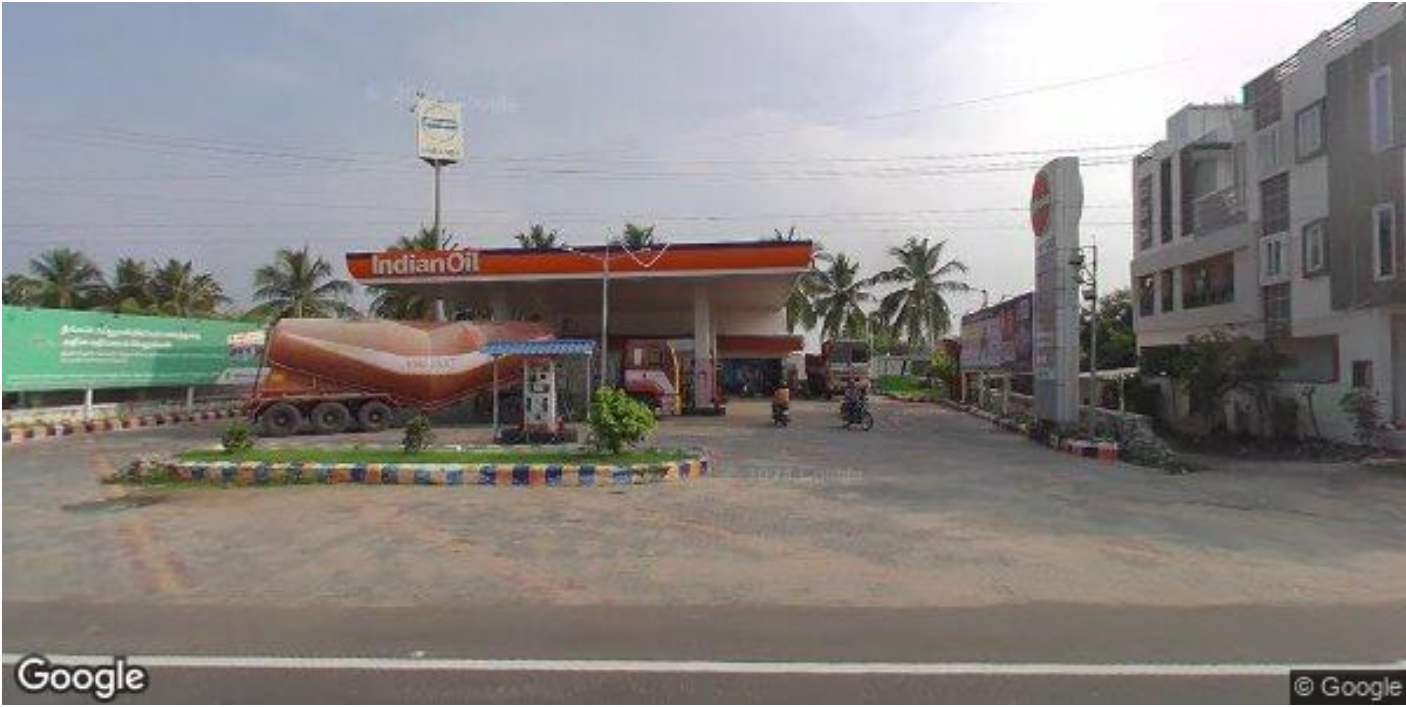
**Risk Type:** Turn  
**Risk Level:** High  
**Speed Limit:** 15 KM/Hr  
**Coordinates:** 10.95877, 77.91380
