# IndianOil

## JOURNEY RISK MANAGEMENT (JRM) STUDY

### Salem Terminal to SRI SHANMUGA AGENCIES

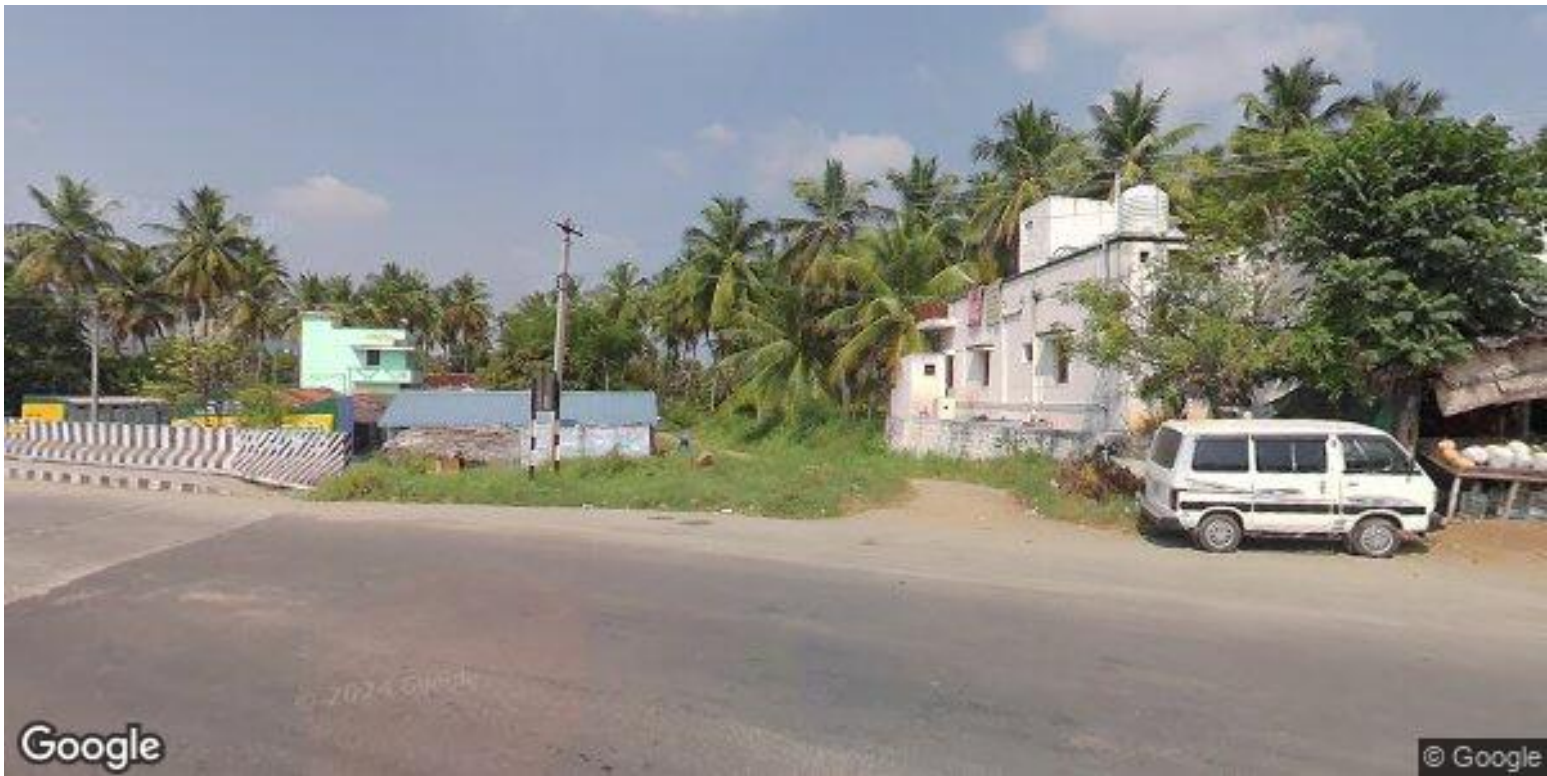
Risk Type: Turn  
Risk Level: Medium  
Speed Limit: 30 KM/Hr  
Coordinates: 11.44898, 77.87410

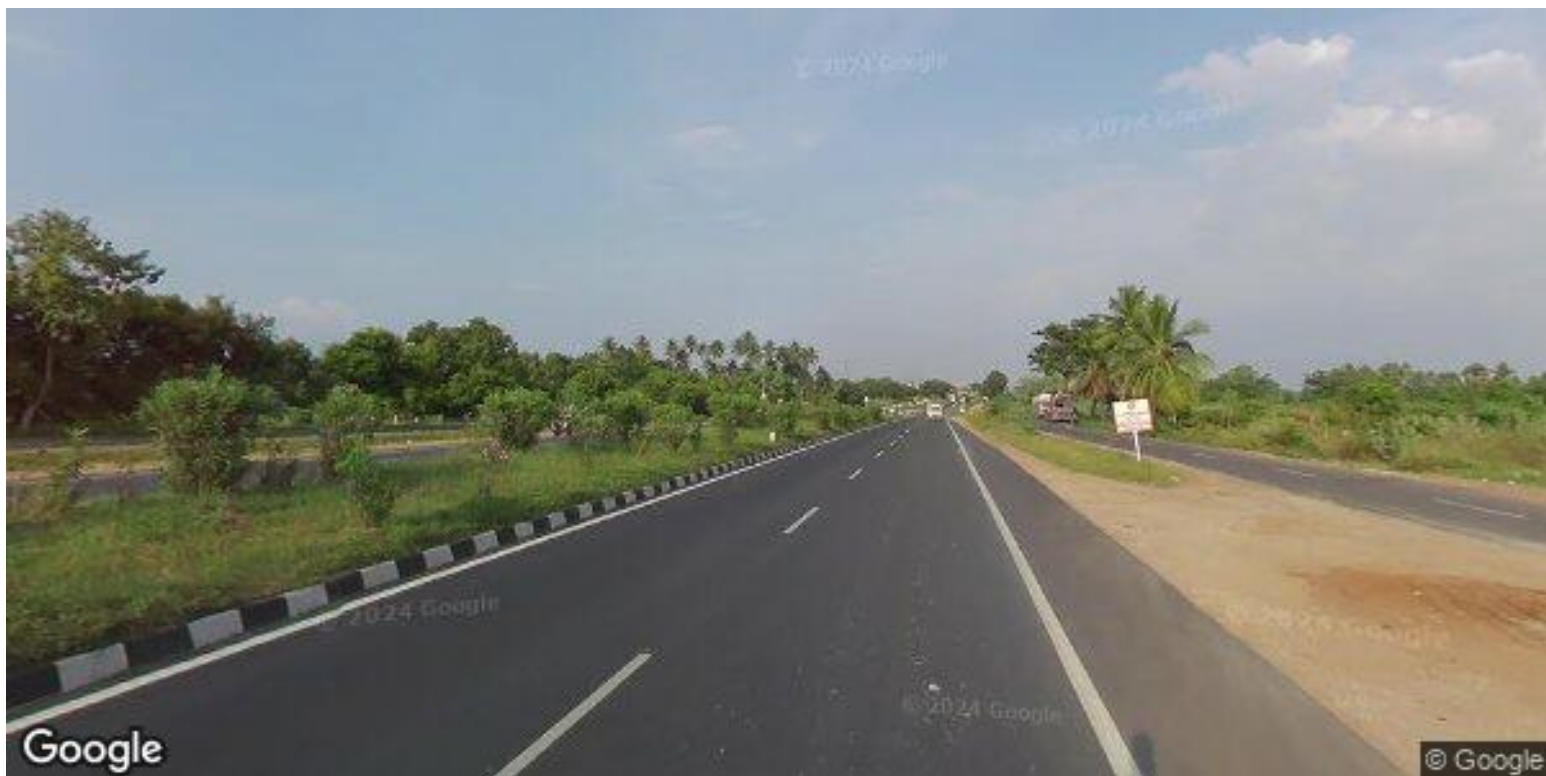
**Coordinates:** 11.31301, 77.61186

**Risk Type:** Blind Spot

**Risk Level:** Blind Spot

**Speed Limit:** 10 KM/Hr

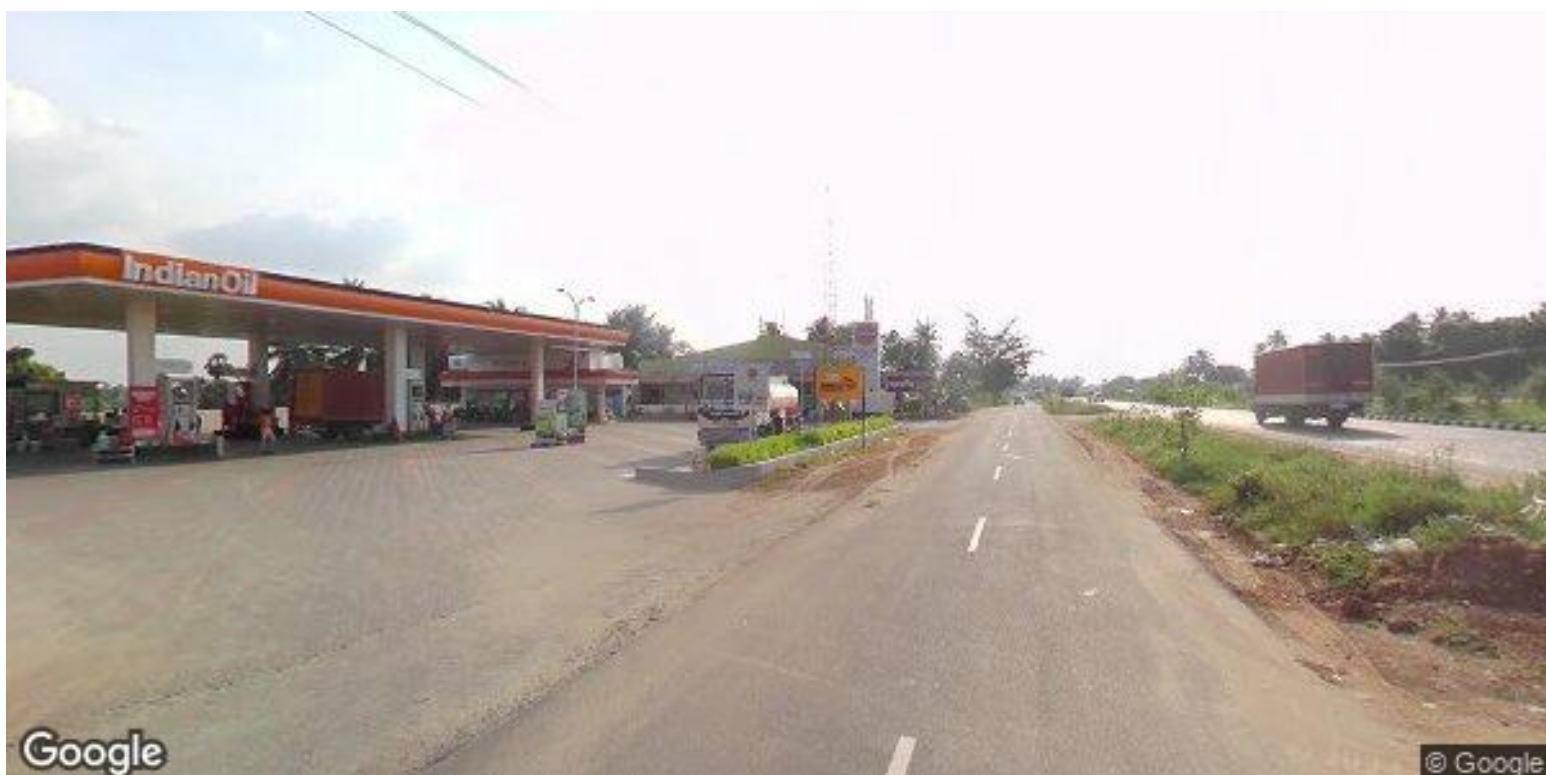
**Risk Type:** Blind Spot  
**Risk Level:** Blind Spot  
**Speed Limit:** 10 KM/Hr  
**Coordinates:** 11.31291, 77.61196
