# IndianOil

## JOURNEY RISK MANAGEMENT (JRM) STUDY

### Salem Terminal TO MANGAI FUELS

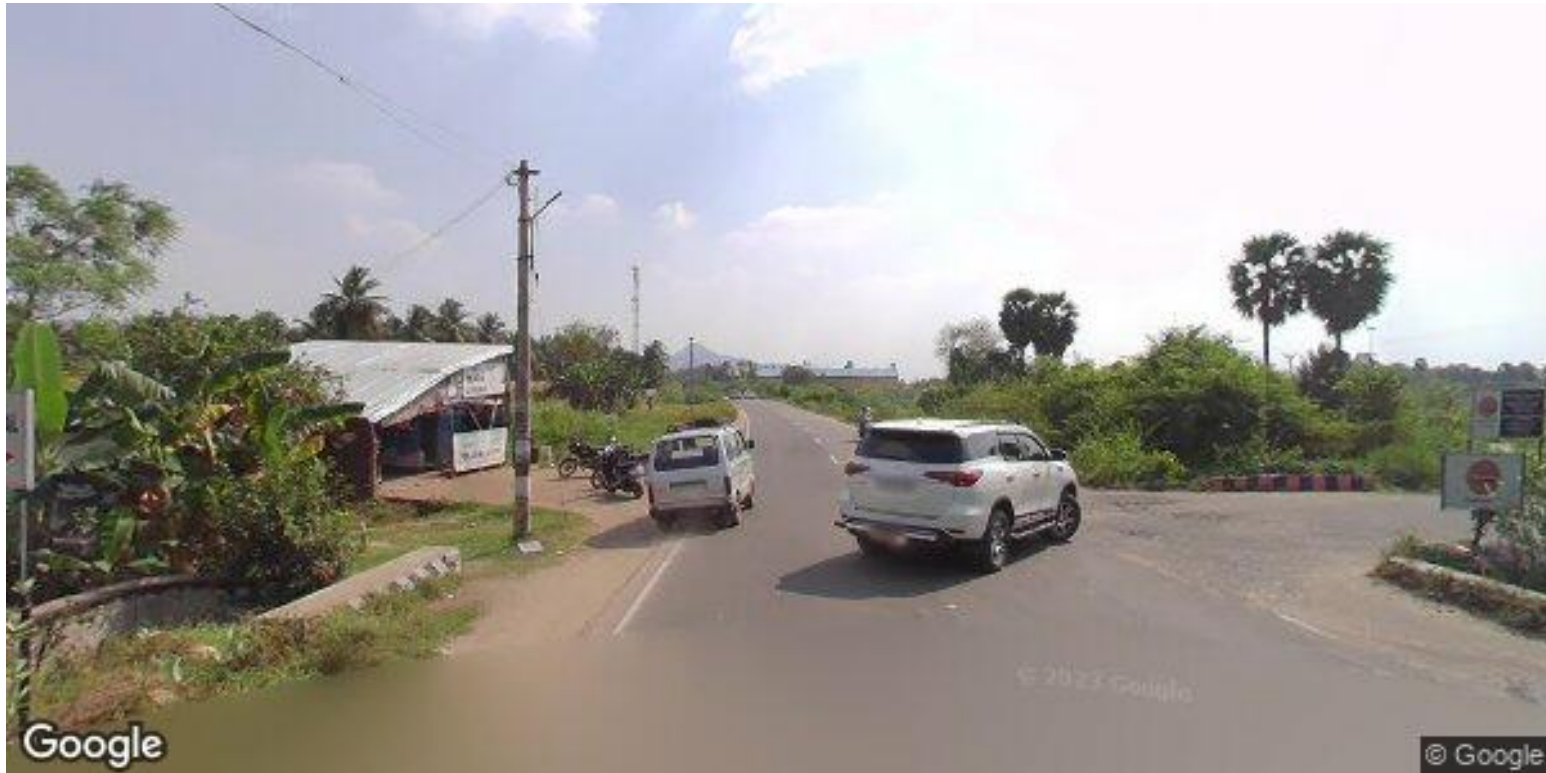
**Coordinates:** 11.44029, 77.87544

**Risk Type:** Turn

**Risk Level:** High

**Speed Limit:** 15 KM/Hr

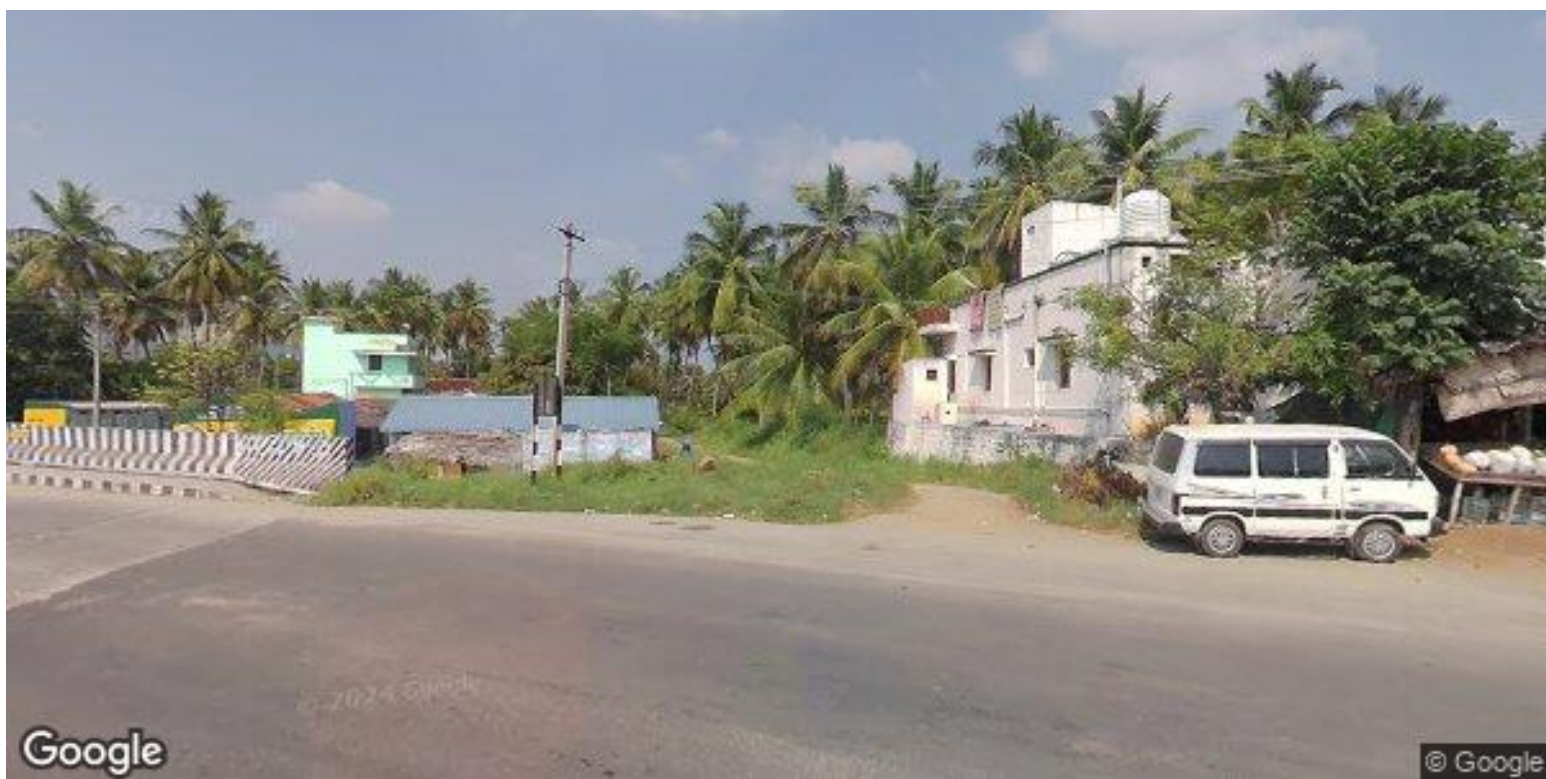
**Coordinates:** 11.44898, 77.87410

**Risk Type:** Turn

**Risk Level:** Medium

**Speed Limit:** 30 KM/Hr

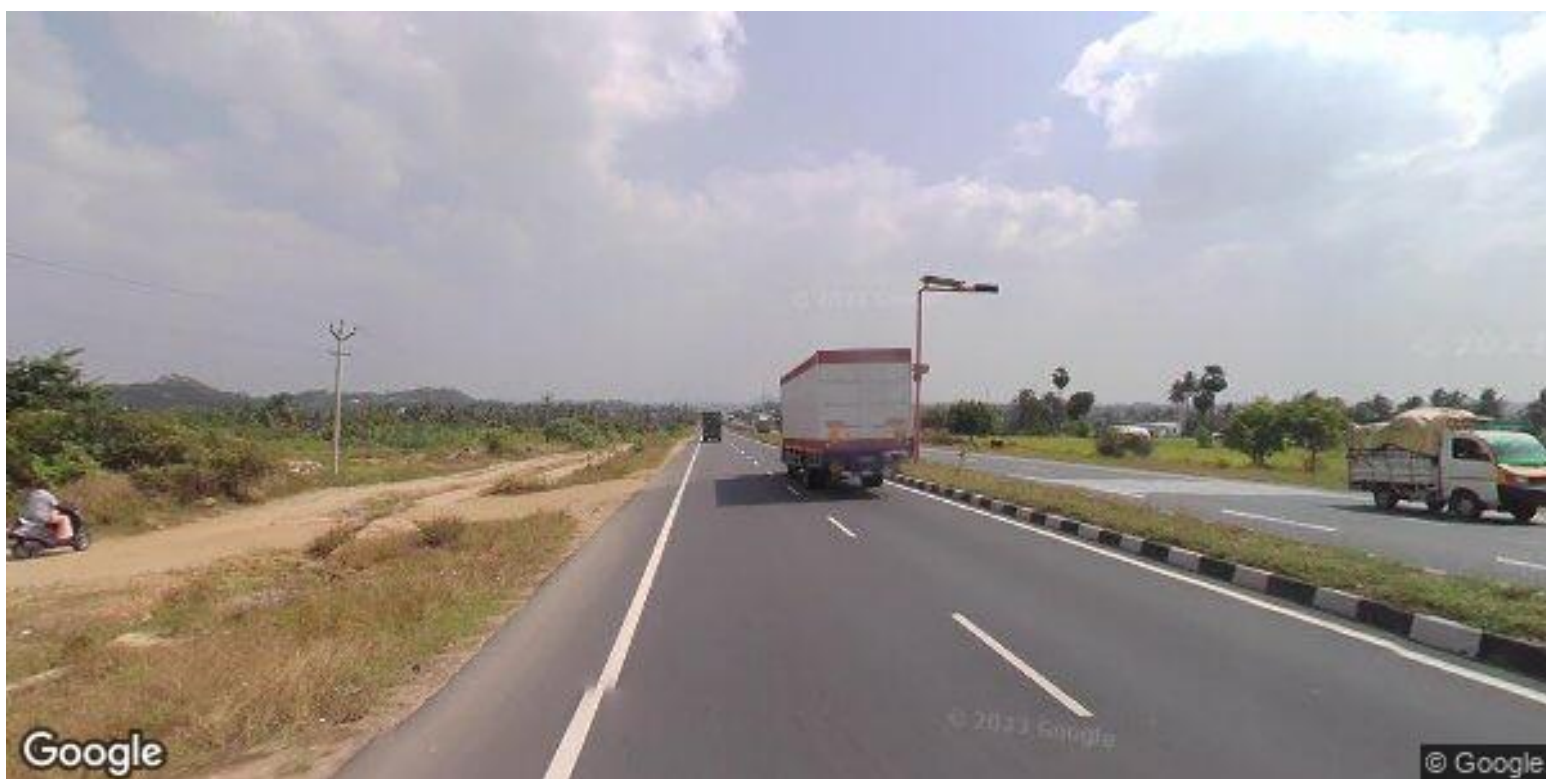
**Coordinates:** 11.49409, 77.88004

**Risk Type:** Turn

**Risk Level:** High

**Speed Limit:** 15 KM/Hr

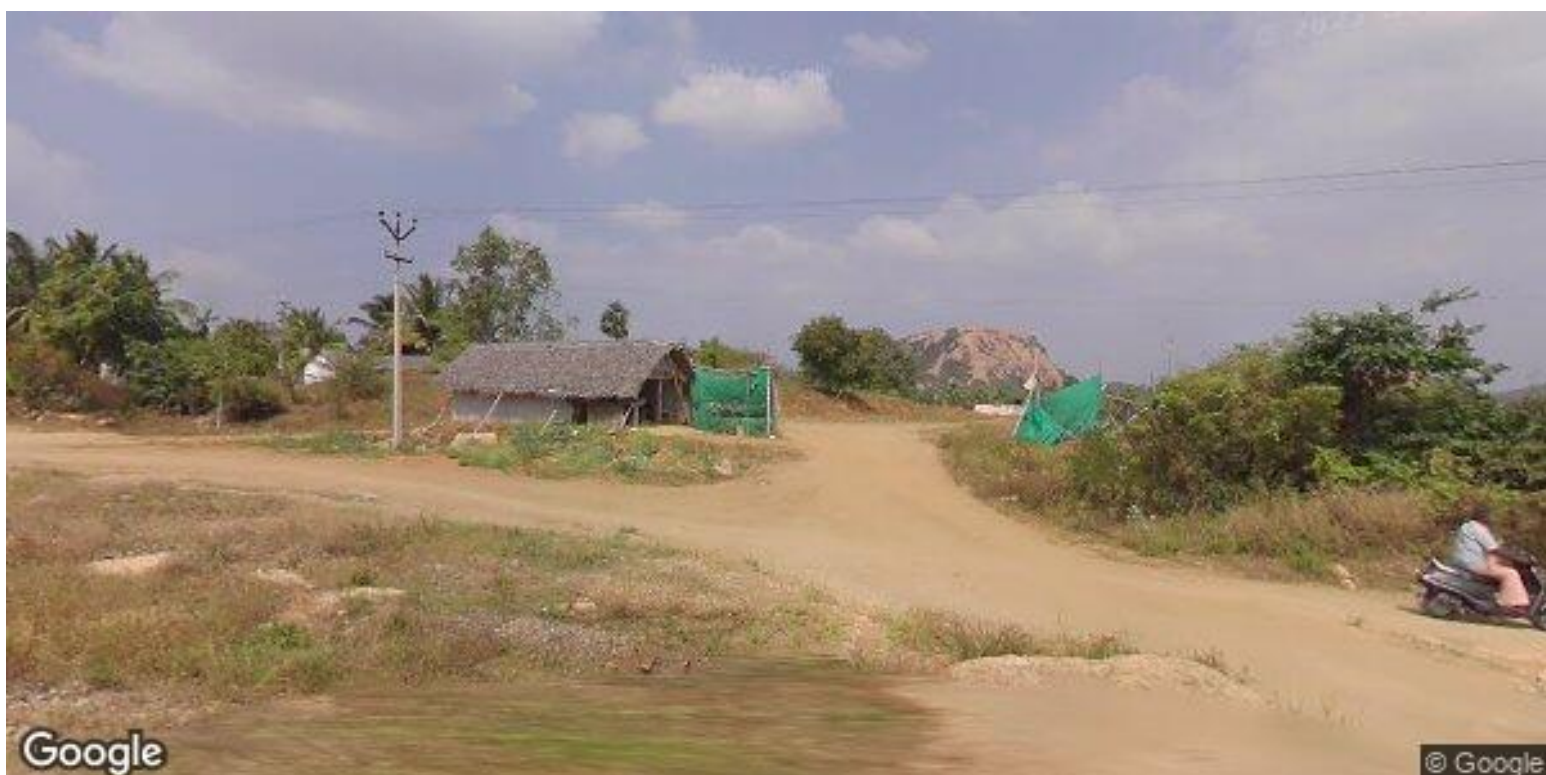
**Risk Type:** Turn  
**Risk Level:** Medium  
**Speed Limit:** 30 KM/Hr  
**Coordinates:** 11.49419, 77.88015

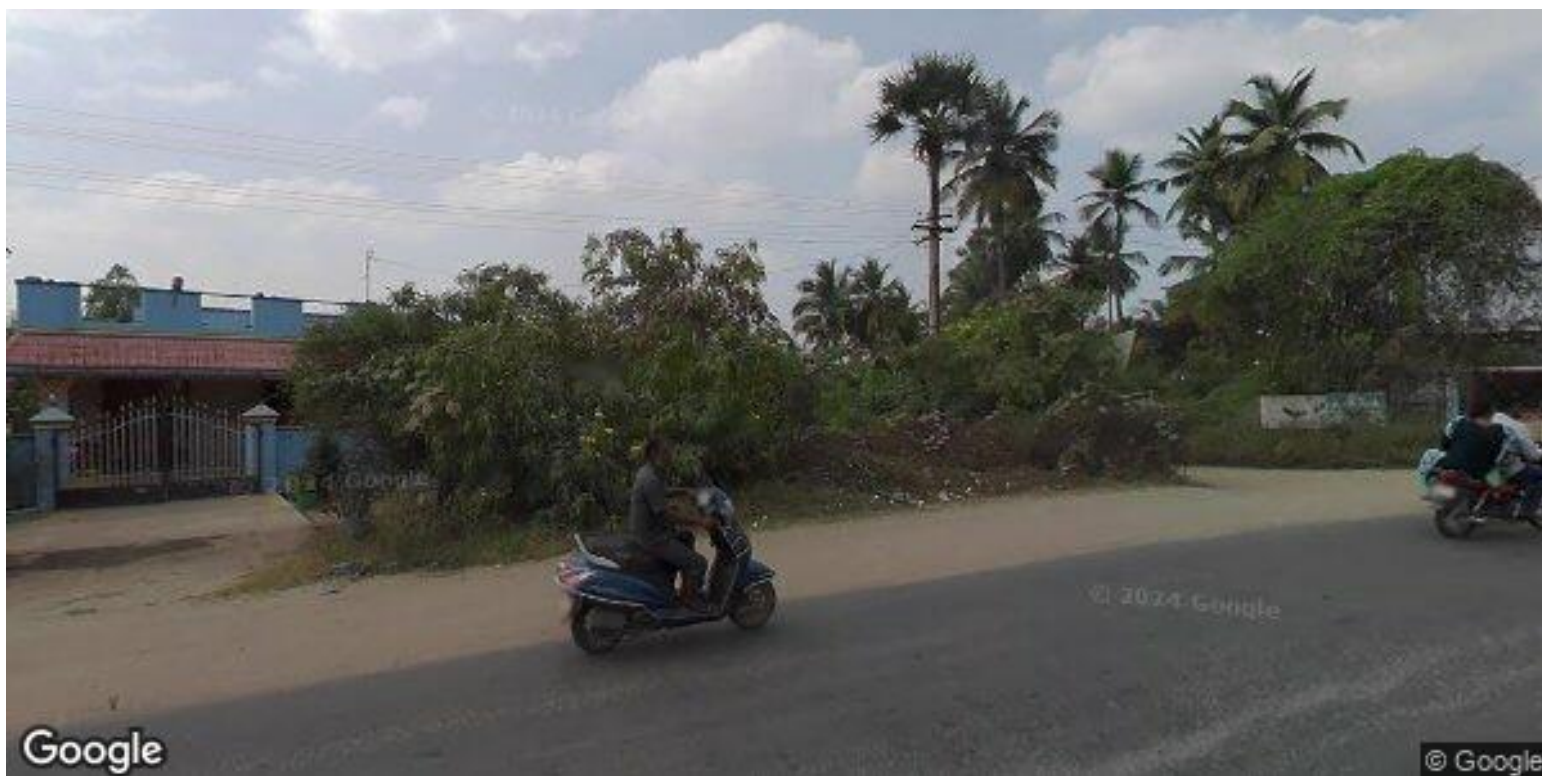
**Risk Type:** Turn  
**Risk Level:** Medium  
**Speed Limit:** 30 KM/Hr  
**Coordinates:** 11.49419, 77.88454

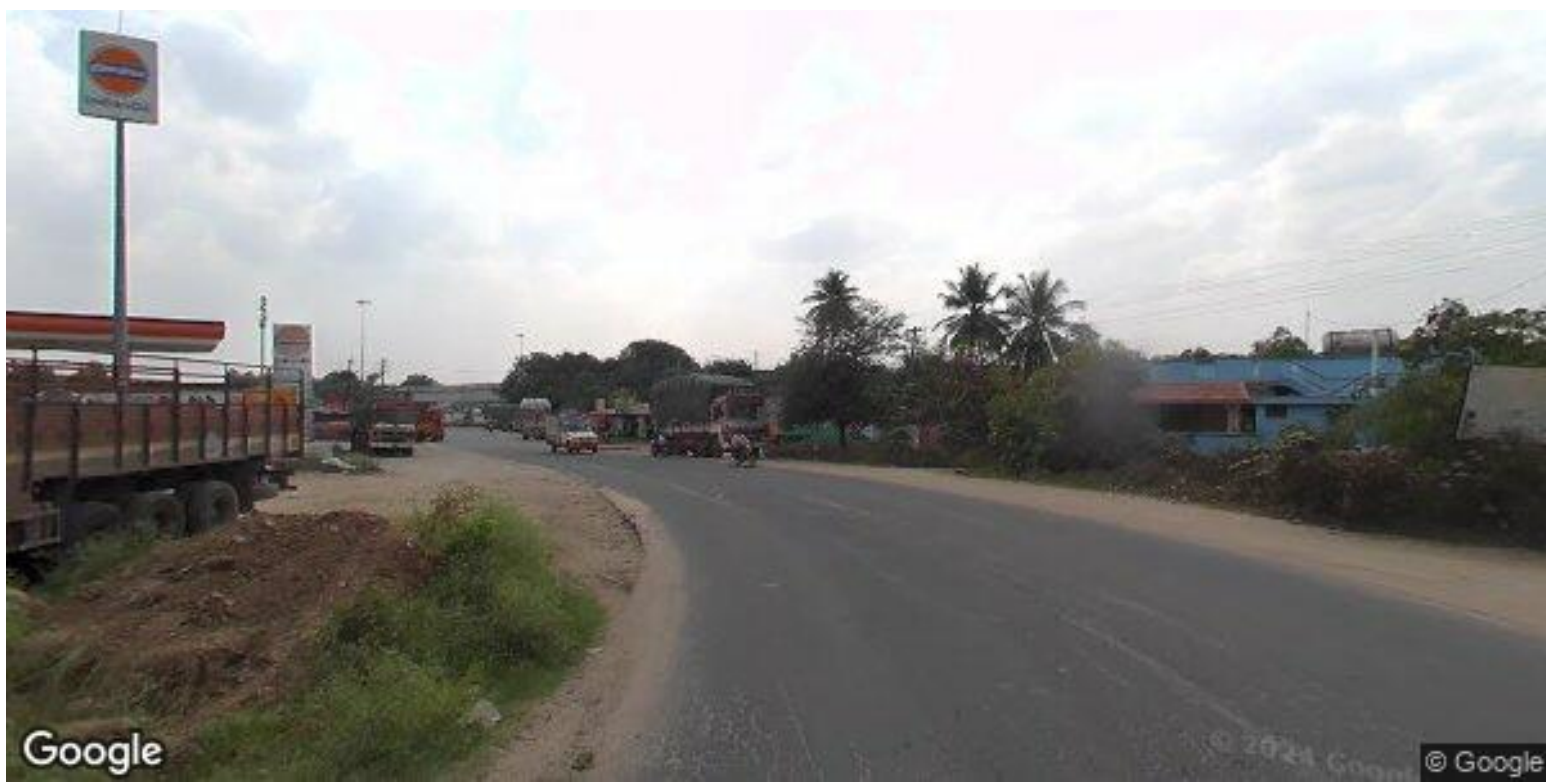
**Coordinates:** 11.49448, 77.88490

**Risk Type:** Turn

**Risk Level:** High

**Speed Limit:** 15 KM/Hr

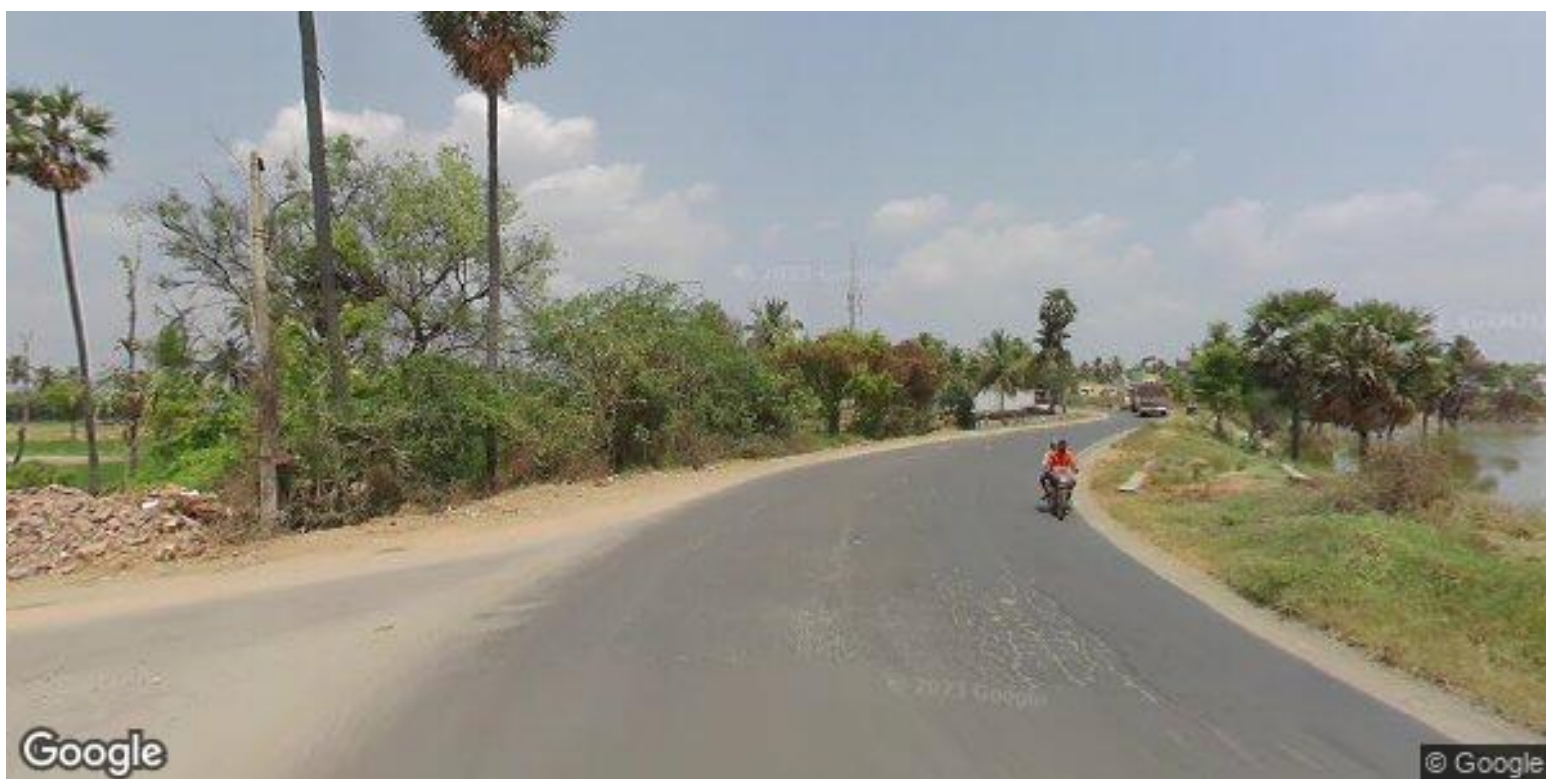
**Coordinates:** 11.56083, 77.89921

**Risk Type:** Turn

**Risk Level:** Medium

**Speed Limit:** 30 KM/Hr

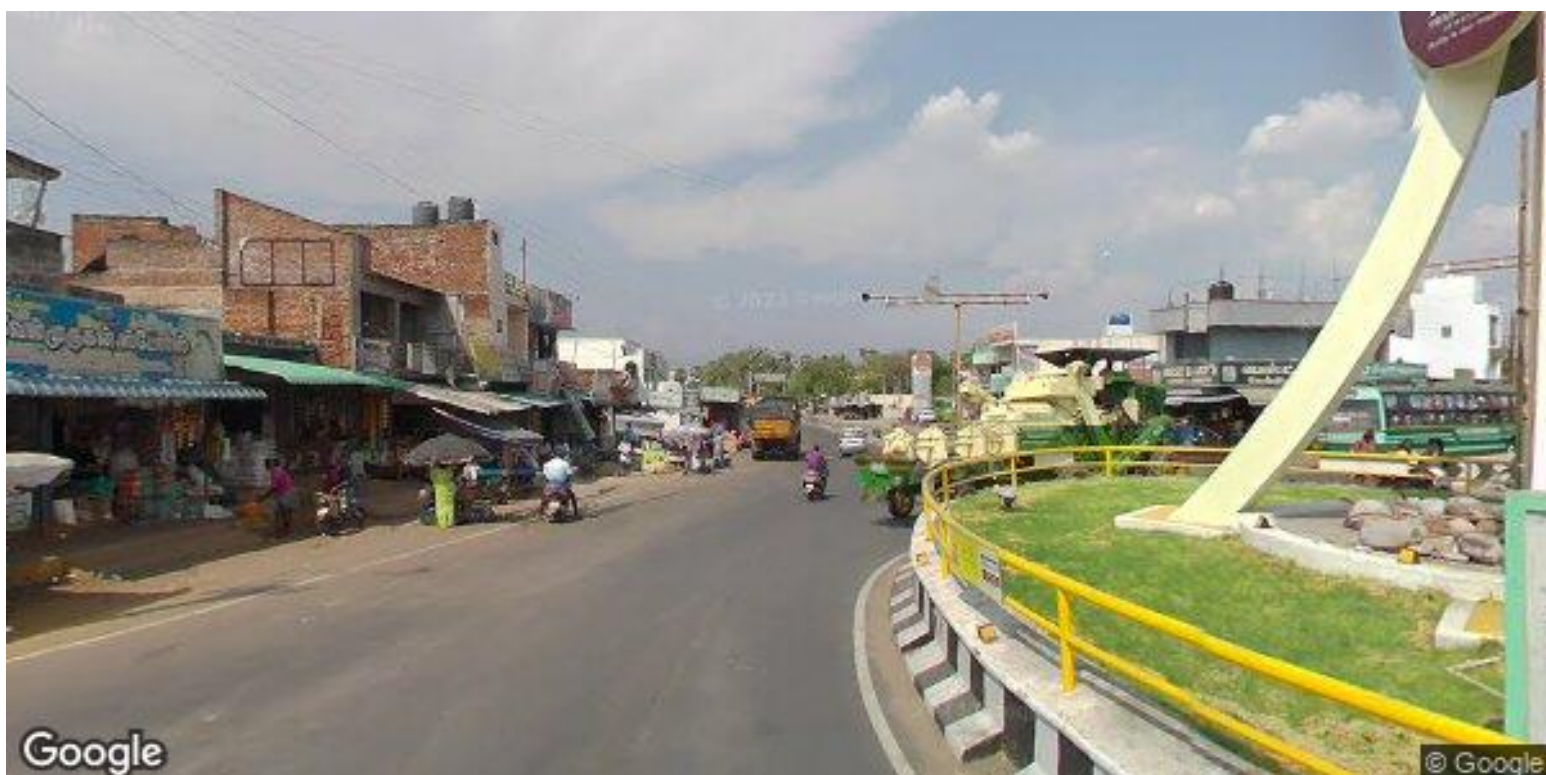
**Risk Type:** Turn  
**Risk Level:** Medium  
**Speed Limit:** 30 KM/Hr  
**Coordinates:** 11.57048, 77.90224

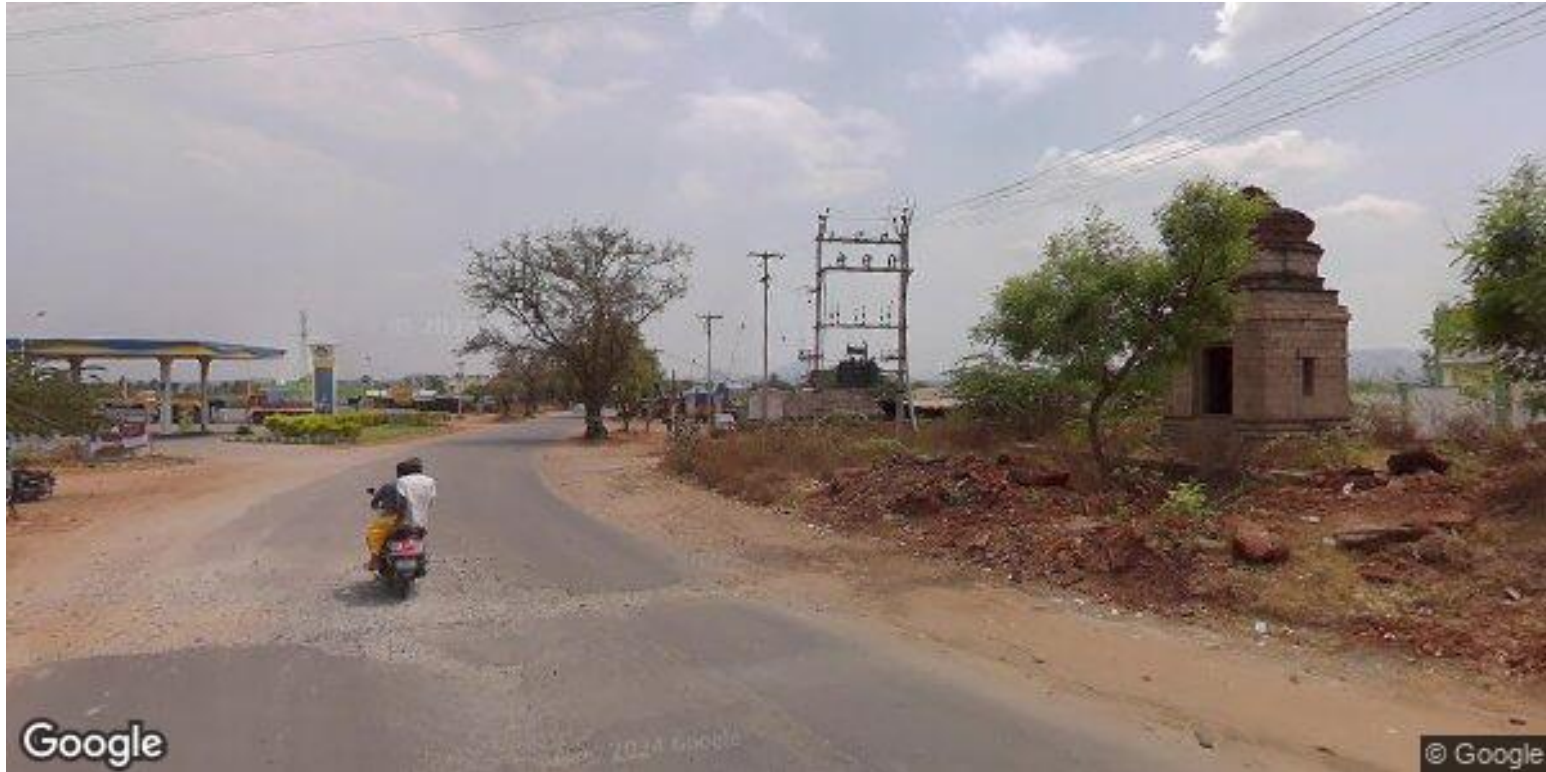
**Risk Type:** Turn  
**Risk Level:** Medium  
**Speed Limit:** 30 KM/Hr  
**Coordinates:** 11.58304, 77.90656

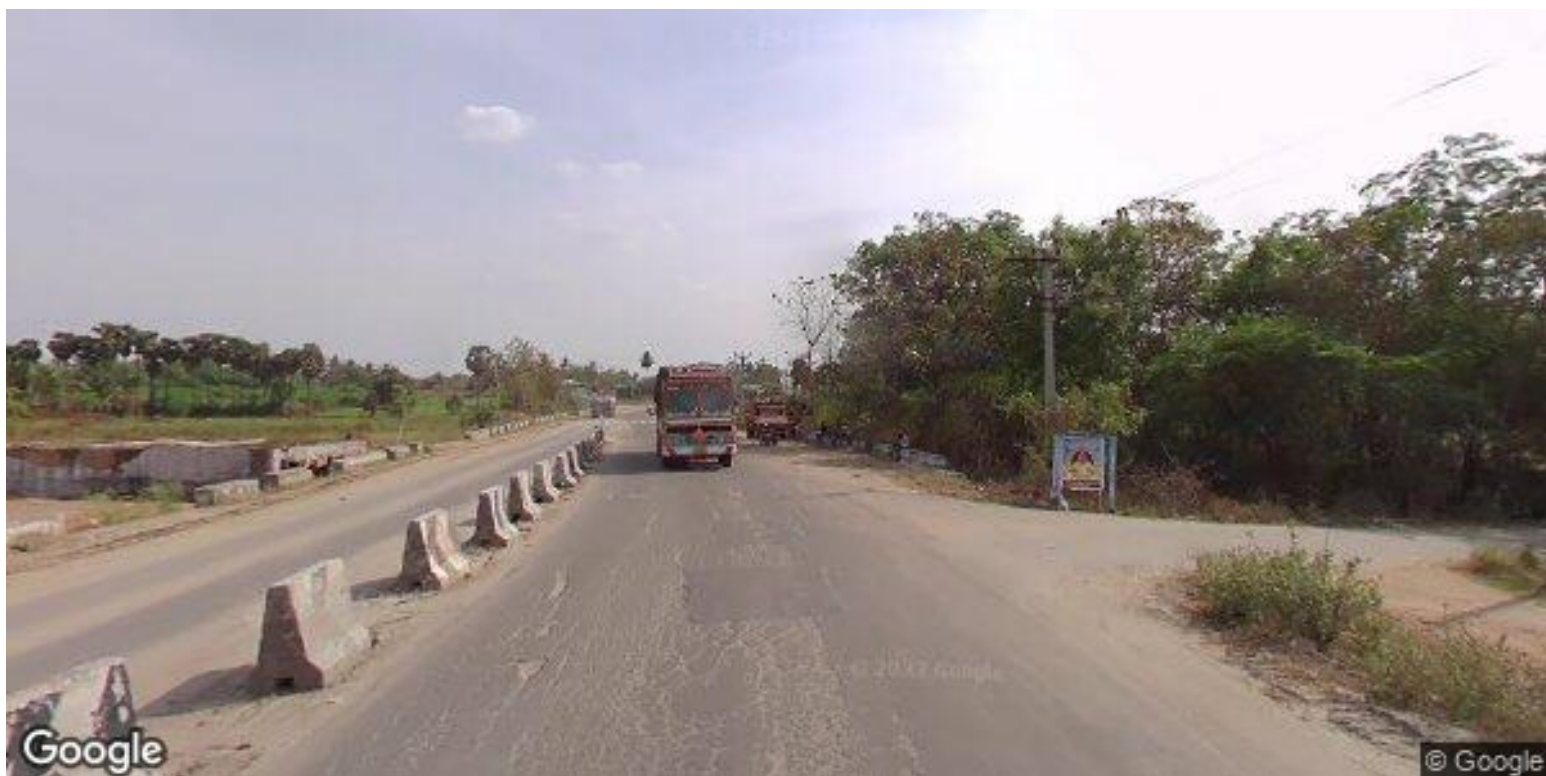
**Risk Type:** Turn  
**Risk Level:** Medium  
**Speed Limit:** 30 KM/Hr  
**Coordinates:** 11.63840, 77.94820

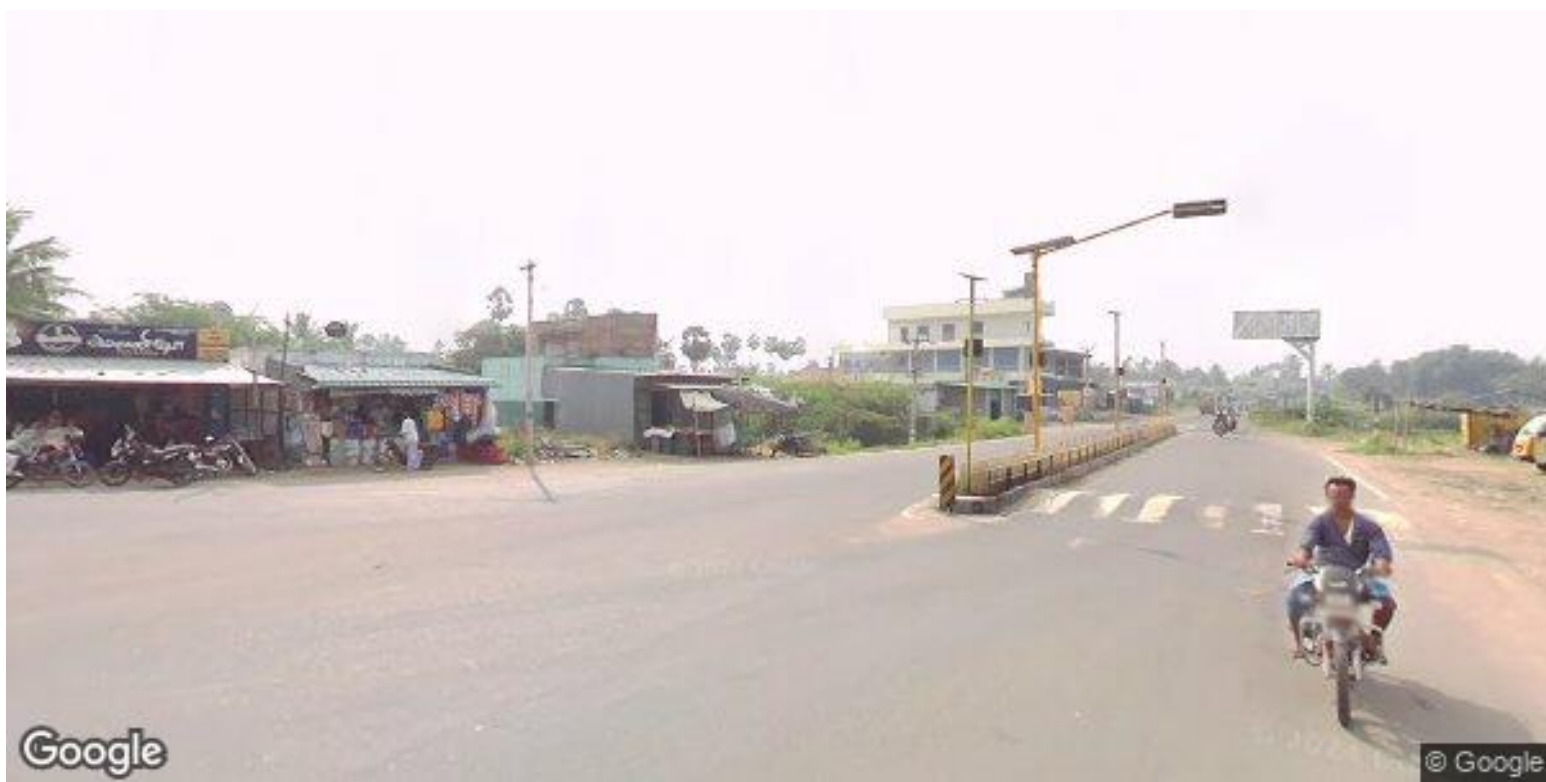
**Coordinates:** 11.67868, 77.96836

**Risk Type:** Turn

**Risk Level:** High

**Speed Limit:** 15 KM/Hr

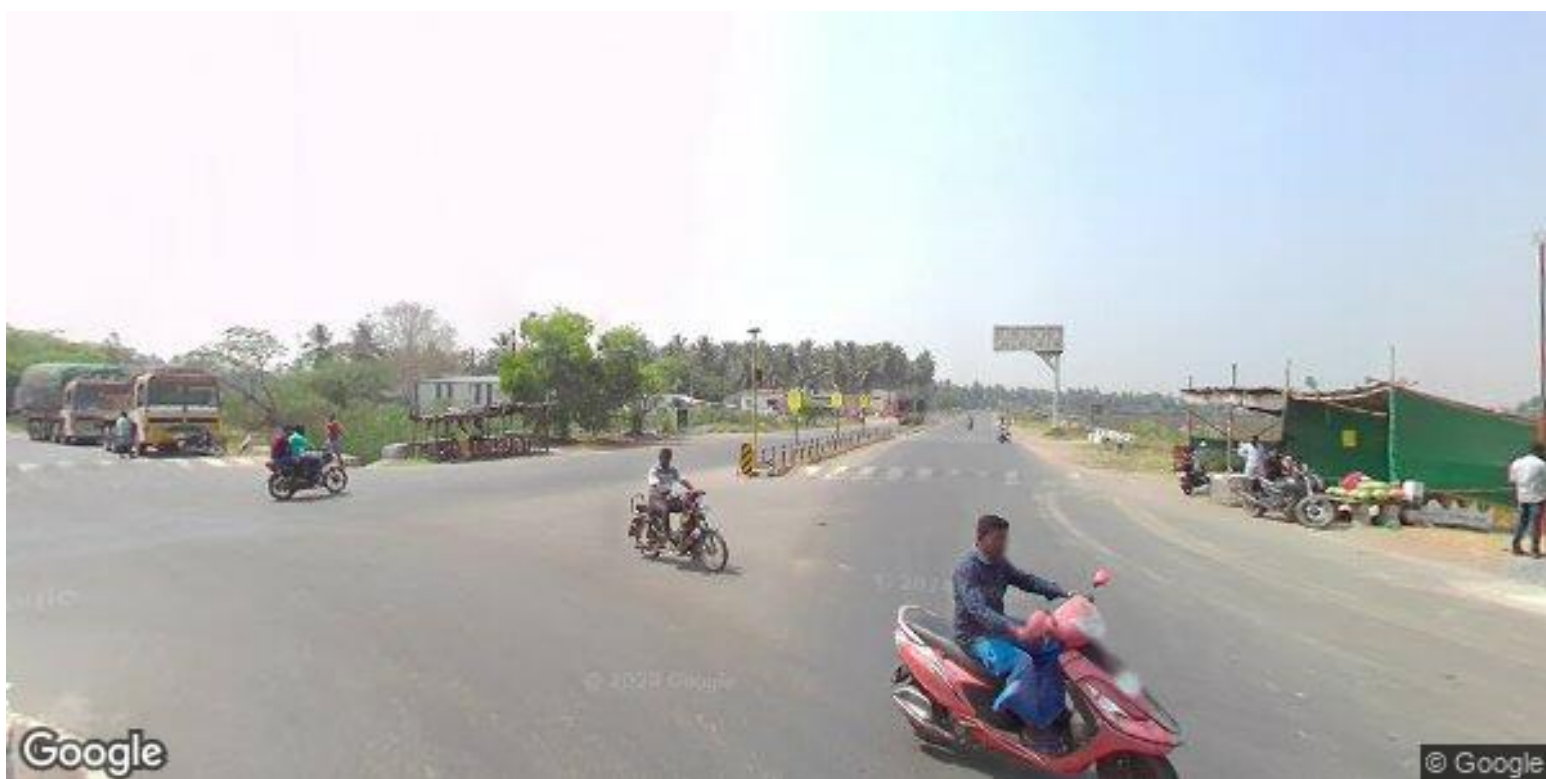
**Coordinates:** 11.68913, 77.97734

**Risk Type:** Turn

**Risk Level:** Medium

**Speed Limit:** 30 KM/Hr

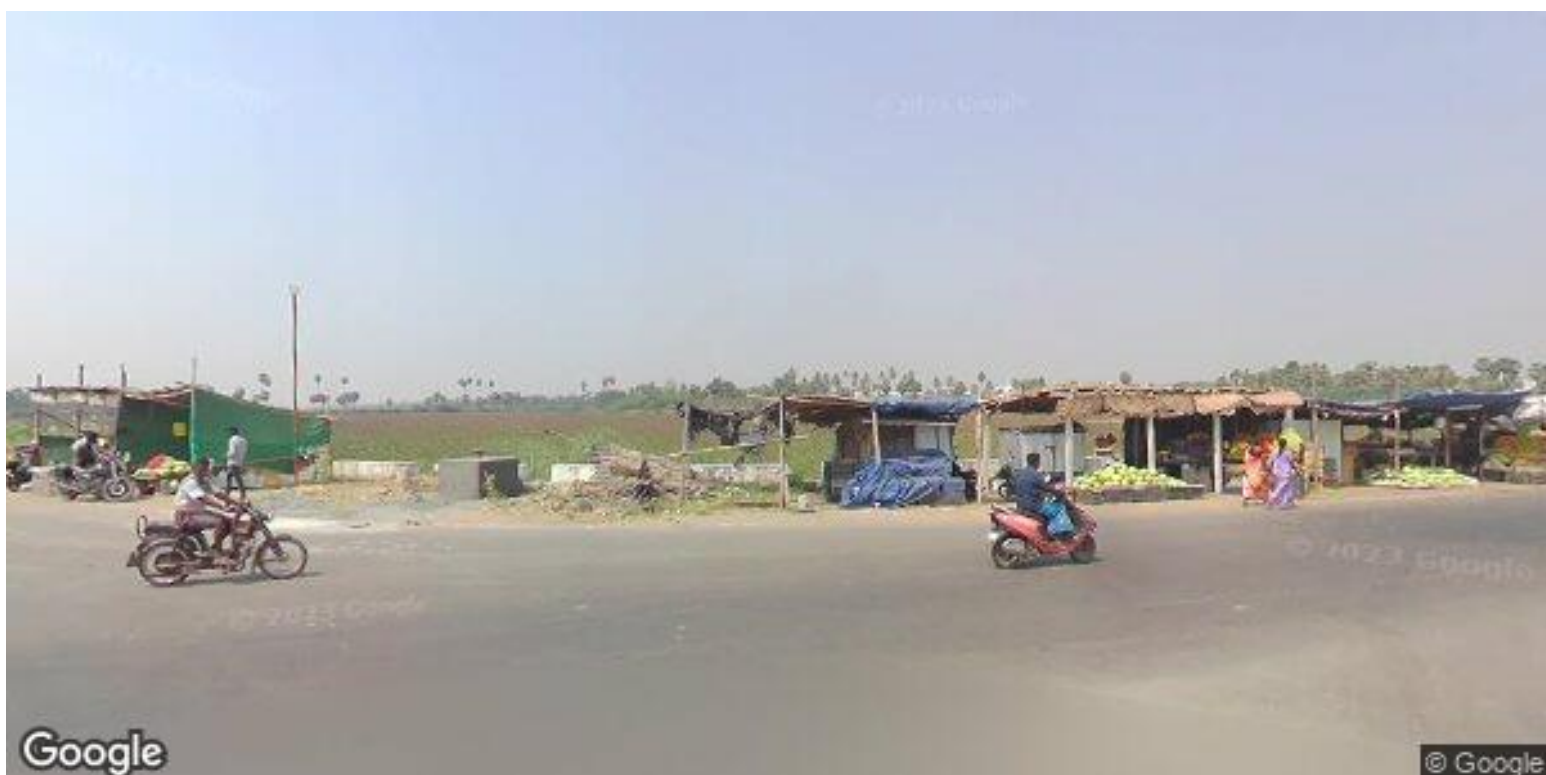
**Risk Type:** Turn  
**Risk Level:** Medium  
**Speed Limit:** 30 KM/Hr  
**Coordinates:** 11.68925, 77.97741

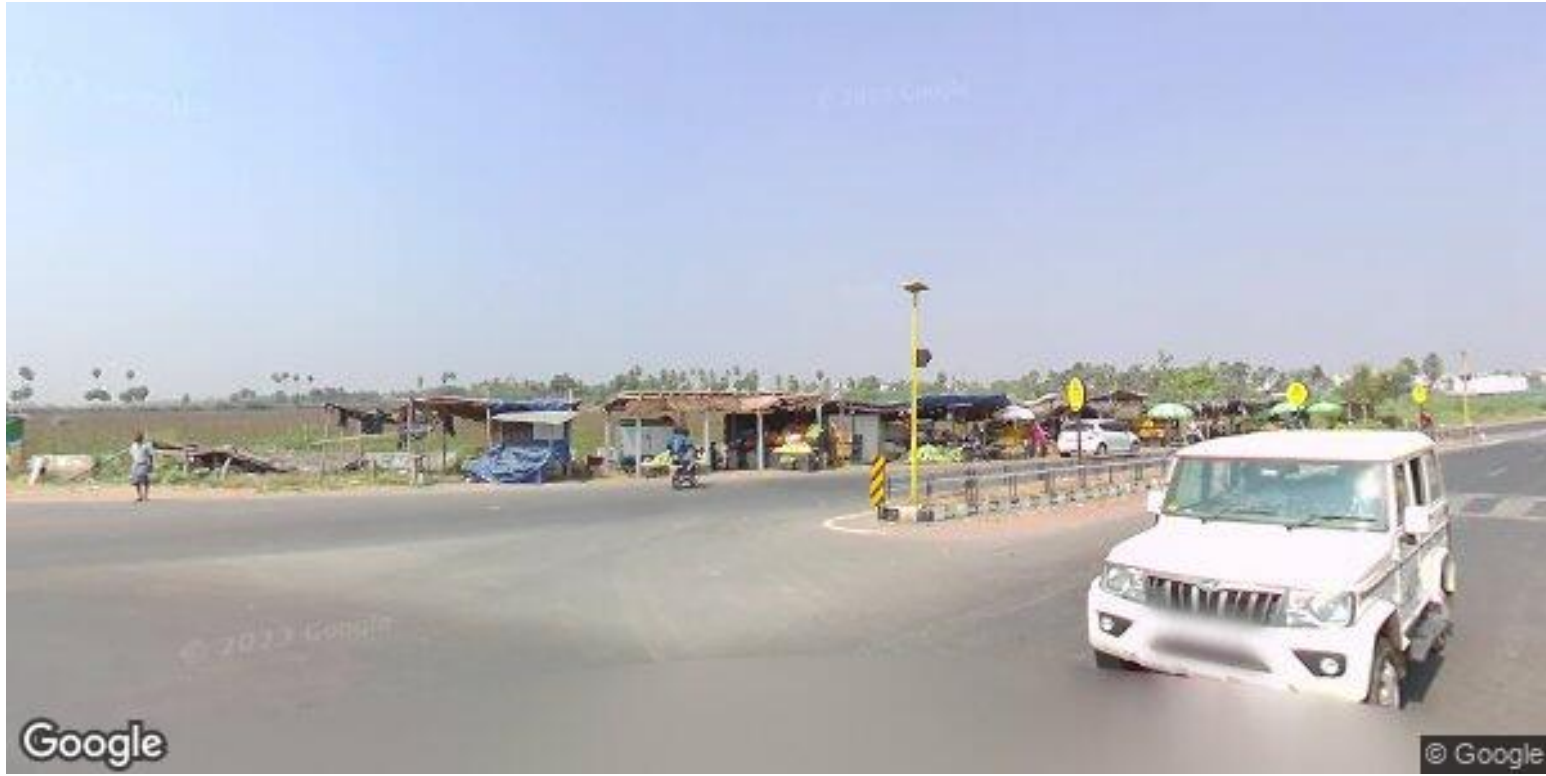
**Risk Type:** Turn  
**Risk Level:** High  
**Speed Limit:** 15 KM/Hr  
**Coordinates:** 11.68927, 77.97747

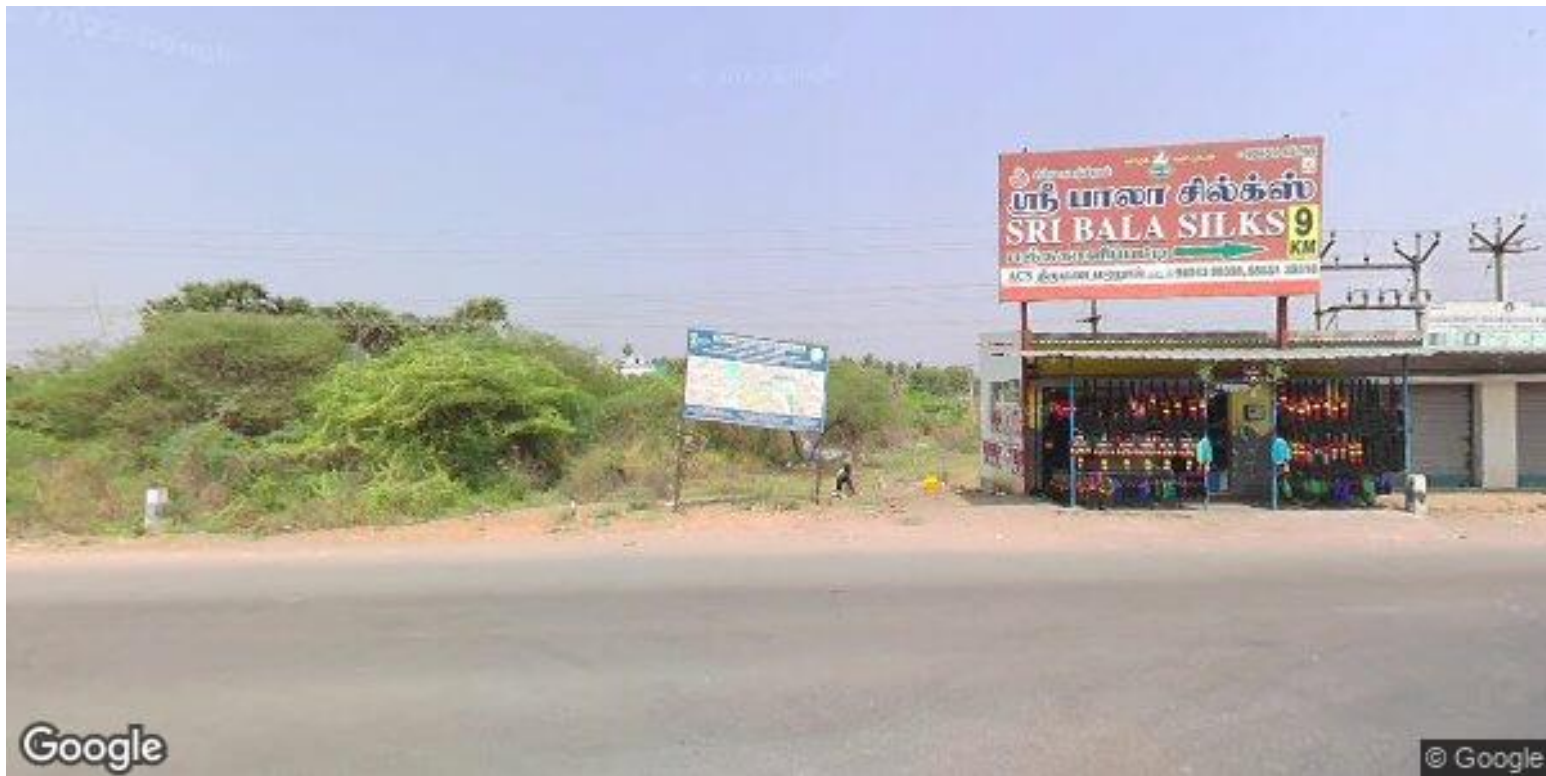
**Risk Type:** Turn  
**Risk Level:** High  
**Speed Limit:** 15 KM/Hr  
**Coordinates:** 11.70223, 77.97860
