# IndianOil

## JOURNEY RISK MANAGEMENT (JRM) STUDY

### Salem Terminal TO MARUDHAN AGENCIES

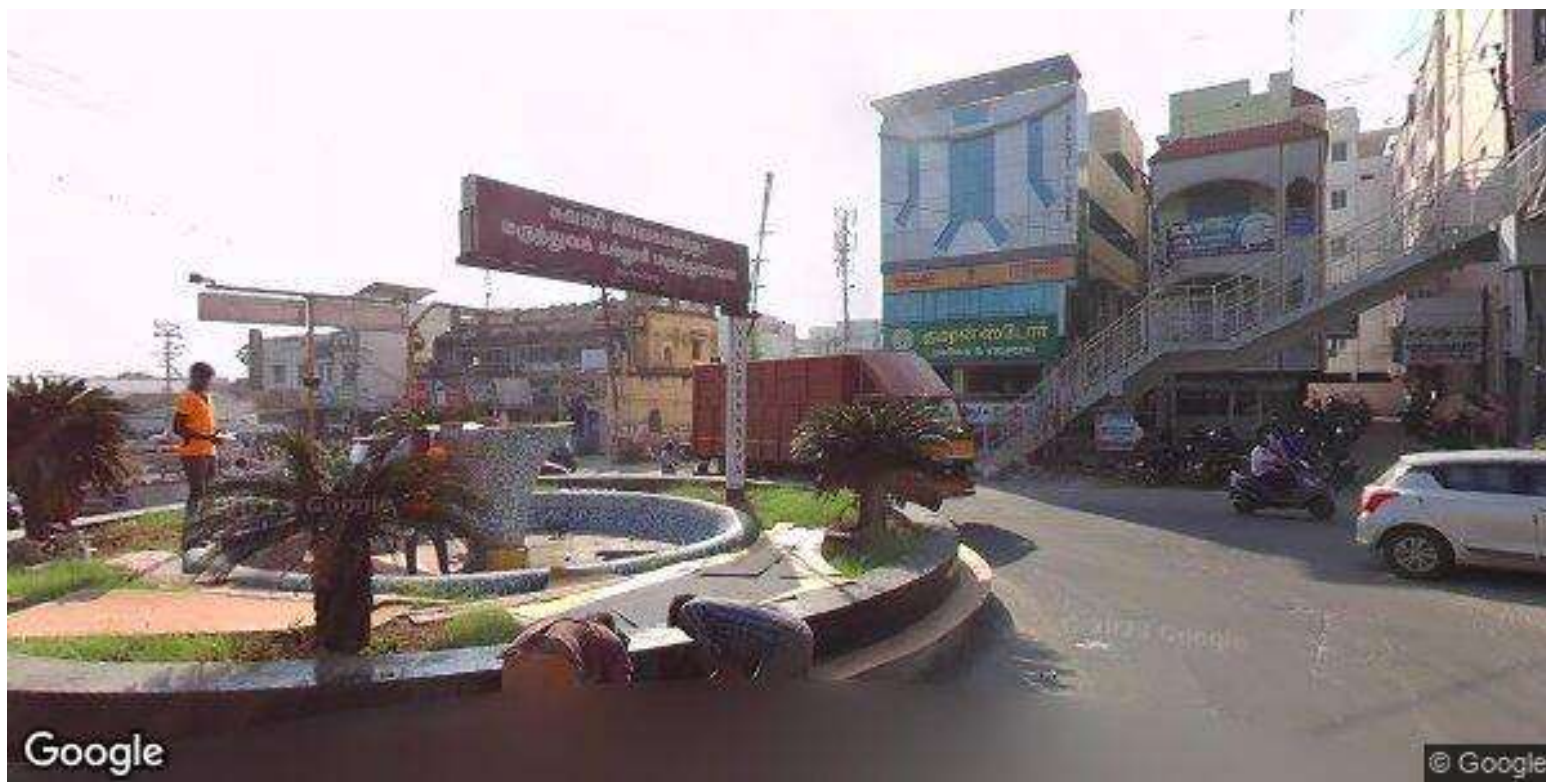
**Coordinates:** 11.38395, 77.89480

**Risk Type:** Roundabout

**Risk Level:** High

**Speed Limit:** 15 KM/Hr

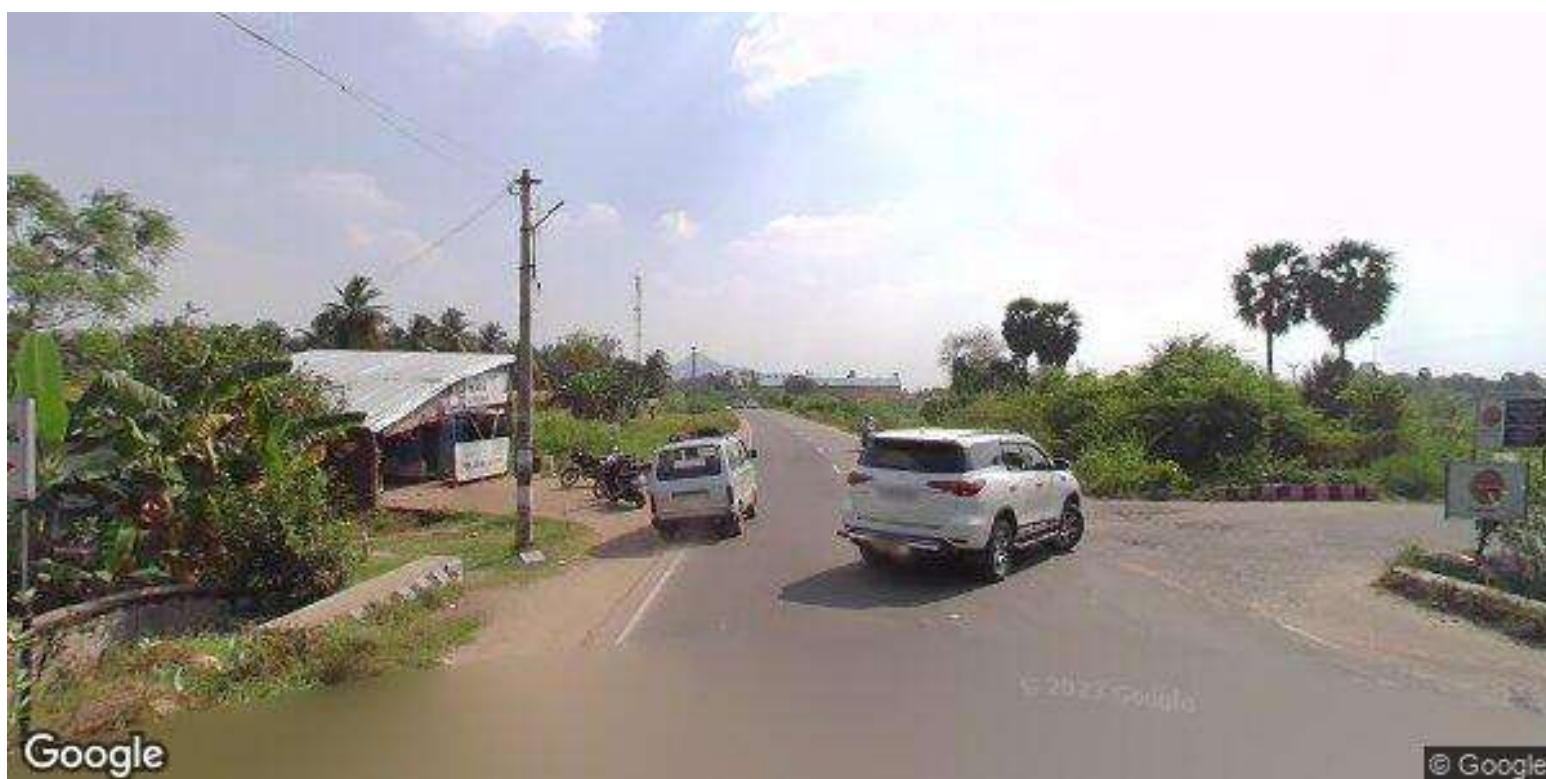
**Coordinates:** 11.44029, 77.87544

**Risk Type:** Blind Spot

**Risk Level:** Blind Spot

**Speed Limit:** 10 KM/Hr

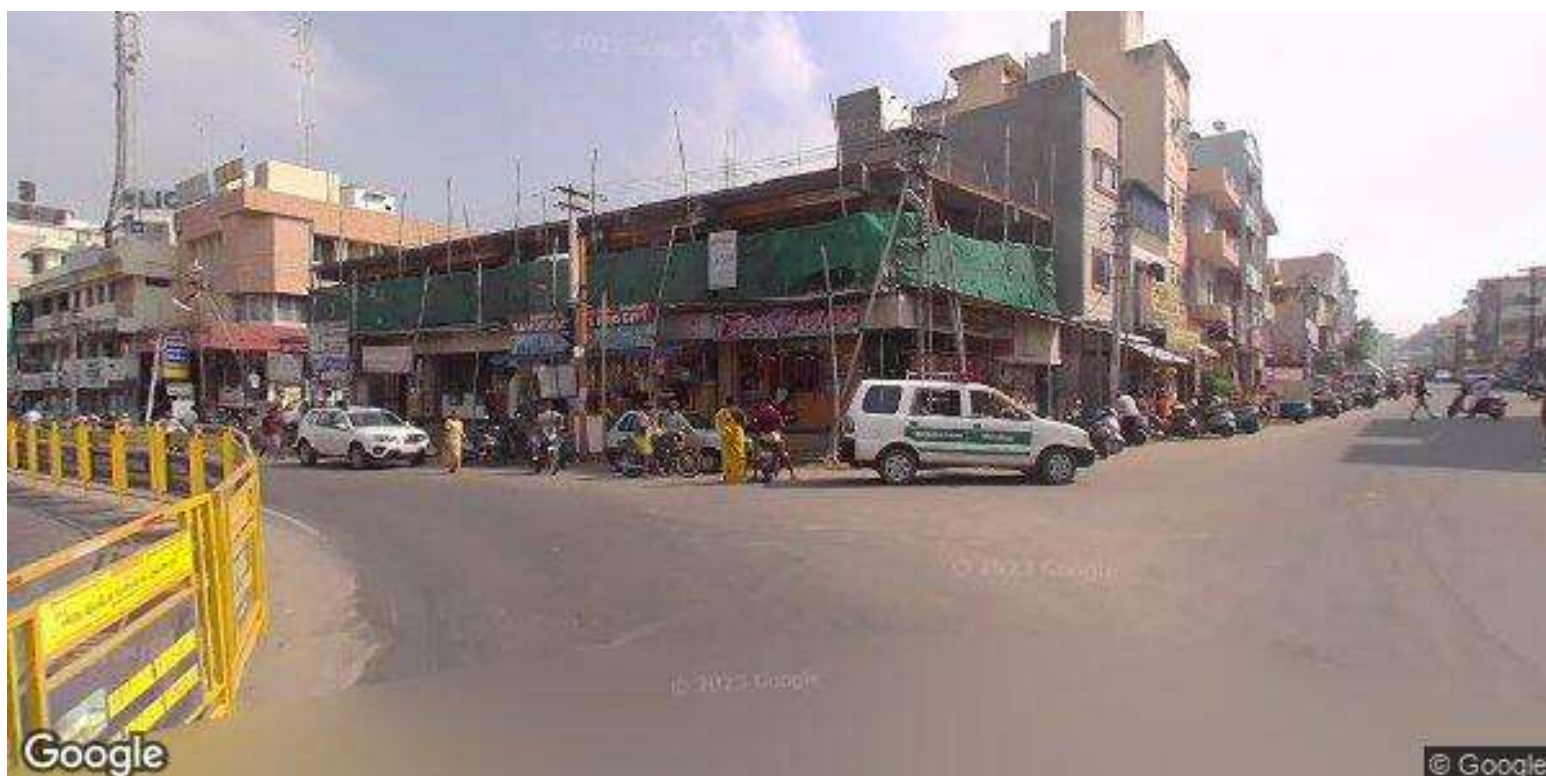
**Coordinates:** 11.37868, 77.89498

**Risk Type:** Turn

**Risk Level:** High

**Speed Limit:** 15 KM/Hr

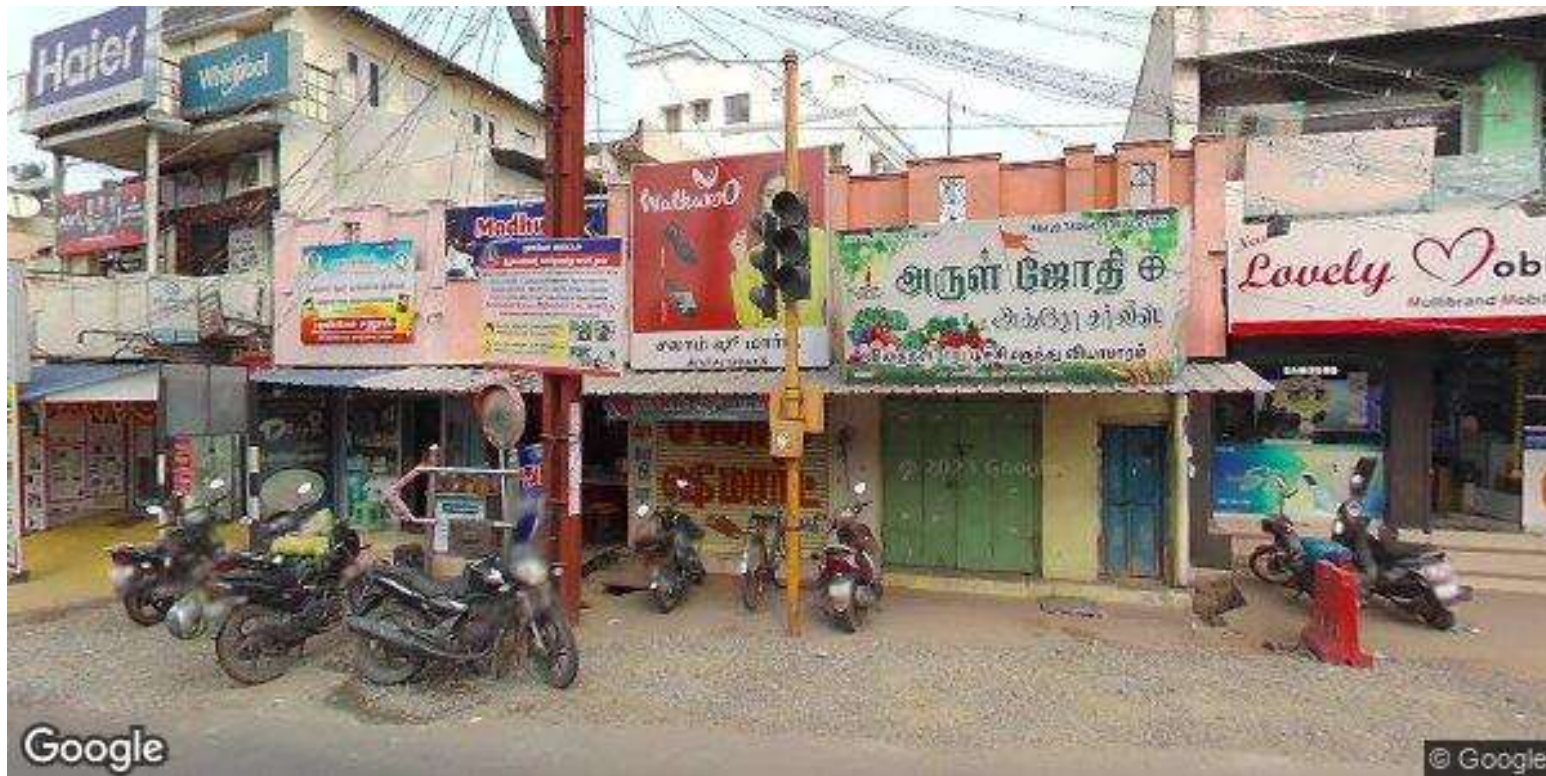
**Coordinates:** 11.37850, 77.89453

**Risk Type:** Turn

**Risk Level:** High

**Speed Limit:** 15 KM/Hr

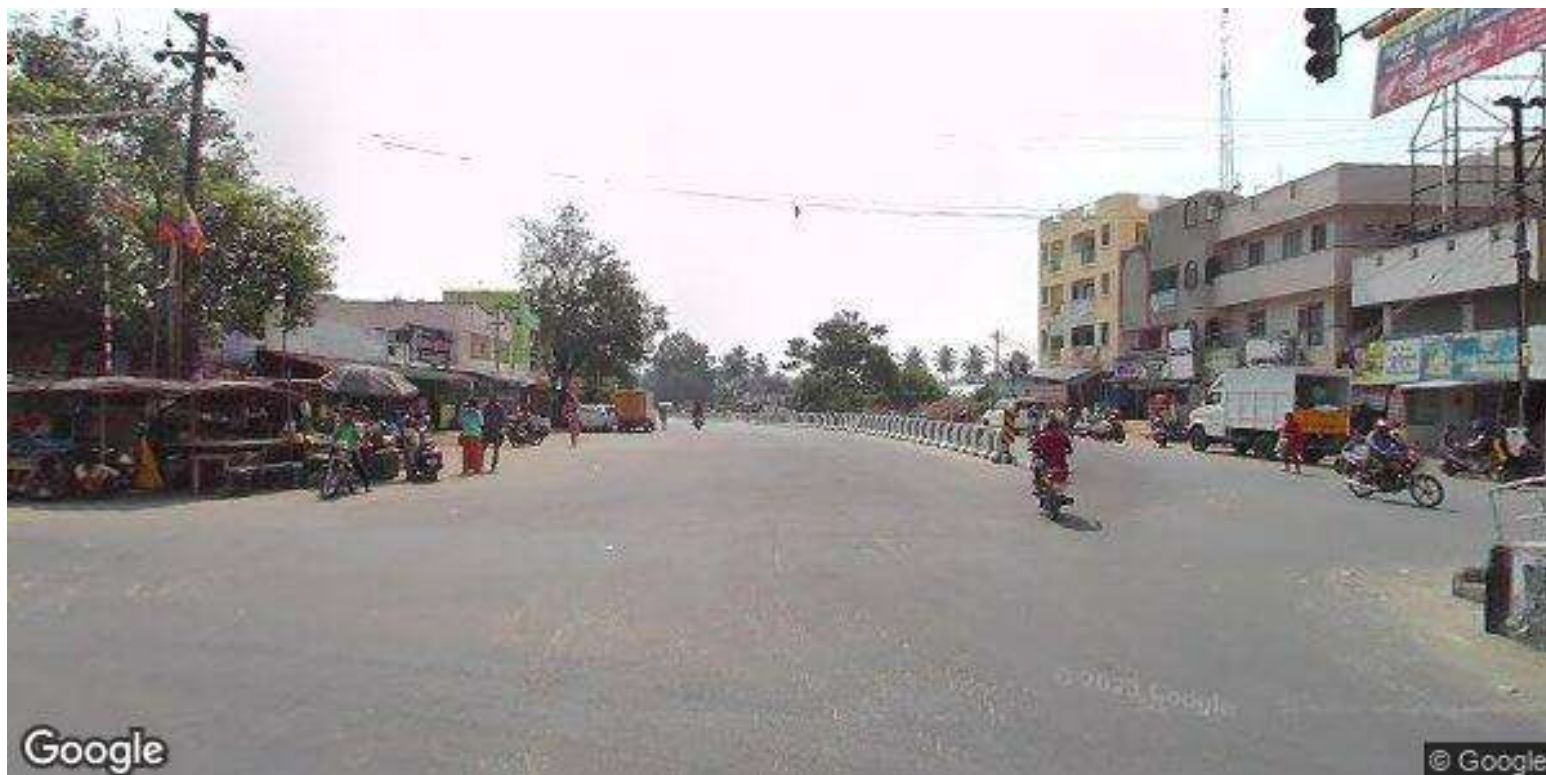
**Coordinates:** 11.36604, 77.88887

**Risk Type:** Turn

**Risk Level:** High

**Speed Limit:** 15 KM/Hr
