# IndianOil

## JOURNEY RISK MANAGEMENT (JRM) STUDY

### Salem Terminal to BALA MURUGAN AGENCY

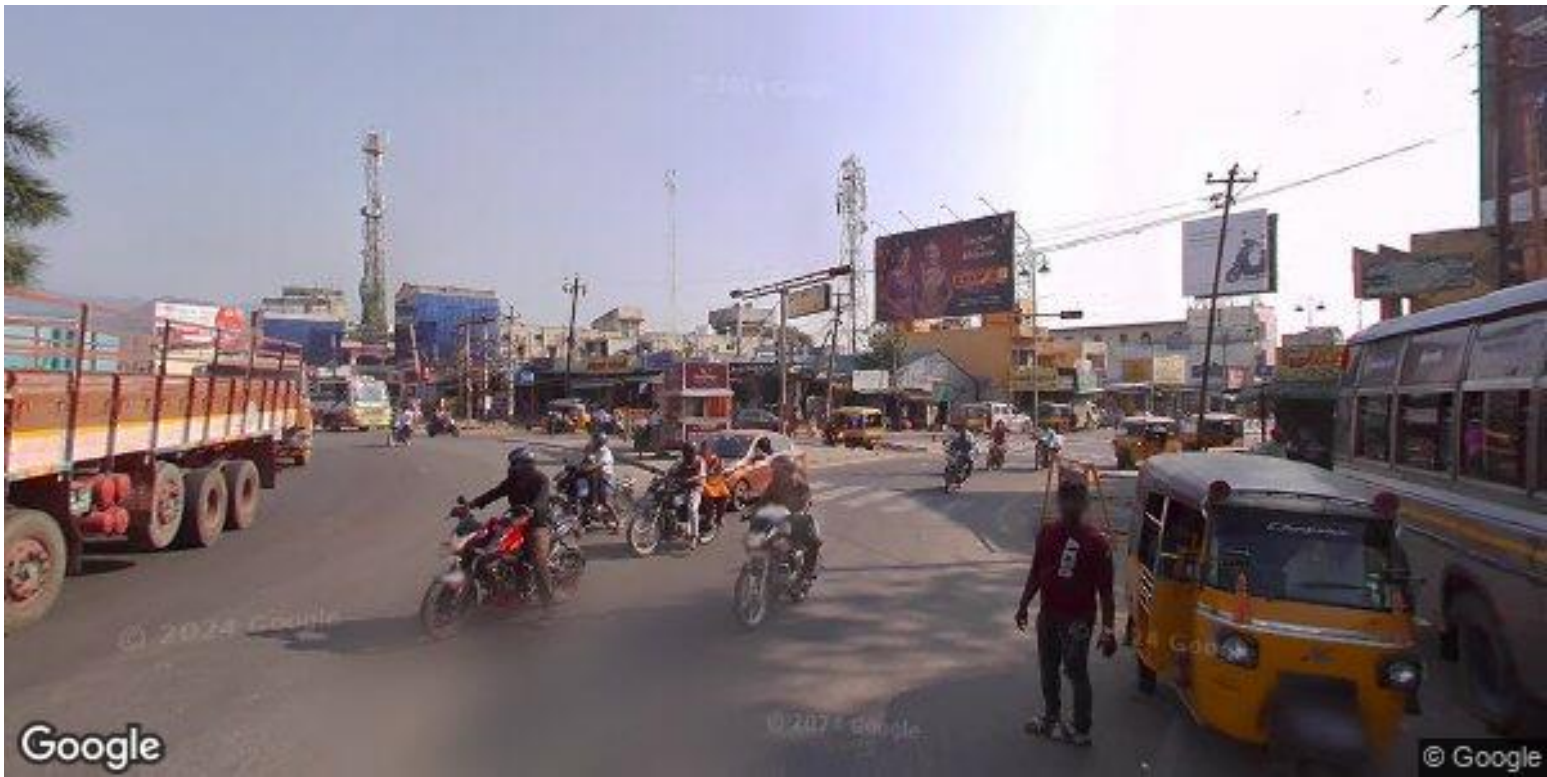
| | Risk Type | Risk Level | Coordinates | Speed Limit |
|---|---|---|---|---|
| 0 | Roundabout | High | 11.63266, 78.12699 | 15 KM/Hr |

**Risk Type:** Roundabout  
**Risk Level:** High  
**Speed Limit:** 15 KM/Hr  
**Coordinates:** 11.63266, 78.12699

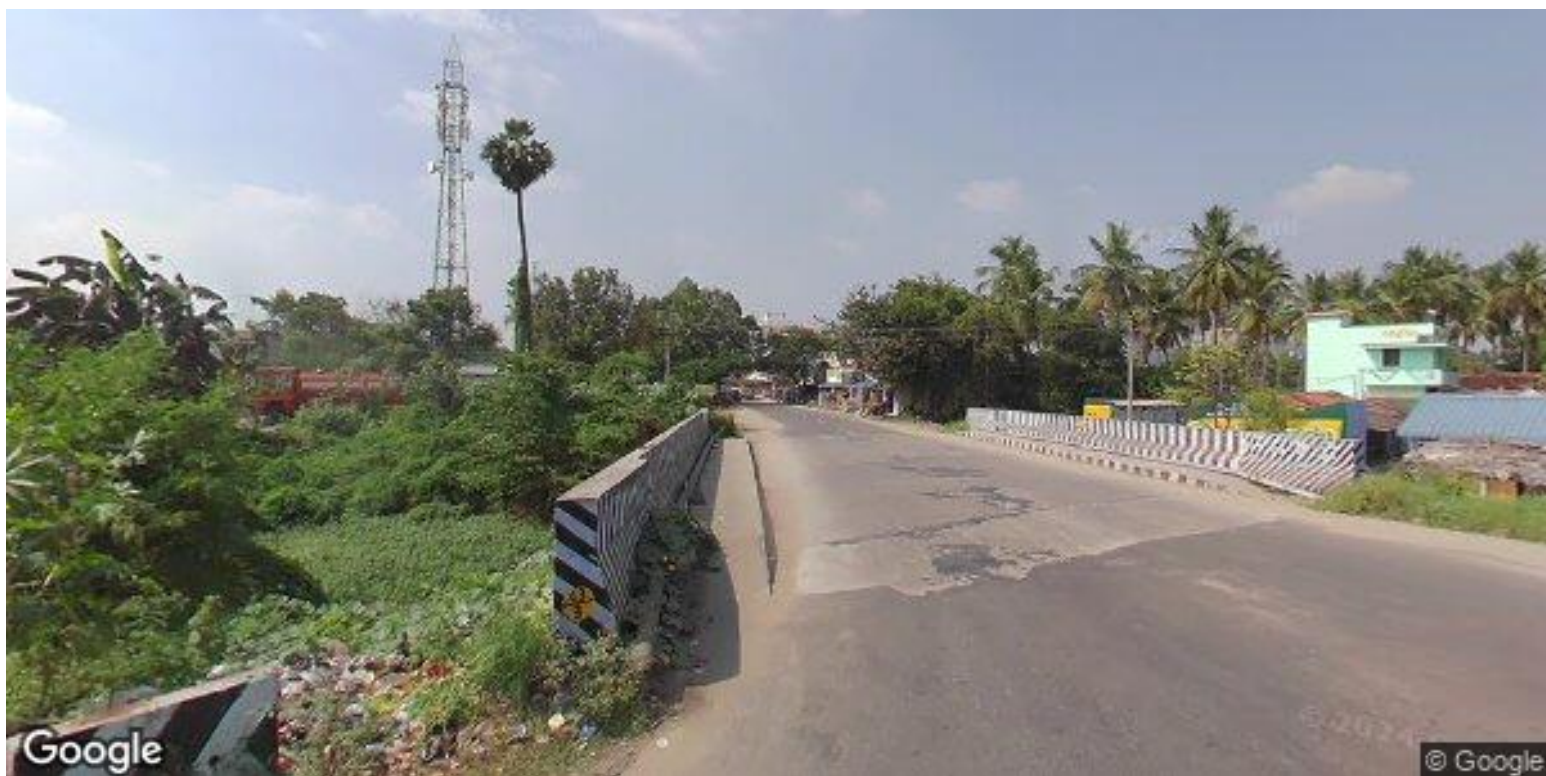
| | Risk Type | Risk Level | Coordinates | Speed Limit |
|---|---|---|---|---|
| 3 | Turn | High | 11.44900, 77.87406 | 15 KM/Hr |

**Risk Type:** Turn  
**Risk Level:** High  
**Speed Limit:** 15 KM/Hr  
**Coordinates:** 11.44900, 77.87406

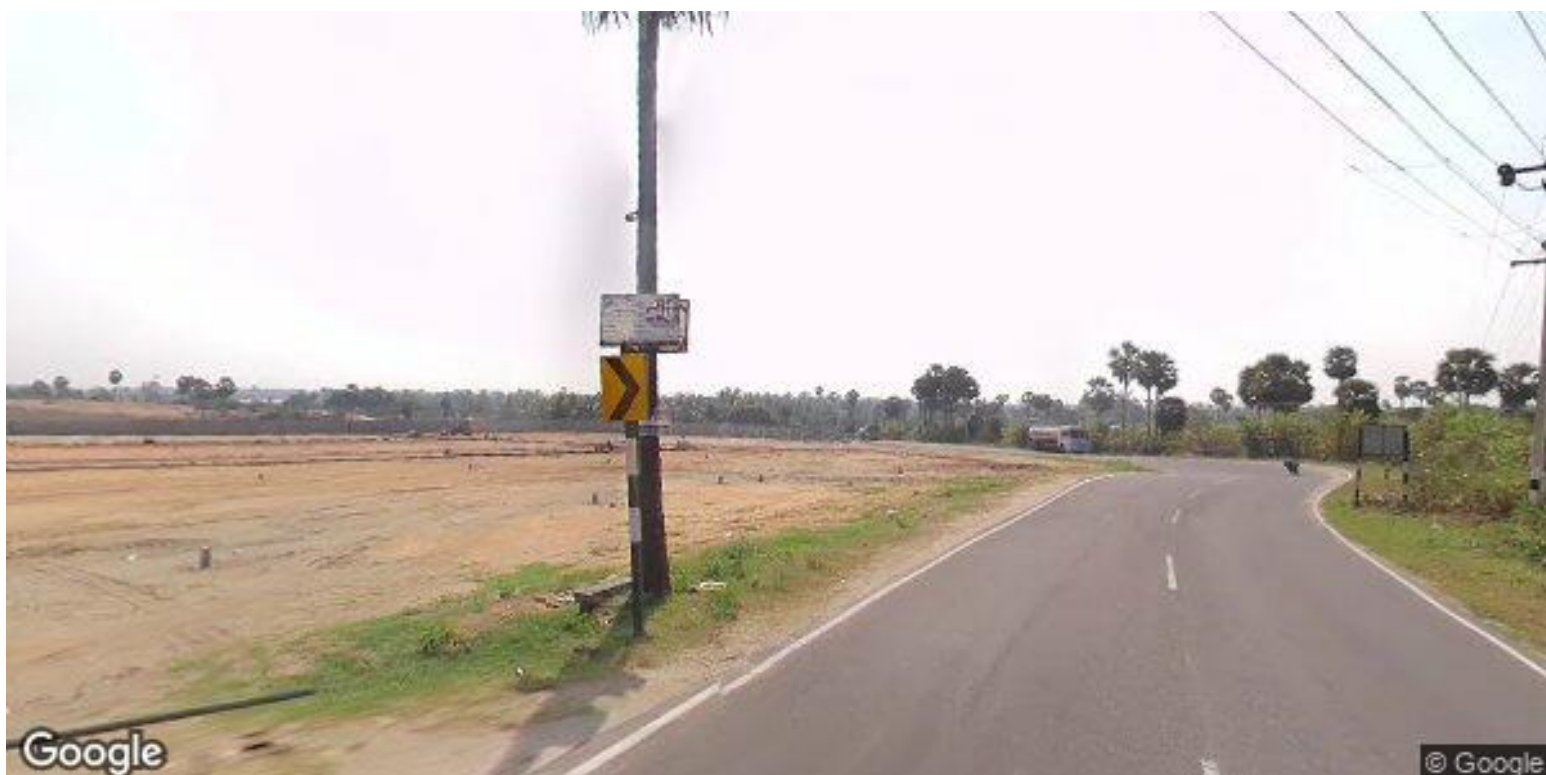
**Risk Type:** Turn

**Risk Level:** Medium

**Speed Limit:** 30 KM/Hr

**Coordinates:** 11.45898, 77.85135

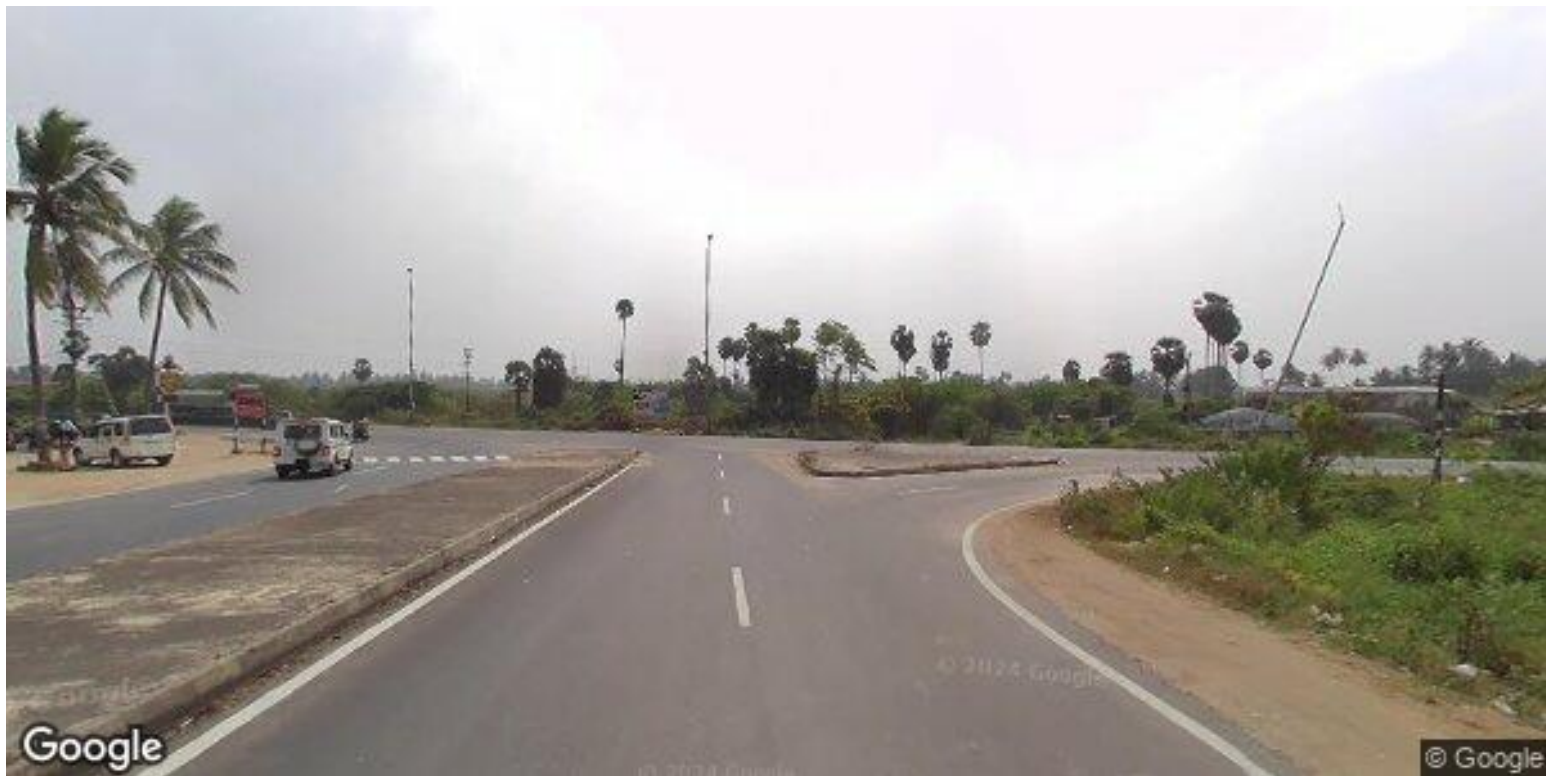
**Risk Type:** Turn

**Risk Level:** Medium

**Speed Limit:** 30 KM/Hr

**Coordinates:** 11.45571, 77.81702

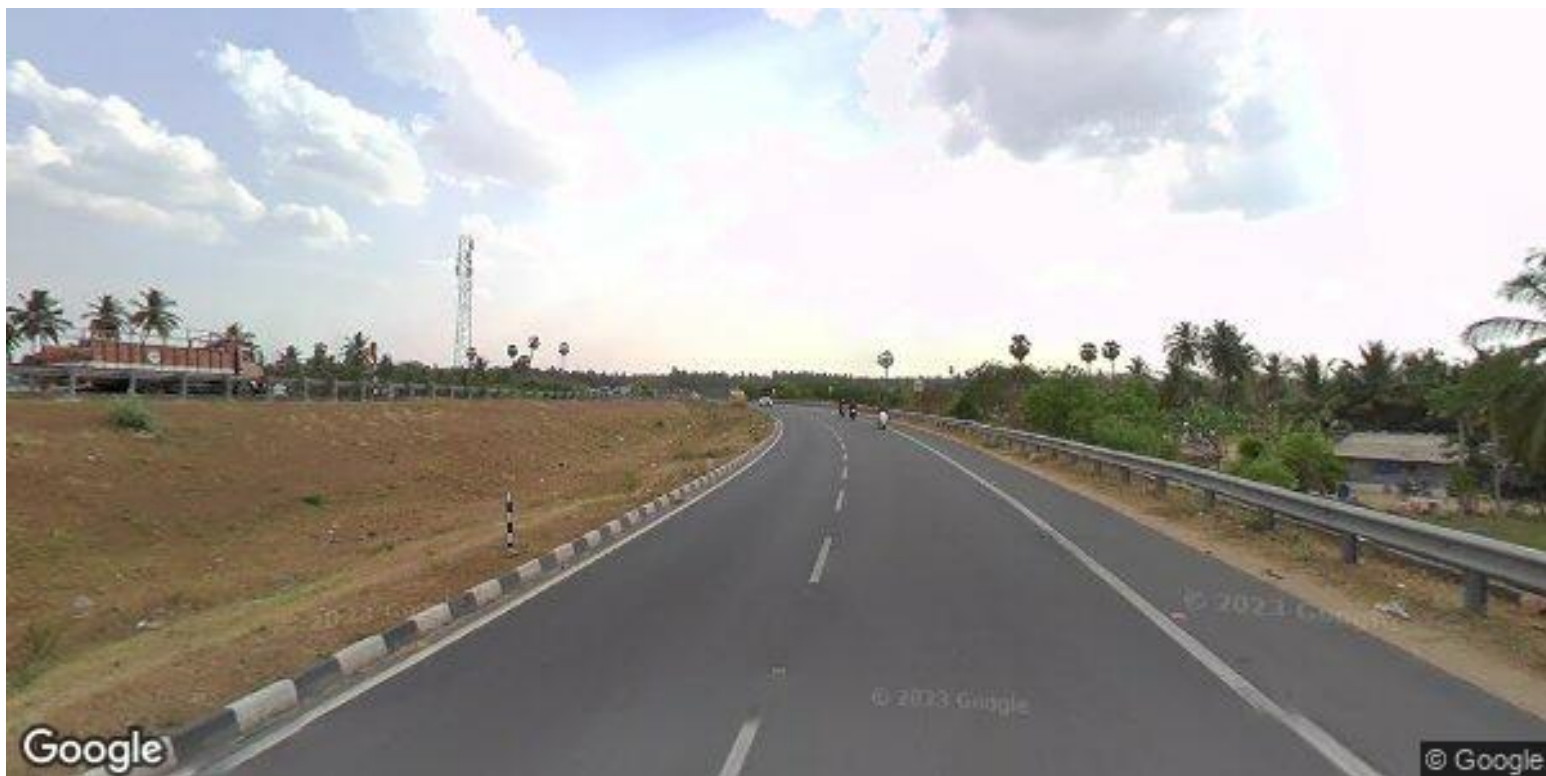
**Risk Type:** Turn

**Risk Level:** Medium

**Speed Limit:** 30 KM/Hr

**Coordinates:** 11.53552, 77.95763

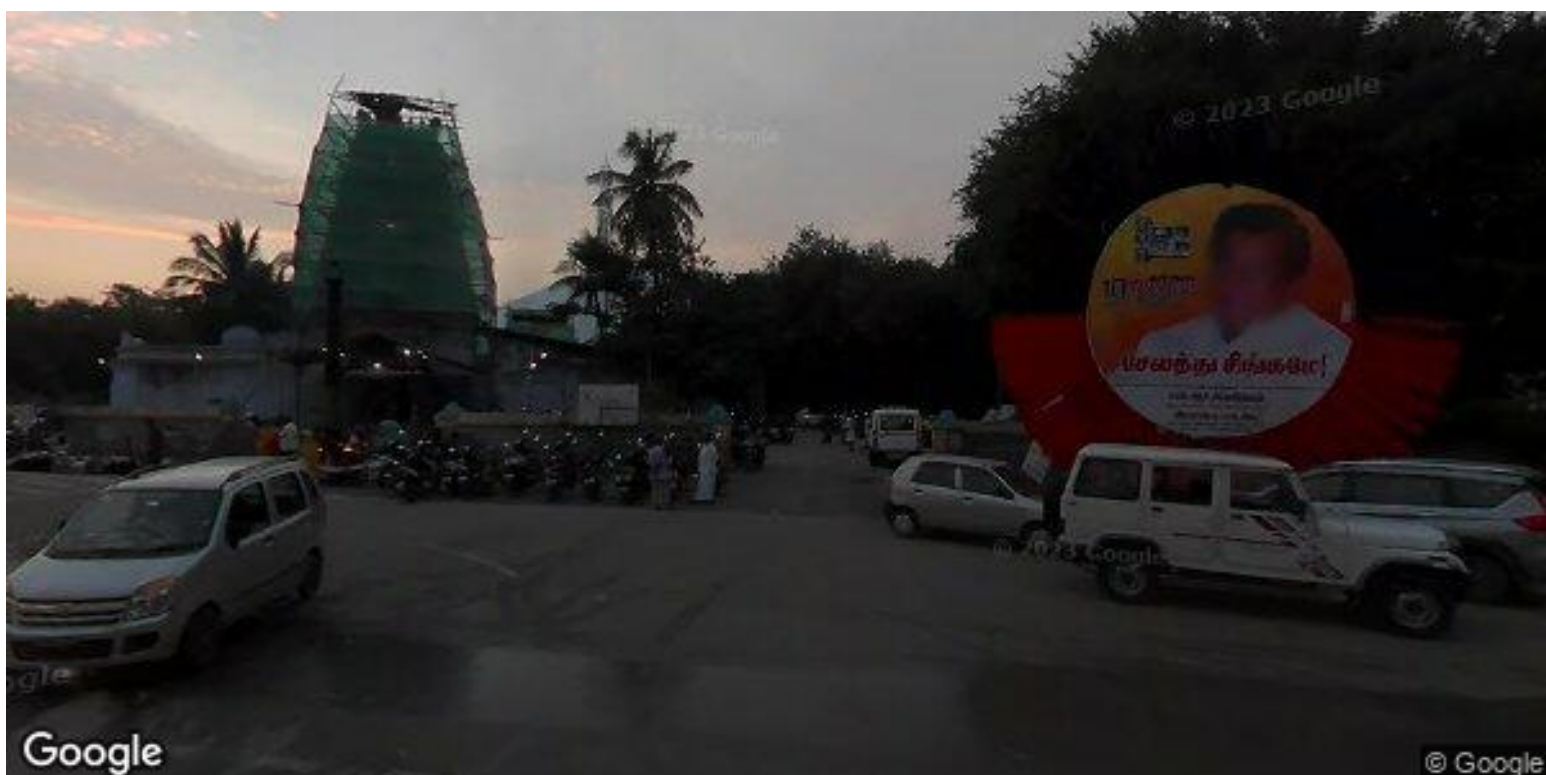
**Risk Type:** Turn  
**Risk Level:** High  
**Speed Limit:** 15 KM/Hr  
**Coordinates:** 11.61233, 78.10397

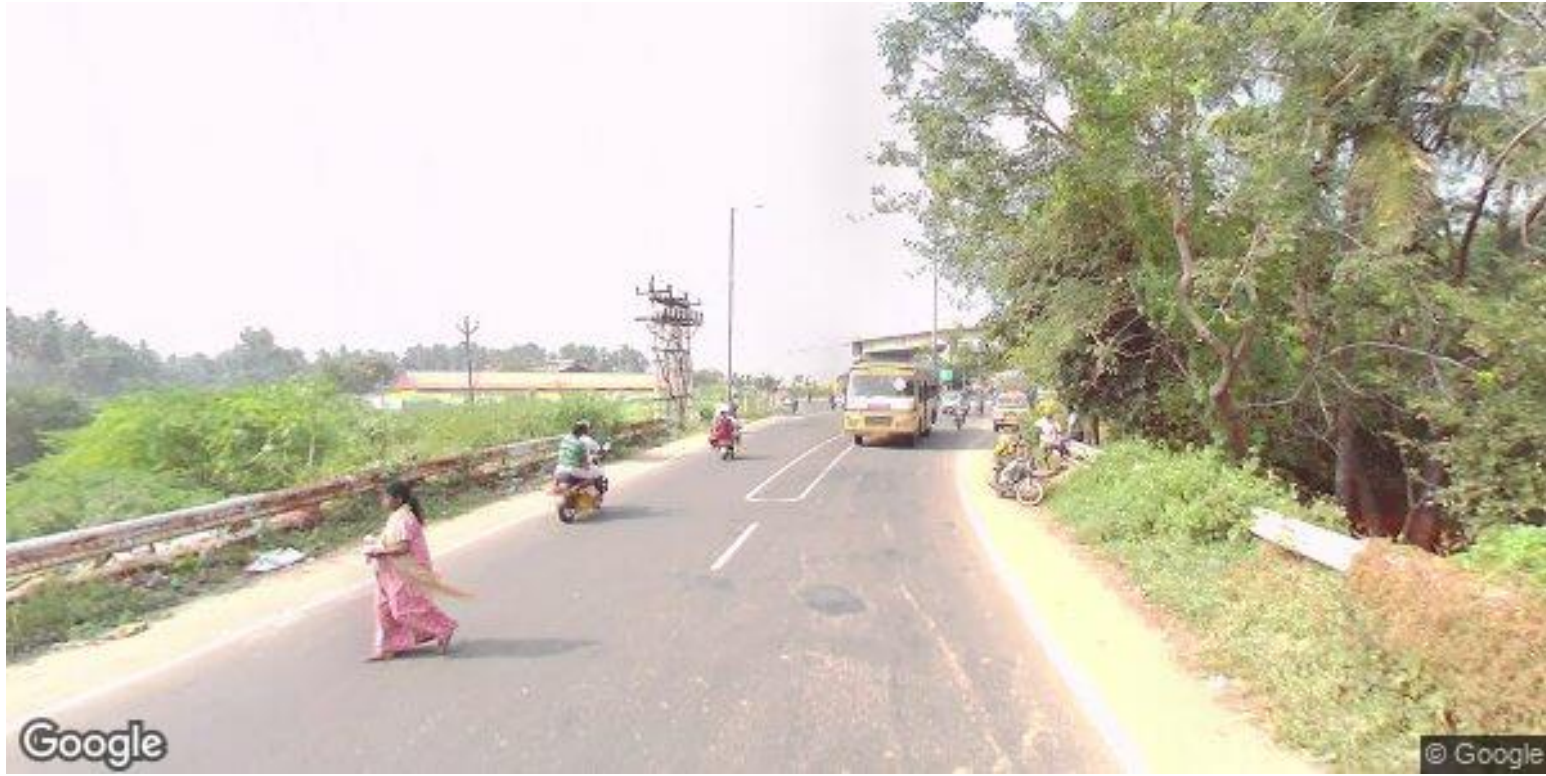
**Risk Type:** Turn  
**Risk Level:** Medium  
**Speed Limit:** 30 KM/Hr  
**Coordinates:** 11.61235, 78.10495

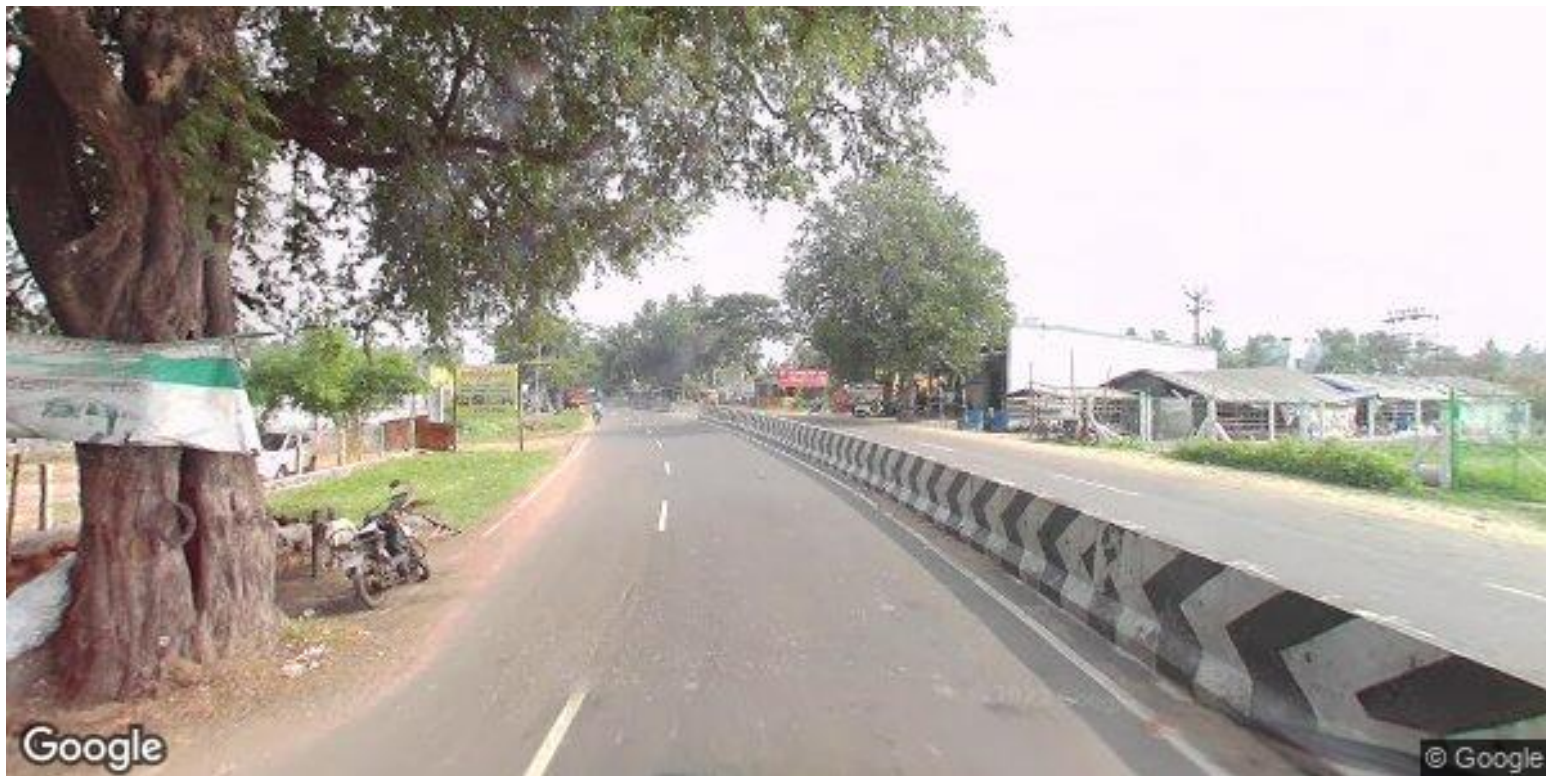
**Risk Type:** Turn  
**Risk Level:** Medium  
**Speed Limit:** 30 KM/Hr  
**Coordinates:** 11.61422, 78.10810

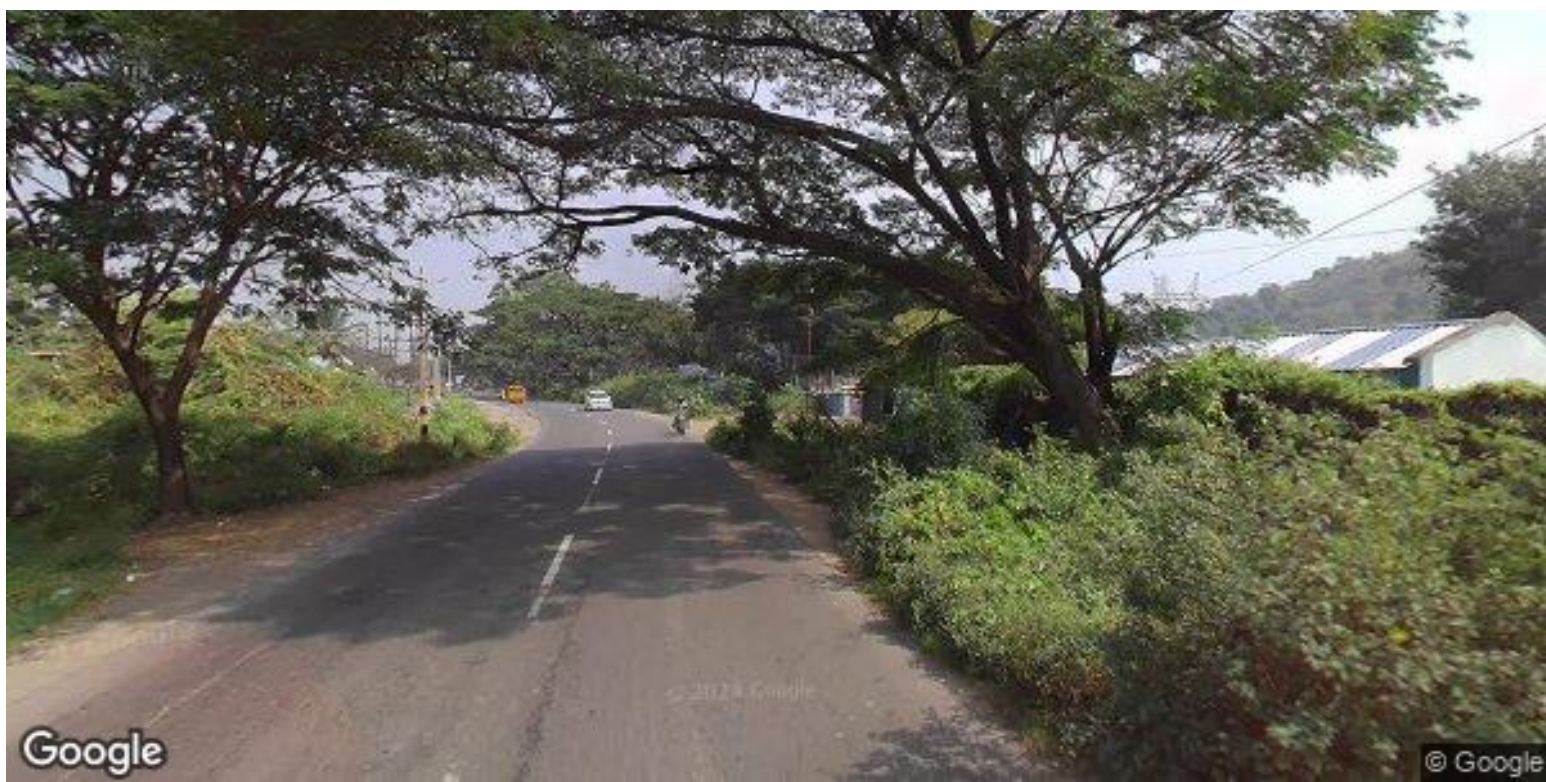
**Risk Type:** Turn

**Risk Level:** Medium

**Speed Limit:** 30 KM/Hr

**Coordinates:** 11.65825, 78.20469

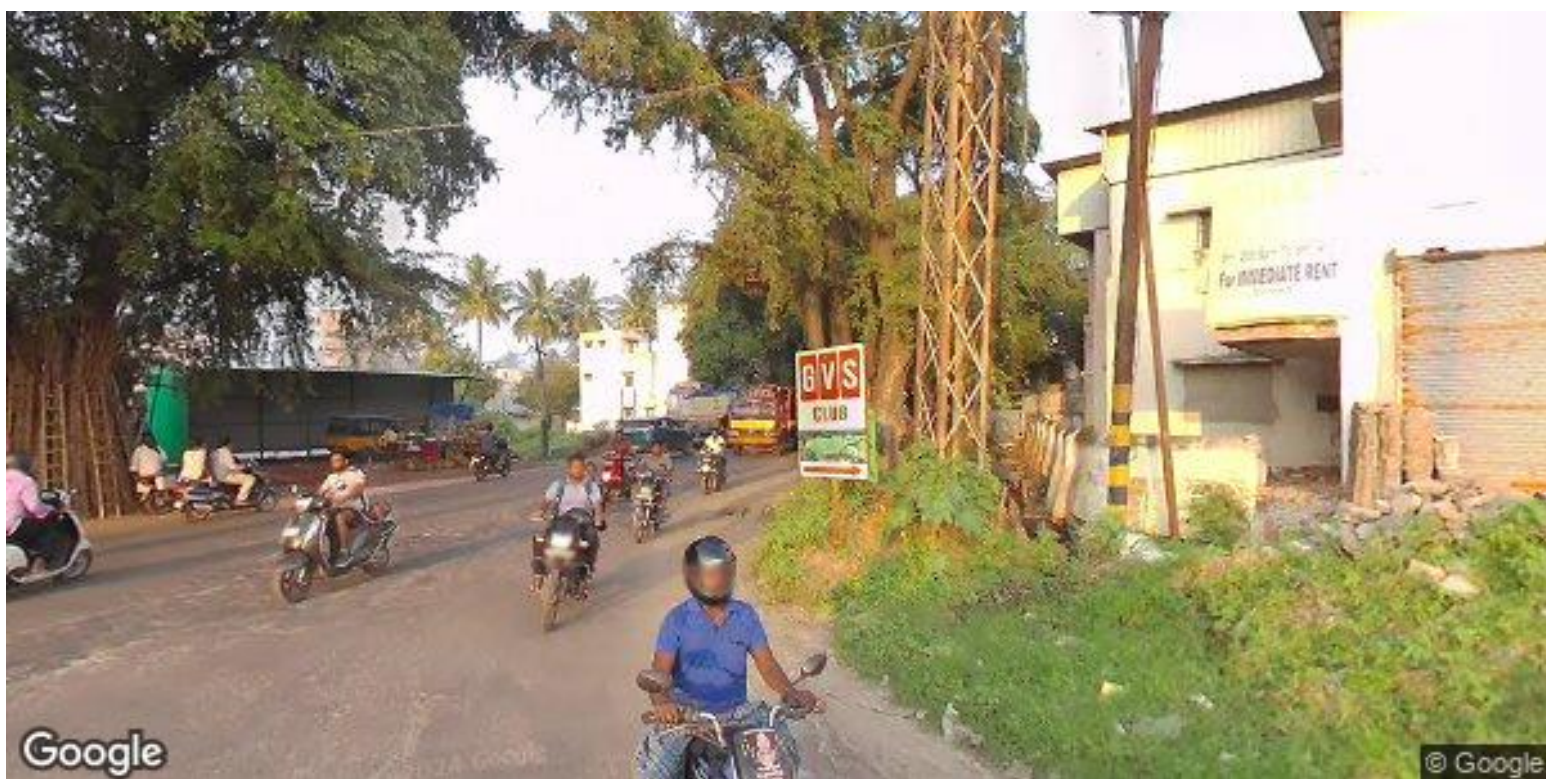
**Risk Type:** Turn

**Risk Level:** High

**Speed Limit:** 15 KM/Hr

**Coordinates:** 11.66366, 78.20649

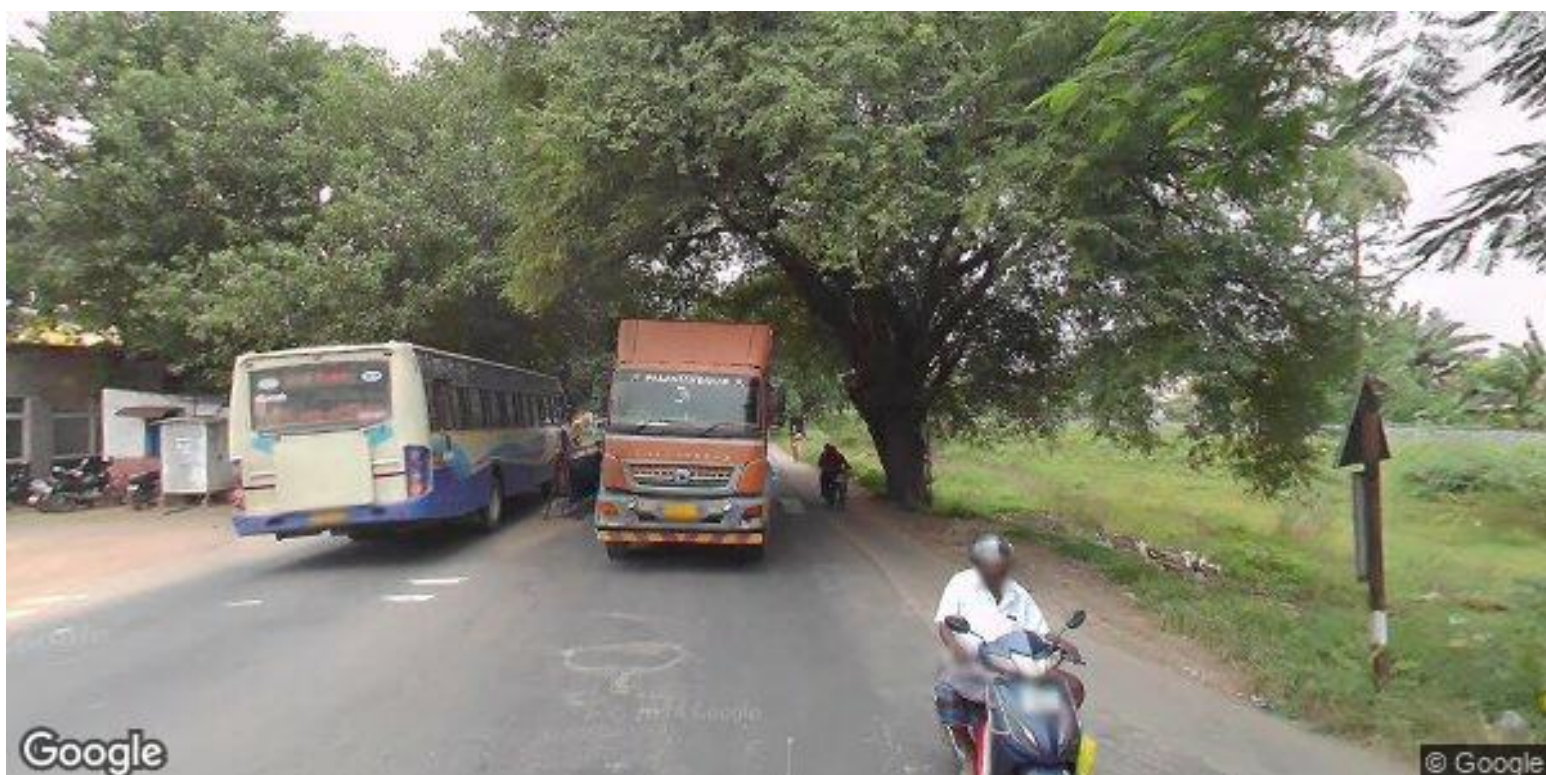
**Risk Type:** Turn  
**Risk Level:** Medium  
**Speed Limit:** 30 KM/Hr  
**Coordinates:** 11.67116, 78.23102

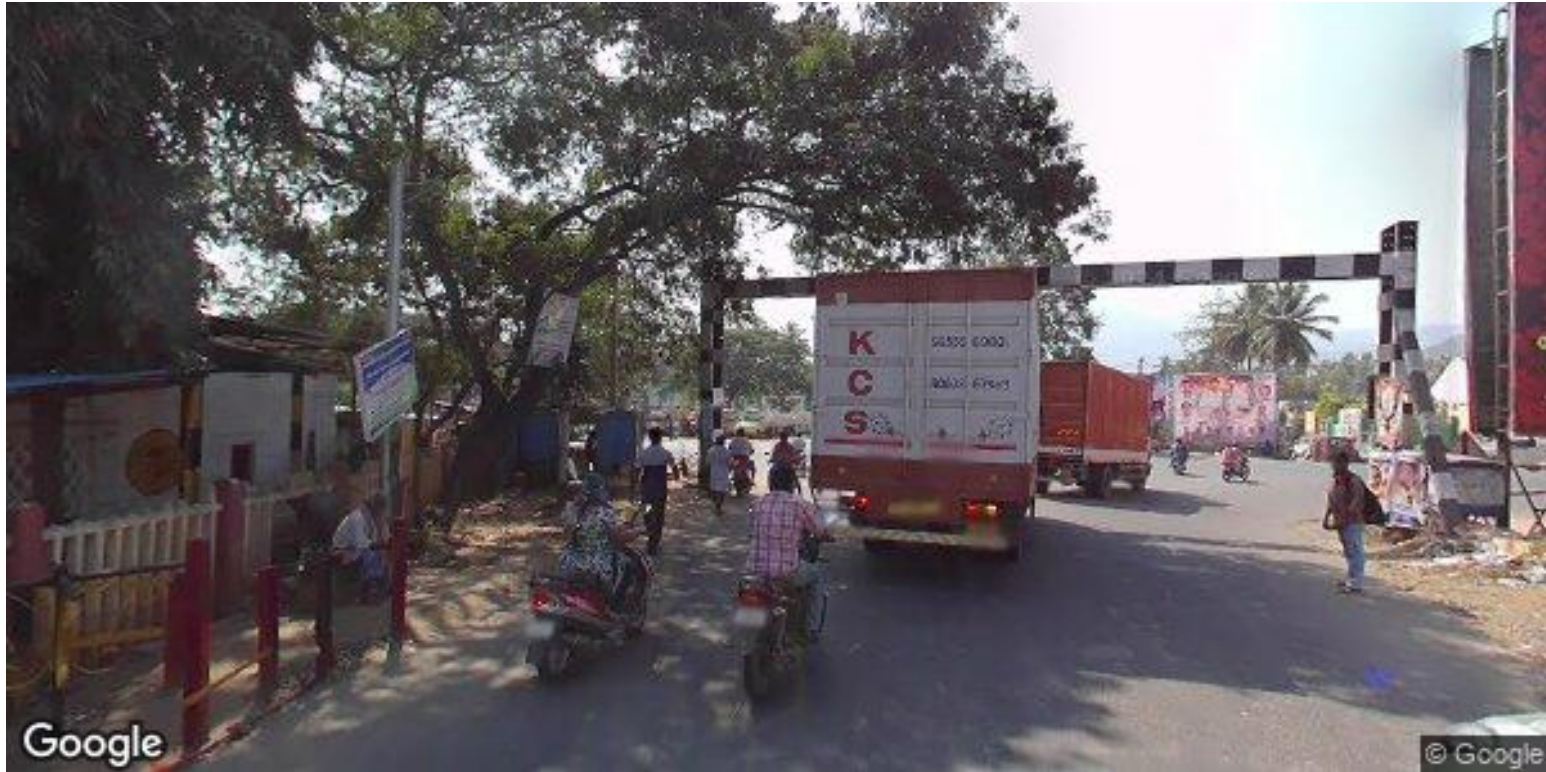
**Risk Type:** Turn  
**Risk Level:** High  
**Speed Limit:** 15 KM/Hr  
**Coordinates:** 11.67145, 78.23141

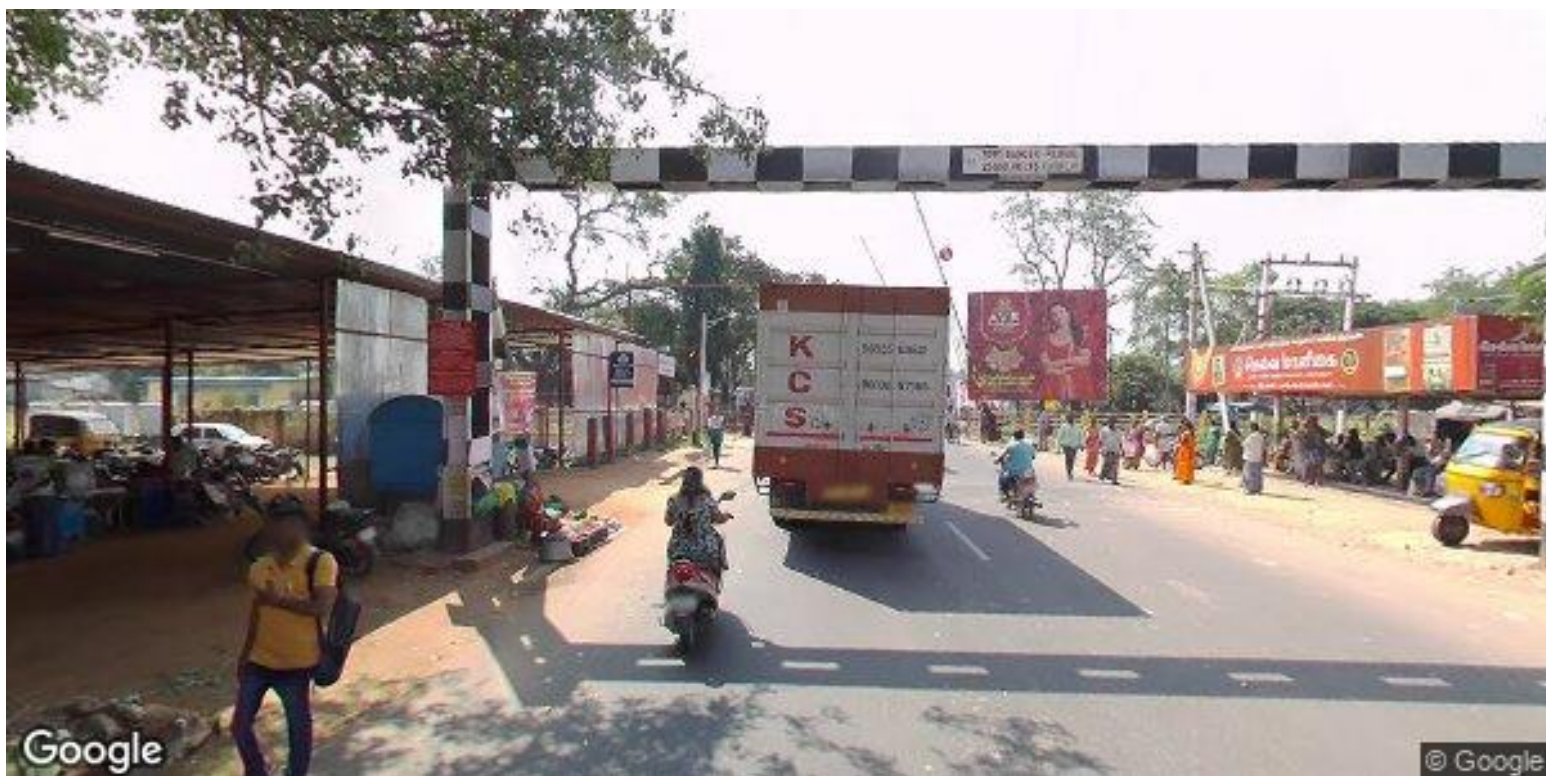
**Risk Type:** Turn  
**Risk Level:** High  
**Speed Limit:** 15 KM/Hr  
**Coordinates:** 11.67182, 78.23141

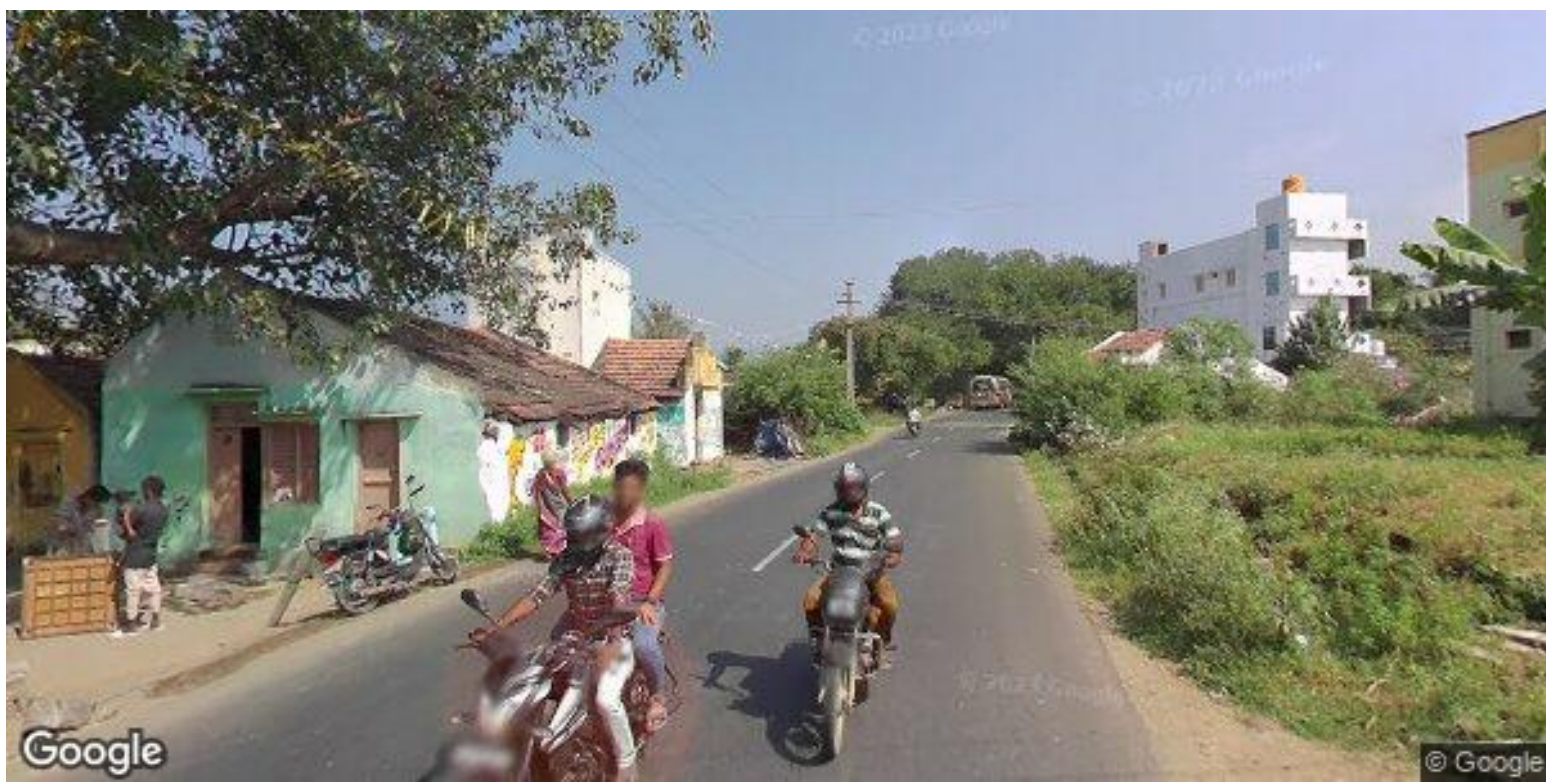
**Risk Type:** Turn

**Risk Level:** Medium

**Speed Limit:** 30 KM/Hr

**Coordinates:** 11.68017, 78.24250

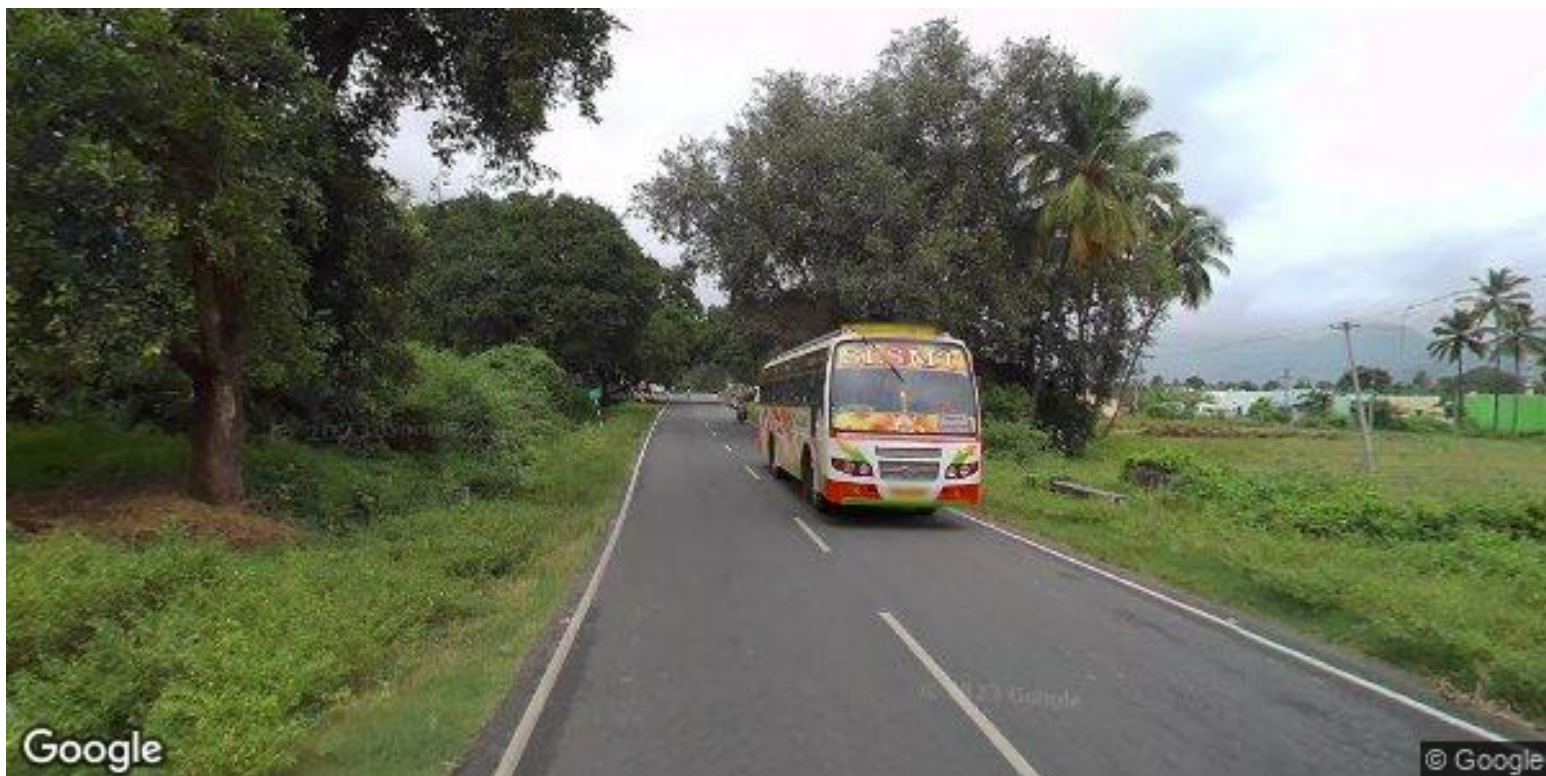
**Risk Type:** Turn

**Risk Level:** Medium

**Speed Limit:** 30 KM/Hr

**Coordinates:** 11.83514, 78.35305

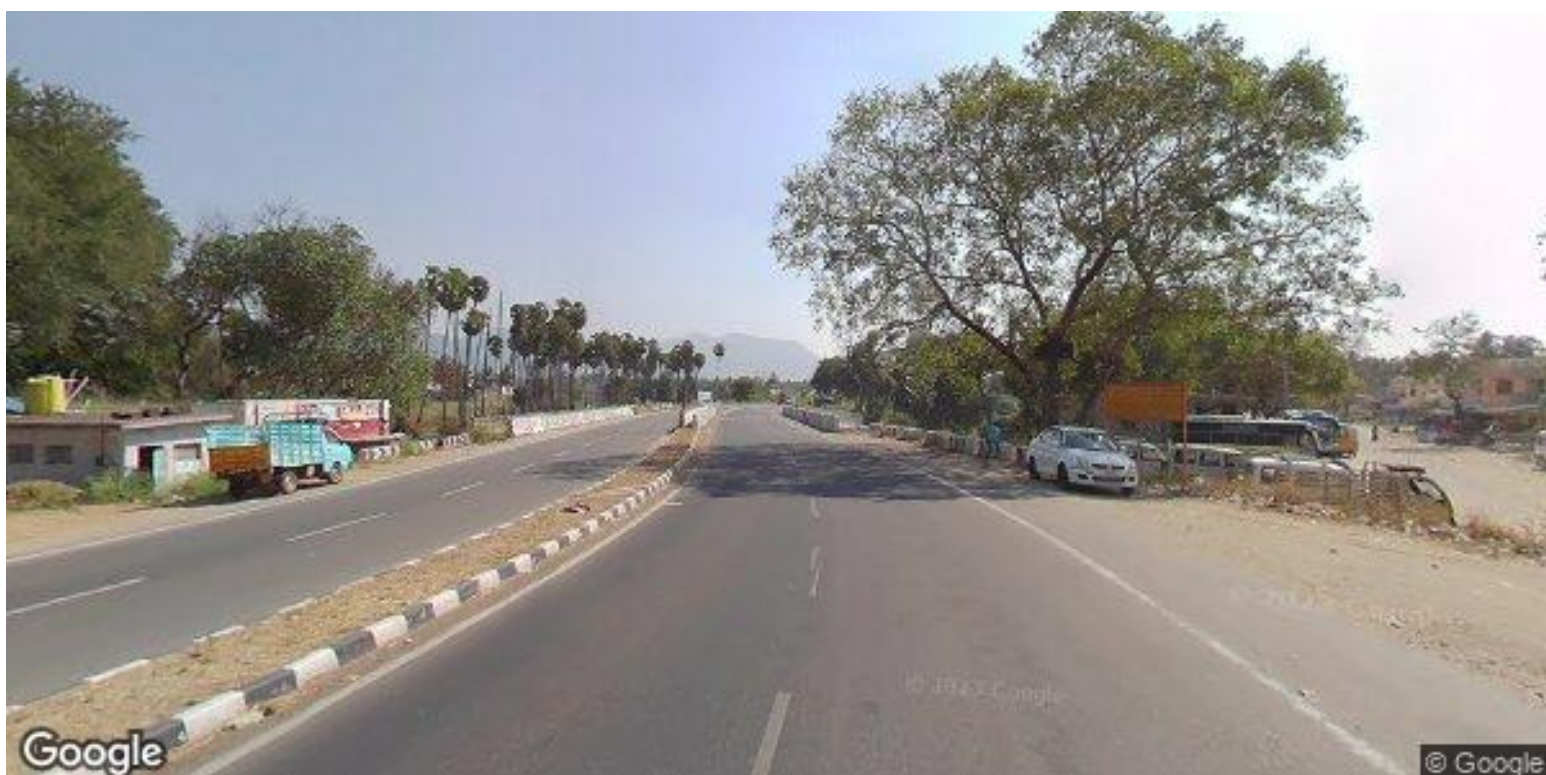
**Risk Type:** Turn  
**Risk Level:** Medium  
**Speed Limit:** 30 KM/Hr  
**Coordinates:** 11.99554, 78.44553

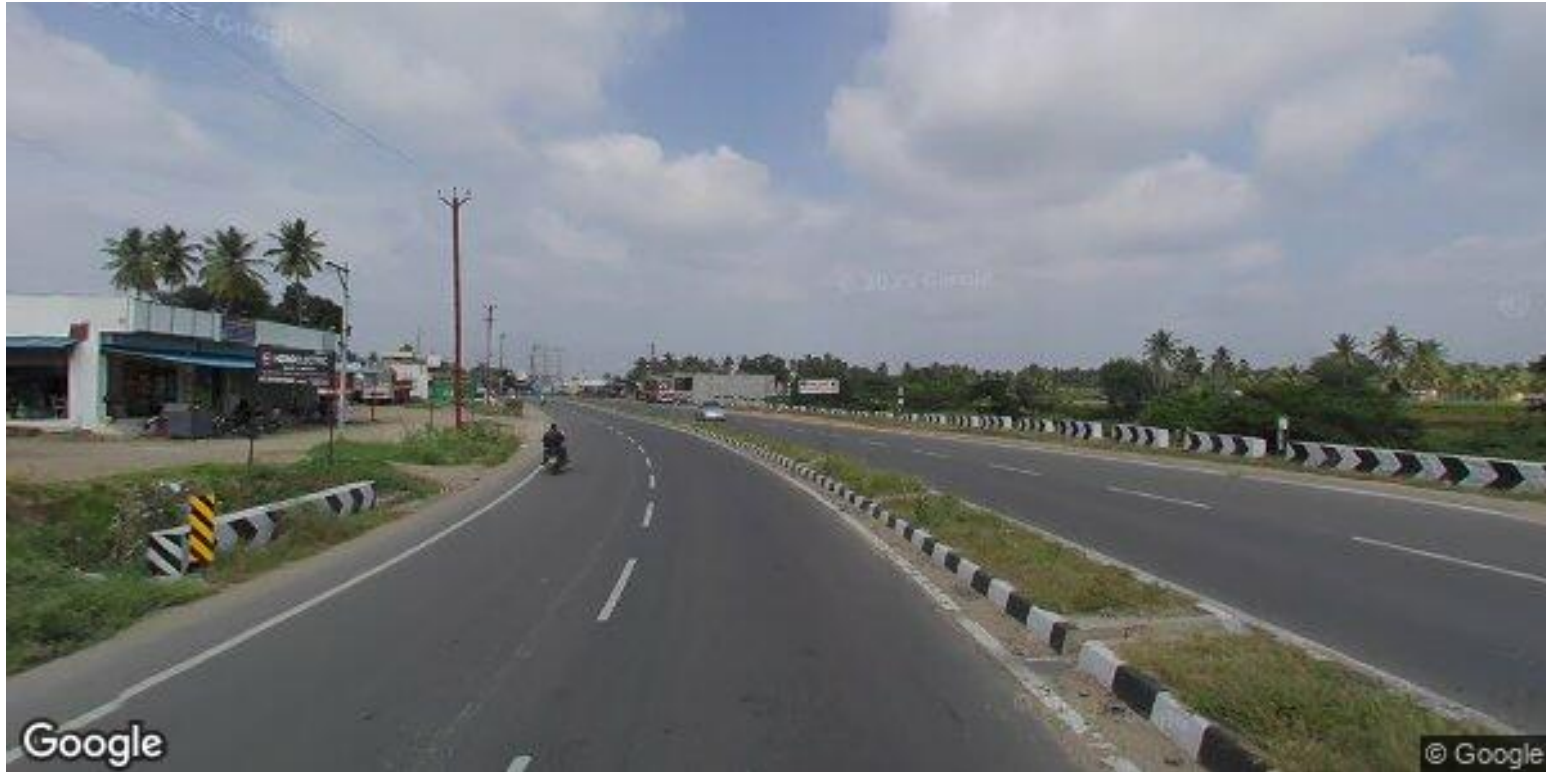
**Risk Type:** Turn  
**Risk Level:** Medium  
**Speed Limit:** 30 KM/Hr  
**Coordinates:** 12.04286, 78.48352

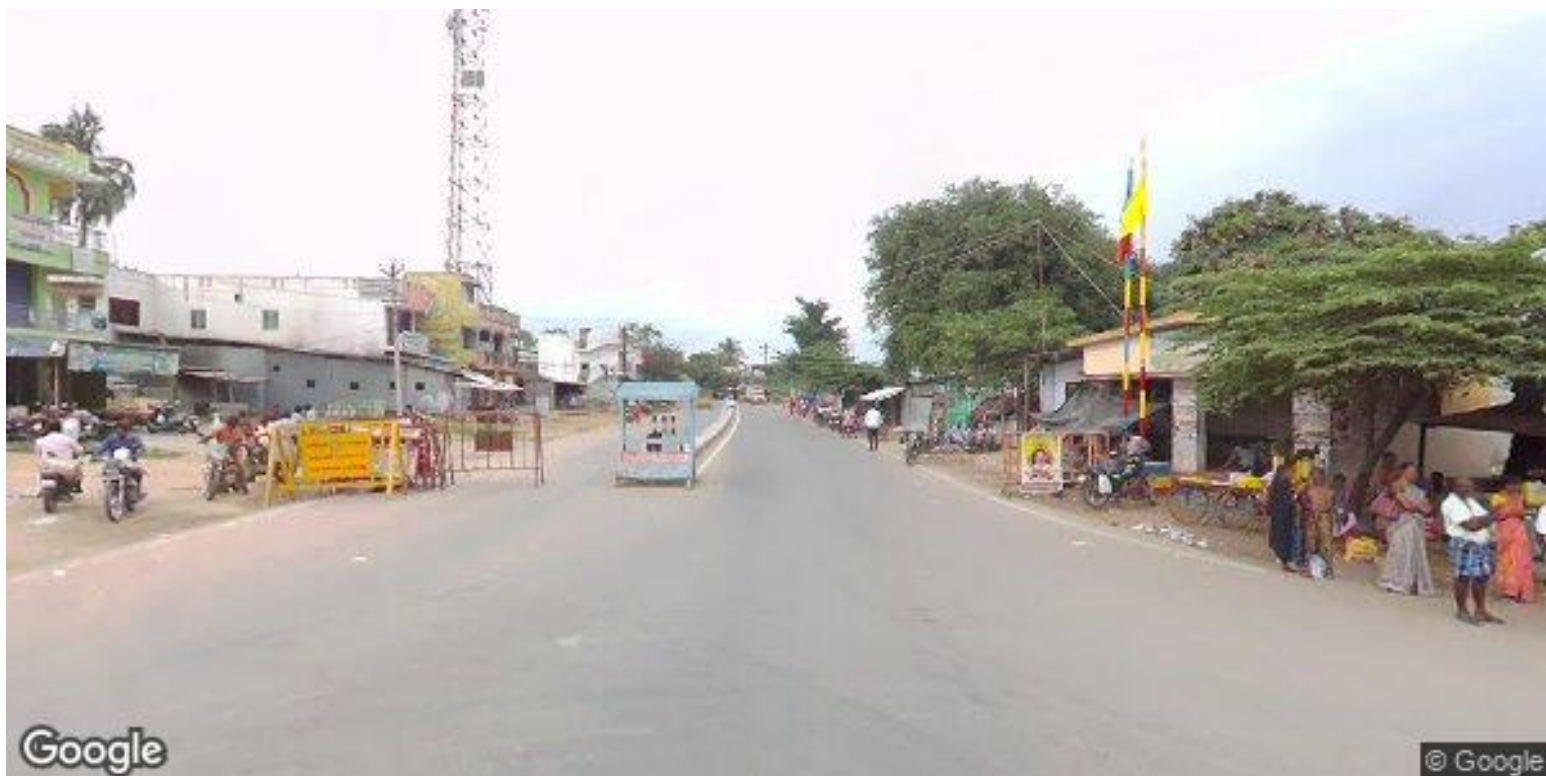
**Risk Type:** Blind Spot  
**Risk Level:** Blind Spot  
**Speed Limit:** 10 KM/Hr  
**Coordinates:** 12.04669, 78.48390
