# IndianOil

## JOURNEY RISK MANAGEMENT (JRM) STUDY

### Salem Terminal to BALA MURUGAN AGENCY

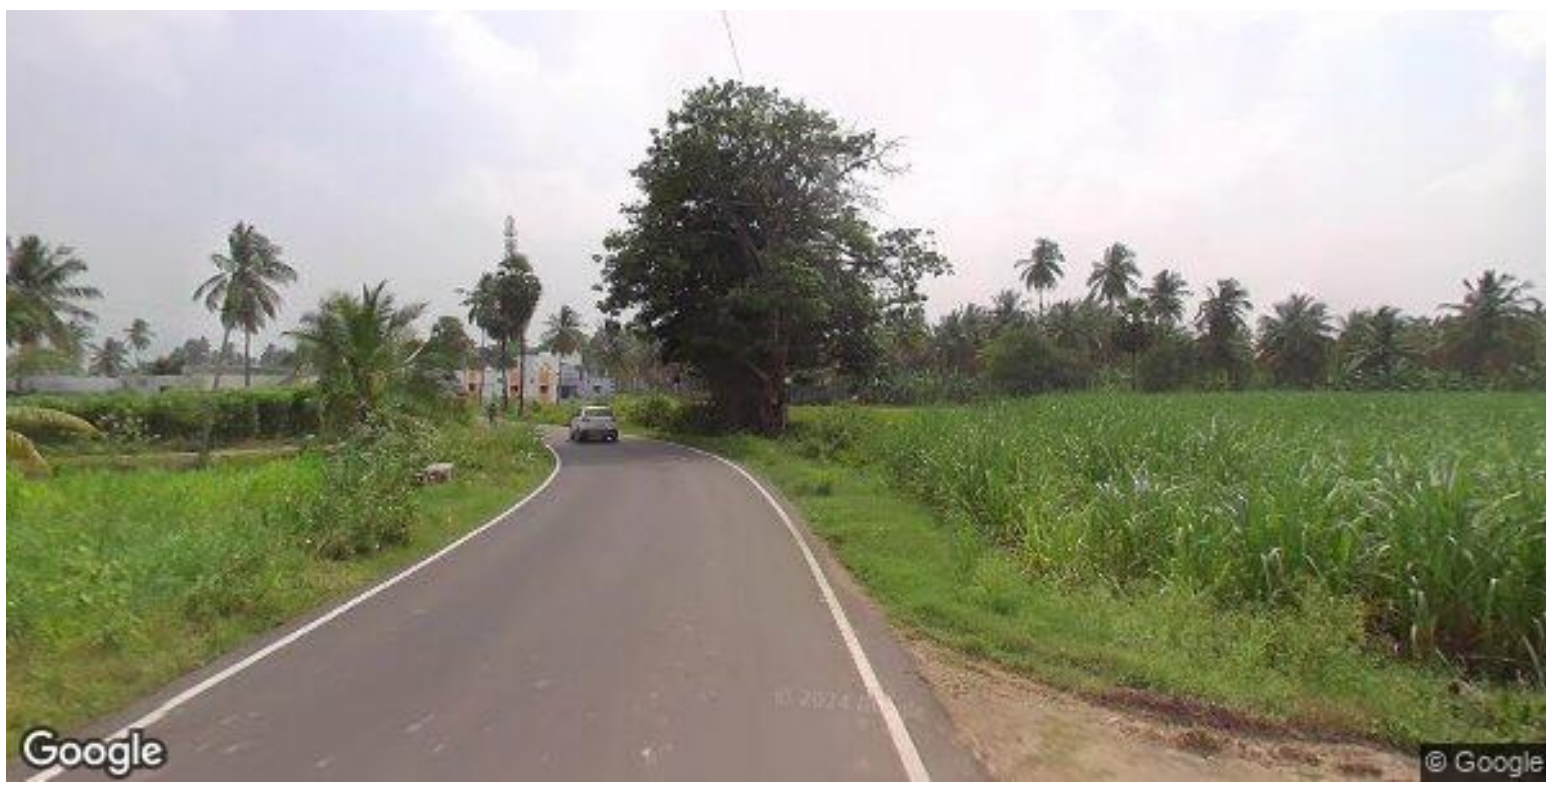
**Risk Type:** Turn

**Risk Level:** Medium

**Speed Limit:** 30 KM/Hr

**Coordinates:** 12.01810, 78.52365

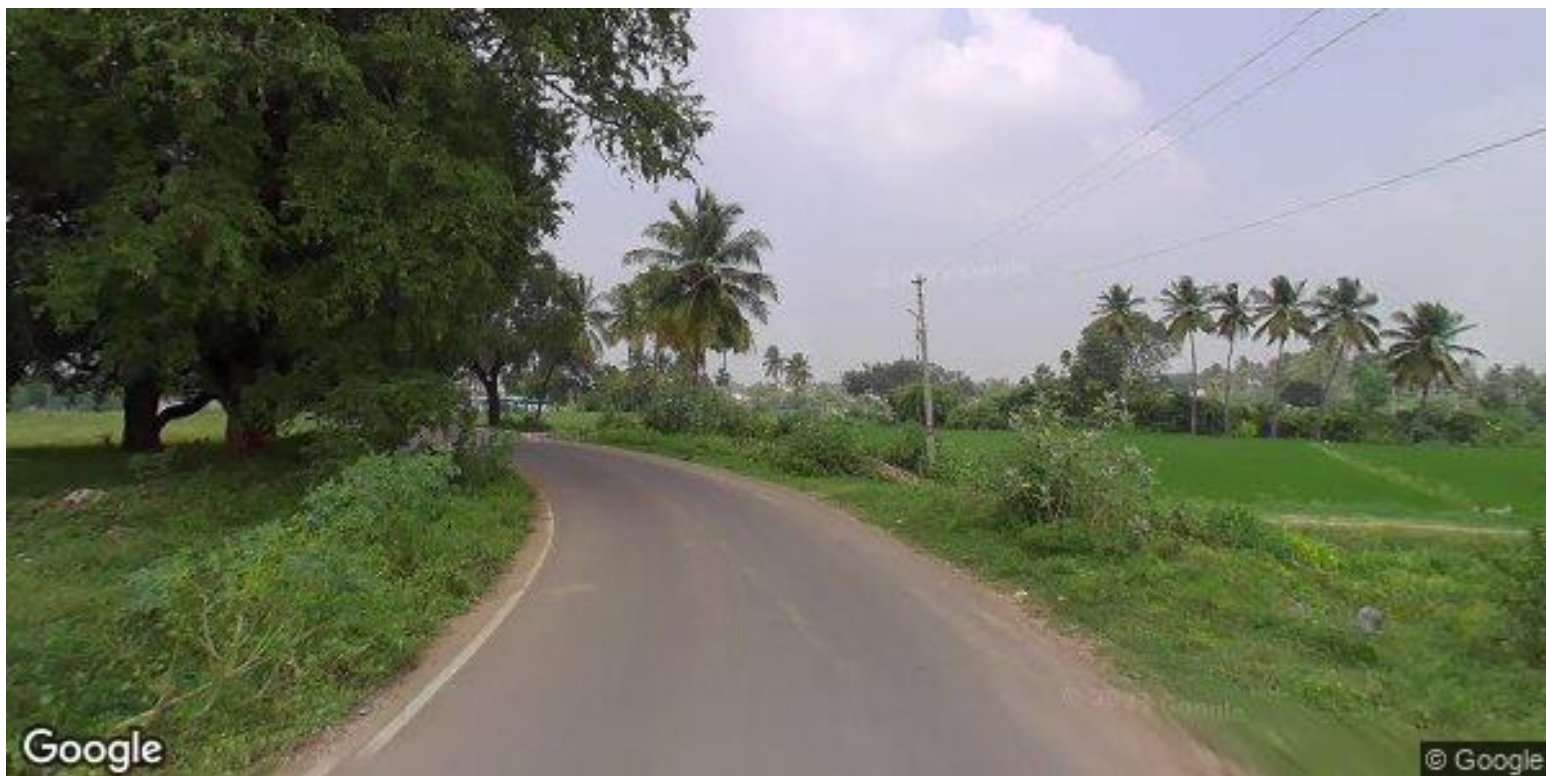
**Risk Type:** Turn

**Risk Level:** High

**Speed Limit:** 15 KM/Hr

**Coordinates:** 12.01502, 78.52619

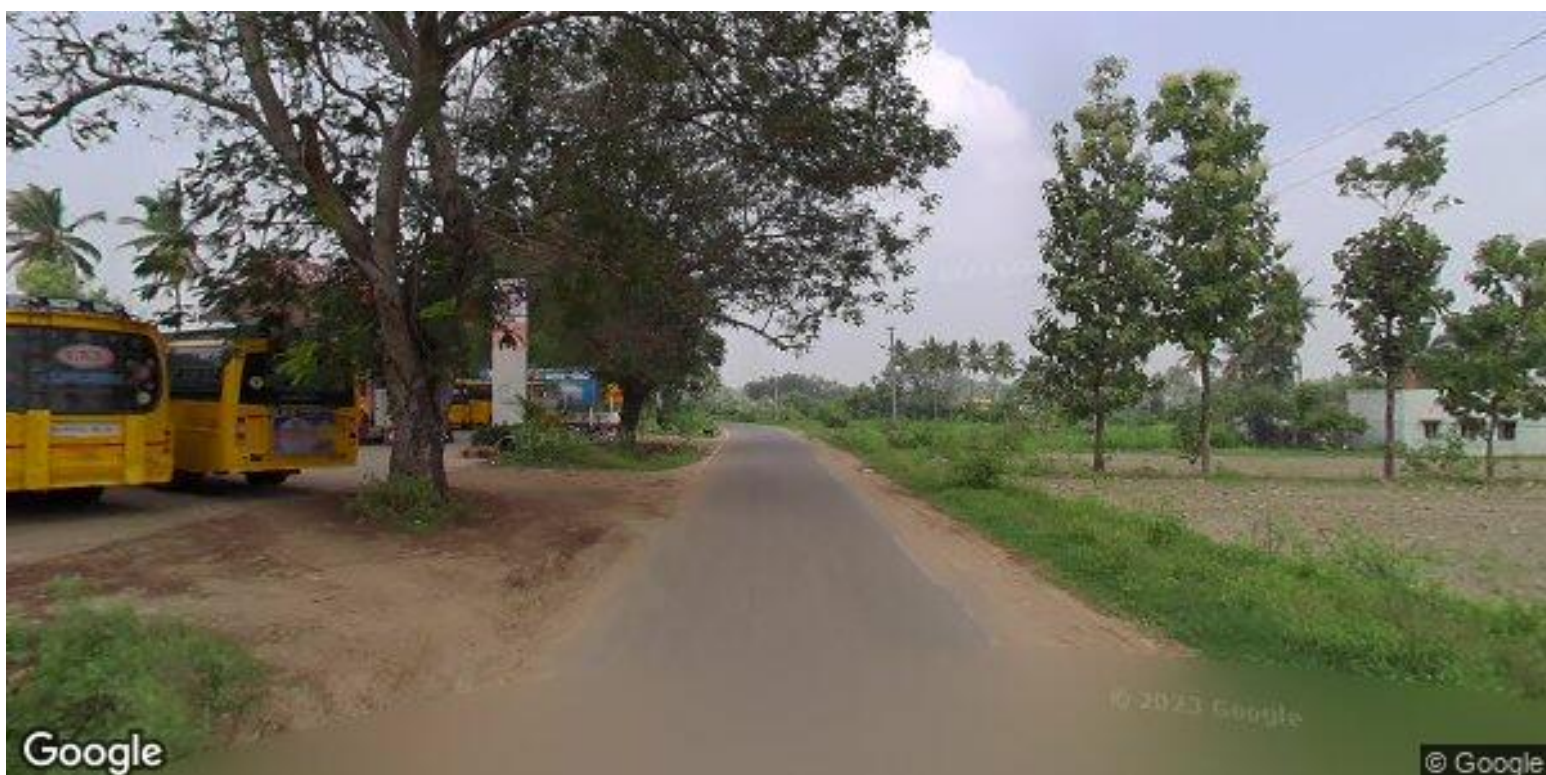
**Risk Type:** Blind Spot

**Risk Level:** Blind Spot

**Speed Limit:** 10 KM/Hr

**Coordinates:** 12.01449, 78.52612
