# IndianOil

## JOURNEY RISK MANAGEMENT (JRM) STUDY

### Salem Terminal TO NAVEEN AGENCY

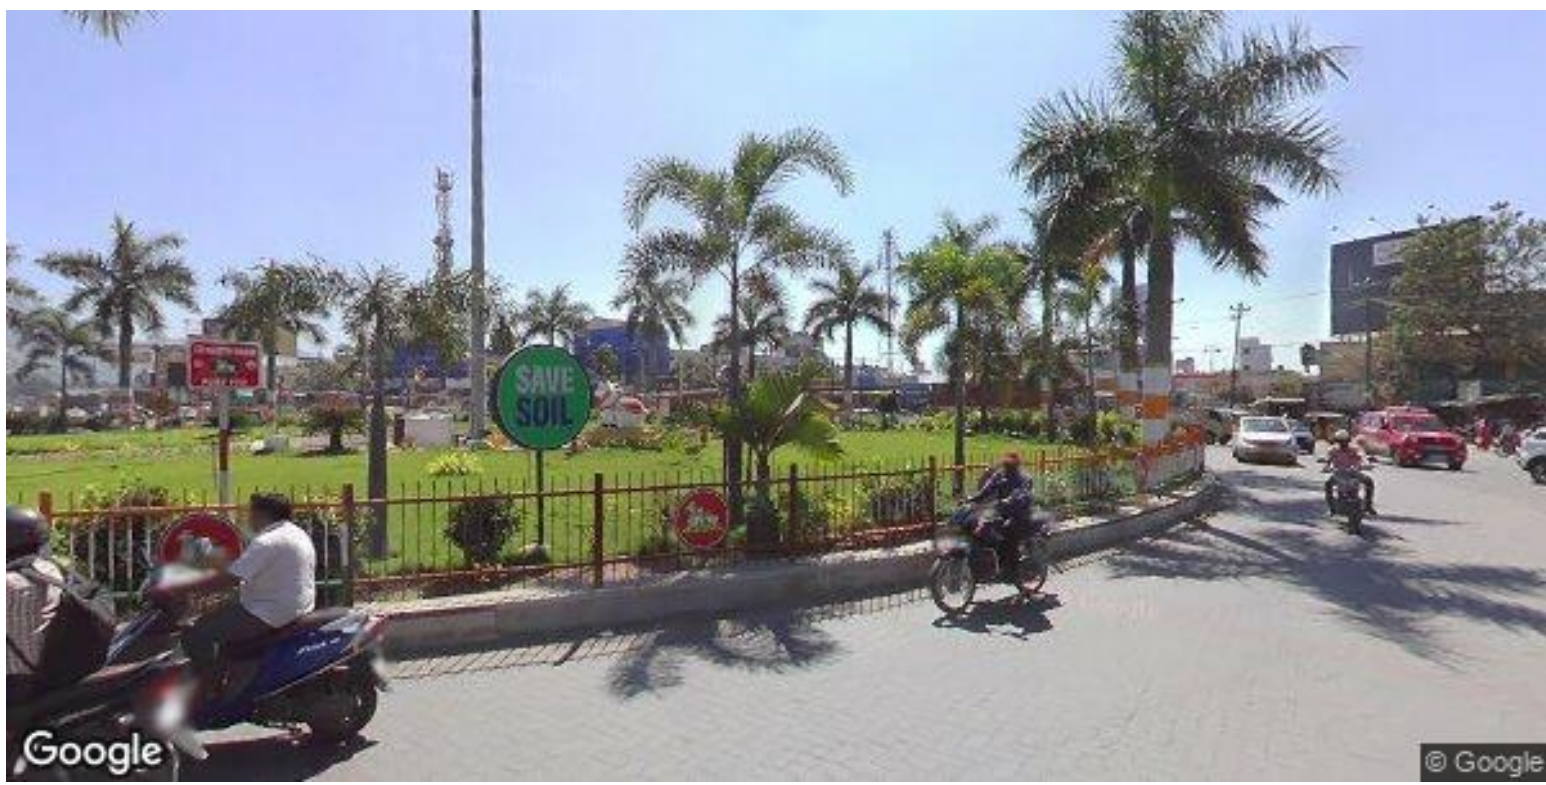
**Coordinates:** 11.63303, 78.12713

**Risk Type:** Roundabout

**Risk Level:** High

**Speed Limit:** 15 KM/Hr

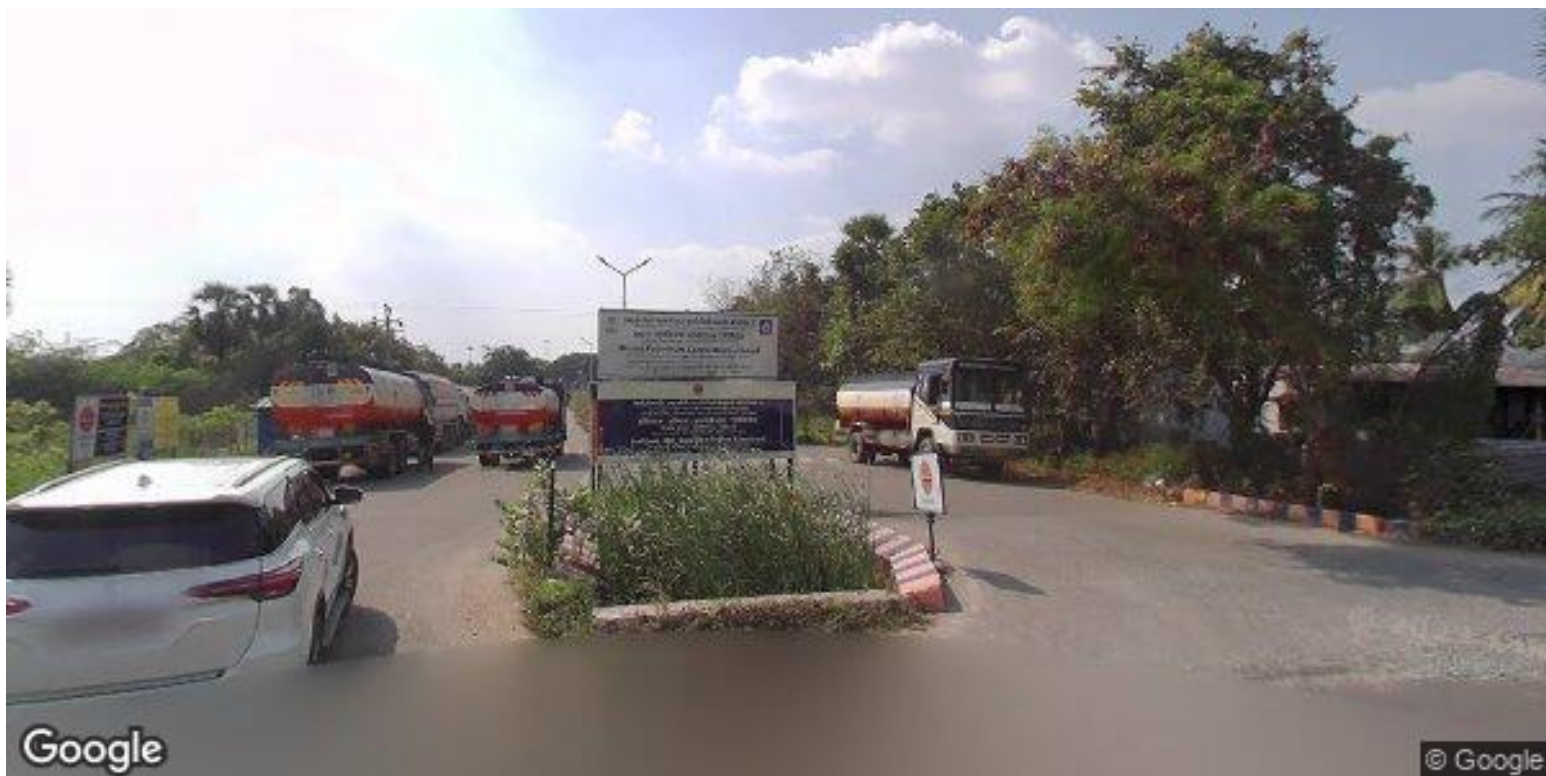
**Coordinates:** 11.44024, 77.87528

**Risk Type:** Turn

**Risk Level:** High

**Speed Limit:** 15 KM/Hr

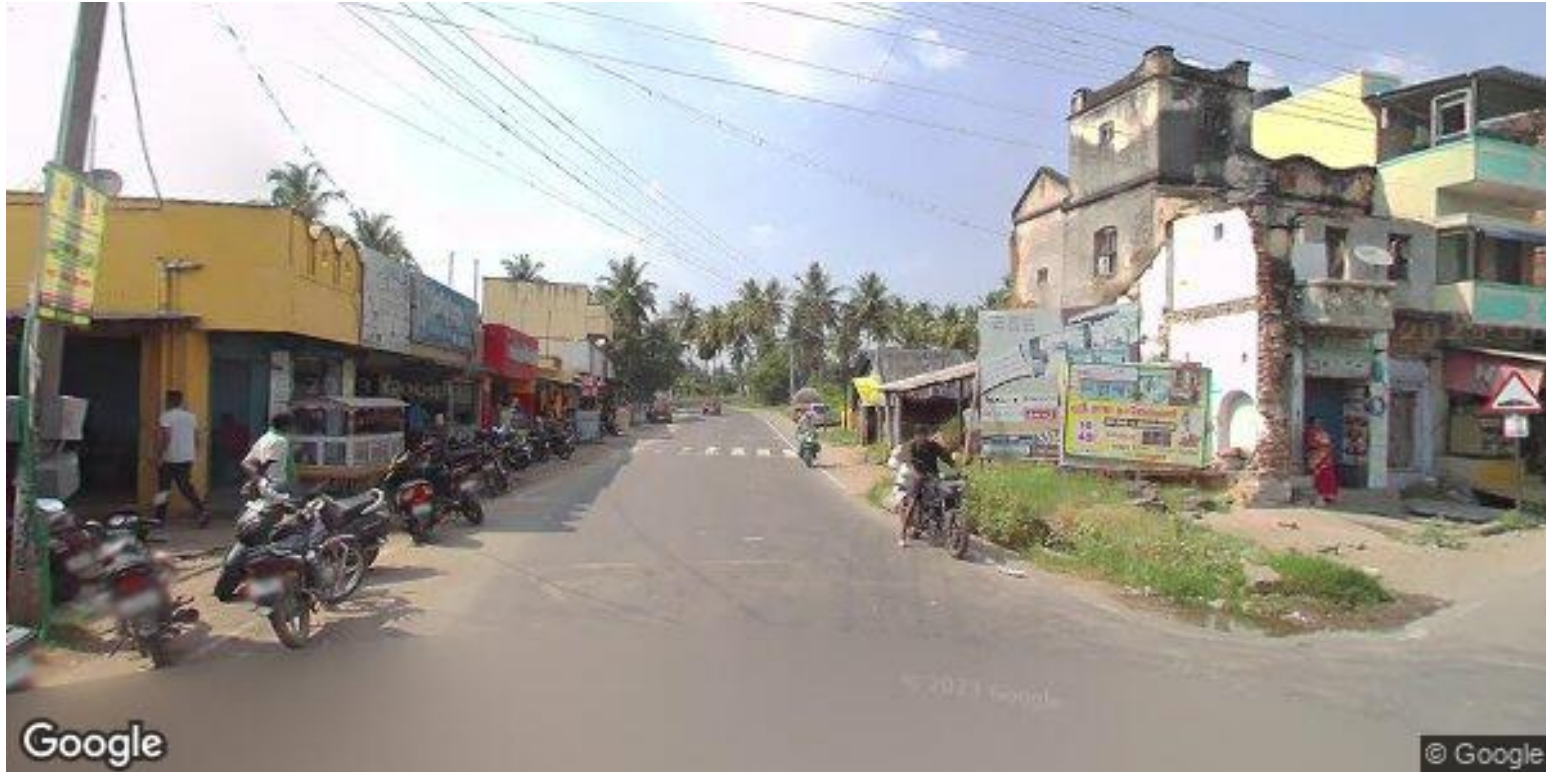
**Risk Type:** Turn  
**Risk Level:** High  
**Speed Limit:** 15 KM/Hr  
**Coordinates:** 11.45007, 77.87201

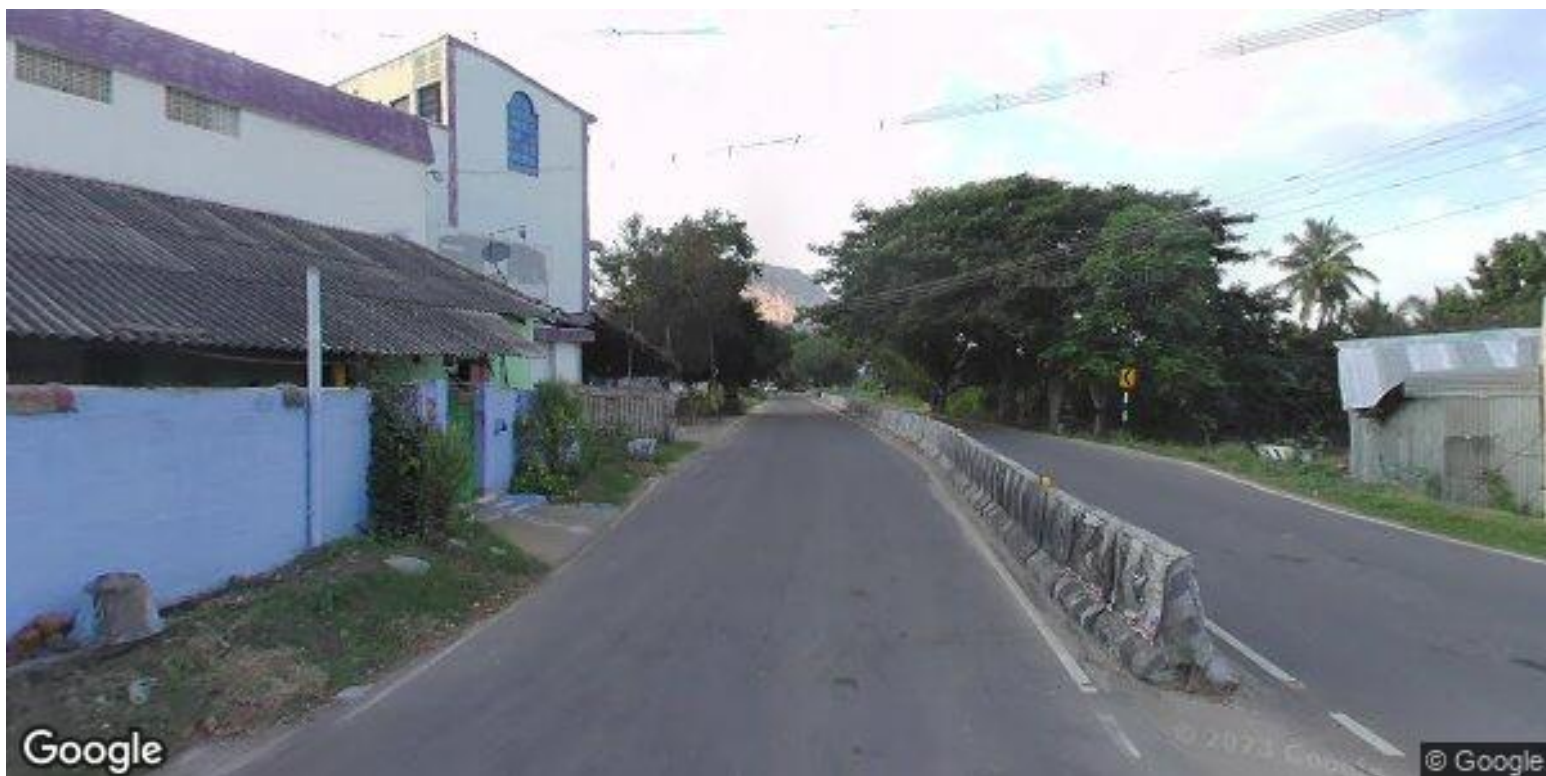
**Risk Type:** Turn  
**Risk Level:** Medium  
**Speed Limit:** 30 KM/Hr  
**Coordinates:** 11.46392, 77.87328

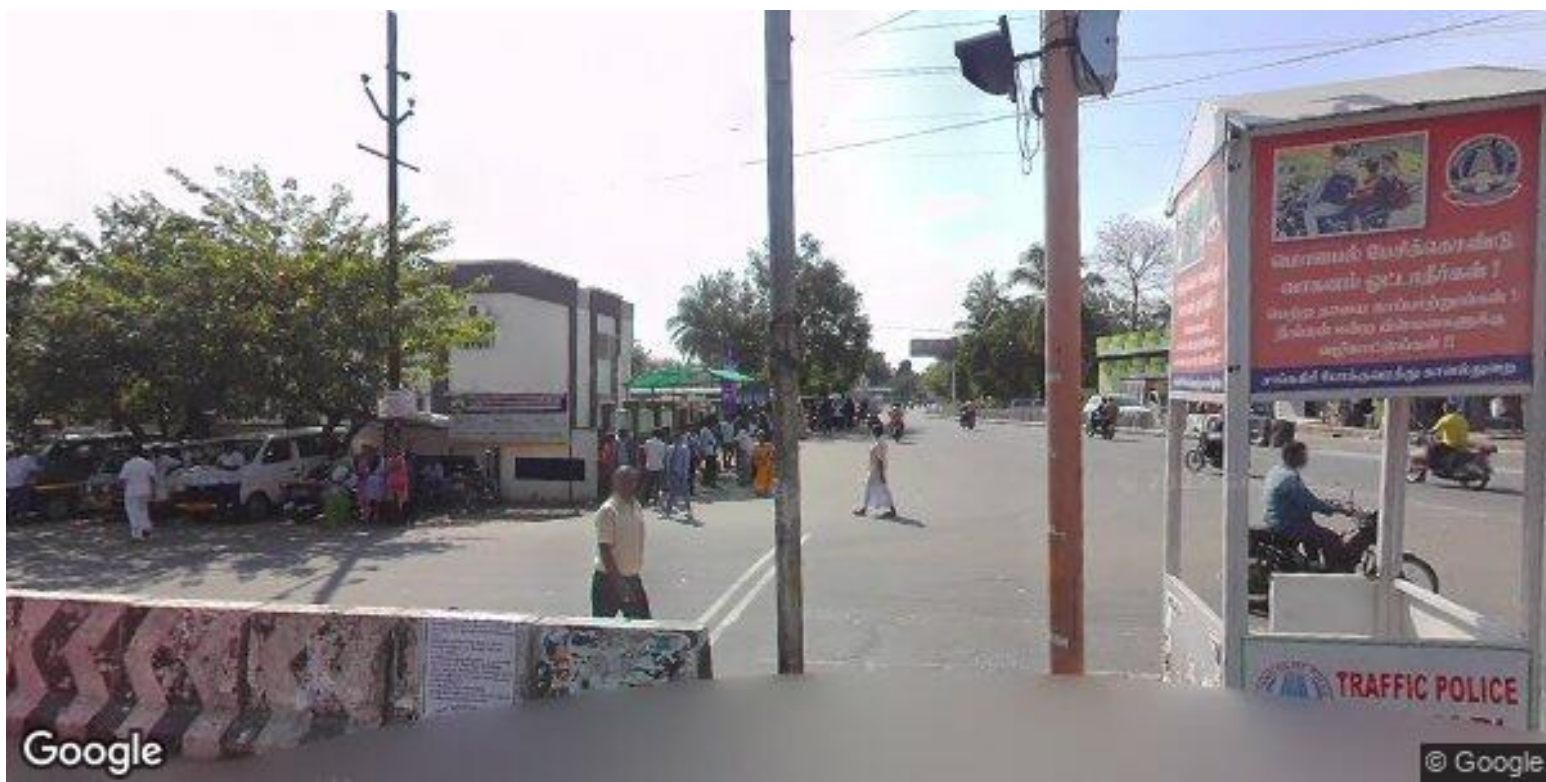
**Coordinates:** 11.47391, 77.86844

**Risk Type:** Turn

**Risk Level:** Medium

**Speed Limit:** 30 KM/Hr

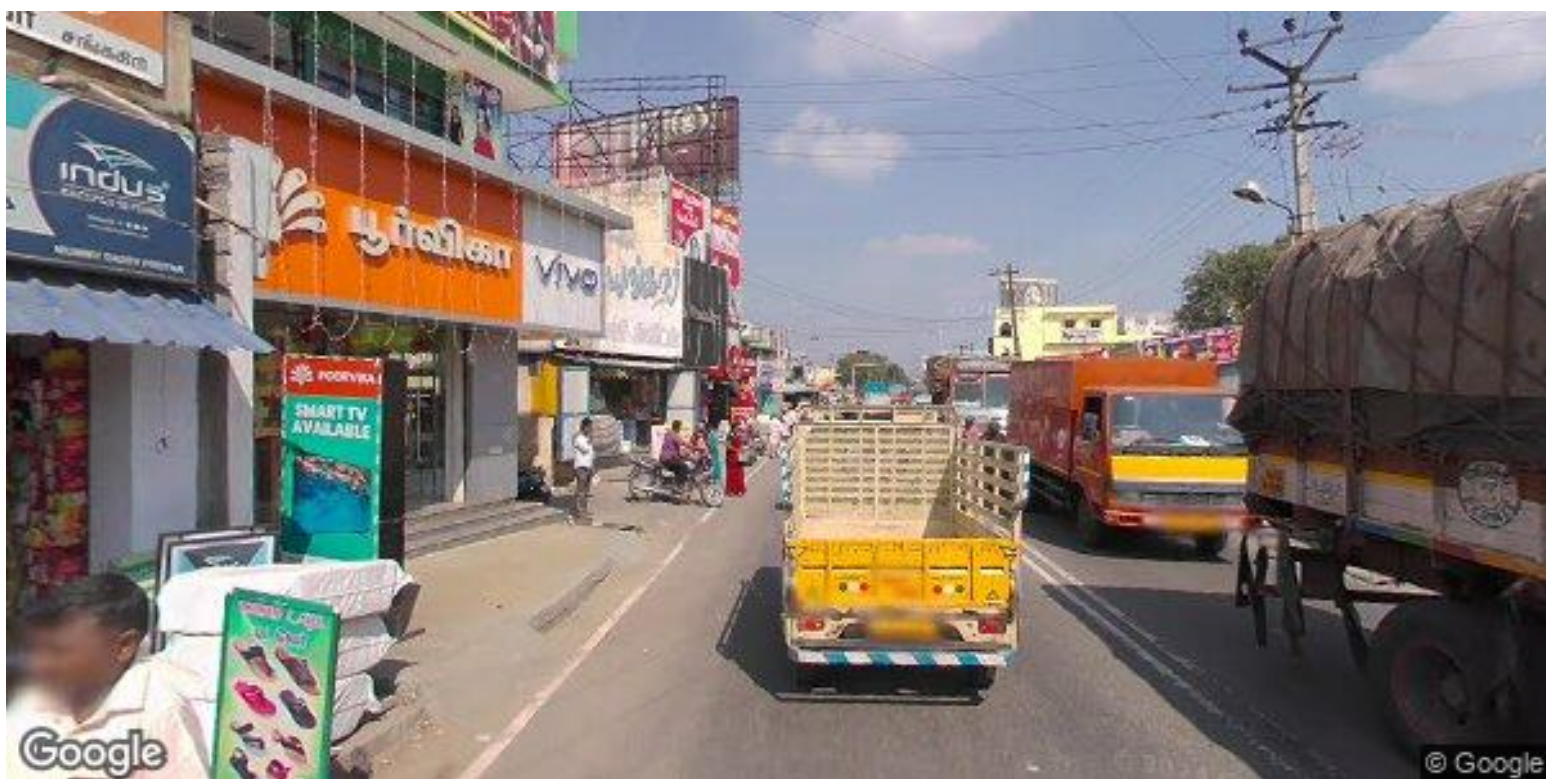
**Coordinates:** 11.47412, 77.86848

**Risk Type:** Turn

**Risk Level:** High

**Speed Limit:** 15 KM/Hr

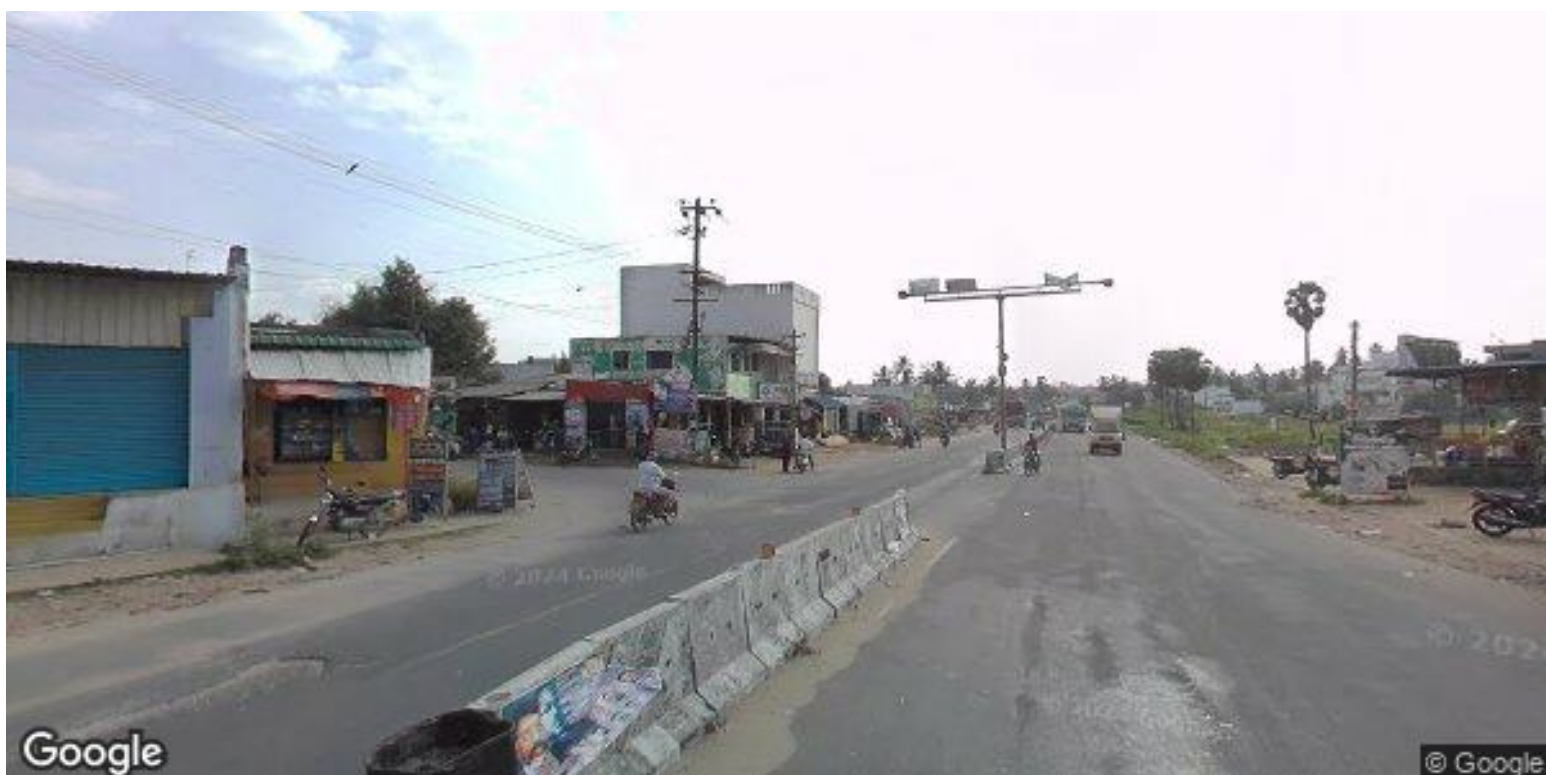
**Risk Type:** Turn  
**Risk Level:** Medium  
**Speed Limit:** 30 KM/Hr  
**Coordinates:** 11.48361, 77.88779

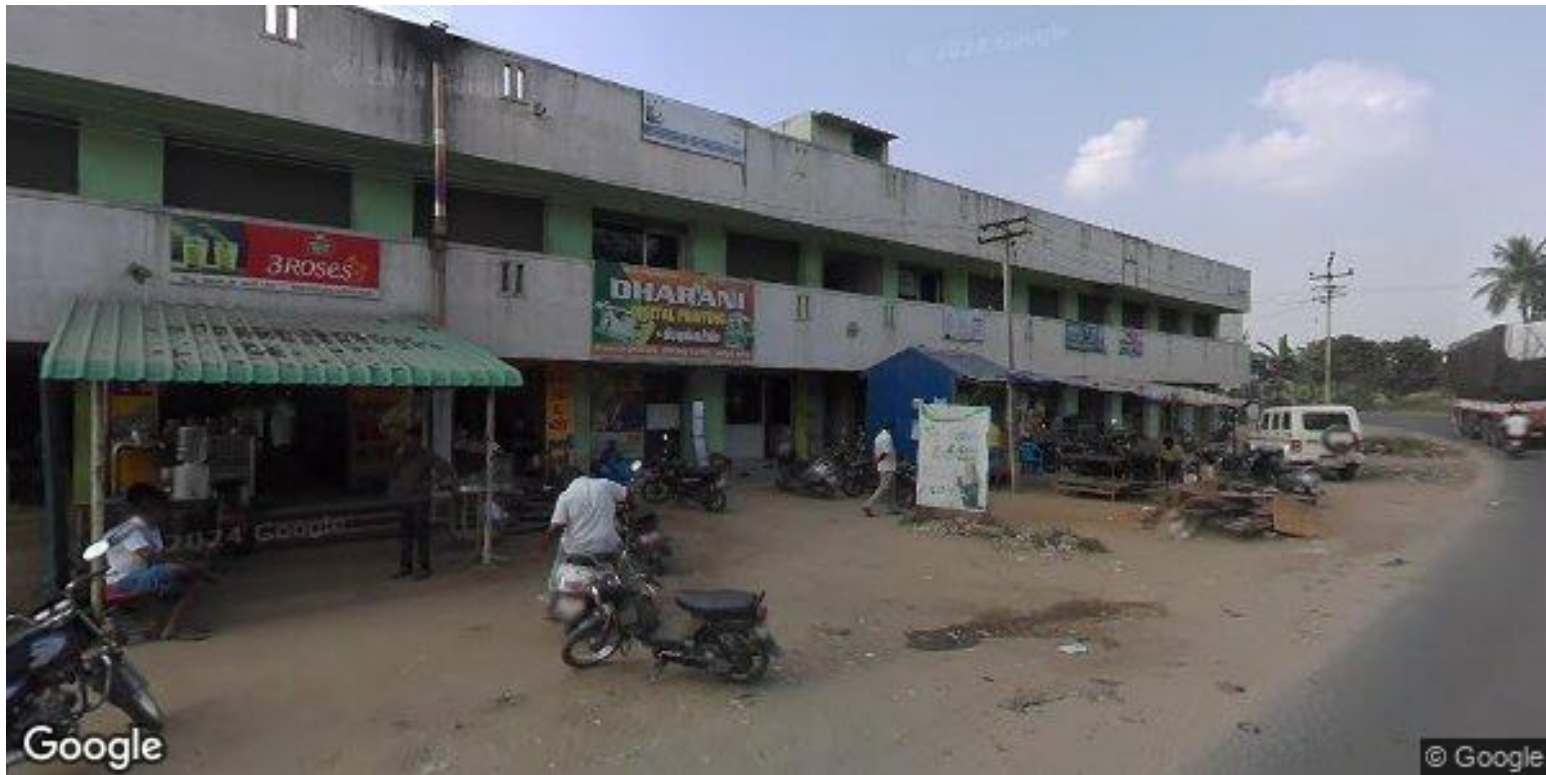
**Risk Type:** Turn  
**Risk Level:** Medium  
**Speed Limit:** 30 KM/Hr  
**Coordinates:** 11.49167, 77.88772

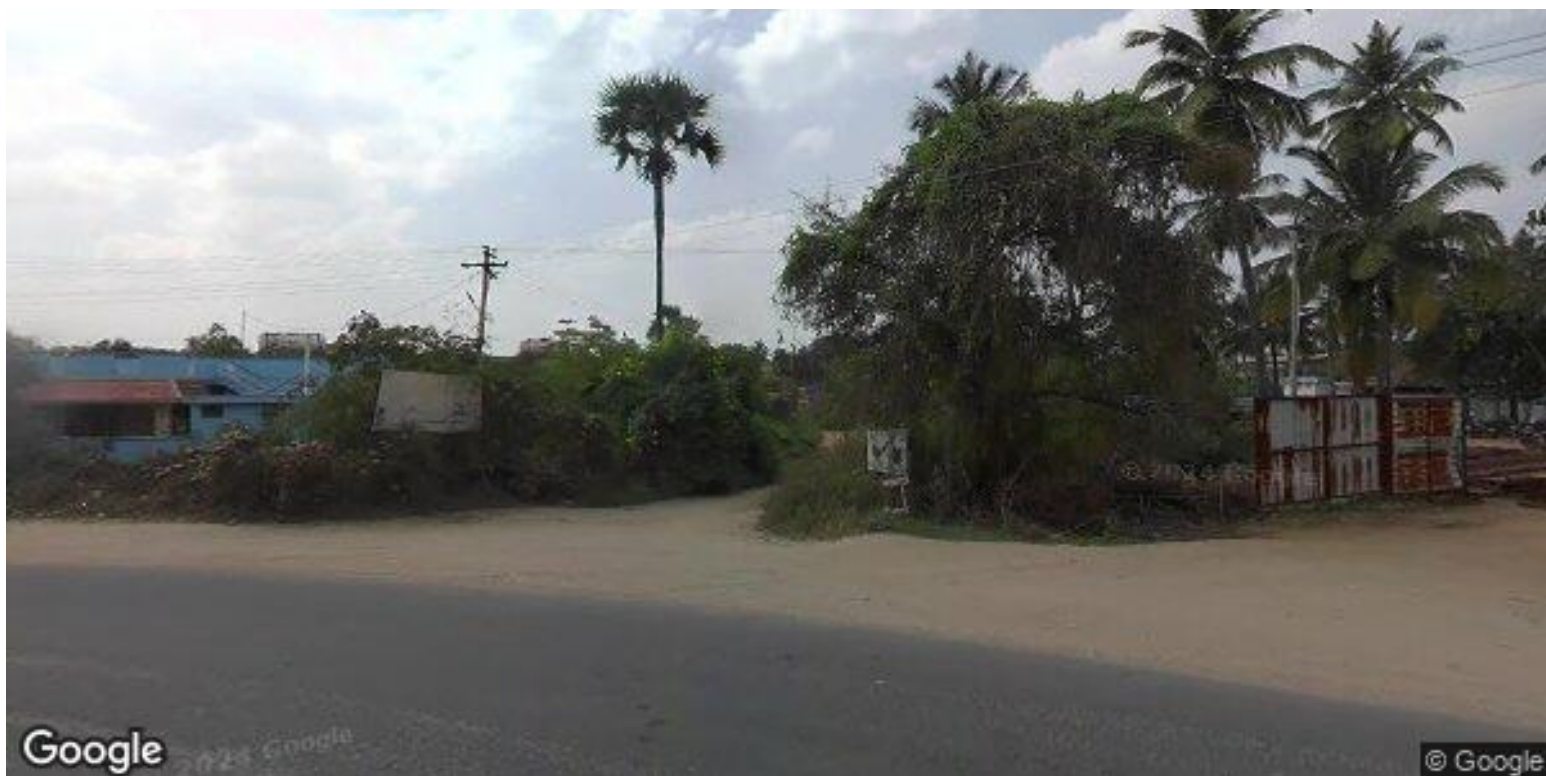
**Risk Type:** Turn  
**Risk Level:** High  
**Speed Limit:** 15 KM/Hr  
**Coordinates:** 11.49440, 77.88480

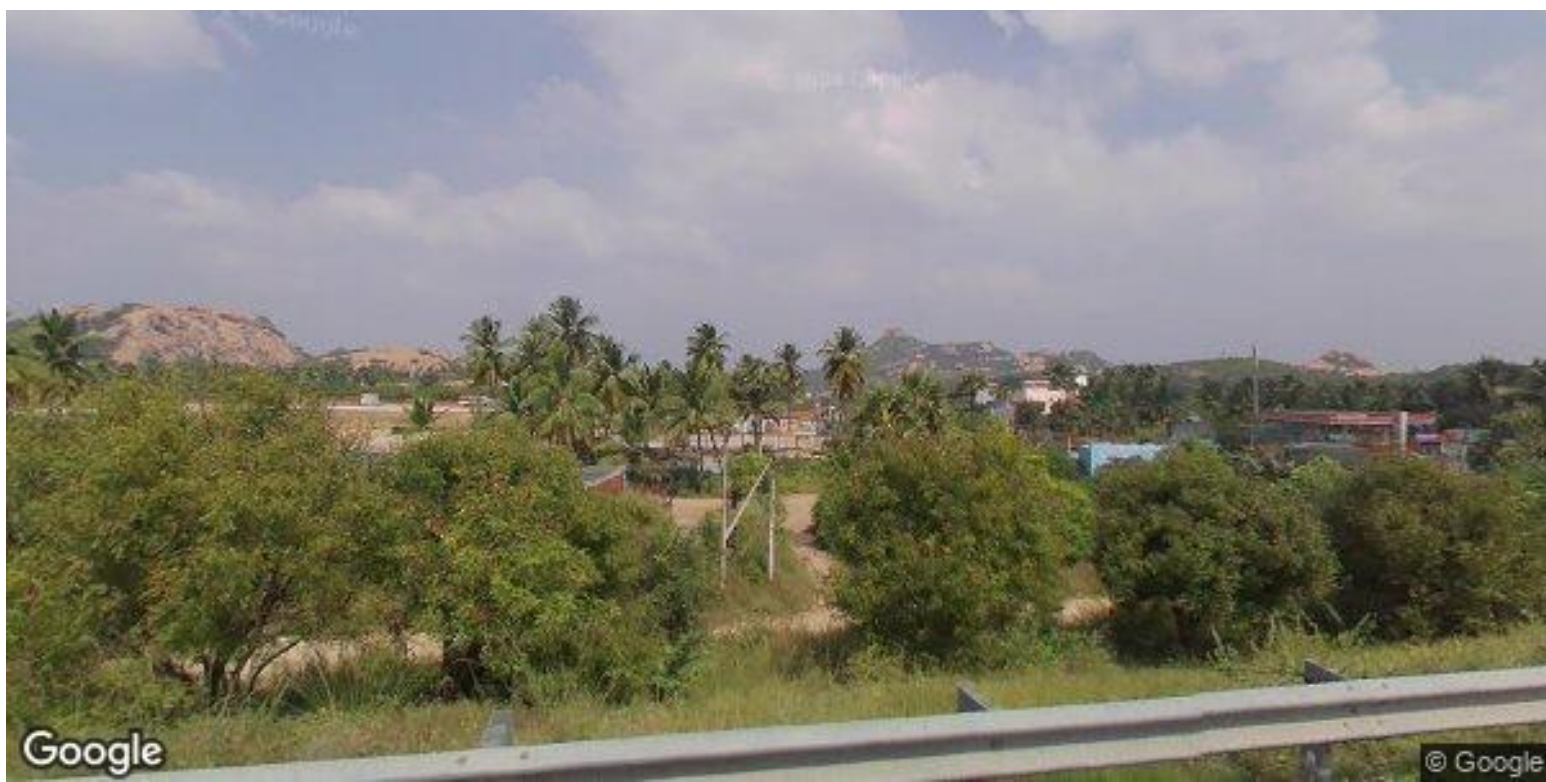
**Coordinates:** 11.49412, 77.88450

**Risk Type:** Turn

**Risk Level:** Medium

**Speed Limit:** 30 KM/Hr

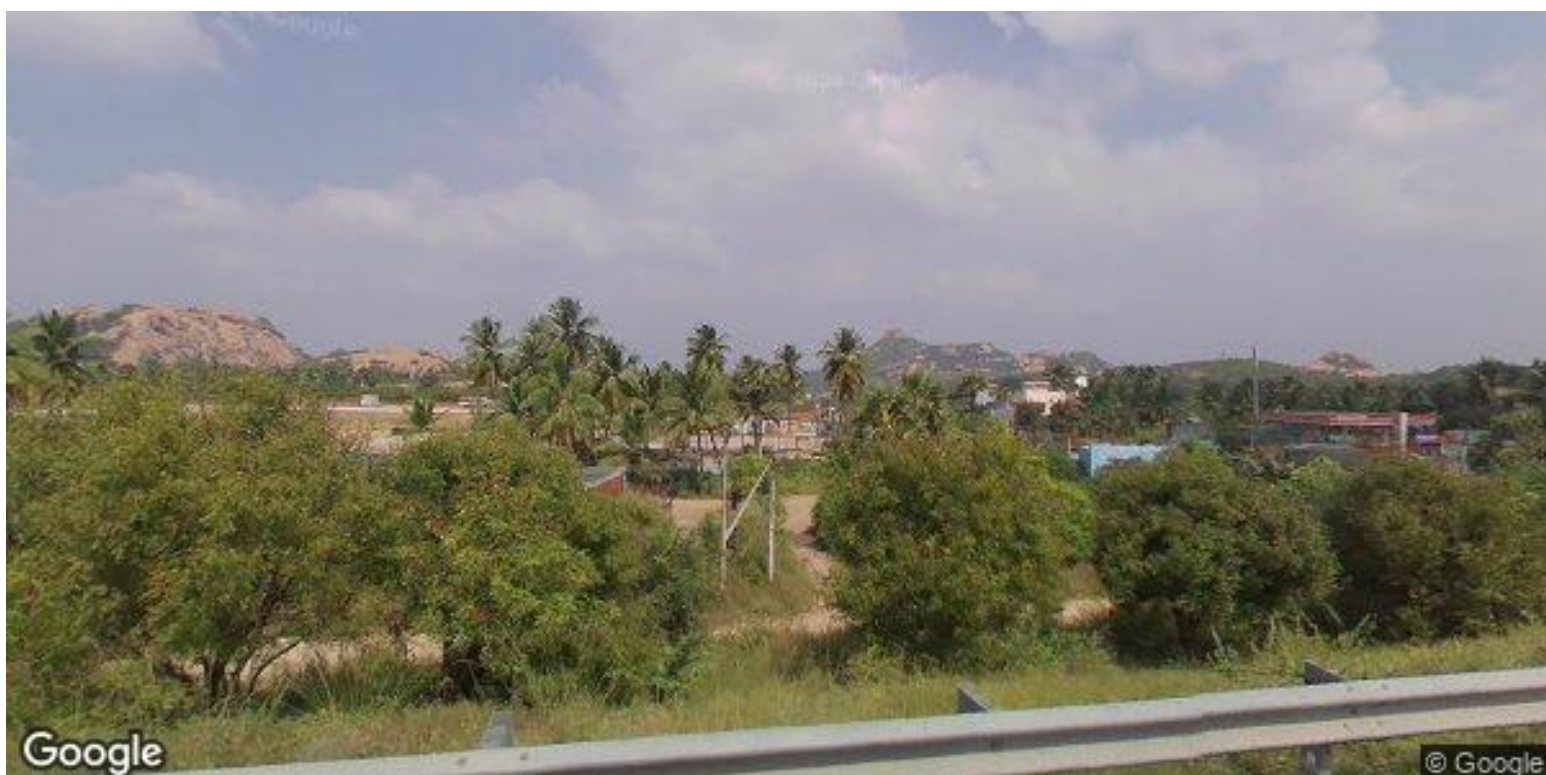
**Coordinates:** 11.49412, 77.88450

**Risk Type:** Turn

**Risk Level:** Medium

**Speed Limit:** 30 KM/Hr

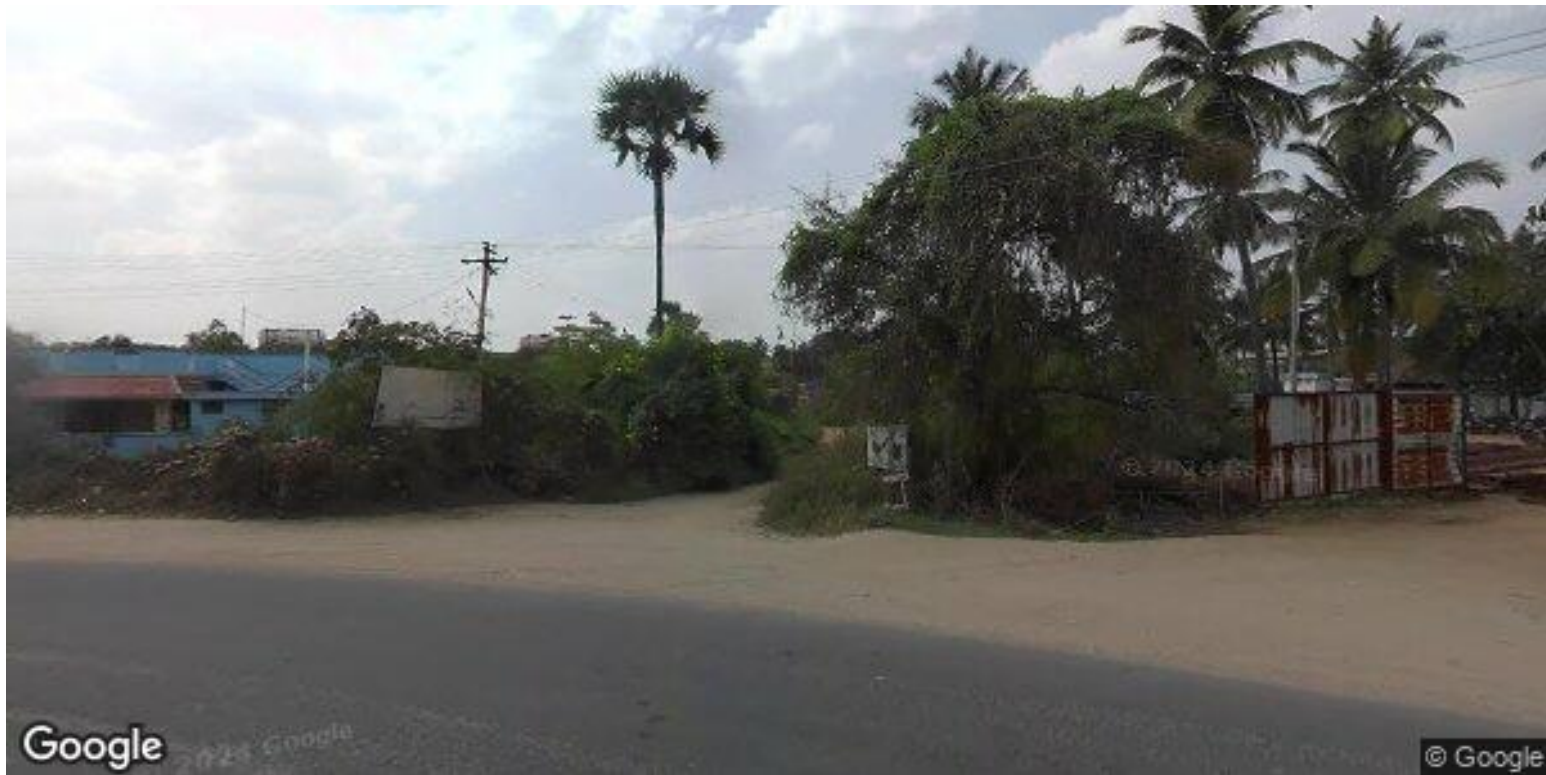
**Coordinates:** 11.49440, 77.88480

**Risk Type:** Turn

**Risk Level:** High

**Speed Limit:** 15 KM/Hr

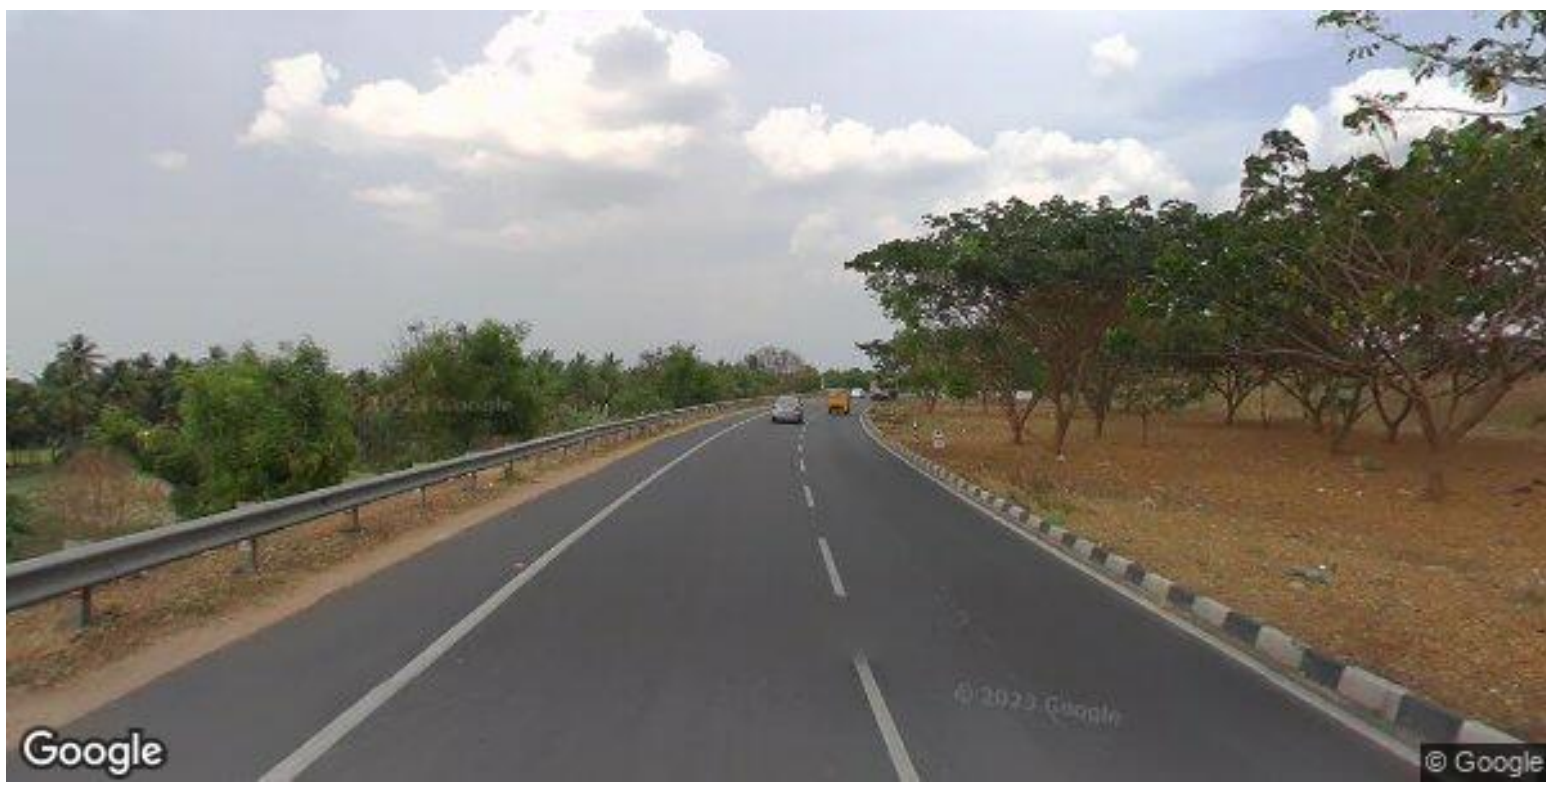
**Coordinates:** 11.53588, 77.95823

**Risk Type:** Turn

**Risk Level:** Medium

**Speed Limit:** 30 KM/Hr

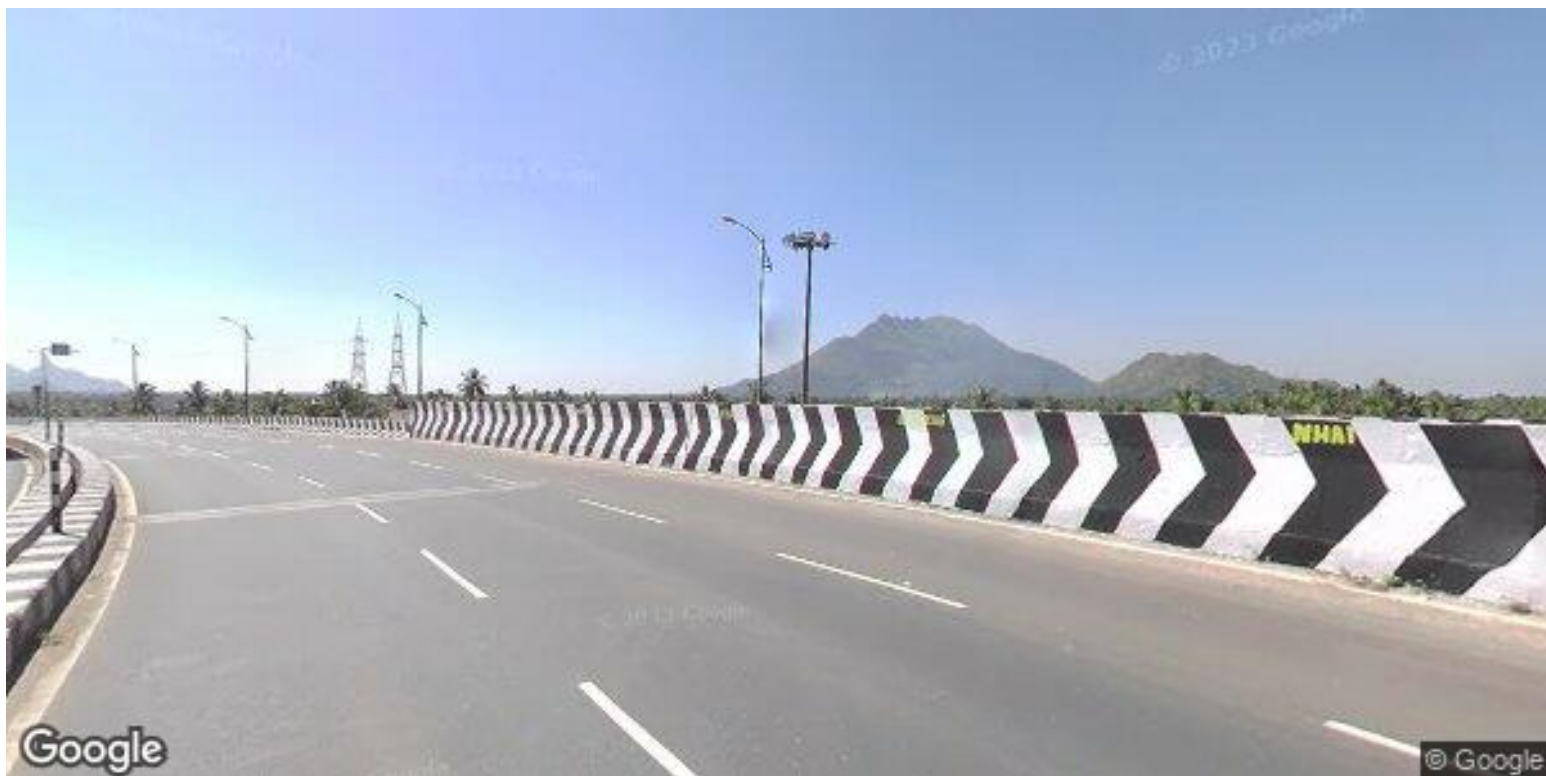
**Coordinates:** 11.64151, 78.11805

**Risk Type:** Turn

**Risk Level:** Medium

**Speed Limit:** 30 KM/Hr

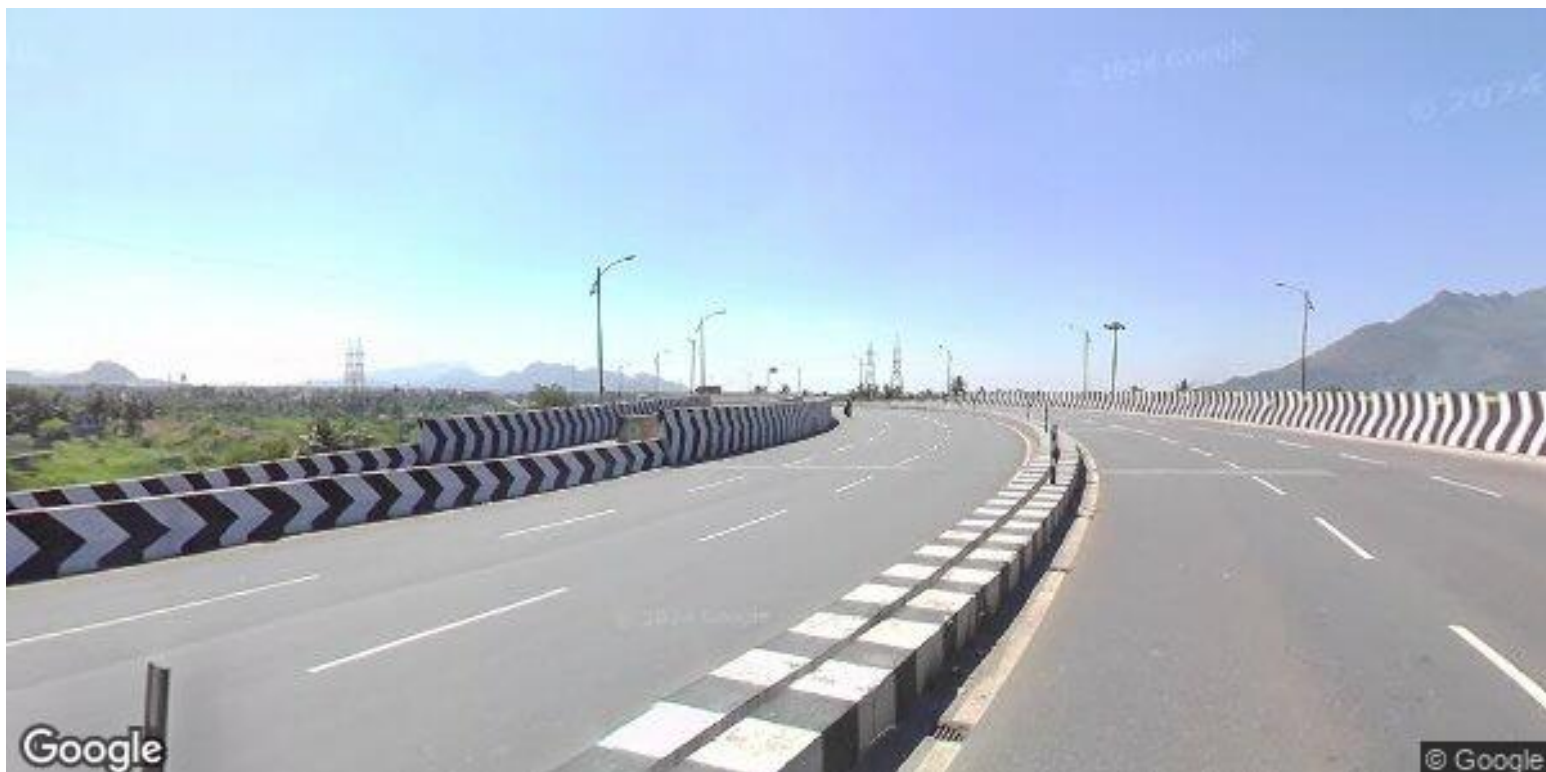
**Risk Type:** Turn  
**Risk Level:** Medium  
**Speed Limit:** 30 KM/Hr  
**Coordinates:** 11.64199, 78.11844

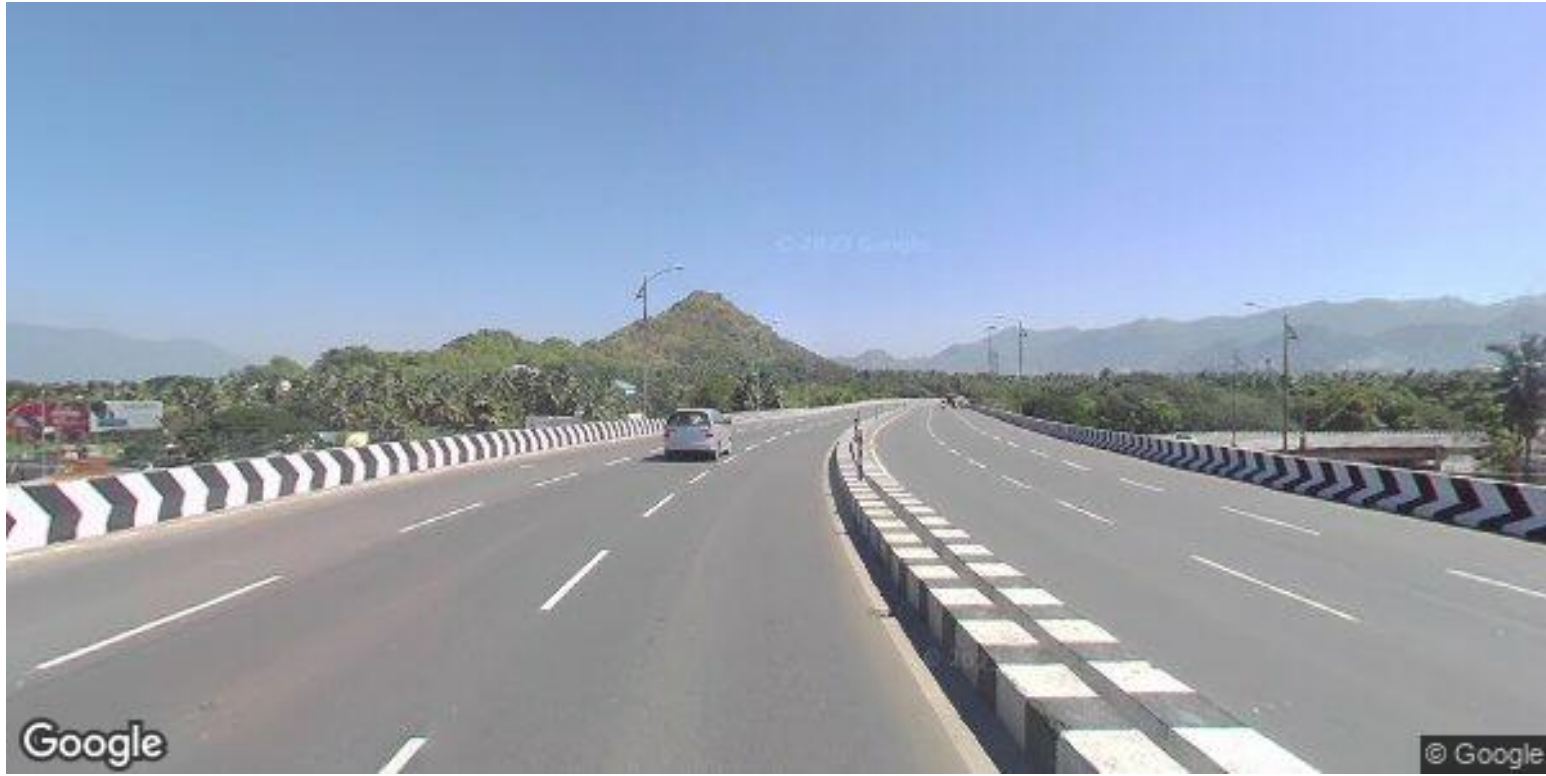
**Risk Type:** Turn  
**Risk Level:** Medium  
**Speed Limit:** 30 KM/Hr  
**Coordinates:** 11.64222, 78.11898

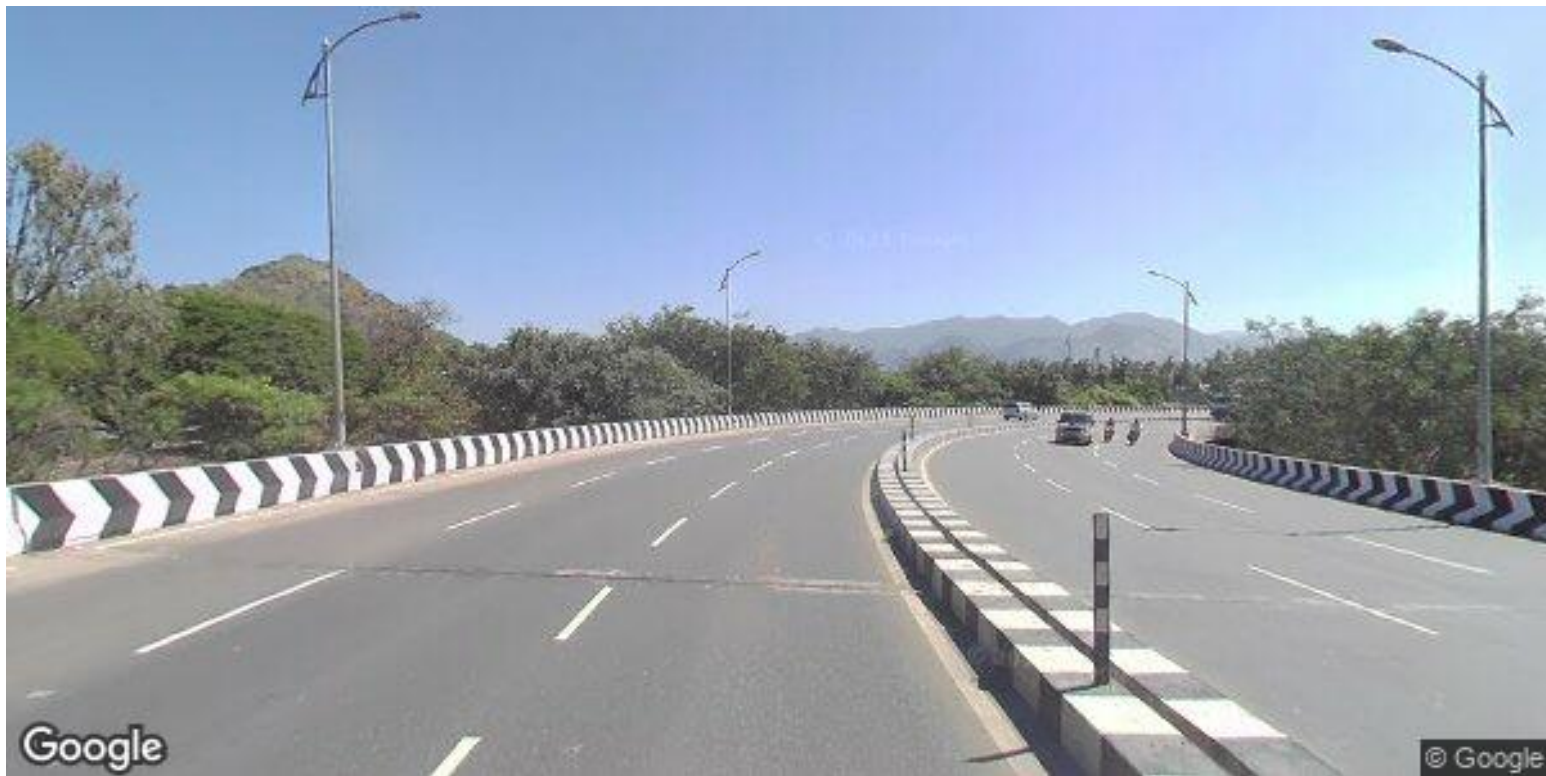
**Risk Type:** Turn  
**Risk Level:** Medium  
**Speed Limit:** 30 KM/Hr  
**Coordinates:** 11.64205, 78.12104

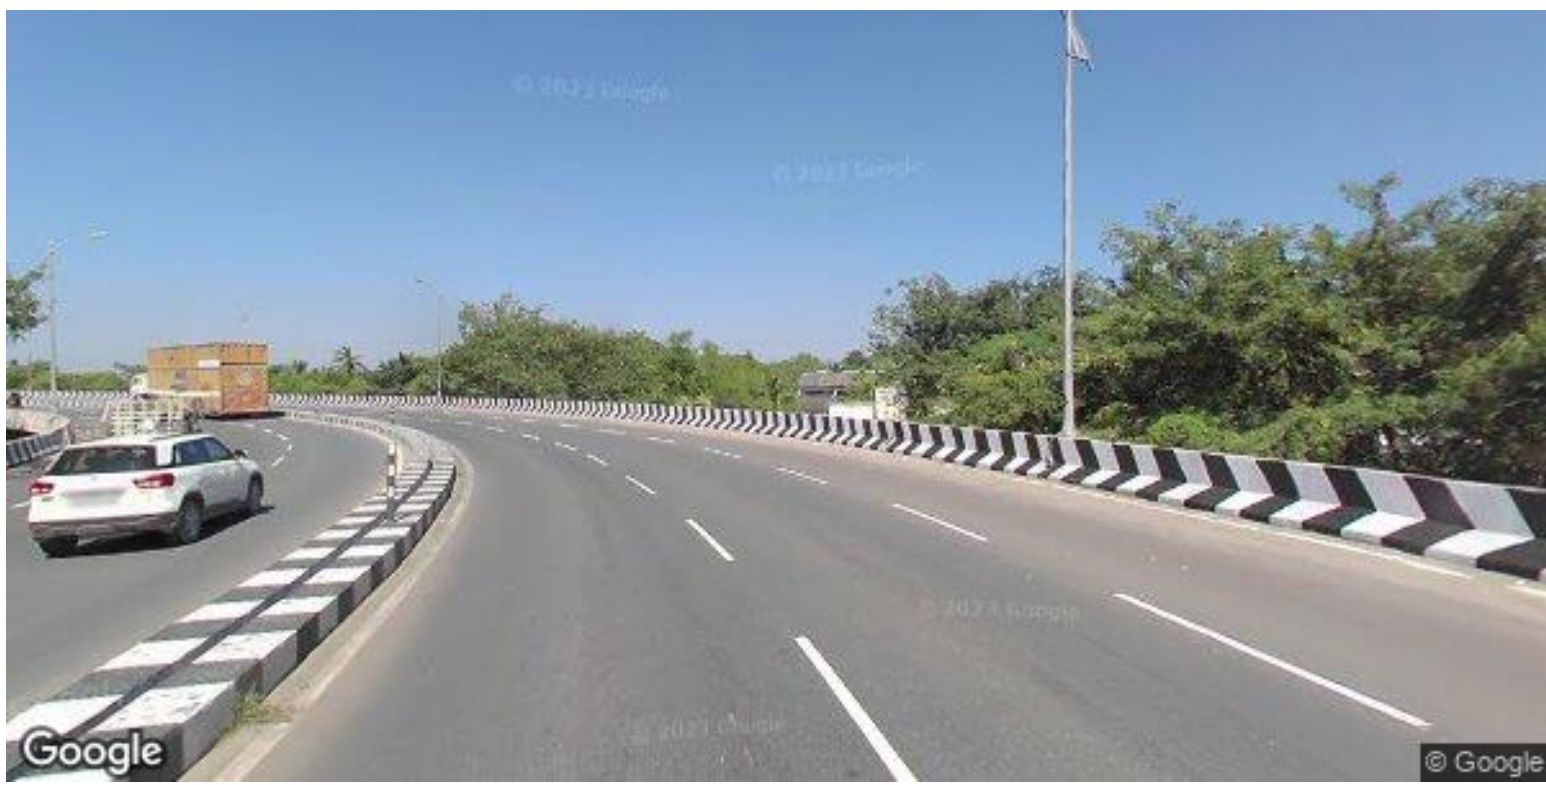
**Coordinates:** 11.64139, 78.12168

**Risk Type:** Turn

**Risk Level:** High

**Speed Limit:** 15 KM/Hr

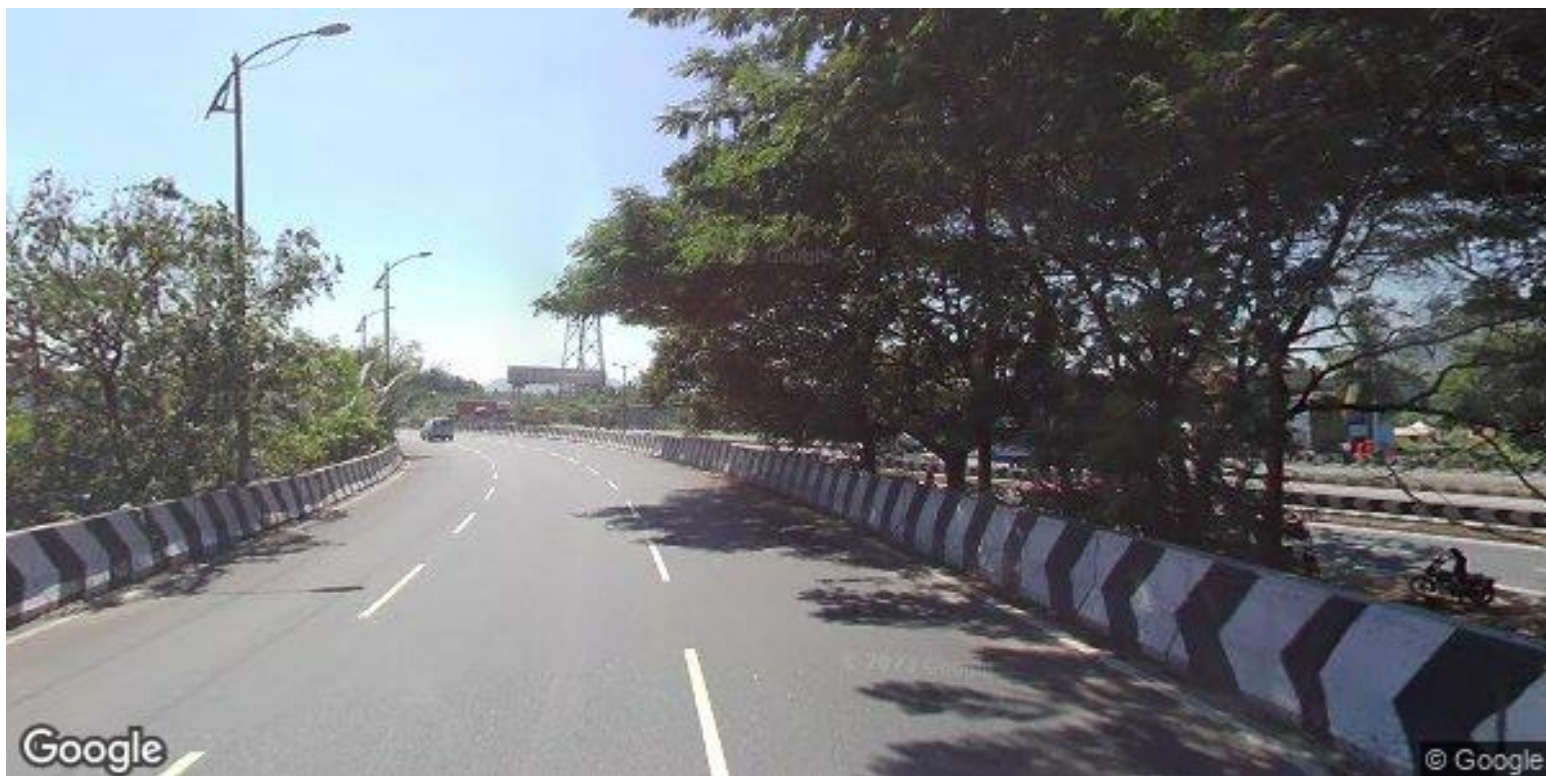
**Coordinates:** 11.63984, 78.12086

**Risk Type:** Turn

**Risk Level:** Medium

**Speed Limit:** 30 KM/Hr
