# IndianOil

## JOURNEY RISK MANAGEMENT (JRM) STUDY

### Salem Terminal TO NAVEEN AGENCY

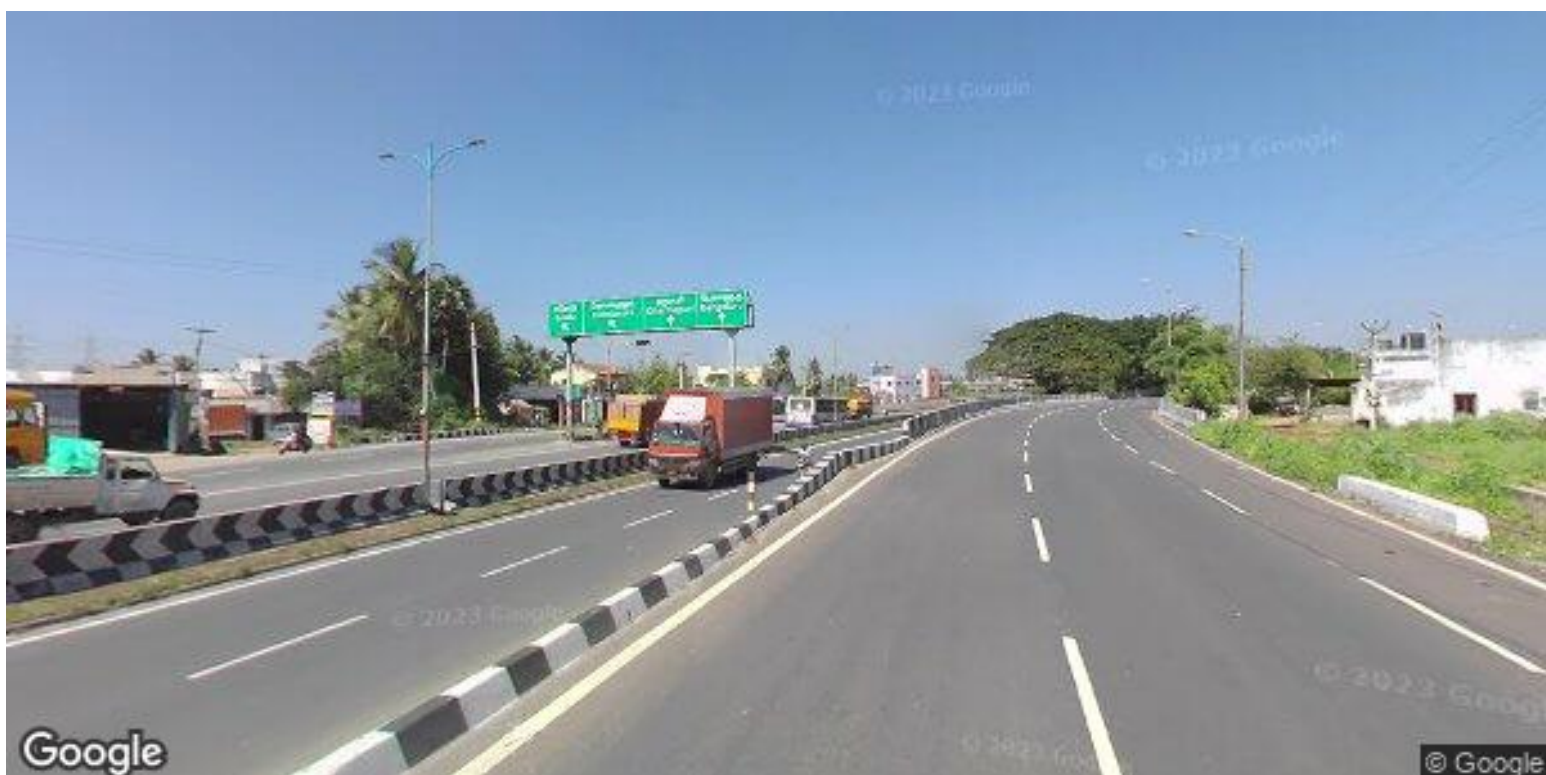
**Risk Type:** Turn  
**Risk Level:** Medium  
**Speed Limit:** 30 KM/Hr  
**Coordinates:** 11.63869, 78.12103

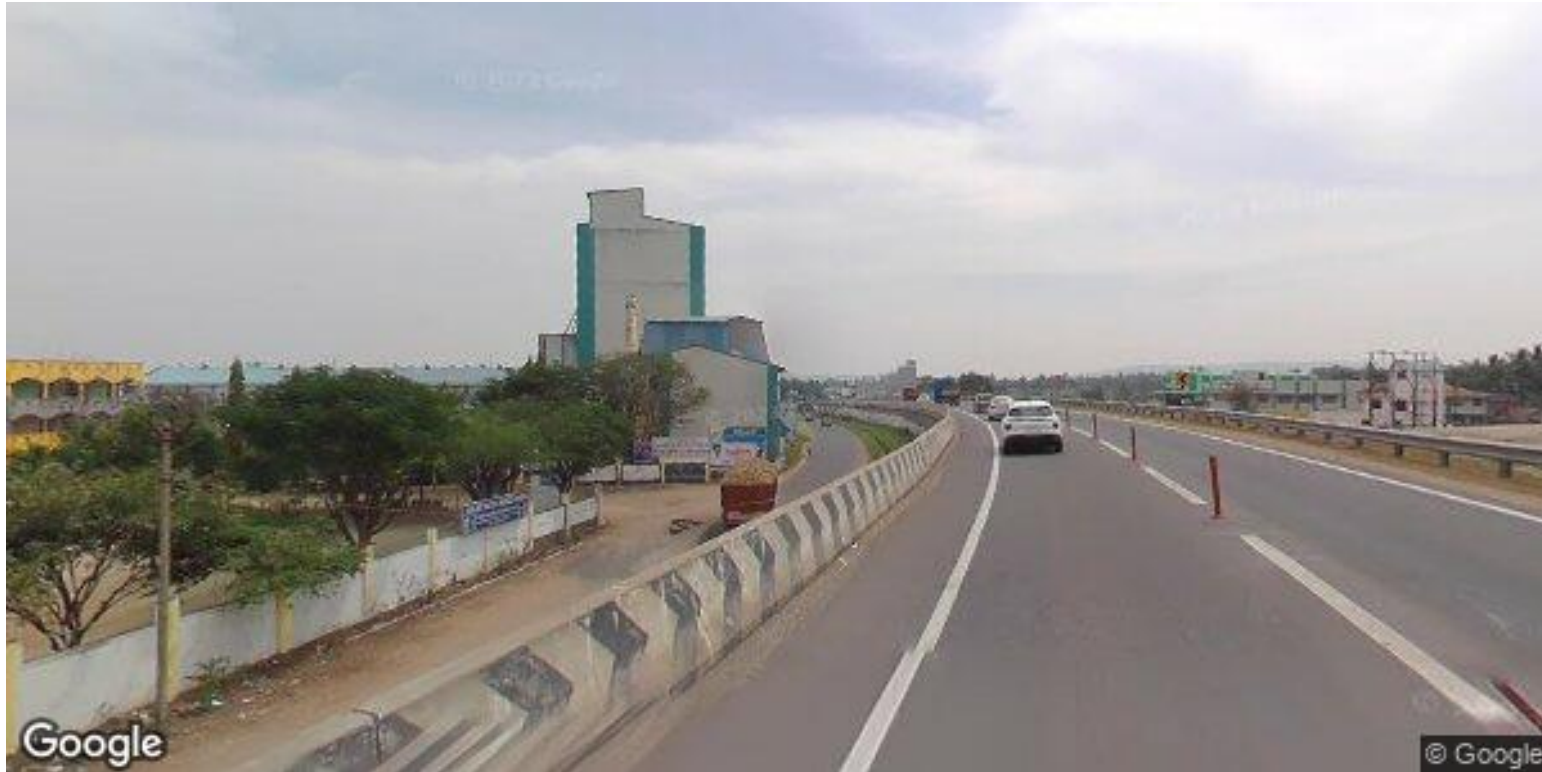
**Risk Type:** Turn  
**Risk Level:** Medium  
**Speed Limit:** 30 KM/Hr  
**Coordinates:** 11.59320, 78.62069

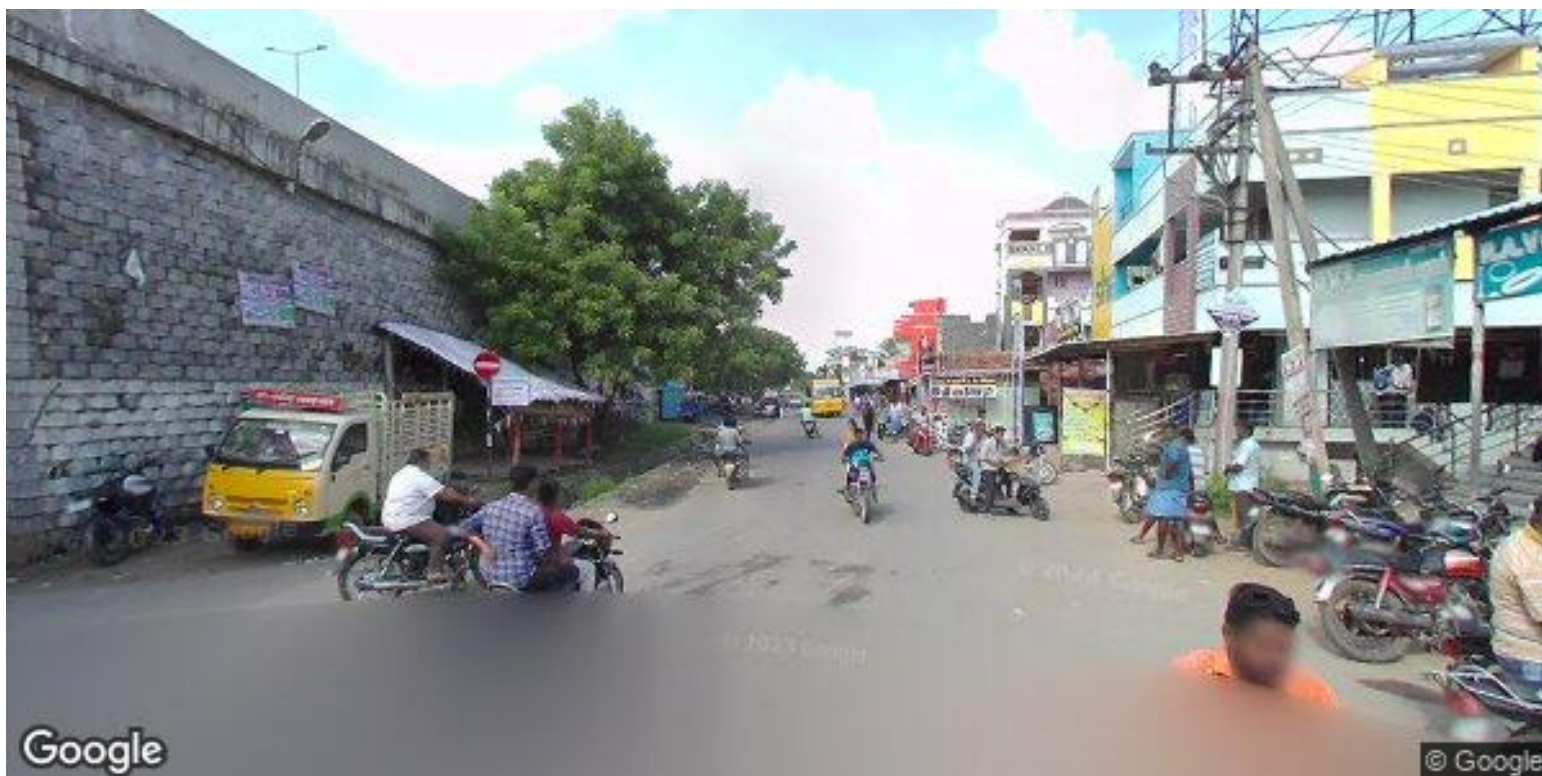
**Risk Type:** Blind Spot  
**Risk Level:** Blind Spot  
**Speed Limit:** 10 KM/Hr  
**Coordinates:** 11.59137, 78.66635

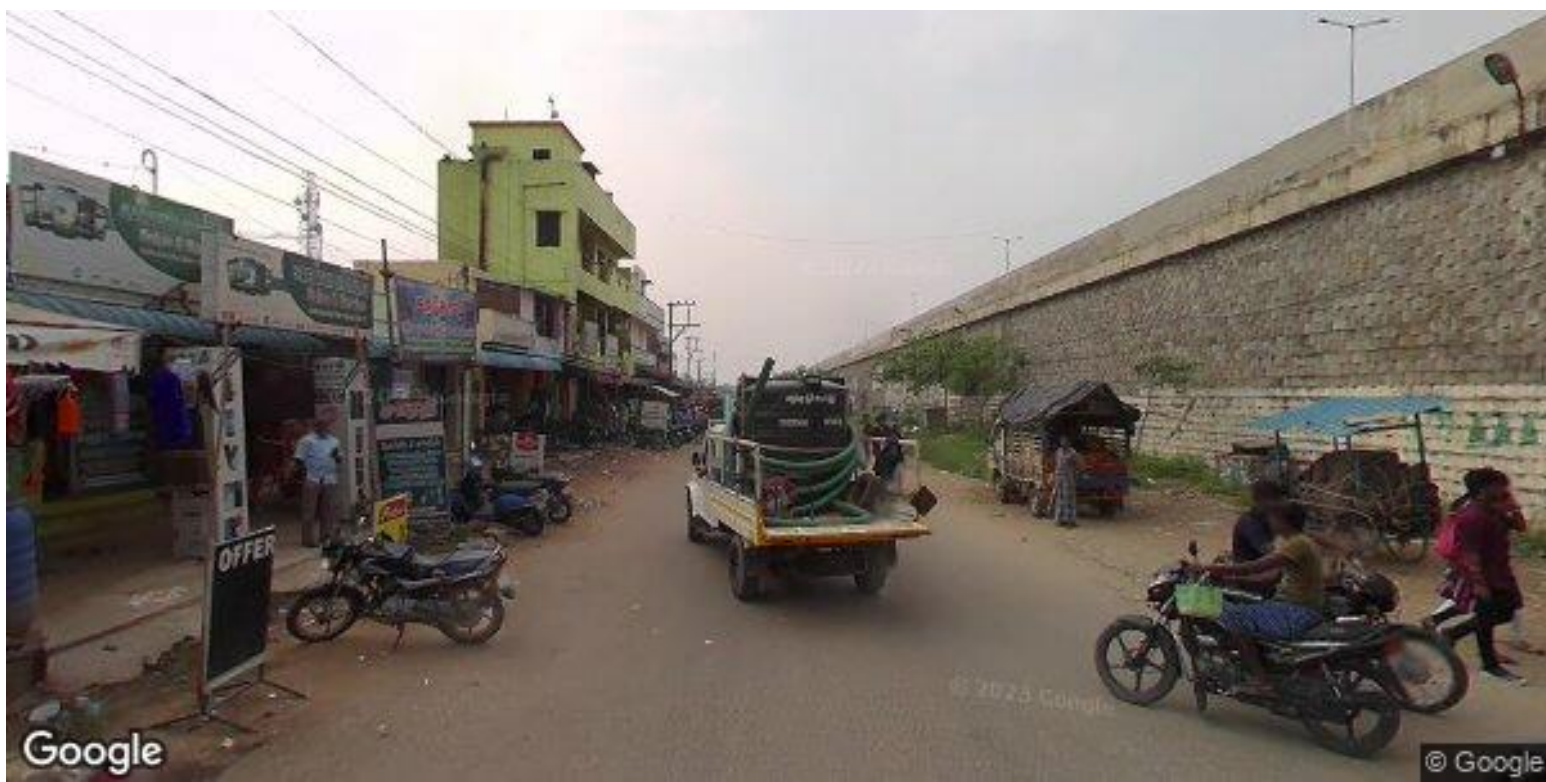
Coordinates: 11.59099, 78.66630

Risk Type: Turn

Risk Level: High

Speed Limit: 15 KM/Hr

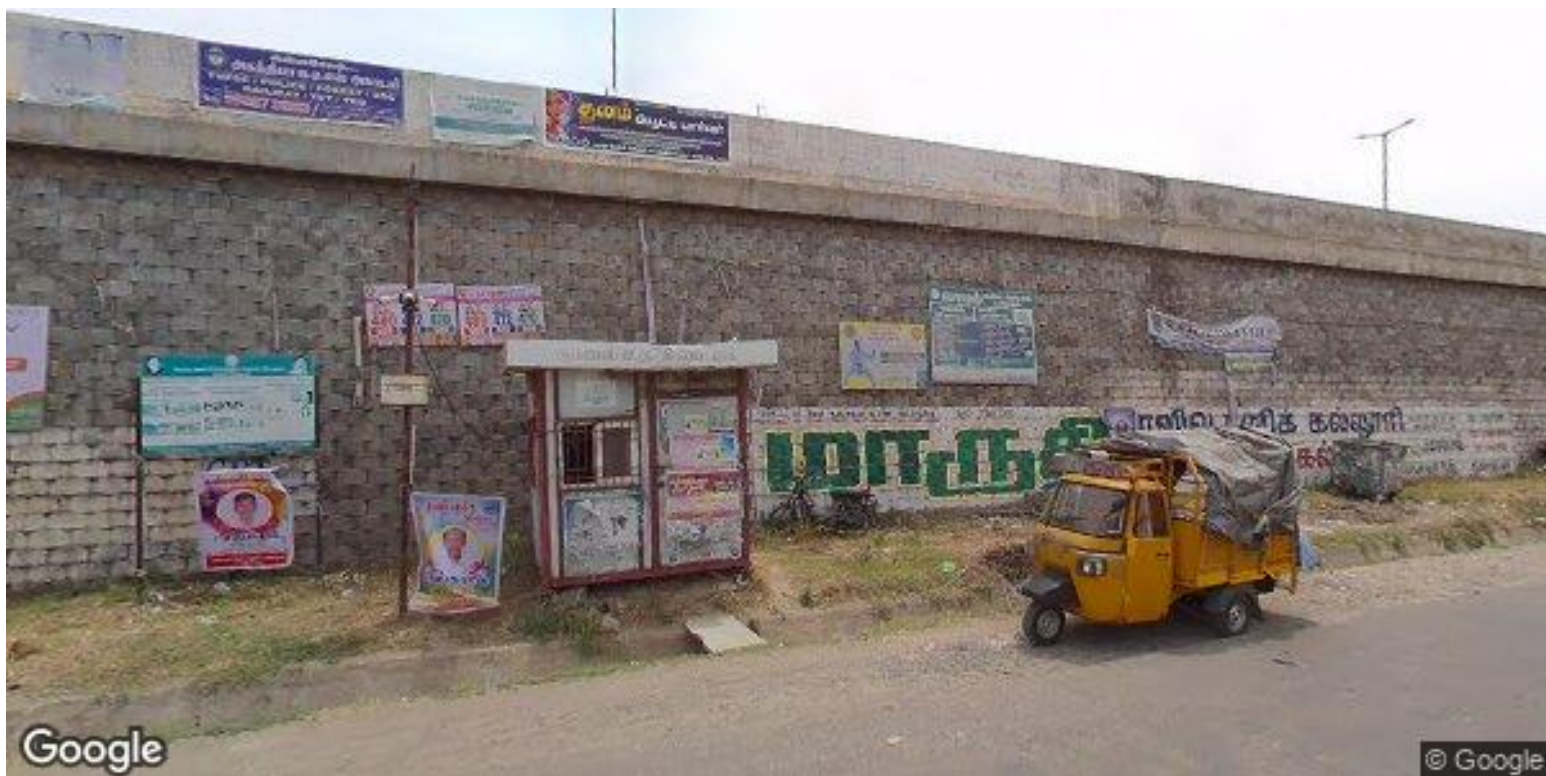
Coordinates: 11.59101, 78.66563

Risk Type: Turn

Risk Level: High

Speed Limit: 15 KM/Hr

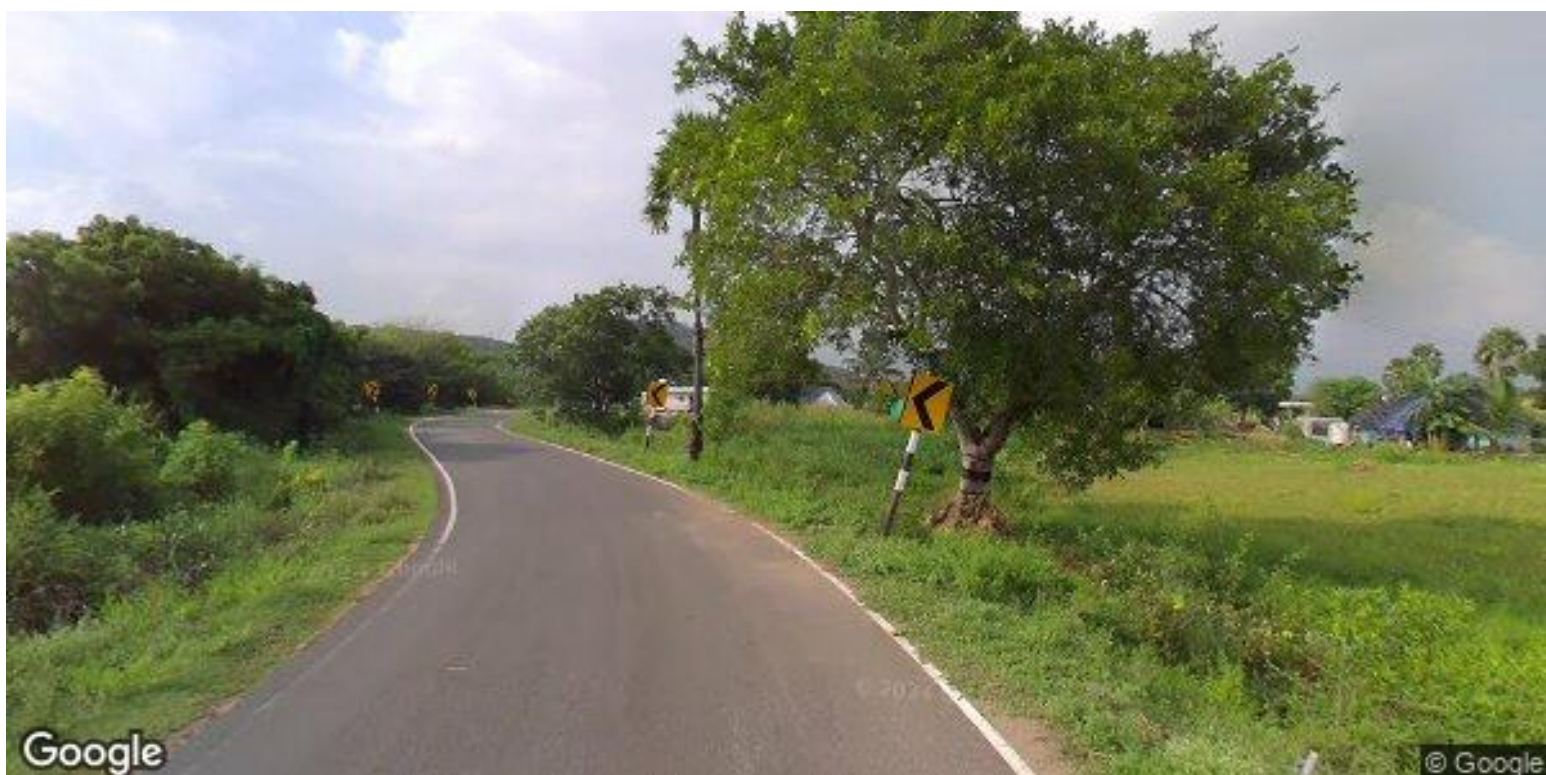
**Coordinates:** 11.57258, 78.66759

**Risk Type:** Turn

**Risk Level:** Medium

**Speed Limit:** 30 KM/Hr

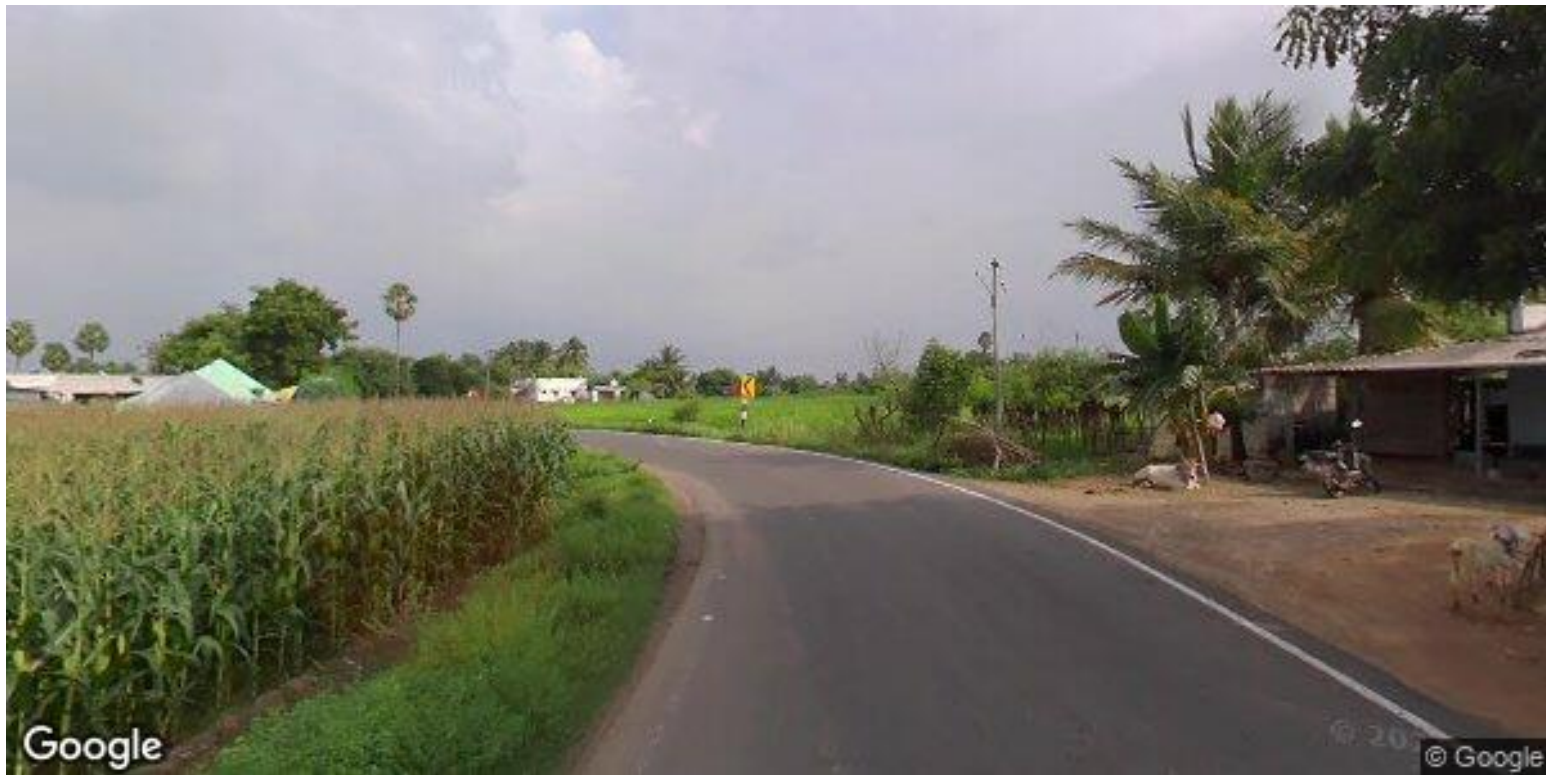
**Coordinates:** 11.57036, 78.66783

**Risk Type:** Turn

**Risk Level:** High

**Speed Limit:** 15 KM/Hr

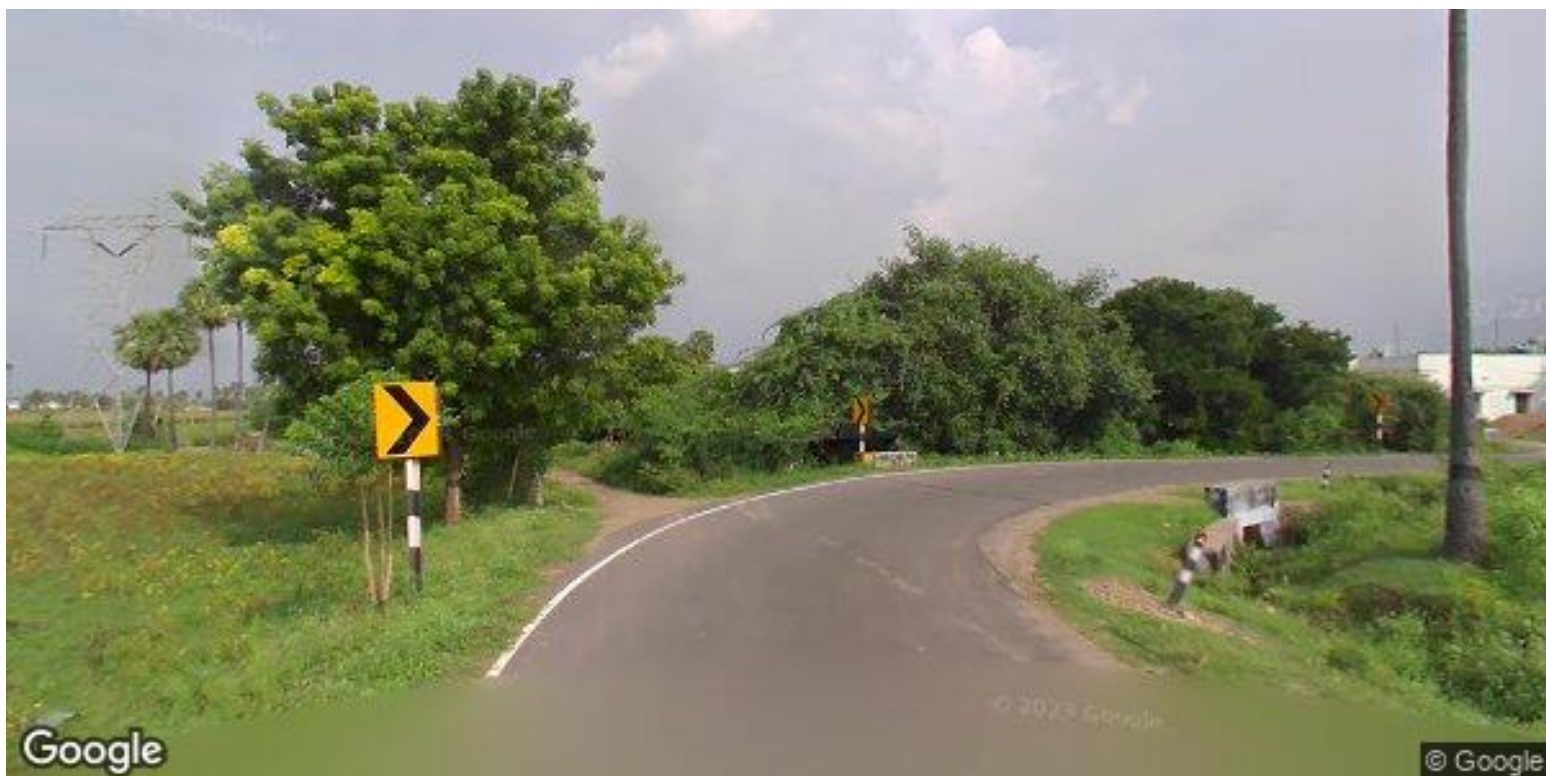
**Coordinates:** 11.57027, 78.66863

**Risk Type:** Turn

**Risk Level:** High

**Speed Limit:** 15 KM/Hr

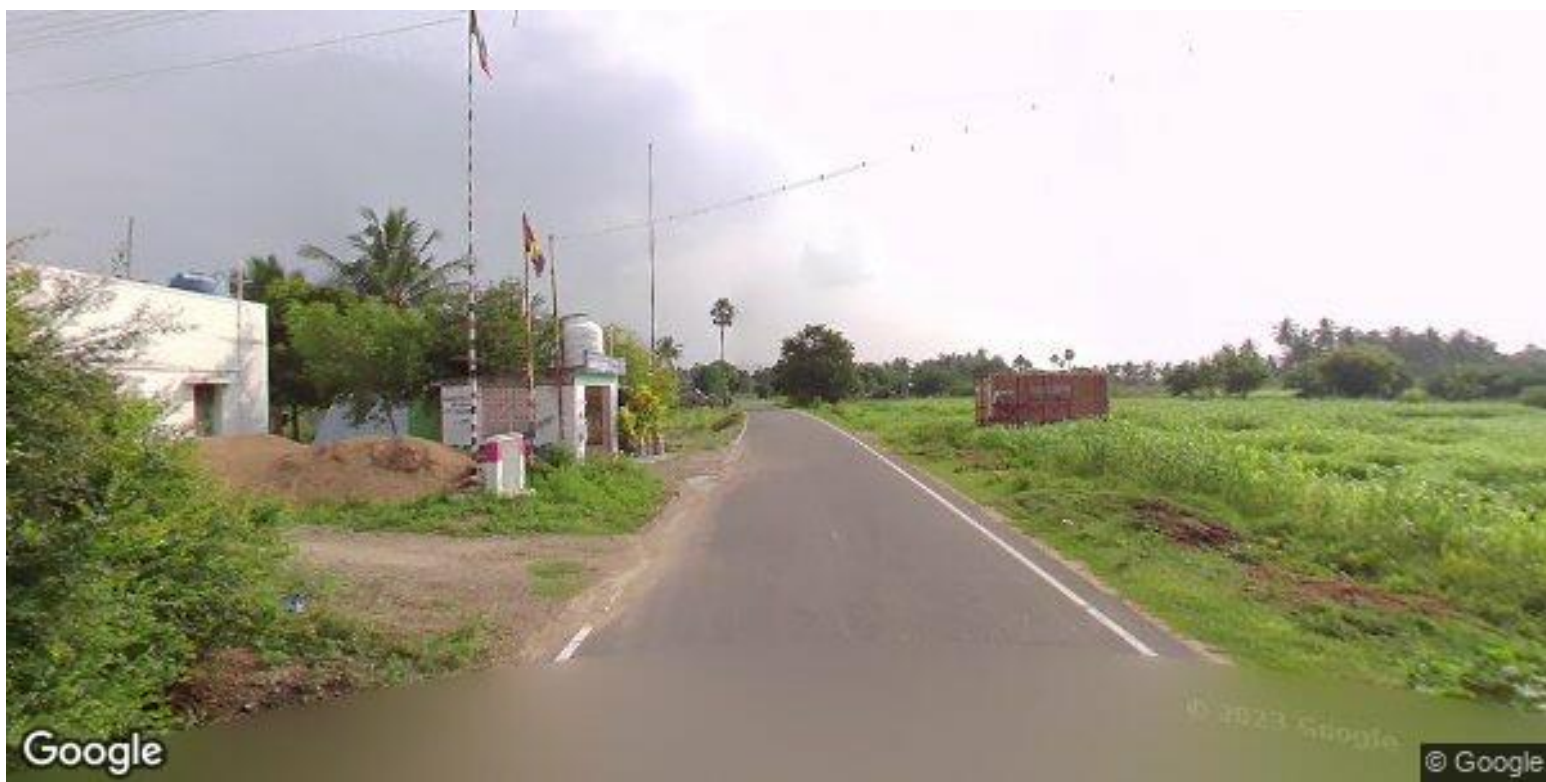
**Coordinates:** 11.57000, 78.66881

**Risk Type:** Turn

**Risk Level:** Medium

**Speed Limit:** 30 KM/Hr

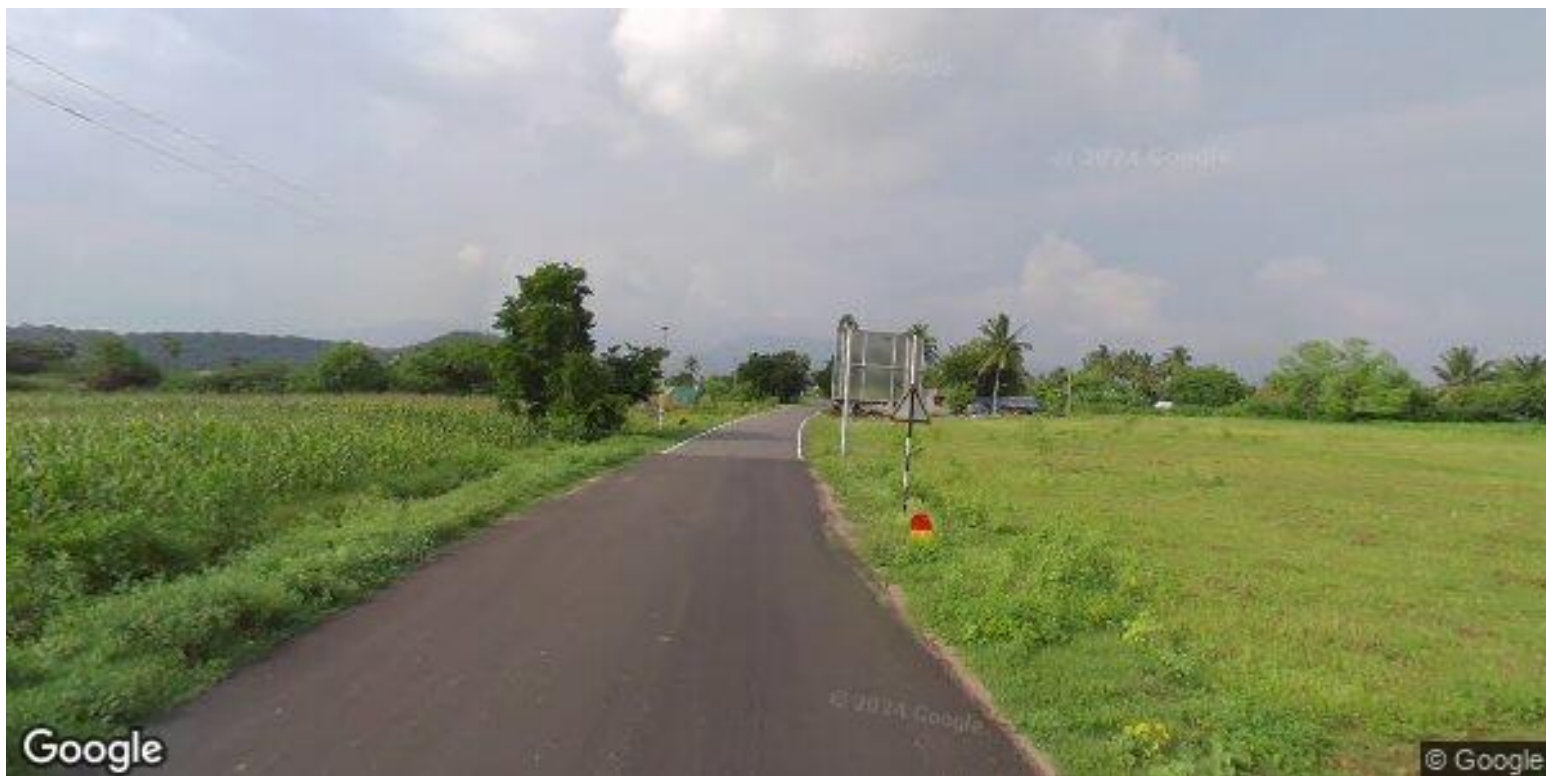
**Coordinates:** 11.56791, 78.66867

**Risk Type:** Turn

**Risk Level:** Medium

**Speed Limit:** 30 KM/Hr

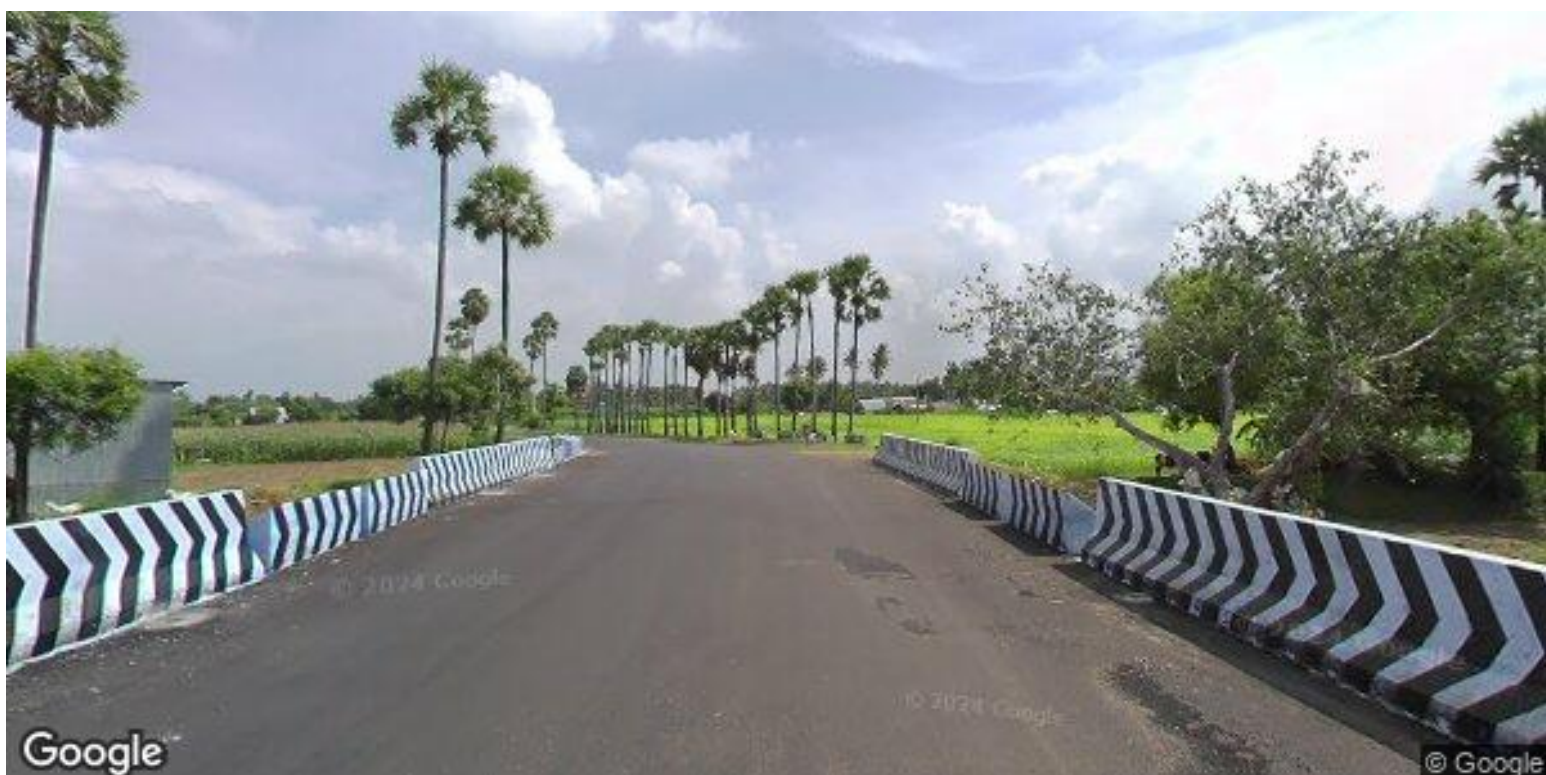
**Coordinates: 11.56688, 78.66914**

**Risk Type: Turn**

**Risk Level: Medium**

**Speed Limit: 30 KM/Hr**

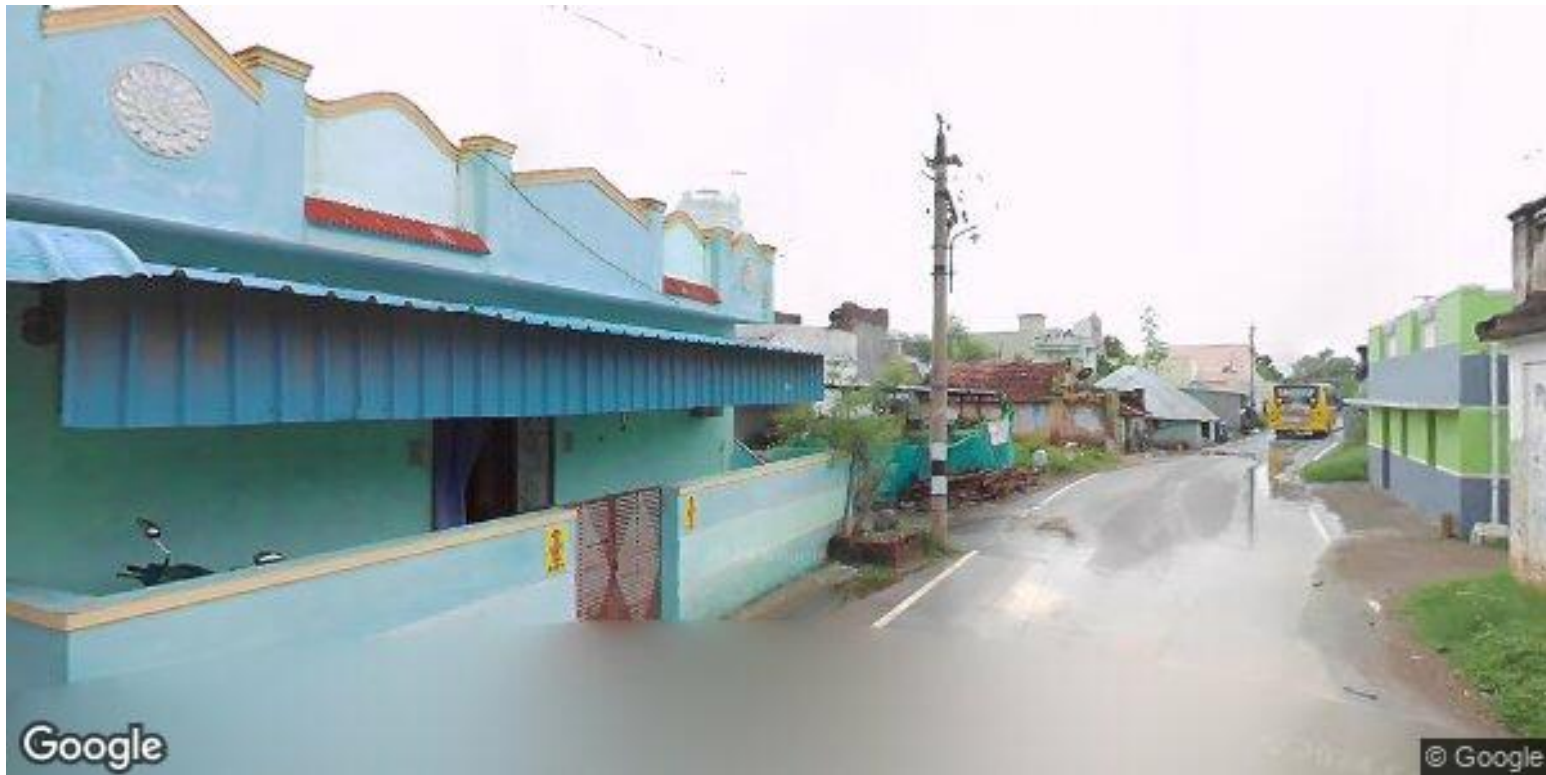
**Coordinates: 11.56113, 78.67725**

**Risk Type: Turn**

**Risk Level: Medium**

**Speed Limit: 30 KM/Hr**

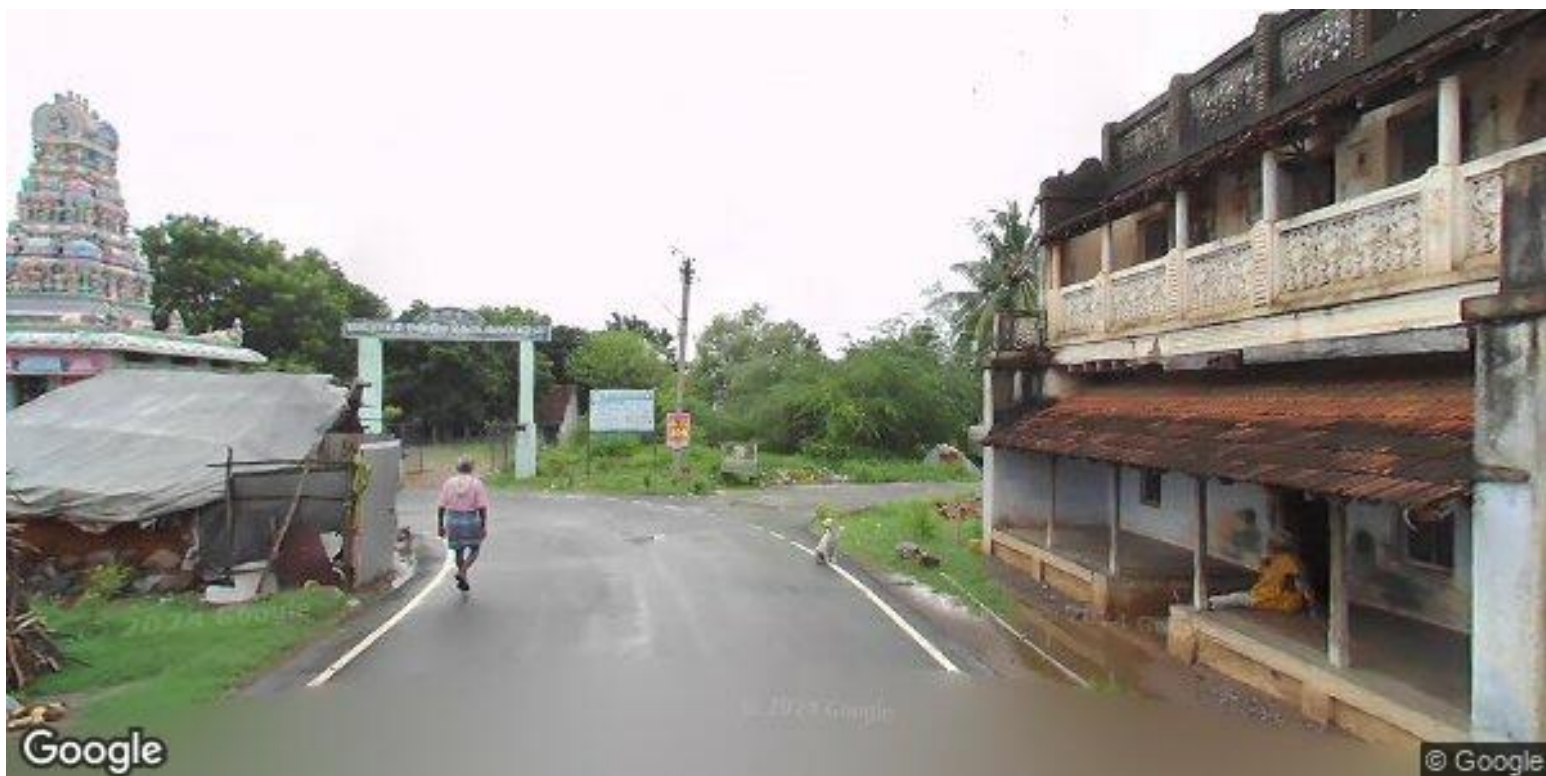
**Coordinates: 11.56034, 78.67714**

**Risk Type: Turn**

**Risk Level: High**

**Speed Limit: 15 KM/Hr**

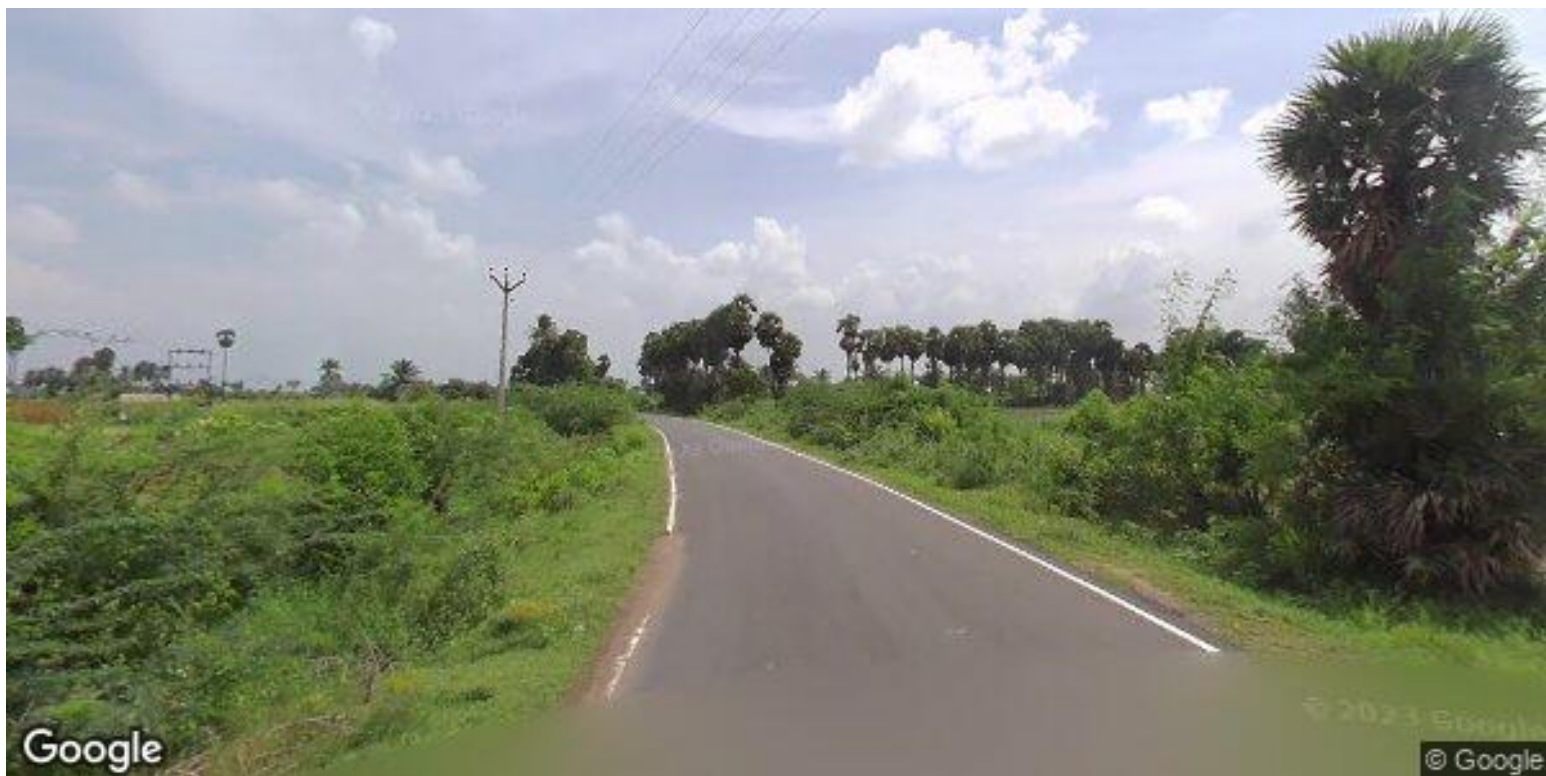
**Coordinates:** 11.55524, 78.67911

**Risk Type:** Turn

**Risk Level:** Medium

**Speed Limit:** 30 KM/Hr

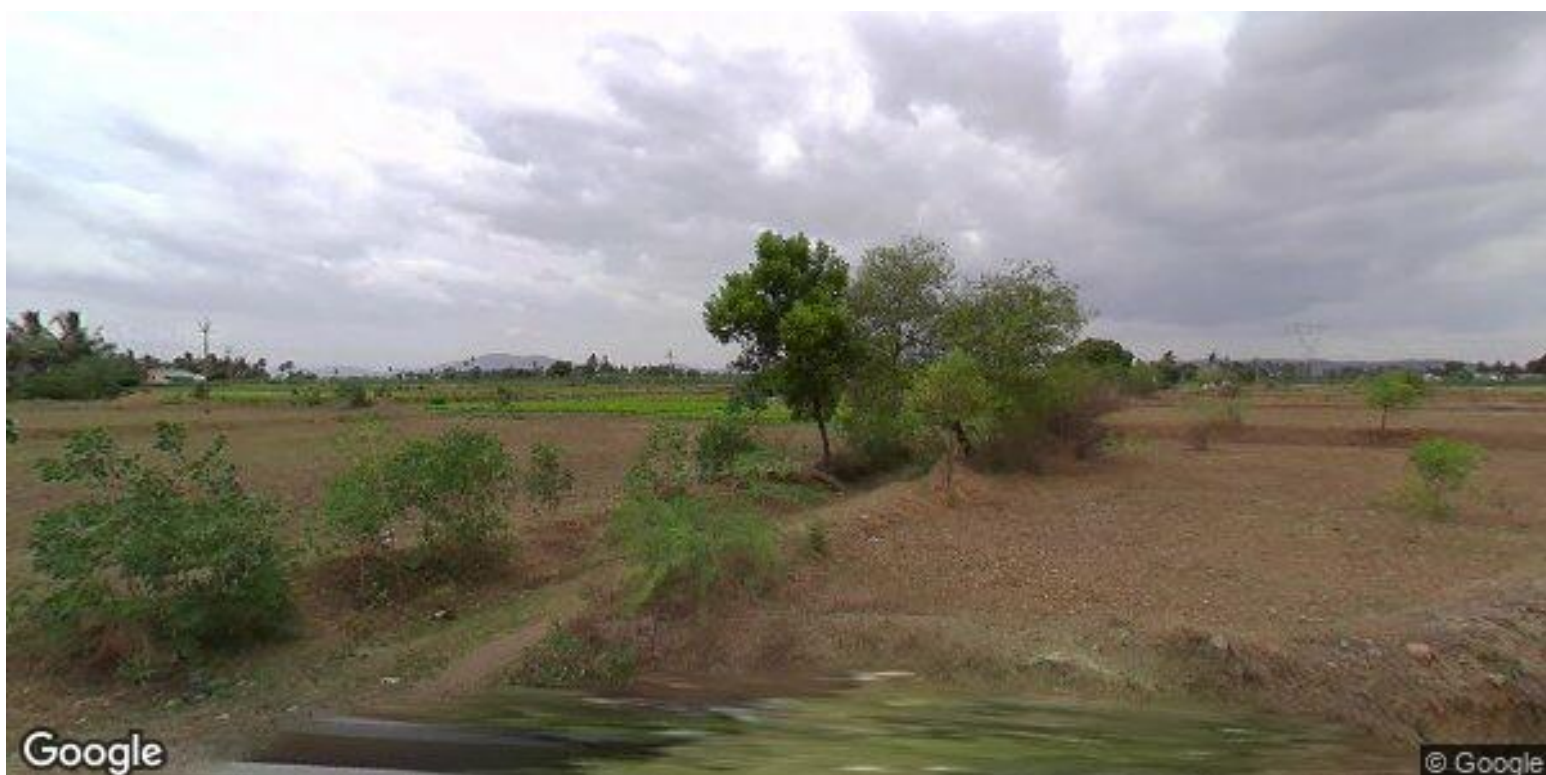
**Risk Type:** Turn  
**Risk Level:** High  
**Speed Limit:** 15 KM/Hr  
**Coordinates:** 11.54254, 78.68881

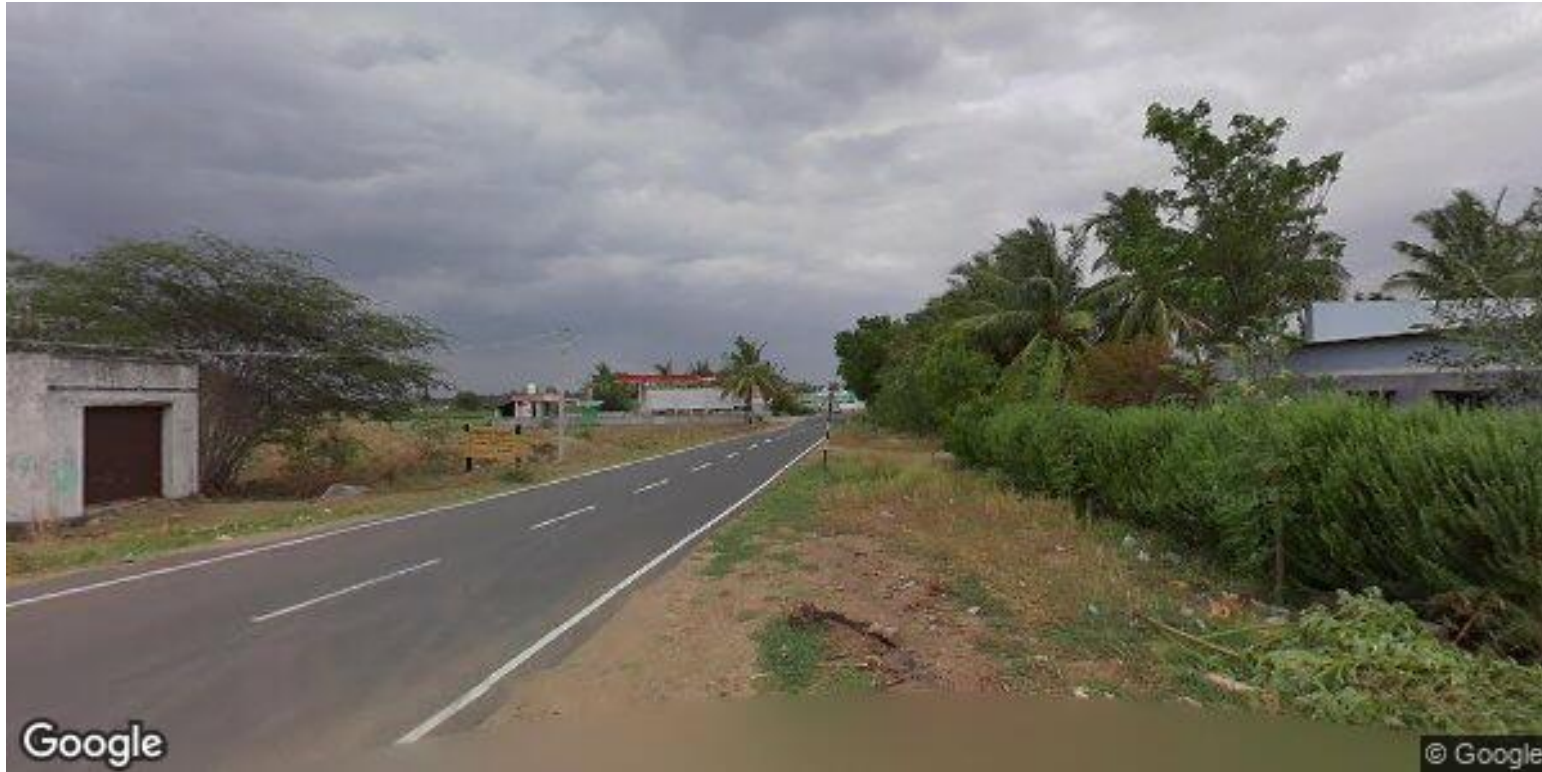
**Risk Type:** Turn  
**Risk Level:** High  
**Speed Limit:** 15 KM/Hr  
**Coordinates:** 11.53979, 78.68804
