# IndianOil

## JOURNEY RISK MANAGEMENT (JRM) STUDY

### Salem Terminal to ABHI FUELS

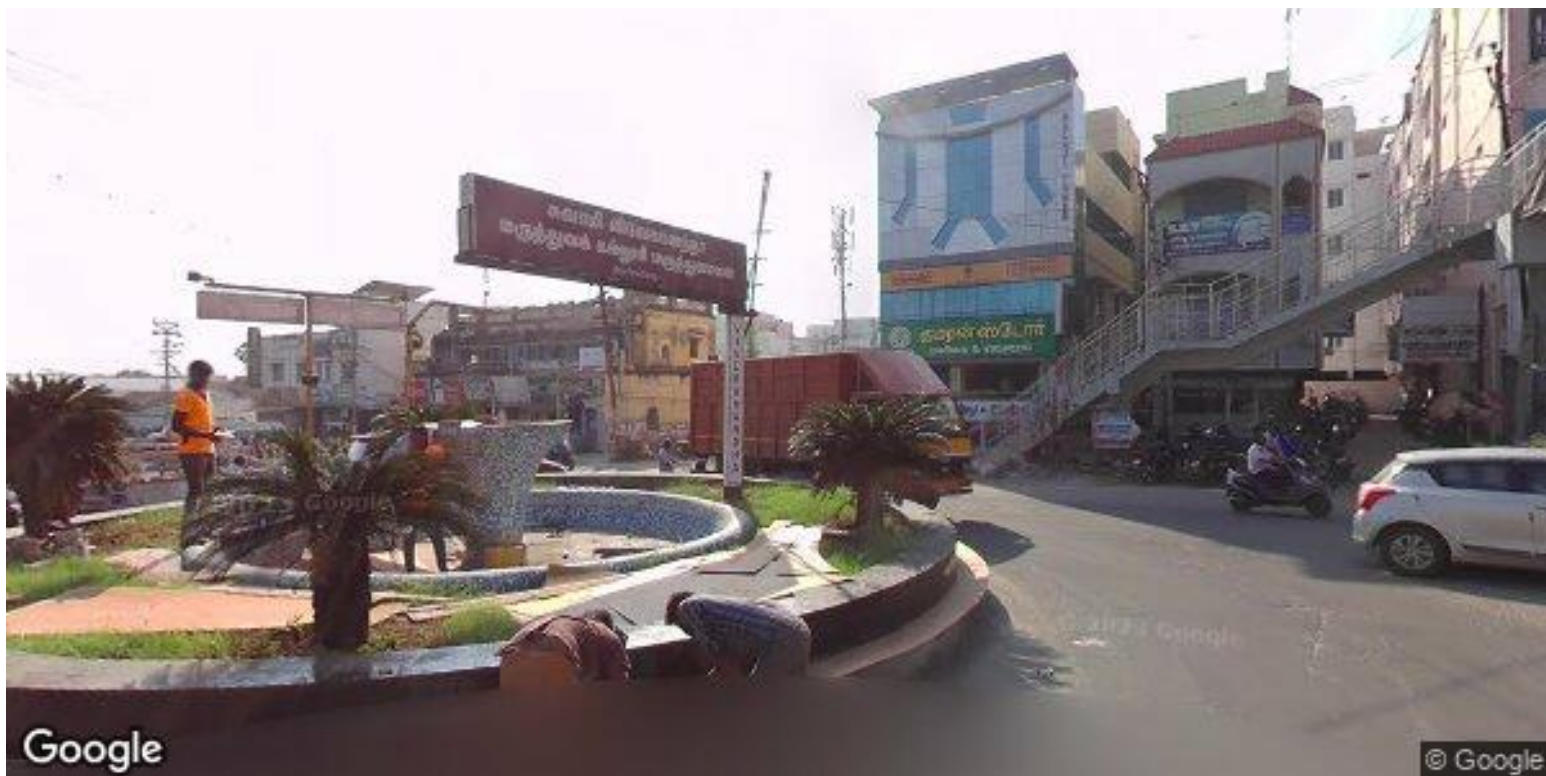
**Coordinates:** 11.38395, 77.89480

**Risk Type:** Roundabout

**Risk Level:** High

**Speed Limit:** 15 KM/Hr

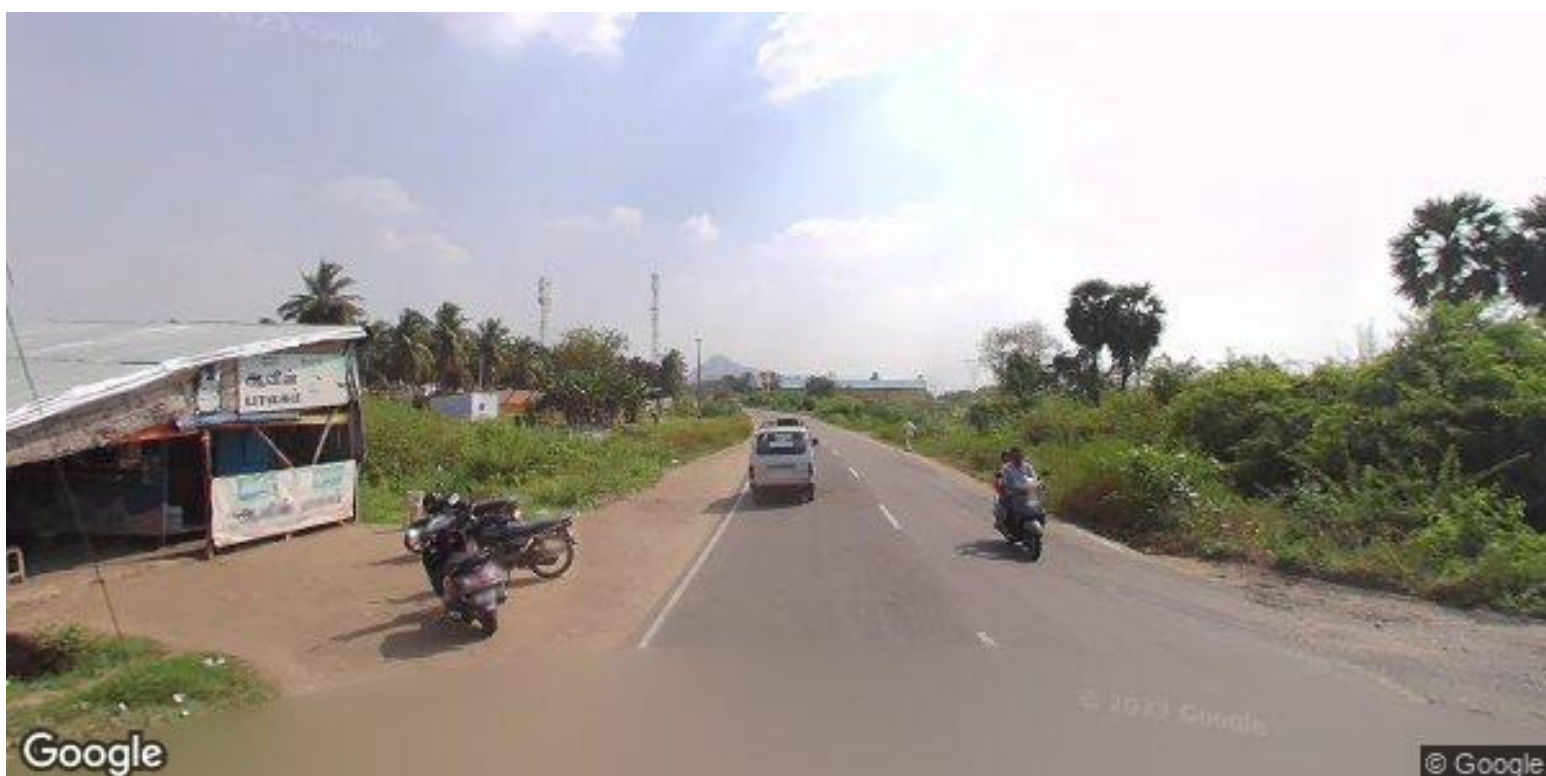
**Risk Type:** Turn

**Risk Level:** High

**Speed Limit: 15 KM/Hr**  
**Coordinates: 11.44022, 77.87546**

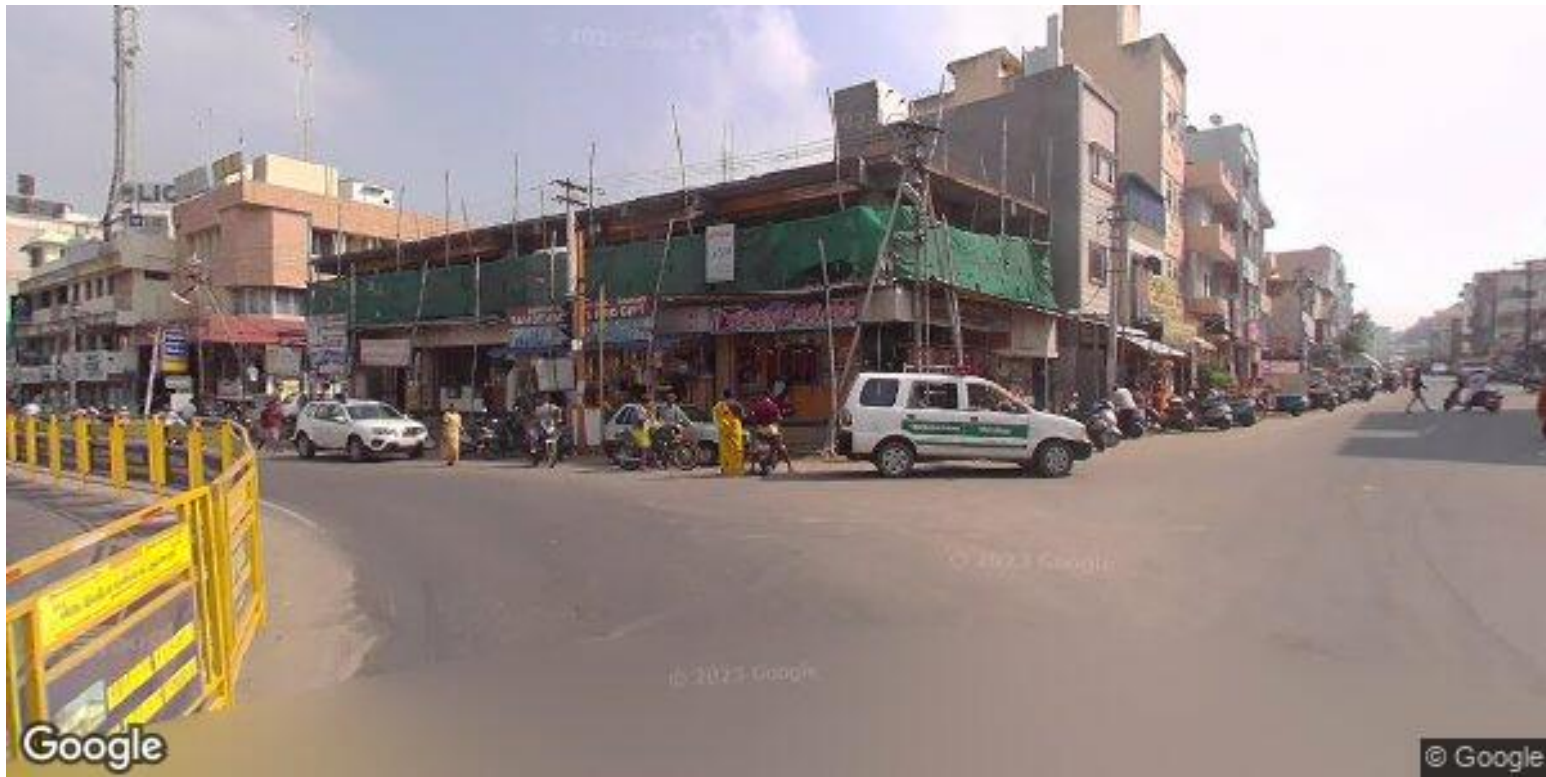
**Risk Type: Turn**  
**Risk Level: High**  
**Speed Limit: 15 KM/Hr**  
**Coordinates: 11.37868, 77.89498**

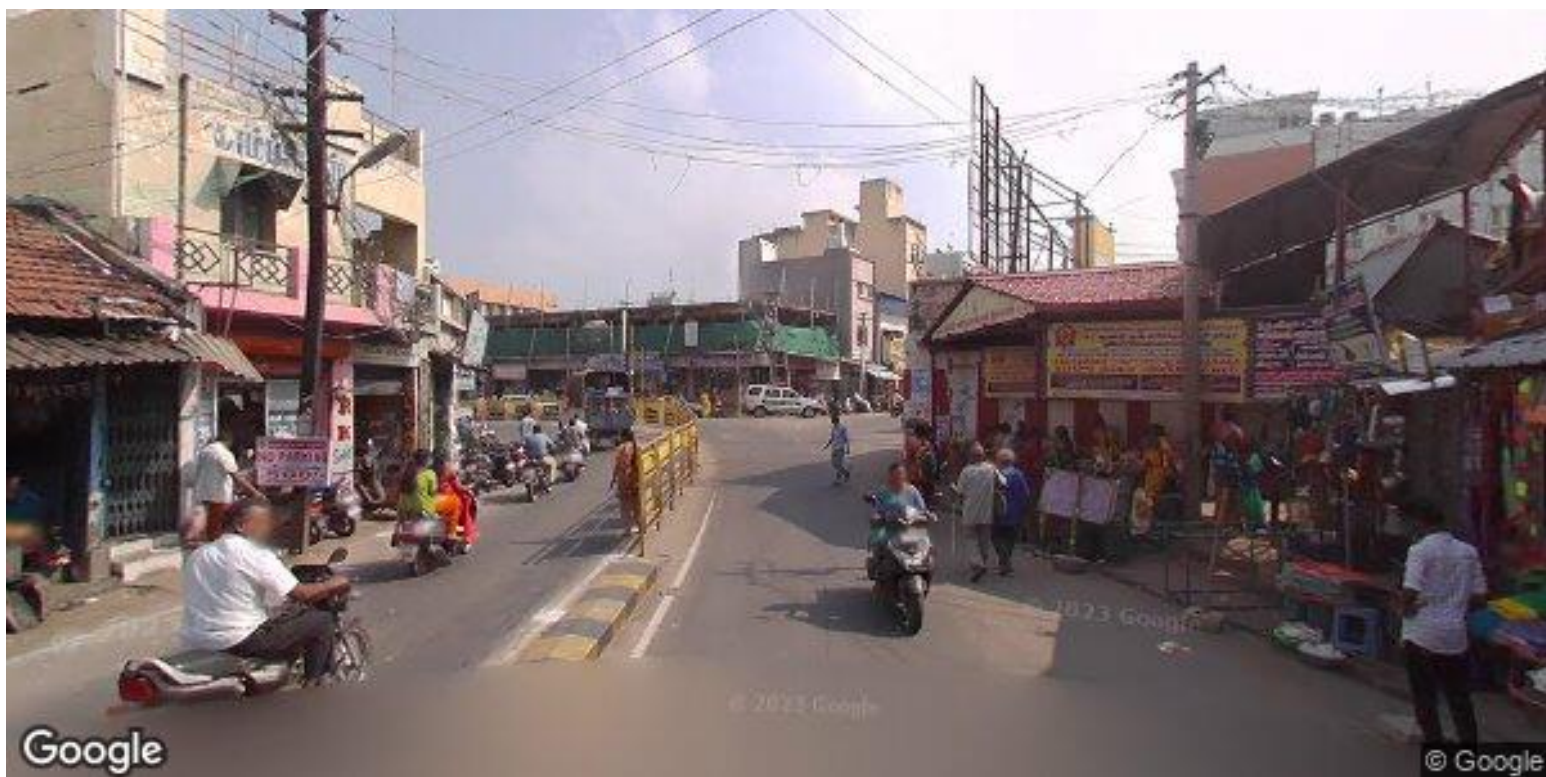
**Risk Type: Turn**  
**Risk Level: Medium**  
**Speed Limit: 30 KM/Hr**  
**Coordinates: 11.37857, 77.89473**

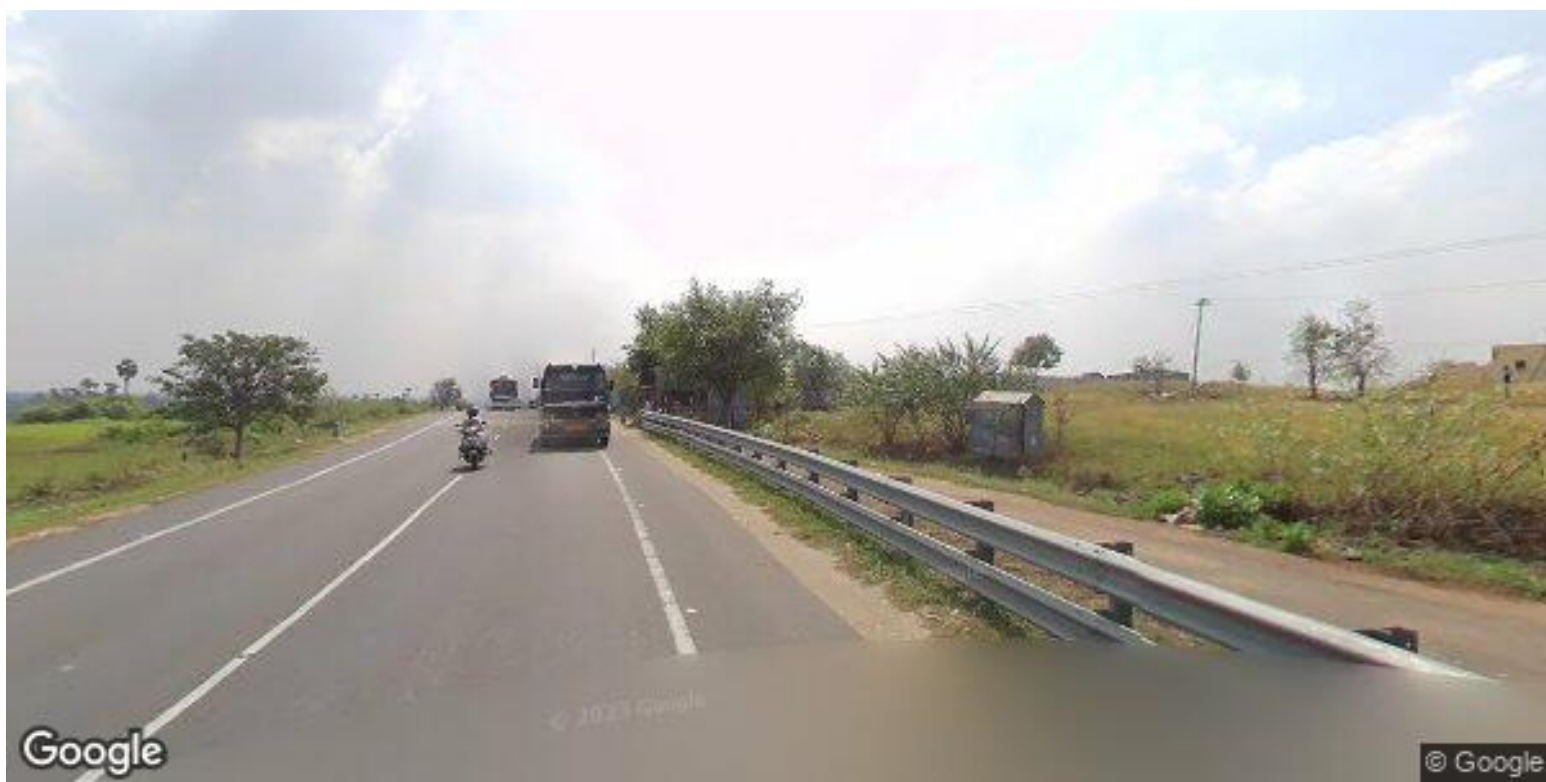
**Coordinates:** 11.34135, 77.90145

**Risk Type:** Turn

**Risk Level:** Medium

**Speed Limit:** 30 KM/Hr

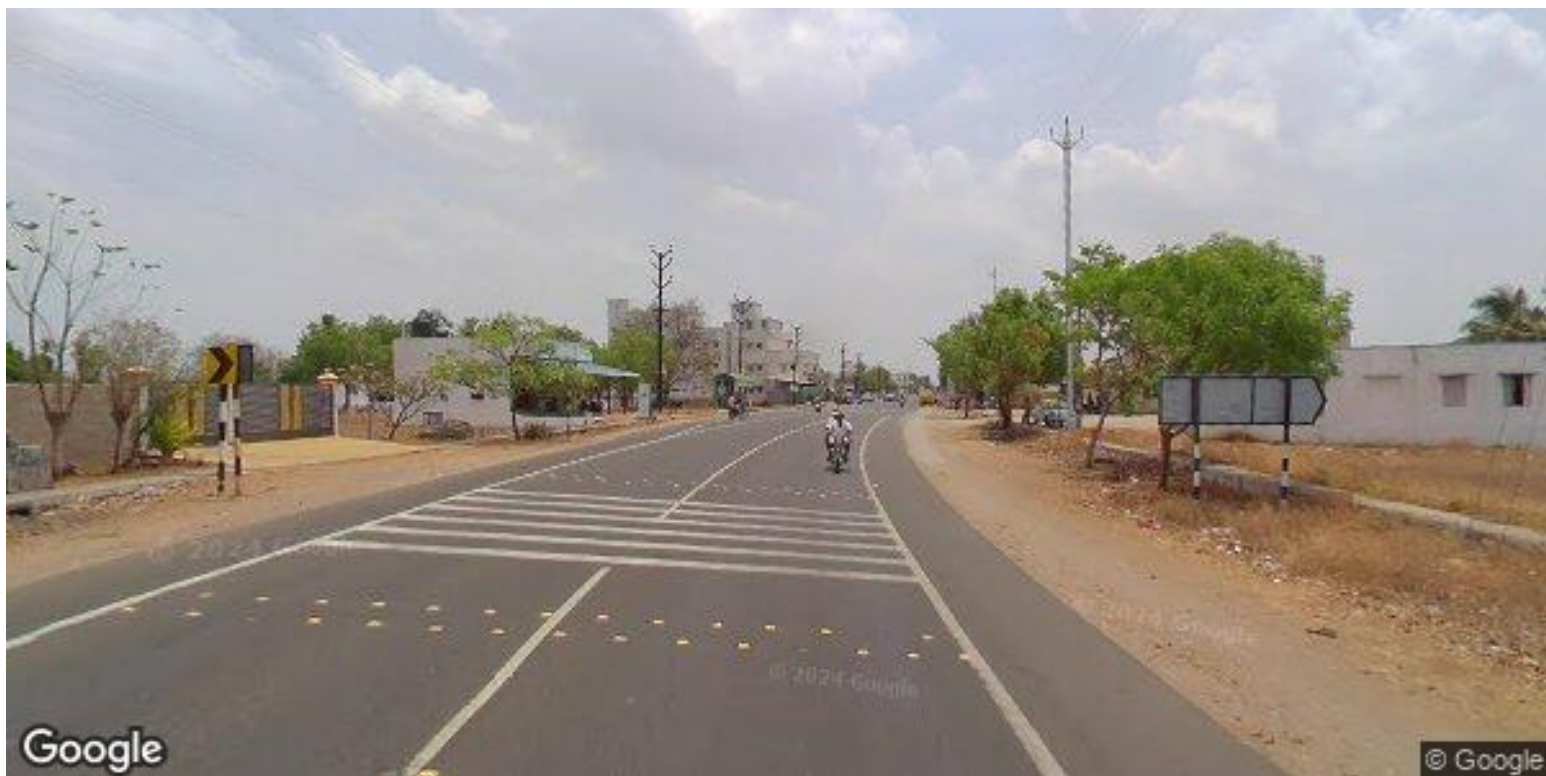
**Coordinates:** 11.26050, 77.94758

**Risk Type:** Turn

**Risk Level:** Medium

**Speed Limit:** 30 KM/Hr

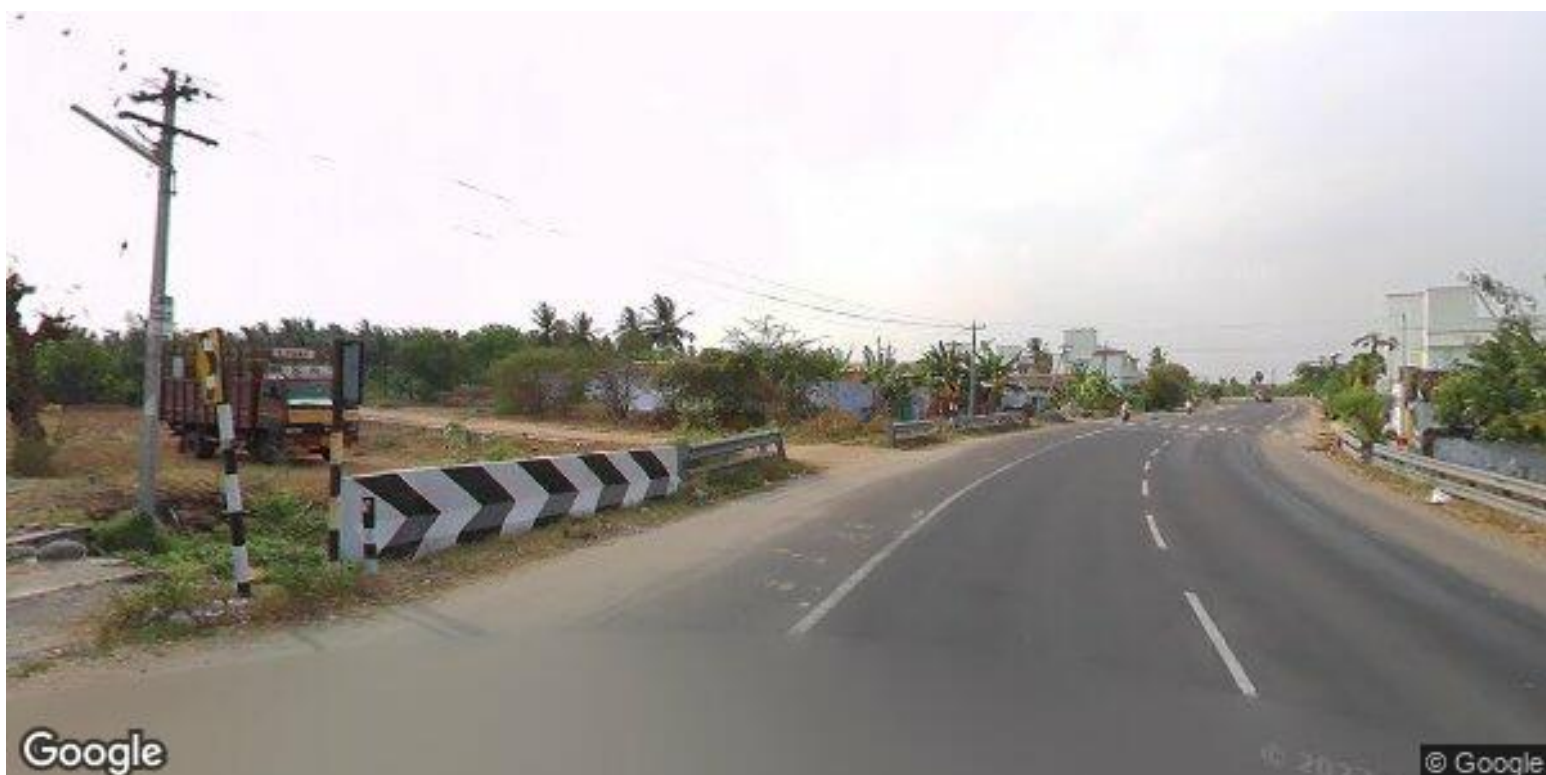
**Coordinates:** 11.16755, 78.01568

**Risk Type:** Turn

**Risk Level:** Medium

**Speed Limit:** 30 KM/Hr

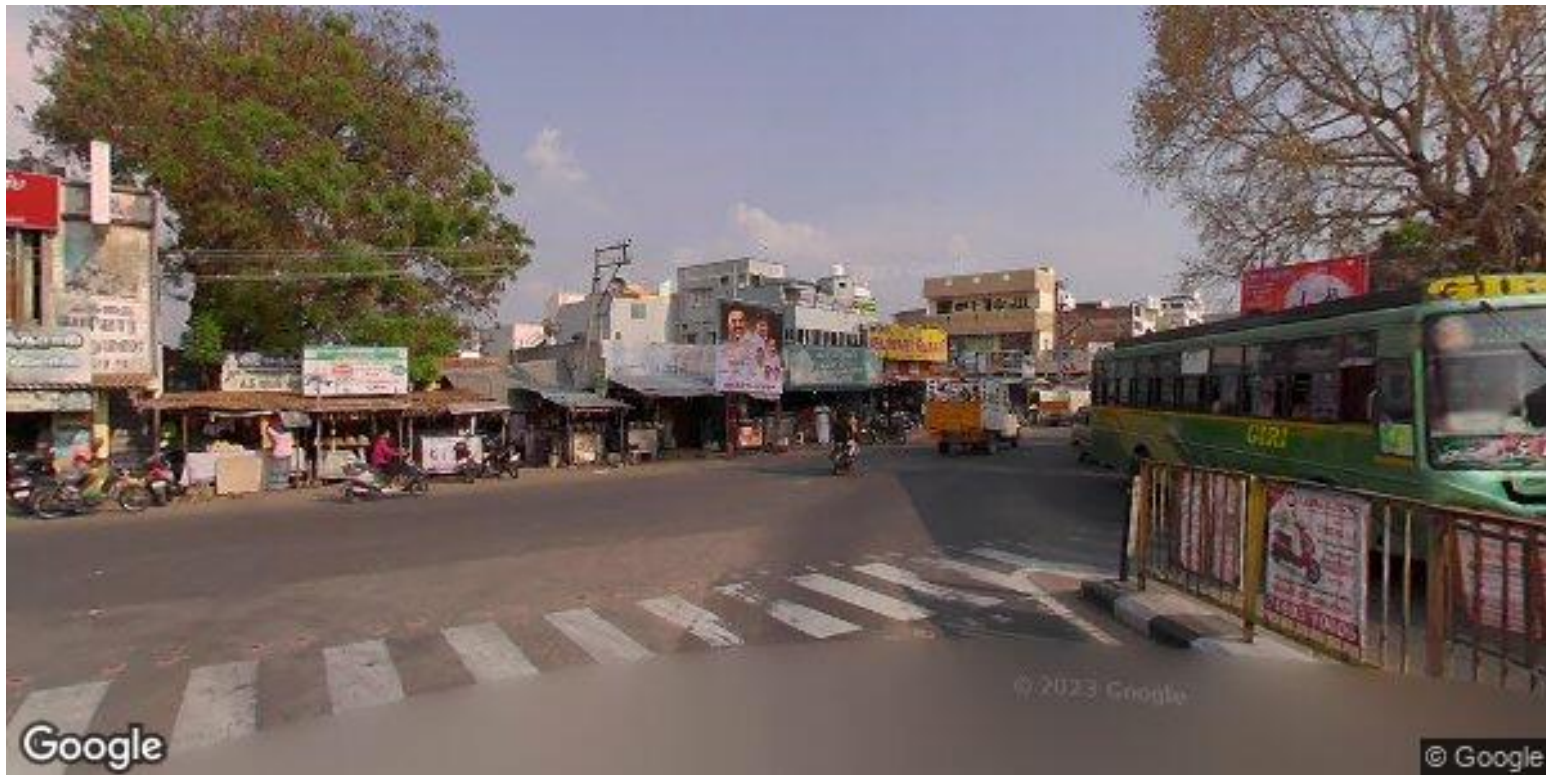
**Coordinates:** 11.15579, 78.02169

**Risk Type:** Turn

**Risk Level:** Medium

**Speed Limit:** 30 KM/Hr

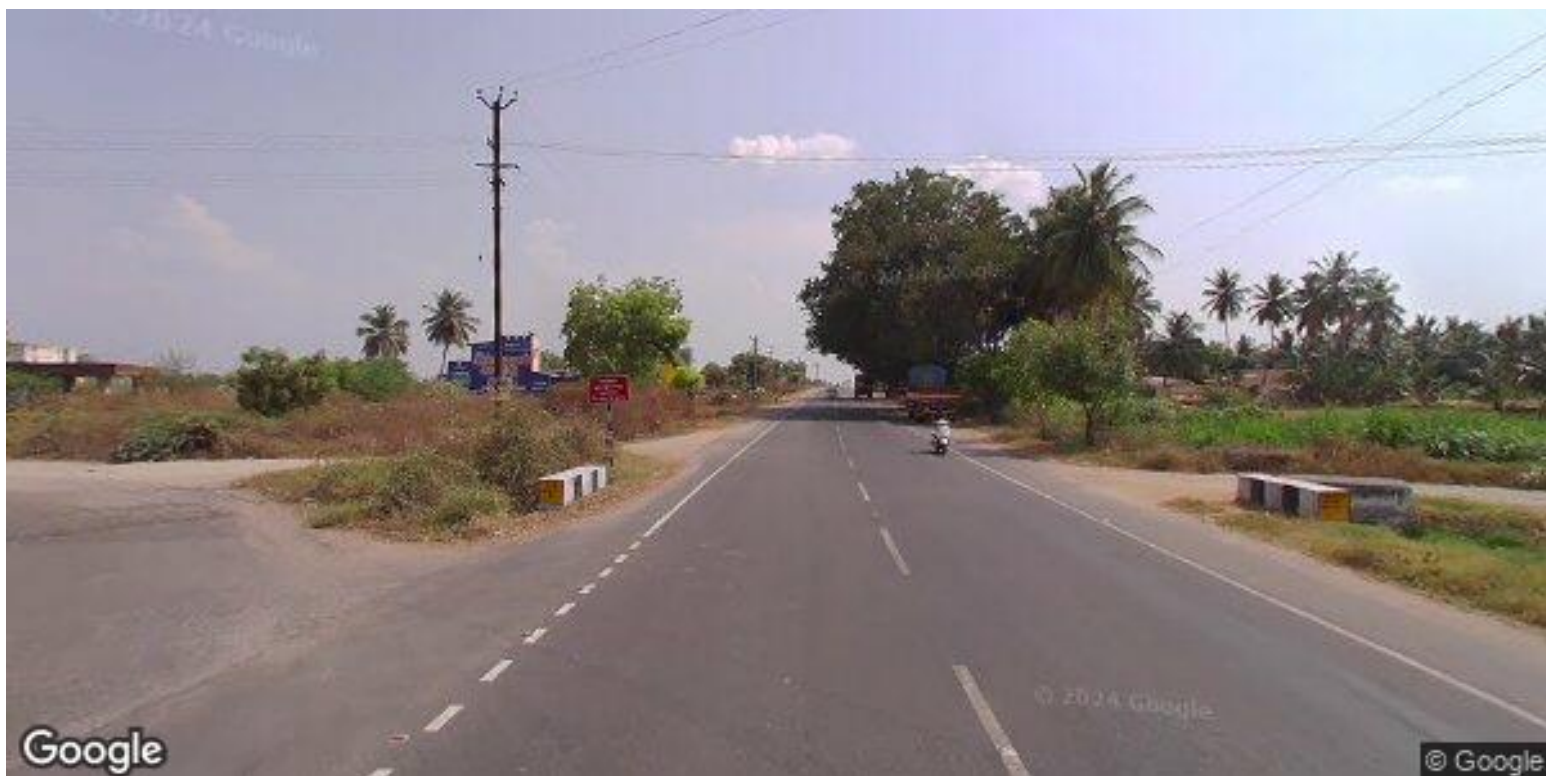
**Coordinates:** 11.14545, 78.02208

**Risk Type:** Turn

**Risk Level:** High

**Speed Limit:** 15 KM/Hr

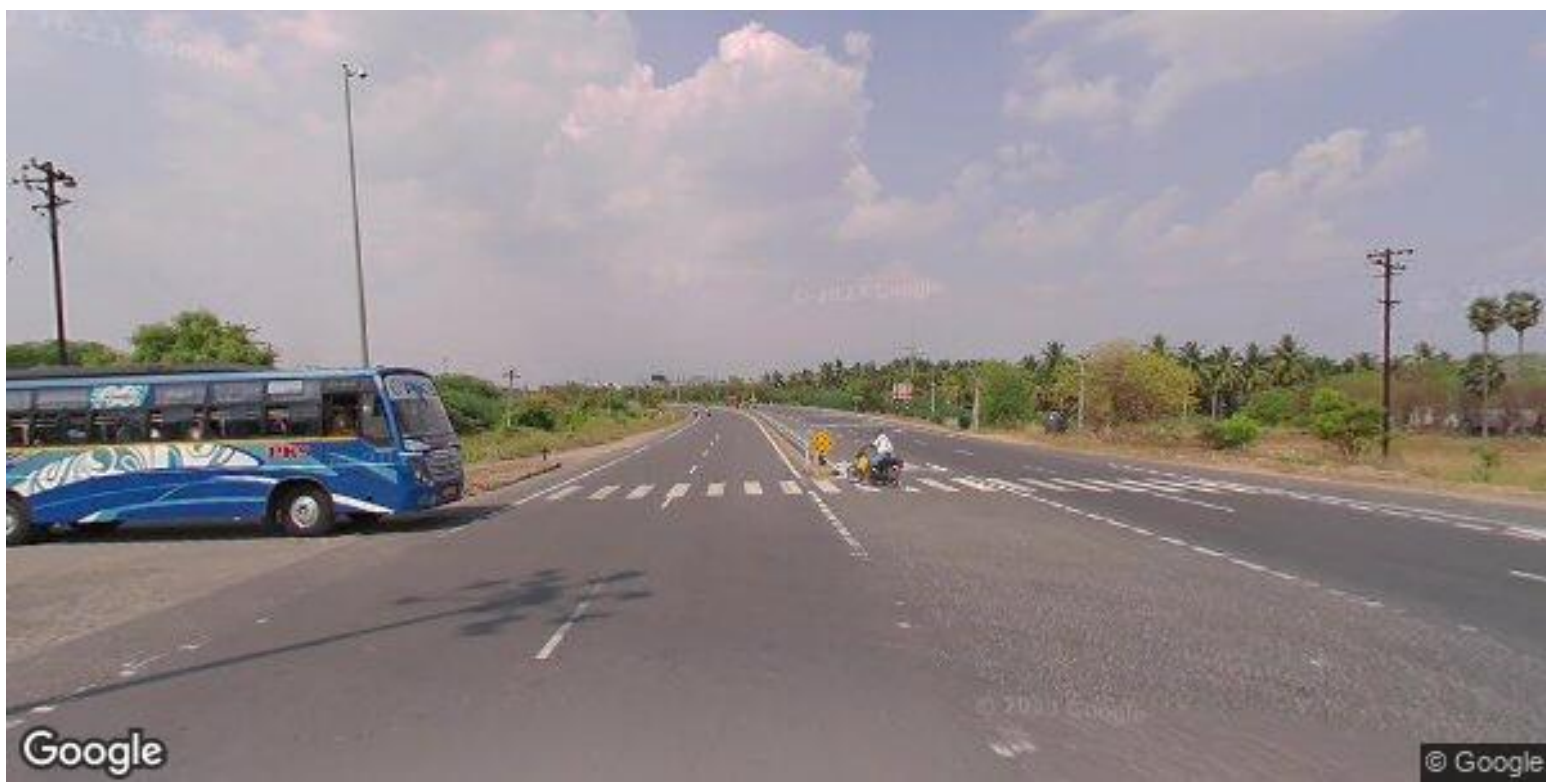
**Coordinates:** 11.14485, 78.02282

**Risk Type:** Turn

**Risk Level:** High

**Speed Limit:** 15 KM/Hr

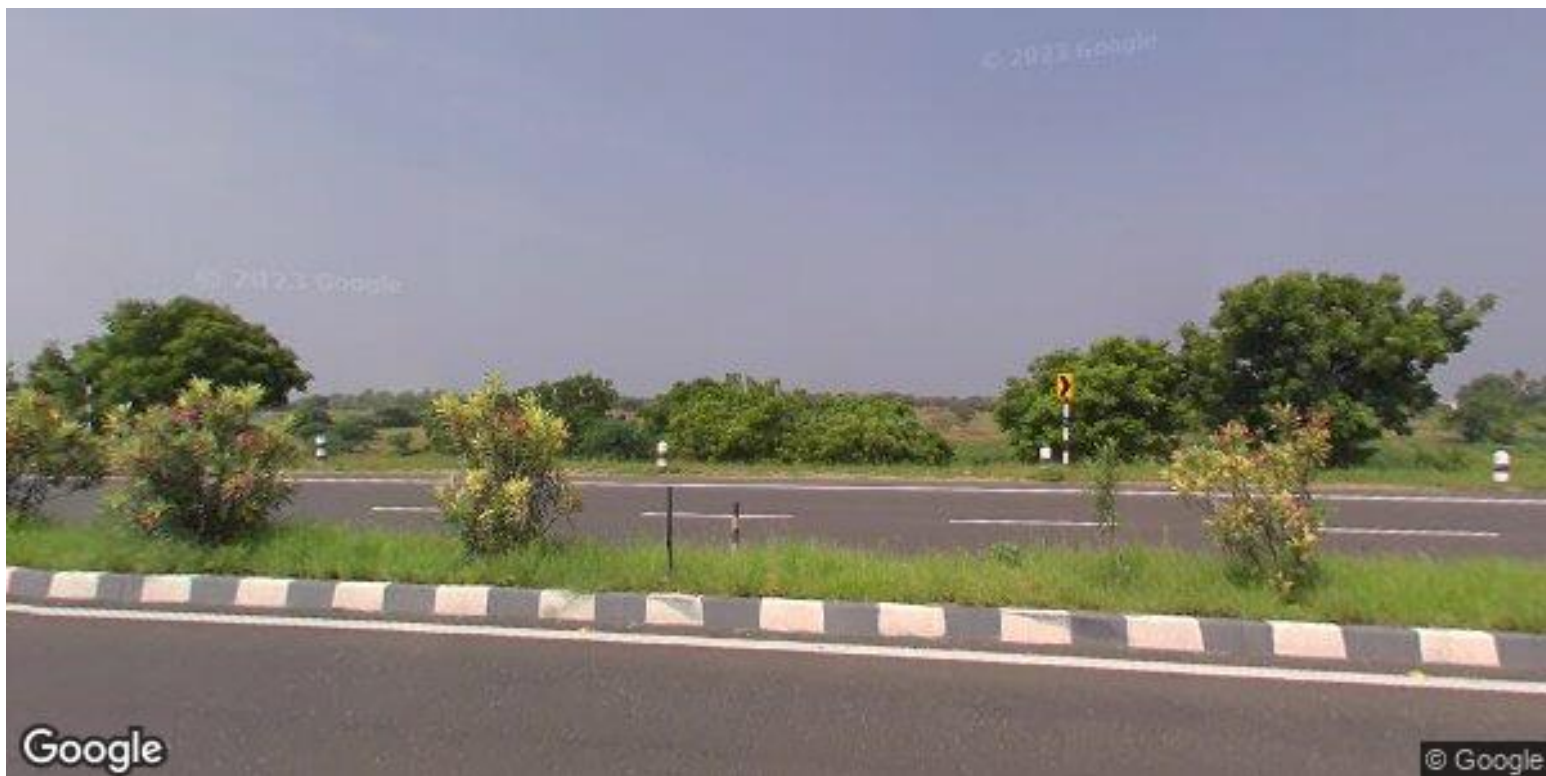
**Coordinates:** 10.79871, 77.92719

**Risk Type:** Turn

**Risk Level:** Medium

**Speed Limit:** 30 KM/Hr

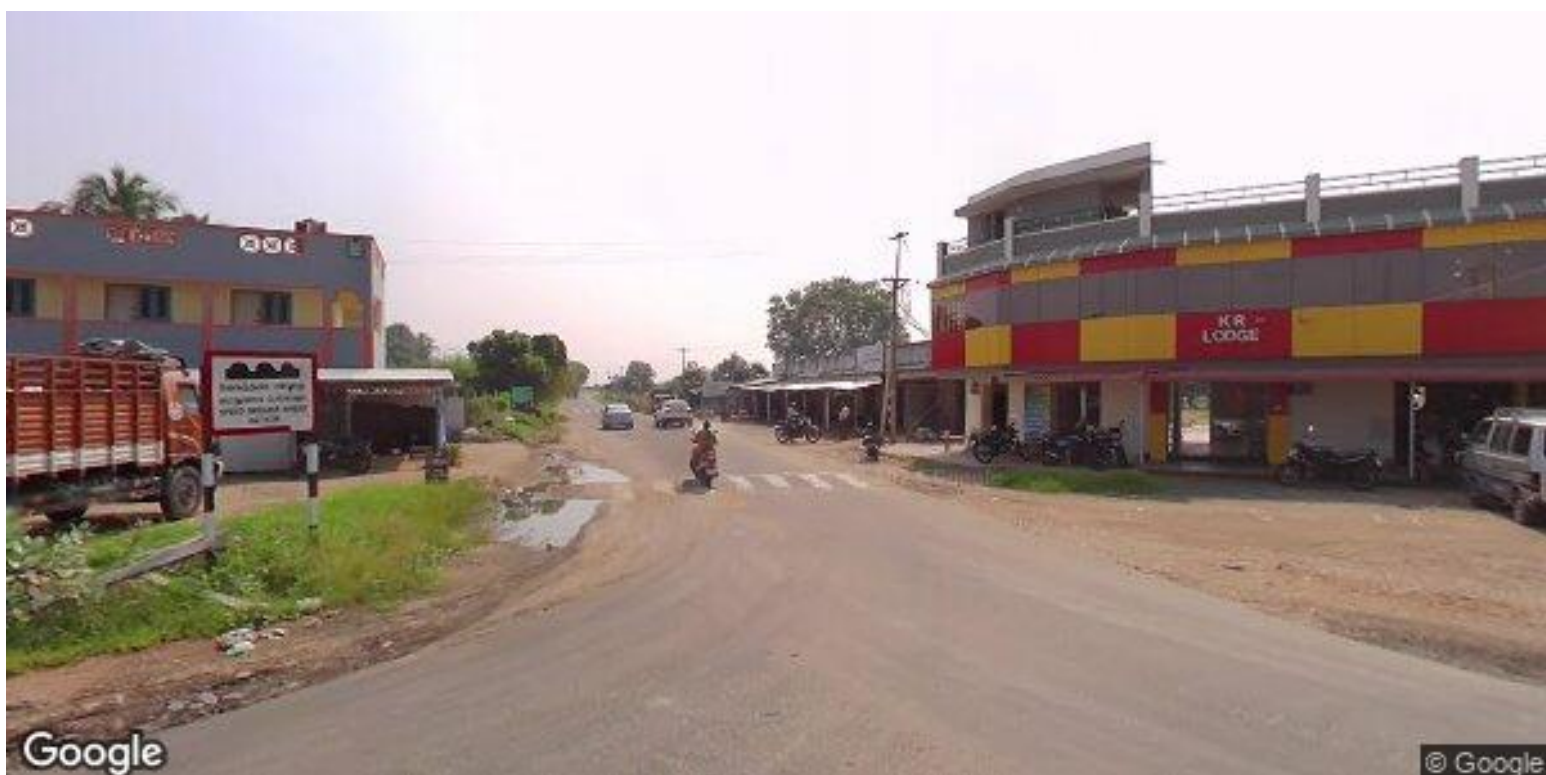
**Risk Type:** Blind Spot  
**Risk Level:** Blind Spot  
**Speed Limit:** 10 KM/Hr  
**Coordinates:** 10.77306, 77.91788

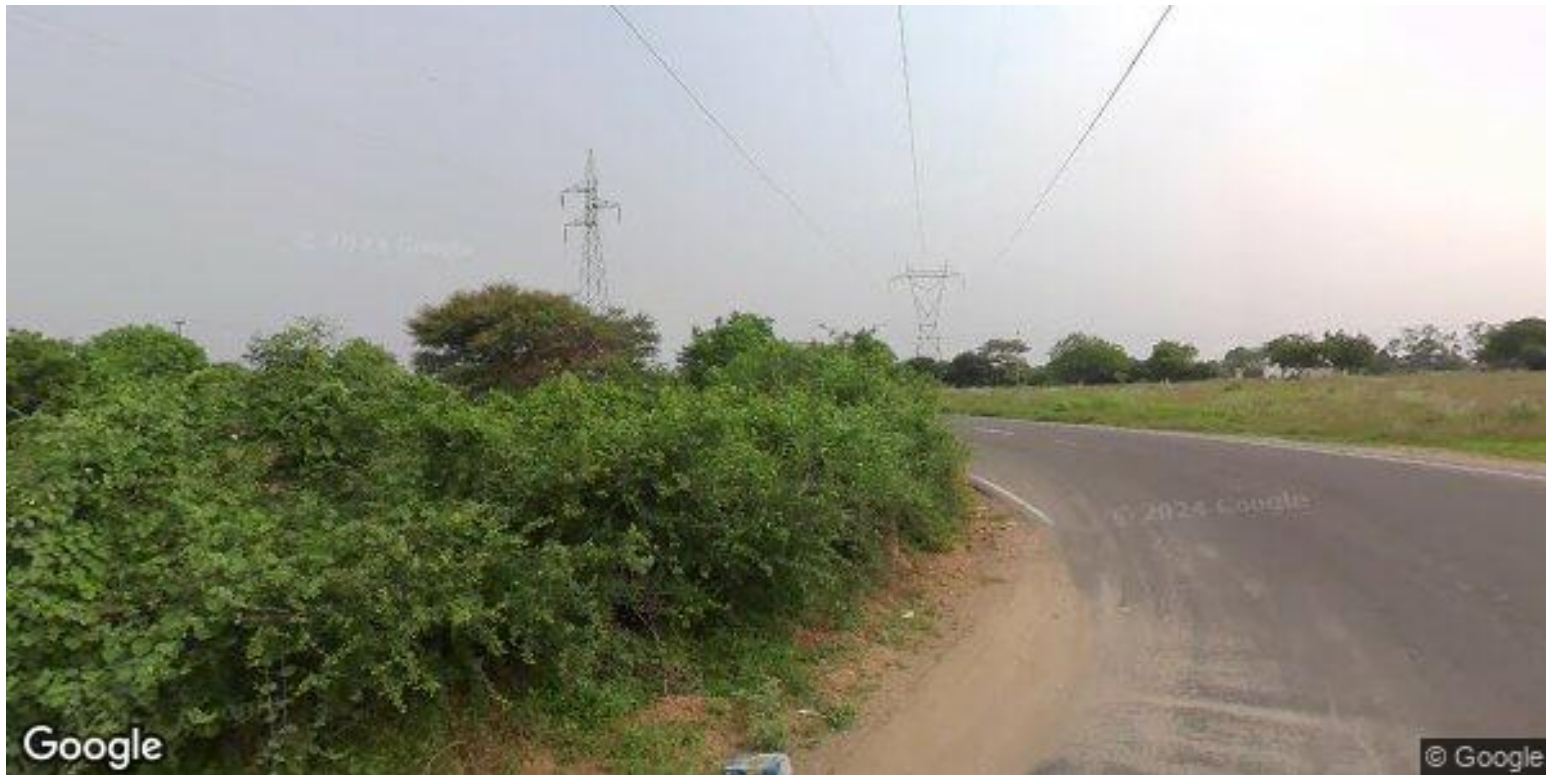
**Risk Type:** Turn  
**Risk Level:** High  
**Speed Limit:** 15 KM/Hr  
**Coordinates:** 10.77230, 77.93223

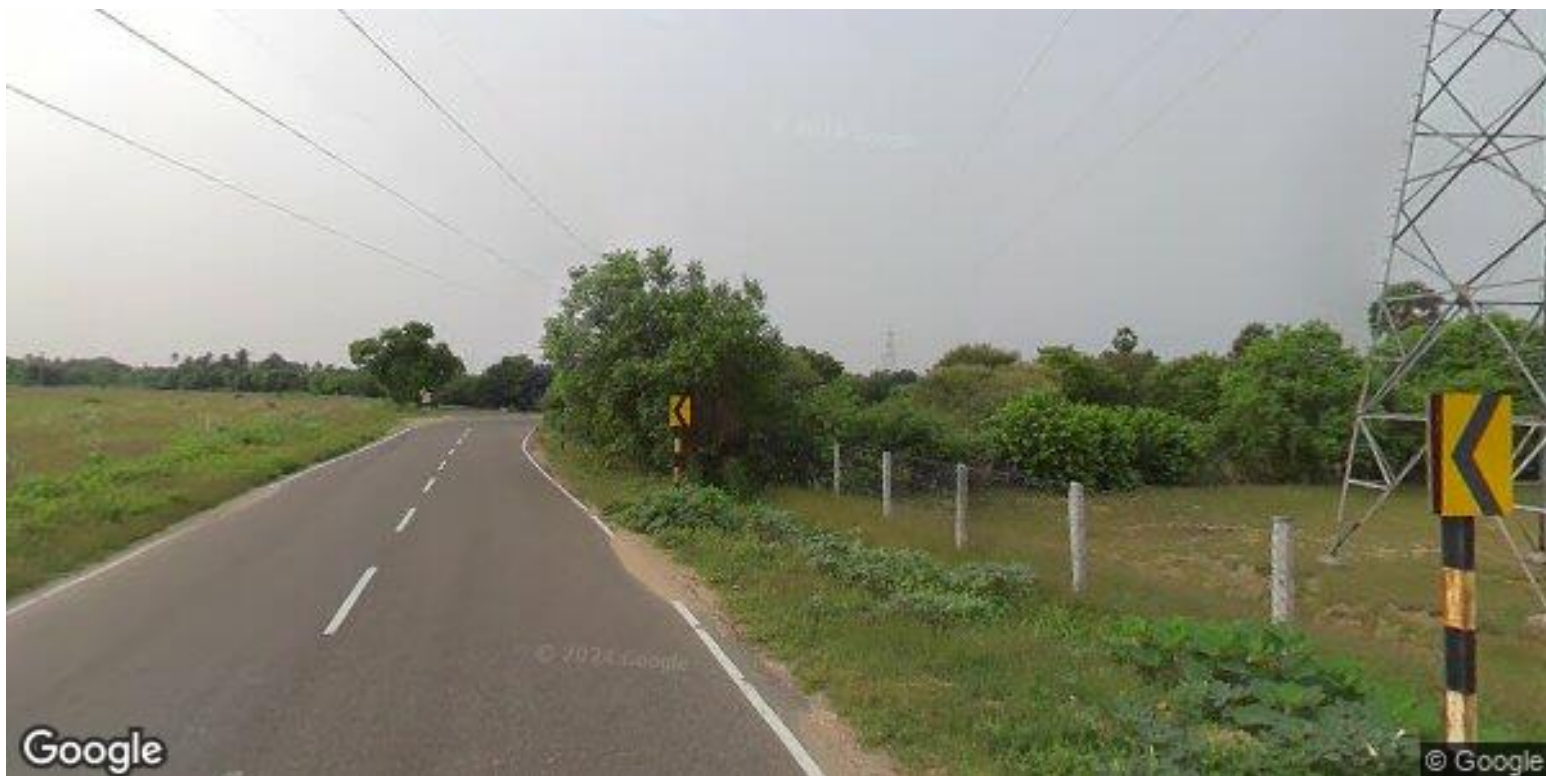
**Risk Type:** Turn  
**Risk Level:** High  
**Speed Limit:** 15 KM/Hr  
**Coordinates:** 10.77294, 77.93238

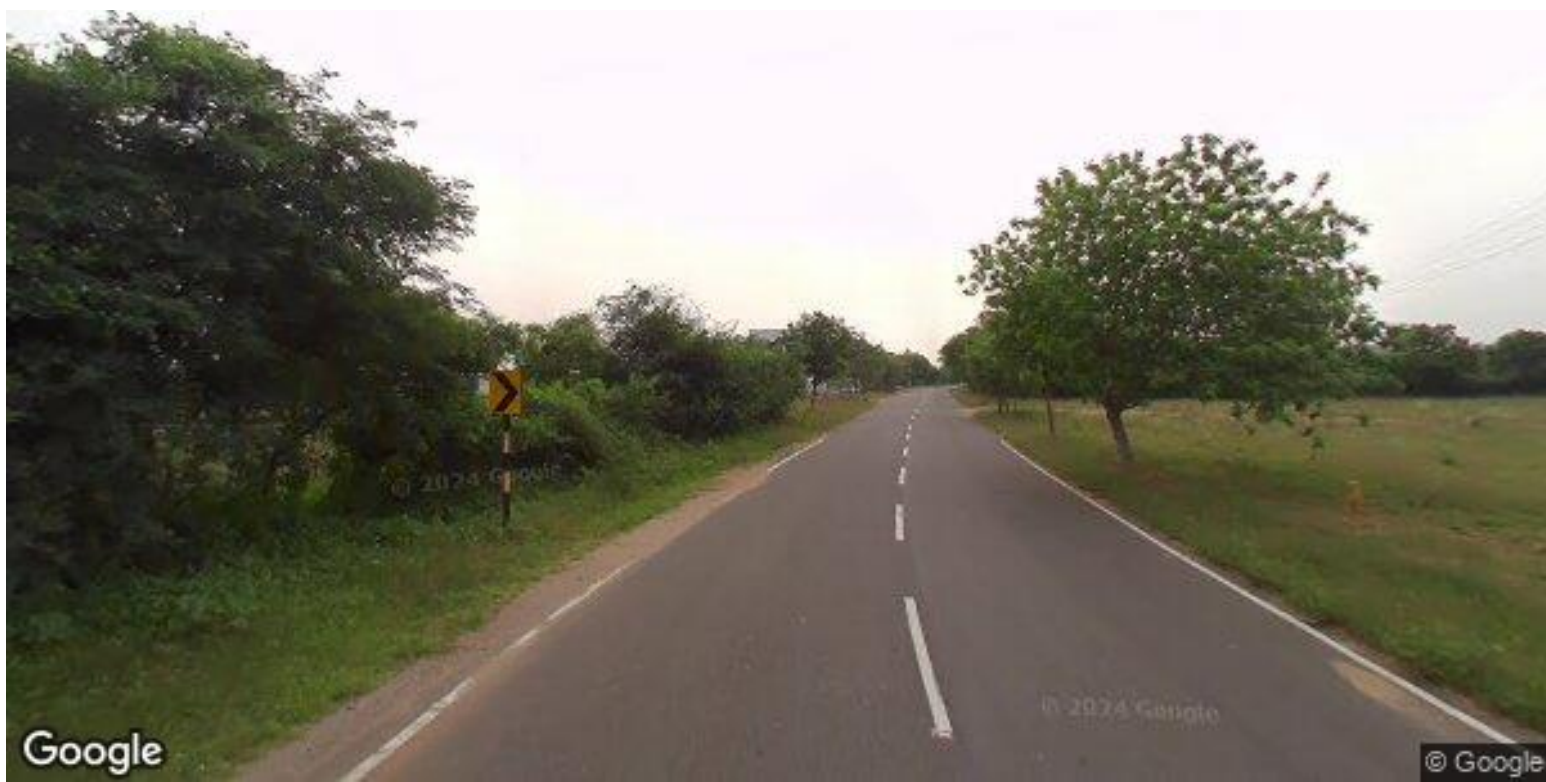
**Coordinates:** 10.77303, 77.93269

**Risk Type:** Turn

**Risk Level:** Medium

**Speed Limit:** 30 KM/Hr

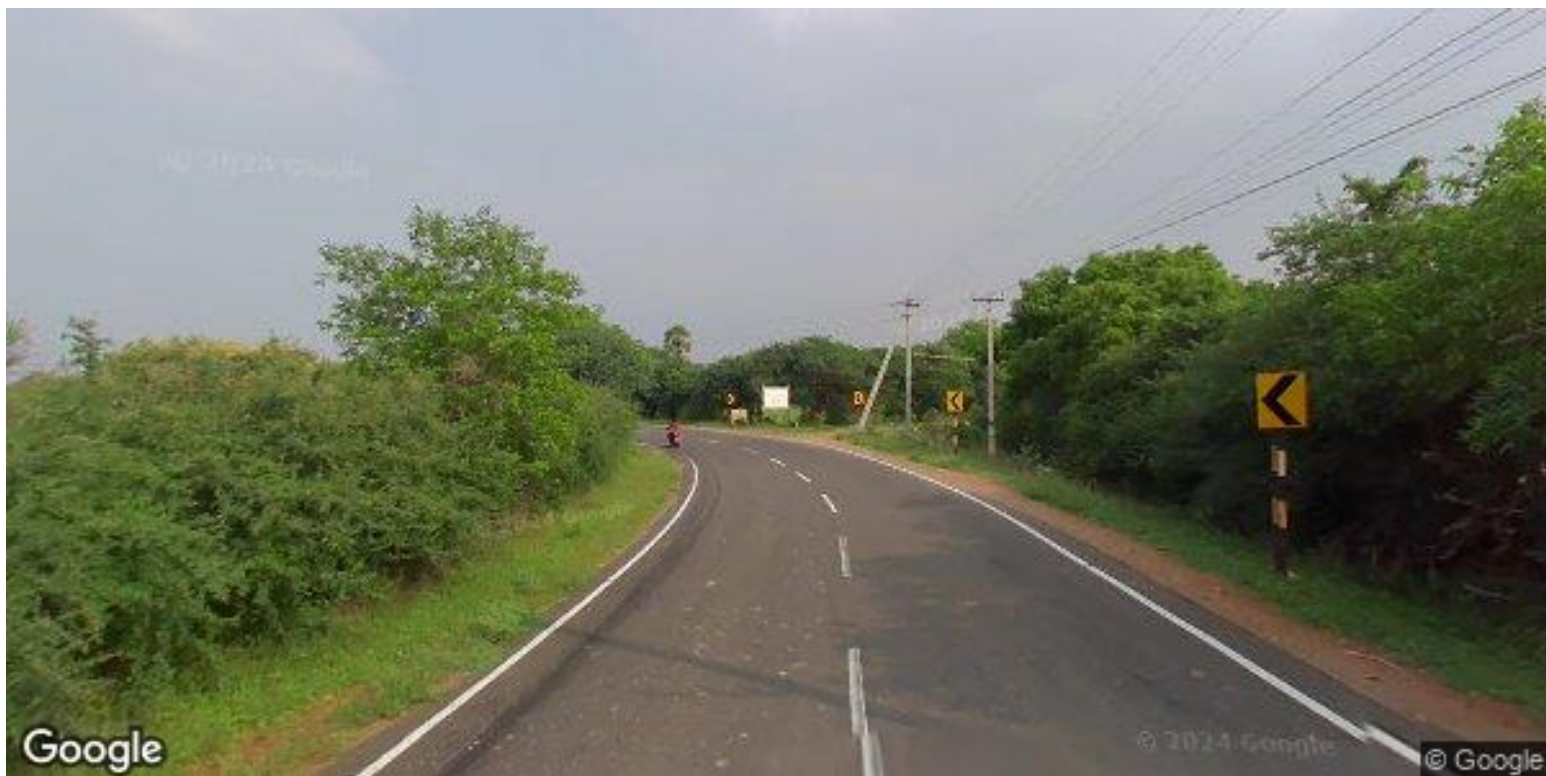
**Coordinates:** 10.76865, 77.93912

**Risk Type:** Turn

**Risk Level:** Medium

**Speed Limit:** 30 KM/Hr

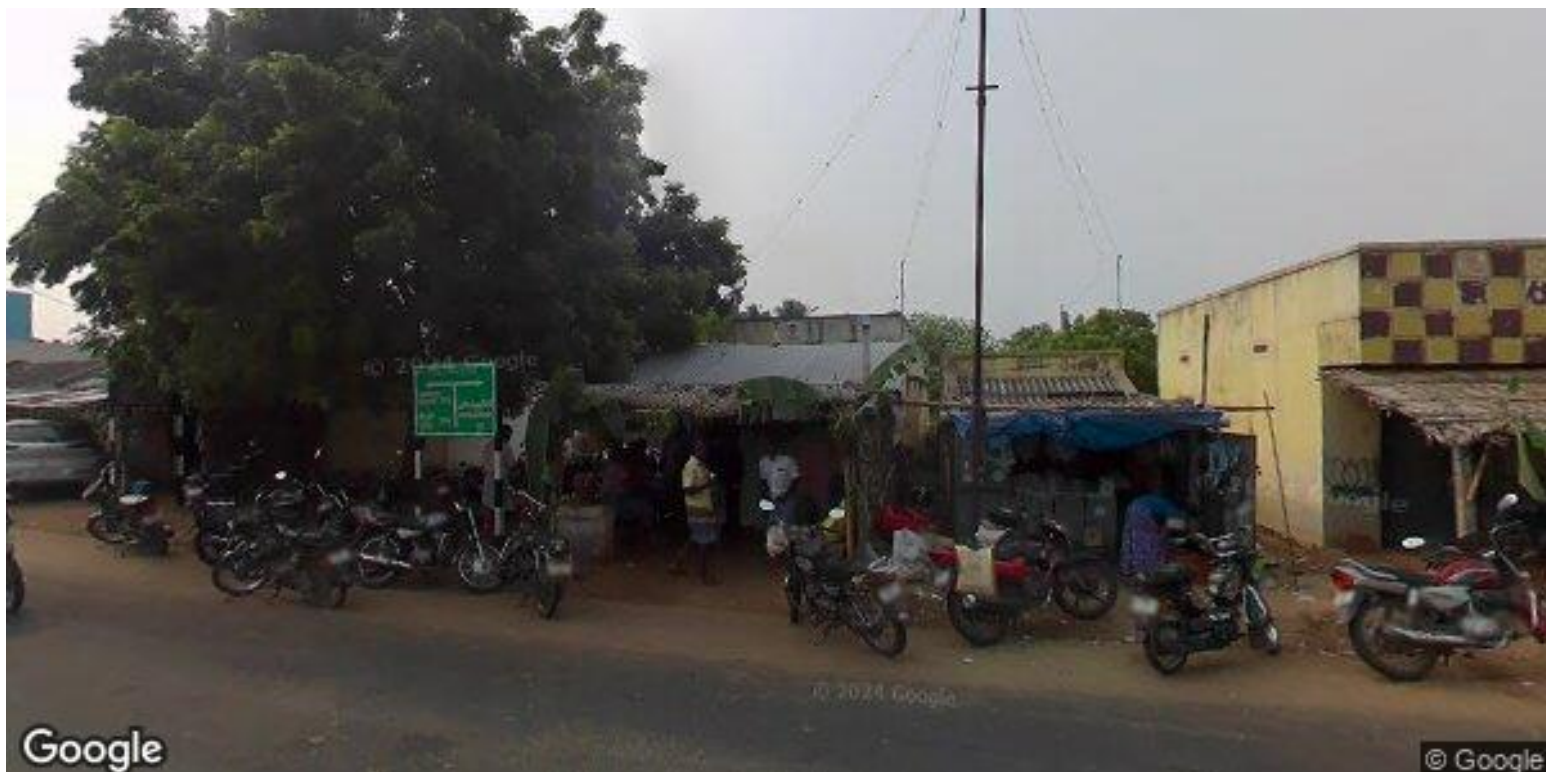
**Coordinates:** 10.76392, 77.96575

**Risk Type:** Turn

**Risk Level:** Medium

**Speed Limit:** 30 KM/Hr
