# IndianOil

## JOURNEY RISK MANAGEMENT (JRM) STUDY

### Salem Terminal TO RAJ FUEL SERVICE

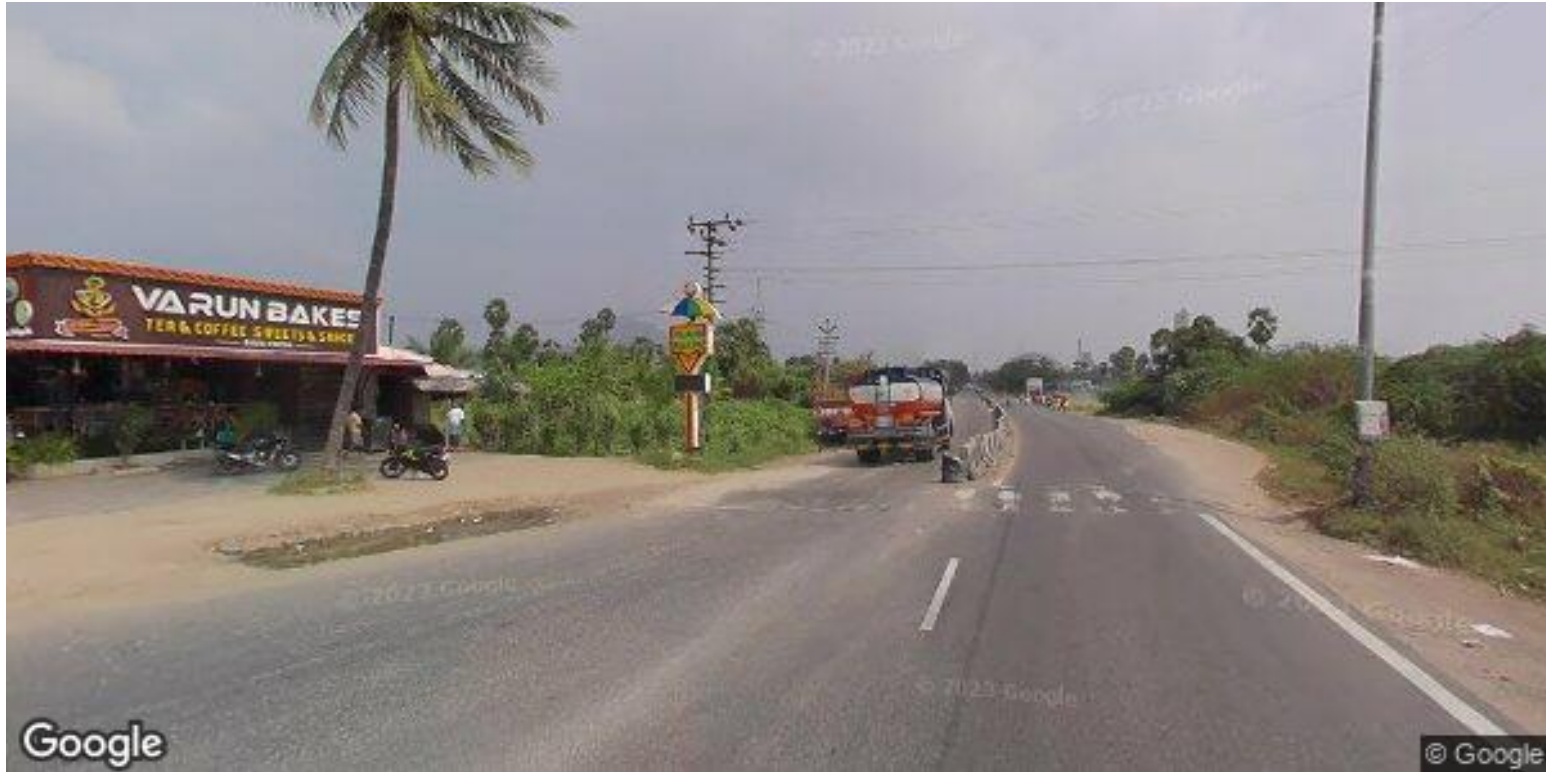
**Coordinates:** 11.45543, 77.81740

**Risk Type:** Blind Spot

**Risk Level:** Blind Spot

**Speed Limit:** 10 KM/Hr

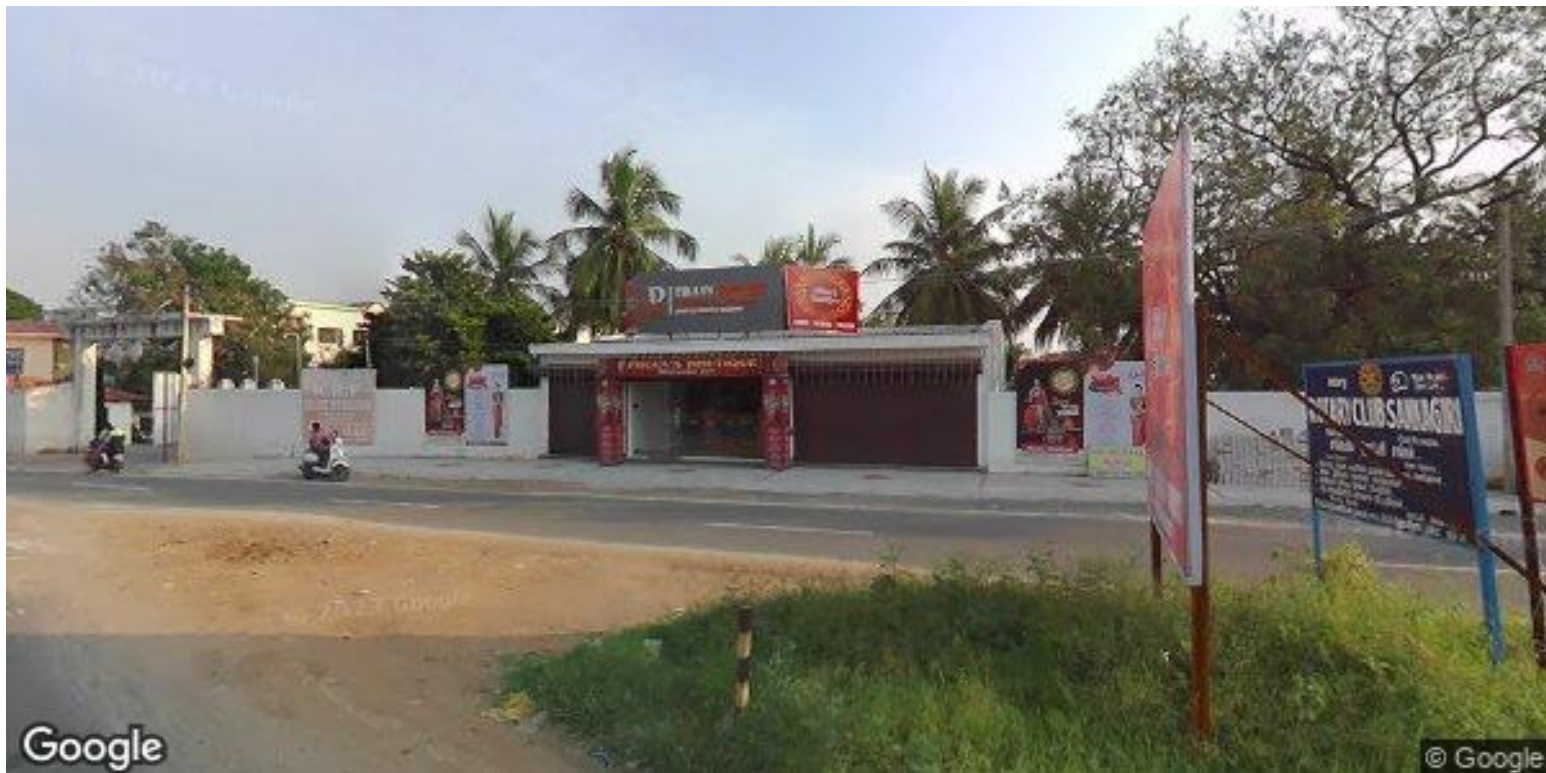
**Coordinates:** 11.45516, 77.81346

**Risk Type:** Turn

**Risk Level:** High

**Speed Limit:** 15 KM/Hr

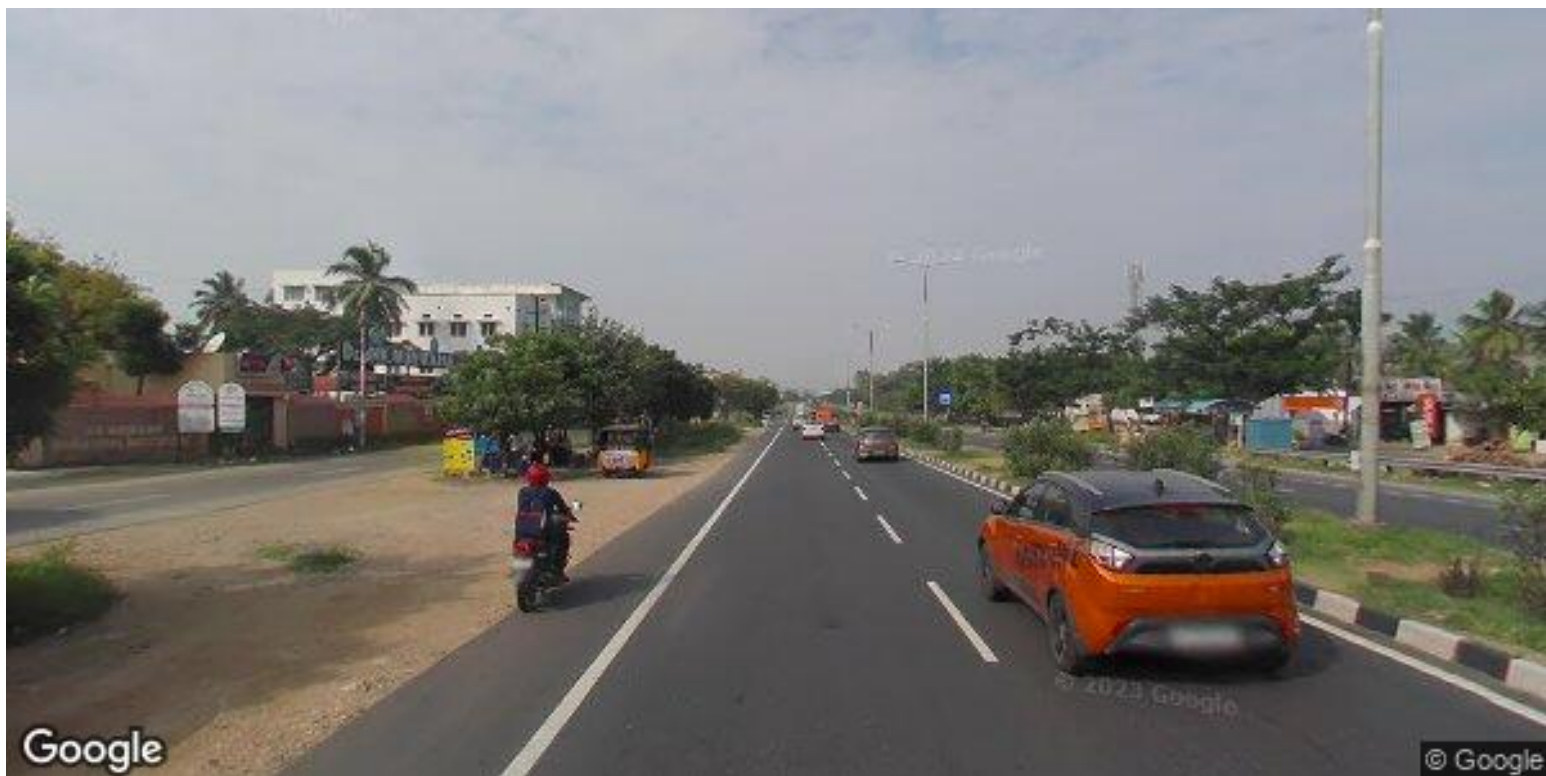
**Coordinates:** 11.44530, 77.72783

**Risk Type:** Blind Spot

**Risk Level:** Blind Spot

**Speed Limit:** 10 KM/Hr

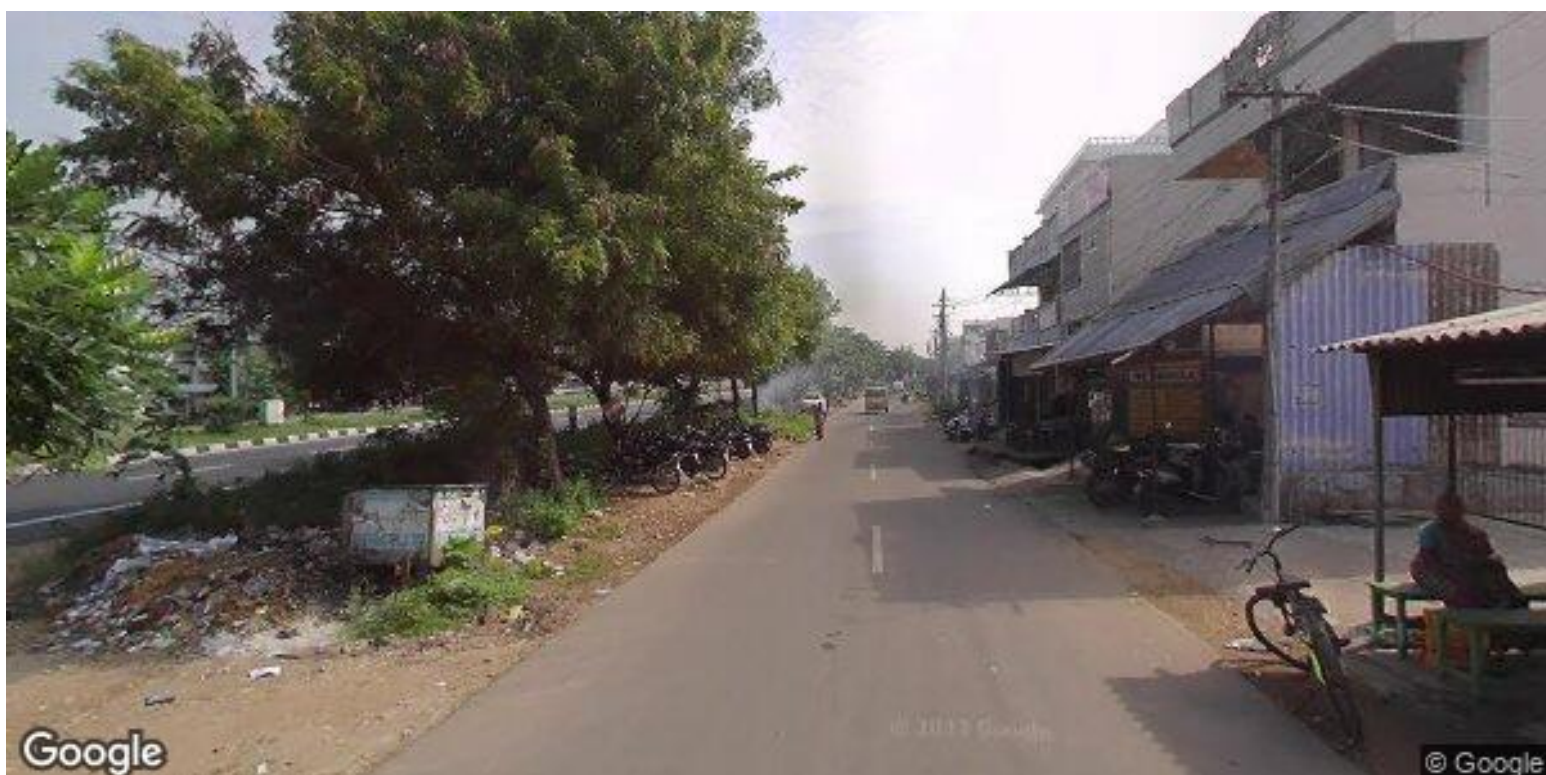
**Risk Type:** Blind Spot  
**Risk Level:** Blind Spot  
**Speed Limit:** 10 KM/Hr  
**Coordinates:** 11.44513, 77.72786

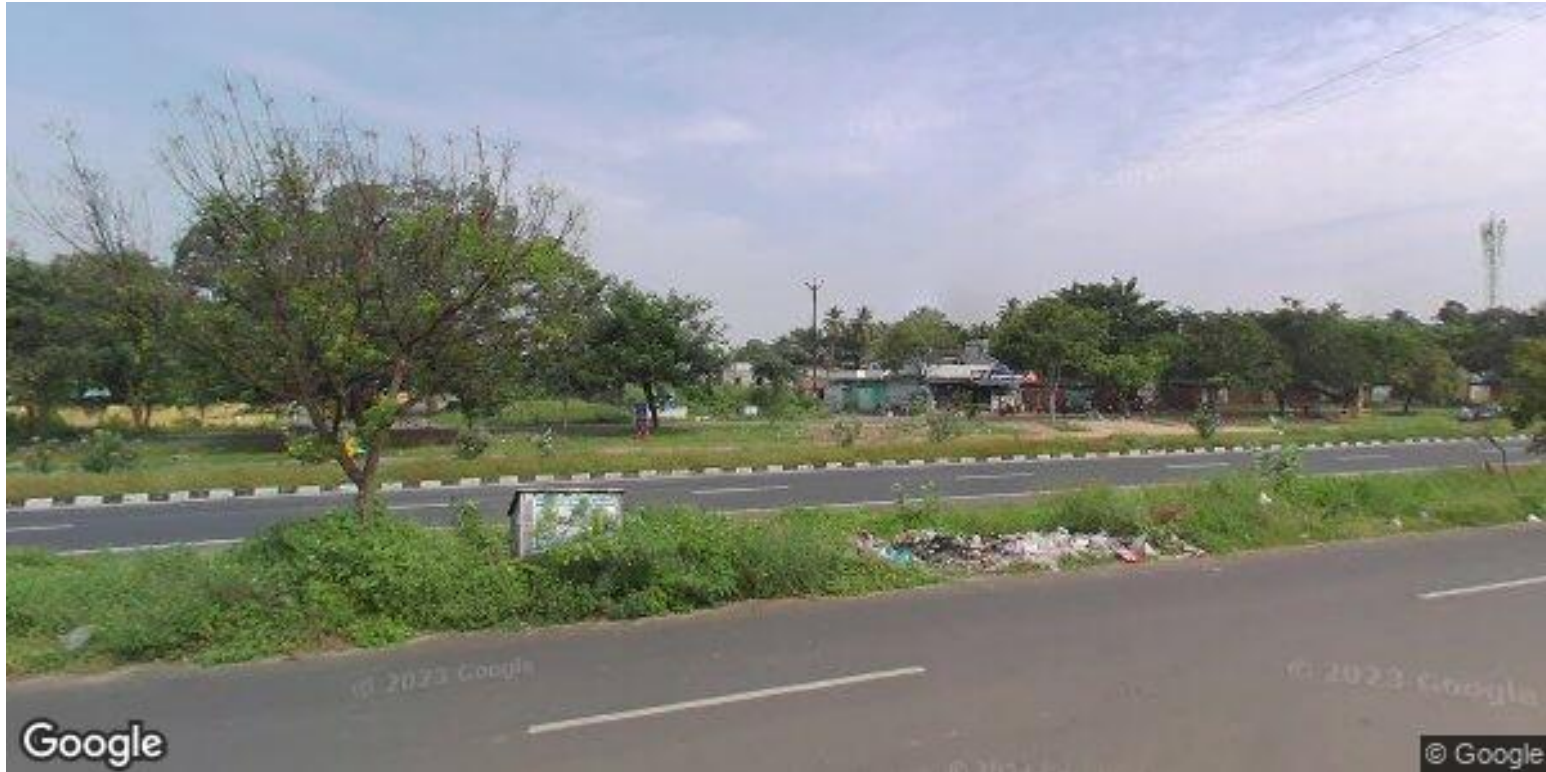
**Risk Type:** Turn  
**Risk Level:** High  
**Speed Limit:** 15 KM/Hr  
**Coordinates:** 11.44474, 77.72485

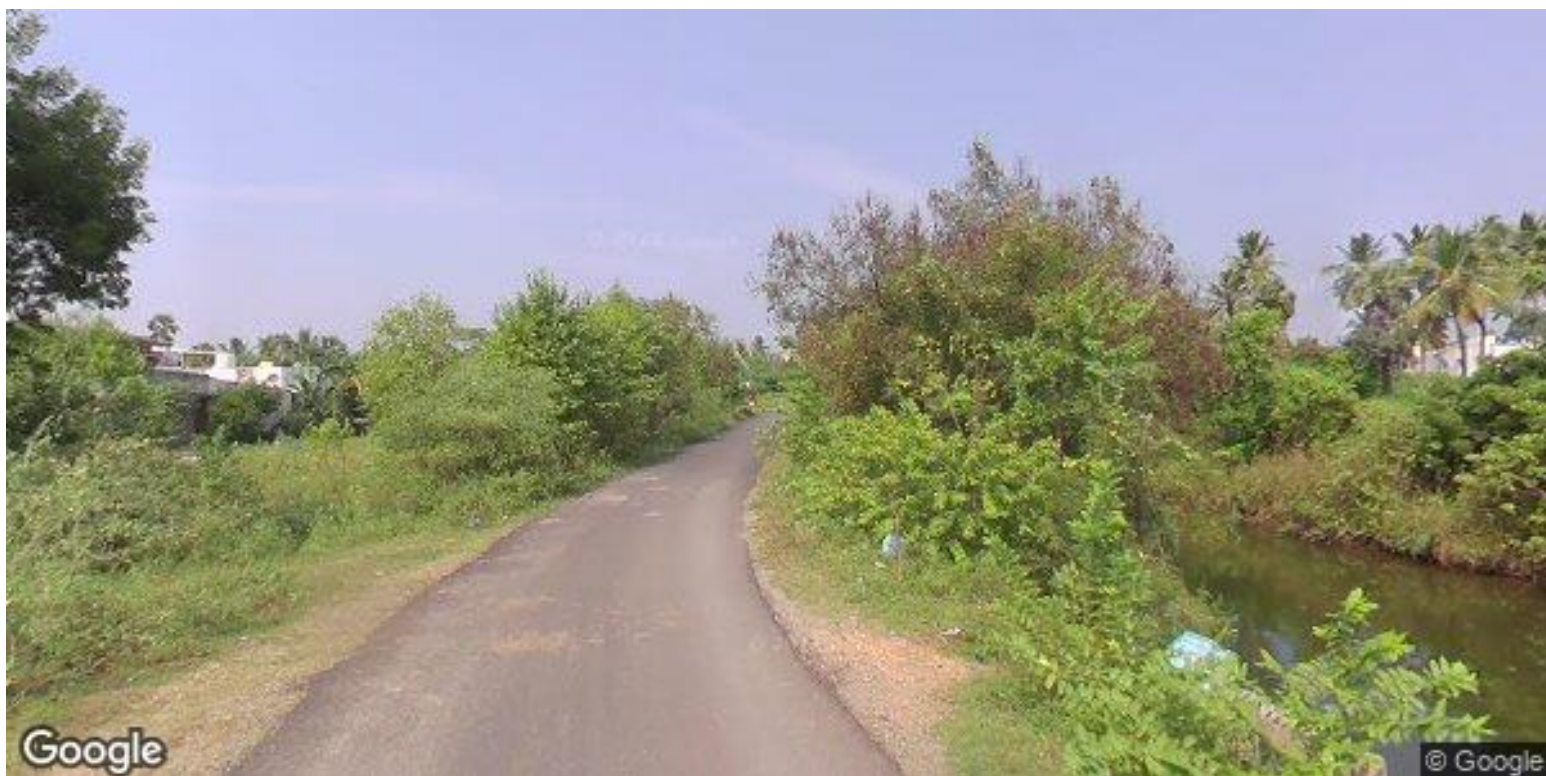
**Risk Type:** Turn  
**Risk Level:** High  
**Speed Limit:** 15 KM/Hr  
**Coordinates:** 11.43618, 77.72111

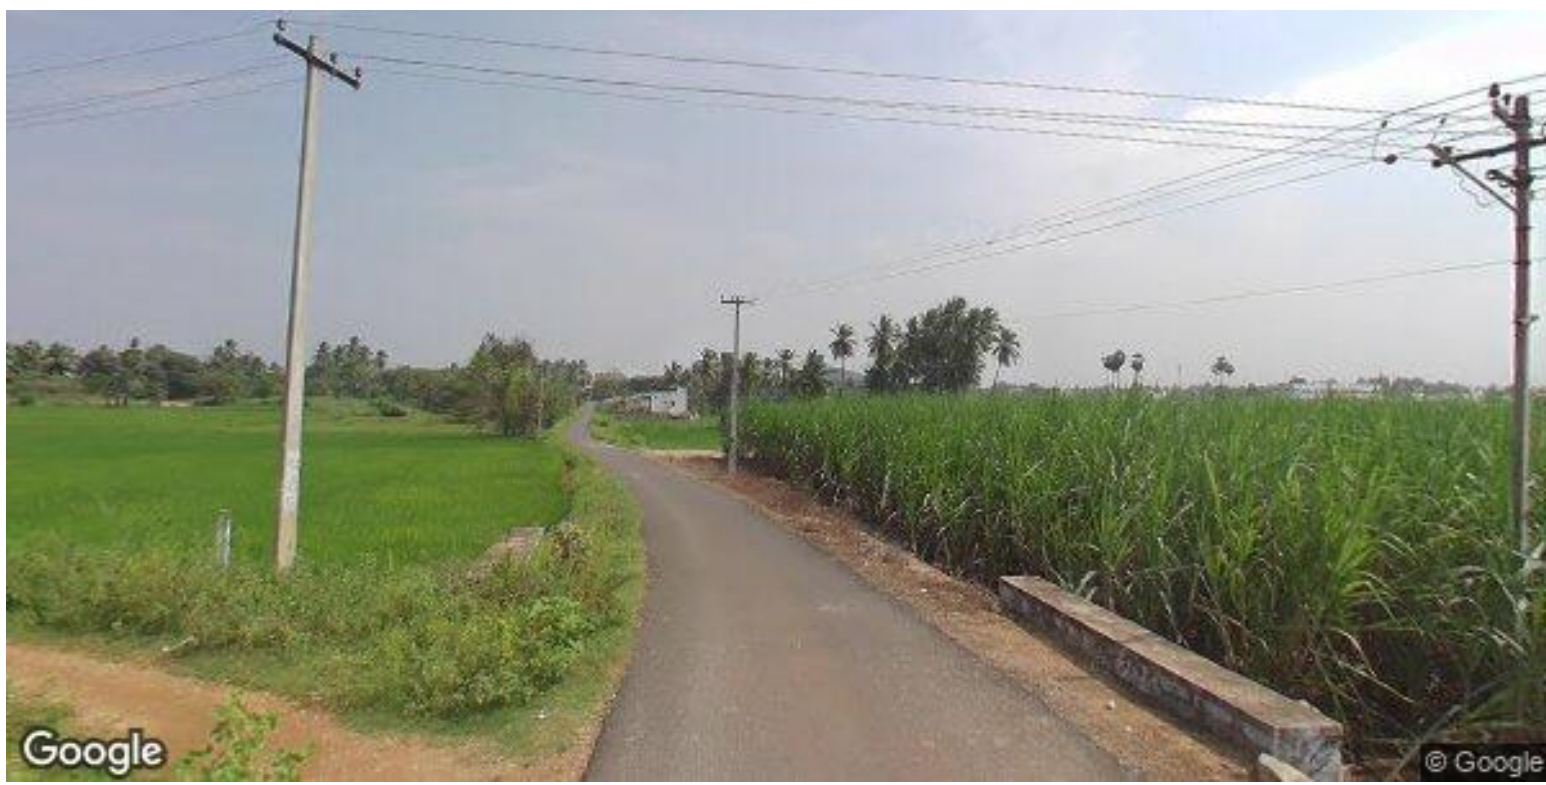
**Coordinates:** 11.43408, 77.72009

**Risk Type:** Turn

**Risk Level:** High

**Speed Limit:** 15 KM/Hr
