## JOURNEY RISK MANAGEMENT (JRM) STUDY

**Salem Terminal TO SDCMPU LTD.**

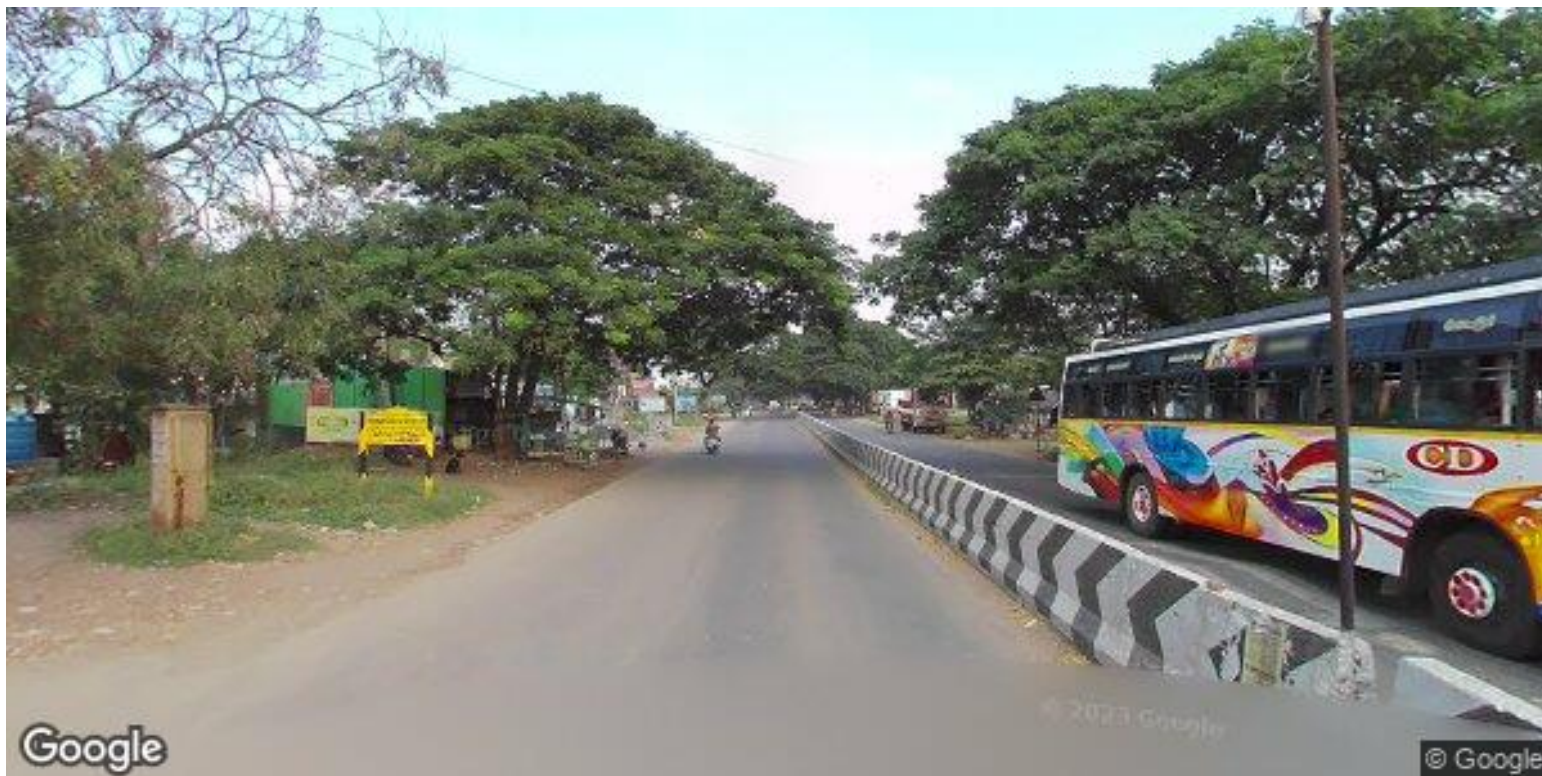
**Coordinates:** 11.6709299, 78.0889282

**Risk Type:** U-Turn

**Risk Level:** High

**Speed Limit:** 10 KM/Hr

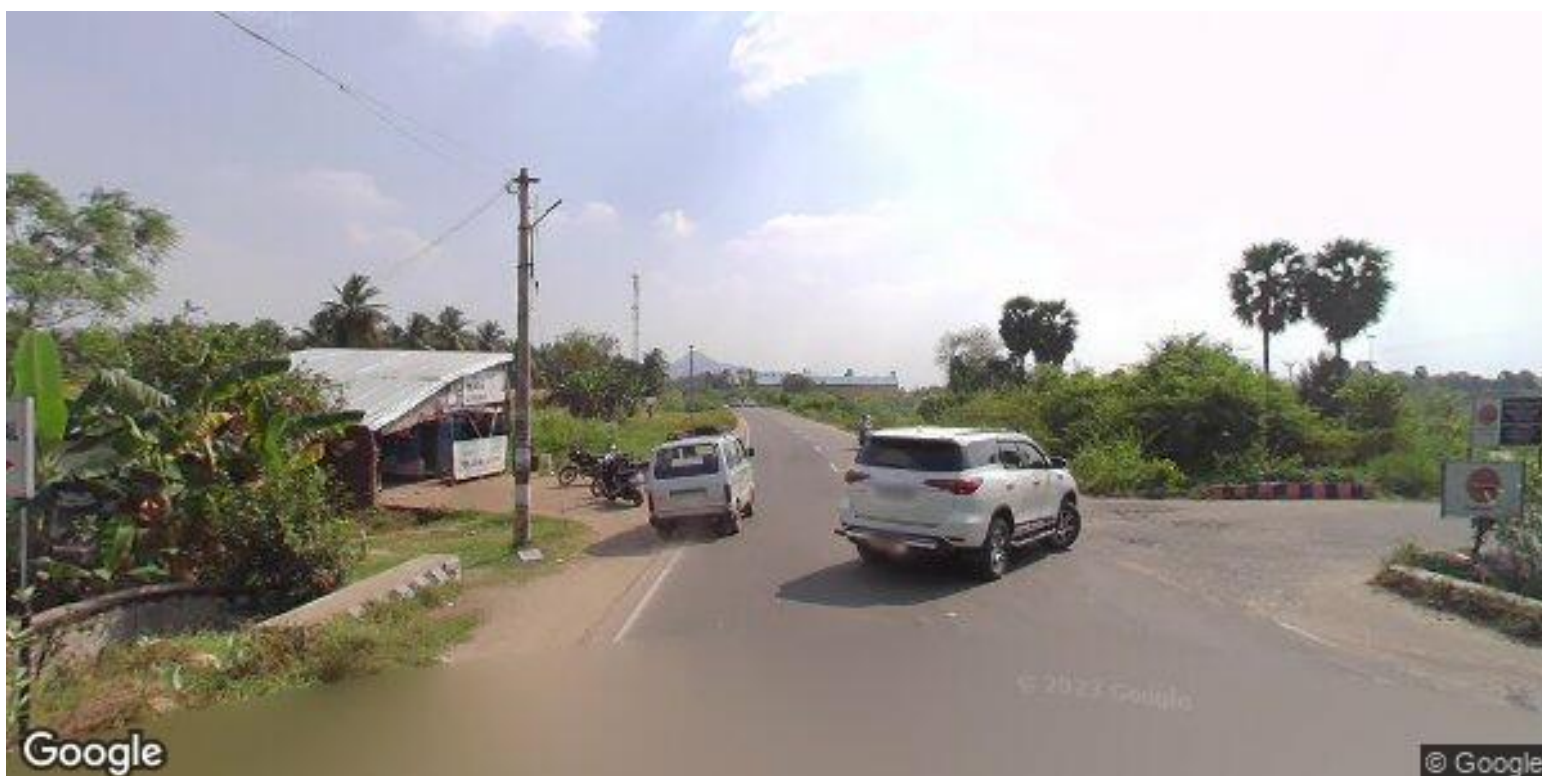
**Coordinates:** 11.44029, 77.87544

**Risk Type:** Turn

**Risk Level:** High

**Speed Limit:** 15 KM/Hr

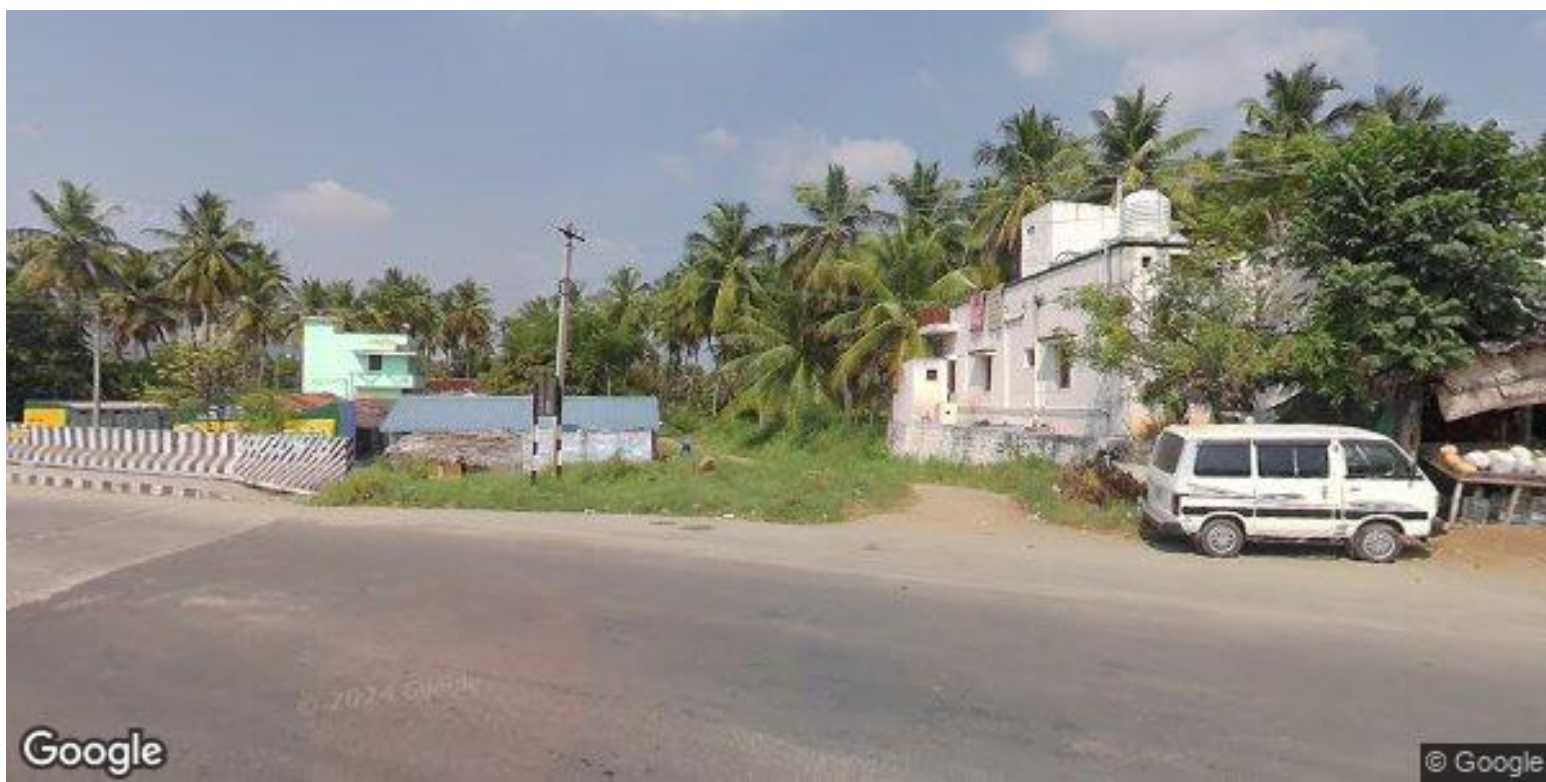
**Coordinates:** 11.44898, 77.87410

**Risk Type:** Turn

**Risk Level:** Medium

**Speed Limit:** 30 KM/Hr

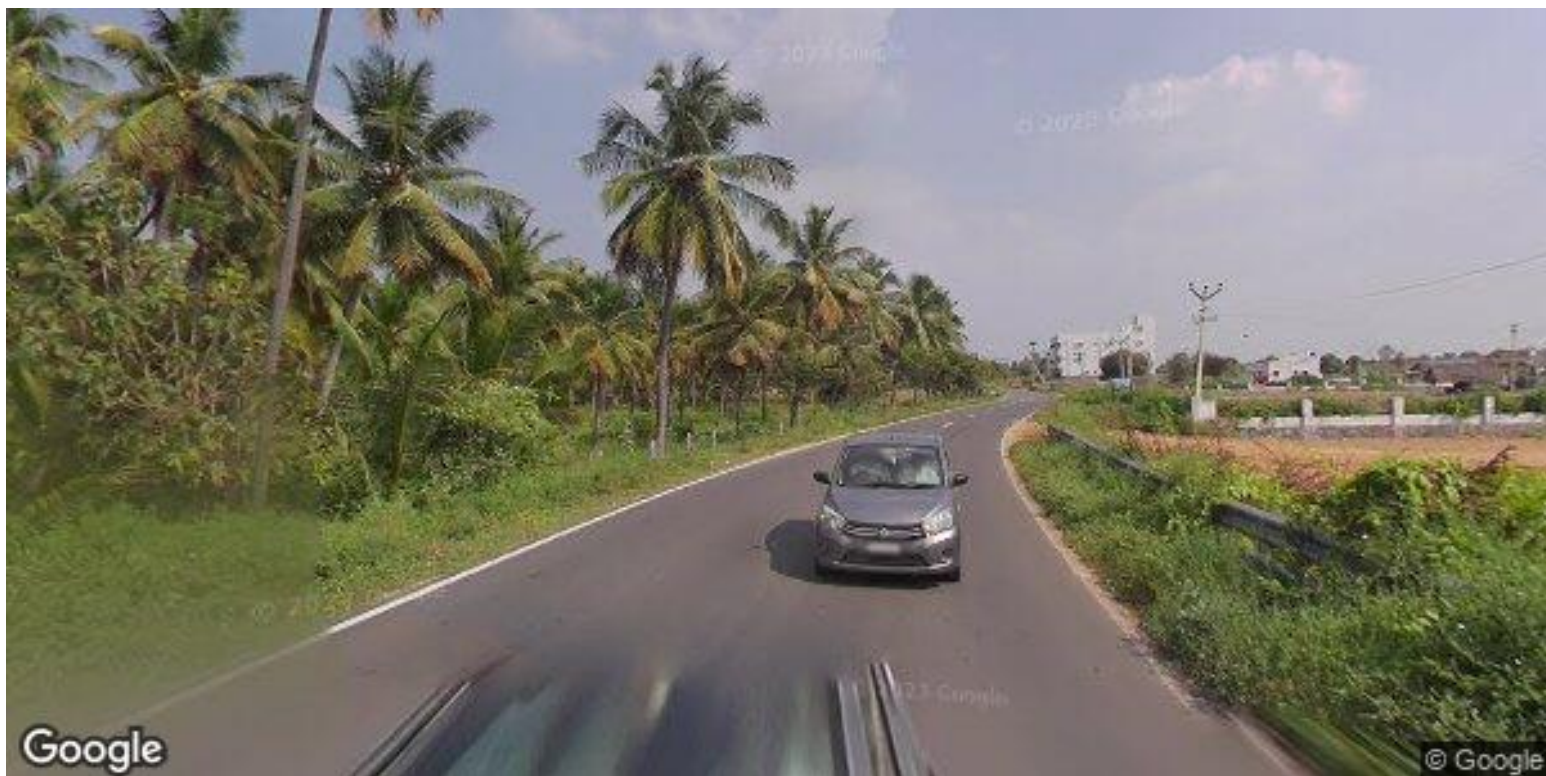
**Coordinates:** 11.45357, 77.85789

**Risk Type:** Turn

**Risk Level:** Medium

**Speed Limit:** 30 KM/Hr

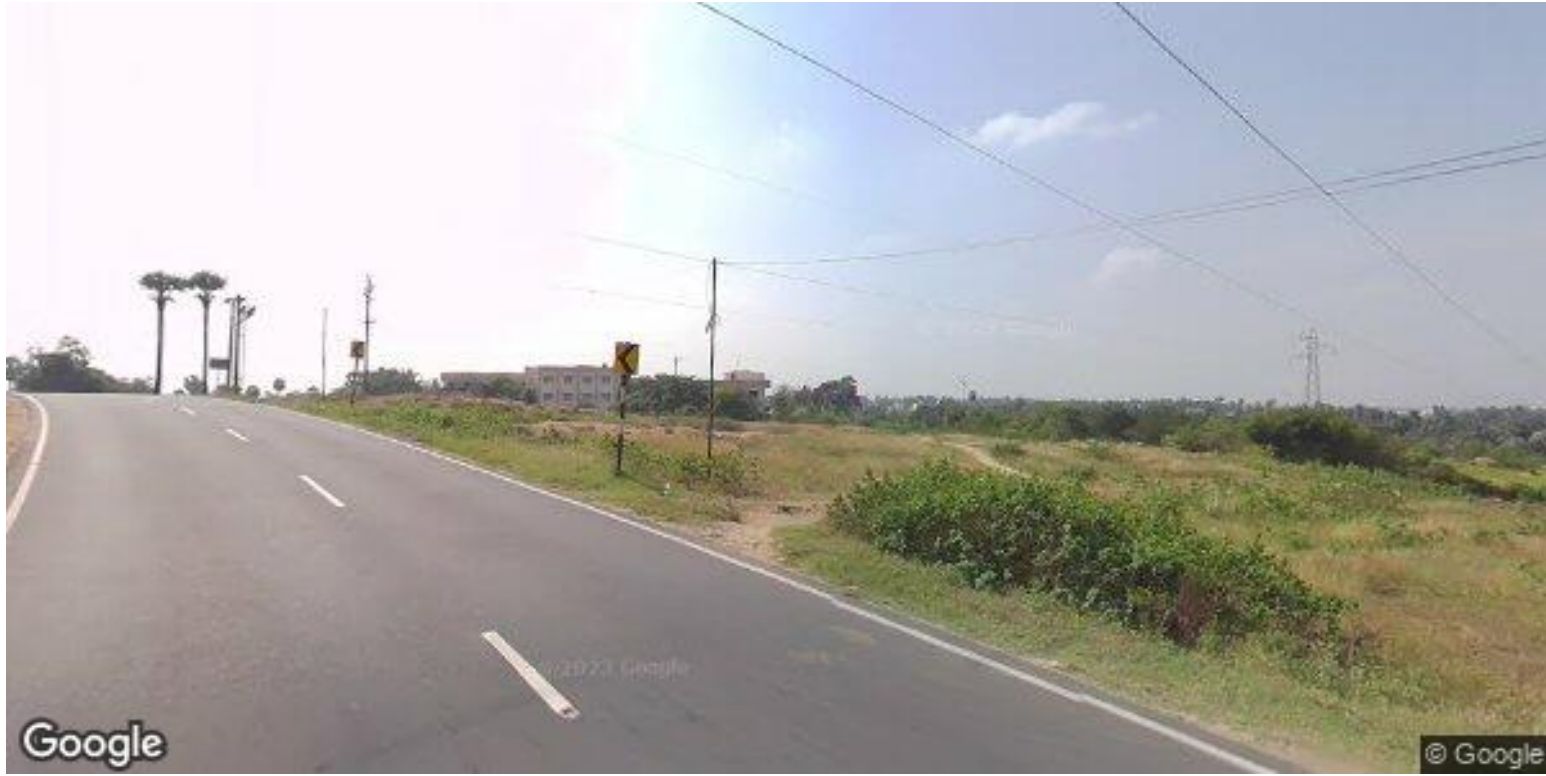
**Risk Type:** Turn  
**Risk Level:** Medium  
**Speed Limit:** 30 KM/Hr  
**Coordinates:** 11.46048, 77.85036

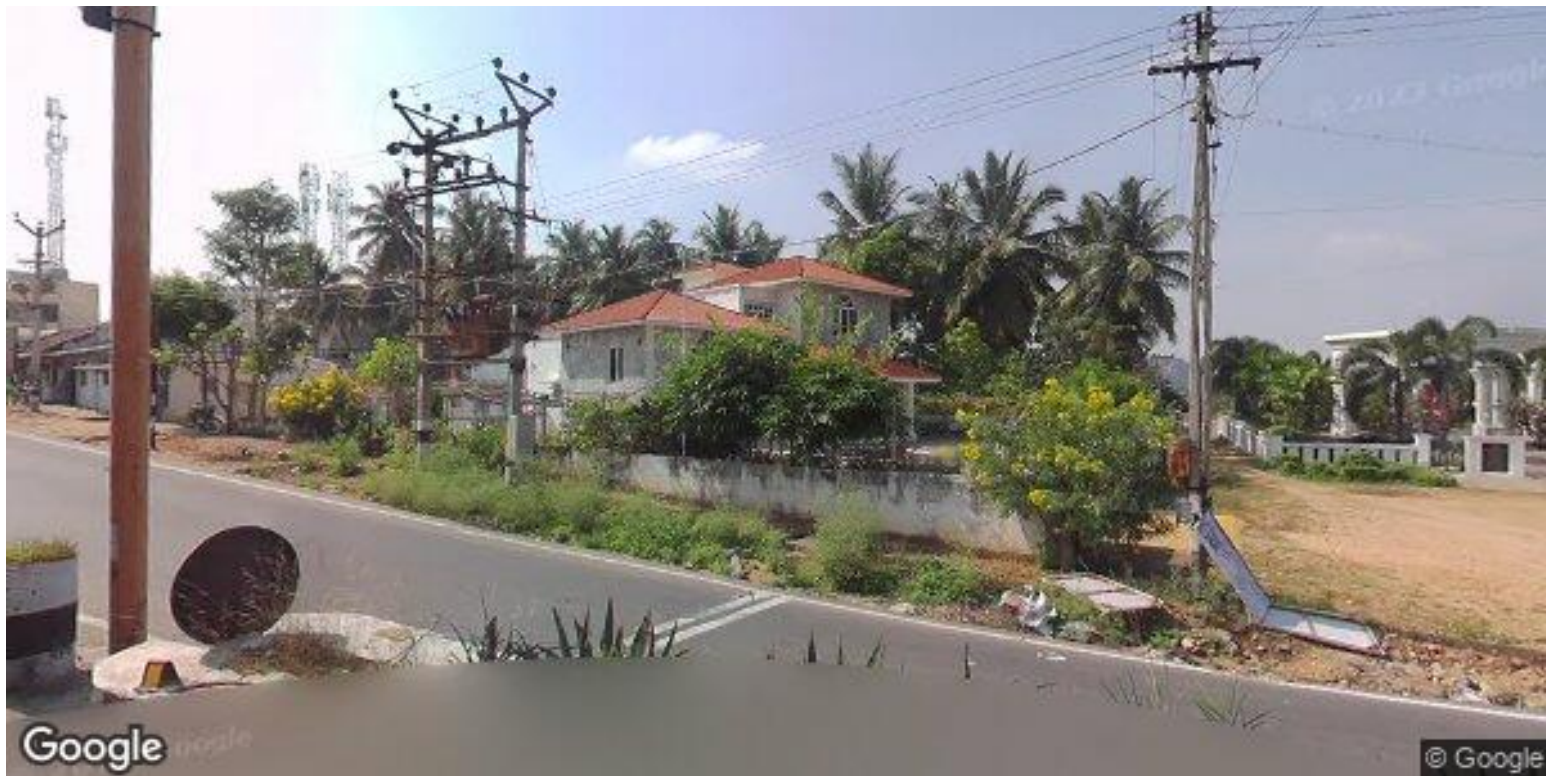
**Risk Type:** Turn  
**Risk Level:** Medium  
**Speed Limit:** 30 KM/Hr  
**Coordinates:** 11.46303, 77.84945

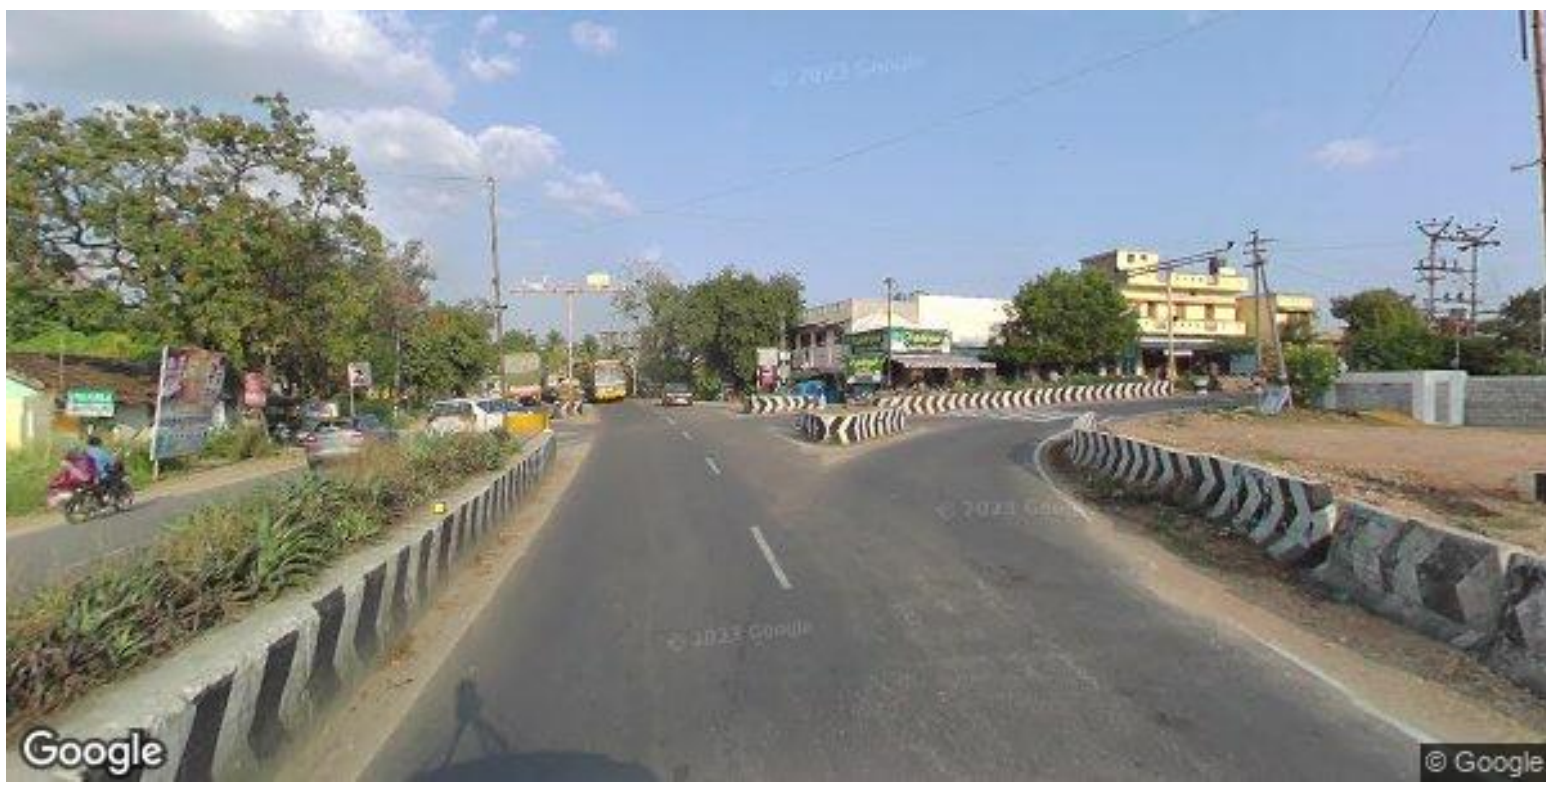
**Coordinates:** 11.46318, 77.84913

**Risk Type:** Turn

**Risk Level:** Medium

**Speed Limit:** 30 KM/Hr

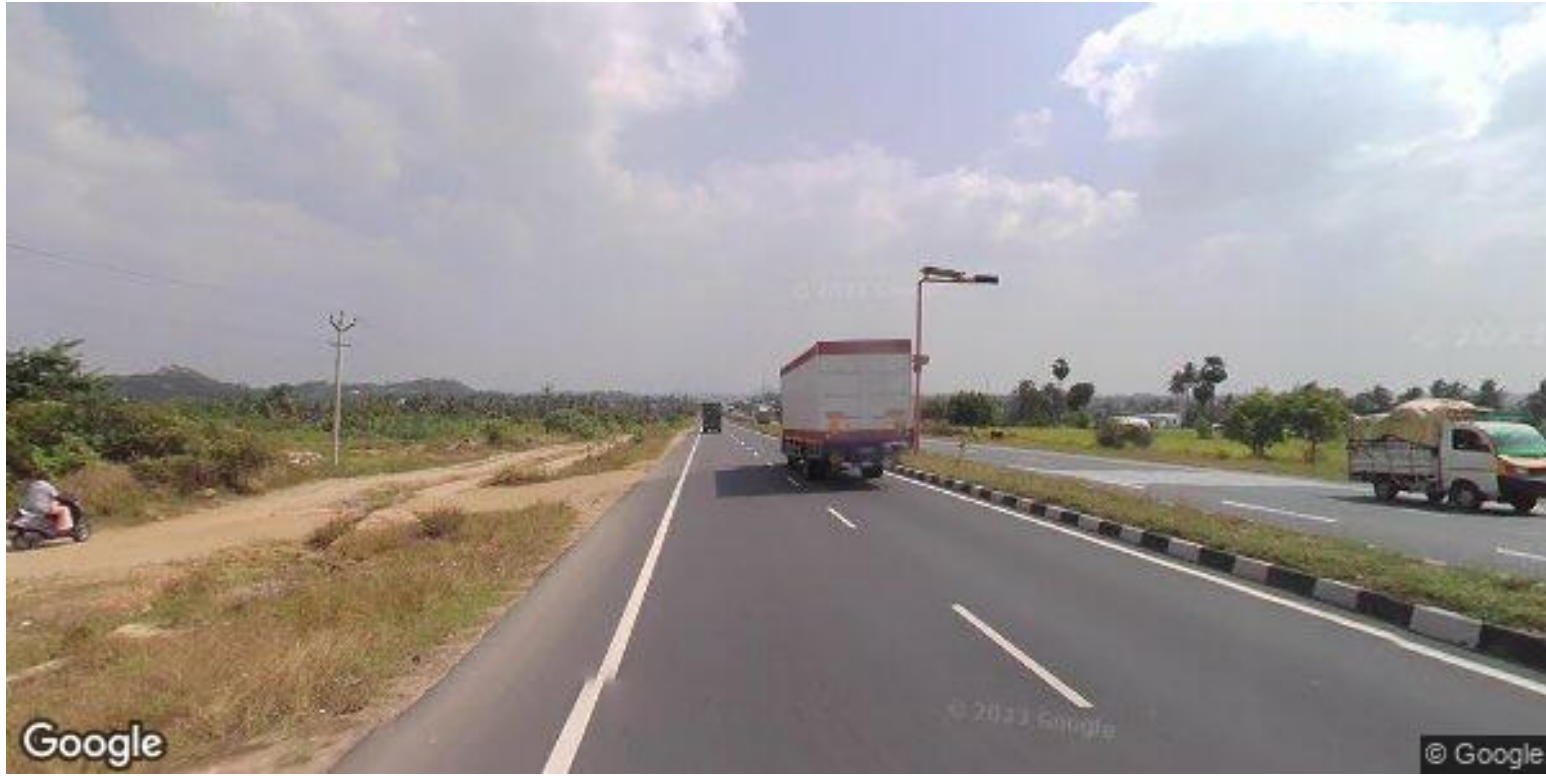
**Risk Type:** Turn  
**Risk Level:** High  
**Speed Limit:** 15 KM/Hr  
**Coordinates:** 11.49409, 77.88004

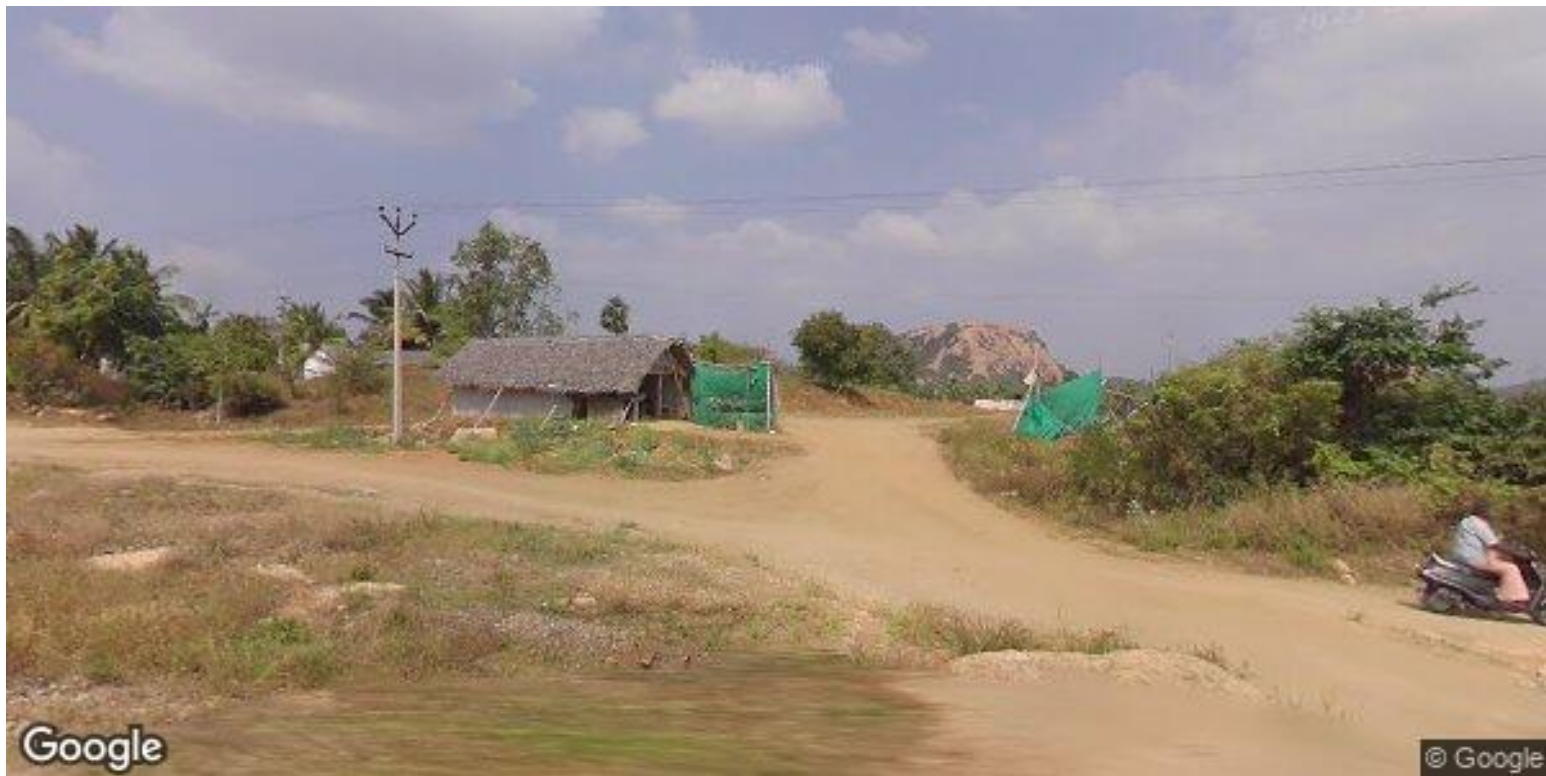
**Risk Type:** Turn  
**Risk Level:** Medium  
**Speed Limit:** 30 KM/Hr  
**Coordinates:** 11.49419, 77.88015

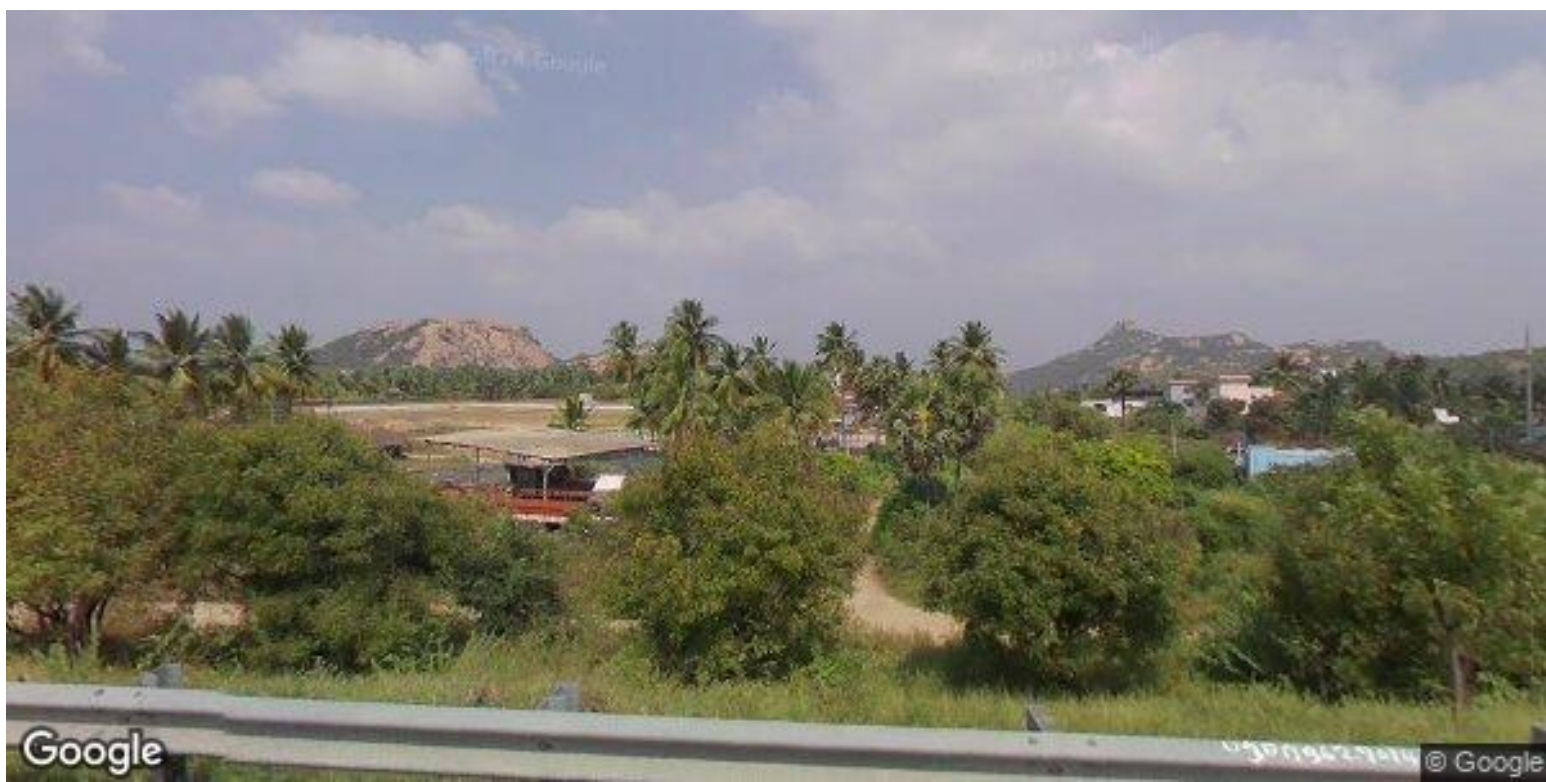
**Coordinates:** 11.49383, 77.88442

**Risk Type:** Turn

**Risk Level:** High

**Speed Limit:** 15 KM/Hr

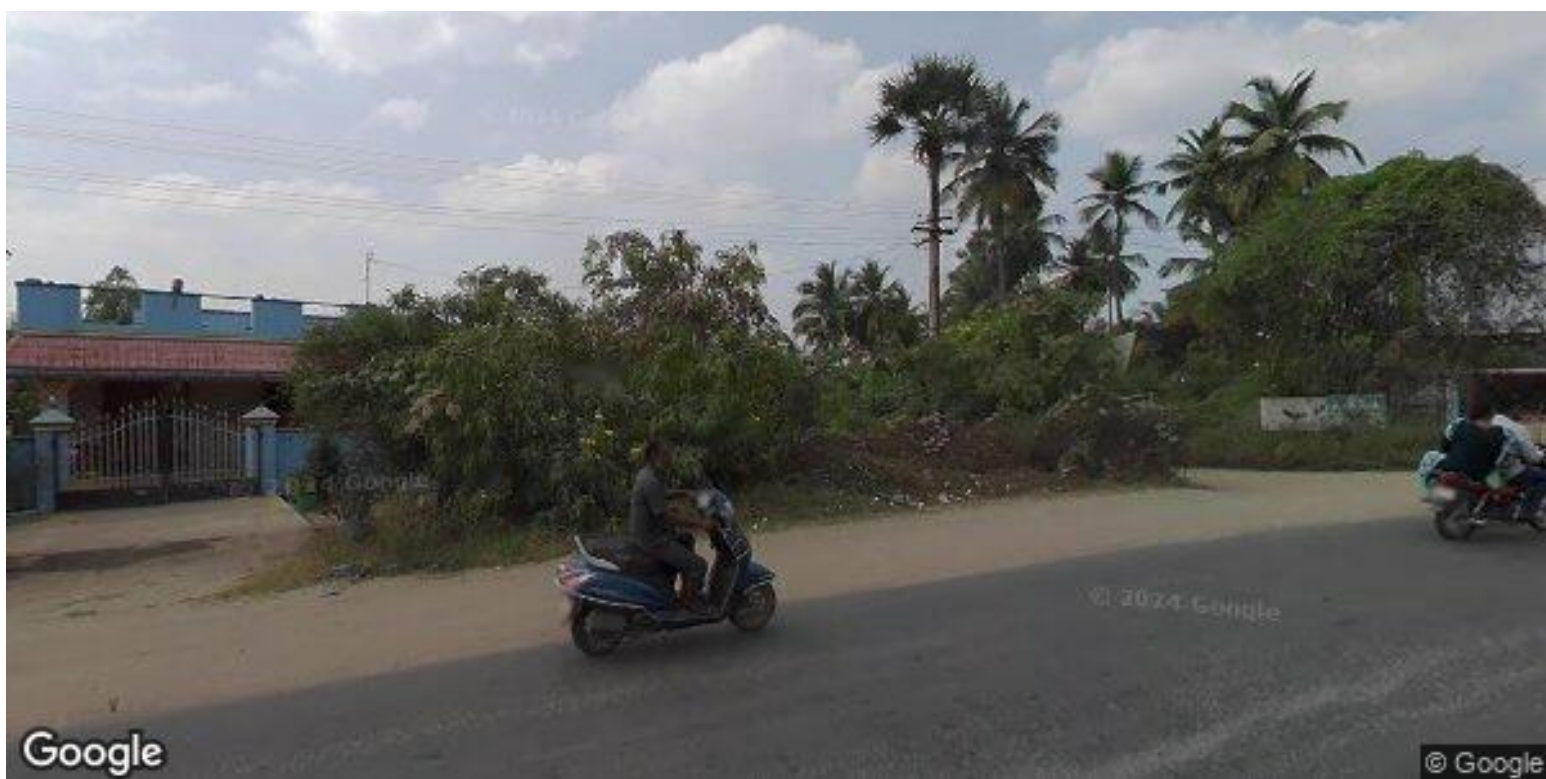
**Coordinates:** 11.49419, 77.88454

**Risk Type:** Turn

**Risk Level:** Medium

**Speed Limit:** 30 KM/Hr

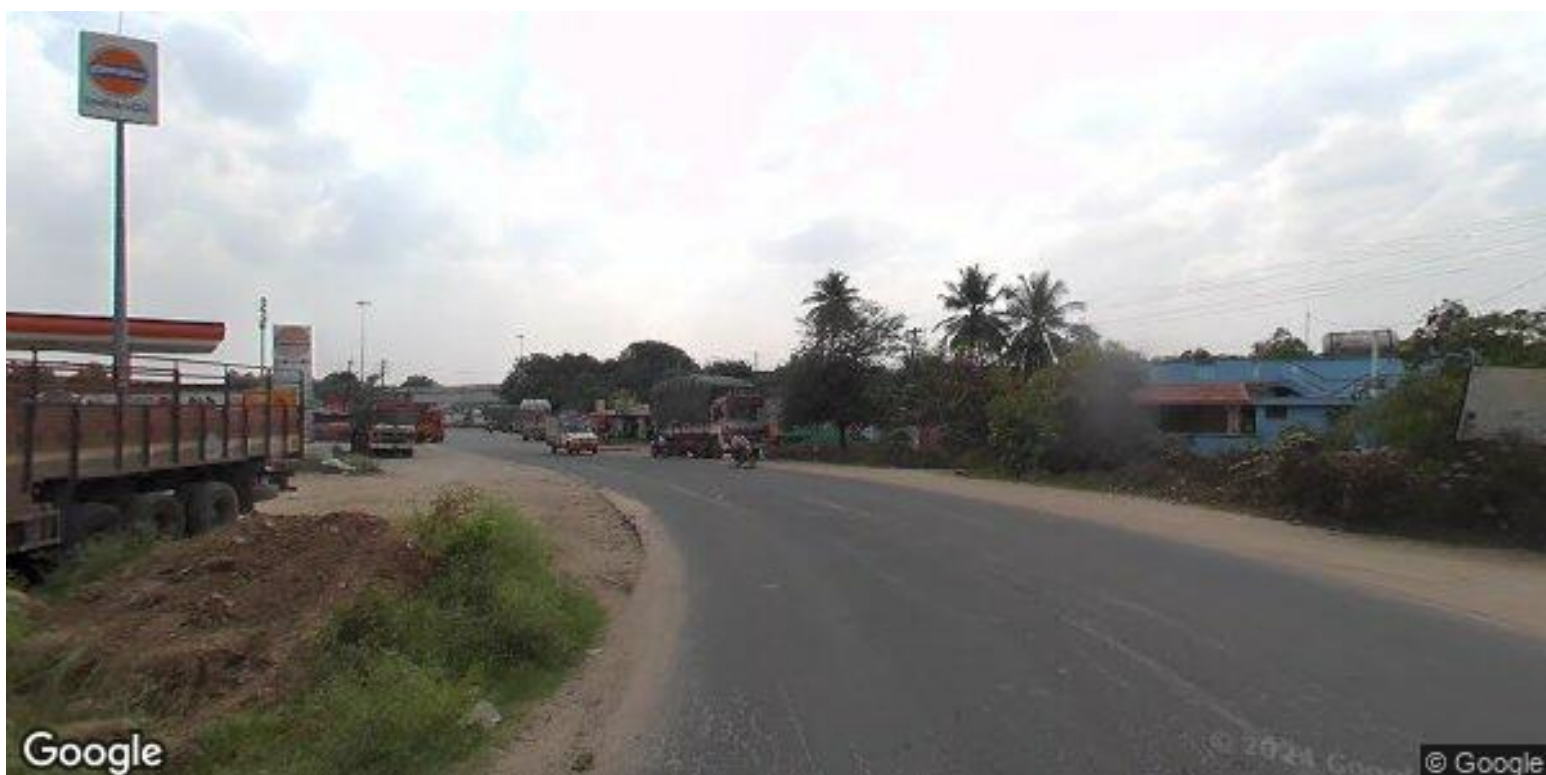
**Risk Type:** Turn  
**Risk Level:** High  
**Speed Limit:** 15 KM/Hr  
**Coordinates:** 11.49448, 77.88490

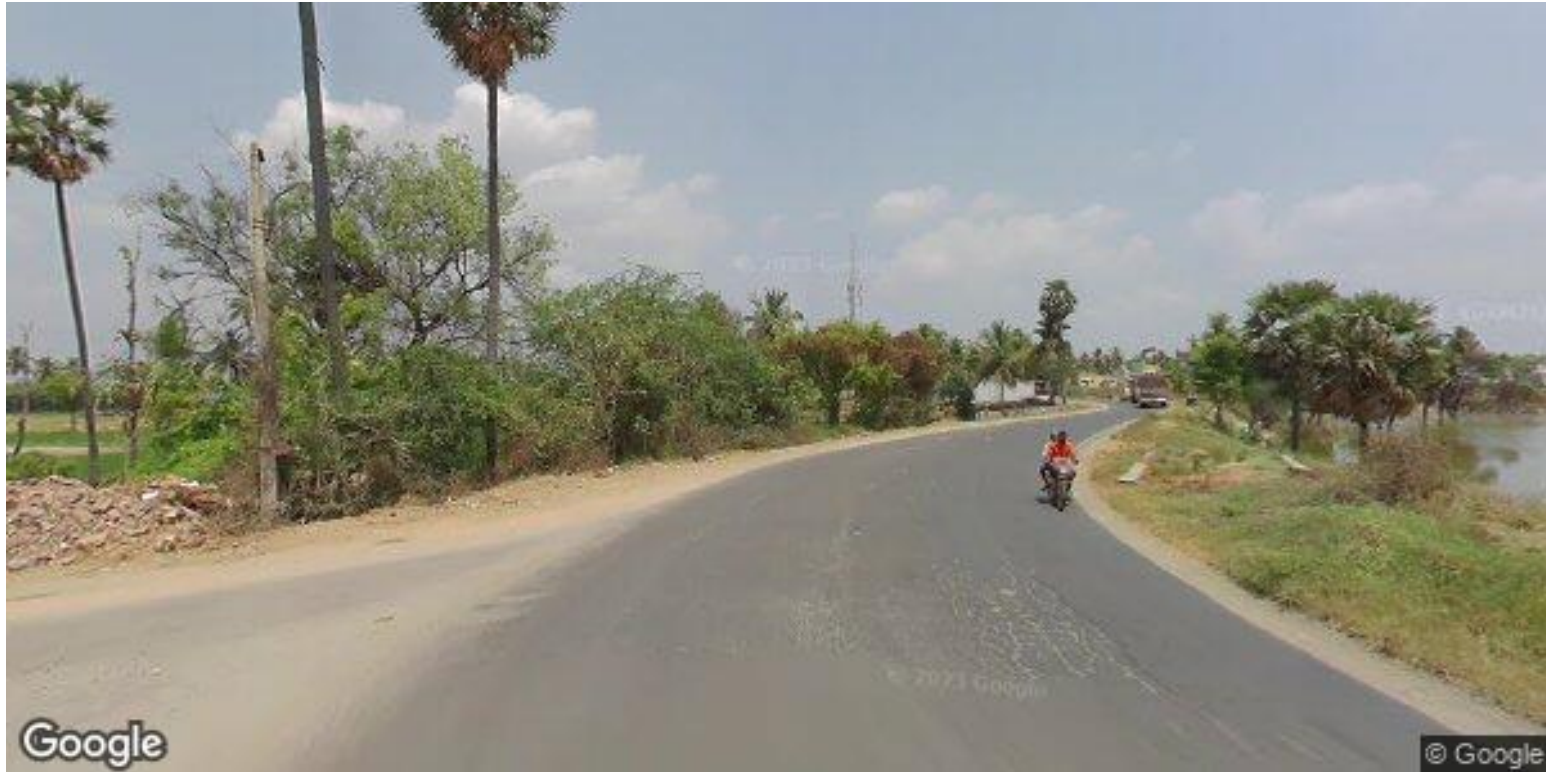
**Risk Type:** Turn  
**Risk Level:** Medium  
**Speed Limit:** 30 KM/Hr  
**Coordinates:** 11.56083, 77.89921

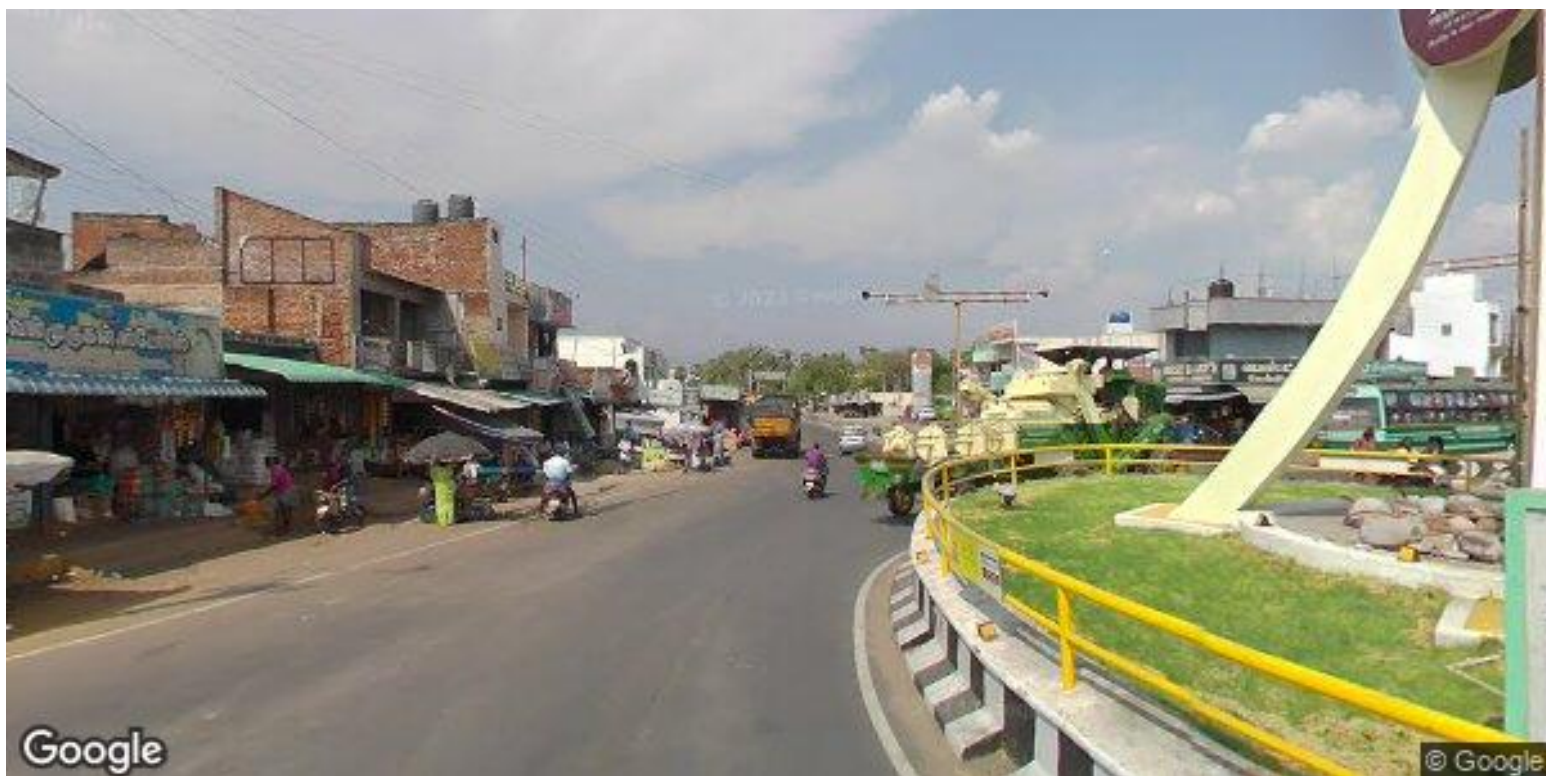
**Risk Type:** Turn  
**Risk Level:** Medium  
**Speed Limit:** 30 KM/Hr  
**Coordinates:** 11.57048, 77.90224

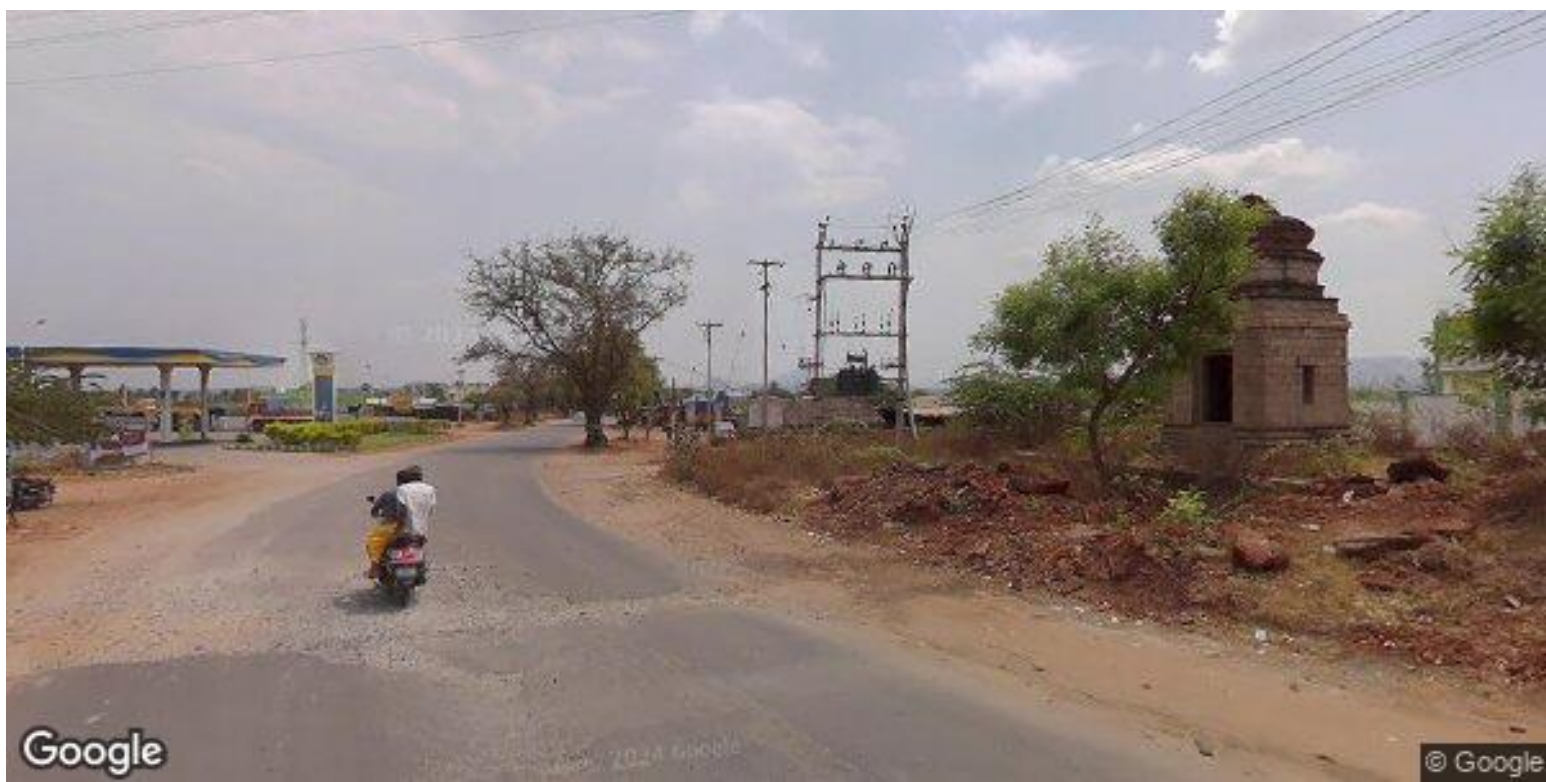
**Coordinates:** 11.58304, 77.90656

**Risk Type:** Turn

**Risk Level:** Medium

**Speed Limit:** 30 KM/Hr

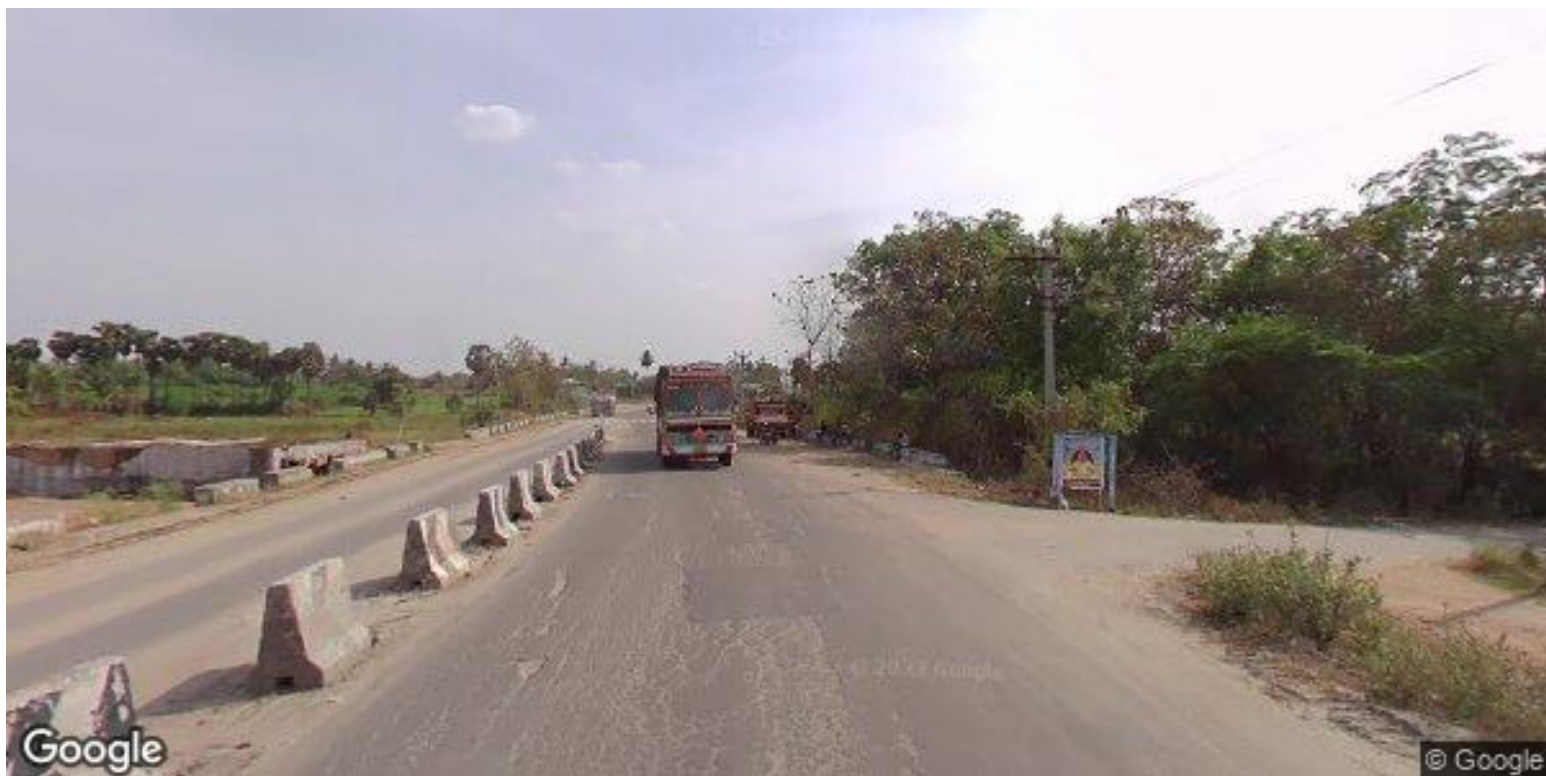
**Coordinates:** 11.63840, 77.94820

**Risk Type:** Turn

**Risk Level:** Medium

**Speed Limit:** 30 KM/Hr

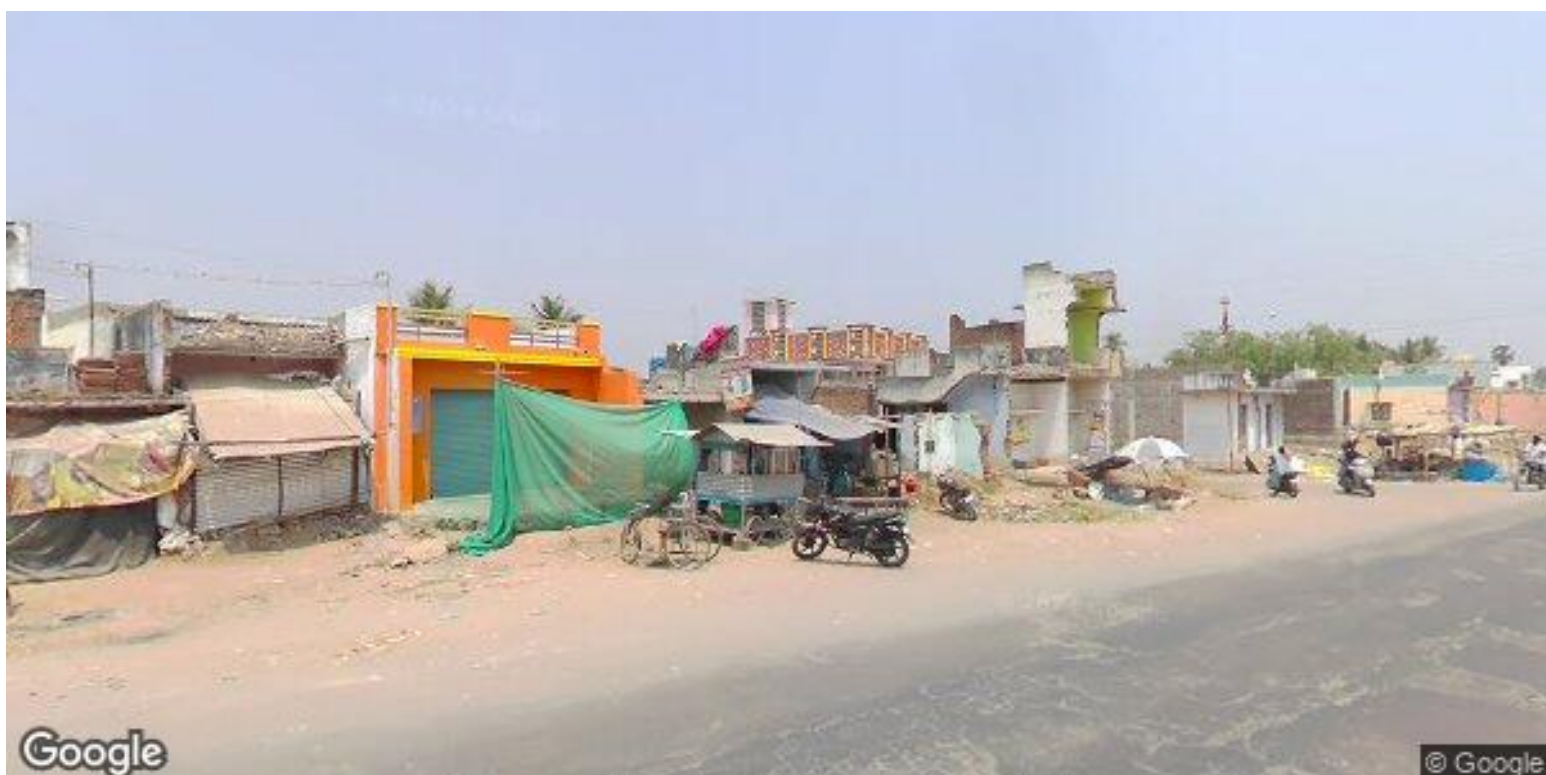
**Risk Type:** Turn  
**Risk Level:** High  
**Speed Limit:** 15 KM/Hr  
**Coordinates:** 11.66254, 77.96043

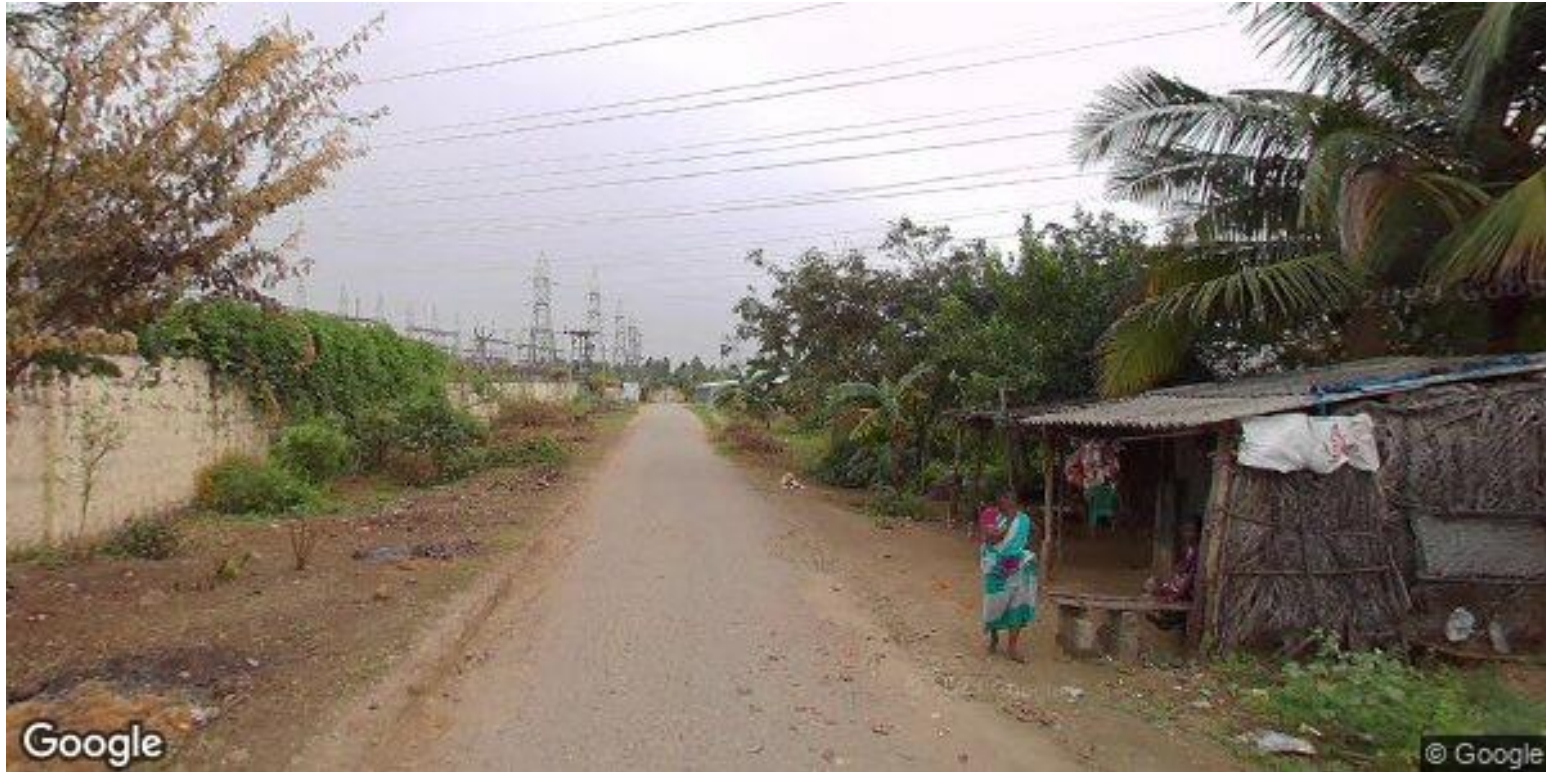
**Risk Type:** Turn  
**Risk Level:** High  
**Speed Limit:** 15 KM/Hr  
**Coordinates:** 11.66790, 78.00500

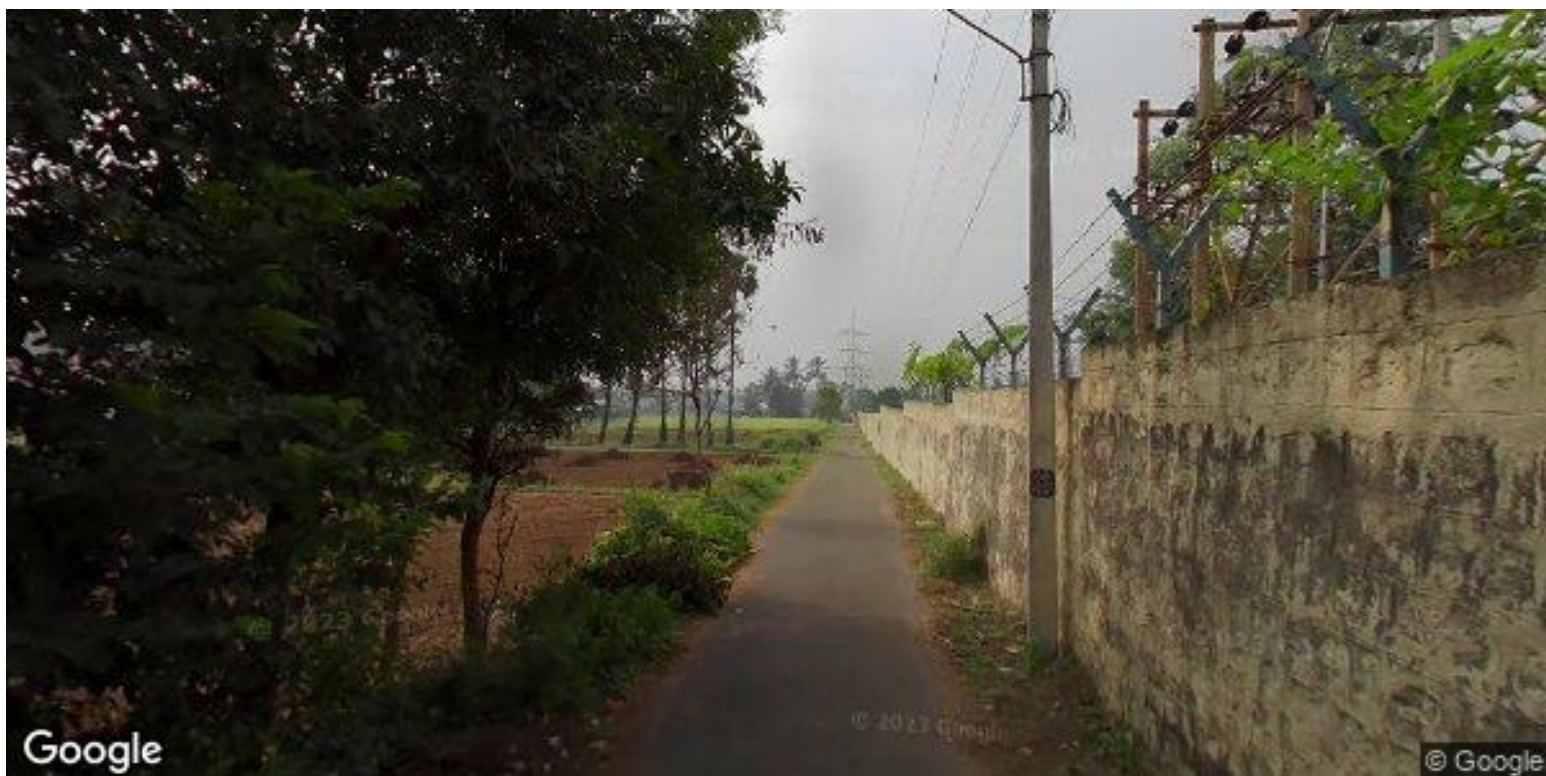
**Risk Type:** Blind Spot  
**Risk Level:** Blind Spot  
**Speed Limit:** 10 KM/Hr  
**Coordinates:** 11.66936, 78.00887
