## JOURNEY RISK MANAGEMENT (JRM) STUDY

**Salem Terminal TO SDCMPU LTD.**

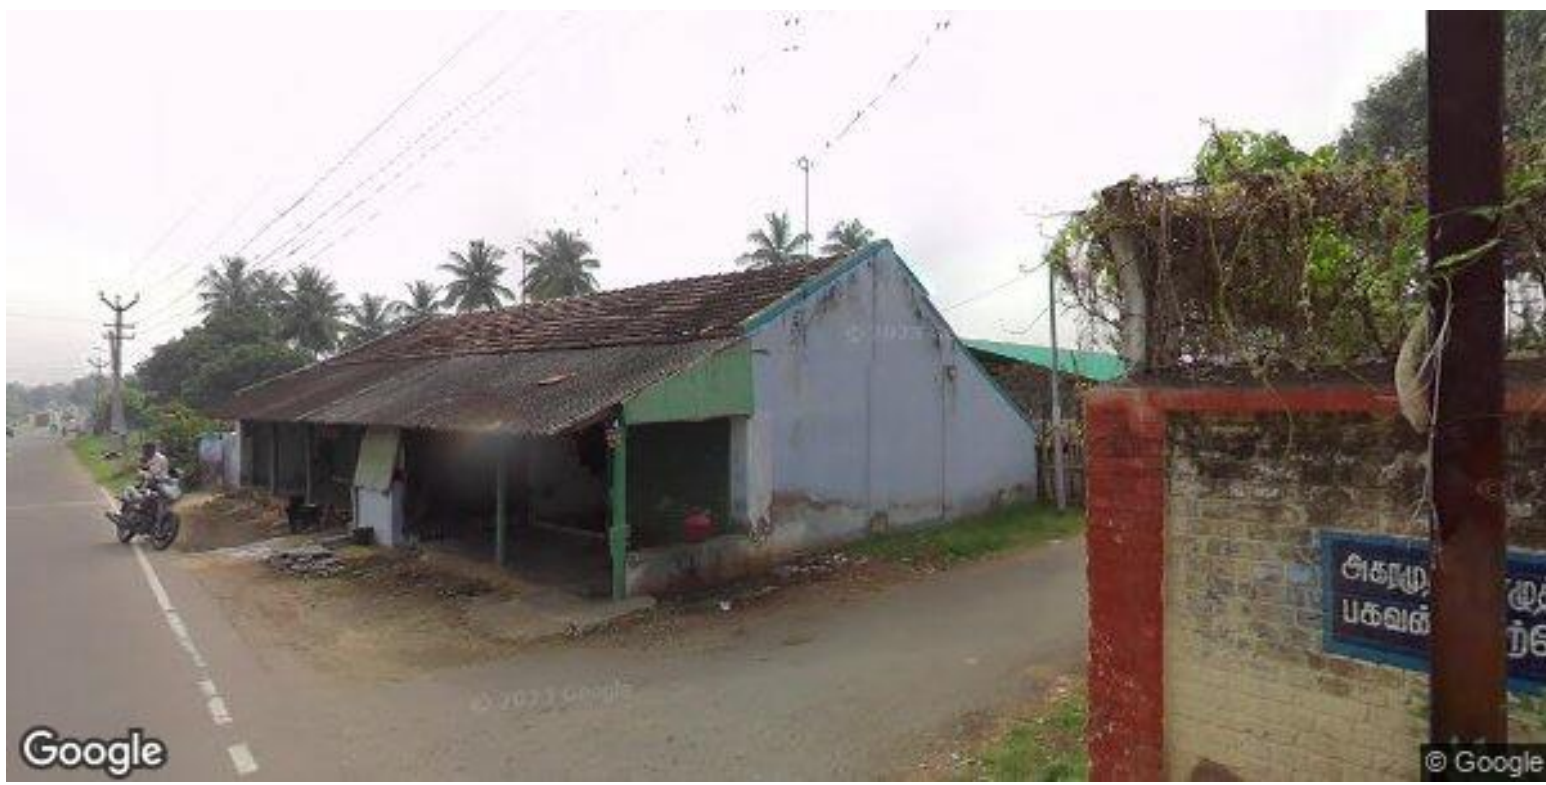
**Coordinates:** 11.67168, 78.00922

**Risk Type:** Turn

**Risk Level:** High

**Speed Limit:** 15 KM/Hr

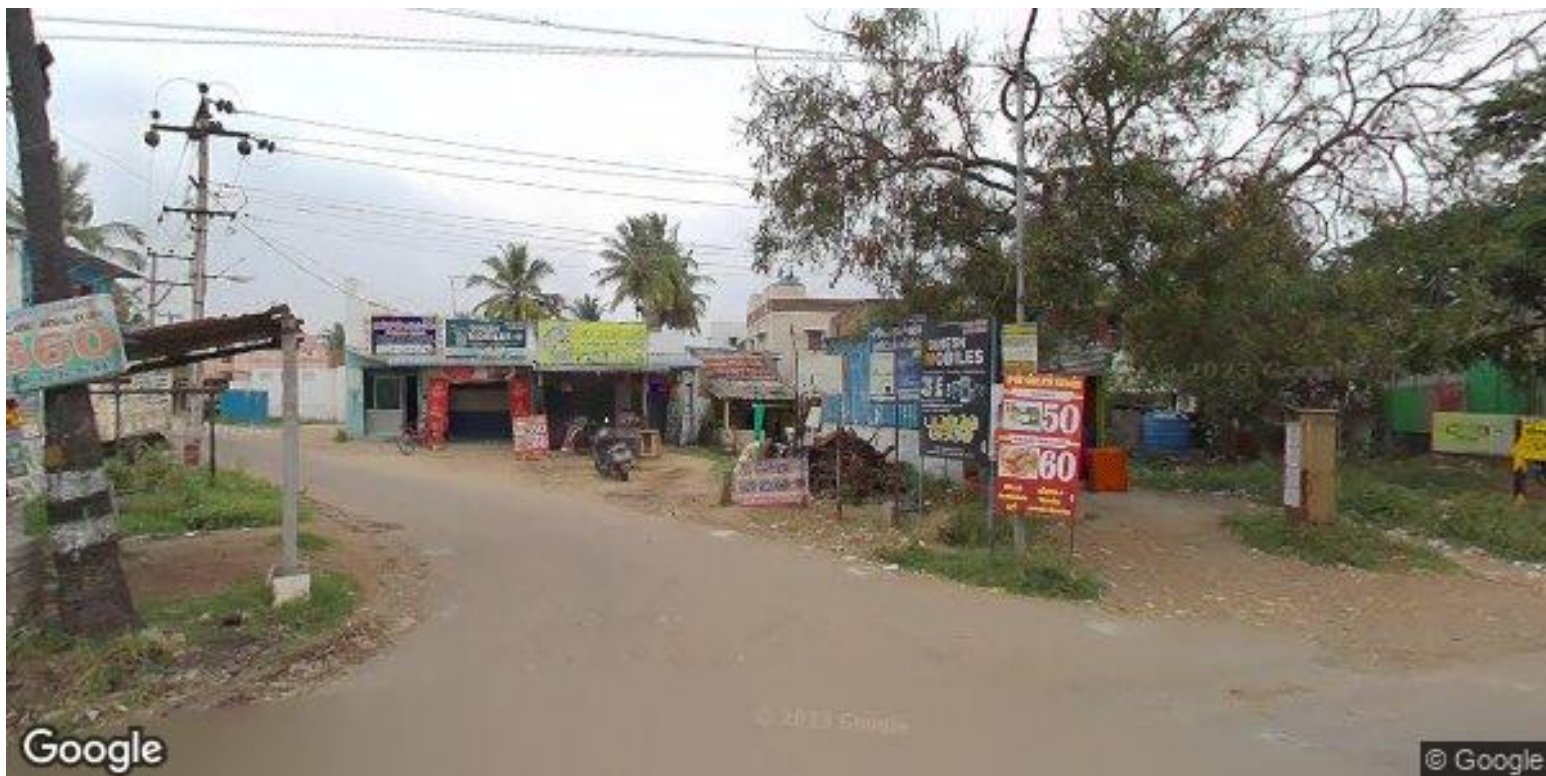
**Coordinates:** 11.67093, 78.08893

**Risk Type:** Blind Spot

**Risk Level:** Blind Spot

**Speed Limit:** 10 KM/Hr

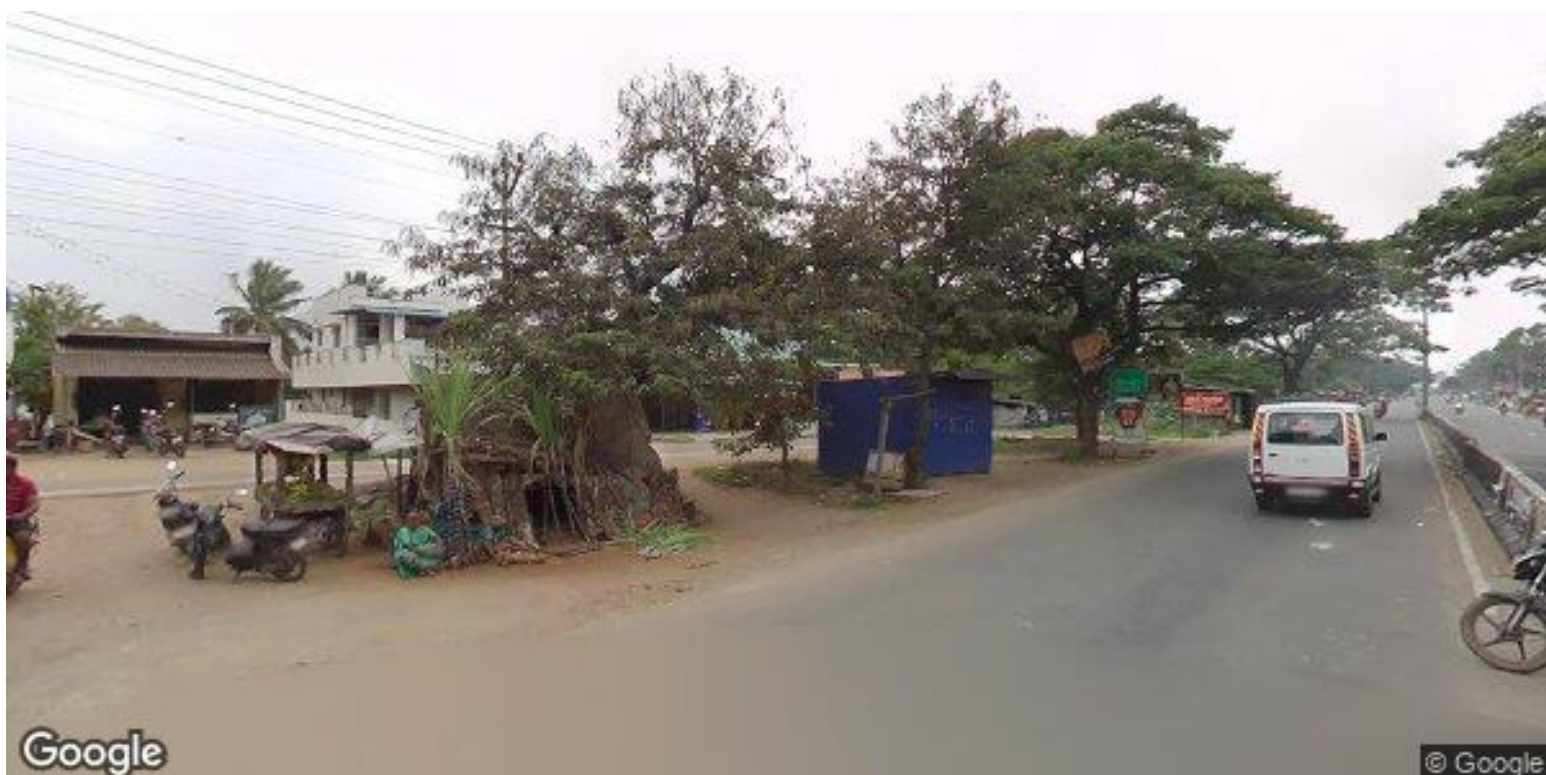
**Risk Type:** Turn  
**Risk Level:** High  
**Speed Limit:** 15 KM/Hr  
**Coordinates:** 11.67087, 78.08893

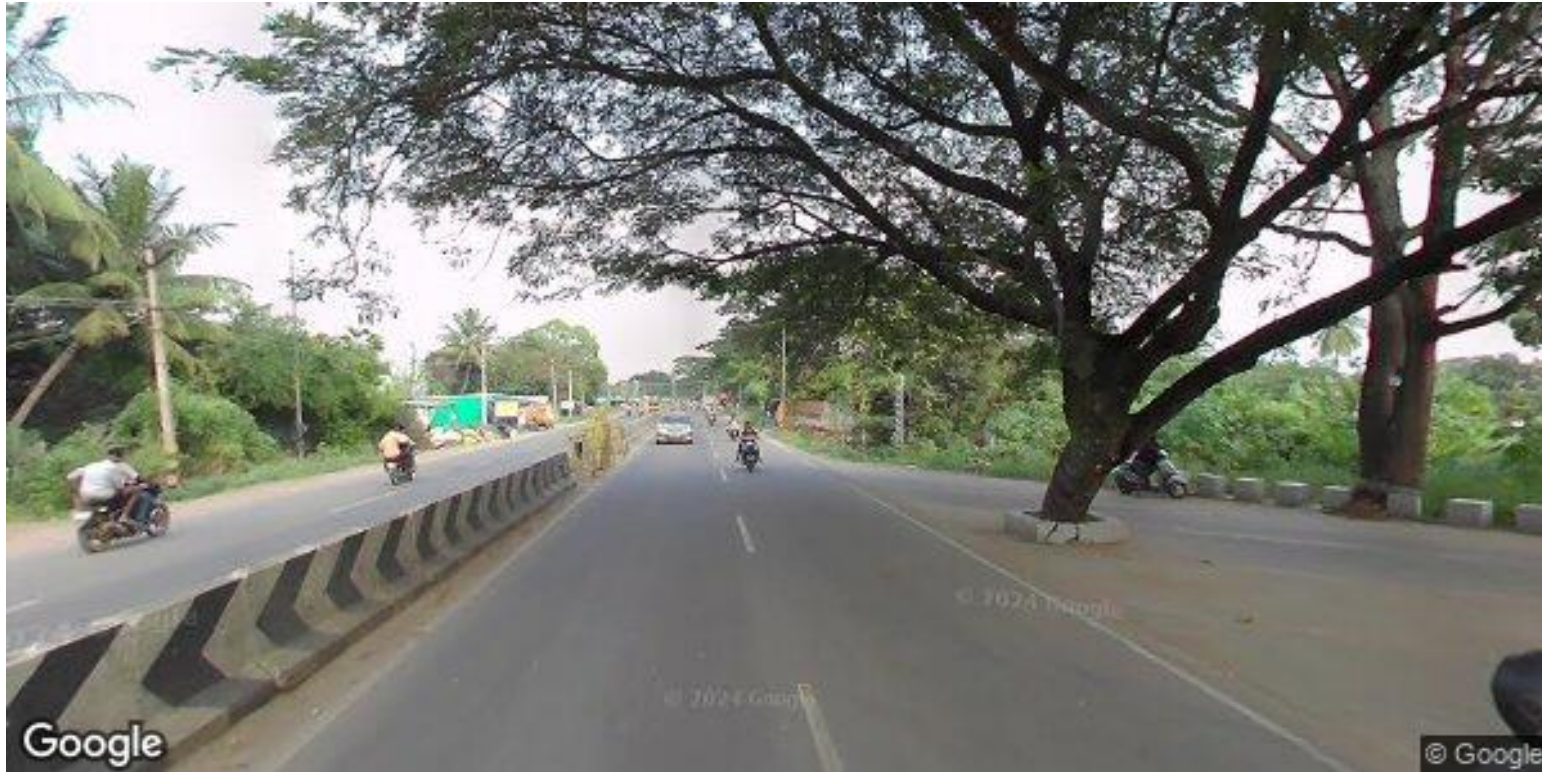
**Risk Type:** Turn  
**Risk Level:** High  
**Speed Limit:** 15 KM/Hr  
**Coordinates:** 11.67071, 78.08567

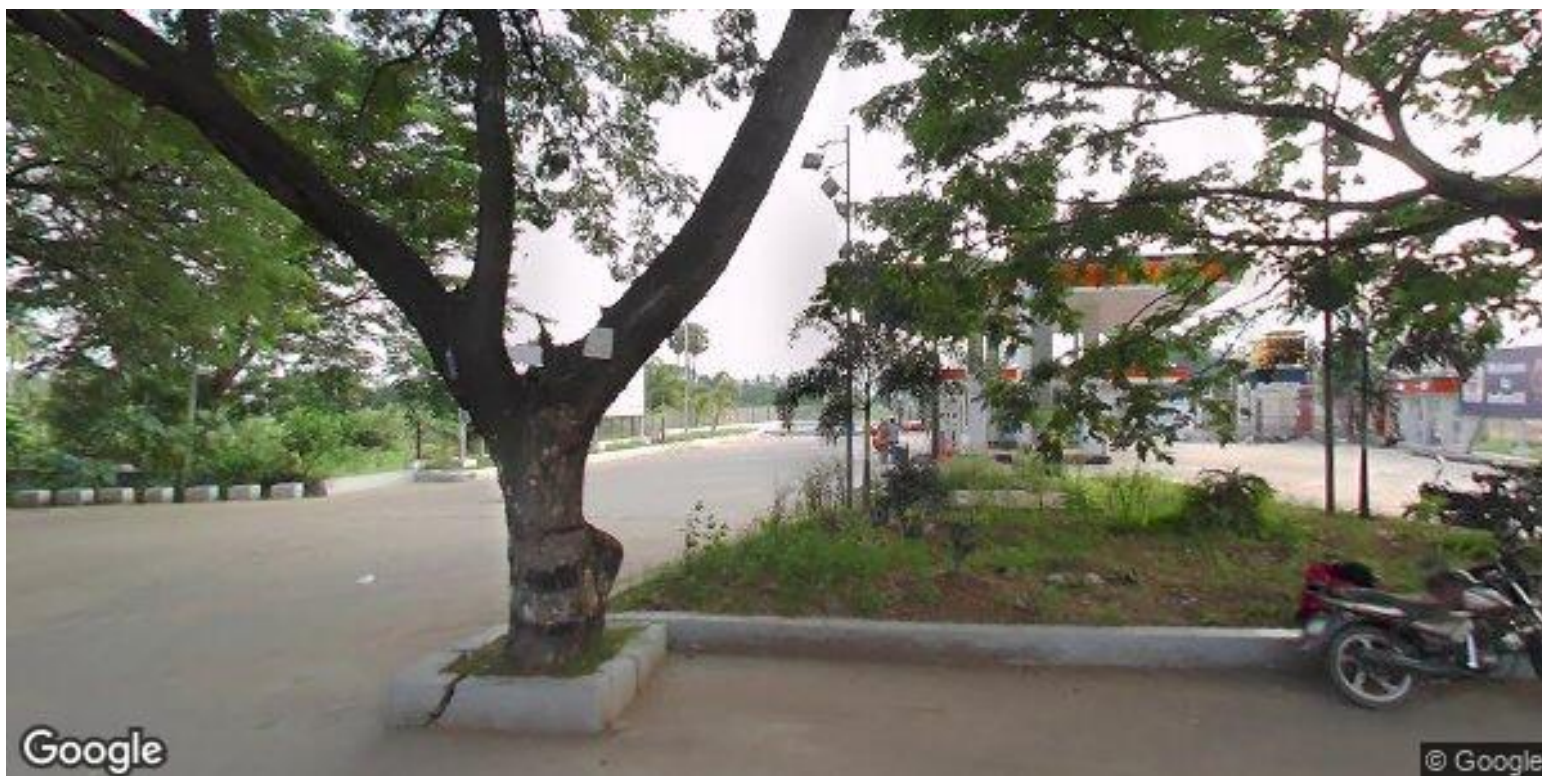
**Risk Type:** Turn  
**Risk Level:** High  
**Speed Limit:** 15 KM/Hr  
**Coordinates:** 11.67041, 78.08559
